ROOFING FAILURES

Carl G. Cash

Roofing faiures / Carl G. Cash.

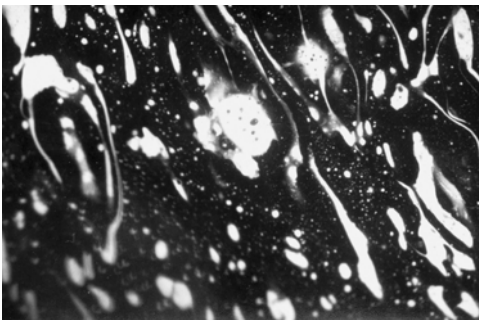
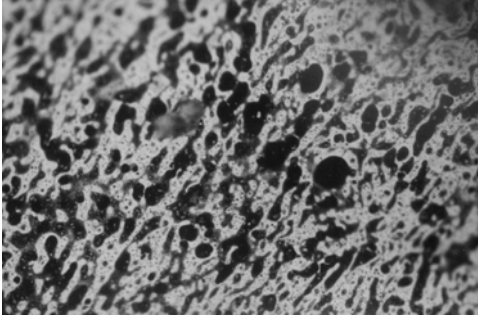
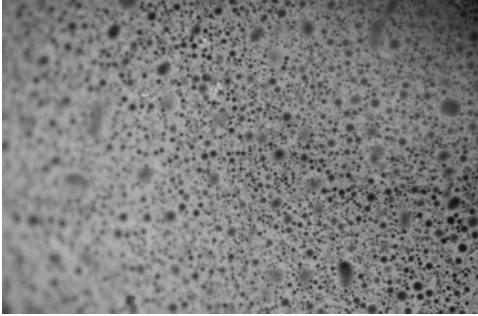
We were approached by a Federal Agency that was having a problem with a polymer modified asphalt roof. Foot traffic was leaving footprints in the soft granule surfaced membrane. We obtained samples of both the exposed and the unexposed granule surfaced sheets for laboratory analyses.

Figure 39.1 Polymer in a sea of asphalt.

Figure 39.2 Just after phase inversion.

Figure 39.3 Final dispersion of asphalt in a polymer.

Our laboratory data showed the composition of the membrane was appropriate, but our check of the asphalt dispersion with a microscope and an ultraviolet source showed the dispersion was poor at best.
