**Emergency repairs  
for  
historic buildings**

Eleanor Michell

*commissioned by the Historic Areas Division of English Heritage*

1988

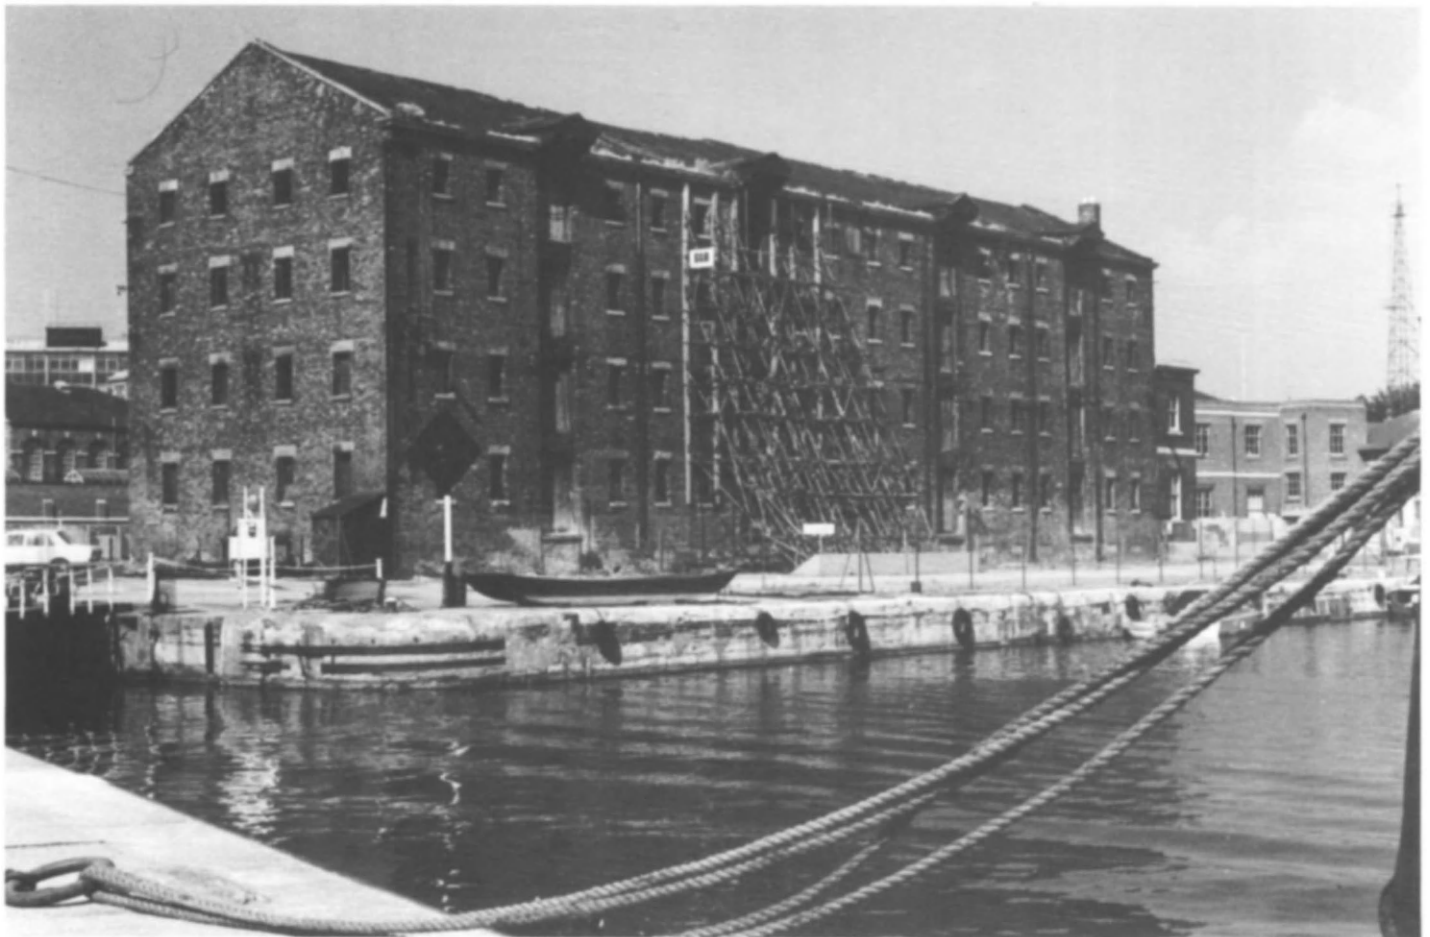
**Fig 8 Support for brickwork which was pushed out by a fallen truss in the North Warehouse, Gloucester Docks; this scaffolding was hired initially for three years but remained in place from 1975 to 1985 (photo: Richard Parsons)**

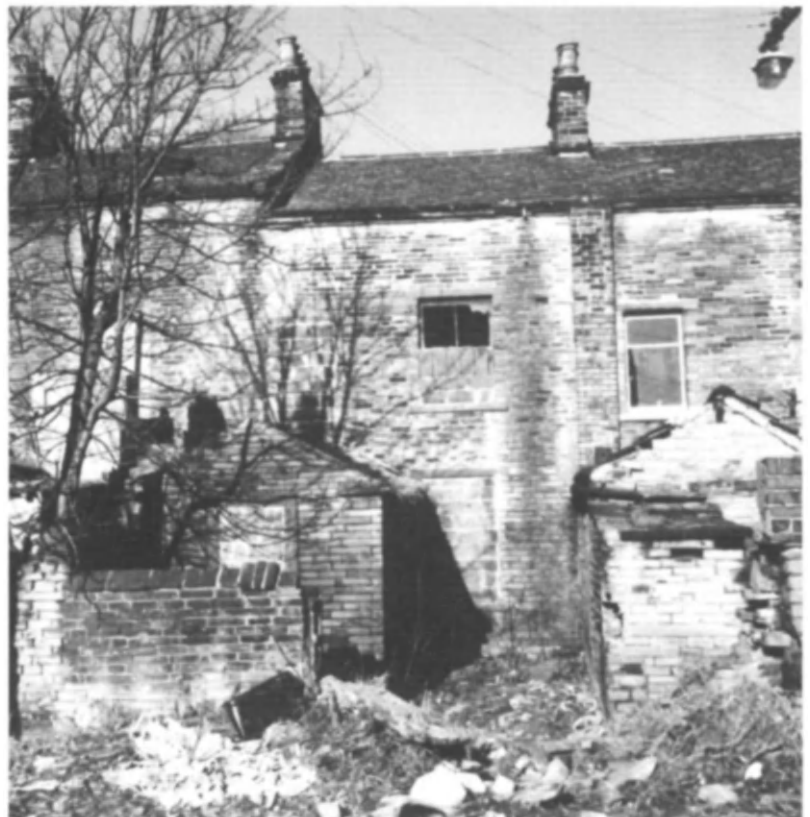
**Fig 14** A good supply of missiles left ready at the back of listed Southfields Square, Bradford, in 1982

- Reglaze a broken window immediately.
- Remove graffiti immediately (see section 2.5.7).
- Consider extra external lighting, taking advice on security wiring and fittings, and using low or high pressure sodium lamps for long life and economy.

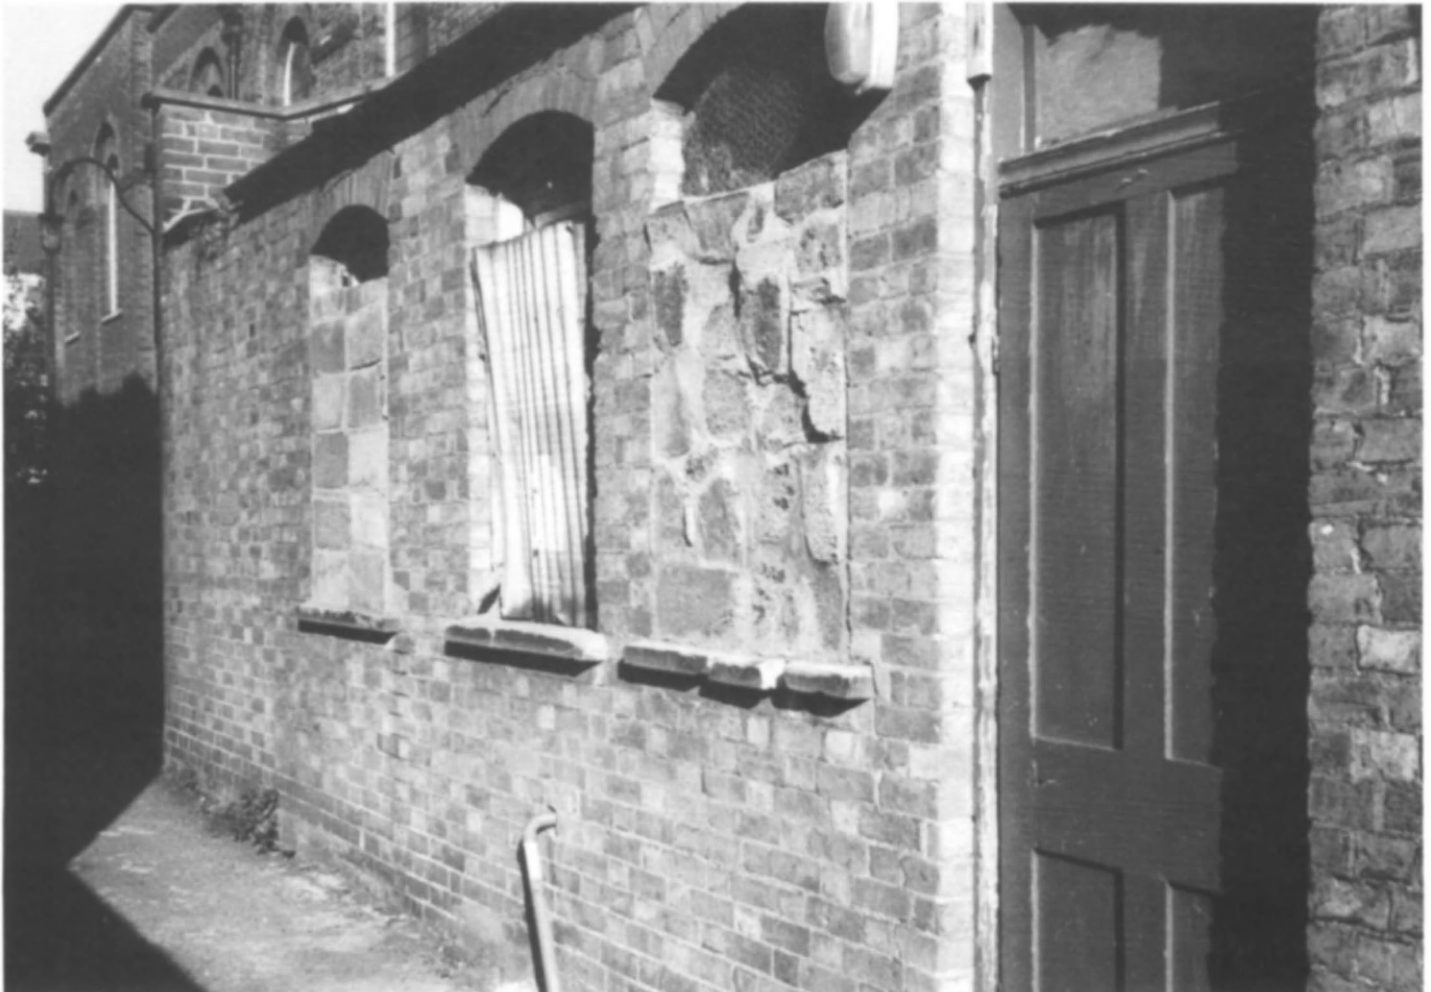
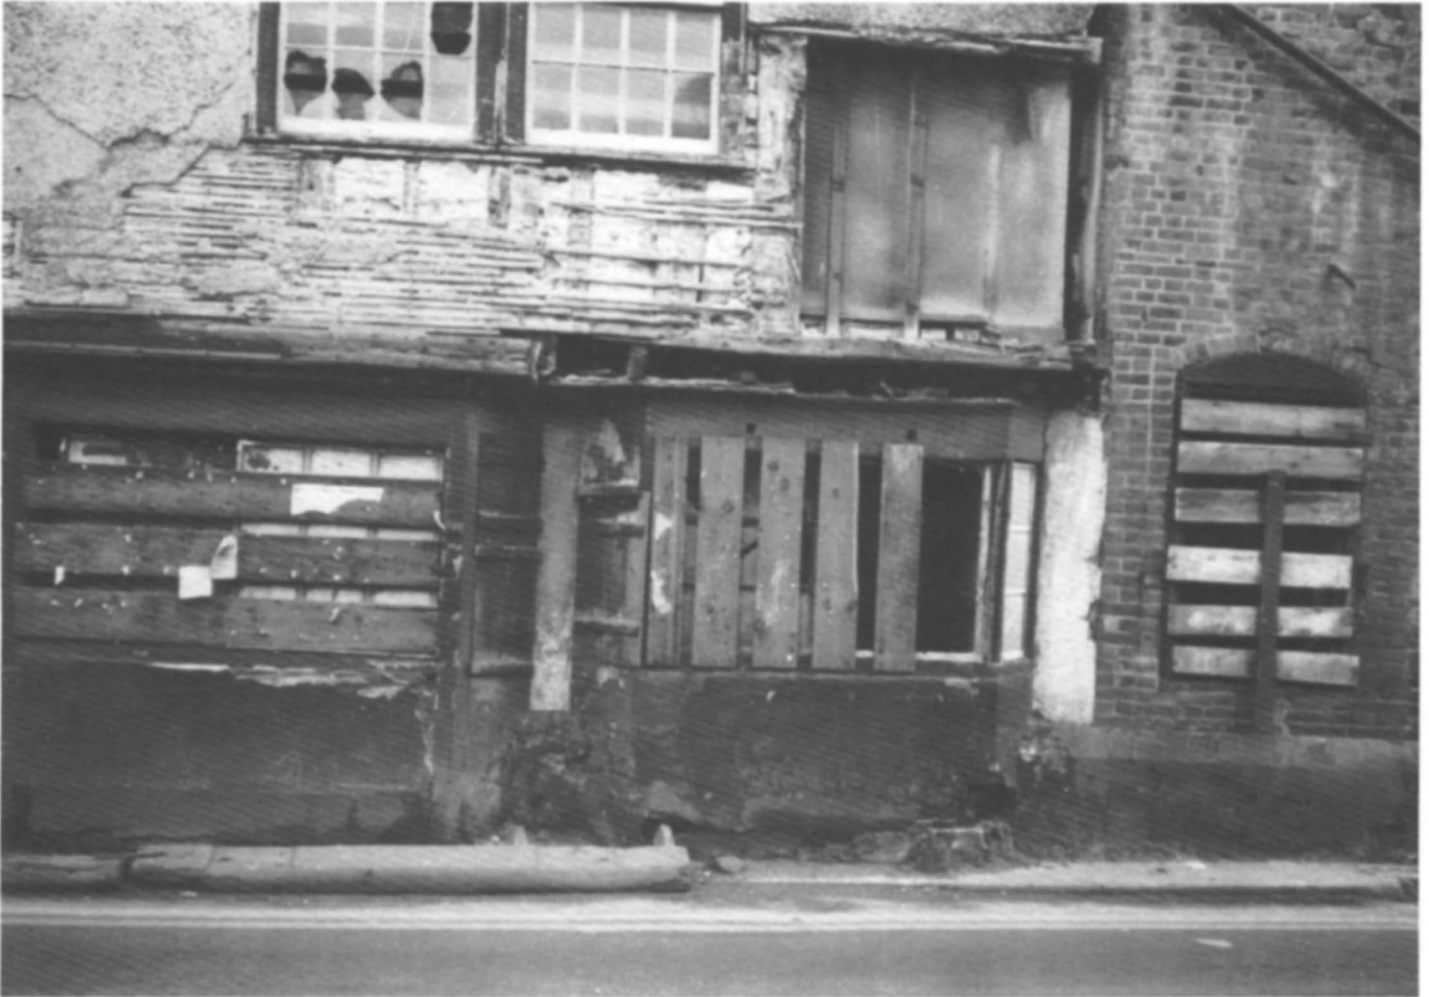
**Fig 17** Miscellaneous blocking materials downgrade an empty church in Bedford

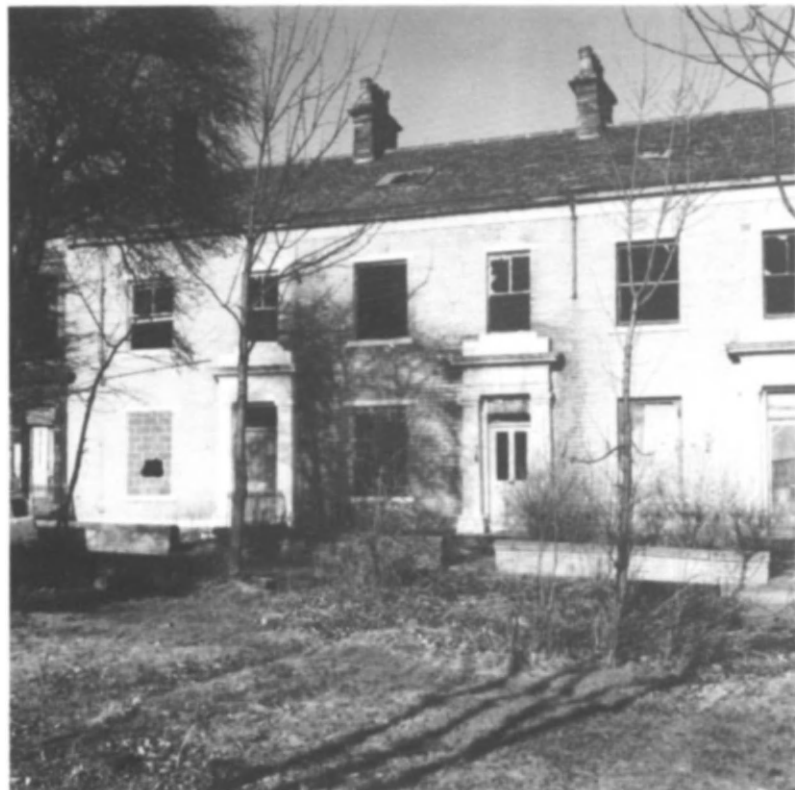
**Fig 22** Single skin blockwork has been penetrated by vandals whilst unprotected windows and skylights admit birds and rain; Southfields Square, Bradford, in 1982

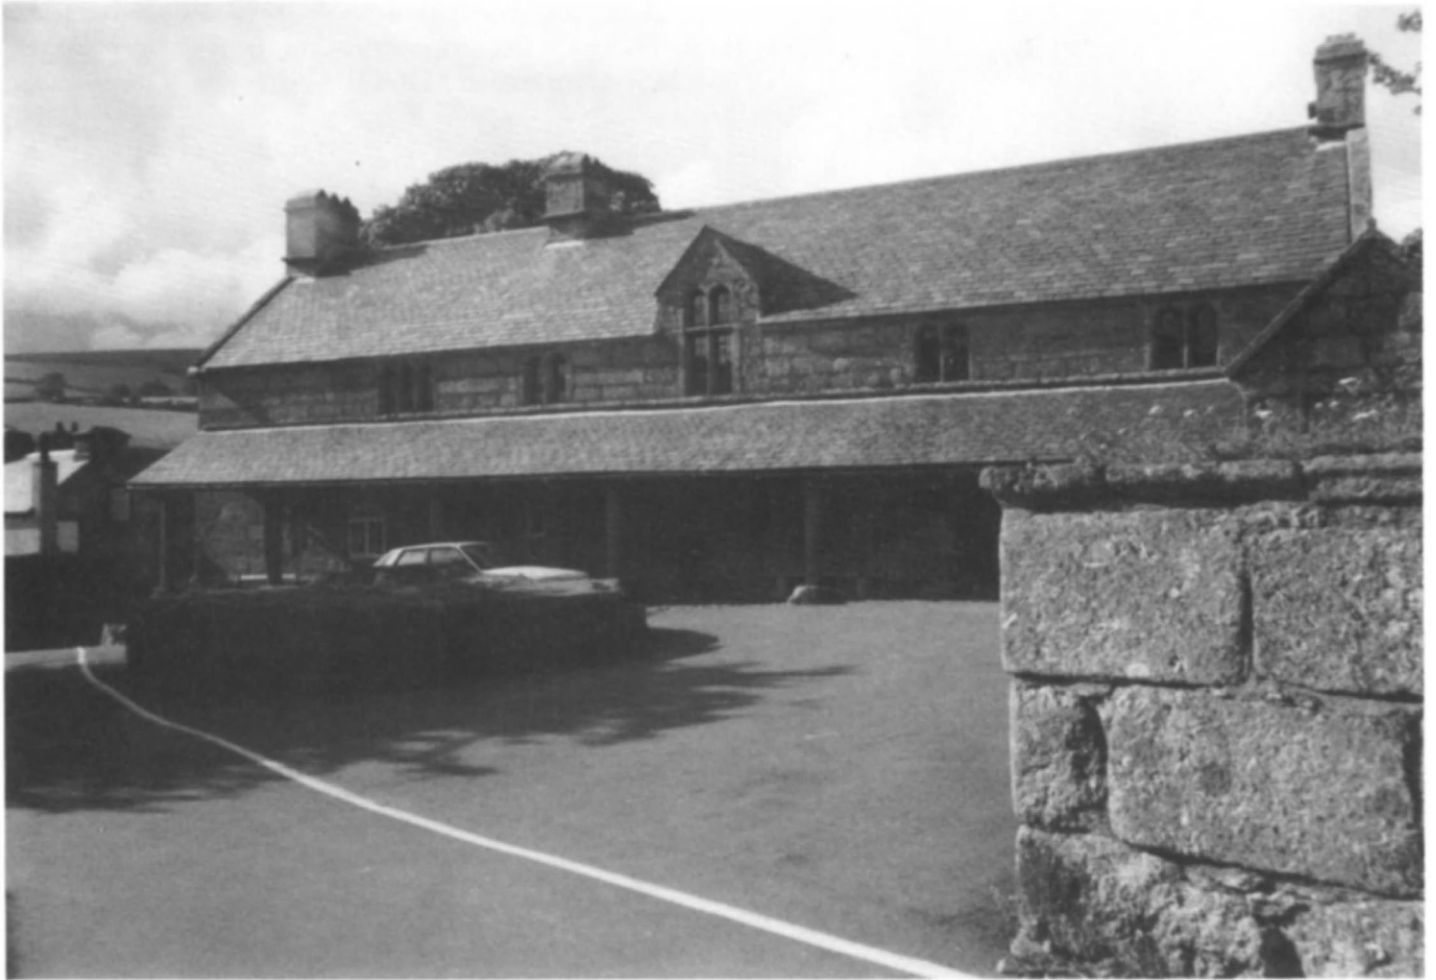
**Fig 26** The Church House at Widcombe-in-the-Moor shows that no gutter at high level can sometimes be better than one that is inaccessible, even in a permanent situation

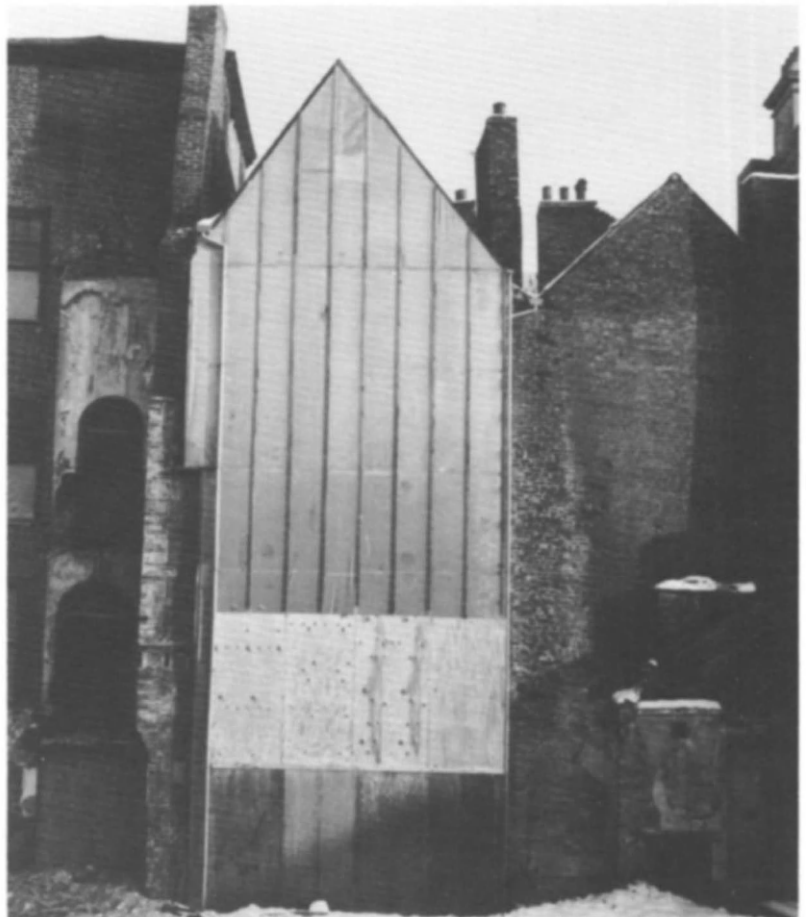
**Fig 27** Temporary screening to a gable wall of the Liberal Club, Newcastle upon Tyne, in 1982; the upper part was translucent to facilitate internal repairs, the lower part was solid to deter intruders (photo: City Engineer, Newcastle upon Tyne)

This should have an ultraviolet inhibitor as for roofs, unless the opening is not exposed to sun. Where intruders are not a problem, nylon or polyester mesh reinforcement would be suitable. This material should be nailed to softwood studs at 600mm centres with fixing laths over the polythene. If the screen is to provide some security it should be wire reinforced; chicken wire or weld mesh can be obtained sandwiched between two layers of light gauge UVI polythene and this can be fixed with staples to the inside of the framing. It is easy to puncture the polythene, but it will not tear beyond the mesh and can be mended with polypropylene tape. It can give a degree of security to upper windows with some holes intentionally cut for ventilation.

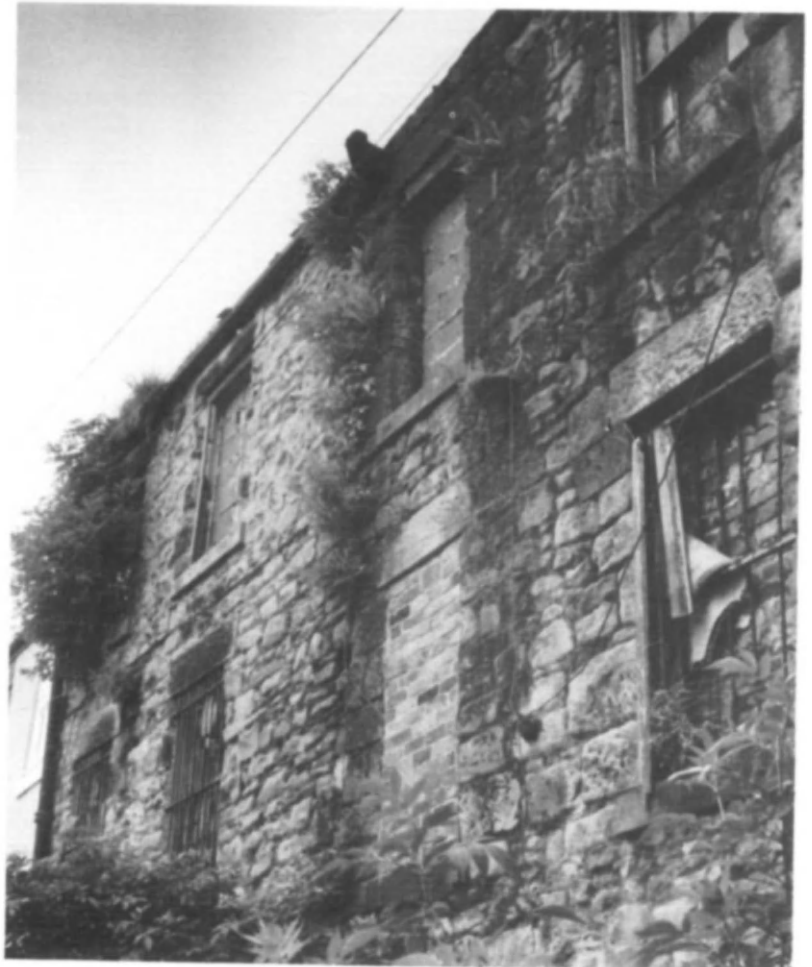
**Fig 28** Plants flourishing in weak mortar joints with an ample water supply from broken gutters

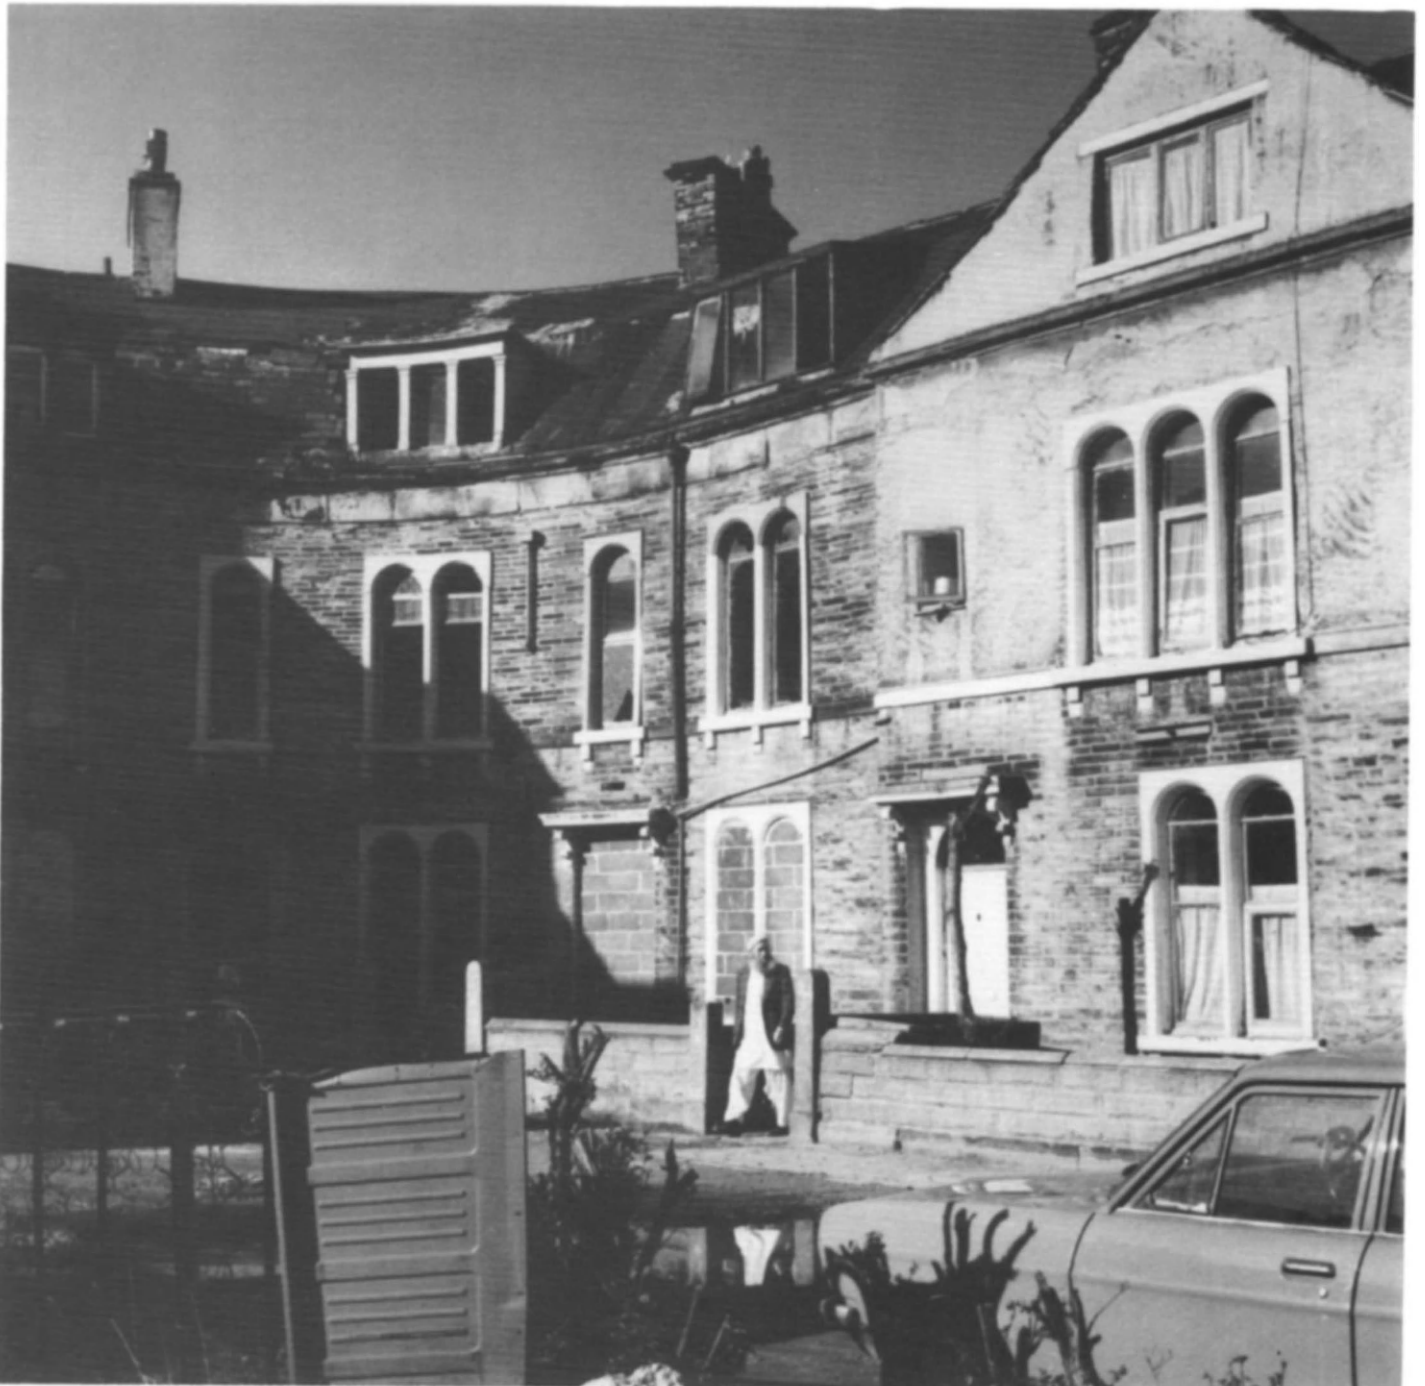
**Fig 36 Unprotected houses and crumbling garden walls in listed Hanover Square, Bradford, downgraded the surrounding properties in 1982**

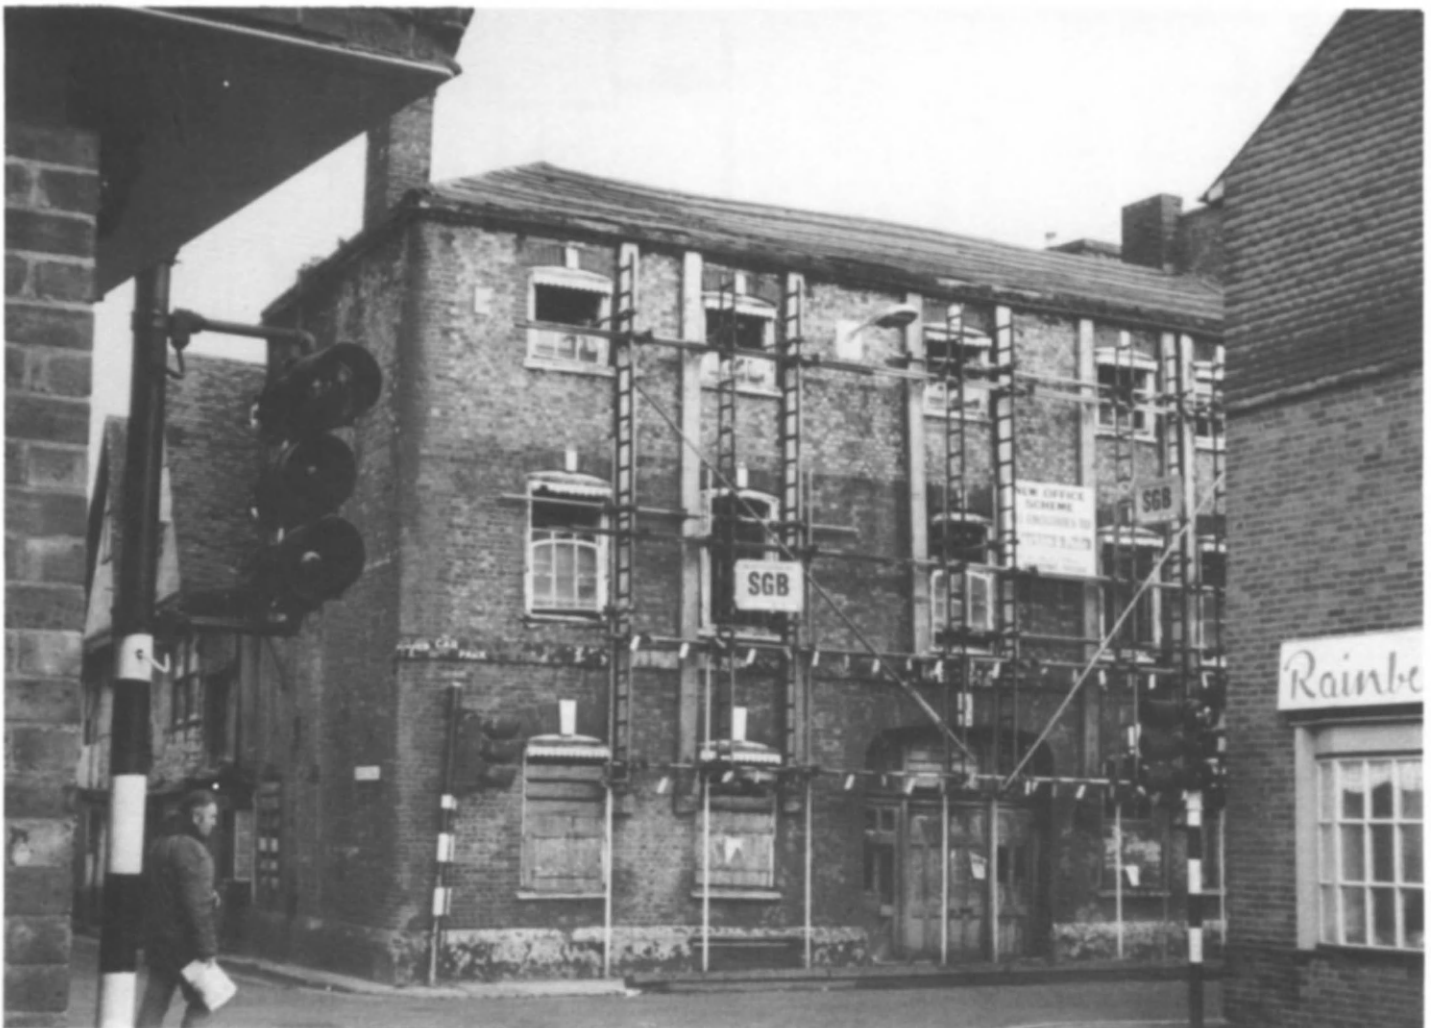
Fig 41 The Lamb Inn before repair in 1978, with support scaffold in position (photo: Colin Bridger)

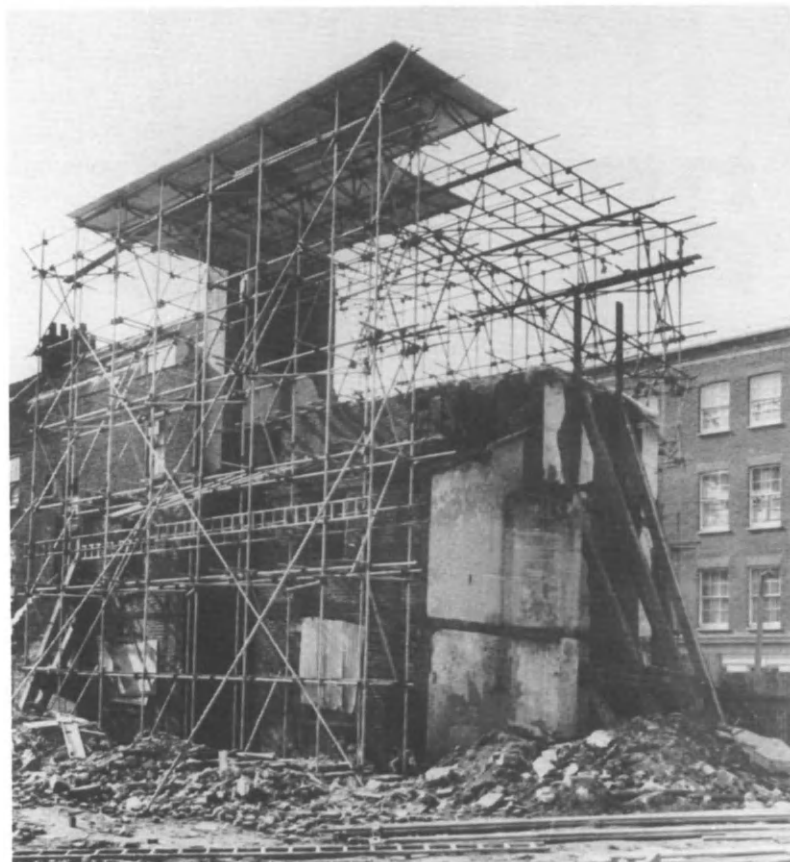
Fig 49 5-7 Elder Street, Spitalfields: an example of the condition of the original panelling which was saved as part of the emergency repairs (photo: Julian Harrap Architects)

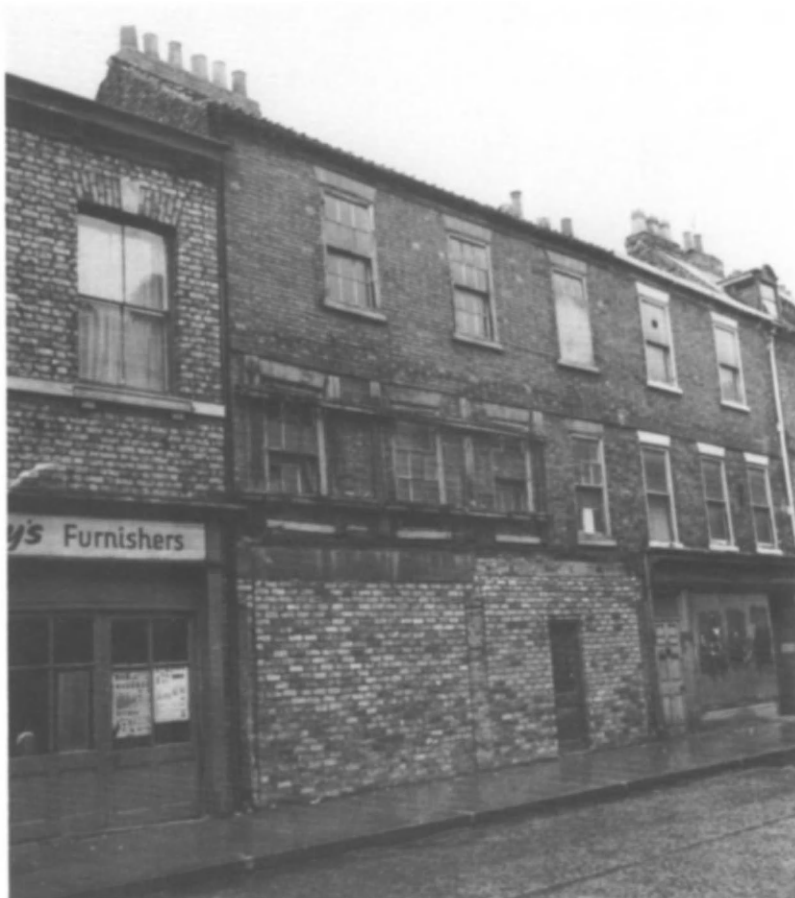
**Fig 71** Gillygate, York: numbers 16–20 in 1979; they remained the worst problem of the street until the shell was repaired by the City Council (photo: York City Council)

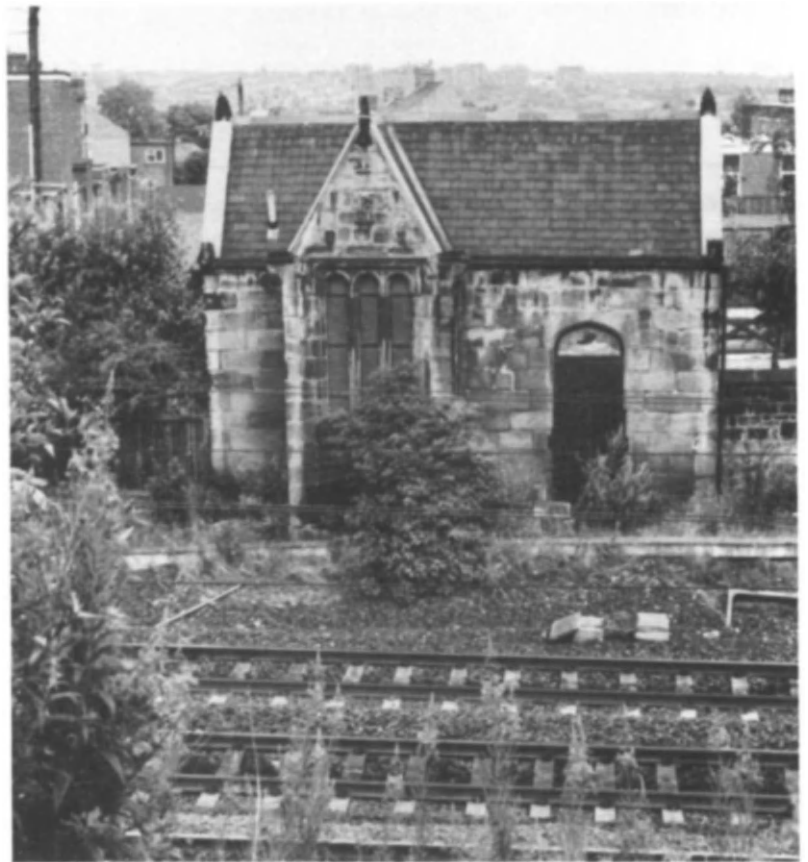
**Fig 103** Brandling Station, Felling: in spite of temporary repairs, the full rehabilitation in 1978 involved demolition of the roof and west gables (photo: Tyne & Wear County Council)

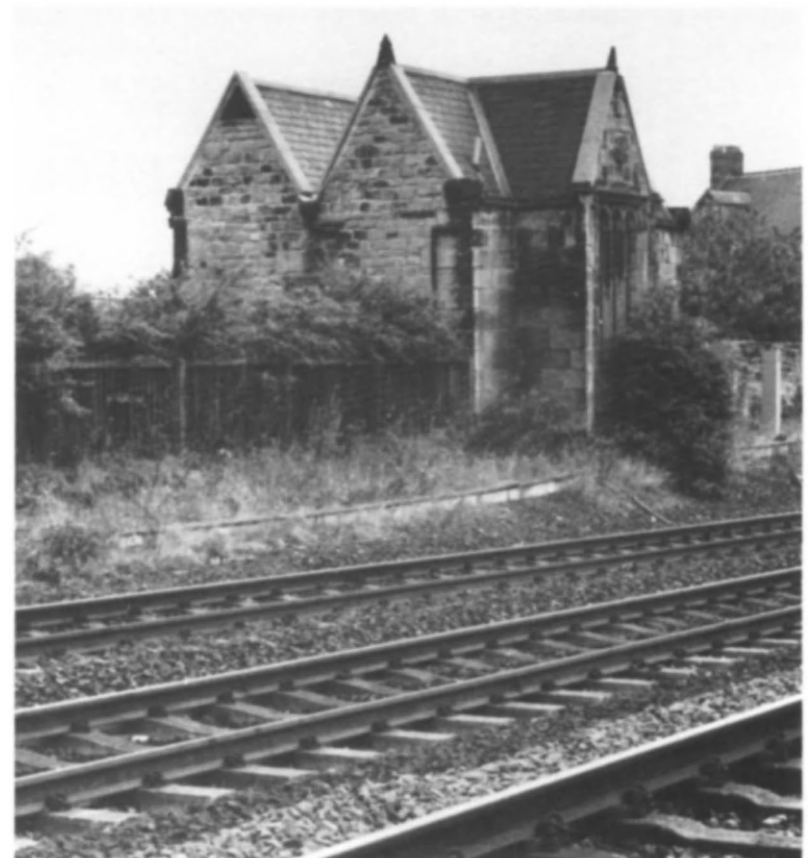
**Fig 105** Brandling Station, Felling: the little building is seen by thousands of people passing daily on the Tyne & Wear Metro. In 1987 two of the finials were missing, three were poorly related to the gable copings, and one of these was truncated; the rainwater pipe was missing from the new rainwater head draining the central valley, which was choked with debris

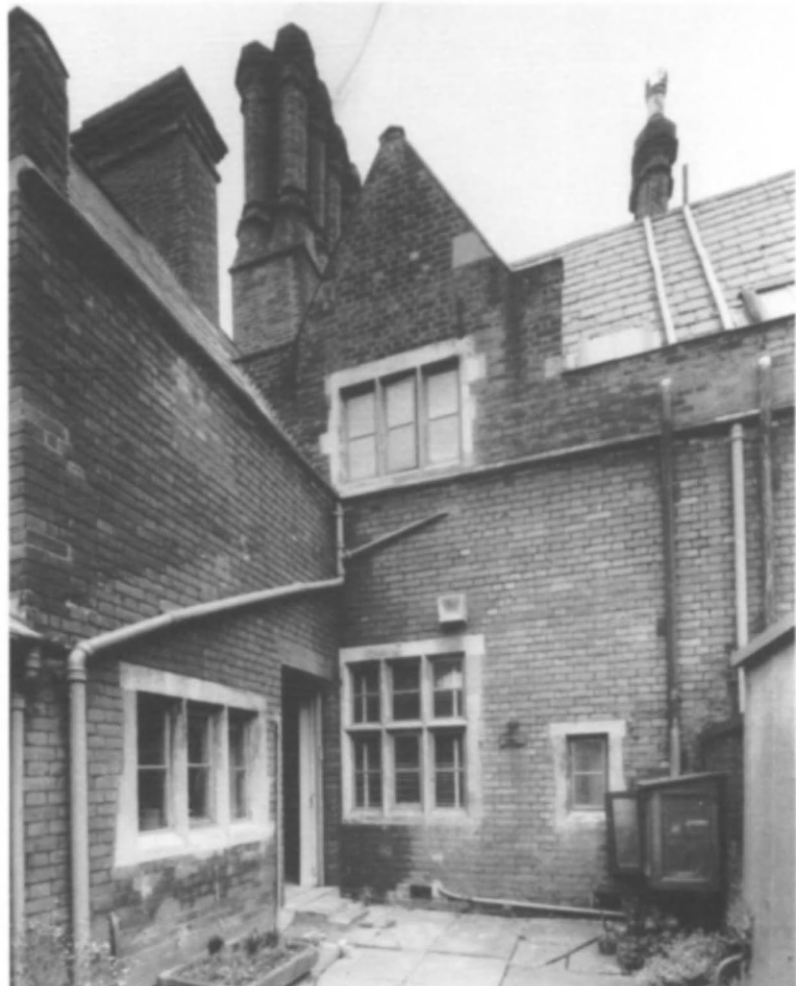
**Fig 113** The Royal Naval Asylum, Penge: the rear of number 7 in 1974 showing the complexity of the rainwater disposal system (photo: Greater London Photograph Library)

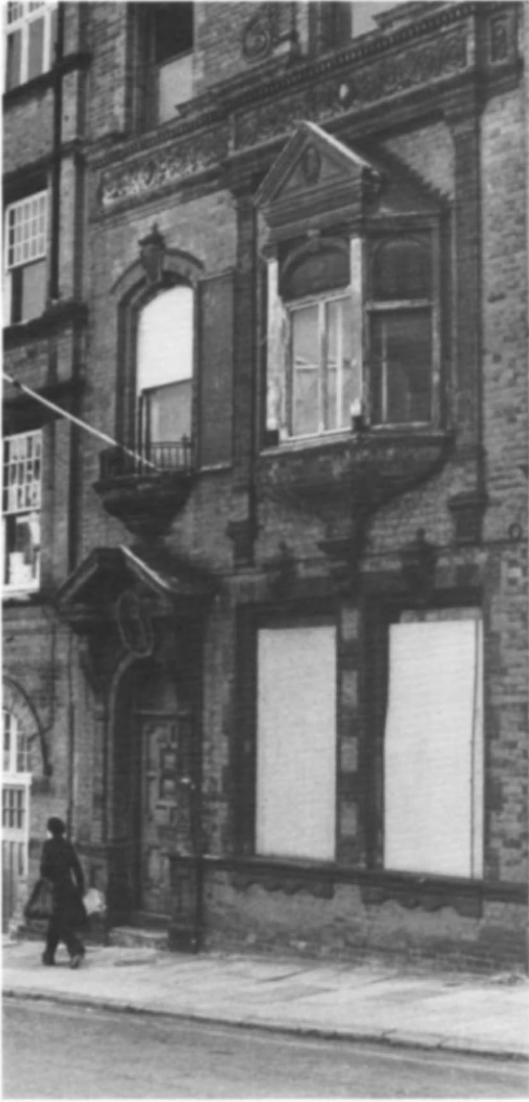
**Fig 137** 32 Heathcoat Street, Nottingham, before emergency repair; with its fine brickwork concealed by 95 years of grime it blended into a drab streetscape and offered no appeal to prospective users (photo: Nottingham City Council Planning Department)
