Building Pathology and Rehabilitation

João M.P.Q. Delgado *Editor*

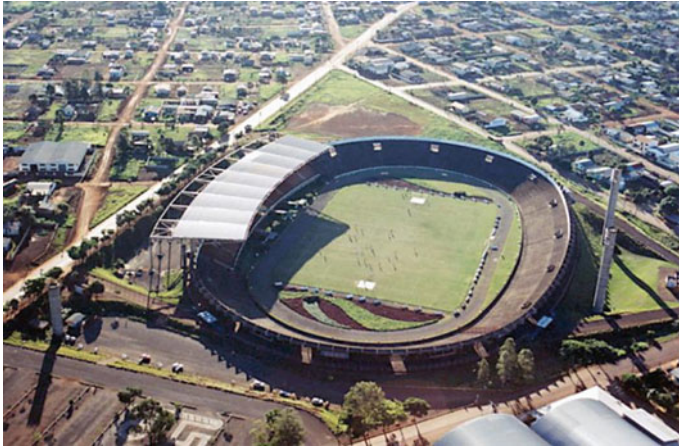
**Fig. 1** Olympic stadium Arnaldo Busatto

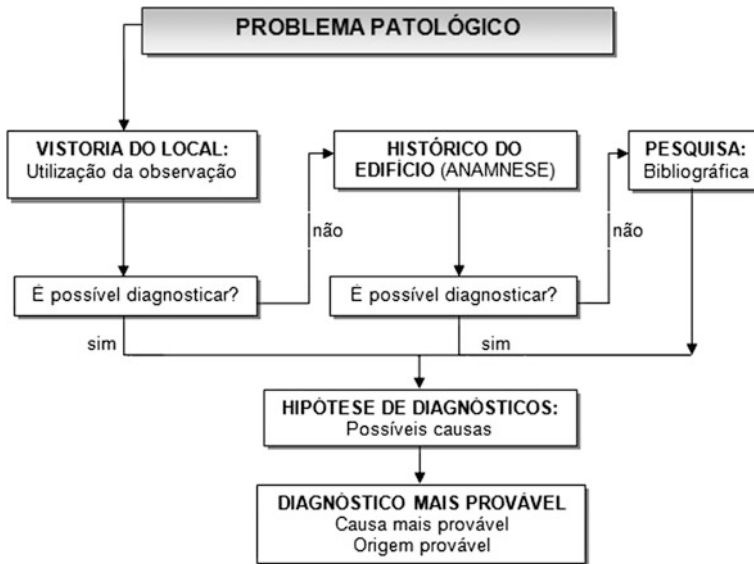
Fig. 2 Schema of method used

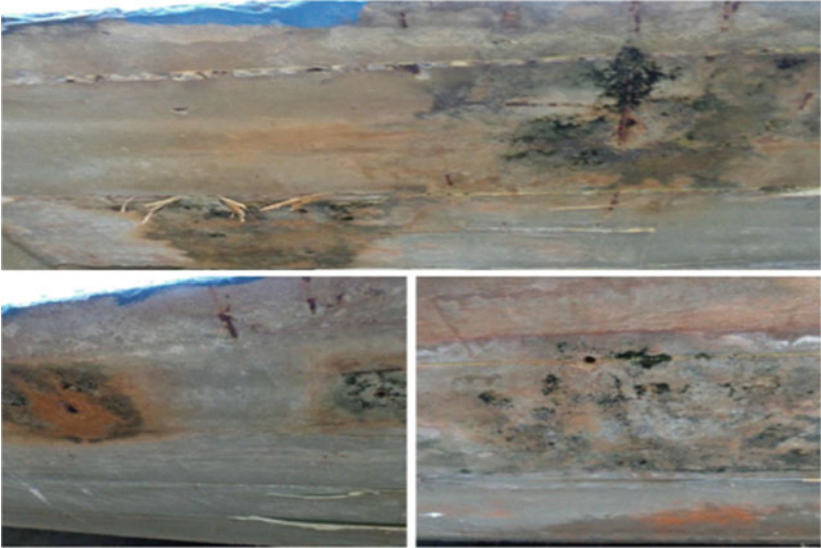
TECHNICAL DATA		
SOURCE: FIELD RESEARCH PERFORMED BY THE AUTHOR		Location - Circulation 04      jan/14
Pathology type	Mold	
Symptom data	There are holes in the slab. At some points it is possible to note the coating detachment, oxidation of the slab reinforcement and deployment of pieces of wood.	
<b>Probable causes</b>	Ineffective waterproofing of the slab	
	Infiltration of rainwater	
Degree of risk	Regular

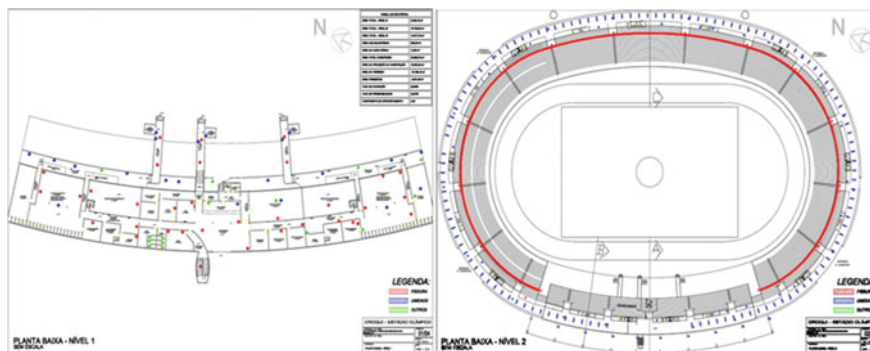
Fig. 5 Mapping of pathologies in the different levels of the stadium

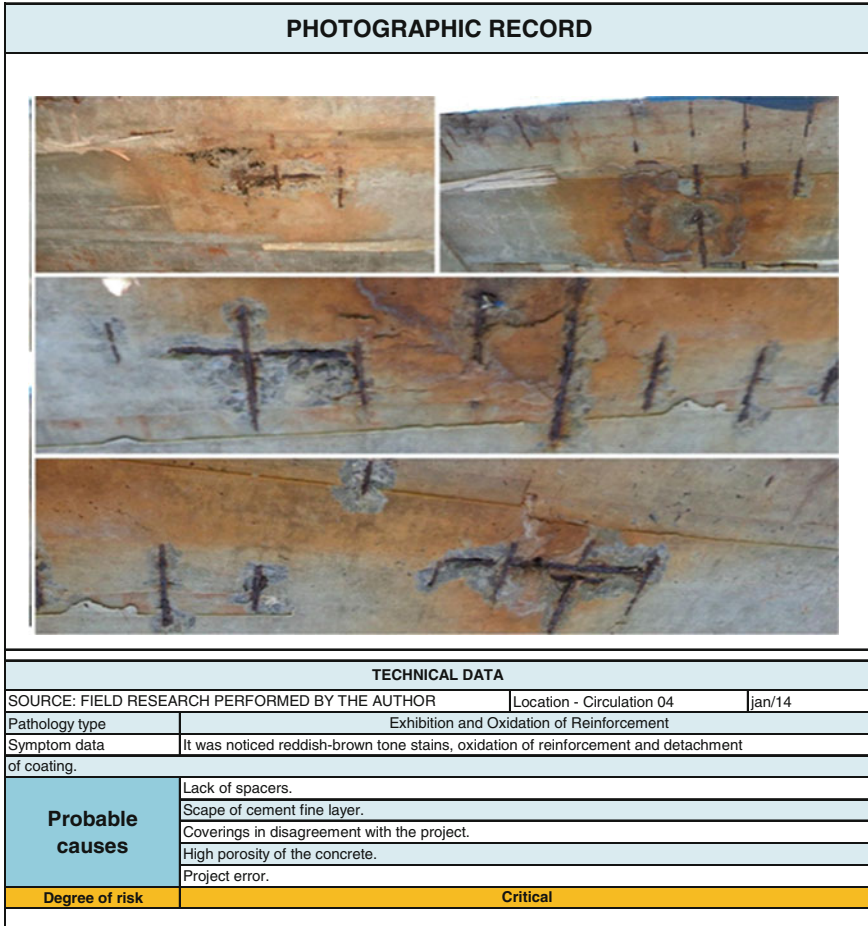
Fig. 6 Oxidation of slabs

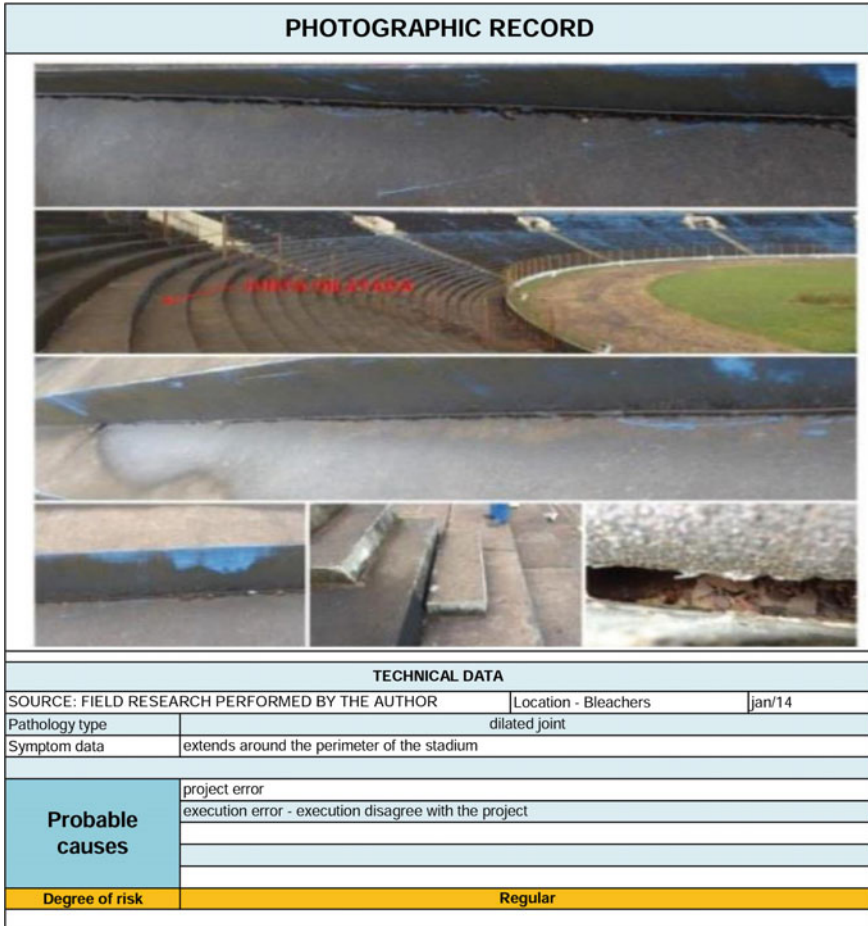
Fig. 8 Dilation of horizontal joint

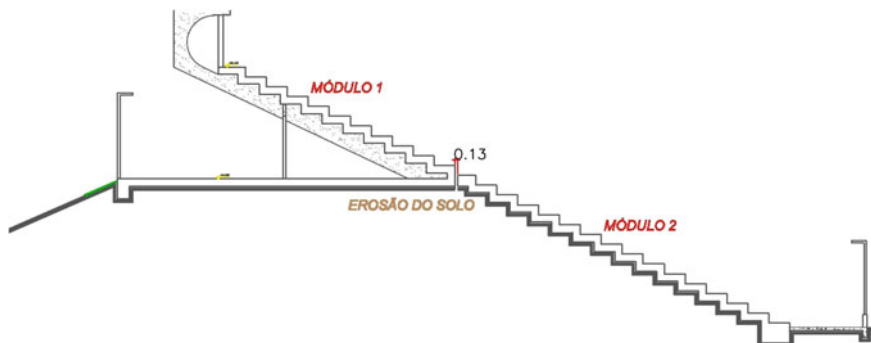
**Fig. 9** Cross section of the bleachers slab

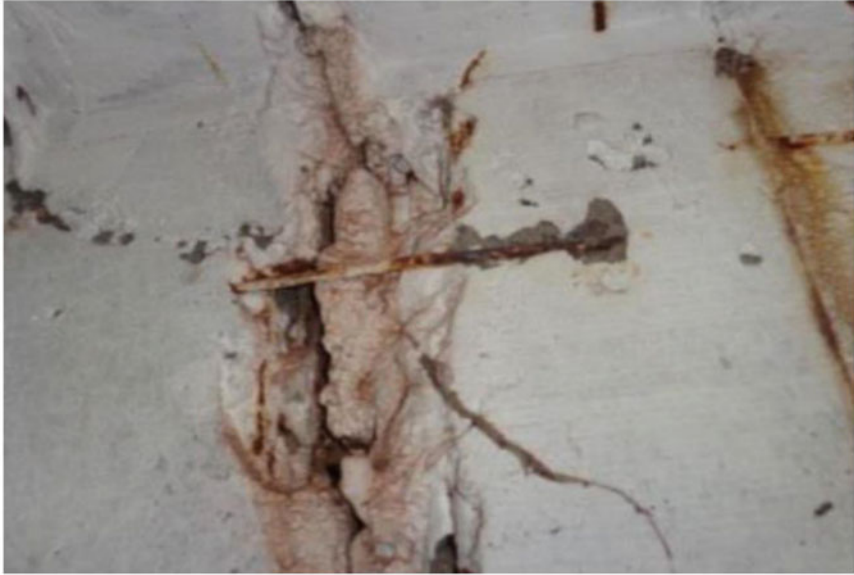
TECHNICAL DATA		
SOURCE: FIELD RESEARCH PERFORMED BY THE AUTHOR		Location - Cabin   jan/14
Pathology type	crack, detachment, armor exhibition	
Symptom data	detachment of coating and oxidation armor in the dilatation joint	
<b>Probable causes</b>	oxidation due to insufficient coverings - project or execution error	
	moving of the joint caused detachment	
<b>Degree of risk</b>	<b>Regular</b>

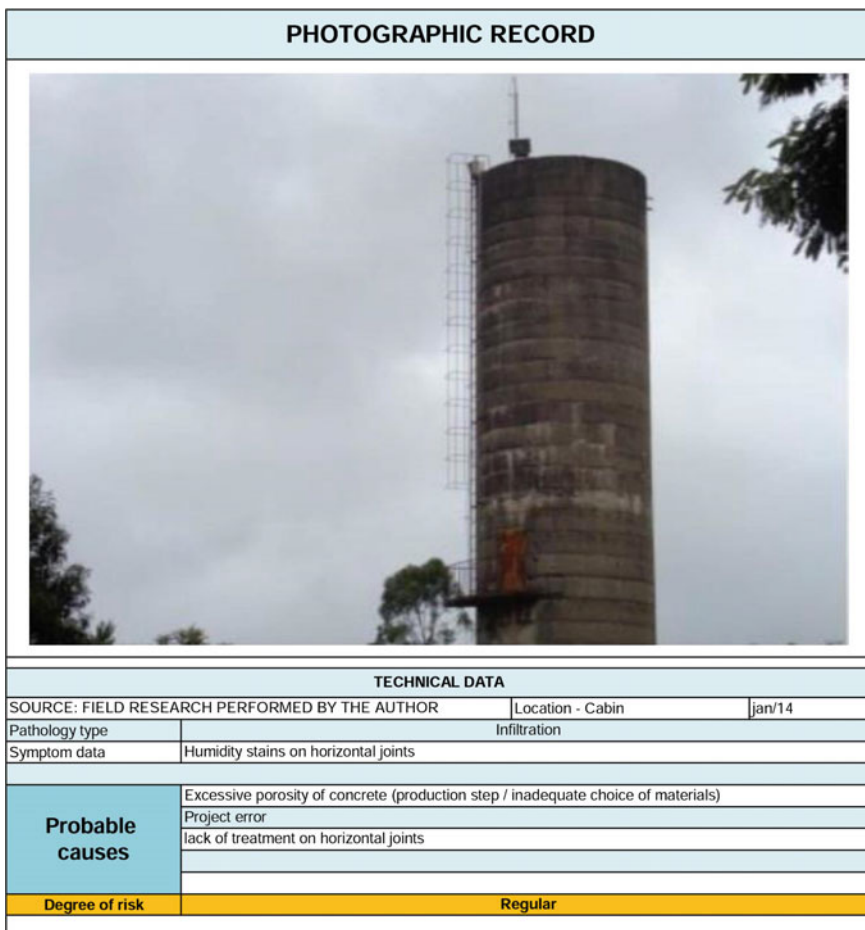
**Fig. 11** Infiltration and carbonation

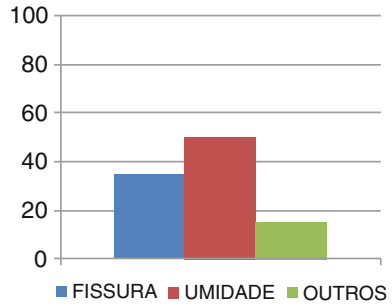
**Fig. 13** Pathologies by degree of risk

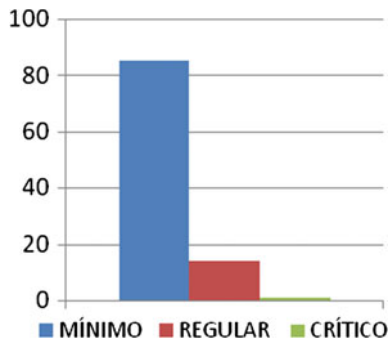
coatings, breaking of ceramic coatings, and detachment of paintings. Such amounts may be related to the exposure of the elements present on the second level to the weather and correlated to possible insufficient waterproofing processes or lack of maintenance of these. In contrast, the third level is where the constructive elements are in lower exposure to weathering external agents causing constructive diseases and, unlike the level 1, does not maintain contact with the ground and possible rise episodes of humidity from this material body.

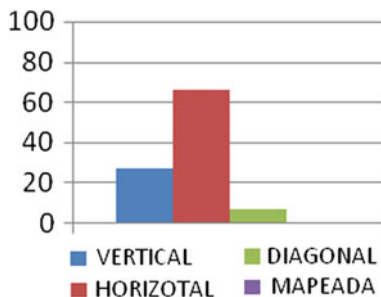
**Fig. 15** Origin of pathological manifestations

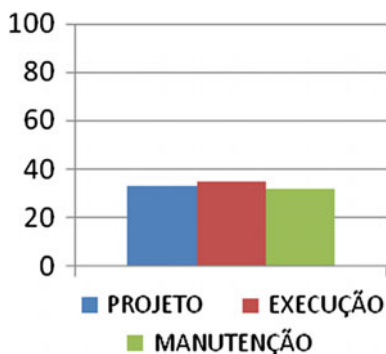
Fig. 14, which in all four evaluated levels stand out the horizontally directed pathologies that may represent inharmonious movement, either by shrinkage and thermal expansion between the ceramic material components walls and concrete structures, or by humidity; as well as the possibility of failure or prematurity of the wedge-shaping procedures perceived in some environments inspected at the first level.

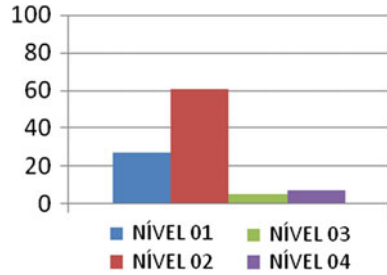
weathering agents and possibly related to insufficient waterproofing processes or lack of maintenance of these. In contrast, the third level is where the building elements have a lower exposure to external agents of weathering causing constructive diseases and, contrary to the level 1, does not maintain direct contact with the ground and possible episodes of moisture ascending from this material body.

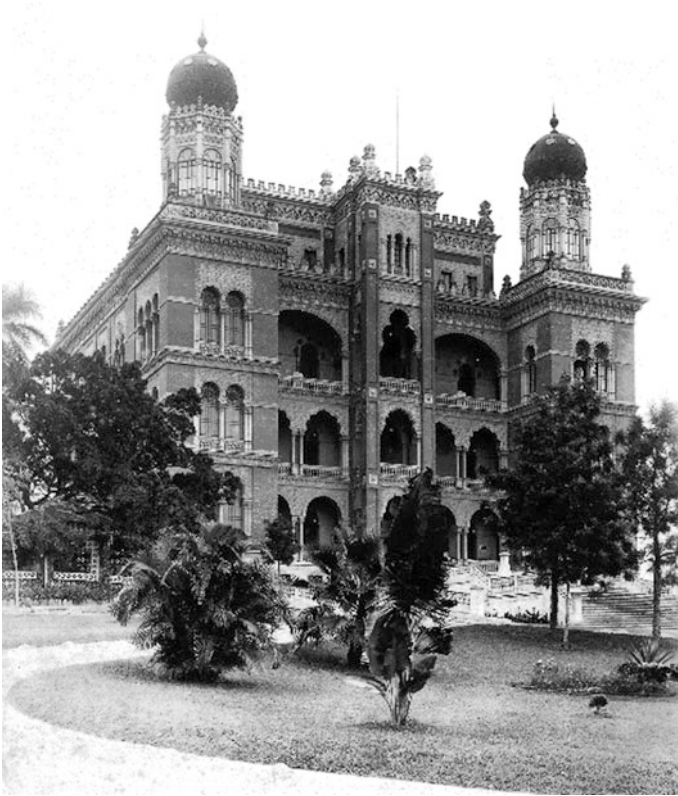
**Fig. 5** Pavilhão Mourisco in 1911

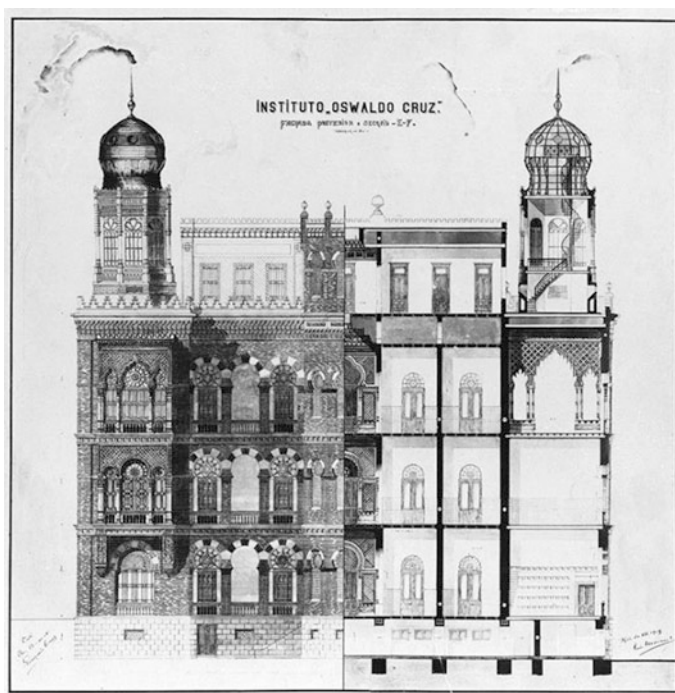
**Fig. 6** Final design for the Pavilhão Mourisco—Elevation and cross section, by Luiz Moraes Jr., made while the pavilion was already being built (1908)

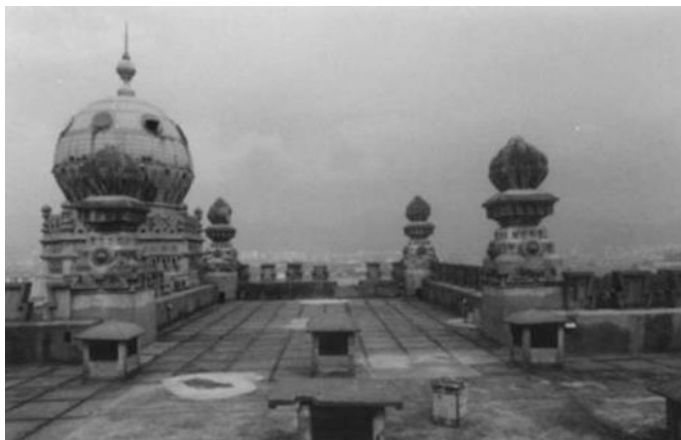
**Fig. 7** View from the seventh-floor terrace, with the old cement tiles (1989)

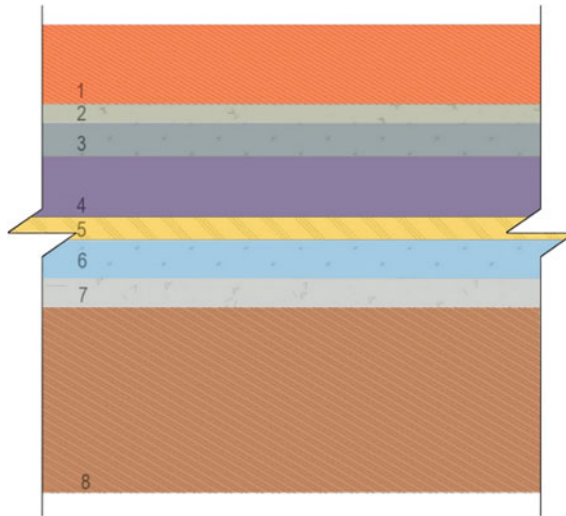
**Fig. 9** Layers scheme on the butyl blanket waterproofing system, where: 1 Ceramic tile laid with cement–sand mortar (1:3 ratio) with waterproofing additive. 2 Cement–sand mortar (1:2 ratio, and 1.5 cm thick) reinforced with steel screen. 3 Bituminous felt sheets 250/15. 4 Butyl rubber blanket (8 mm thick) set with vulcanising adhesive. 5 “Cradle” composed of bitumen emulsion and rubber flakes at a 1:2 ratio. 6 Dihydric bitumen emulsion diluted in 50 % water. 7 Settlement mortar, at a 1:3 cement–sand ratio. 8 Slab (steel beam and brick stuck)

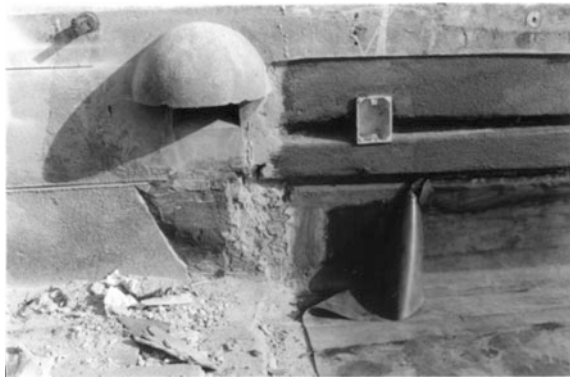
uncoated and do not show any kind of stress or leakage points (Figs. 14, 15, and 16).

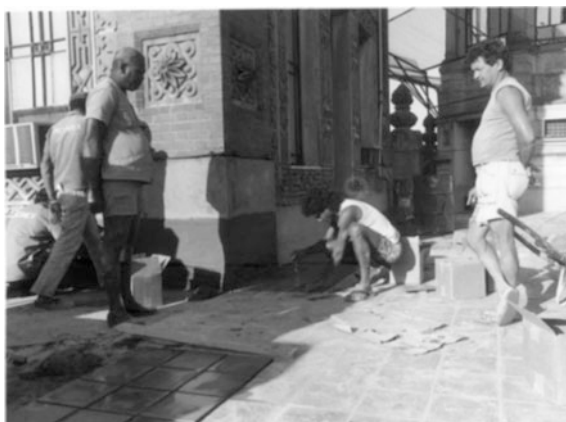
**Fig. 12** North wing terrace on the seventh floor (1990)

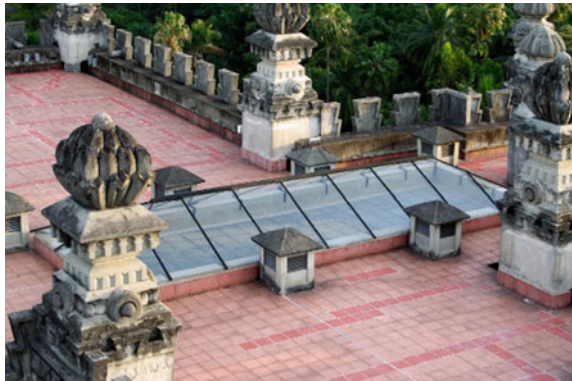
The report states that the cracks on the fifth floor result from thermal variation due to extreme temperatures in Rio de Janeiro and do not represent structural damage to the building. The report also shows that, on the seventh floor, the damage was related to the poor quality of the ceramic tiles used in the 1990s intervention (Cerne Engenharia e Projetos 2006) (Figs. 17 and 18).

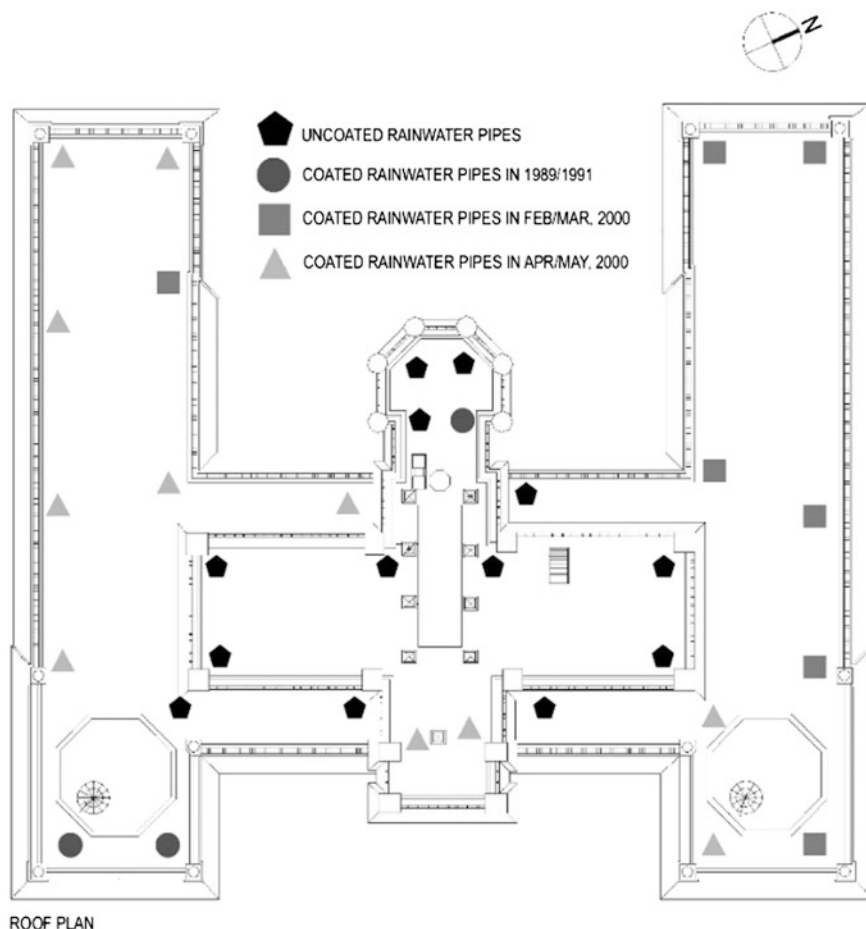
**Fig. 16** Roof plan (seventh floor on the central area and fifth floor on the rest of the plan) indicating the location of the drain pipes and their interventions

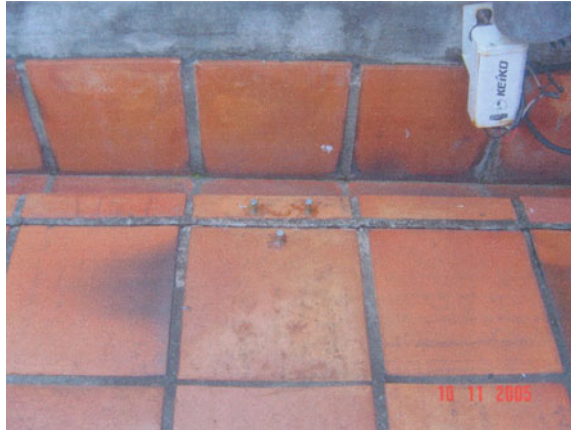
**Fig. 18** Monitoring station placed by a turret on the seventh-floor terrace (Nov 2005—Cerme Engenharia)

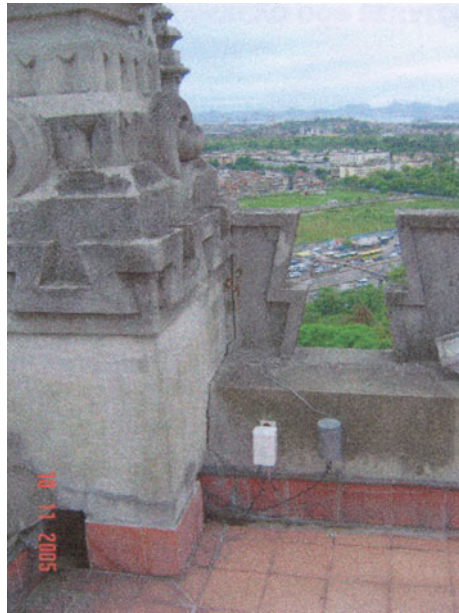
#### **4 Intervention at the Eaves and Parapets from the Terraces**

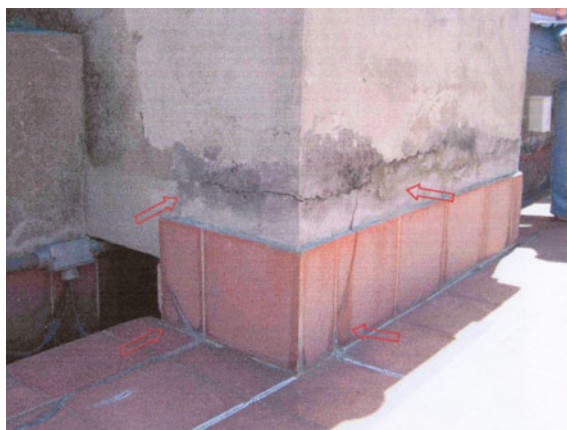
**Fig. 19** Cracks on the mortar indicating the displacement of the waterproofing blanket (Nov 2005 —Cerme Engenharia)

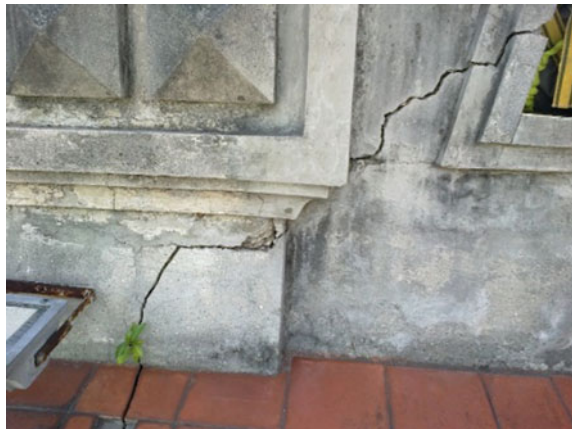
**Fig. 22** Black crust on the external ceramic tiles (May 2014)

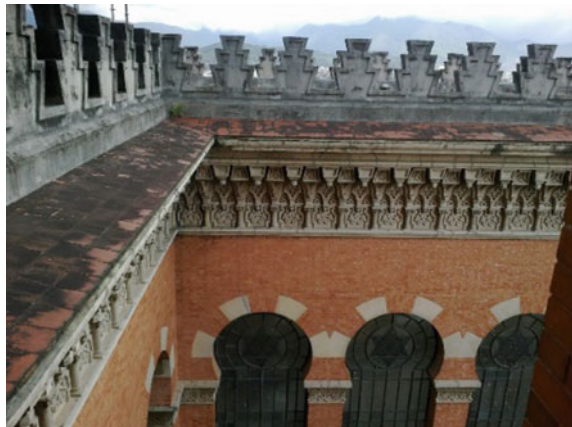
the second one, the western part of it. The two pictures below show the scaffolds installed for the first phase of the work.

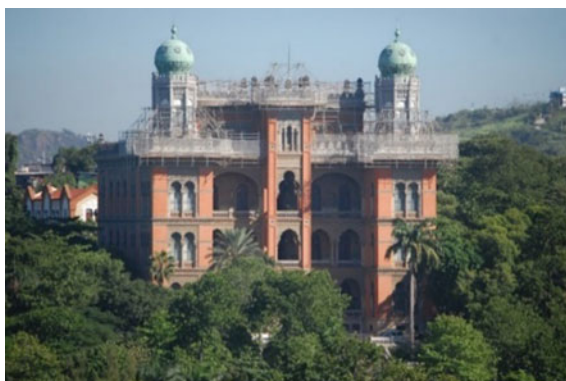
**Fig. 24** Scaffolds on the seventh-floor terrace (May 2014)

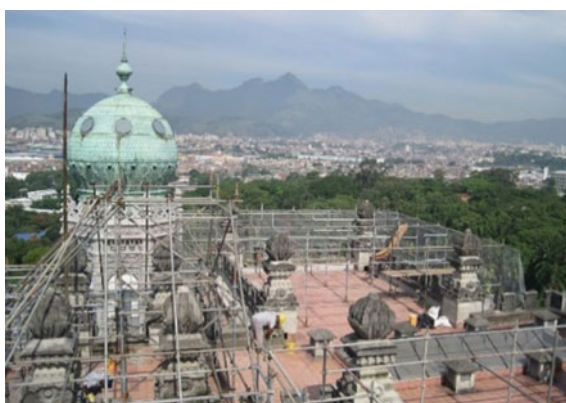
A new cement mortar was laid over the waterproofing system, the paint formula to cover the new surface was determined through the analysis of the demolished mortar. The plastic membrane was also applied to every surface that could accumulate water (gutters, ornaments, etc.), and near the fissures and cracks. Some places were reinforced with a thin net below the new cement layer (Figs. 25 and 26).

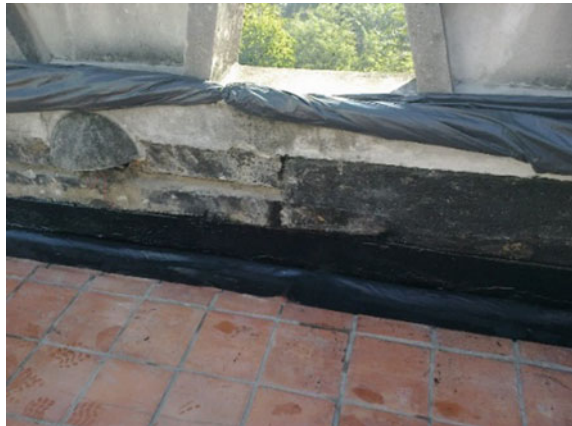
**Fig. 26** Plastic membrane applied on top of the butyl rubber blanket in order to improve waterproofing in the lower part of the parapet (Apr 2014)

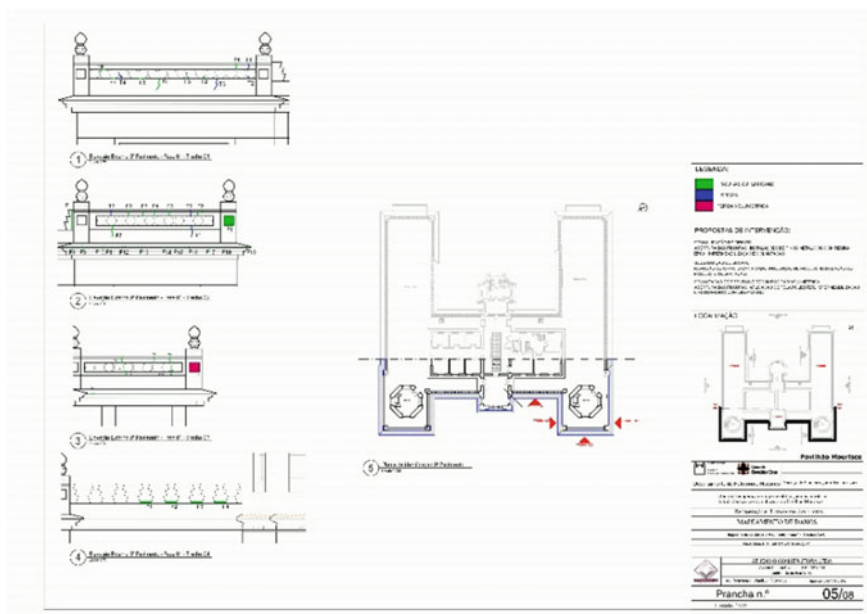
Fig. 27 Pathology and damage mapping survey—elements on the fifth-floor terrace, north wing

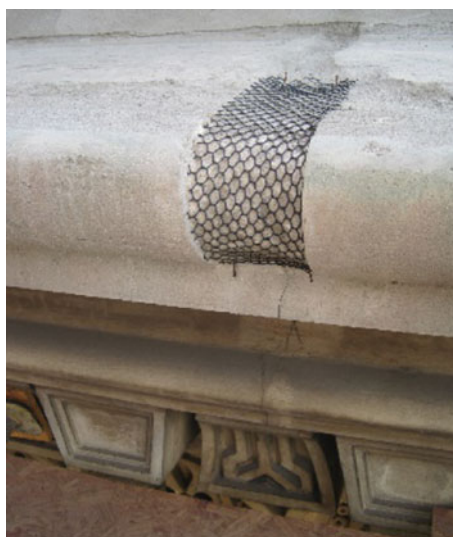
The copper plaques located below the ceramic tiles on the eaves work as a drip edge for the building and were subject to physical intervention. The copper drip edges were removed, received anticorrosion treatment, and were finally put back in

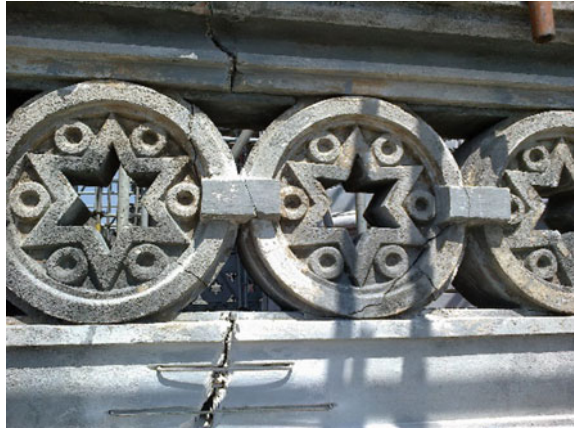
**Fig. 30** Structural damage seen at the seventh floor, north wing, eave: crack opening, affecting also the copper plaque (Feb 2014)

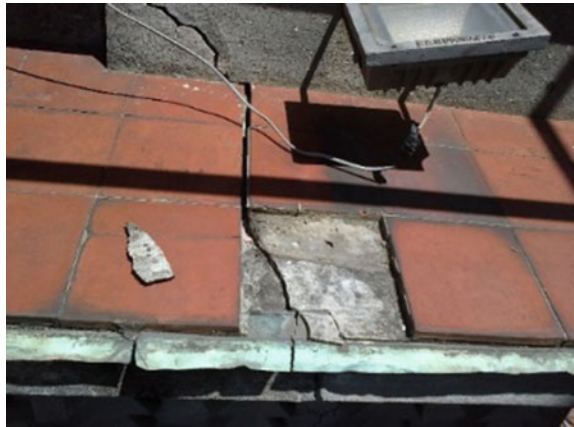
place before being welded back together and coated with automotive varnish (Figs. 30, 31, and 32).

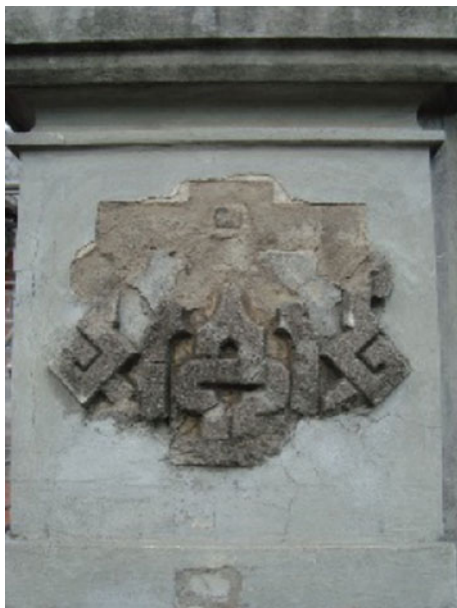
**Fig. 34** Ornament on the fifth-floor terrace, north wing, external wall—the damage goes deep into its metallic structure (Mar 2014)

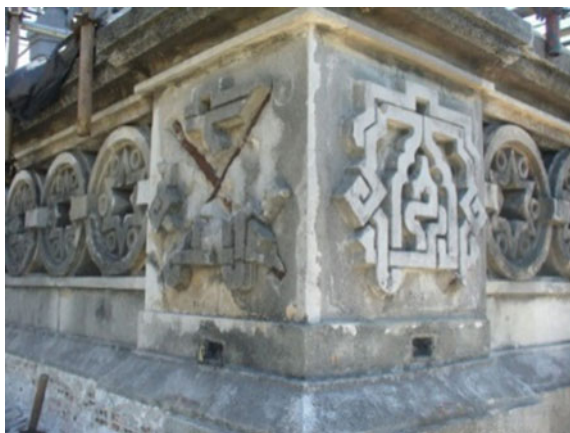
and worked alongside the DPH personnel and construction staff, in order to better perform the restoration of the mortars of this historic building (Fig. 38).

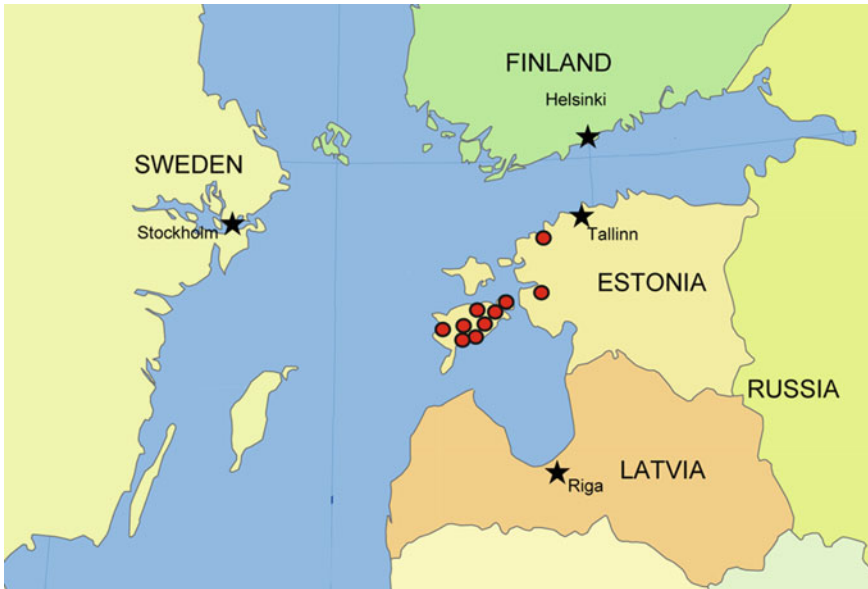
**Fig. 1** Locations of studied medieval churches on the island of Saaremaa and in Western Estonia are marked with a *red* dot

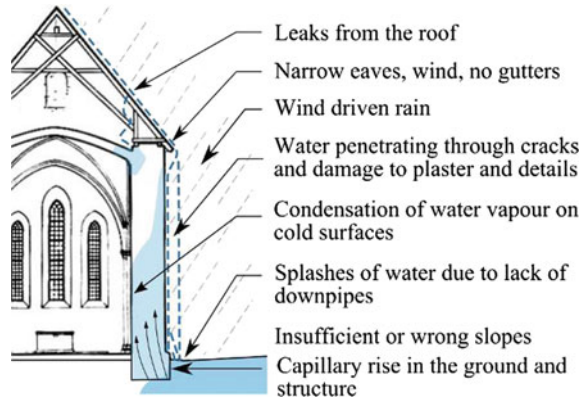
structure of the churches. The performance of the buildings and their deficiencies are highly dependent on the building management.

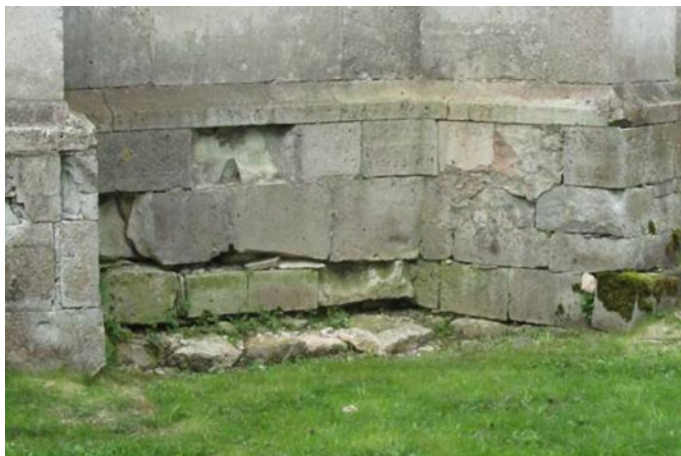
**Fig. 3** Ground around the church is sloped towards the building and leads water to the structure, frost damage caused by excess moisture is also visible

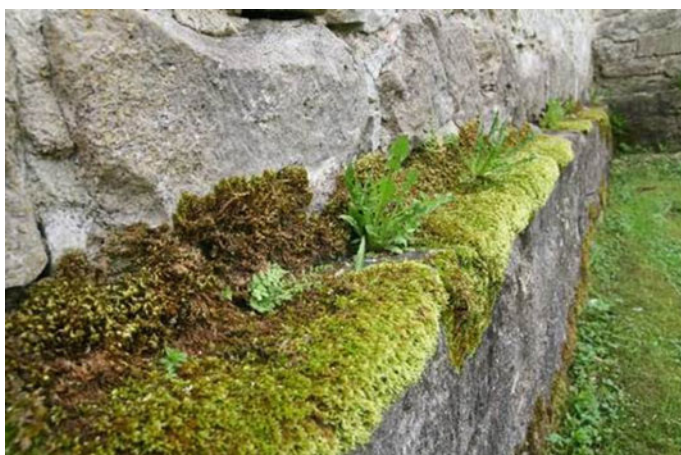
**Fig. 4** Protruding foundation wall ought to have sufficient slopes and a cornice to lead the water away safely. Foundation wall has been wet enough to facilitate the growth of moss

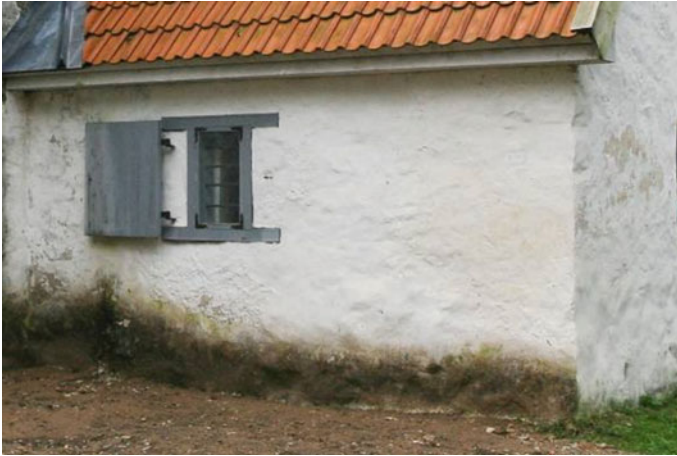
**Fig. 5** Water falling from the gutterless eaves moistens the façade while exhausting the frost resistance of the plaster, splashing water also carries soil—the foundation wall is dirty and suitable habitat for algal growth

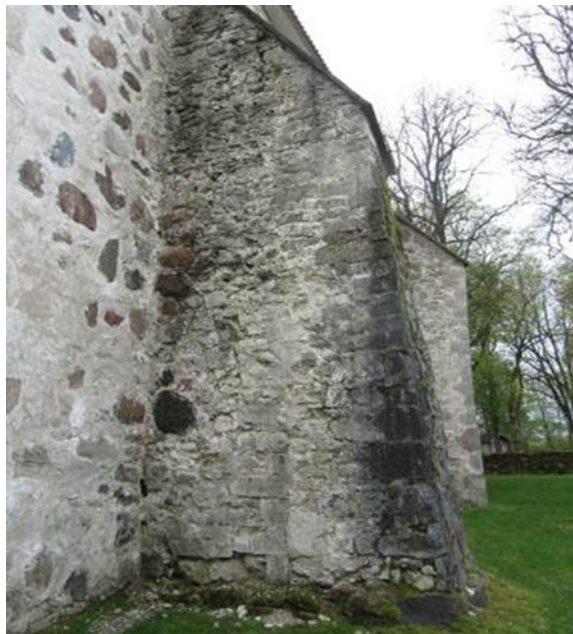
**Fig. 6** Roof covers only part of the buttress resulting in discoloration, frost damage, and wetting of the wall

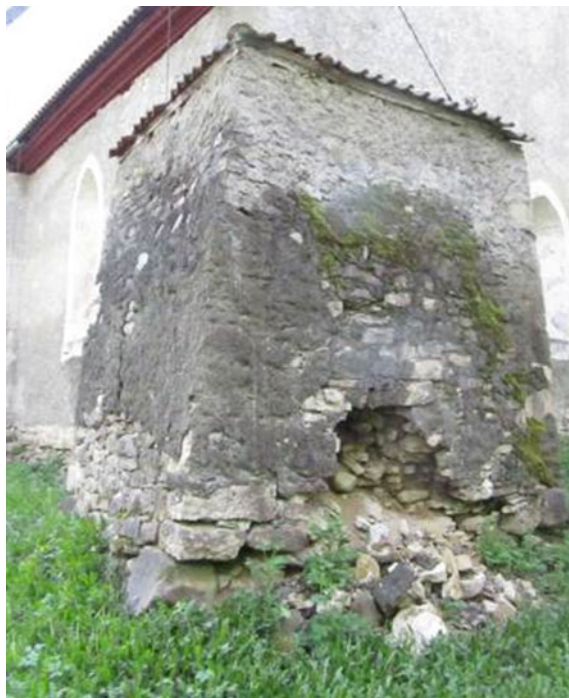
**Fig. 7** Only surface layers of the masonry wall were built using binder, damage to these layers can cause collapse

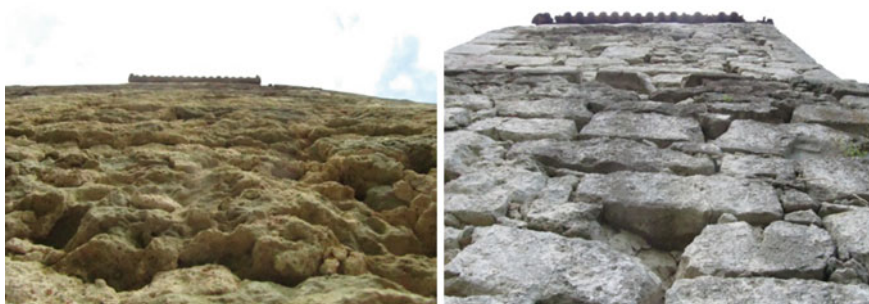
**Fig. 8** Parts of the façade uncovered by eaves are exposed to high water loads, frost damage to mortar and stone is visible

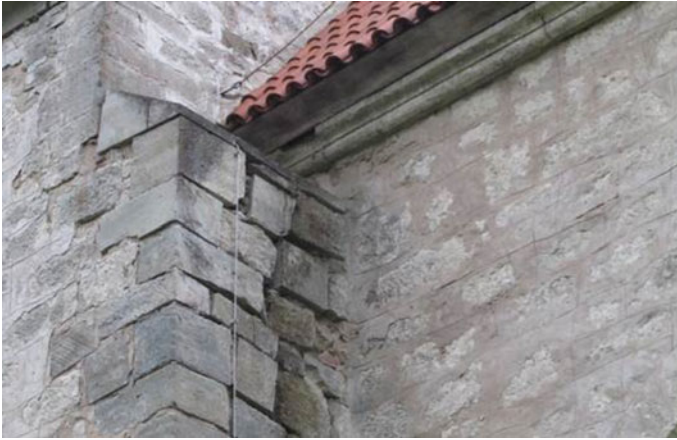
**Fig. 9** Due to incorrectly designed details, concentrated amounts of rainwater are able to penetrate the wall

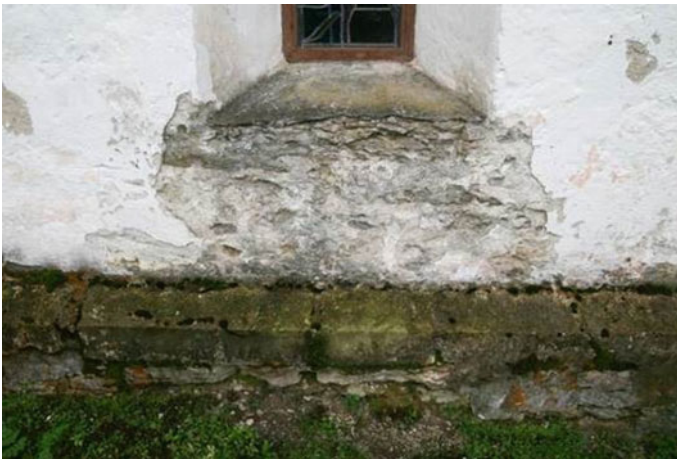
**Fig. 10** Proper detailing of façade elements has an important role in the service life of the whole wall. Window flashing made of mortar has failed to lead the water away safely

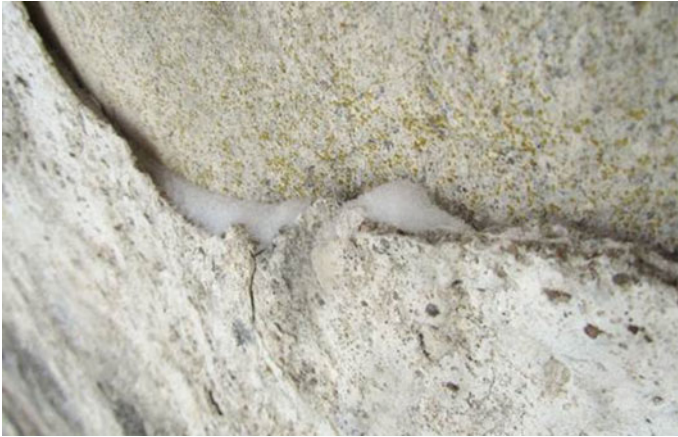
**Fig. 11** Damaged plaster contributes to wetting of the wall and accelerated corrosion of the building components

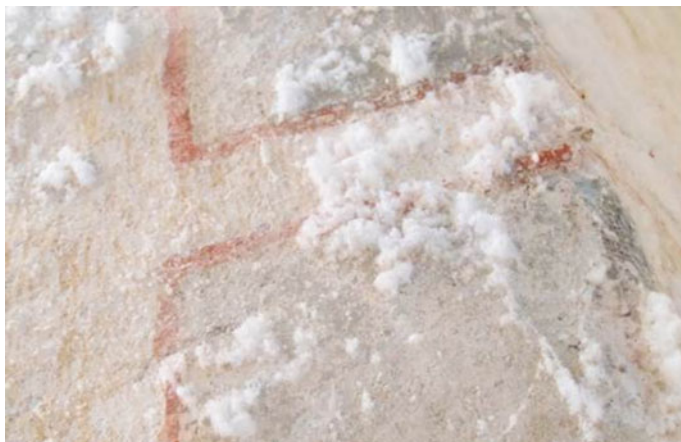
**Fig. 12** Efflorescence of salts can disfigure and ruin historic paintings

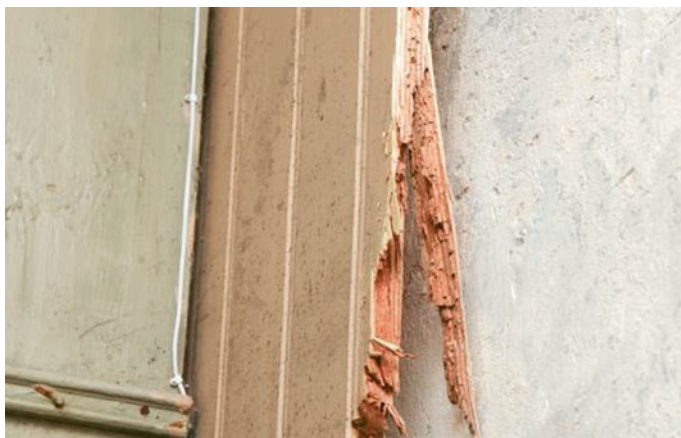
**Fig. 13** Rotten wooden cladding on the interior surface of the wall—covering up wet masonry wall causes high levels of relative humidity in the space between—suitable for mould and rot growth

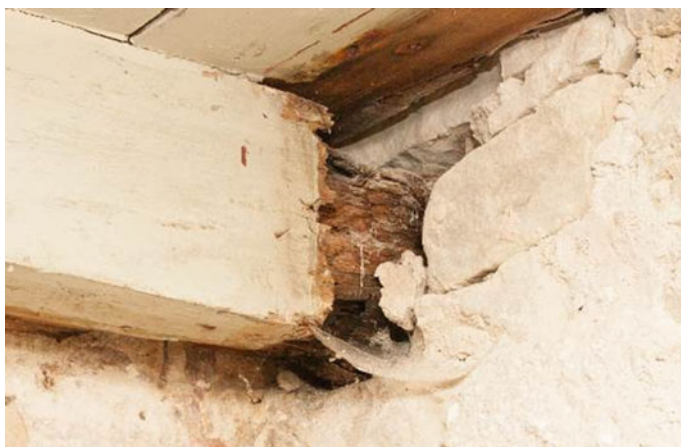
**Fig. 14** Wooden beam has become a suitable habitat for rot. Wooden cladding on the interior surface has speeded up the process

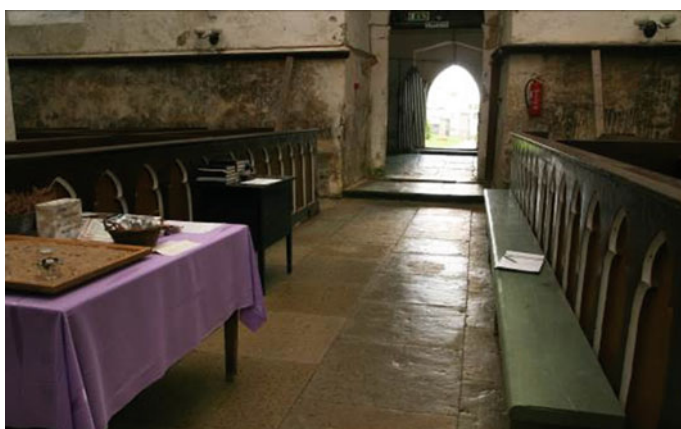
**Fig. 15** Condensation on cold surfaces due to ventilation with moist air is an important factor in wetting of the structures (note the reflection from the moist floor)

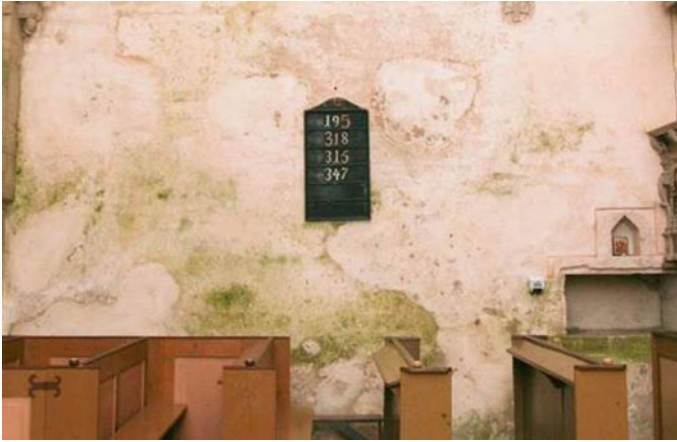
**Fig. 16** Flaking due to crystallization of salts and growth of pink bacteria and algae is also visible

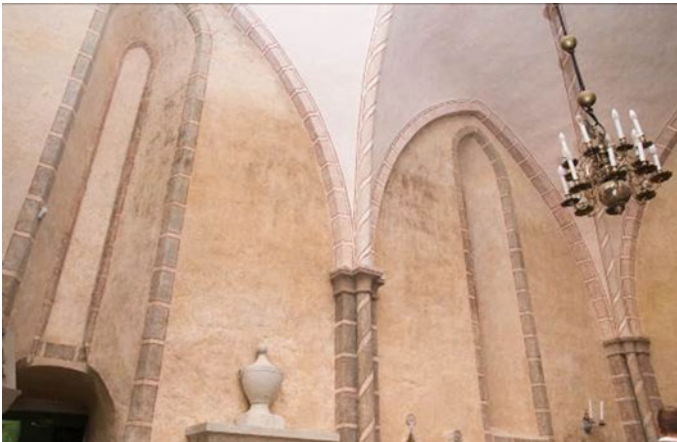
**Fig. 17** Growth of mould and pink bacteria can indicate moist surfaces and cause discoloration.

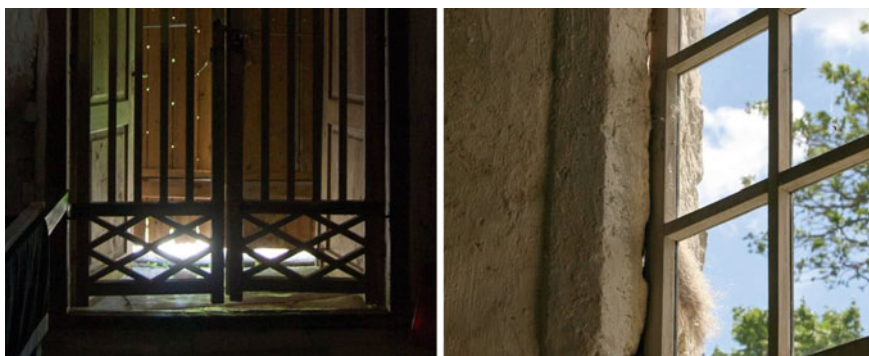
**Fig. 18** Airtightness of the openings was visibly low

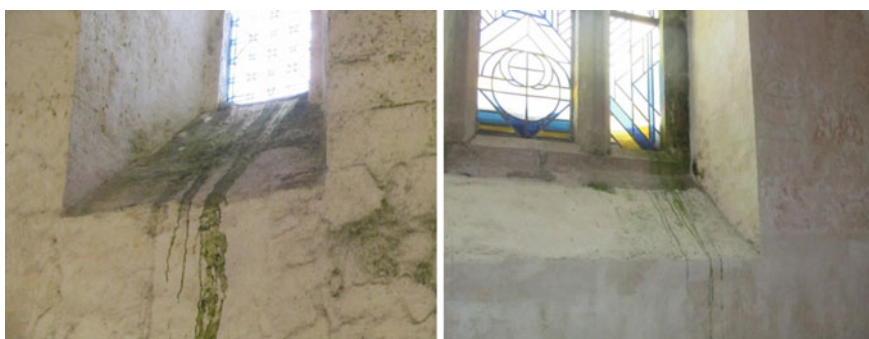
**Fig. 20** Results of surface condensation and leaks on the interior surfaces of window sills: growth of algae, salt efflorescence

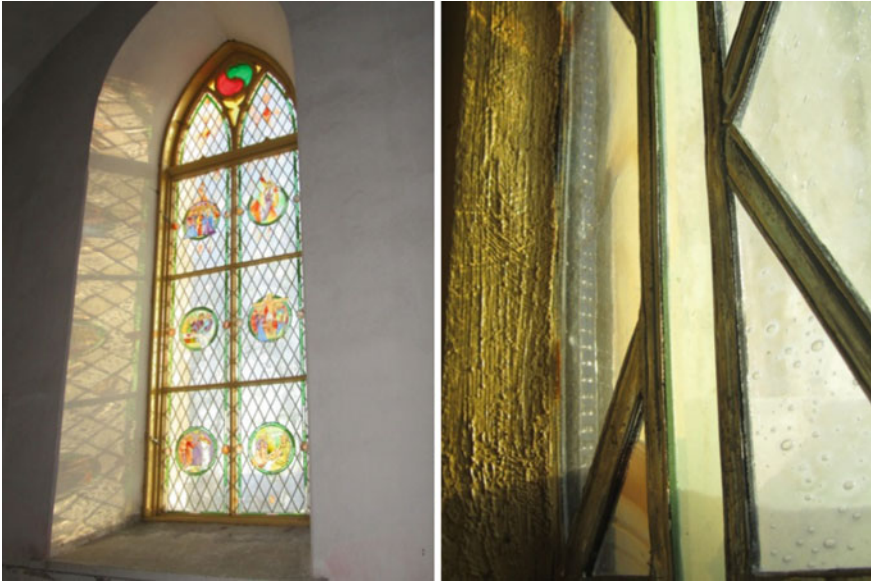
**Fig. 21** A modern glazing unit on the exterior side of the historic window preserves the original appearance while reducing thermal conductivity and air leakages

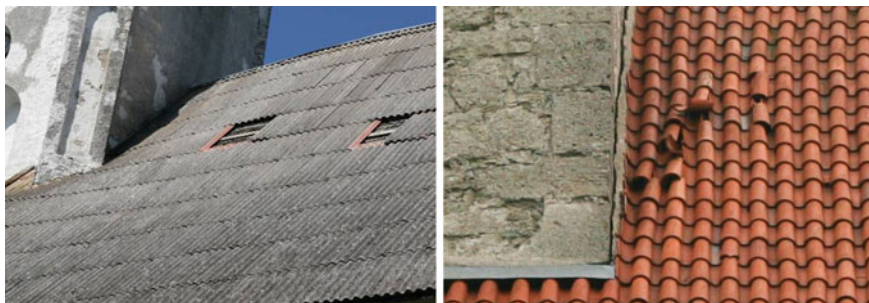
**Fig. 24** *Left* Loss of already one sheet of cement fibreboard roofing causes a serious problem—large area of the roof is exposed to the elements. *Right* Displaced monk and nun type of tiles cannot be refitted from the inside and due to the lack of specialized equipment, the leaks in rural areas might be exist for a long time

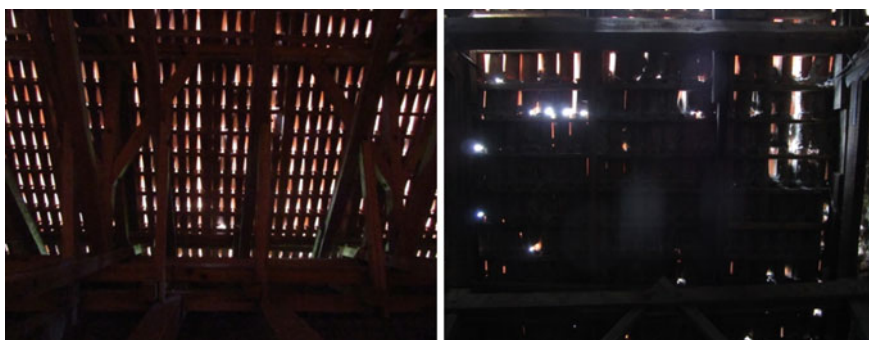
**Fig. 25** Tile roofs require underlayment—driving rain and snow cause additional moisture load on the building, underlayment also provides additional protection in case of loss of tiles

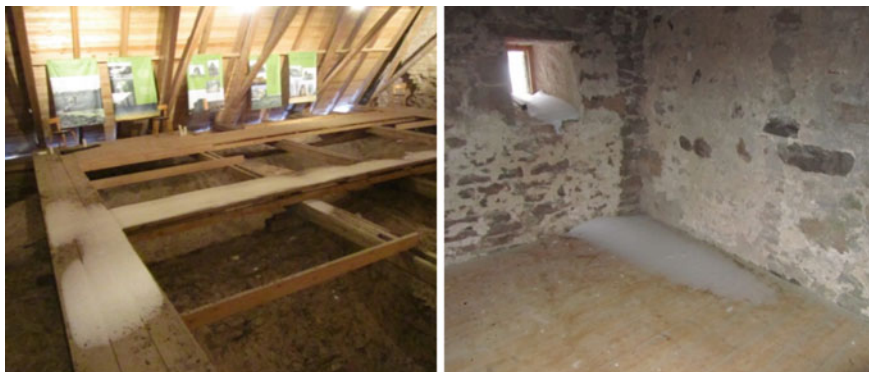
**Fig. 26** *Left* Snow has penetrated the roofing and will cause an additional moisture load on the structure once it melts. *Right* Snow has penetrated a window

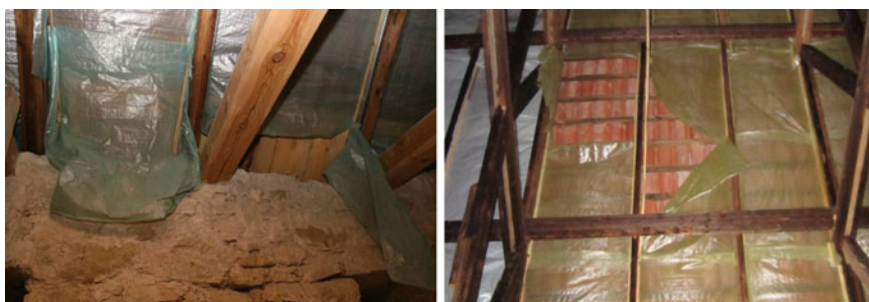
**Fig. 27** Underlayment added after the main roofing has lower reliability, safe drainage of water may also be difficult to accomplish

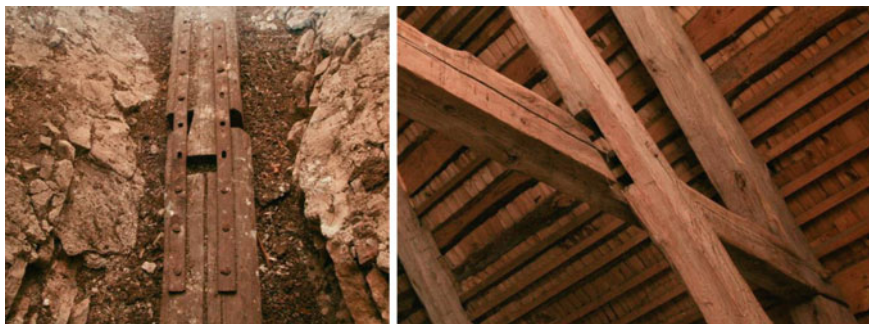
**Fig. 28** *Left* Deformed bottom splice causes a change in the truss geometry and possibly an additional lateral load on the walls. *Right* Connection with wooden pin needs urgent intervention

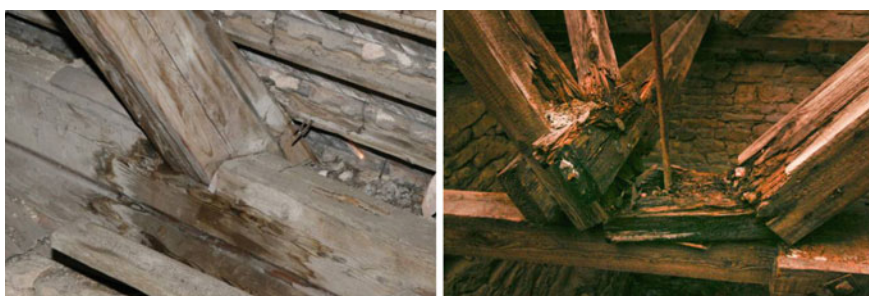
**Fig. 29** *Left* Leaks and contact with a moist wall cause wood decay. *Right* Almost fully decayed connection needs prompt repairs
