Building Pathology and Rehabilitation

João M.P.Q. Delgado *Editor*

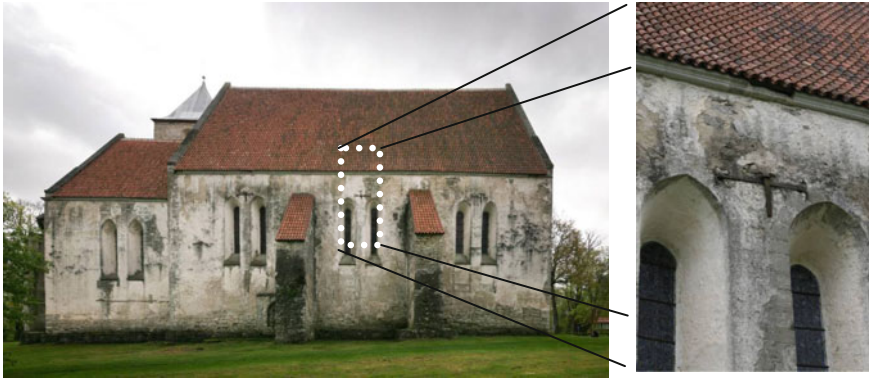
**Fig. 30** Narrow eaves without rainwater disposal systems offer no protection against driving rain while being a contributing factor to the wetting of the structure and also to the damage on the interior surface

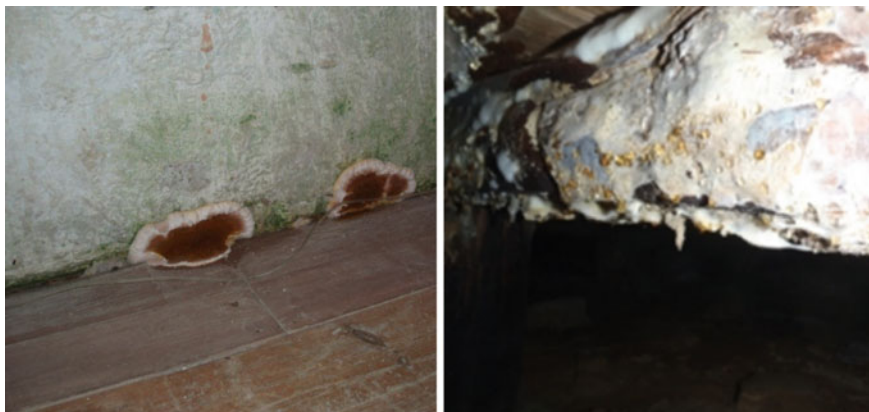
**Fig. 31** Wooden floor infected with rot causing fungi from the top (*left*) and below (*right*)

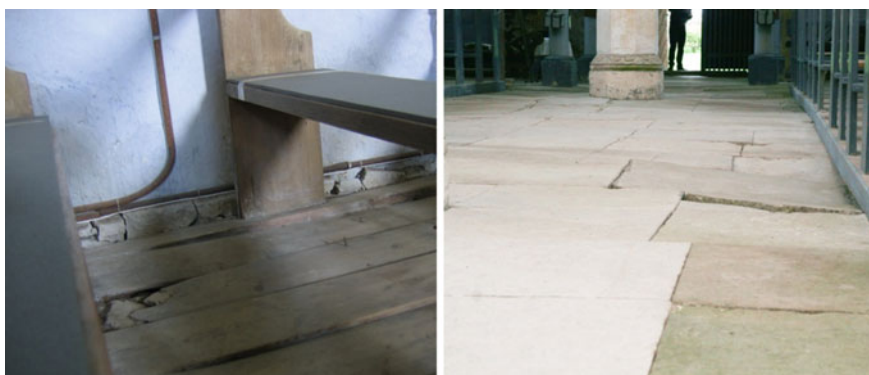
**Fig. 32** *Left* Wooden floor with fungal infection. *Right* Uneven stone floor

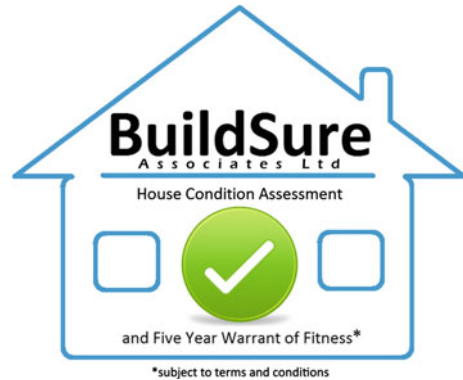
**Fig. 1** House condition assessment logo

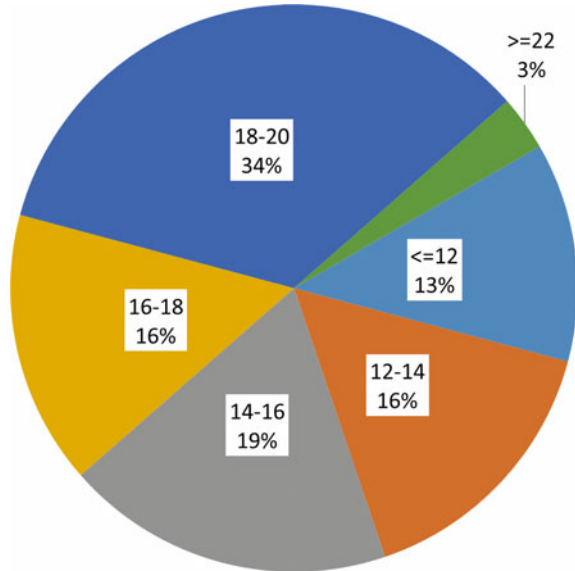
**Fig. 4** Debris resulting from a nearby stream flooding

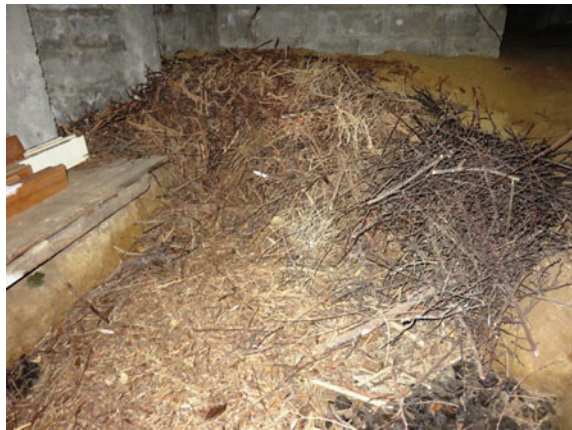
Although perhaps an extreme example, Fig. 4 shows the collection of debris found underneath a house. These had been deposited as a result of heavy rainfall leading to the nearby stream overflowing its banks, flooding neighboring properties. The flood waters carried the debris into the subfloor area, leaving behind the potential for decay or fire.

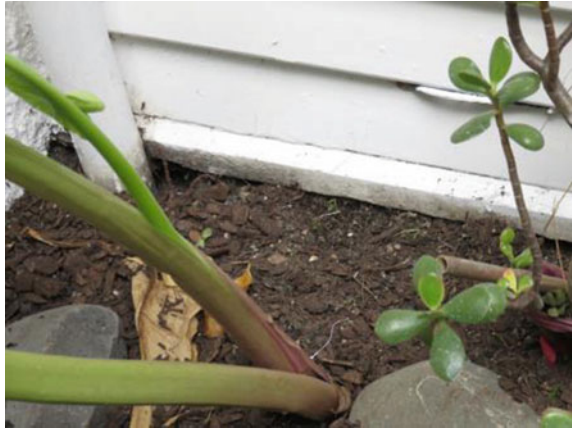
continuous high levels of dampness can delaminate, while timber (even when treated) will rot.

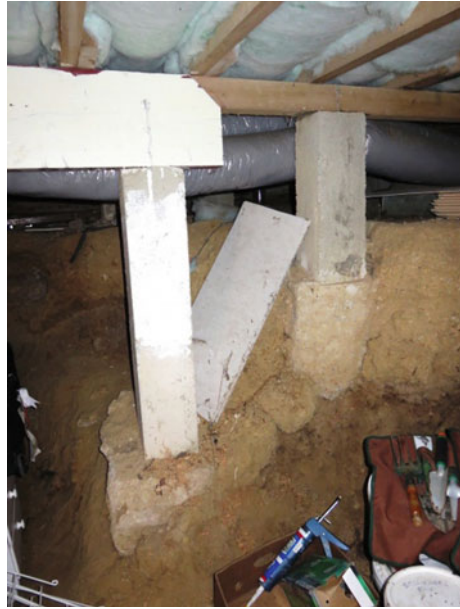
**Fig. 7** Untreated floor bearer rests on treated pile

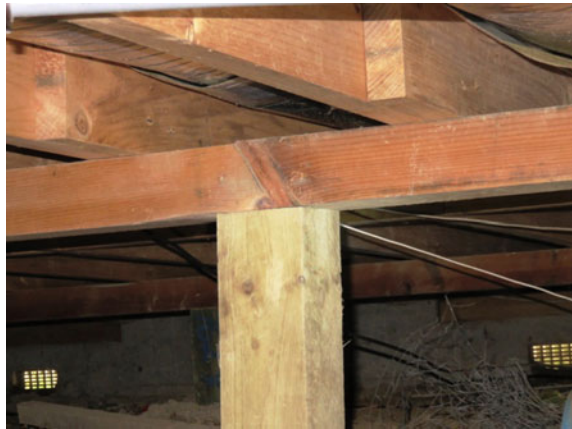
moisture levels as low as 20–25 %. Several fungi, including certain species of *Aspergillus* and *Penicillium*, grow at water activities as low as 0.70–0.80, which correspond to wood moisture contents of approximately 16 %.

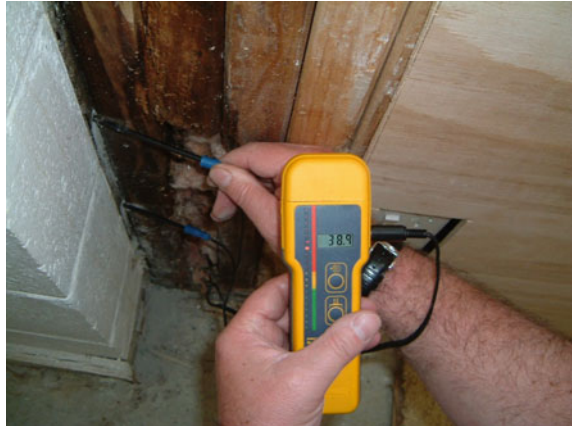
on the inside wall of all external openings, heads, jambs, and sills. Where any other areas visually indicate moisture ingress, then readings are also taken.

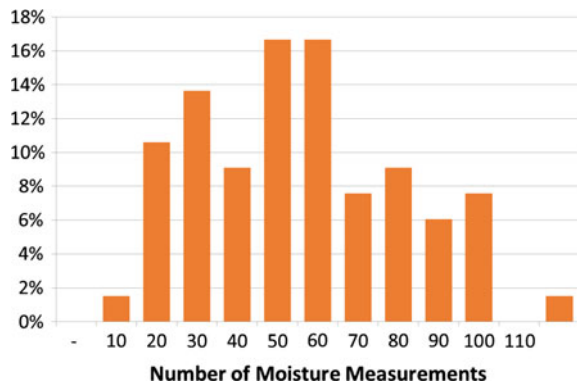
**Fig. 10** Houses with mean interior wall moisture level

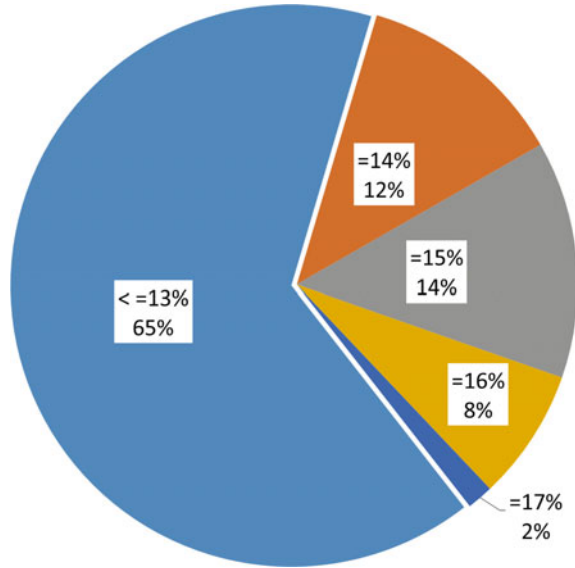
**Fig. 11** Houses with given maximum interior wall moisture level

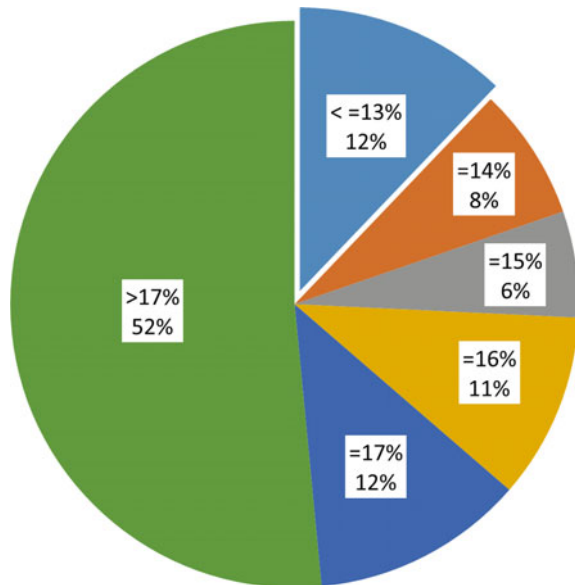
moisture level of below 13 %. In 88 % of the houses, the moisture level was so high in one or more locations as to give concern.

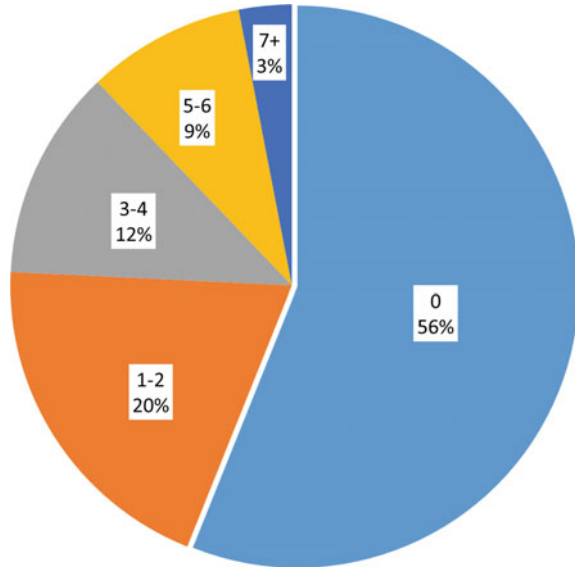
mold growth; and finally, degradation of finishes (paint/wallpaper, etc.). At around 16 % moisture content, fungal attack is likely to occur, with the possibility of danger to occupant’s health (Andrews 2002; Lstiburek 2002). These expectations are matched by the experience of house surveyors. Figure 11 shows this was found nearly a quarter (23 %) of the inspected houses.

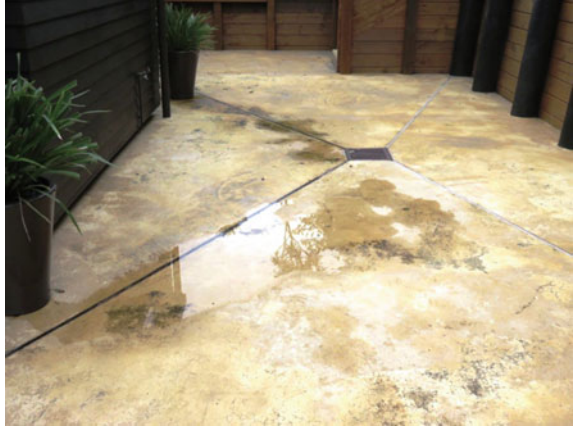
shown in Fig. 4. If regular flooding is likely, then exterior water management work is required.

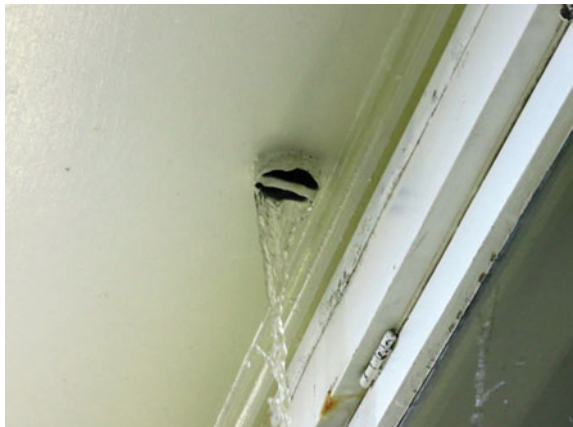
**Fig. 15** Guttering blocked by vegetation

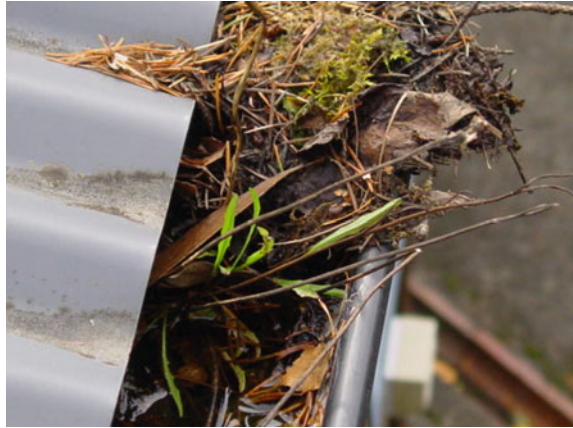
**Fig. 16** Gutter joint failure

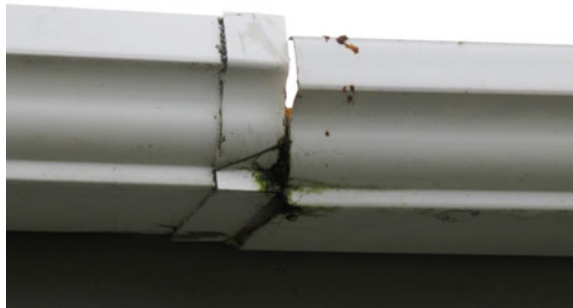
Overhanging vegetation, including trees and creepers, can lead to debris being left in the gutter which may not be either readily visible or removable. Figure 15 shows a gutter blocked by vegetation from nearby trees and plants. Regular maintenance is required; otherwise, the trapped water can lead to corrosion and ultimate failure of the gutter or to overflowing and the delivery of stormwater to areas ill-equipped to deal with it.

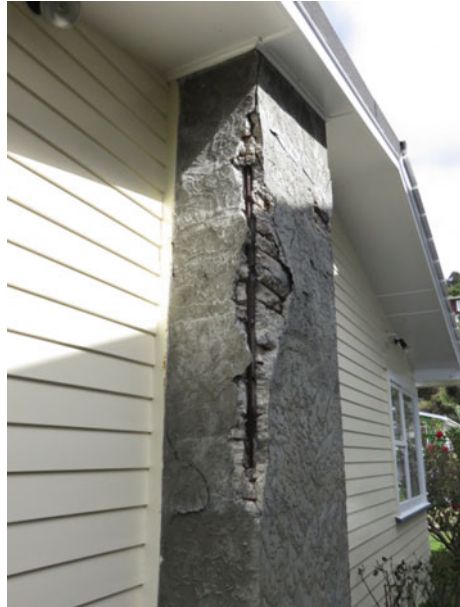
steel reinforcing rusting. As the rust occupies a greater volume than the steel from which it is originated, the expansion can push off the external concrete, exposing the steel and creating a cycle of self-destruction.

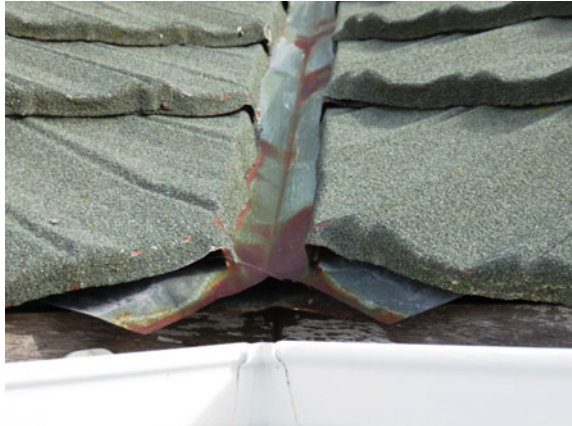
### **6.7 Fungal, Plant, and Animal Impacts**

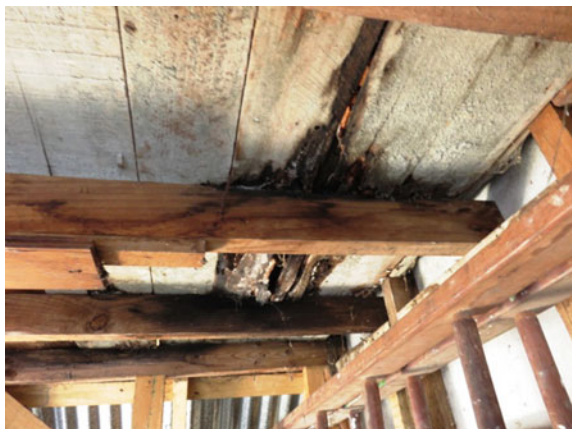
**Fig. 20** Weatherboard decay probably due to ground moisture

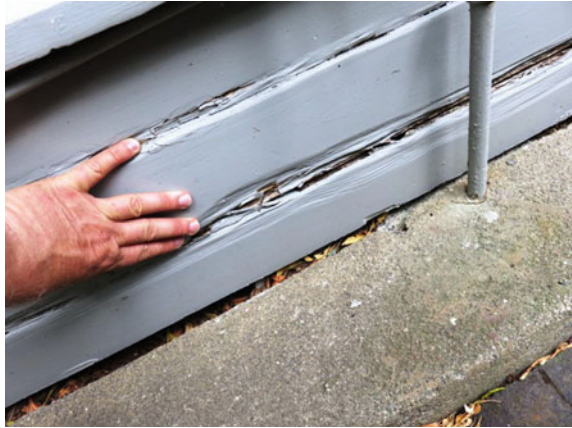
borer has a similar impact to woodworms found in other countries. The flying insect lays its eggs inside timber, originally native timbers, but it adapted well to imported exotic timber. When the eggs hatch, the grub bores its way to the surface before starting the cycle again (BRANZ Ltd 2000; New Zealand Technical Correspondence Institute 1980). Figure 21 shows the lighter colored “frass” which has fallen from the grubs’ flight holes.

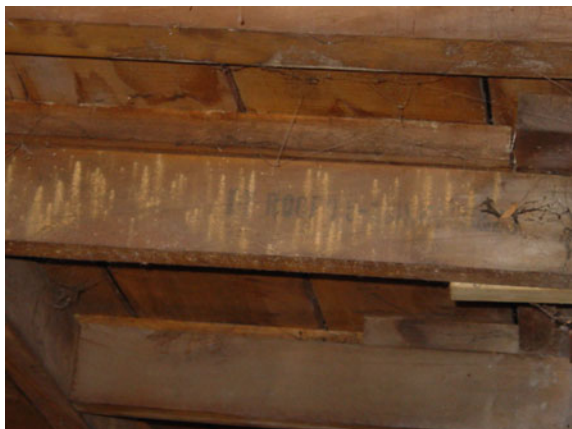
**Fig. 22** Insect damage revealed by floor sanding

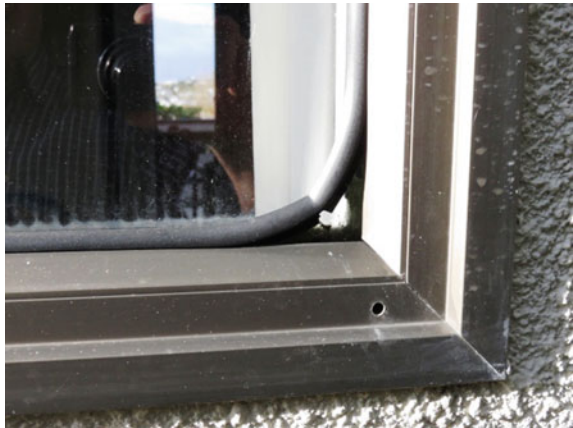
**Fig. 24** Poor timber joinery maintenance

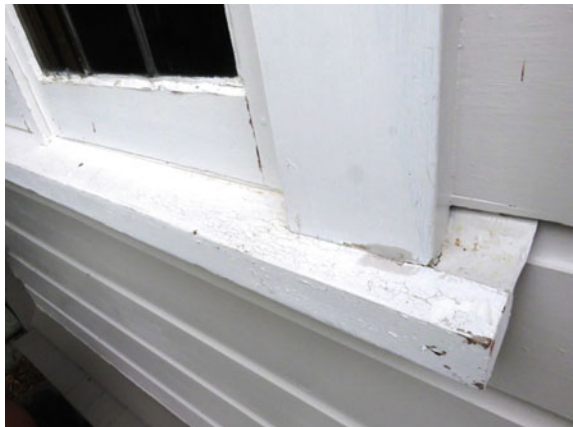
to UV, wind, salt, etc. Where maintenance has been deferred or ignored, cracks between the timber pieces can open or the putty holding the glass in place can fail. An early repair can minimize costs, but eventually, the failure can reach a level where the only solution is complete replacement of the joinery.

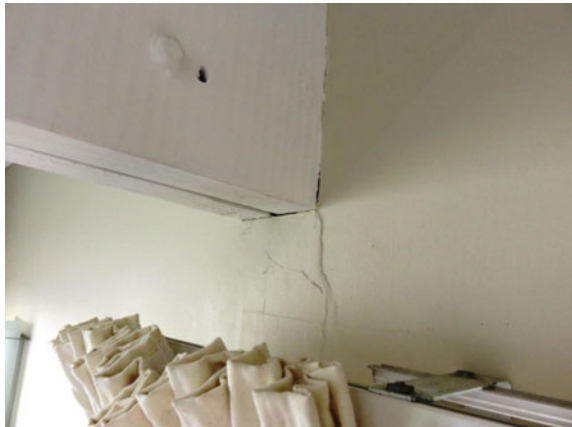
**Fig. 26** Crack in monolithic cladding allows water ingress

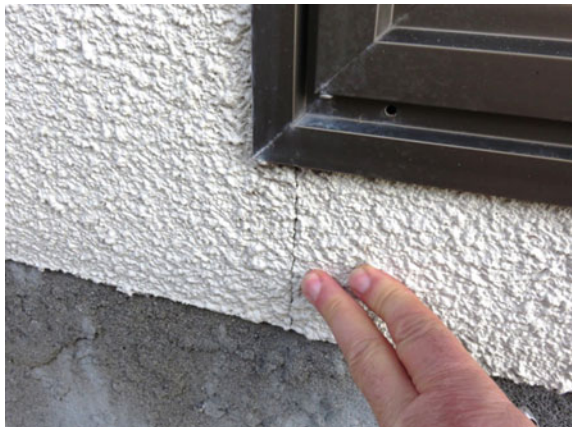
knowledge and skill not just of the material but also the use of flashings and the conditions likely to be created behind the panels. Over the 1990s to early 2000s, this led to the so-called leaky buildings problem. Large numbers of houses and apartments built during this time are expected to require significant investment to correct the problem (Hunn et al. 2002). This part of the inspection can be essential for the inexperienced purchaser.

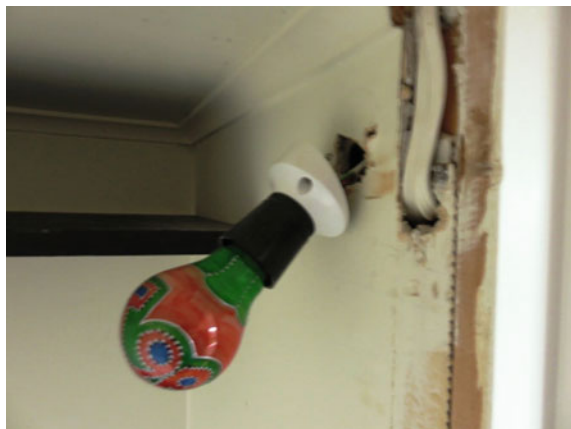
**Fig. 28** Three generations of wiring insulation—only one is safe

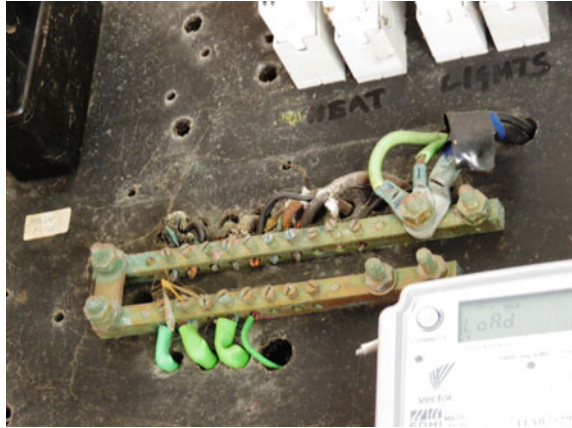
Figure 28 shows a close-up of an electrical switchboard in an older house with three generations of electrical cable visible. The older rubber-insulated cables need to be replaced to reduce the risk of fire.

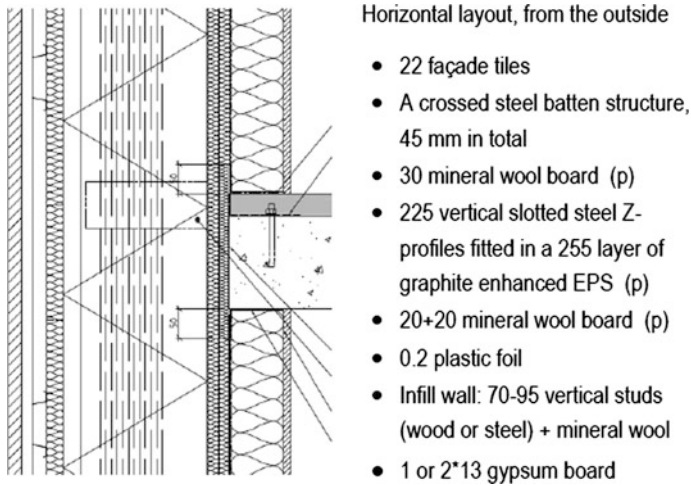
**Fig. 2** Design of the wall element System B. Picture from Martinsson (2012)

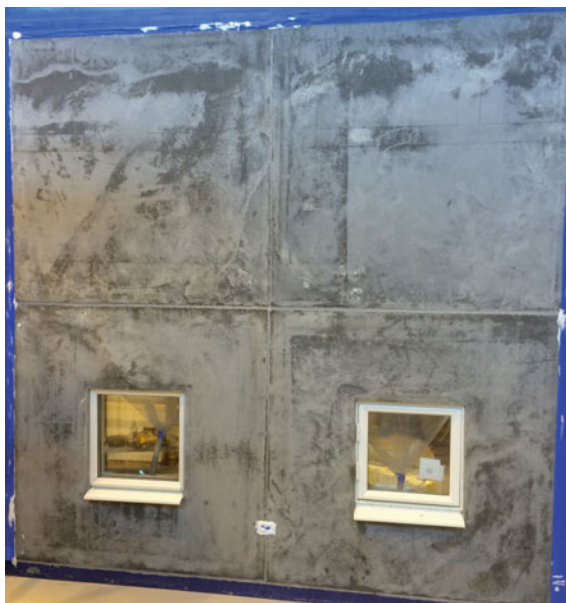
## 5 Experience from Using the Prefabricated Systems on Site

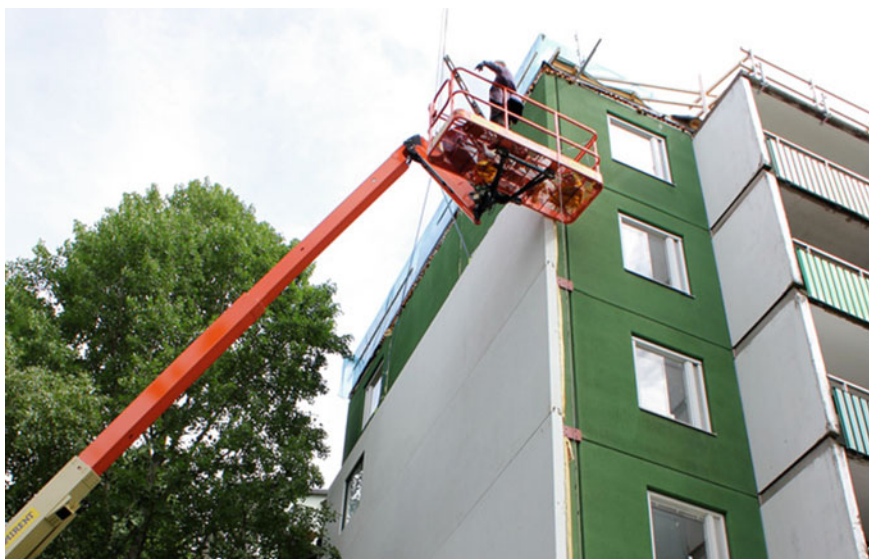
**Fig. 5** Mounting of prefabricated elements was done with crane and sky lift

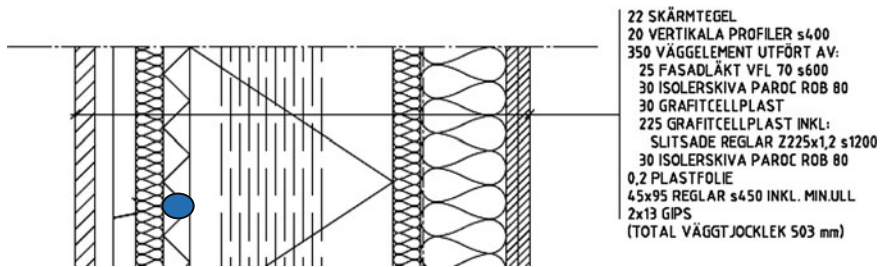
Fig. 10 Placement of gauges measuring relative humidity and temperature

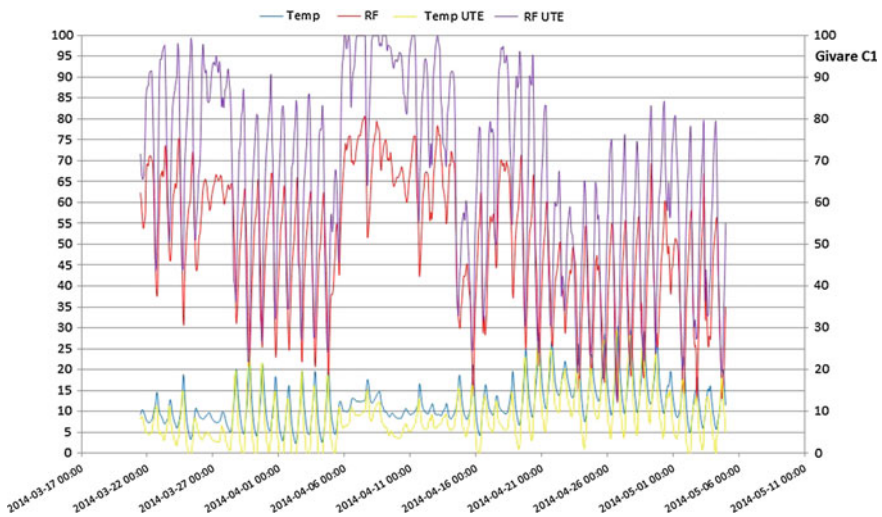
Fig. 11 An example of measured RH and temperature in the prefabricated wall element

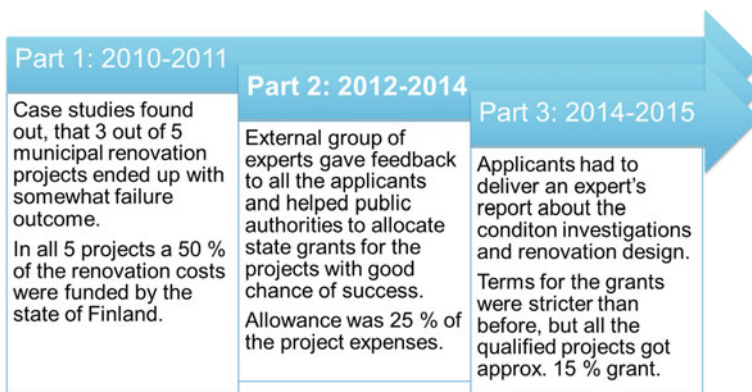
**Fig. 1** Timeline of the research and development of the state grant procedures in Finland

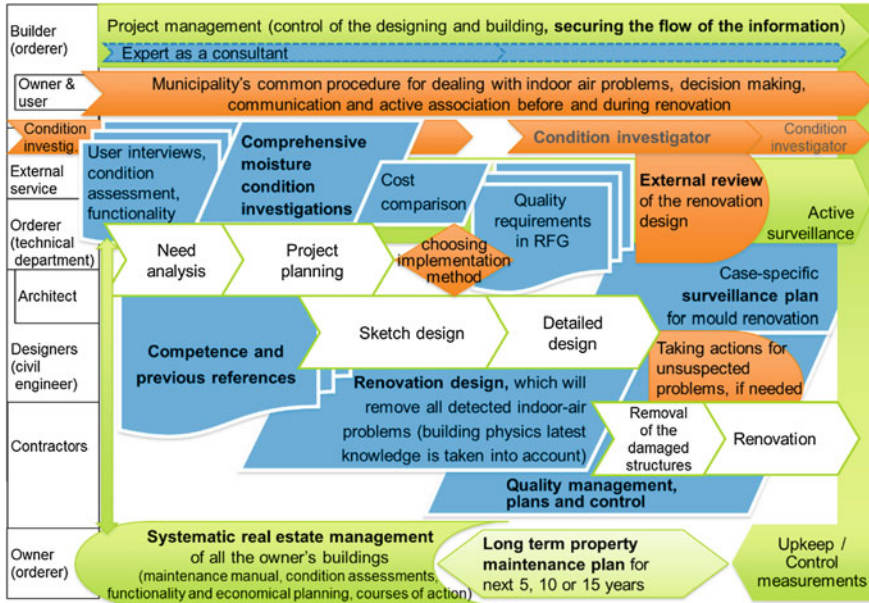
Fig. 3 Phases of the successful mould renovation

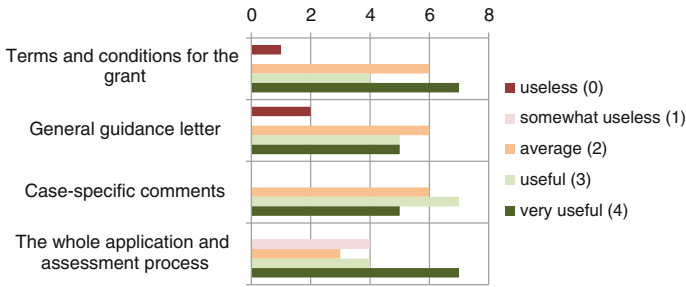
**Fig. 4** Interviewees’ opinions about the different phases and the entirety of the application process. Scale is from 0 to 4, and 18 responses was collected. Length of the bar indicates the amount of opinions to the specific subject

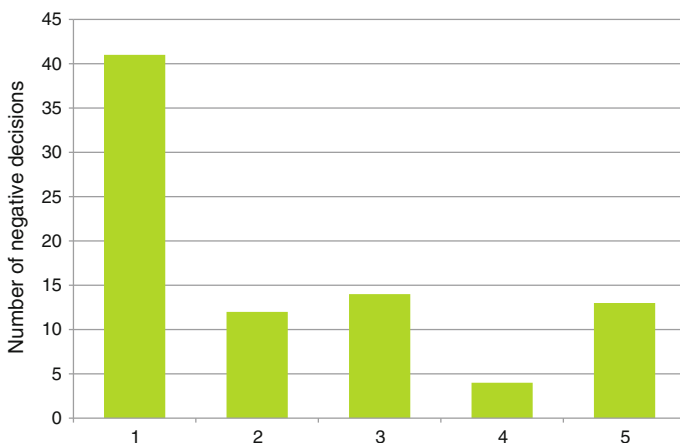
Fig. 5 Reasons for rejecting applications

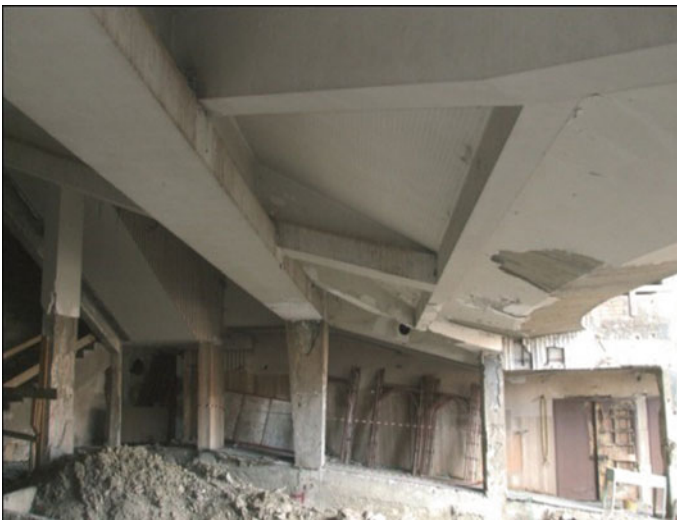
**Fig. 5** The stall area view

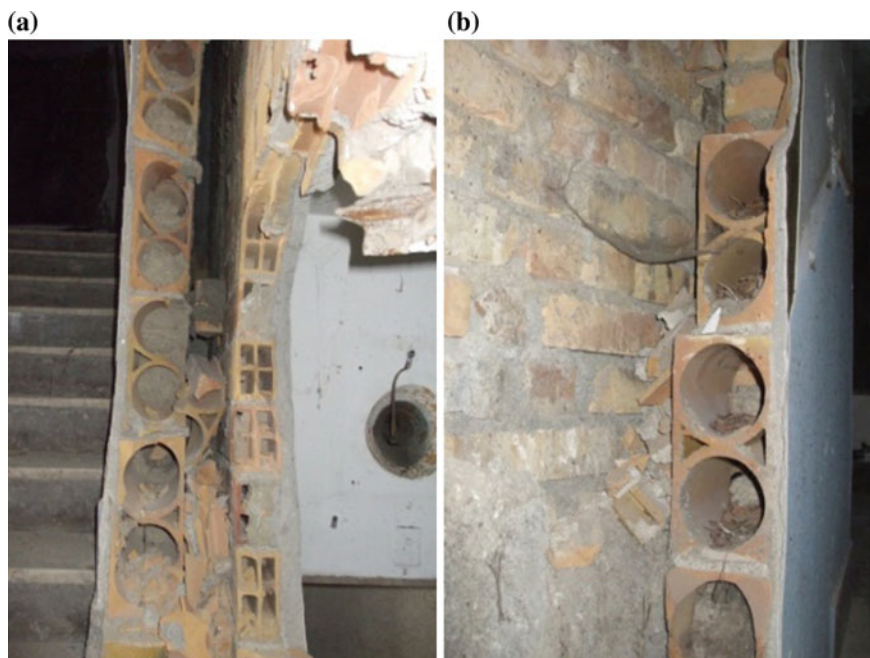
**Fig. 7** Walls with “goggles”. **a** Wall with “goggles” type 1; **b** Wall with “goggles” type 2

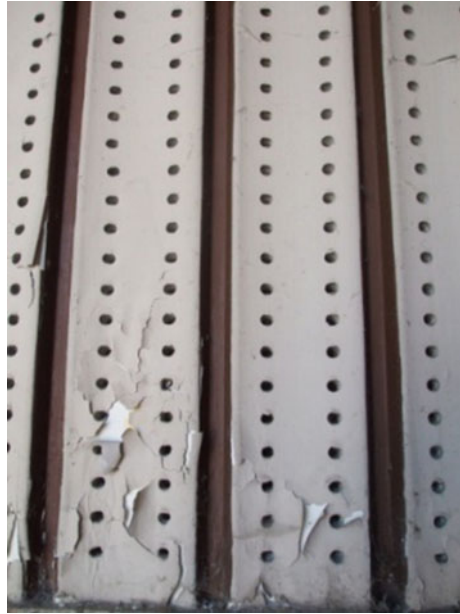
The horizontal elements, such as roofs and floors are made partly of hollow-core concrete and partly of reinforced concrete slabs, which were found in the steps of the circle and in the vaulted ceilings. The material survey made it possible to identify the different types of brick used, the various types of masonry adopted and the thickness of some walls that could not be measured easily. As for the cladding and finishing materials, it is important to note the acoustic panels, which can be divided into grooved, perforated panels in pink plaster, used for cladding the walls inside the theatre, and other grooved panels in blue plaster, in the foyer that were fixed onto a wooden framework (Fig. 9).

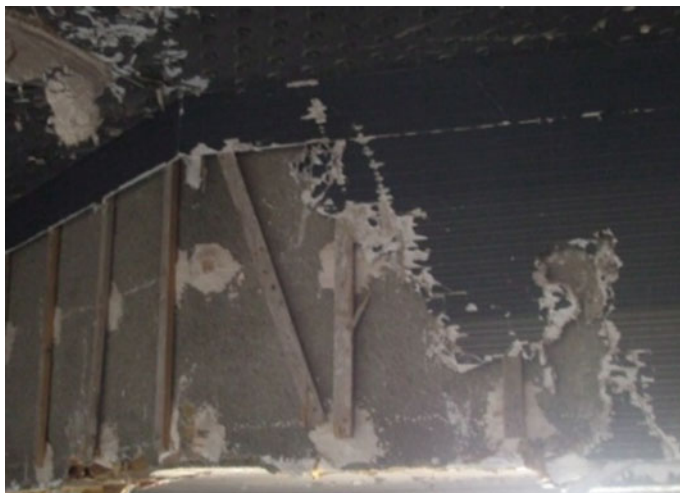
**Fig. 9** Acoustic grooved panels in blue plaster

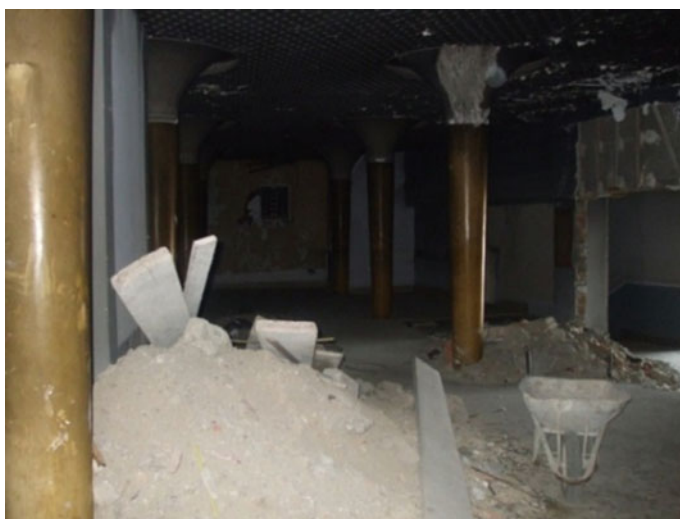
**Fig. 10** Degradation of the foyer

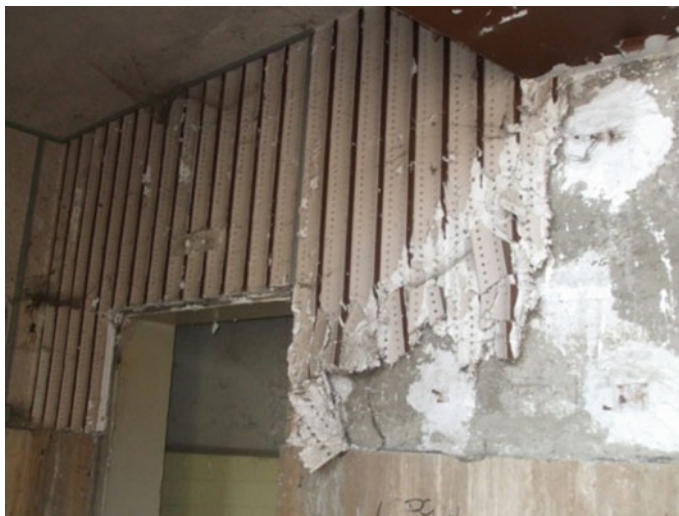
**Fig. 11** Degradation of walls in the circle area

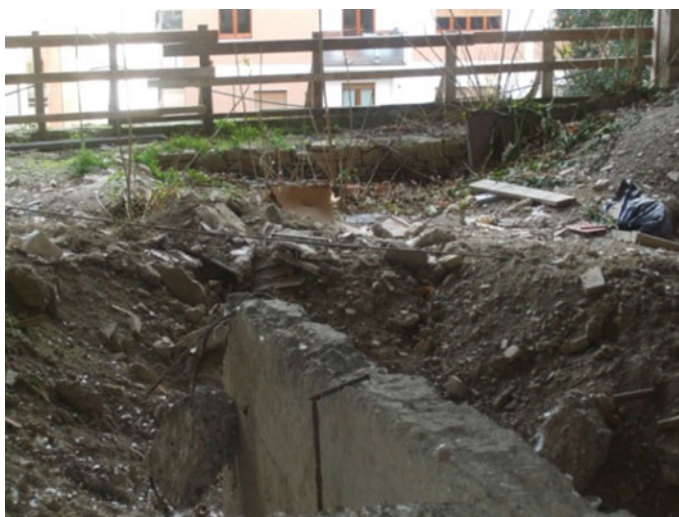
**Fig. 12** Degradation of the stall area

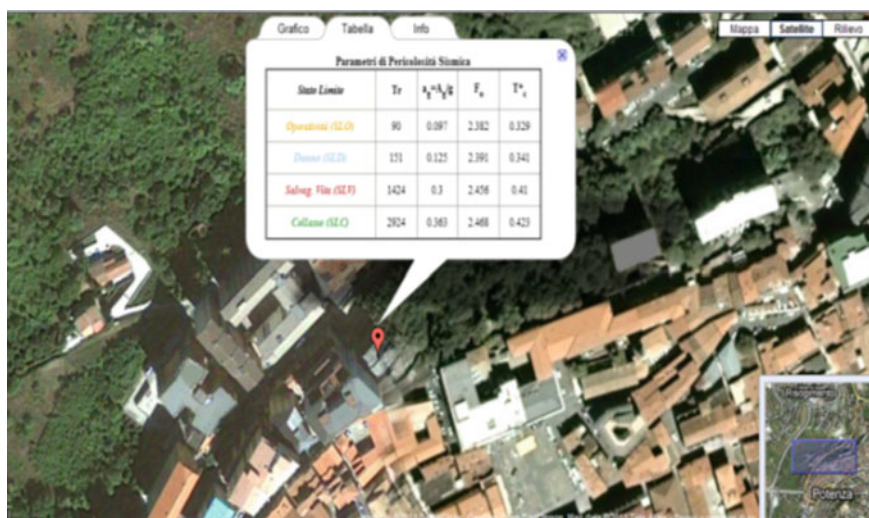
Fig. 15 Parameters of seismic hazard of the Cinema Ariston

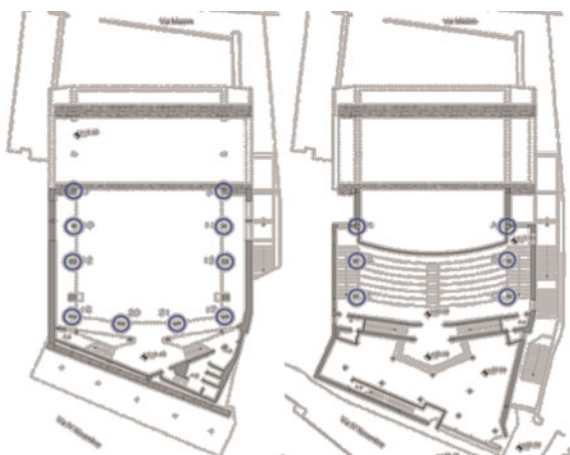
**Fig. 17** Cladding of the structural elements in reinforced concrete

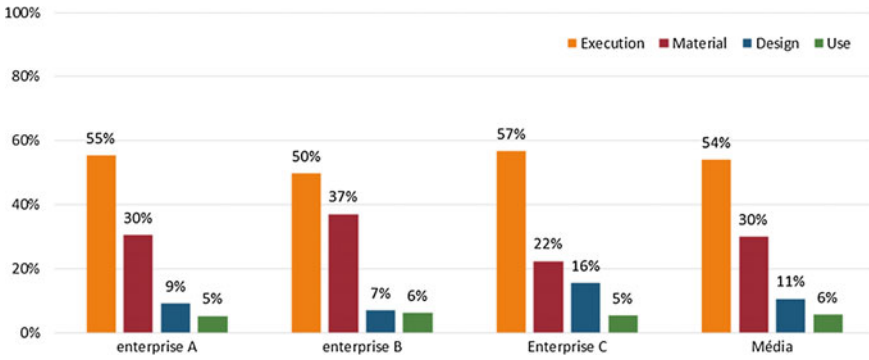
**Fig. 1** Most likely causes of the plumbing system pathologies

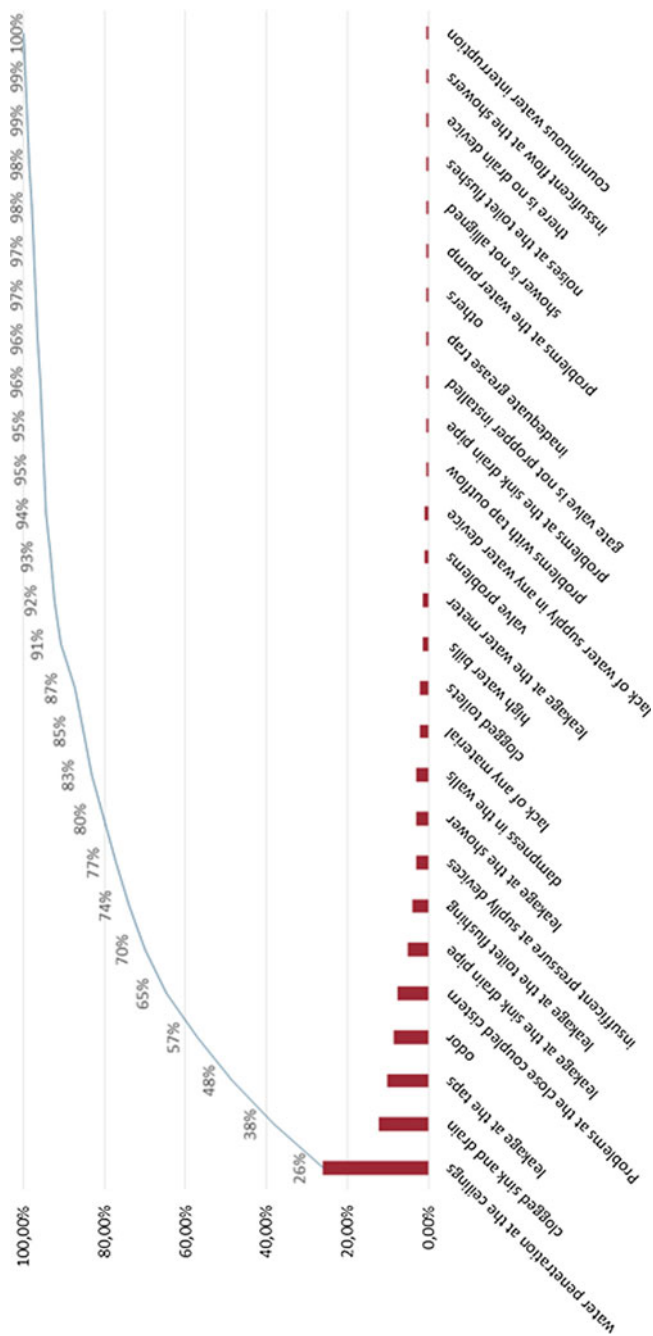
Fig. 2 Main reported requests related to hydraulic and sanitary facilities

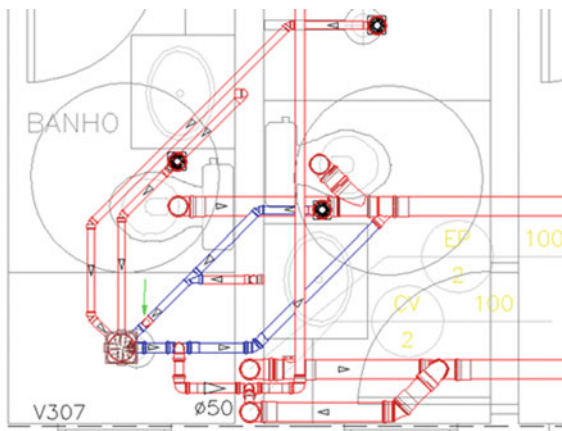
might be supposed. One of the major factors that can lead to frequent clogging is the connections used in pipes and deviations from the prescribed slope.

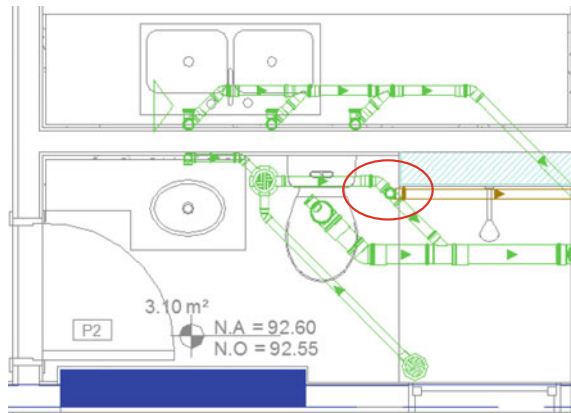
This could easily be avoided by replacing the use a  $45^\circ$  junction in all horizontal deviation, as shown in Fig. 6.

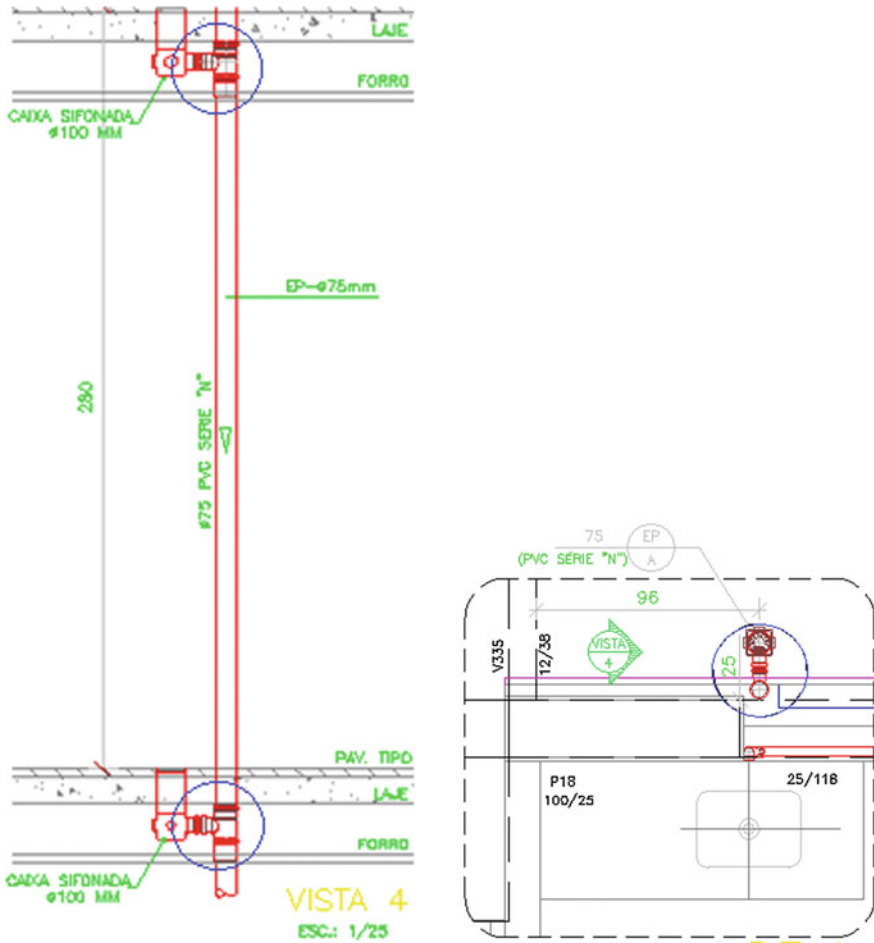
Fig. 7 Detail of siphoned box and sewage downpipe connection

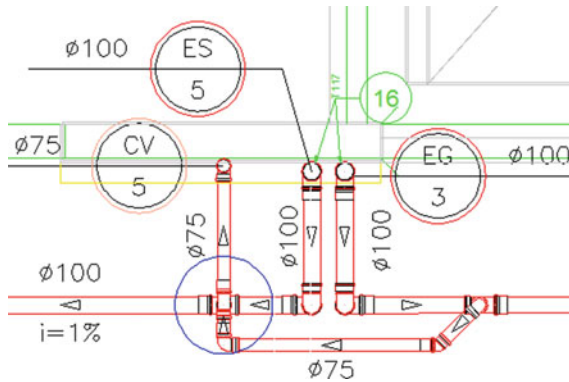
**Fig. 11** Ventilation branch at the different level of the sewage pipes

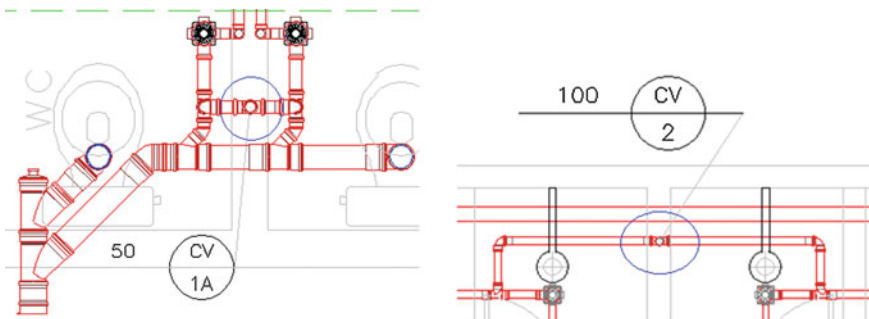
**Fig. 12** Inappropriate ventilation loop

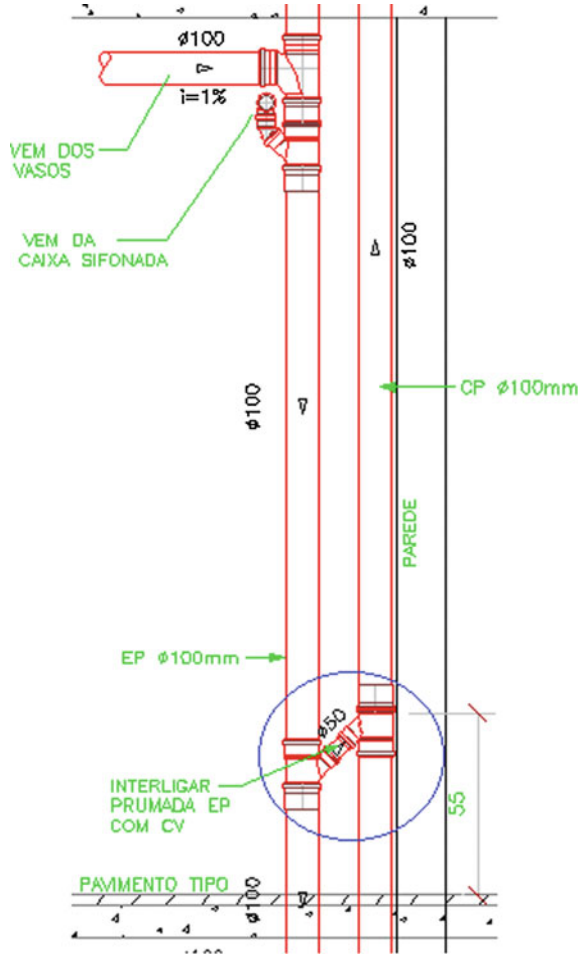
**Fig. 15** Connection of the stack to the venting system according to the standard. Source ABNT (1999)

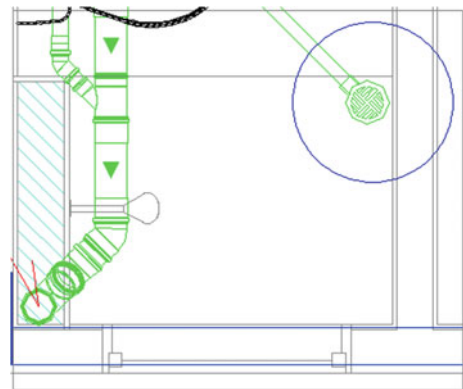
### 3.6 Analysis of the Results

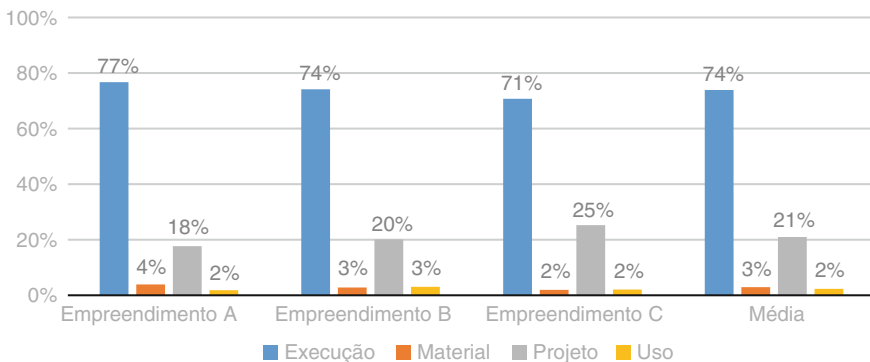
**Fig. 18** Most likely causes of the plumbing system pathologies after reported reclassification

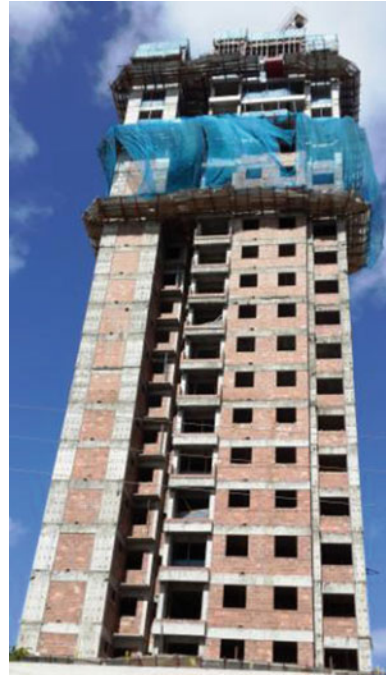
In contrast, wall partition masonries suffer from the reduced capacity to absorb deformations, resulting from the increased rigidity with the advent of more resistant and larger hollowed blocks as well as by the connection with the structure.

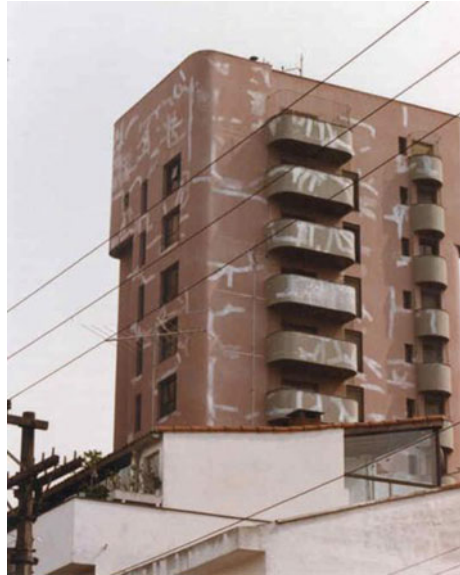
point of view, many of the user requirements are compromised: impermeability; the hygrothermal comfort; the visual comfort; the acoustic comfort; the tactile comfort and durability, as analysed by Martins (2010), Oliveira et al. (2010) and Silva and Abrantes (2007).

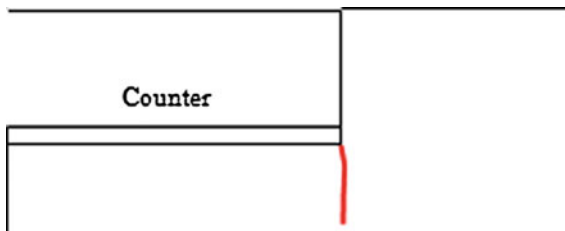
**Fig. 6** Wall of the bathroom door and wall on the left

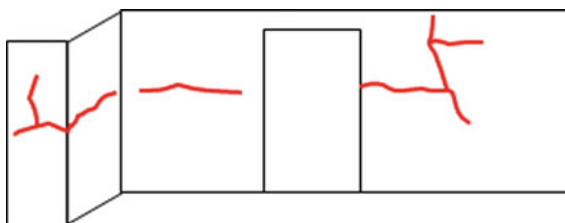
The cracks verified in the bathroom shafts are manifested on the mortar coating and also on the masonry partition walls. It was possible to verify in this region (Fig. 13), that the mortar coating was 5 cm thick [contrary to standard specifications (Costa 2012)], being the wall supported on a very deformable slab.

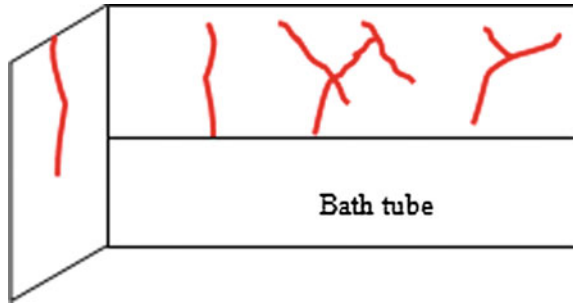
**Fig. 8** Division wall living/bedroom

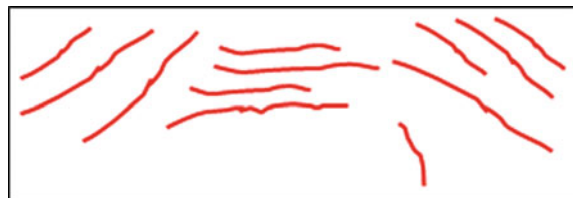
**Fig. 11** Wall of the air conditioning room (mezzanine)

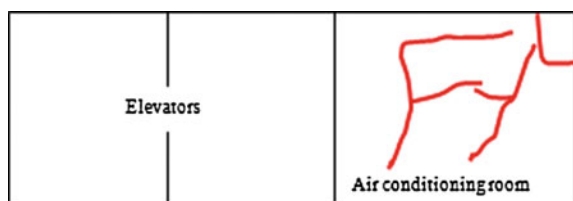
**Fig. 12** Wall of the business center (mezzanine)

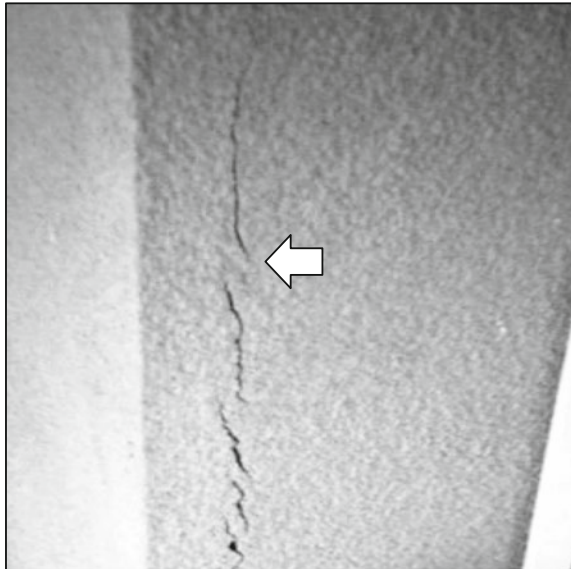
According to Franco et al. (1994), slabs with thickness inferior to  $C/60$  and beams under  $C/16$  high are considered highly deformable elements, where  $C$  is the length of the wall.

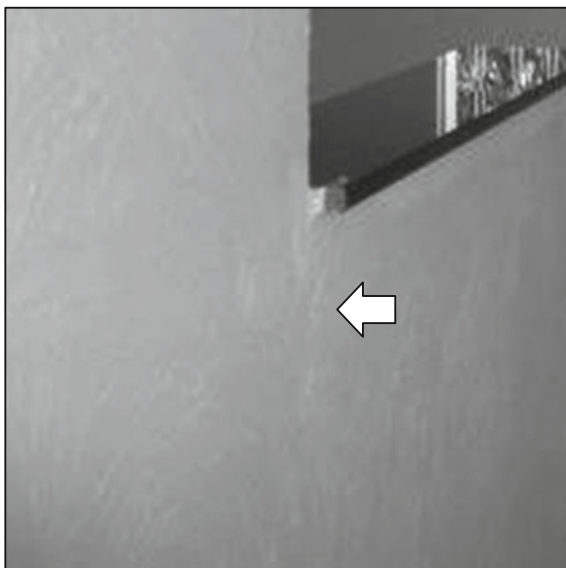
Cracks with mapped configuration observed in coatings above the bath tubs were probably caused by the retraction of mortar. The humidity loss at early stages triggers retraction movements, which generate internal traction stresses and hence, the fissuring of the coating.

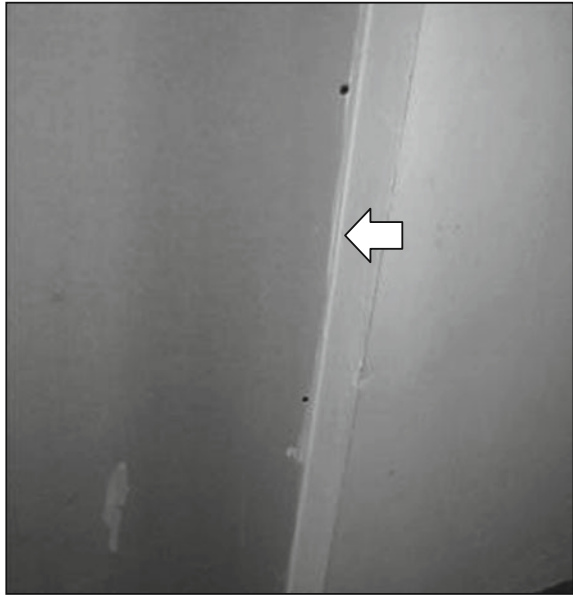
**Fig. 16** The vertical crack on the corner of doors in plasterboard walls (not original—just for example)
