Building Pathology and Rehabilitation

João M.P.Q. Delgado *Editor*

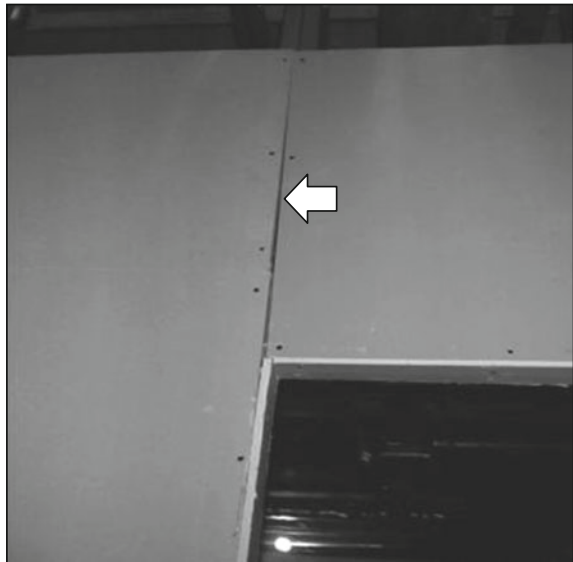
mezzanine, on the walls of the air conditioning business center rooms, are slanted and with analogous orientation, suggesting the occurrence of a more pronounced deformation on the opposite side of the elevator pillars, which are elements of high rigidity.

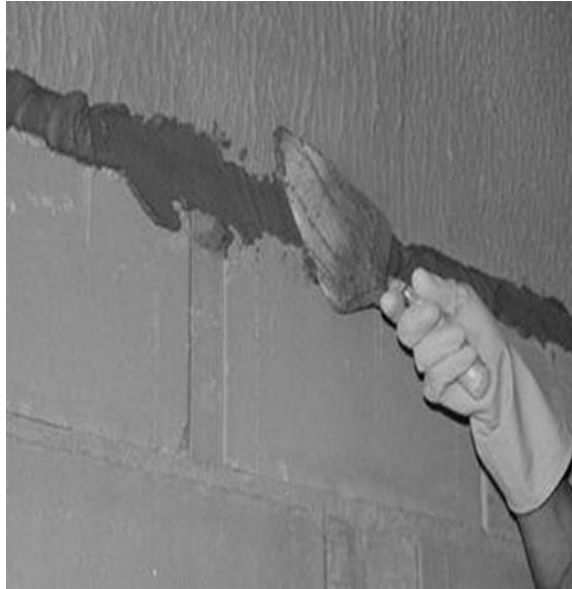
Additionally, in this region the wall is supported on a very deformable slab (10 cm thick).

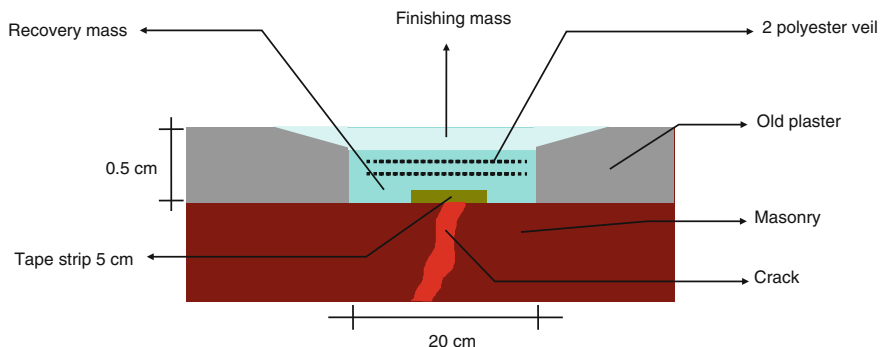
**Fig. 18** Overview of the recovery procedure

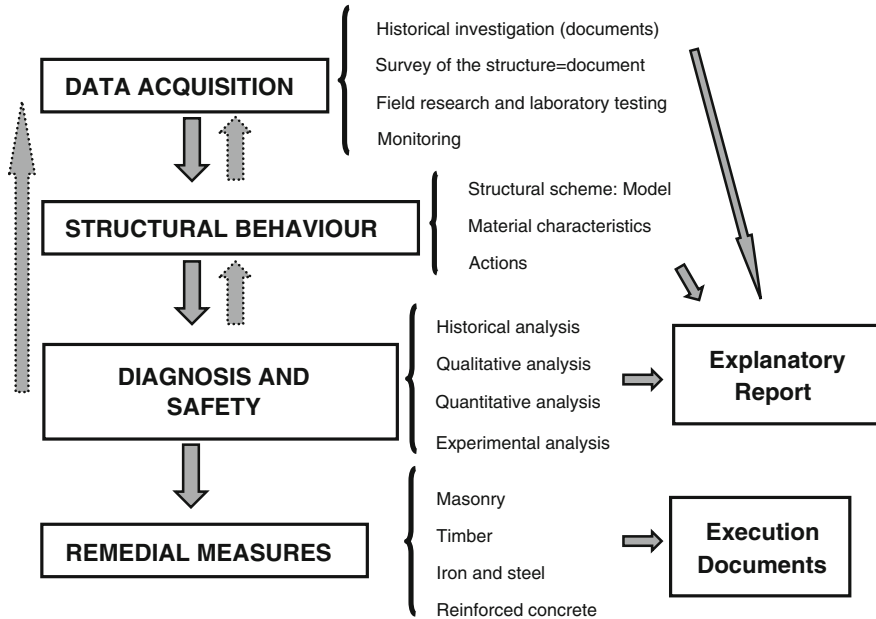
Fig. 1 Flowchart with methodology for structural interventions (ICOMOS 2005)

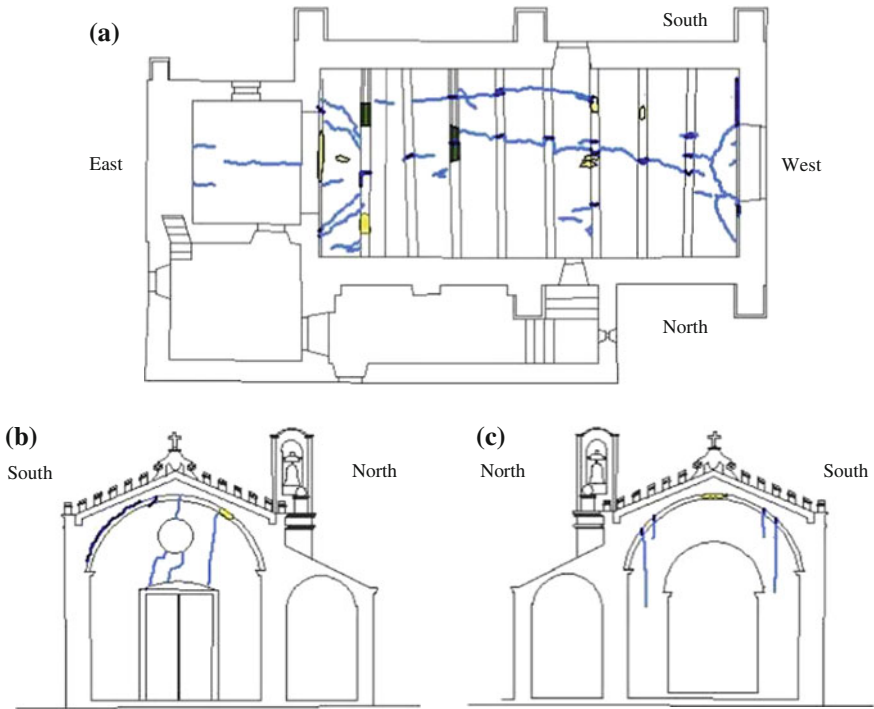
**Fig. 5** Crack pattern (interior view): **a** barrer vault of the chancel and nave; **b** main façade; **c** chancel arch

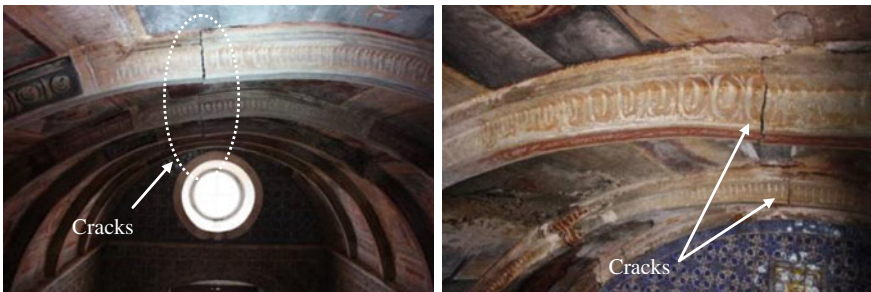
**Fig. 6** Cracks at the barrel vault of the nave

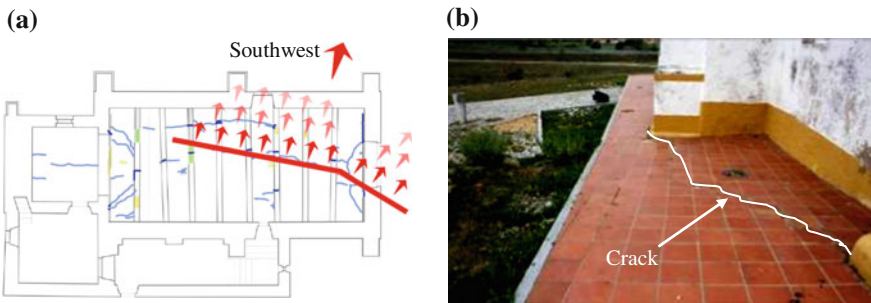
**Fig. 7** Deformation of the external floor: **a** direction of the deformation; **b** detail of the crack on the external floor

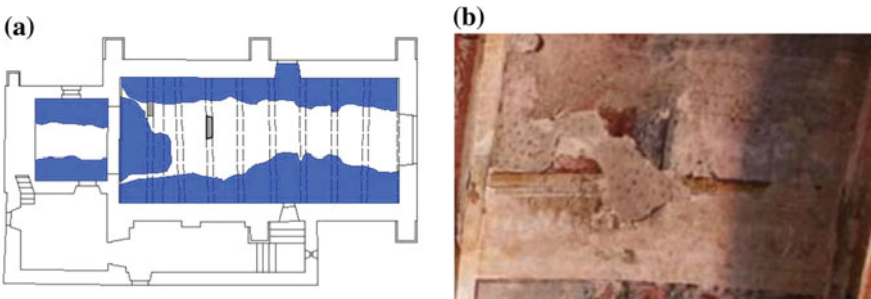
**Fig. 8** Damp patches: **a** barrel vaults of the chancel and nave; **b** detail of the deterioration of the paintings at the ceilings of the nave

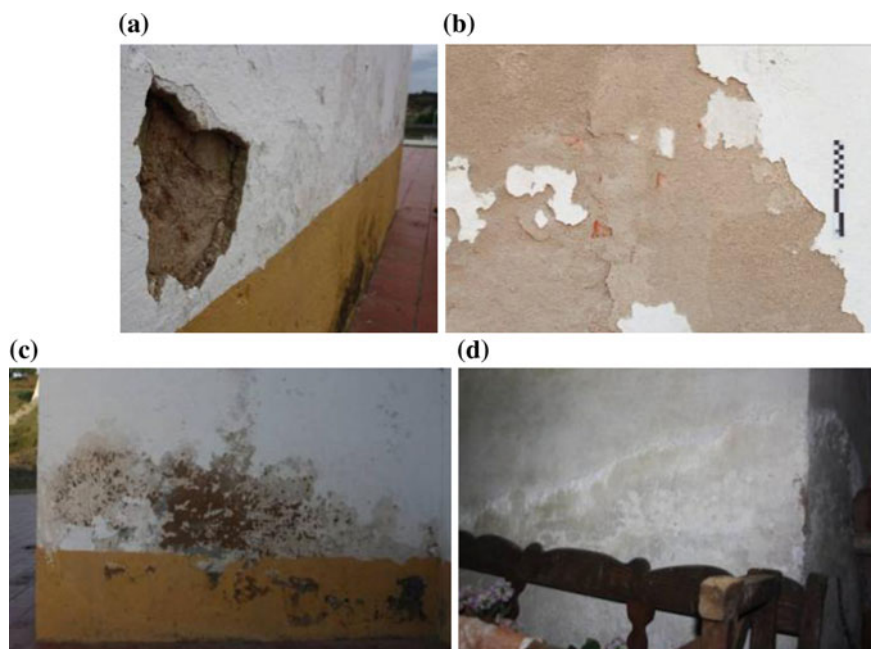
**Fig. 9** Damage on the walls: **a** plaster detachment; **b** deterioration of the plaster and paint; **c** rising damp at the external surface; **d** rising damp at the interior surface

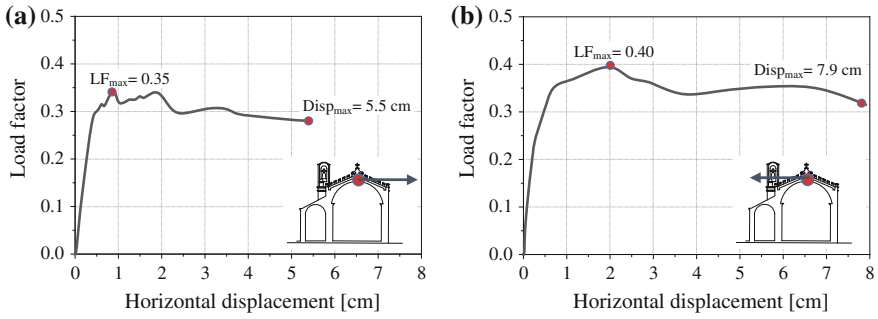
**Fig. 14** Capacity curves for the pushover analysis in the transversal direction (X direction): **a** +X direction; **b** -X direction

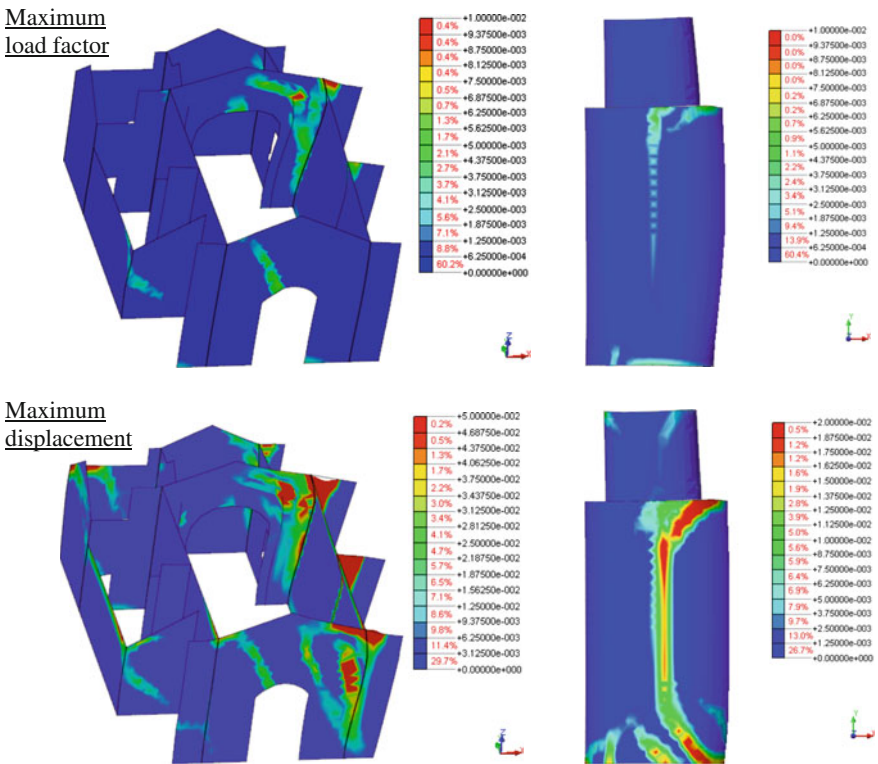
**Fig. 15** Tensile principal strains for the pushover analysis in the +X direction

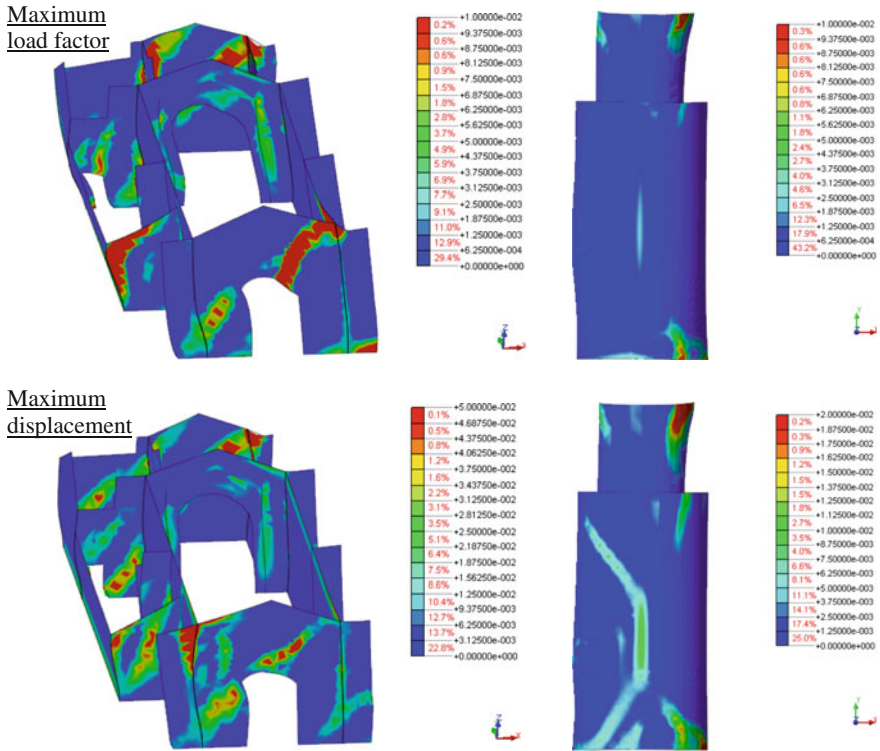
**Fig. 16** Tensile principal strains for the pushover analysis in the  $-X$  direction

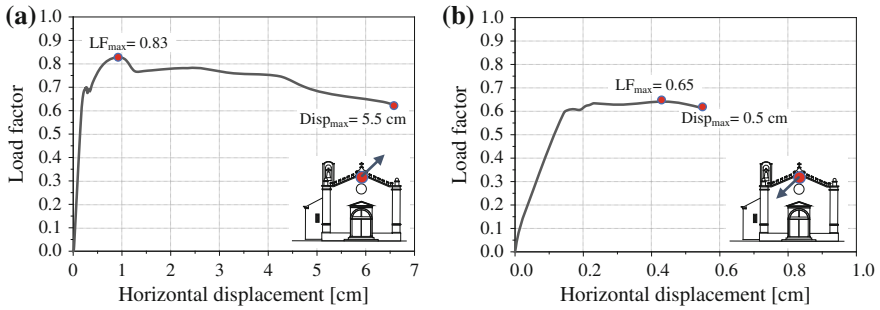
**Fig. 17** Capacity curves for the pushover analysis in the longitudinal direction (Y direction): **a** +Y direction; **b** -Y direction

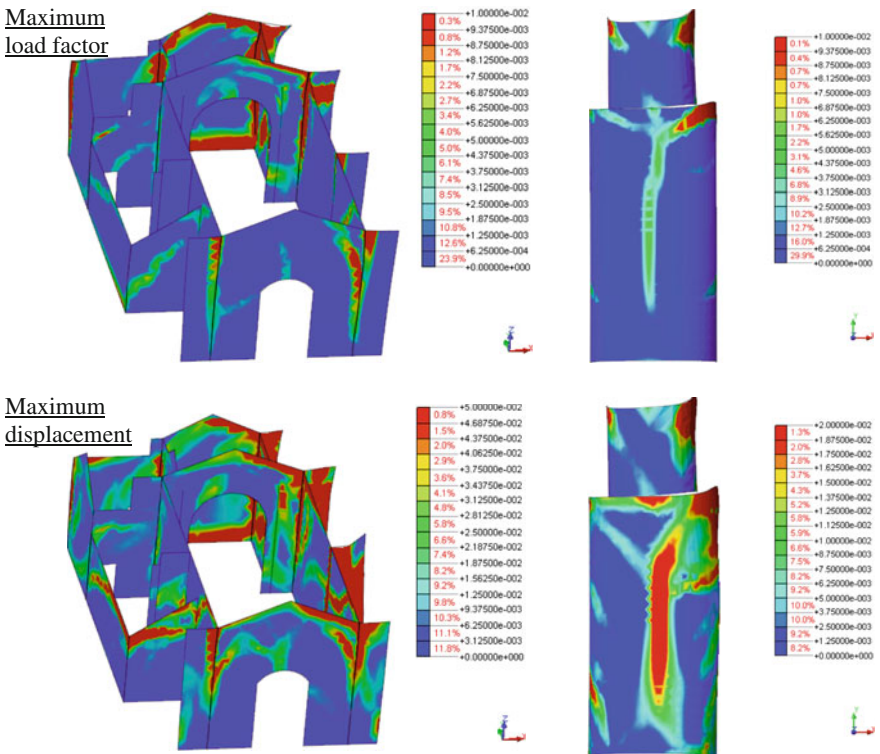
**Fig. 18** Tensile principal strains for the pushover analysis in the +Y direction

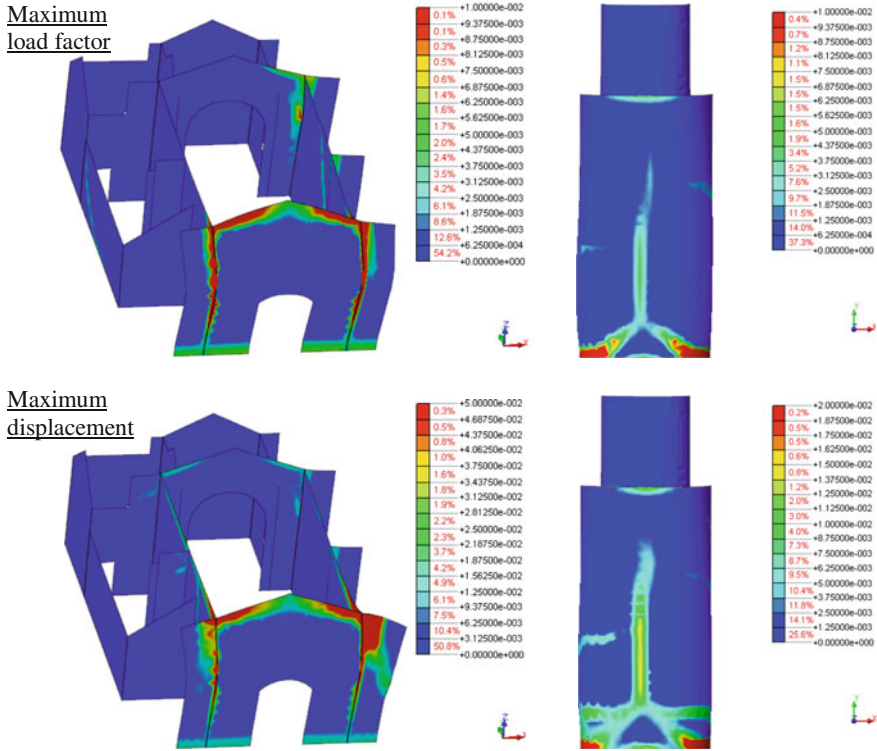
**Fig. 19** Tensile principal strains for the pushover analysis in the  $-Y$  direction

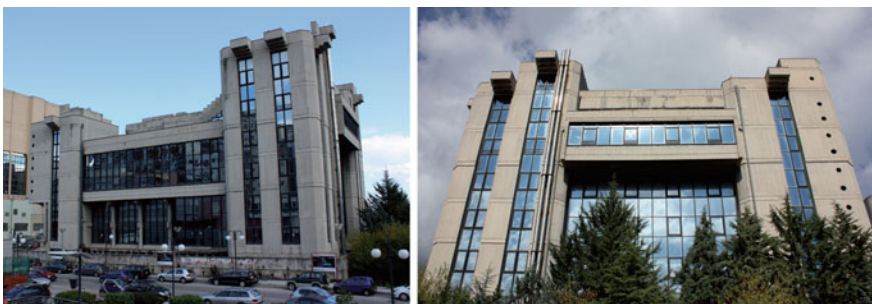
**Fig. 1** West (on the *left*) and south (on the *right*) view

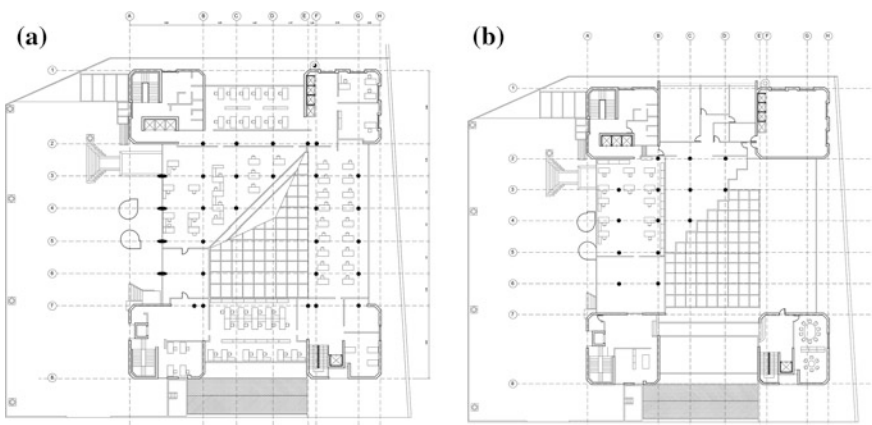
**Fig. 3** Third-floor plan (on the left) and fourth-floor plan (on the right)

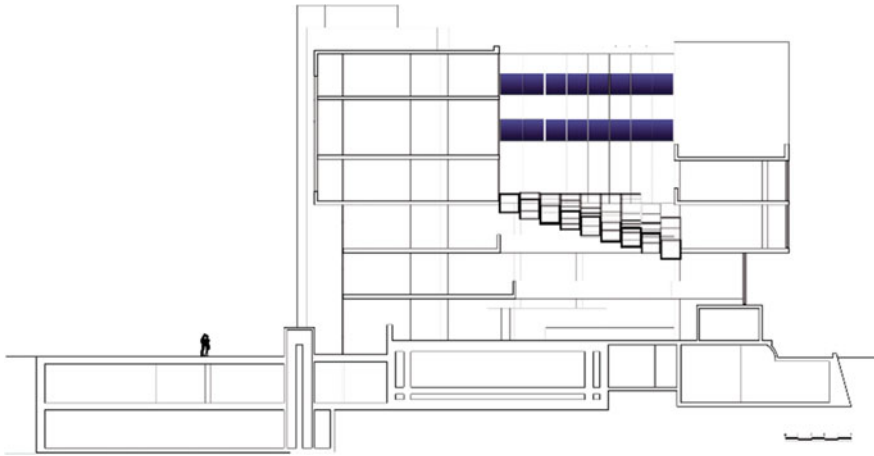
**Fig. 4** East–west section

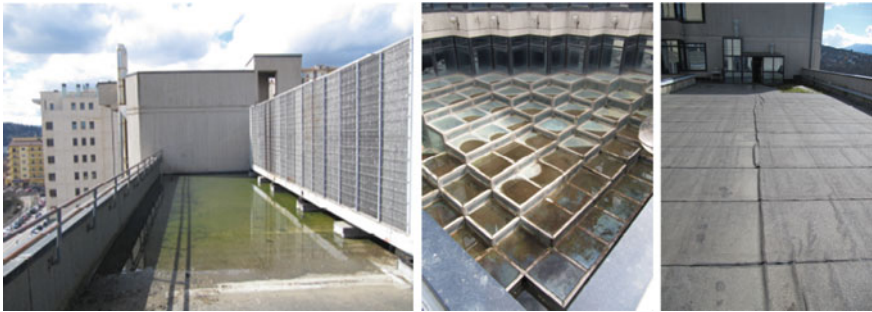
**Fig. 5** Design errors and defects of the cover: water stagnation (on the *left* and *center*) and decay of the roof waterproofing (on the *right*)

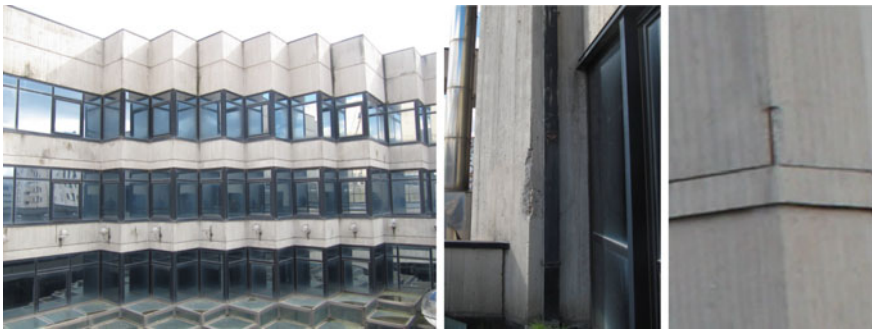
**Fig. 6** Leaching on the surfaces of facing reinforced concrete (on the *left*); corrosion of reinforced steel (on the *center*); exposure of reinforcing bars (on the *right*)

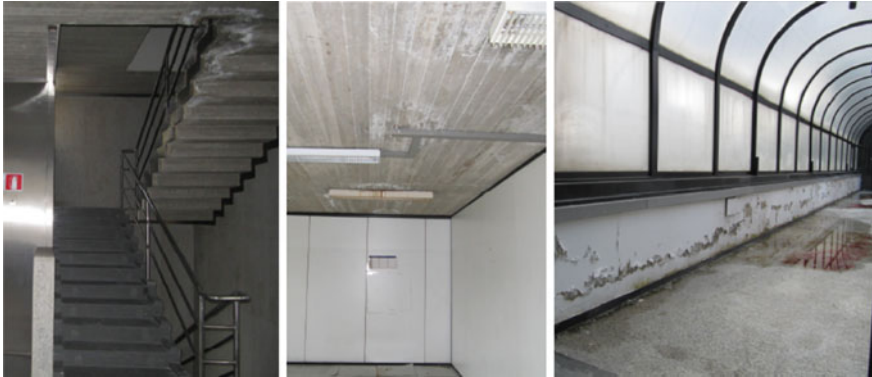
**Fig. 7** Efflorescence and surface wash in the stairwells (on the *left*) and on the floors of the higher levels corrosion (on the *center*); gallery decay (on the *right*)

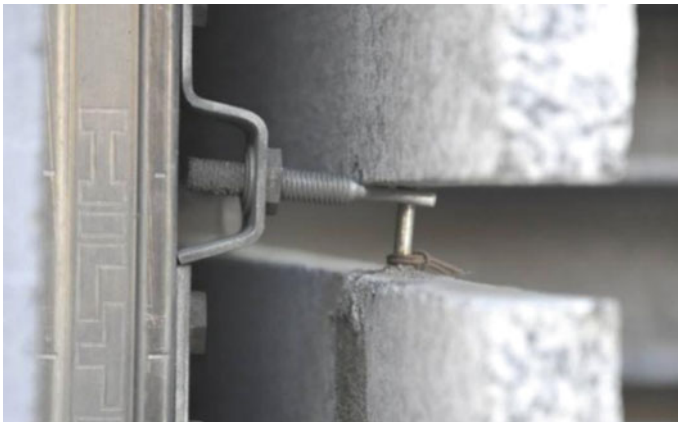
**Fig. 3** Photograph of a stone panel with air chamber

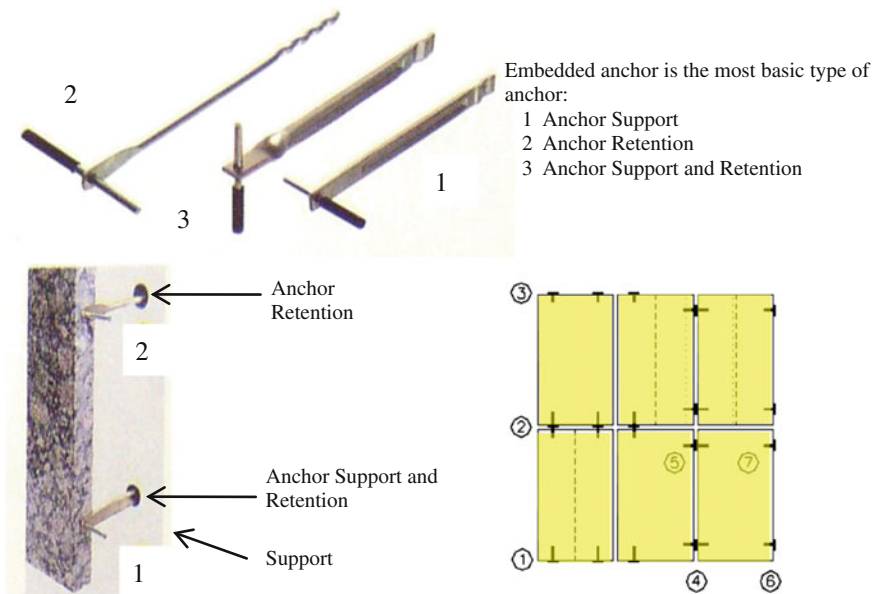
Fig. 4 Types of panel anchors

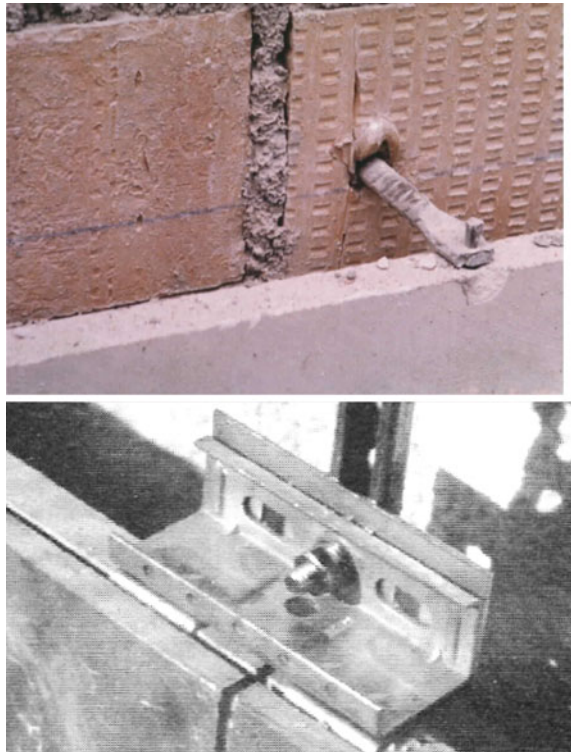
For greater joints, recesses are carved into the edge of the piece. False joints use a piece with greater hardness and thickness.

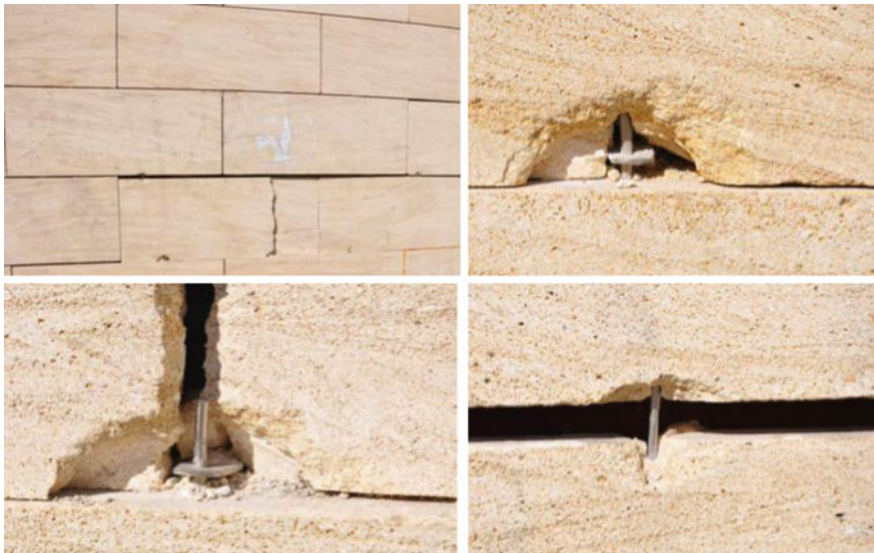
Fig. 6 Panel break around the anchor points

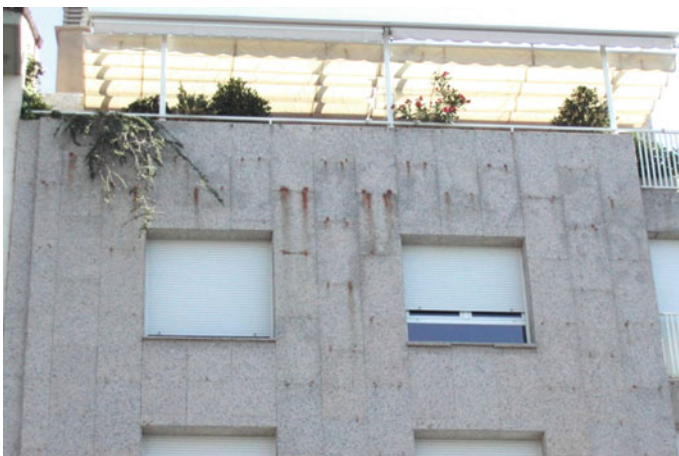
**Fig. 7** Anchor corrosions

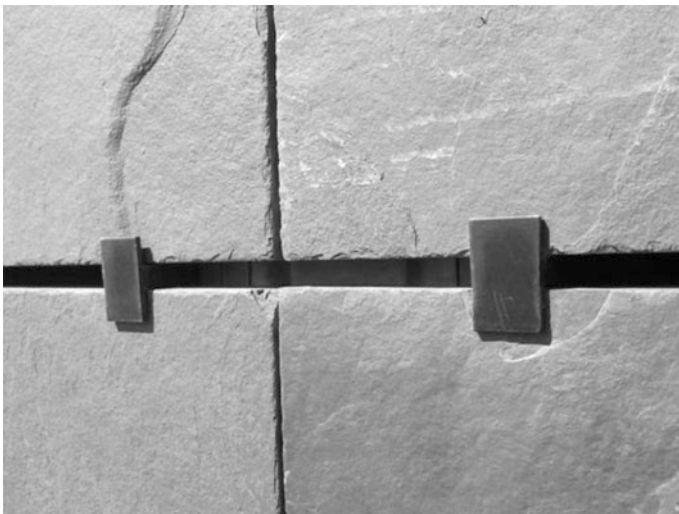
**Fig. 10** Natural stone panels held by viewed fixings

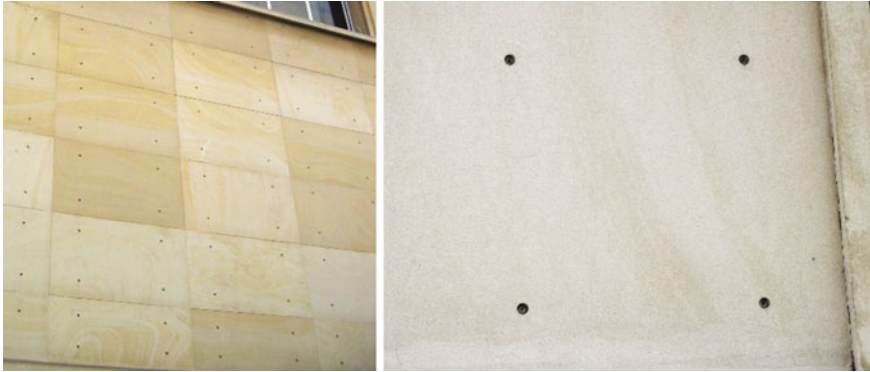
**Fig. 11** Stone panels previously taken with mortar and repaired with screws

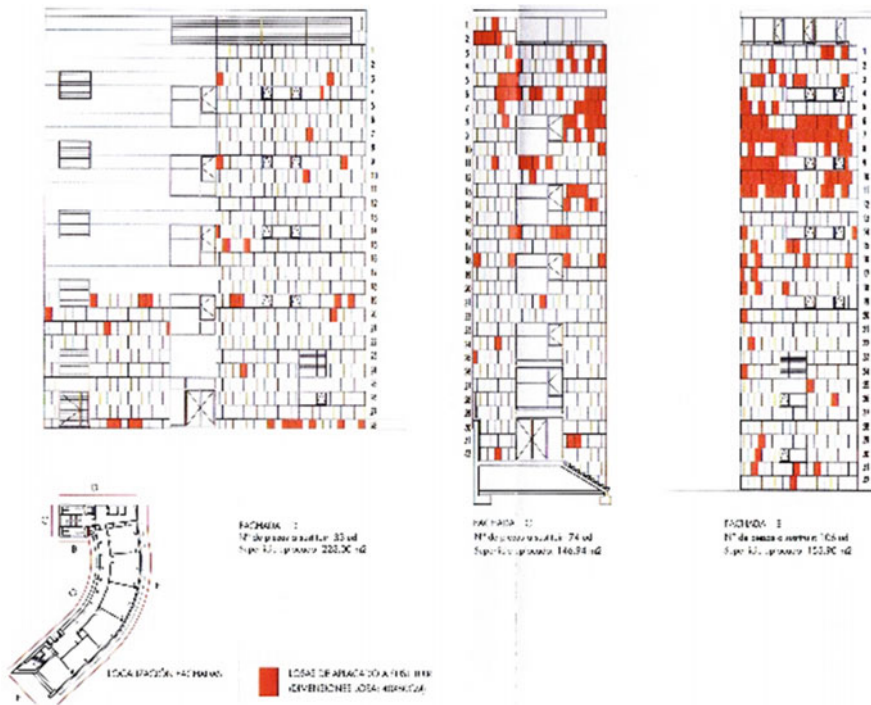
Fig. 12 Elevations and plant of Tourism Building of Valencia (Spain)

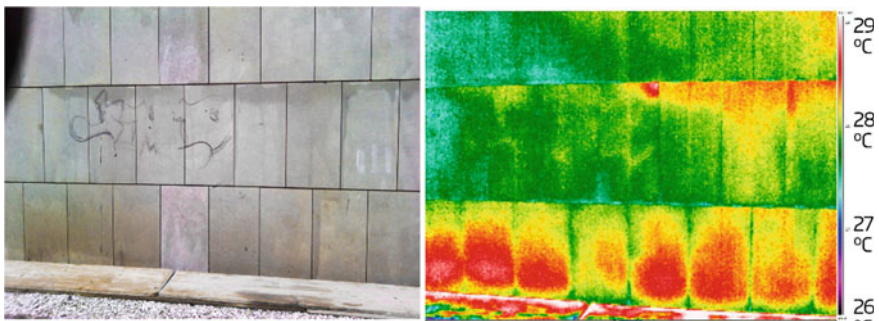
**Fig. 16** Panels thermal response of the bottom of the façade

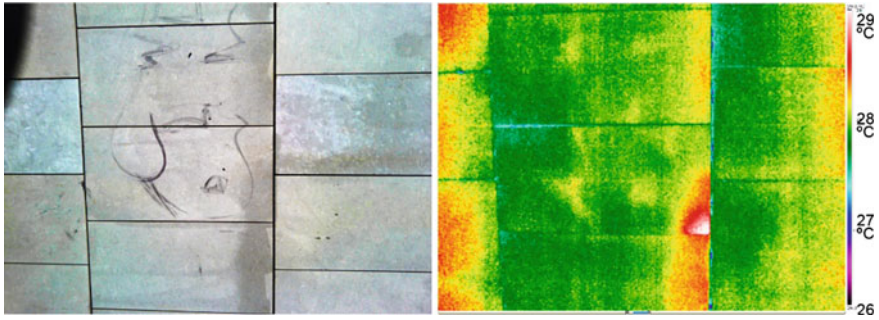
Fig. 17 Overview of the panels with defect in a corner

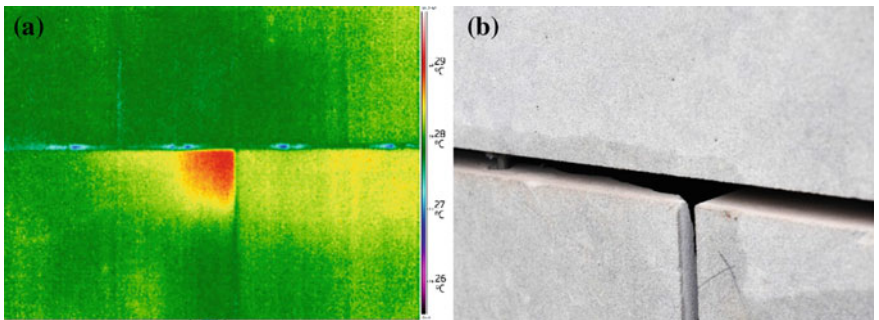
Fig. 18 The corner of this panel has less thickness than the rest

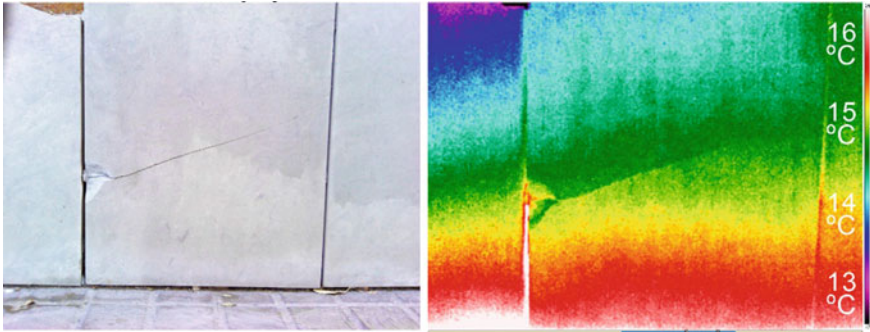
**Fig. 19** Break from the anchor on a stone panel

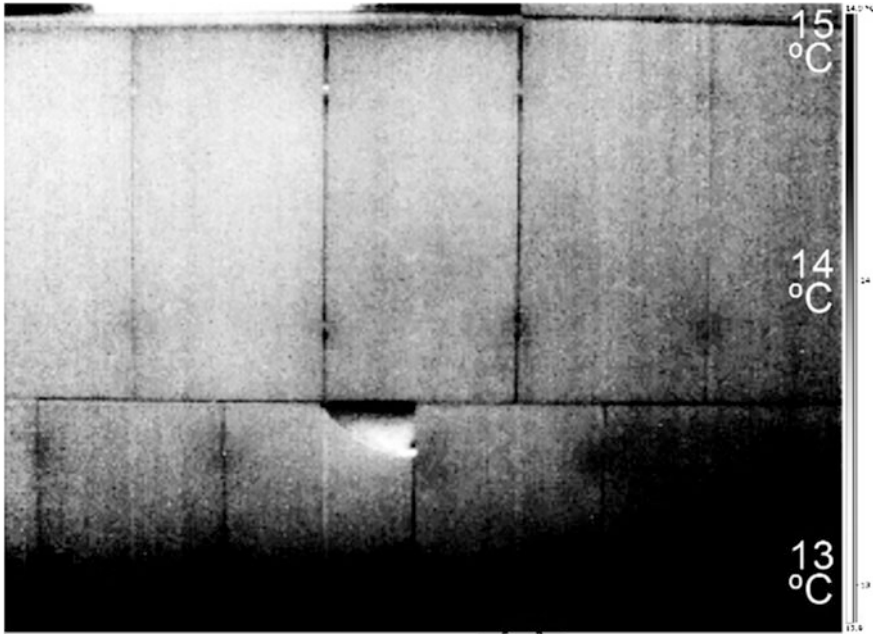
**Fig. 21** Area around the anchors at different temperatures
