WENCHUAN, SICHUAN PROVINCE, CHINA, EARTHQUAKE OF 2008

Lifeline Performance

Technical Council on Lifeline Earthquake Engineering
Monograph No. 39

Earthquake Investigation Committee of the
Technical Council on Lifeline Earthquake Engineering

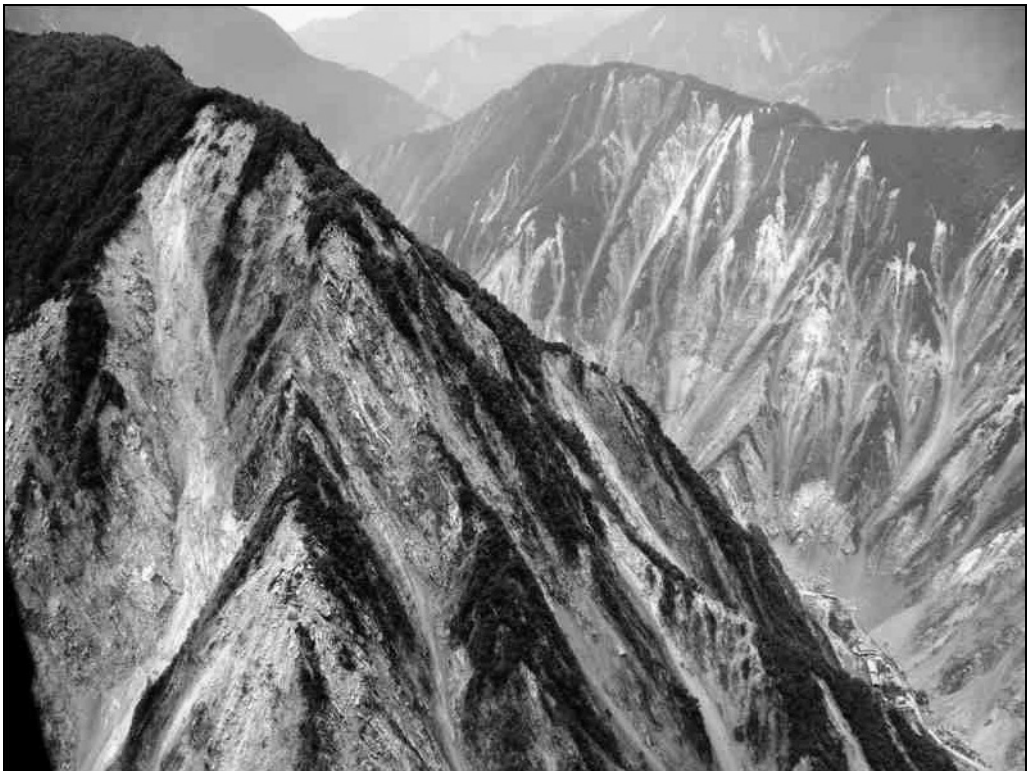
Fig. 2.21. Landslides (80 percent slope failure) (Courtesy IEM)

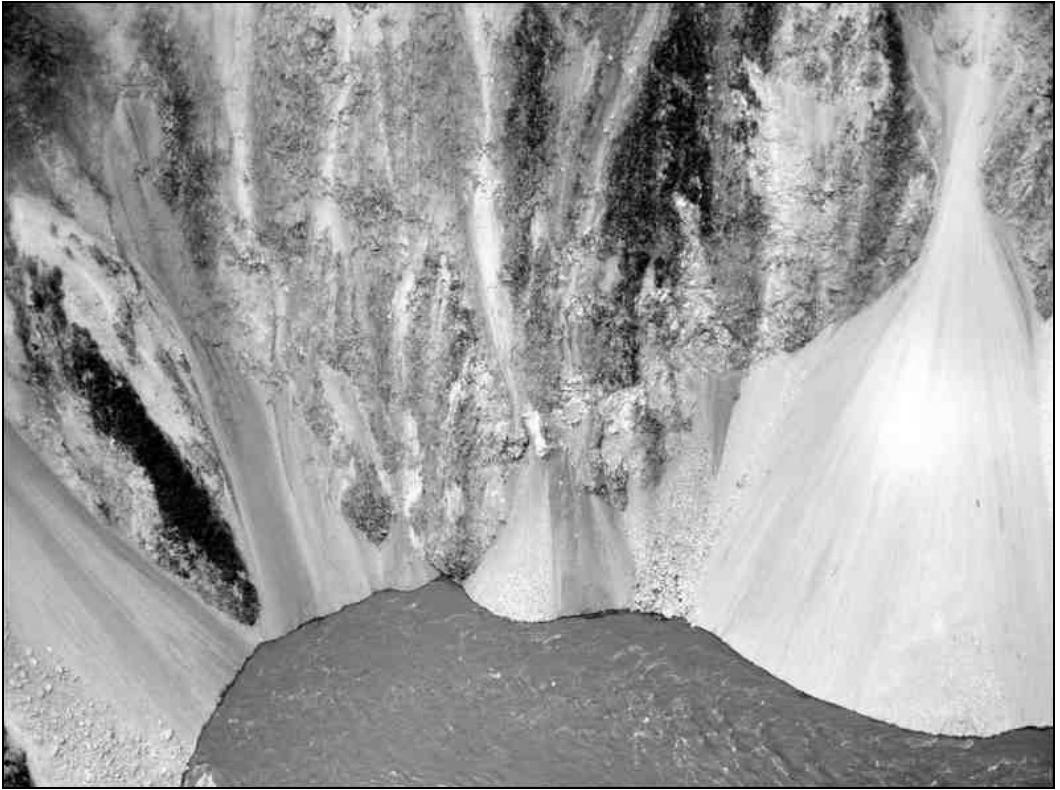
Fig. 2.22. Landslides with debris fans entering a river (Courtesy IEM)

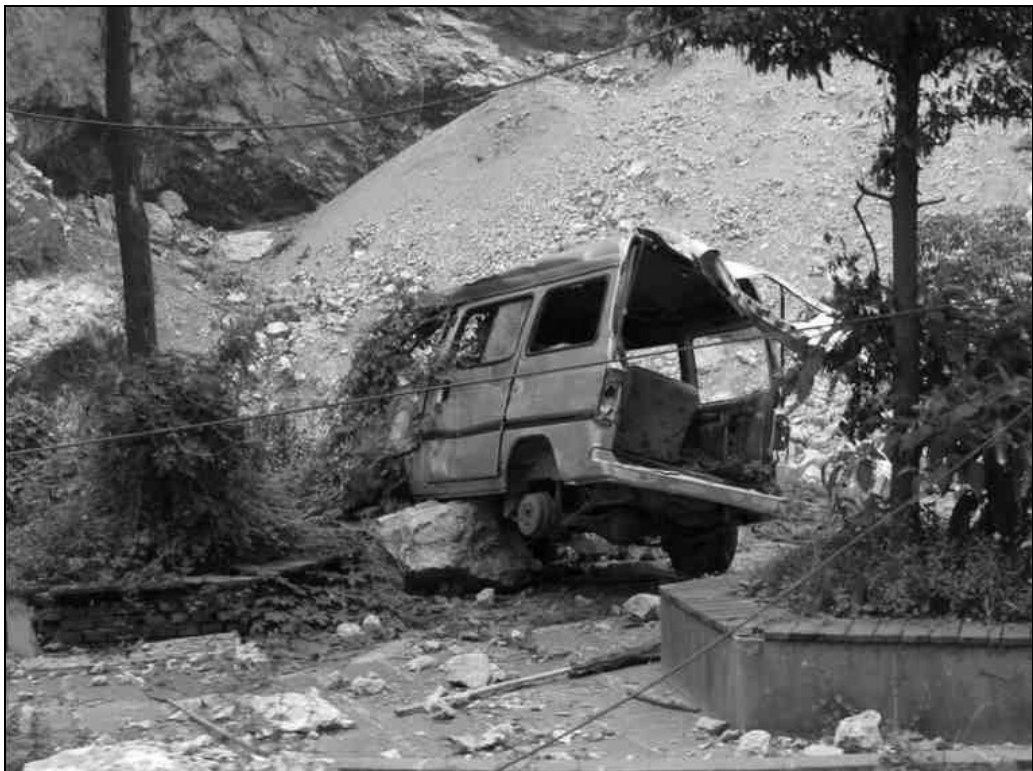
Fig. 2.25. A car crushed by a fallen rock

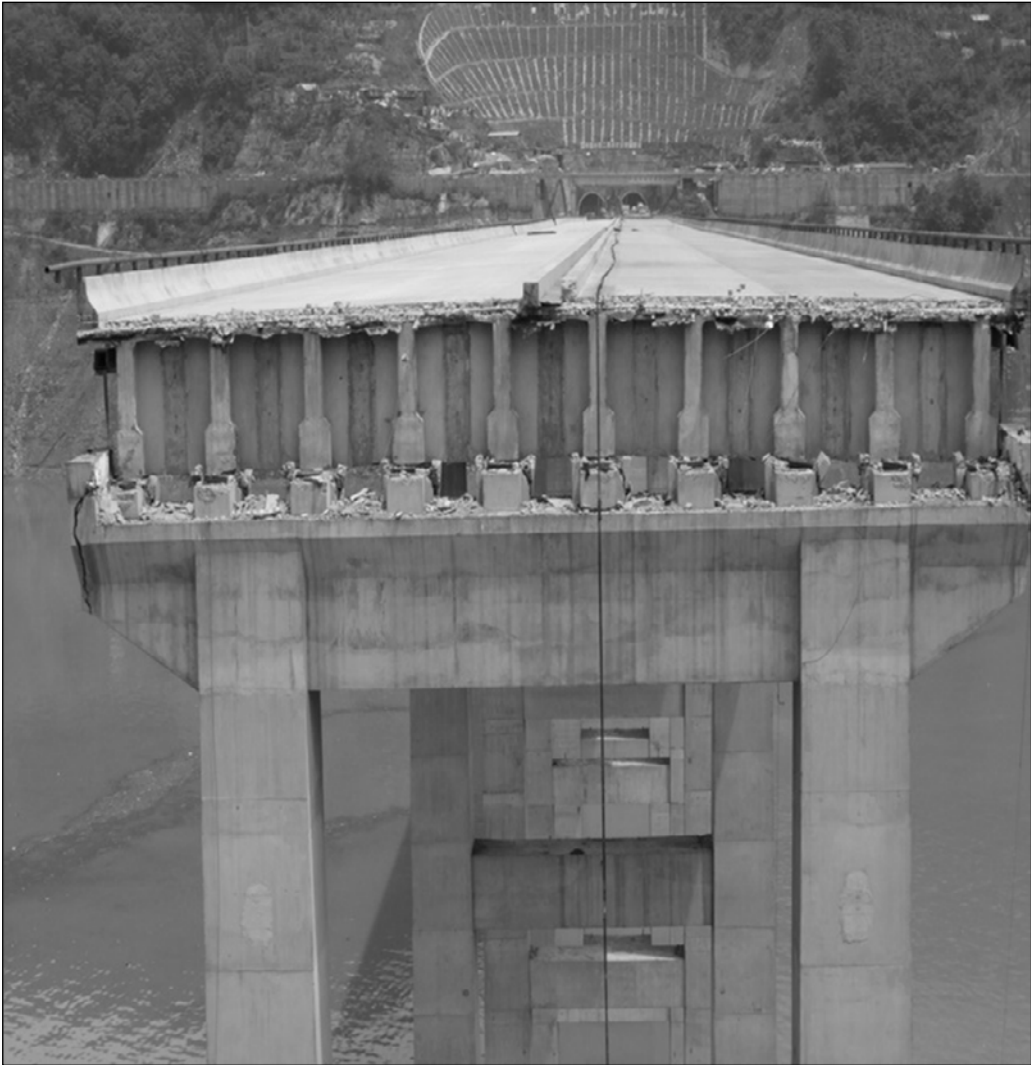
Fig. 3.29. Close-up of the Miaoziping Bridge with missing span shown in Fig. 3.28

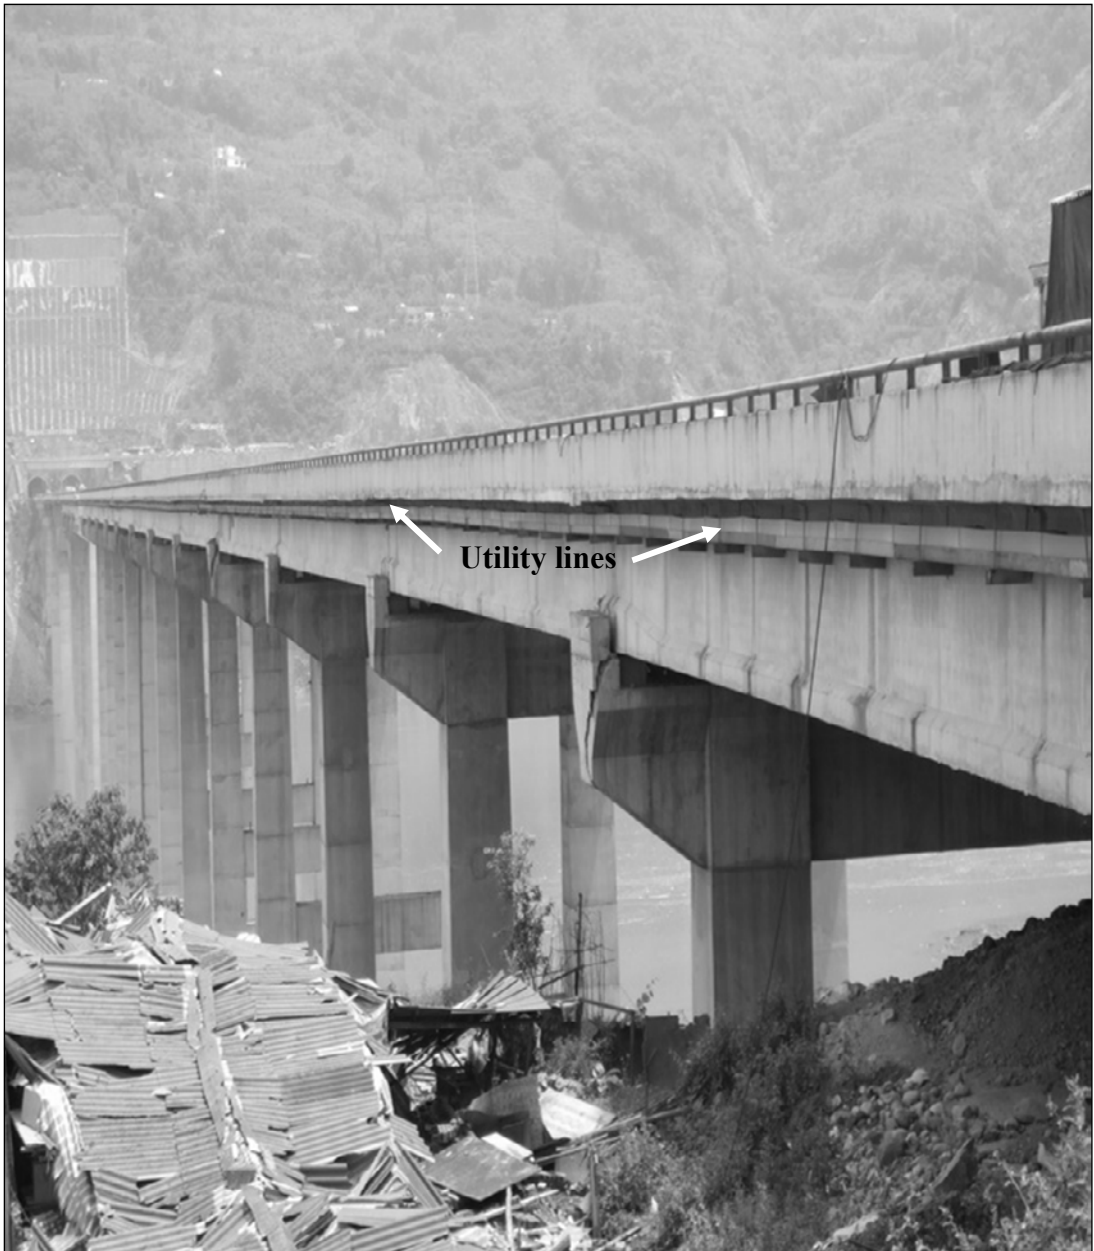
Fig. 3.30. Miaoziping Bridge with shear keys damaged

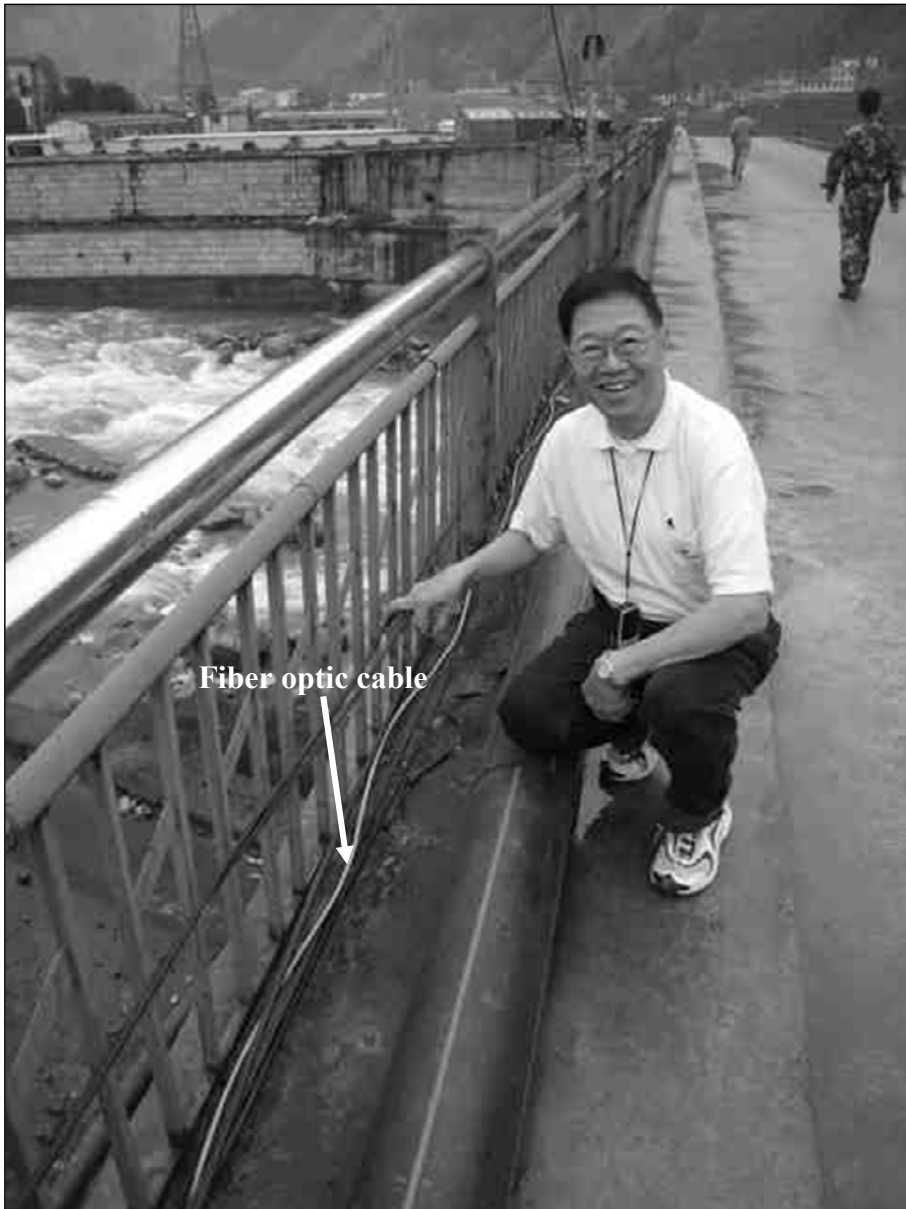
Fig. 3.41. Temporarily rerouted utilities (power, telecommunication, and water) on the three-span bridge, Yingxiu

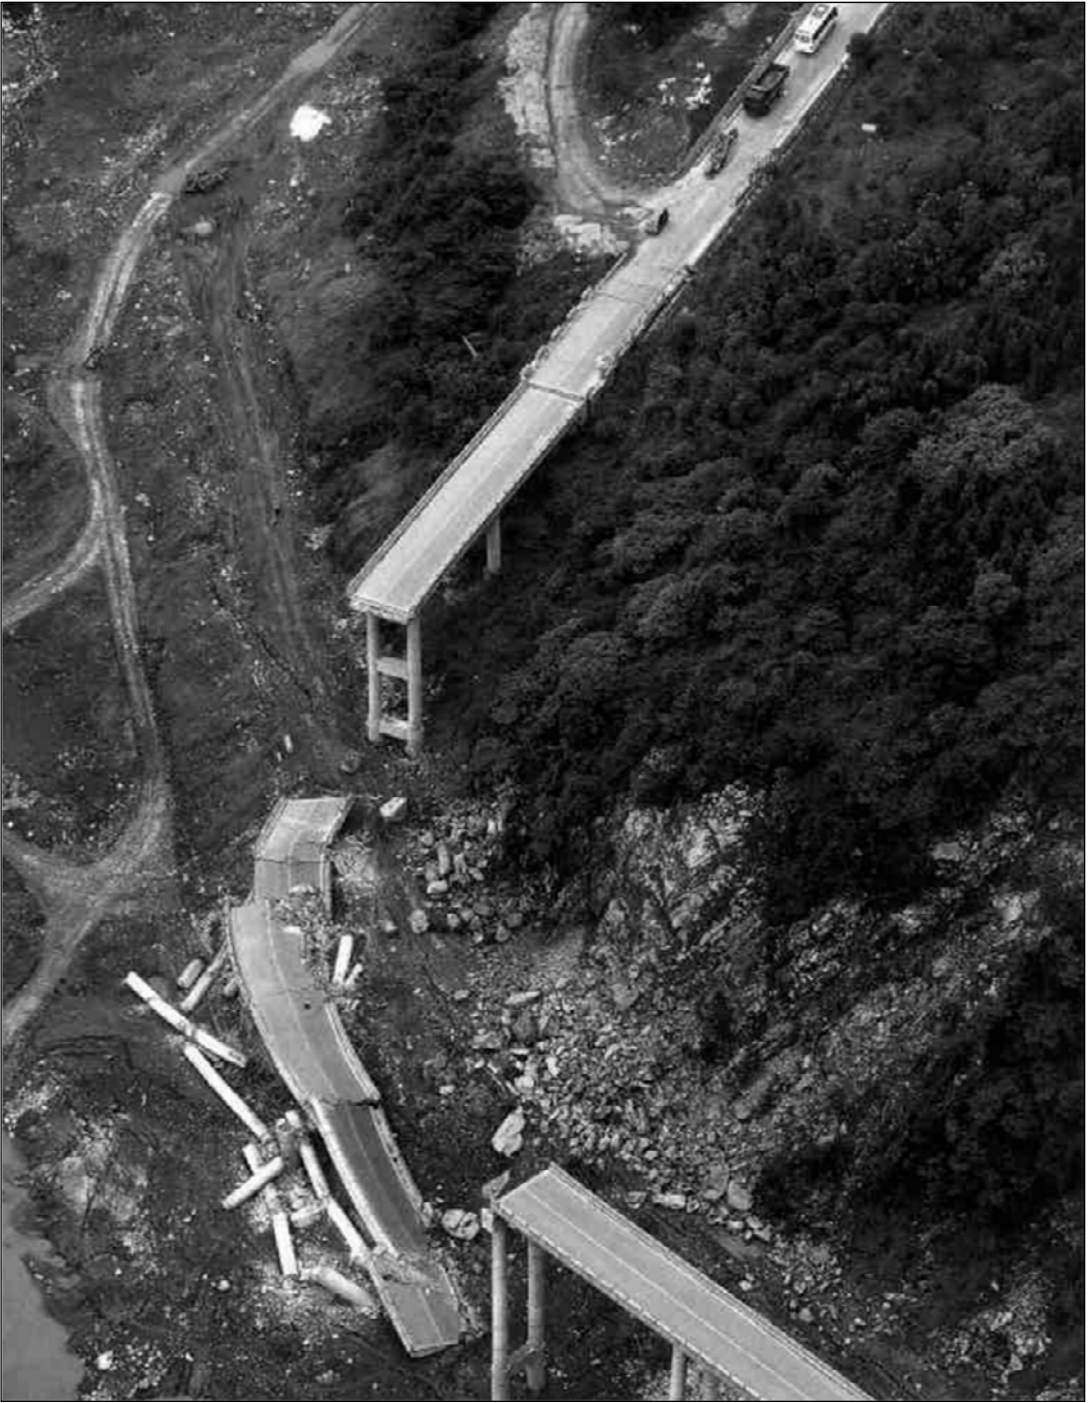
Fig. 3.42. Collapsed Baihua Bridge

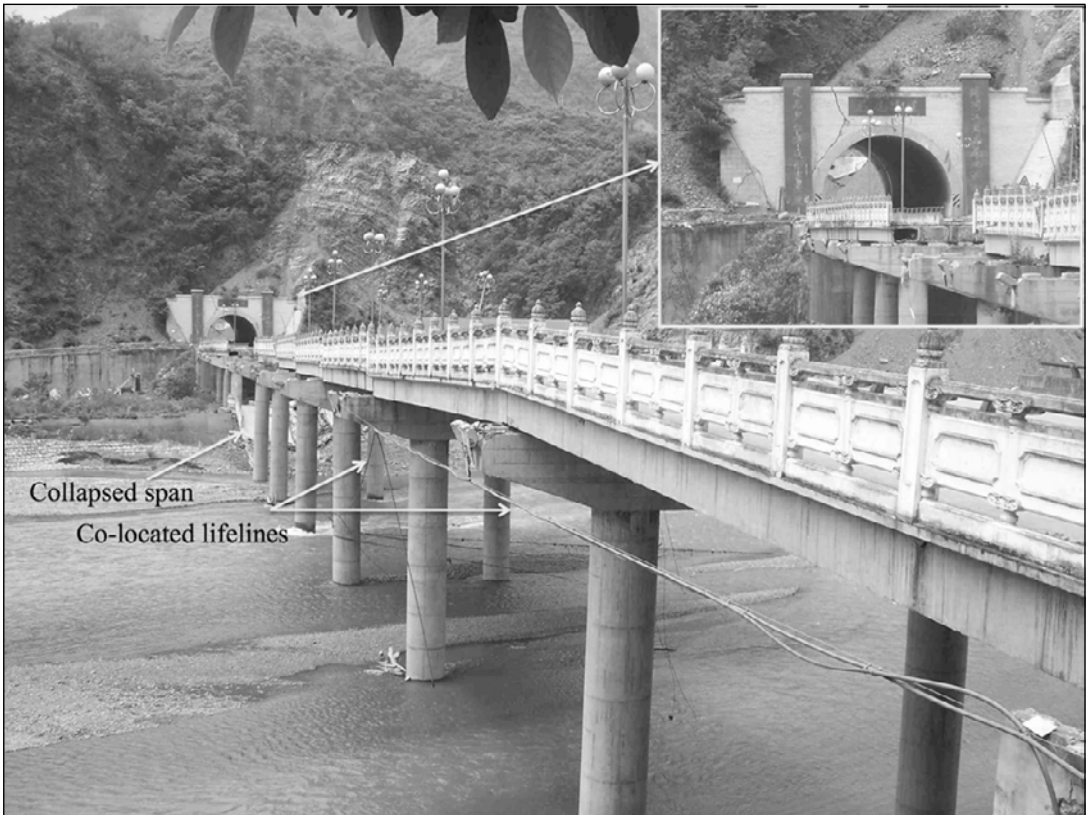
Fig. 3.54. Side view of damaged bridge near Beichuan County

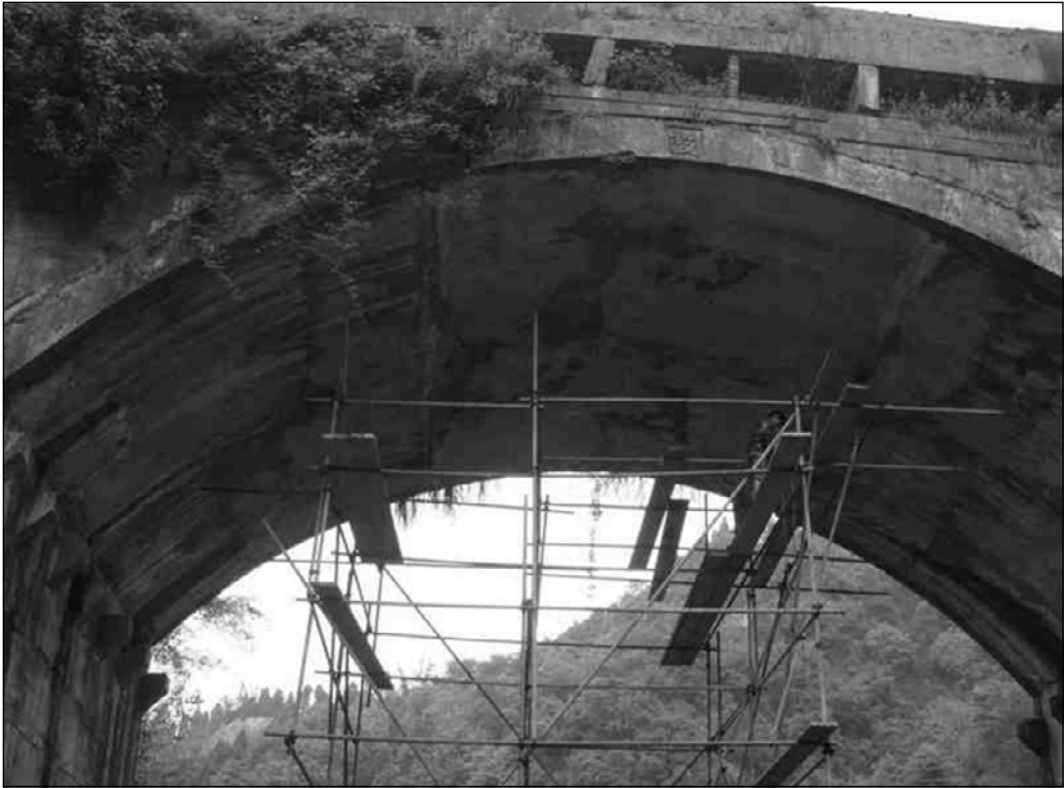
Fig. 3.64. Arch bridge sustained damage, Zhongba Village of Pengzhou City

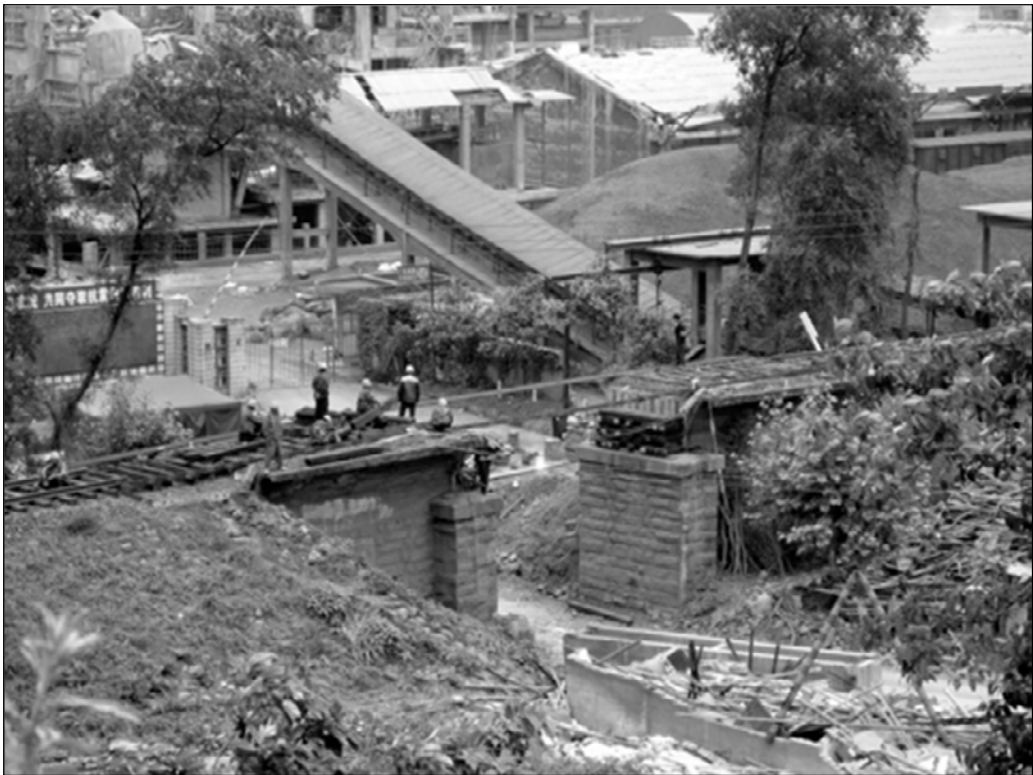
Fig. 3.87. Collapsed railroad bridge in Shifang (Courtesy of Prof. Mei and Dr. Zhang)

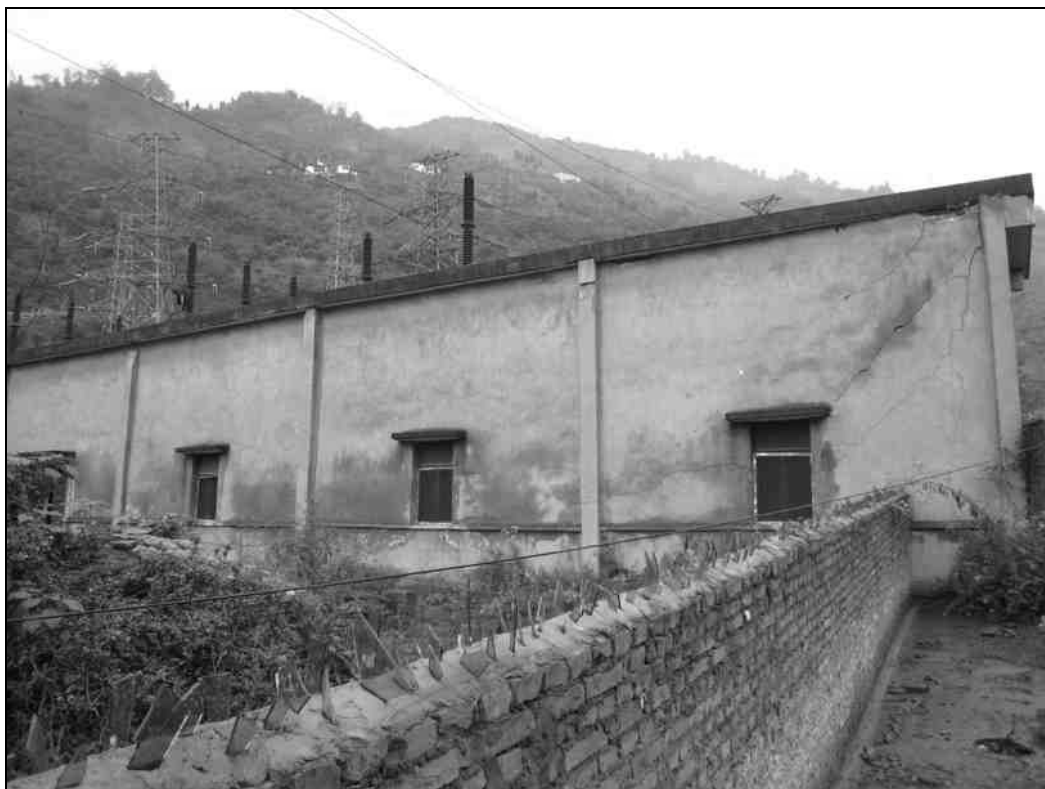
Fig. 4.23. Control building with large cracks on top right corner, small cracks in walls, and columns between windows

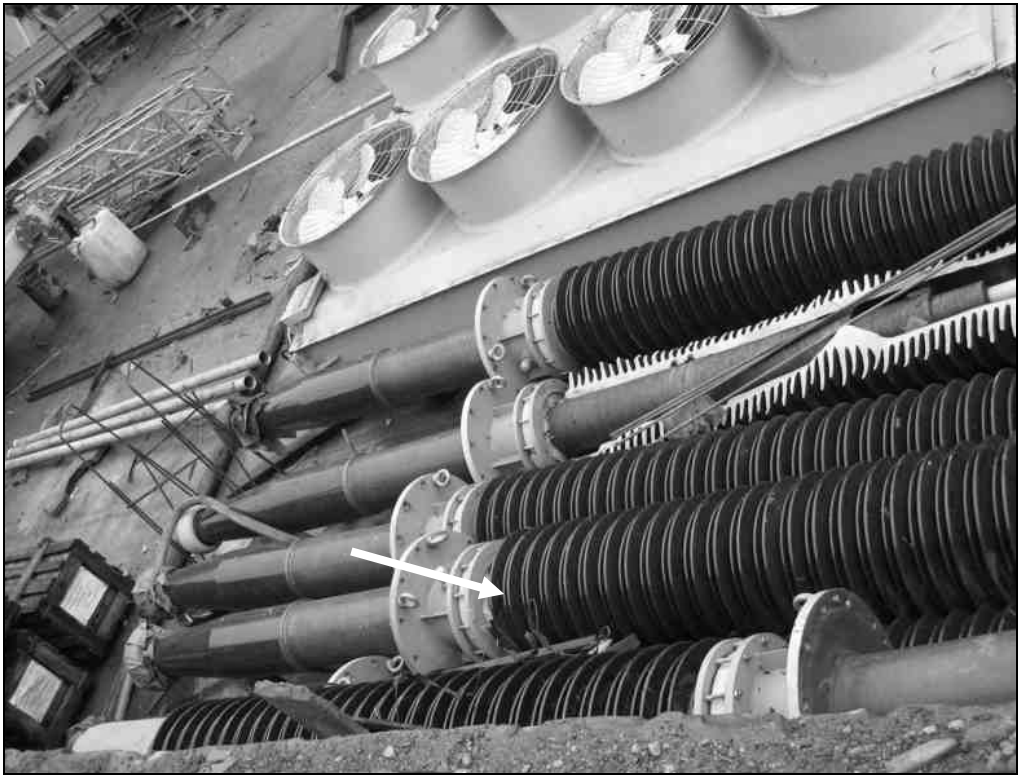
Fig. 4.29. Slipped porcelain bushing is fourth from top

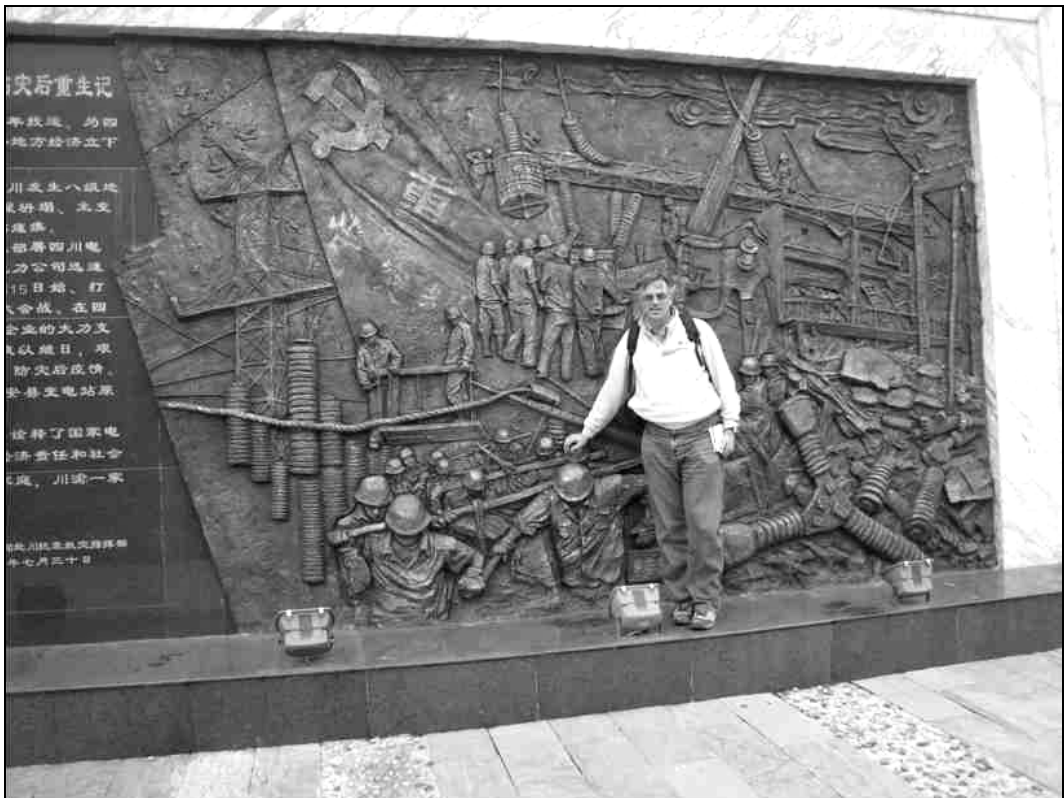
Fig. 4.37. Memorial erected at Beichuan Substation, 220 kV (Note the failed LTCB on the right side of John Eidinger, typical of all observed failures).

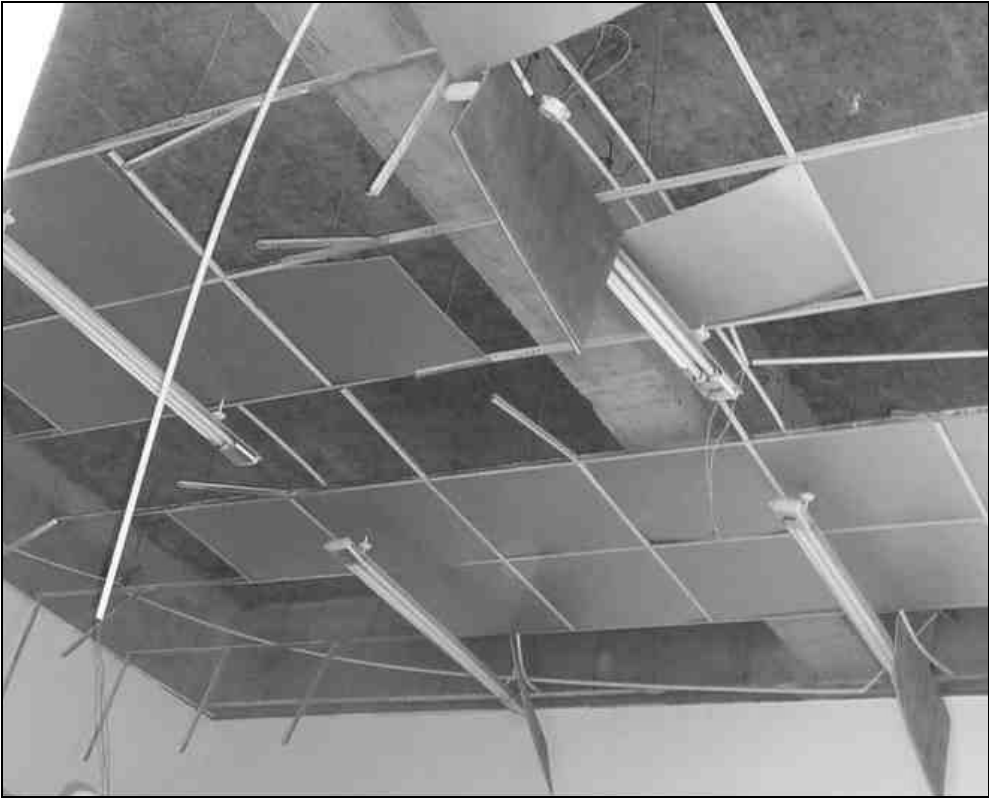
Fig. 4.53. Control building nonstructural damage

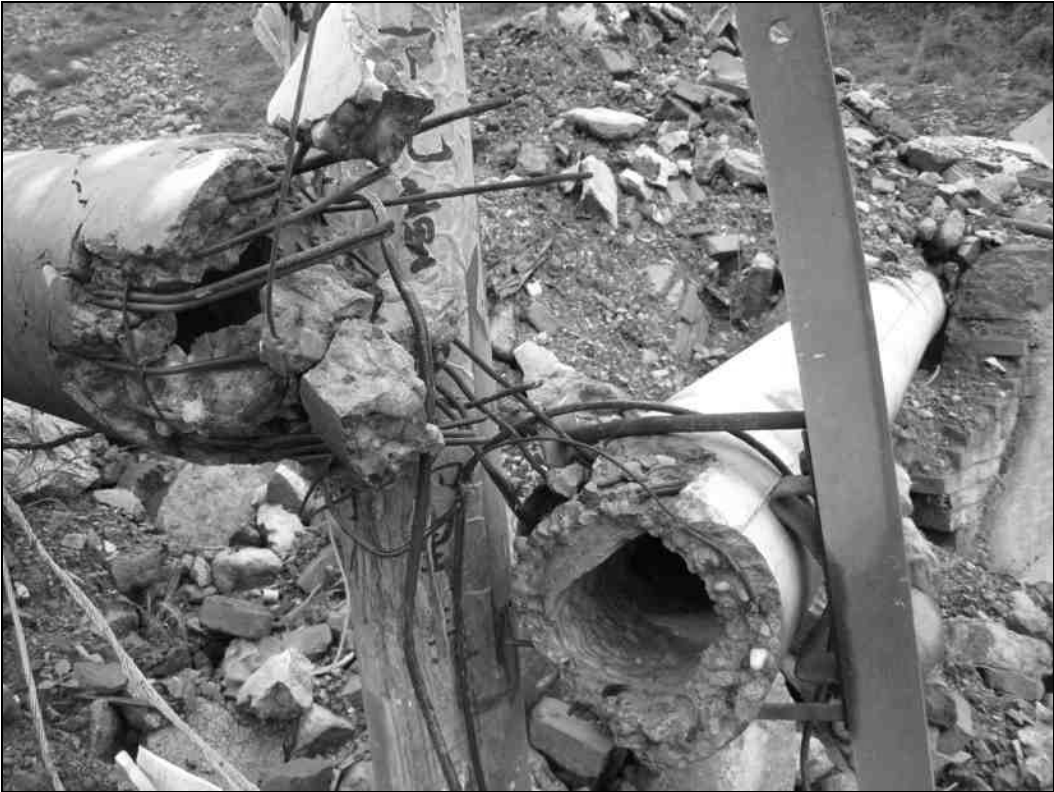
Fig. 4.71. Collapsed 10 kV distribution pole (10-in. diameter, 2.5-in. wall thickness)

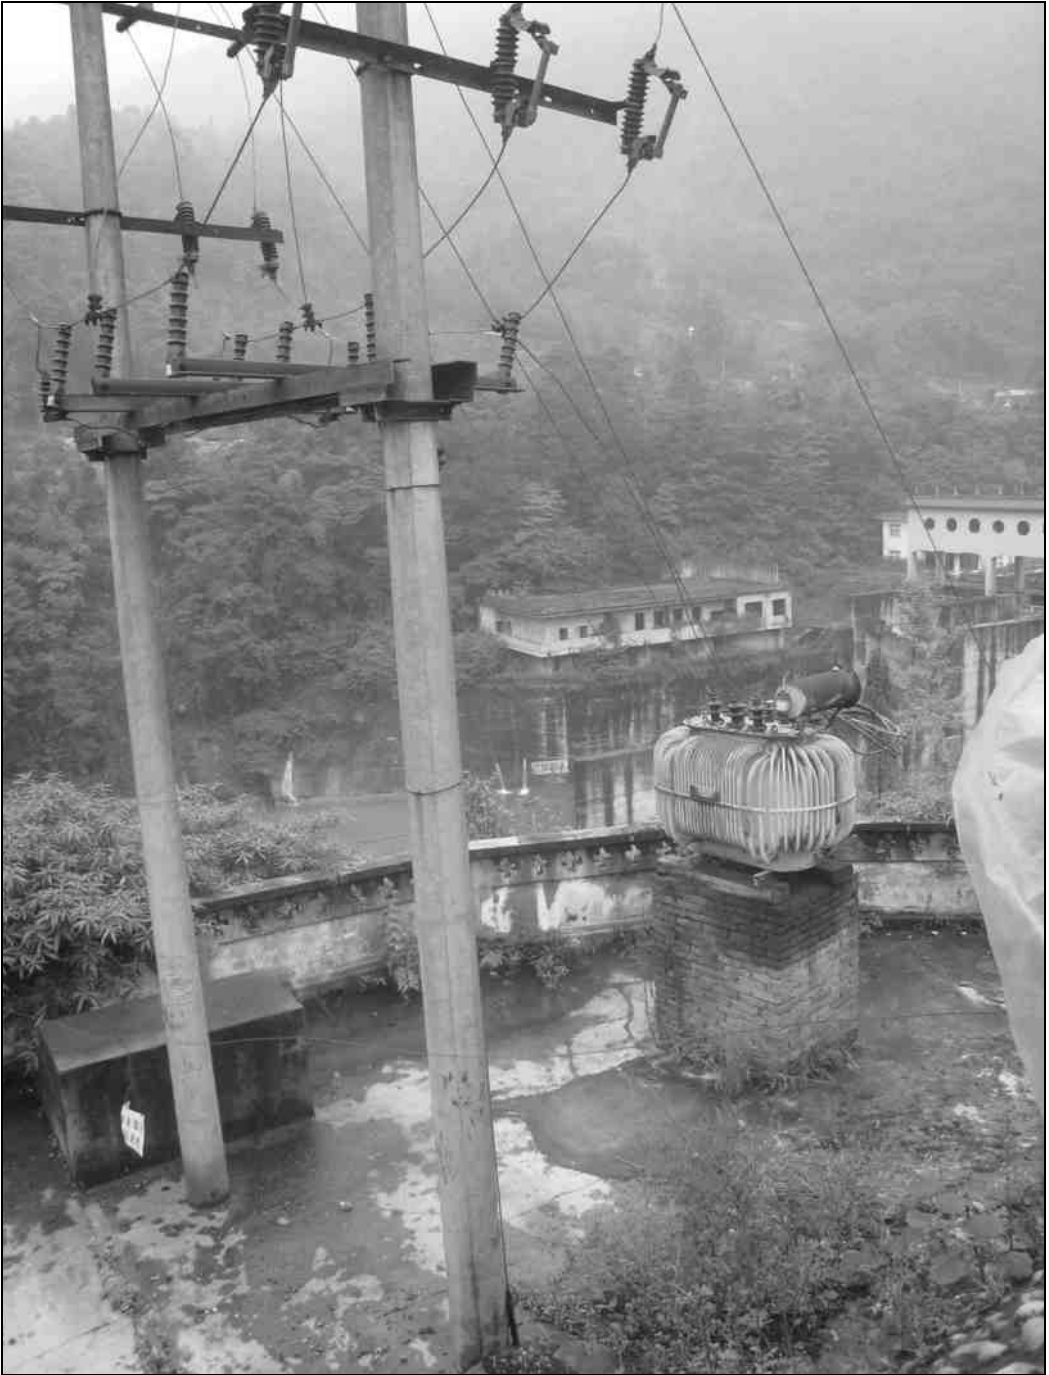
Fig. 4.77. Unanchored distribution transformer

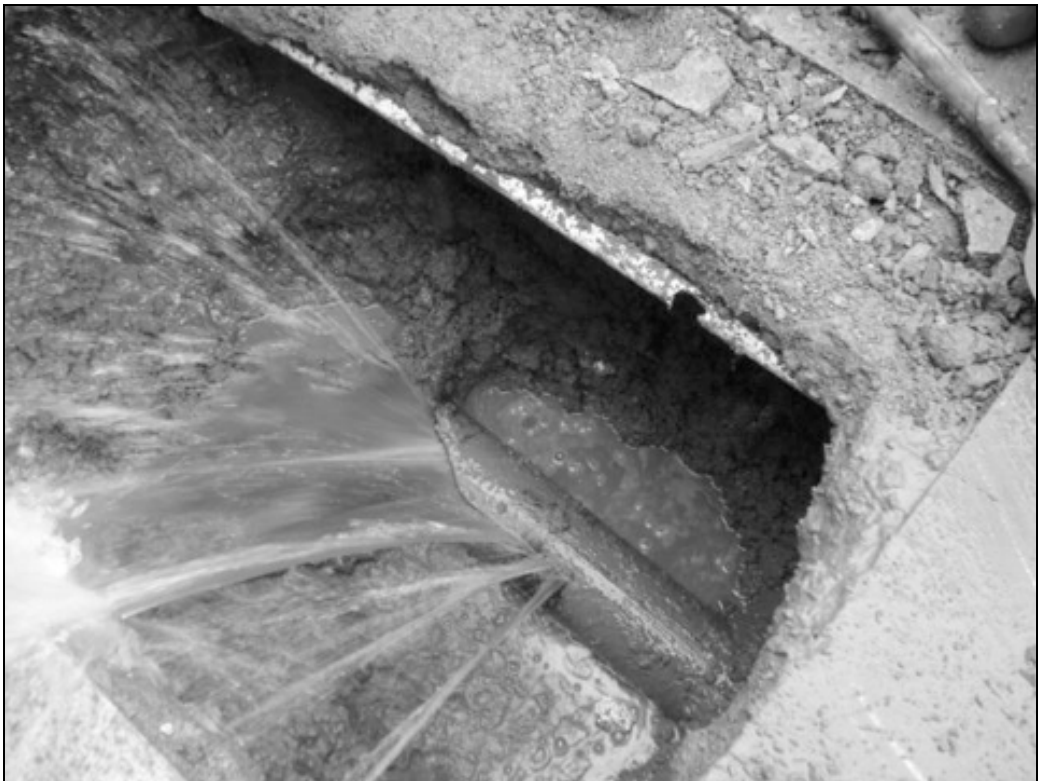
Fig. 5.1. PVC water pipe with split

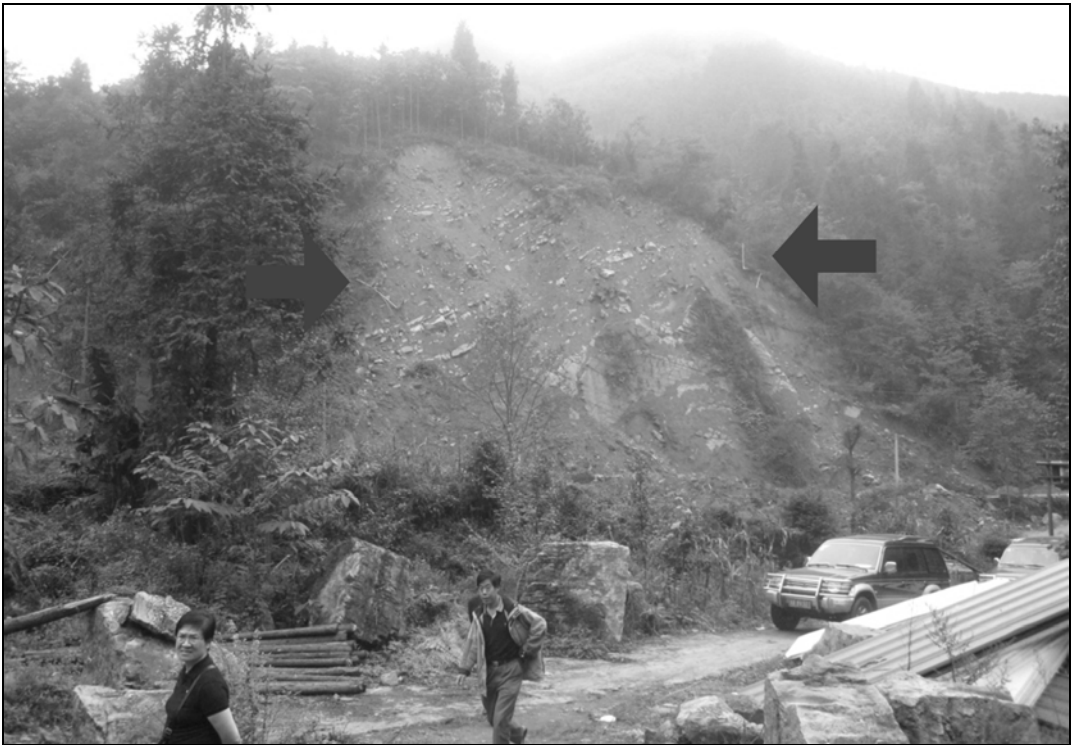
Fig. 5.5. Broken water pipes at either side of a landslide, Shenxigou Village (near Hongkou); landslides cause more damage than earthquakes.

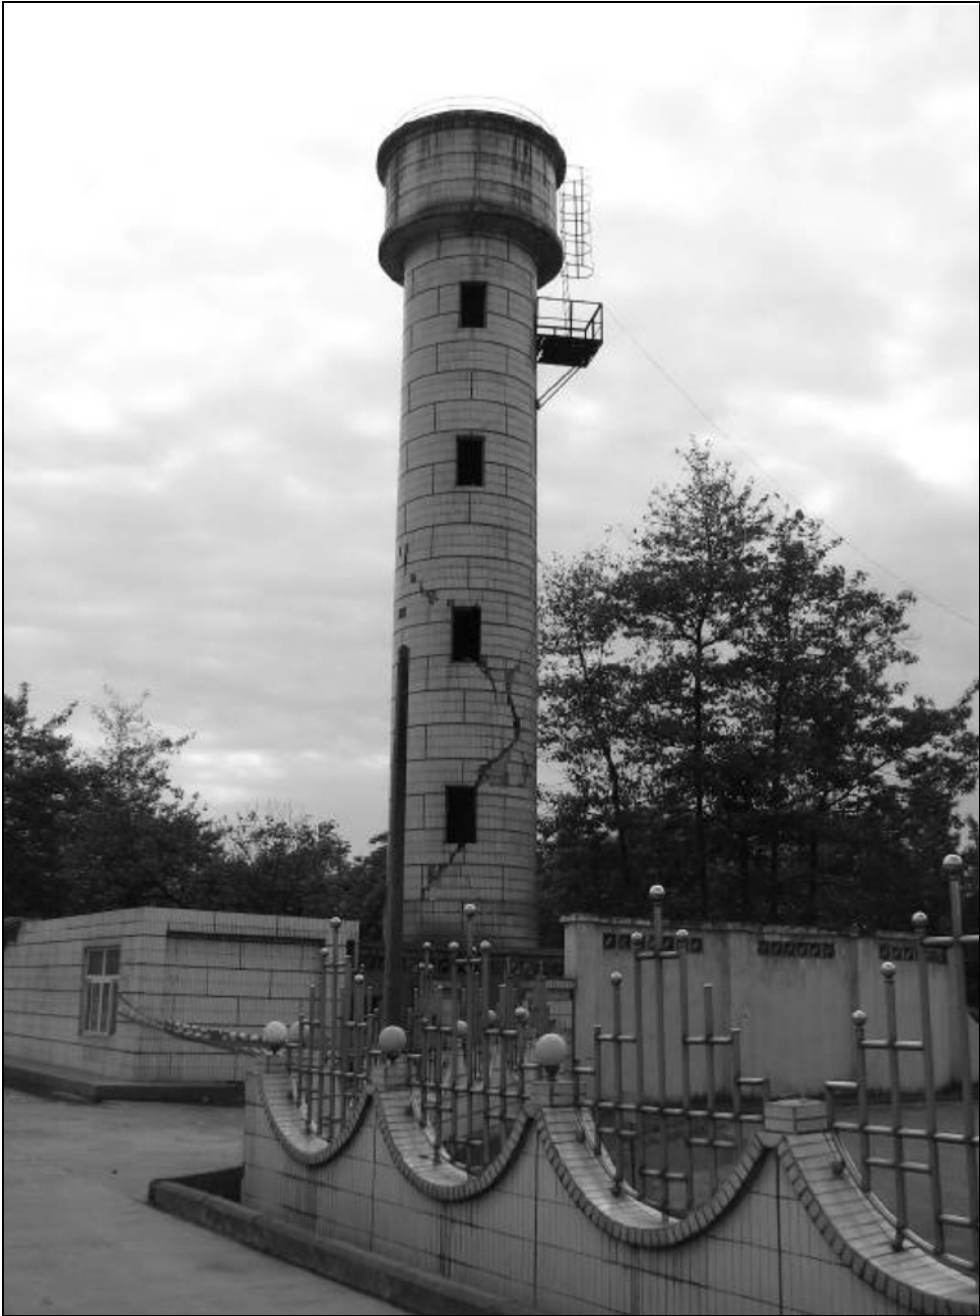
Fig. 5.12. Elevated concrete water tank with heavy damage to tower

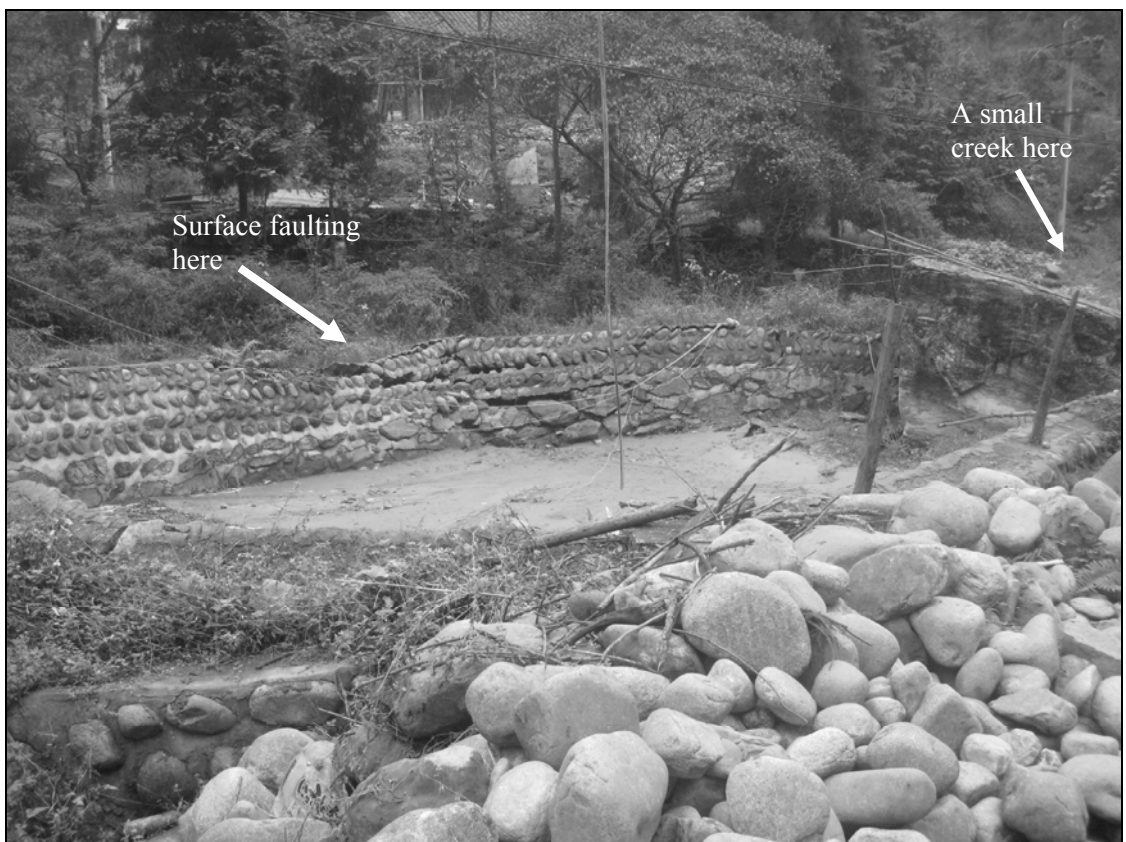
We noted that the style of wall, with the mortar-cemented stonework, remained mostly intact so that the release rate would have been modest. We did not observe gross downstream erosion; the bulk of the water would have been released into a small creek. Also notable is that 160 days after the earthquake neither reservoir was restored to service. This reservoir was used as fish-holding ponds, demonstrating that the economic activity in the area was still affected by the quake.

Fig. 5.17. URM water storage basin, Shenxigou Village

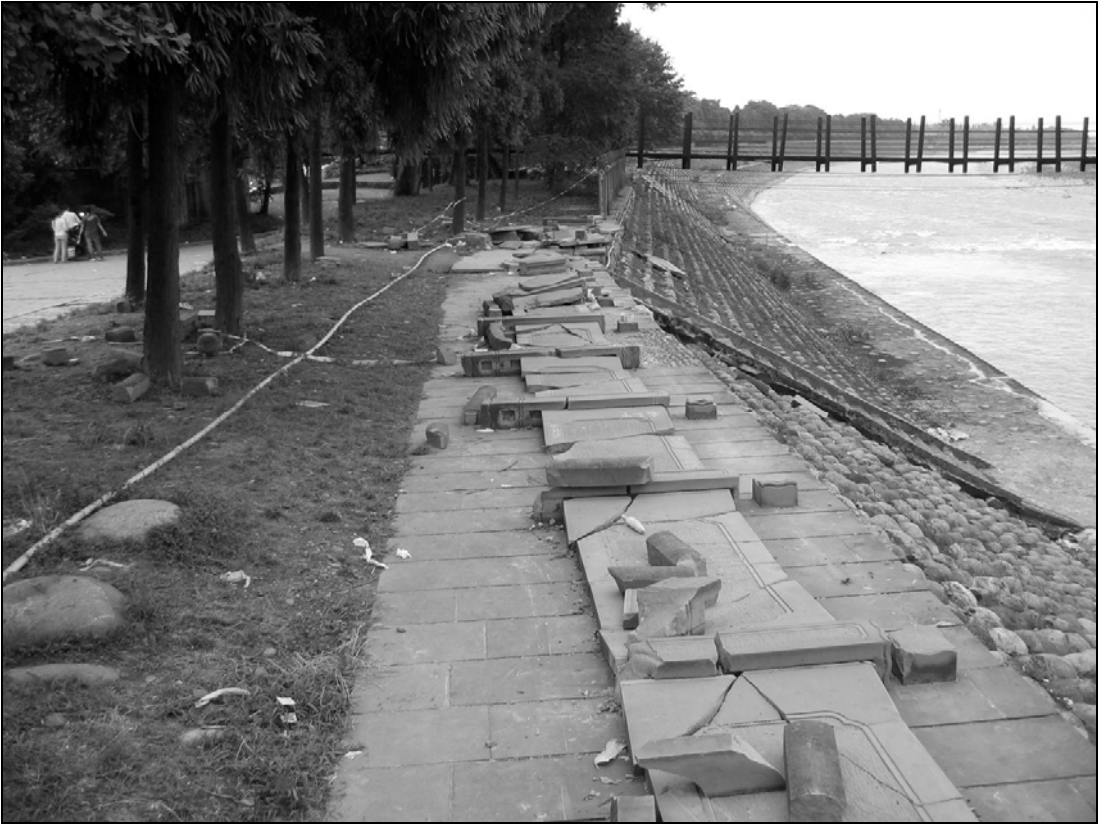
Fig. 5.22. Broken railing wall, note the posts snapped at the base

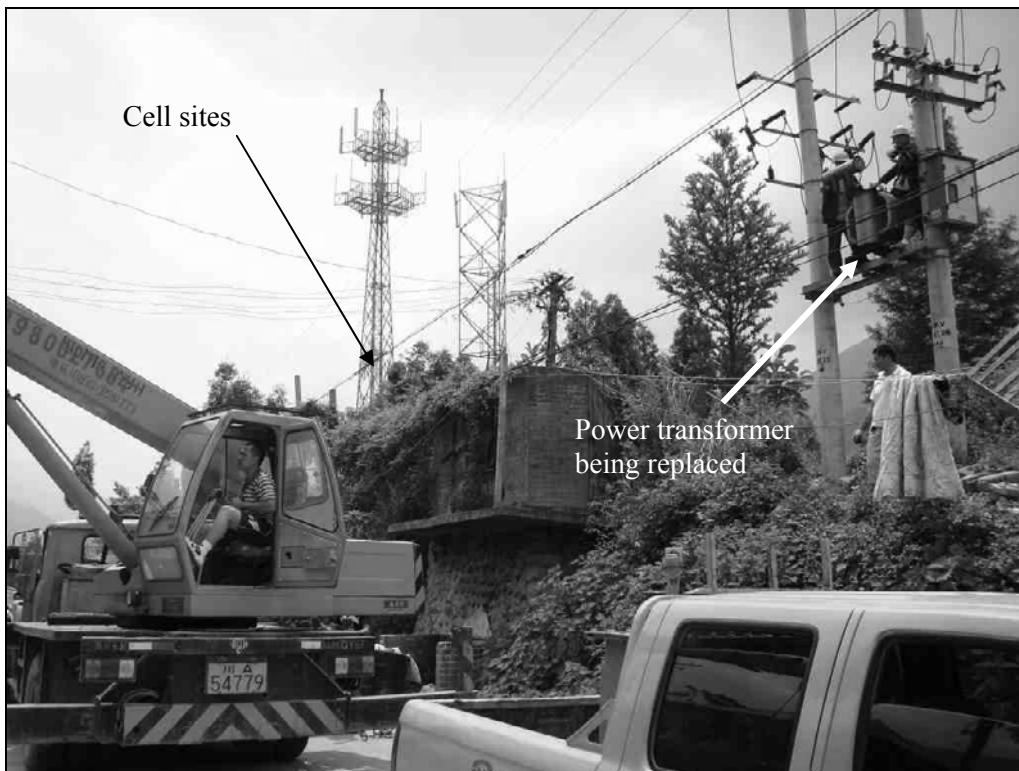
Fig. 6.7. The damaged 10-kV pole mounted transformer was being replaced during our site visit on July 17, 2008. Note the location of the cell site with towers showing.

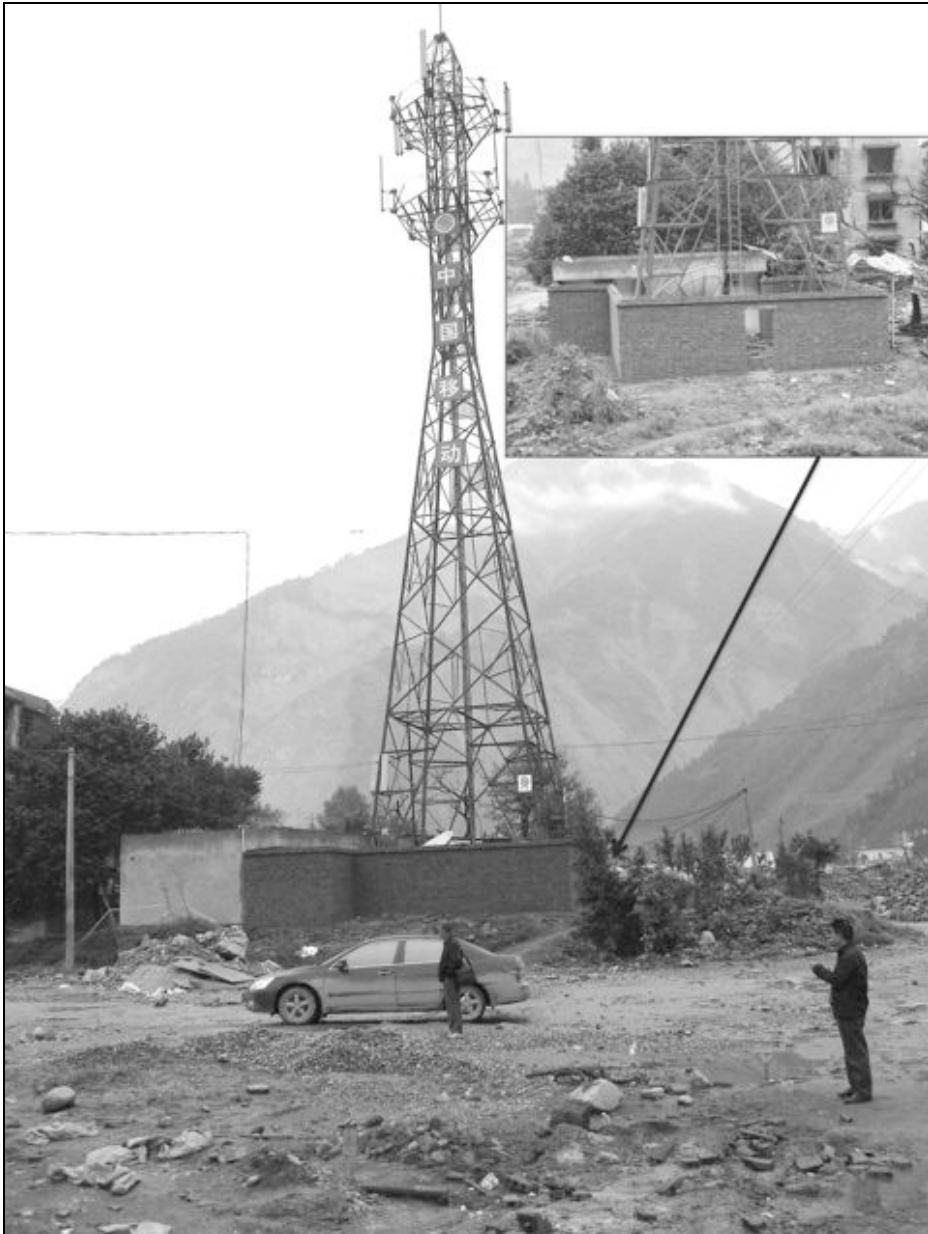
Fig. 6.9. A China Mobile cell site in Yingxiu. Insert shows a missing door in the new wall.
