WENCHUAN, SICHUAN PROVINCE, CHINA, EARTHQUAKE OF 2008

Lifeline Performance

Technical Council on Lifeline Earthquake Engineering
Monograph No. 39

Earthquake Investigation Committee of the
Technical Council on Lifeline Earthquake Engineering

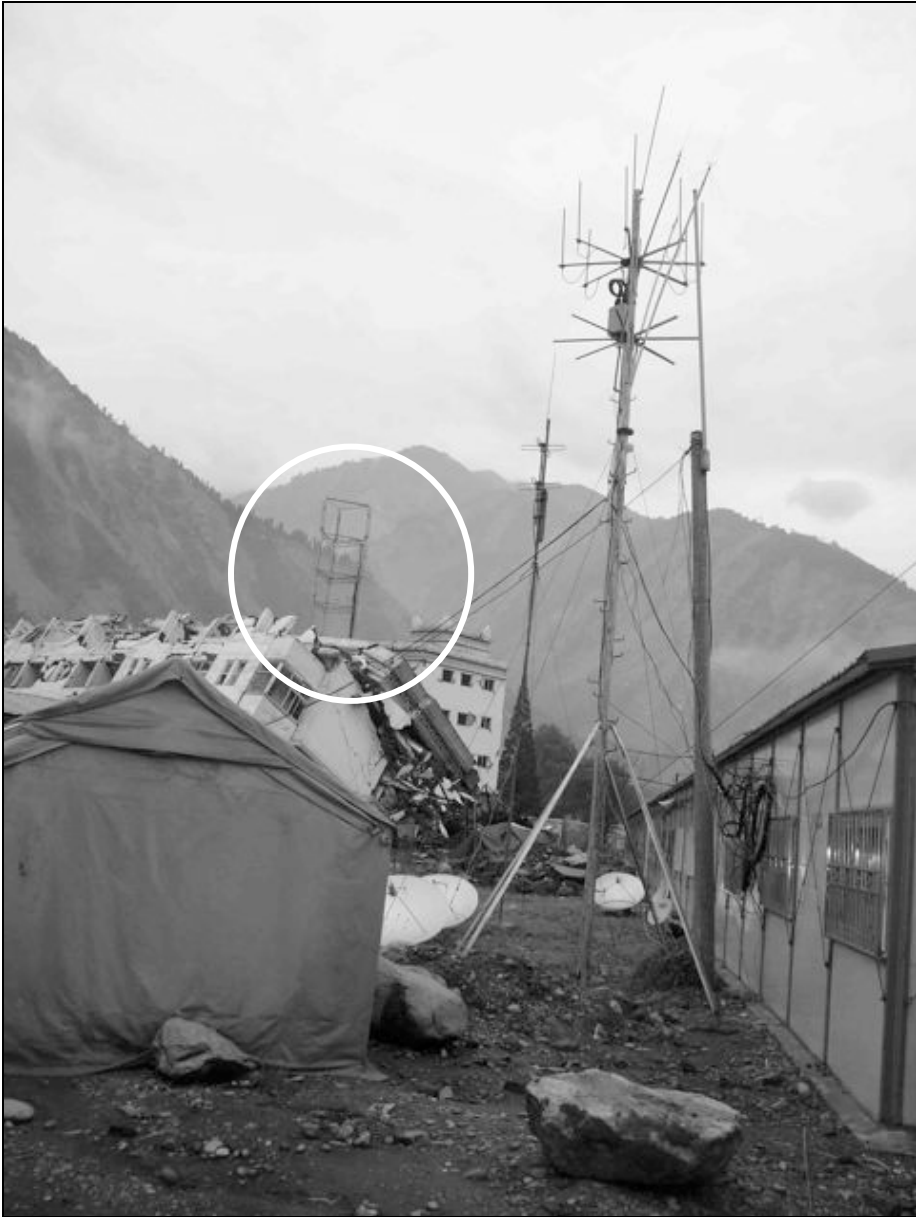
Fig. 6.18. Cell site antennae tower (circled) slanting about 10° from its vertical position. It might be leaning against one of the collapsed buildings.

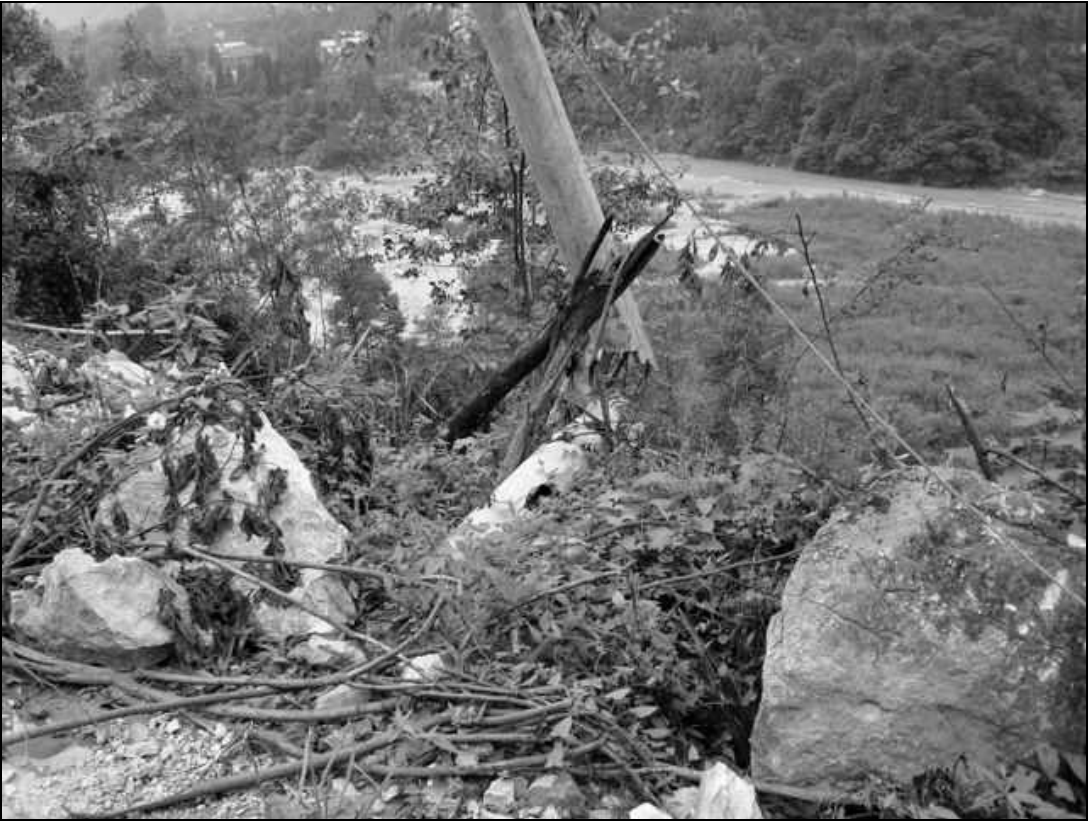
Fig. 6.40. A pole damaged by the rock falling from the slope across the road

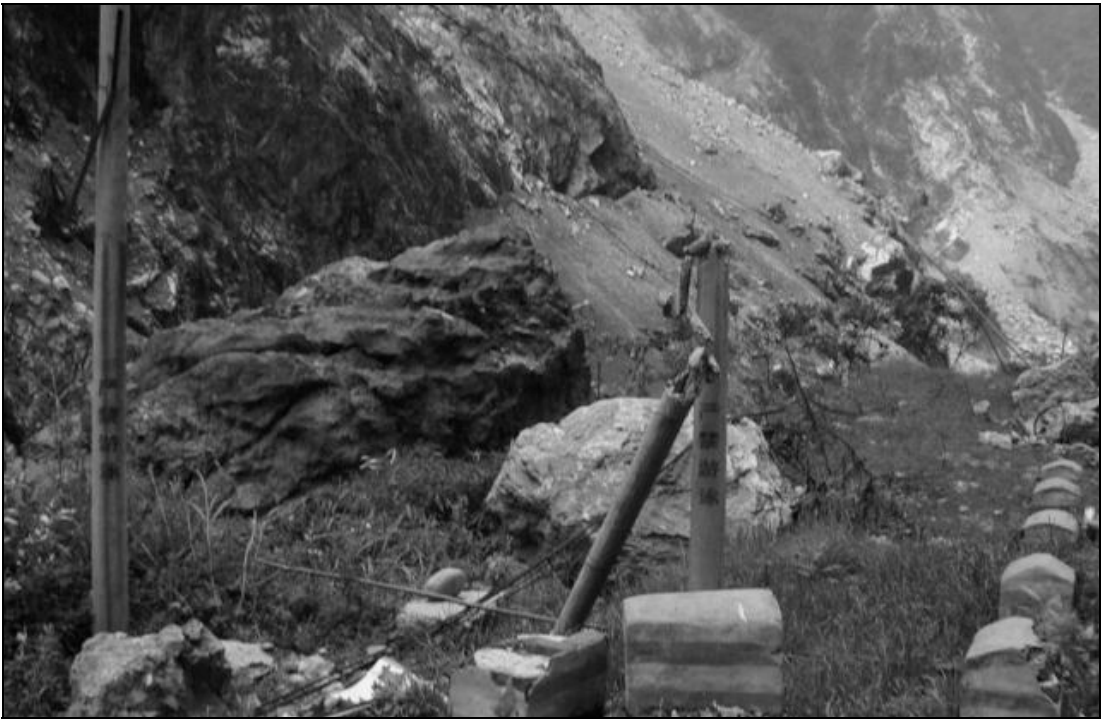
Fig. 6.41. A pole damaged by the rock fall, note that pole on the left was not damaged

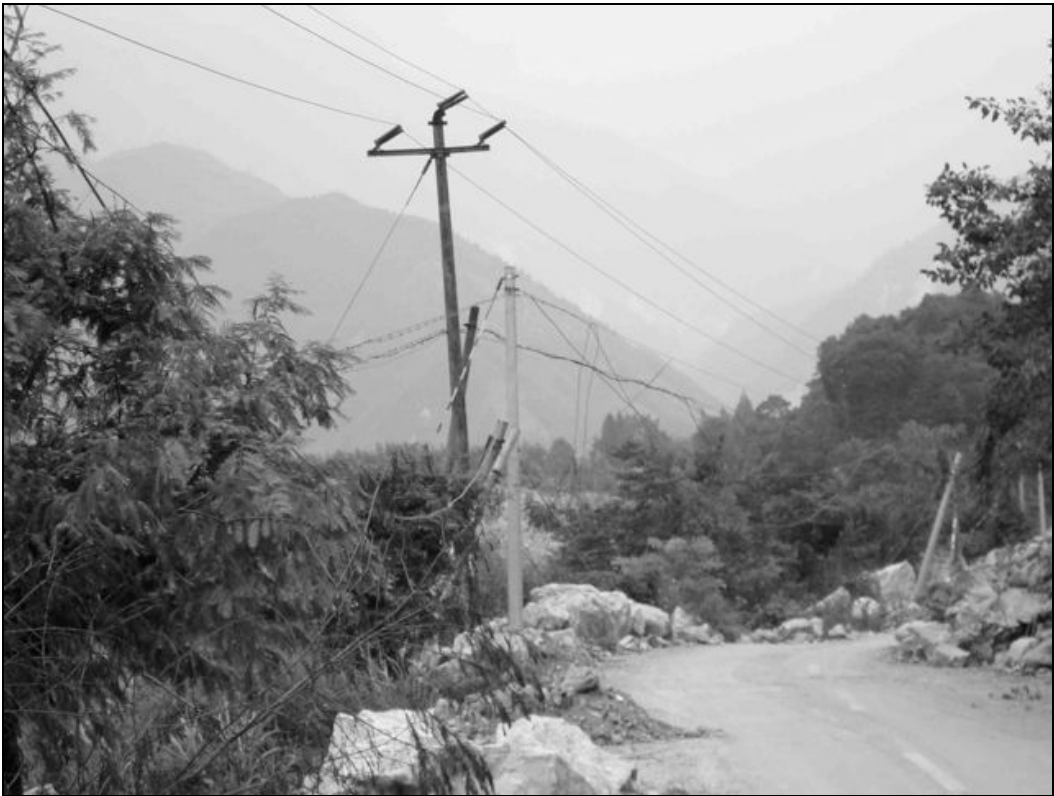
Fig. 6.42. Both concrete and wood poles were damaged at this section of the road leading to Hongkou. Fallen rocks were pushed to both sides of the road to clear the road for cars.

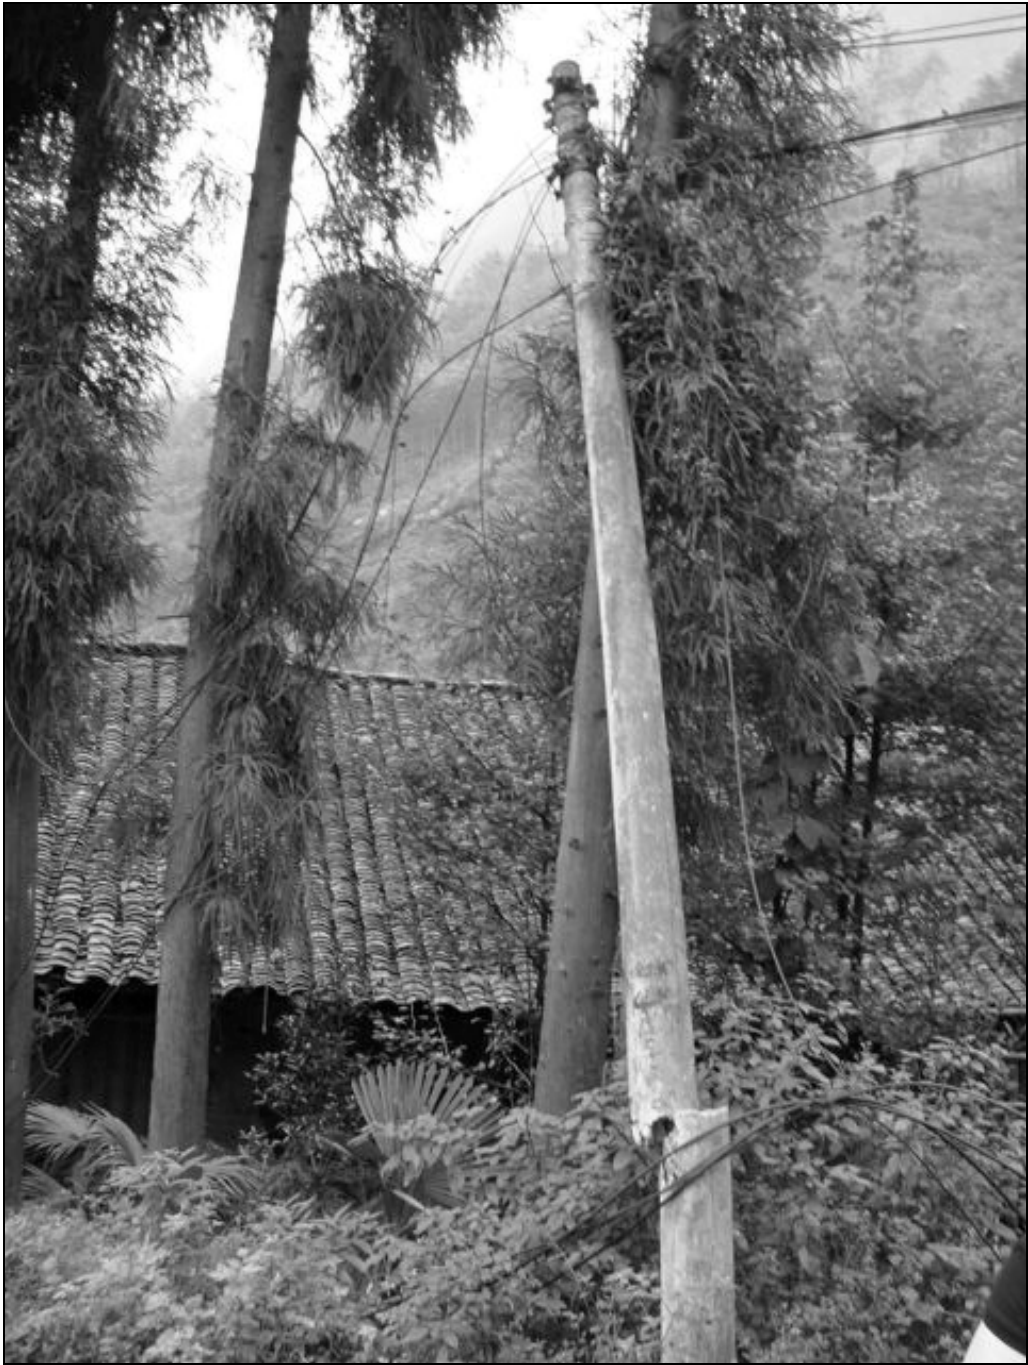
Fig. 6.43. There was no rock fall and no landslide in this neighborhood. Most likely this pole was damaged by the strong shaking as surface fault was observed in this area.

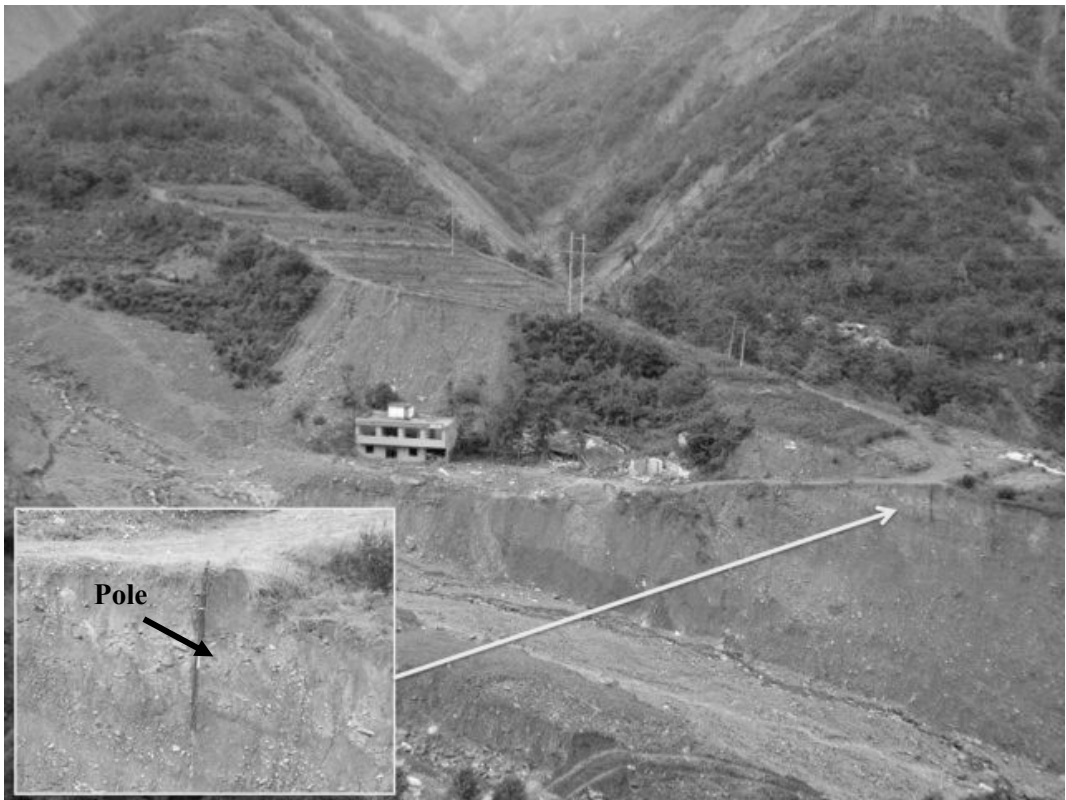
Fig. 6.54. Due to landslide a pole was hanging by the cables along the edge of the slope failure.

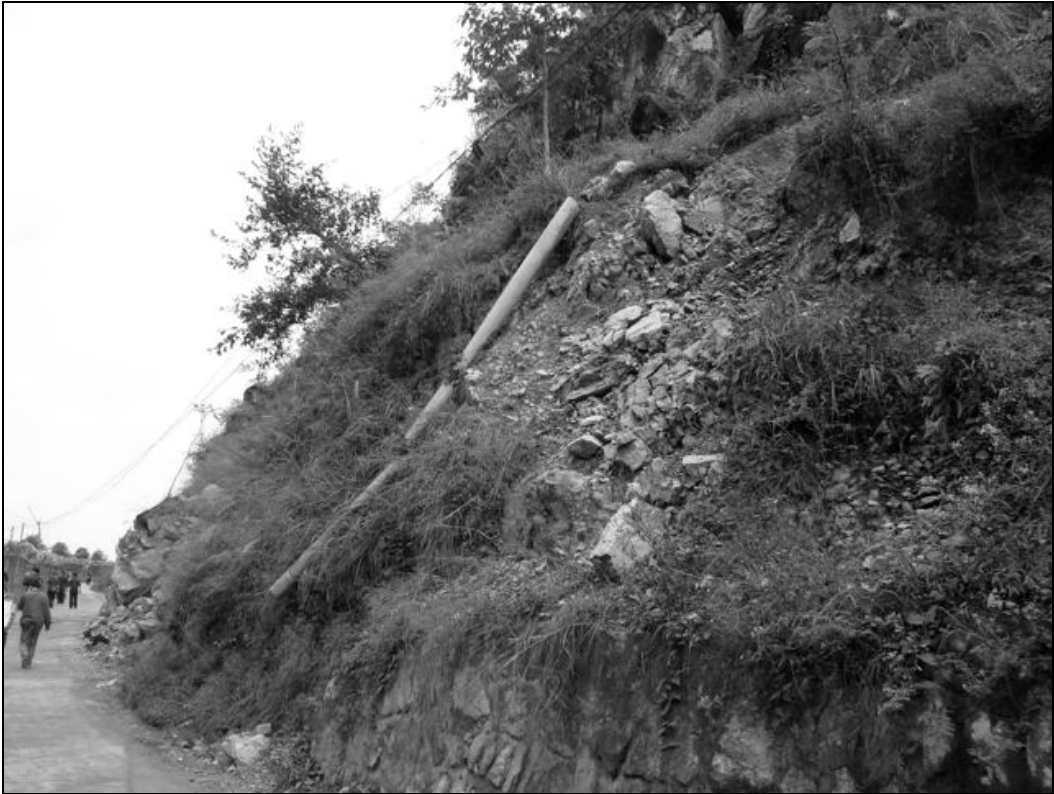
Fig. 6.55 A pole collapsed along the slope and broke into four pieces.

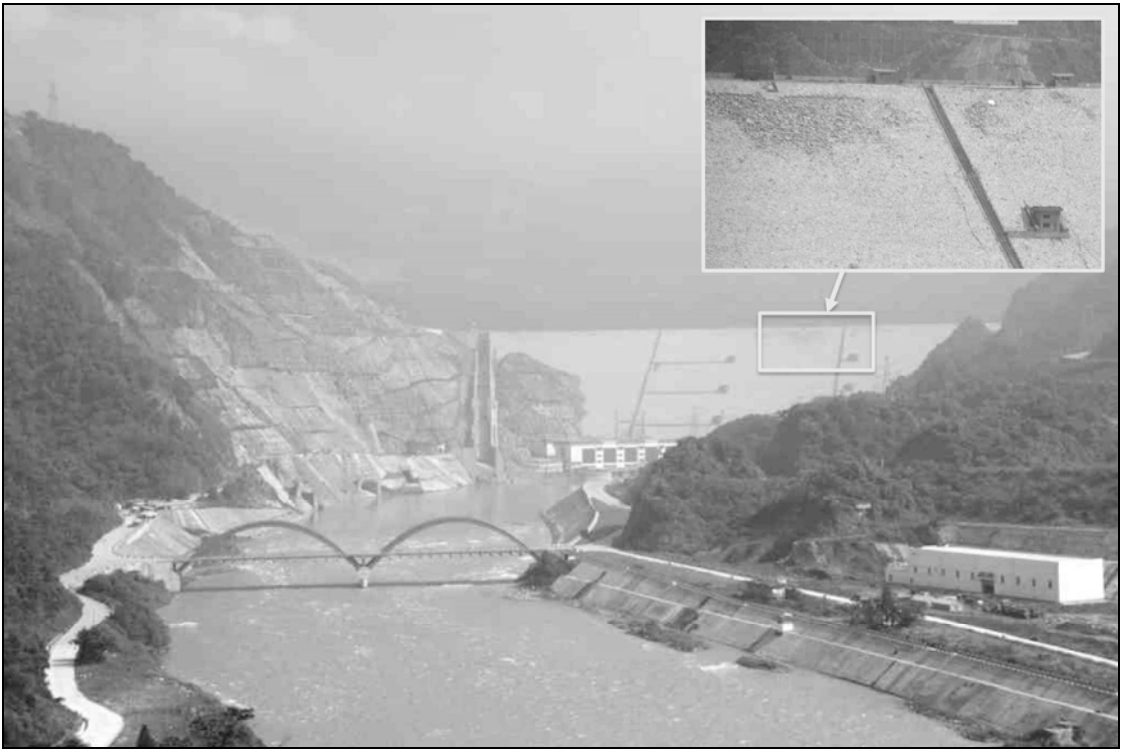
Fig. 8.3. Zipingpu Dam; insert shows surface cracking on the down stream dam face.

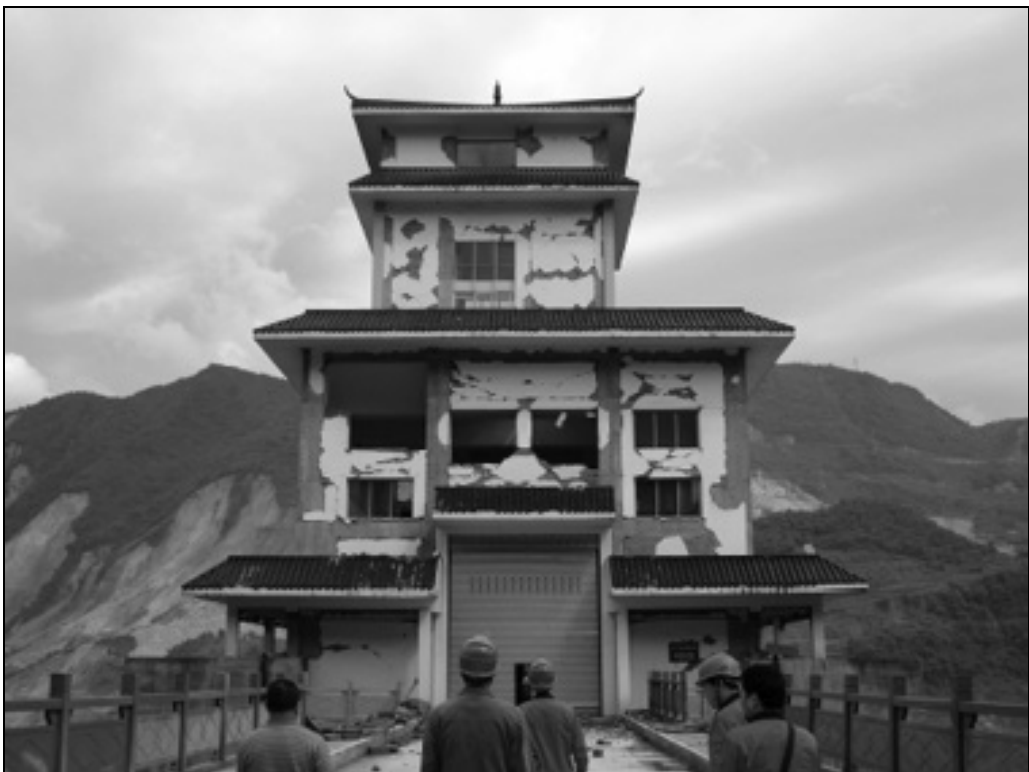
Fig. 8.6. Gate lifting equipment building sustained serious damage but did not collapse (Courtesy IEM)

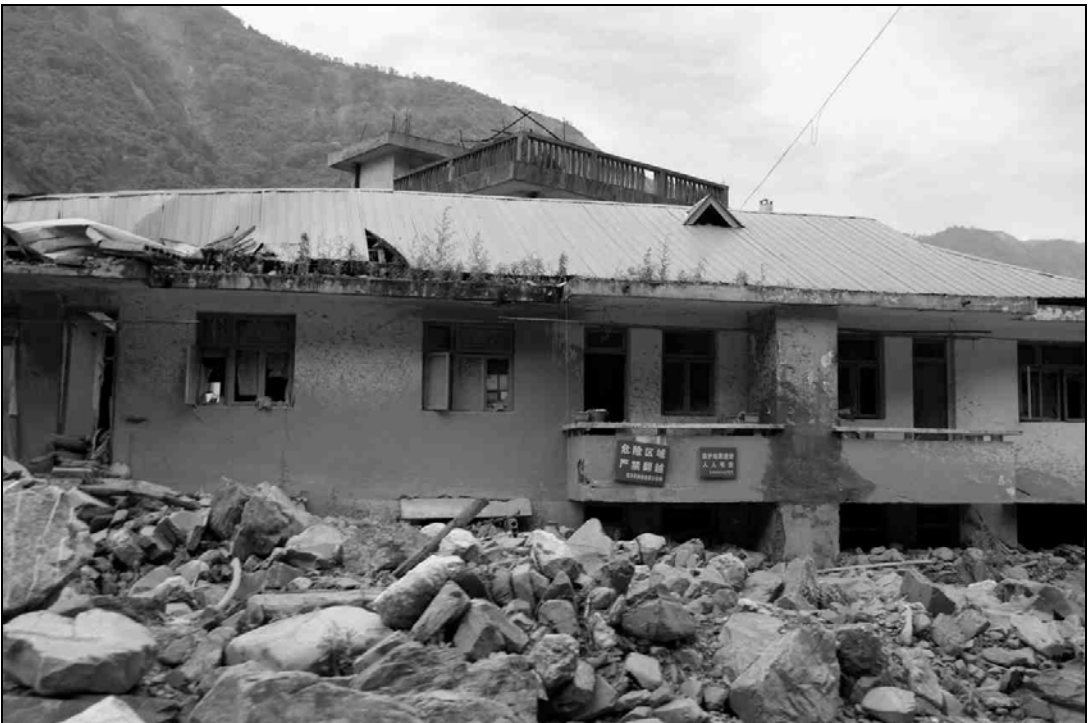
Fig. 9.24. The debris flow carried rocks that did the most damage.

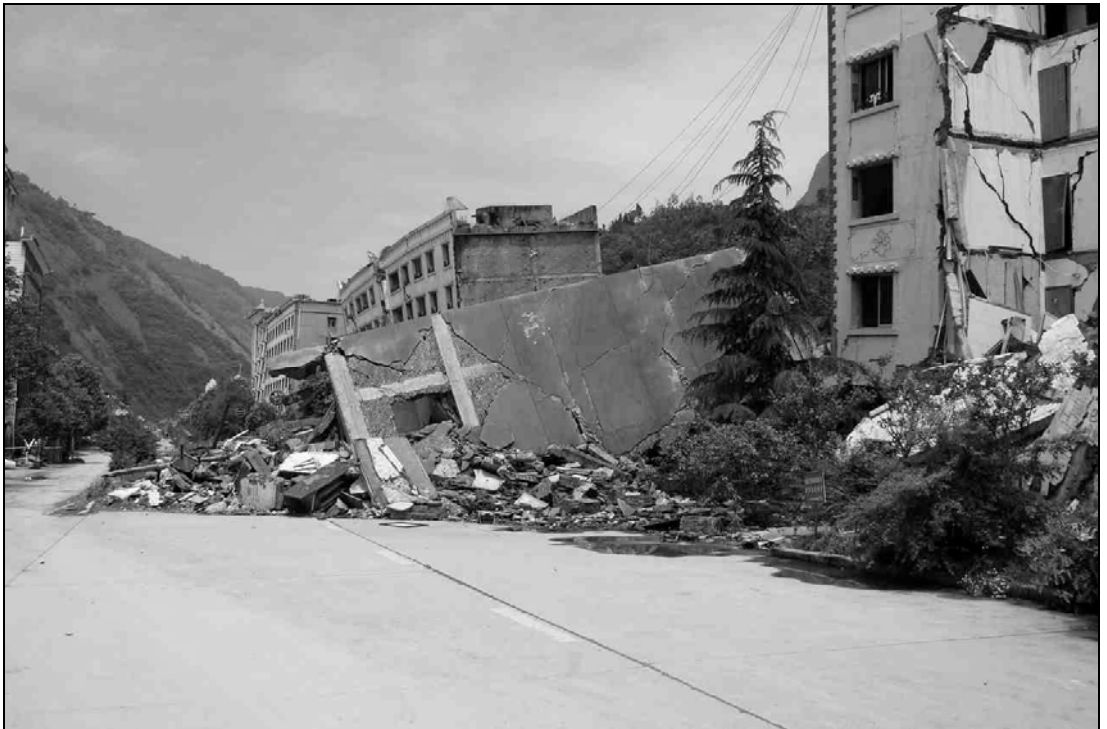
Fig. 9.28. Buildings damaged due to strong shaking

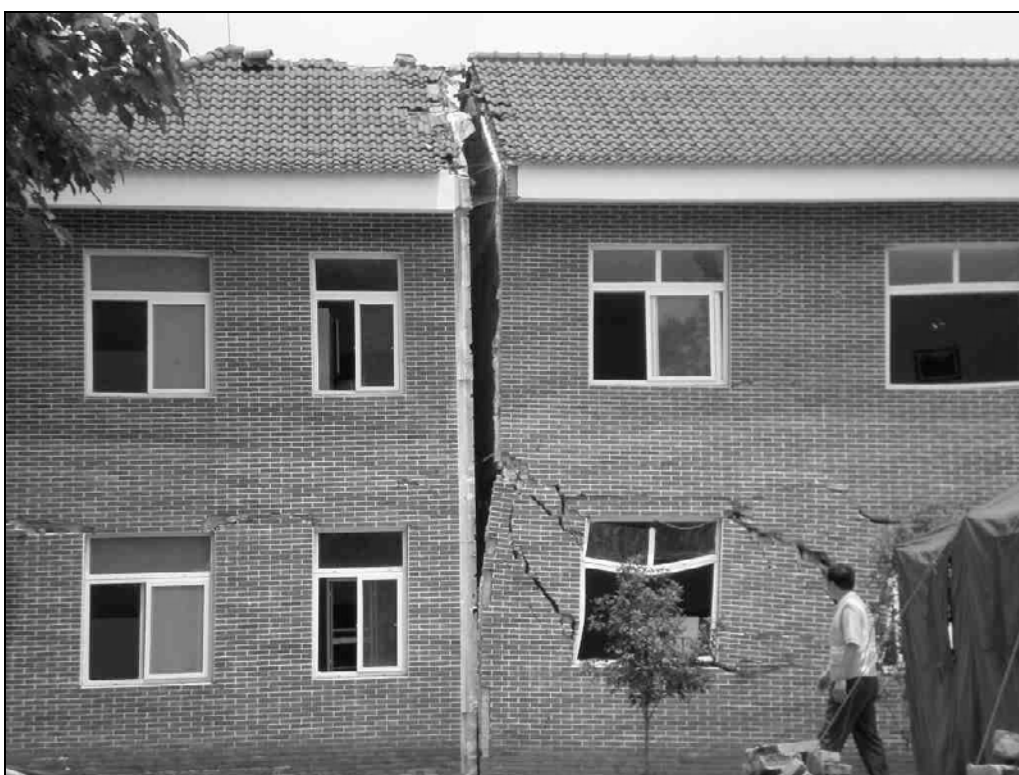
Fig. 9.37. These houses showed significant structural damage but did not collapse.

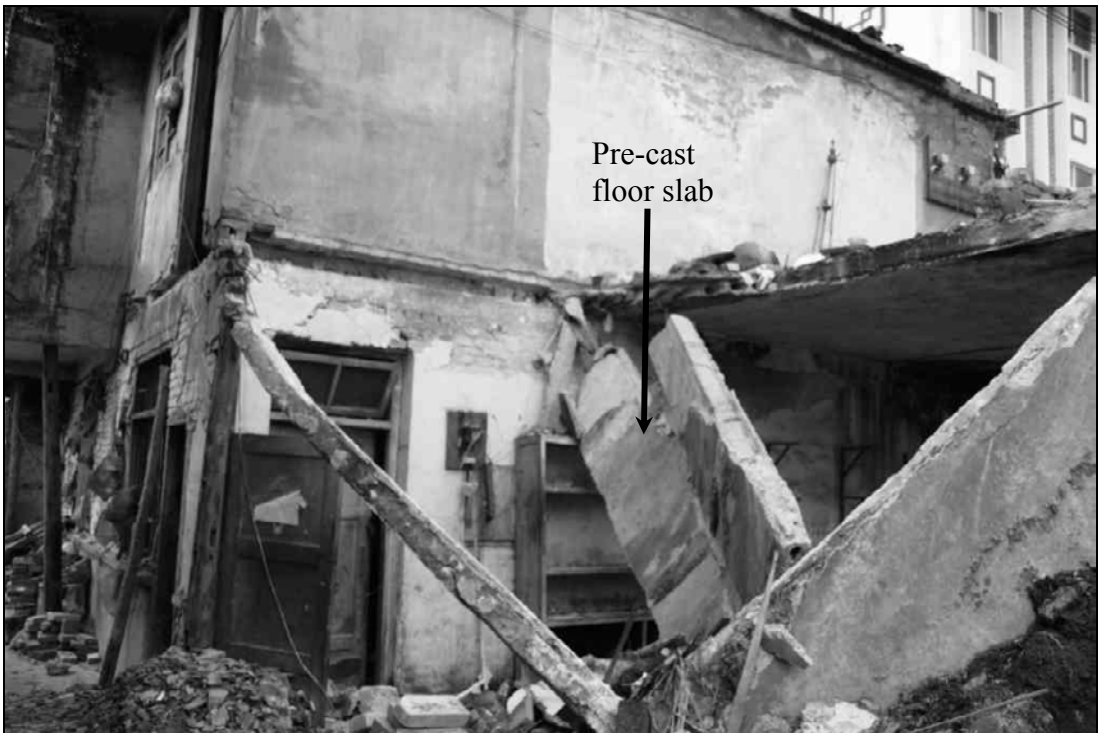
Fig. 9.48. Two-story URM building with pre-cast concrete floor slabs collapsed, which was common in the older part of the city.

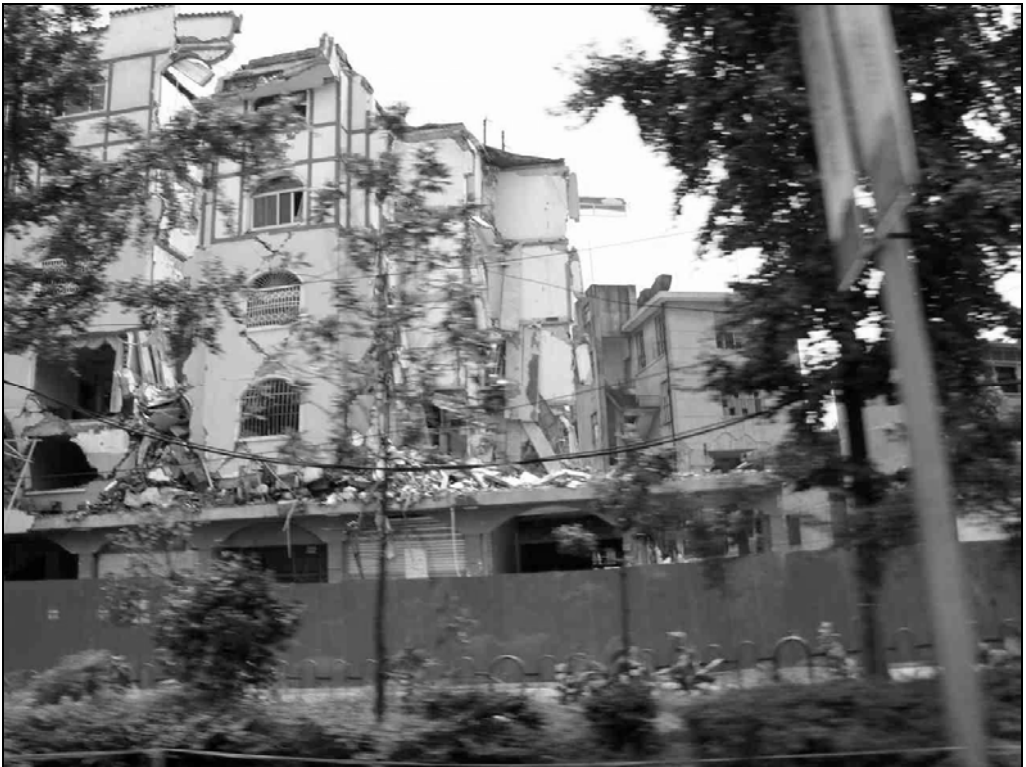
Fig. 9.56. More than one-third of this five-story apartment building collapsed. The remaining structure was condemned as unsafe.

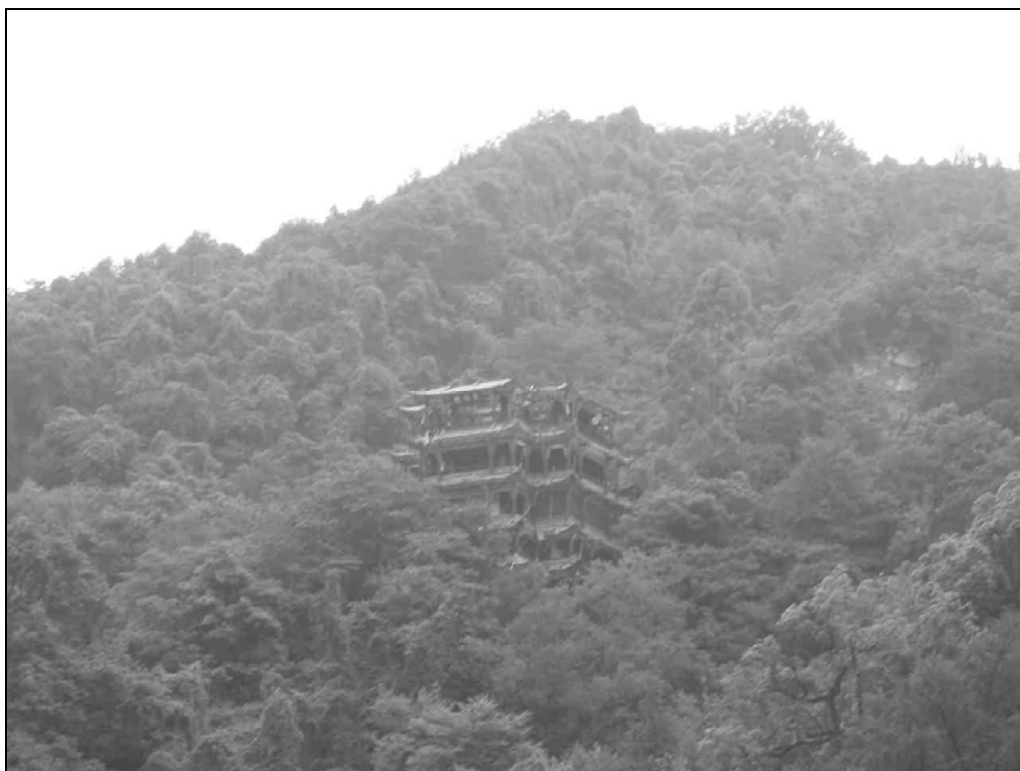
Fig. 9.59. This Li Bing Temple had significant damage but did not collapse.

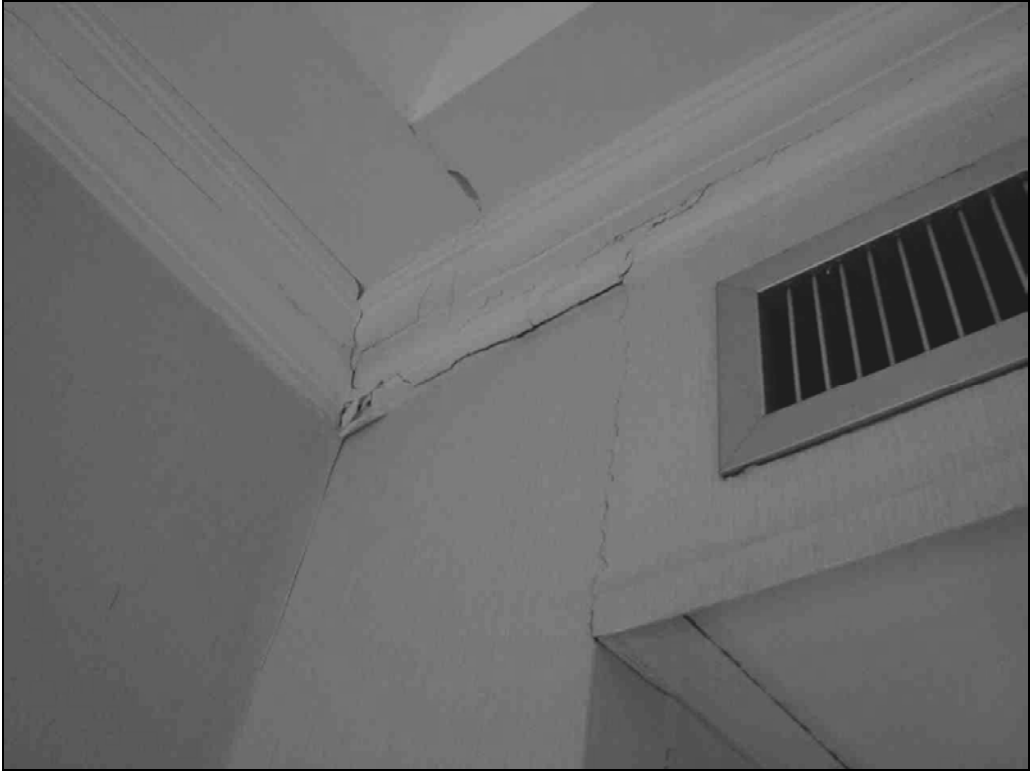
Fig. 9.68. Cracks on walls inside the hotel rooms were evident of strong shaking in this city.

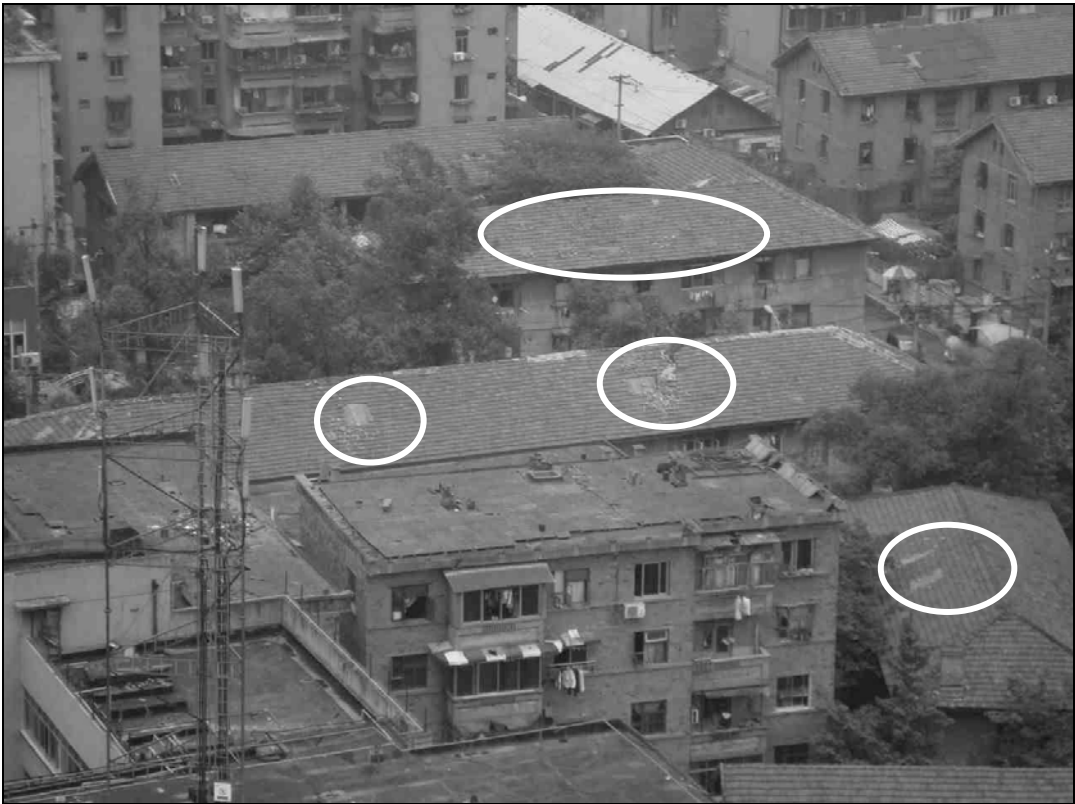
Fig. 9.70. Tiles fell of the roofs of these buildings in the center of Chengdu.

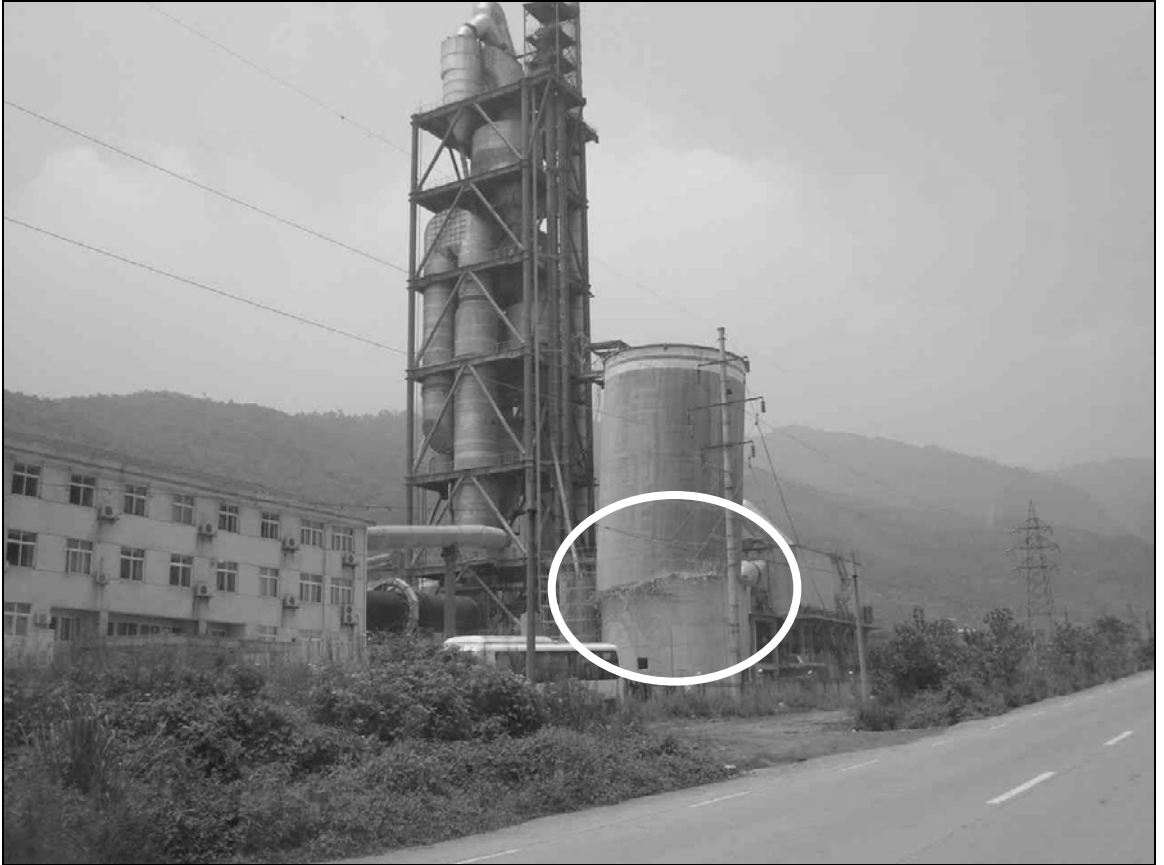
Fig. 9.73. The raw material silo at this chemical processing plant in Shifang collapsed at about mid-height. This is the only silo in this plant that was damaged.

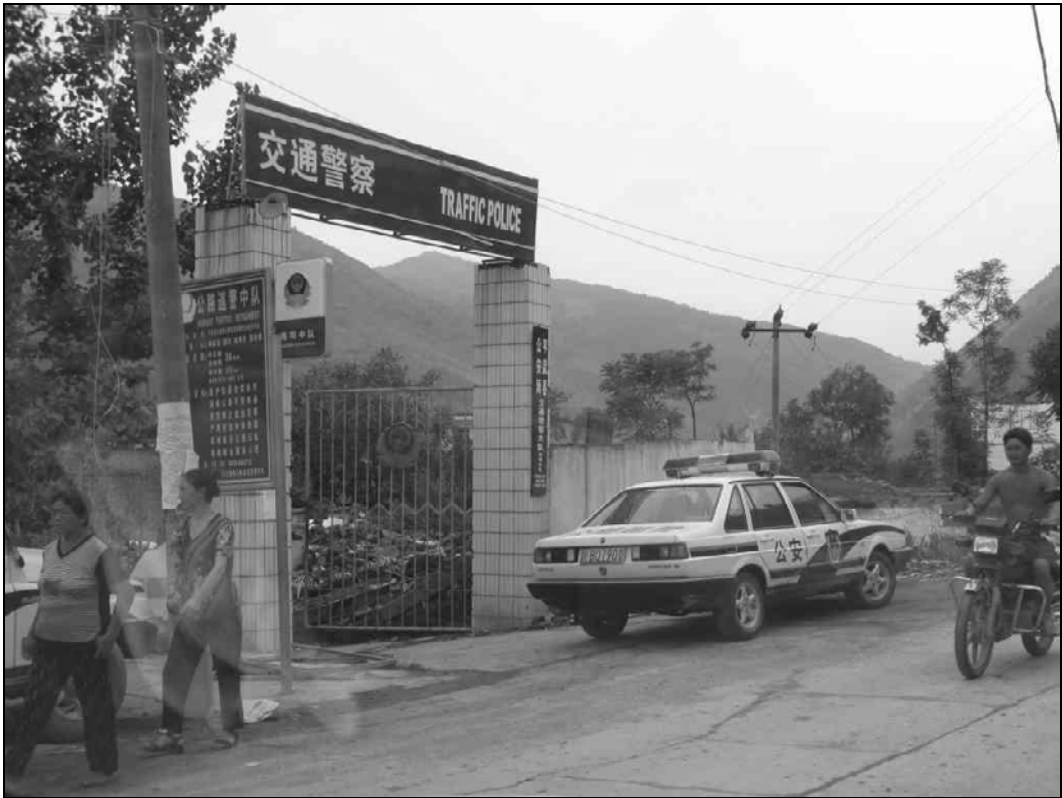
Fig. 9.86. The traffic police office building on the main road in Nanba collapsed, but the front gate remained standing

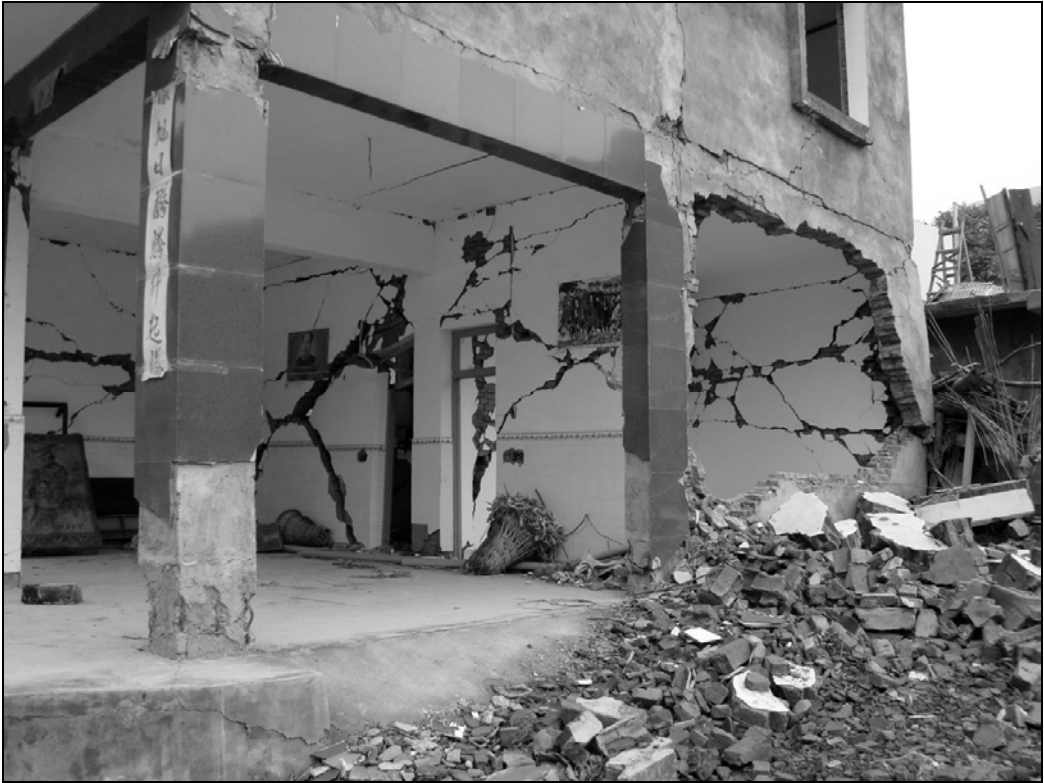
Fig. 9.90. Details of the damage to the ground floor of the building shown in Fig. 9.90
