Beyond Failure

*Forensic
Case Studies
For Civil Engineers*

Norbert J. Delatte Jr.,
Ph.D., P.E.

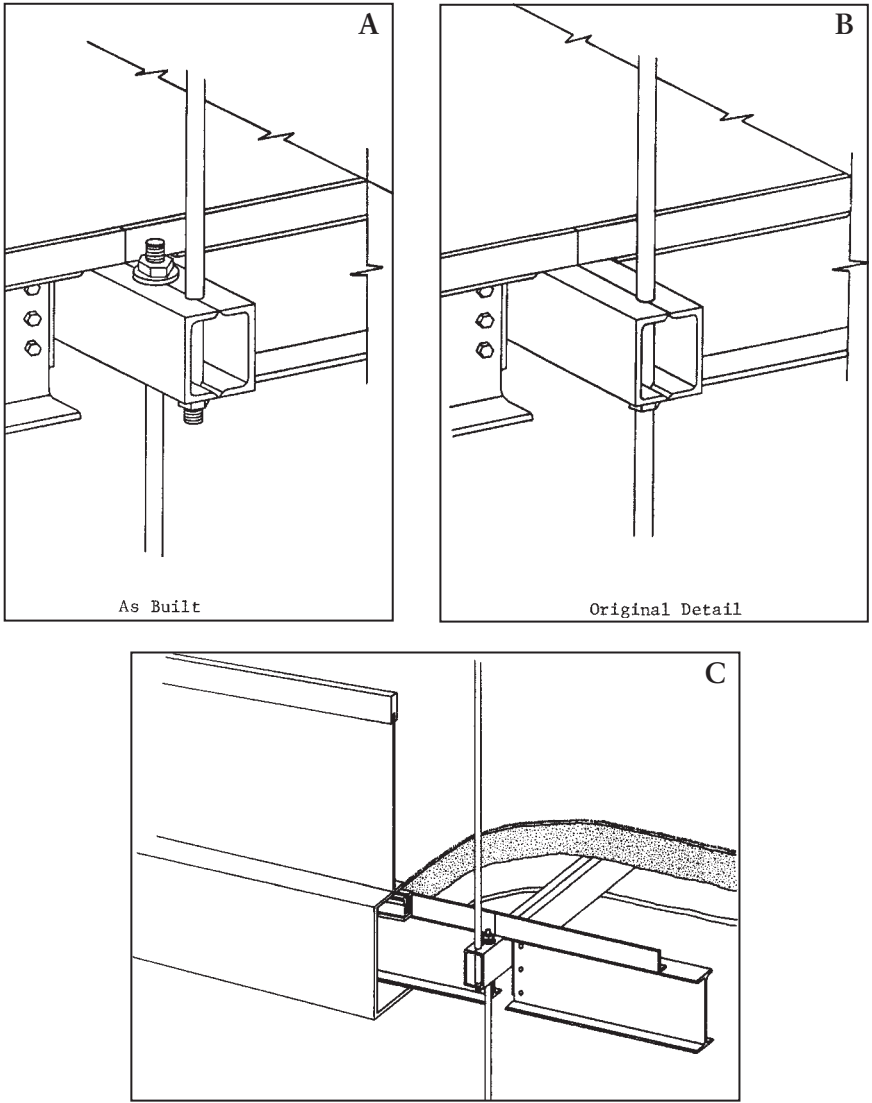
Originally, the second- and fourth-floor walkways were to be suspended from the same rod (Fig. 2-4a) and held in place by nuts. The preliminary design sketches contained a note specifying a strength of 413 MPa

Figure 2-4. Original and as-built hanger details a, b, c.
Courtesy National Bureau of Standards/National Institute of Standards and Technology.

Analysis of these two details revealed that the original design of the rod hanger connection would have supported 90 kN (20,000 lb), only 60% of the 151 kN (34,000 lb) required by the Kansas City building code. Even if the details had not been modified, the rod hanger connection would have violated building standards. As built, however, the connection only supported 30% of the minimum load, which explains why the walkways collapsed at well below maximum load (Feld and Carper 1997, pp. 218–222). The NBS built and tested a full-scale mock-up to simulate the failure and found that the static effects were much more significant than the dynamic effects (Kaminetzky 1991, p. 219).

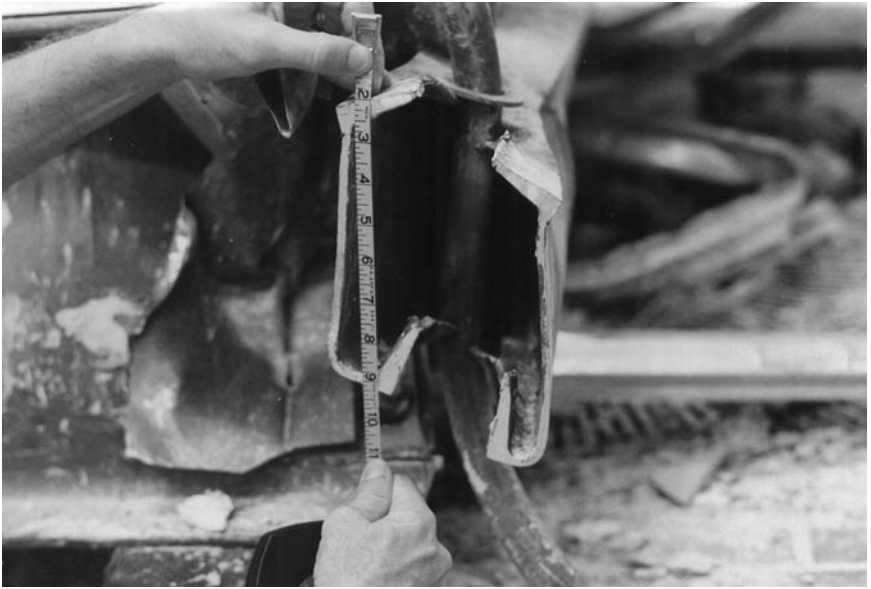
Figure 2-5. Failed fourth-floor beam.
Courtesy Lee Lowery, Texas A&M University.

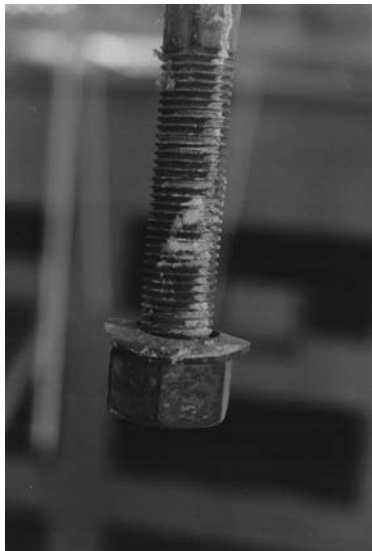
Figure 2-6. Hanger rod.
Courtesy Lee Lowery, Texas A&M University.

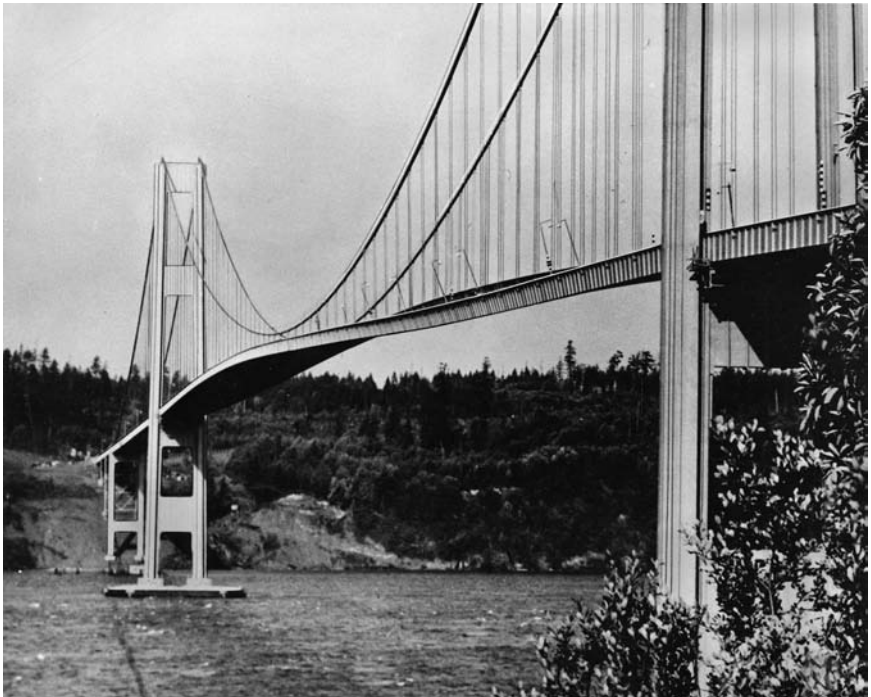
The onlookers had not been concerned up to this point. Although the wind was the strongest so far since the bridge had been built, the motions were in line with what had been observed earlier. However, the sudden change in motion was alarming. Without any intermediate stage, violent torsional movement started. The movement changed from nine or ten smaller waves to the two dominant twisting waves. Farquharson was surprised because he had not observed this phenomenon in his wind tunnel tests (Scott 2001, p. 50). Figure 2-10 shows the torsional motions of the bridge.

Figure 2-10. Tacoma Narrows Bridge torsional motion.
Courtesy University of Washington Special Collections, photo UW21413.

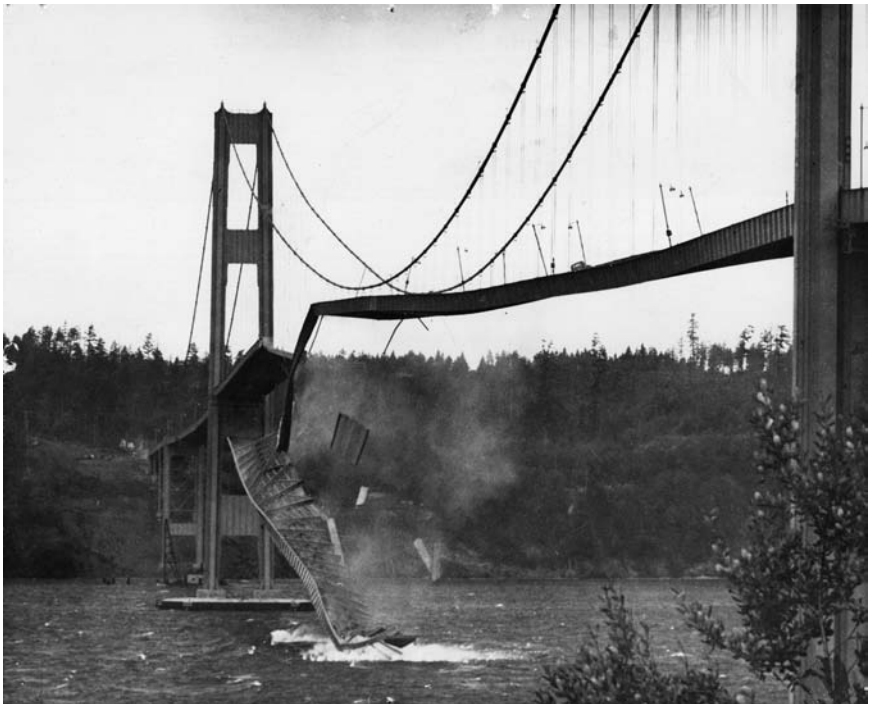
The concrete sidewalks and curbs were beginning to crumble, and lampposts were coming loose. A couple of minutes later, the stiffening girders in the middle of the bridge buckled, initiating the collapse. Then the suspender cables broke, and large sections of the main span dropped progressively, from the center outward, into the river below. Loud bangs were heard, similar to gunfire. The weight of the sagging side spans pulled the towers 3.7 m (12 ft) toward the shore, and the ruined bridge finally came to rest. The side spans, no longer balanced by the main span, dropped 18 m (60 ft) before coming back to a final sag of about 9 m (30 ft) (Feld and Carper 1997, Scott 2001, pp. 51–53). The bridge's only fatality was Coatsworth's cocker spaniel. Figure 2-11 shows the bridge collapsing.

Figure 2-11. Tacoma Narrows Bridge collapse.
Courtesy University of Washington Special Collections, photo UW21422.

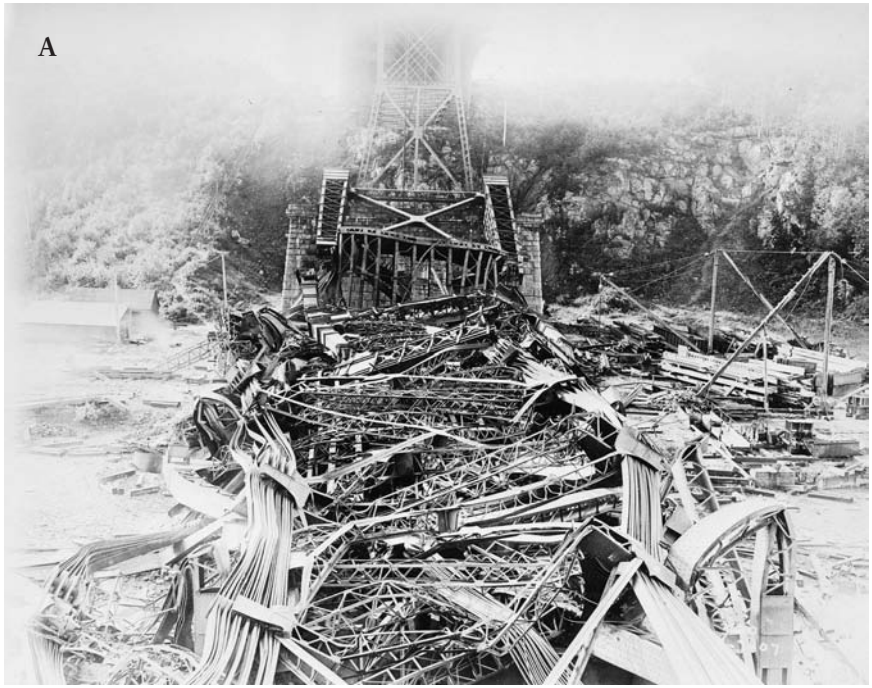
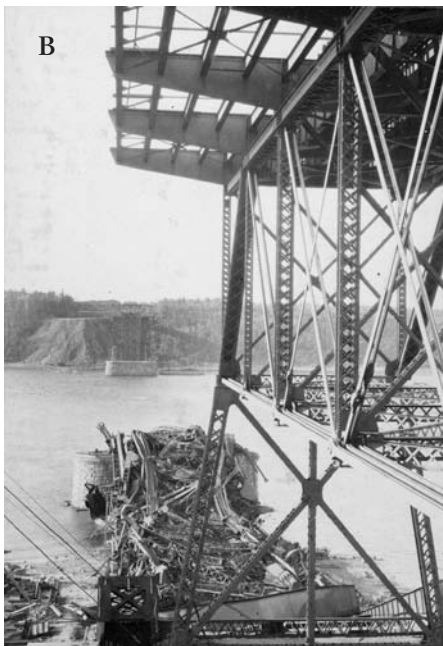
1. The collapse of the Quebec Bridge resulted from the failure of the lower chords in the anchor arm near the main pier. The failure of these chords was due to their defective design.

Figure 3-2a, b. The collapsed Quebec Bridge. Courtesy Archives Canada.

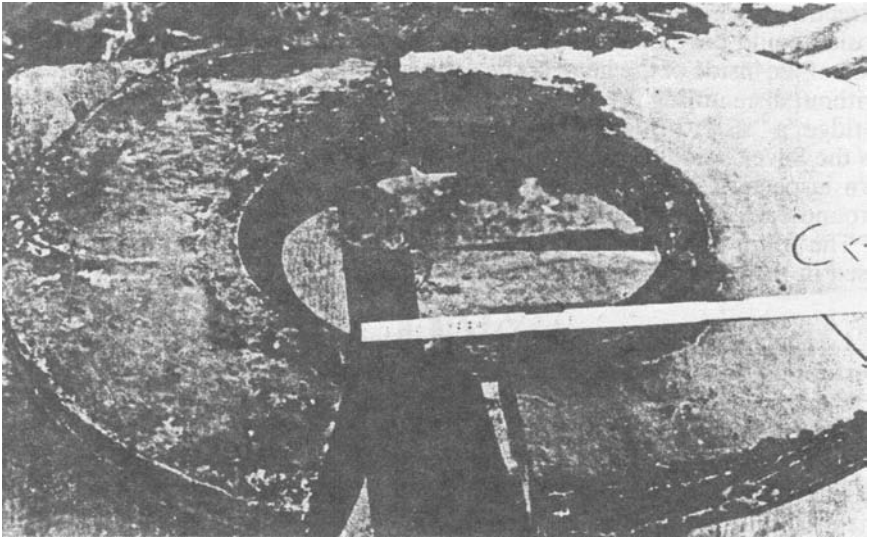
Figure 3-10. Fractured eyebar.
Source: NTSB (1970).

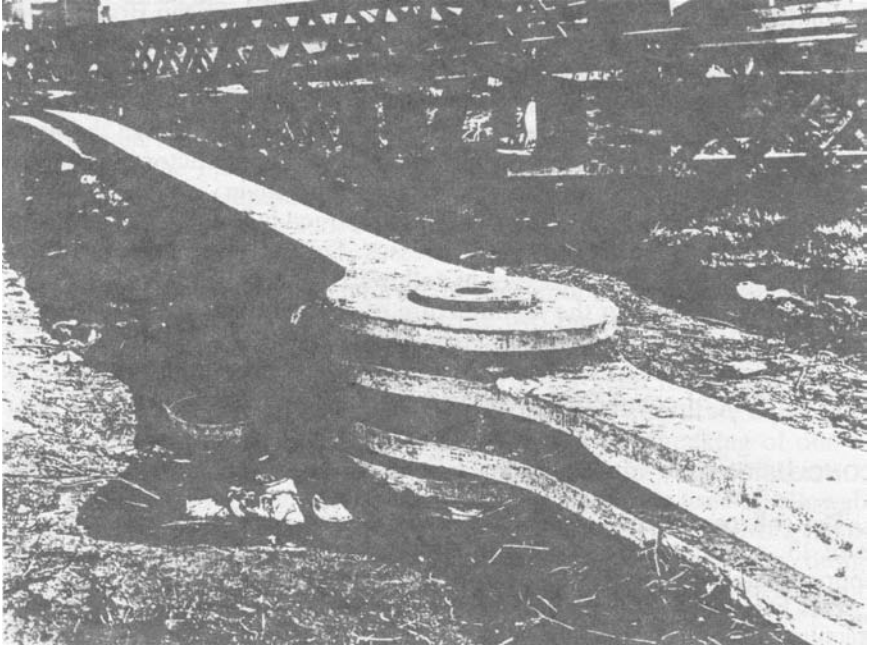
Figure 3-11. The failed joint reassembled.
Source: NTSB (1970).

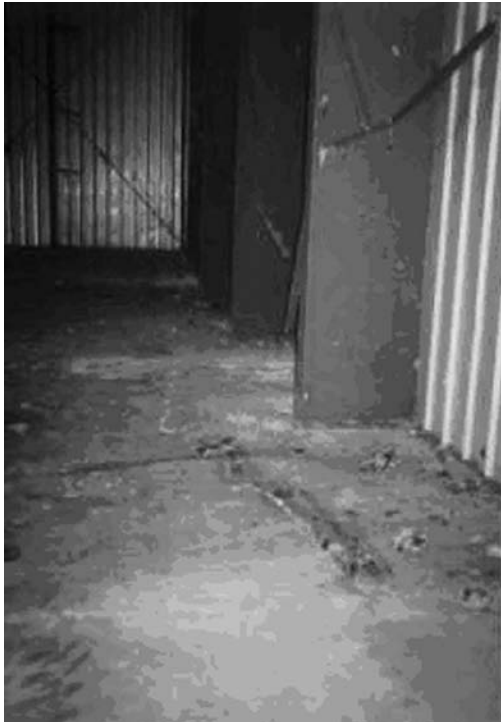
Figure 4-3. Damage to concrete foundation.

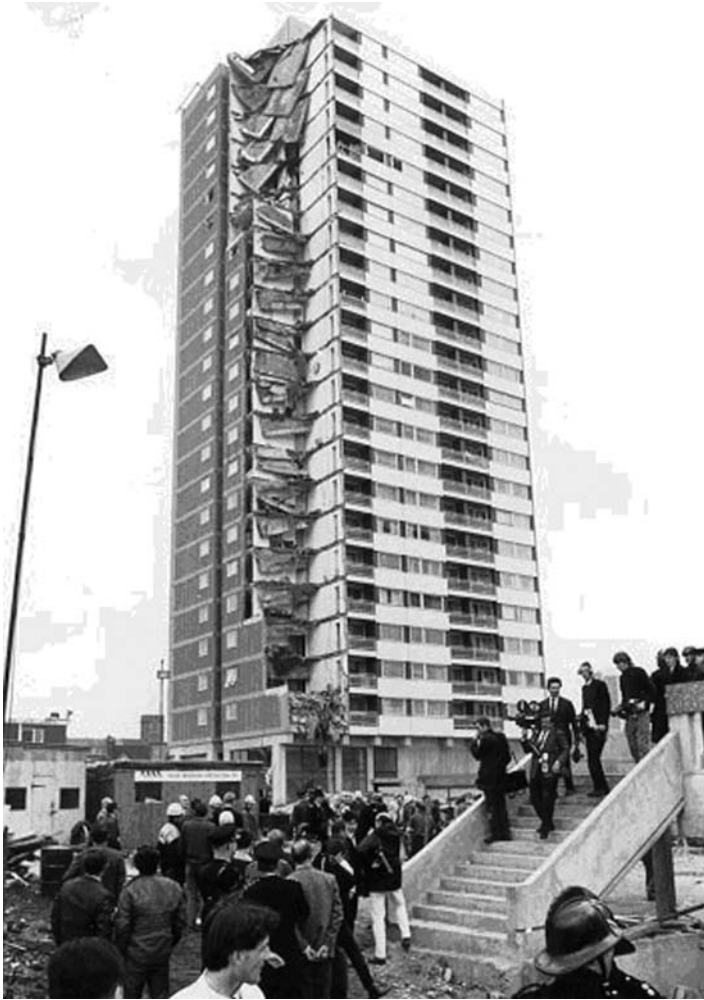
The pressure of the small gas explosion blew out the walls of her apartment and initiated a partial collapse of the structure that killed 4 people and injured 17. The partially collapsed structure is shown in Fig. 4-5, and the floor plan for apartment 90 is provided in Fig. 4-6.

Figure 4-5. Ronan Point after collapse.
Source: Pearson and Delatte (2005).

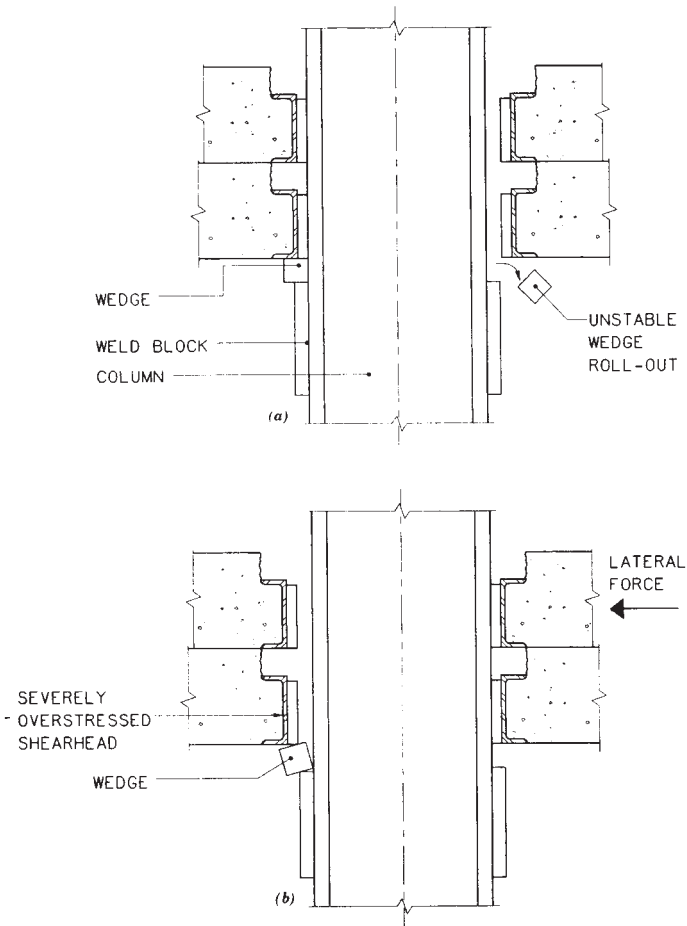
On the day of collapse, the lateral load from the hydraulic jack was exerted on the heavily loaded wedges, causing the west wedge to roll. Then the local adjustments to slab elevations caused the remaining wedge to roll out, initiating the collapse of the 12th floor–roof package and the west tower (Fig. 4-14). Forces transmitted through the pour strips or the horizontal jack, or the impact of the debris from the west tower, triggered the east tower's collapse (Cuoco et al. 1992). Zallen and Peraza (2004, pp. 28–29) refer to this as “theory 3—wedges falling out.”

Figure 4-14. Wedges and wedge roll-out mechanism.

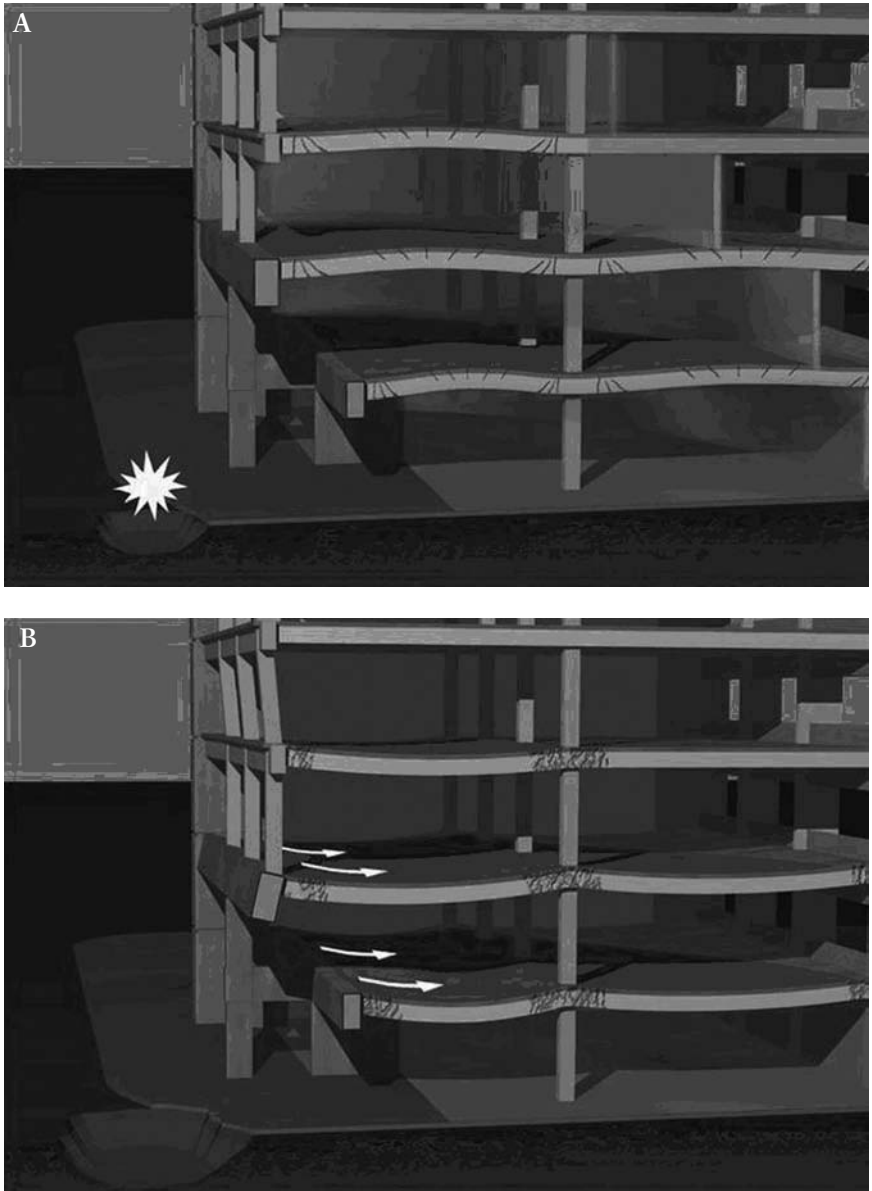
Figure 5-11a, b. Failure of the floor slabs.
Source: Oстераas (2006).

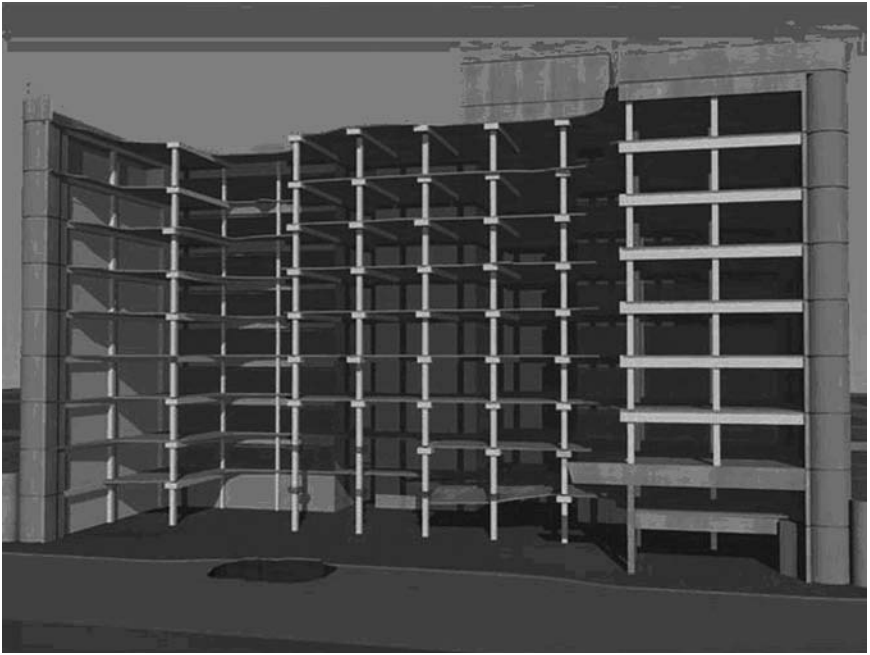
Figure 5-12. Murrah Building following the attack and partial collapse.
Source: Osteraas (2006).

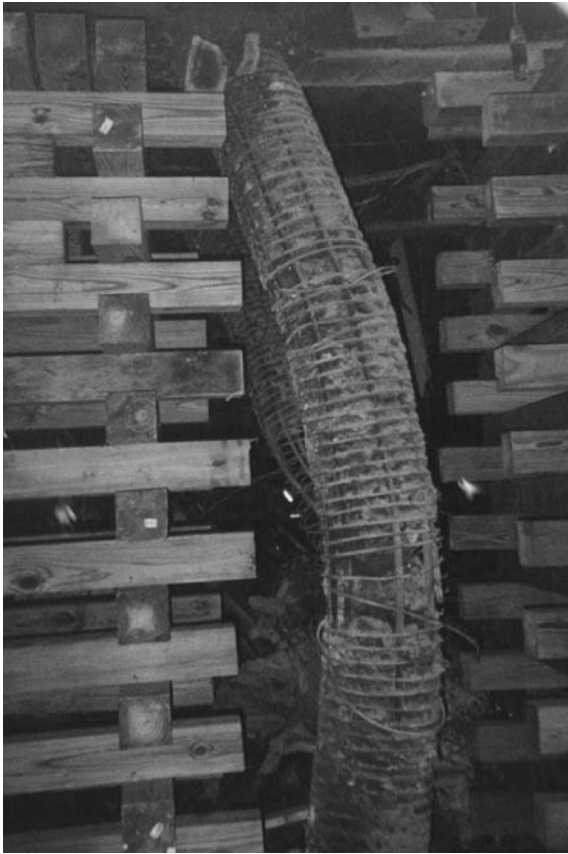
Figure 5-14. Damage to a spiral column.

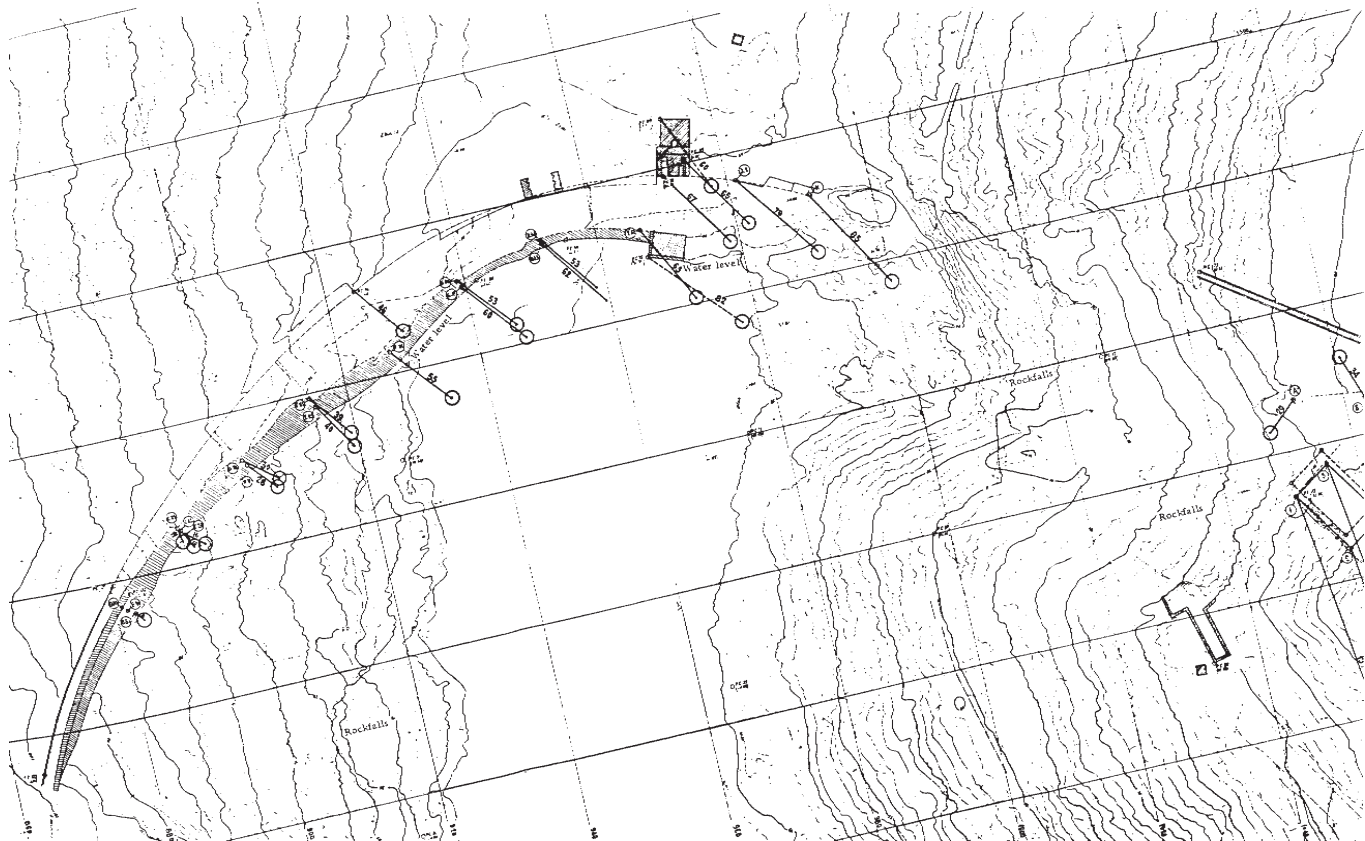
Figure 8-6. The dam following the failure.
Source: Ministère de l'Agriculture (1960).

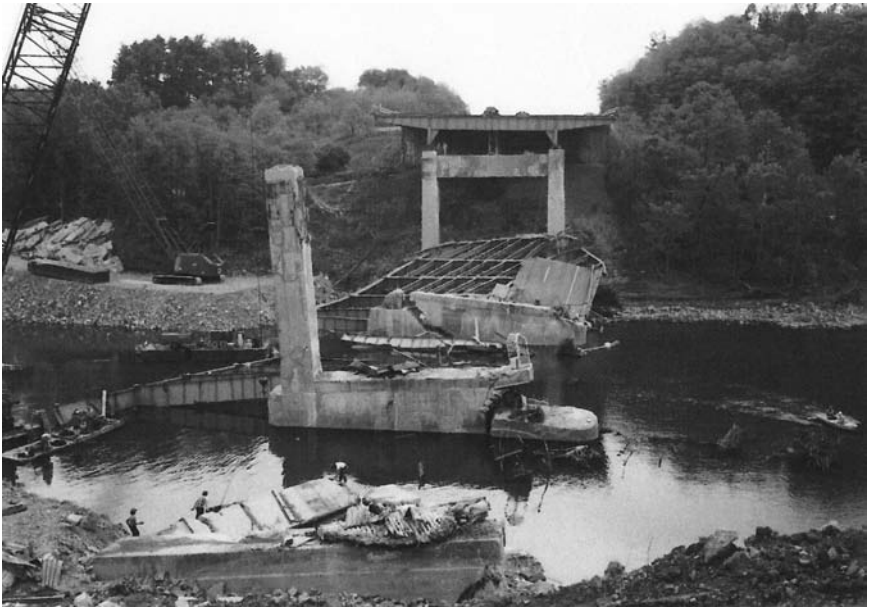
Figure 8-9. Schoharie Creek Bridge collapsed spans.
Courtesy Howard F. Greenspan.

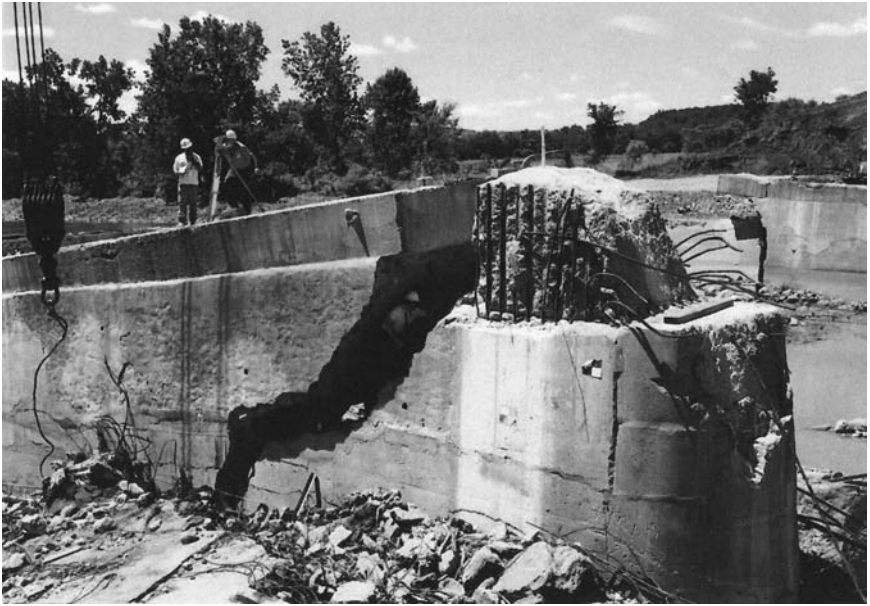
Figure 8-10. Schoharie Creek Bridge failed plinth.
Courtesy Howard F. Greenspan.

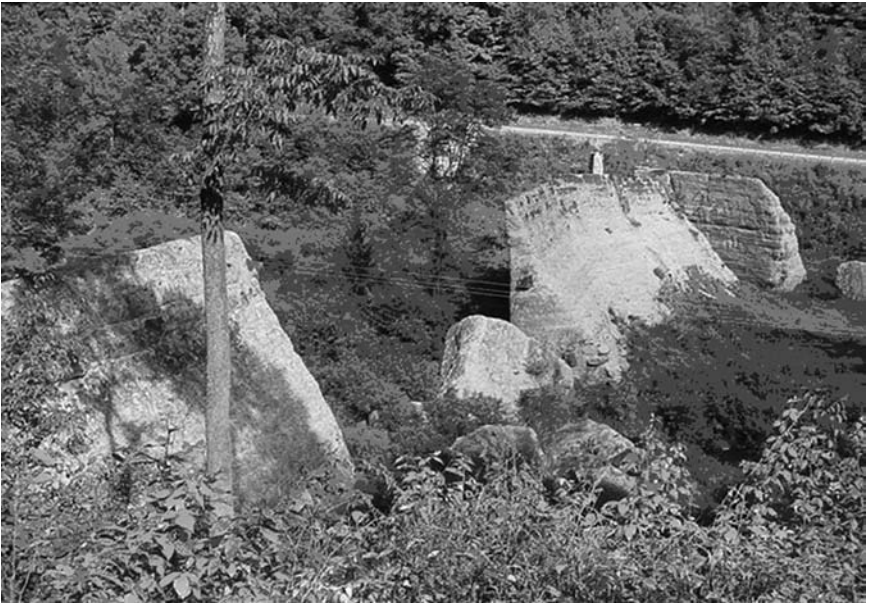
Figure 9-1. The failed Austin Dam.

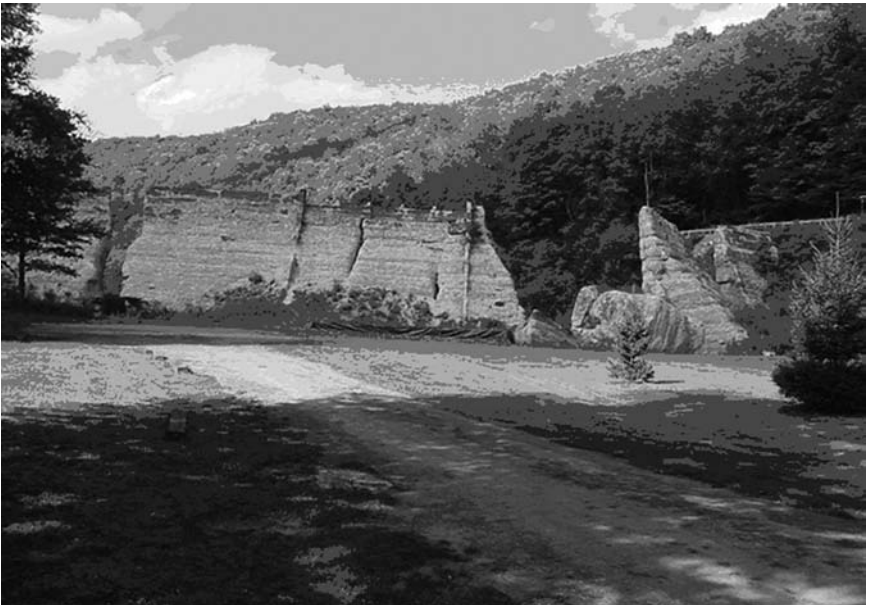
Figure 9-2. The failed Austin Dam.

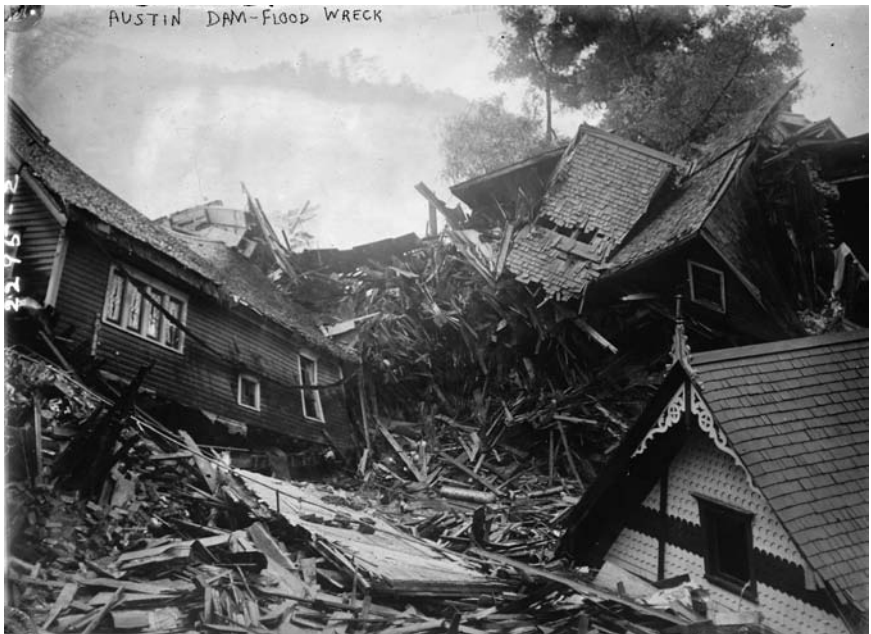
Figure 9-3. Damage from the Austin Dam failure.
Courtesy Library of Congress.

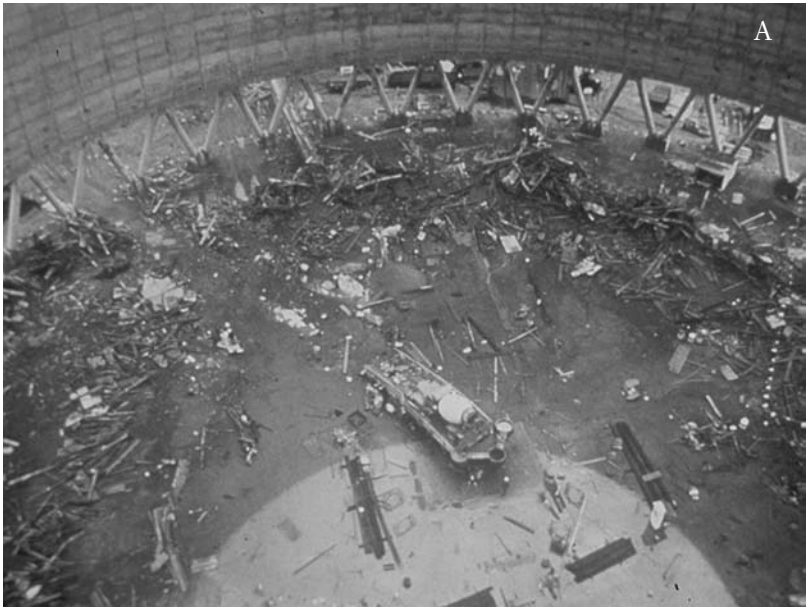
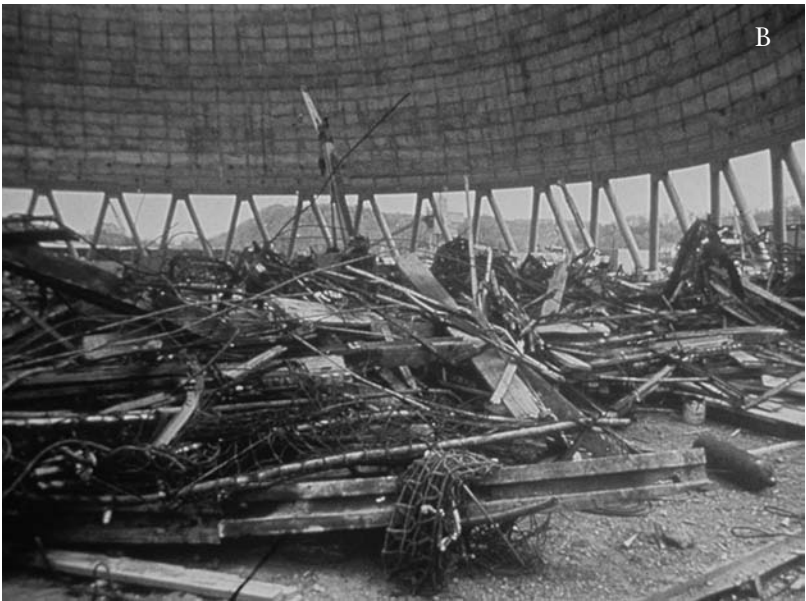
Figure 9-9a, b. Willow Island Cooling Tower collapse.
Courtesy National Bureau of Standards/National Institute of Standards and Technology.
