Residential Property Appraisal

Phil Parnham and Chris Rispin

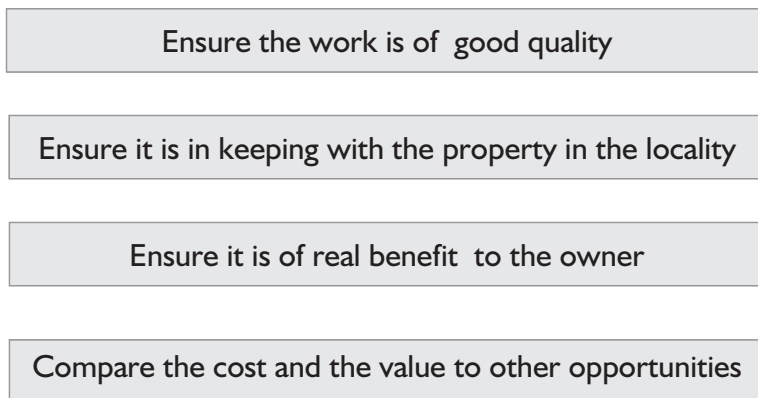
Figure 2.13 Summary of guidance when assessing the relative value of home improvements.

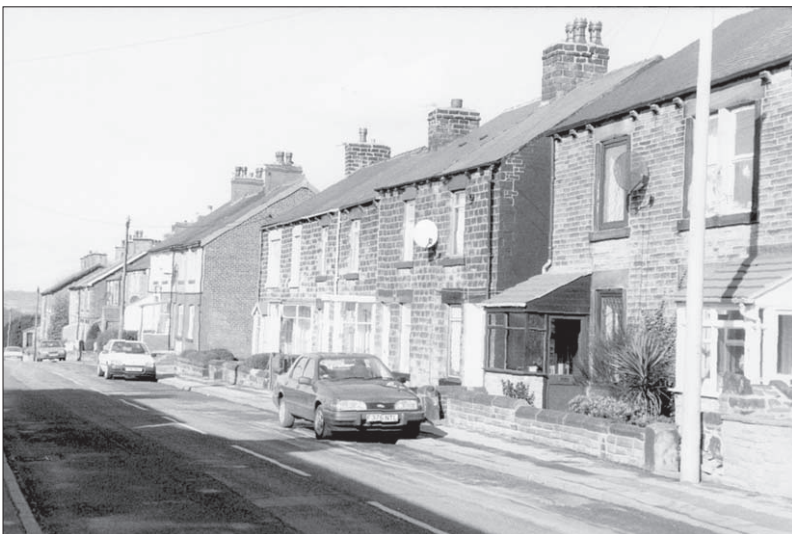
Figure 2.14 Properties in one street in a similar condition.

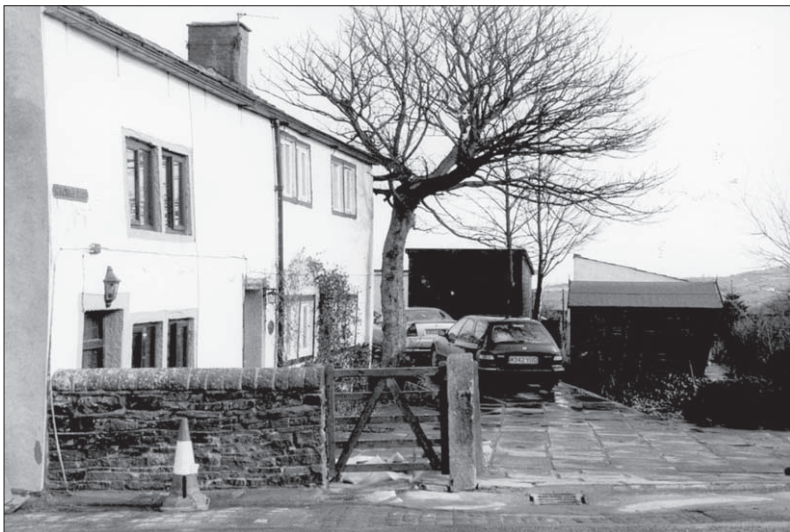
Figure 2.15 The proximity of the tree to the cottage should be of clear concern to any surveyor and a justifiable reason for recommending further investigations.

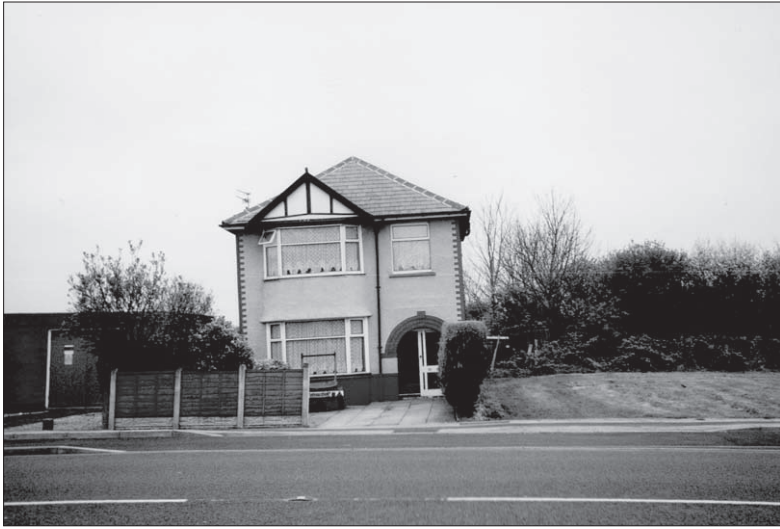
Figure 2.16 No it isn't the way this photograph has been printed! The front fence posts are vertical, it is the house that is leaning over!

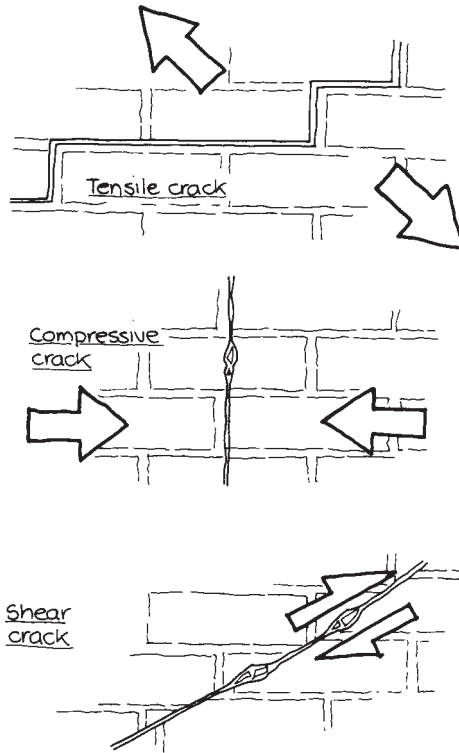
Figure 4.1 Different types of crack that can occur in masonry walls that result from tensile, compressive and shear forces.

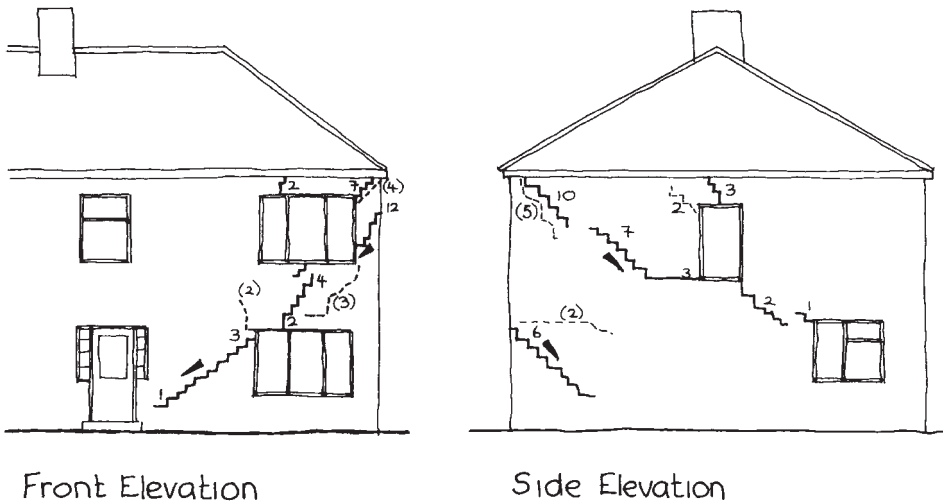
Figure 4.2 Typical 'present condition' sketch of a dwelling that a surveyor should make once building damage is noticed in a property.

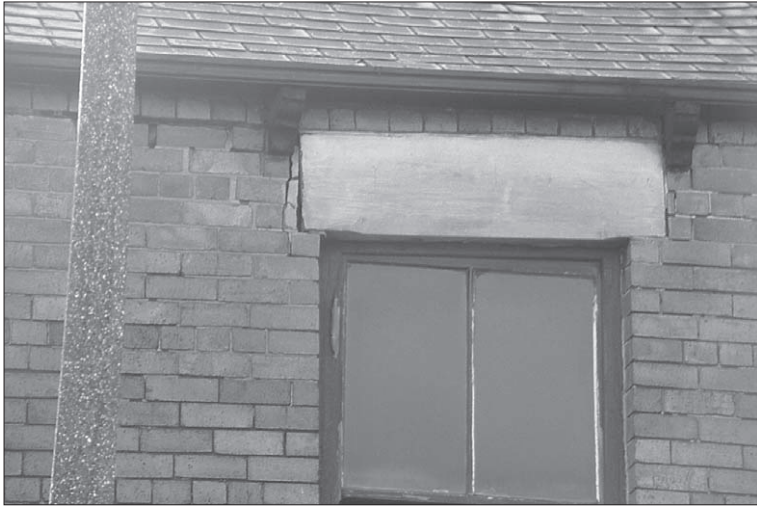
Figure 4.3 Distorted window opening in a damaged building. The top sash has been regularly adjusted so that it will close. What will the carpenter do when she gets down to the glass?

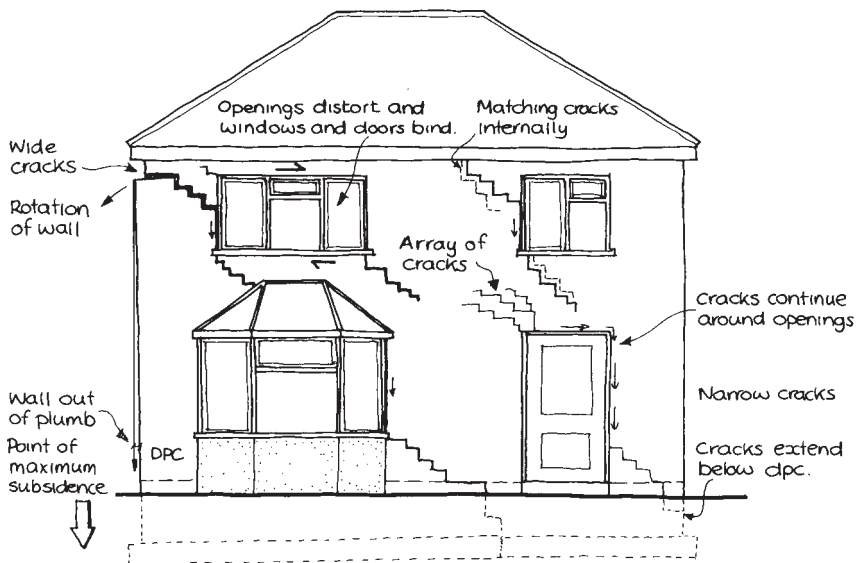
Figure 4.5 Sketch showing characteristic signs of subsidence damage to a domestic property (reproduced courtesy of Structural Engineers Trading Organisation).

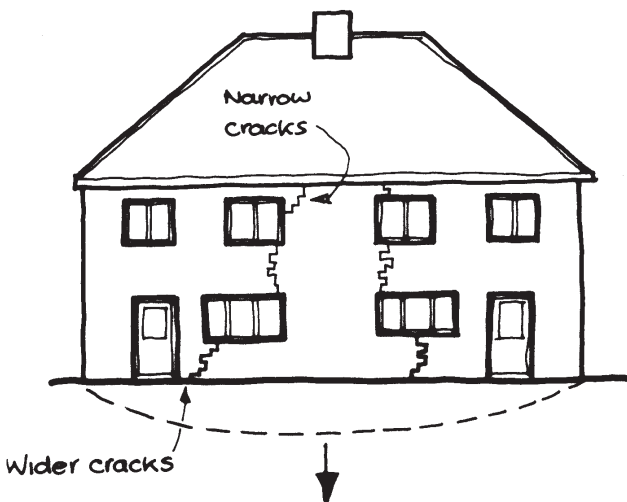
Figure 4.6 Sagging of a building in the middle. It is important to note that the cracks are wider towards the bottom of the building in this case.

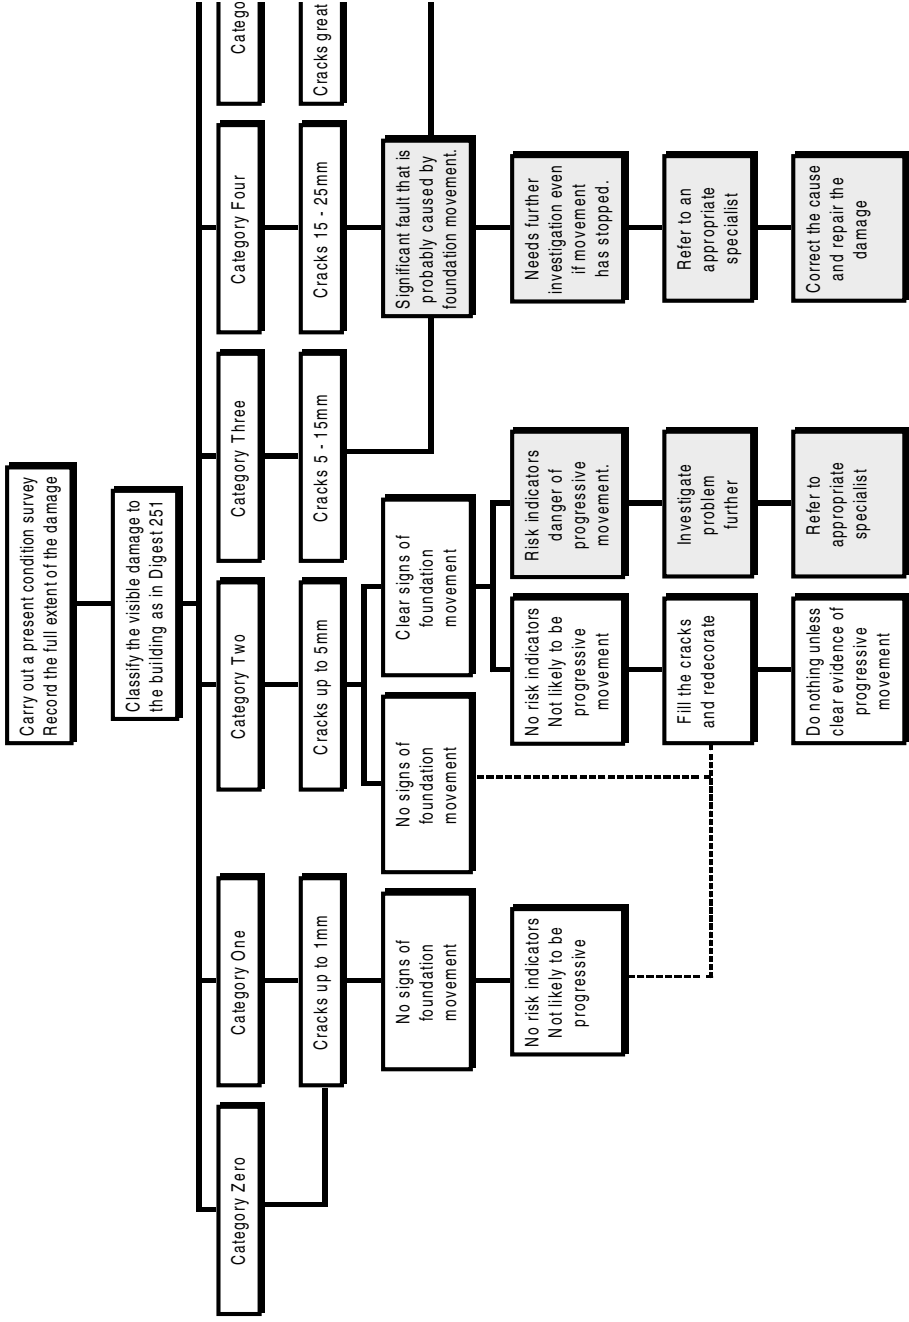
Figure 4.7 Summary of the process of assessment of building movement. This table identifies the main stages in the process. The shaded boxes represent those situations when a referral to a specialist may be required (reproduced courtesy of BRE).

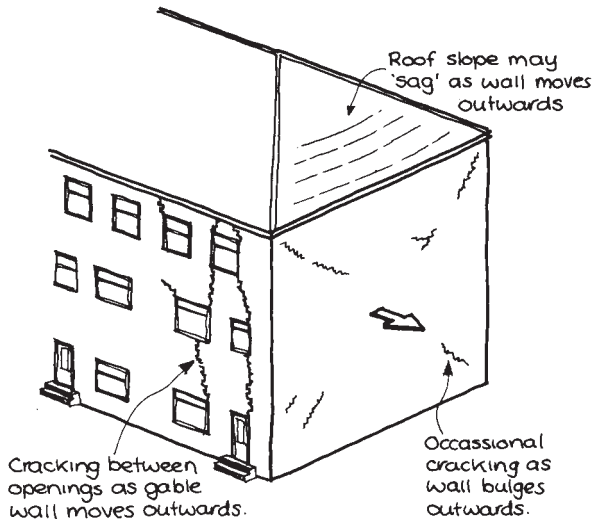
Figure 4.15 Typical cracking patterns associated with lateral instability to gable and flank walls.

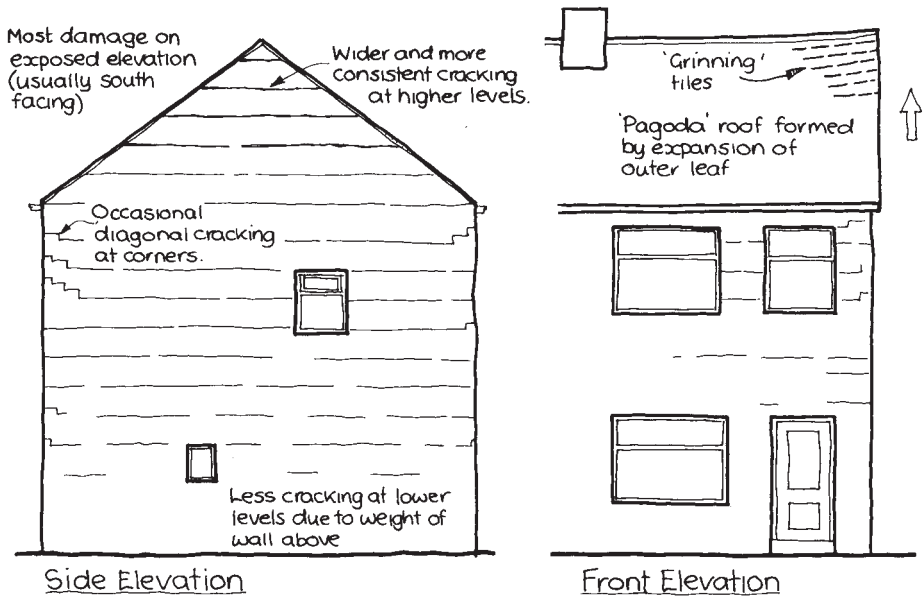
Figure 4.17 Typical signs of cavity wall tie failure.

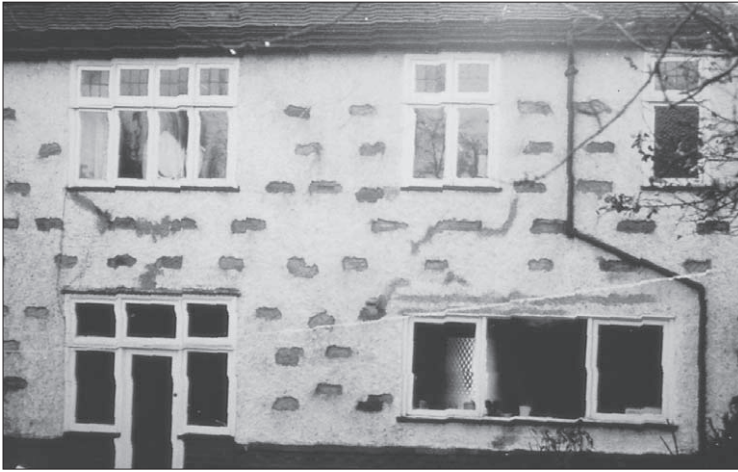
Figure 4.18 A dwelling that has had its cavity wall ties replaced. The technique probably involved the complete removal of the defective wall ties. The guarantee for this work would have to be checked and should be backed by an appropriate insurance scheme.

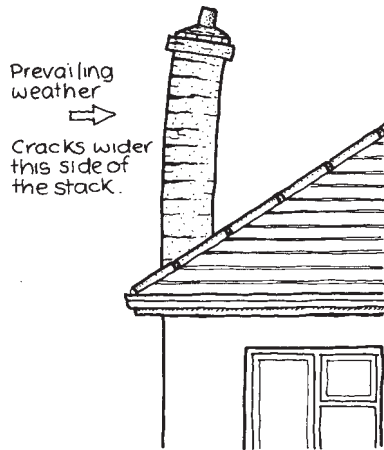
Figure 4.19 Typical damage to a chimney caused by sulfate attack.

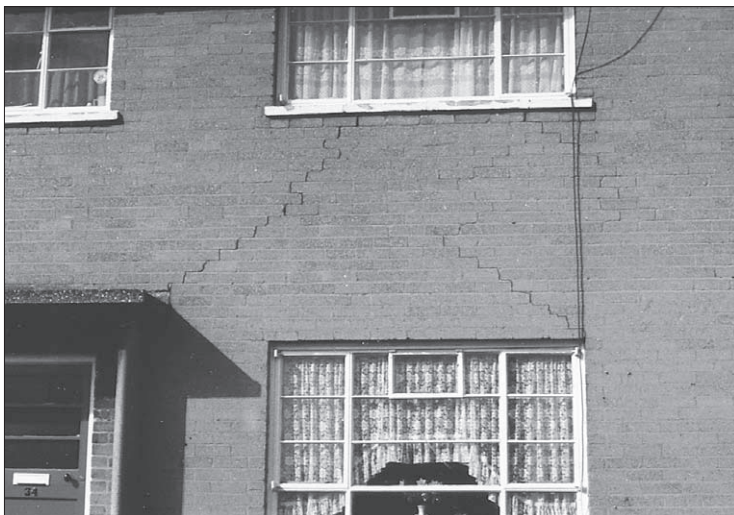
Figure 4.21 Cracking to a masonry elevation caused by expansion of brickwork. These semi-detached properties are built of calcium silicate bricks that are vulnerable to expansion defects.

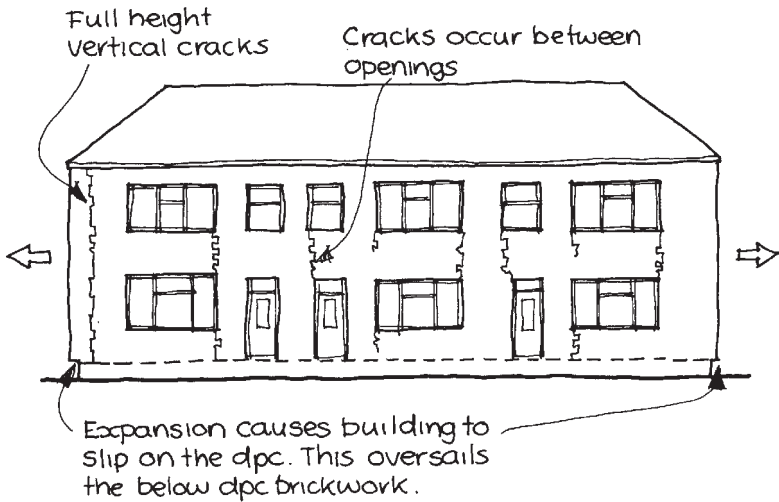
Figure 4.22 Sketch showing typical damage caused by expansion of masonry walls.

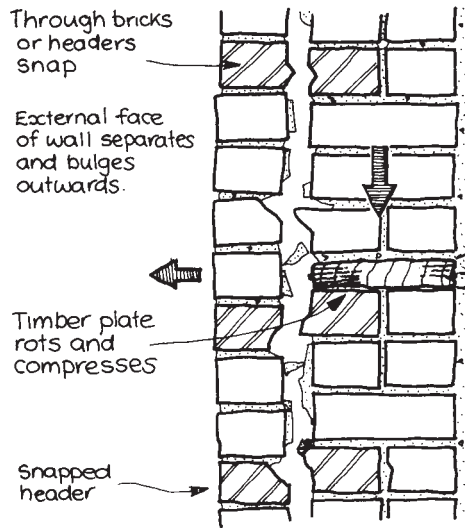
Figure 4.23 Damage caused to a solid wall by the failure of an embedded timber.

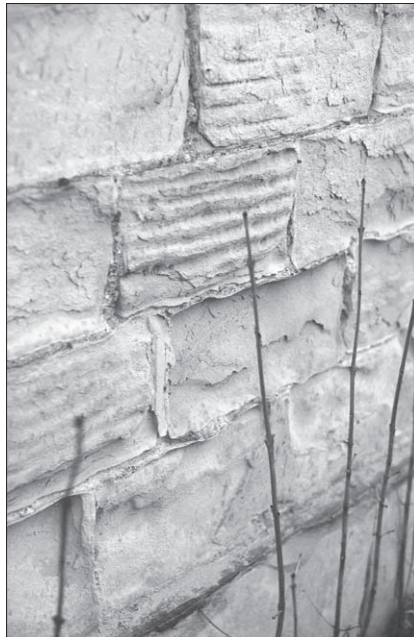
Figure 4.25 Face bedded masonry wall. The outer layers of the stone can easily be ‘peeled’ away by the action of salts and frost. In this photograph the stones that have deteriorated the most are face bedded.

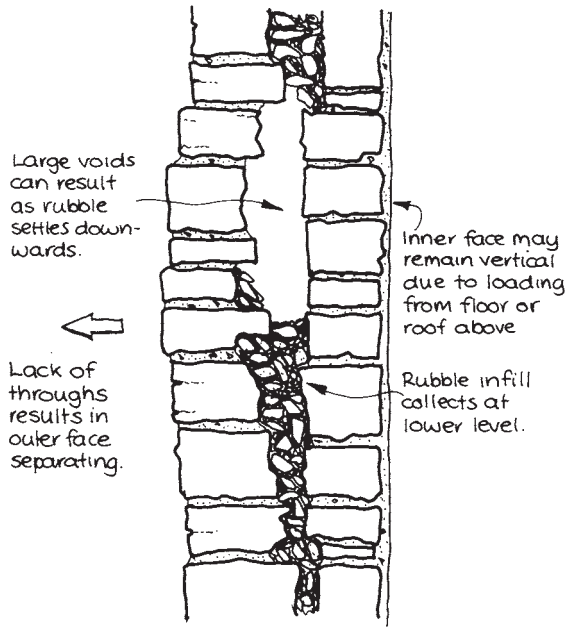
Figure 4.26 Separation of stone leaves can lead to the bulging of the external face of the wall leaving the internal side vertical.

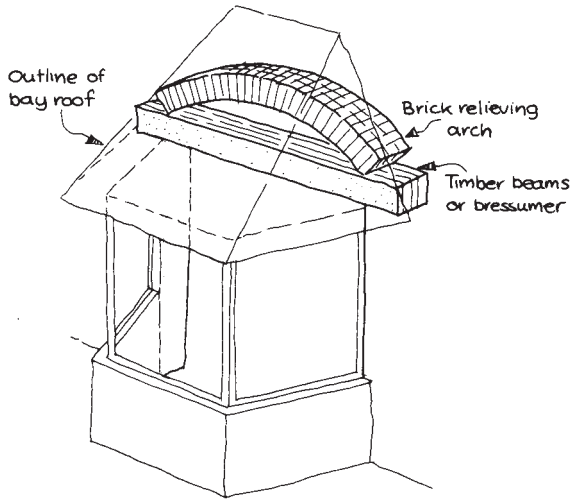
Figure 4.27 Diagram of timber 'bressumer' beams over a typical bay window opening.

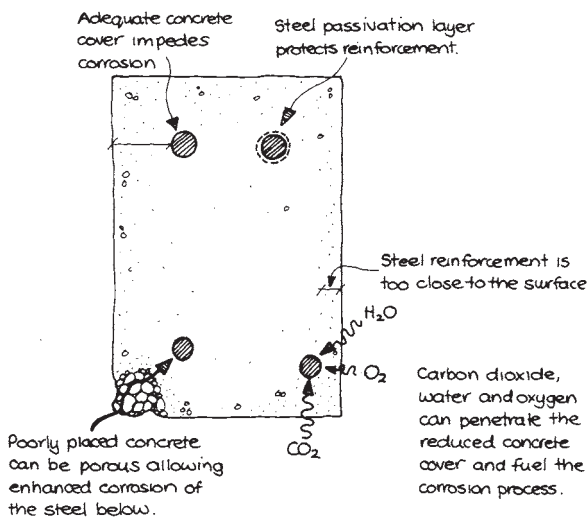
Figure 4.28 Diagram showing the main influences on the durability of concrete.

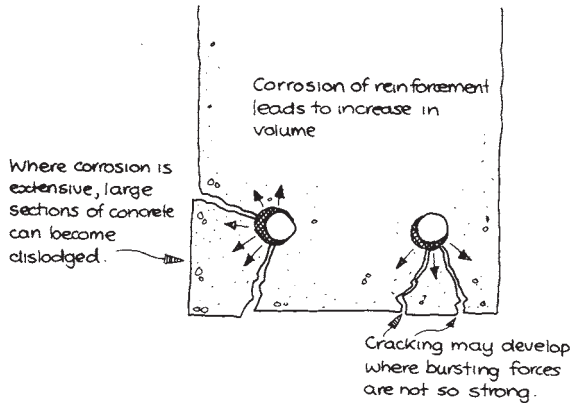
Figure 4.29 The affect of corrosion of reinforcement in concrete sections.

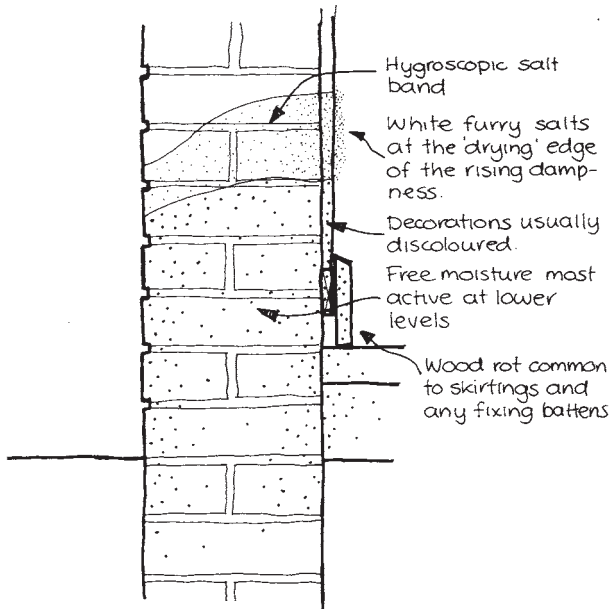
Figure 5.1 Cross section through a typical solid wall that has been affected by rising dampness and hygroscopic salts.

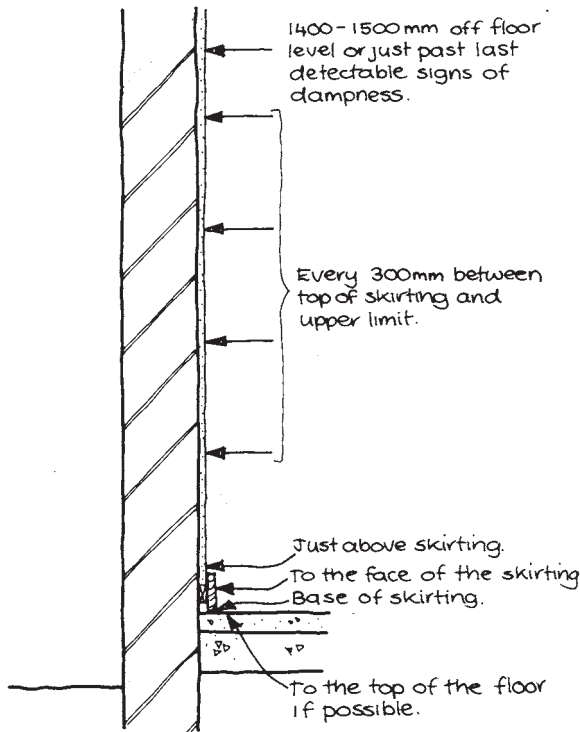
Figure 5.2 Cross section through a typical wall showing the vertical spacings at which moisture readings should be taken.

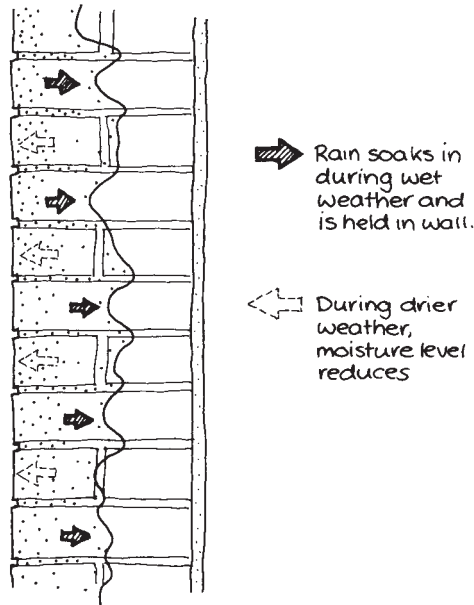
Figure 5.3 Cross section through a solid wall showing how it resists the passage of dampness.

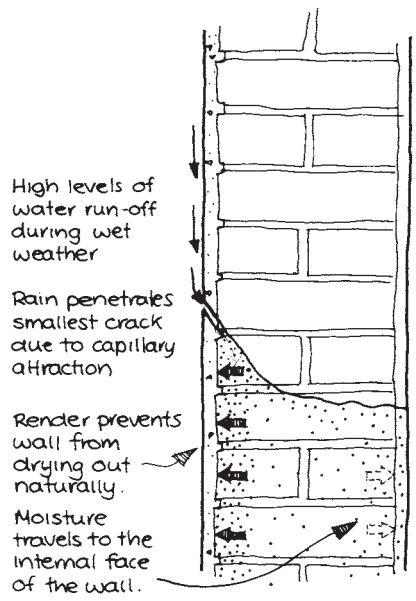
Figure 5.4 Sketch showing the effects of a cracked render finish to a solid wall.

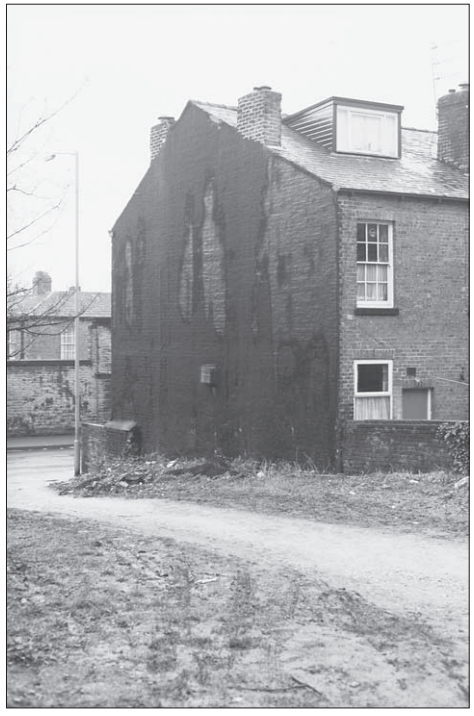
Figure 5.5 A gable elevation of a house that has been treated with a bitumen-based compound in an attempt to improve its moisture resisting properties.

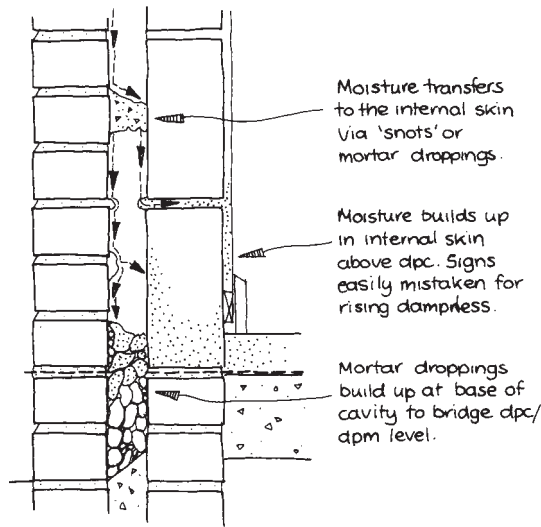
Figure 5.7 Section through the base of a cavity wall where the build up of debris and other faults can result in dampness problems internally. This can easily be mistaken for rising dampness.

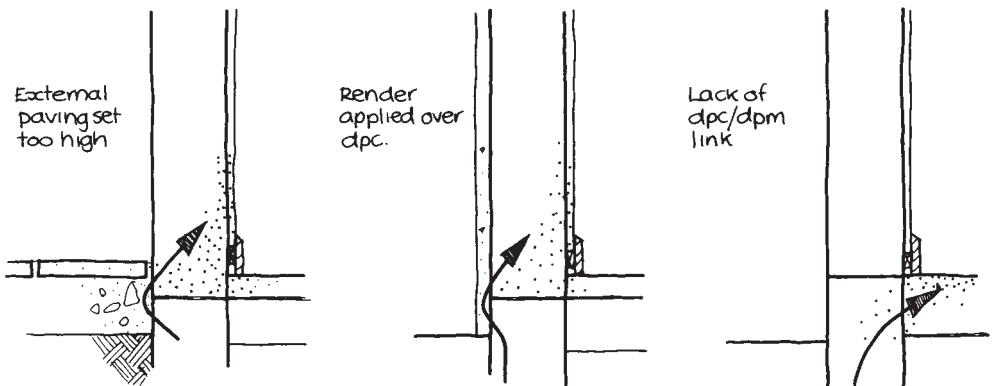
Figure 5.8 Examples of rising dampness that have been caused by the physical bridging of the damp proof course.

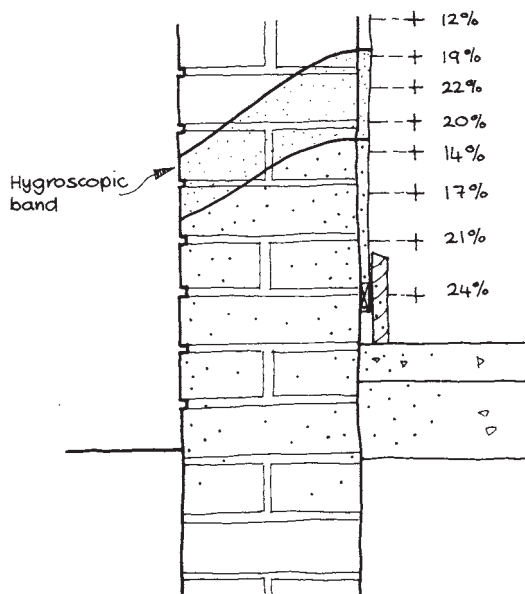
Figure 5.9 Section through a typical solid wall that has been affected by rising dampness. This shows the variation in moisture meter readings that can be expected. Note the higher values in the hygroscopic salts band.

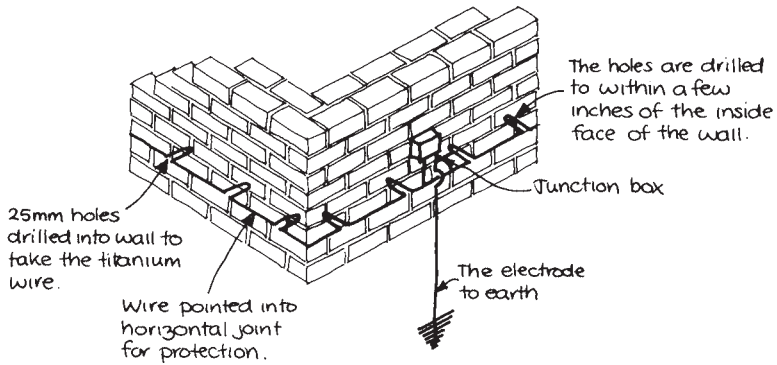
Figure 5.10 A diagrammatic sketch illustrating the normal arrangement of an electro-osmotic damp proof course.

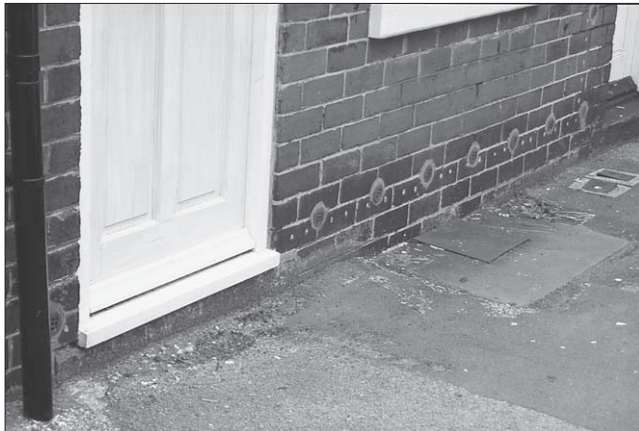
Figure 5.11 This photograph shows ceramic ‘drying tubes’ that have been installed in a brick wall. The smaller filled holes close by suggests that a chemical damp proof course may also have been installed.

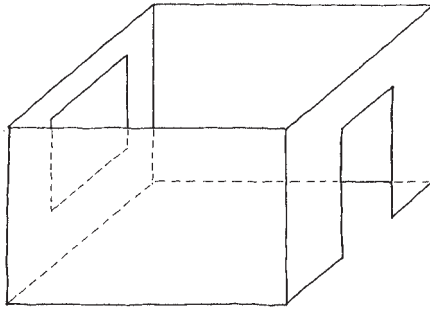
Relationship between relative humidity (RH) and temperature

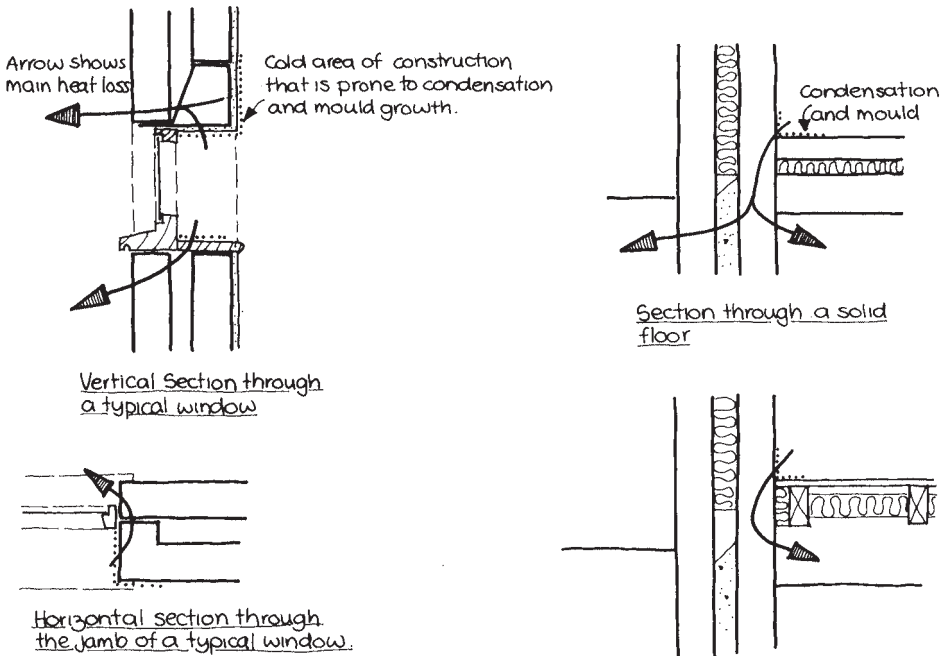
Figure 5.15 Typical locations of 'cold bridges' in domestic construction.

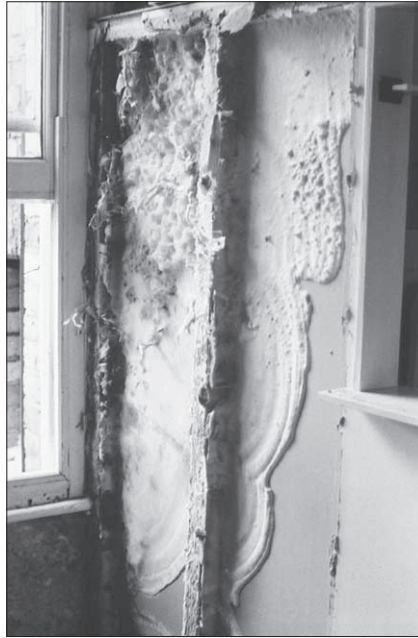
Figure 6.1 Photograph of dry rot within a timber partition. The plasterboard to the wall has been removed to reveal a luxurious dry rot growth. The outbreak began in the vertical timber stud that is fixed to the inside face of the external wall (to the LHS of the picture). The source of moisture and the cause of the outbreak was a leaking gutter that saturated the wall.

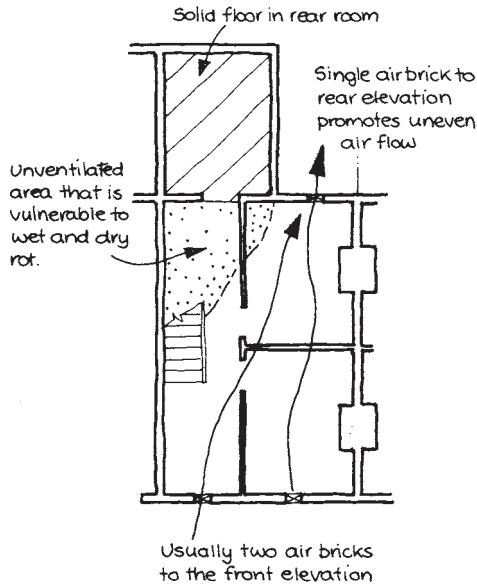
Figure 6.2 Plan of a typical suspended timber floor showing inadequate ventilation because of a lack of through flow of air.

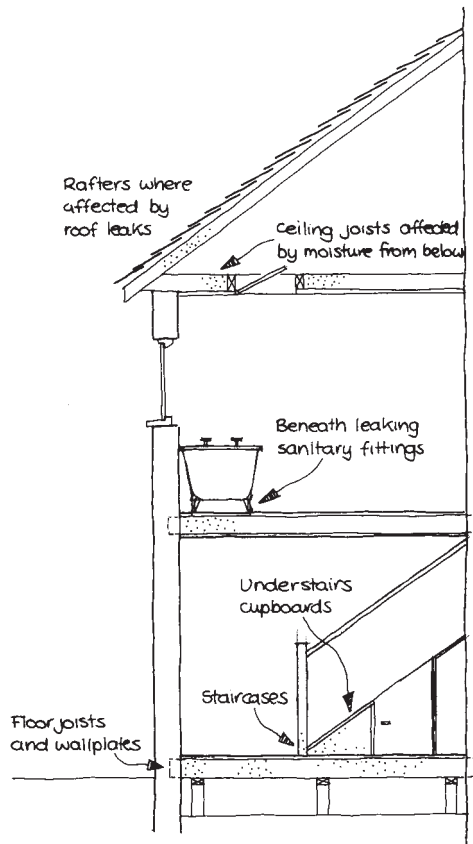
Figure 6.3 Common locations of insect attack in a domestic dwelling. The risk of insect attack is higher where the moisture levels in the timber are greater.

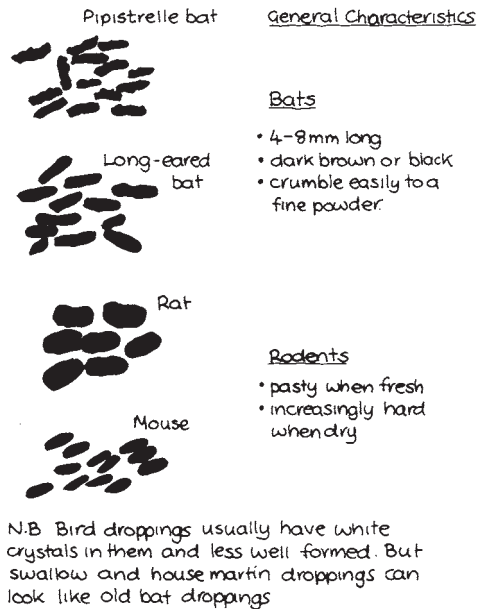
Figure 6.4 Comparison of bat droppings to those of other animals (reproduced courtesy of English Nature 1995).

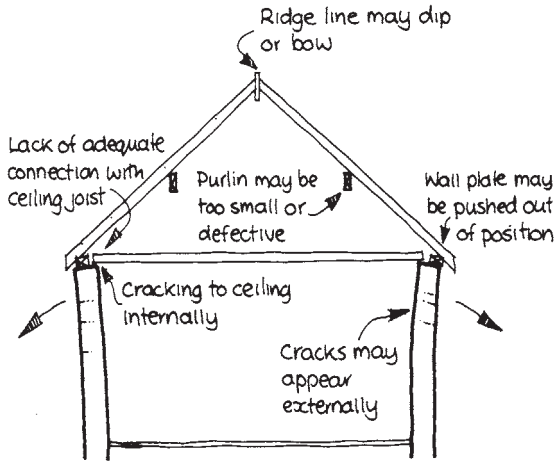
Figure 7.2 Sketch showing the typical signs of roof spread.

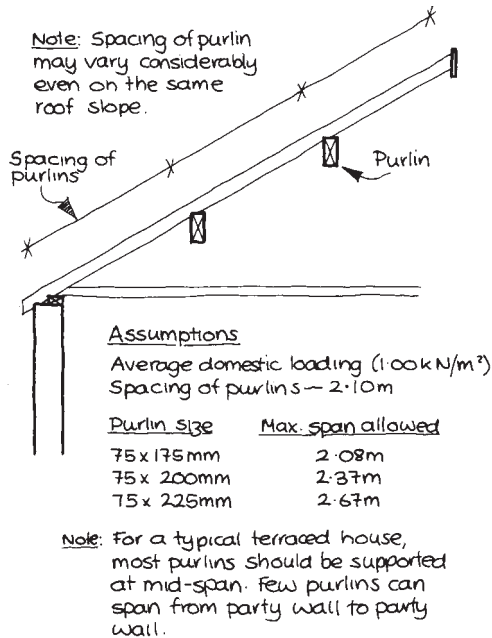
Figure 7.4 Guide to assessing the size and span of typical purlins in a traditionally constructed roof.

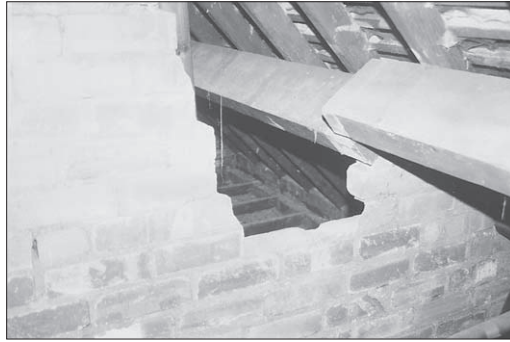
Figure 7.5 Inadequate support to purlins at the end bearing. These purlins are poorly supported by this partial party wall.

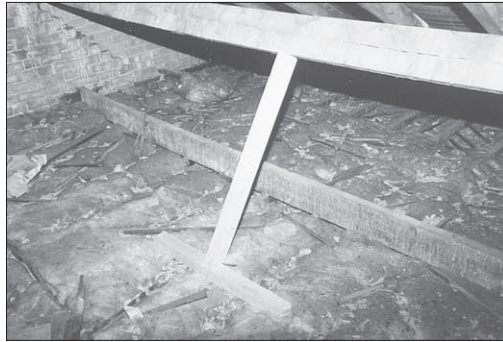
Figure 7.6 Inadequate strut support to a purlin. This traditionally constructed roof had been recovered with concrete tiles and had begun to deflect under the excessive weight. The purlin was visibly deflecting and in an effort to limit this problem a contractor installed a small strut. This was poorly supported by a timber plate at its base. The timber plate was fixed to the back of the ceiling joists at mid span causing considerable deflection to the ceiling below.

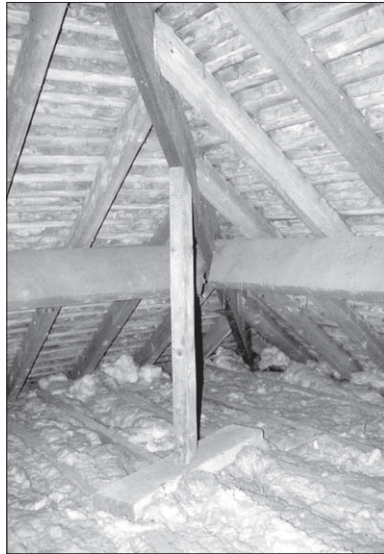
Figure 7.8 The hip rafter to this roof was deflecting because the wall plates were being spread apart by the thrust of the roof slopes. There were no dragon ties to restrain them. A builder had inserted a crude vertical strut to take the weight of the hip rafter. This was supported off the top of the ceiling joists below. A clearly inadequate solution.

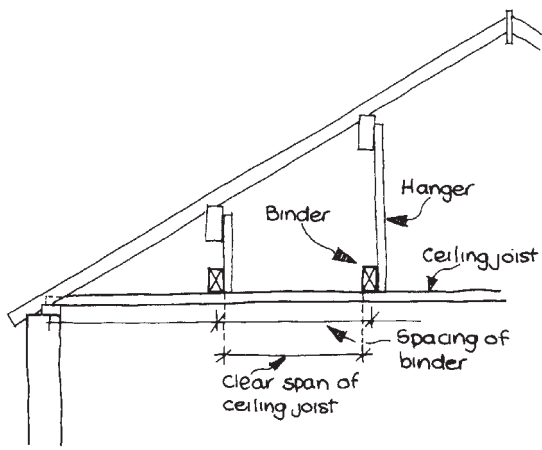
Dry rot is not common in roof spaces because the environmental conditions change so quickly. Wet rot can affect timbers especially where they are built into or in contact with damp masonry. Typical locations would include trimming rafters around chimney

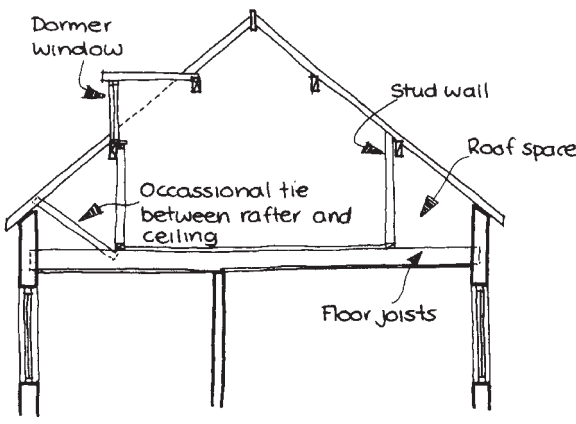
Figure 7.10 Room-in-the-roof structure. The lack of connection between the floor/ceiling joists and the rafter feet can often result in roof spread.

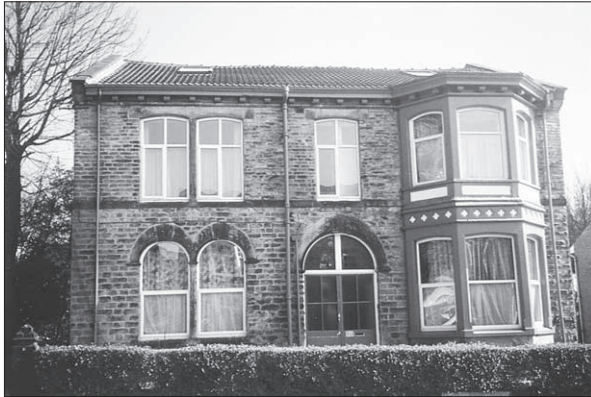
Figure 7.11a The roof to this dwelling has been affected by roof spread. Based on the external visual clues, the likely causes are heavier replacement concrete tiles and the installation of the roof windows.

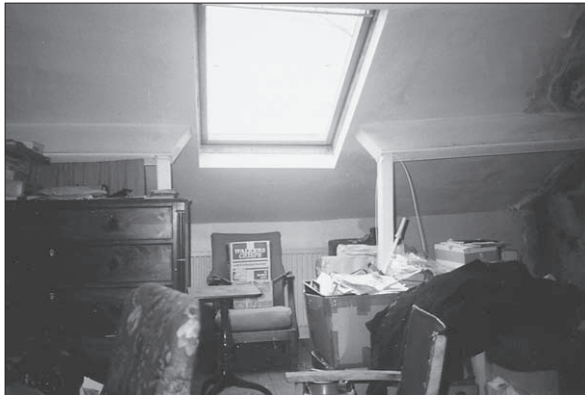
Figure 7.11b An internal view of one of the new roof windows. The purlin has been cut through so the window could be fitted. The vertical posts supporting the ends of the purlins are supported off the existing floorboards and floor structure. Little surprise the roof covering is uneven!

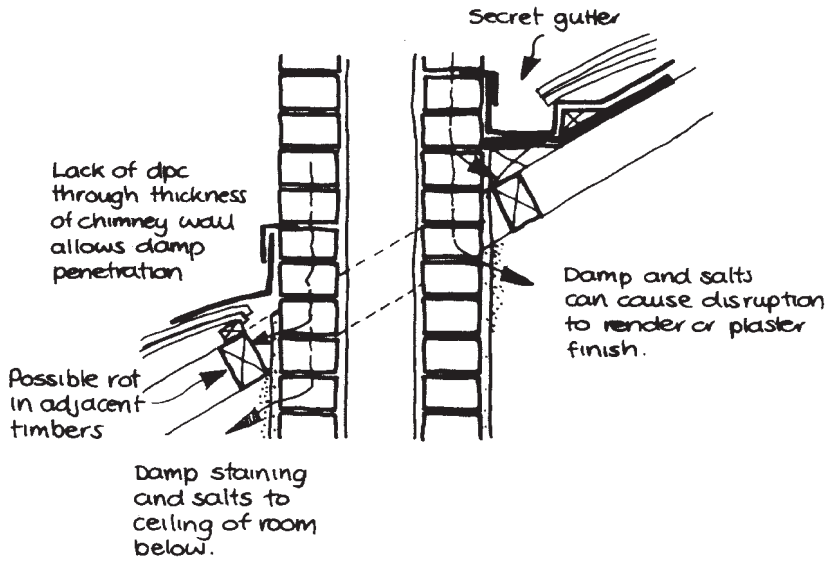
Figure 7.16 Possible routes for penetrating dampness around a chimney.

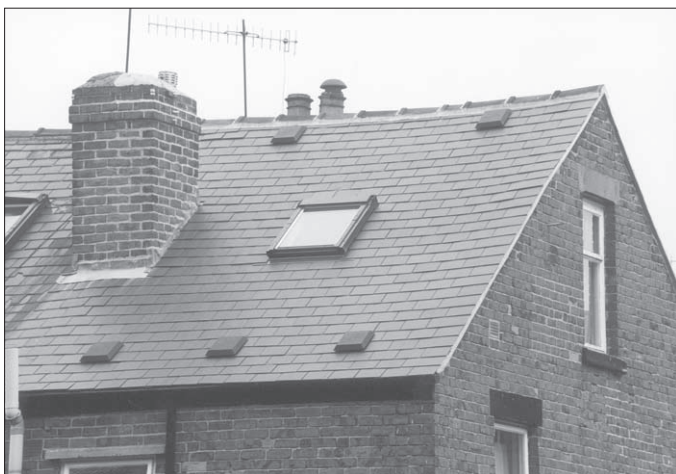
Figure 7.18 Ventilating tiles to a pitched roof. Where continuous ventilation is not provided at fascia level, a number of special ventilating tiles should be present near to the eaves.

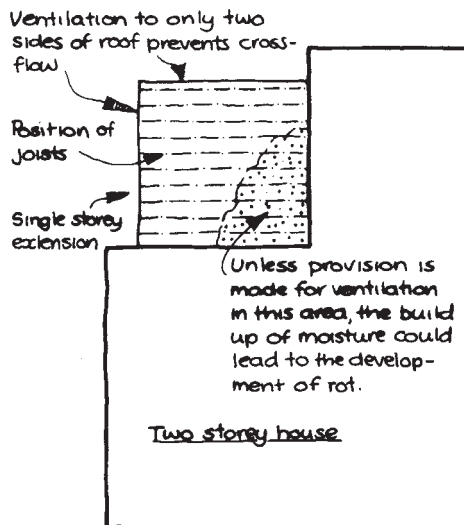
Figure 7.19 Diagrammatic sketch showing inadequate ventilation to flat roof because of lack of through ventilation.

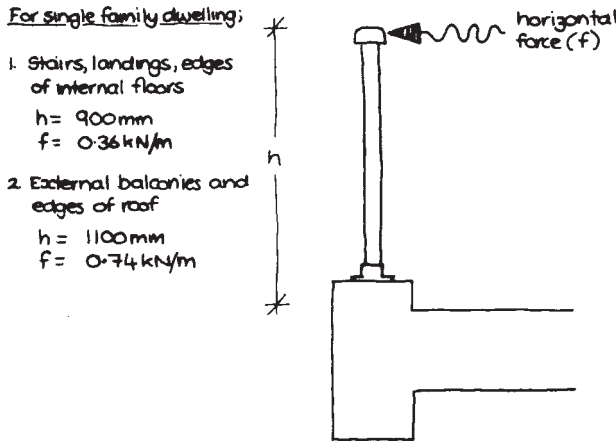
Figure 7.20 Balustrades to a balcony. The Building Regulations (Part K) require all balustrades and handrails to resist a certain level of horizontal force. This is higher for external balustrades.

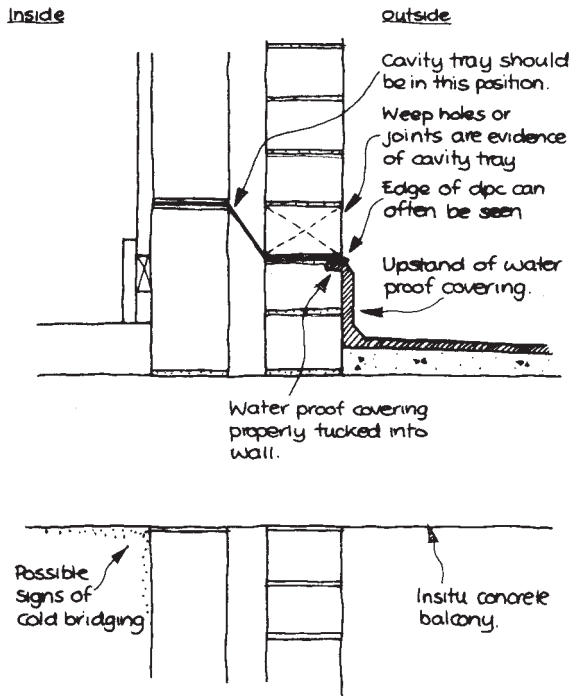
Figure 7.21 Link between a concrete balcony and a cavity wall. It is essential that the balcony has a waterproof covering and upstand that links in with the dpc and cavity tray of the wall.

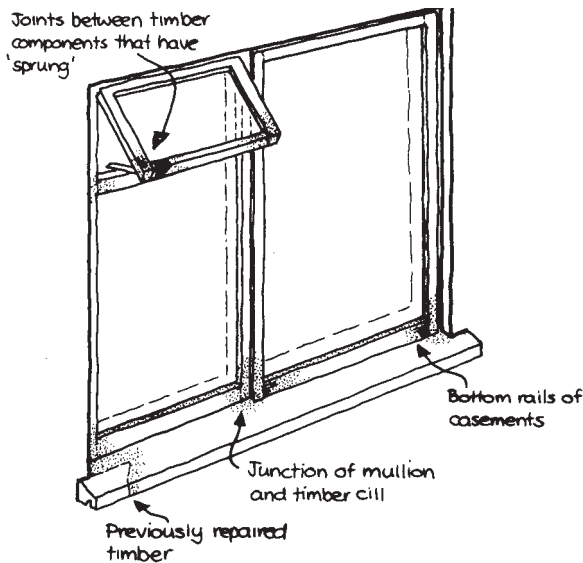
Figure 8.1 Vulnerable parts of a typical casement window.

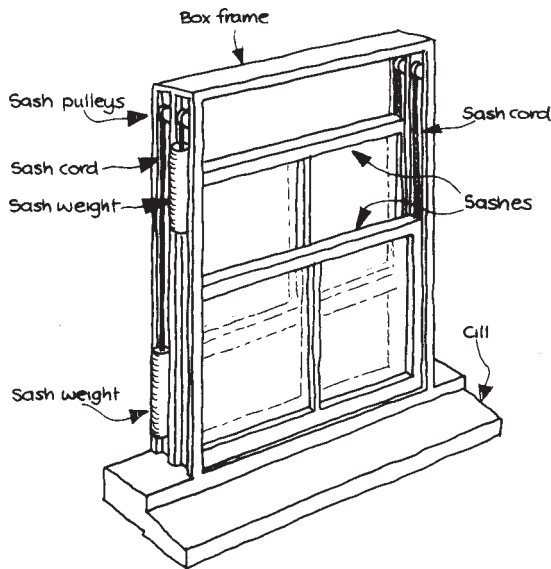
Figure 8.3 Sketch showing the construction of a typical sash window.

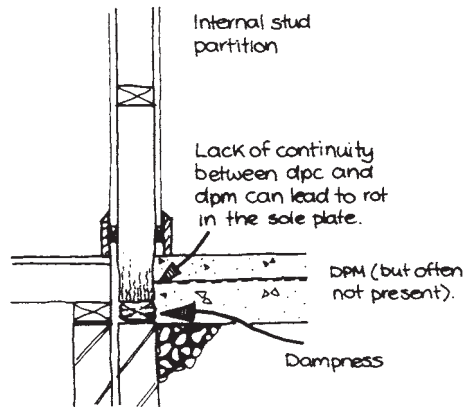
Figure 9.2 Sketch section showing junction of a solid and suspended floor with an internal partition.

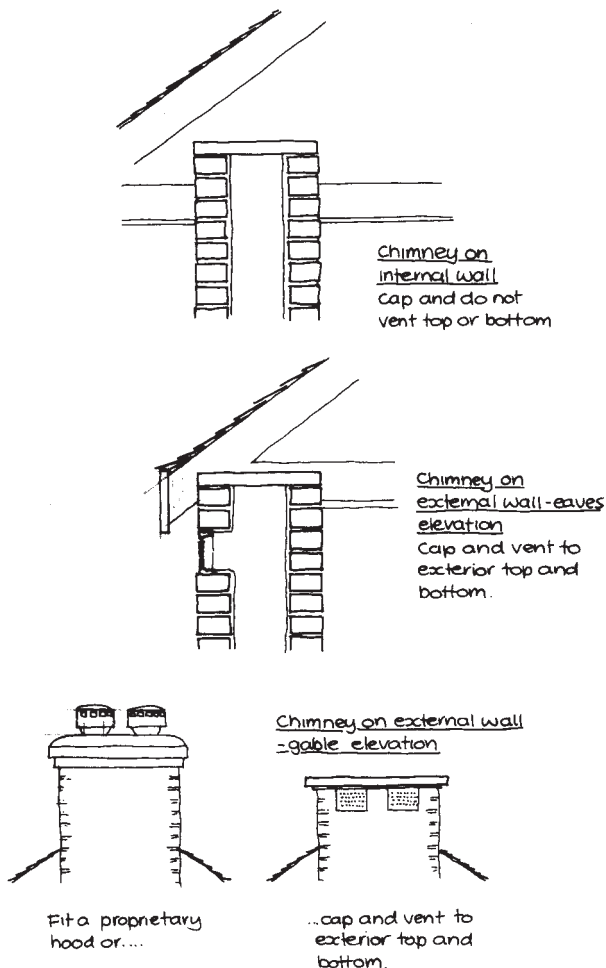
Figure 9.3 Sketch of different ventilation arrangements for chimneys when they are capped off (reproduced courtesy of BRE).

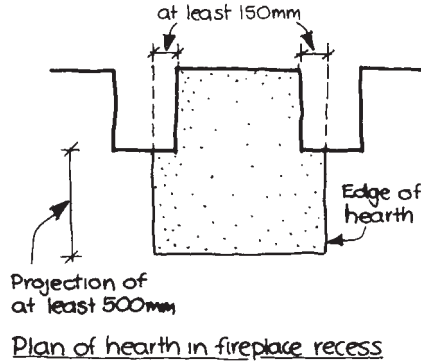
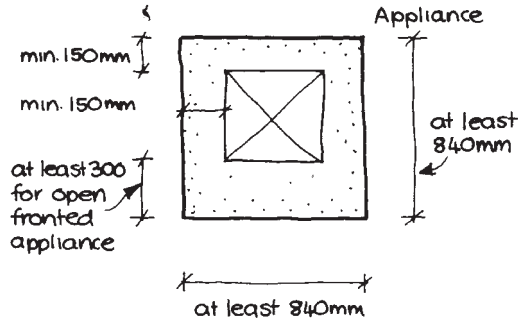
Figure 9.5 Minimum sizes of different hearth constructions (Crown copyright. Reproduced with the permission of the Controller of Her Majesty's Stationery Office).

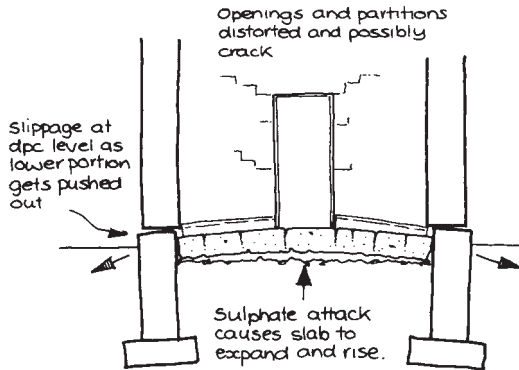
Figure 9.8 Sketch showing effects of sulfate attack to a solid floor.

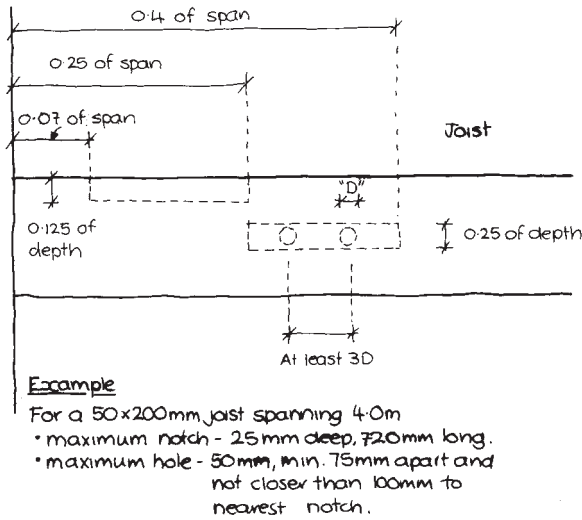
Figure 9.9 Recommended notching sizes and spacings.

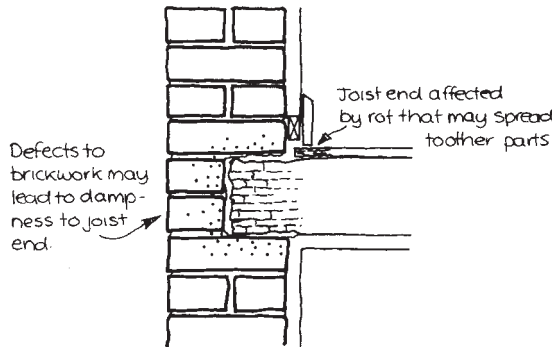
Figure 9.10 Section through external solid wall showing the bearing of internal floor joists. If the external face is exposed to driving rain and the pointing is in a poor condition then the joist ends are vulnerable to wet or dry rot.

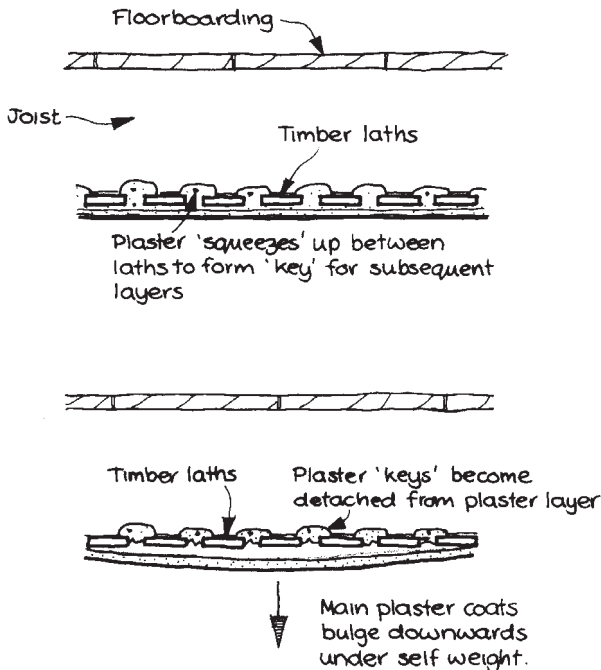
Figure 9.11 Sketch section through a lath and plaster ceiling. The lower drawing shows what can happen when there is a failure of plaster ‘key’ to the ceiling.

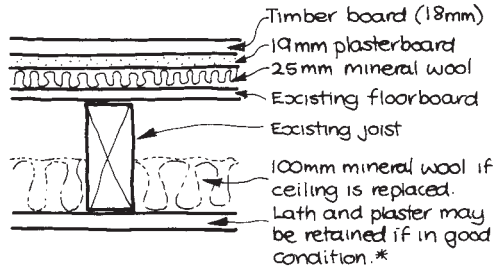
* If original ceiling to be replaced then
30mm plasterboard in 2-3 layers
