Residential Property Appraisal

Phil Parnham and Chris Rispin

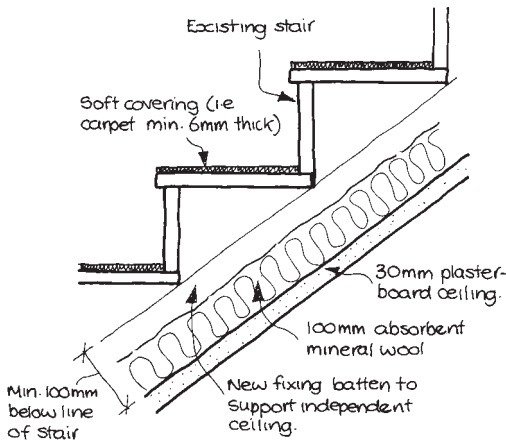
Note: Where underside of staircase is fully exposed, new independent ceiling provided. Where staircase has a cupboard beneath, the underside can be lined with 12.5mm plasterboard and void filled with mineral wool.

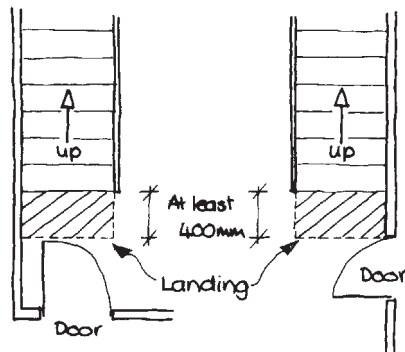
Figure 9.14 Safe arrangements for landings and doors on staircases (Crown copyright. Reproduced with the permission of the Controller of Her Majesty's Stationery Office).

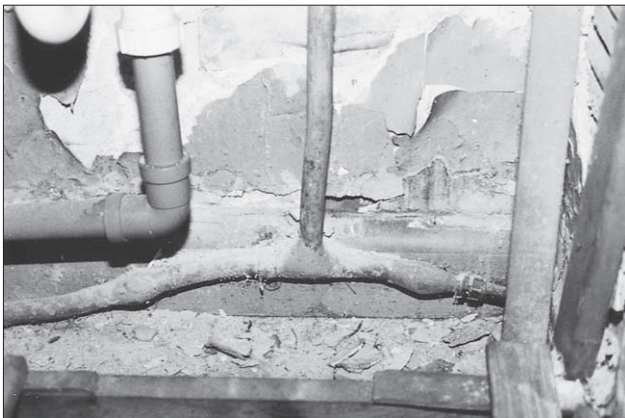
Figure 10.2 Lead water pipes are clearly thicker than other types. The bulbous joints shown in this photograph are typical of this material.

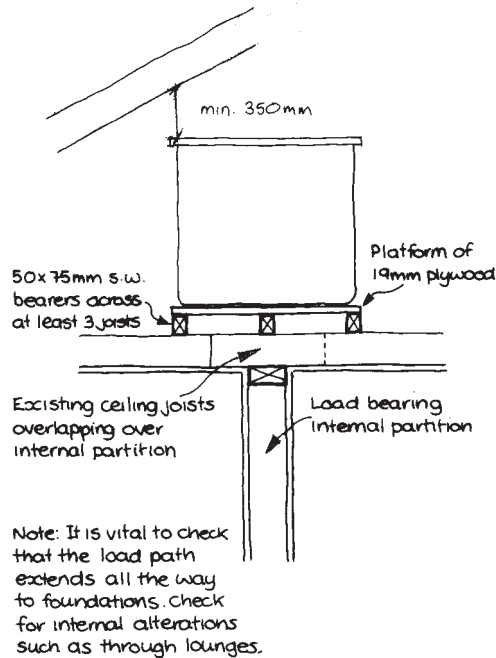
Figure 10.5 Support for a cold water storage tank in a traditionally built roof.

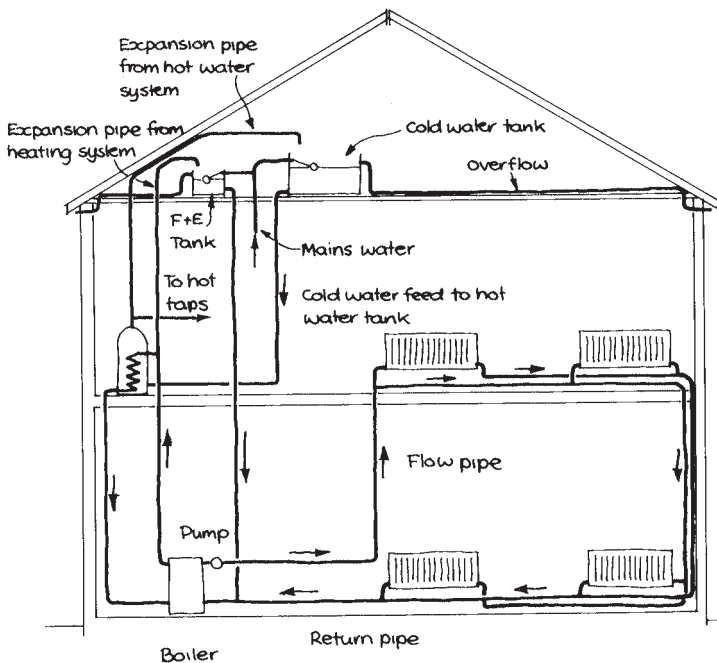
Figure 10.6 Indirect hot water and central heating system.

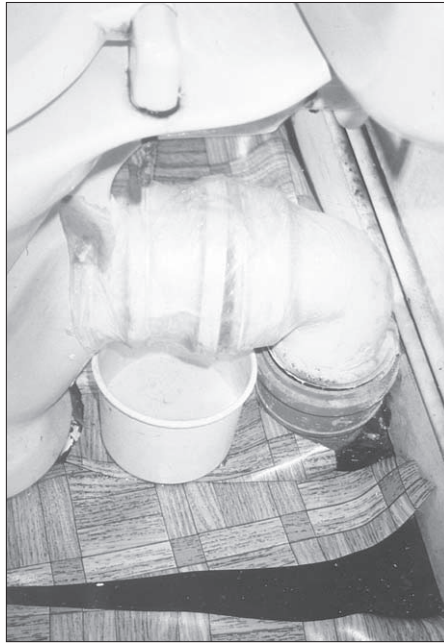
Figure 10.7 Leaks behind the WC are surprisingly common. A variety of 'drip bowls' can give vital clues to developing problems. The risk of wet or dry rot in this type of location is very high.

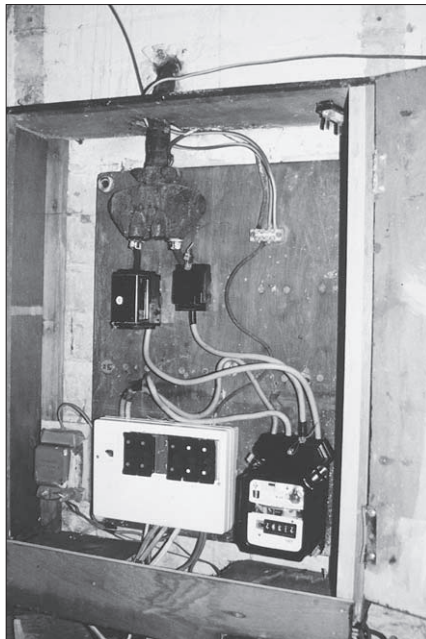
Figure 10.13 Old or unusual switch gear may give important clues about the suitability of the system.

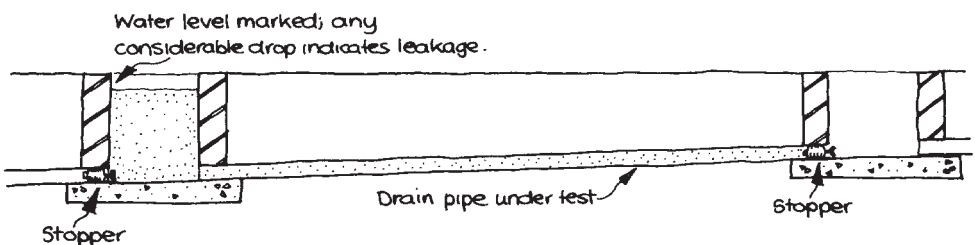
Figure 10.15 Typical arrangement for a water test of an underground drain.

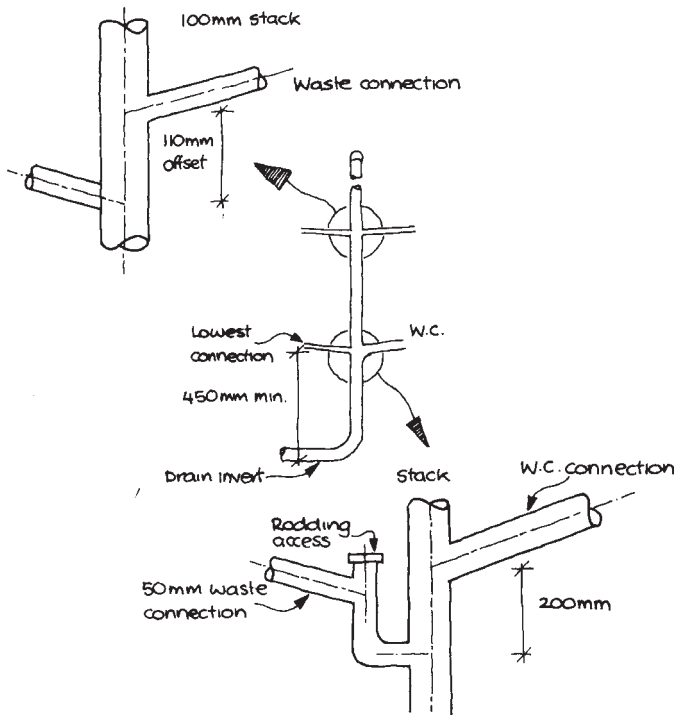
Figure 10.17 Offset connections to a soil and vent pipe to prevent siphonage and cross flow (Crown copyright. Reproduced with the permission of the Controller of Her Majesty's Stationery Office).

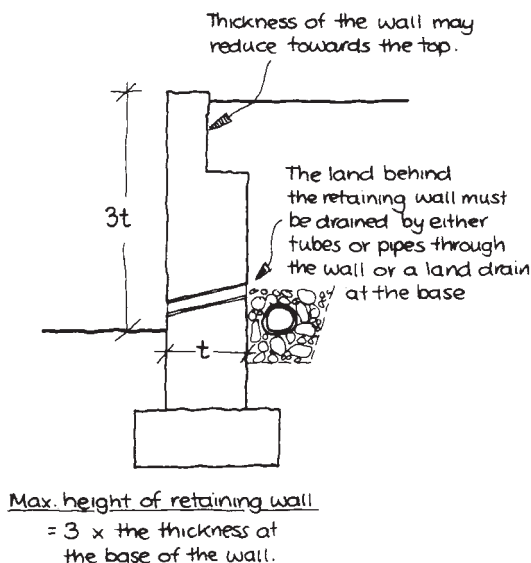
Figure 11.1 Sketch section through a typical retaining wall

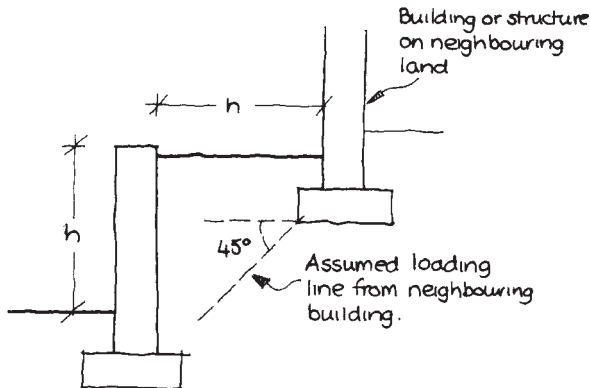
Figure 11.2 Relationship between imposed loads and retaining walls.

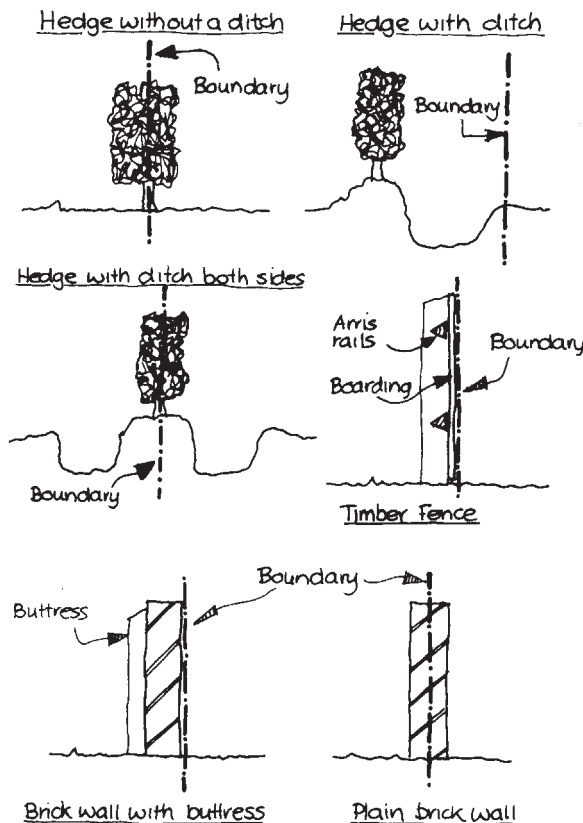
Figure 11.3 Typical boundary positions.

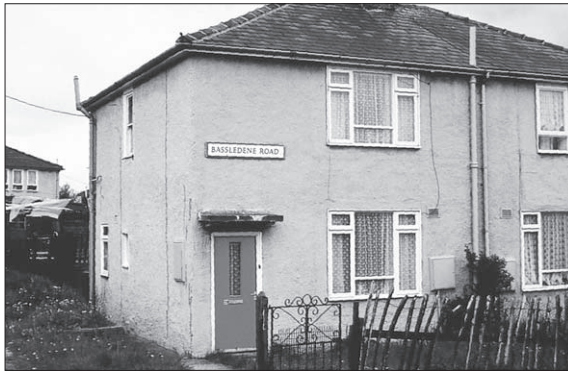
Figure 12.4 Boot house. The externally-rendered exterior can make them difficult to identify. Vertical cracking at the corners is a very common feature.

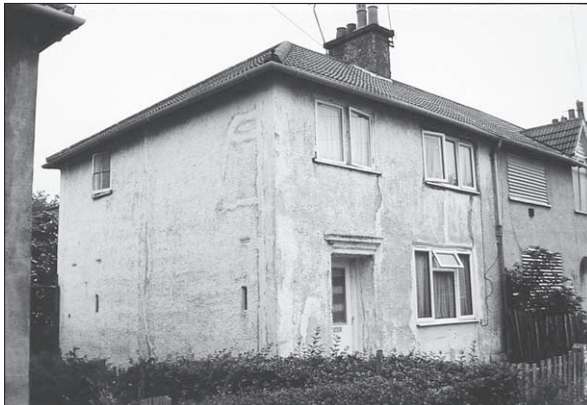
Figure 12.5 Boswell house. The Boot and Boswell houses can appear very similar. When they are well maintained and painted they can be mistaken for a 'Wimpey no fines' house which is not designated.

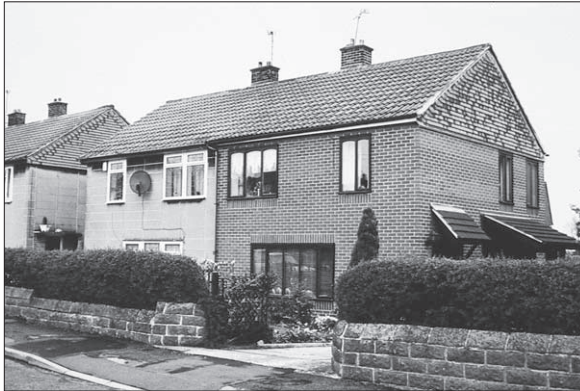
Figure 12.6 A re clad Unity house. The new cladding is easy to spot when the other semi-detached house is unimproved but what if the whole street has been altered?

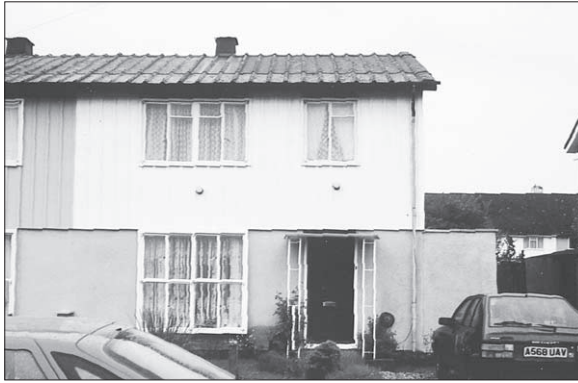
Figure 12.8 The front elevation of a typical BISF house.

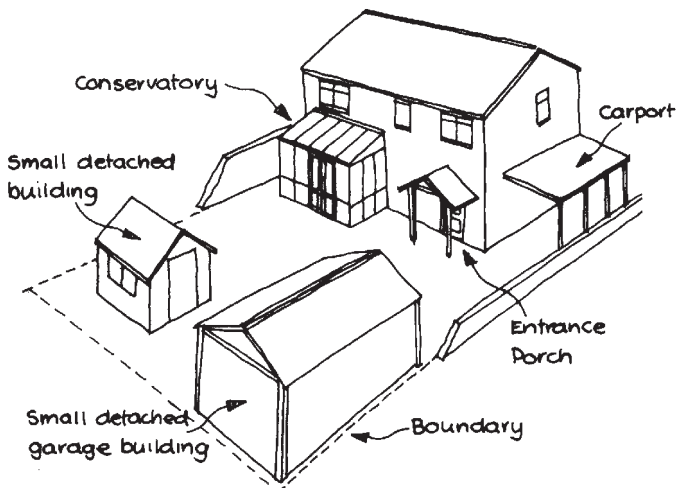
Figure 13.1 Exempted work. The illustrated projects do not usually require building regulation approval.
