Repair, Rejuvenation and Enhancement of Concrete

Proceedings of the International Seminar
held at the University of Dundee, Scotland, UK
on 5-6 September 2002

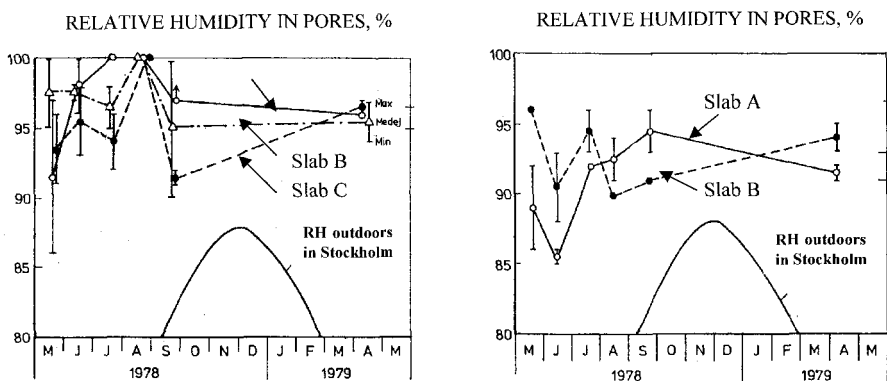
Figure 6 The Figure on the left shows measured relative humidity during a year in repaired concretes where the applied materials are impermeable. The Figure on the right illustrates the moisture conditions in repaired concretes where the repair material is permeable, as concrete with water cement ratio 0,45. An impermeable surface, even if it will prevent water suction into the material, could increase the water content in the old concrete behind a dense surface layer, Fagerlund and Svensson [5]

Choice of repair method must be adjusted to cause of damage or deterioration mechanism, range of damage and damage position. New polymer-based repair materials are introduced on the market, more or less impermeable, and must act together with the old concrete. The role of water is significant some processes will increase in rate with increasing water content other processes will act oppositely. Impermeable repair layers will raise negative properties in cold regions where frost attack is considerably destructive, see Figure 6.

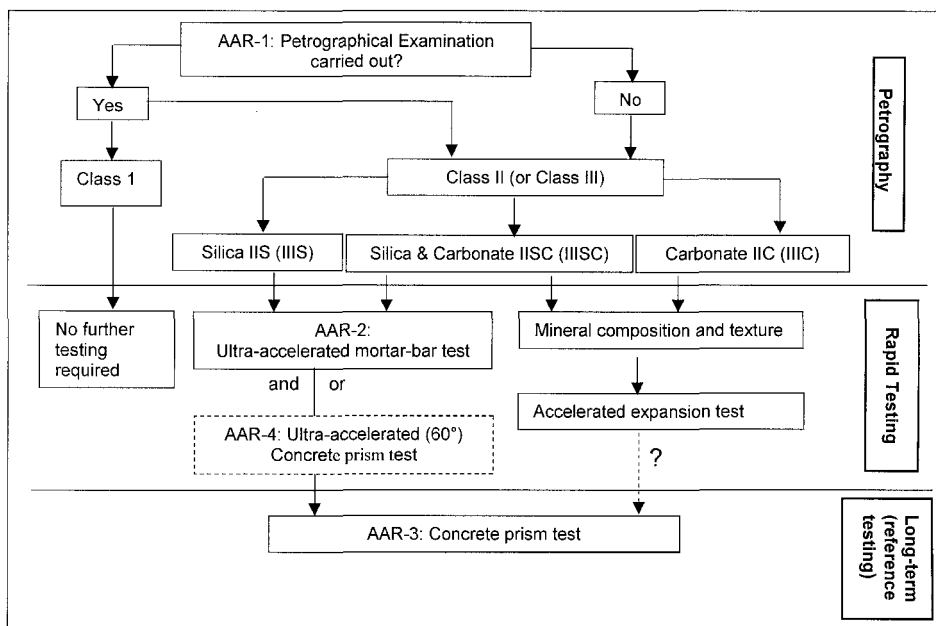
Figure 3 RILEM TC-ARP integrated aggregate assessment scheme

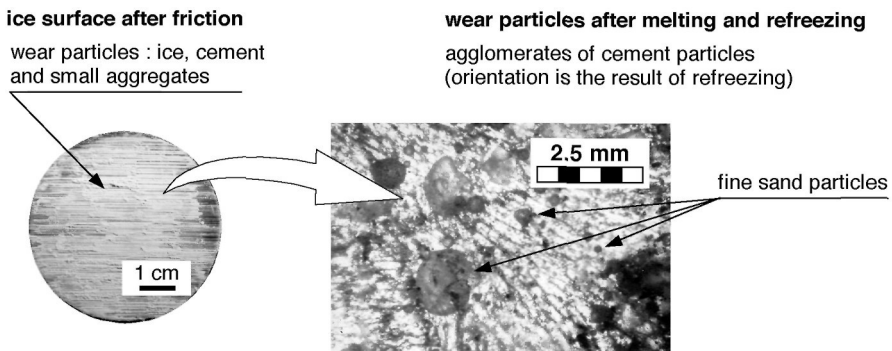
Figure 5 Wear particles at the concrete-ice interface

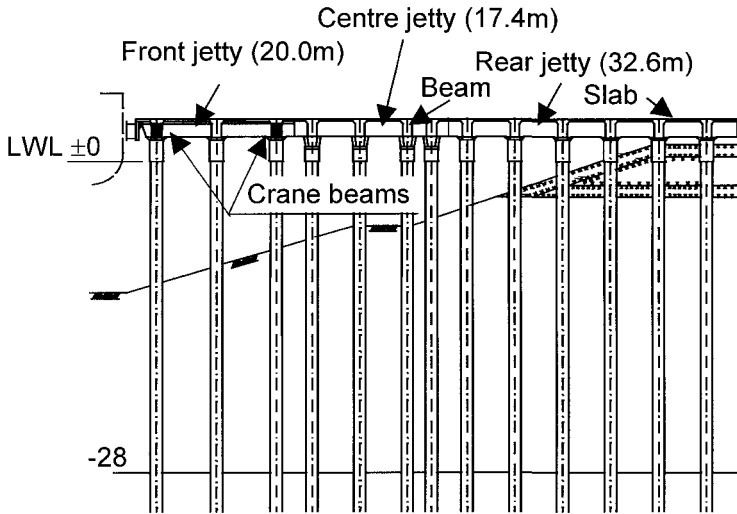
Figure 6 Section of the target wharf

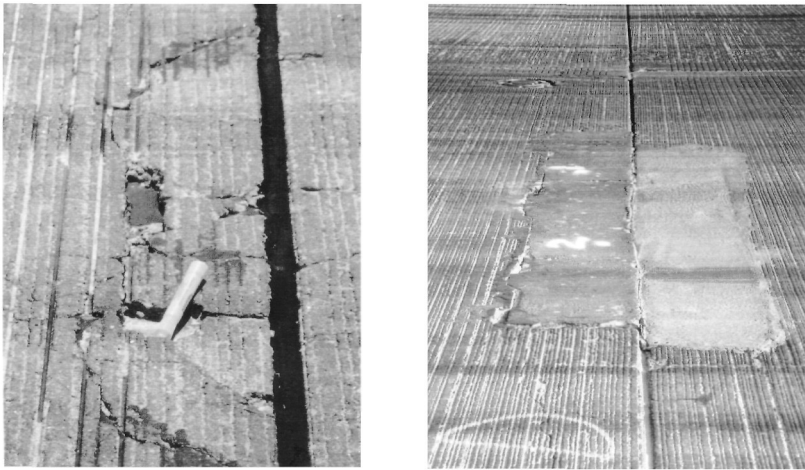
Figure 1 Typical joint distress

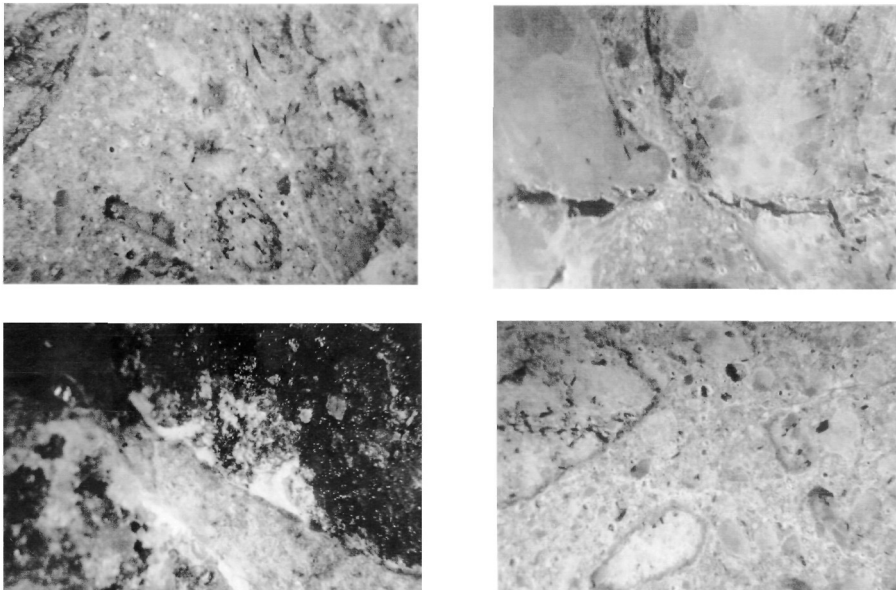
Figure 3 Indications of ASR Deterioration

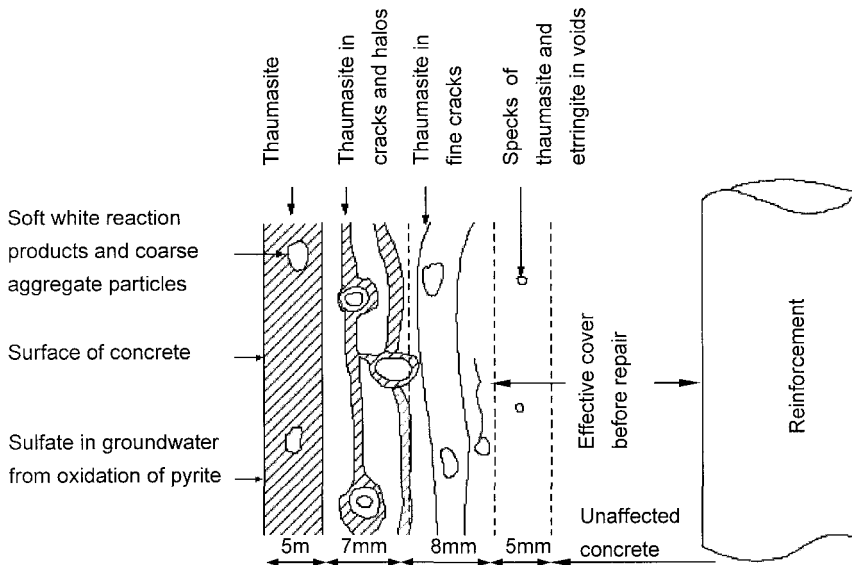
Figure 1 Schematic representation of TSA affected concrete

The attacked concrete was observed to have a soft, white pasty layer, typically 5mm in thickness, but no visible cracking. Below this layer, the concrete was found to have cracks running sub-parallel to the surface and the coarse aggregate particles were surrounded by white 'halos' of reaction products. The frequency and size of the halos reduced with depth below the exposed surface such that typically at 20mm depth only occasional white specks of reaction products were present in pores without any physical disruption to the cement matrix; this is described as Thaumasite Formation (TF) rather than TSA (see Figure 1).

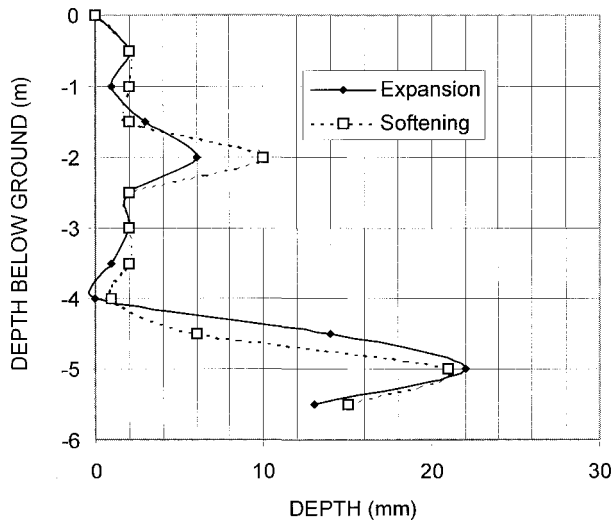
Figure 3 Typical pattern of softening and expansion to columns

The typical pattern of softening and expansion to the columns is indicated in Figure 3. Areas of expansion and softening are closely associated. The maximum net loss of cross-section for this site was 33mm, which is less than the value associated with a risk of buckling failure to the columns. However, in view of the possibility of further deterioration during the remaining service life it was decided to replace the affected lower portion of the columns and recast a new spread footing above the old base [5].

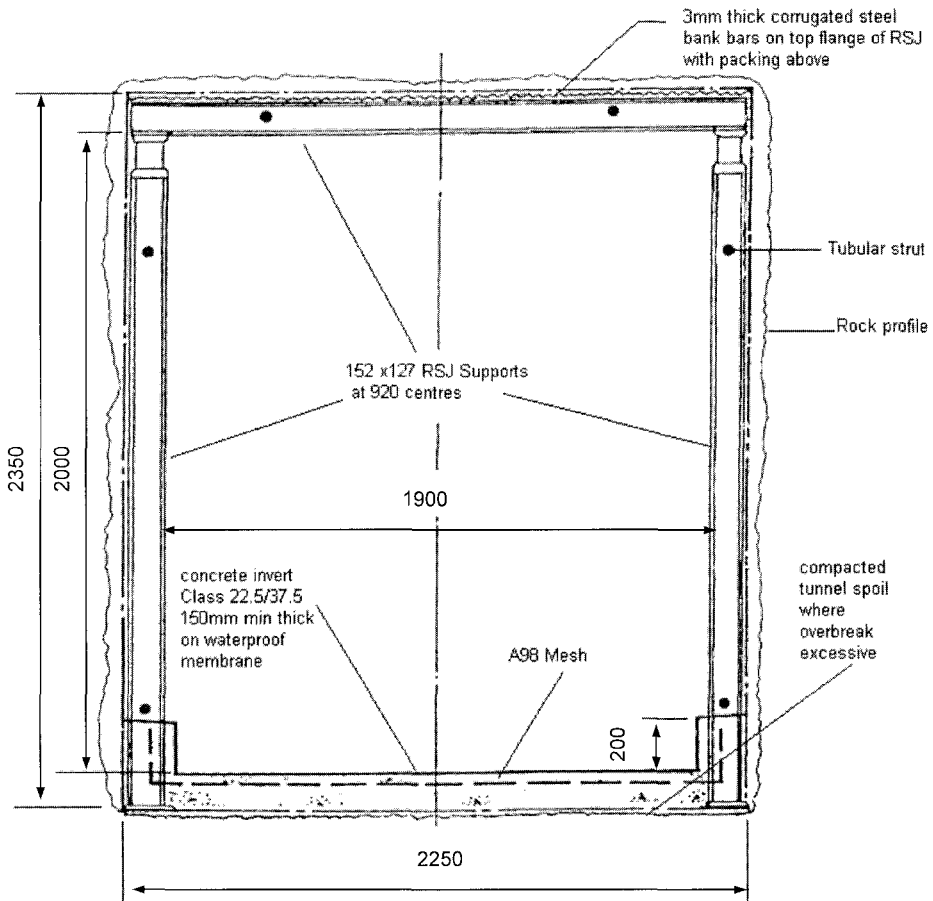
Figure 5 Cross-section through adit

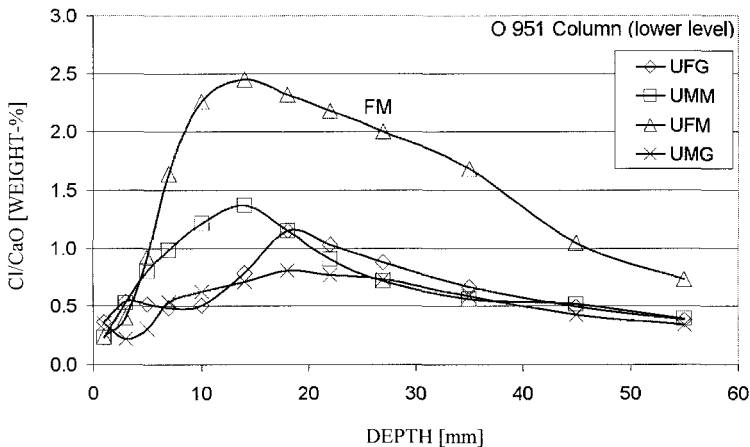
Figure 5 Chloride profiles from the lower level on bridge O 951

De-icing salts are normally applied during the nighttime or early in the morning. Thus, the surface on a concrete structure exposed to splash from the morning commuter-traffic is also the surface with the highest chloride exposure. This can be observed on bridge O 951 where the surface orientated towards the traffic to Göteborg (index FM) has larger chloride penetration compared to the other surfaces, see Figure 5.

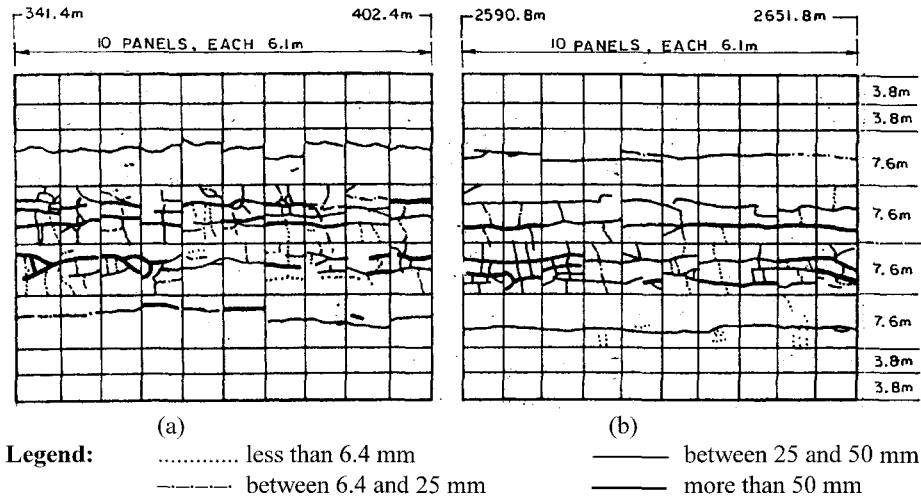
Figure 1 Typical portions of the slabs at the touch-down and take-off areas of runway showing cracks of varying widths (a) North end (b) South end

To assess the repair needs an extensive survey of the existing cracks was carried out in 1993 and documented. The cracks were classified into four categories according to their width. A typical account of cracked pavement is presented in Figure 1.

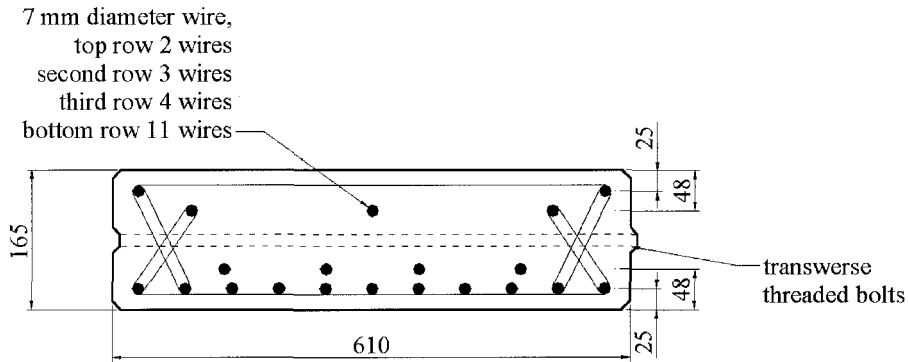
Figure 1 Cross section for 4.5m prestressed beams (in mm)

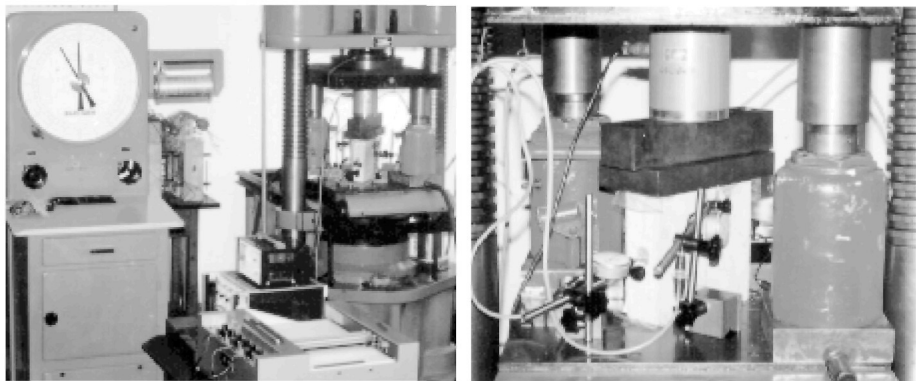
(a) Full view of the testing device

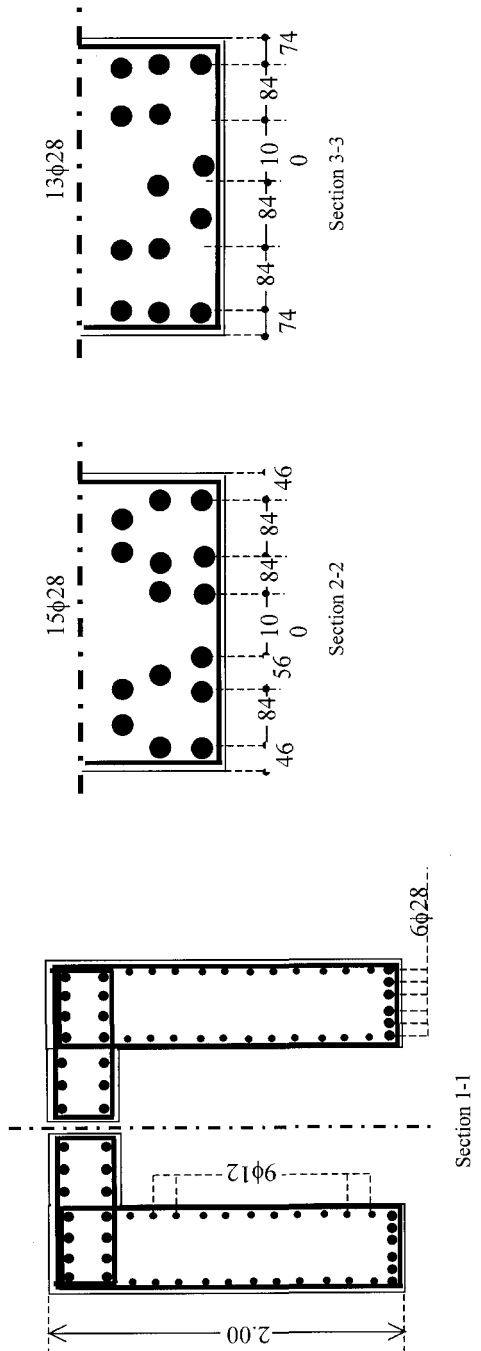
Figure 1 A view of beam and reinforcement details

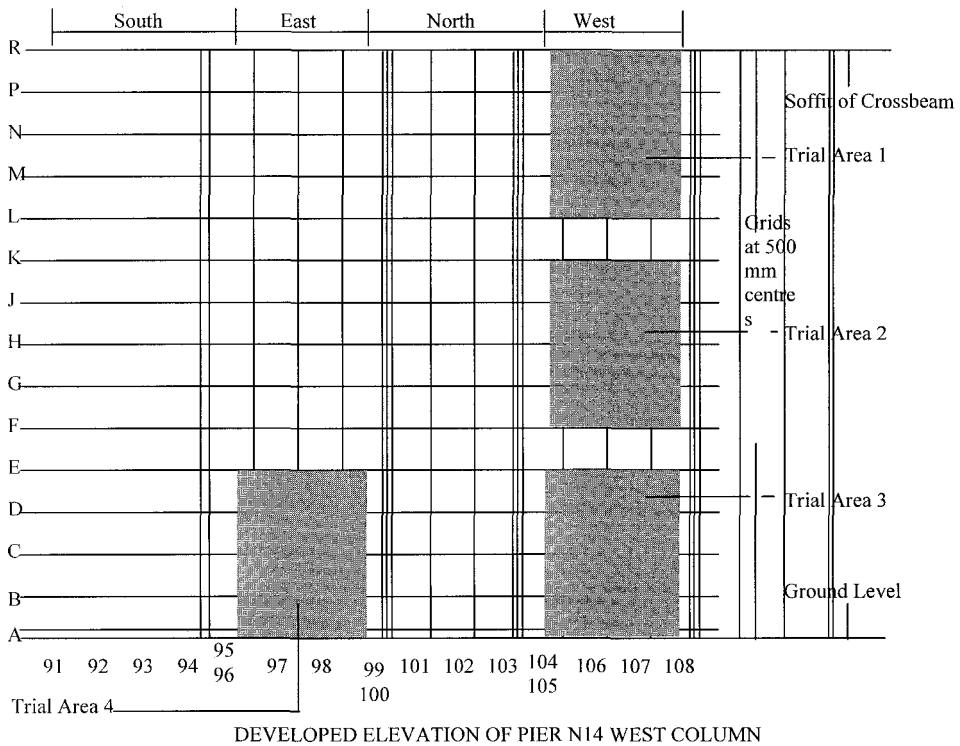
Figure 1 Arrangement of the trial areas

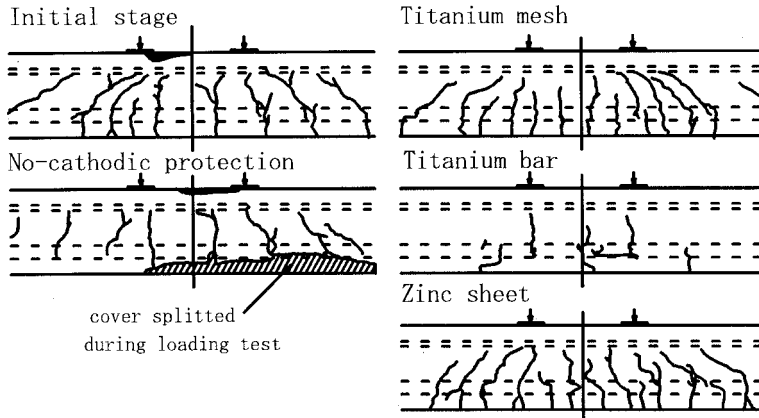
Figure 7 Cracking patterns after loading

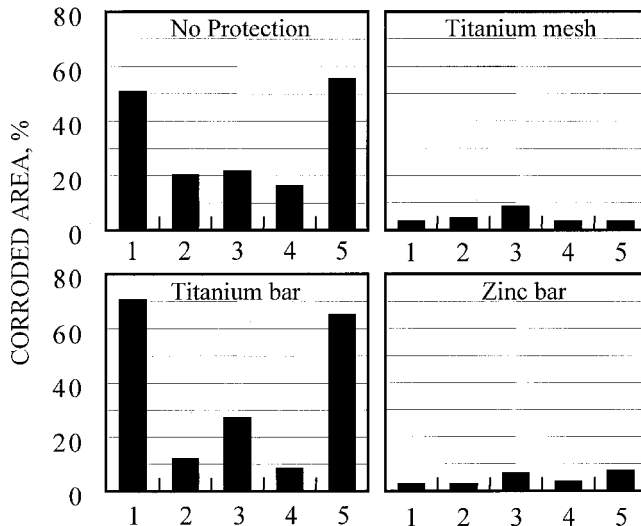
Figure 8 Corroded area of PC strand

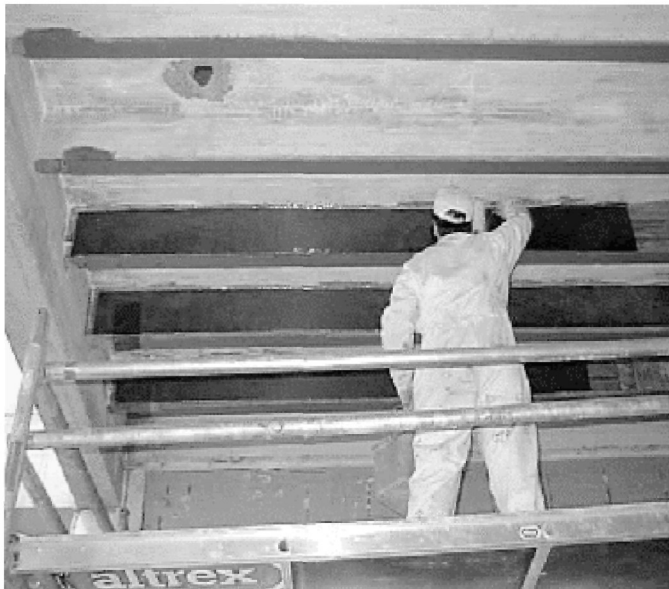
Figure 3 Application of the CFRP sheets

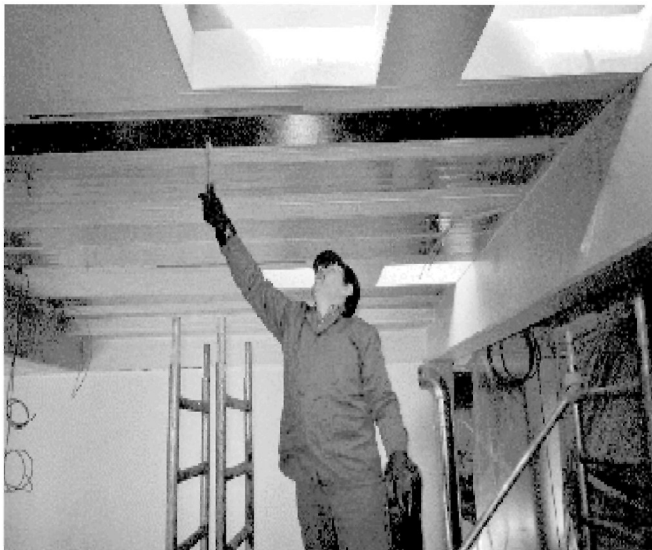
Figure 7 Impregnation of CFRP-sheets

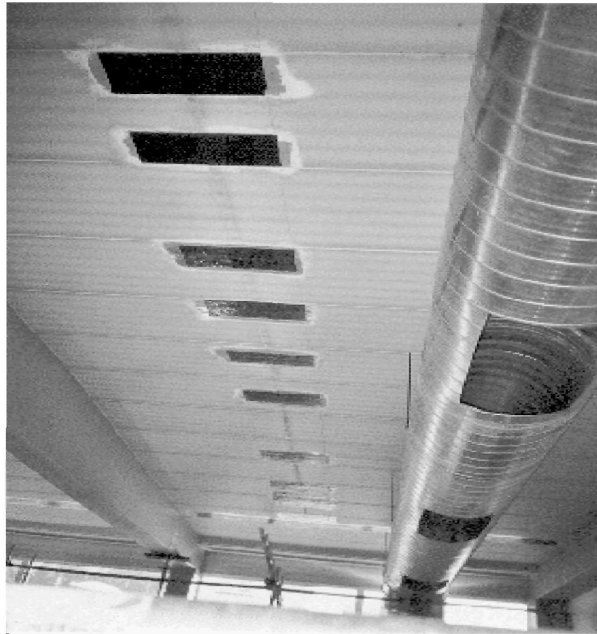
Figure 8 Reinforcement of drilling holes

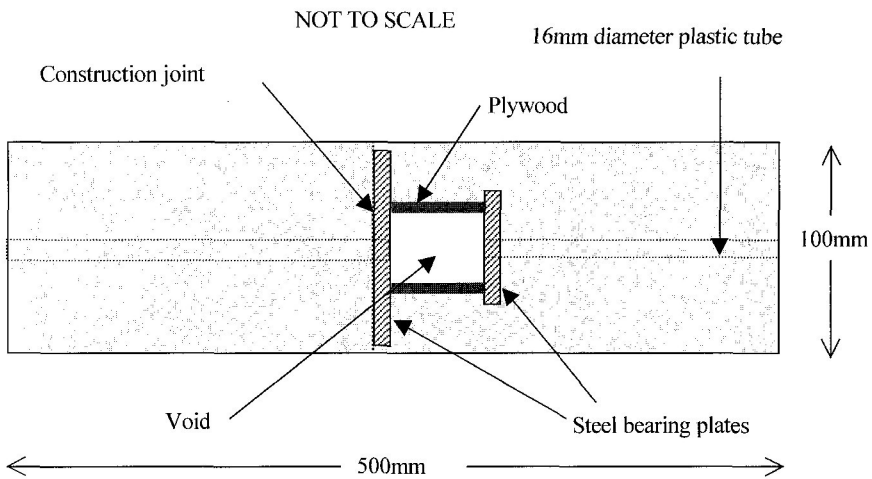
Figure 1 Prism specimen

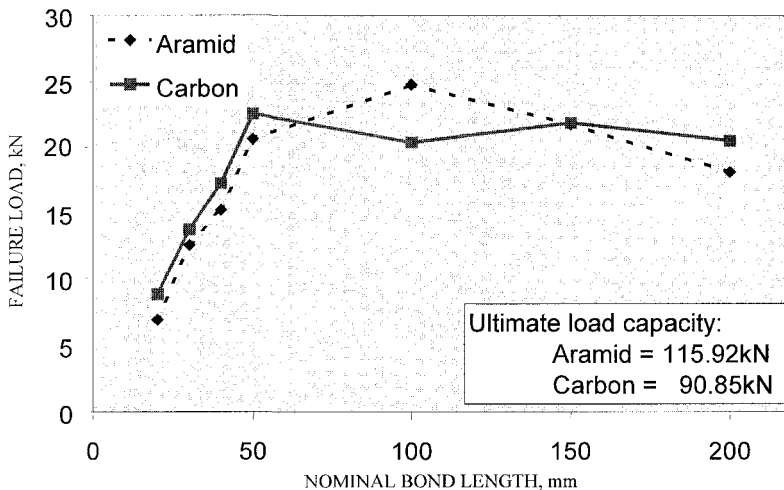
Figure 3 Failure load as a function of bond length

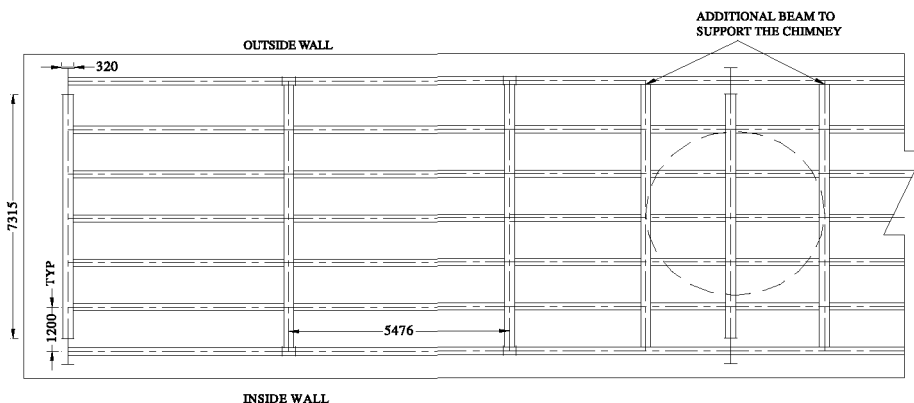
Figure 1 Structural layout of the test location at bunker bay roof

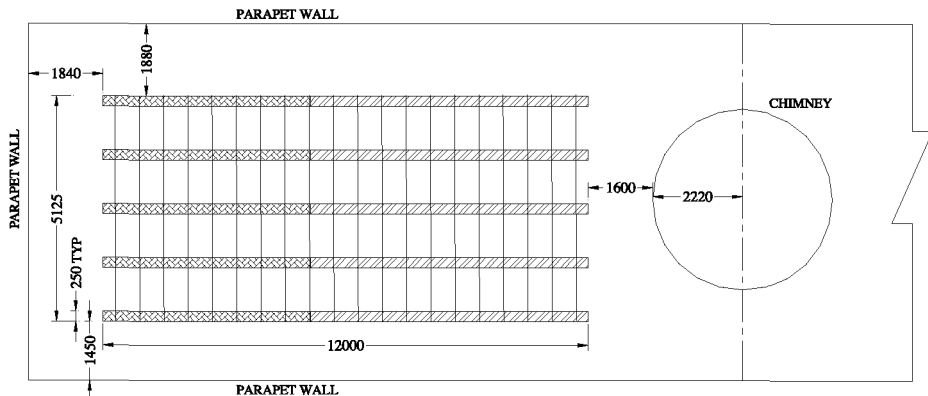
Figure 2 Loading arrangement at the test location of bunker bay roof

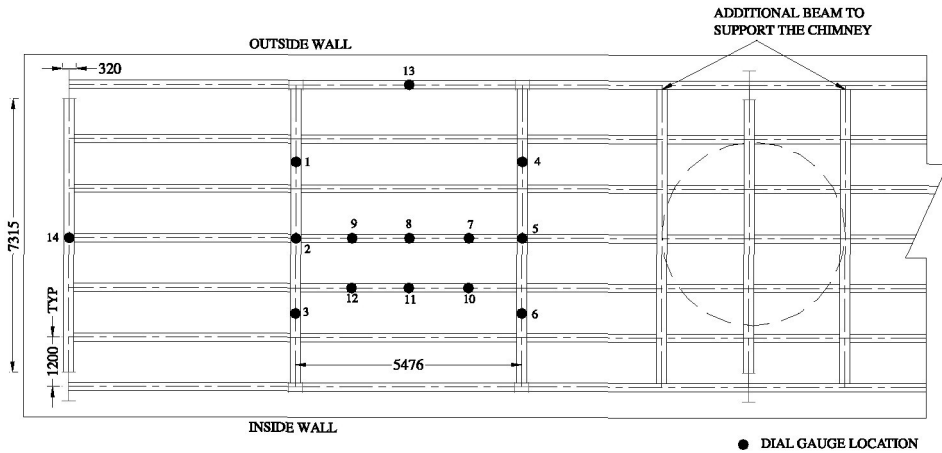
Figure 3 Layout of the dial gauge location at the test spot

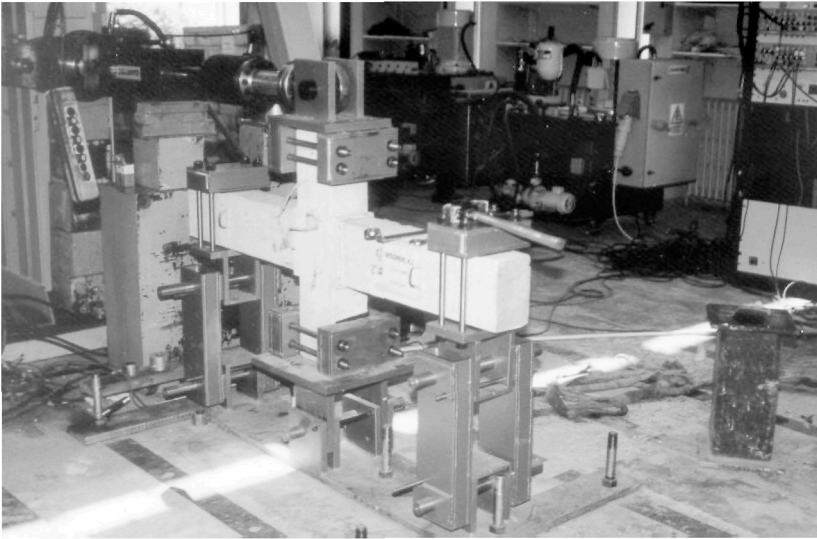
Figure 2 Layout of the specimen with its steel supports and loading actuator

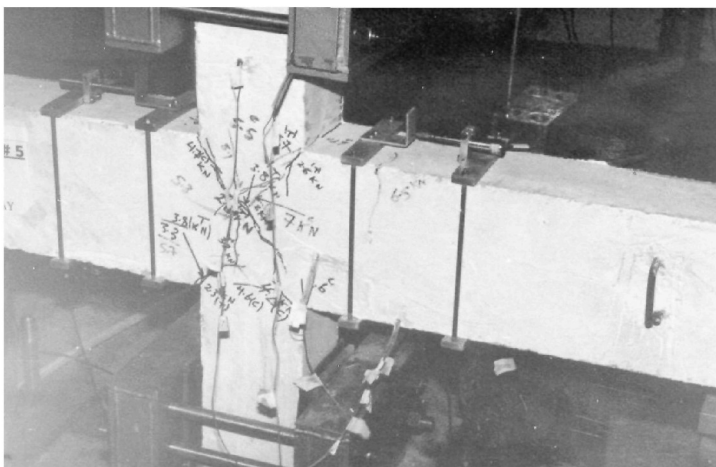
Figure 4 Failure of the beam-column joint region of reference specimen

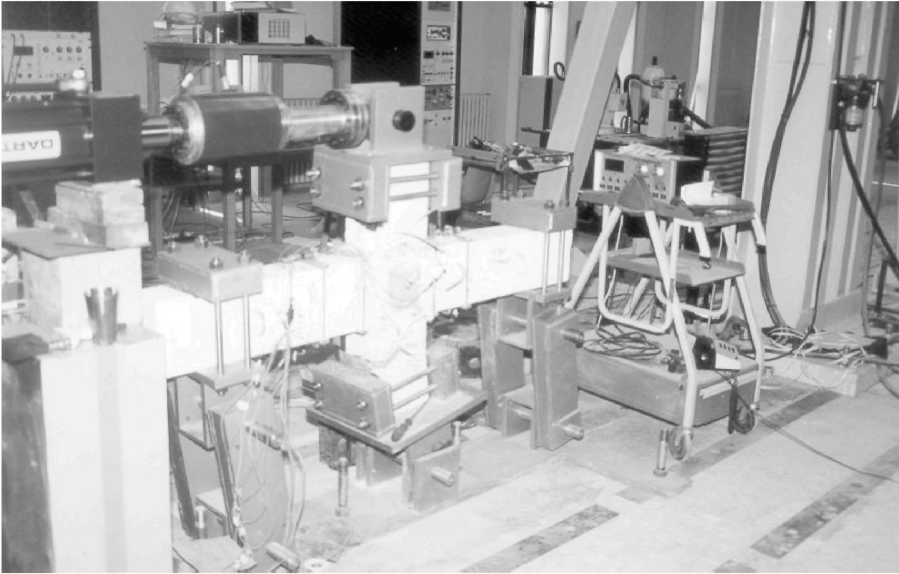
Figure 5 Failure of the beam-column joint region of repaired specimen
(note the large rotation at both rollers and hinge supports at final cycles of the test)

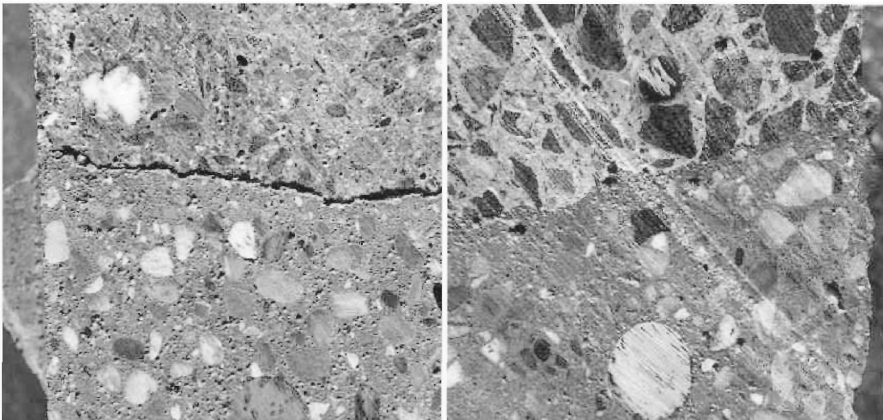
Figure 3 Repair to a beam soffit using a high bleed, cohesive mix (left) and a low bleed, superplasticised mix (right)
