# **COLLAPSE OF BURNING BUILDINGS**

**A GUIDE TO FIREGROUND SAFETY** SECOND  
EDITION

**Vincent Dunn**

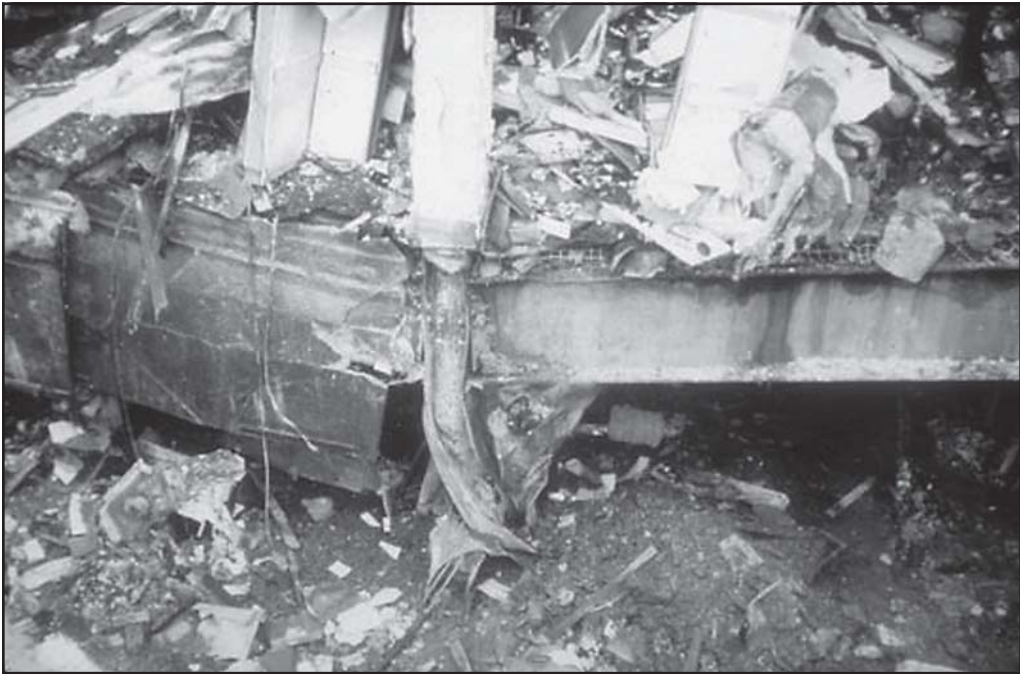
**Fig. 1–1.** Column failure was the cause of this floor collapse that killed four Brackenridge, PA, firefighters.

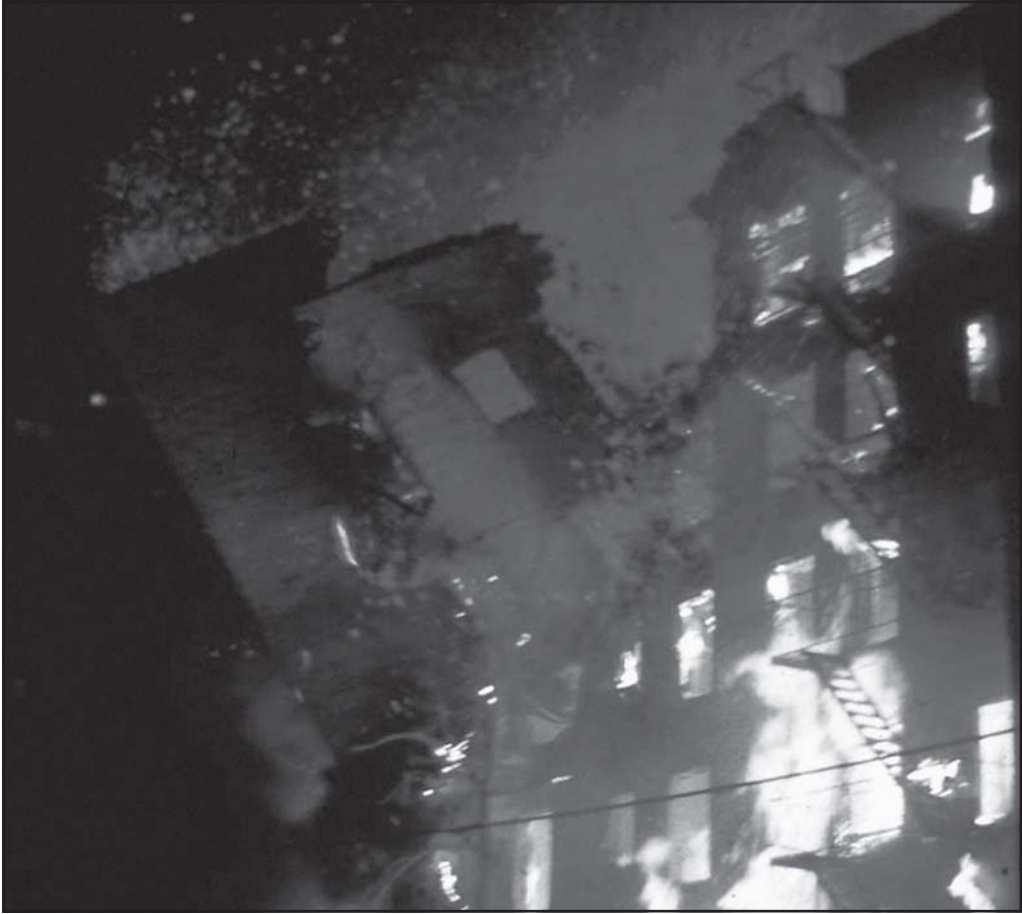
Fig. 1–2. The age of a building increases its collapse danger.

qualities, and steel rusts. Unless there is a much greater effort toward building preservation, rehabilitation, and legal renovation, the older structures of this country will collapse at an increasing rate and kill more firefighters (fig. 1–2).

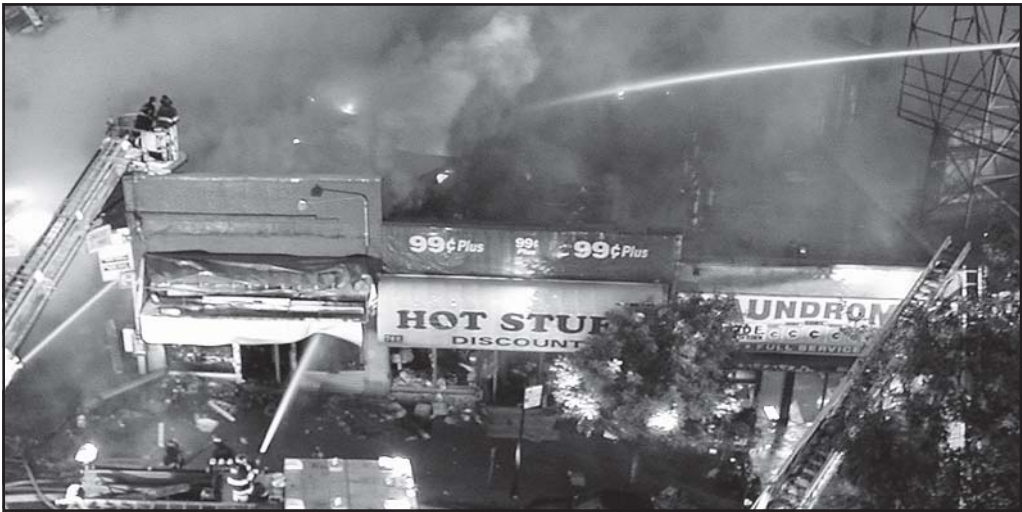
Fig. 1–3. Floor collapse in this 99-cent store killed two FDNY firefighters.

not because an illegal or improper renovation is undertaken. The Vendome Hotel floor and wall collapse in Boston and the New York City 23rd Street Wonder Drug Store floor collapse had improper and illegal renovations as contributing causes. The cause of several recent burning building collapses in New York City that killed and injured firefighters were determined to be due to poor illegal or improper renovations. For example: fire walls that supported a floor were removed to increase rentable space; firefighters operating hose lines on this floor above a fire were killed when the unsupported floor collapsed (Captain Scott LaPedria and Lieutenant James Blackmore); the roof of a building constructed without building department notification or approval collapsed killing a firefighter advancing with a hose team (Firefighter Louis Valentino); illegal renovation was a factor in a store fire floor collapse that took the lives of Lieutenant Howard Carpluk and firefighter Mike Reilly (fig. 1–3).

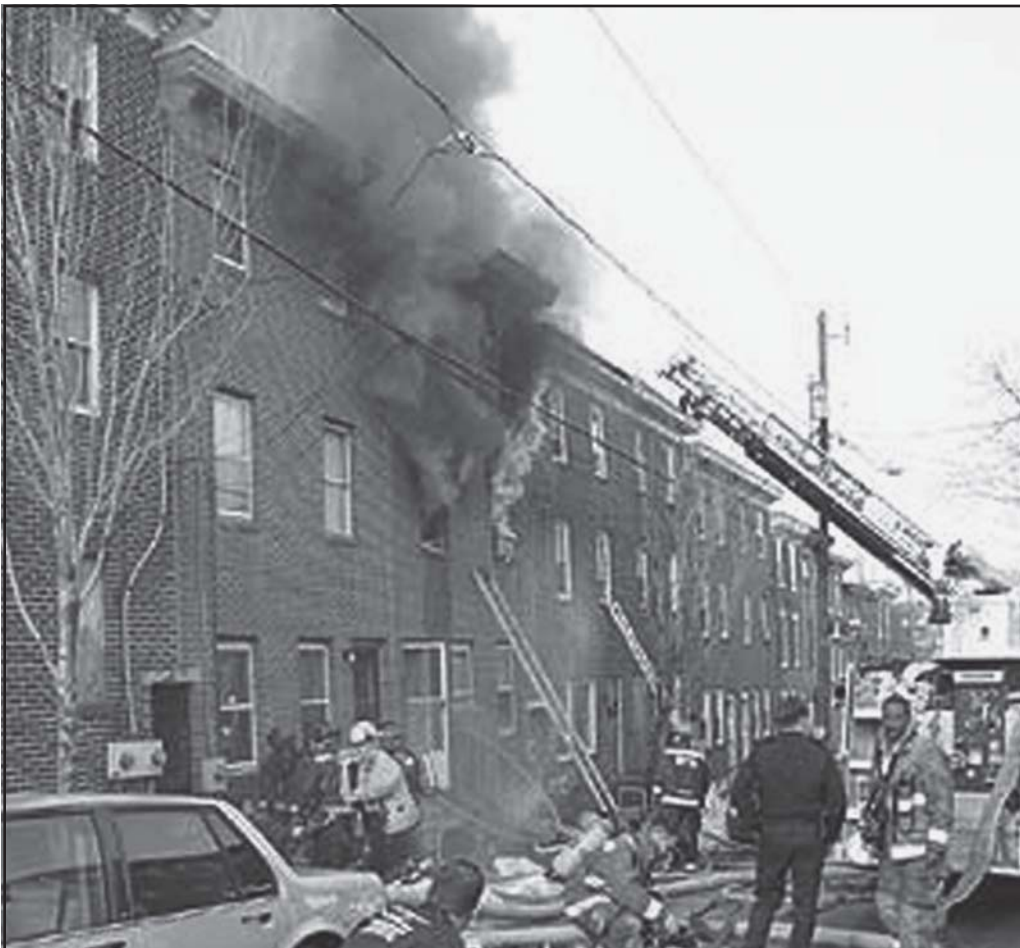
Fig. 2-1. Fuel load consists of content fuel and fuel in the structure.

After knocking down a fire in a three-story brick residence, firefighters are working on the first floor of the fire-damaged, oven-like house, opening up walls and ceilings and checking for concealed fire (fig. 2-1). Hot water drips from the soot-covered ceiling, and pieces of plaster drop to the floor. Smoke drifts up from the charred lumps of wood and plastic that once were furniture. Every square inch of the room is scorched black. Heat, smoke, and steam hang in the humid atmosphere.

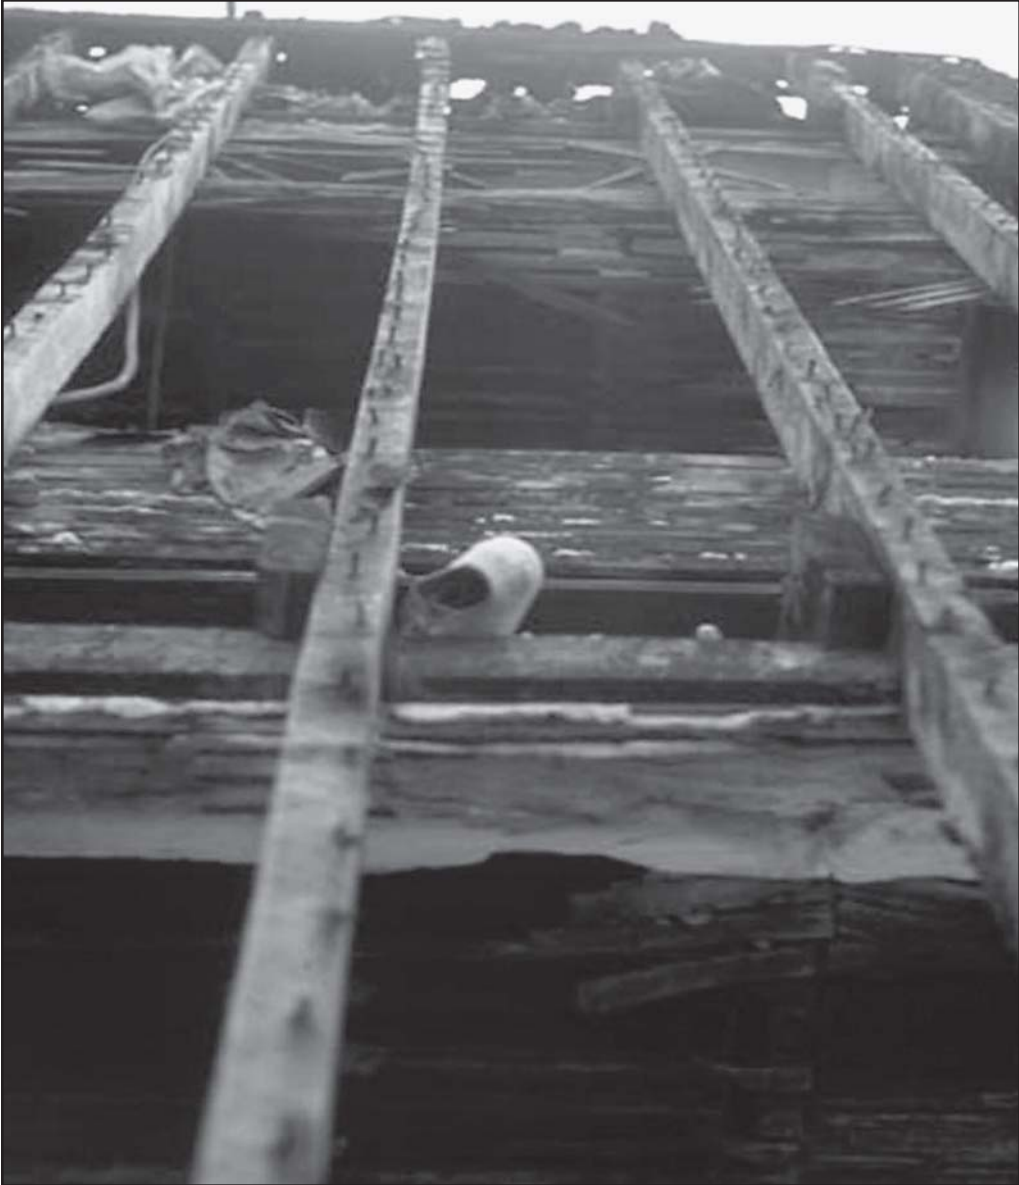
Fig. 2–2. Balloon frame construction has exterior walls that have studs extending continuously from the foundation to the top plate near the attic. This concealed space allows rapid fire spread from the cellar to the attic.

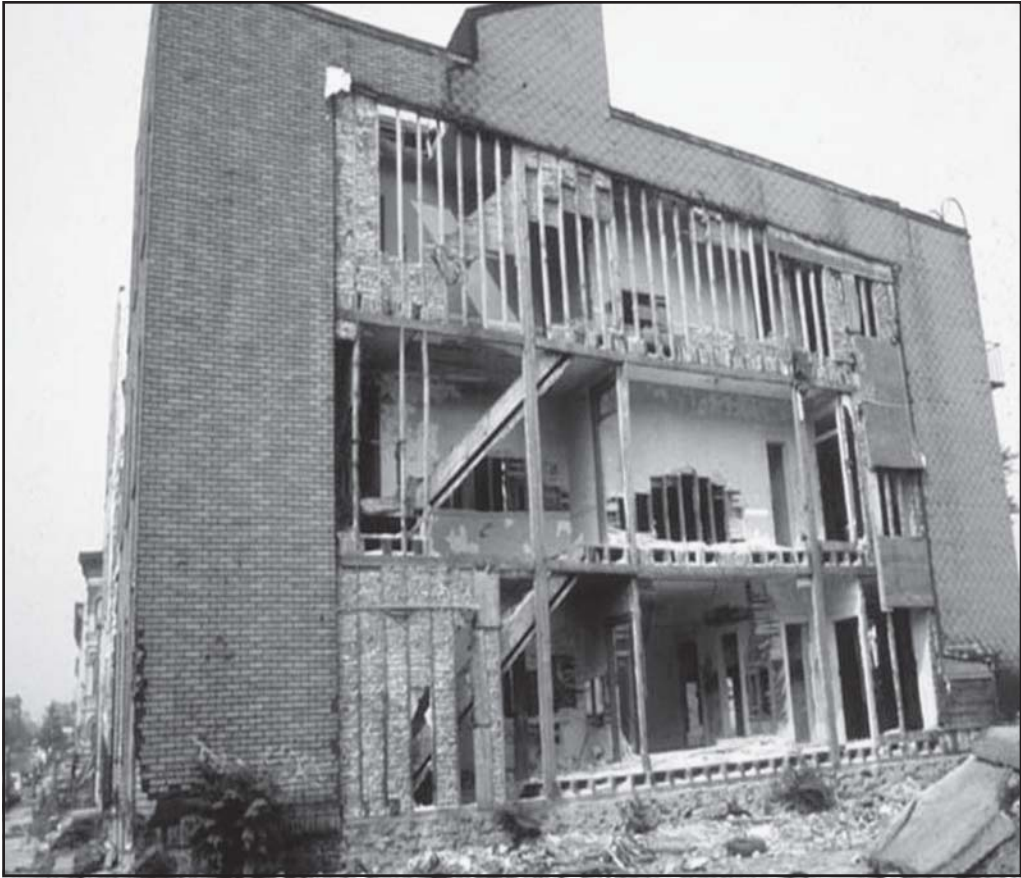
Fig. 2–3. Brace-framed construction has posts and girts fastened by mortise-and-tenon joints.

**BRACED-FRAME CONSTRUCTION.** One of three basic methods of constructing wood-frame residential buildings (balloon and platform are the other methods); sometimes called “post-and-girt” construction. Vertical timbers called posts reinforce each of the four corners of the structure, and horizontal timbers called girts reinforce each floor level. Posts and girts are connected by fastenings called mortise-and-tenon joints. During a fire, a braced-frame building wall often fails in an inward/outward collapse. The wall breaks apart with the top part collapsing inward on top of the pancaked floors, and the bottom part collapsing outward on the street (fig. 2-3).

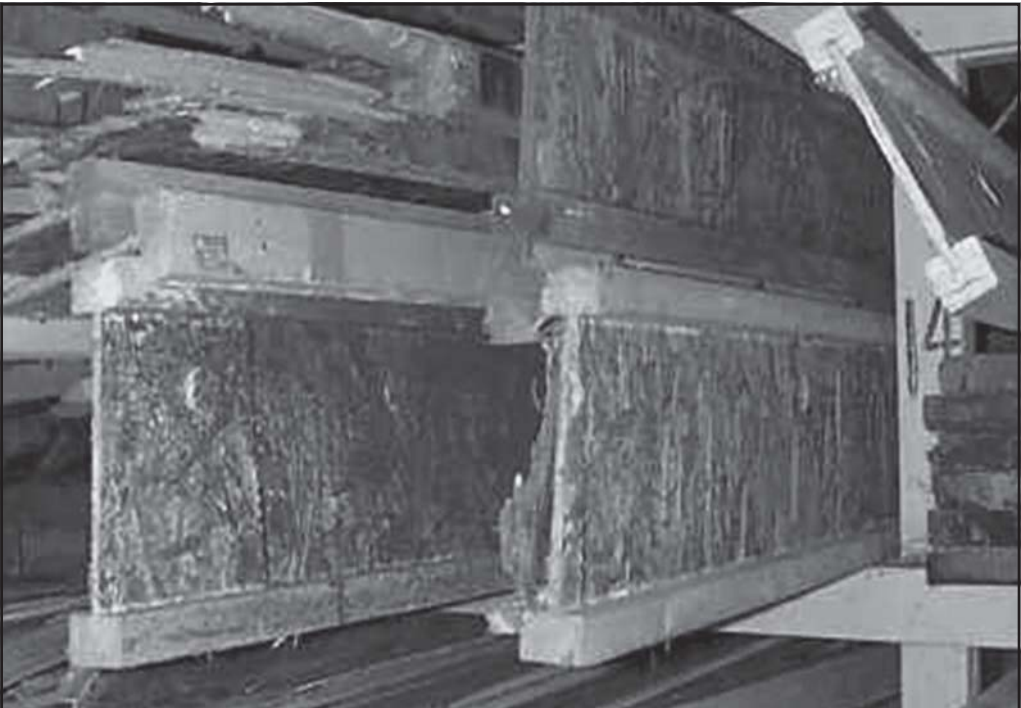
Fig. 2–14. Wood I-beams have a web section connected with top and bottom wood flanges.

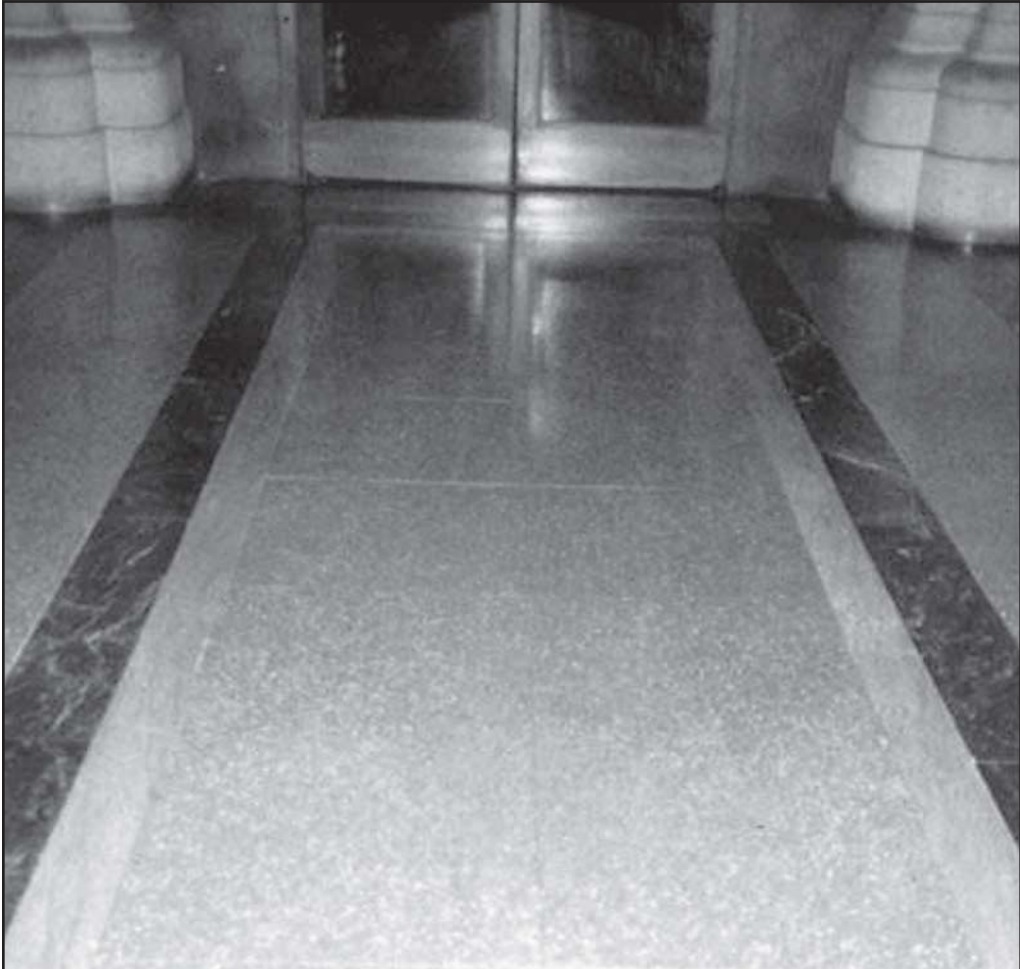
**Fig. 2-19.** Terrazzo floors have polished marble chips in cement.

to accumulate and build up to dangerous proportions. In New York City in 1966, a fire burning in a cellar below a terrazzo floor burned away the floor beams, although little heat and smoke penetrated the floor itself. The floor suddenly collapsed, killing 12 firefighters (fig. 2-19).

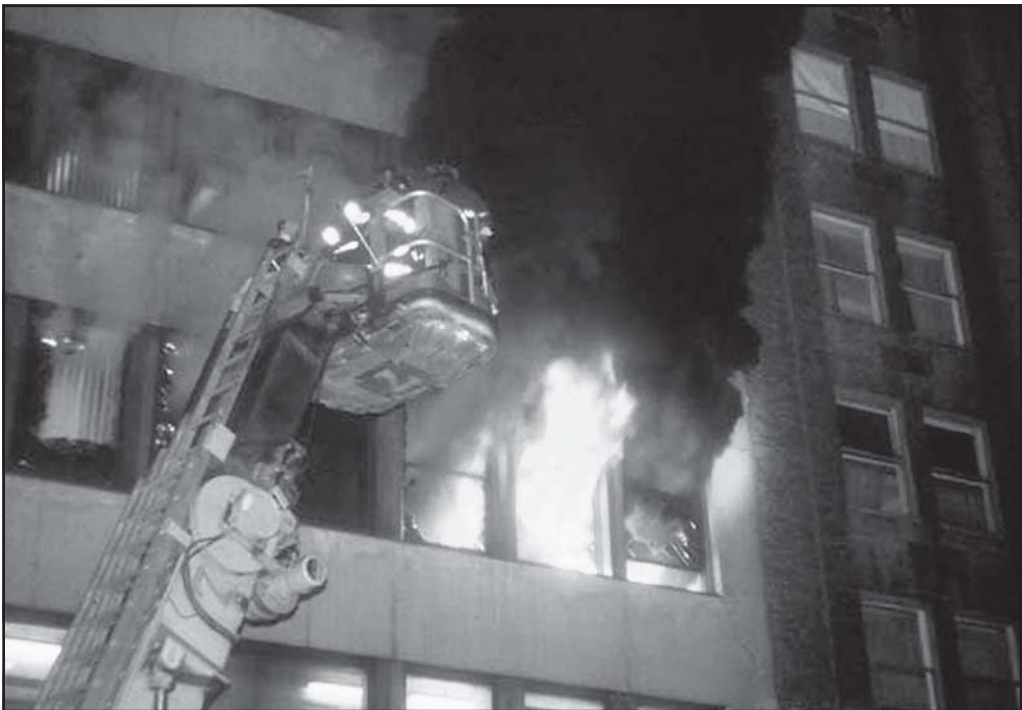
Fig. 3-1. Type 1 fire-resistive construction may allow fire spread by auto exposure from window to window.

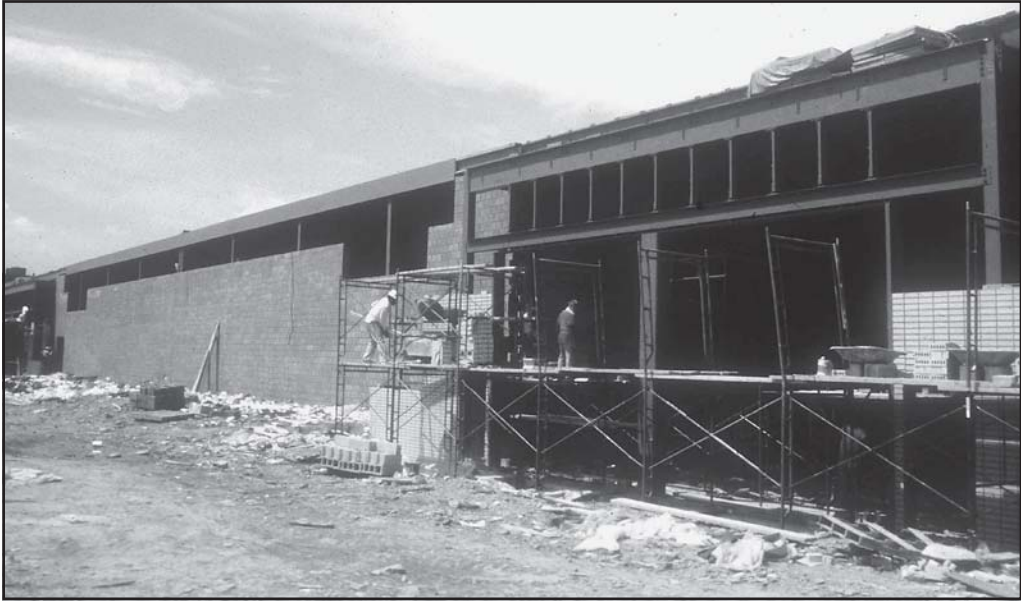
Fig. 3–2. Type 2 construction may allow fire spread in the combustible roof deck.

The National Fire Protection Association (NFPA) recommends that the roof of a noncombustible/limited combustible structure be built up as follows: The total weight of asphalt used between the steel deck and the insulation should not exceed 12 to 15 pounds per 100 square feet of roof area. The felt, paper and rigid insulation should be noncombustible. Any hot asphalt mopping or application should not cover the roof deck completely but should cover only the overlapping edges between sections of steel deck, felt paper, or rigid insulation (strip mopping). When a fire occurs in a noncombustible/limited combustible building, as soon as possible after the fire is darkened down, the officer in command should have a firefighter check the roof covering above the fluted metal deck for fire extension. During a fire, heat may conduct through the metal roof deck and ignite the combustible roof covering

above. After a fire is extinguished in a building of noncombustible construction, the officer in command should order a fire company to the roof to check the combustible asphalt roof covering. Heat may be conducted through the steel fluted roof deck and ignite that roof covering.

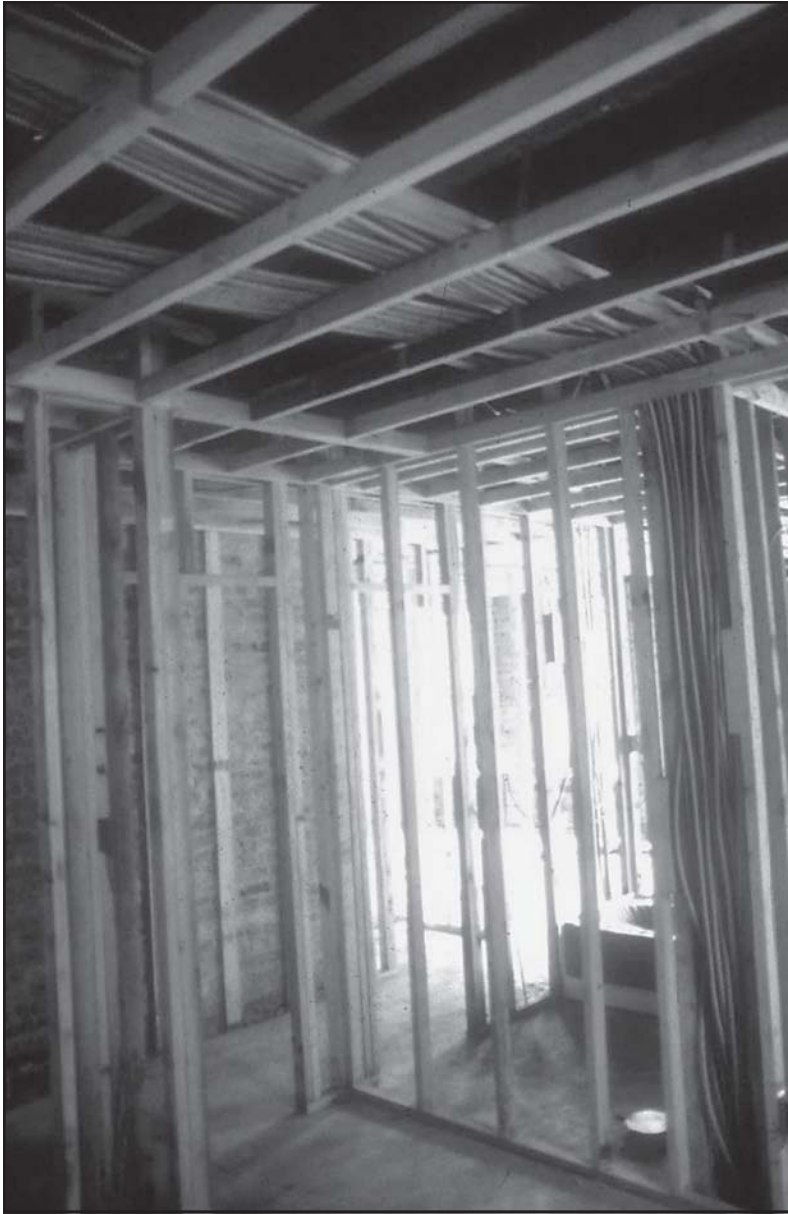
Fig. 3–3. Type 3 ordinary construction has many concealed spaces that allow fire spread.

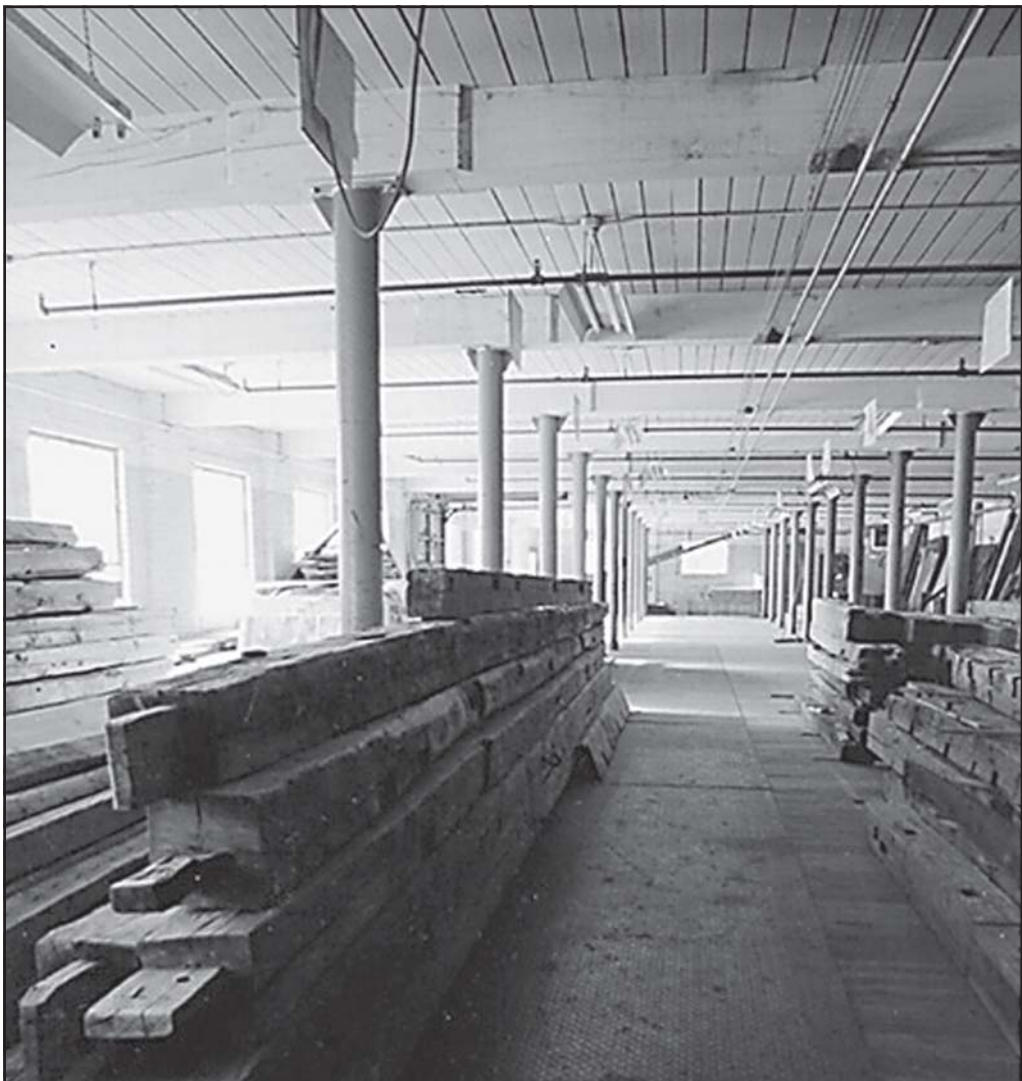
**Fig. 3-4.** Heavy timber construction with large content and structure fuel load

This type of construction was originally designed for textile mills during the last century. These four-to-seven-story brick-walled buildings, featuring large wooden timbers to support heavy machinery, are very stable structures. For a building to qualify as heavy timber construction, a wood column cannot be less than 8 inches thick in any dimension and a wood girder cannot be less than 6 inches thick (fig. 3-4). Instead of fire-resistive ratings for structural members, each interior wood structure must meet size specifications.

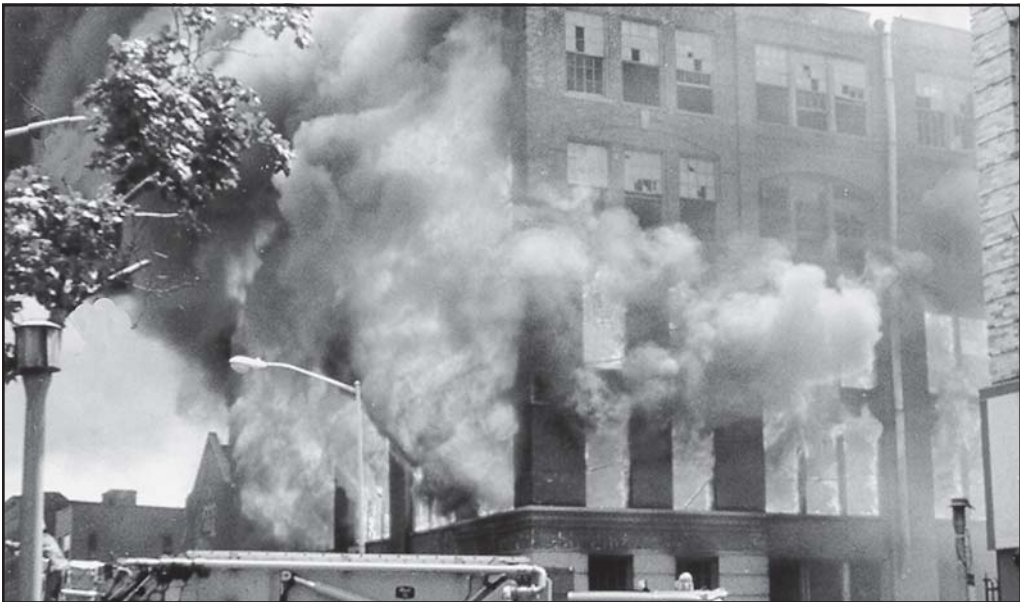
**Fig. 3-5.** Large fire in a Type IV heavy timber construction that creates a radiated heat fire spread problem for surrounding structures.

Today, heavy timber construction can be found in modern churches or in storage facilities in the old commercial areas of a city. The major fire problem of this brick-enclosed timber structure is the large wooden interior timber framework. When large timber columns, girders, and wood ceilings are not covered with plaster and become involved in a fire, flames shooting out the windows quickly spread fire to nearby buildings by radiant heat waves. Some heat waves travel distances of 80 feet and ignite combustible portions of nearby buildings. The advantages of not enclosing ceilings or timber in plaster are that there will be no concealed spaces, no obstructions to the firefighter's hose stream, and no hidden flames behind ceilings or walls. If the initial firefighting efforts are unsuccessful, however, and firefighters are forced off the fire floor to begin an exterior attack, the exposed structural wood will become a great disadvantage to operating fire forces. The heavy timber building will experience a large fire, and radiated heat from the windows will ignite the adjoining structures (fig. 3-5).

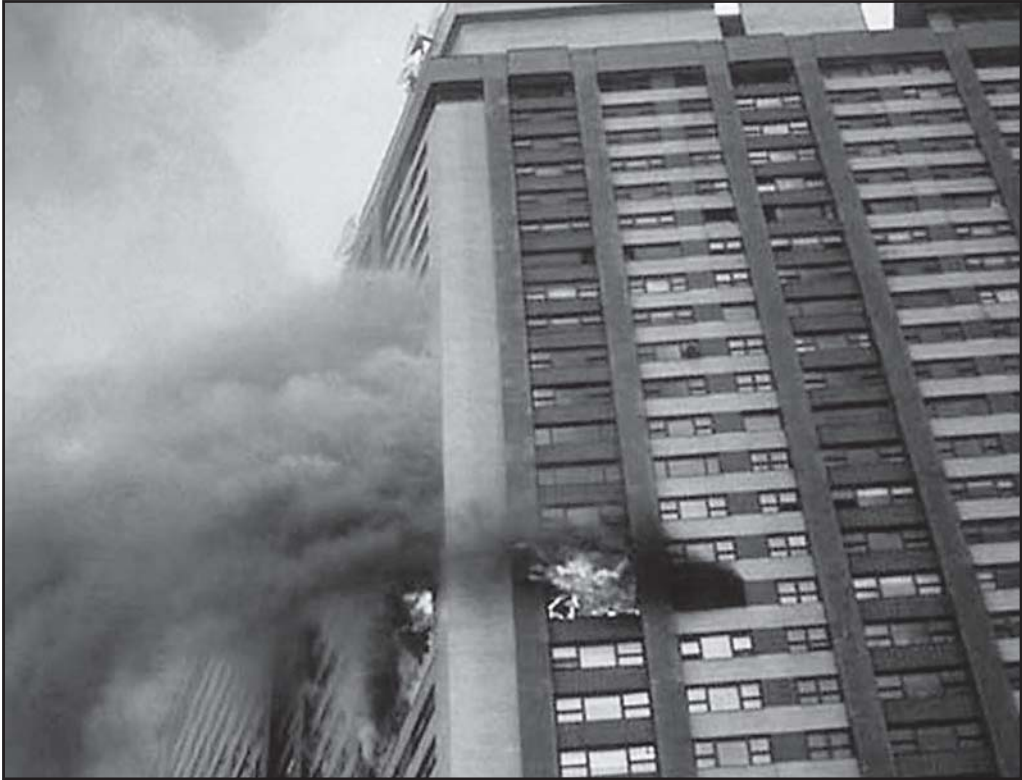
**Fig. 3–6.** Type I reinforced concrete structure suffers concrete spalling during a fire.

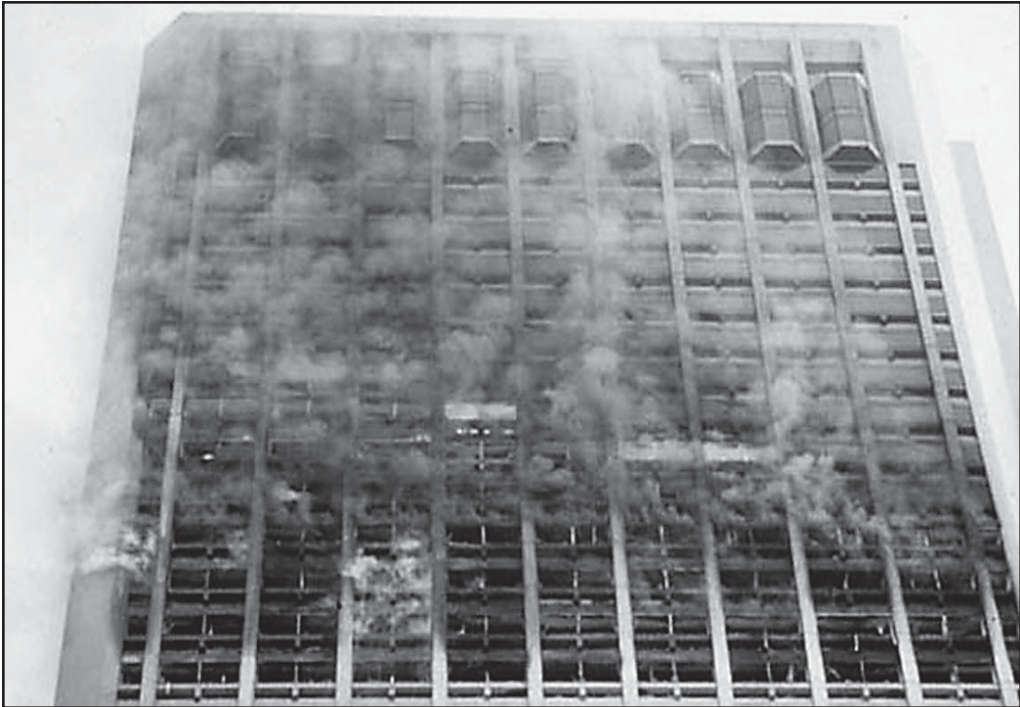
Fig. 3–7. Type I steel skeleton construction. The heat from a fire reaching the underside of a corrugated steel deck is transmitted upward to the concrete floor above. The concrete floor may buckle upward between 6 and 12 inches. The floor may also bow and sag downward as well.

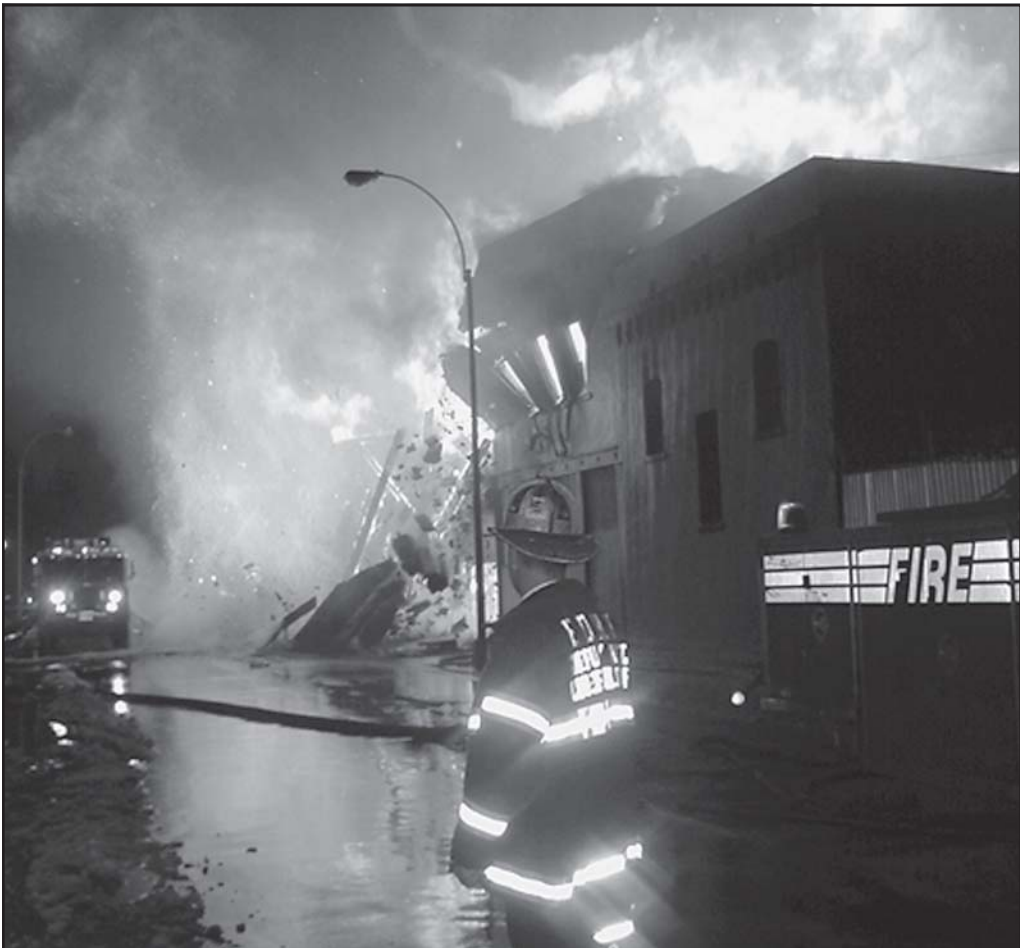
**Fig. 4–2.** A masonry wall falling at a 90-degree angle

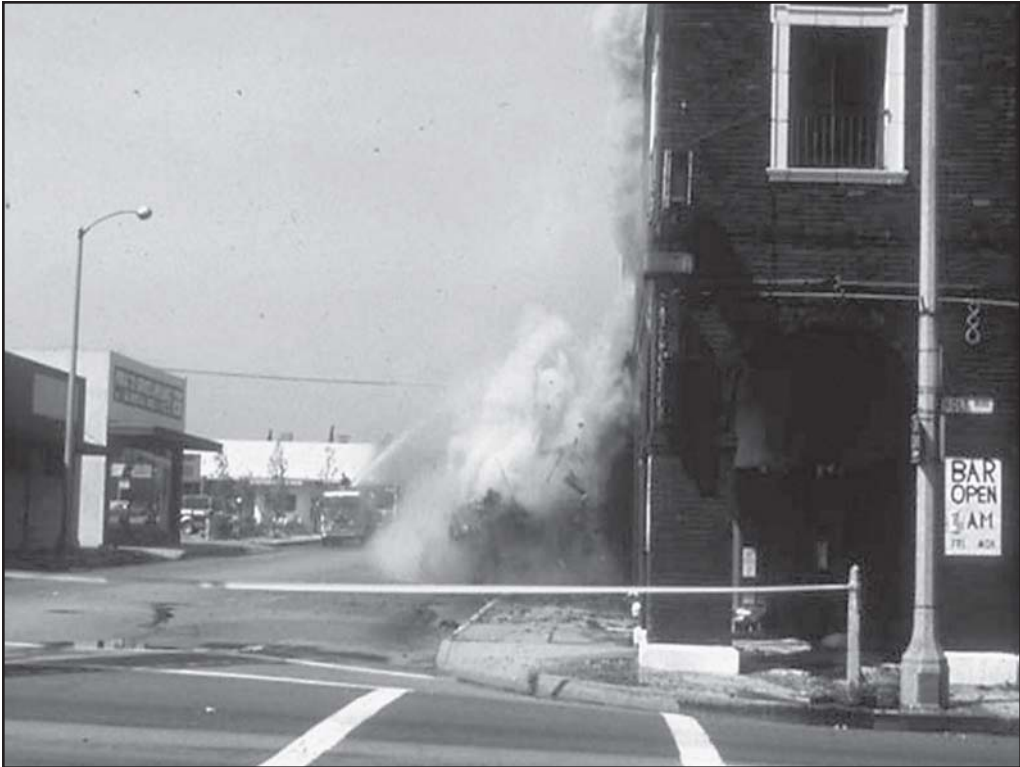
Fig. 4-4. An example of a curtain-fall collapse of a masonry wall

In a curtain-fall collapse, the exterior masonry wall drops like a falling curtain cut loose at the top (fig. 4-3). The wall crumbles and falls straight down, with bricks and mortar forming a pile on the ground near the base of the wall. The collapse of the brick veneer, brick cavity, or masonry-backed stone wall often occurs in a curtain-fall manner. If the metal ties holding a brick veneer wall to plywood backing are destroyed by fire, or if mortar bonding between an exterior finished stone wall and a masonry-backed wall is washed away by hose streams, large sections of brick or stone veneer may fall off the building's exterior. Firefighters entering, leaving, or operating near the doorways beneath the curtain-fall collapse may be killed or seriously injured by falling brick. Another situation of potential curtain-fall collapse occurs when fire has collapsed the interior of a multi-story brick-and-joist structure and the remaining freestanding walls have many window openings with brick arches serving as lintels. If one of the masonry walls starts to fall and the brick arches spanning the tops of the wall openings crumble and fall apart, the wall will fall downward rather than straight out (fig. 4-4).

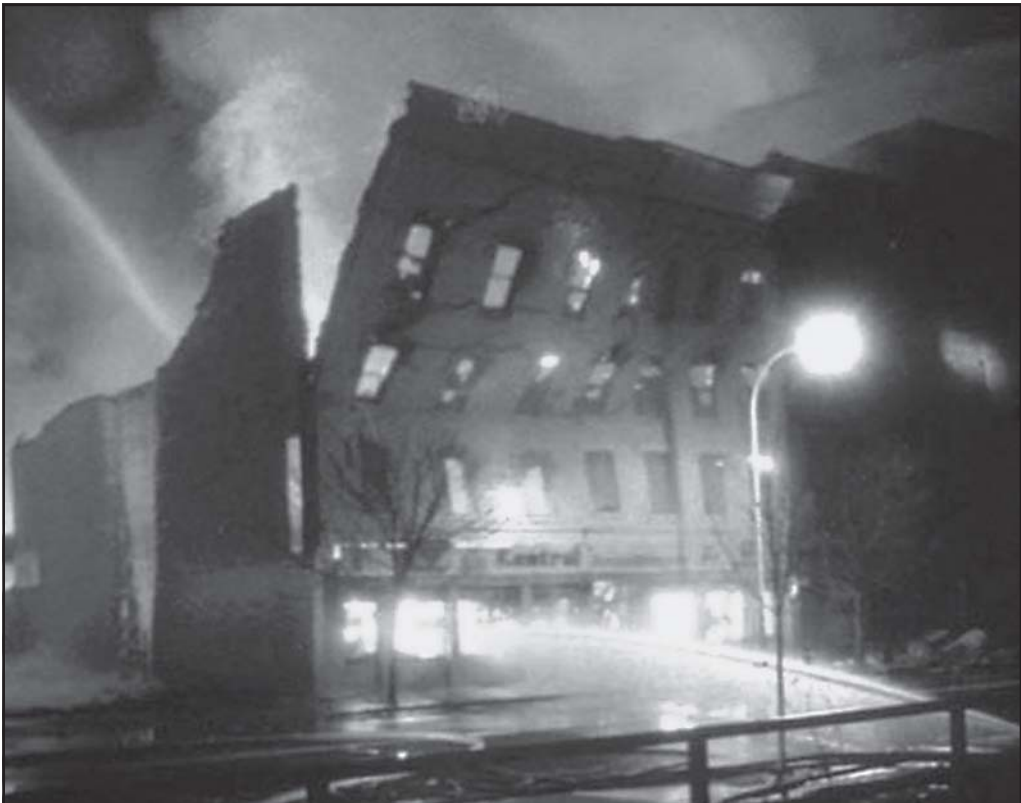
Fig. 4–6. An example of an inward outward wall collapse

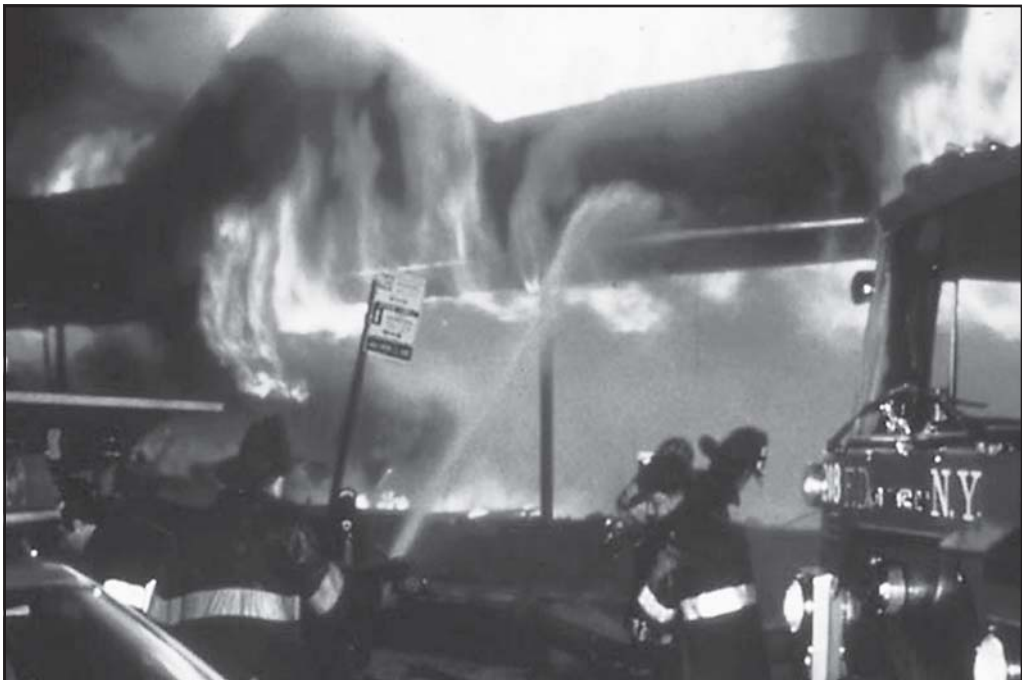
**Fig. 5-1.** A parapet wall supported by a steel lintel with flame flowing out the opening below the steel lintel is distorting the steel support.

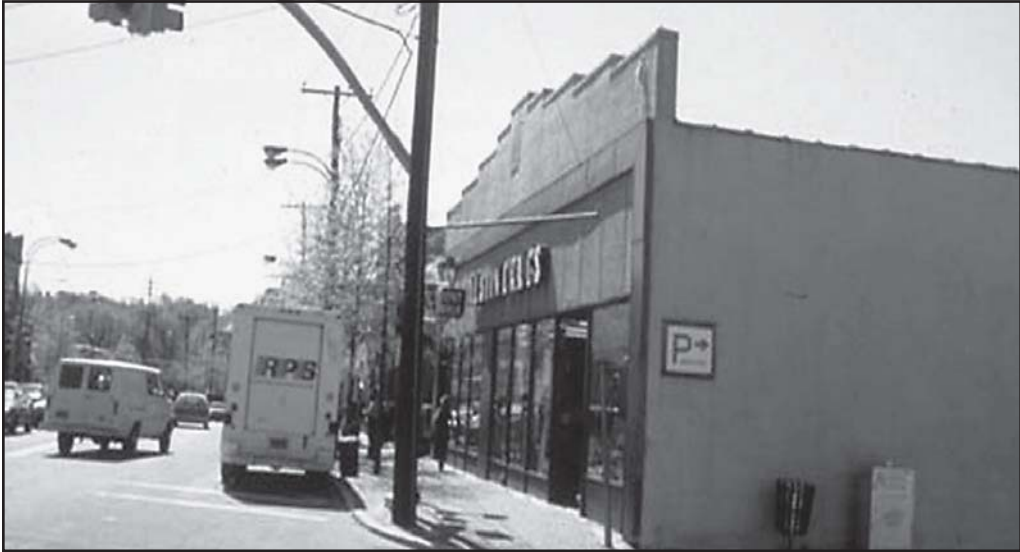
**Fig. 5–3.** A freestanding parapet wall. A master stream striking the back of this wall could cause it to collapse outward onto the sidewalk.

The parapet described in the scenario above is a freestanding wall (fig. 5-3). It does not support any other part of the structure, it is balanced on top of a steel I-beam, and, as the term implies, it just stands in place. Because a wall receives its stability from other portions of the structure to which it is connected, a freestanding parapet of an exterior wall is less stable than either a nonbearing wall or a bearing wall. The more

connections a wall has to other portions of the structure, the more stable it becomes, but the more damage it will cause to other portions of the structure when it collapses. A front, freestanding parapet wall over a store can be considered a cantiliver beam. It is a vertical cantilever wall supported from one end, the bottom.

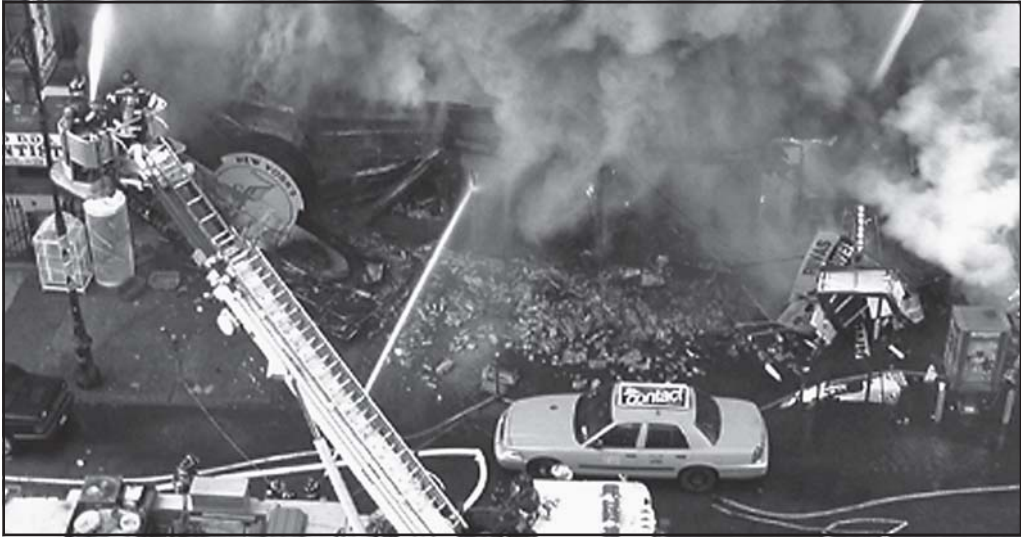
Fig. 5–4. This parapet wall supported by steel lintel collapsed suddenly during a fire.

is unstable (fig. 5–4). Ornamental cast stone and decorative terra-cotta parapet walls are often attached to steel reinforcement rods and angle irons, making them the most susceptible to total collapse during firefighting operations.

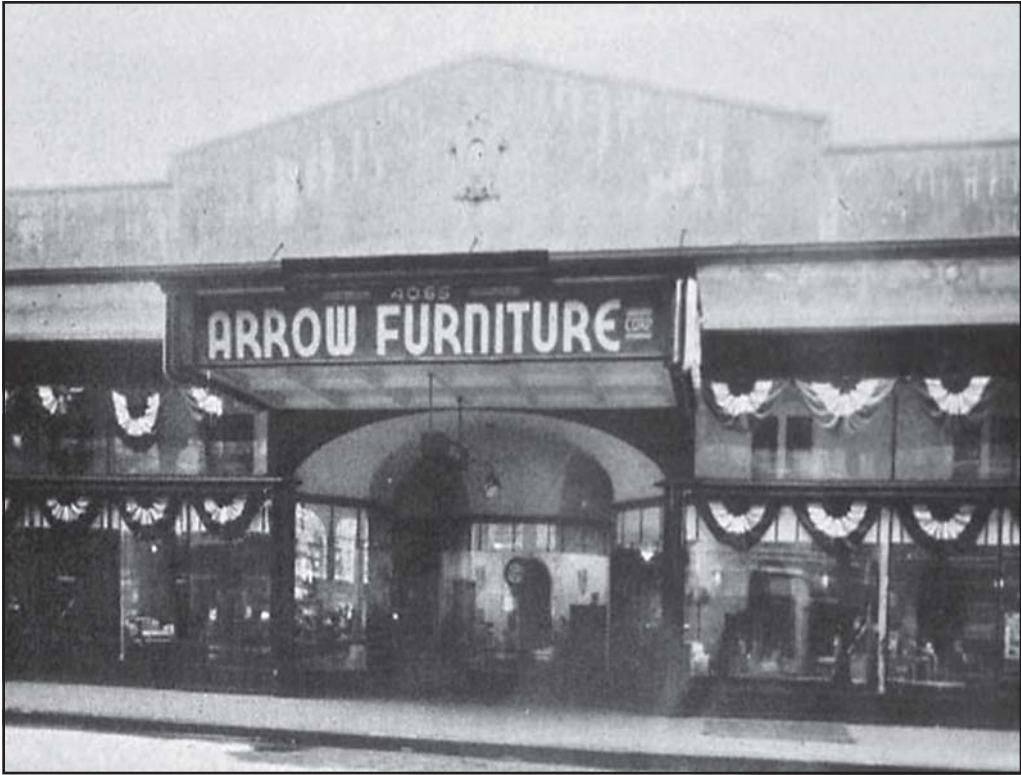
Fig. 5-5. This marquee and parapet wall collapsed and killed six FDNY firefighters.

In the 1956 collapse that killed six firefighters, the parapet wall supported a marquee, whose weight was determined to be one of the causes of the collapse. The firefighters who perished were not under the marquee but were operating well to one side of it, but when the marquee collapsed, the entire parapet wall was pulled down with it (fig 5-5).

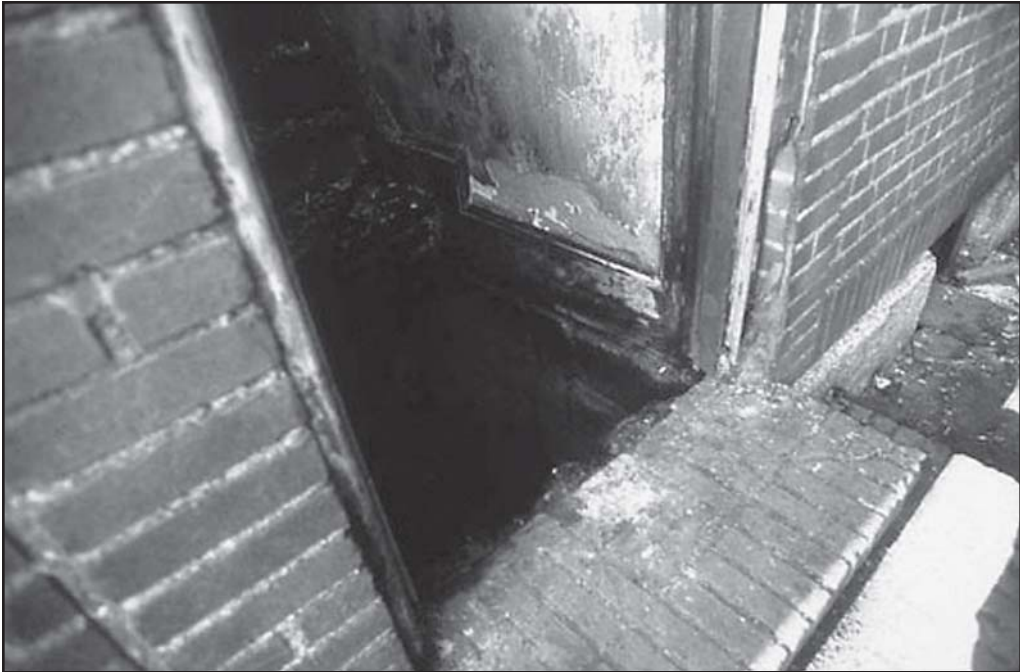
Fig. 6–2. Lieutenant John Clancy died when this floor deck collapsed.

1. Floor deck may collapse, where only the wood deck may burn through and collapse, leaving the supporting joists intact. An example of a floor deck collapse occurred when FDNY Fire Lieutenant John Clancy died December 31 1995. The floor deck of an entrance landing on a two-story ordinary constructed private dwelling collapsed (fig. 6-2). This was a vacant building, and the fire was in the cellar when Lieutenant Clancy stepped inside a smoke-filled, first-floor, side doorway. The floor deck collapsed sending him into the burning cellar. Visibility was zero as the door opening was completely filled with smoke.

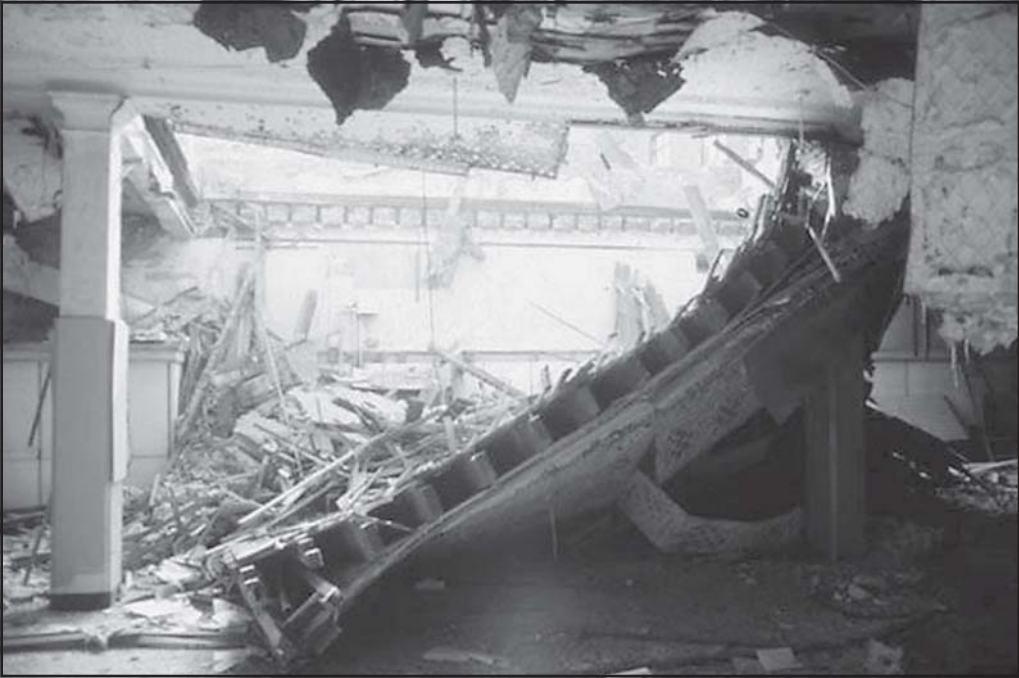
Fig. 6–3. An example of a floor beam collapse

2. Floor beam collapse, where several floor joists fail, causing a localized failure of a section of floor within room is a more deadly collapse (fig. 6–3). An example of a, recent, deadly floor beam collapse occurred when FDNY Lieutenant Howard Carpluk and firefighter Michael Reilly were killed at a Bronx fire on April 27, 2006, when the conventional solid wood floor beams of a one-story ordinary constructed strip store collapsed. The most deadly floor beam collapse occurred on October 17, 1966, when 12 FDNY firefighters were killed in the Wonder Drug store located on 23rd Street in Manhattan.
