# **COLLAPSE OF BURNING BUILDINGS**

**A GUIDE TO FIREGROUND SAFETY** SECOND  
EDITION

**Vincent Dunn**

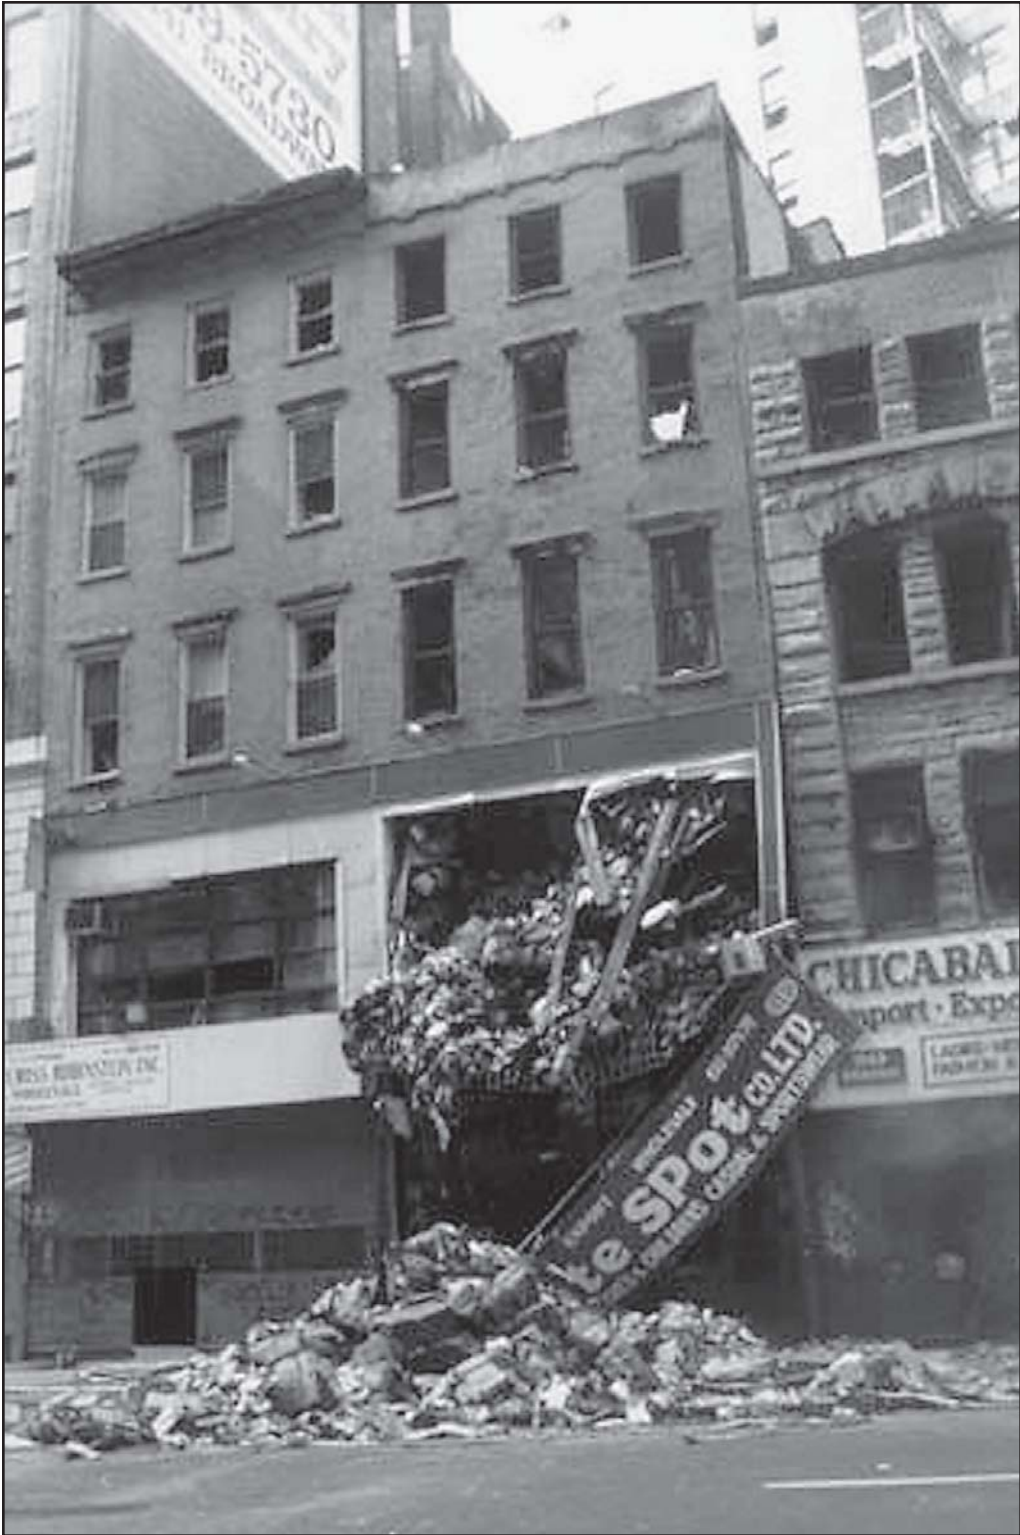
Fig. 6-4. An example of a multilevel floor collapse

3. A multilevel floor collapse describes a progressive floor failure. Here a floor collapse triggers the subsequent collapse of floors below and of one or more enclosing walls (fig. 6–4). This is the most deadly type of collapse. The two most deadly multilevel floor collapses in the history of the fire service occurred June 17, 1972, when the Vendome Hotel collapsed and killed 9 Boston firefighters, and on September 11, 2001, when the terrorists attacked the World Trade Center. The two towers collapsed and killed 2,749 people, including 343 New York City firefighters.

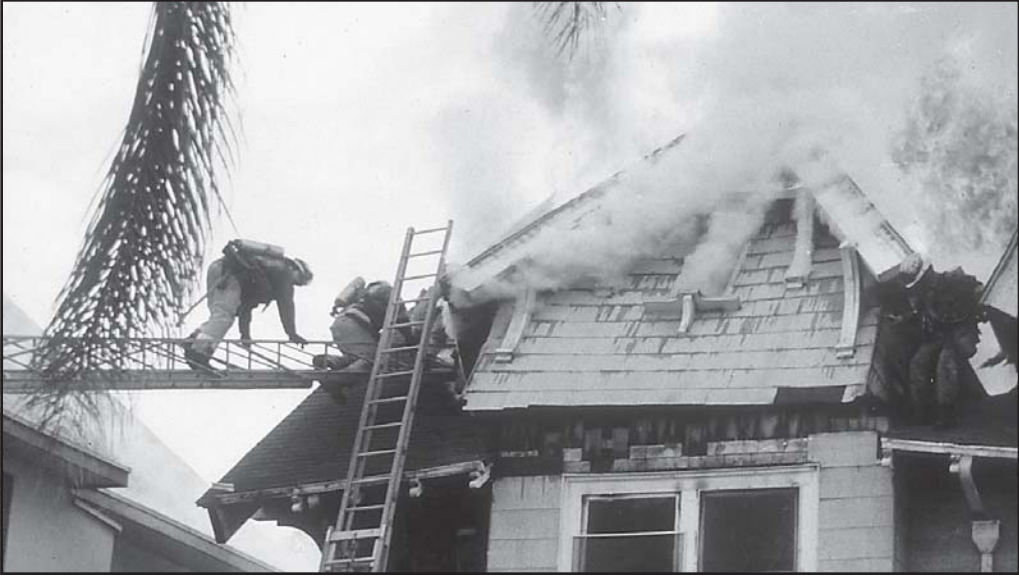
Fig. 7-1. A ridge rafter peaked roof collapse

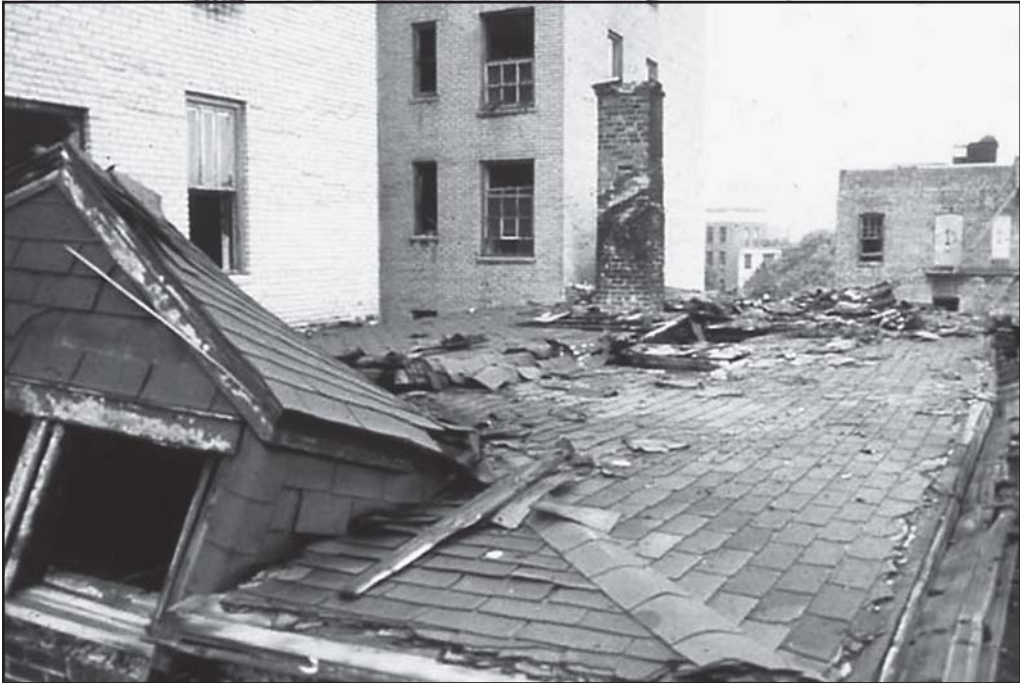
**Fig. 7-2.** This hip roof collapsed and trapped a firefighter working in the attic space.

Ladder 44 firefighter, Michael Brady, entered the attic space and a hoseline was passed to him through a 3-by-3-foot access opening from the top floor. Meanwhile, three firefighters were working on top of the hip roof: one cutting the roof deck above the smoldering hot spots with a power saw; another acting as his guide, as he stepped backward with the spinning, highspeed saw blade; and the third standing by ready to pull up the cut roof deck with a Halligan tool. Suddenly the roof started to collapse (fig. 7-2). The deck and shingles near the two remaining front hip rafters ripped apart. The peak of the roof fell, sliding down around a masonry chimney, and the eaves pushed out beyond the bearing walls on both sides. Several rows of bricks at the top of the side bearing walls fell into an alley. One firefighter on the roof leaped across a 3-foot alley to the roof of an adjoining building; the other two rode the roof down. Brady, inside the attic, sensing the collapse above him, dove headfirst for the opening in the attic floor but the collapsing roof pinned the lower half of his body before he could escape. Crying out for help, the firefighter was caught with his head and shoulders hanging out of the access opening and his hips and legs pinned between

the underside of the heavy collapsed roof rafters and the attic floor. A firefighter standing on the ladder leading to the access opening saw what had happened and quickly wedged the point of his Halligan tool between a roof rafter and the attic floor, where Brady was caught, holding the roof up several inches above the floor. Although the trapped firefighter could not free himself, this action temporarily kept the full weight of the roof from crushing his lower torso. Rescuers carefully cut away the roof rafters round the trapped firefighter, releasing him from beneath the collapsed hip roof. Brady survived and returned to active fire duty.

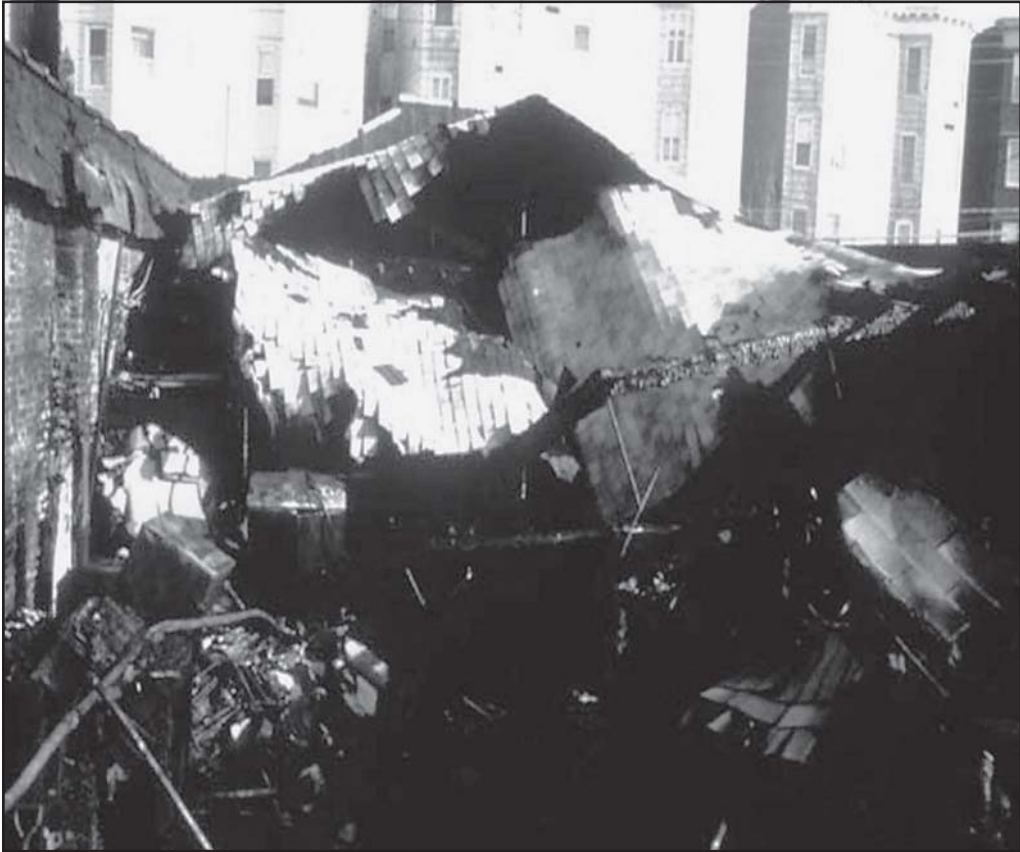
**Fig. 7-4.** Lieutenant Harry Korwatch of the Yonkers, NY, FD was killed when the roof deck collapsed.

The fire described at the beginning of this chapter was an actual incident which took the life of veteran fire officer Harry Korwatch of the Yonkers, New York, Fire Department. A preliminary investigation of the fire building revealed that the roof of the structure was a sloping gable roof supported by heavy timber trusses, spaced 15 feet on center. On each sloping side of the roof, there were timber purlins running the length of the 105-foot structure, perpendicular to the trusses. Outside of these few structural elements, the sole support of the firefighters on the roof was a 1-inch tongue-and-groove board. A purlin is a timber laid horizontally and perpendicular to support the common rafters of a roof (fig 7-4).

Approximately 80 percent of the roof area was unsupported, 1-inch thick wood decking. Unlike a rafter roof, whose structural roof supports are close together, large areas of this roof were thin tongue-and-groove roof board. (Yonkers firefighters who walked on it described it as “bouncy” or “springy.” The roof deck did not feel “spongy,” which would indicate char or fire weakening; a roof or floor which has structural supports spaced several feet apart creates a springboard effect.) Flames from the fire below charred and weakened the 1-inch roof deck. When the officer stepped on this

area, he plunged through the roof deck area between the widely spaced trusses and purlins. The firefighter trapped on the roof was rescued from the roof at the rear of the building.

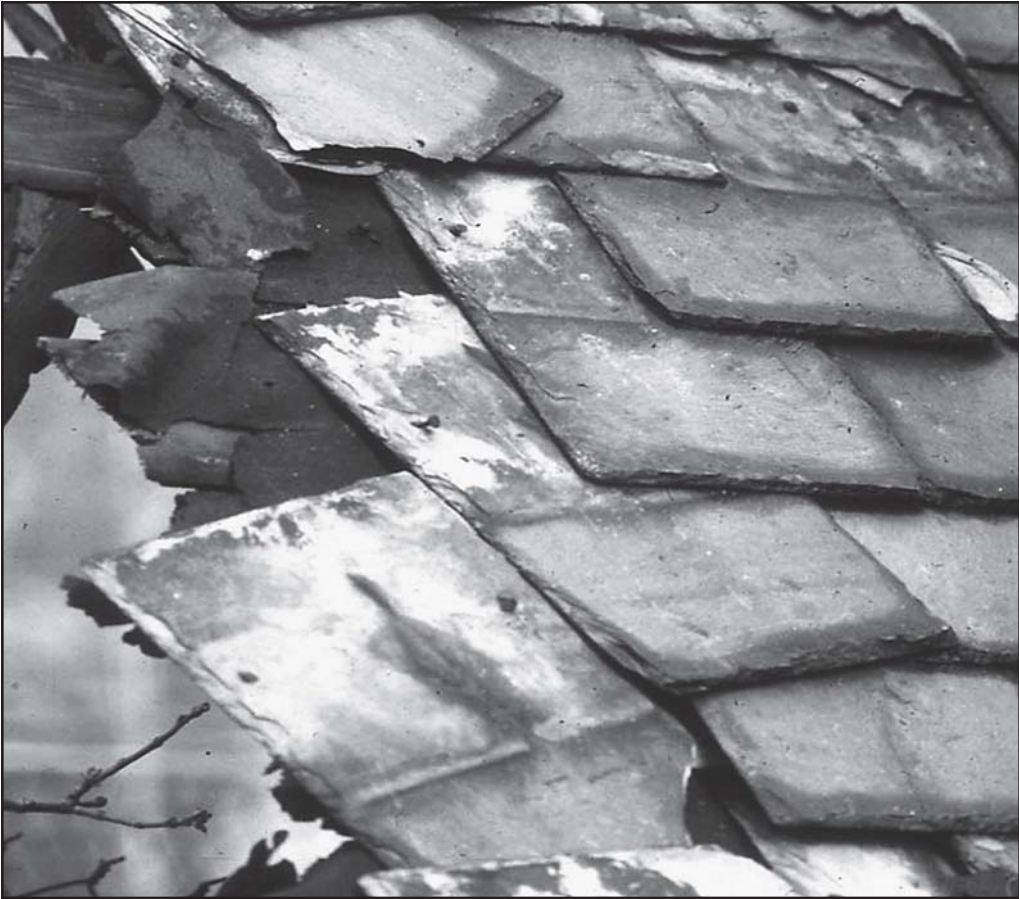
**Fig. 7–6.** Razor sharp slate shingles falling from a roof can seriously injure a firefighter.

Roof coverings can be divided into two categories: built-up roof coverings and prepared roof coverings. Built-up roof coverings consist of several layers of materials applied to a roof; for example, a tar and gravel roof. Prepared roof coverings have materials nailed to a roof deck, such as slate, tile, asbestos, wood, asphalt, and sheet metal. Slate and tile shingles present a collapse hazard to firefighters. Slate is a rock naturally found in smooth-surfaced layers; tile shingles are pieces of unglazed, fired clay, stone, or concrete (fig. 7–6). One slate or tile shingle can be 2 inches thick and weigh up to 10 pounds. Ten or twenty broken, razor-sharp shingles falling several stories from a roof can be extremely dangerous to firefighters working below.

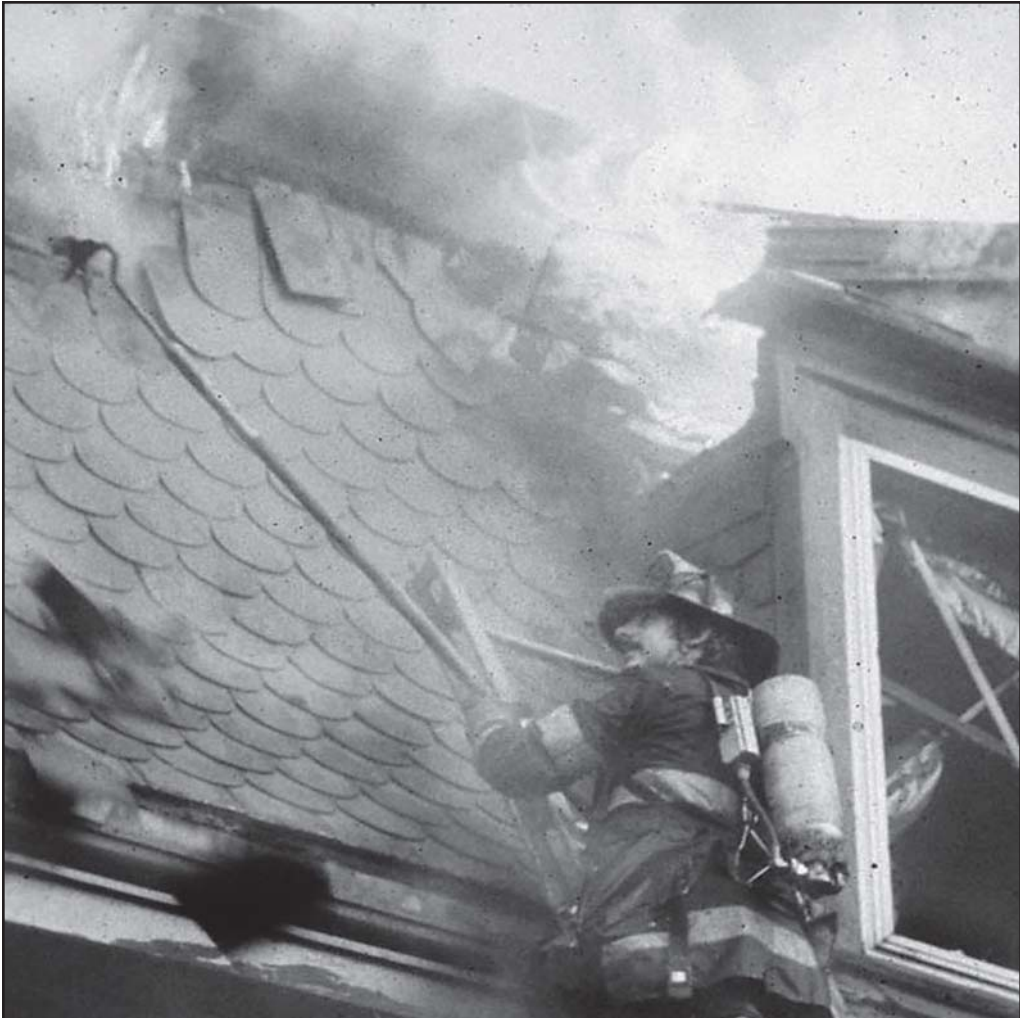
Fig. 7-7. Falling shingles and other debris can injure firefighters below.

Firefighters stretching hoselines, climbing ladders, or donning breathing equipment near fire buildings have been killed and seriously injured by falling objects. Window air conditioners, broken glass, building fragments, slate shingles, tools dropped accidentally, large pieces of smoldering furniture, and even people jumping from windows have fallen on firefighters below (fig. 7-7). Another danger of slate and tile roofs is that they conceal a fire-weakened roof structure. Slate and tile, considered fire-retardant roof coverings, will protect a wooden roof deck from sparks or airborne burning embers which land on a roof. This fire-retarding effect, however, also slows any fire and heat in an attic from traveling upward. The roof deck and roof rafters below a slate roof can be almost completely destroyed by fire, and yet the roof shingles can look stable and undamaged. There will be no scorch marks or blistering on the slate from the fire below. Firefighters have been killed by falling through collapsing slate and tile roofs which appeared sound from above, but which had the wood supports and rafters below charred and burned away. Slate and tile roofs have the same dangerous effect as a tile or terrazzo floor above a serious fire: they conceal the amount of heat, smoke, and flame below and then collapse in one large section without any warning signs.

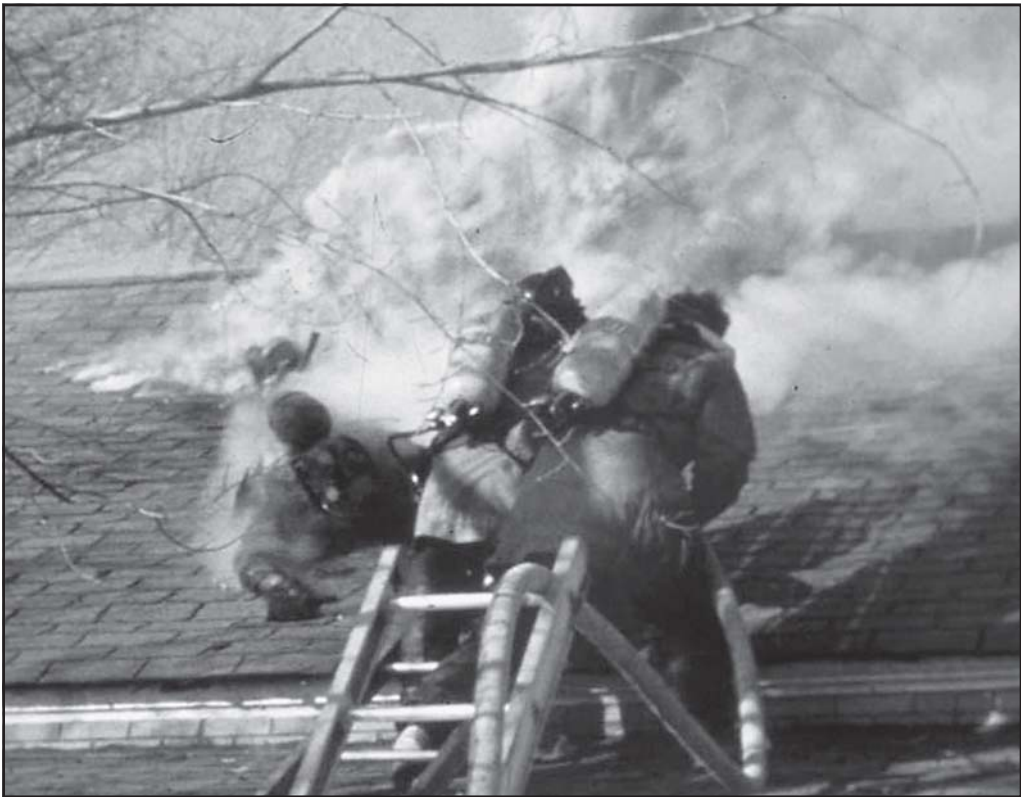
Fig. 7-9. Using a roof ladder can protect a firefighter from a roof deck collapse.

There are two ways firefighters can protect themselves when working on a peaked roof. They can use a roof ladder that is hooked on to the ridge rafter or they can operate from an aerial or tower ladder. A roof ladder will protect firefighters from a roof deck collapse and falling from the roof. However a roof ladder will not protect a firefighter from a roof rafter collapse. If the rafters collapse, the roof ladder will collapse into the burning attic with the firefighters (fig. 7-9). Only standing and operating from an aerial ladder or aerial platform can protect a firefighter from a rafter collapse. If the roof rafters collapse, the firefighter will be independently supported by the aerial or platform when the entire roof fails. If a fire department has a standard operating procedure that requires firefighters to operate and vent peaked roofs the department must have an aerial ladder to do this safely.

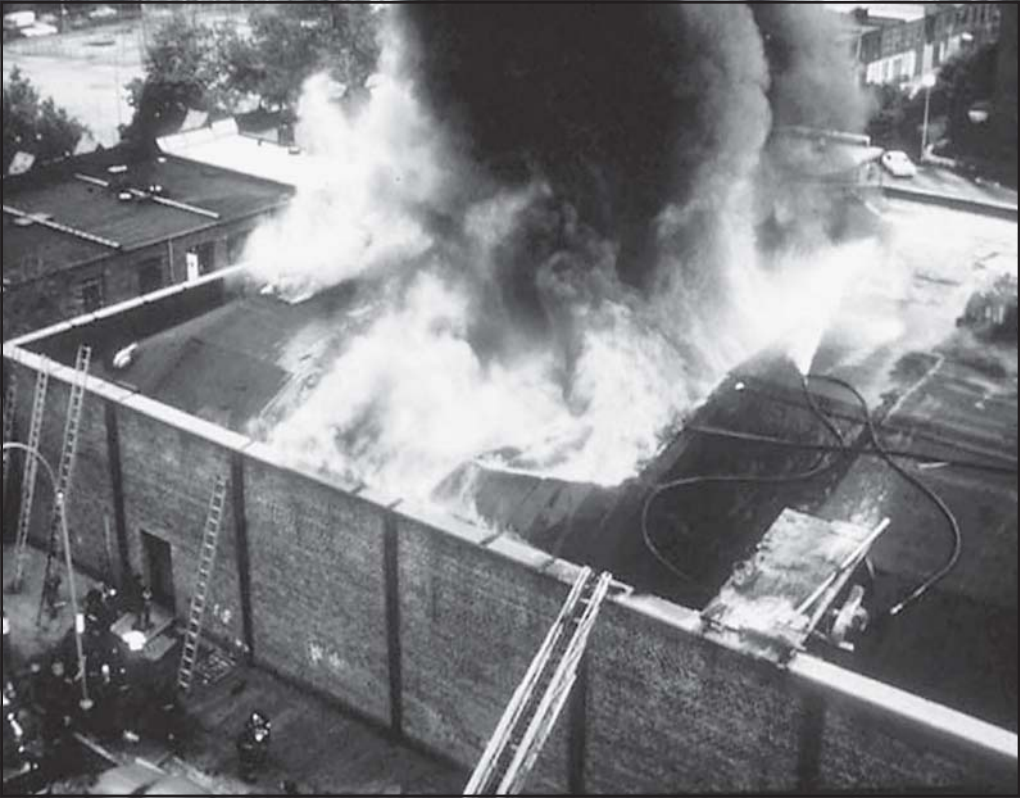
**Fig 8–1.** The truss roof collapse at the Waldbaum's supermarket in Brooklyn, NY, in 1978

The Brooklyn supermarket timber truss collapse occurred in a one-story ordinary constructed timber truss roof and brick walled building, 120×120 feet with a suspended ceiling 18 inches below an ornamental tin ceiling attached to the bottom chords of the truss. The fire, on arrival, was in a mezzanine—a small intermediate landing between the first floor and the roof. An interior firefighting strategy was launched and the visible fire in the mezzanine was quickly extinguished. However, unknown to the firefighters, concealed fire traveled up in to the truss roof space area and spread outward. Twelve firefighters fell into the burning crevice after the roof failed. Six fell into the store and survived and six other firefighters were killed in the explosive roof fire after the collapse. The truss roof collapsed 32 minutes after arrival of the firefighters.

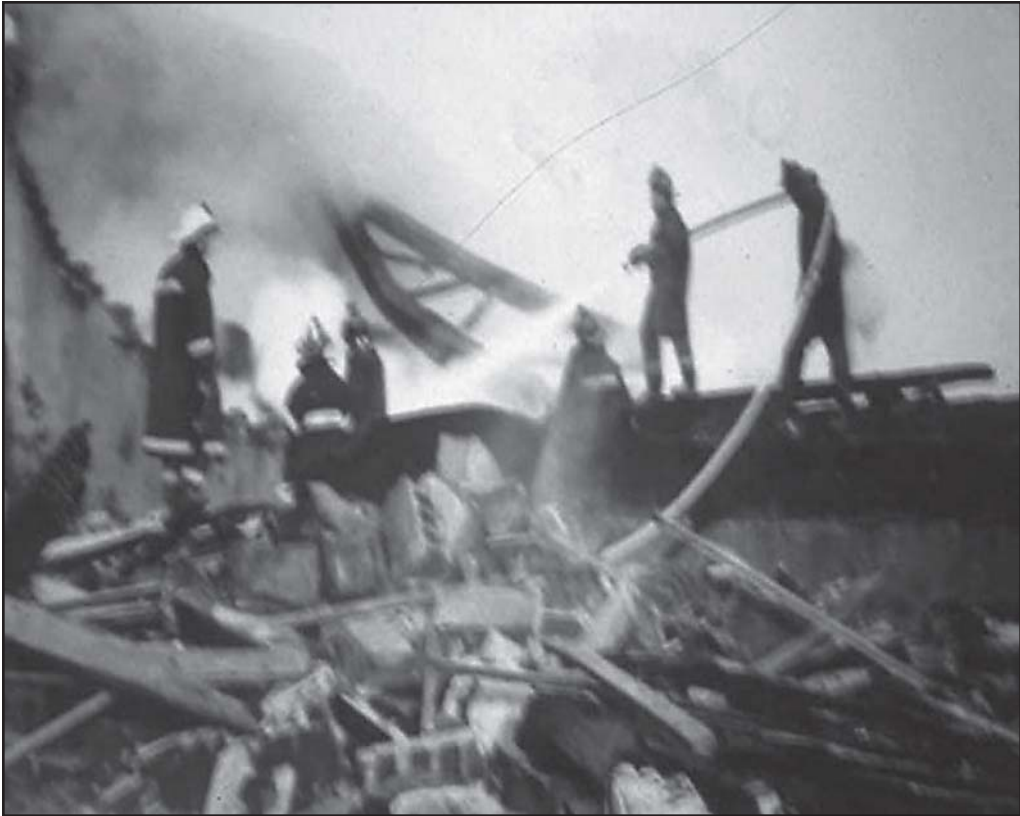
**Fig. 8–2.** This truss roof collapse in Cliffside Park, NJ, killed five firefighters from Ridgefield, NJ, who responded on mutual aid.

The Cliffside Park, New Jersey, Cardinal bowling alley building was one story, 106×120 Type III ordinary construction with a timber truss roof and cinder block wall. The fire on arrival involved a large area of the bowling alley. Soon after arrival there was an explosion and the interior attack strategy was changed to exterior operation and roof venting ordered. When the roof collapsed it pushed out an enclosing wall. The falling wall killed five firefighters from Ridgefield, New Jersey, operating a hoseline outside the building. There could have been more deaths. When the roof collapsed, one firefighter slid down the sloping roof and was hanging on a hoseline. Another firefighter lowered himself, while hanging on to a broken edge of the roof, and extended his leg to the trapped firefighter, who then scrambled up his leg and body to safety. The truss roof collapsed 30 minutes after arrival of the firefighters (fig. 8-2).

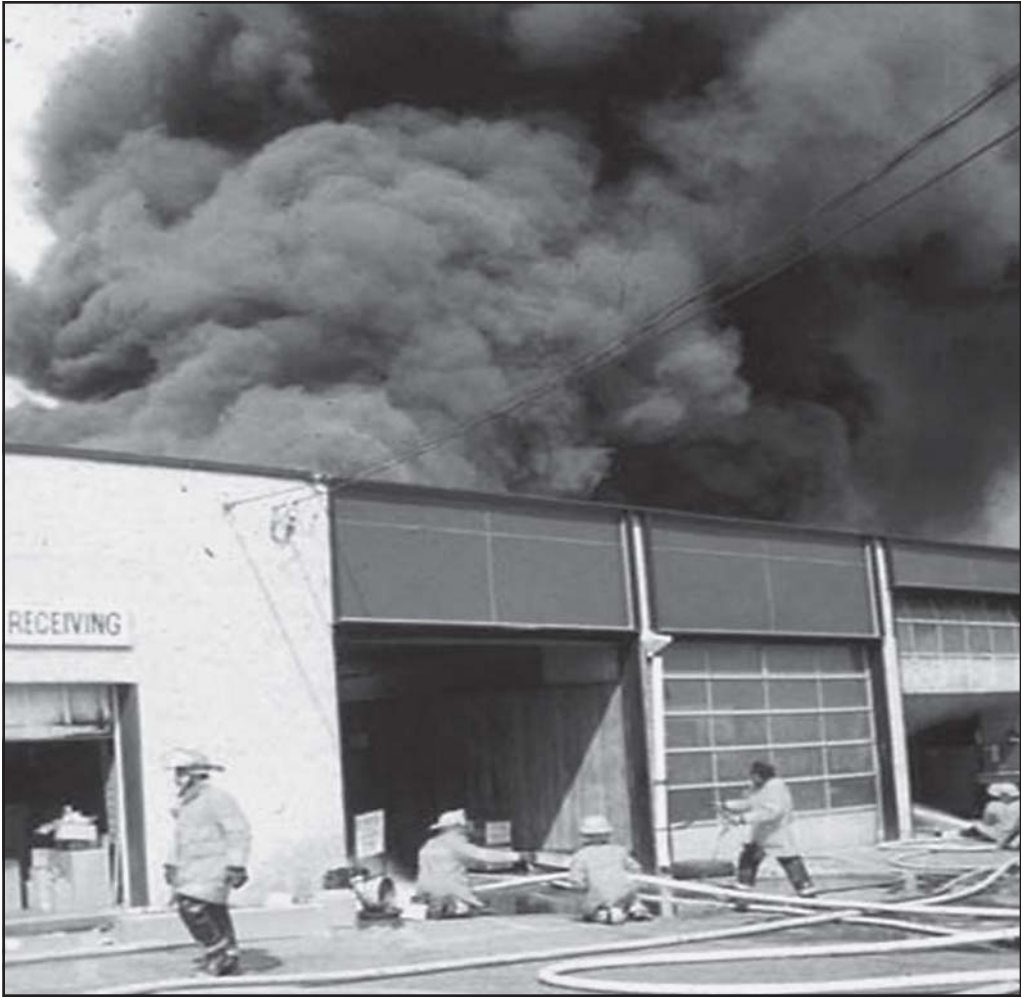
Fig. 8–3. Five firefighters from the Hackensack, NJ, FD were killed in this bowstring truss roof collapse.

The Hackensack, New Jersey, building was a one story brick and timber truss roof 224×175 foot auto dealership of Type III ordinary construction with a wire-and-lath and ½-inch cement ceiling. The fire, on arrival, was in the attic roof space created by the bowstring timber truss section. Firefighters were attempting to extinguish the fire from inside the building when one burning 80-foot timber truss crashed through the ceiling and trapped six firefighters in the building. One firefighter was able to escape, two other firefighters retreated to a dead end storage room, where they were asphyxiated, and three firefighters were pinned beneath the falling roof and ceiling. The truss roof collapsed 36 minutes after arrival of the firefighters (fig. 8-3).

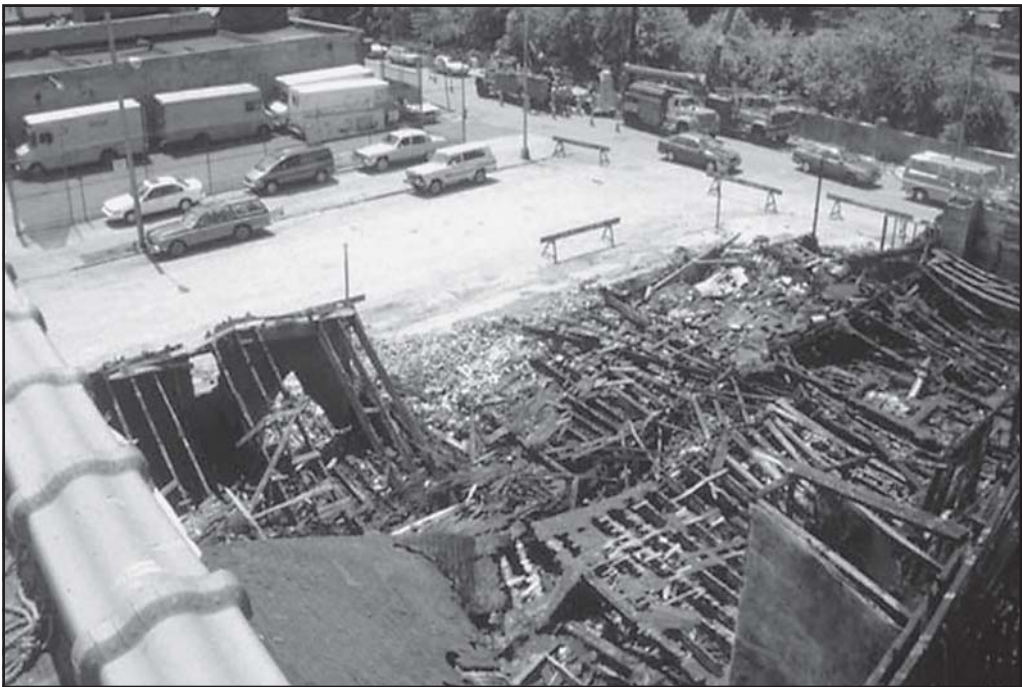
Fig. 8–6. A timber truss roof that caused the collapse of a front wall

Truss construction is the most dangerous roof system that a firefighter will encounter. It is known to collapse during the early stages of a fire, and it will often cause the subsequent collapse of the front or rear masonry enclosure wall of the structure (fig. 8–6).

In the Bronx, New York City, two bowstring truss roofs collapsed. At each fire, when the truss roof fell, it caused the collapse of the front masonry wall. A close examination of both collapsed structures revealed that the front wall, which had failed, had received in recessed pockets, the ends of roof joists, which sloped down from the top chord of the front truss. These joist ends did not have self-releasing fire cuts. As the ends of the roof joists resting on the upper chord of the front truss went down with the collapsing roof, the ends of the joists rigidly held in the front wall were forced up and outward. These joists acted as levers, toppling the upper portion of the front wall out into the street. A bowstring truss roof has four bearing walls. The ends of the truss sections are supported by the side walls. The front and rear walls support the sloping hip rafter or roof joists extending from the front and rear truss sections.

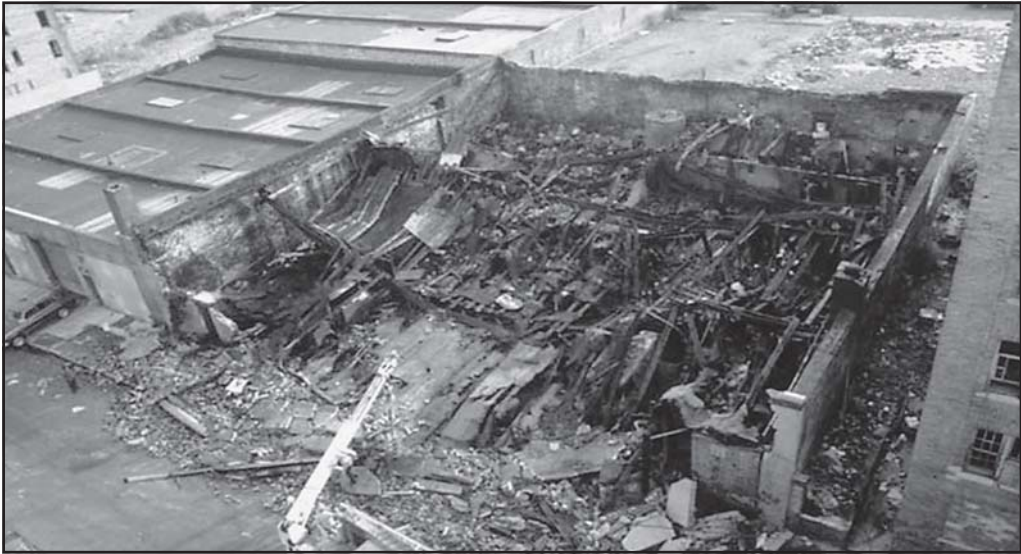
**Fig. 8-7.** The roof size-up is more accurate than the size-up report given by interior operating forces. When a chief officer receives conflicting reports the chief should rely on the roof report over the interior report.

Chief officers who have directed fire operations in buildings with bowstring timber truss roofs tell of receiving conflicting reports from those firefighters operating above and below a fire. The firefighters on the roof state that the fire is severe and beyond control of the hose team operating below. The firefighters within the building state that the fire is small and that quick extinguishment will be forthcoming. The chiefs who have operated at such fires successfully are guided by the report from above, and they withdraw the men working above and below the fire (fig. 8-7).

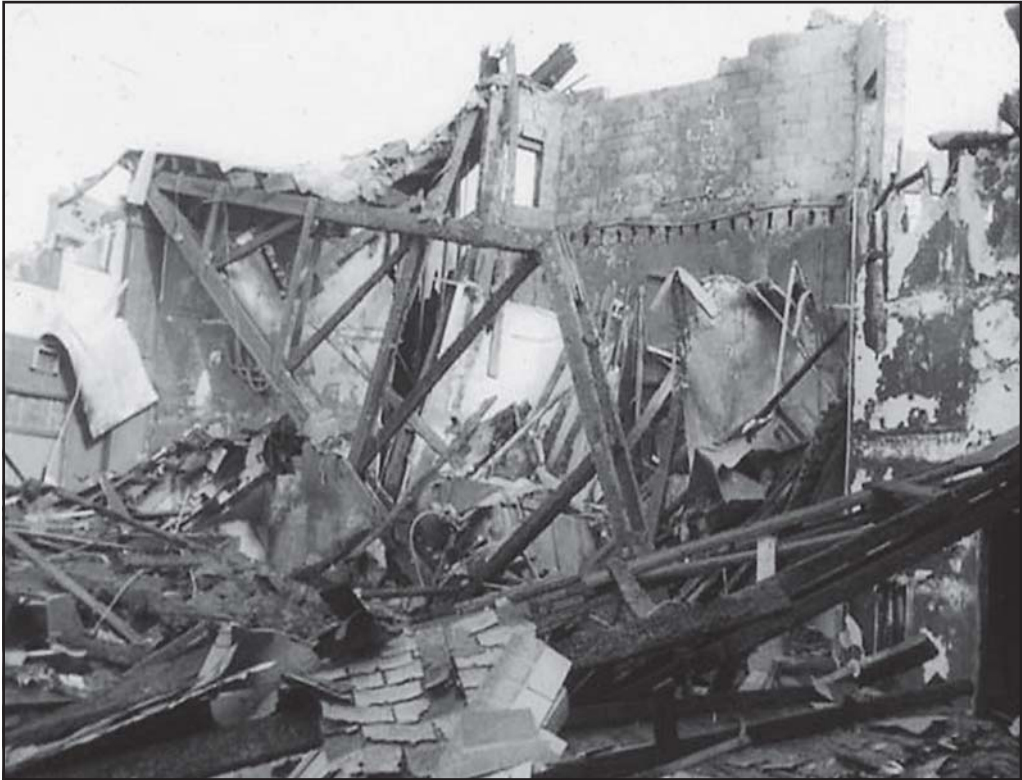
**Fig. 8-10.** Two Valley Stream, NY, firefighters were killed when this inclined plane timber truss roof collapsed.

In 1979, two Valley Stream, New York, firefighters John Tate and Michael Moran, were killed in a synagogue fire. After knocking down a fire in a small room next to the main altar, heat and flame were quickly reduced and firefighters assumed the blaze was extinguished. But unnoticed in the smoke, flame had spread up to the attic space through a small spiral staircase leading to the attic. In the attic, concealed by a recently installed ceiling, truss roof supports were burning. As firefighters were leaving to refill air masks, the ceiling and timber truss roof collapsed. The collapse and ensuing fire trapped several firefighters, killing two (fig. 8-10).

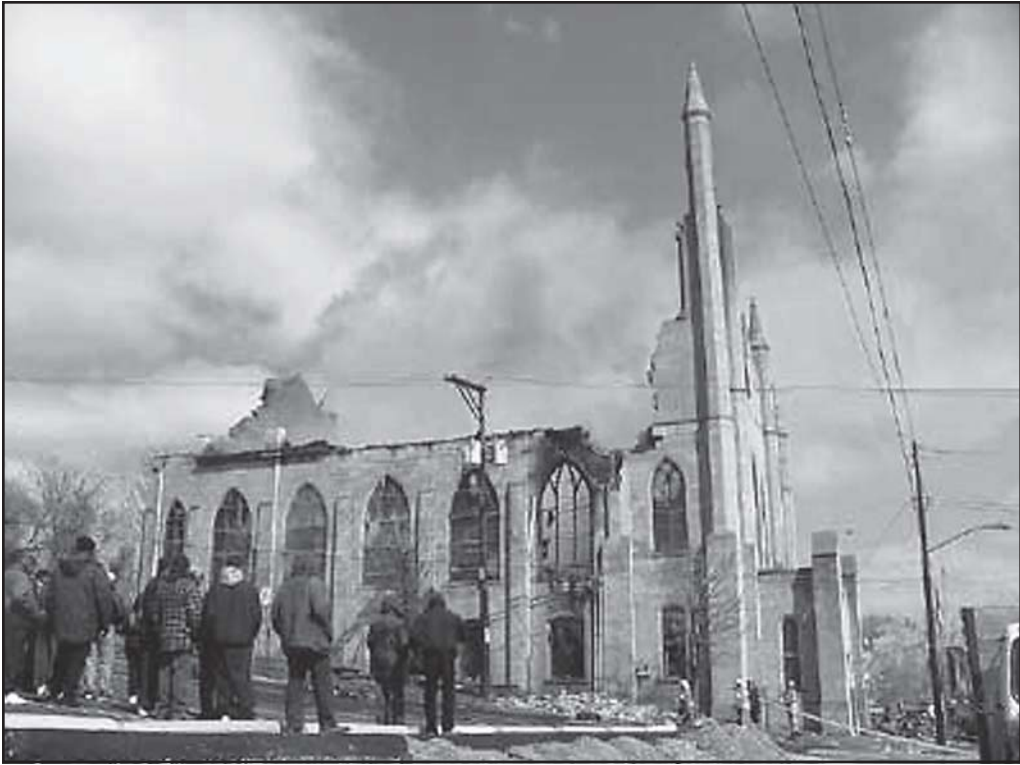
Fig. 8–12. The scene after the steeple and roof collapsed in Pittsburgh, PA

be fooled by this imitation stone veneer surface. As one firefighter, who survived the Ebenezer Baptist church collapse in Pittsburgh that killed two firefighters said, “Beware of the house of worship stone veneer. This veneer makes the structure appear to be constructed of something other than it is. The church had a false appearance of solid 1×3-foot limestone blocks. This was only a façade and gave a false sense of security to the structure. We were under the impression the building was a lot stronger than it was; and there was not way it could collapse.” Behind a stone veneer could be lath and plaster concealing a hidden space (fig. 8-11 and fig. 8-12).

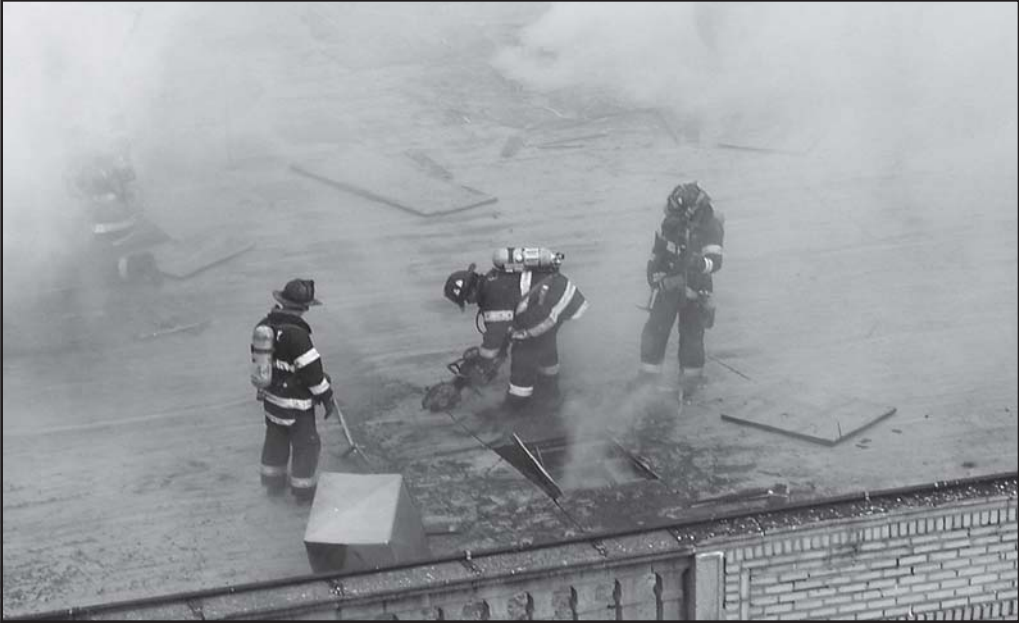
Fig. 9–2. A firefighter must know a building’s roof system to operate safely.

This is easier said than done. Size-up of a fire below is difficult because a watertight, wooden roof deck, covered with many layers of paper and tar, acts as insulation, concealing the heat of the fire and roof instability (fig. 9–2). Some textbooks tell firefighters to use their senses of sight, hearing, and touch to determine roof stability and that they should always look for signs of structural failure, or listen for noises which precede collapse. However, firefighters' senses are considerably reduced at the scene of a fire. Smoke or darkness often limits vision; the screeching of power saws and the rumble of hose streams below can drown out most sounds; and moving firefighters can keep a roof bouncing. Firefighters need more than their senses to evaluate a roof's stability. They must know roof construction.

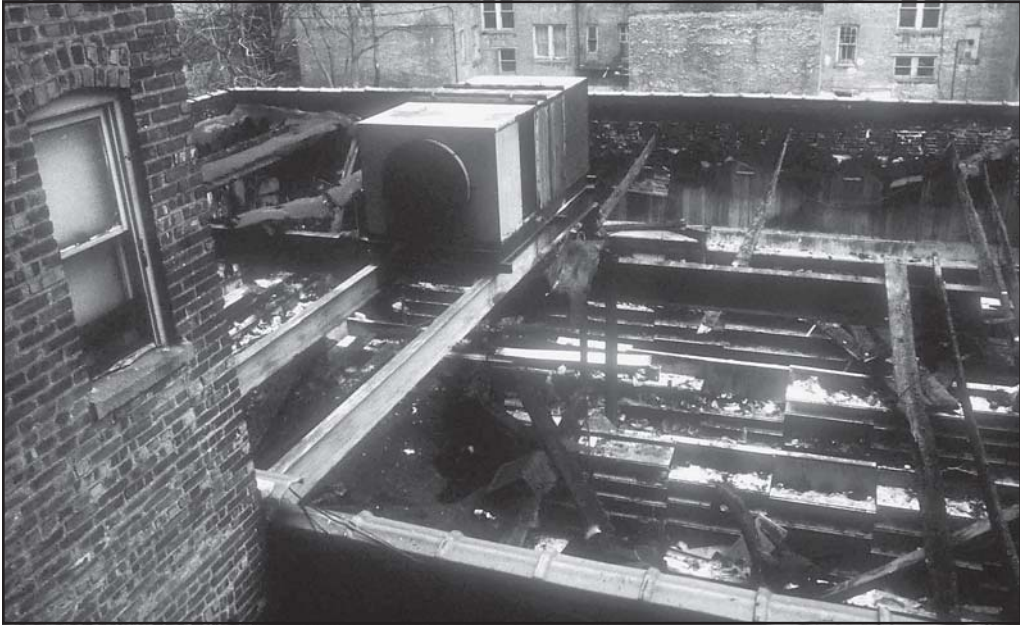
**Fig. 9-9.** The roof edge around a vent cut may suddenly collapse causing firefighters to lose their balance and fall with a power saw.

An inverted roof can present other dangers to firefighters. While a member is attempting to cut a roof vent opening, the smaller framework supporting the inverted, or raised, roof deck could burn away and collapse. The roof deck edge, dropping suddenly into the opening, could cause a firefighter who is operating the saw to lose balance. Additionally, the inverted roof’s 2×4-inch framework is spaced farther apart than the roof beams, so there is less of a chance that a member will be stepping on a

roof joist. Both feet could plunge through a fire weakened roof deck and a firefighter's body could become wedged in the roof deck and suffer serious burns before he could extricate himself (fig. 9-9).

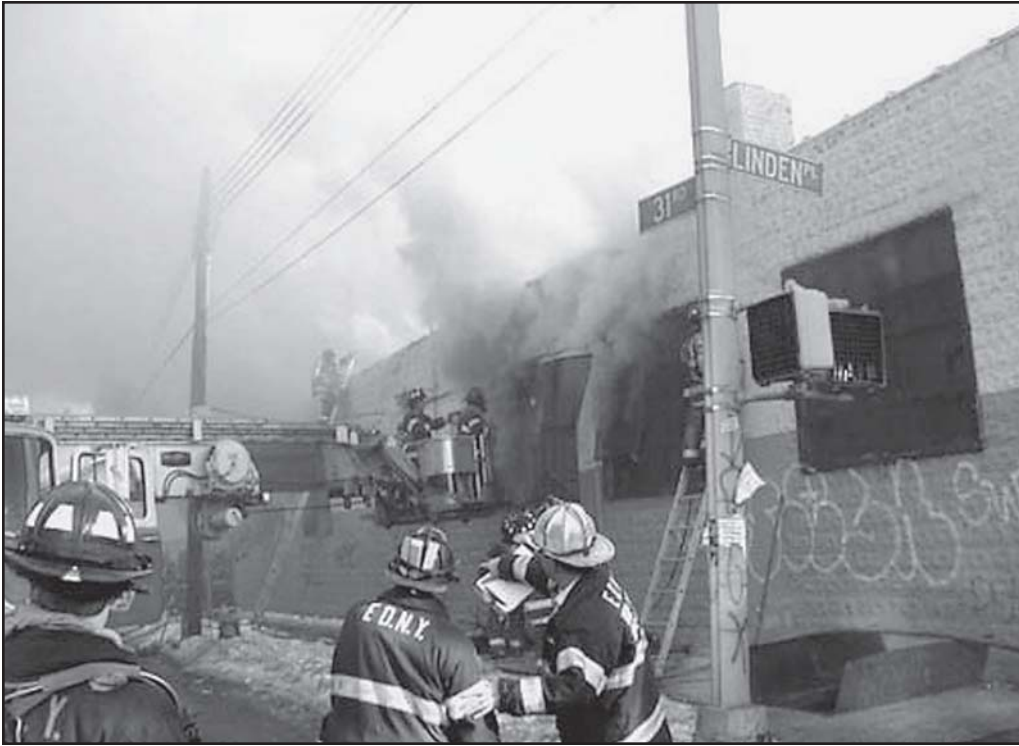
**Fig. 10–1.** A lightweight Type II constructed building with an open-web bar joist roof presents a collapse danger to firefighters. As a precaution, the use of horizontal ventilation is recommended.

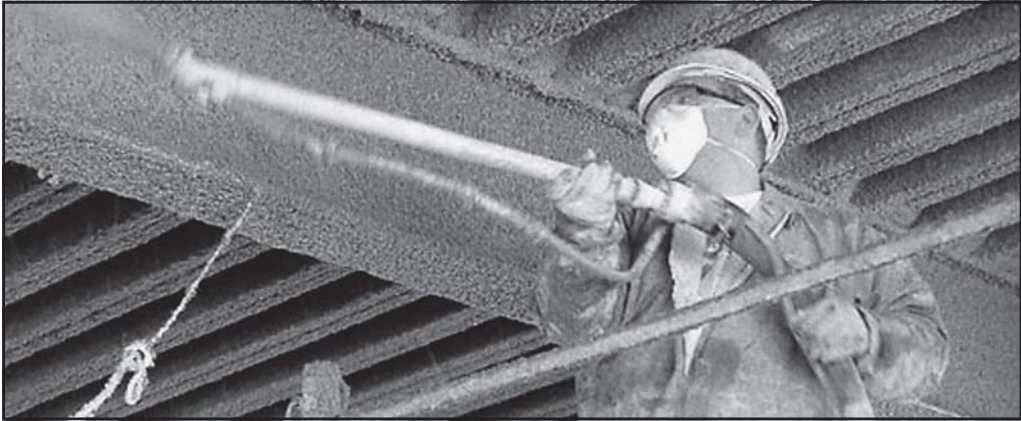
Fig. 10–3. Spray-on fire retarding material to protect steel

The third, and least effective, method of protecting steel from heat of a fire is the spray on application of a fire-retarding material over the steel surface (fig. 10-3). This spray on fire-retarding material (SFRM) is applied over the entire surface of a steel column, girder, and beam. The fire retarding is also sprayed over the entire underside of steel-fluted floor deck and is supposed to insulate and protect the steel from the heat of a fire. Depending on the thickness of the sprayed material, the steel may receive a one-, two-, or three-hour fire-resistive rating. It rarely protects steel for the designated time at a serious fire. Post-fire investigations have shown this spray-on material to be dissipated by the fire and the steel to be distorted by heat. Despite these findings, this fire-retarding method for steel continues to be the preferred method to protect steel in new buildings because of its cost effectiveness when compared to the other methods. This so-called “direct application” of fire protecting structural steel is less expensive and a faster method than encasement or use of a membrane ceiling. In the past, an asbestos base liquid was sprayed on steel for fire protection, but today it is outlawed. The material sprayed on steel today for fire protection is a slurry of vermiculite, volcanic rock, or mineral fiber mixed.

The fire service has known this method of spray-on fire protection was ineffective since its introduction in the 1970s. For example, after every serious fire in New York City fire-resistive, high-rise office buildings, the spray-on material was missing in the fire area and the steel floors and ceilings protected by this spray-on fire retardant were seriously buckled, warped, and sagging. The concrete floors in the fire area were cracked, sagging, and heaved upward. The floor above the fire had become too dangerous for firefighters because of this distortion. In Type I resistive and Type II noncombustible construction, steel-fluted floor systems protected by spray on fire retarding material often supports 2 or 3 inches of concrete flooring above. The spray-on fire retardant fails and steel floor beams and girders are visually sagging and warped. When spray-on fire retarding material (SFRM) fails to protect steel from the heat of a fire it is because

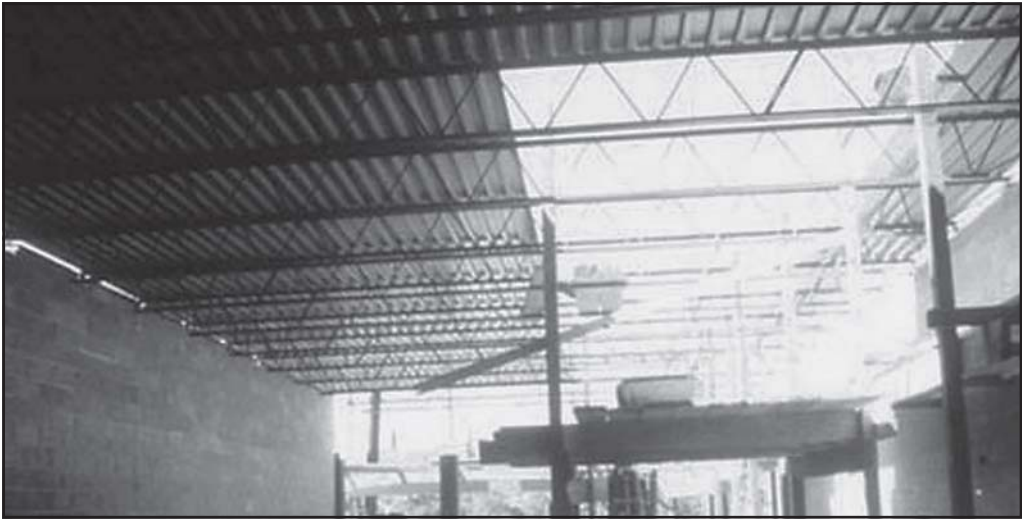
**Fig. 10–4.** Lightweight steel bar joist roof construction

Many renovated buildings replace wood and masonry structural elements with steel. The replacement of heavy wooden roof and floor joists with the lighter steel open-web bar truss joists is a common renovation change (fig. 10–4). A lightweight steel open-web bar truss joist supported the floors of the World Trade Center and the roof of the Charleston, South Carolina, Sofa Super Store. The open-web bar joist is a long steel bar (web) bent at 90-degree angles and welded to angle irons (chords) at the top and bottom of the bar bends. This type of construction is used in new commercial buildings classified as Type II noncombustible construction. However, it is also used to replace old wooden joists in renovated ordinary type, brick-and-joist, buildings. Buildings of noncombustible construction have masonry or steel nonbearing enclosure walls and steel column-and-girder framework and use lightweight steel open-web bar joists as roof and floor supports. Noncombustible construction, using steel in place of wood for interior structural framework, is well suited for large-area, commercial buildings with low hazard content.

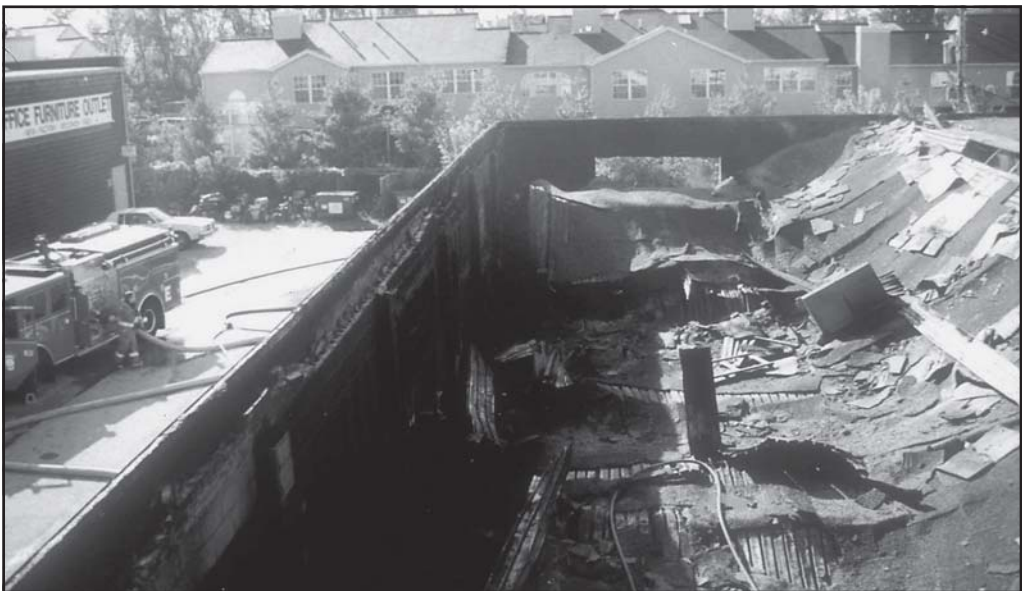
**Fig. 10–5.** Unprotected lightweight open-web steel bar joist can collapse within 5 to 10 minutes of exposure to fire.

The lightweight steel bar joist must be viewed by firefighters as extremely hazardous in roof and floor construction for two reasons: the failure characteristics of unprotected steel and the joist spacing (fig. 10–5). The fire service has known for decades, when unprotected, the steel bar joist may collapse after five or ten minutes of fire exposure. Advancing a hoseline inside, or operating on a roof of a burning

building, built with steel bar joist trusses is a high risk because of early collapse. If the average response time of an urban fire company is five minutes; a suburban or rural fire company is somewhat longer. If a serious fire occurs in an unoccupied building with a roof supported by unprotected lightweight steel bar joists or today's new steel C-beam is so severe that the stability of the roof is in question, then it must be considered too dangerous to send firefighters on the roof for ventilation and for interior attack with a hoseline. In an unprotected Type II steel building, fireground commanders should consider a strategy of horizontal ventilation and defensive exterior attack.

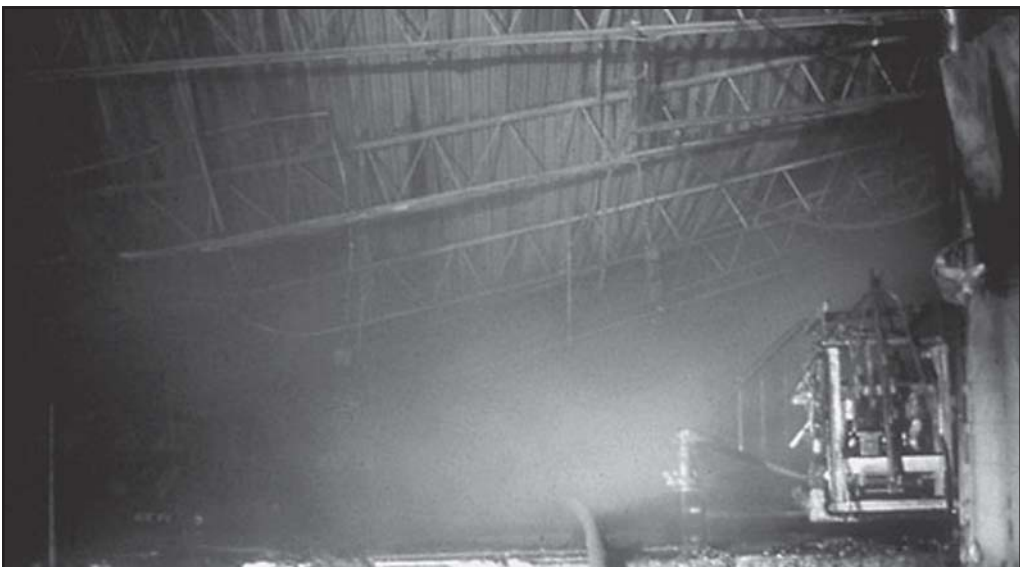
**Fig. 10-6.** This roof supported by lightweight steel bar joist collapsed during the early stages of the fire.

This is not the case in the 21st century. Roof construction that varies from this solid wood joist design is more dangerous. When a different roof construction, such as lightweight steel bar joists, or C-beam is introduced into a community in which standard wood construction has predominated, the different collapse characteristics present a new safety hazard to firefighters. The steel bar joist and C-beam will collapse more quickly. An experienced firefighter who has advanced hoselines into burning ordinary constructed buildings or who cut vent openings in a roof of solid wood joists cannot transfer his or her sense of safe operating time to a building with a lightweight steel roof. Firefighters have developed a sense of how long they can work, inside a burning building or operate on a roof over a fire, based on the type of roof construction used in ordinary construction. This experience can not be applied in Type II noncombustible construction with steel trusses. Over the years fire officers develop an ability to size up a fire. This size-up is correct 99 percent of the time; however, the 1 percent of the time when this size-up is incorrect, a roof or floor collapses, killing or seriously injuring a firefighter. Today this incorrect size-up is occurring more often because of a change in noncombustible Type II construction throughout America. Unprotected lightweight construction using steel bar trusses or steel C-beams, which fail during the early stages of a fire are often the cause of the size-up misjudgment (fig. 10-6).
