# **COLLAPSE OF BURNING BUILDINGS**

**A GUIDE TO FIREGROUND SAFETY** SECOND  
EDITION

**Vincent Dunn**

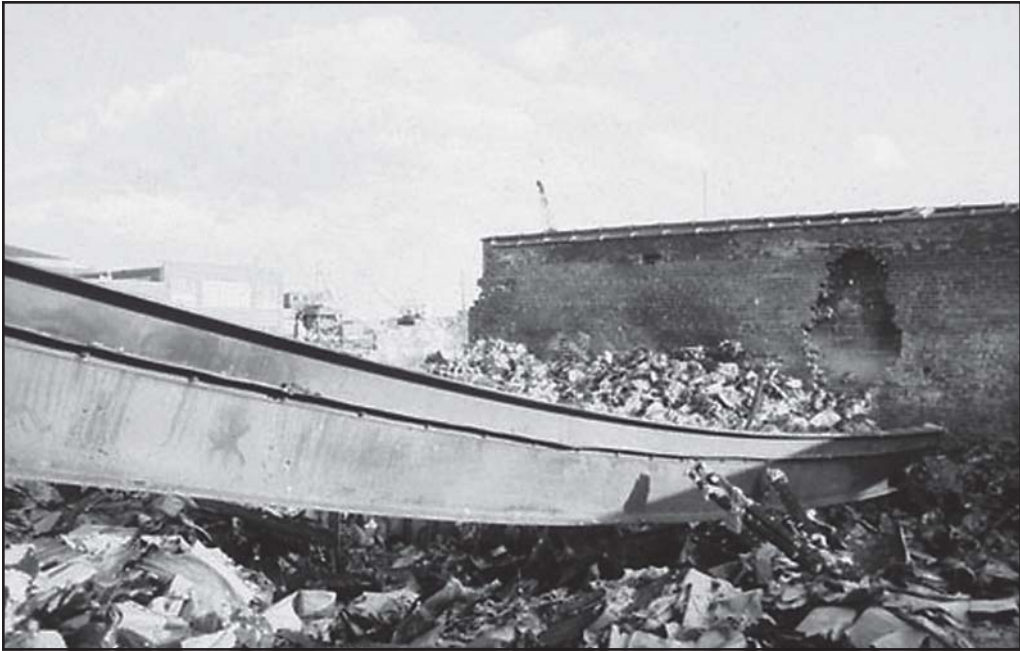
**Fig. 10–7.** This large steel girder buckled and pulled away from the wall and collapsed during a large area fire in a stationary store.

The size of the fire is the final factor that can affect steel failure. If a small-area fire comes in contact with a portion of a large steel beam, the steel will absorb heat and transfer it away from the flaming area to cooler parts of the structural element. A fire could burn for some period of time before it heats the entire steel beam to its failure temperature. On the other hand, a large-area fire in which flames involve much of the steel beam in a short period of time will heat the steel beam to its critical temperature more quickly (fig. 10-7). A so-called "flash fire," suddenly involving a large area with flame, can heat steel rapidly to its failure temperature. Type II noncombustible unprotected steel buildings are designed for low hazard occupancies like schools, offices, and retail shops. This unprotected steel construction should not house high hazard occupancies like wood-working shops, furniture storage, flammable liquids, and furniture refinishing plants unless deluge-type sprinklers and smoke detectors are installed.

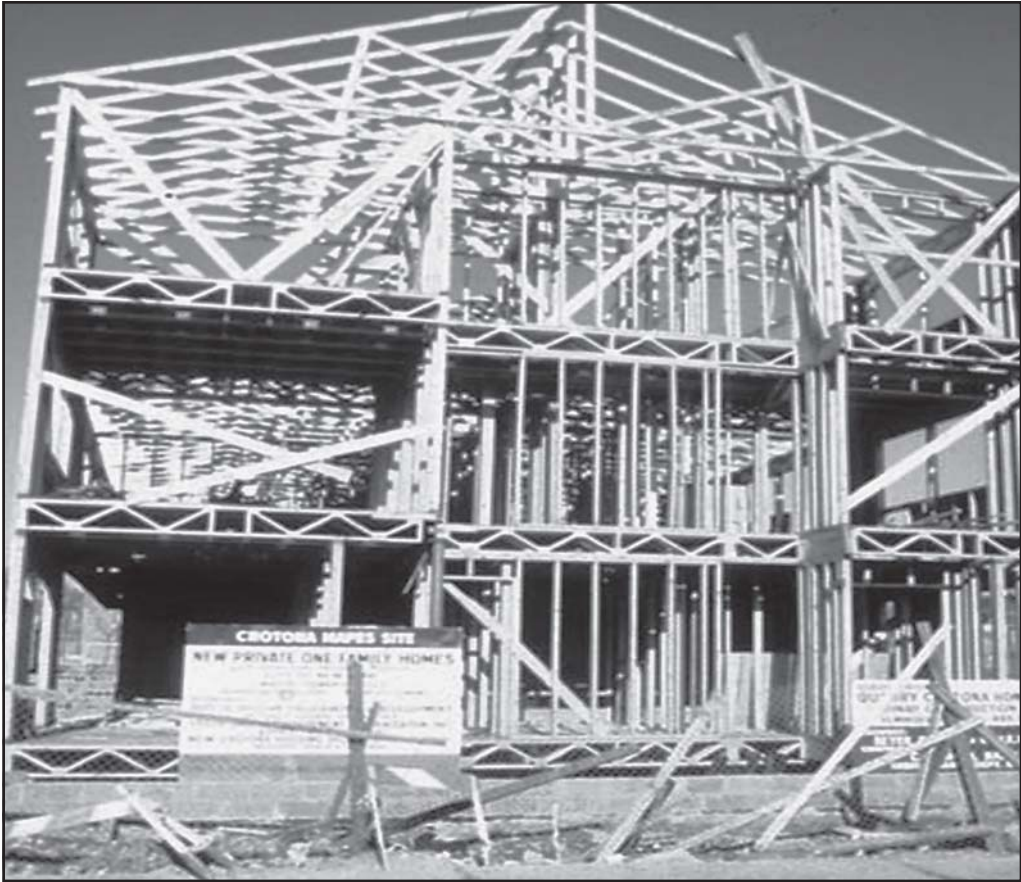
**Fig. 11–1.** There is nothing larger than 2×4-inch lumber in this lightweight truss roof and floor constructed building.

There are two types of wood truss systems used in building construction: heavy timber truss systems and lightweight wood truss systems. Most building codes define heavy timber roof construction as that in which the wood dimension is at least 4 inches wide and 6 inches deep. Connections and fastenings used to connect web members and chords of heavy timber trusses are made of steel bolts and plates. The lightweight wood truss, on the other hand, incorporates wooden members which can be as small as 2 inches wide and 4 inches deep—and these wood pieces are connected by sheet metal surface fasteners called *gusset plates* or gang nails. This connector, which is critical to the integrity of the lightweight truss during a fire, is a piece of sheet metal with many V-shaped points punched through it. These V-shaped nailing points fasten only the surface of the 2×4-inch wood truss. Three wood truss members are sometimes held together by sheet metal points that penetrate the wood surface to a depth of only ¼ inch to ½ inch. This type of lightweight truss system is being used at an increasing rate in the construction of homes and apartment houses throughout this nation (fig. 11-1). By engineering calculations and practical firefighting experience, lightweight trussed rafters may be expected to collapse after about ten minutes in a fully developed fire. The fire services of this nation are alarmed and disturbed by this new lightweight structural element.

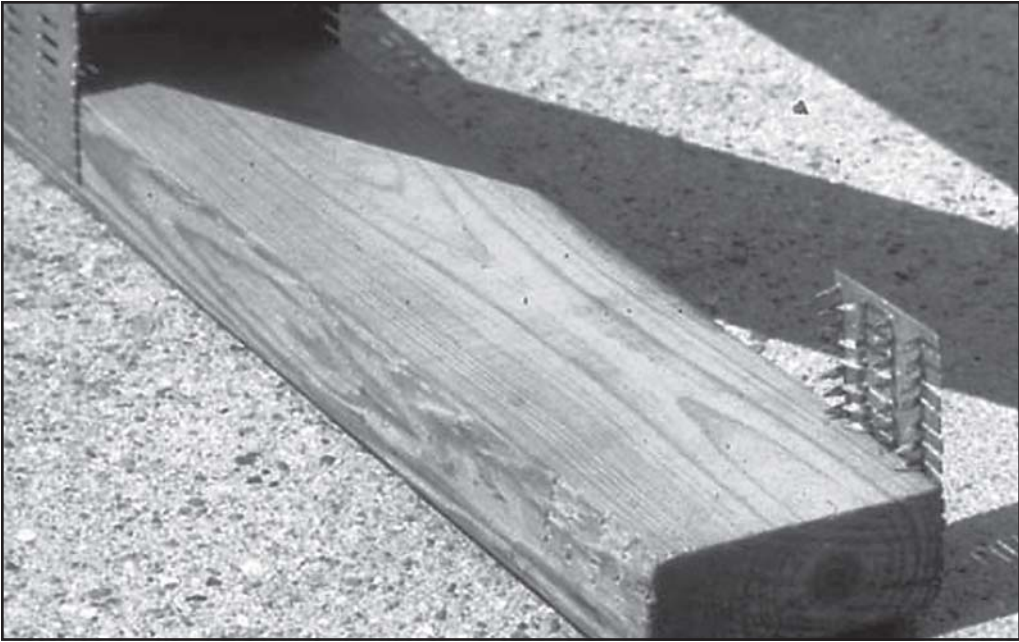
**Fig. 11–2.** The fire service should seek to outlaw the sheet metal surface fastener.

The main concern of the fire service is the sheet metal surface fastener used to connect the truss members together. The surface fastener, which only connects the outer ½ inch of wood truss members, is a deficient structural connection from a fire protection point of view. The design of the truss can be defended from an engineering viewpoint, but no architect, engineer, building construction contractor, or code official can defend the sheet metal surface fastener. This device is a dangerous structural connection (fig. 11–2).

In any structural element, the critical area subject to failure during fire is the point of connection. At a fire, the points of connection are the first to fail. The most serious defect in the surface fastener connecting lightweight wood trusses is the insufficient depth of penetration of the nailing points. As the name indicates, the metal surface fastener only fastens the outer  $\frac{1}{2}$ -inch surface of the truss. The V-shaped nailing points enter the wood to a depth of only  $\frac{1}{2}$  inch. During a fire, when the outer layers of wood char, the surface fastener loosens more quickly than would a nail or steel bolt, which penetrates the entire thicknesses of truss members. In addition, even if the fire is not of sufficient intensity to char the wood, heat from the flames can warp the thin sheet metal surface fastener and cause it to curl up and pull away from the wood truss.

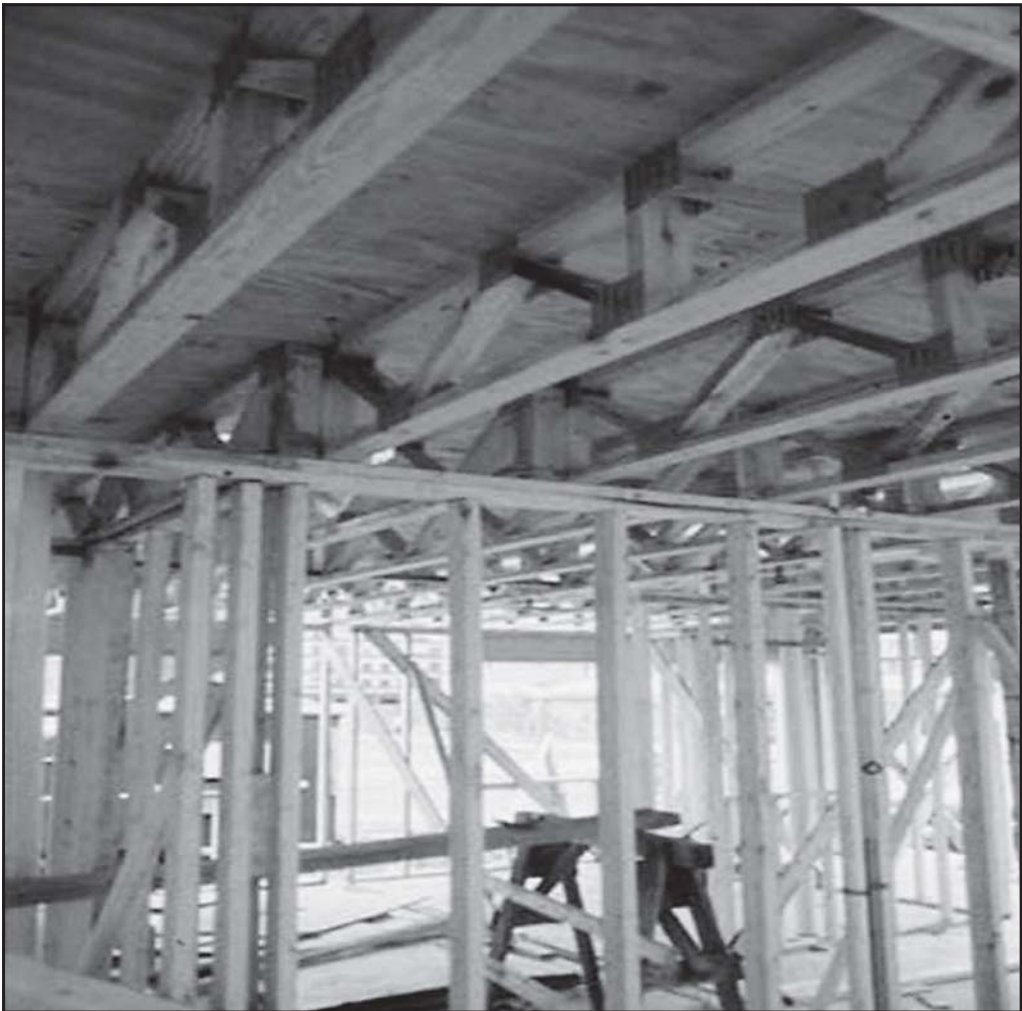
**Fig. 11-3.** When fire enters the concealed spaces there is a 100% faster fire spread. Flames spread through web members.

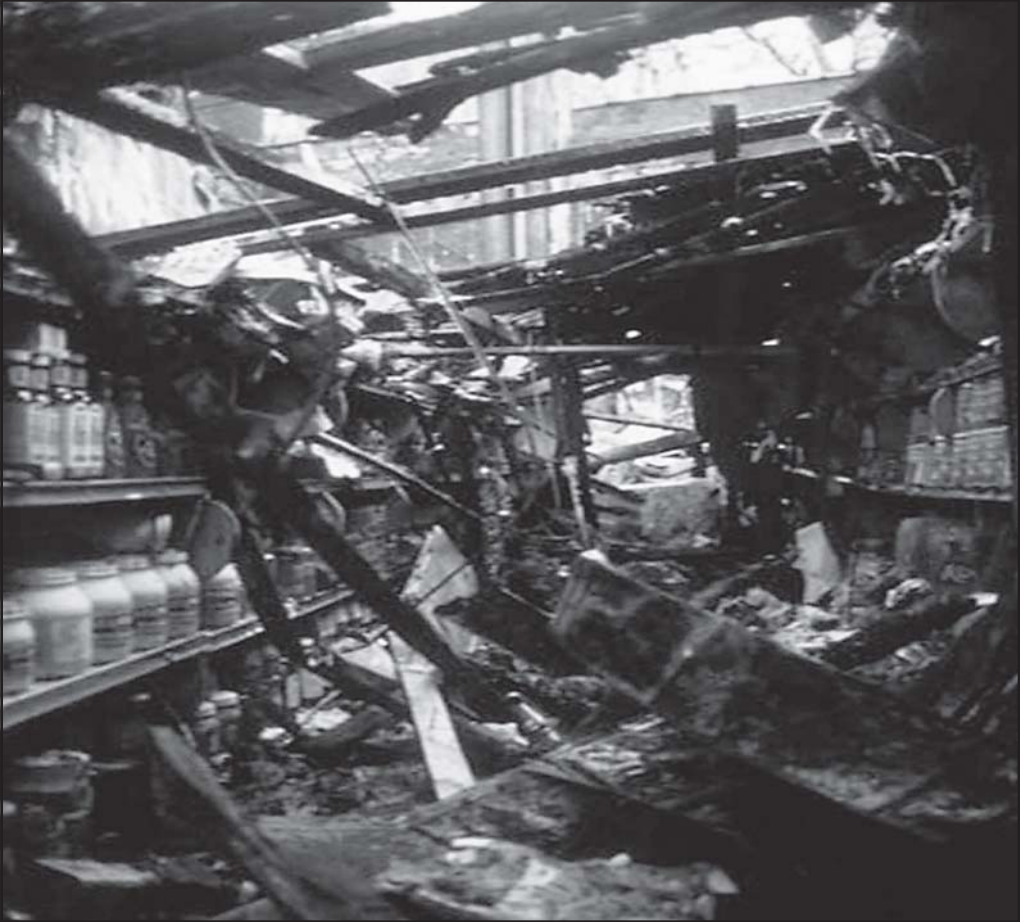
**Fig. 12–1.** Voids allowing firefighters to escape are created near centers and shelves when a ceiling collapses.

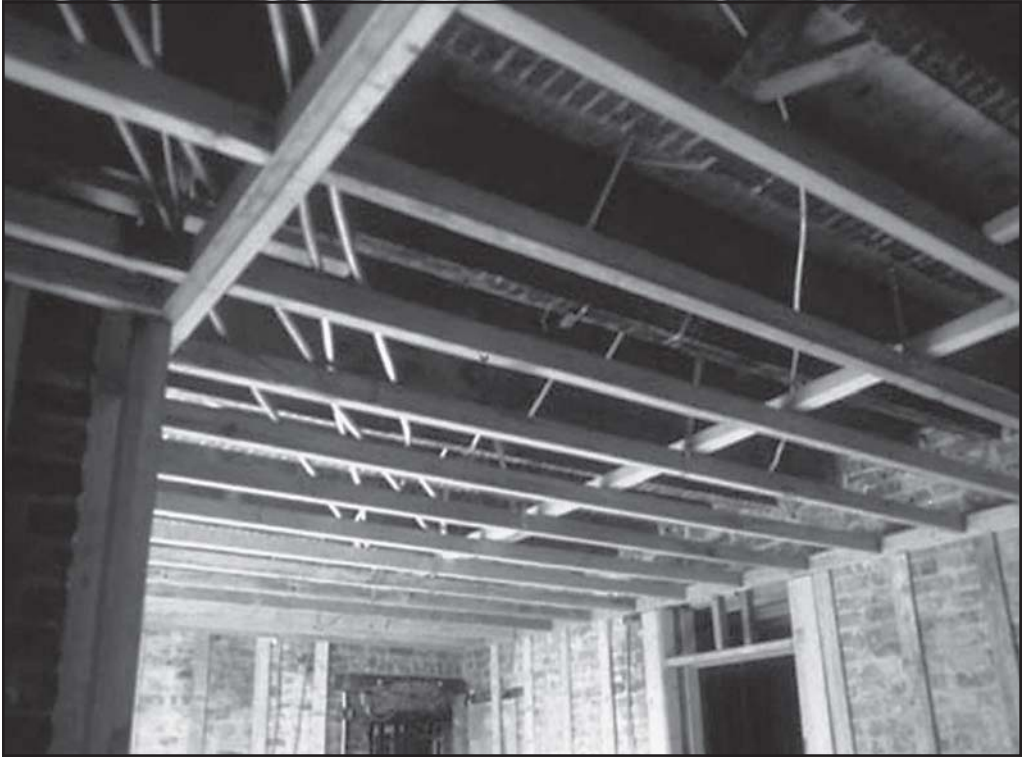
Fig. 12–3. Suspended ceiling are found in renovated buildings on all floors.

The most dangerous ceiling is a suspended ceiling. Suspended ceilings are most often found in three types of occupancies: stores, top floors of multiple dwellings, and renovated buildings. These suspended ceilings sometimes called “dropped ceilings” or “hanging ceilings” are constructed several inches or several feet below the supporting roof or floor joists above, the ceiling hangs below the joist, connected by vertical hangers that may be strips of wood, steel, or thin wire. The reason for a suspended ceilings in stores is to cover the prior out-of-fashion old ceiling above (fig. 12–3). Instead of removing the old ceiling, a new ceiling is installed to cover the old one.

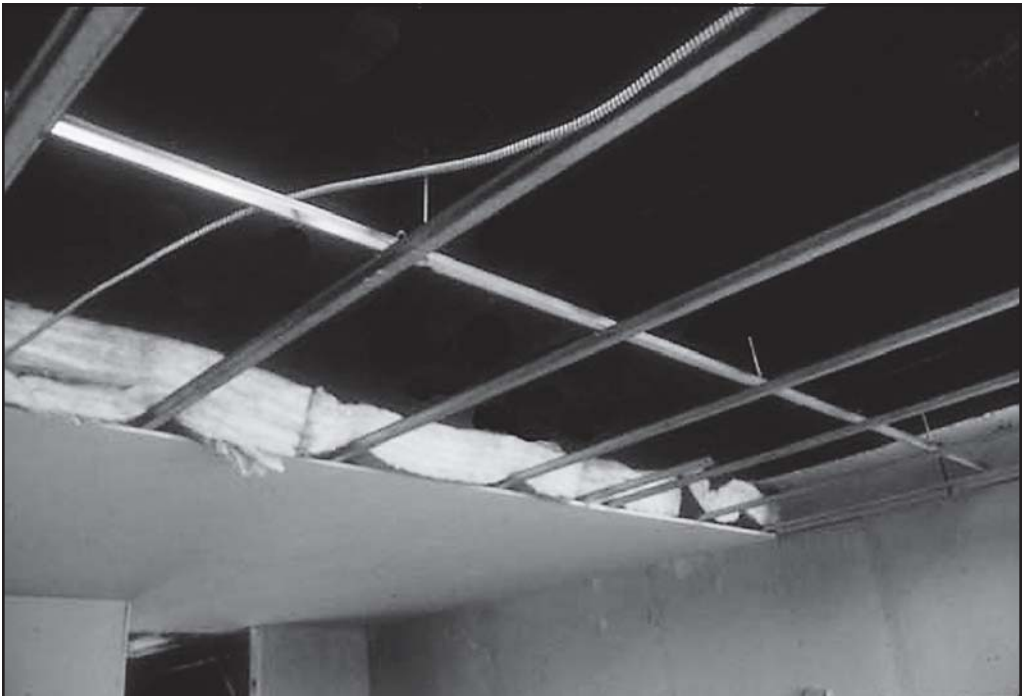
Fig. 12–4. The grid work and framing can trap a firefighter if the ceiling collapses.

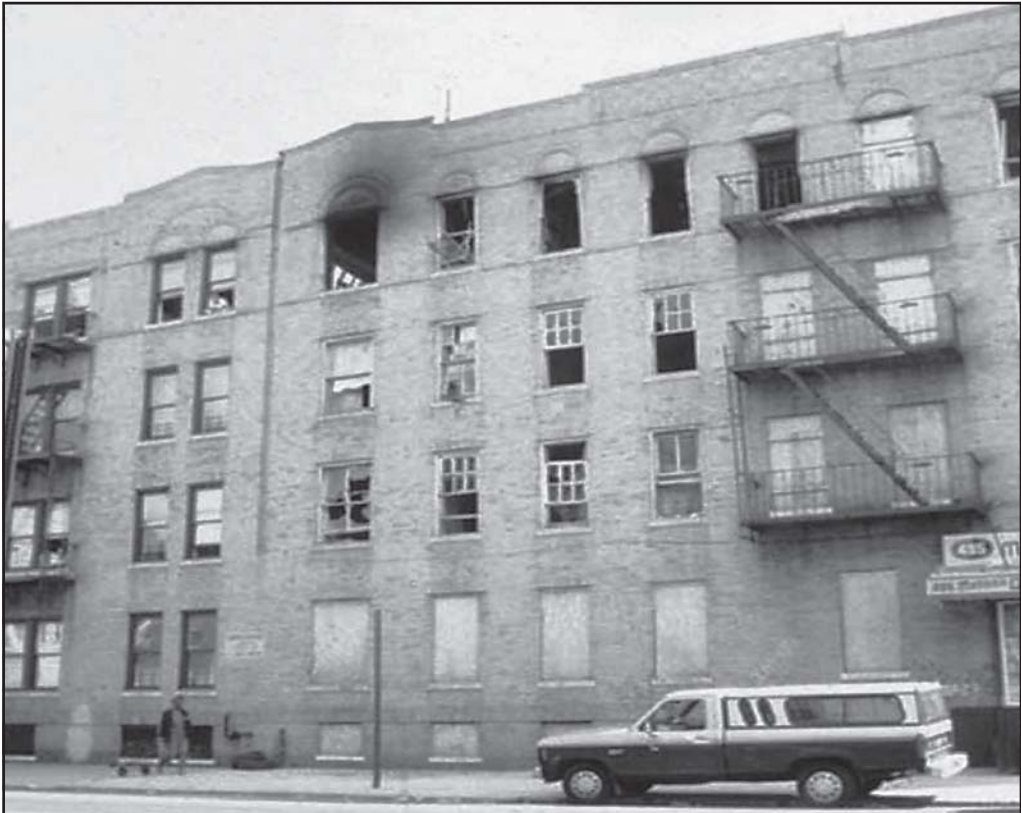
Fig. 12-5. FDNY firefighter Kevin Kane of Ladder 110 died when a suspended ceiling on the top floor of this multiple dwelling collapsed.

There is often a subsequent rapid fire increase after a suspended ceiling collapse, and firefighters pinned by the ceiling or trapped inside a sealed void or breaking through the falling ceiling can be burned to death or asphyxiated by the toxic smoke. Firefighter Kevin Kane of FDNY, Ladder Company 110, was caught and trapped by a collapsing suspended ceiling in a top floor fire in a vacant multiple dwelling. While pulling ceilings to check for fire in the space above a suspended ceiling in an adjoining apartment, the ceiling and grid collapsed. He broke through the collapsing ceiling framework, was engulfed in flame, and killed (fig. 12-5).

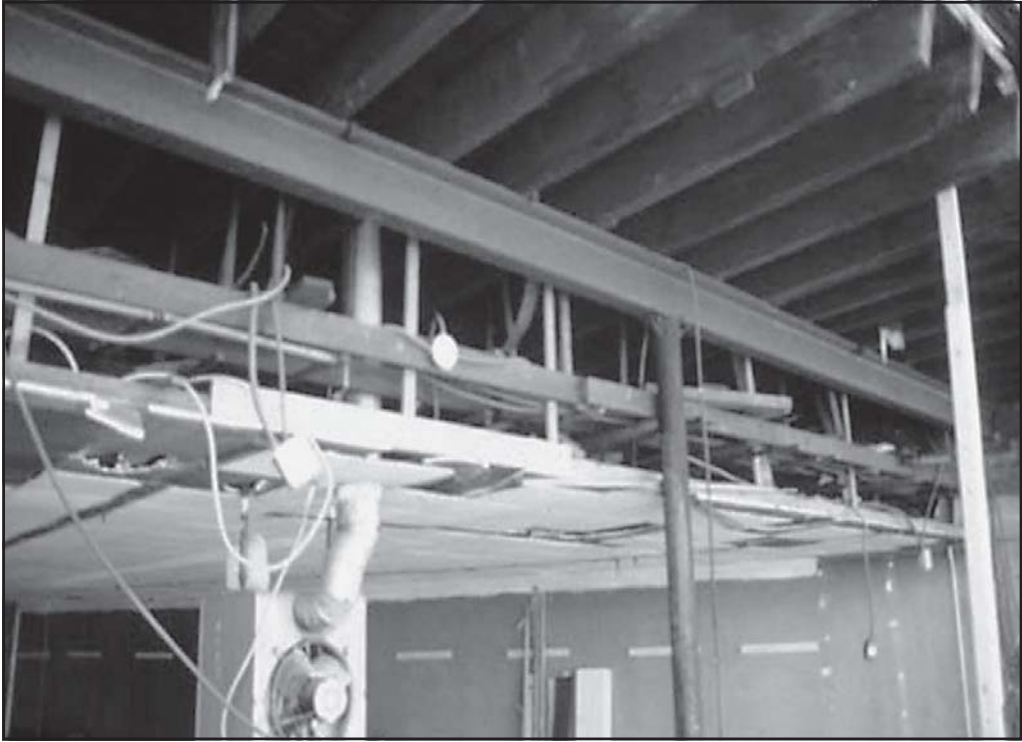
**Fig. 12–9.** When fire enters a ceiling with two dropped ceilings, fire extinguishment is difficult to nearly impossible.

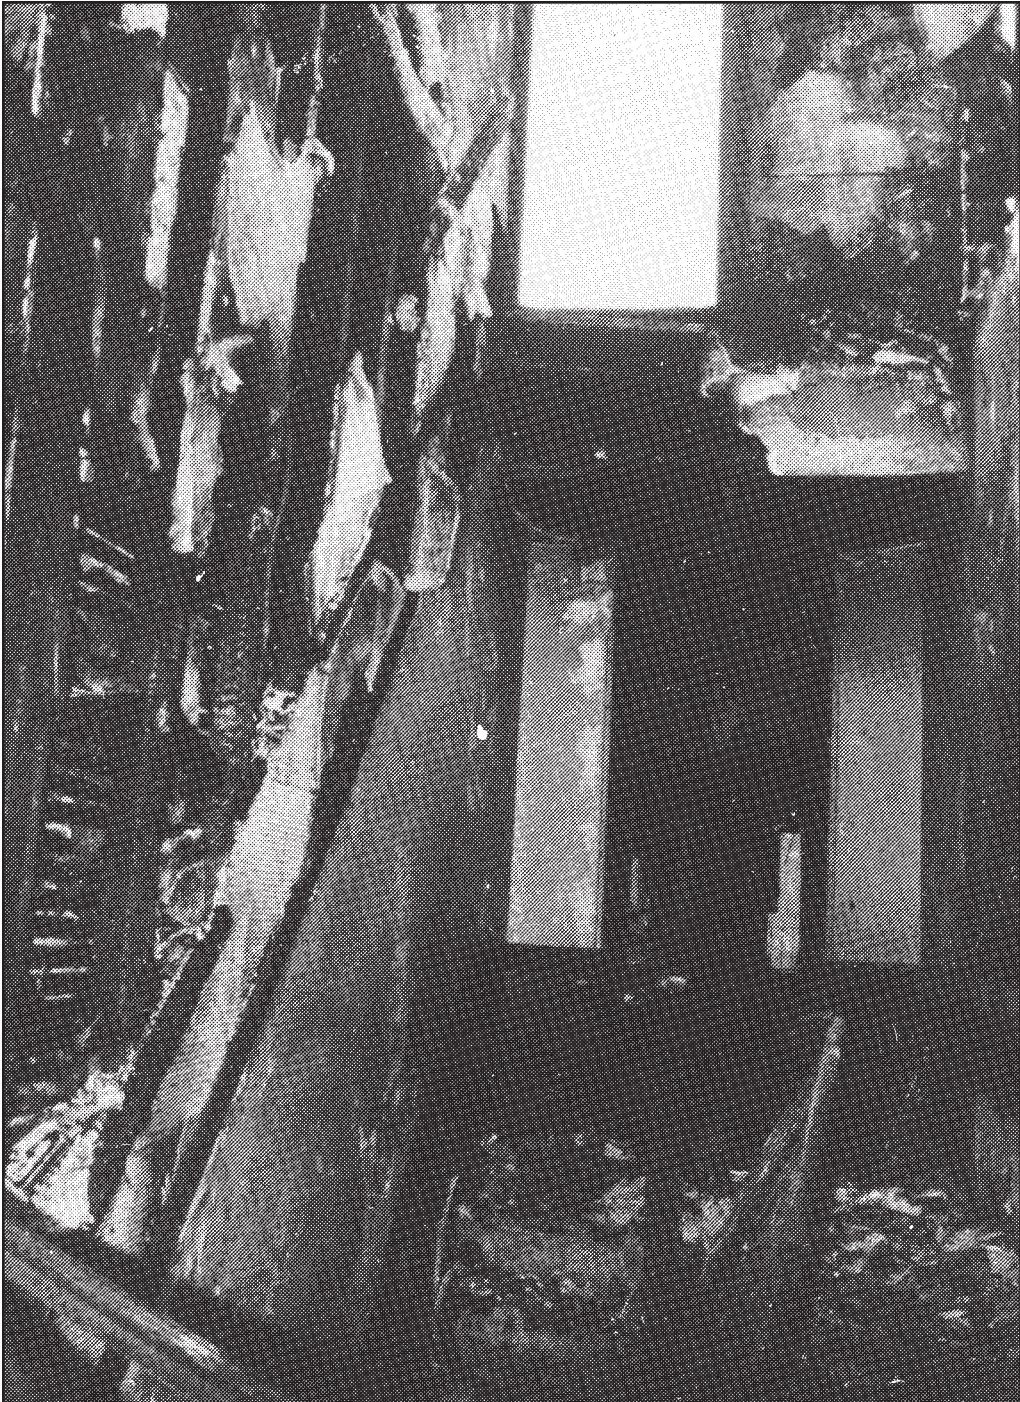
Fig. 13–1. A collapsed wooden straight-run stair

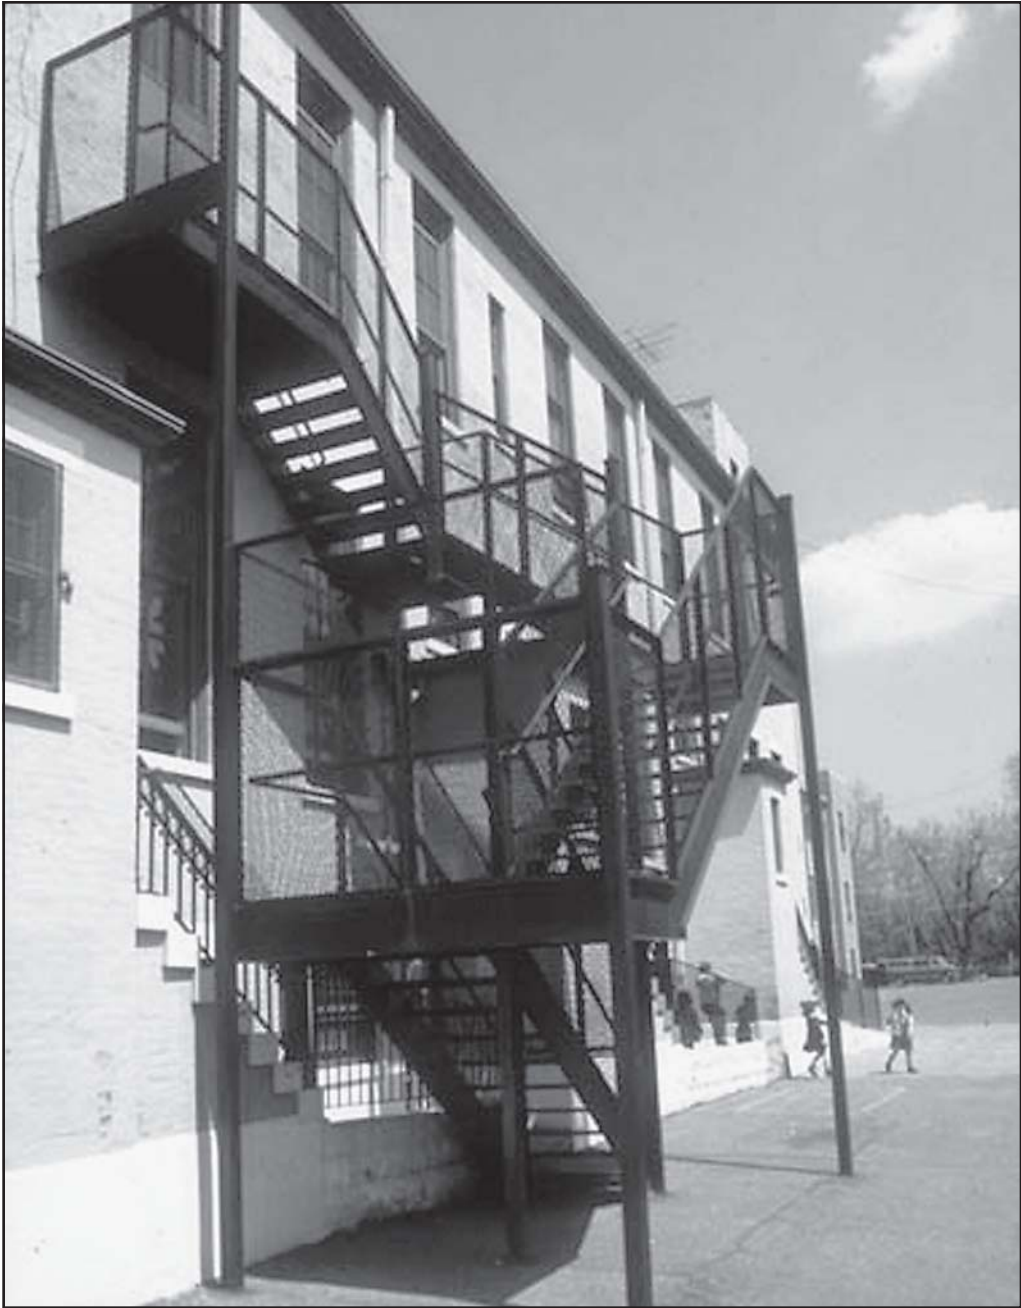
**Fig. 14–1.** An exterior fire escape screened-in balcony is the safest type of fire escape exit.

The safest type of fire escape, the exterior screened stairway used as an exit from schools and theaters is enclosed by a high metal screen or railing, and extends from the top floor of the building to the street by way of a permanent, stationary metal stair (fig. 14-1).

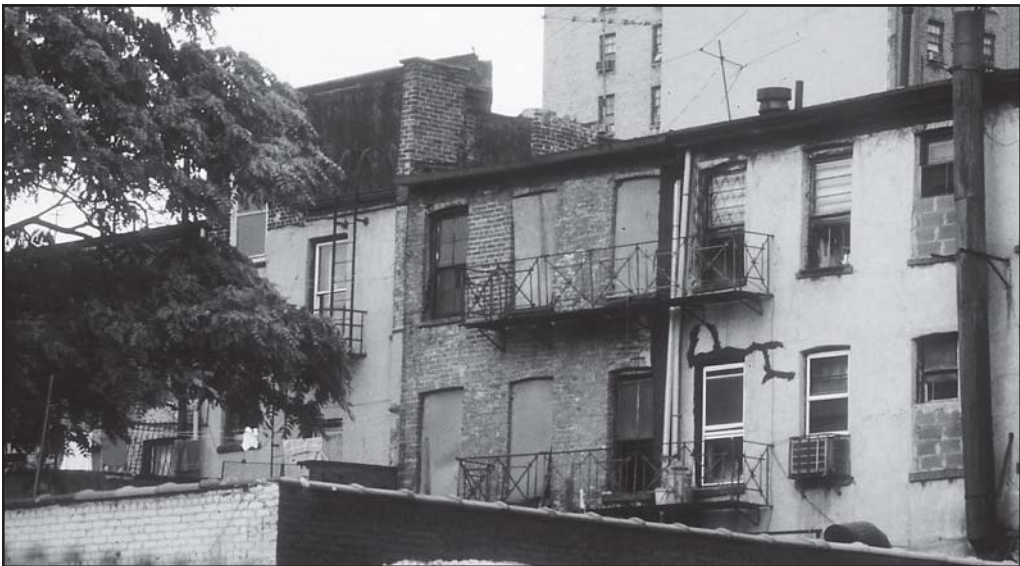
**Fig. 14–2.** A party balcony fire escape is often overloaded with occupants fleeing a fire.

Unlike the exterior screened stairway or the standard fire escape, the party balcony fire escape has no stairway or ladder connecting intermediate balconies. There is no access to the balconies above or below, or to the street. The party balcony is strictly a horizontal emergency exit, with an exit pathway afforded through the adjoining occupancy. A person fleeing a fire opens a door or window, enters the outside party balcony, walks several feet to the adjoining occupancy, and enters it through a door or window (fig. 14–2). The real protection provided by a party balcony is the unpierced fire division between the two adjoining occupancies. Formerly constructed of metal, the party balcony today is made of wood or concrete. The hazard of the party balcony is collapse from overloading or failure of the supports fastening the balcony to the outside of the building.

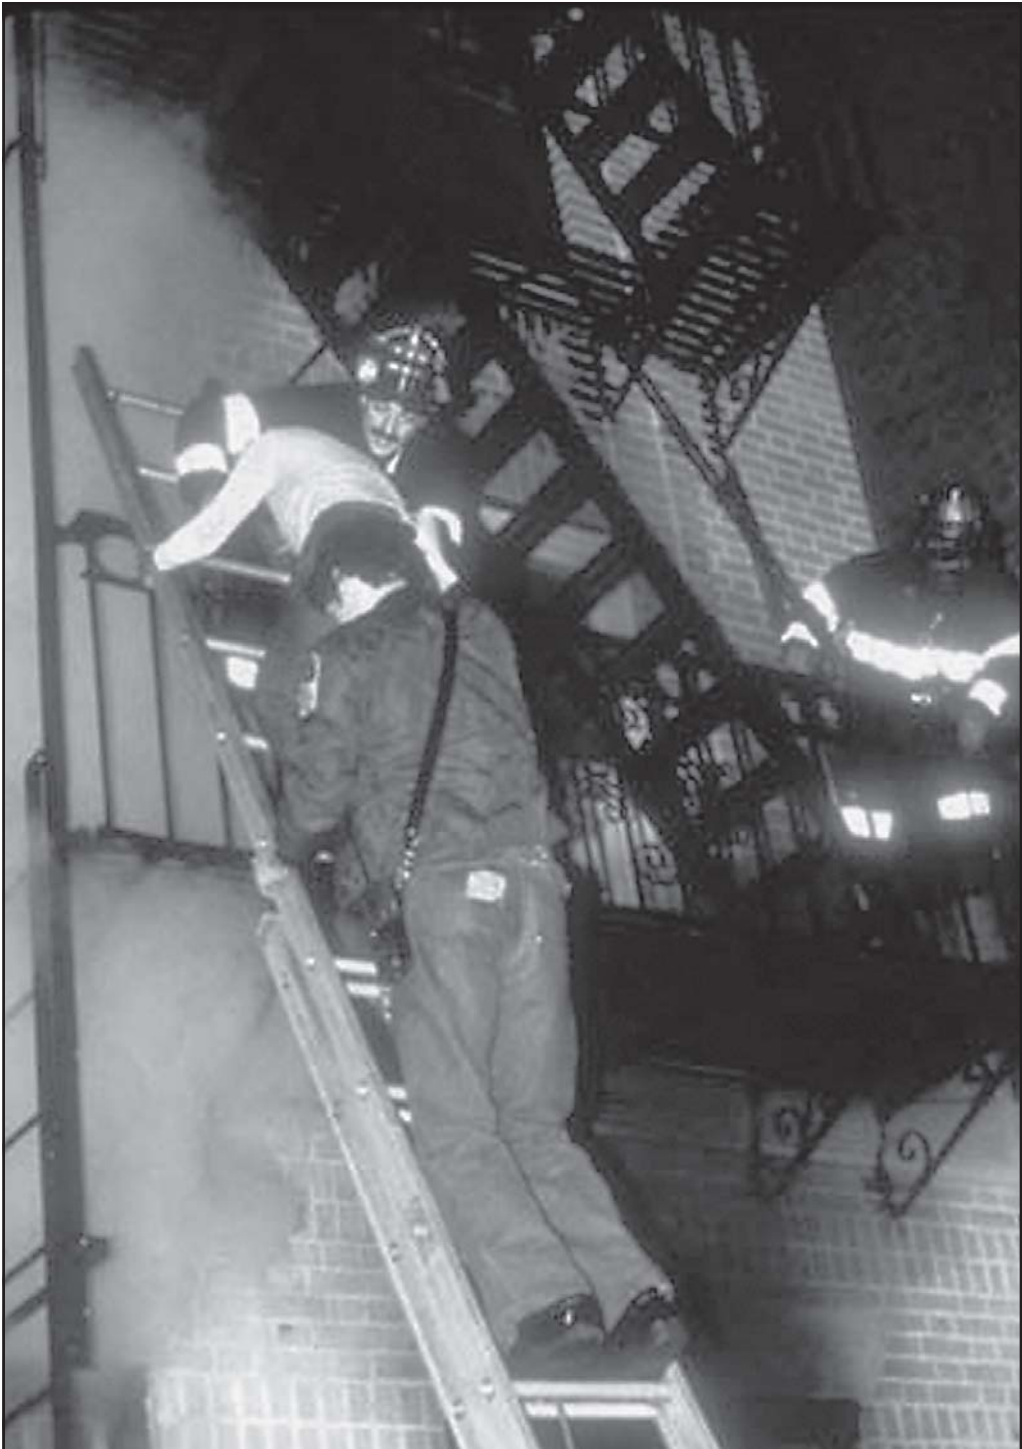
Fig. 14–5. There is less danger in using a fire department ground ladder than a fire escape drop ladder.

should stand beneath the fire escape. If the drop ladder falls out of its track, it will fall out away from the fire escape so the firefighter beneath the balcony will be protected. A safer alternative would be to use a fire department ground ladder (fig. 14–5).

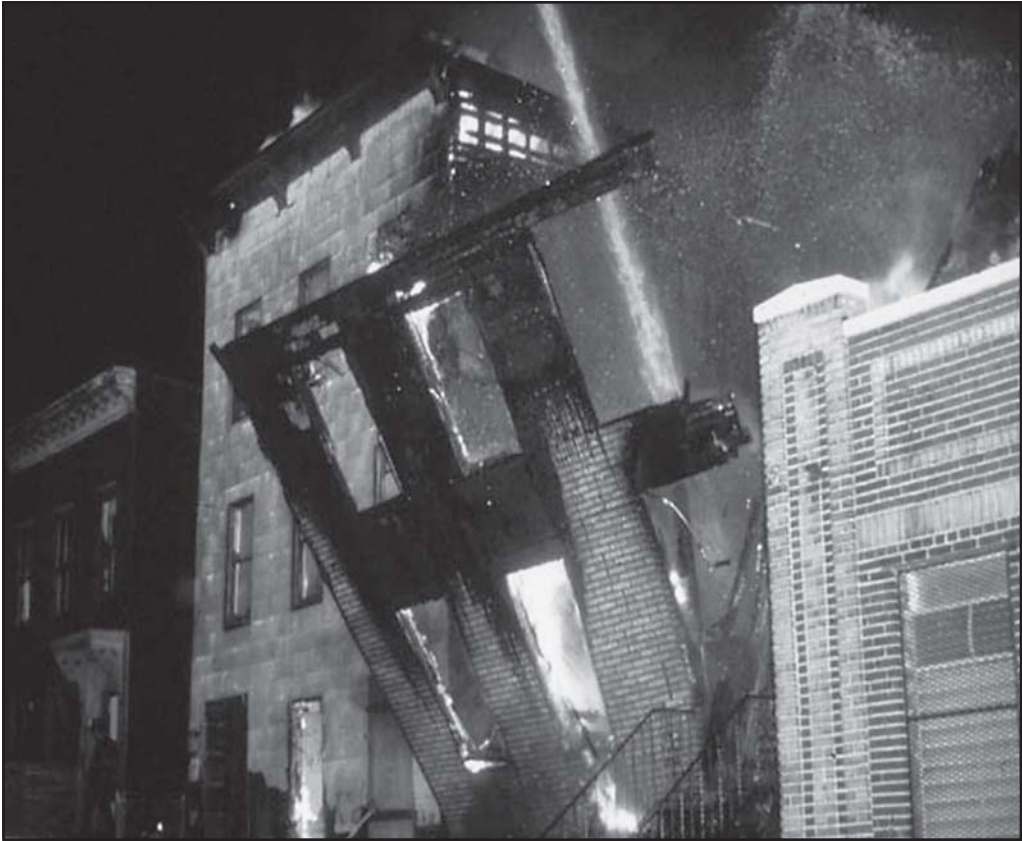
Fig. 15–2. A 90-degree wall collapse

There are three ways that a wood-frame building can collapse during a fire: one wall may fall straight outward at a 90-degree angle (fig. 15-1 and fig. 15-2), the entire building may lean over and collapse on its side (fig. 15-3), or one or all four wood enclosing walls may crack apart and fall in an inward/outward collapse (fig. 15-4). A three-story braced frame structure frequently falls in an inward/outward collapse. The top two stories collapse inward, back on top of the pancaked floors; the lower story collapses outward on to the sidewalk.

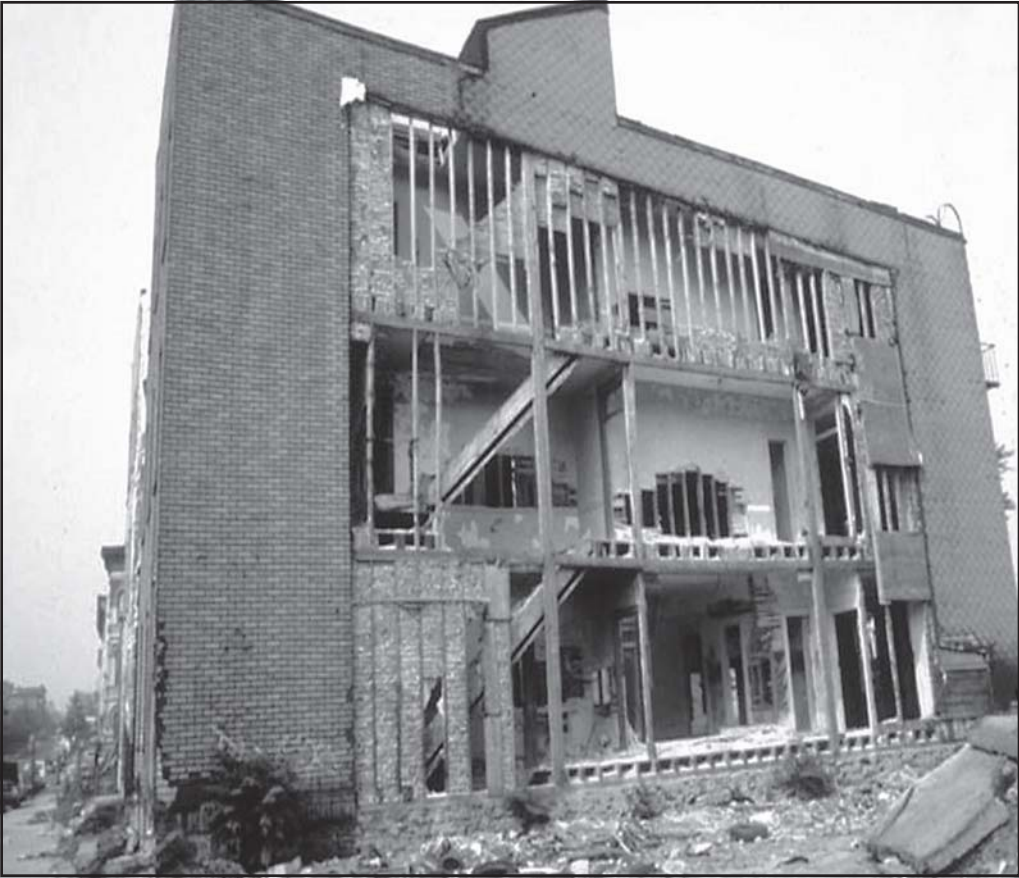
Fig. 15–5. Braced-frame construction

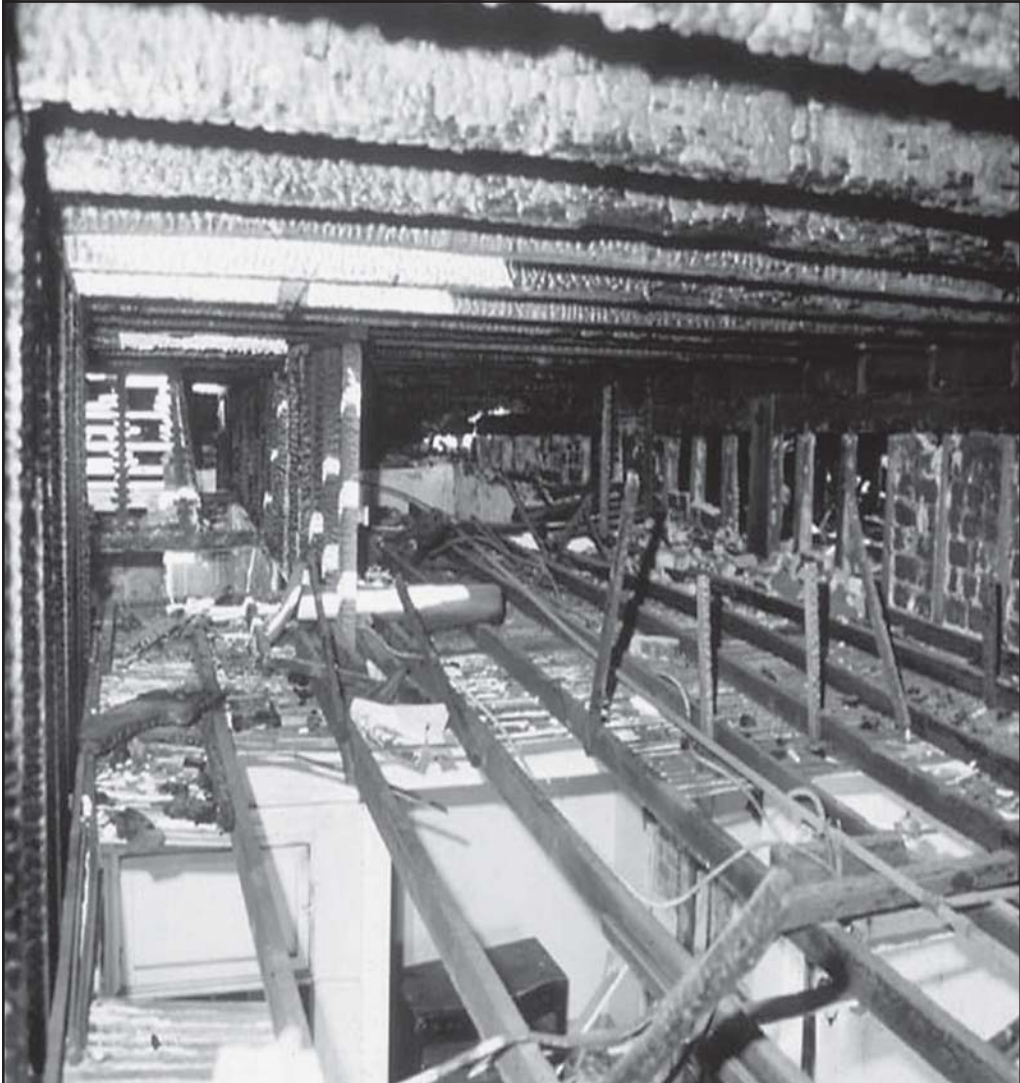
**Fig. 15–6.** The common roof space is a structural defect in row buildings.

Unlike the exterior walls of the four other basic construction types (fire-resistive, noncombustible, ordinary brick-and-joist, and heavy timber), the bearing wall of wood-frame construction *can* be destroyed by fire and can collapse when flames spread out of a window and consume the outside or inside of this load-bearing wall. Burning wood-frame buildings exhibit a rapid fire spread. When the fire department arrives on the scene, both the wooden exterior walls and the structure’s interior are often involved with flame. When wood buildings are built close together or when there is a common roof space running through a row of wood houses, fire spread will be

extremely rapid and will probably involve more than one structure (fig. 15–6). In addition to placing hose streams in the interior of the burning structure, firefighters will need one or more hoselines to control exterior fire spread along the outside combustible walls and to protect exposures from radiated heat.

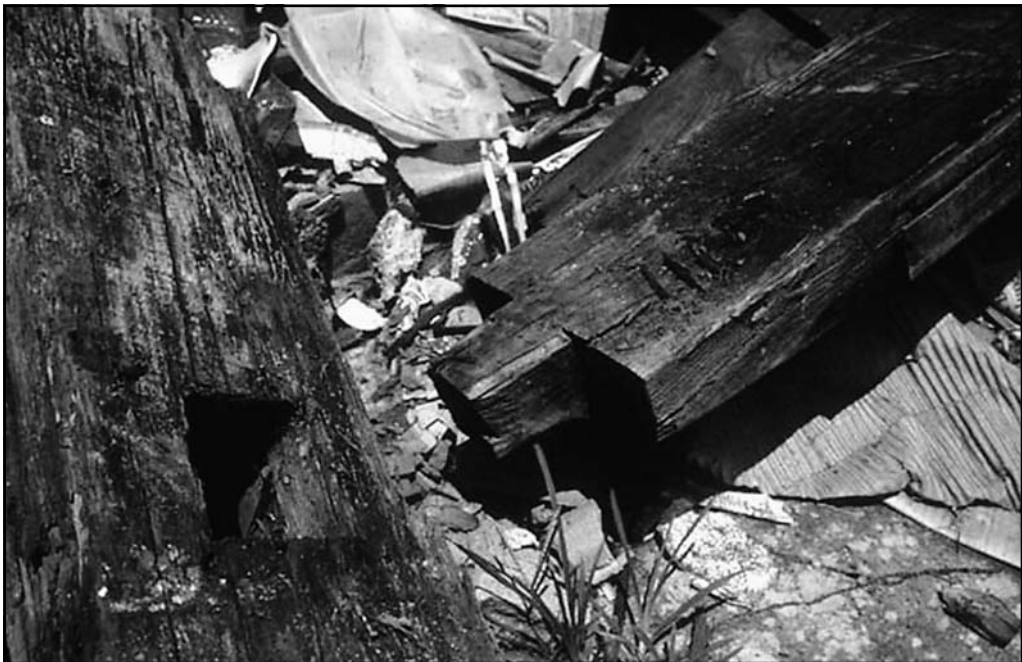
Fig. 15-7. A wood mortise and tenon connection

The structural framework of a braced-frame wooden building that collapses inward/outward consists of vertical timber corner posts and horizontal timber girders or girts at each floor level. The corner posts and girders are connected by mortise-and-tenon joints (fig. 15-7). When a braced-frame wood timber collapses, it fails at the weakest points—often the mortise-and-tenon connection. The mortise hole has removed the center section of the corner post timber and reduced its strength; the tenon end of the girder is only a fraction of the original girder's thickness and therefore has only a fraction of its strength. In addition to this design weakness, the connection can be destroyed by fire. Furthermore, unlike concrete and steel fastenings, the wood mortise-and-tenon connection is susceptible to collapse by rotting. A vacant wooden building open to the elements can be quickly weakened by rotting structural components like the mortise-and-tenon connections.

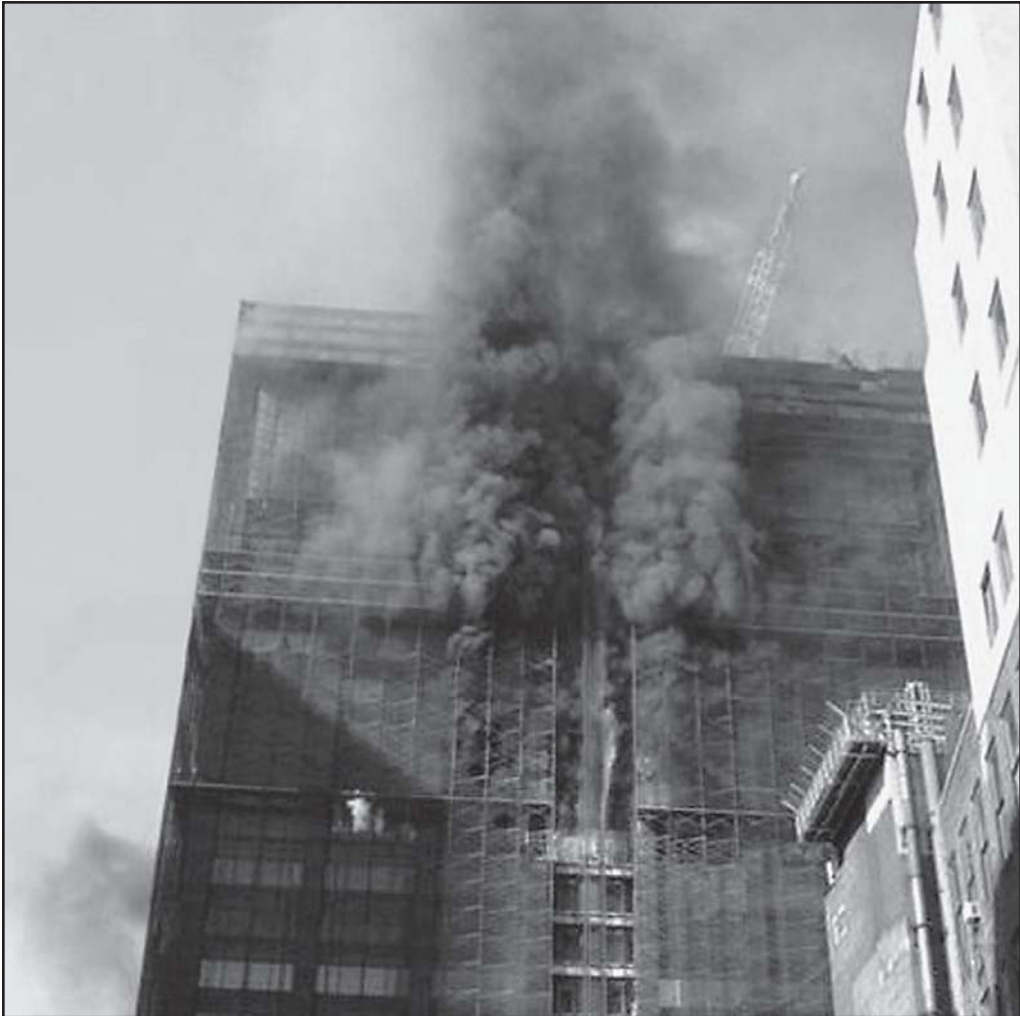
**Fig. 16–1.** Buildings under construction or demolition are more dangerous than occupied buildings.

A building, when being built or dismantled, is more deadly than an occupied and completed building (fig. 16-1). In a completed building there are many safeguards, we take for granted that do not exist in a half finished structure. For example, without enclosing walls, flame quickly spreads up the outside of the building from floor to floor at the perimeter; without interior partitions a wind-driven fire can sweep across an entire open floor instantly; without walls and doors around stairs, elevator shafts, and utility closets, fire can rapidly spread up openings at the interior; and finally, without doors and partitions, there can be no close-approach firefighting shielded behind a barrier.

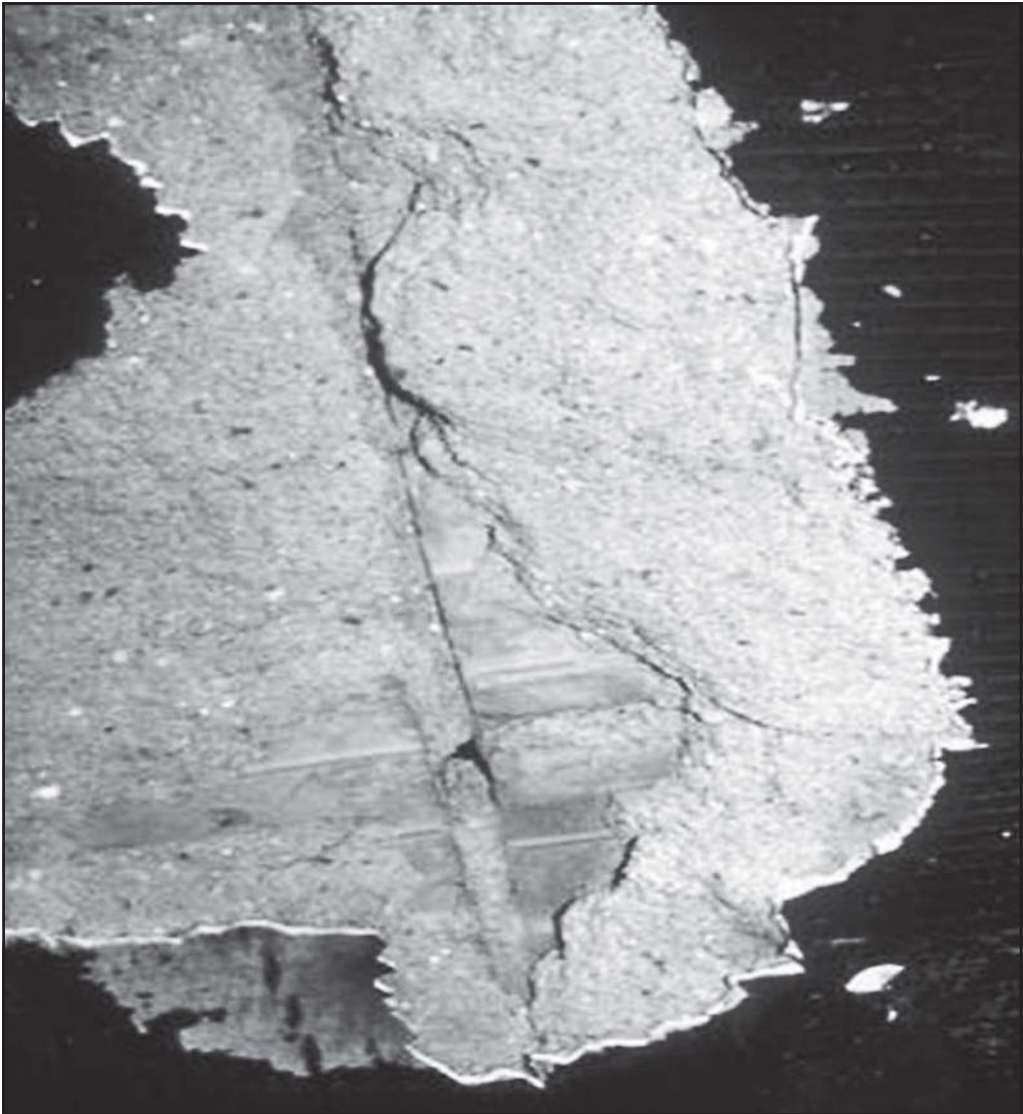
Fig. 16-2. Large chunks of concrete can collapse from a ceiling when heated by a fire.

moisture from the atmosphere. The relative moisture content of concrete is greatest during the first 27 days after pouring. This outer layer of concrete, when heated causes a rapid expansion of entrapped moisture. This moisture expansion can cause a chunk of concrete to collapse. A piece of falling concrete can be a small section or it can be 3 or 4 inches thick, 5 or 6 square feet in area, and weigh over a hundred pounds. Two types of concrete spalling are experienced during fires: an *explosive* spalling, which propels concrete downward with an explosive force and is accompanied by a loud noise, and a *dropping* spalling, which is similar to a plaster ceiling collapse. Whether the collapse is explosive or not, a firefighter can be killed or seriously injured if he is struck by the spalling concrete (fig. 16-2).

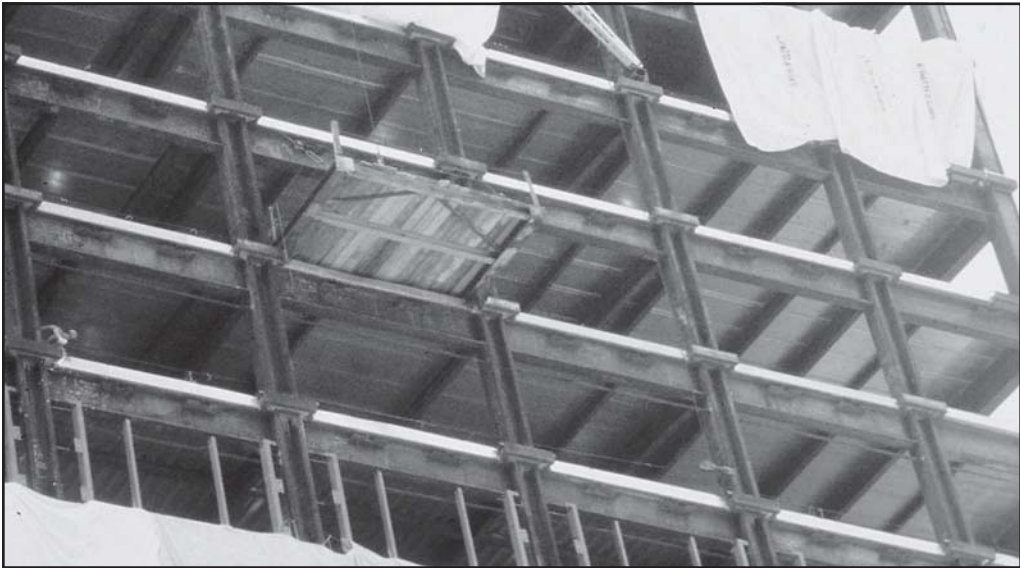
**Fig. 16–4.** Scaffolding can extend beyond the edge of a building under construction.

enclosure wall from the outside. The scaffolding presents a serious collapse danger during a fire. It extends beyond the outer edge of the structure and is constructed of heavy 2×8-inch timbers (fig. 16–4).

Usually supporting large bundles of brick, wheelbarrows full of sand and mortar, and heavy tools and equipment, scaffolding is combustible; sometimes it is supported by metal frame work, or by cantilevered aluminum beams extending out beyond the structure several floors above. Fires can start or spread to the scaffolding and weaken the scaffolding itself, and then it can collapse around the sides of the building under construction. Hundreds of pounds of scaffolding, timbers, bricks, wheelbarrows, and mortar will rain down around the building, striking apparatus and firefighters and crashing through the roofs and floors of smaller structures nearby.
