# **COLLAPSE OF BURNING BUILDINGS**

**A GUIDE TO FIREGROUND SAFETY** SECOND  
EDITION

**Vincent Dunn**

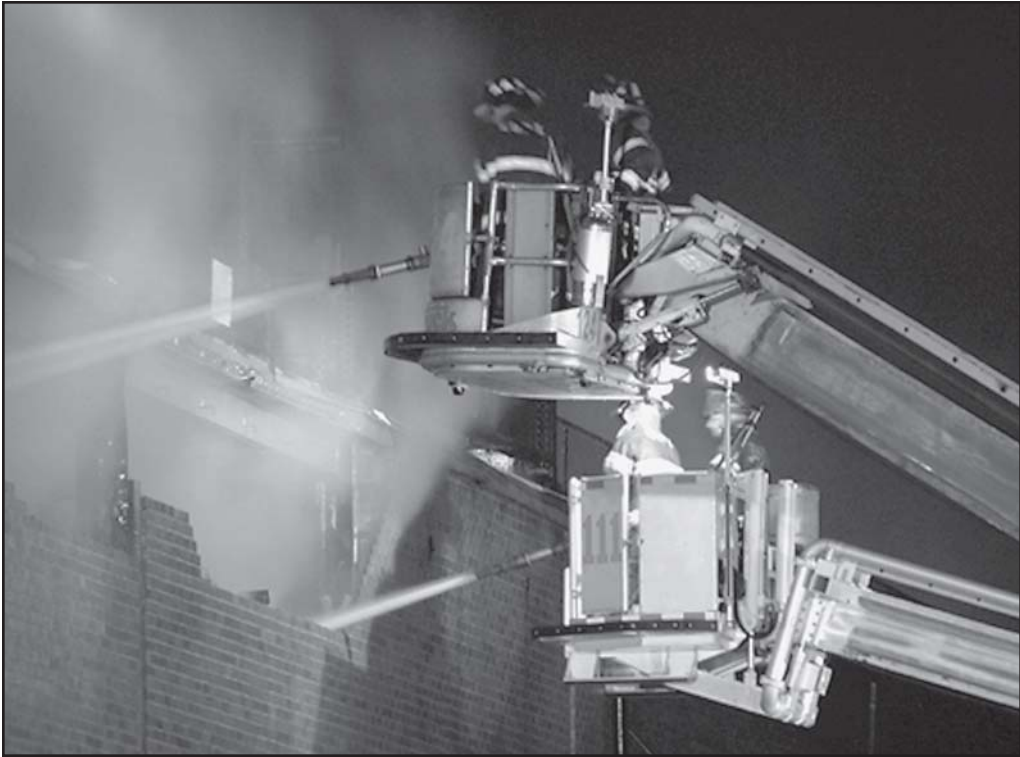
Fig. 17–1. Two tons of water delivered by master streams can cause a building collapse.

Water from streams also can become trapped inside a watertight, sealed floor area and quickly build up to dangerous proportions—sometimes as high as windowsill level. At one fire, water from stream accumulations was seen spilling over windowsills and running down the front of a fire building seconds before all interior floors suddenly collapsed. Firefighters operating on floors below the fire were buried in the collapse.

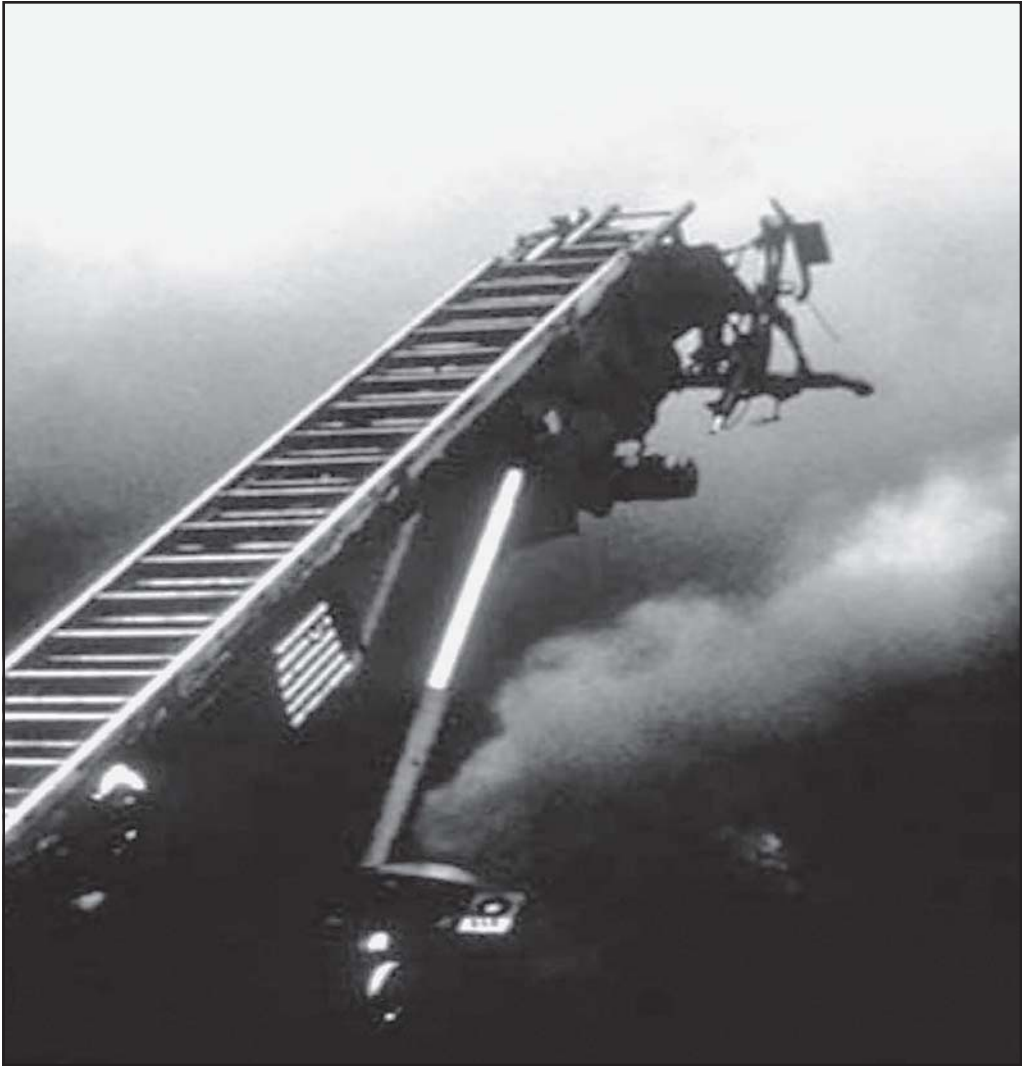
Fig. 17–2. This aerial master stream was operating in the collapse danger zone.

In the past, some chief and company officers used a dangerous firefighting strategy when operating large-caliber streams at major fires. When the wall of a building was in danger of collapse, all firefighters working at ground level were ordered to withdraw from the perimeter of the building and a collapse danger zone was established. Then, firefighters operating tower ladder streams were ordered to begin operations, with the elevated stream operating close to the perimeter of the building and within the collapse danger zone. This no longer is the strategy (fig. 17-2).

When chiefs establish a collapse zone for firefighters operating in the street, they now take a similar safety precaution for firefighters operating aerial large-caliber streams. This is imperative because, in recent years, an increasing number of building collapses have seriously injured firefighters operating aerial master streams. The collapse zone for an aerial stream will vary slightly because of the height of the nozzle above ground level. The tip of the aerial ladder or platform basket should be kept away from a weakened wall a distance greater than the height of the wall above the bucket floor.

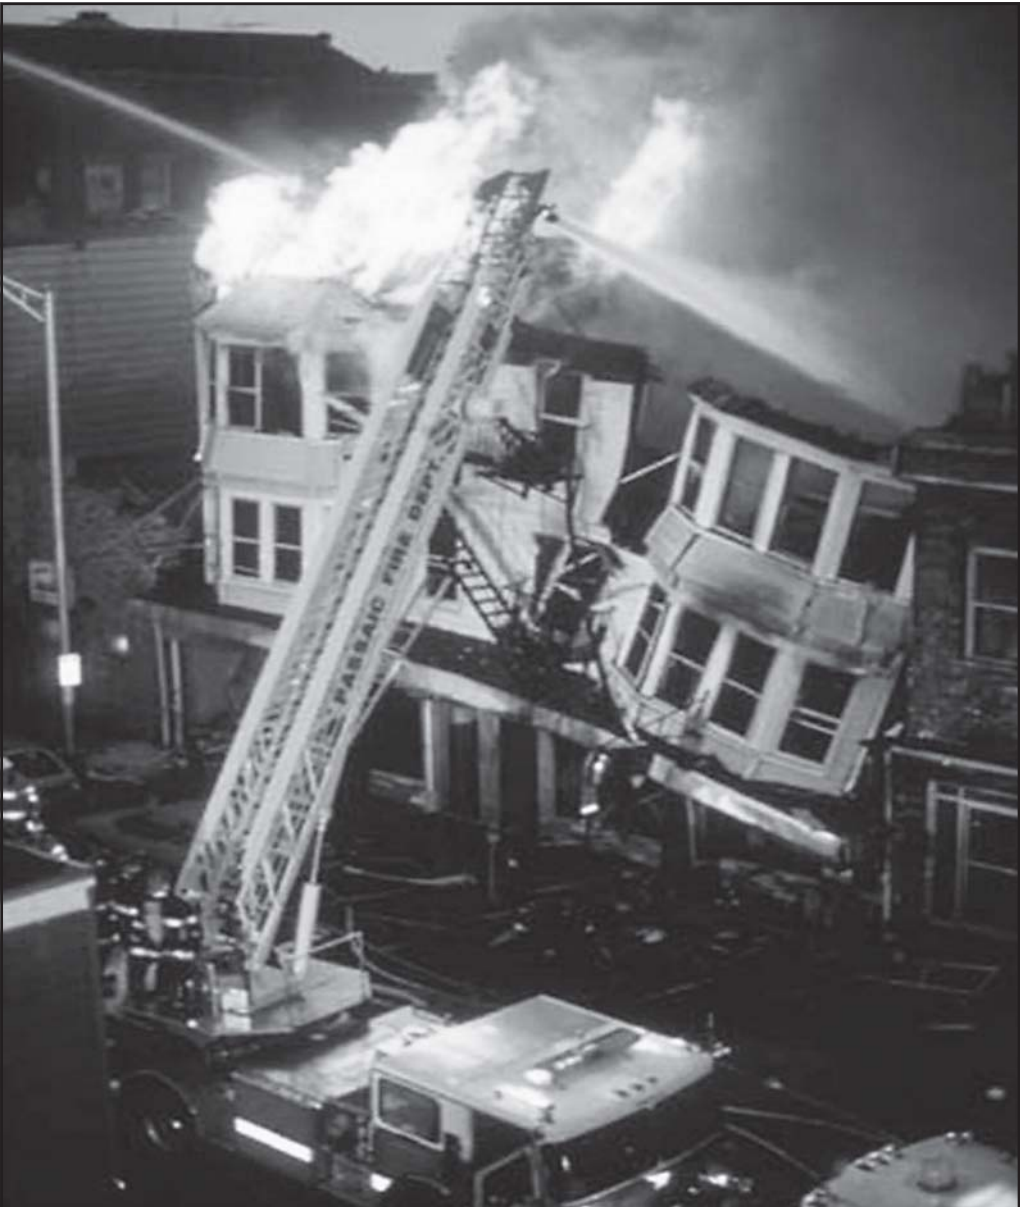
Fig. 18-3. Aerial devices cover the front and are positioned at the corner outside of the collapse zone.

stretched and an aerial platform master stream must be quickly positioned near the collapse site. There could be an explosion or rapid fire throughout the collapse rubble. For example, when a collapse occurs in a downtown area in a row house, hoselines should be positioned at the front and rear of the collapsed building to protect trapped victims, protect adjoining exposures, and to prevent fire spread in the pile. In addition, an aerial master stream with greater reach should also be positioned near the collapse site. If the aerial platform is not needed for the fire extinguishment, it can be effectively used for aerial reconnaissance and viewing the overall collapse site fire and rescue operations (fig. 18-3).

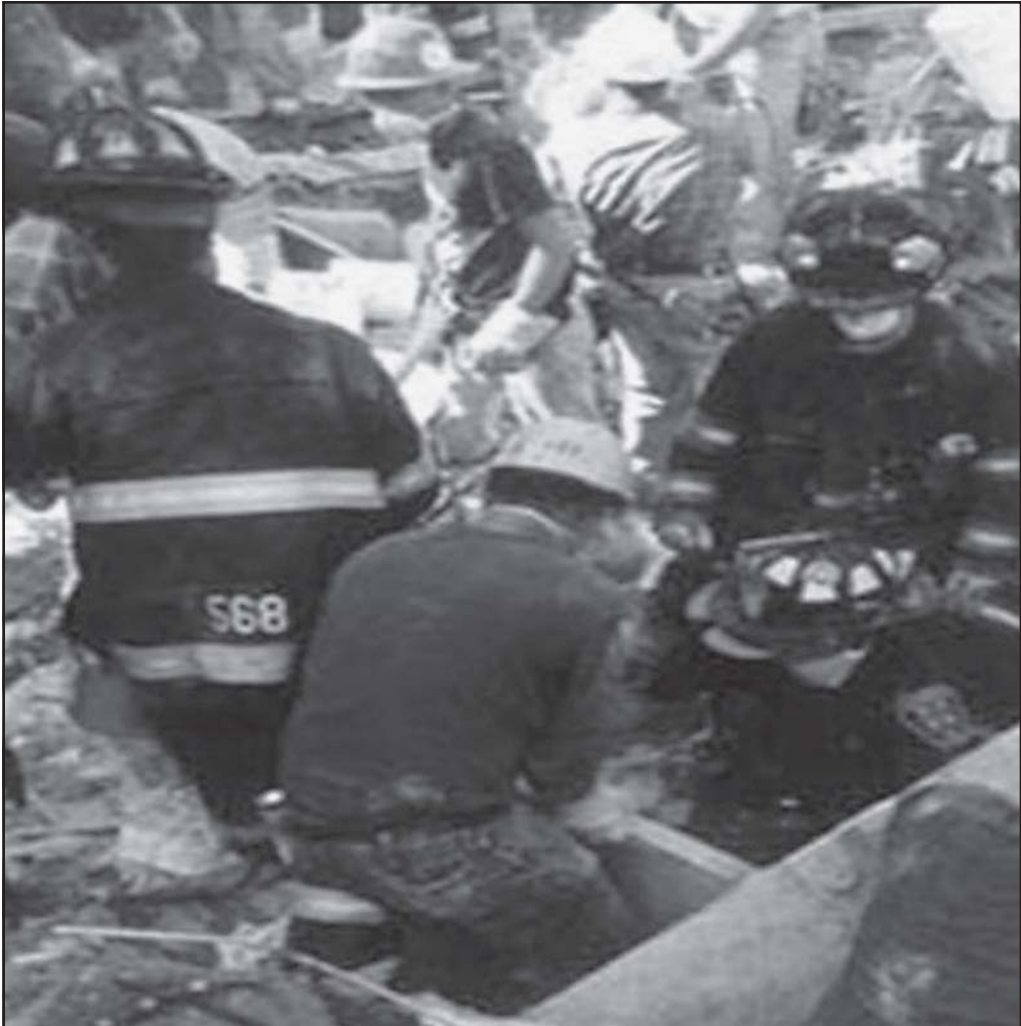
Fig. 18–5. As victims are removed from the surface, a search should also be done of void spaces.

Large sections of collapsed floors or walls sometimes form large spaces, crevices, and voids in the collapse rubble where victims are trapped, but alive. If voids or spaces are stable, and accessible through openings, they may be quickly entered and searched. In smaller voids, firefighters may shine lights and call out to any victims pinned inside these small voids. If a call for help is heard, a tunnel or trench search is started. Some voids have no avenues of access and are completely sealed by the falling structure. People trapped inside can only be heard calling for help. These concealed spaces should be cut open and examined during the void search of a collapse rescue plan. The results of all void searches must be reported to the incident commander.

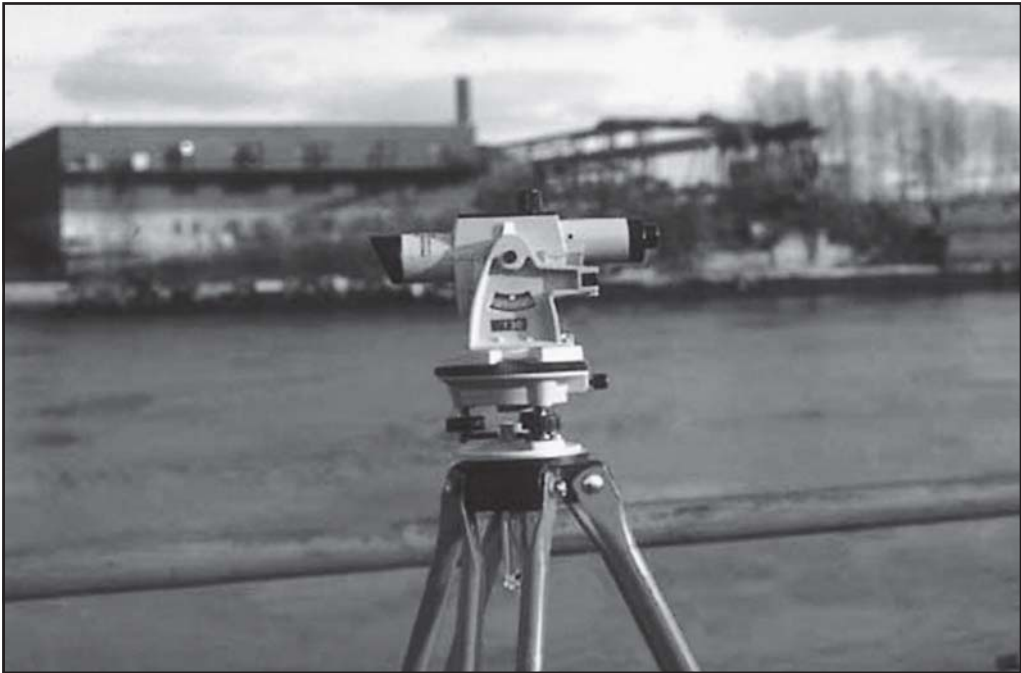
Fig. 18-11. A transit can monitor the slight movement of an unstable secondary collapse danger.

During the time-out, the incident commander orders another safety survey and ensures utilities are shut off. Any unstable portions of the collapsed building must be shored up. Lighting is positioned around the site in preparation for the onset of darkness. A transit to monitor unstable walls is set up. A *transit* is a surveyor's tool that has a telescope that can be sighted on a crack in an unstable wall. The transit can see a crack in a wall or a wall movement not visible to the human eye from a safe distance. If the crack widens or enlarges, it can be detected through the transit telescope. The firefighter manning the transit should continually monitor an unstable part of the structure and report back to the incident commander if there's the need for additional shoring, or removal of the unstable structure (fig. 18-11).

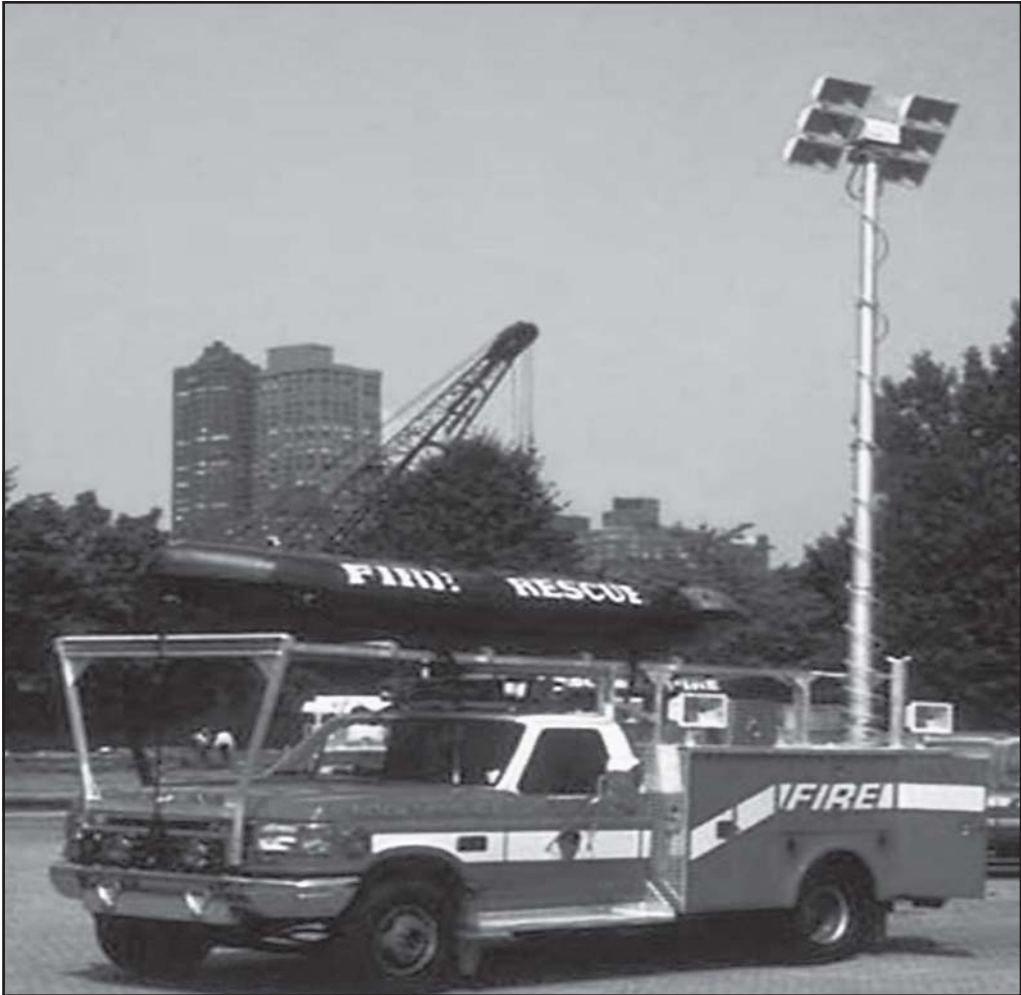
Fig. 19–2. Lighting is an important safety precaution at a fire operation.

During a night fire, if a danger is reported, the incident commander may order increased lighting to be placed near the area (fig. 19–2). A spotlight could be directed on a cracked wall or partly collapsed cornice; a floodlight could be ordered to illuminate the entire area in front of a burning building where a structural defect has been discovered. This action is often taken during an initial stage of a nighttime fire when a chimney or advertising sign has become unstable or partially collapsed and is hanging down on one side.

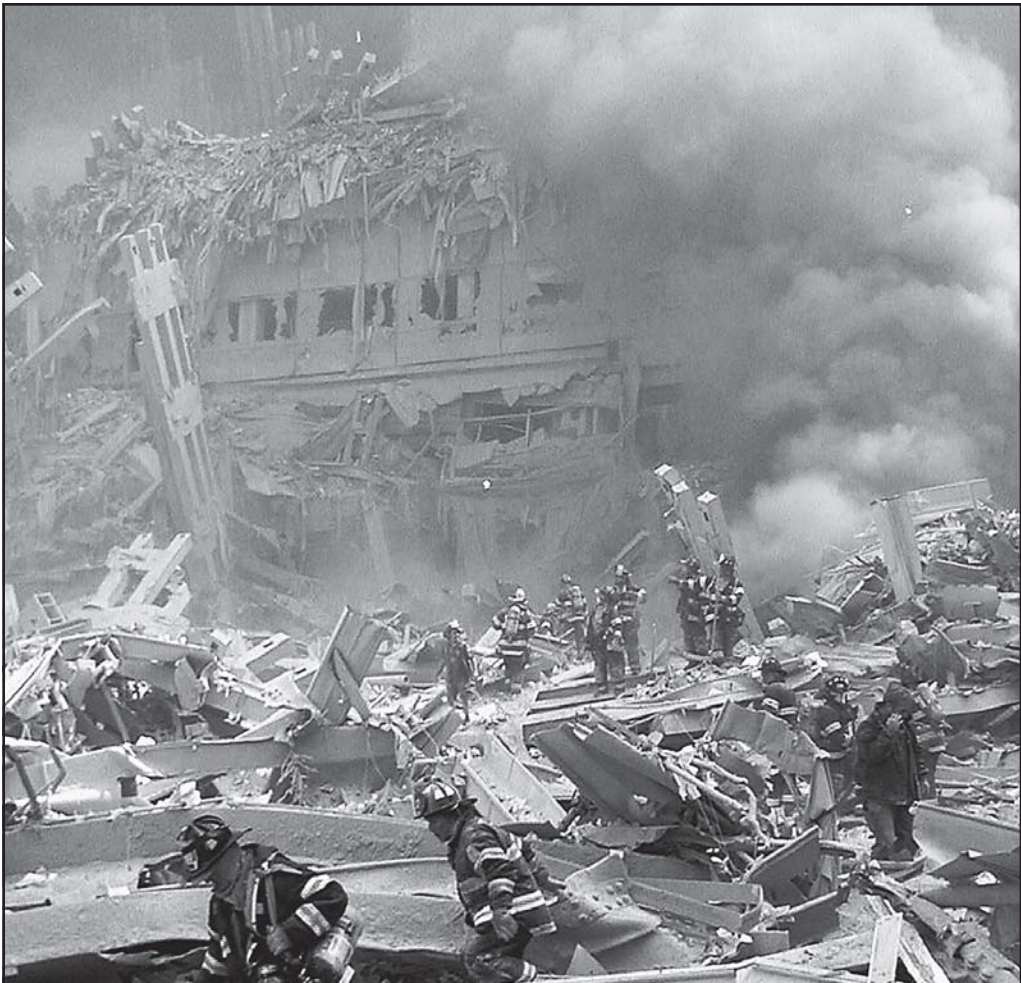
Fig. 20-1. The World Trade Center following its collapse

Terrorists crashed two 767 jetliners into the World Trade Center buildings, killing 2,752 people, including 343 FDNY members, and creating the worst high-rise fires and burning building collapse in the history of this country (fig. 20-1). A resulting fire burned for 56 minutes inside the World Trade Center Building 2. Fire caused this 110-story building to completely collapse in eight seconds. A fire raged in WTC Tower 1 for 102 minutes and this 110-story building pancaked down in 10 seconds. You can

When the terrorists crashed the jets into the towers, based upon knowledge of the tower construction and high-rise firefighting experience, the following happened. First, the plane broke through the tubular-steel bearing wall. This started the building failure. Next, the exploding, disintegrating jet plane slid across an open, office floor area and severed many of the steel interior columns in the center core area. Plane parts also crashed through the plasterboard-enclosed stairways, cutting off the exits from the upper floors. The jet collapsed the ceilings and scraped most of the spray-on, fire-retarding asbestos from the steel trusses and thousands of gallons of jet fuel exploded into flame. The steel truss floor supports probably started to fail quickly from the heat of the fire and the center steel supporting columns severed by plane parts and heated by the flames, began to sag, warp, buckle, and fail. Then, the top part of the flaming tower crashed down on the lower portion of the structure. This collapse triggered the entire cascading collapse of the 110-story structure.

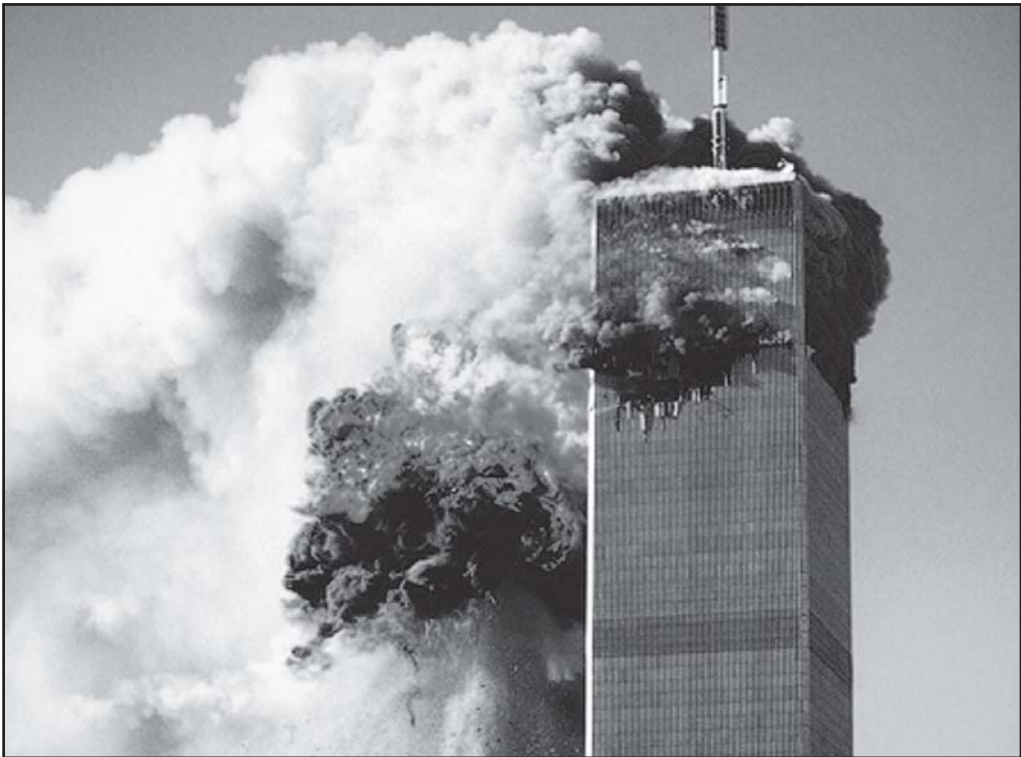
**Fig. 20-5.** Because the Port Authority was a bi-state agency, it was exempt from complying with the New York City building or fire codes.

The WTC towers built by the Port Authority of New York did not comply with the New York City building or fire codes (fig. 20-5).

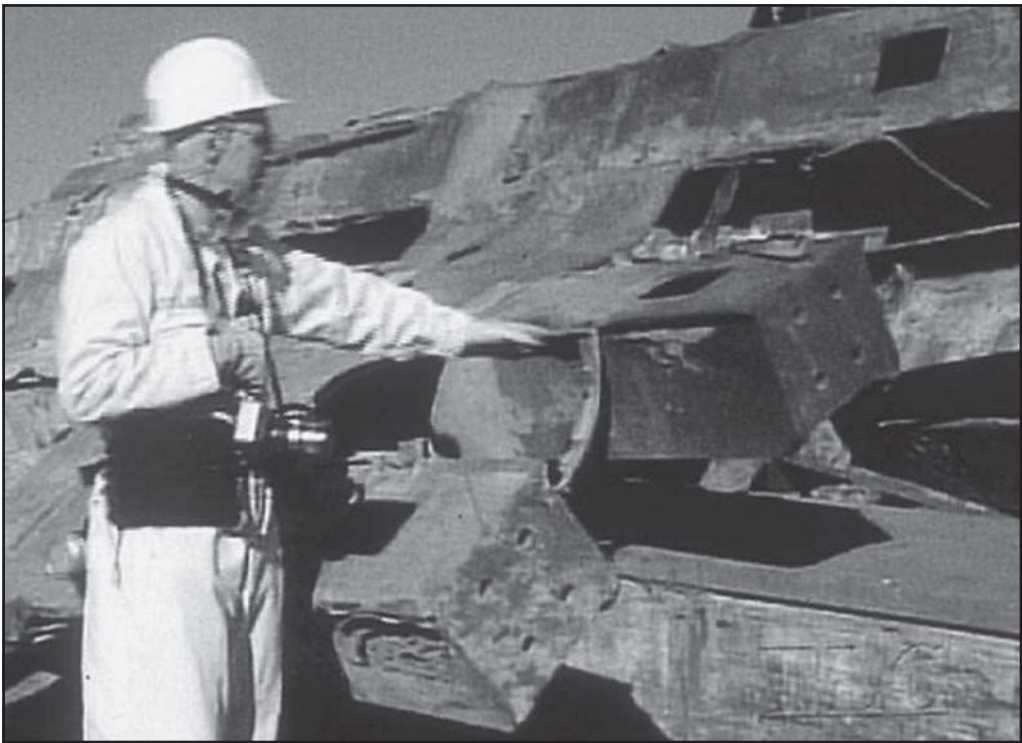
Fig. 20–6. The World Trade Center had tubular bearing walls; some only one-half-inch thick on the upper floors.

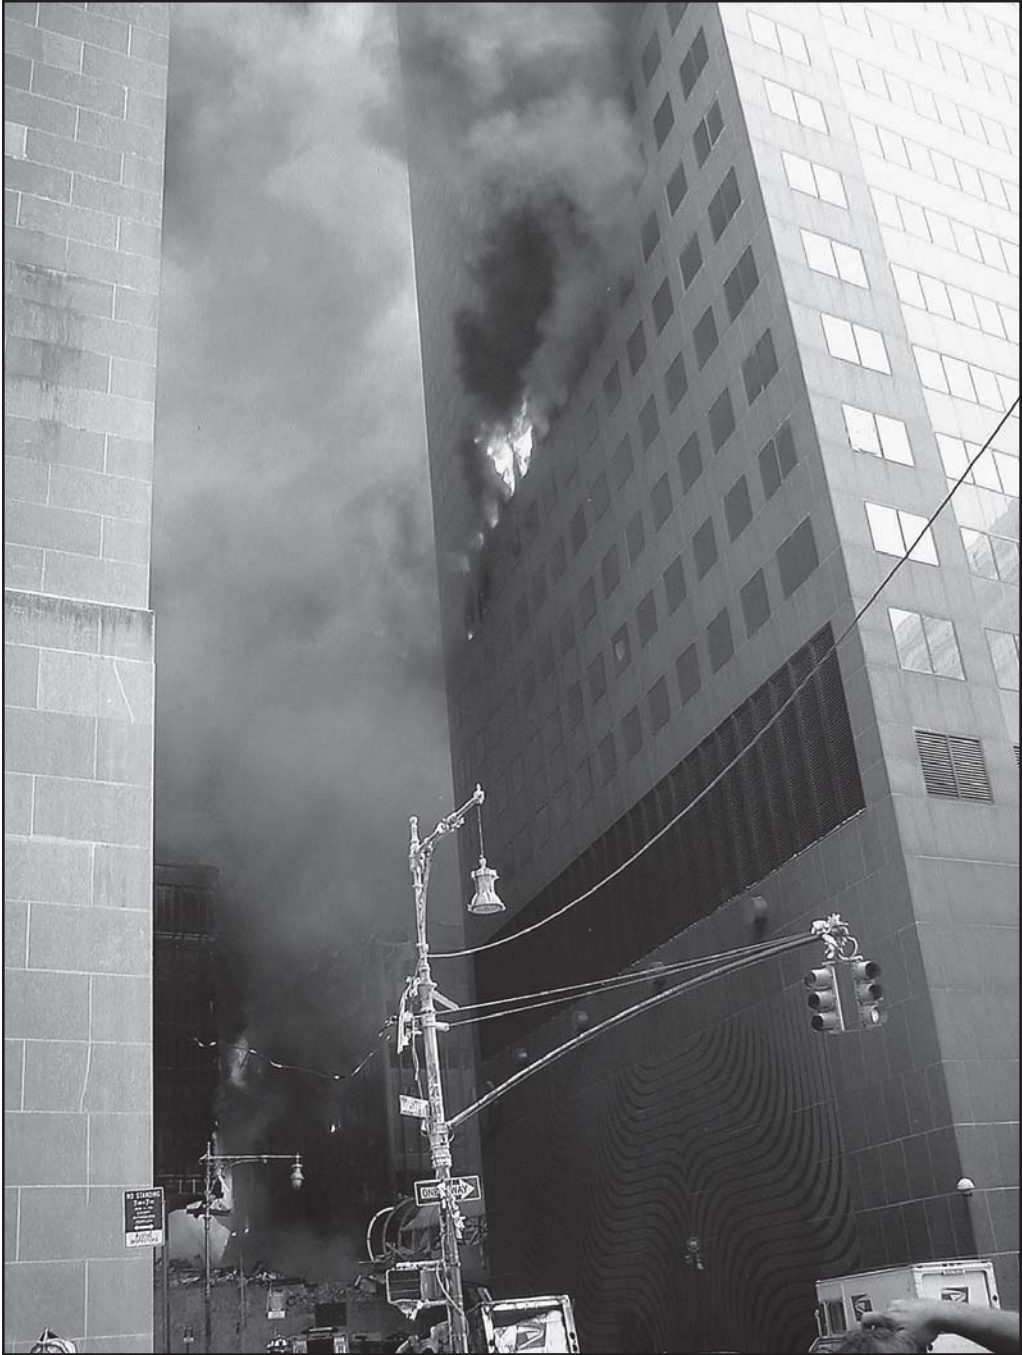
**Fig. 21–1.** World Trade Center Building 7 burning before building collapse

The spray-on fire retarding material (SFRM) covering steel in Building 7 was assumed sufficient for a Type 1-C fire-resistive building. The Type 1-C building requires that the fluffy spray-on protect columns for 2 hours and beams for one and a half hours. The thickness of spray-on fire retarding (estimated by NIST) was less than 1 inch thick throughout the entire steel structure, including 875 covered columns and girders, 5-inch covered beams, and 0.375 covered floor deck undersides. The steel is supposed to be unpainted for good adhesion of the spray on fire-retarding material, however evidence suggested steel was covered with primer paint. The structure had a fully installed automatic sprinkler, which did not function on the lower floors where the main body of fire grew. The sprinklers on the lower floors of WTC 7 were supplied by water mains and the upper floors were supplied by gravity supply tanks. The collapse of Towers 1 and 2 damaged the water mains. Figure 21–2 depicts the World Trade Center complex layout.

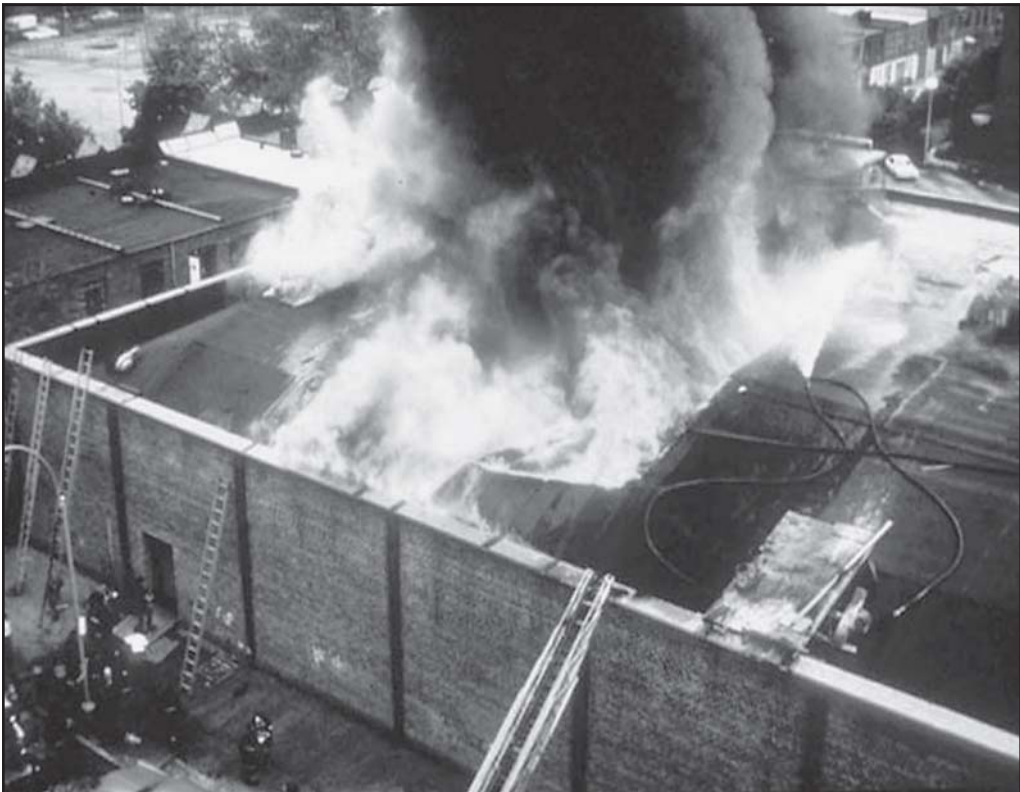
**Fig. 22–1.** Waldbaum's Supermarket timber truss roof collapse killed six FDNY firefighters in 1978.

The final report of the fire department's investigation into the supermarket roof collapse stated that the firefighters had died partly because "the extent, the severity, and to some extent, the location of the fire had not been clearly defined prior to the collapse." One of the most important size-up duties of first-in chiefs and company officers is locating the fire and determining its severity. This information lays the foundation for the entire operation. First, it determines the number of firefighters and amount of equipment needed to control the blaze. Second, until the location and extent of the fire are known, firefighters cannot determine the overall life hazard, the most effective point of fire attack, and the most efficient method of venting heat and smoke. Sometimes, however, the location and severity of a fire cannot be assessed by the chiefs and company officers first on the scene. This inability is often caused by alterations or unusual construction of the fire building. In a fire that killed 12 FDNY firefighters in 1966, the exact location of the fire was not discovered because of alterations. Similarly, the severity and extent of the Brooklyn supermarket fire was not "clearly defined" because of three factors: an unusual alteration called a "rain roof," the fire-retarding compartmentation of the trusses, and the large heat collection space created by the bowstring design of the structure (fig. 22-1).

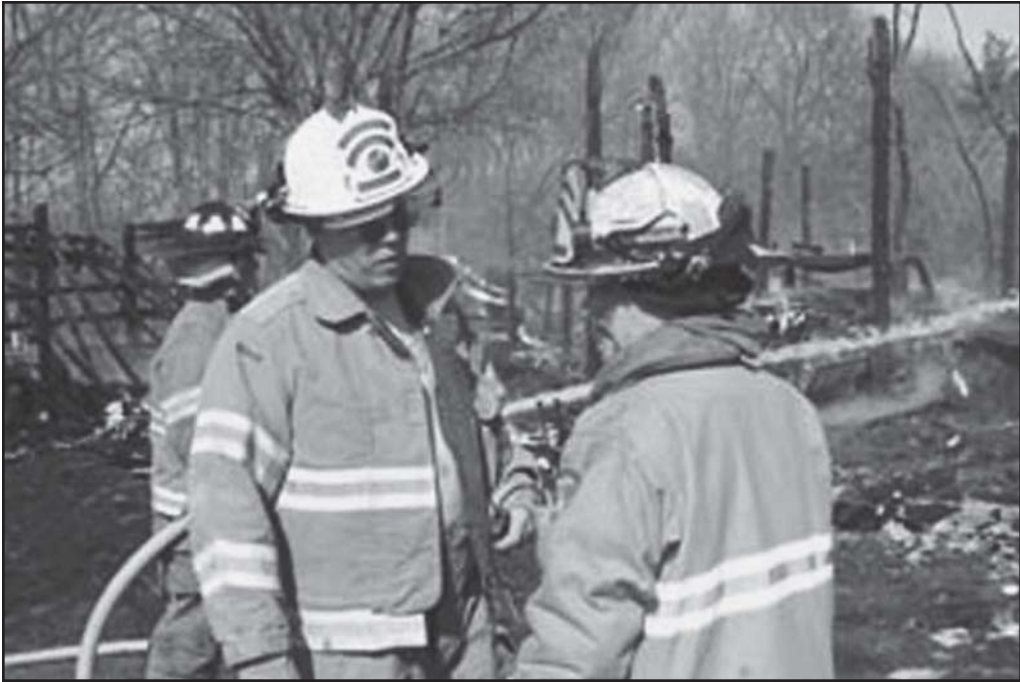
**Fig. 23–1.** Steve Smith, Wea Township FD, was the first firefighter to die in a wood I-beam floor collapse.

This “*through the door through the floor*” story is being repeated throughout the country. A veteran fire officer said to me, “Floor collapse seems to be happening during the early stages of a fire, too often, and at too many fires. Some one has to sound an alarm.” For example, in the FDNY, Howard Carpluk, Mike Reilly, and John Clancy. Across the river in New Jersey, East Franklin Fire Department, Kevin Appuzzio. Across the nation, Brant Chesney, Forsythe County, Georgia; John Ginocchetti, Tim Lynch, Manlius County, New York; Steve Smith, Wea Township, Indiana; Arnie Wolfe, Green Bay, Wisconsin. All of them went “through the door through the floor” with collapsing first floors (fig. 23-1).

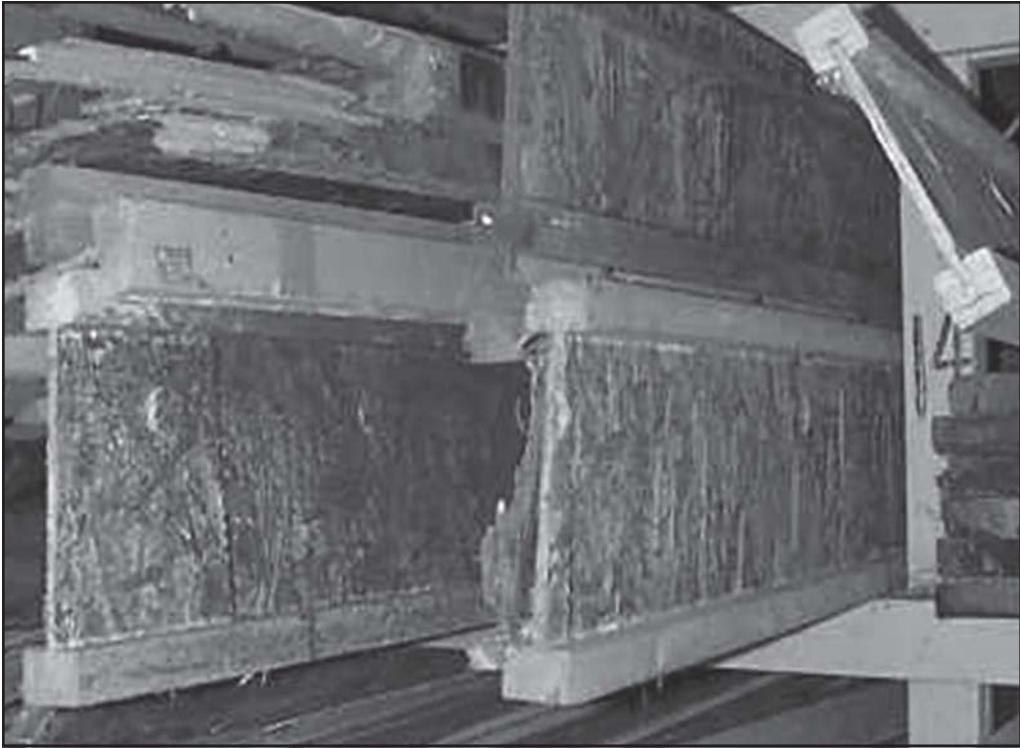
**Fig 23–2.** Lightweight wood I-beams have a wood web member and a 2×2 inch top and bottom flange.

The increase of “through the door, through the floor” collapse, makes initial size-up upon arrival critical for first responders. In addition to the size-up of smoke and flame from outside the building, first responders must then ask themselves “Is this a cellar fire?” When responding to a dwelling fire and smoke involves one of the upper floors, the cellar must be checked to see the blaze has not originated there. The small basement windows or double cellar doors at the side or back of the house should be checked for signs of cellar fire. At strip store fires, tragic experience over the years has taught incident commanders to order someone to check the cellar for fire origin. This is because of the danger of floor collapse. In New York City, 12 firefighters were killed when a first floor collapsed into a burning cellar. Have someone check the cellar for fire. This size-up is even more critical if you know the building is lightweight wood truss or I-beam construction (fig. 23–2).

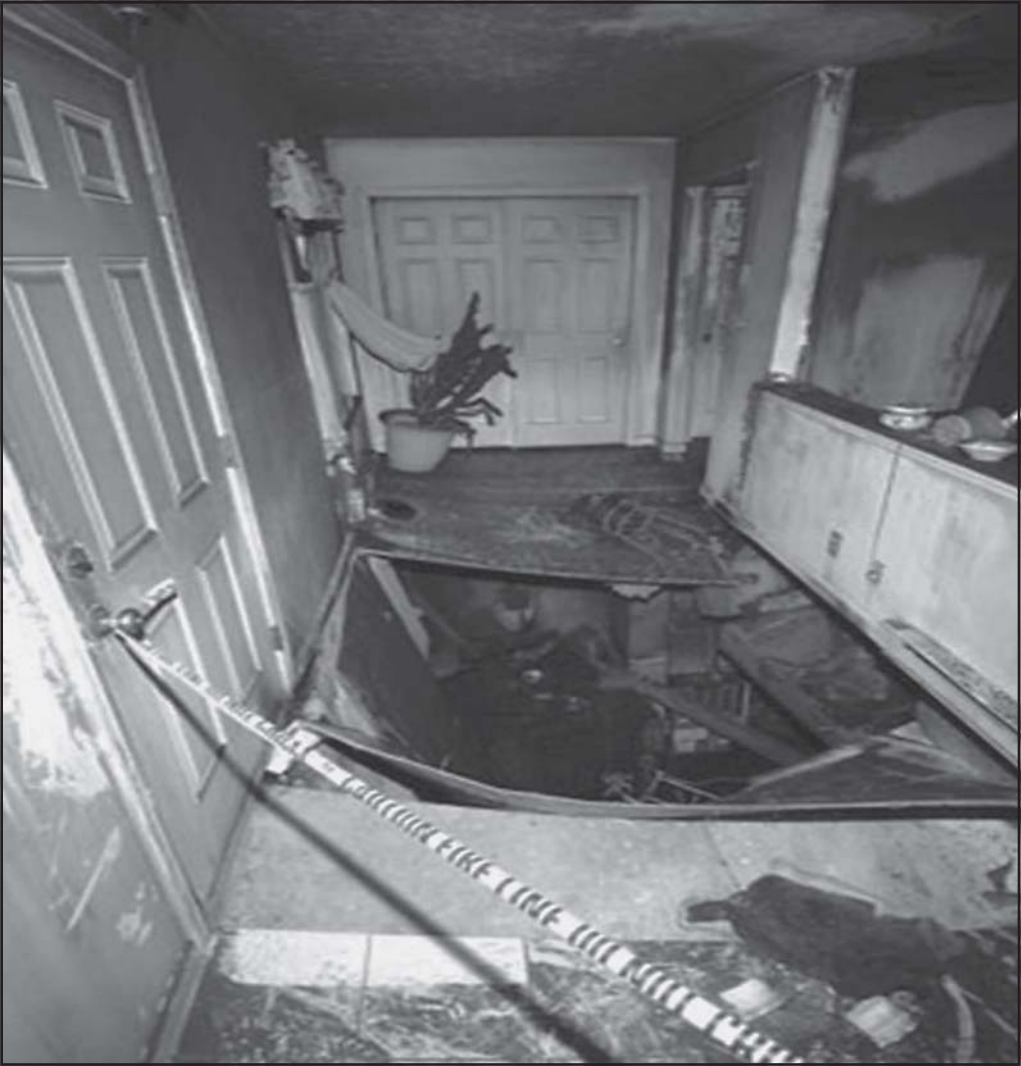
**Fig. 23–3.** The wood I-beam floor collapsed and killed Chief Steve Smith.

A post-fire investigation (NIOSH F 2006-26) and photo analysis revealed that the cellar was unfinished and there was no ceiling. The first floor was supported by wood I-beams. During the post-fire investigation, the open joist wood I-beams showed exactly how the fire burned and the floor collapsed: First the hot electric cable wiring extended through holes drilled through the web section ignited several I-beams simultaneously. Flames spread outward from the wire, consuming the web sections constructed of wood shavings and glue. When the web sections burned away completely, the top flanges of the I-beams (2×2-inch wood pieces) bowed downward at the center. The top flange compressed downward to the bottom flange and then the bottom flange broke and fell away from the burned web section and top flange (fig. 23–4). There was no beam support for a section of the floor deck. A section of floor deck and several burned wood I-beams collapsed under the weight of Chief Smith as he entered the first floor to locate the fire’s origin.

After a lecture on lightweight wood truss collapse and a slide show that names 21 firefighters who have died, I am sometimes asked, “Chief do you know anyone who has died from wood I-beam floor collapse?” My answer was no until I went to Lafayette, Indiana. The firefighters from Wea Township, Indiana, told me about Chief Steve Smith. He died in a floor collapse during a cellar fire on June 26, 2006 (fig. 23–3). Chief Smith is the first firefighter to die by the floor collapse of a wood I-beam floor failure.

The Lafayette, Indiana, building was one-story wood frame 1,200-square-foot private dwelling built in 2004. The fire started in the unfinished basement that had no ceiling. A lightning strike hit the cable TV roof antenna. The TV cable ran down through the building into the cellar and through the laminated glue-and-wood shaving web section of several wood I-beams supporting the first floor. The hot antenna wire ignited the cellar wood I-beam. Smoke showed from the first floor of the building. Chief Smith, first on the scene, entered the first floor to make a quick size-up before the first engine arrived. He entered the front door, made a left turn, and the floor collapsed. The first floor caved in less than 10 feet from the front door, and he fell into the burning basement, where he was trapped.

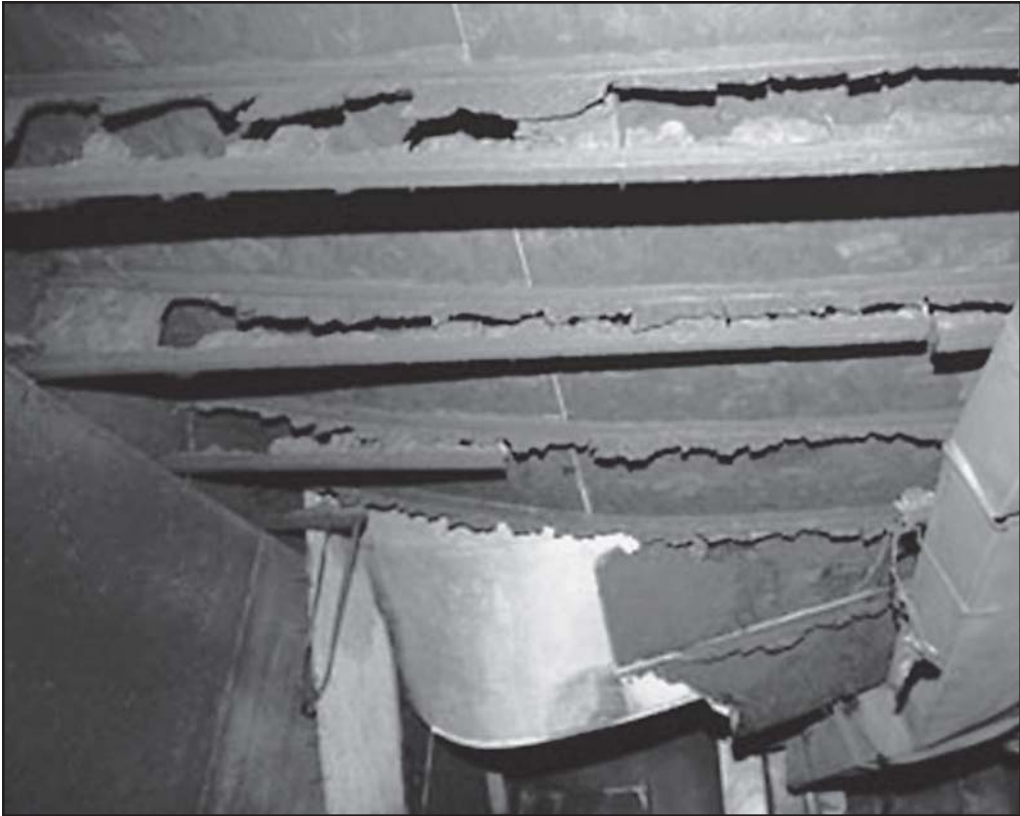
Fig. 23–4. The destruction of wood I-beam floor by fire
