PROCEEDINGS OF THE INTERNATIONAL CONGRESS ON SCIENCE AND TECHNOLOGY
FOR THE CONSERVATION OF CULTURAL HERITAGE, SANTIAGO DE COMPOSTELA,
SPAIN, 2–5 OCTOBER 2012

Science and Technology for the Conservation of Cultural Heritage

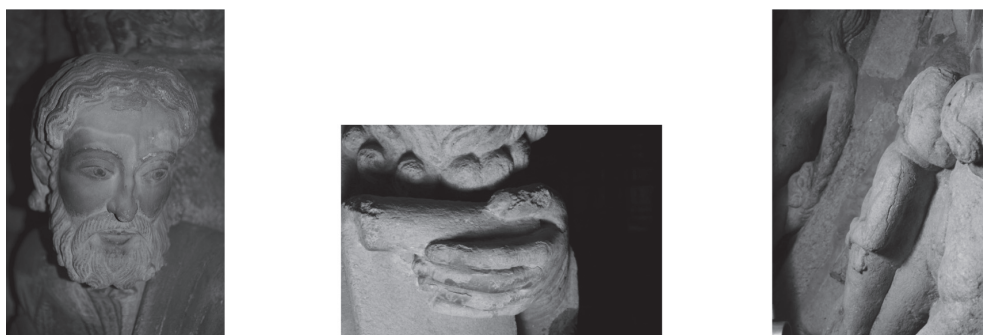
Figure 1. Deterioration processes affecting the Portico de la Gloria, from left to right: efflorescences on the edges of polychromy; arenization due to seritic alteration of the granite; microfractures.

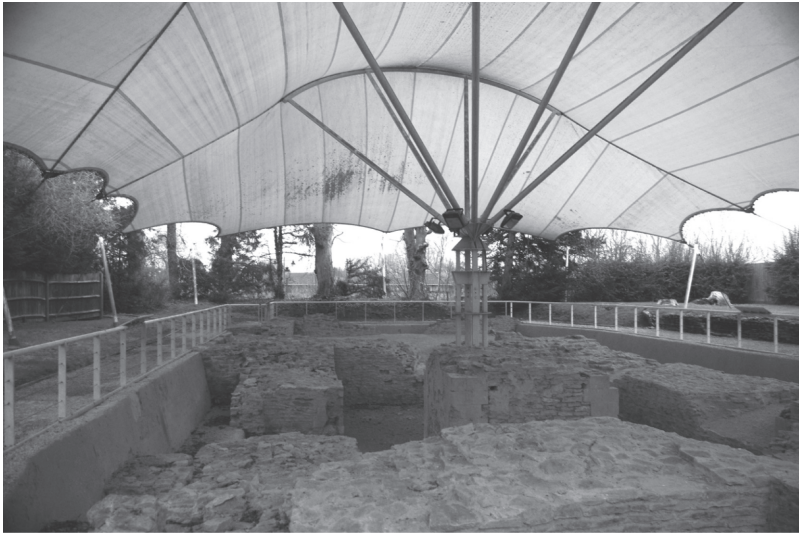
Figure 1. View of the Bishop's Palace archaeological site from the West.

Shortly after the excavation of the medieval palace in Witney (Oxfordshire) in 1984, the oolitic Cotswold limestone began to erode and salt efflorescences appeared on the stone surfaces (Historic Buildings and Monuments Commission for England 1988). The majority of the remains were then buried but the most significant elements, including the solar tower, were sheltered in 1991 with a polytetrafluoroethylene (PTFE) and glassfibre fabric open shelter (Fig. 1).

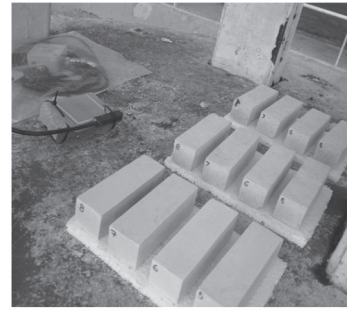
Figure 2. Surface wetness beneath and outside the shelter from the 07/08/2012 to the 22/08/12 (left) and soiling and decay stone sensors placed beneath the Bishop's Palace shelter (right).

In order to understand how shelters reduce environmental events causing stone decay such as temperature extremes, freeze-thaw cycles, relative humidity fluctuations, and wetting events, environmental parameters are being monitored both inside and outside the Bishop's Palace shelter in this study (Fig. 2). Temperature and relative humidity are being recorded through hydrochron iButton[®] loggers (DS1923, Maxim Integrated Products, range = -20°C to $+85^{\circ}\text{C}$ and 0 to 100% RH, accuracy = $\pm 0.5^{\circ}\text{C}$ and $\pm 5\%$ RH). These sensors have been placed over the surface of stone samples, in the shelter itself and outside. The surface wetness is measured with electrical impedance grids (TGP-0903, Tinytag leaf wetness logger, reading range = 0 to 100%, accuracy = $\pm 2\%$). These loggers have been placed inside and outside the shelter in a horizontal position to simulate time of wetness on horizontal stone surfaces. In addition, data regarding the amount of rainfall and wind speed and direction is obtained through a nearby meteorological station in Minster Lovell, located less than 3 miles from the site.

Limestone blocks of different expected durability have been used as soiling and decay sensors. Cotswold cream limestone is a heterogeneous local oolitic limestone very similar to the one used for the construction of the Bishop's Palace. Portland limestone is a widely researched bioclastic limestone more dense than the Cotswold limestone. In addition, a particularly vulnerable chalk

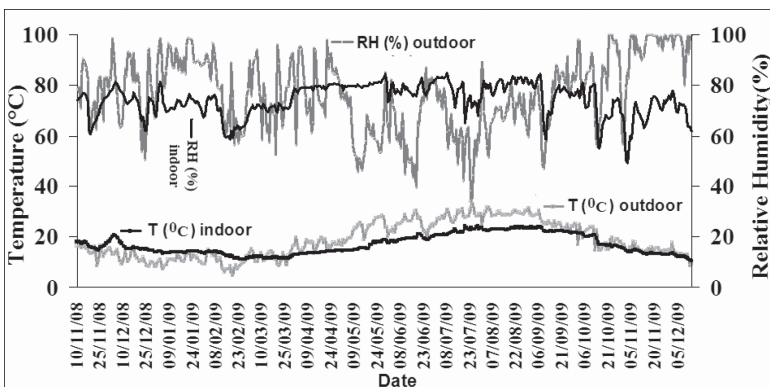
Figure 2. Indoor and outdoor temperature and relative humidity during the monitoring period.

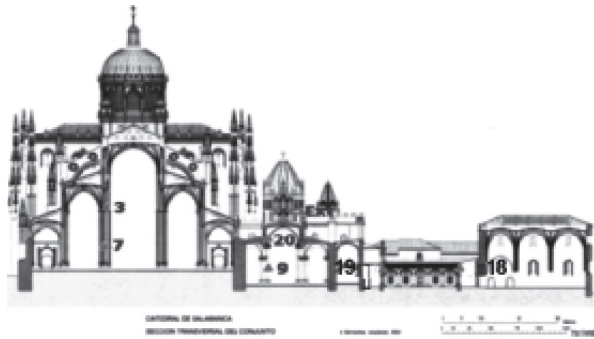
Figure 1. Sensor location in the Cathedrals Salamanca's cross section.

TESTO home. The location of all the sensors in the Cathedrals of Salamanca (New and Old Cathedral and Cloister) is shown in Figure 1.

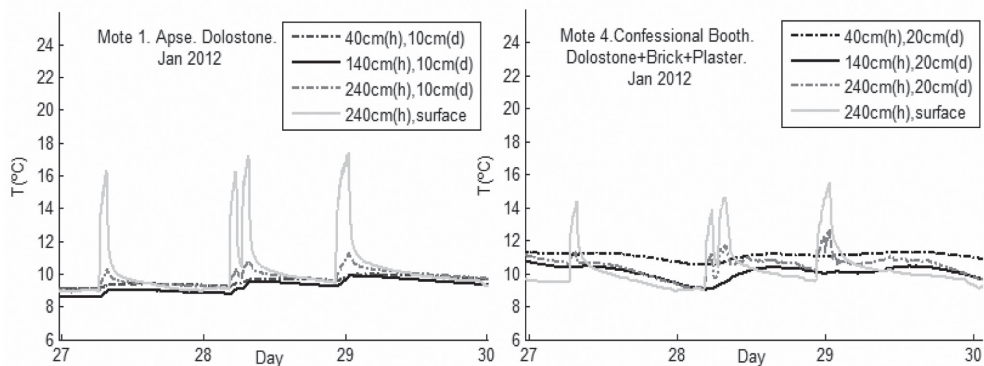
Figure 3. Comparison of the effect of the heating system based on the temperatures recorded for a given orientation at different heights (h) and depths (d) on different materials: mote 1 (dolostone), mote 4 (dolostone, plaster and brick).

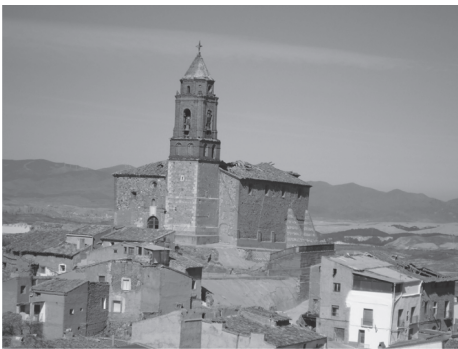
Figure 1. Church actual state. It is sited on vil-lage top. The roof is broken. Some of the neigh-bouring houses are collapsing.

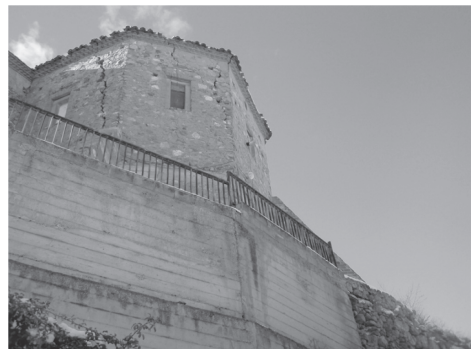
Figure 2. Actual church situation, over a retain-ing wall and very cracked, specially the apse.

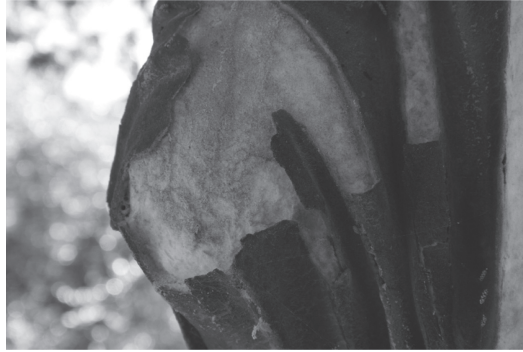
Figure 1. Severe deterioration on one of the marble sculptures studied.

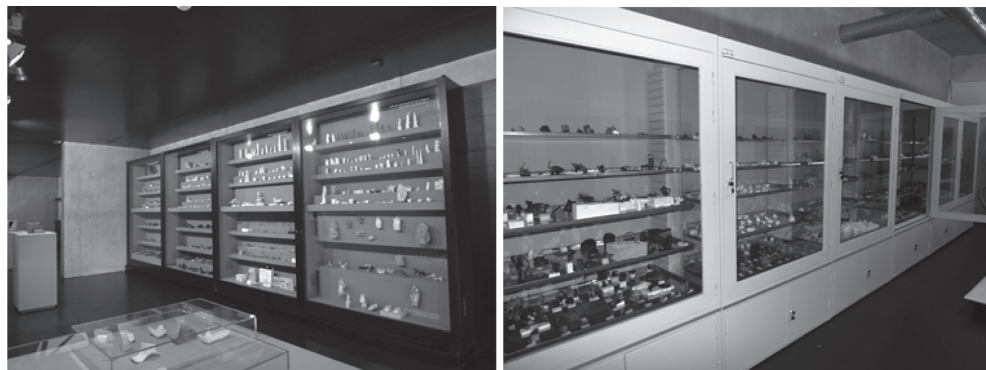
Figure 1. Photograph of the exhibition room (on the left) and the storage (on the right).

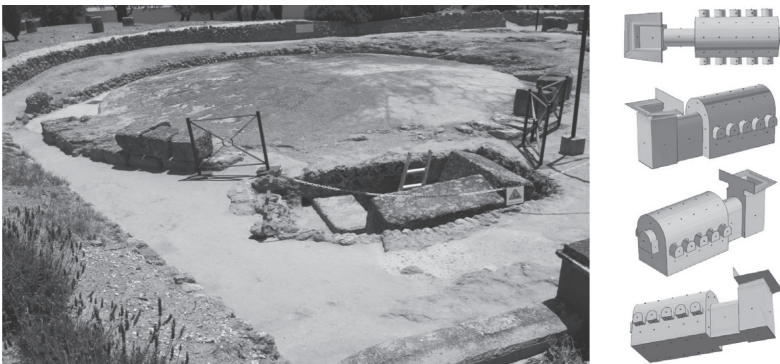
Figure 1. The Circular Mausoleum and its 3D rendering.

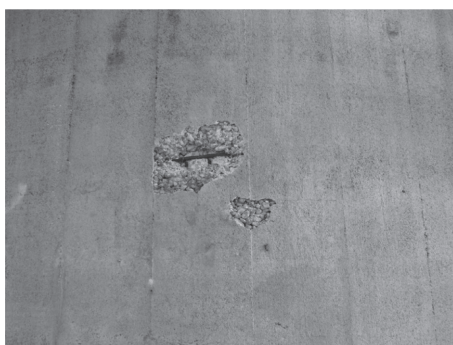
Figure 2. Spalling due to corrosion of reinforcement in the upper zone.

In the 1990s, vandalism left the inner metal structure visible, thereby requiring restoration work to counter the accelerated corrosion of the steel. Since this intervention, the most serious changes have derived from high environmental humidity, which has little by little caused corrosion of the steelwork and partial spalling of the concrete due to expansion of the iron oxides. On a purely aesthetic level, graffiti damage has had to be cleaned on several occasions.

As concerns the quality of the materials used, the sculptor's intention in his reinforced concrete works was to achieve a rust-coloured finish that would provide, from the start, the type of patina only time can give. Therefore, as far as can be gathered from the documentation gathered, the artist resorted to including steel shavings in the composition of the concrete with the aim of causing general corrosion so that the products of this corrosion would alter the original colour of the concrete. This solution involved a problem due to the microstresses produced throughout the mass from the expansive nature of the reactions, which has favoured the partial spalling.

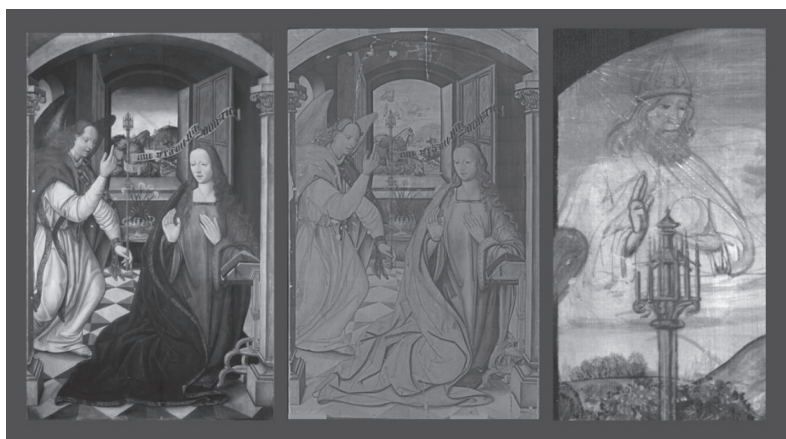
Figure 3. *The Annunciation* (Bartolomé de Castro, XVI Century). Lázaro Galdiano Museum (Madrid). Photography in visible range; broad band reflectography (900–1700 nm); detail on narrow band (1000 nm).

Tests on a 16th century piece of art being restored in the IPCE have been performed (Fig. 3). Five narrow band reflectographies, progressively increasing wavelengths, and a reflectography in broad band were performed. The images show that a greater transparency at higher wavelengths for blues and greens is achieved and the shaded drawing in the figures and robes also becomes more transparent. However, the intensity of the main drawing lines of the overall composition of the scene do not change. This result may provide information about the way of working in the workshop of the painter.

In addition, the reflectography performed at 1000 nm revealed composition changes in a more clearly way than the one performed on broad band. One of those changes is the presence of the figure of God Father in the sky, not seen in the painting to the naked eye (Figure 3). From the result of the broad band reflectography, one might think that this is a change of composition at the drawing stage, but, in fact, the different grey levels of this figure respect to the background, indicates that it is a paint rectification. The significance of this change has a meaning broader than a mere esthetic formulation and it could be related to religious matters, involving an old modification of the painting by a different artist. Other imaging

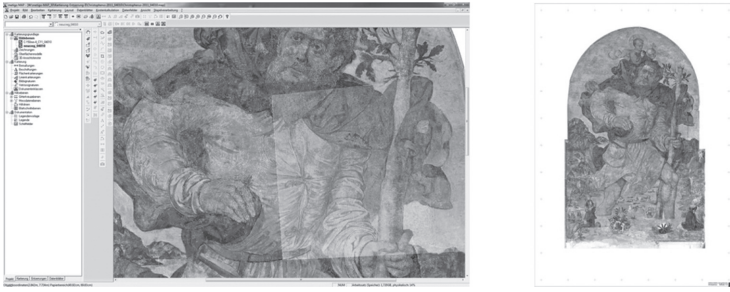
Figure 3. Detail rectification with image matching church Creglingen (Germany), St. Christopher, fokus GmbH Leipzig.

Correlation techniques provide automated measurements of subpixel precision for corresponding image points and congruently rectification. Therefore it is necessary to rectify one image to scale. The resulting rectified image is used as matching reference. The user has to define only an approximate rectangle on the first rectified image for each of the other images.

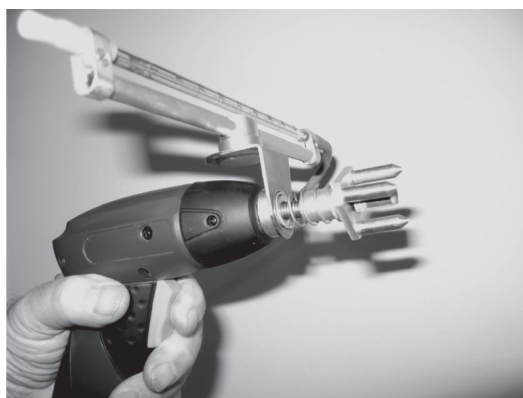
Figure 1. Pistol like device consists in a scaled capillary tube in a tube holder adjustable in horizontal or vertical position (swivel connected), a connecting plastic hose ended with an outlet hinged head with a three point support and cigarette filter “sponge” transferring liquid into measured surface, a switch for manual recording data, and a connection cable to data storage unit.

The version for *in situ* measurements is shown in Figure 1. The mechanical part of this pistol-like device consists in a scaled capillary tube or some other scaled glass tube in a swivel connected tube holder that is adjustable in horizontal or vertical position, a connecting

plastic hose, an outlet hinged head with a three-point support, a switch for recording the data manually, and a connection cable to the data storage unit.

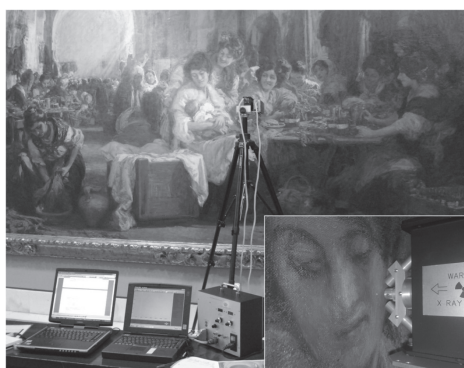
Figure 1. *In situ* XRF analysis of Gonzalo Bilbao's *Las Cigarreras*.

The principal aim of the present research was to identify pigments used by Bilbao through different periods of his artistic activity, as well as to find out what kind of preparation/priming he applied on canvases. There was a major interest in finding out, whether his palette and the system of preparing the painting ground were changing through time, according to new materials and pigments that emerged especially at the end of the 19th and in the beginning of the 20th centuries. The analysis was carried out by a non-destructive X-ray Fluorescence (XRF) technique (Fig. 1). We used a portable equipment composed by an EIS X-Ray generator RX38 with a W anode and a SDD detector with 140 eV of energy resolution. All paintings were measured under the same fixed conditions, which allowed the direct comparison among the results of the different points analysed and a semi-quantitative analysis. These conditions were: 80 μ A of cathode

current, 29.5 kV of applied high voltage and 300 s of preset live time. This non-destructive analysis offers the identification of inorganic materials on the basis of their characteristic chemical elements present in an irradiated point. The pigments were identified according to the characteristic energy (keV) of the X-ray peaks in each obtained spectrum, which correspond to specific chemical elements (Volpin & Appolonia 2002, Seccaroni & Moiola 2004, Artioli 2010).

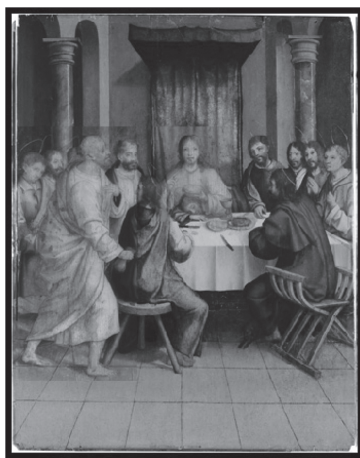
Figure 2. “Last Supper”, Photography and IR Reflectography, reveals well-defined outlines and very detailed demarcation of the shadow areas in all the elements depicted. Can be assumed as an exception.

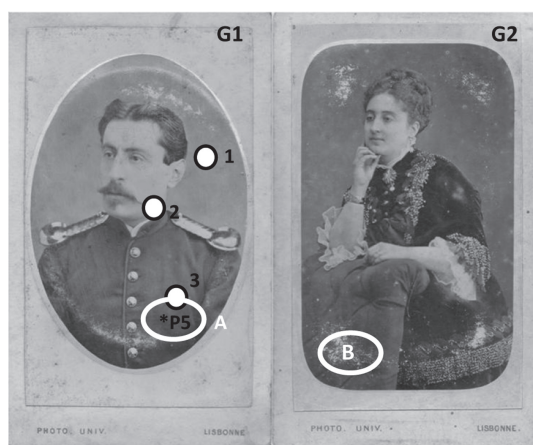
Figure 1. Photographic samples: G1 and G2 (A. Solas, c. 1896—collection M. Peres).

The experimental set-up for EDXRF analysis consists of a commercial X-ray tube (PW 1140; 100 kV, 80 mA) equipped with a molybdenum secondary target and a Si (Li) detector, with a 30 mm² active area and 8 μm beryllium window. The analyzed areas (Fig. 1A, B) were ellipses with the axes dimensions of 1.0 cm and 1.4 cm.

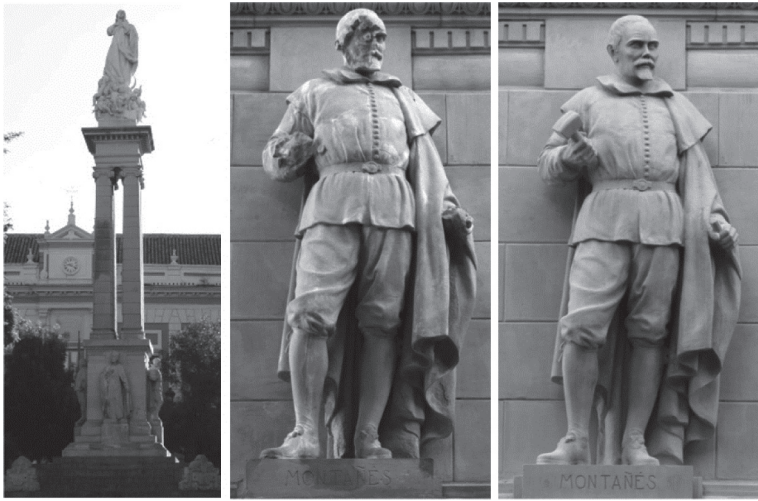
Figure 1. Immaculate Conception monument (left); Martínez Montañés sculpture before and after restoration (center and right).

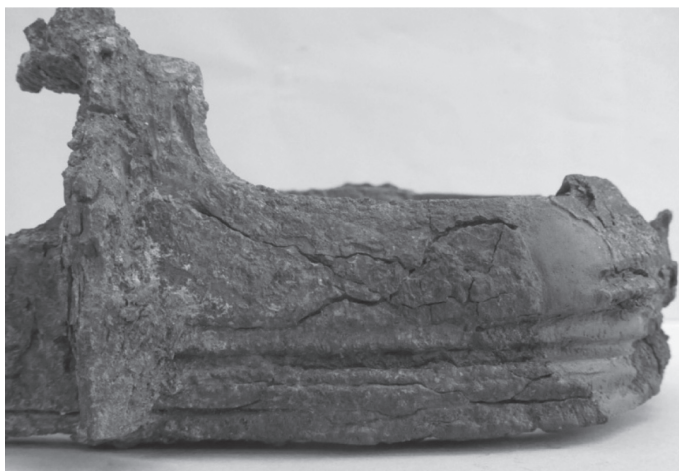
Figure 1. Recovery of the fuller in the core of the falcata after treatment.

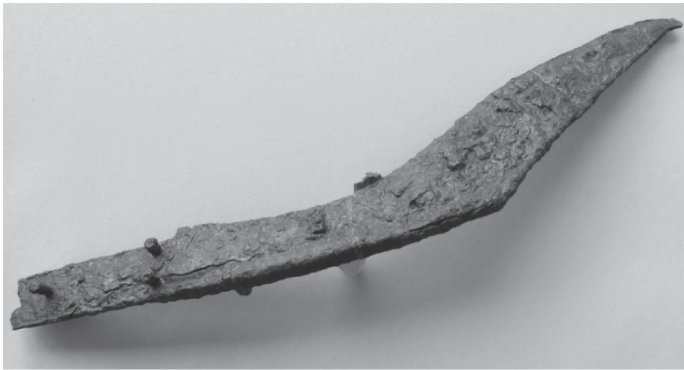
Figure 2. Falcata-style knife after laser restoration remaining the rivets from the handle.

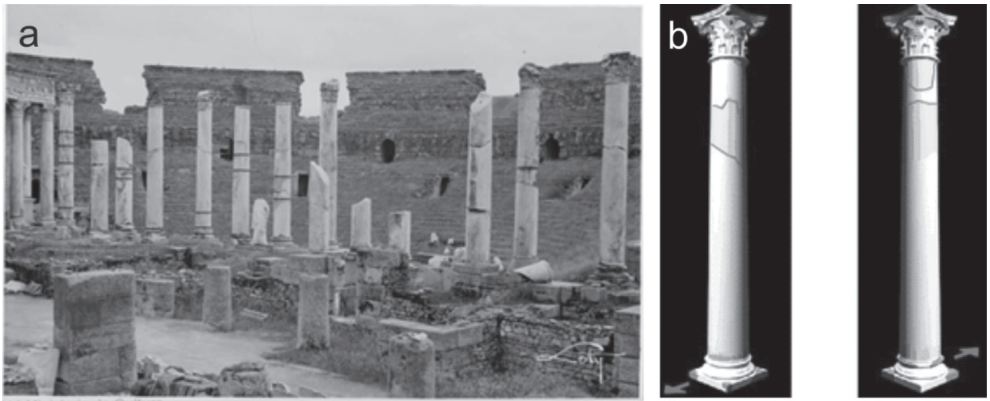
Figure 1. a. Structural consolidation and reintegration of elements LOTY Archive (07606), IPCE. b. Treatments on marble elements. Source: Agora S.L.

- General cleaning with an alkaline solution in order to neutralize the acidity of the substrate, due to accumulation of pigeon droppings.
- Repair and fixation of elements with epoxy resin and plaster.
- Removal of former decayed restorations such as iron staples or epoxy resins.
- Treatments on marble elements (Fig. 1b).

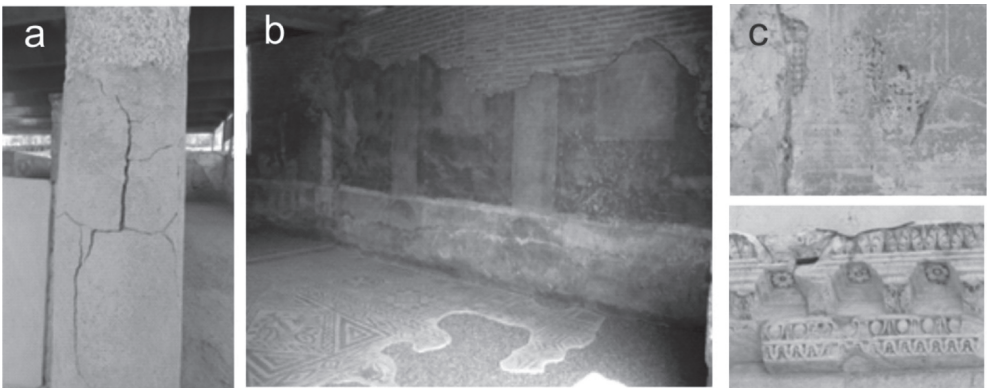
Figure 2. a. Restored column; b. Damages caused by cement pavement in Basilica House; c. Metallic elements.
