Lucia Toniolo
Maurizio Boriani
Gabriele Guidi *Editors*

Built Heritage: Monitoring Conservation Management

Fondazione
Politecnico
di Milano

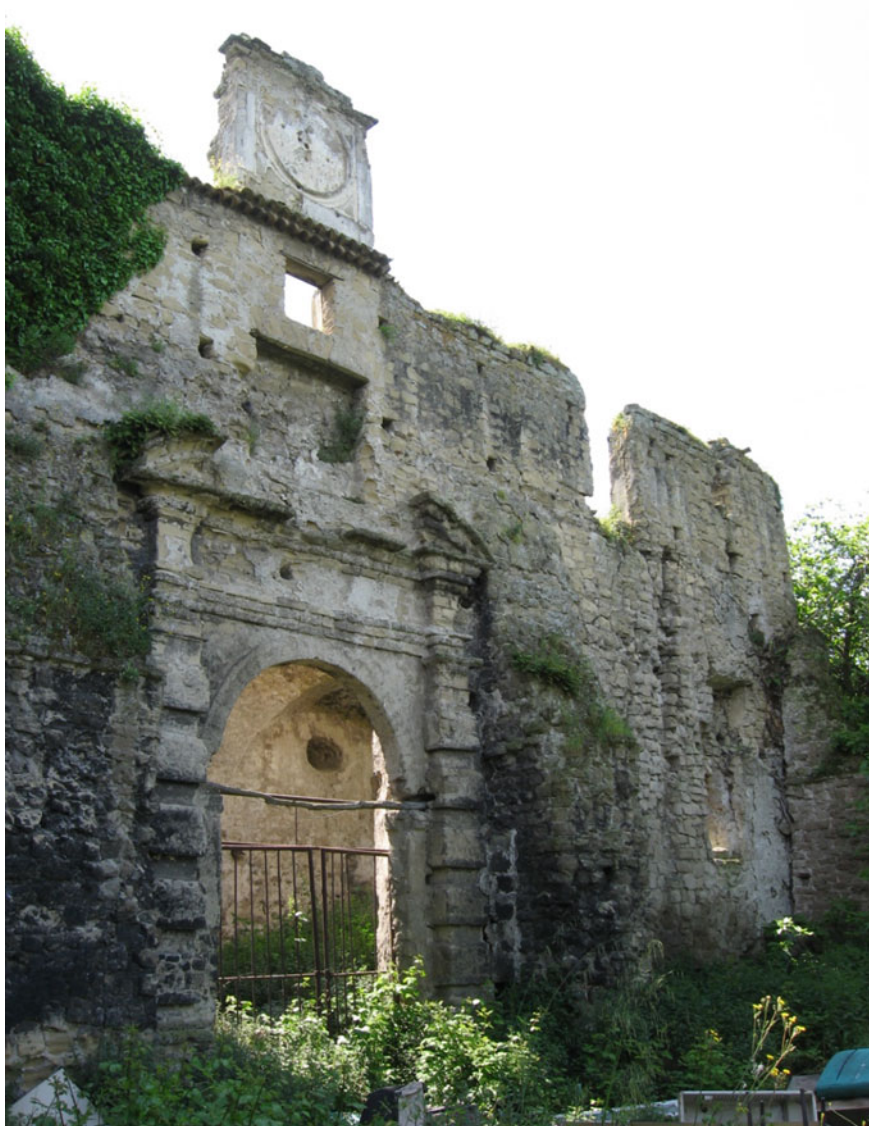
Pozzuoli (NA), Frà Vecchia farmhouse (XVIII sec.). Main facade of the manor house

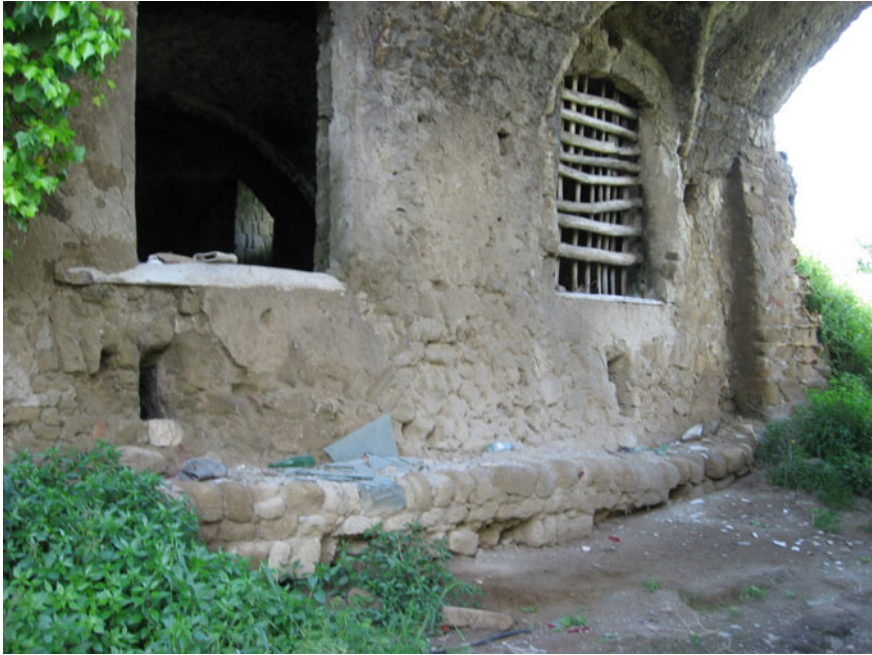
Pozzuoli (NA), Frà Vecchia farmhouse (XVIII sec.). Exterior view of the “order to sit”, where the harvest was positioned (note the presence of the wooden elements used instead of the iron for the closing of the compartments-window)

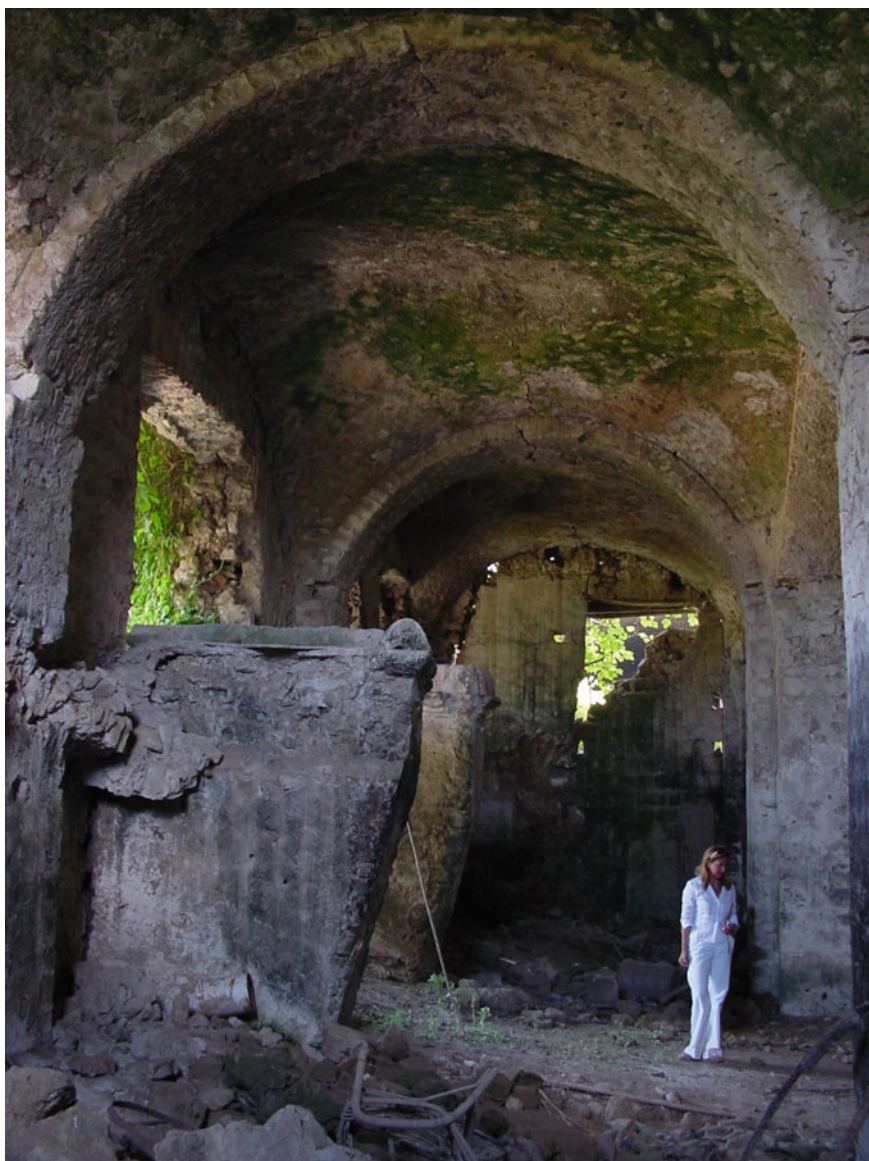
Pozzuoli (NA), Frà Vecchia farmhouse (XVIII sec.). Internal view of the cellaio

or simple agricultural warehouses. In many cases, they are areas used for wine and olive oil processing, with torches, pressing vats, and wine aging barrels. Except for more complex cases, cellars have a rectangular shape and are covered in *Lamia*, i.e. masonry barrels vaults; they are characterised by a bare prospect on the short side, with an opening in the centre with a rectilinear trabeation surmounted by a square window, enclosed by wooden lattices to ensure internal ventilation. Many rural houses were provided with tanks, an environment under the threshing yard or the outside yard sealed in *cocciopesto* or *lapillus*, which, by storing rainwater, ensured the irrigation of appurtenant fields even in periods of low rainfall. This shows how the types of settlements spread around the Phlegrean agricultural land have been influenced by the landscape features of the 'burning fields' (Picone 2005b, pp. 153–159) and by the agricultural use of its soil. However, we should not underestimate the influence that the type of ownership (private or religious) and the sheer size of the estate have had on the conformation of these architectures. Some poor or lofty formal solutions are in fact justifiable on the basis of whether the building belonged to noble families, landowners or to simple peasants. The presence of a private chapel on the farm is usually due to the historical monastic property of the farm where it is located.

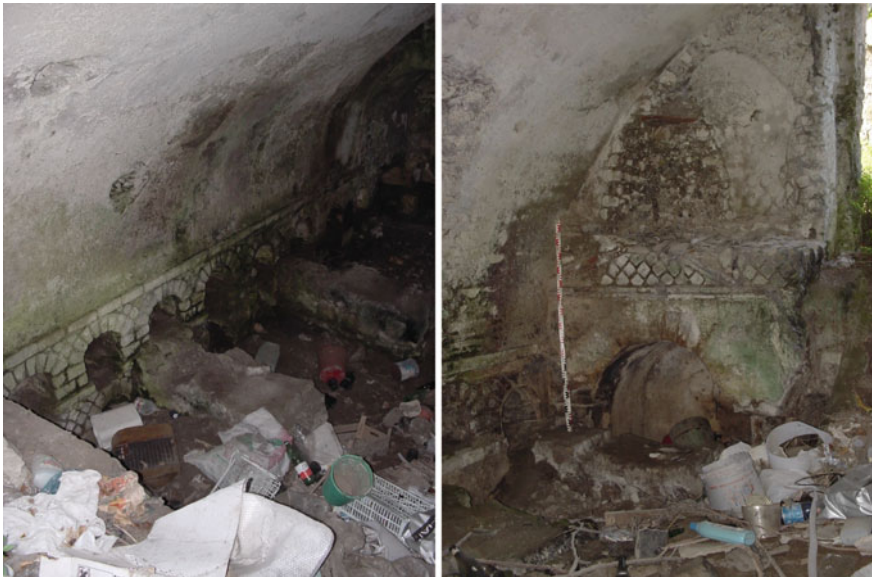
Pozzuoli, Masseria Caleo farmhouse. Remains of the Roman ninfeo reused inside the cellaio and remains of walls in opus reticulatum reused in the structure of the furnace (picture by R. Picone)

The two case studies chosen are representative of some of the aspects set out above; one, related to the via Consolare Campana, consists of a farmhouse built on pre-existing Roman ruins testified by the presence of a nymph in opus reticulatum, and another, relating to a more complex farm house, was built in the eighteenth century for the production of wine. In both cases, we highlight the conservative issues and the recurrent mechanisms of degradation and damage, to detect the correct methods for the conservation of this ‘fragile’ asset.

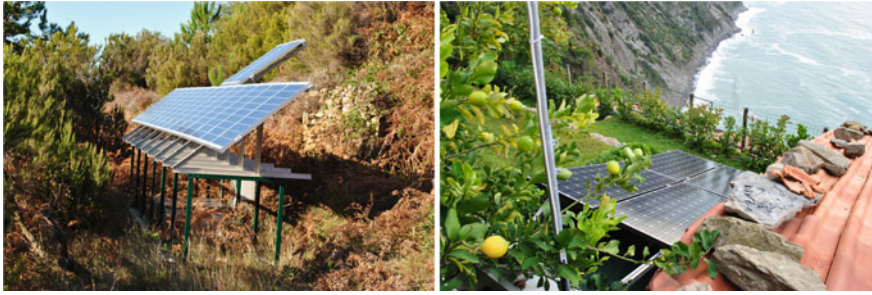
Fig. 1 PV cells already installed in the world heritage property

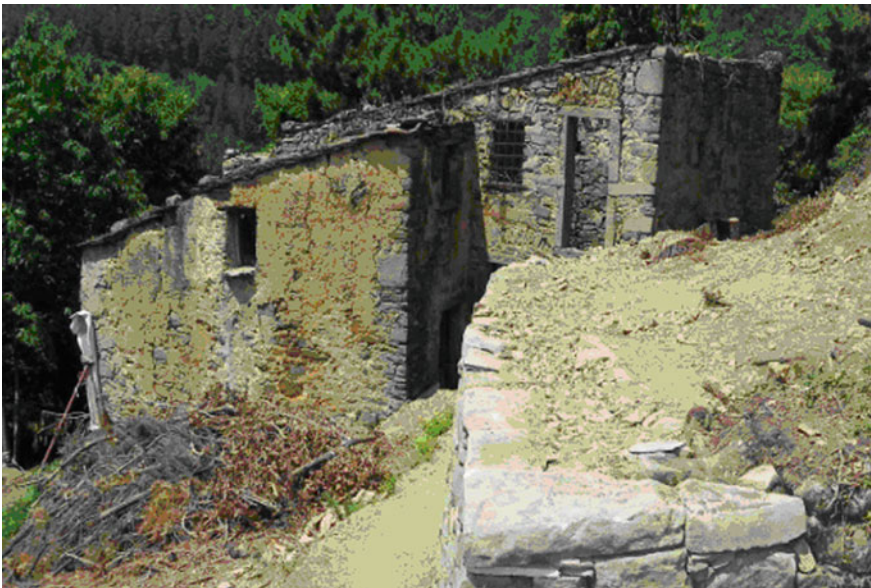
Fig. 2 Case study n. 1 located in Cacinagora. View of the double-cellular building

The first two examples are located in Cacinagora, near Riomaggiore, and feature 1,437 Degree Days, in climatic zone D, corresponding to a heating season of 166 days, from 1st November to 15th April (Figs. 2, 3, 4 and 5).

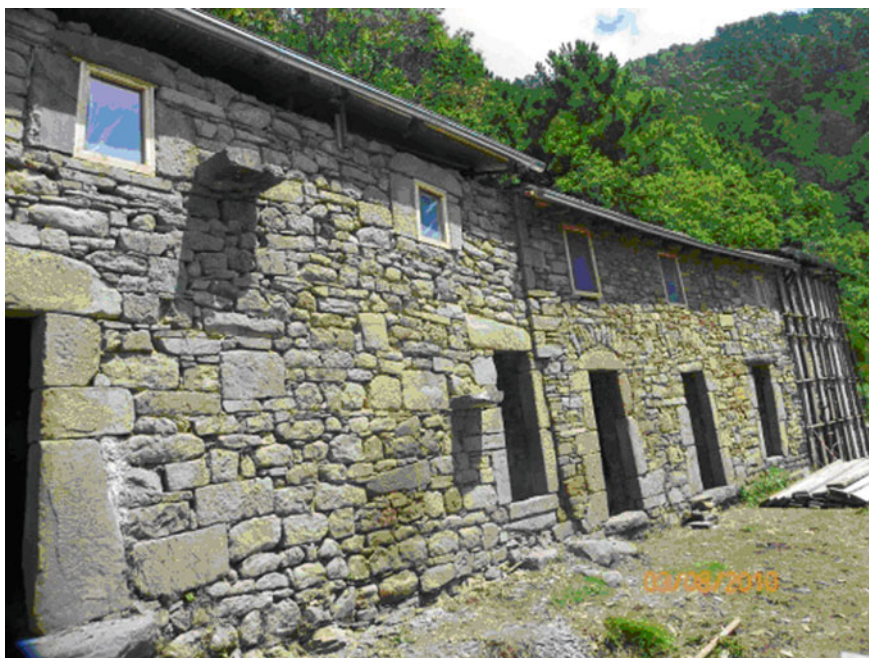
Fig. 4 Case study n. 2 located in Cacinagora. View of the multi-cellular building

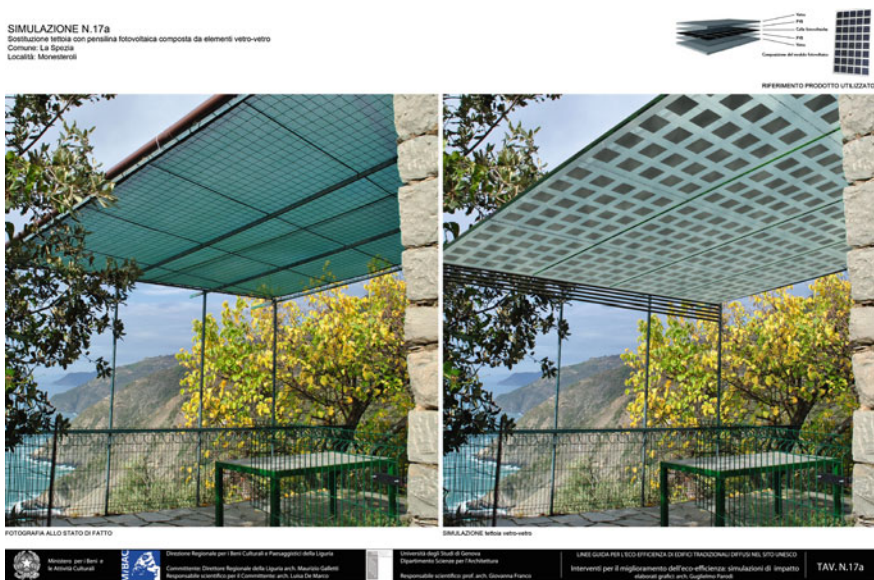
Fig. 8 Photo simulation of the substitution of a plastic shelter with PV glass cells

Creativity can find expression through the design of components that can be easily integrated with traditional architecture, hand in hand with the most recent experiments in the field of new materials, i.e. the production of organic photovoltaic cells, of films or thin wraps that can be transferred on other surfaces through a photographic print process, of photovoltaic elements on flexible membranes, therefore more suitable for the realisation of canvases or added elements (Fig. 8).

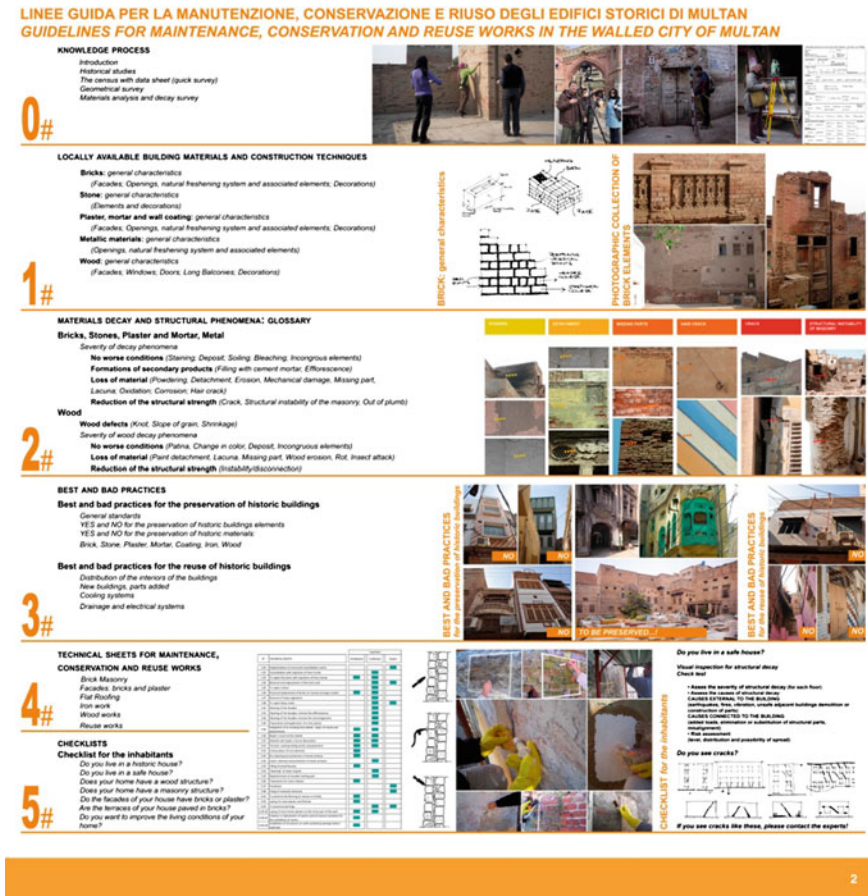
Fig. 6 Guidelines for maintenance, conservation and reuse works in the Walled city of Multan: the structure of the book

In a such difficult context, the enhancement of the Walled City of Multan should provide synergistic actions for the conservation and rehabilitation of historical heritage (Fig. 6). The Guidelines are just designed as a friendly tool but at the same time a technical guidebook with indications and virtuous suggestions (best and bad practices, technical sheets for interventions, check lists) for different levels of

intervention: maintenance, repairs and restoration. An urban regeneration process that starts directly from the main users, the inhabitants, through works realized in self-made: choices easily feasible, economic, easy to implement and capable to give results in short times. The structure of the Guidelines is designed to develop, at first, the knowledge and awareness of designers and inhabitants about the importance of the historical context in which they live: historical research, geometrical survey, materials historically used in the construction of buildings and decay phenomena survey. A *Glossary* of materials decay and structural phenomena observed in the historic buildings of the Walled City helps designers, engineers and inhabitants to recognize if their buildings require urgent actions or are affected by only superficial decays.

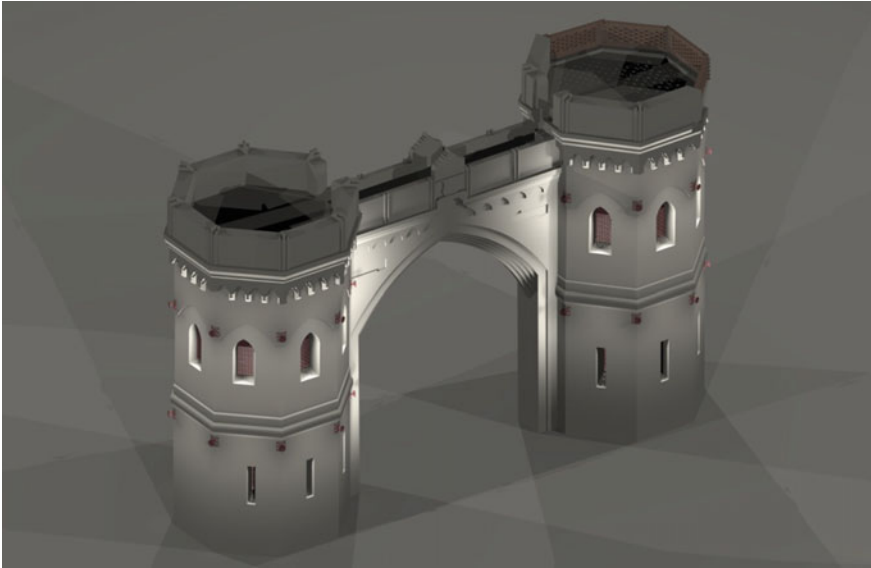
Fig. 7 Haram Gate project: 3 dimensional model of the Gate (by Andrea Garzulino)

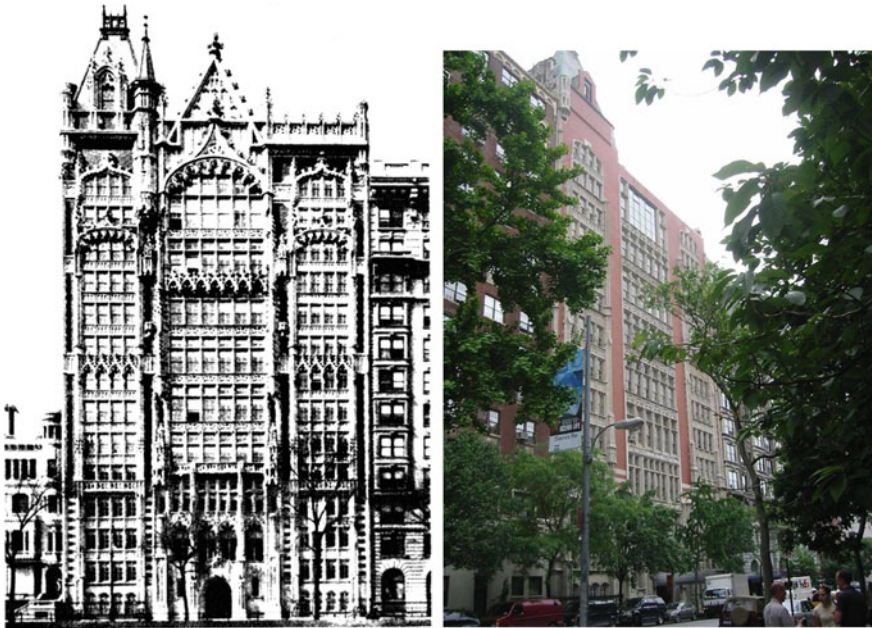
Fig. 1 The upper west side building façade before the majority of the terra-cotta decoration (*left*) was removed in the 1950s and how it looks today after the repair campaign (*right*)

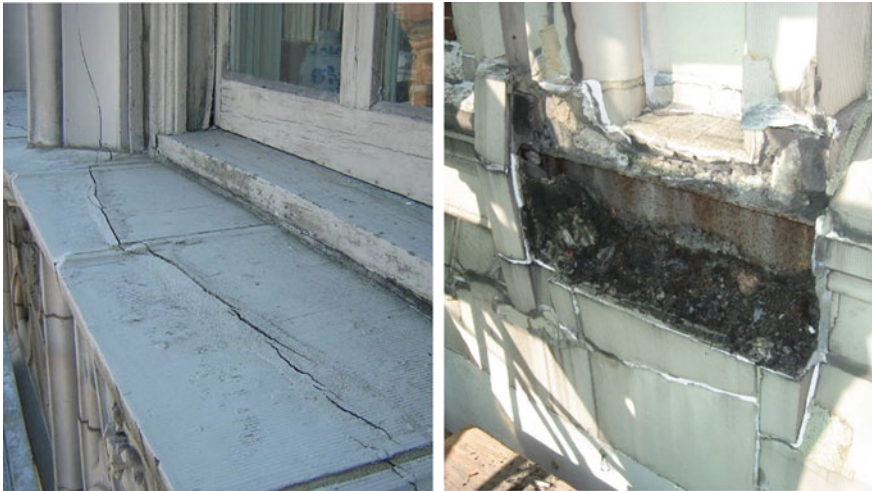
Fig. 2 Upper west side building. Fractured terra-cotta sill: cracking propagates along the entire length of the sill and up into the vertical pier (*left*). Extreme deterioration of terra-cotta ashlars due to the corrosion of the steel beam behind them (*right*)

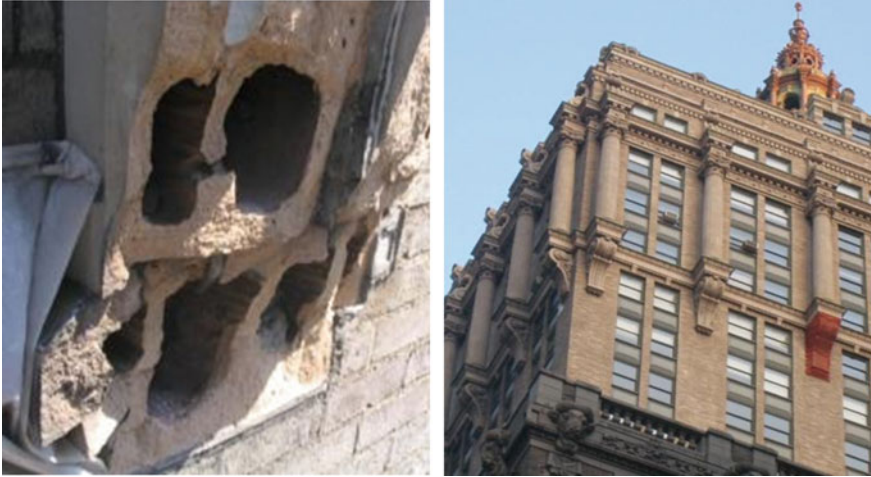
Fig. 3 Fractured terra-cotta bracket (*left*); brackets are located below the three-storey tall columns at the 28th floor of 230 park avenue, New York City (*right*)

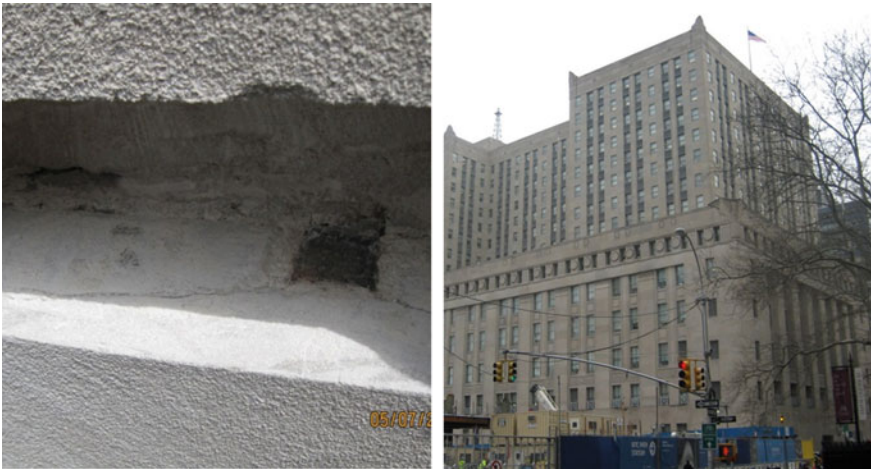
Fig. 4 A crack, originated by the corroded steel cramp and exposed by the removal of the adjacent stone unit, is visible at the cut line of the probe but not yet visible on face of the stone (*left*). Limestone façades of the office building (*right*)

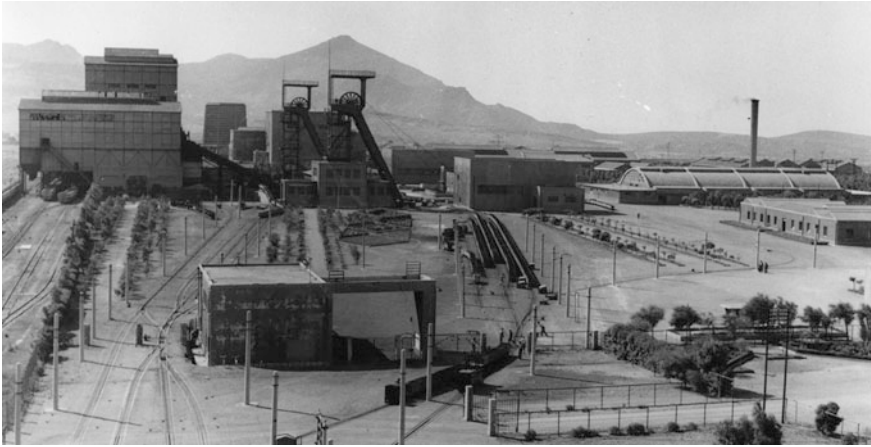
Fig. 3 The “Great Mine” of Serbariu and its infrastructures

sustainable recovery based on the culture’s economy and the search for renewable energy. The program focuses primarily on the recovery of the ‘Great Mine’ of Serbariu that, in the time frame of 10 years, has been turned from a symbol of the industrial modernization into a centre of cultural and technological development. And thanks to the restoration project for this industrial landscape, characterized by its rationalist architecture, Carbonia won the *Landscape Award of the Council of Europe* in 2010–2011. It is then added to the most famous European cases regarding the restoration of a company town, a large development project based on the construction of an integrated industrial landscape (Fig. 3).

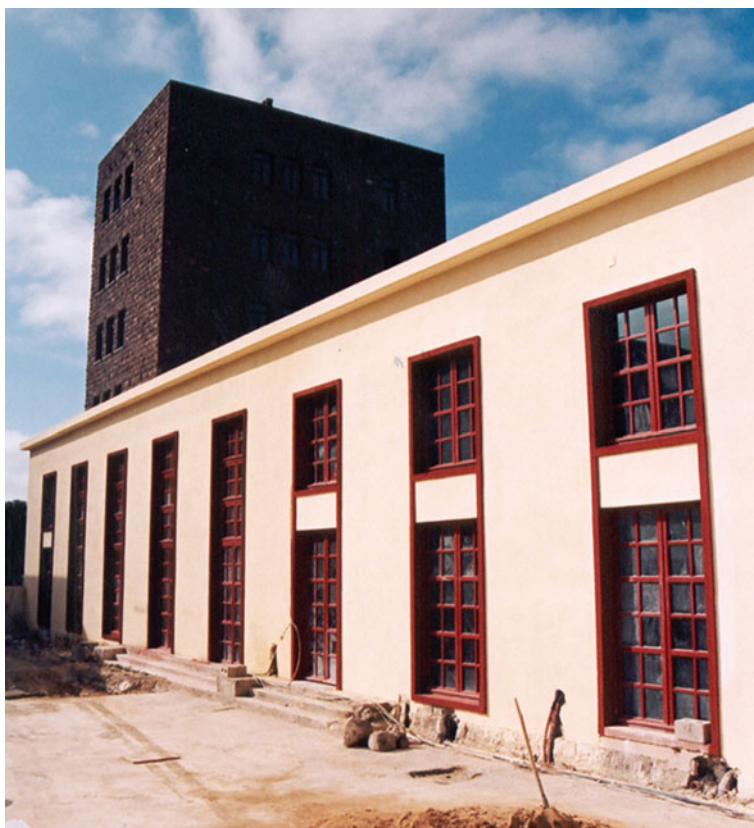
Fig. 9 The restoration of the *Dopolavoro* with the design of the gutter

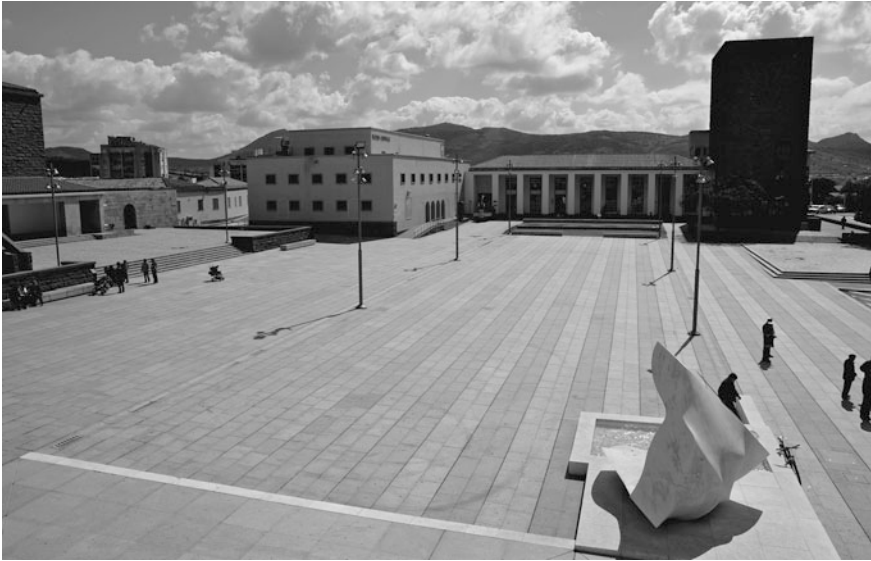
Fig. 11 Piazza Roma. Restoration of the public space

The urban regeneration project, organized by the City Hall-University Laboratory, has reconstructed the original concept of the central square, transforming it into a pedestrian space with a homogeneous and “abstract” stone surface recovering also the meaning of “metaphysics” of the great urban space and with the inclusion of a ‘contemporary work of art, the “empty fragment” by Pomodoro (Fig. 11).

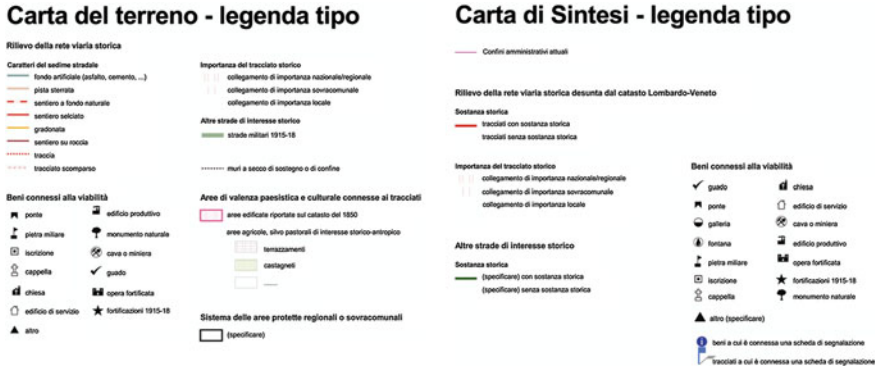
Fig. 3 Map of Terrain and Synthesis Map legend to survey historic roads analyzing materials, building techniques, decay problems and transformations, to evaluate their level of conservation and permanence to define conservation and rehabilitation treatments

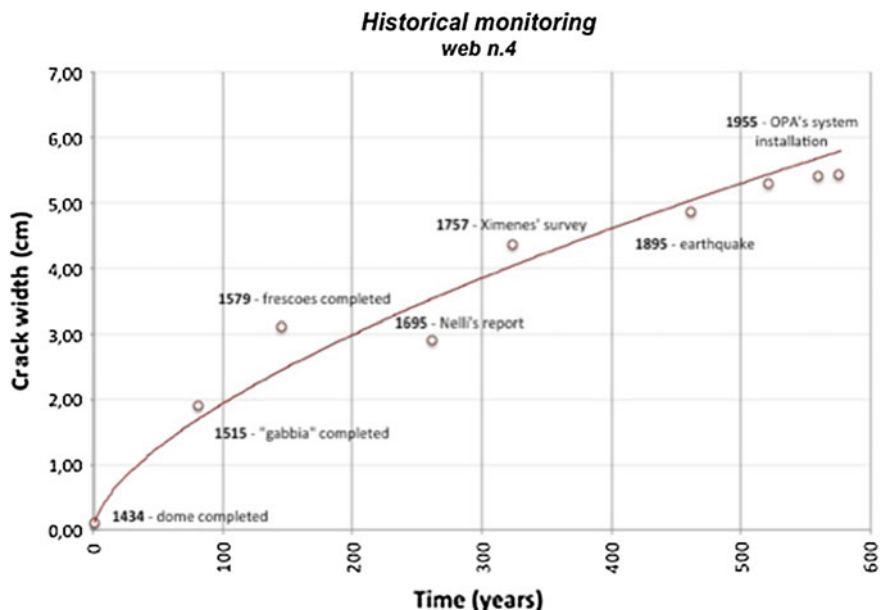
Fig. 1 Evolution of the main crack amplitude in web n. 4, Santa Maria del Fiore dome from the construction to date

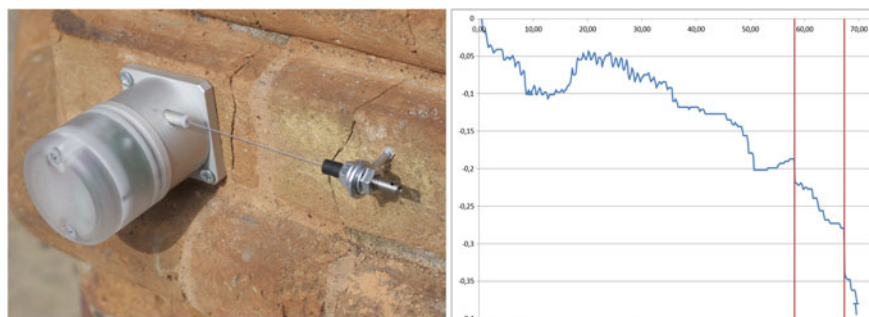
Fig. 3 When the damage mechanism is well understood, even very small, single point instruments (in the picture, one by Fiama srl, Parma) can allow to precisely control the evolution of cracks and to check the reaction of the building in case of singular events (in this case: earthquakes)

quantities to be monitored: the more meaningful ones for the stability of a structure. This process requires not only a previous clear identification of the expected behaviour of the structure, which can only derive from a deep knowledge of the past movements and of the characteristic parameters of the structure, but also, consequently, a critical classification of the detected parameters (crack widths, temperature variations, inclination, levels, etc.). What is clear is then the need, in the design of a monitoring, to organize the information acquired, or rather, their classification in terms of relevance. This classification needs to be assessed in relation to the peculiar history of damage and deformation of the monument. Ultimately, the monitoring system must be designed not only to be complete and exhaustive, but especially targeted, and therefore a minimum, like every intervention (Fig. 3).

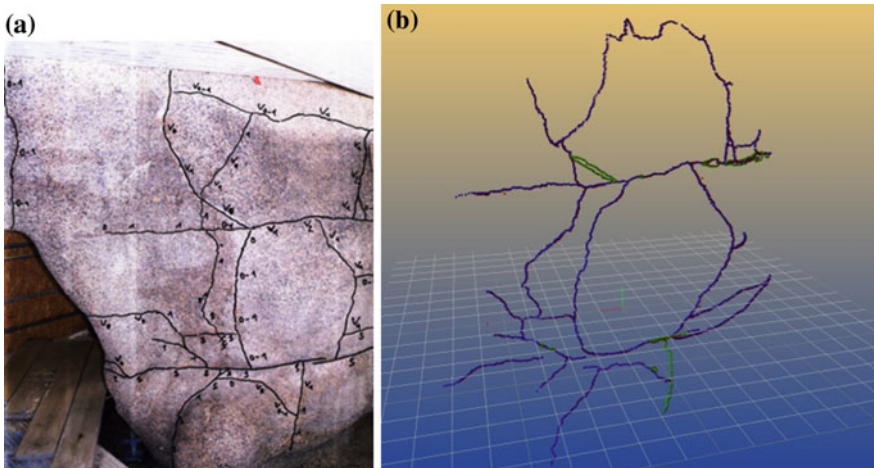
Fig. 6 **a** Manual mapped cracks on the cow sculpture of the Giebichensteinbrücke. **b** 3D visualization of the cracks with the tracking system

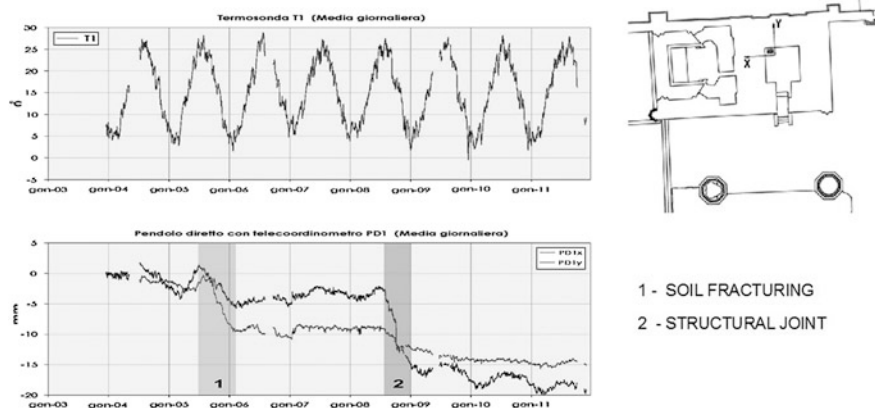
Fig. 8 Complete history of the displacement components measured by the direct pendulum with the indication of the intervention phases (soil-fracturing and structural joint execution)

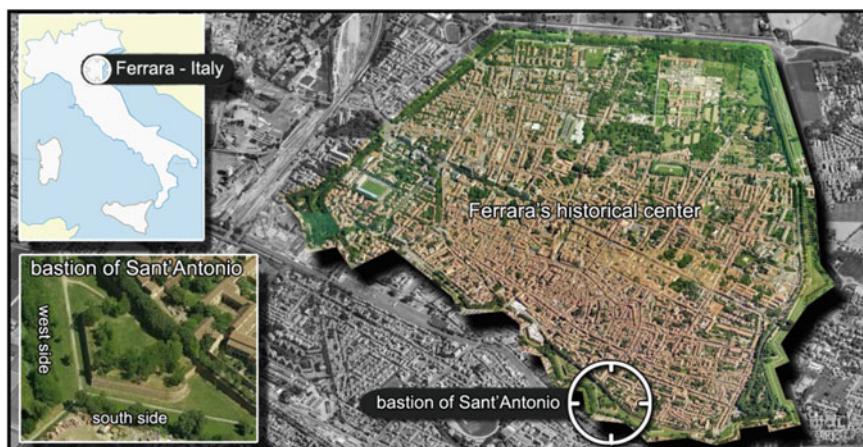
Fig. 1 Ferrara's historical center and the bastion of "Sant'Antonio" of the ancient walls

which brought cycling and pedestrian routes on the external perimeter, along with restoration of the brickwork where the masonry was seriously damaged. The paper focuses on the bastion of "Sant'Antonio" (Figs. 1 and 2), which has the characteristic shape of a "spike". The outer wall of the bastion presents a remarkable slope, a height between 7 and 10 m and has a constant thickness of 85 cm. The wall was originally leaning against numerous counterforts, placed at regular intervals within the structure. Because of the action of the ground and the settlement of foundations, the wall is now detached from the counterforts, which have lost their function of support. The static situation of the bastion is further aggravated by the presence of tunnels that were dug during the Second World War to protect the population by aerial bombing (Fig. 3). Moreover two major near-vertical cracks are present on the wall in correspondence of the tip of the bastion (Fig. 2b, c) and other diffuse lesions were observed on the internal counterforts. The geological survey of the ground showed a fairly homogeneous stratigraphy compatible with the presence of the ancient riverbed of a branch of the Po river, which in the past centuries supplied water to the moat of the city walls.

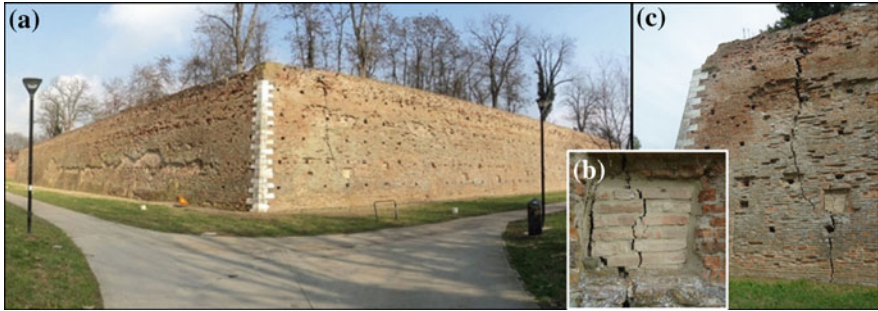
Fig. 2 a The tip of the bastion of Sant'Antonio and b, c detail of one of the major cracks

On May 2012 two major earthquakes occurred in the Po river valley (Scognamiglio et al. 2012; Pellegrinelli et al. 2014), causing serious damages in many buildings in Ferrara and in the surrounding area. As a consequence of the seismic events the cracks of the bastion visibly increased and other minor ones took place. In order to

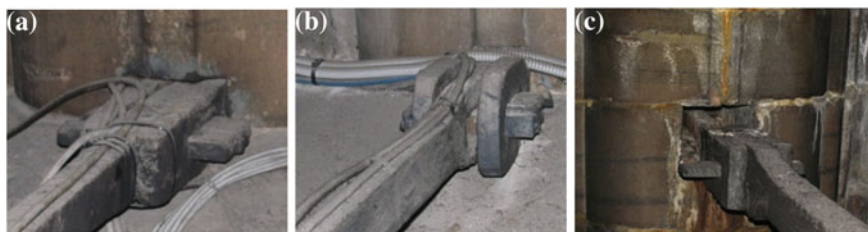
Fig. 2 Typical appearance of ties in the Cathedral of Milano

During the on-site inspection, 51 ties were examined visually, building up a photographic database and measuring their average cross sectional and length dimensions (Fig. 1, Table 2). Based on the results, three types of tie anchorage into the gothic arches under the vaults were distinguished: Fig. 2 shows typical anchorages of the inner lateral nave (Fig. 2a, b) and the main nave (Fig. 2c) with the visible part of the clamping inside the masonry structure. These different types give valuable indications regarding the construction period, since types in Fig. 2a, b are observed in two different parts of the structure, representing possibly two different construction periods. Moreover, on one of the historical photos provided by the archive of Fabbrica del Duomo (Fig. 3) two different parts can be distinguished in zone of the main nave vaults; possibly corresponding to different construction periods. As for the appearance of the ties, their cross section is rectangular and oriented vertically, covered with a layer of rust—typical for the wrought iron (Fig. 2).

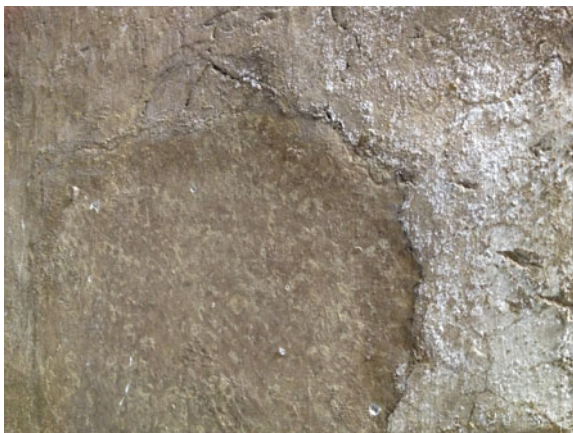
Fig. 9 White efflorescences are concentrated alongside the border of a patch which is composed by a different cement mix respect to the surrounding matrix

On the monochrome wall (NW wall) four samples have been collected by light brushing on the plaster surface. The decay morphology corresponds to micro blistering and white efflorescences as it is possible to see in Figs. 9 and 10.

Efflorescences are mostly localized close to recent cement plastering. On the plaster surface it is possible to observe also some patches probably composed by a different cement mixture. The white efflorescences are concentrated alongside the border of the patches described above, most probably due to a difference in the porosity distribution in between the matrix cement plaster and the cement patch (see Fig. 10). The same decay pattern is visible where the original white plaster is still present. These salt formations have been sampled and analysed by means of X-ray Diffraction (X Panalytical X'Pert PRO). The results are showed in Table 1. It is possible to see that the main soluble salts responsible of the micro-blistering are nitratine (NaNO_3) and gypsum ($\text{CaSO}_4 \cdot 2\text{H}_2\text{O}$); it is possible to hypothesize that nitratine is coming from the cement matrix.

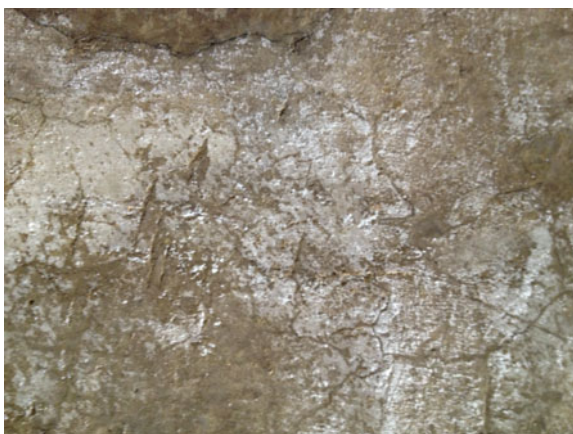
Fig. 10 White efflorescences are spread all over the surface but the patches

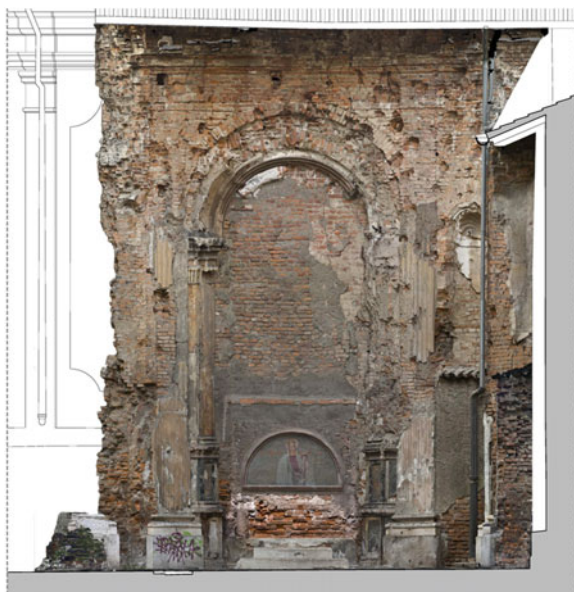
Fig. 2 3D Model with application of the photomosaic for the generation of the main façade photoplan

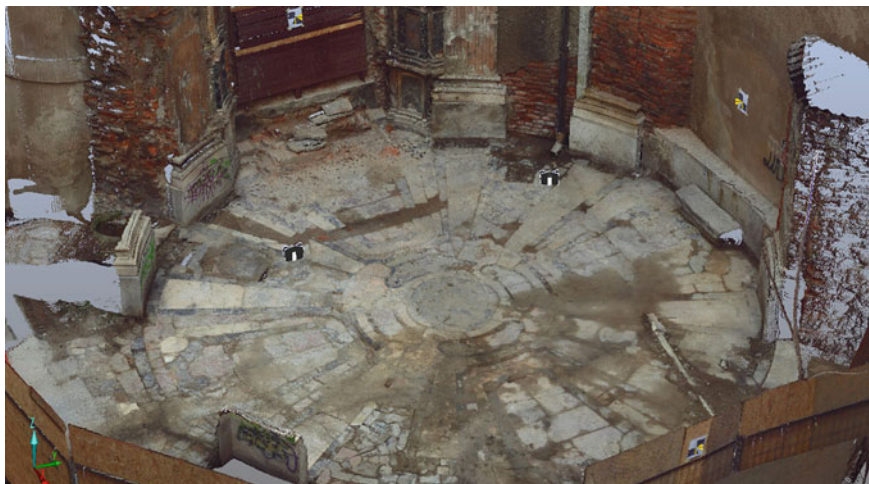
Fig. 3 Axonometric view of the point cloud, in light grey lack of data caused by the position of the scanner

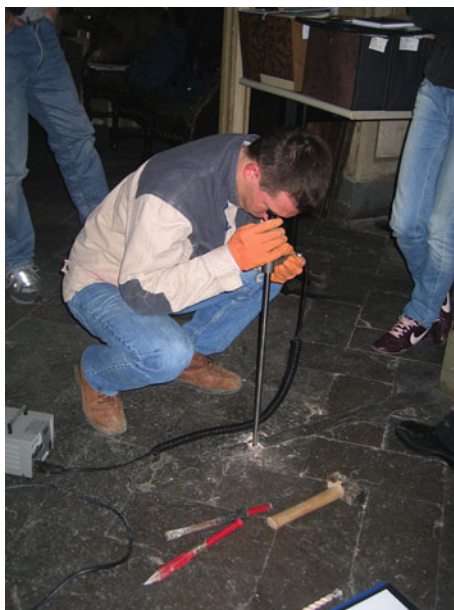
Fig. 7 The video endoscopy for the investigation of the features of the vaults between the basement and the Capitolò d’Estate

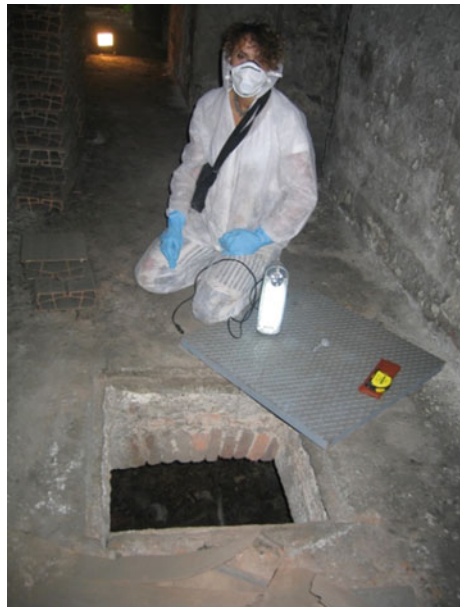
Fig. 10 The inspection and survey of the sepulchers that still keep the human remains, leaning inside with the chest

The urgency conditions requested to acquire data on the places’ consistency and conditions that could made it possible to recognize the critical situations in terms of safeness and to identify the processes, the causes and the extent of decay. This, having to avoid interruptions in the Archive activities and having no basic documentation at all, not even the boundary delimitation of the places (see Fig. 10).

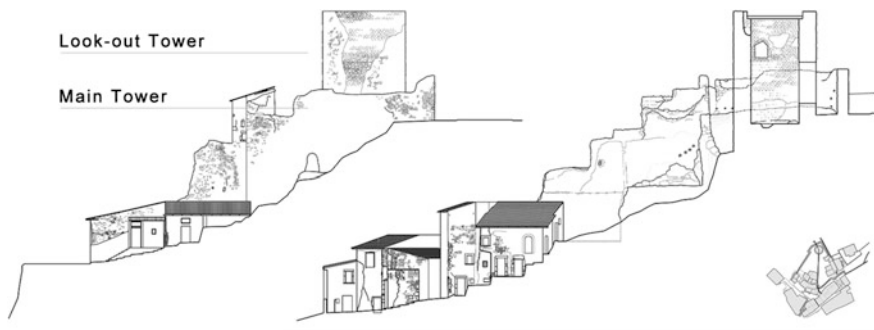
Fig. 4 The lateral view of the wall enclosure and section through the look-out tower

The first step included both the carrying out of the geometric-architectural on-site survey and data research based on historical documents from published works and archives. On the bases of the first set of results, a subsequent interpretation step was performed. This last aimed to outline: (i) the principal evolutionary phases of the monument by identifying—through a second on-site investigation—the signs and traces of historical or recent transformations; (ii) the weaknesses or critical points of the masonry complex (e.g. structural vulnerabilities or damage) as well as its favourable aspects (e.g. its historical value, but also positive constructional features) by reading systematically the results of the analyses. The aim of this ‘critical reading’ is to establish a concise but robust cognitive base to be placed at the heart of the project and to which the last step of the methodology is devoted. In so doing, a close link between the actual state of the masonry complex and the definition of the design criteria is stated. A significant part of the on-site work was dedicated to surveying the entire fortified monument and the buildings included within its defensive walls, including the linear block situated immediately below the Castle, considered a particularly good case study as regards the typology and aggregation of its buildings (Fig. 4).

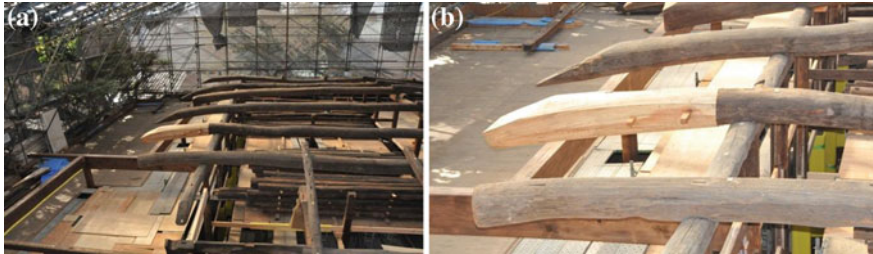
Fig. 5 (a, b) Wooden members of larger dimensions need minimal replacement. An Adze is used to seal the surface of the wood, ensuring resistance to moisture penetration and absorption (Photographs by author)

The adze (Fig. 4b) is used to skim off the outer molecular surface of the wood which creates a barrier. It is well documented that the use of the adze gives a smooth finish, ensuring the longevity of the wood due to its superior resistance to moisture. Due to the adze being a traditional tool the timber has a finish matching other timbers, ensuring aesthetic and similar aging. Hand used adzes consisted of wooden curved handle and a steel blade. For optimal operation of the adze the handle is meant to be curved to fit perfectly the individual user's body, ensuring optimal angle (Suzuki 2012) (Fig. 5).

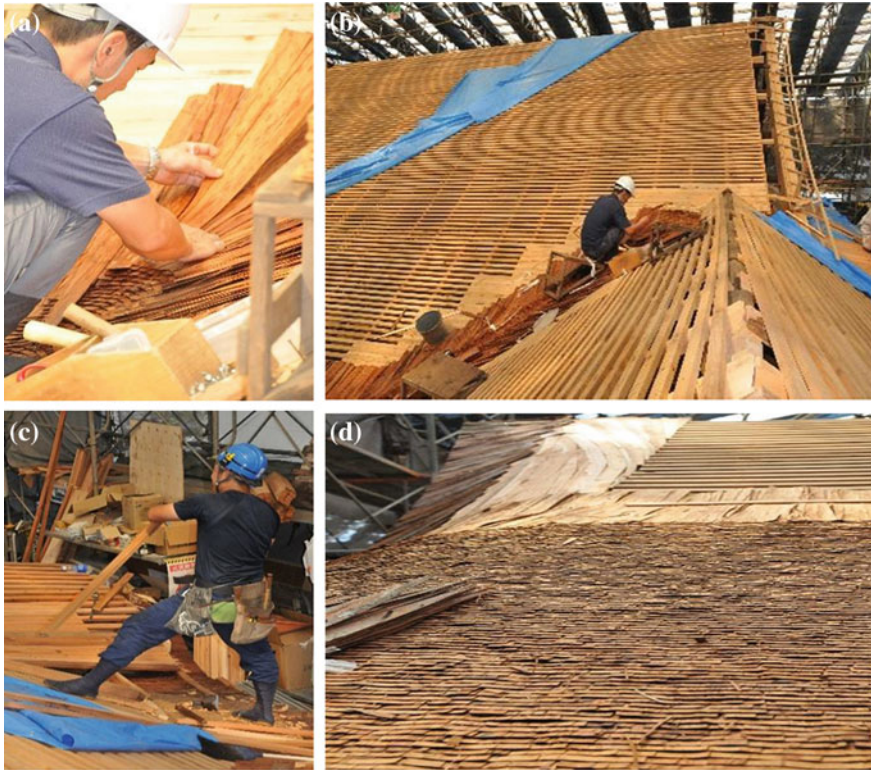
Fig. 6 (a-d) Cypress bark roof installation at Gekkodden pavilion. Hiwada contractors, specialised in cypress bark roofing, work in a team of four to five, commencing with the layering from the base of the roof line moving towards the top. Singular cypress strips are secured with small galvanised steel nails (*photographs by author*)

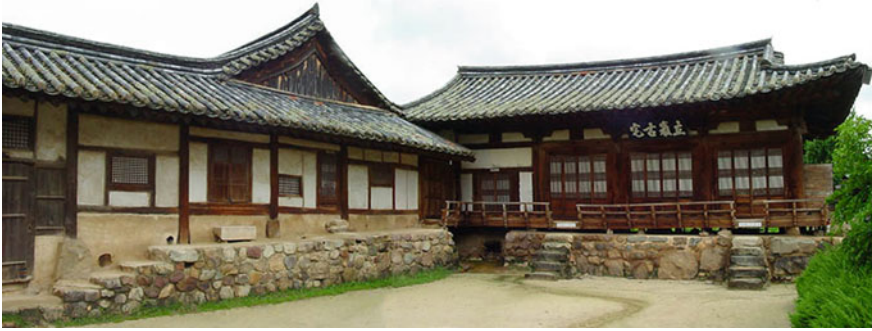
Fig. 3 Yangjindang, in Hahoe (Source <http://www.orientalarchitecture.com/koreasouth/hahoe/yangjindang.php>)

Residences architecturally categorized as *hanok* (韓屋, 한옥) refers to a vernacular style of home built prior to and during the Joseon Dynasty and continually through the first half of the twentieth Century (Fig. 3). Structurally, *hanok* are built on a raised platform encompassed by granite stonework upon which are placed the stone foundations for vertical pillars bearing the heavy timber frame. The walls between pillars are made of wattle-mud/clay coated with a type of plaster, latticed and papered wooden doors/windows, and either thatched or ceramic tiled roofs (Fig. 4).¹ While the fundamental timber-frame design concept was based on the Chinese-derived design of parallel-weight distribution (Lee and Peter 1997), *hanok* (and all other Korean wooden buildings) are differentiated by technological innovations and aesthetics that evolved during the past two millennia to create the sophisticated, multi-dimensional forms unique to Korea.

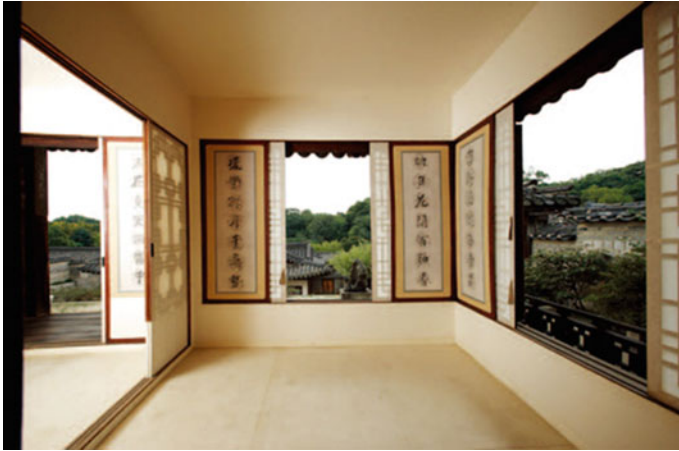
Fig. 8 Interior of *Hanjeongdang* showing papered, clay floor with the doors/windows opened

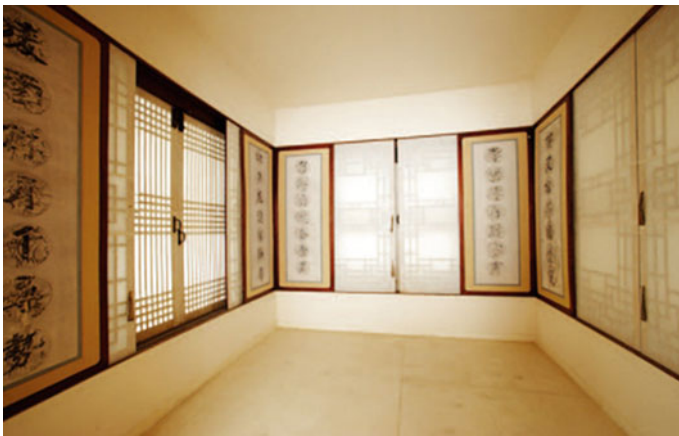
Fig. 9 Interior of *Hanjeongdang* showing papered, clay floor with the doors/windows closed

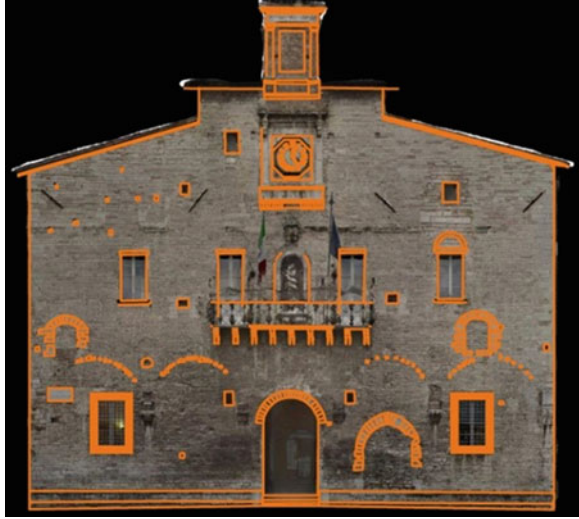
Fig. 1 Cagli, Italy, the façade of the city hall, the rectified photomosaic as a background of the line plot (*orange*), where many details are derived from monoplotting (restitution L. Piermattei)

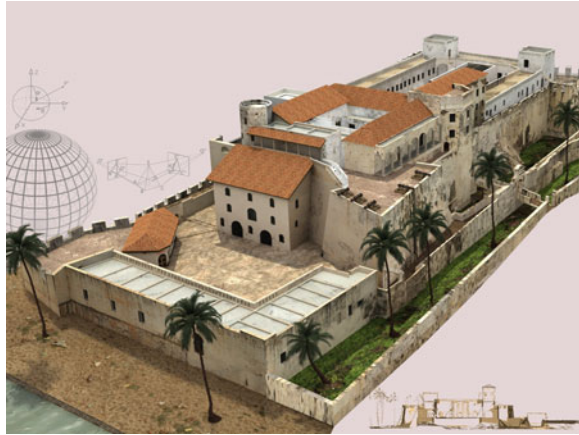
Fig. 4 The solid model of the Castle (restitution by I. Pasqualini, S. Morgiani, S. Falasconi, M.P. Sparvieri)

panoramas were taken. The set of panoramas was subdivided into one main network and 4 sub-projects. The main network comprises the exterior traverse and the panoramas connecting the exterior traverse with the inner main courtyard. The restitution consists in the construction of the wire-frame of the model, including, points, lines, and primitives, such as arcs, circles, and so on. Using the wire-frame, the solid model was built (Fig. 4).

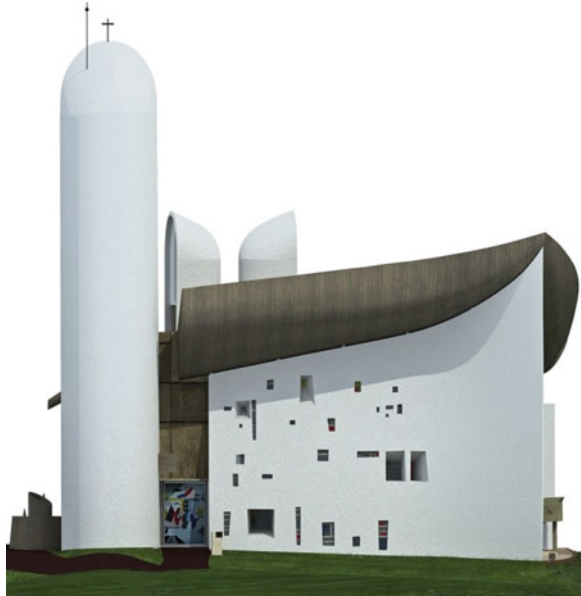
Fig. 8 Notre Dame du Haut, the rendered model

The church of Notre Dame du Haut is an example of Contemporary Architecture, designed by Le Corbusier in 1950 and built in 1954. It is perhaps Le Corbusier's most important project. The most difficult part to plot is undoubtedly the shell-shaped roof; its strange profile made the survey a challenging test. Thirty seven panoramas of the exterior and nine of the interior of the church were performed during a field trip to Ronchamp in May 2011. A topographic control network of about 100 natural points was already available, created by Fangi in the 1990s. Therefore the photogrammetric models were oriented using this control network, achieving centimeter accuracy. This phase of the work ended with the restitution of all the recognizable points of the buildings that allowed a wire model to be created (Fig. 8).
