Lucia Toniolo
Maurizio Boriani
Gabriele Guidi *Editors*

Built Heritage: Monitoring Conservation Management

Fondazione
Politecnico
di Milano

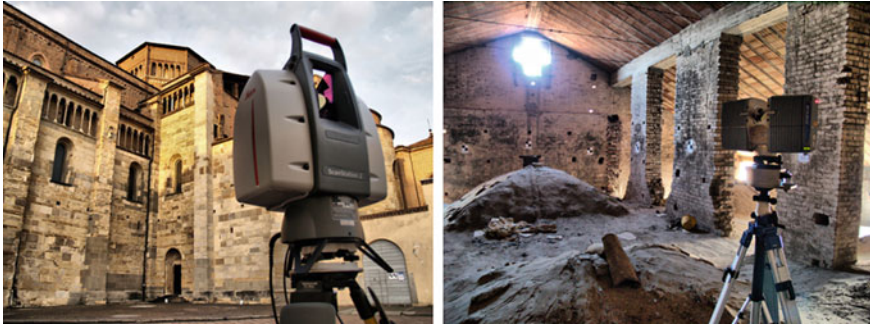
Fig. 1 The two 3D laser scanners at work during the first survey campaign

Any good survey works has two main steps: the planning and the campaign: this obvious consideration was at the base of the Piacenza cathedral survey. The whole work was made possible thanks to the collaboration between the “Facoltà di Architettura” (now Dipartimento di Architettura) in Firenze and Area3D s.r.l. Livorno. The survey was a digitally generated work, based on the use of both time of flight and phase shift 3D laser scanner technologies to achieve a good, reliable, and easy to manage dataset, all the survey work was integrated by a general topographical network and by an accurate photographic documentation. The survey phases were divided in two main sessions, each with a duration of 7 days. In this way it was possible to have a good control on the quality of the gathered data and an optimal organization of all the operators involved in the survey. The first survey session has been conducted by six operators divided in three groups. The first group has operated using a phase shift 3D laser scanner (a Cam/2 Faro LS880), used in all the internal spaces of the church (Fig. 1).

The second group has operated using a Time of Flight 3D laser scanner (Leica ScanStation), used to cover the fronts and to operate along the roofs and from the streets around and the building surrounding the cathedral. The second survey session has been operated by five operators divided in three units. This time the 3D laser scanners were both based on phase shift technology (a Cam/2 Faro LS880 and a Cam/2 Faro Photon 120), used to complete the internal spaces and the external galleries of the church. The third unit was involved in the photographic documentation, aimed to produce highly detailed orthophotos and to document all the useful reference details for the further drawing and surface model creations. A complete topographic network was developed to allow the full integration of all the scans. The total station (Leica TCR 705) was operated by two surveyors, gathering a main network of points all over the 3D laser scanner targets and a secondary network based on geometrical features recognized around the cathedral, this secondary network was used as a sort of backup to resolve any later point cloud alignment issue. The overall time needed for the topographical survey was about 7 days. The topographical network has covered all the external fronts, has passed by the main external galleries and was developed across the roofs and the bell tower. It has of course crossed all the main internal spaces from the crypt to the attic, to allow a well consolidated and closed network some station points were taken from the frontal square, targeting the attic and the galleries across the openings in the main façade. With all the 3D scans aligned on the topographical network, it was easy to optimize the overall survey work, because, as it is well known, such a condition allows a well working reference system with better and faster alignment with a lower number of scanning operations and a substantial reduction of the need for large overlapping between one scan and the following one. To get a general idea about the extension of the surveyed building it can be useful to list its quantitative data: the total accessible floor surface is about 3,312 m²; the accessible floor surface beneath the roofs is about 2,332 m²; the total length of all the external galleries is

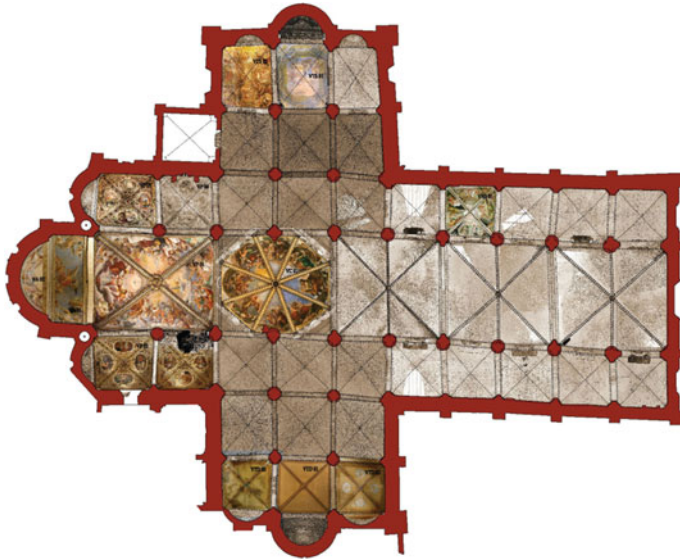
Fig. 2 The plan looking towards the vaults of the Piacenza Cathedral

The main task in the 2008–2010 plans was the realization of a complete 2D set of drawings, aimed to produce clear, detailed and great looking images of the state of the cathedral, with a full architectural detail about every meaningful elements. So, after the organization of the whole amount of gathered data, a long operation of data treatment started to produce more and more detailed representation of the cathedral. The first step was the alignment of all the scans according to the Topographical network. This was done using Cam/2 Faro Scene software and Gexcel 3D Reconstructor. The following processing was aimed to extract traditional drawing and the photo plan imaging combined with the vectors coming from the drawings. In this way it was possible to produce a complete and easy to use set of descriptive vector drawings in a fully compliant condition towards any CAD software. This kind of representation is referred to the common and well consolidated representation standards, but it's also for these reasons that the most easily employable by any kind of users today, is also the one with the better changes to survive data

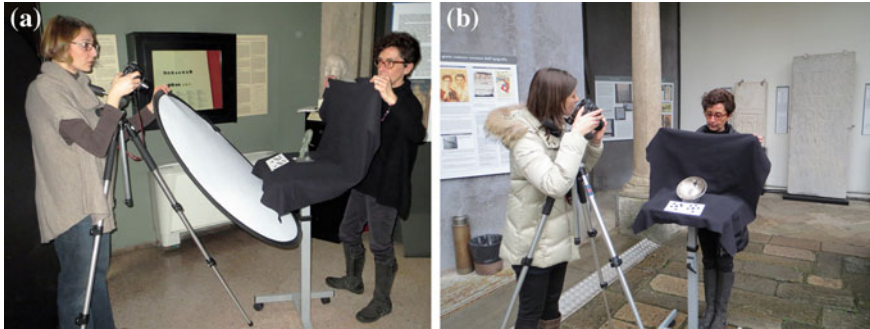
Fig. 3 Typical shooting scenarios: **a** indoor. The window behind the operator is shielded with a movable black panel. The subject is shoot with a reflective panel for brightening the shadowed parts; **b** outdoor. In winter days with no sun the light is much more uniform and no special aids are needed. In both cases a black background and a metric target on the support plane were used

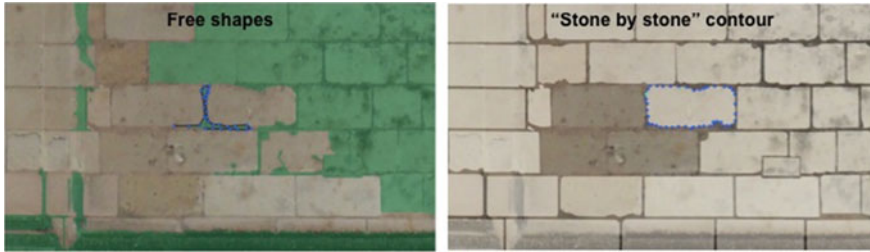
Fig. 2 Drawing method of the two types of mappings

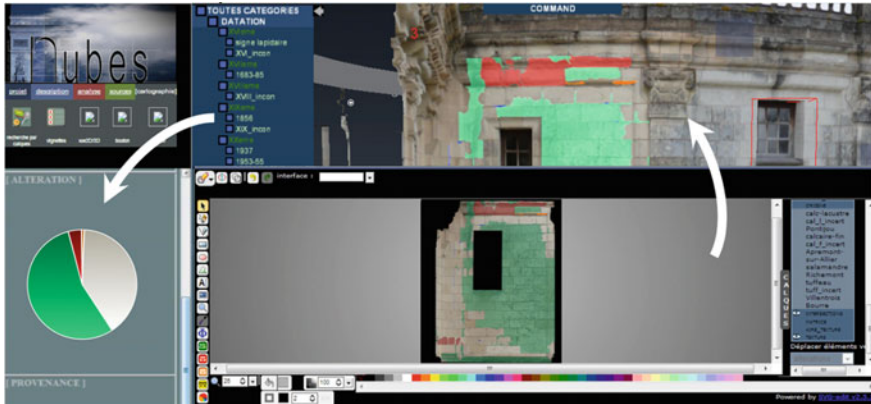
Fig. 3 Display of mappings of damage on the 3D model and statistical analysis of weathered surfaces

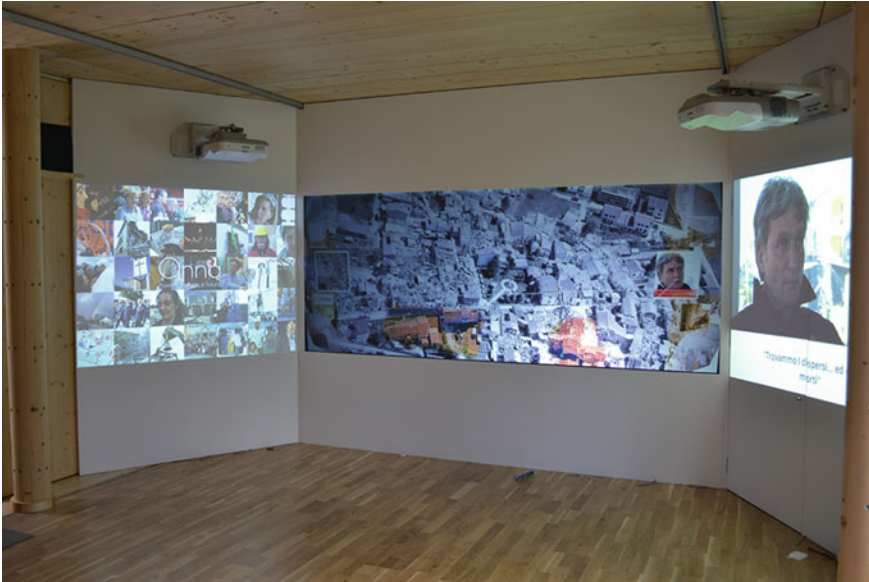
Fig. 1 The installation is composed of a central interactive rear-projected screen and two lateral screens used for displaying non-interactive multimedia contents

The system is composed of a central large display made with a slab of opaque plexiglass and a short throw projector illuminating it from behind. At the two sides of the main screen, are positioned two opaque panels illuminated by two projectors installed in their upper part, in order to have two lateral displays. A stereoscopic camera placed behind the central display captures the interaction in the front area in real-time, recognizing gestures and then processing them through a Computer Vision module based on diffused illumination technique (Baraldi et al. 2009). In order to make vision sensing reliable and robust to light changes in the environment, the camera works in the near infrared spectrum and the scene is illuminated with NIR lights.

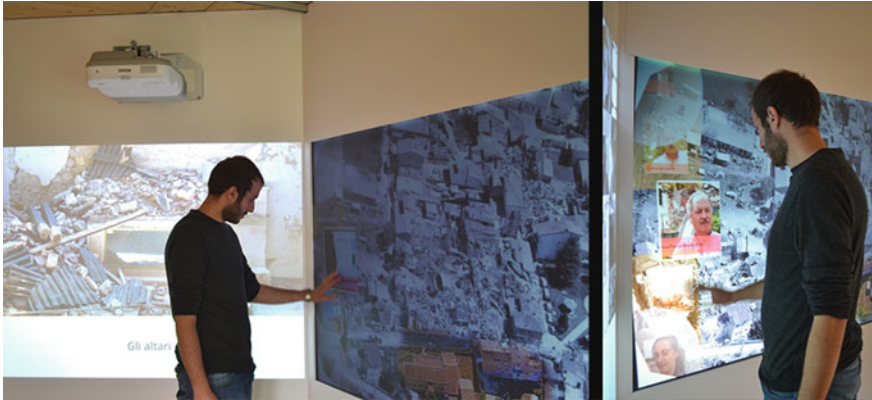
Fig. 2 The user interface of the installation presents an aerial view of the town after the earthquake. Visitors can move the hand close to a zone of the town and visualize the pre-earthquake status. For each selected zone a carousel of images is shown, which can be activated with the same gesture in order to start the playing of video stories on the lateral screens

The natural interface presents the post-earthquake map of Onna visualizing pre-earthquake areas when the hands of the visitor are close to the surface of the main screen (Fig. 2). For each selected zone the interface shows a carousel of images as thumbnails, which can be activated via gestures by the visitor in order to start the play of multimedia contents on the lateral displays. These contents consist of videos and texts reporting the history of the town through testimonies, interviews and institutional events.

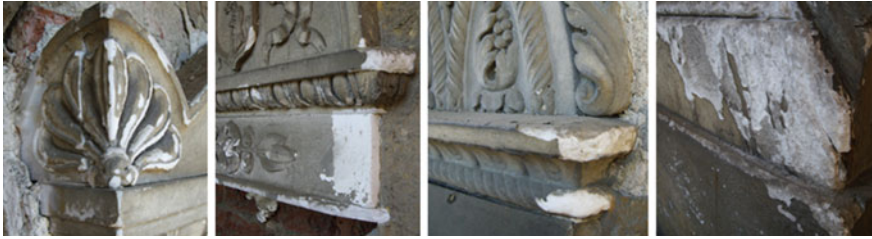
Fig. 1 Sugaring marble elements in the monumental cemetery in Bologna (Italy, 19th century)

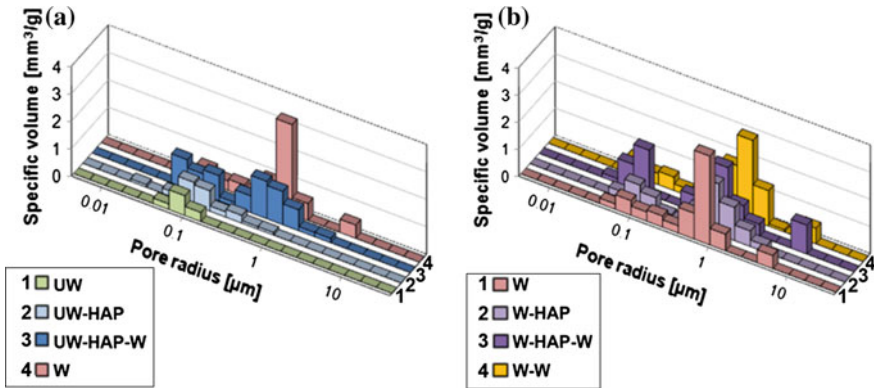
Fig. 9 Pore size distribution of unweathered (a) and artificially weathered samples (b), both untreated and HAP-treated, after the final thermal treatment

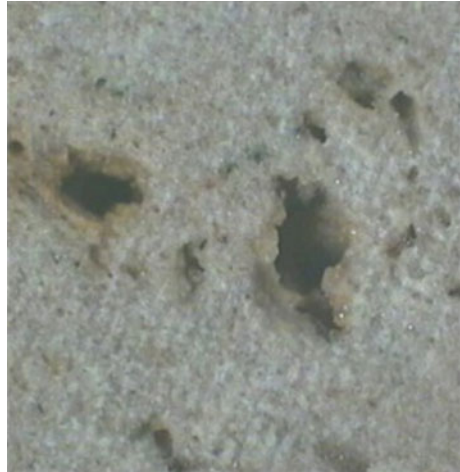
Fig. 3 Compact limestone

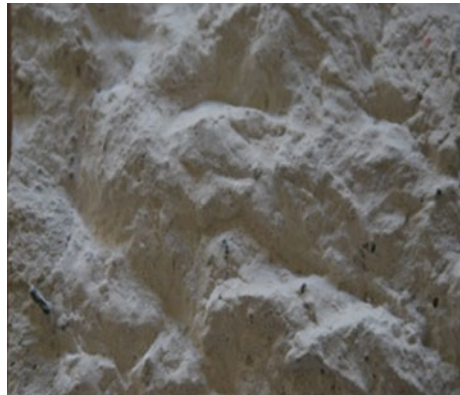
biological alteration, localized mainly on the surface or up to some millimeters in depth, was observed. Flakes of 1 mm depth were often detached from the surface, leading to the loss of the material.

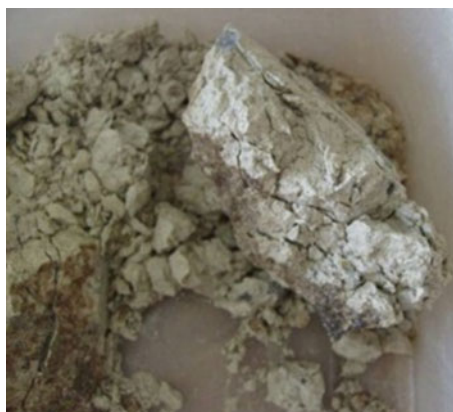
Fig. 4 Deteriorated limestone

From the point of view of the mechanical and physical properties recorded in structural samples, Table 1 shows the variations in compressive strength, porosity, specific gravity and water absorption according to the different deteriorating grade.

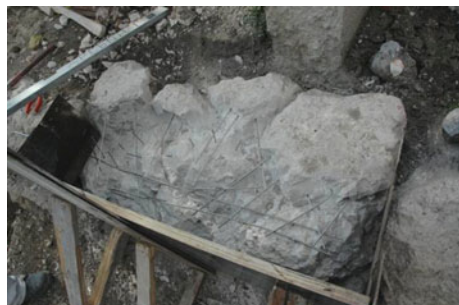
Fig. 5 Metallic connections (stainless steel) for completing missing parts of stones

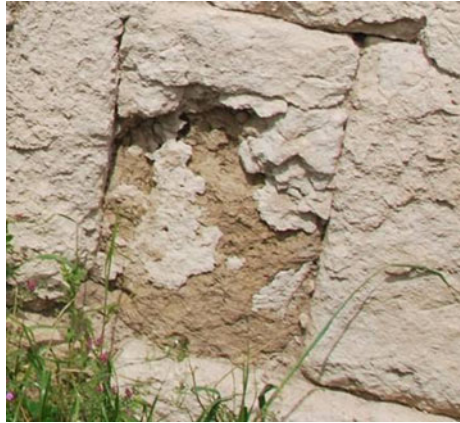
Fig. 7 Mortar for superficial repair of stones

The repair mortar of Table 2, has been used to cover parts of the surface of old stones (Figs. 7 and 8) which have been deteriorated. In general, the performance was quite good. Color hue was harmonious with that of the old stone. The adhesion with the substrate was very good and long-lasting after the natural wet-dry cycling and thermal changes. Salts on the surface were not detected. However, very few repaired pieces (Fig. 9a, b) have shown visible cracks, due to improper application, such as thin layer of mortar on a bulging part of the stone or insufficient wetting of the substrate before mortar's application.

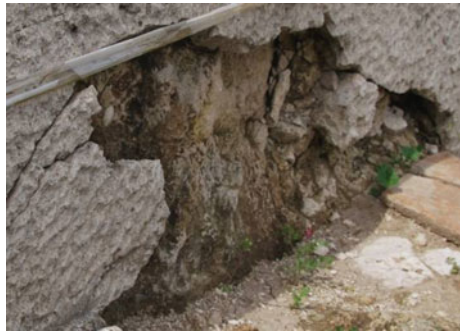
Fig. 8 Cracks of repaired stones
