Restoring Disturbed Landscapes

Putting Principles into Practice

DAVID J. TONGWAY *and* JOHN A. LUDWIG

The Science and Practice of Ecological Restoration

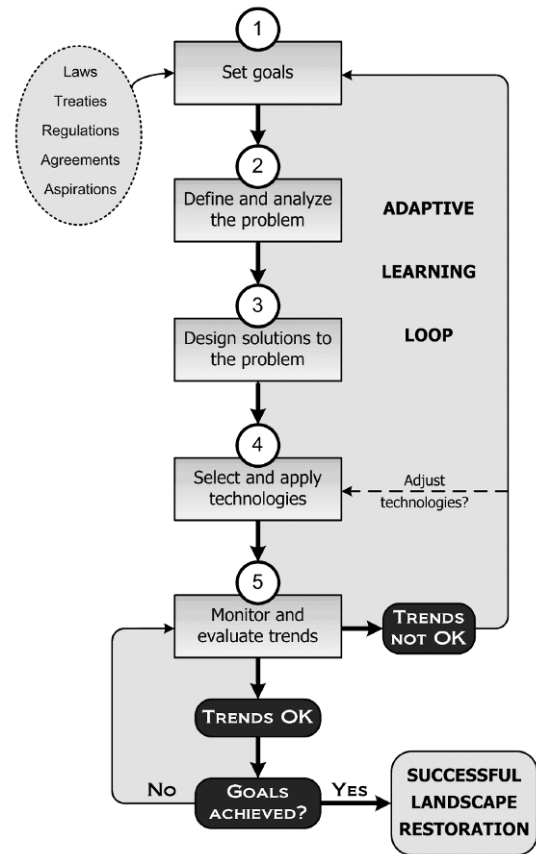
FIGURE 1.1. An orderly five-step procedure for restoring damaged landscapes that, if assessed trends are not OK, includes an adaptive learning loop to help achieve success by adjusting restoration technologies.

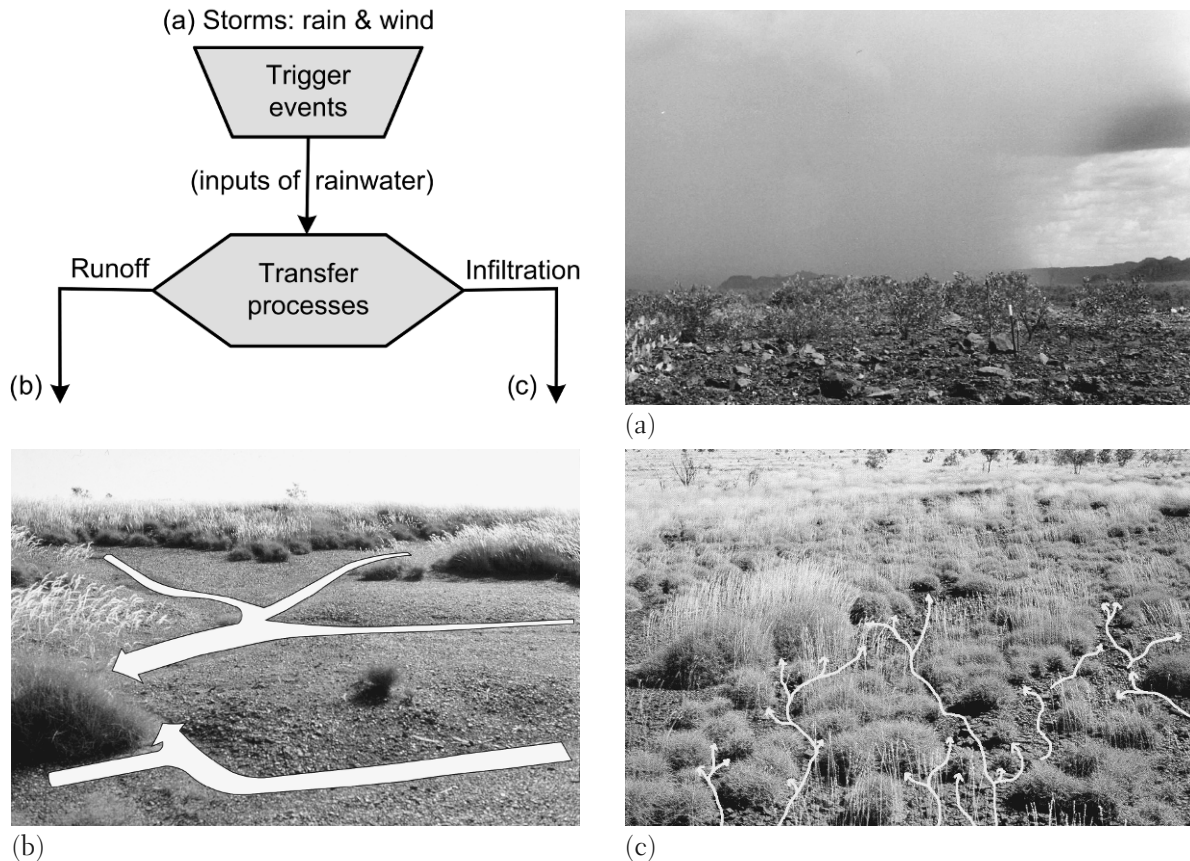
FIGURE 2.1. Rainstorm events (a) can *trigger* large inputs of waters to a landscape, which then initiate *transfer* processes such as runoff and infiltration. A dysfunctional landscape (b) has a low capacity to capture flows of runoff water (illustrated by long, wide arrows representing flow pathways between vegetation patches and down the slope), whereas a functional landscape (c) has dense vegetation patches with a high capacity to obstruct runoff and to infiltrate water (depicted by numerous, short arrows representing contorted flow pathways).

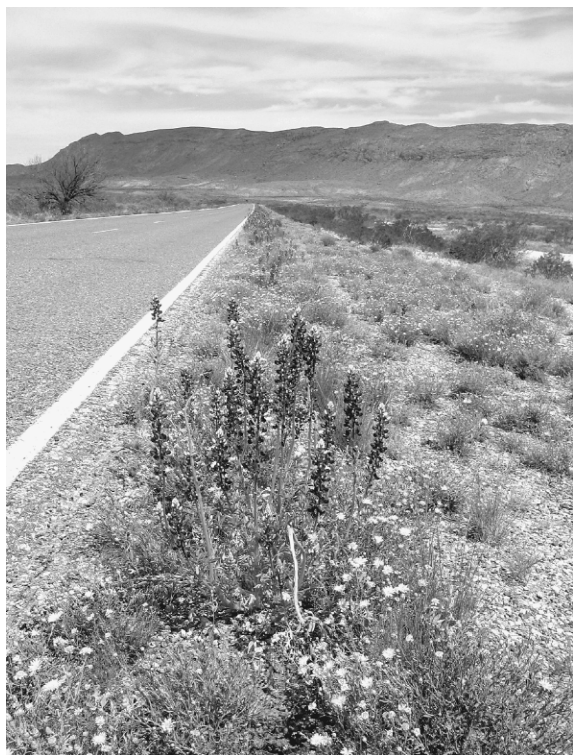
FIGURE 2.2. A highly functional landscape that retains water from small rainfall events, which is important for ephemeral plants (foreground).

than for intense events. Highly functional landscapes typically have the capacity to infiltrate most of the inputs of water during small, less intense events. In functional landscapes, small rainfall events are of great value to organisms, such as ephemeral plants (figure 2.2) or fungi. In dysfunctional landscapes, small rainfall events can quickly initiate runoff (figure 2.3). An example of this would be a landscape in which excessive grazing has reduced vegetation cover so that soil surfaces have become compacted and crusted. In this situation, flows are less impeded and surfaces readily erode (plate 2.1).

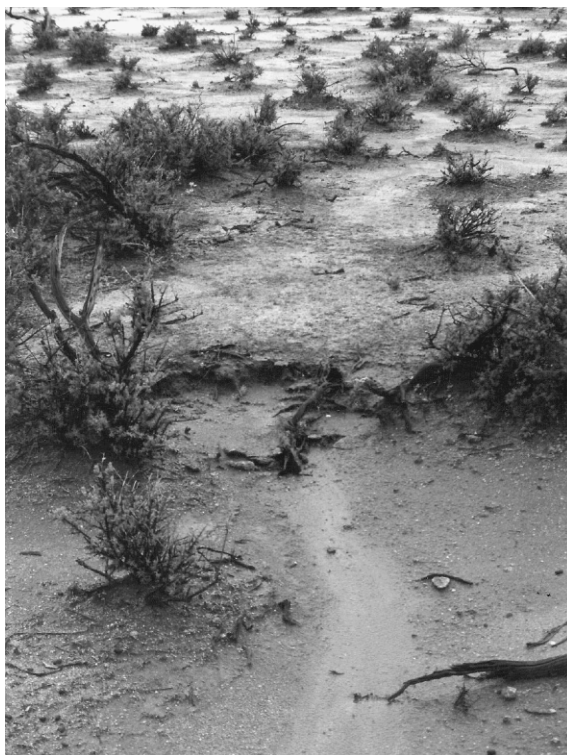
FIGURE 2.3. An example of a dysfunctional landscape where water mostly runs off to trigger soil erosion.

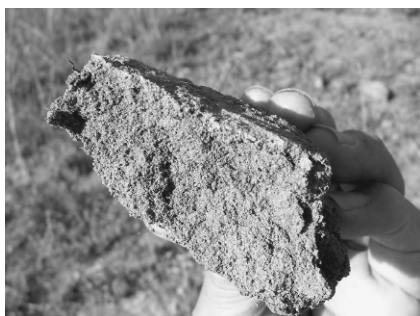
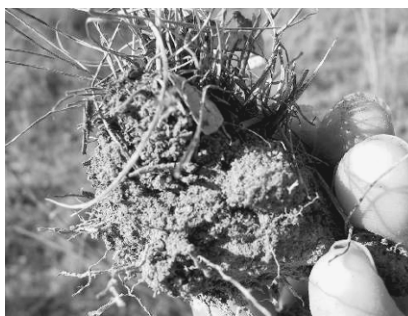
FIGURE 2.4. (a) Soils with dense physical surface crusts and compacted subcrusts have low infiltration rates, which are typical of many dysfunctional landscapes around the globe. (b) Porous soils have high infiltration capacity, which typically occur under plants in highly functional landscapes.

In functional landscapes, processes such as the infiltration of rainwater into the soil will build up stores or *reserves* of moisture. Dysfunctional landscapes with low plant cover and soils with physical surface crusts and compacted subcrusts (figure 2.4a) have low infiltration rates, hence most inputs of rainwater flow or run off along soil surfaces causing erosion (figure 2.5a). Even on mildly sloping landscapes, runoff can become channelized into gullies (plate 2.2). Dysfunctional landscapes have a relatively low capacity

with plant roots and have a highly porous structure (figure 2.4b) and high infiltration rates. Functional landscapes have a high capacity for building

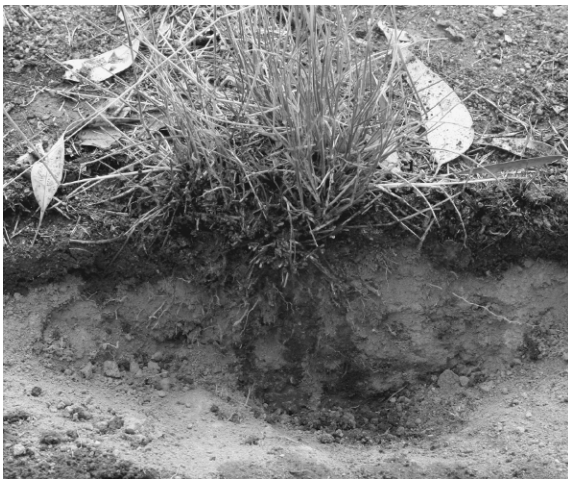
(b)

FIGURE 2.5. Inputs of rainwater to dysfunctional landscapes store little water because of runoff (a). Inputs of rainwater to functional landscapes initiate infiltration processes that store water in the soil, which can be called *reserves*. For example, an 11 mm input event wets a sandy loam soil to a depth of about 12 mm ([b] dark surface layer), and under the grass plant water flowed deeper along root channels or macropores ([b] dark tubes).

reserves of soil moisture, and even small rainfall events can store useful amounts of water under plants (figure 2.5b).

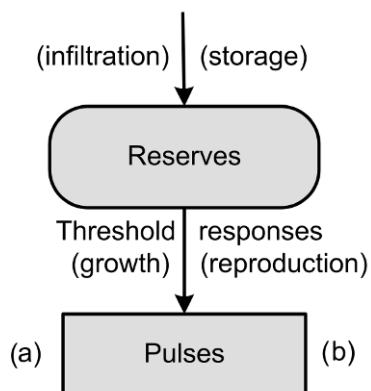
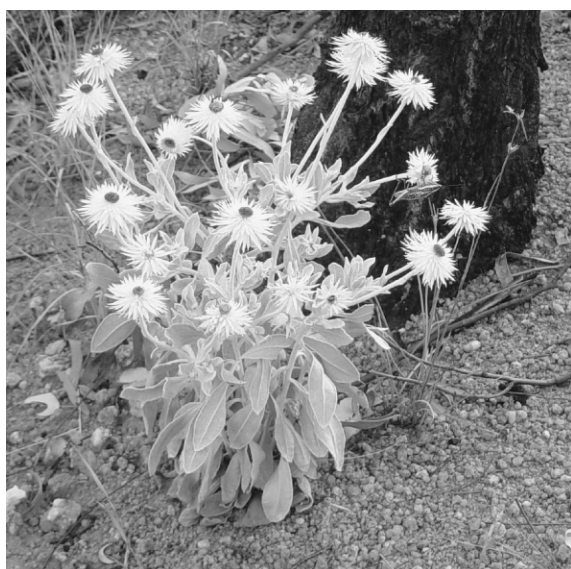
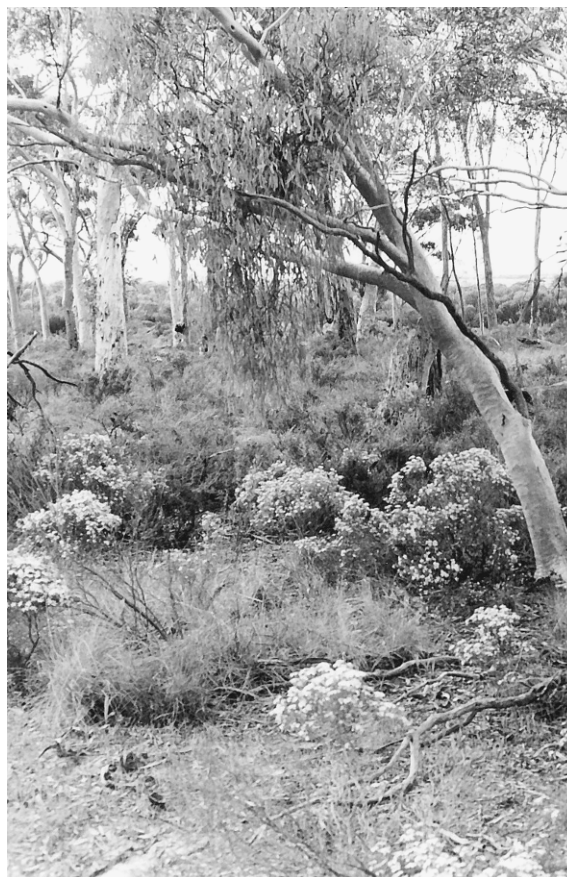
FIGURE 2.6. During rainfall events functional landscapes infiltrate and store water, and if *reserves* of soil moisture are adequate, they respond with (a) *pulses* of growth in vegetation and (b) plant reproduction.

If the amount of soil moisture stored in the soil is above that required by plants to initiate growth (an amount referred to as a *critical moisture threshold*), and other environmental factors, such as temperature, are favorable, these conditions can initiate responses or *pulses* of vegetative growth in a landscape (figure 2.6a). Microbial activity simultaneously

leads to pulses of mineralization so that nutrients, such as nitrogen and phosphorus in plant-available forms, are produced. Thus plants grow, flower, and produce seeds (figure 2.6b). Also, by retaining vital water and nutrient resources in soil and plant reserves, functional landscapes provide the food and shelter (habitat) needs of wildlife (figure 2.7).

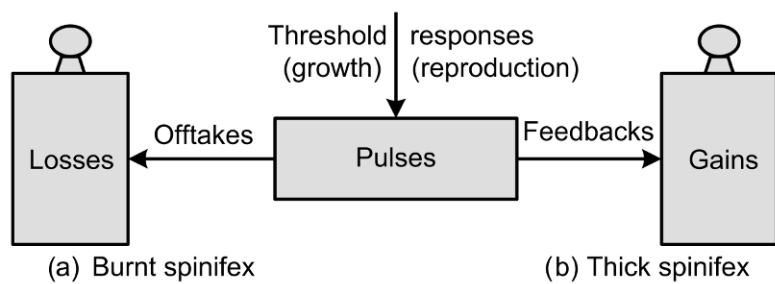
FIGURE 2.8. In a landscape system, *pulses* of growth and reproduction represent *losses* if, for example, (a) spinifex grassland biomass is removed in a wildfire, but *gains* if, for example, (b) there is an increase in the thickness of spinifex.

that is, the amount of moisture stored in the soil. If adequate, soil moisture initiates pulses of plant, animal, and microbial growth, for example, pulses of new plant leaves, stems, roots, and seeds, larger and more animals, and increased microbial activity. If the products from these growth and reproduction pulses stay within the landscape, as is largely the case in functional landscapes, they represent feedbacks and gains to the system as seen, for example, in a thick growth of perennial grasses such as spinifex (figure 2.8b).

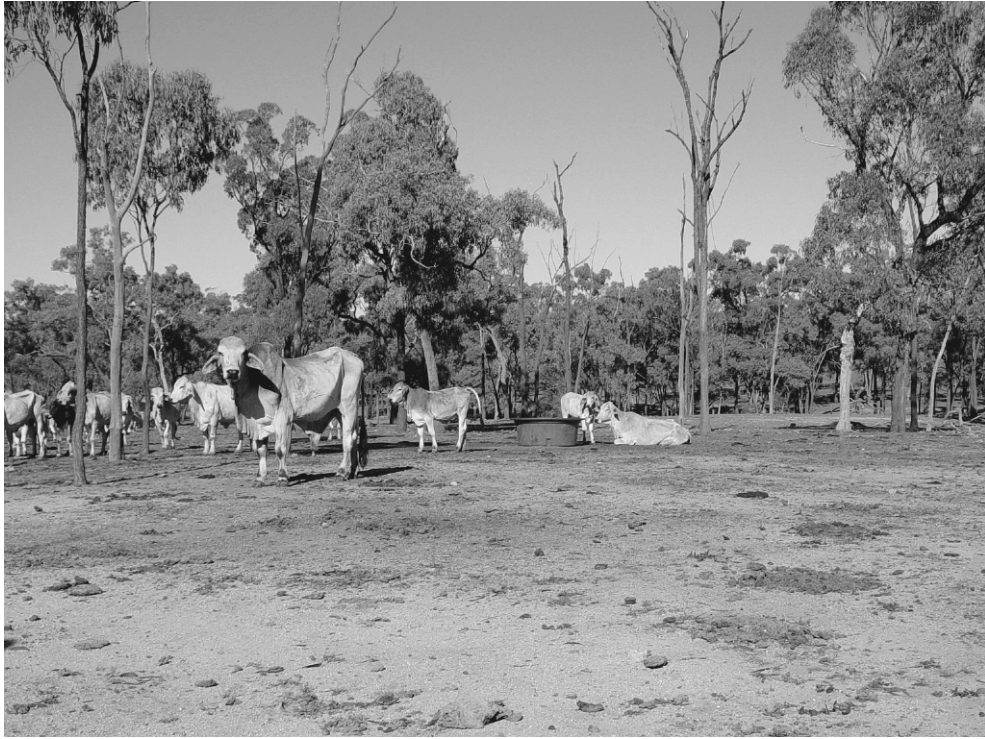
FIGURE 2.9. Landscape offtake occurs when cattle consume forage and are then taken off the landscape and sold.

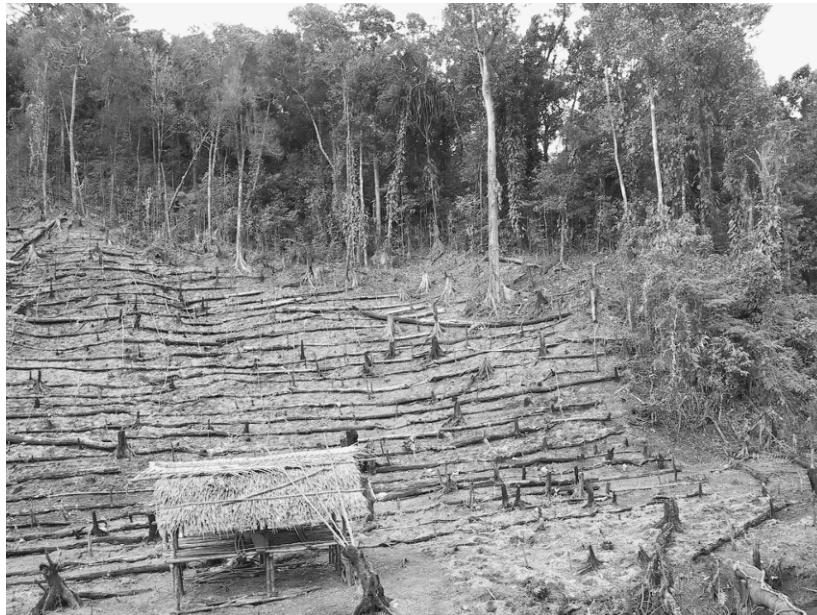
FIGURE 2.10. Landscape offtake occurs when rainforest is cut and burned to grow crops that are sold out of the area.

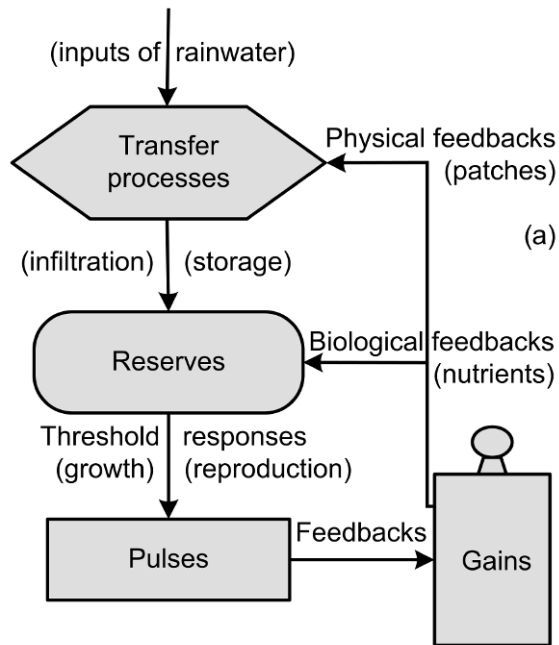
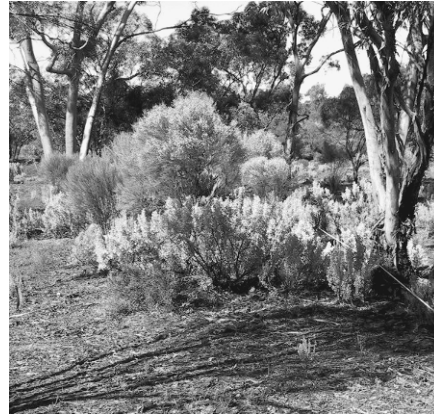
FIGURE 2.11. Pulses of growth and reproduction represent feedbacks or gains to the landscape by building, for example, a higher density and diversity of vegetation patches, (a) which obstruct flows of water during future rainfall events (a physical feedback process), and also store larger reserves of soil nutrients including organic carbon (a biological feedback process).

Resource gains to a landscape initiate a number of biological and physical feedback processes (figure 2.11). Such processes are called *positive feedbacks* because they positively, or beneficially, affect components and processes within the landscape system. For example, a positive *biological* feedback process occurs when gains in plant biomass build the structural diversity of vegetation in the landscape (plate

Biological feedback processes also enhance *physical* feedback processes. This is because an increase in the number, density, and diversity of vegetation patches covering the landscape surface (figure 2.11a) also improves the capacity of that landscape to retain more rainfall in the next storm event. Vegetation patches function by obstructing more flows and allowing more time for more water to soak into the soil, which can ultimately

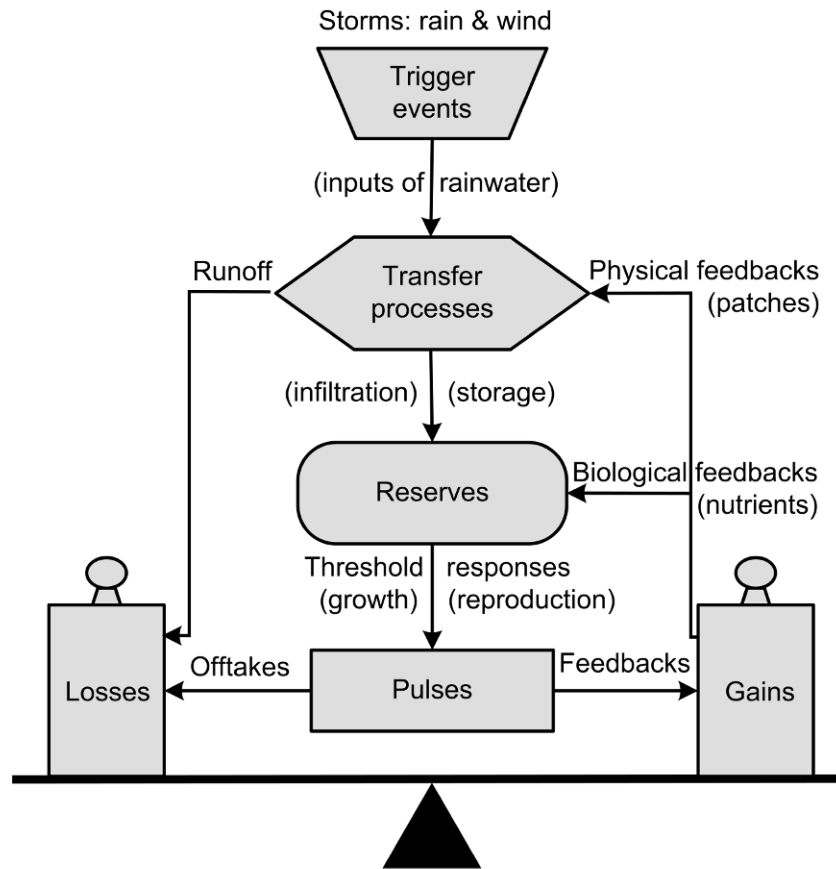
FIGURE 2.12. A completed conceptual framework depicting how functional landscapes, when triggered by events such as rainfall, respond in space and time with processes that transfer water by runoff and storage in soil reserves, which then initiate pulses of growth that are gained or lost by the system. The landscape system sits on a fulcrum to represent the fact that, in the long term, internal gains and external losses are dynamically balanced.

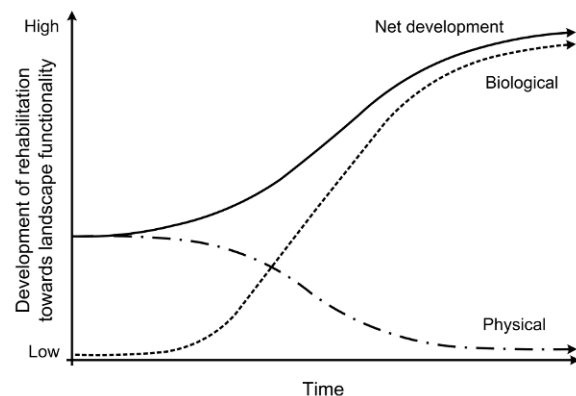
FIGURE 3.1. The net development of a rehabilitated landscape toward becoming a highly functional, self-sustaining, dynamically balanced system initially depends on applying technologies to improve physical processes (e.g., water retention), but over time the role of these processes is largely taken over by self-replacing biological processes (e.g., plant growth and reproduction).

processes applies universally to all cases of successful rehabilitation of seriously disturbed landscapes. We will document this principle repeatedly by presenting graphs of data for indicators of rehabilitation progress in later chapters. Recall from chapter 2 that we defined indicators as simple surrogates for difficult-to-measure landscape processes. Data trends for biological indicators reflecting the development of landscape functionality typically follow an upward or increasing S-shaped (sigmoidal) curve with time (dashed line; figure 3.1). Indicators of physical processes typically follow a downward or declining S-shaped curve (dash-dot line). Net or whole landscape development is an upward S-shaped curve (solid line). Although rates (slopes of the curves in figure 3.1) vary, the contribution of physical technologies to improve functions such as water retention diminish as biological processes come increasingly into play and largely take over as the landscape progresses toward becoming a fully functional, self-sustaining system (leveling off of curves after time).

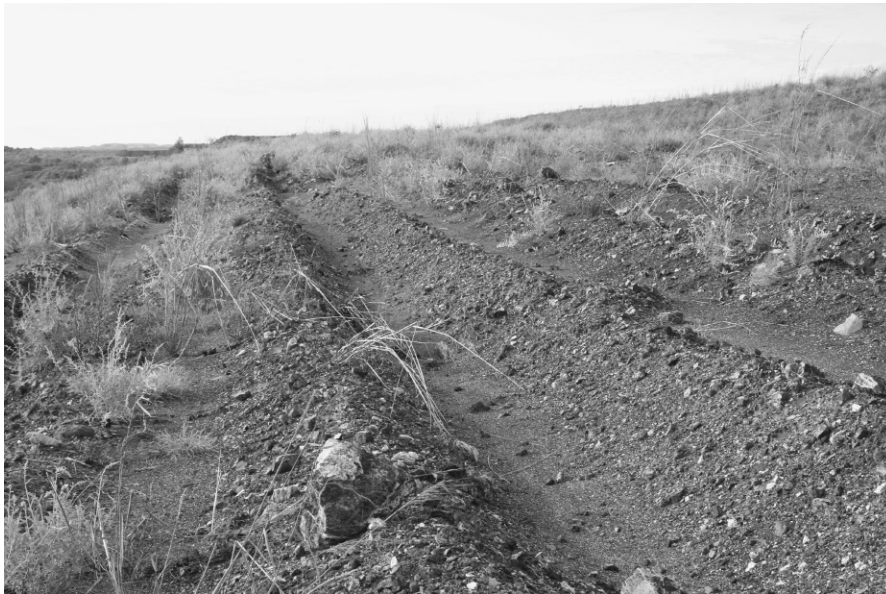
FIGURE 3.2. A landscape where piles of waste rock were reshaped to have minimum slopes. The reshaped surface was then deep-ripped to create banks and troughs.

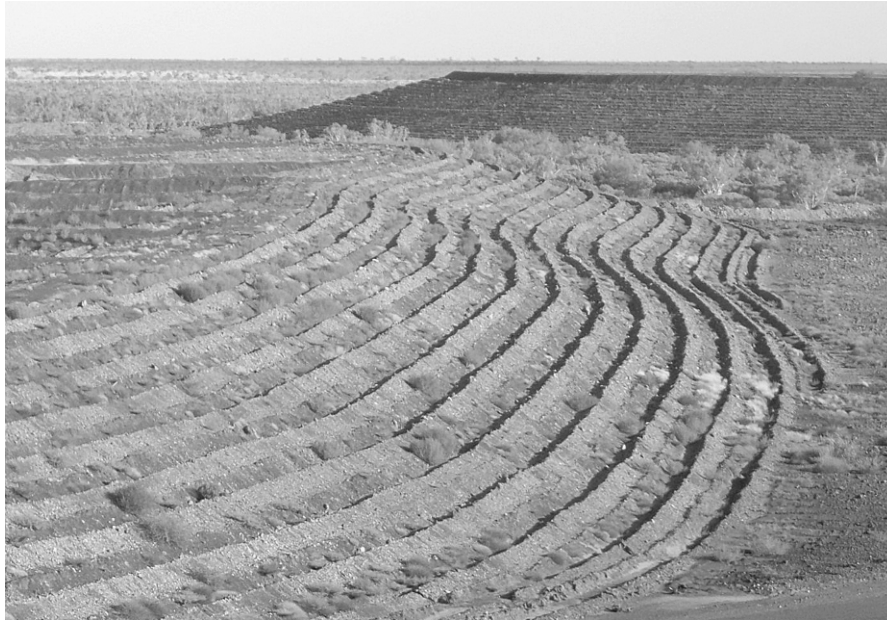
FIGURE 3.3. A landscape reformed from piles of waste rock into one with sloping sides and a series of banks and troughs shaped along slope contours.

disturbed landscape so that it does not lose excessive amounts of runoff during and after rainstorm events. After applying steps 2 and 3 (problem analysis and designing solutions), two physical technologies were selected and applied (step 4) to enhance water retention in the landscape. First, the mined landscape was physically reshaped into a new landform using a design that minimizes runoff rate and sediment transport, which is to reduce slopes to a minimum (figure 3.2). Second, these slopes were deep-ripped along contours to reduce the compaction caused by the heavy machinery used in land forming. As seen in figure 3.2, deep-ripping forms banks and troughs, which are known to be very effective for improving landscape processes such as increasing rates of water infiltration and the amount of water stored in the soil. If it is necessary to form steep slopes, then to reduce runoff and erosion, large banks and troughs are constructed along slopes (figure 3.3).

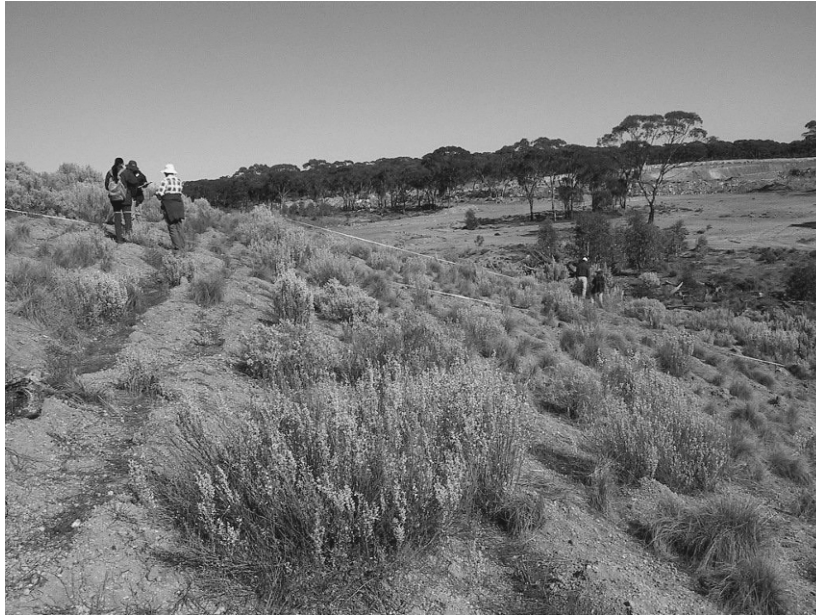
FIGURE 3.4. Vegetation has successfully established in troughs on a slope.

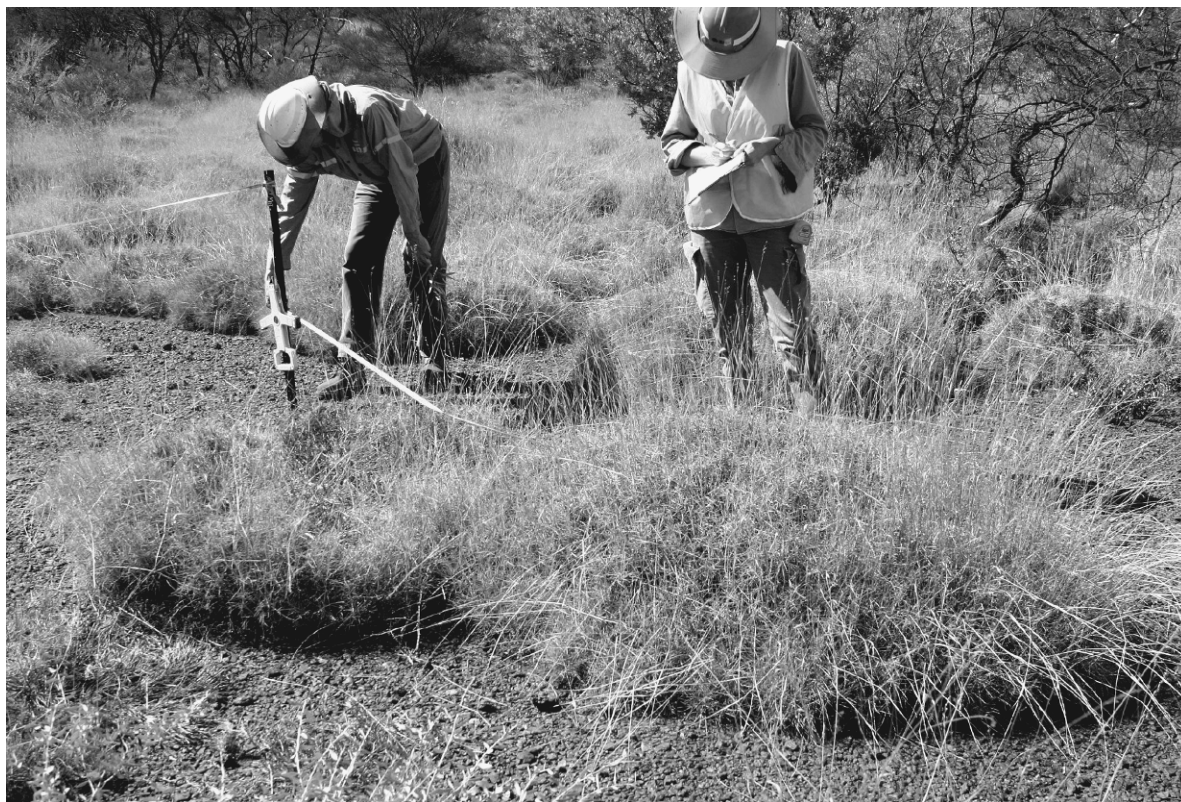
FIGURE 3.5. Measuring the size of vegetation clumps along a transect.

width) of perennial vegetation clumps (patches) can be readily measured along transects (defined by a measuring tape) on a site (figure 3.5). Vegetation patch density and size indicate the potential capacity of the landscape to retain water after storm events. The functional role of different plant species can be indicated by measuring the shape and thickness of the foliage comprising different types of vegetation patches, which also function as habitat for a variety of fauna. We place far less weight on indicators such as the absence of species, which may simply show that a problem exists. The kinds of indicators we and others have found most useful for monitoring landscape functionality will become evident as we describe examples in later chapters.

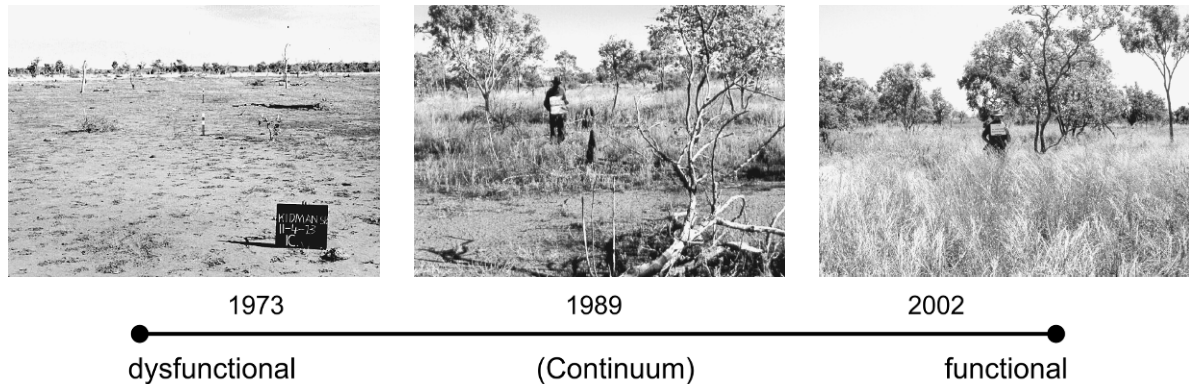
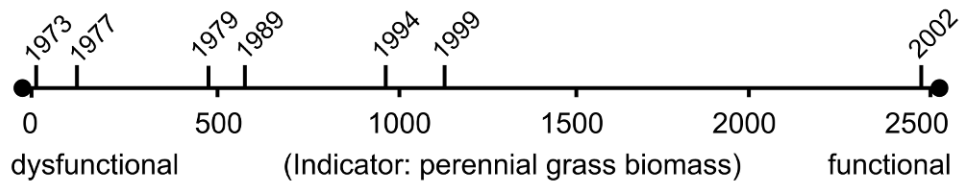
FIGURE 3.6. Photographs taken at the same photo point illustrating vegetation development from a very dysfunctional landscape in 1973 (top left), to intermediate functionality in 1989 (top center), and to a highly functional landscape in 2002 (top right). Cattle grazing and fire were strictly controlled to restore this savanna landscape. Time-marks for a perennial grass indicator (biomass as kilograms per hectare) were measured to reflect landscape restoration over time, which aimed to promote the retention of water and to reduce erosion by water and wind.

A useful graphical approach is to show photographs illustrating changes in landscape functionality along a continuum (figure 3.6a). These photographs

validate the axiom that a picture is worth a thousand words. It is also useful to plot trends in landscape functionality as *time-marks* along a line representing a continuum (figure 3.6b). Marks (vertical bars) noting the time (year) that indicators were measured are positioned along a continuum; these time-marks document any trends in the monitoring data.

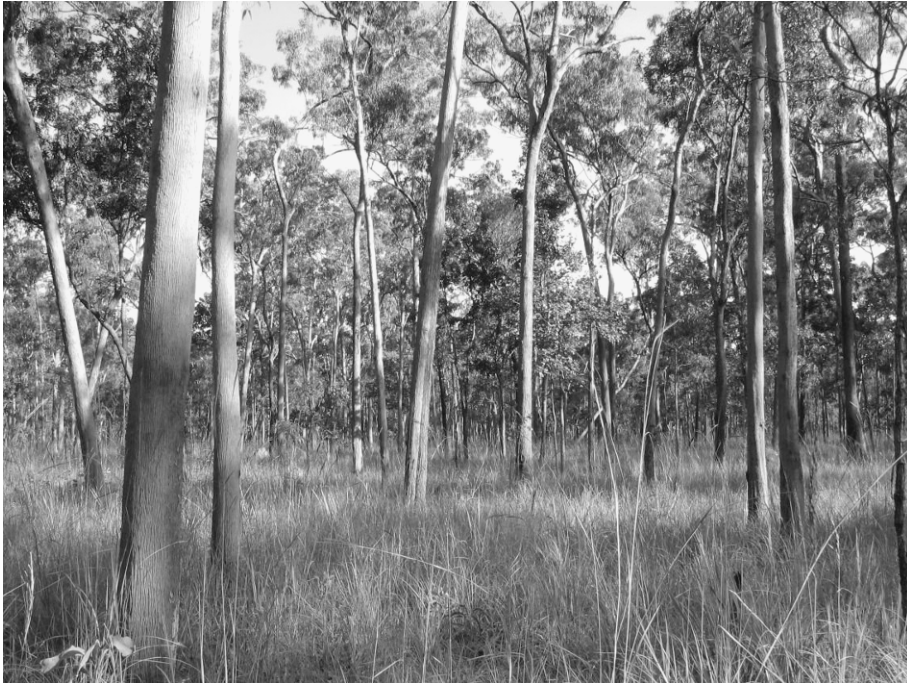
FIGURE 4.2. A typical grassy open forest (savanna) in northern Australia, which serves as a reference area for evaluating rehabilitated sites. Photograph courtesy of Sue Gould.

years had very well-developed trees, and the ground was covered with grasses and tree litter (figure 4.7). The appearance of the vegetation in this photograph is quite typical for natural forest sites in the region. (See figure 4.2.) The twenty-six-year-old site was the oldest restored mine site we studied.

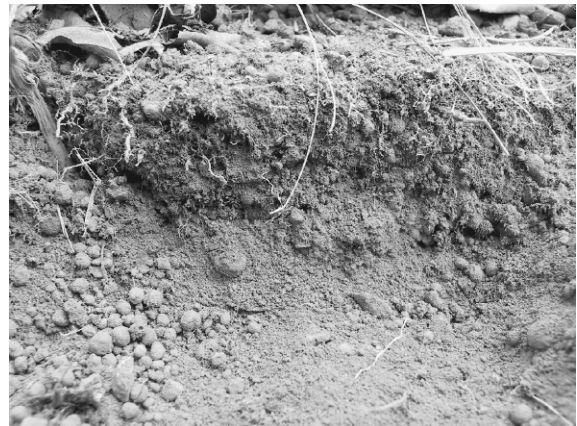
FIGURE 4.3. A typical soil profile under grassy open forests on the Gove Peninsula showing the friable soil structure and the abundance of pisolites in the profile.

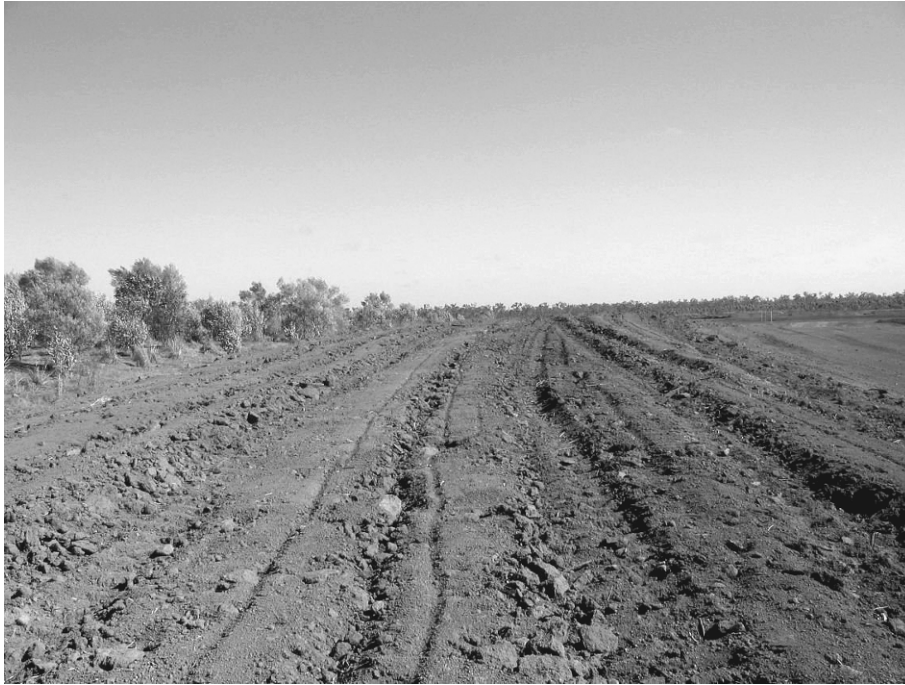
FIGURE 4.4. A landscape prepared for sowing (age zero) by reshaping, deep-ripping (after returning subsoil), and surface tilling (after returning topsoil). Photograph courtesy of Sue Gould.

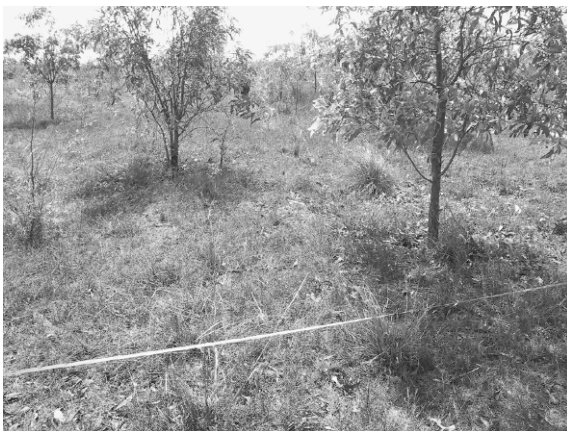
FIGURE 4.5. Three-year-old rehabilitation site at Gove illustrating how tree and grass species have established.

Initially, sites rehabilitated just prior to the onset of the wet season are completely bare of vegetation (figure 4.4), but, in the wet season, seeds rapidly germinated and seedlings successfully established so that a three-year-old site had well-developed tree saplings and grasses (figure 4.5). On a thirteen-year-old site, trees were more fully developed (figure 4.6). Also evident in this photograph is that small tree and shrub species are dead or dying because of self-thinning. A site at a rehabilitation age of twenty-six

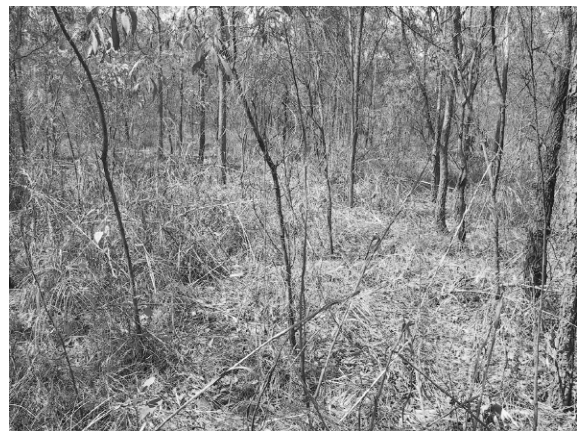
FIGURE 4.6. Thirteen-year-old rehabilitation at Gove showing how dense tree and shrub saplings are dying due to self-thinning processes.

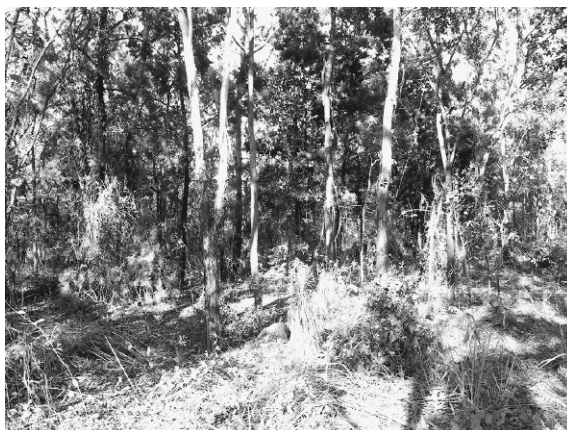
FIGURE 4.7. Twenty-six-year-old rehabilitation at Gove having large trees and a thick layer of tree and grass litter.

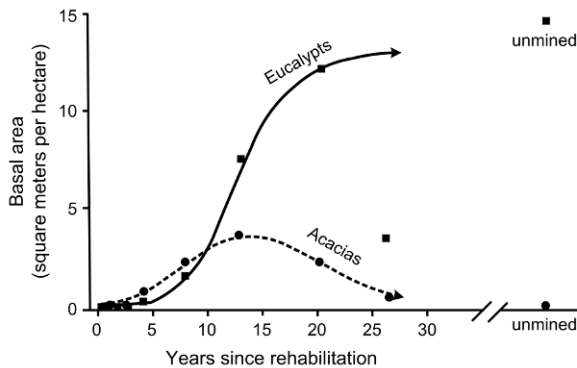
FIGURE 4.8. Basal areas of eucalypts and acacias on rehabilitated mine sites of increasing age and on an unmined site at Gove.

Although the establishment of native trees is evident in figures 4.5 to 4.7 and in color plates 4.4 to 4.6, we noted earlier in this chapter that the species composition of the trees is also important. Recall that our desired goal is to have a dominance of native eucalypt trees, not fire-prone acacias. At Gove, our data on basal areas (a measure of tree size) of eucalypts and acacias at restoration sites of increasing age showed that trends were, in fact, toward the desired goal of eucalypt dominance (figure 4.8). Note that at the twenty-year-old site, eucalypt basal area (e.g., *Eucalyptus miniata* and *E. tetradonta*) was approaching the mean basal areas measured at a number of native forest sites. This is a positive finding for tree composition and size. Also note that eucalypt basal area at the twenty-six-year-old site was well below that expected from the trend line. This is because the basal area at this site was dominated by native noneucalypt trees such as *Brachychiton diversifolius*, *Callitris intratropica*, and *Ficus opposita*. Although the reason for this twenty-six-year-old site being dominated by non-eucalypts is unknown, the total basal area of all trees on the site was 21.3 m² per hectare compared to a mean of 15.7 m² per hectare on nearby unmined sites, thus devel-

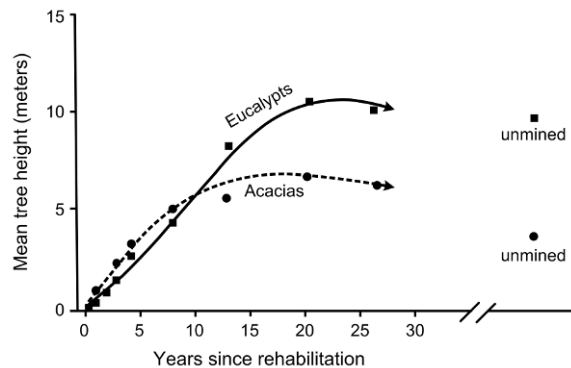
FIGURE 4.9. Heights of eucalypt and acacia trees on rehabilitated mine sites of increasing age and on an unmined reference site at Gove.

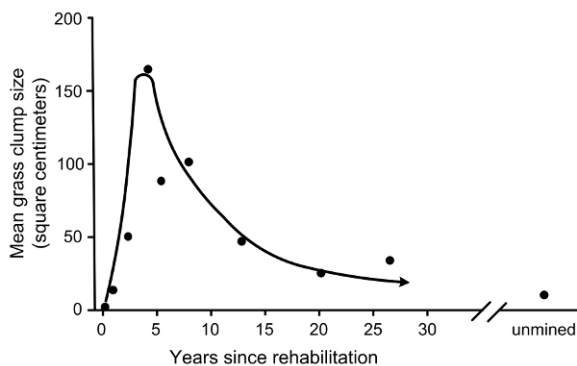
FIGURE 4.10. The mean size of grass clumps on rehabilitated mine sites of increasing age at Gove and on a nearby unmined site.

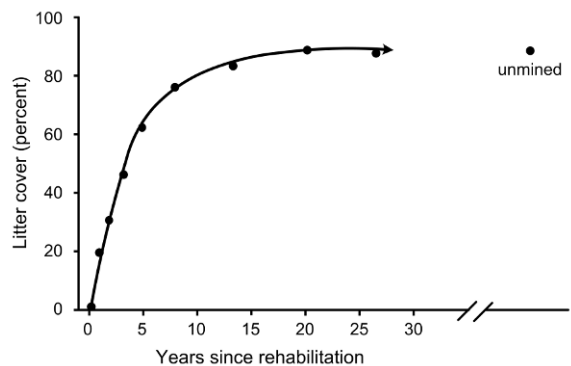
FIGURE 4.11. Mean litter cover on rehabilitation sites of increasing age and on an unmined site at Gove.

than 85 percent (figure 4.11) and showed abundant evidence of litter decomposition and incorporation into the mineral soil. These high values for litter cover were very similar to those for an unmined natural site that had not been burned. Sites recently burned by wildfires will have reduced covers of litter.

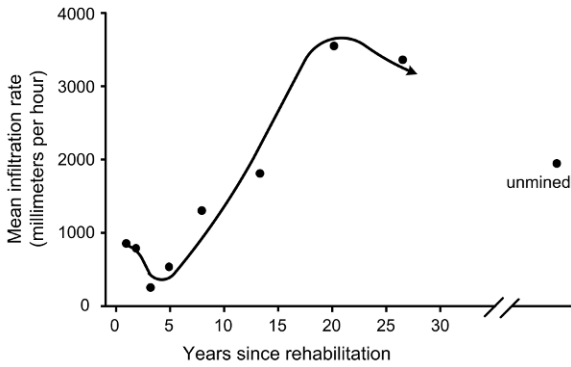
FIGURE 4.12. Measured water infiltration rates on rehabilitated sites of increasing age and on an unmined site at Gove.

On rehabilitated sites we measured rates of water infiltration into soils using specialized equipment (Spain et al. 2009). We found that rates were initially about 1,000 mm per hour on freshly tilled soil but declined to about 200 mm per hour on a three-year-old site (figure 4.12). These low rates were

related to the formation of surface physical crusts, and to the natural consolidation and compaction of the tilled surface. After three years, soils become much more porous to water, primarily because of the construction of *biopores* by soil macrofauna such as termites. Plants also produced litter to promote termite activity and other macrofauna, and plant canopies protected the soil surface from compaction by rainsplash. We found that mean infiltration rates on twenty- and twenty-six-year-old sites increased to about 3,400 mm per hour, which exceeded the mean value of 1,875 mm per hour we found on a nearby unmined site. This lower infiltration rate

on a natural site is likely caused by frequent use of fire, which removes plant litter thus depriving termites and other soil macrofauna with the resources they need to provide ecosystem services, such as building biopores. Compared to water infiltration rates for soils in other regions of northern Australia, these rates are relatively high because of the permeable pisolitic soils found at Gove (figure 4.3).

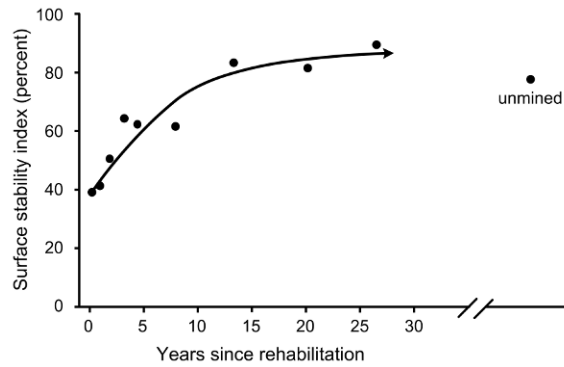
FIGURE 4.13. Surface stability index values assessed on rehabilitated sites of increasing age at Gove and on a nearby unmined site.

Lateritic bauxite materials also form relatively stable surfaces. On rehabilitated sites at Gove we estimated surface stability using a synthetic index, which is derived from a number of readily observed indicators such as the amount of litter covering the soil surface. (See chapter 14.) The surface stability index is scaled as a percentage, where greater values indicate an increased resistance of the surface to erosion (i.e., stability). We found that a site of age zero had a mean surface stability index of about 40 percent (figure 4.13), which reflects the intrinsic resistance to erosion by mineral soil properties alone. This site had no vegetation (figure 4.4) and therefore had no biological feedbacks from plant growth pulses to improve soil-surface stability. But, as vegetation developed, we found that the surface stability index steadily increased so that a thirteen-year-old rehabilitation site had a stability index of about 80 percent, as did older sites, which exceeded that expected from an unmined site.

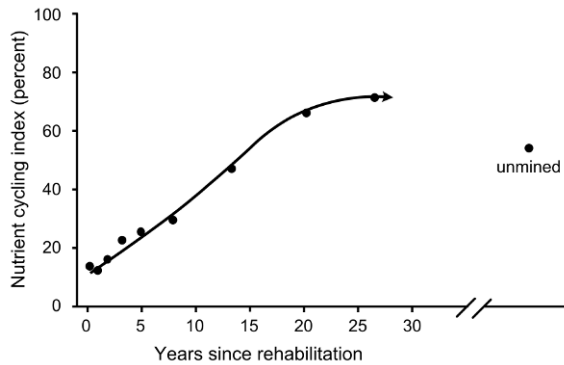
FIGURE 4.14. Nutrient-cycling index values for rehabilitated sites of increasing age and for an unmined site at Gove.

On each of the rehabilitated sites we studied at Gove, we also estimated a nutrient-cycling index, which is assessed with indicators of the effectiveness of nutrient-cycling processes and is expressed as a percentage. (See chapter 14.) For example, the nutrient-cycling index strongly draws on the amount and degree of incorporation of organic matter to form humus at the soil surface (e.g., the amount of litter and activity of decomposing organisms). We found that rehabilitated sites less than three years of age had nutrient-cycling indices of less than 20 percent (figure 4.14). The nutrient-cycling index then steadily increased to about 75 percent on a twenty-six-year-old site, which exceeded the expected value of about 50 percent on an unmined natural site. However, this lower value of 50 percent indicates that most of the natural open forests on the Gove Peninsula are frequently burned so that the litter layer is frequently lost, which results in a lower nutrient-cycling index and a reduction in the decomposition processes that improve soil biological quality.

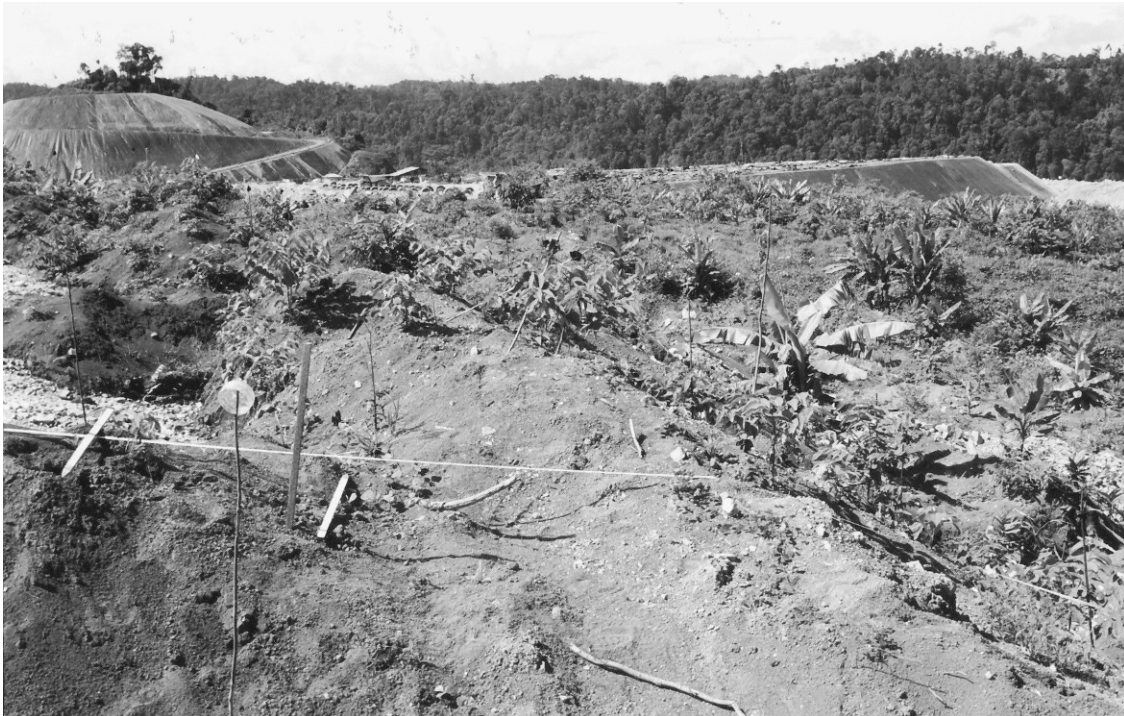
FIGURE 4.16. Topsoil has been dumped in discrete heaps to form a patchwork of microcatchments across a slope on a mine site in East Kalimantan.

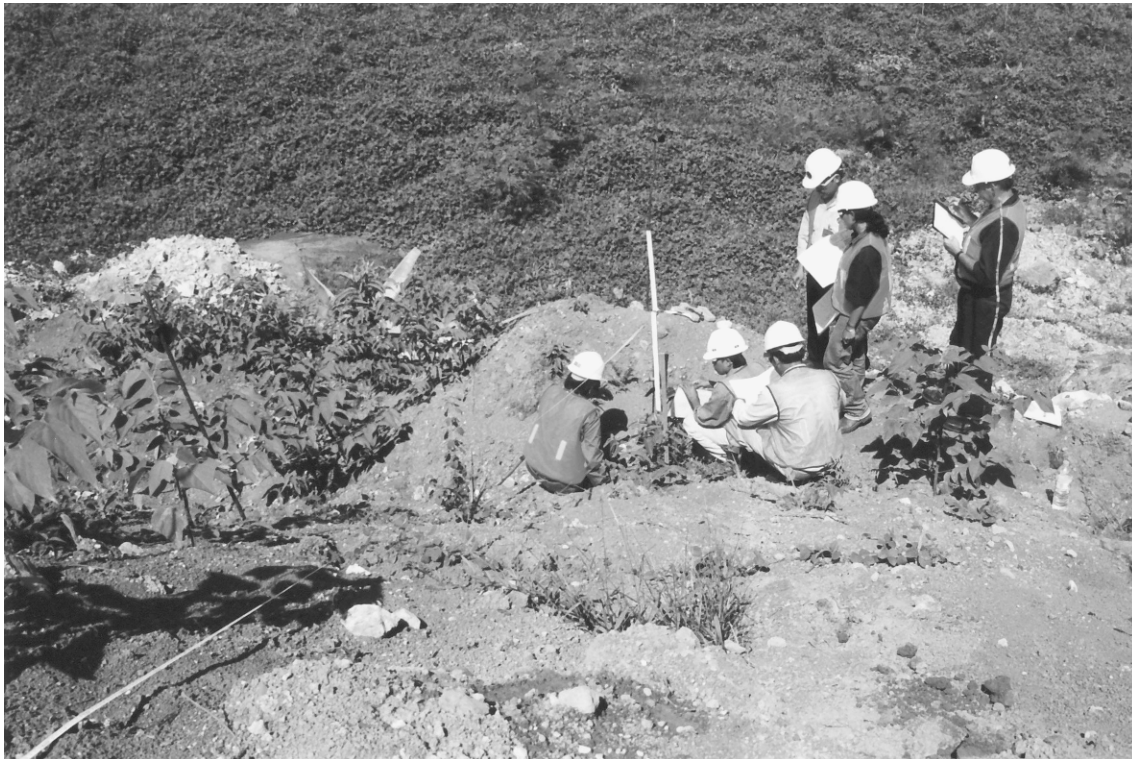
FIGURE 4.17. Restoration practitioners measuring surface condition indicators on “paddock-dumped” locations on a mine site in East Kalimantan (photo looking downslope).

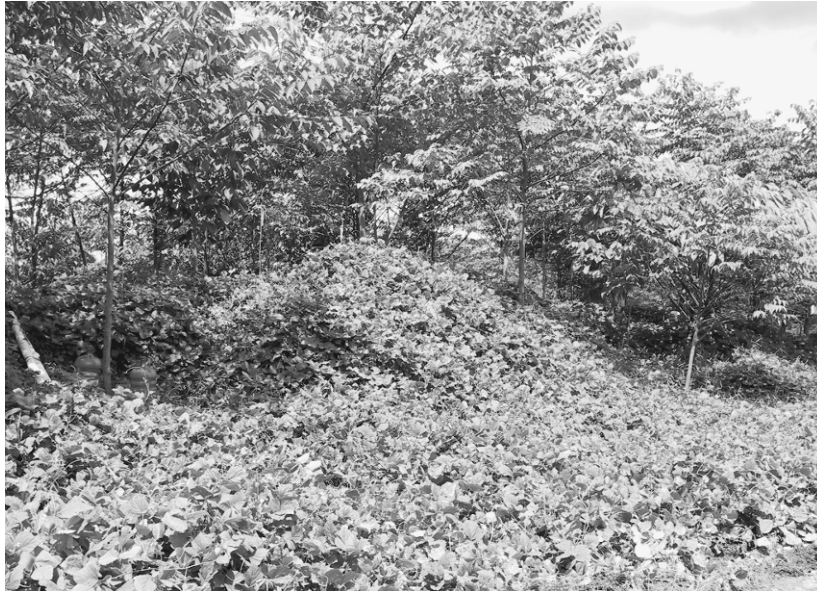
FIGURE 4.18. Vines growing on a rehabilitated slope at a East Kalimantan mine site. A paddock-dumped pile of soil is clearly visible in the center of the photograph.

Mine sites at Kelian rapidly rehabilitated when the RPs put principles into practice to restore key landscape processes. They sequentially applied technologies to retaining water and soil resources on disturbed slopes by first physically creating microcatchments and then planting rainforest vegetation. During rains, the microcatchments held and slowed surface runoff so that runoff did not cause erosion rills and gullies down the slopes (figure 4.17). In just weeks, vines were growing on rehabilitated slopes (figure 4.18), further protecting these slopes from

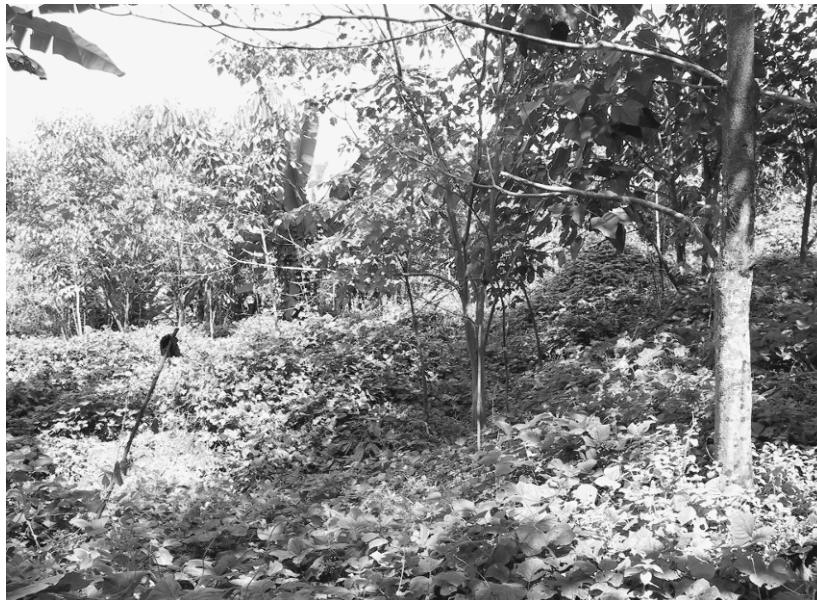
FIGURE 4.19. A mix of rainforest plants growing on a rehabilitated mine site in East Kalimantan fourteen months after commencing restoration.

erosion. After about twelve months of vegetation growth, the team (with help from local people) was able to physically clear small spots within the emerging tropical forest floor to plant seedlings of selected food species grown at the mine site's plant nursery. After only fourteen months, rehabilitated slopes were growing a diverse mix of rainforest plants (figure 4.19).

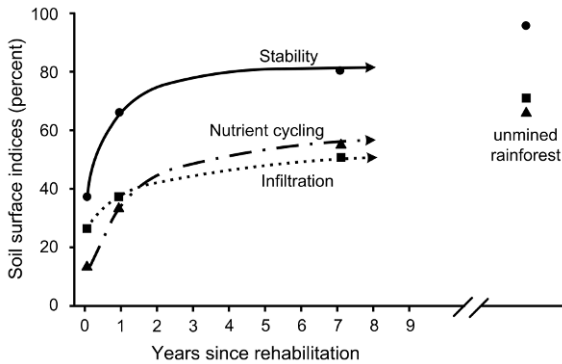
FIGURE 4.20. Trends in three soil-surface indicators on rehabilitated sites aged from three months to seven years, and in nearby rainforests, East Kalimantan.

face condition: stability, infiltration potential, and nutrient-cycling capacity. (See chapter 14.) Here, we present these findings, which show that all

three indicators rapidly increased from three months to seven years (figure 4.20). The seven-year-old rehabilitated site already had indicator

values that were trending toward those expected for a nearby unmined rainforest.
