Restoring Disturbed Landscapes

Putting Principles into Practice

DAVID J. TONGWAY *and* JOHN A. LUDWIG

The Science and Practice of Ecological Restoration

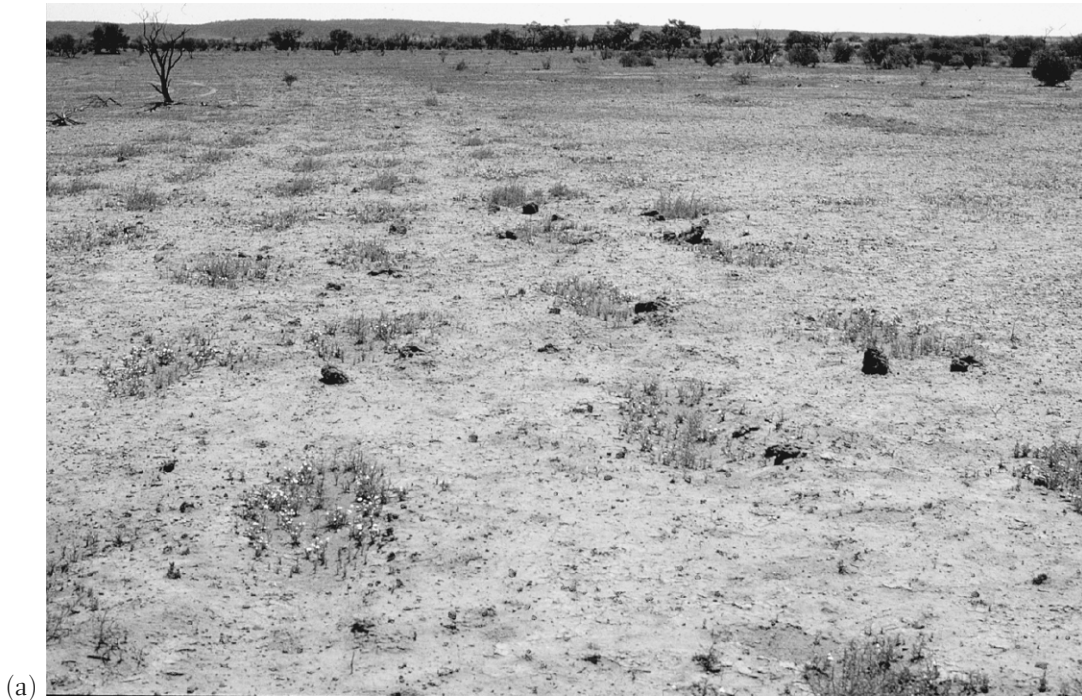
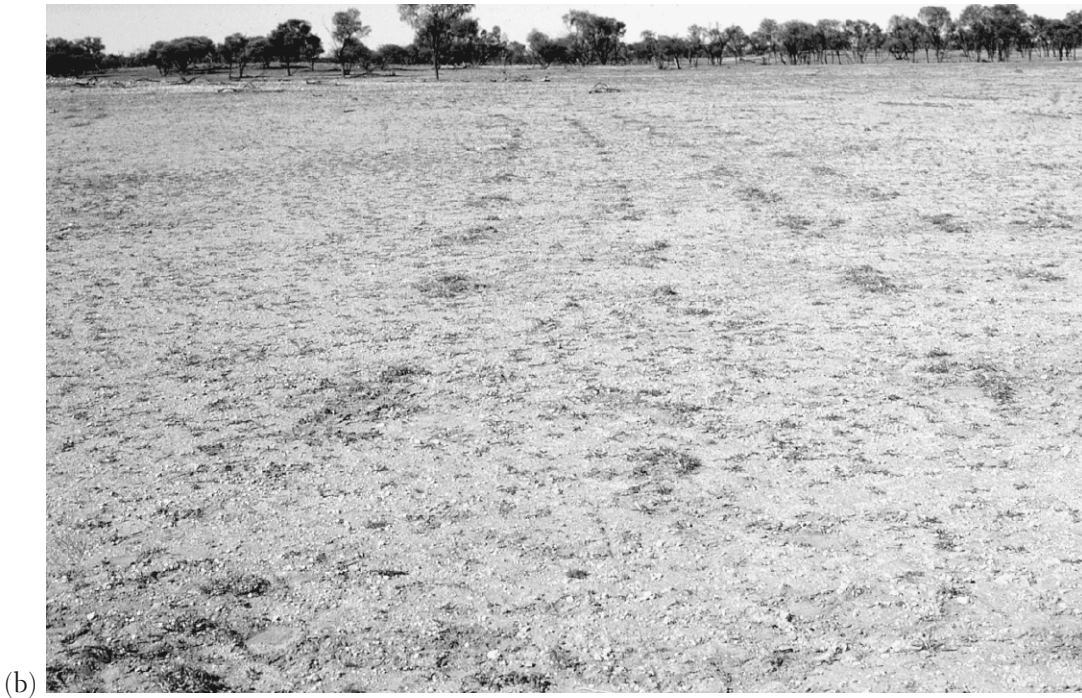
FIGURE 5.2. Landscapes with bare dispersive soils near Alice Springs where tine-pitting was applied as a restoration technology: (a) pits initially captured enough water to allow a few plants to grow, but (b) the shallow pits soon slumped and filled with sediment so that most plants died. Photographs courtesy Margaret Friedel.

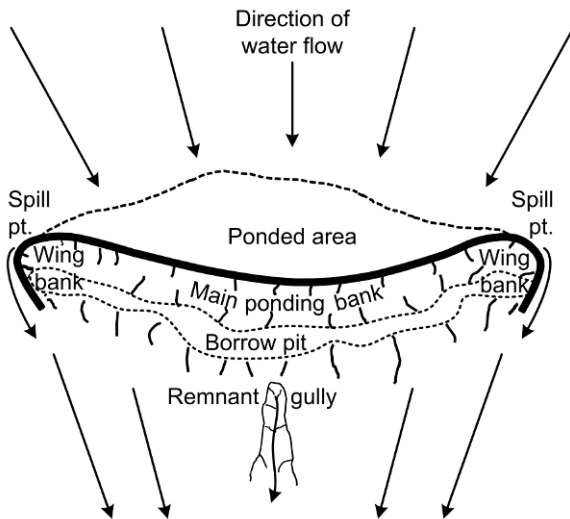
FIGURE 5.3. A sketch of the water-ponding bank design Mr. Purvis applied on Woodgreen.

Mr. Purvis changed his water-ponding design. He formed banks by pushing earth upslope from a borrow-pit below the bank (figure 5.3). Instead of exposing deeper subsoils in borrow-pits in front for the bank, which plants then had to colonize, the new design preserved the existing soils and any remnant vegetation upslope of the bank (plate 5.1). The bank was curved slightly to retain rainwater to a depth of about 150 mm, after which it was able to flow gently around the ends (spill points; figure 5.3). The banks were constructed to be about 2.5 m wide at the base and about 1.2 m high. The ends of banks were shaped like wings so that excess water would run gently down the hillslope well away from any gullies below the pond. The earth banks were created with a bulldozer, usually in the few days after significant rains when the soils were soft enough to work.

Mr. Purvis learned that the size and shape of water-ponding banks is extremely important (figure 5.3). The curve of earthen banks was built sharper on steeper slopes to avoid banks being washed out during big storm events. Water-ponding banks must be sufficient in size to efficiently harvest water from large catchment areas, but these areas must not be too large because then big storm events would wash out earthen banks. Where water-ponding banks were positioned in the landscape was also very important. Mr. Purvis first built shorter, lower banks near the top of the watershed in paddocks. Then he built wider, higher banks farther down the watershed as the area of catchment increased. When feasible, Mr. Purvis built water-ponding banks on existing flats because he knew that soils on flats typically have swell/shrink properties and are inherently more fertile.

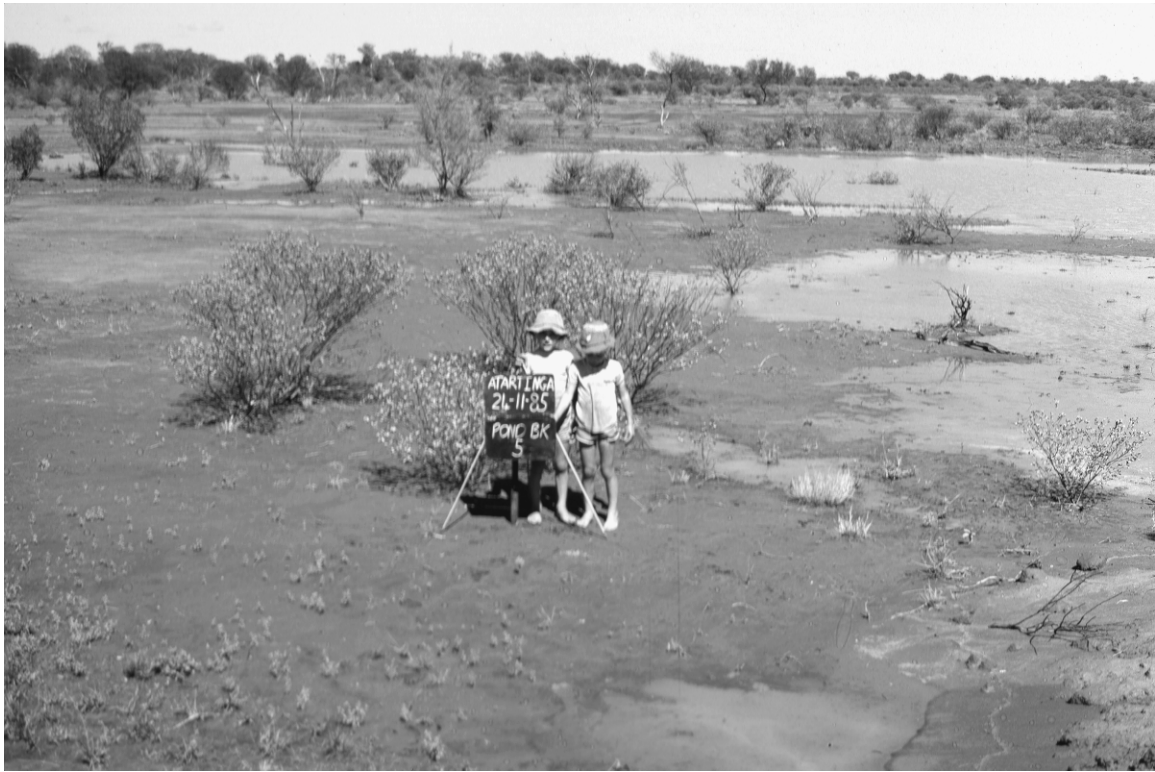
FIGURE 5.4. An example of water ponding on hard soil above a recently constructed bank (off the photo to the right). The flooding followed a storm event of approximately 20 mm in November 1985. Photograph courtesy Gary Bastin.

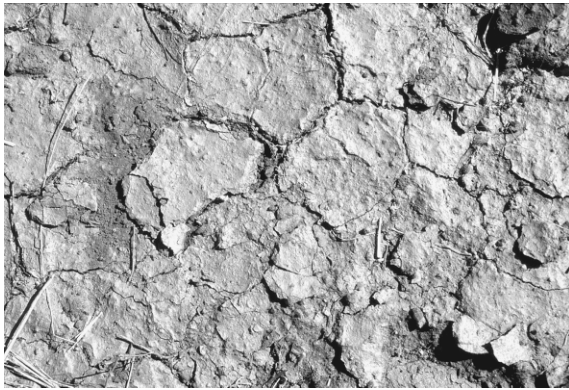
FIGURE 5.5. The soft, friable cracked soil surface that developed on a ponded area above a ponding bank constructed at Woodgreen.

Finally, to evaluate whether soils were improving within ponded areas, Mr. Purvis worked with one of us (DT) to assess indicators of soil-surface condition such as friability and cracking (figure 5.5), which indicate a greater potential for higher infiltration rates after the soil surface dries and cracks. (See chapter 14.)

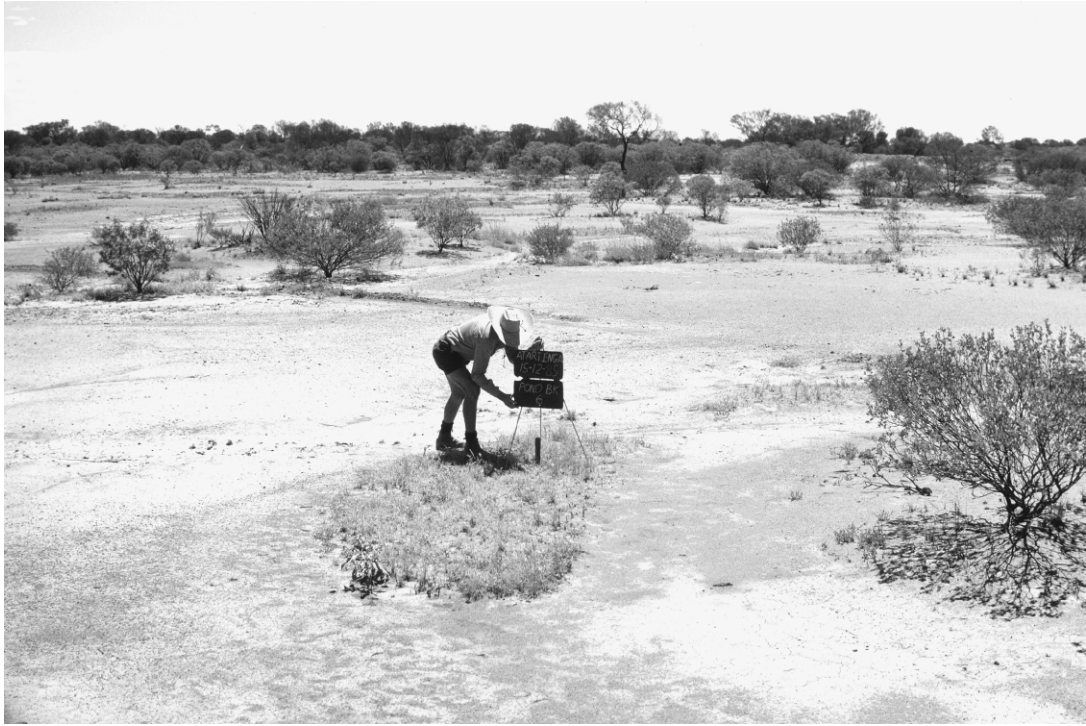
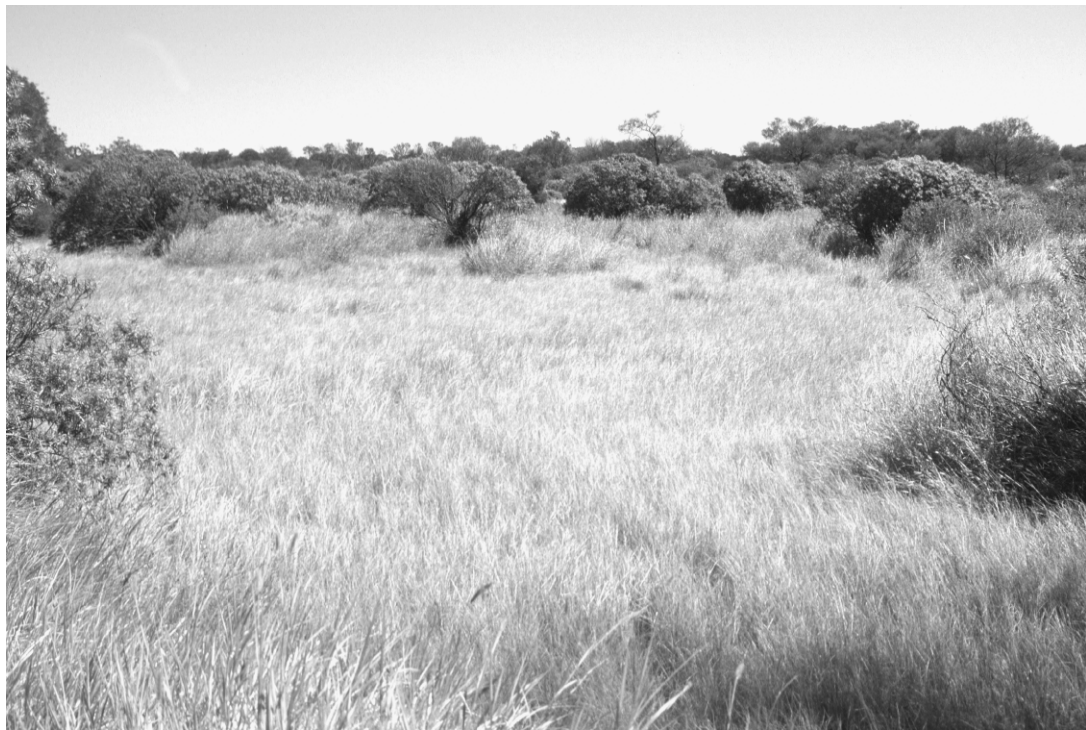
FIGURE 5.6. The renewal of productive pastures above water-ponding bank number 6 at a fixed photo point from 1985 (a) to 2001 (b). Photographs courtesy Gary Bastin.

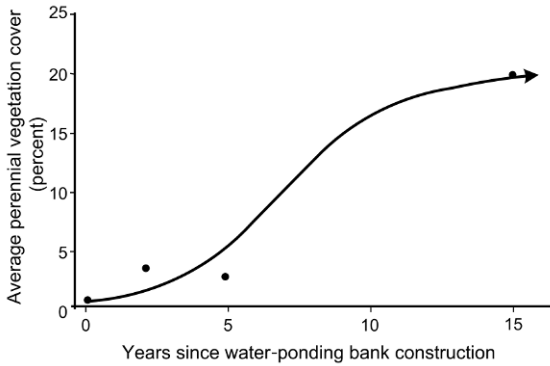
FIGURE 5.7. Vegetation cover increased with time since water-ponding bank construction.

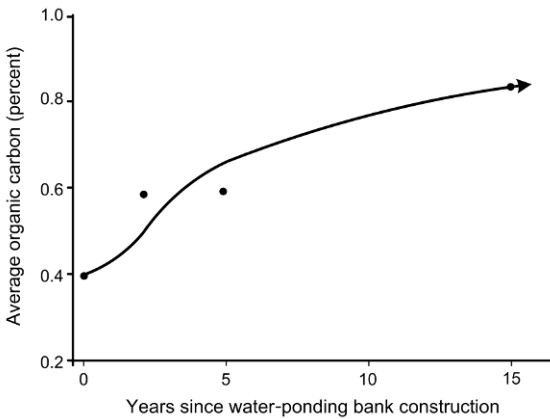
FIGURE 5.8. Soil organic carbon increased with age of water-ponding banks. Organic carbon was measured in the 0 to 10 cm soil layer within the 10 m above a bank.

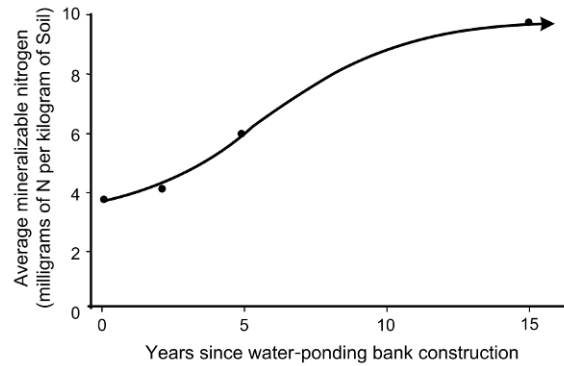
FIGURE 5.9. Available nitrogen increased with water-ponding bank age. Available or mineralizable nitrogen was measured in the top 10 cm of soil sampled close to banks (within 10 m).

banks (figure 5.9). The concentration of AN had more than doubled near ponding banks compared to never-ponded areas. Average amount of AN in soils collected well above the four ponding banks (i.e., where ponding never occurred) was, on average, only 2.7 milligrams of AN per kilogram of soil. Soil AN in samples collected 10 to 15 m and 25 to 45 m from water-ponding banks were, as expected, intermediate (for brevity, data not shown) between those collected near (less than 10 m) and far (greater than 45 m) from banks. These data indicate a marked improvement in soil fertility.

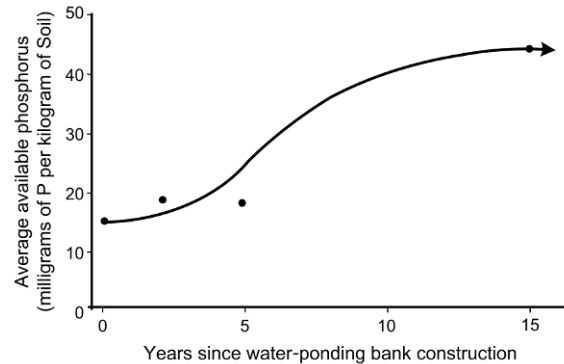
FIGURE 5.10. Available phosphorus increased with water-ponding bank age. Soil phosphorus was measured in samples collected in the top 10 cm within 10 m of banks.

Another indicator of soil fertility is phosphorus (P). As the age of water-ponding banks increased, they found available soil P increased in soils sampled within 10 m upslope of banks (figure 5.10). The mean concentration of available P in soils collected away from areas that ponded was only 17.8 milligrams of P per kilogram of soil. As expected (data not shown) soil P contents were generally intermediate in samples collected between those near and far from banks.

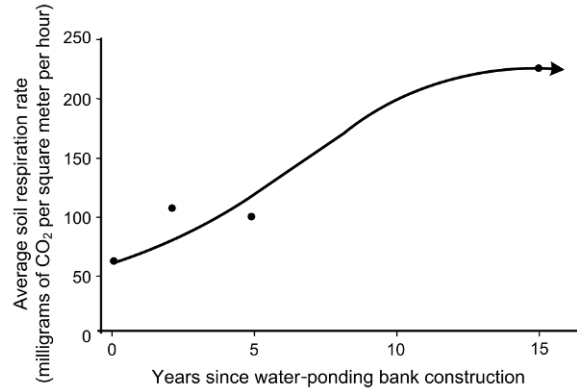
FIGURE 5.11. Soil biological activity (measured as soil respiration rate) increased with time since water-ponding bank construction. Activity was measured within 10 m of banks.

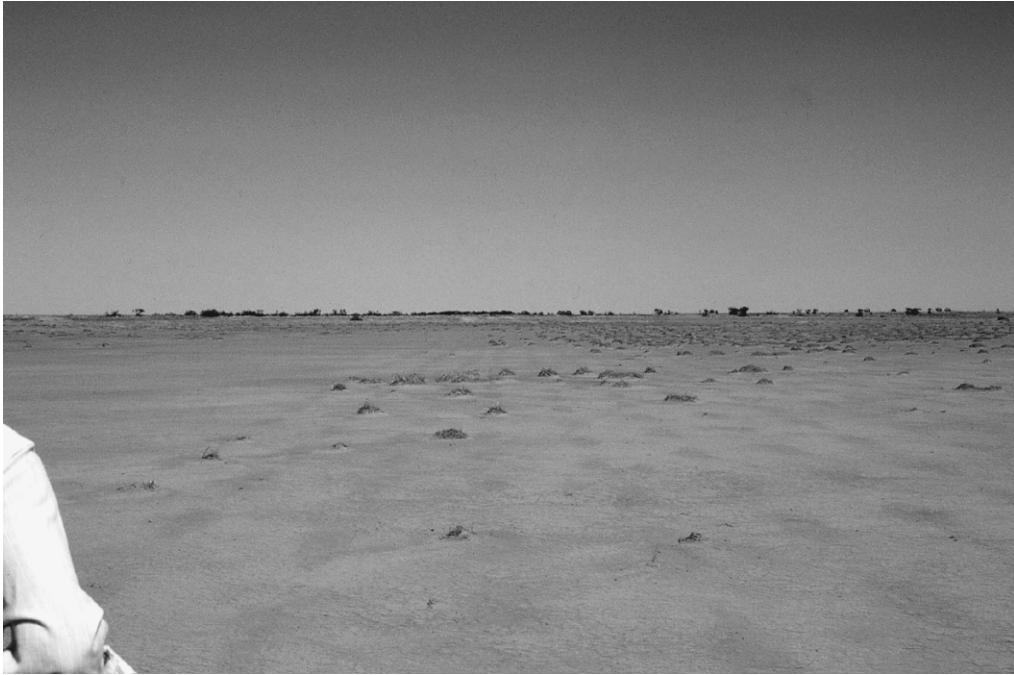
FIGURE 5.12. An extensive scald. Photograph courtesy David Eldridge. (Note in the foreground of this photograph that the scald had been ripped in lines to form shallow troughs and low banks. But, because of the dispersive nature of the exposed soil, these structures rapidly slumped and filled in after rains, so they no longer held water.)

Prolonged disturbances in rangelands around the world often cause scalds, a severe form of soil erosion seen as large areas of bare soil (figure 5.12), which remain in this condition for decades, no matter what how good the season or low the grazing pressure. Cunningham (1987) estimated that tens of thousands of square kilometers of rangelands in western New South Wales, Australia, were scalded

Scalds represent extreme cases of sheet erosion where flows of water and wind have caused the extensive loss of surface soils (figure 5.12). Scalds typically occur on near-level areas, or what are commonly called flats. Prior to being scalded, soils on flats typically have sharp texture boundaries between the A and B horizons. The A horizon erodes because it has a sandy loam texture that is subject to loss by wind and water action when the soils' protective plant cover is damaged. Stripping of the A horizon exposes a hard-setting and dispersive B horizon. Plants have great difficulty establishing and growing on these hard-set soils, hence, scalds tend to stay bare even if conditions improve (e.g., droughts break; grazing pressure is reduced).

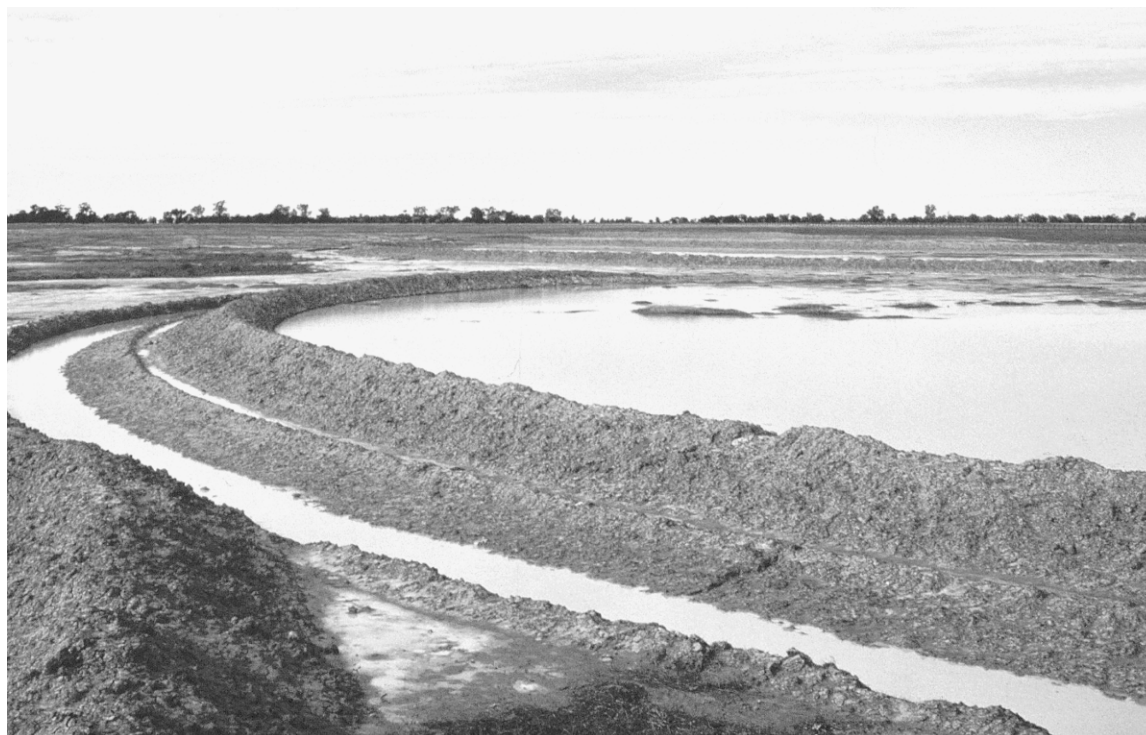
FIGURE 5.13. An example of a water-ponding bank constructed on a scald. The bank is successfully retaining water after a rain event. Photograph courtesy David Eldridge.

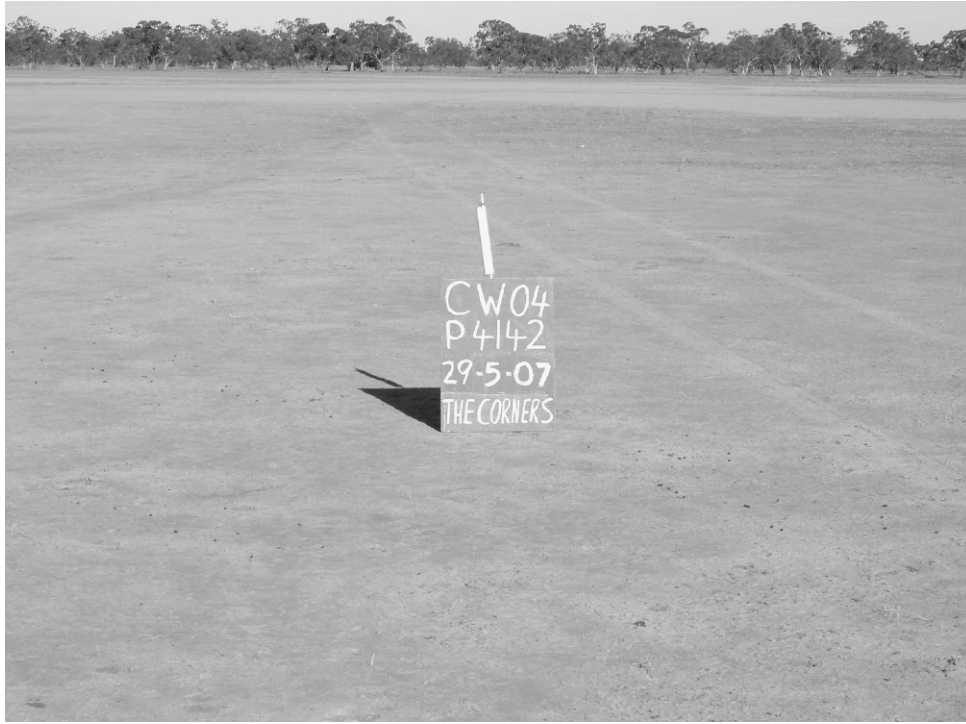
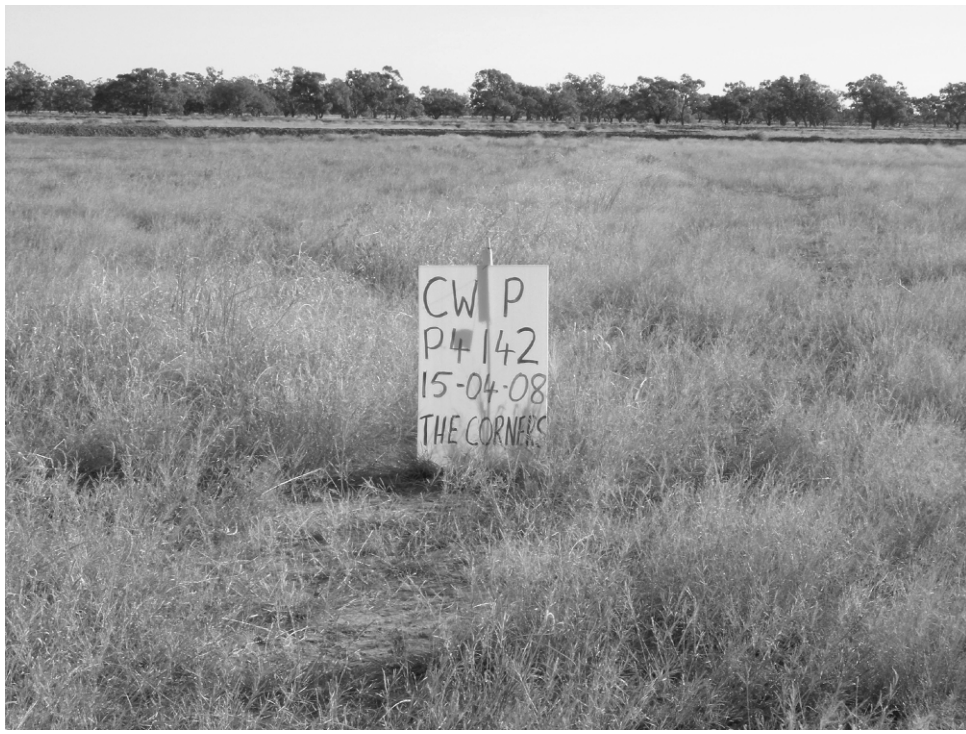
FIGURE 5.15. A severely scalded area just prior to water-ponding bank construction (a), and eleven months later (b). Photographs courtesy Ray Thompson.

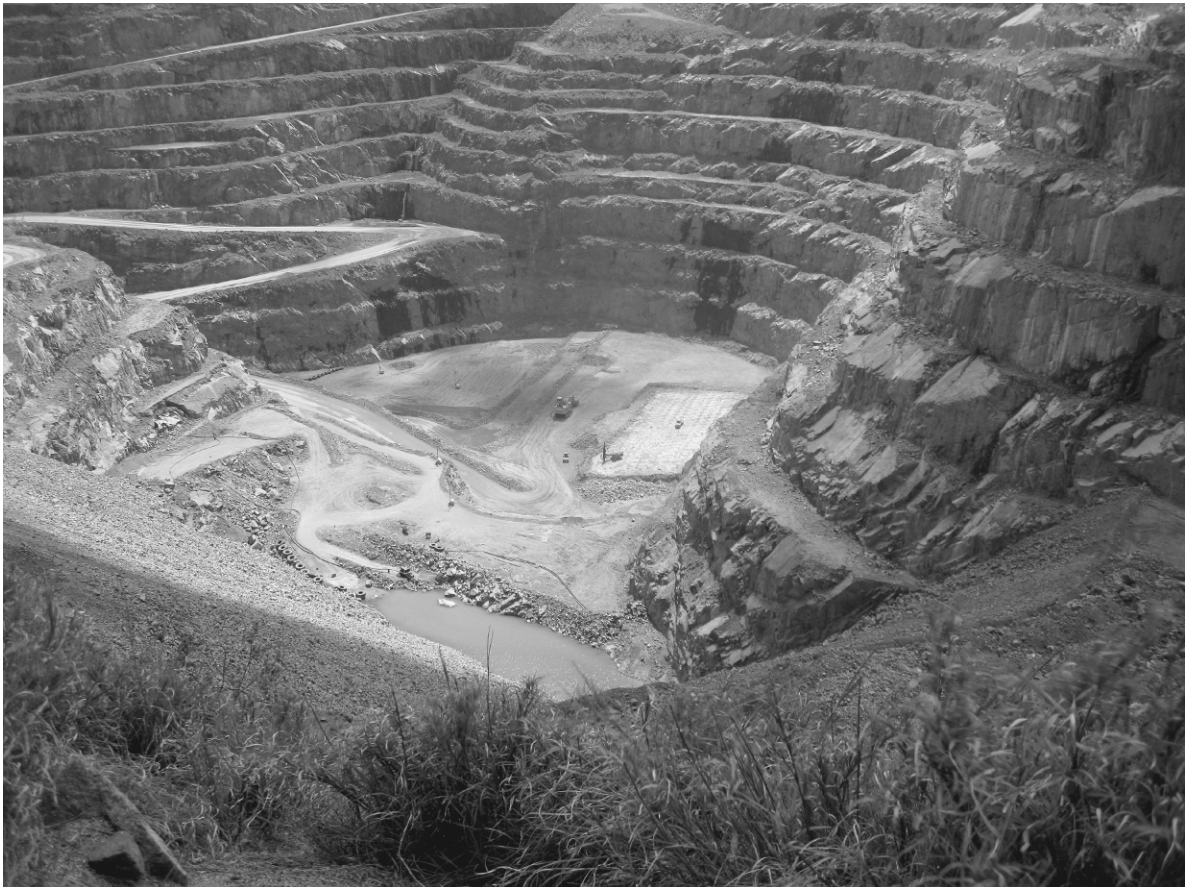
FIGURE 6.1. A typical deep open-pit created by a hard-rock mining operation. In this case, about 50 m of regolith (mostly oxidized broken rock or oxide) is located above the main ore body.

1. If close to the surface, open-pit excavations are used to mine minerals (figure 6.1). Waste rock and regolith (the layer of heterogeneous materials covering an ore body) are removed from the pit, dumped in piles, and pushed into plateau-like waste dumps (plate 6.1), which can cover hundreds of hectares. These waste-rock dumps are usually located near the pit to minimize haul distances. Mineral extraction processes also produce finely ground

This scenario deals specifically with restoring waste-rock dumps (plate 6.1) created by operations at a typical open-pit, hard-rock mine site (figure 6.1). For this scenario, we assume the following:

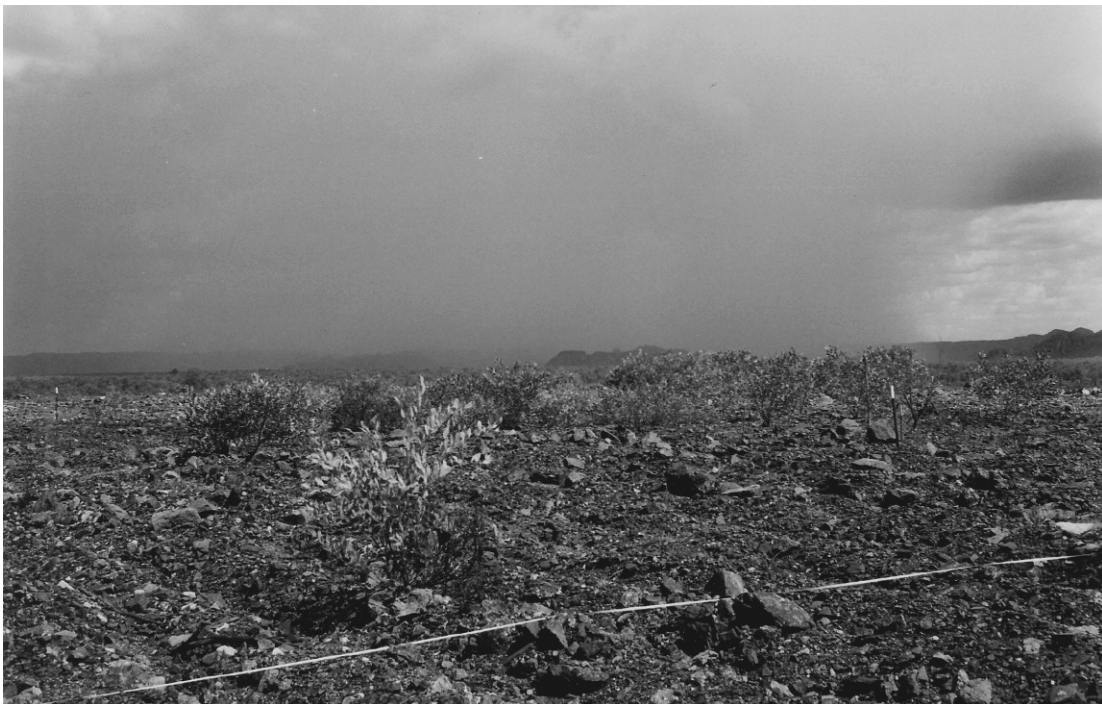
FIGURE 6.2. An example of a waste-rock dump that has been shaped into a plateau-like landscape and covered with coarse regolith materials. Note the approaching rainstorm.

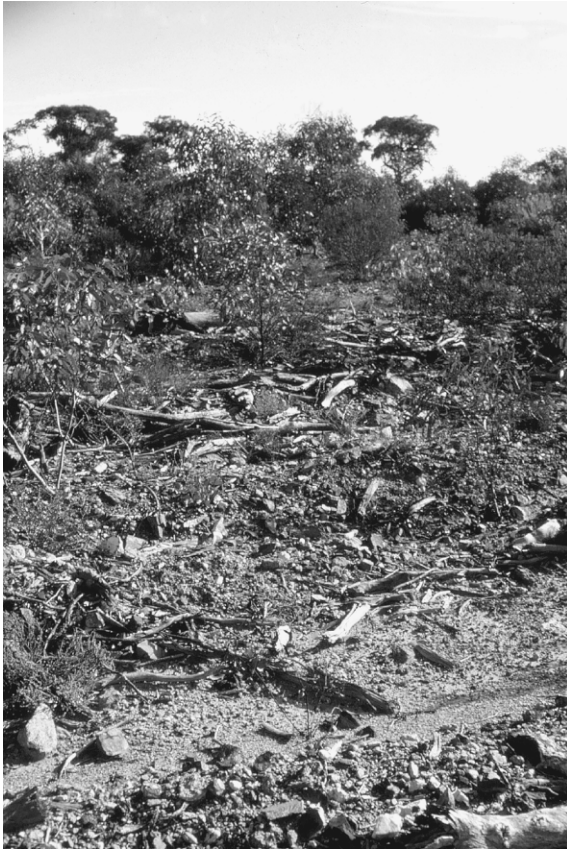
FIGURE 6.3. A rehabilitated mine site where woody debris has been applied to the surface of a reshaped waste-rock dump.

- To create surfaces favorable for plants, they first covered reshaped surfaces with regolith, which was mostly coarse broken rock (figure 6.2). Then they applied available topsoil, and mulch and woody debris (figure 6.3), because these surface coverings function to (1) prevent direct raindrop impact onto the soil surface, (2) obstruct and deenergize overland flows, (3) enhance infiltration, and (4) reduce the potential for wind to blow dust off-site.

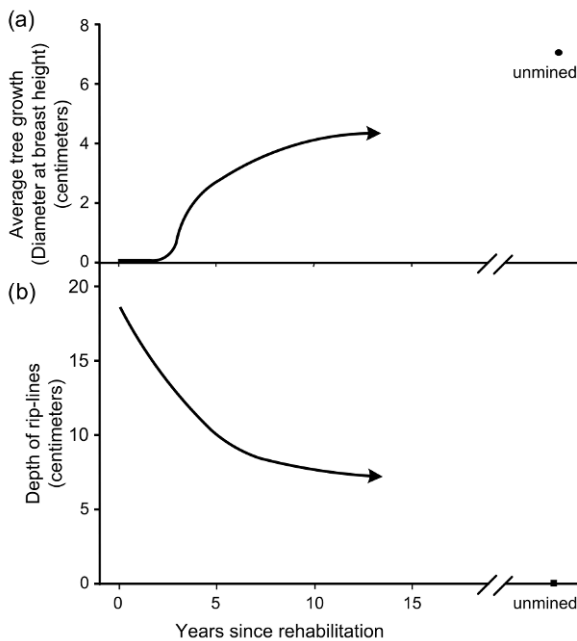
FIGURE 6.4. (a) Trend in tree growth (mean DBH) on rehabilitated mine sites was toward that expected for unmined sites. (b) Rip-lines created in surface materials remained 7 cm deep after 10 years (no rip-lines on unmined sites).

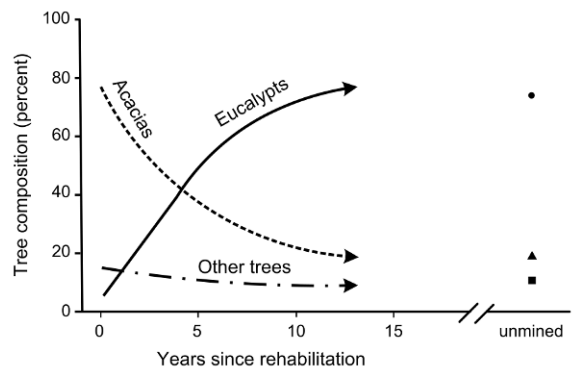
FIGURE 6.5. Trends in tree composition on rehabilitation sites toward those expected from nearby unmined reference sites for acacias (square), eucalypts (circle), and “other” tree species (triangle).

The RP found that trends in the percentage composition of the trees were generally toward an increase in long-lived *Eucalyptus* species and a decrease in short-lived *Acacia* species (figure 6.5) as would be expected for the development of self-sus-

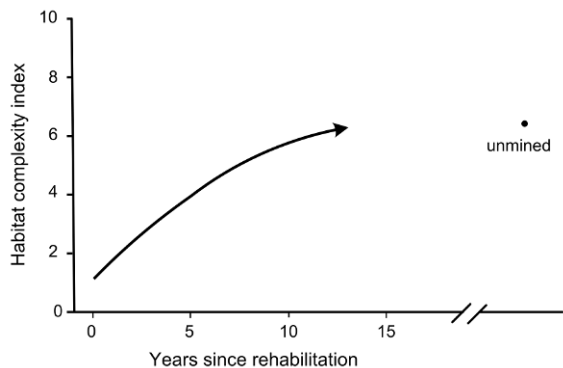
FIGURE 6.6. The trend in the habitat complexity index is toward the level expected for a natural unmined landscape.

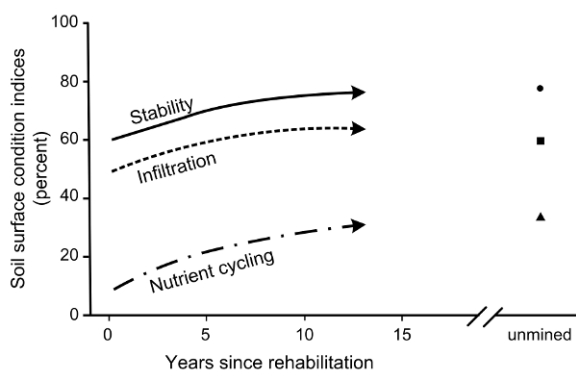
FIGURE 6.7. Trends in soil-surface condition indicators on rehabilitation sites: stability (circle), infiltration (square), and nutrient cycling (triangle) are toward values on unmined sites.

unmined sites. The RP found that surface stability and infiltration indices were initially high (figure 6.7), and remained so because the surfaces formed by the physical ripping of coarse waste-rock/regolith materials were inherently stable and readily took in water. The nutrient-cycling index steadily increased

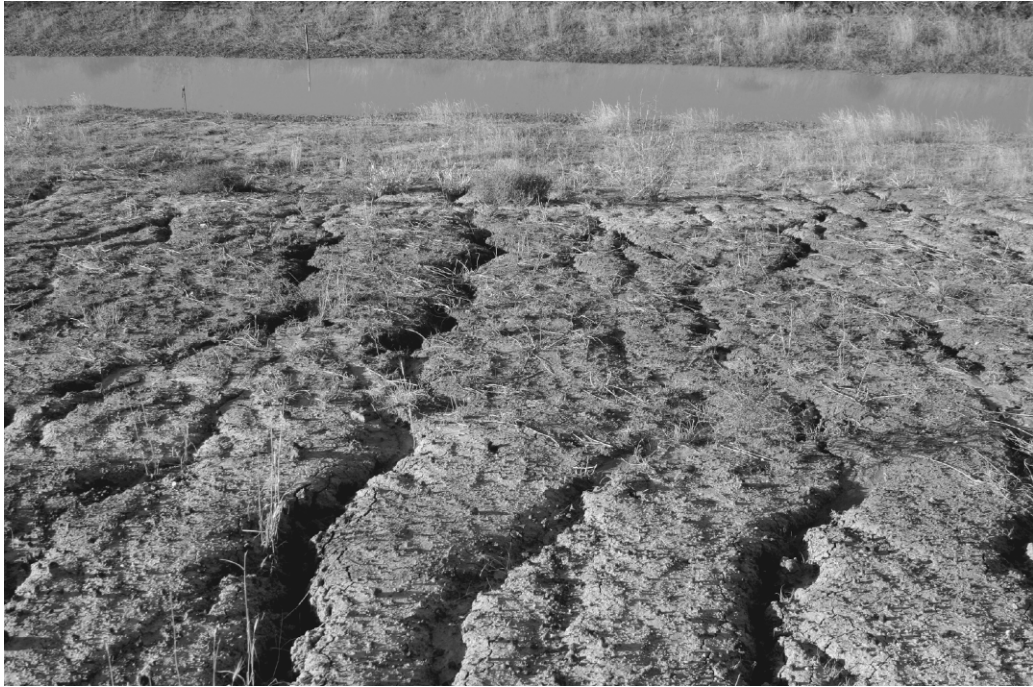
FIGURE 6.8. An example of a slope that has eroded into rills, with water ponding at the base of the slope rather than infiltrating into the slope to benefit plants.

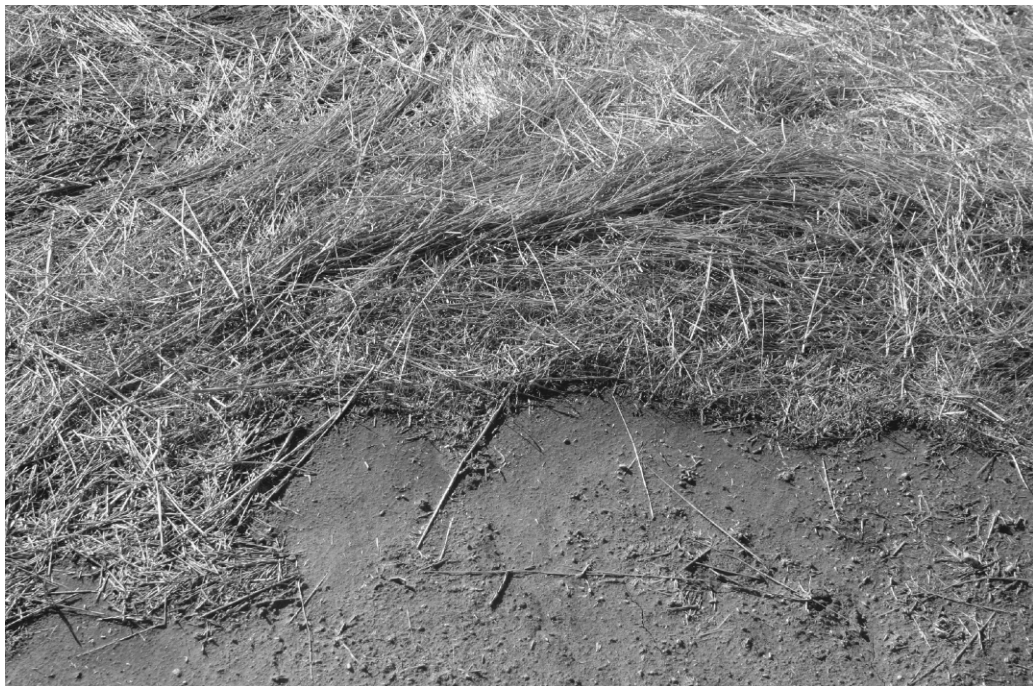
FIGURE 6.9. An example of the application of hay mulch to trap sediments on an eroding slope (see figure 6.8). All sediments were being trapped in the upper 40 cm of the applied mulch.

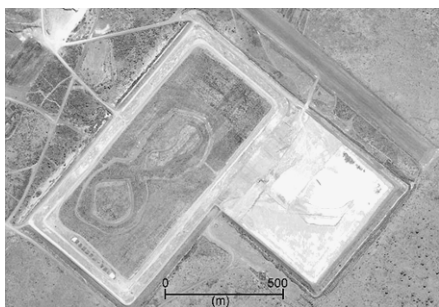
FIGURE 7.1. An aerial view of tailings storage facilities constructed as rectangular ponds with steep sides to reduce their landscape footprint. Photograph courtesy of Harley Lacy.

Globally, tailings are stored within constructed aboveground embankments (figure 7.1). Although

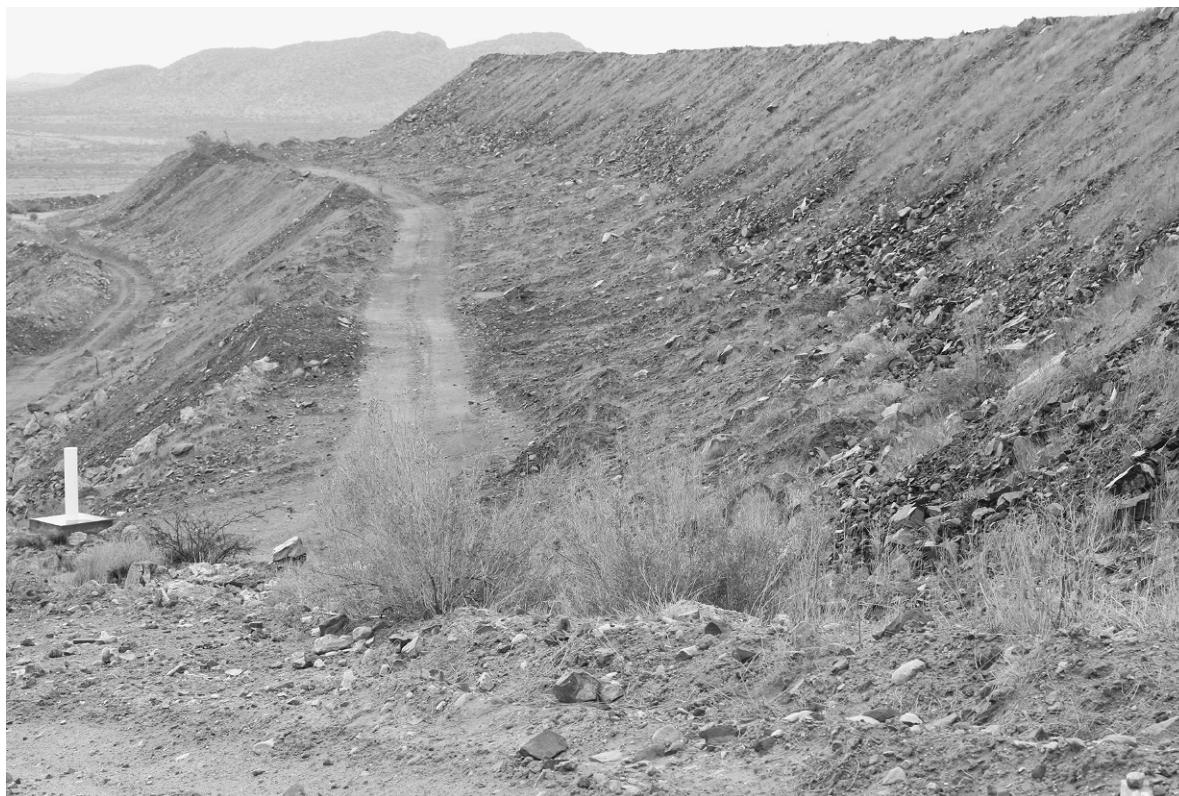
FIGURE 7.2. Stepped walls of a tailings storage facility built from dry tailings and covered with nonreactive waste rock.

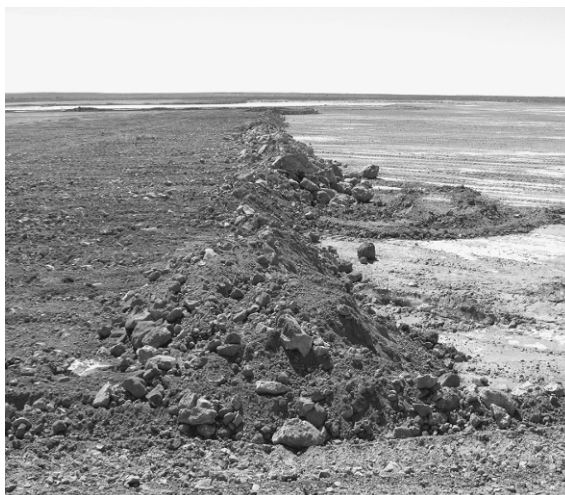
FIGURE 7.3. The entire top of a TSF is being covered with earth and waste rock. Photograph courtesy of Harley Lacy.

face open-pit operations or by tunneling underground. Around the world, open-pit mining operations typically produce sufficient waste-rock and regolith materials to completely cover tailings as part of the landscape restoration procedure (e.g., figure 7.3; plate 7.1). In this case we recommend RPs put into practice our five-step adaptive procedure and its principles. We described these practices in our chapter 6 scenario where, to retain water and promote vegetation on waste-rock dump slopes (figure 7.4), for example, RPs constructed bank-and-trough systems along contours (figure 7.5). Because these same landscape restoration procedures and technologies also apply to reclaiming waste-rock/regolith-covered TSFs, we will not repeat these procedures here.

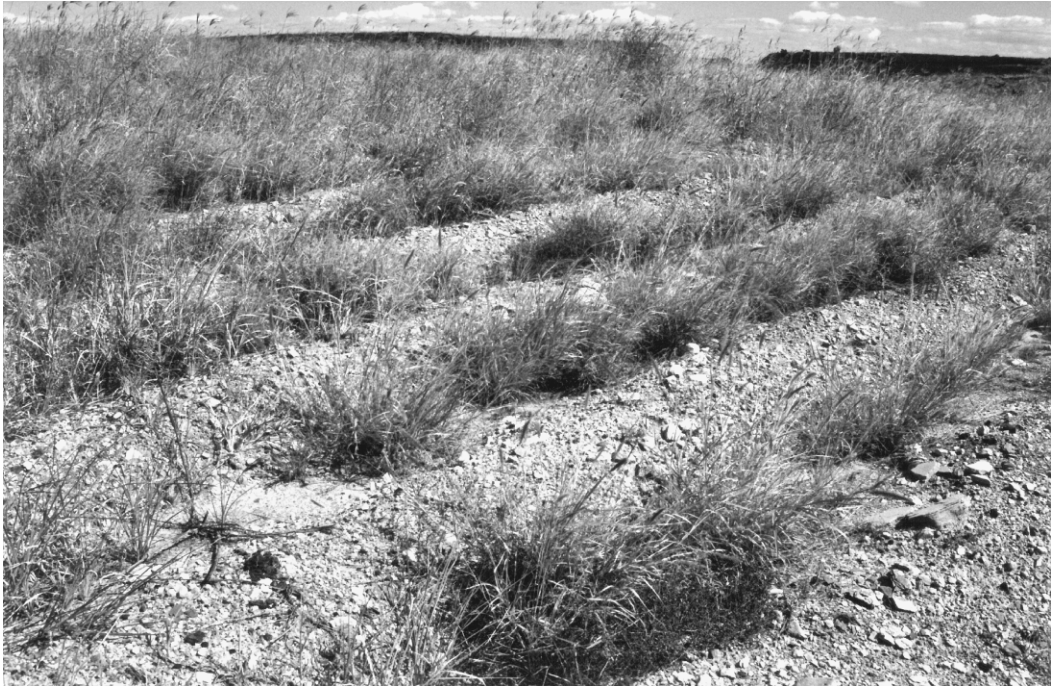
FIGURE 7.4. An example of vegetation established on a gently sloping TSF wall covered with earth and waste rock in a semiarid environment.

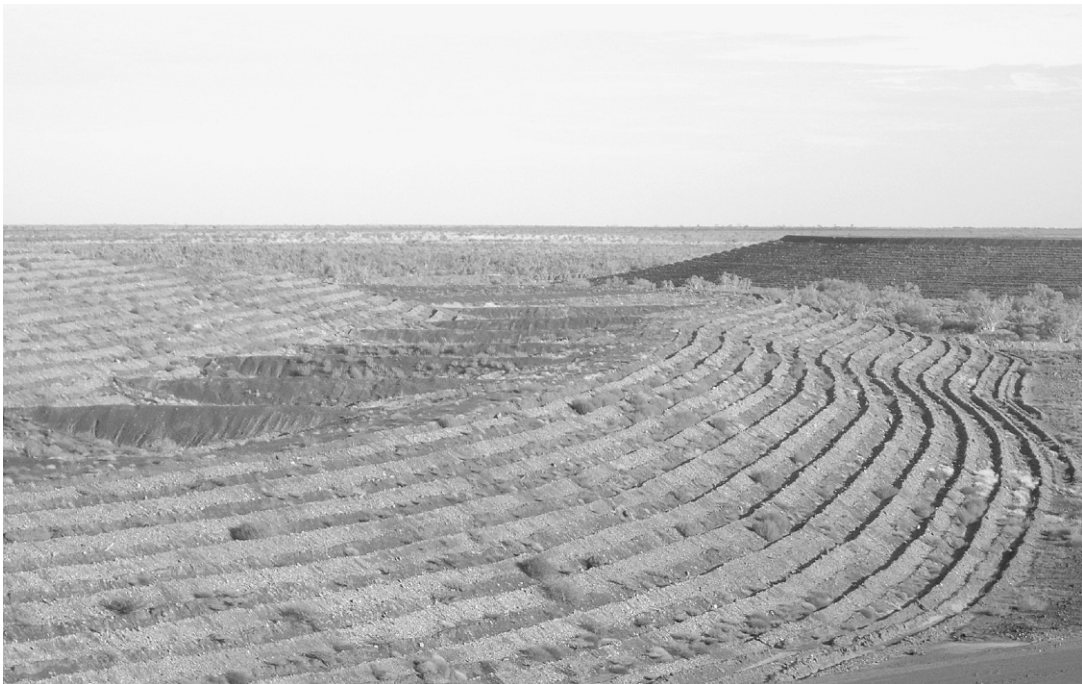
FIGURE 7.5. An example of a bank-and-trough system constructed on a low-angled TSF wall. Natural landforms can be seen in the background. Photograph courtesy of Roger Potts.

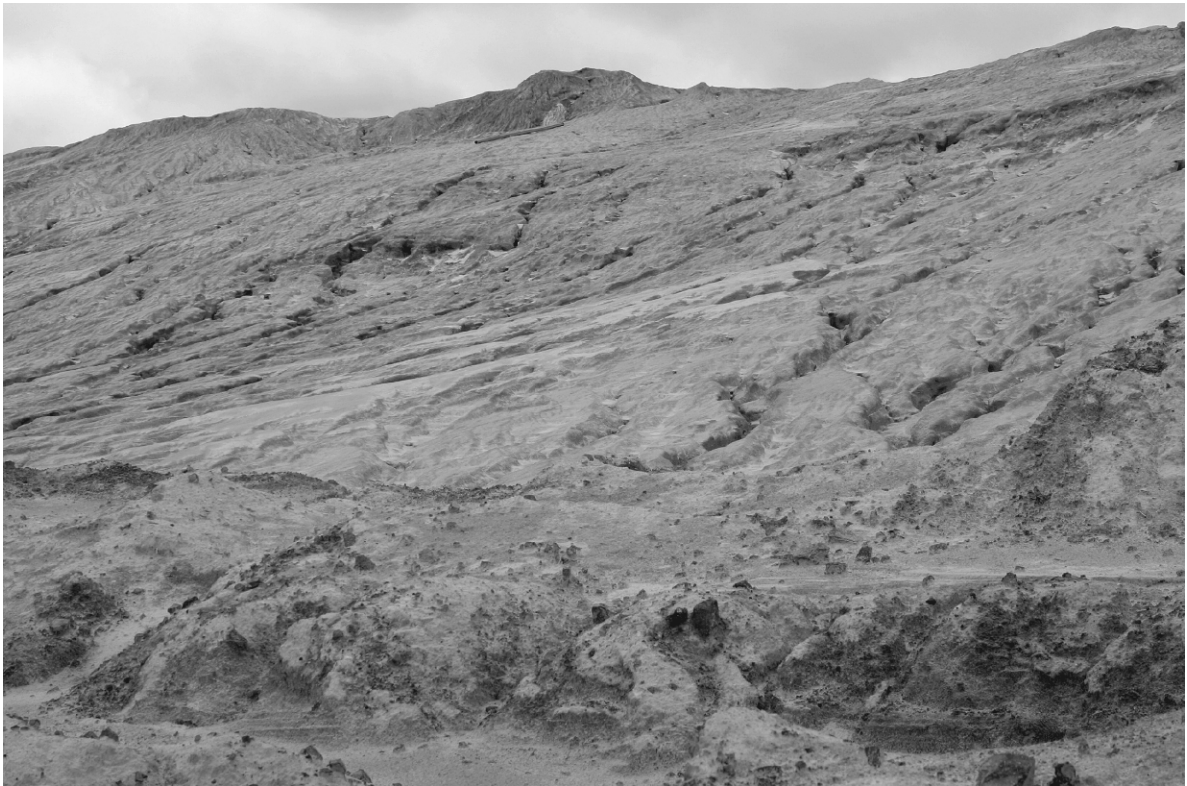
FIGURE 7.6. Overflow from the top of a TSF (at top right) has eroded the wall, carrying tailings off the site.

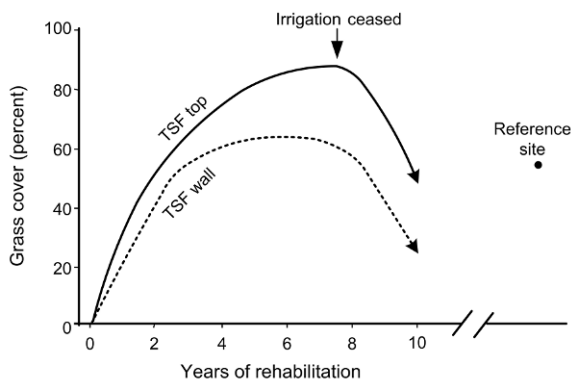
FIGURE 7.7. The mean trends in grass cover on rehabilitating TSF tops and walls. As a reference point, grass cover was also measured on nearby natural grassland sites.

- Because the grass root systems had developed to expect about twice the natural rainfall, grass cover on the top and walls of the rehabilitated TSF rapidly declined from high eight-year values of 85 percent obtained under irrigation and fertilization down to about half these maximums in year ten (figure 7.7). The natu-

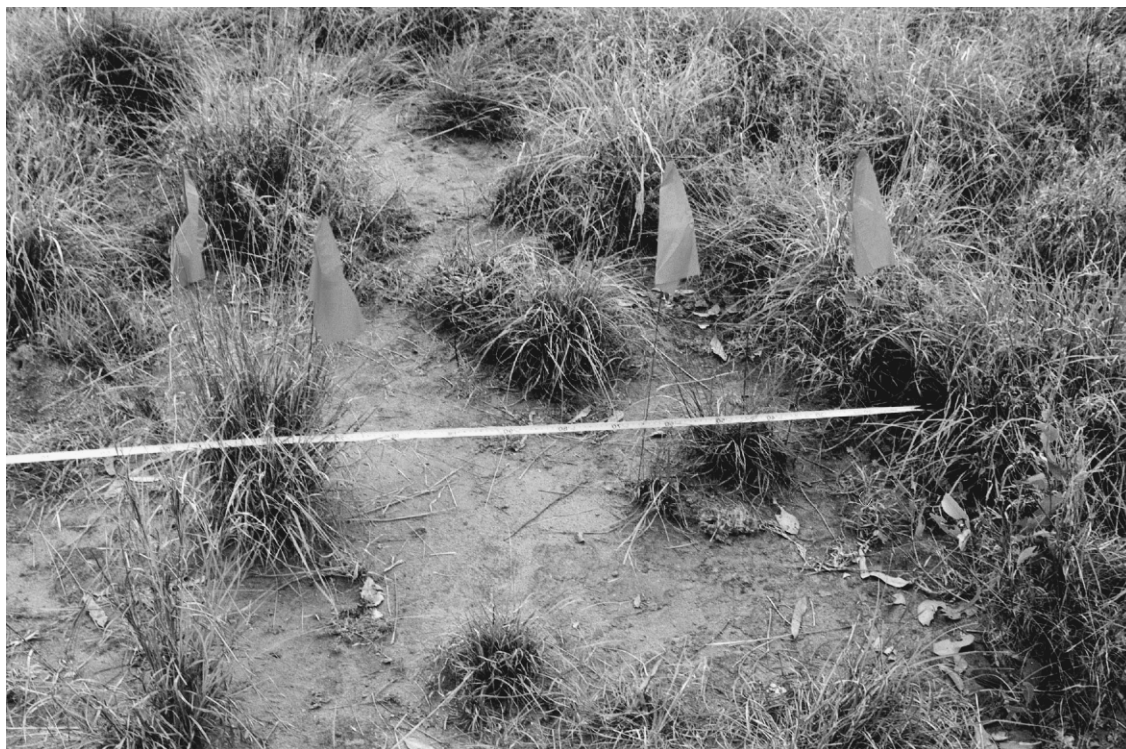
FIGURE 7.8. Signs of surface erosion and compact physical crusts are evident between grass clumps along a transect being monitored on the walls of a rehabilitated TSF.

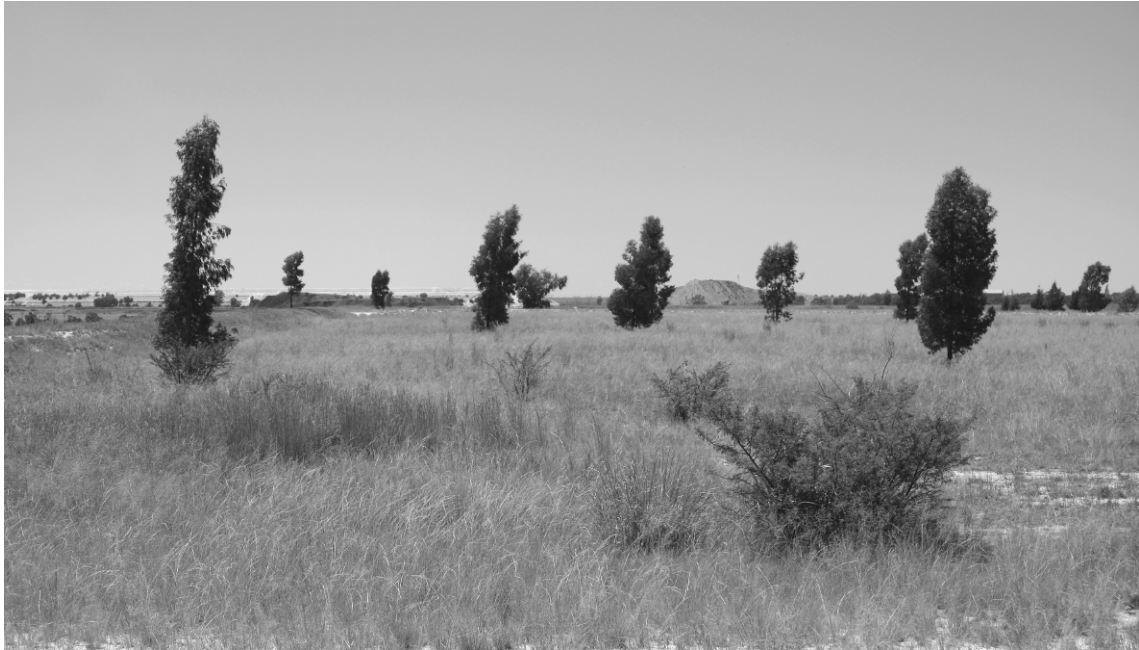
FIGURE 7.9. An open pseudosavanna landscape where raw tailings were used to form low banks and shallow depressions on top of a TSF, thus replicating the spatial heterogeneity found in natural landscapes. Variations in vegetation density reflect the bank and depression structure.
