Restoring Disturbed Landscapes

Putting Principles into Practice

DAVID J. TONGWAY *and* JOHN A. LUDWIG

The Science and Practice of Ecological Restoration

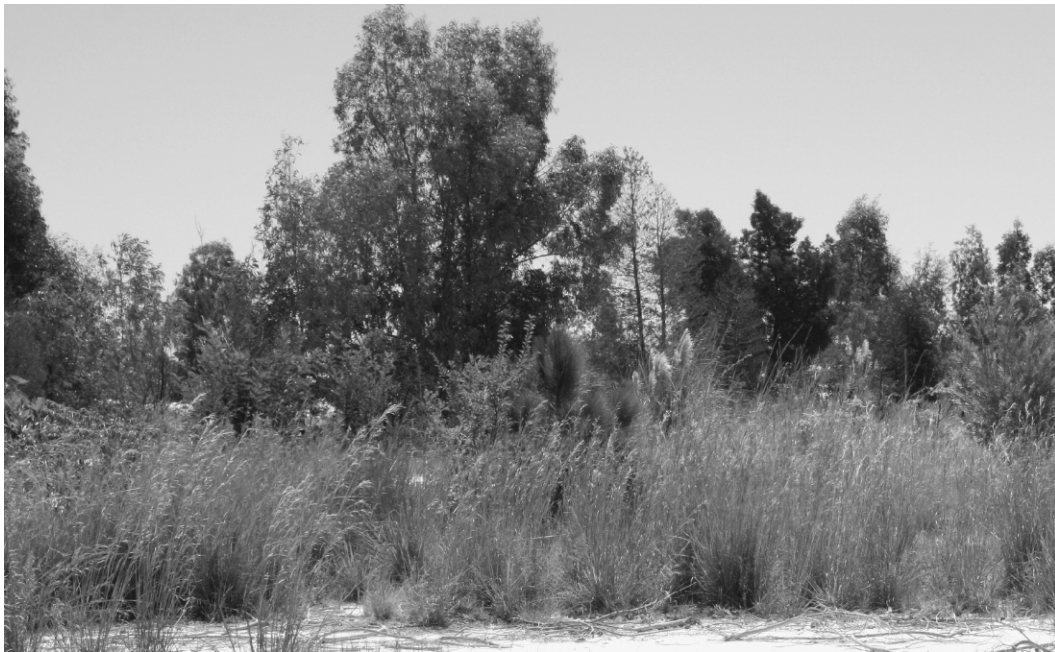
FIGURE 7.10. An example of vegetation development on the top of a rehabilitated TSF after more than five years where paddock-dumped garden refuse was the principle treatment; this refuse provided both substrate and microorganisms to accelerate soil-formation processes.

For the tops of the rehabilitated TSF, the RP found that after only five years a dense and fine-scale patchy cover of grasses with a few trees had developed, which resembled the desired pseudosavanna (figure 7.9). To kick-start biological processes, the RP found a rich diversity of plant forms on mounds where garden refuse had been dumped (figure 7.10).

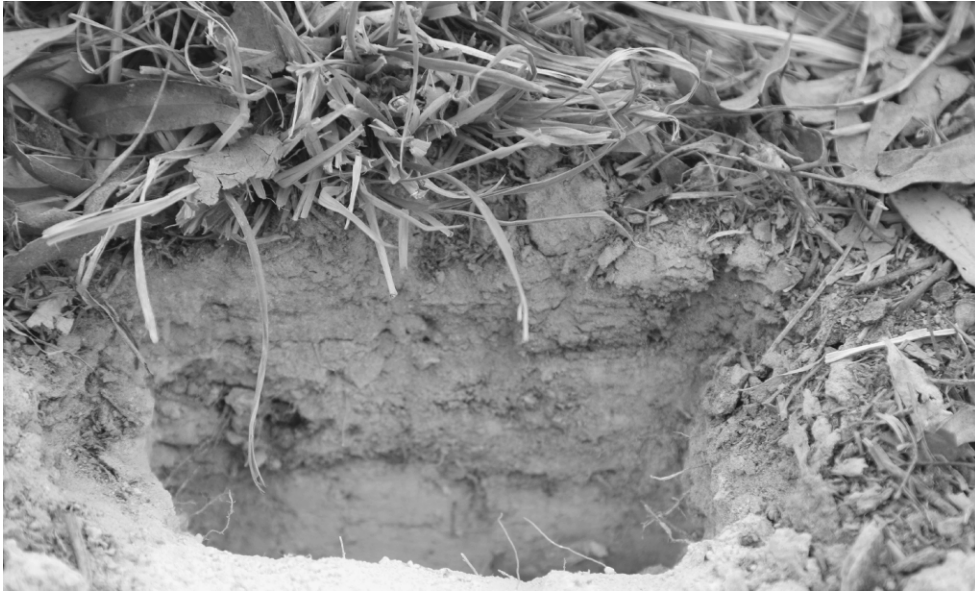
FIGURE 7.11. A profile of a soil forming under mulch applied to a mound on the top of a rehabilitated TSF.

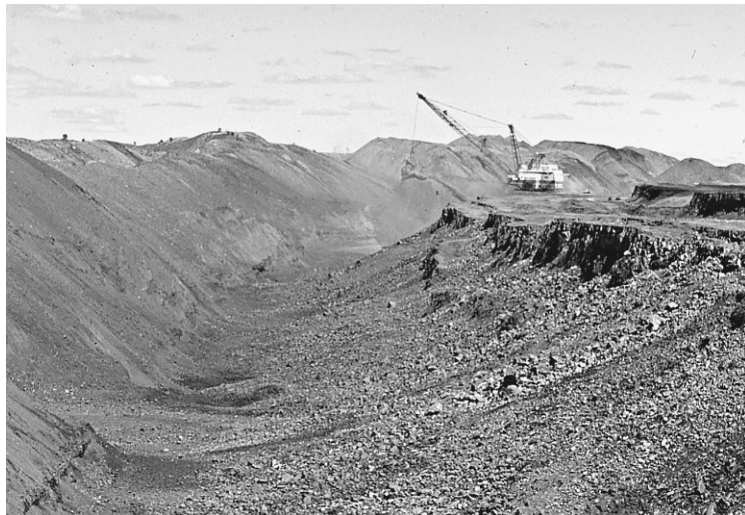
FIGURE 8.1. An example of an open-cut coal mining operation where massive drag-lines are used to strip soil and over-burden and expose the coal layer.

operations (figure 8.1). To reach coal deposits near the earth's surface, open-cut mining operations remove over-burden (regolith) materials to create large and extensive piles of waste material called spoil (figure 8.2).

- Because of the way spoil materials were deposited by dragline operations (figure 8.1), spoil piles were unconsolidated mixes of materials (figure 8.2). This meant that reshaping these large, steep spoil piles into the landforms desired by stakeholders would be costly.
- Because of alkalinity (pH greater than 8) and sodicity (high concentrations of exchangeable sodium), spoil materials were highly dispersive and sides of piles readily eroded. (See figure 8.2.)
- Due to potential failures from pipe and tunnel erosion, dispersive spoil materials would not be suitable for building earthen banks to pond water for cattle and to form artificial wetlands.
- Because quality topsoil (pH around 7) was stripped off surfaces prior to mining and was stockpiled into hills, or buried, topsoil ended up being stored for so long that its biological activity was greatly reduced.

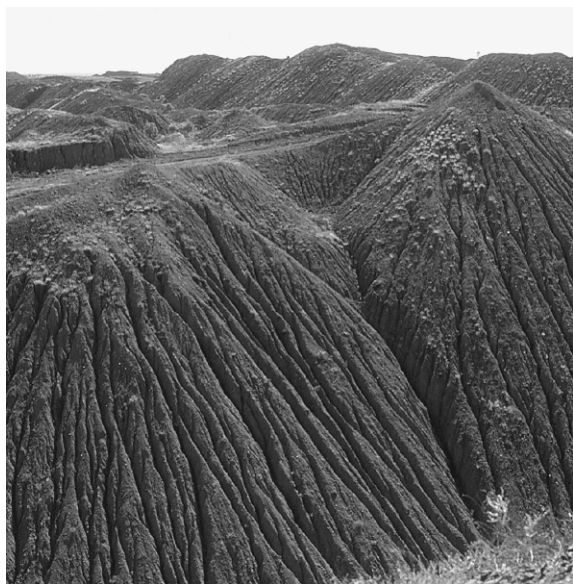
FIGURE 8.2. A typical open-cut coal mining operation that has created extensive piles of spoil (over-burden). Note the erosion on the steep slopes of these spoil piles. The road on the top indicates that these spoil piles are up to 50 m high.

This scenario addresses restoring landscapes covered with large piles of coal-mine spoil. (See figure 8.2.)

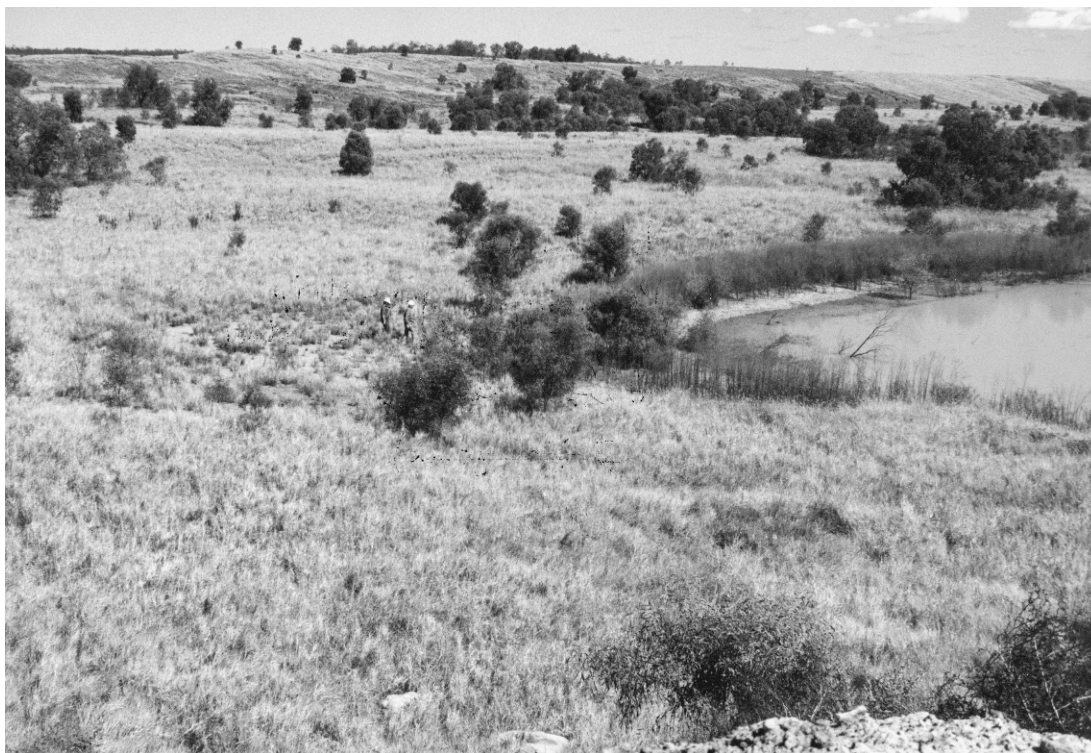
FIGURE 8.5. A rehabilitated landscape shaped from coalmine spoil into gently rolling pastureland with low ridges and a valley draining into a wetland.

- To retain water within the rehabilitated landscape, the RP designed gently rolling pasturelands with a wetland. This landscape was built to be roughly saucer shaped, having widely spaced perimeter ridges (1,000 m apart), gentle slopes, and a central valley that drained into an artificial wetland (figure 8.5).
- To roughen pastureland surfaces to slow overland flows of water and reduce surface winds, the RP capped surfaces with topsoil and ripped slopes along contours.
- To establish pasture grasses and forbs on these rehabilitated surfaces, the RP sowed a seed mix of pasture species known to suit the prevailing climate and soil type, and known to be valued by local cattle producers; this seed mix included short-lived acacia shrub species.
- To ensure good shrub, grass, and forb growth after rains, the RP applied fertilizer.

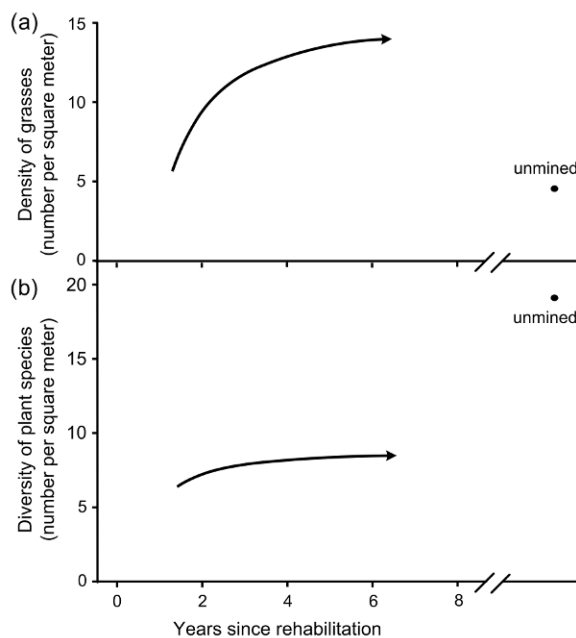
FIGURE 8.6. (a) Trends in the density of grass plants; (b) diversity of pasture species on rehabilitated pasture sites toward those expected from nearby unmined pastures.

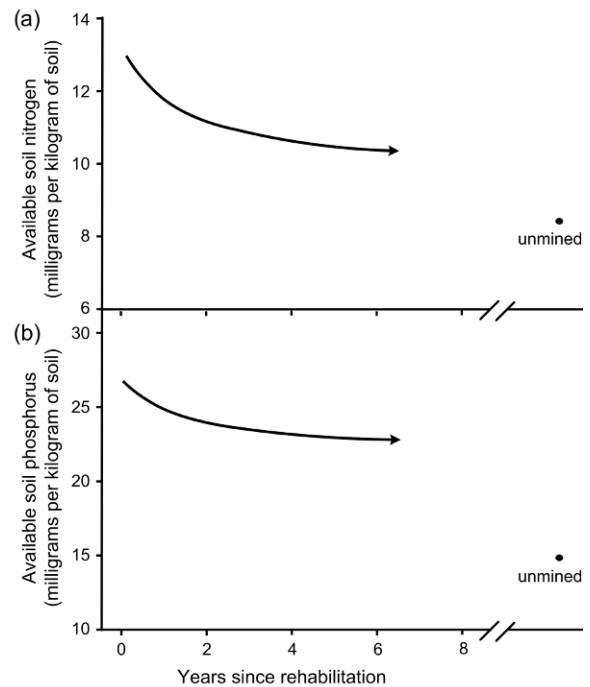
FIGURE 8.7. (a) Mean available soil nitrogen; (b) mean available phosphorus in samples collected from the 0 to 5 cm depth on rehabilitated mine-spill sites and on unmined pasture sites.

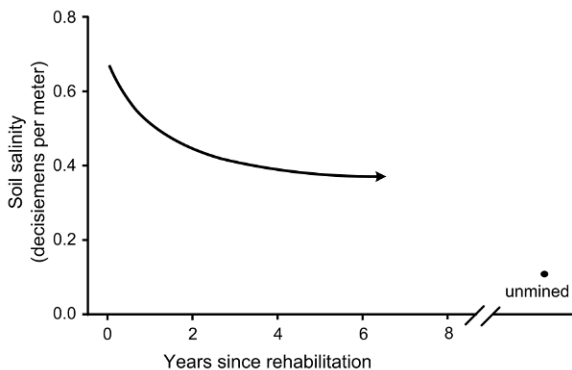
FIGURE 8.8. Soil salinity in the top 0 to 5 cm on rehabilitated mine-spoil sites compared with top-soil from unmined pasture sites.

- The salinity of topsoil (0 to 5 cm) was initially fairly high (figure 8.8), but this diminished with time as leaching processes took effect. Although the salinity trend was toward that expected for natural pastures, the RP found that after six years soil sodicity (high exchangeable sodium) was still so high that soils remained dispersive (unstable).
- Due to the soil dispersion and slaking during rainfall, the RP found that after six years the rip-lines installed along slope contours had largely filled with sediments (figure 8.9).
- After only one year, the RP also found rills and gullies on rehabilitated slopes; these erosion features numbered as high as forty-five along a 100 m transect, and averaged 60 cm wide and 12 cm deep. Some gullies were over 1 m deep (figure 8.10). These erosion features imply

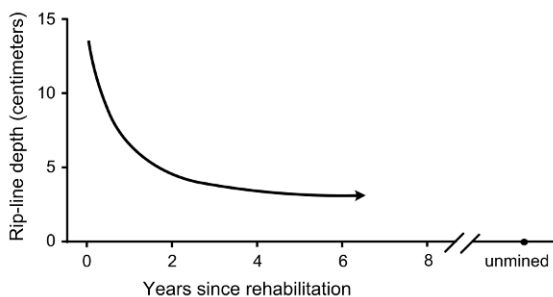
FIGURE 8.9. Mean depth of rip-lines on rehabilitated sites of increasing age. Depth is measured from bank tops to trough bottoms. Unmined natural pasture sites do not have rip-lines.

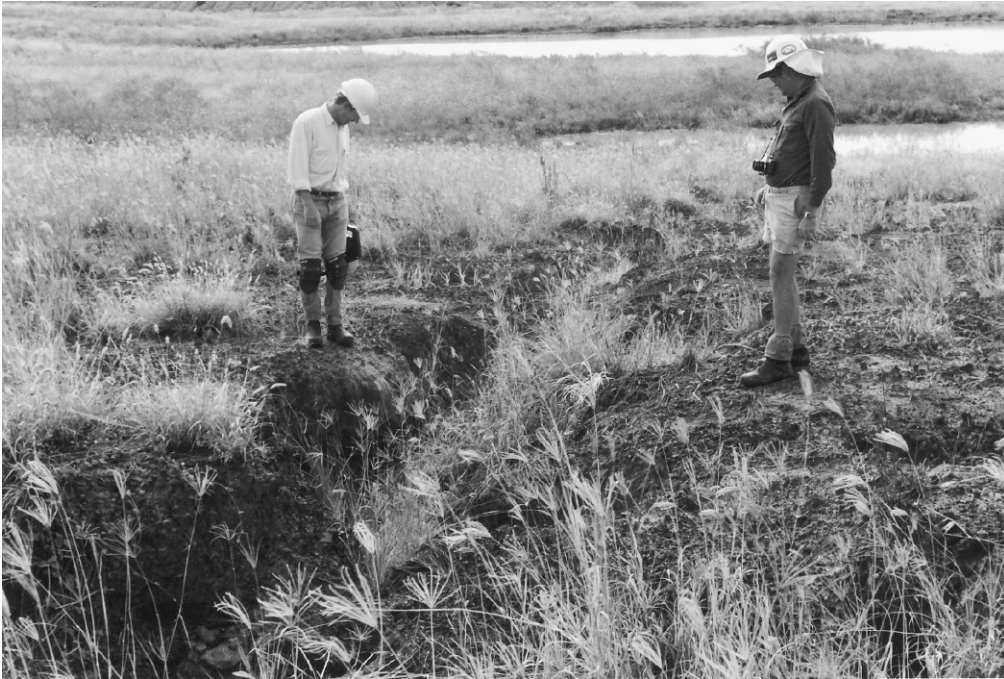
FIGURE 8.10. An example of a gully cutting into a slope reformed from spoil heaps created by open-cut coal mining. Grass plant root systems were unable to sufficiently ameliorate the dispersion properties of the spoil.

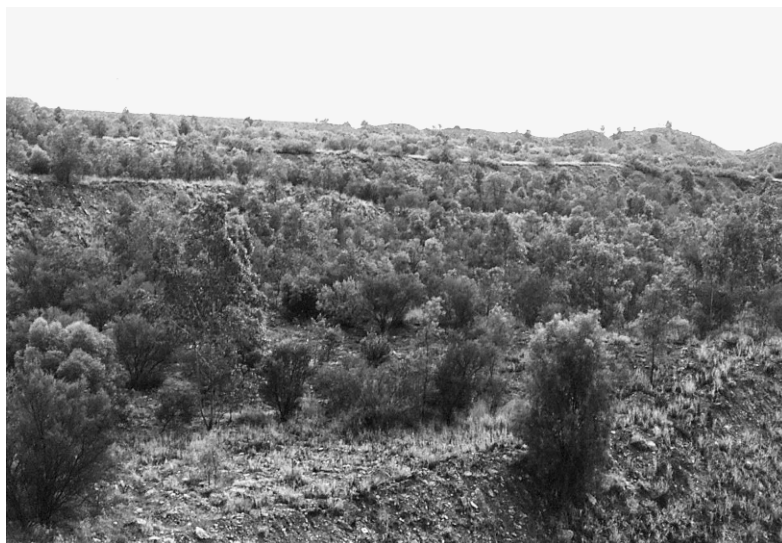
FIGURE 8.11. An example of a landscape reformed into small catchments (about 50 m from rim to rim) from spoil heaps produced by open-cut coal mining.

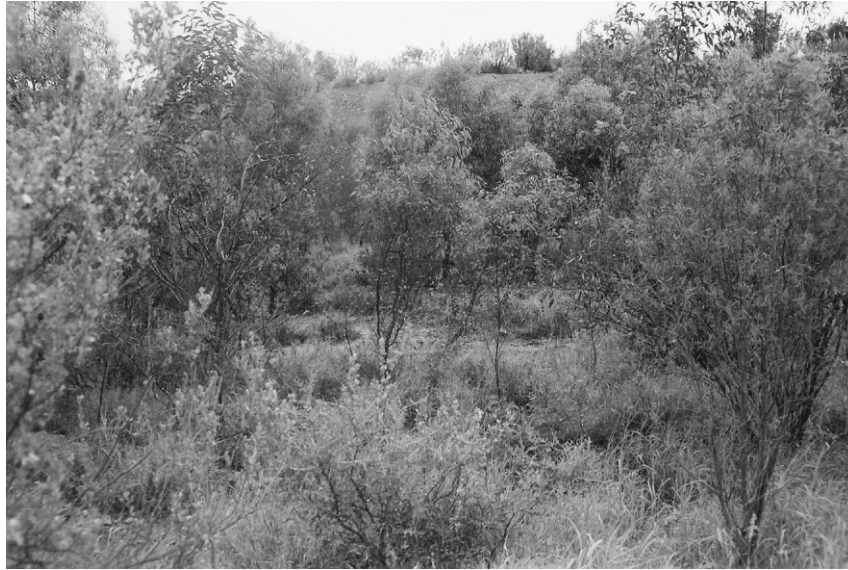
FIGURE 8.12. After four years, native trees, shrubs, and grasses successfully established in small catchments created on rehabilitated coal-mine sites.

- There were no signs of leakage from the small internally draining catchments. Although the RP found some small rills on the sides of banks, all water and sediments were being contained within catchments.
- Native trees, shrubs, and perennial grasses readily established and grew within the small catchments (figures 8.12). The RP found that densities for trees and shrubs in catchments were toward those found on nearby unmined woodlands (figure 8.13).
- Trends in soil-surface condition indicators on rehabilitated spoil sites were also toward values found on unmined sites (figure 8.14). The RP concluded that these indicators provided evidence of soil formation processes (e.g., incorporation of organic matter from plant litter into the soil).

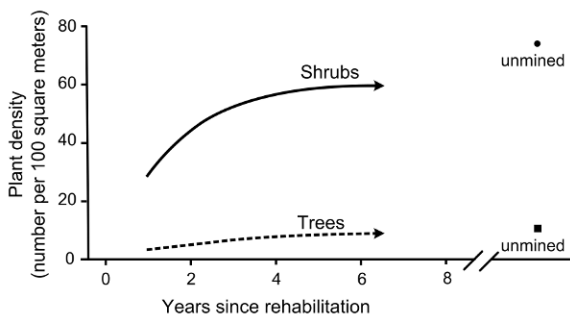
FIGURE 8.13. Density of trees and shrubs on rehabilitated sites shaped as small catchments and on nearby unmined woodland sites. Symbols: circle = shrubs; square = trees.

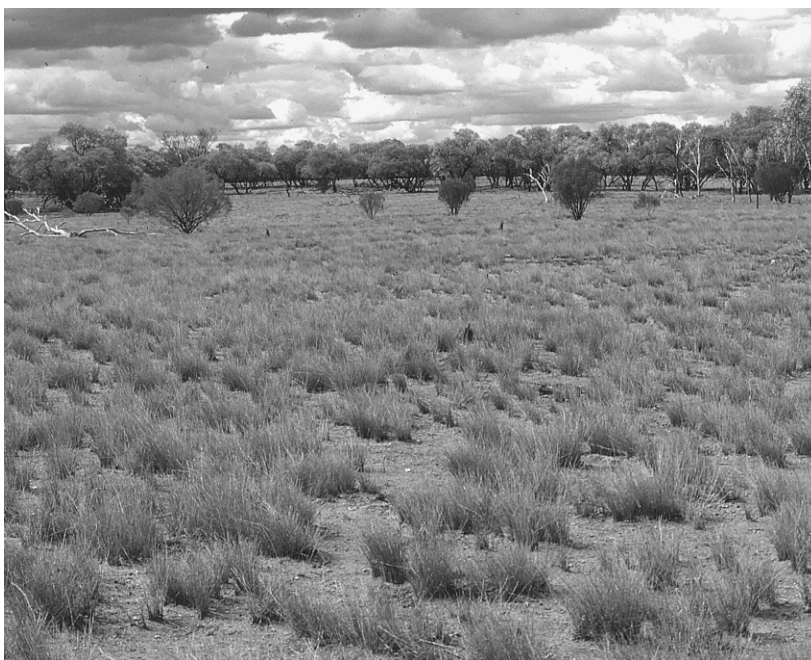
FIGURE 9.1. A highly functional rangeland with a high cover of palatable perennial grasses and a few scattered shrubs. There are few signs of accelerated soil erosion. Denser shrub and tree associations are confined to drainage lines in the background.

This scenario describes the problem of restoring rangelands that were once open and grassy (figure 9.1) but have lost their groundcover and have become dense with unpalatable shrubs (figure 9.2). These dramatic changes are usually the result of many years of heavy grazing by livestock and, in numerous cases, by feral animals, such as rabbits, goats, camels, horses, and donkeys. Because of low

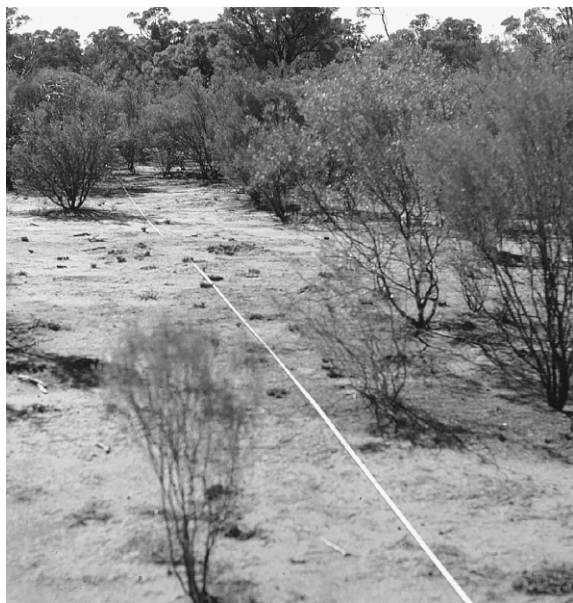
FIGURE 9.2. A monitoring transect in a dysfunctional rangeland where grasses have been replaced by dense unpalatable shrubs. Bare soil areas between the shrubs have high rates of wind and water erosion.

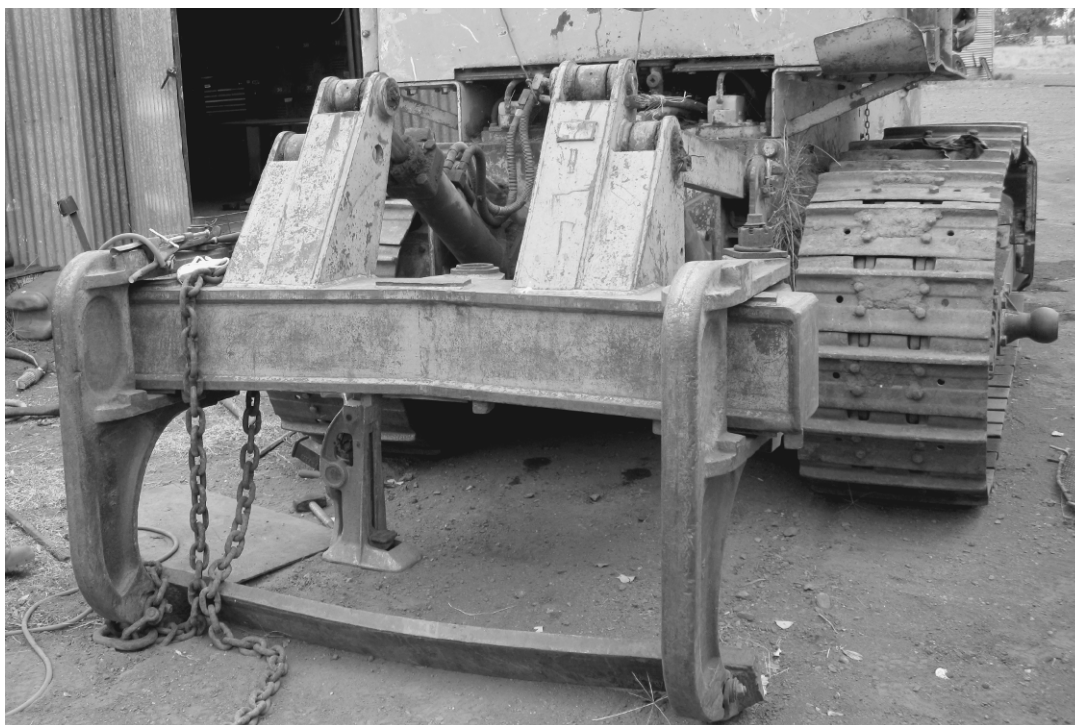
FIGURE 9.3. A blade-plow used to control rangeland shrubs by severing their roots below ground.

(figure 9.3). Experimental trials had demonstrated that blade-plowing efficiently deals with small to large shrubs by (1) severing the roots, (2) uprooting the crown, and (3) leaving most of the severed roots buried. These factors significantly increase the mortality of the shrubs in treated rangelands. (See Wiedemann and Kelly 2001.)

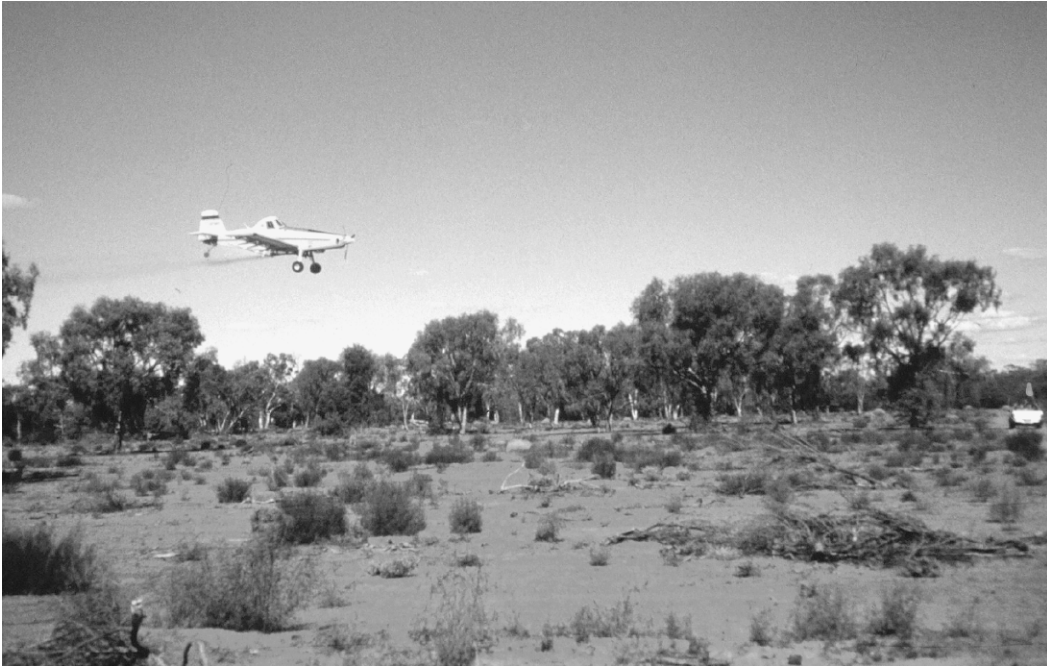
FIGURE 9.4. Aerial application of chemicals for controlling rangeland shrubs. Photograph courtesy Jim Noble.

- To target any shrubs emerging after blade-plowing (from sprouts or seeds), they designed aerial applications of chemicals (figure 9.4). They only selected chemicals known from experimental trials to effectively kill unpalatable shrubs. (See Noble et al. 2001.)
- To promote the establishment of grasses, they designed a plan to sow grass seeds at a time when significant rains were expected (determined by tracking daily weather reports).
- To promote native perennial grasses, they chose to sow annual grasses as nurse plants.

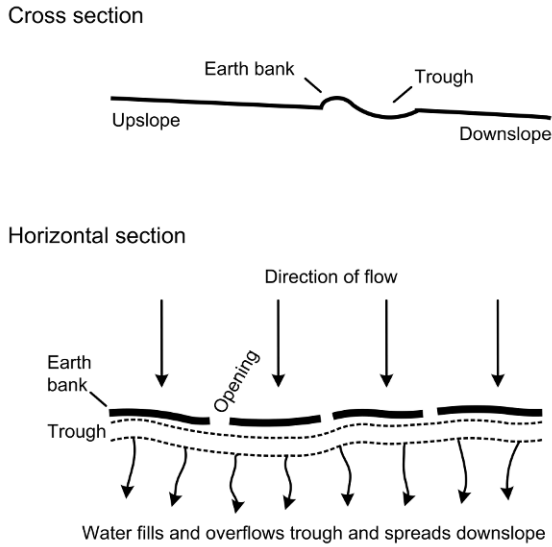
FIGURE 9.5. A design sketch of how earth banks were constructed to slow and spread surface flows of water.

- To reduce shrub densities and sow annual nurse grasses at the same time, they attached a seeder to a blade-plow.
- To redistribute water slowly across the landscape (water spreading), especially in areas showing signs of rill and gully erosion, they built contour banks and troughs (figure 9.5). Their design used an upslope bank (by pushing earth from downslope) to arrest overland flows and distribute water through small openings into shallow downslope troughs, which, when full, overflow to gently release water across the entire slope contour. They precisely positioned earthen banks along contours

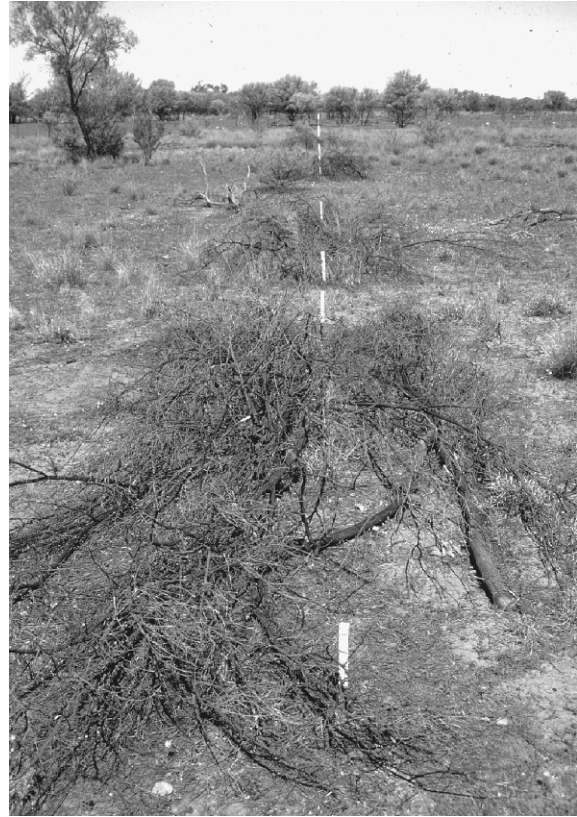
FIGURE 9.6. Brush packs constructed along a contour line.

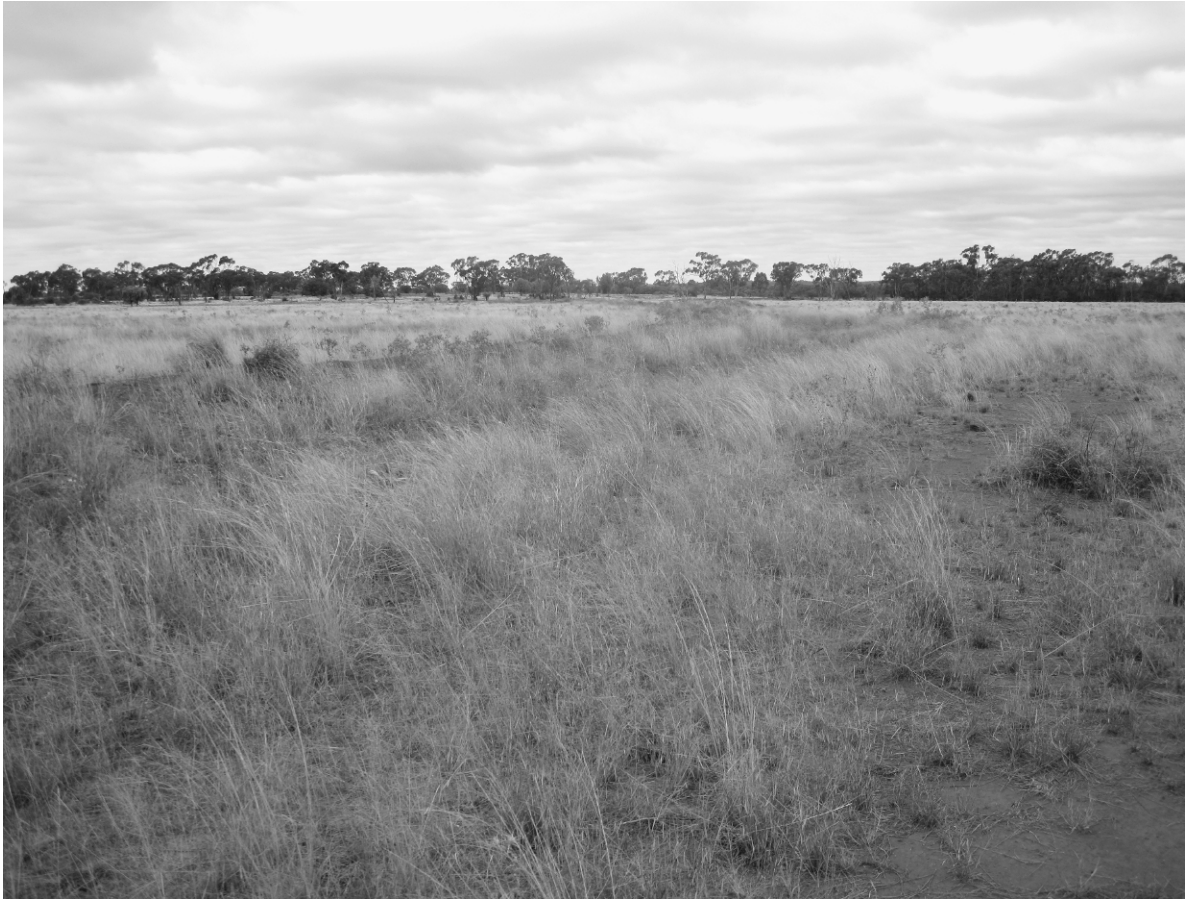
FIGURE 9.7. An example of the high grass cover found in rehabilitated rangelands where earth banks were used to spread water over the landscape.

- Earthen banks and troughs were effectively slowing and spreading surface flows and promoting the establishment, growth, and reproduction of pasture grasses and forbs, especially in areas above earth banks (figure 9.7).
- Soil-surface condition indicators in water-spreading areas had greatly improved, including surface stability, infiltration capacity, and nutrient-cycling potential, and they were trending toward values expected from reference sites (figure 9.8). (Although generalized for the purposes of this scenario, these findings are based on one of us (DT) working

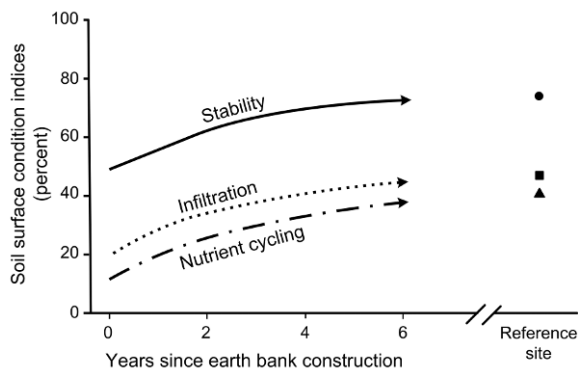
FIGURE 9.8. Soil-surface condition indicators six years after construction of water-spreading earth banks compared to values for reference areas. Symbols: circle = stability index; square = infiltration index; triangle = nutrient-cycling index.

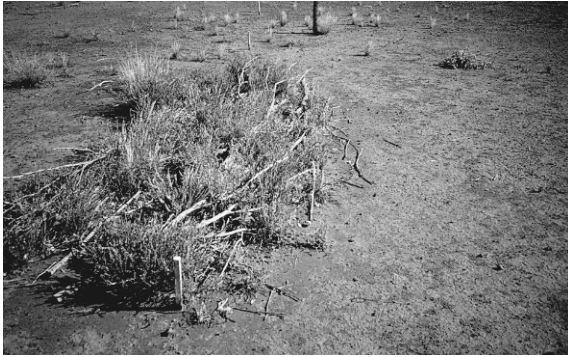
FIGURE 9.9. An abundance of palatable perennial grasses, forbs, and subshrubs have established within brush packs. The brush packs prevented grasses being grazed down to ground level by sheep and kangaroos. Plants outside brush packs are scattered and mostly unpalatable ephemerals.

- Brush packs had enhanced the establishment of native pasture species (figure 9.9), so that after ten years, recovery of palatable perennial grasses and palatable shrubs was clearly trending toward values expected from reference sites (figure 9.10).

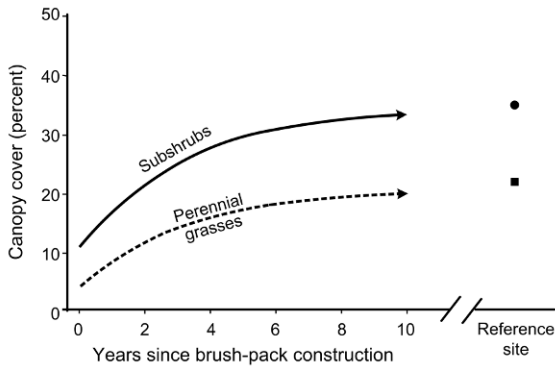
FIGURE 9.10. Canopy cover for palatable perennial grasses and subshrubs within brush packs after ten years was toward that expected from reference site data. Symbols: circle = subshrubs; square = perennial grasses.

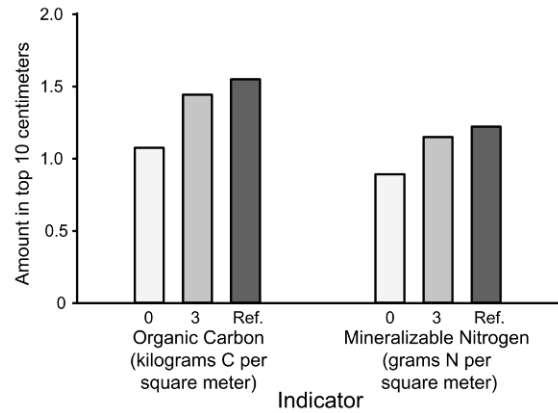
FIGURE 9.11. Values for soil organic carbon and mineralizable nitrogen within brush packs after three years compared to preconstruction (0) values and those for reference (Ref.) sites.

- Soil fertility within brush packs had increased. After only three years, they recorded significant increases in soil carbon and nitrogen concentrations in the top 10 cm of soil (figure 9.11).
- Soil infiltration and respiration rates had also markedly improved within brush packs (figure 9.12).

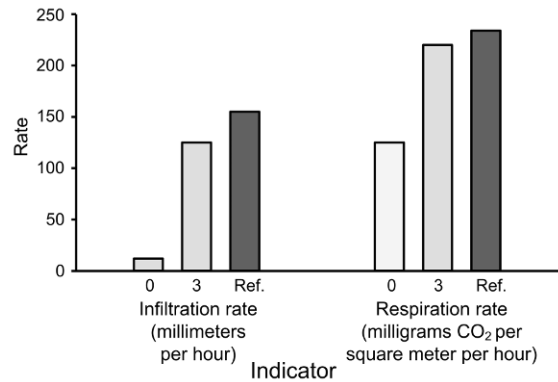
FIGURE 9.12. Rates for water infiltration and soil respiration within brush packs after three years since construction (0) compared to values measured on reference (Ref.) sites.

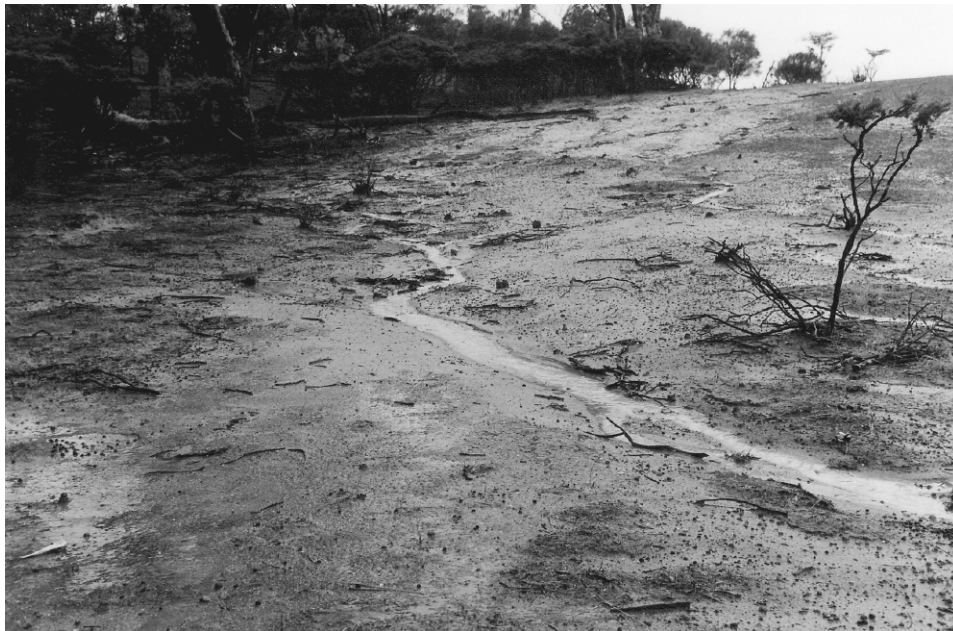
FIGURE 10.1. An example of runoff eroding soil from a recently cleared woodland slope.

even in relatively gently sloping landscapes (figure 10.1). Attempts to avoid such problems by growing pastures for livestock, rather than farming crops, have often failed because closely grazed pastures provide very little resistance to overland flows, especially when rainfall events are intense. Even moderate rainstorm events can wash soil sediments, animal dung, and plant litter from hillslopes into riparian zones and can create further difficulties, such as the clogging of natural drainages.

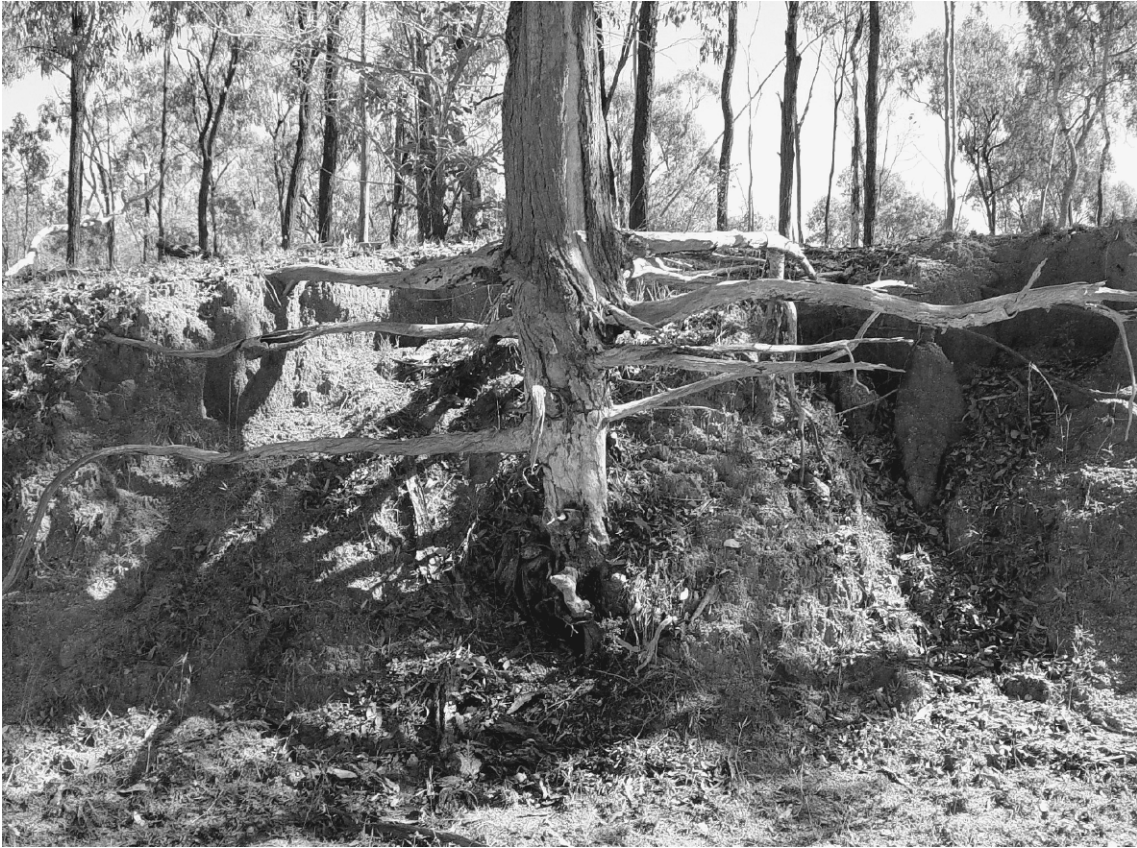
FIGURE 10.2. Excessive overland flows from upslope pastures have caused stream bank erosion, which has exposed the roots of a woodland tree.

Members of a Landcare group met and agreed to have RPs plant trees in belts within their pasturelands to provide more woodland habitat for a range of wildlife species, create wildlife corridors by linking existing woodlands, provide more shade and shelter for their sheep, and reduce the flashiness of runoff and erosion events on their pastures. Reducing runoff from pastures has the benefit of reducing flow rates into drainage lines such as streams, which reduces, for example, severe erosion along stream banks (figure 10.2).

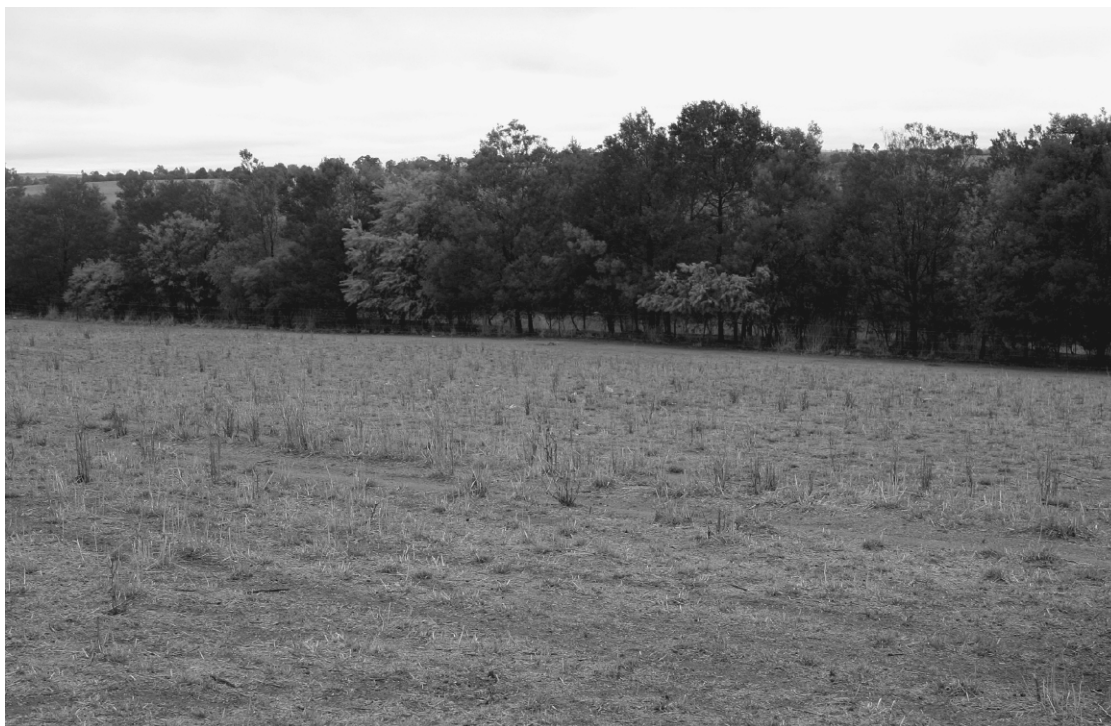
FIGURE 10.3. An example of a 15-year-old tree belt viewed from upslope looking down to the belt. The open pasture (foreground), although not overgrazed, has a low capacity for slowing overland water flows.

- Planted trees had successfully established and grown to form thick, robust belts several meters high within their pasturelands (figure 10.3).

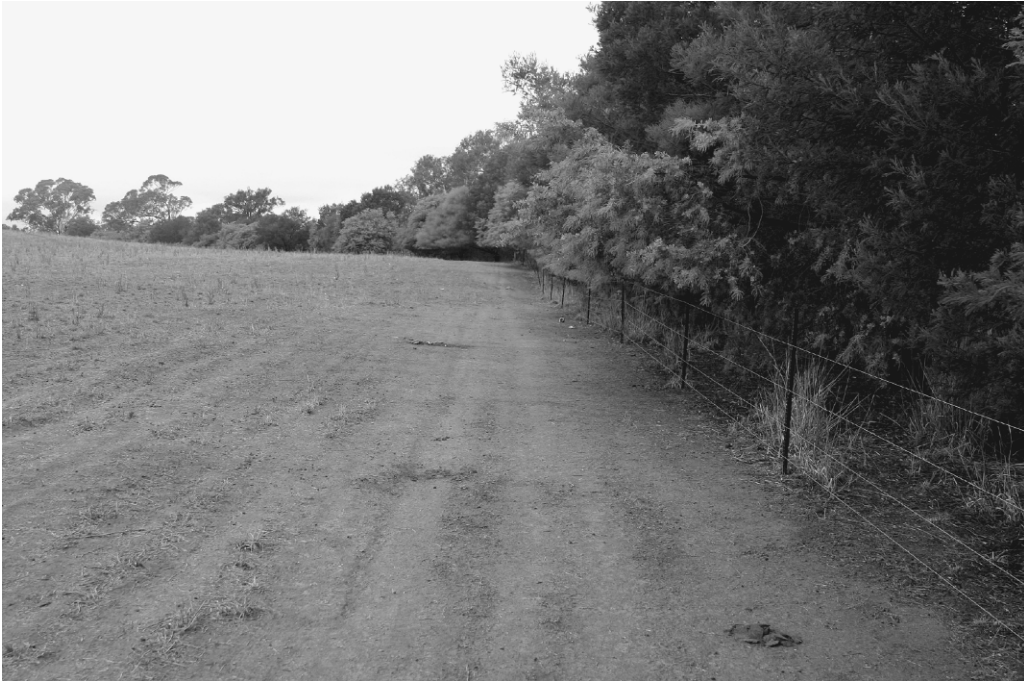
FIGURE 10.4. A 15-year-old tree belt viewed along the slope contour showing how sheep traffic and camping close to the plantation has created a bare crusted soil with high runoff rates.

- Tree belts appeared to be effectively capturing runoff from the pasture above the belt and from the zone of bare, compacted, and crusted soil immediately above the belt where sheep formed trails (figure 10.4).
- A variety of birds, such as the rainbow lorikeet (figure 10.5), were now readily observed in tree belts.

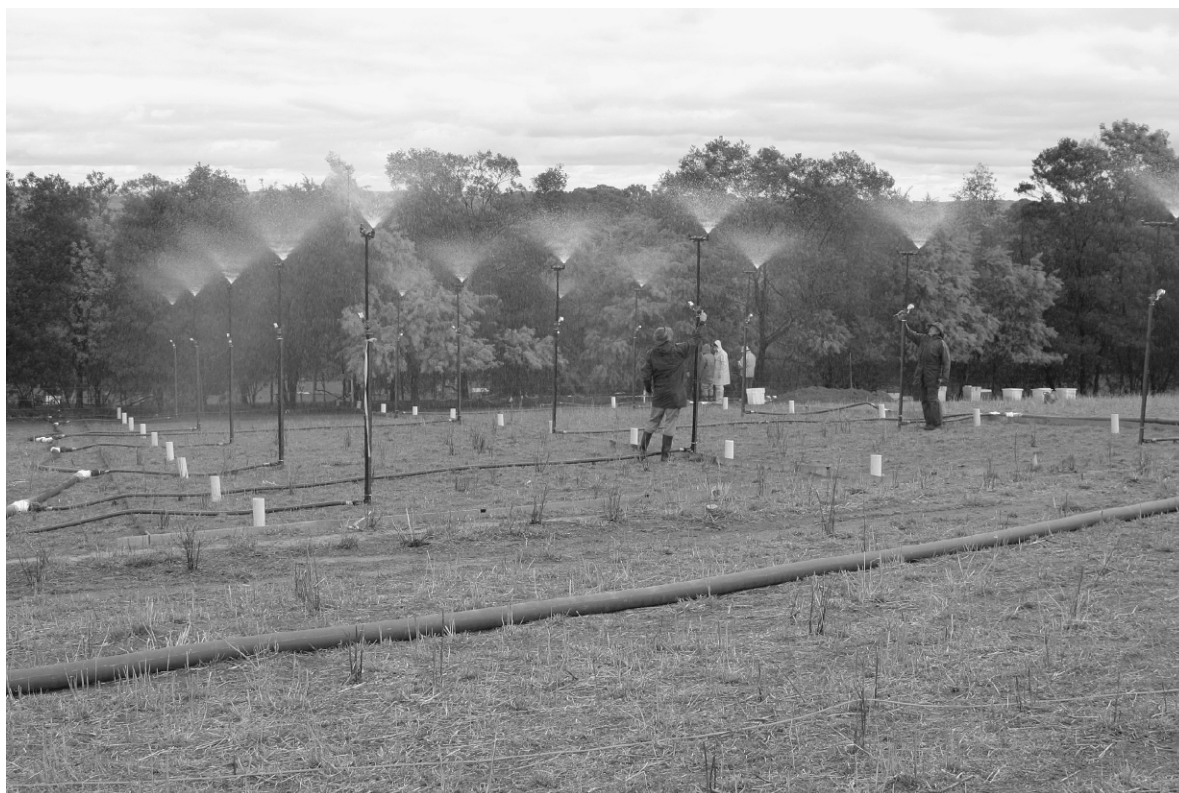
FIGURE 10.6. A rainfall simulator in action delivering water from sprinklers to pasture and tree-belt plots at about 45 mm per hour.

lator setup (figure 10.6) to apply the equivalent of a one-in-ten-year rainfall event (45 mm per hour) for thirty minutes to 90 m² tree-belt plots and to 210 m² pasture plots, which were located upslope of the tree belts. From this experiment they found a number of differences: (These findings are generalized from studies by Ellis et al., and Leguédouis et al. 2008.)

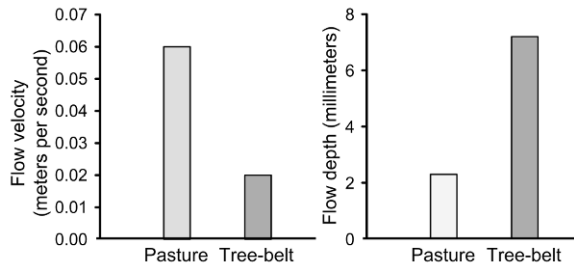
FIGURE 10.7. Runoff or overland flow velocities and depths produced by applying 24.4 mm of water in 30 minutes to pasture and tree-belt plots. See Ellis et al. (2006).

- Runoff flowed faster and shallower down open pasture slopes than within tree belts (figure 10.7).
- There was virtually no resistance to overland flow in the bare hard-crust zone immediately above tree belts where sheep trails were common (figure 10.8) and only slightly more resistance in the pasture, as indicated by twinkling light reflections in the induced turbulence. There was much greater surface resistance to flows within tree belts due to a layer of tree litter and debris (figure 10.9), which was up to 50 mm deep.
- Overland flows delivered a total of 19.8 kg of soil sediment off the pasture plots, but only 0.9

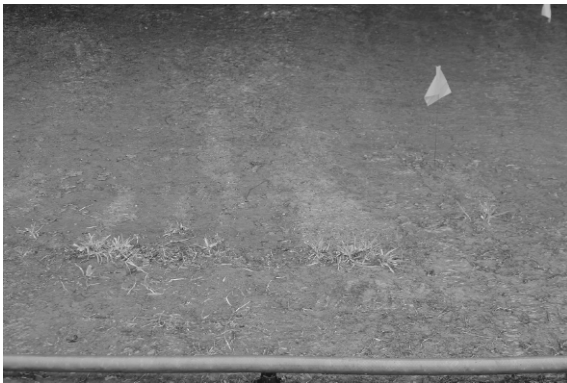
FIGURE 10.8. During simulated rainfall, an experimental plot located within the bare zone upslope of the tree belts provided little resistance to flows of water.

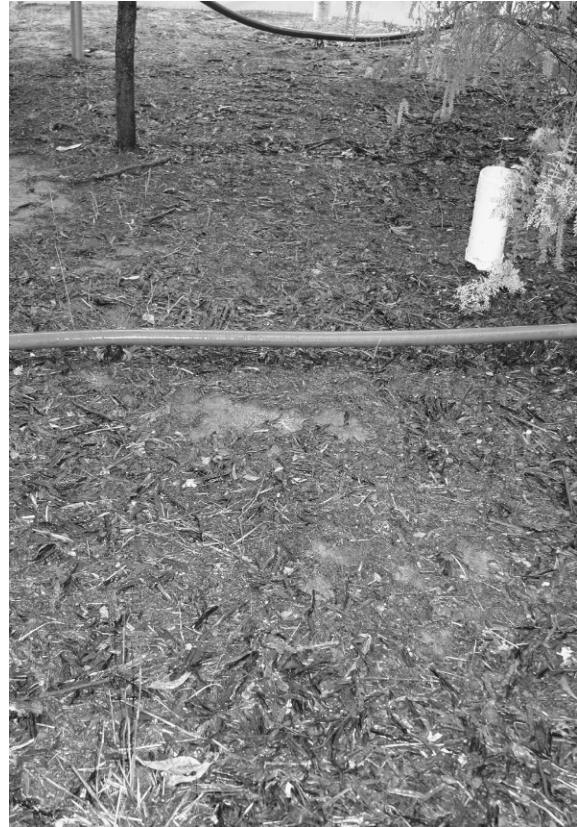
FIGURE 10.9. During rainfall simulation experiments, litter and woody debris within tree belts provided high surface resistance to flows of water and also filtered out soil particulates.

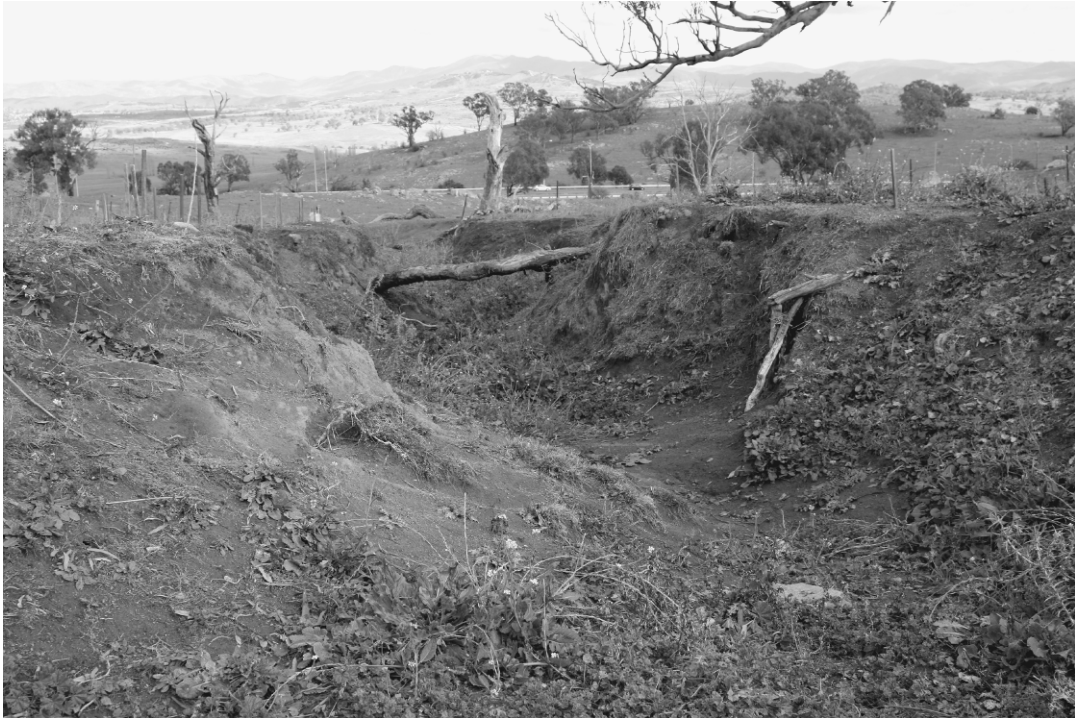
FIGURE 11.6. An example of an eroding and weedy drainage line on a hillslope pasture in former ACT farmland.

Community groups were concerned about other issues and aimed to control and eliminate soil erosion, such as the sheeting and gullying that had damaged the former farmlands (figure 11.6). They also intended to eliminate the aggressive weed species growing in gullies and in patches where remnant trees provided shady “camps” for sheep and kangaroos (figure 11.7), whose dung, in turn, increased soil fertility.

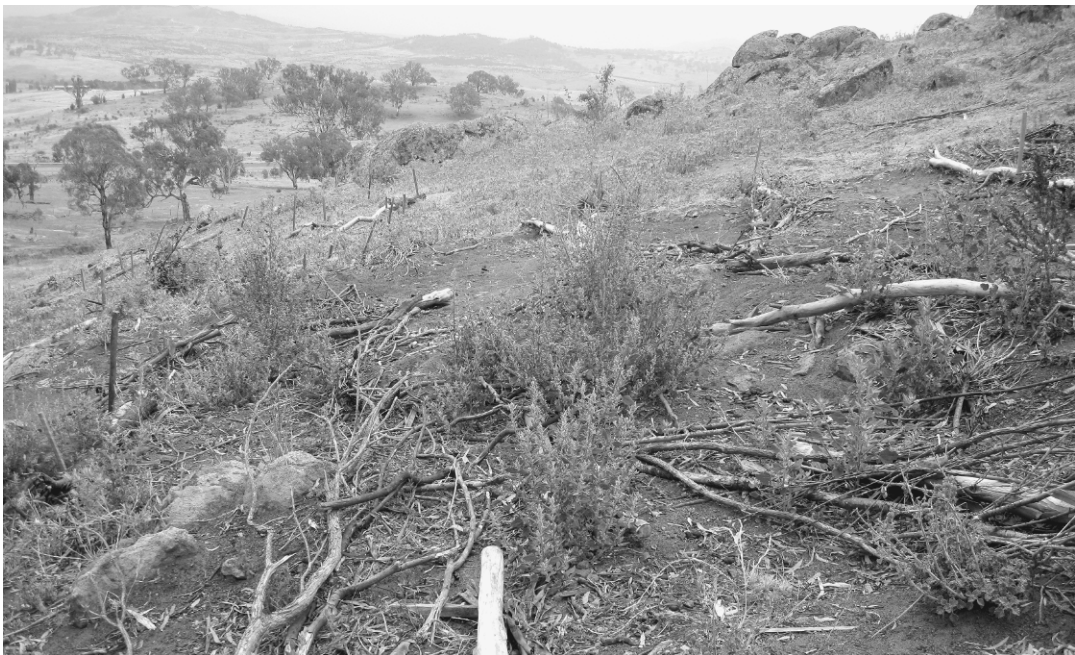
FIGURE 11.7. Weeds colonizing brush packs built on the hillslope where trees have been killed by “camping” animals (livestock and kangaroos).

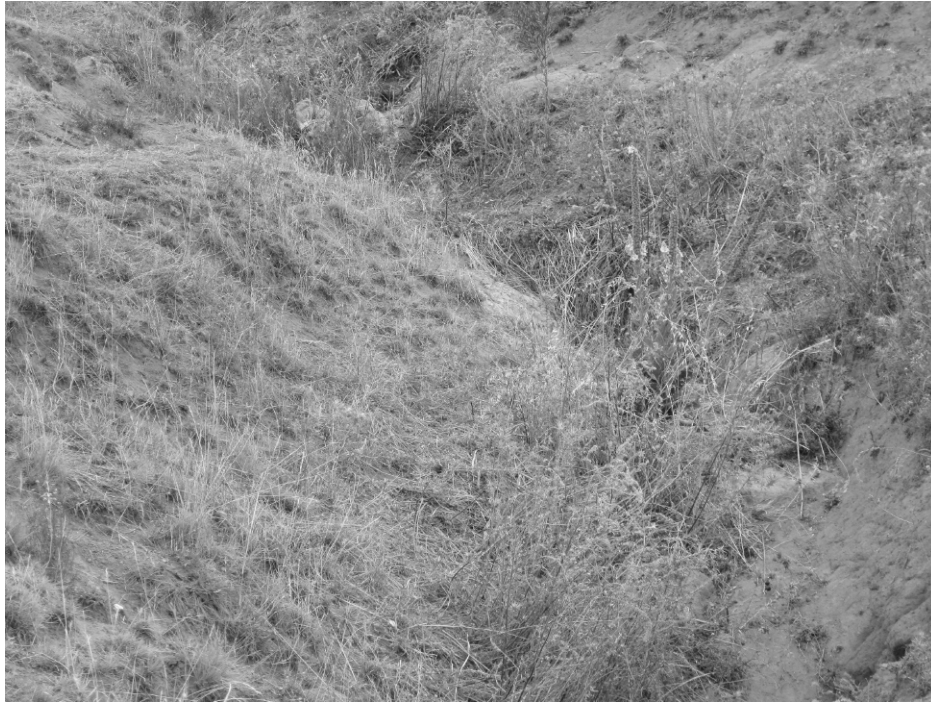
FIGURE 11.8. An ephemeral drainage line showing signs of self-repair (grassy rounded walls and floor).

- Some erosion features, such as gullies, were showing signs of self-repair (figure 11.8).
- Most former farmland areas in the ACT had some official protection status, so restoration activities would not be threatened by other land uses. However, this protection status also meant that community groups had to obtain permission from ACT government departments for their restoration activities, which could cause delays.
