Restoring Disturbed Landscapes

Putting Principles into Practice

DAVID J. TONGWAY *and* JOHN A. LUDWIG

The Science and Practice of Ecological Restoration

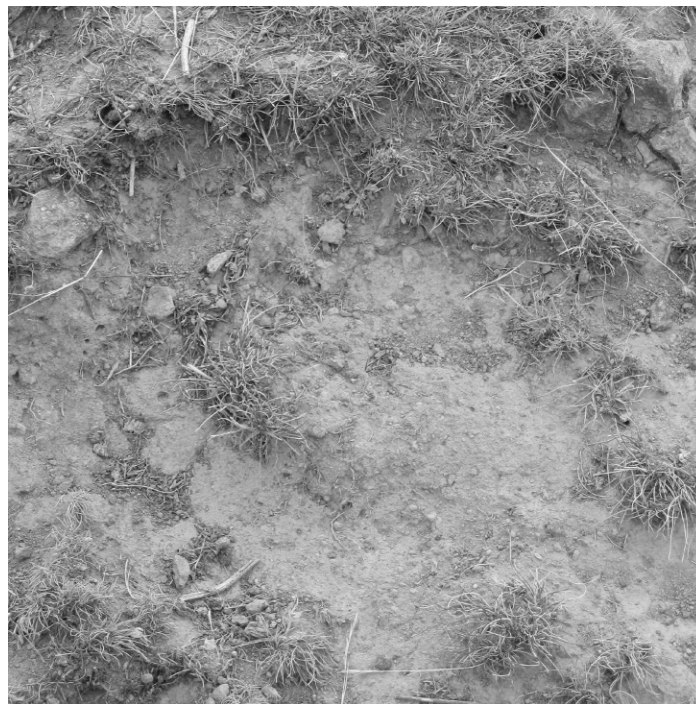
FIGURE 11.9. Soil-surface erosion on a hillslope caused by kangaroo grazing. Surviving grass plants have been pedestalled (top of photograph).

- Because of stripping of topsoil layers, they found that soil fertility was too low in some places, but also too high in other places due to past fertilizer applications and enrichment by dung at animal camps under remaining trees, which promoted weeds. Camps also suffered from soil erosion due to trampling and exposure of hard-setting subsoils (figure 11.9).

A key restoration principle is to restore those landscape processes that are currently most dysfunctional and that have caused the most serious problems. In this case, excessive flows of runoff down hillslopes of former farmlands had cut gullies, and sheet erosion was continuing to strip away valuable topsoil around grass plants—a process called *pedestalling*. (See figure 11.9.) Essentially, if these landscapes were to be successfully converted into valuable green

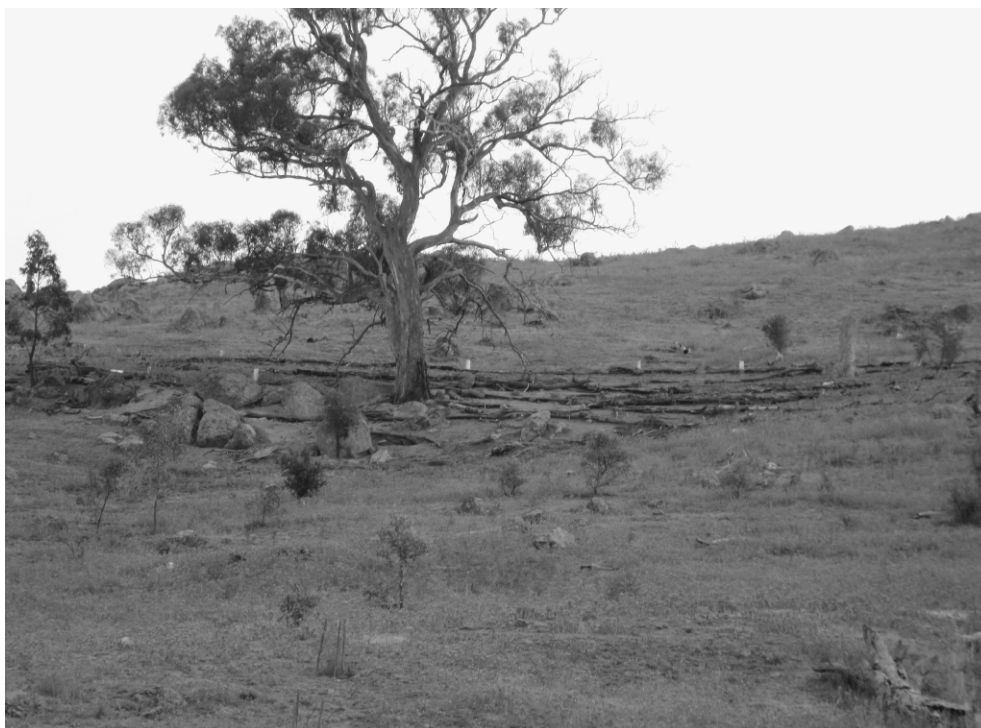
FIGURE 11.10. Logs and other coarse woody debris have been placed high on the hillslope to obstruct overland flows.

1. Logs barriers were positioned across hillslopes (figure 11.10) targeting those areas having excessive runoff rates and obvious sheet erosion. By first placing logs high on the hillslopes, they effectively intercepted and slowed overland flow at its source.

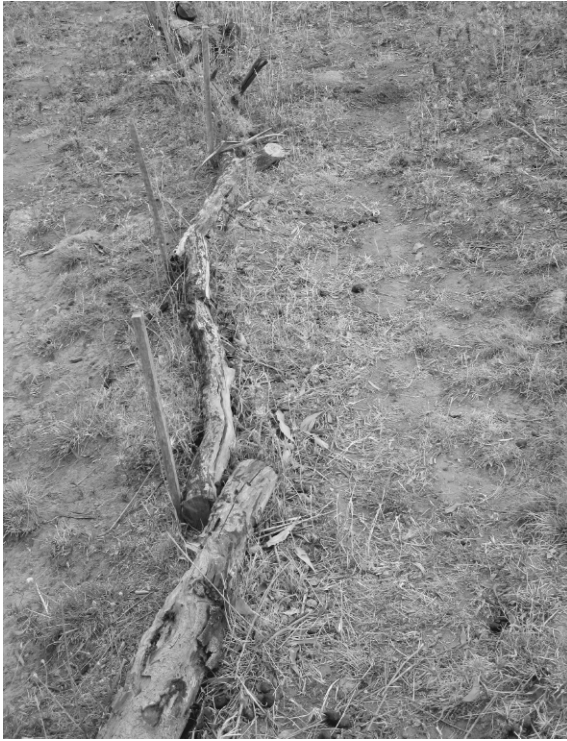
FIGURE 11.11. The upslope side of logs (to the right) accumulated litter and soil, but did not protect plants from being grazed.

Zones just upslope of these logs became run-on patches where litter and sediments accumulated (figure 11.11).

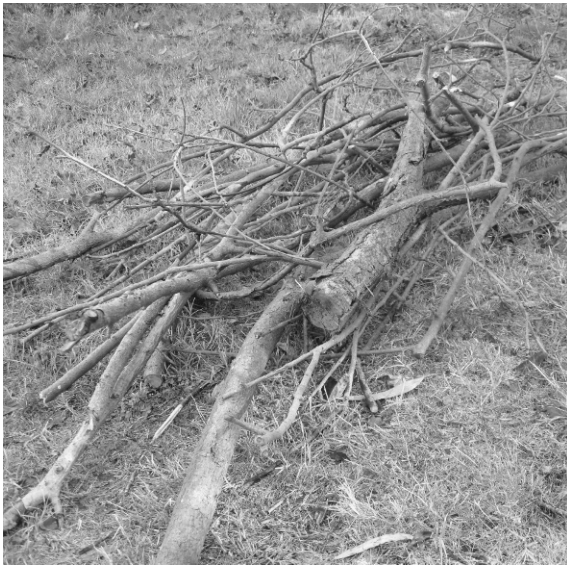
FIGURE 11.12. Brush packs constructed on the slopes of former farmland pastures to obstruct sheet flows.

2. Brush packs composed of woody branches were also constructed on hillslopes (figure 11.12). Commencing high in the landscape, brush packs were built just upslope of points where sheet erosion appeared to begin. This is where it is most critical to initially control overland flows. Brush packs were then constructed progressively farther down the slope. Brush packs are known to be very effective in arresting soil losses due to sheeting and, like log barriers, they eventually became patches of resource accumulation. (See Tongway and Ludwig 1996.)

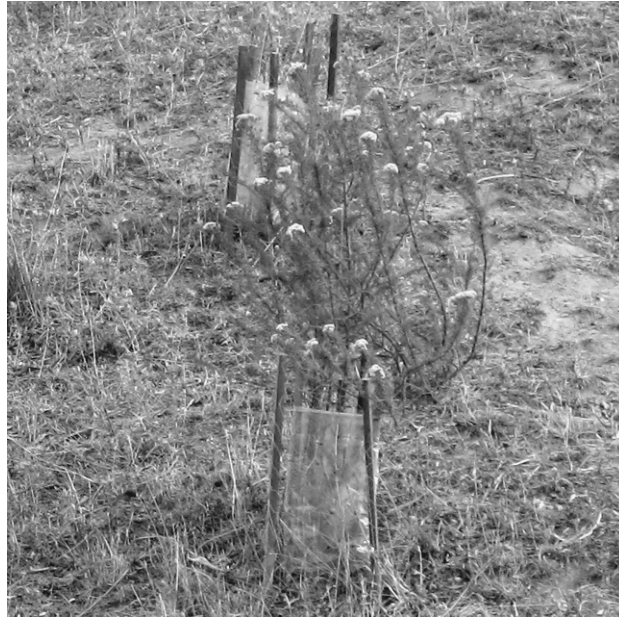
FIGURE 11.13. Trees and shrubs planted as tube stock in resource accumulation patches.

stock) in resource-rich run-on patches above log barriers (figure 11.13) and desirable trees and shrubs within brush packs. Although the branches provided some protection from browsing, plant guards were used to provide seedlings additional protection (figure 11.14).

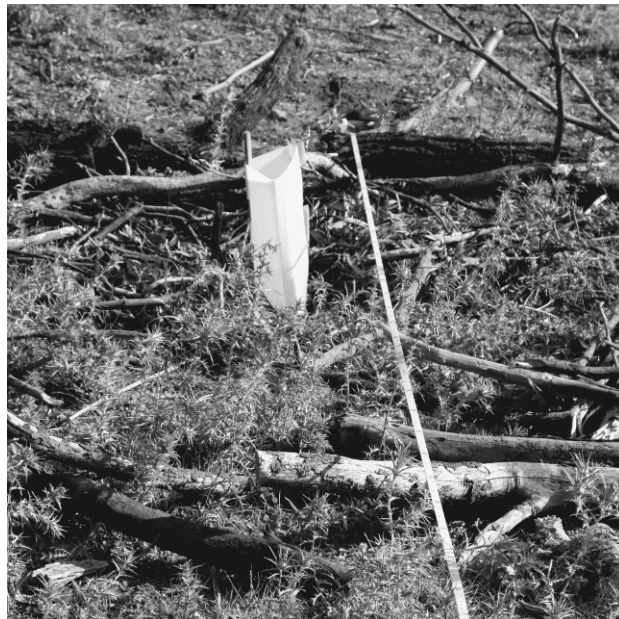
FIGURE 11.14. Tree seedlings with “plant-guards” planted within brush packs.

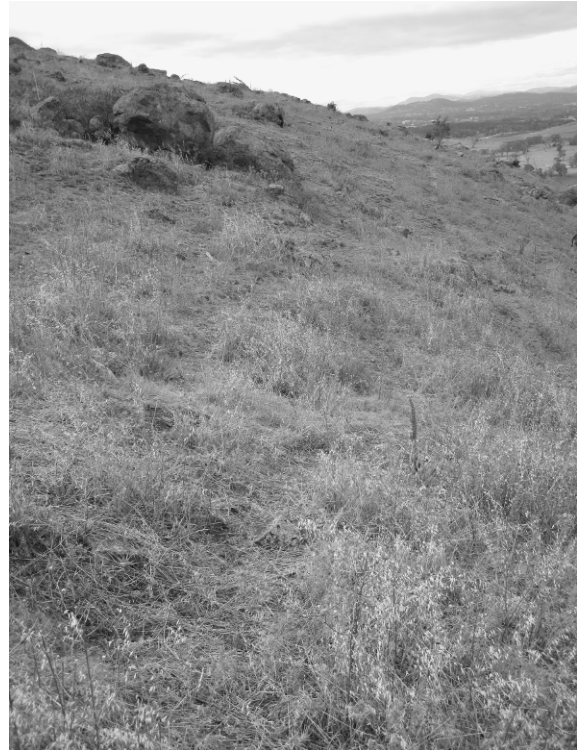
FIGURE 11.15. Dense groundcover on an upper hillslope within a former farmland pasture, which serves as a reference area.

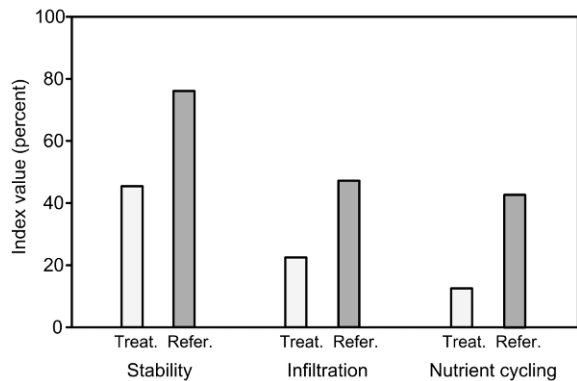
FIGURE 11.16. Values for three soil-surface condition indicators measured on treated areas (Treat.) compared to values for a reference area (Refer.).

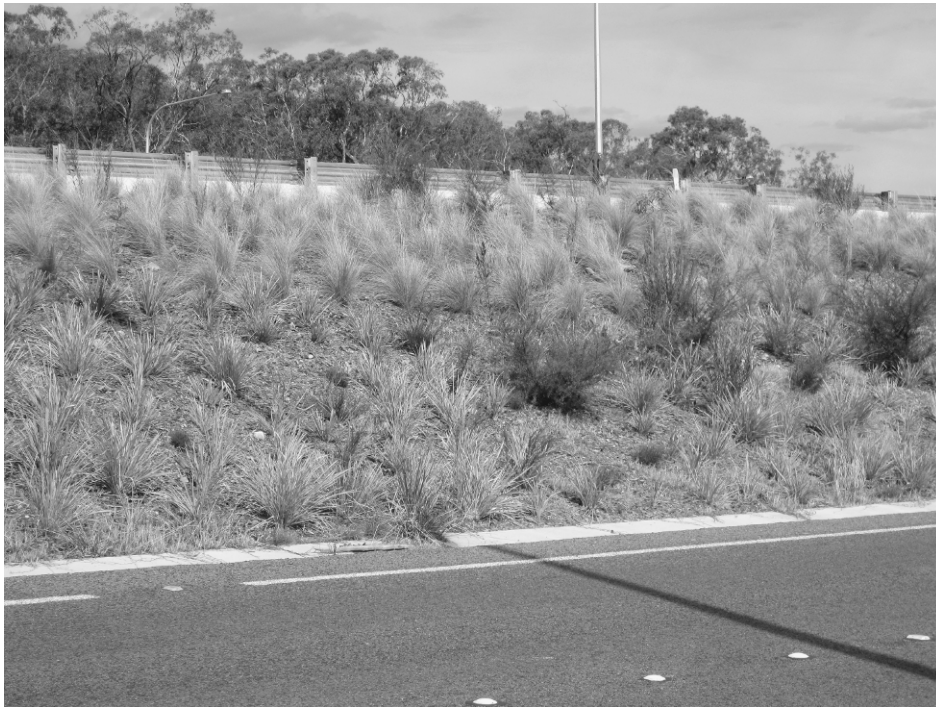
FIGURE 12.1. A road verge where native grasses, mat rushes, and shrubs have successfully established and are providing an attractive and protective roadside covering. After rainfall events, no sediments accumulate at the foot of this embankment.

In many places around the world, roads bombard our senses with unattractive and unnatural landscapes, especially during and immediately after construction. To improved the aesthetic value of roads, RPs need to establish attractive vegetation along road verges. (See figure 12.1.) So as not to threaten the stability and safety of roads, RPs must also design ways to

- To assess how well vegetation had established on planted sections of road verge, the RP looked to see if plantings had taken hold and were serving to protect surfaces and provide an attractive look. (See figure 12.1.) The RP also assessed if surface coverings (mulch, stone) in the spaces between plants were stable (figure 12.5). However, if the RP found that road verge planting had largely failed and that verge surfaces were showing signs of erosion, such as sediment and litter wash (figure 12.6), then the RP took corrective actions, such as using different plants or replacing plantings with rock and mulch coverings.
- The RP also looked along verges for any dead plants needing replacement or weeds requiring control treatments.

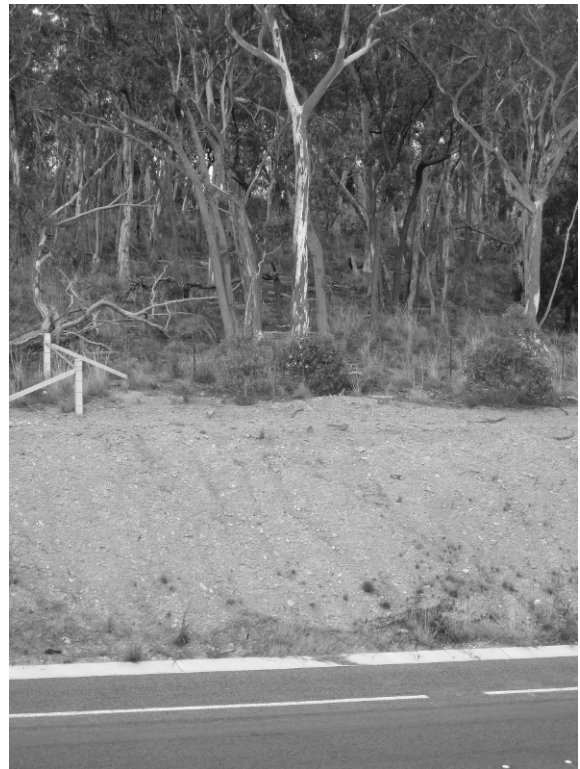
FIGURE 12.2. A road verge slope showing signs of sheet and rill erosion caused by excessive overland flows from above the roadway. Flows have also washed away the mulch that was originally applied to this slope.

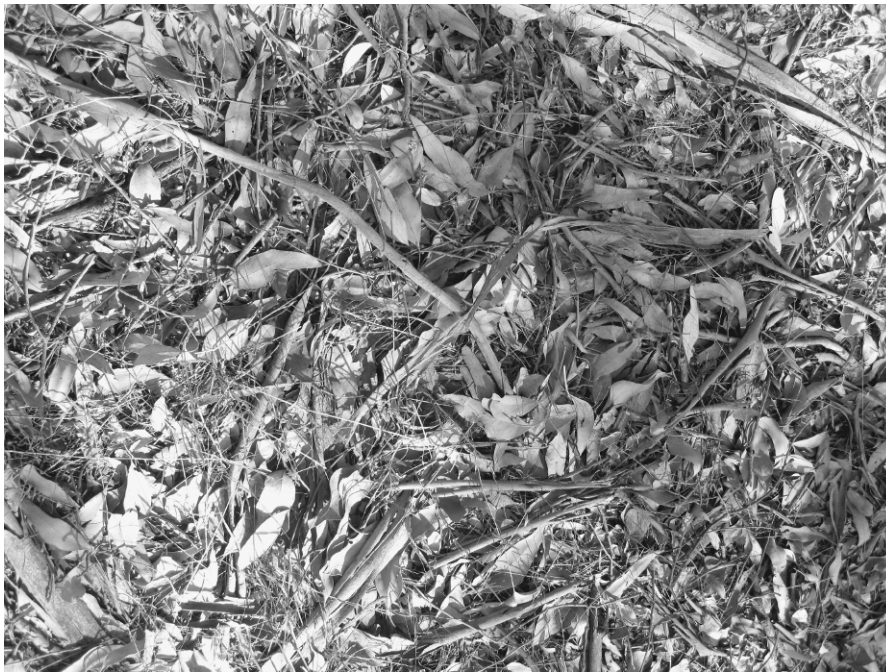
FIGURE 12.3. Coarse mulch material has remained intact on a verge slope, protecting it from the erosive forces of rain and wind storm events. This mulch was sourced from when the forest was cleared to construct the roadway.

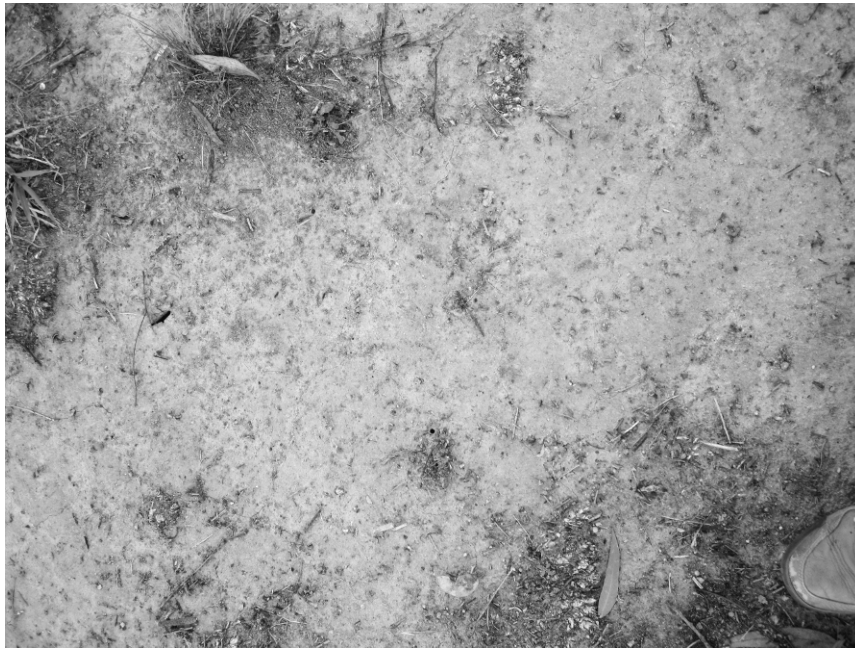
FIGURE 12.4. An area where mulch has been blown and washed off a verge surface leaving it unprotected. The soil now has an impermeable surface crust.

- To evaluate the stability of verge surfaces covered with rock and mulch materials, the RP examined whether mulch remained in place after intense rainstorms. If mulch remained in place (figure 12.3), this indicates that it is providing a stable protective covering. However, if mulch on the verge surface had been washed or blown away (figure 12.4) then surface protection has been lost, and the surface is prone to erosion, particularly where raindrop impacts

have crusted the surface. The result would be high runoff rates. In this case, the RP took remedial actions, such as applying a coarser mulch or rock material.

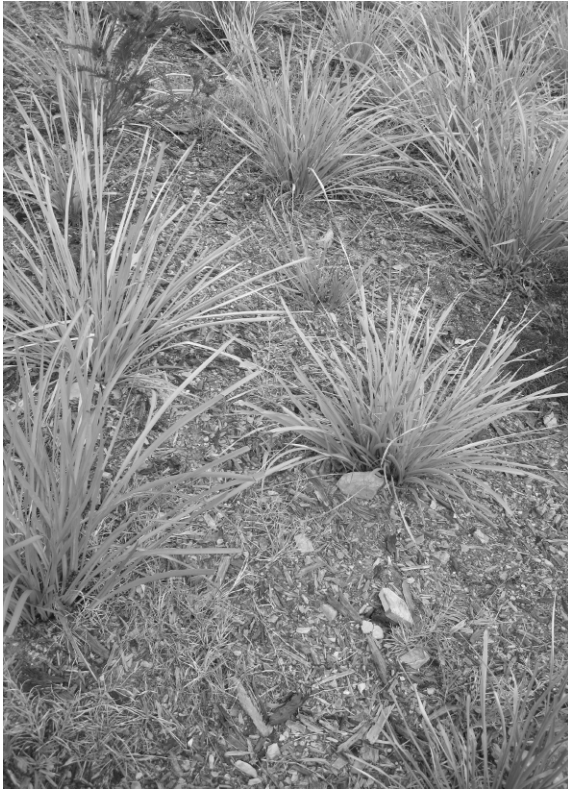
FIGURE 12.5. A protective wood-chip mulch and stone covering between plantings.

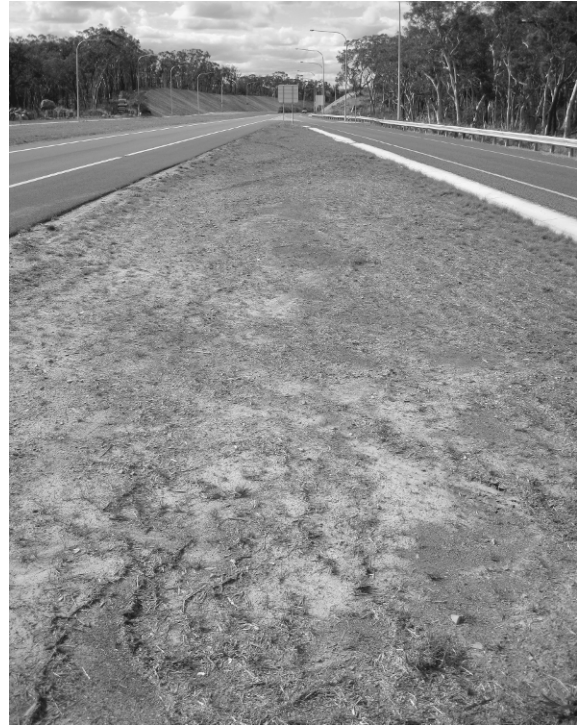
FIGURE 12.6. An “island” road verge where a surface mulch of fine stones has failed to resist erosion by overland flows. Note the wash of surface litter and sediments.

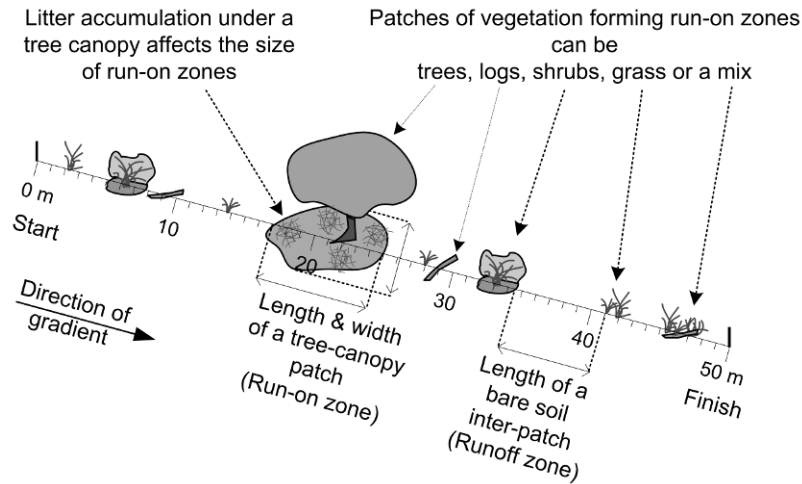
FIGURE 13.1. A diagram representing a 50 m gradient with continuous recording of resource accumulating patches (run-on zones) such as grass clumps, shrubs, and trees, and resource shedding interpatches (runoff zones) such as bare soil.

Starting at the top of the gradsect, a continuous record of patches and interpatches is recorded as line intercept distances between their respective boundaries (zones of resource accumulation versus loss). (See figure 13.1.) These patch/interpatch tabulations are completed before commencing tasks such as soil-surface assessments. (See chapter 14.) We find it useful to tabulate patch/interpatch data using the spreadsheet (available online) that automatically calculates patch and interpatch indicators of landscape functionality. See, for example, the patch and interpatch data in table 13.2. Sometimes a site

* Sum of all individual patch lengths measured along the gradsect (see figure 13.1) divided by the total length of the gradsect

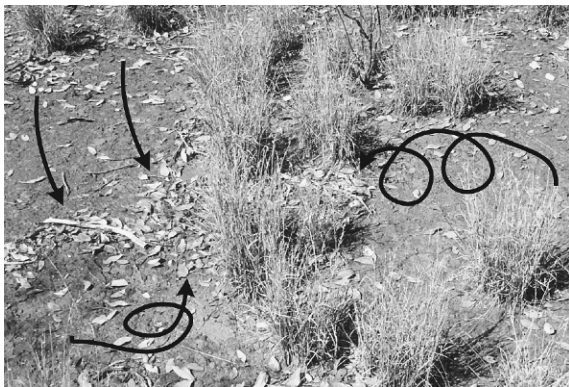
FIGURE 13.2. Clumps of grass plants facilitate the capture and accumulation of resources driven by both water and wind processes (depicted as arrows).

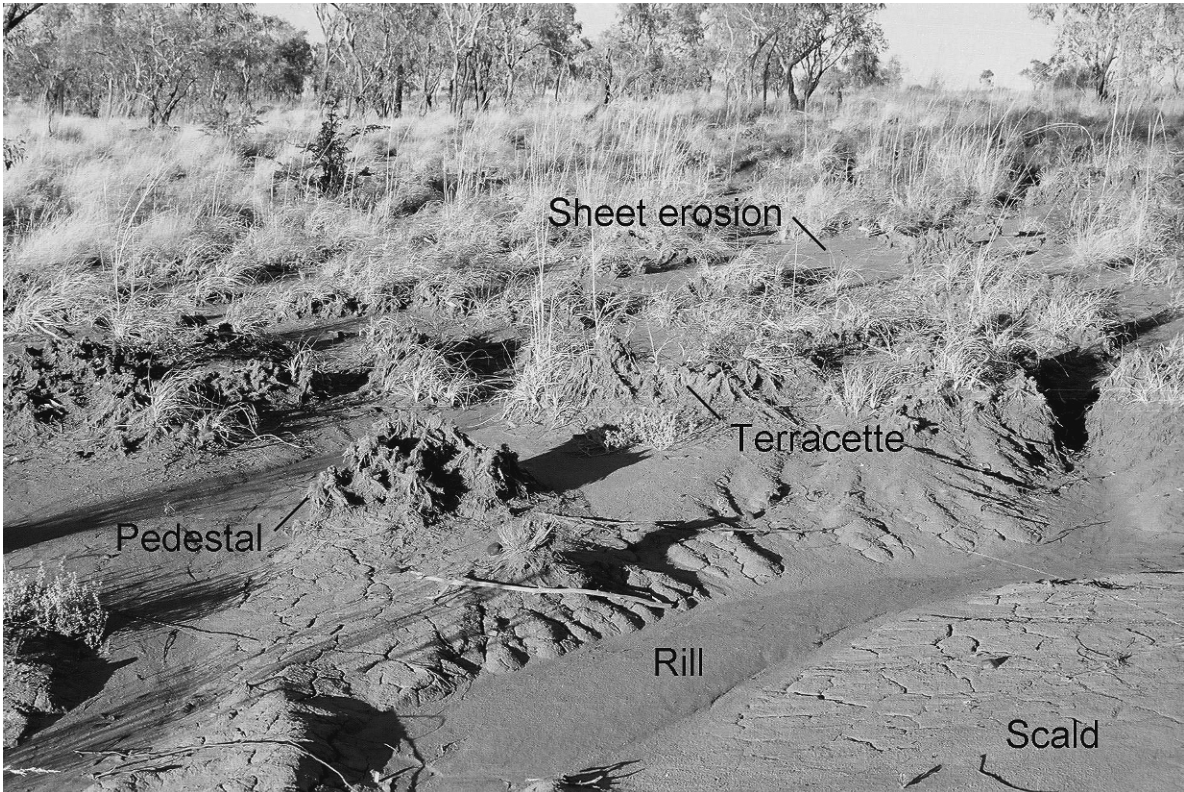
FIGURE 14.1. Five types of soil-surface erosion: sheeting, pedestal formation, rilling, terracette formation, and scalding.

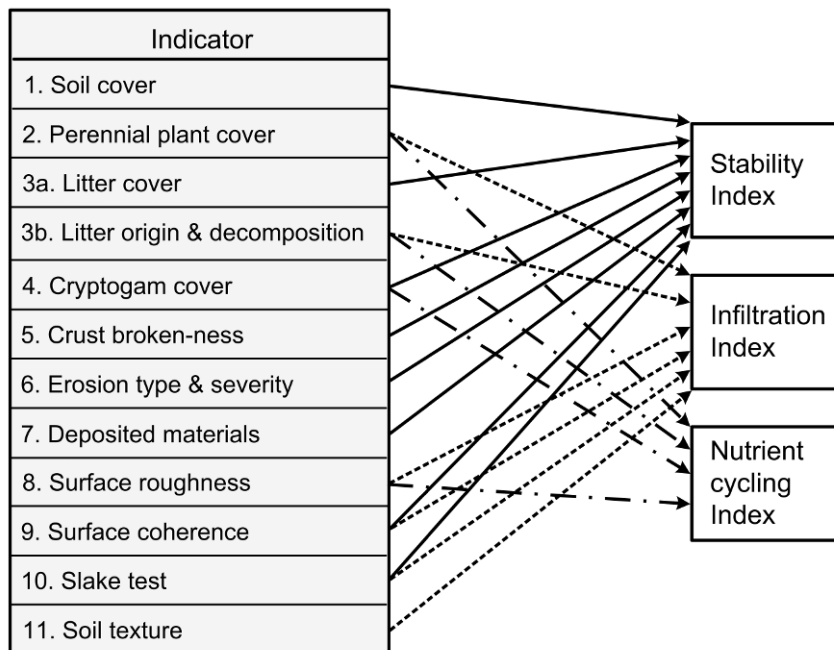
FIGURE 14.2. Different combinations of 11 soil-surface condition indicators are used to calculate three synthetic indices of the potential for the site to resist erosion (stability), retain and store water (infiltration), and cycle nutrients to enhance plant growth (nutrient cycling).

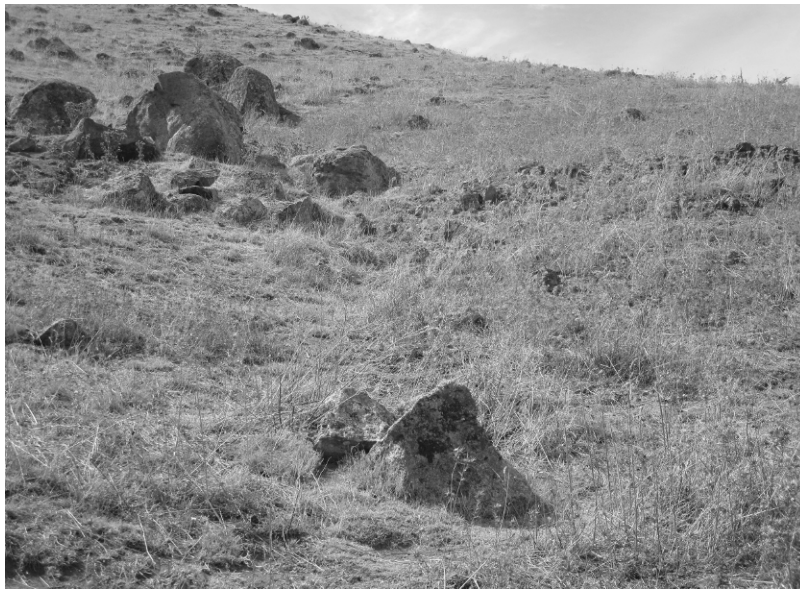
FIGURE 15.1. A hillslope on which the natural ephemeral drainage line shows no sign of an incised channel. Lateral water flows into the drainage line are diffuse and slow and the cross-section of the line is smoothly concave.

surrounding slopes. (See figure 15.1.) These undisturbed landscapes do not have high rates of runoff or erosion. Landscapes that have a history of disturbance, however, often have hillslopes where drainage lines have become incised. (See figure 15.2.) If erosion cuts a channel deeper than 0.3 m, the drainage line is defined as a gully; if the cut is less than 0.3 m, it is called a rill.

Vegetation growing within an ephemeral drainage line that has, for example, eroded into a gully provides RPs with an indication of the potential for the gully to erode. Dense, long-lived, perennial vegetation within a drainage line indicates that the line has been stable for a substantial period of time and has resisted erosion during recent runoff events. (See figure 15.1.) Short-lived vegetation within the drainage line provides some resistance but indi-

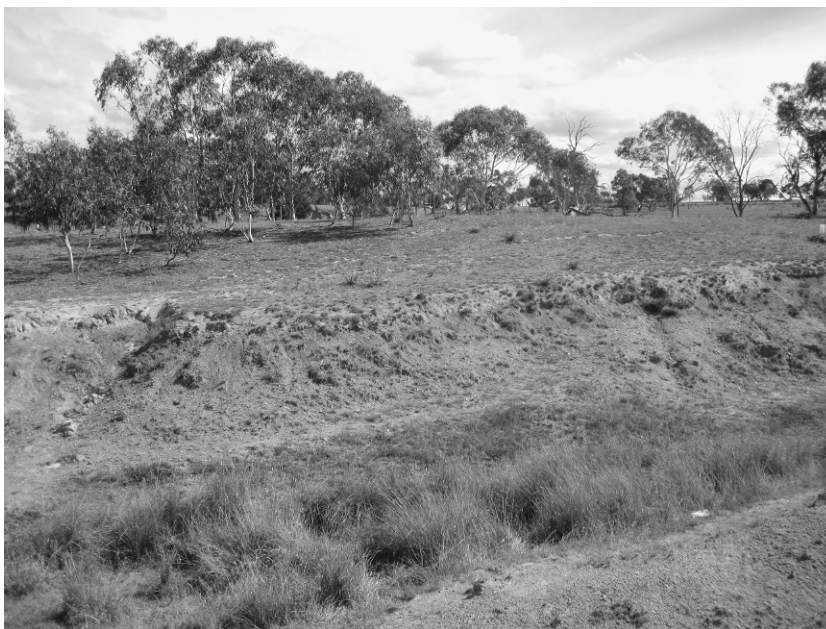
FIGURE 15.2. A channelized ephemeral drainage line on a hillslope shows signs of rapid over-bank flow (bare side-walls) but a stabilizing grassy floor. This implies that the restoration solution involves reducing flow rates from the hillslope above the channel, rather than within the channel itself.

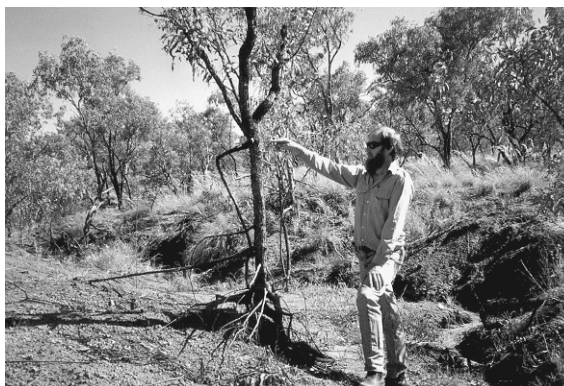
FIGURE 15.3. A gully 1.5 m deep has been cut into a hillslope ephemeral drainage line. Note the original position of the soil level at the root crown on a small tree.

gullies. (See figure 15.3.) Restoring even small but heavily eroded drainage lines presents RPs with major landscape restoration challenges, let alone those that are large, deep, steep-walled gullies. (See figure 15.4.) However, we know that RPs can successfully restore ephemeral drainage lines by putting into practice our five-step adaptive procedure and its underlying principles, because RPs met similar challenges in our case studies on restoring damaged rangelands. (See chapter 5.)

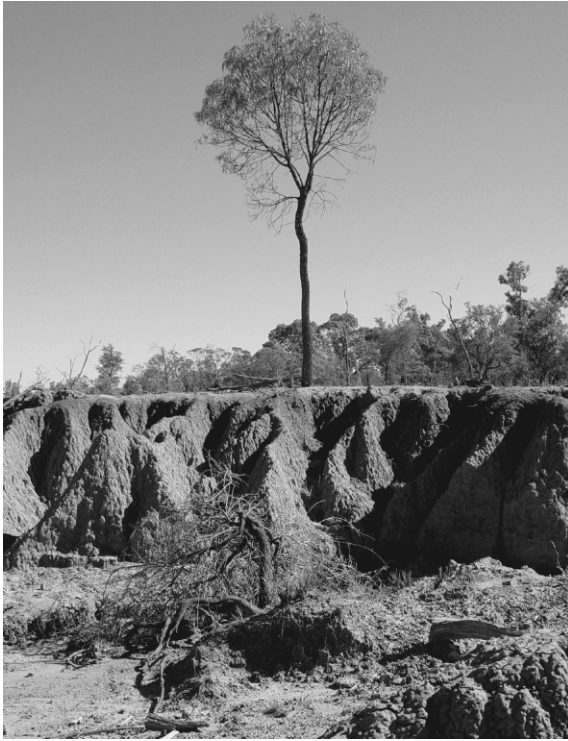
FIGURE 15.4. A deep, steep-sided gully

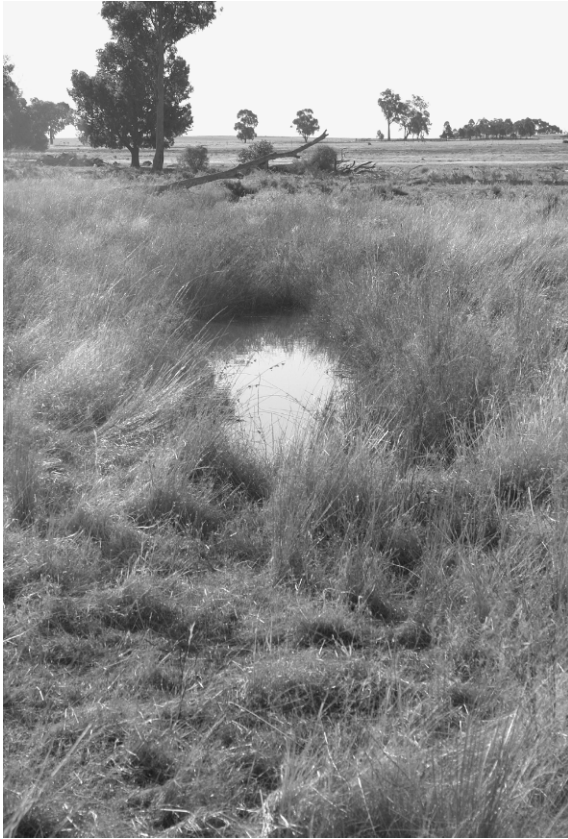
FIGURE 15.5. A naturally stabilized channel characterized as a “chain of ponds” with low flow energy.

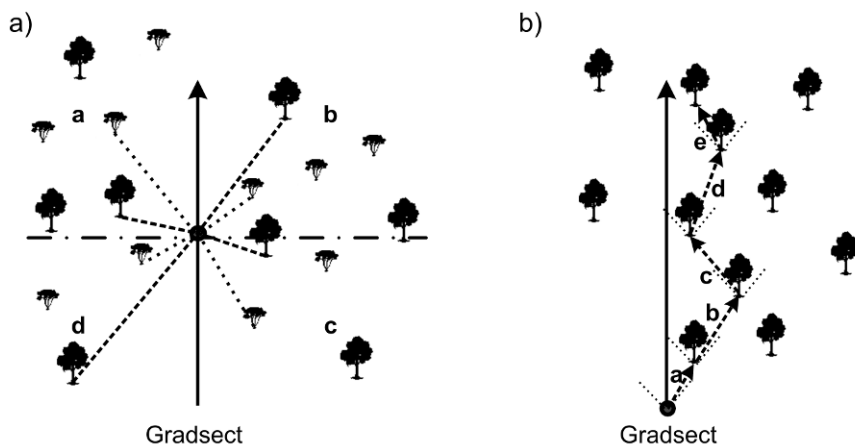
FIGURE 16.1. Plotless vegetation sampling procedures: (a) point-centered quarter method, where distances from a number of points selected along a gradsect are measured to trees (dashed-lines) and shrubs (dotted lines) in each of four quarters (a–d). (b) Wandering quarter method, where distances from a starting point selected on a gradsect are measured between trees (dashed-lines, a–e) within a quarter (90° angle) opening in the direction of the gradsect. Wandering quarter distances can also be measured between shrubs or grasses (for brevity, not shown).

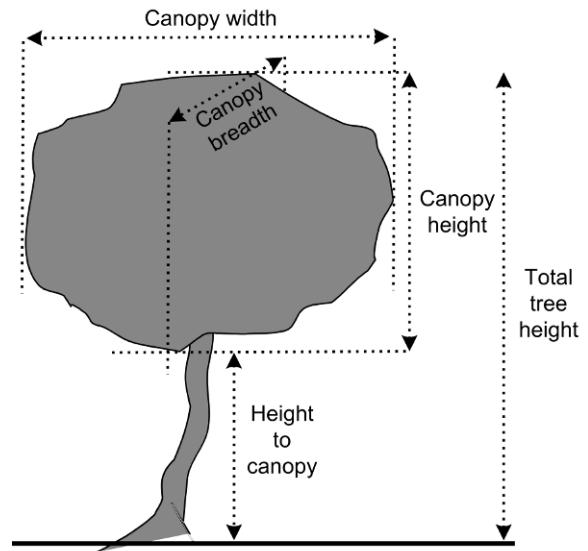
FIGURE 16.2. A diagram illustrating the different canopy structural attributes that can be measured on a tree.

When measuring vegetation patch size, density, and species composition within life-forms (e.g., trees, shrubs, perennial grasses) using plot or plotless methods, we have found it useful and convenient to measure other attributes at the same time. For example, the architecture of tree canopies can be defined by measuring overall tree height, the height from the ground to the bottom of the foliage, and the width and breadth of the canopy. (See figure 16.2.) These

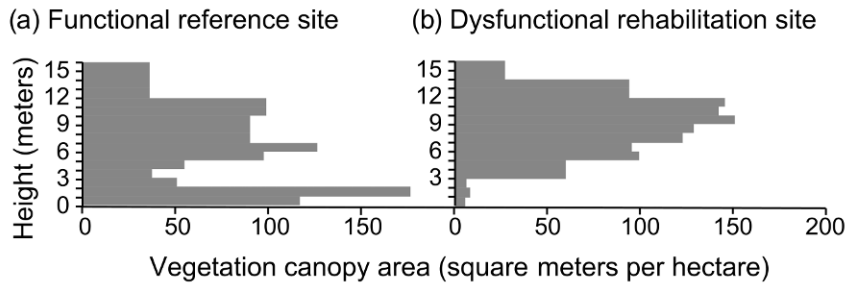
FIGURE 16.3. (a) The vertical distribution of woodland vegetation canopy areas plotted here at 1 m height intervals on a highly functional reference site. (b) A dysfunctional rehabilitation site where the ground and shrub layers, up to about 3 m, have been eliminated by grazing animals.

If such data by life-form groups are obtained by the plotless method and recorded in the LFA vegetation data entry spreadsheet, the RP will find an embedded set of equations that calculate the number of plants per hectare and the canopy cover (square meters per hectare) and volume (cubic meters per hectare) for each plant life-form sampled. This spreadsheet also has an option for plotting the vertical distribution of canopy cover (square meters per hectare) at height increments of 1 m. For example, the vertical cover frequency distribution of combined grass, shrub, and tree canopies on a site can indicate how the landscape on a rehabilitation site is developing toward that expected from a reference site. (See figure 16.3.)

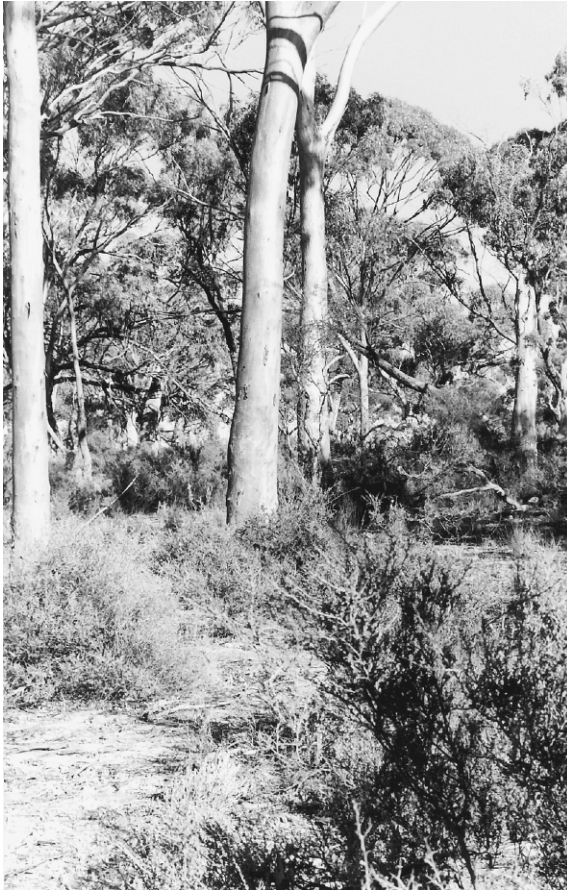
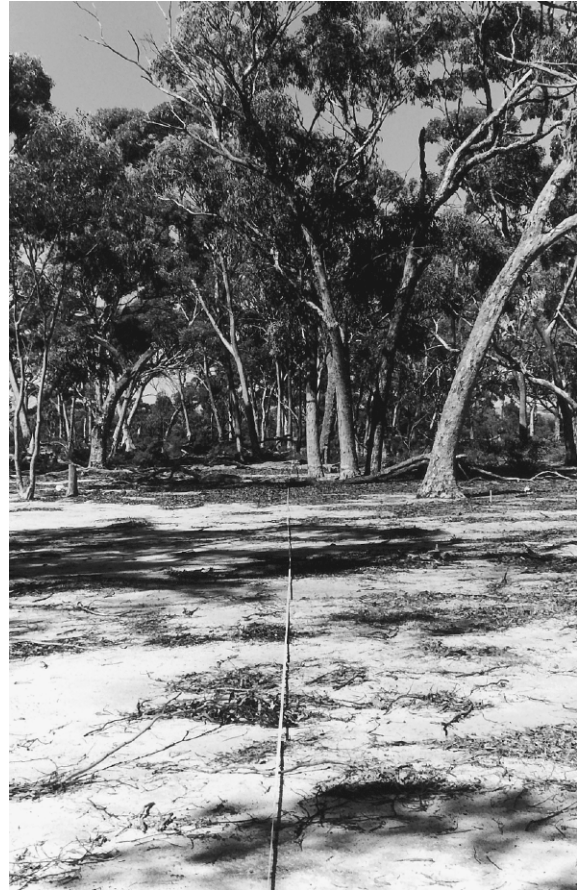
FIGURE 16.4. (a) A highly functional woodland has a complex vertical distribution of vegetation from the ground layer up to the top of the tree canopy. (b) A woodland heavily disturbed by livestock lacks vegetation structure at heights below 3 m.

Such vertical profiles of vegetation structure provide RPs with useful functional interpretations. For example, we have observed woodland landscapes where a reference site had a well-developed shrub canopy layer near the ground. (See figure

16.4a.) On this site the shrub canopy merges with the tree canopy layer to provide a continuous vertical canopy cover. In contrast, we observed a nearby disturbed site that lacked both a shrub canopy and grass cover. (See figure 16.4b.) This lack of lower vegetation was caused by excessive livestock grazing and trampling. This means that this site is partially dysfunctional and needs active rehabilitation because of the lack of vegetation on, or just above, the surface. These surface and low vegetation layers would normally protect the landscape from excessive erosion by water and wind.

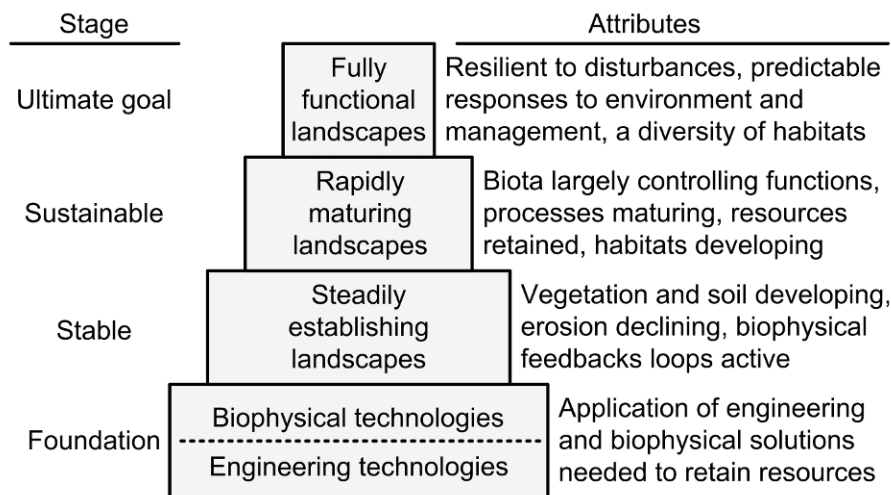
FIGURE 17.1. A four-tier pyramid illustrating how goals and attributes for rehabilitating landscapes are achieved in stages. Adapted from figure 9.5 in Tongway and Ludwig (2007).

Applying this to landscape restoration, progress can be conceptualized as a series of constructive stages toward achieving restoration goals. (See figure 17.1.) Each stage builds on earlier stages. The ultimate goal is to build a complex landscape that possesses a multiplicity of life-forms (biological diversity) and regulatory processes (functional diversity). Such landscapes will be buffered against environmental and management disturbances both by their accumulated natural capital and by the

feel that it is the role of indicator continuums, and the pyramid in figure 17.1, to invite RPs to use monitoring data to reflect on their restoration progress.

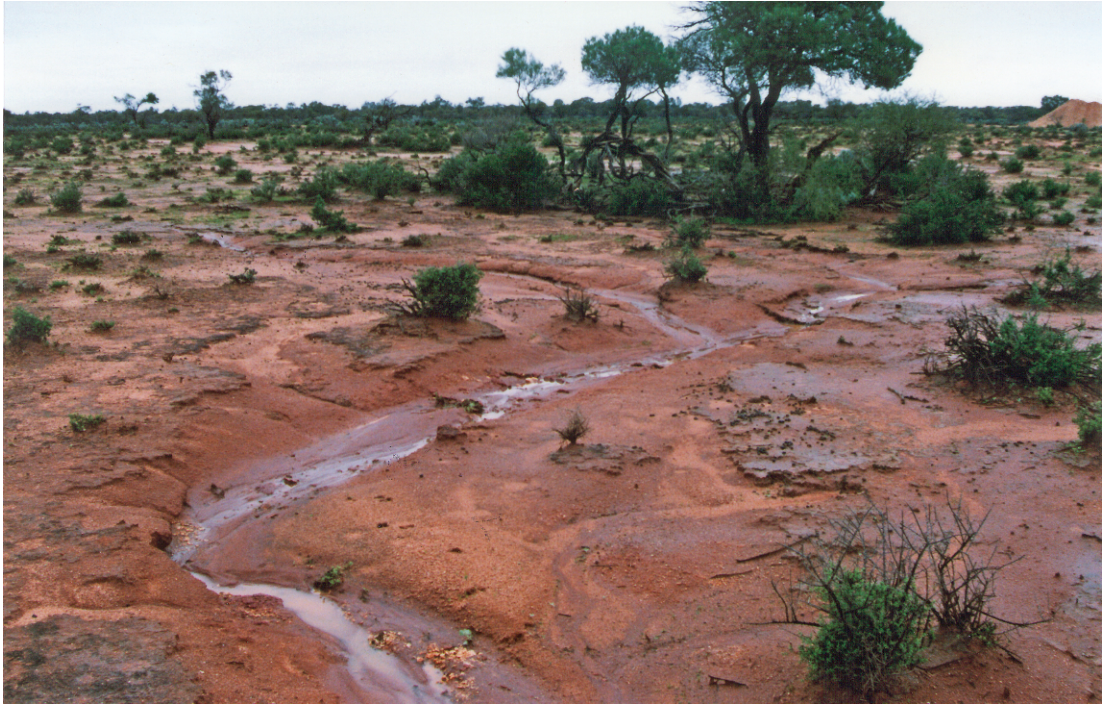
PLATE 2.1. Damaged landscape with active runoff and surface erosion processes. Note the “milky” runoff indicating how fine soil sediments are being removed from this landscape.

than for intense events. Highly functional landscapes typically have the capacity to infiltrate most of the inputs of water during small, less intense events. In functional landscapes, small rainfall events are of great value to organisms, such as ephemeral plants (figure 2.2) or fungi. In dysfunctional landscapes, small rainfall events can quickly initiate runoff (figure 2.3). An example of this would be a landscape in which excessive grazing has reduced vegetation cover so that soil surfaces have become compacted and crusted. In this situation, flows are less impeded and surfaces readily erode (plate 2.1).

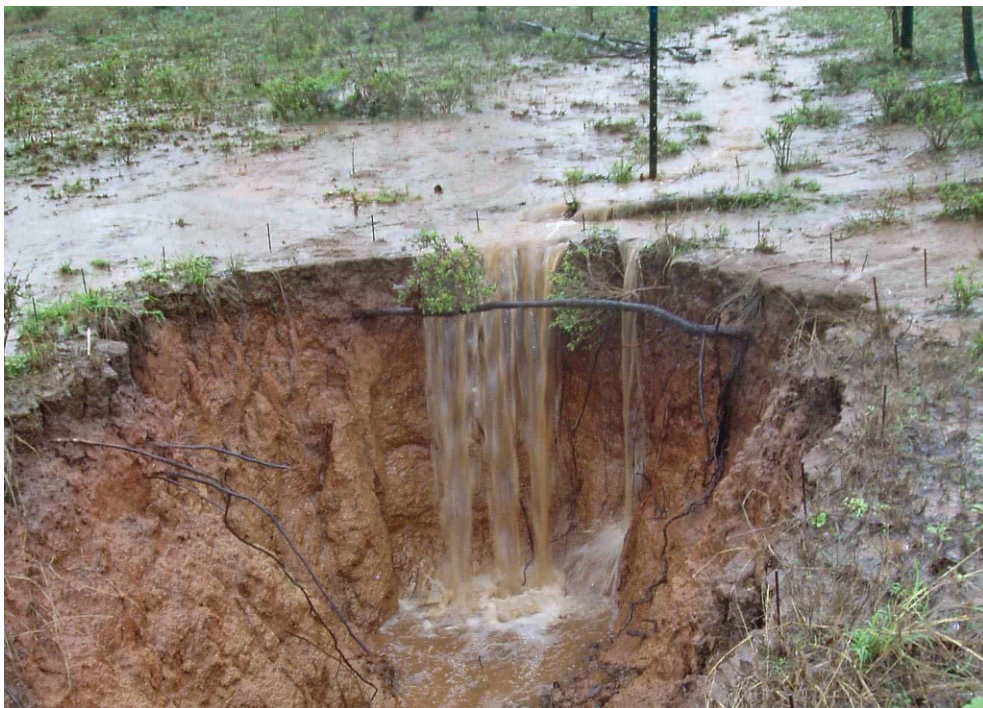
PLATE 2.2. Landscape where runoff is cutting a gully. Photograph courtesy of Aaron Hawdon.

The above two indicators help RPs determine whether any ephemeral drainage-line erosion is being caused by flows of water from farther upstream in the channel or by water cascading over the lip of the drainage line from areas directly adjacent to it. (See plate 2.2.) Identifying the source of excessive overland flows can assist RPs in designing appropriate ephemeral drainage-line restoration technologies. This restoration design can also be aided by assessing soil-surface condition indicators along gradsects oriented upslope and adjacent to the drainage line. (See chapter 14.)

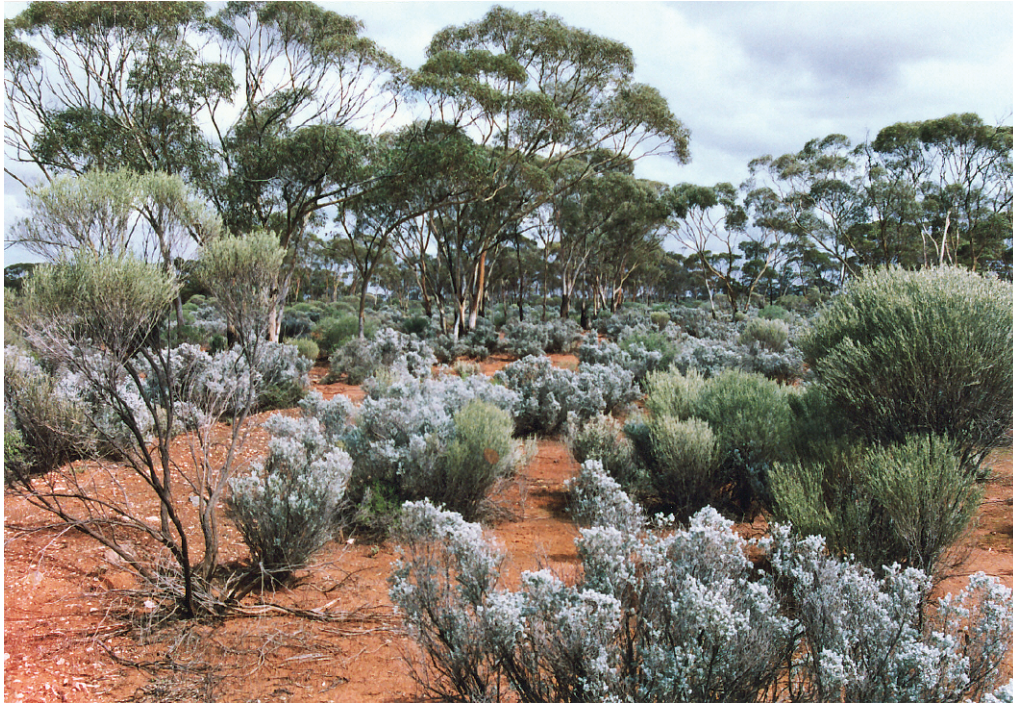
PLATE 2.3. Example of a structurally diverse and highly functional landscape where resources are retained and habitats are available for a diverse fauna.

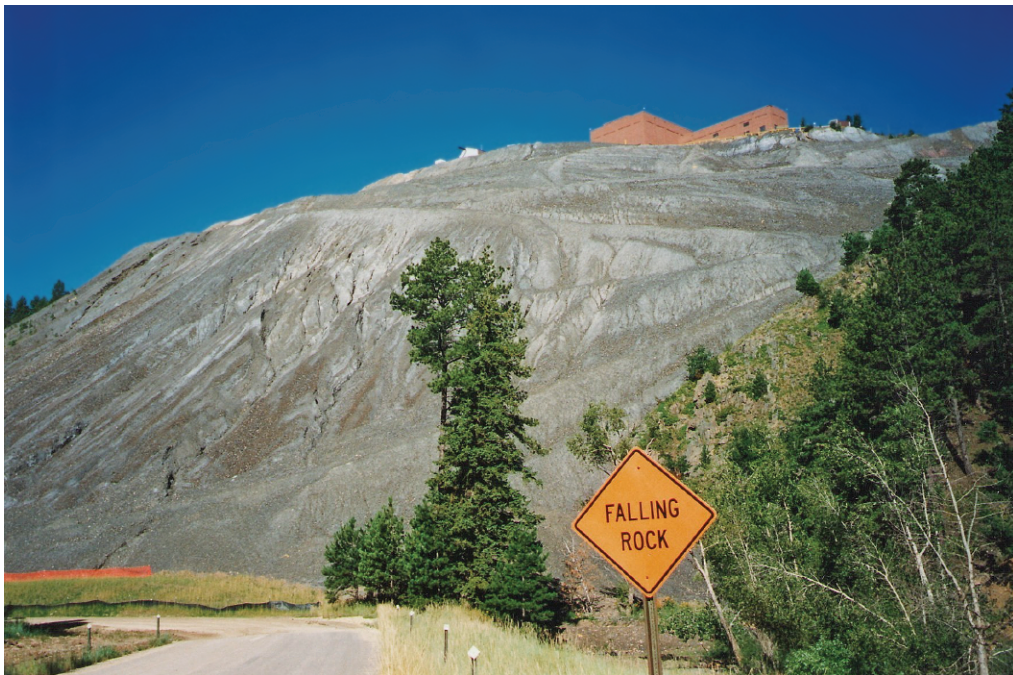
PLATE 3.1. Forest landscape has been buried by waste materials (spoil) created by mining. Gullies are cutting into the steep slopes, but this has not deterred someone from building a house on top of this mine-spoil heap.

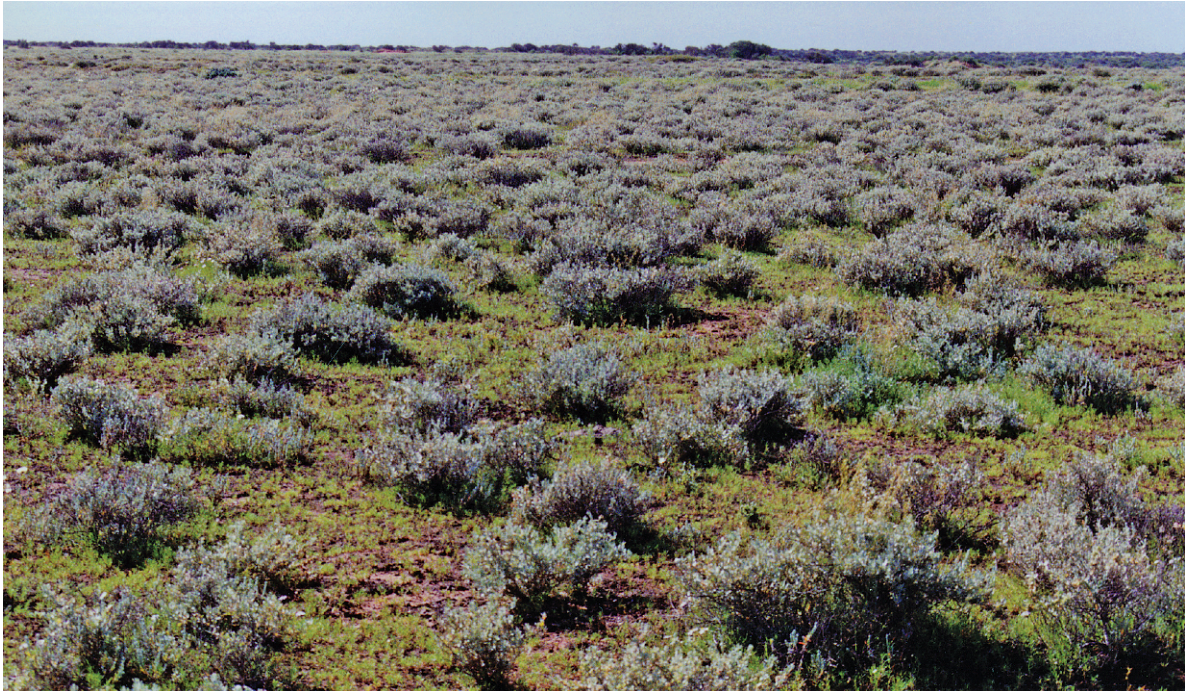
PLATE 3.2. A highly functional landscape having a dense cover of shrubland vegetation to protect soil surfaces from wind and water erosion.

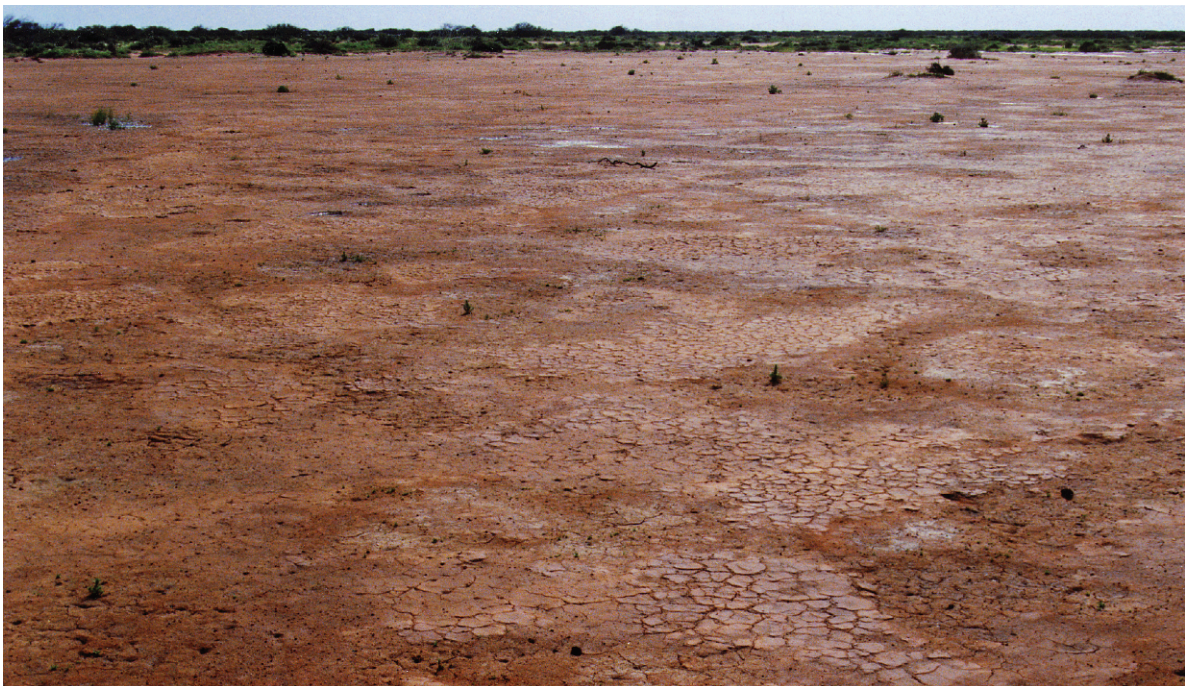
PLATE 3.3. A heavily grazed dysfunctional landscape having very little shrubland vegetation to protect soil surfaces from erosion; this landscape is located near the one shown in plate 3.2.

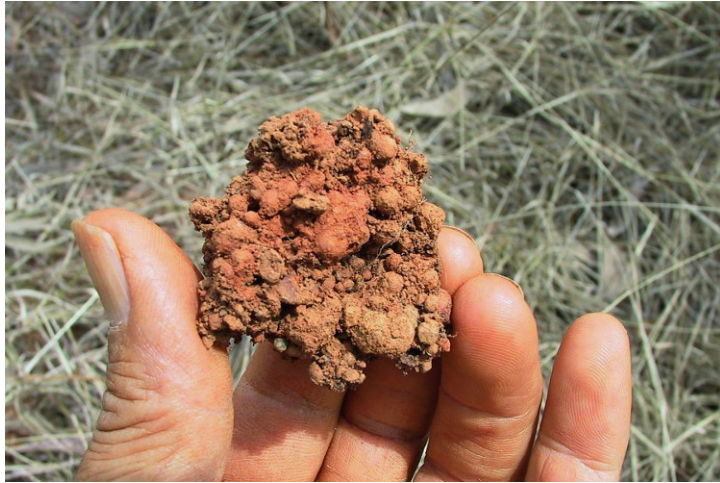
PLATE 4.1. Typical soil aggregate found in topsoils of open forests at Gove.
