Restoring Disturbed Landscapes

Putting Principles into Practice

DAVID J. TONGWAY *and* JOHN A. LUDWIG

The Science and Practice of Ecological Restoration

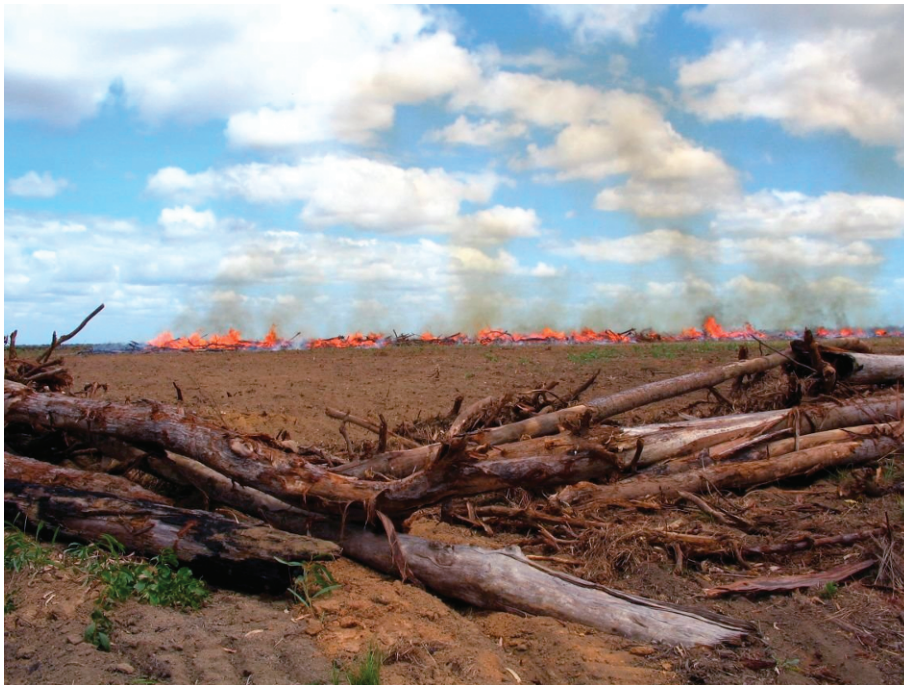
PLATE 4.2. Landscape being prepared for mining bauxite by pushing open forest vegetation into windrows that are burnt when dry. Photograph courtesy of Sue Gould.

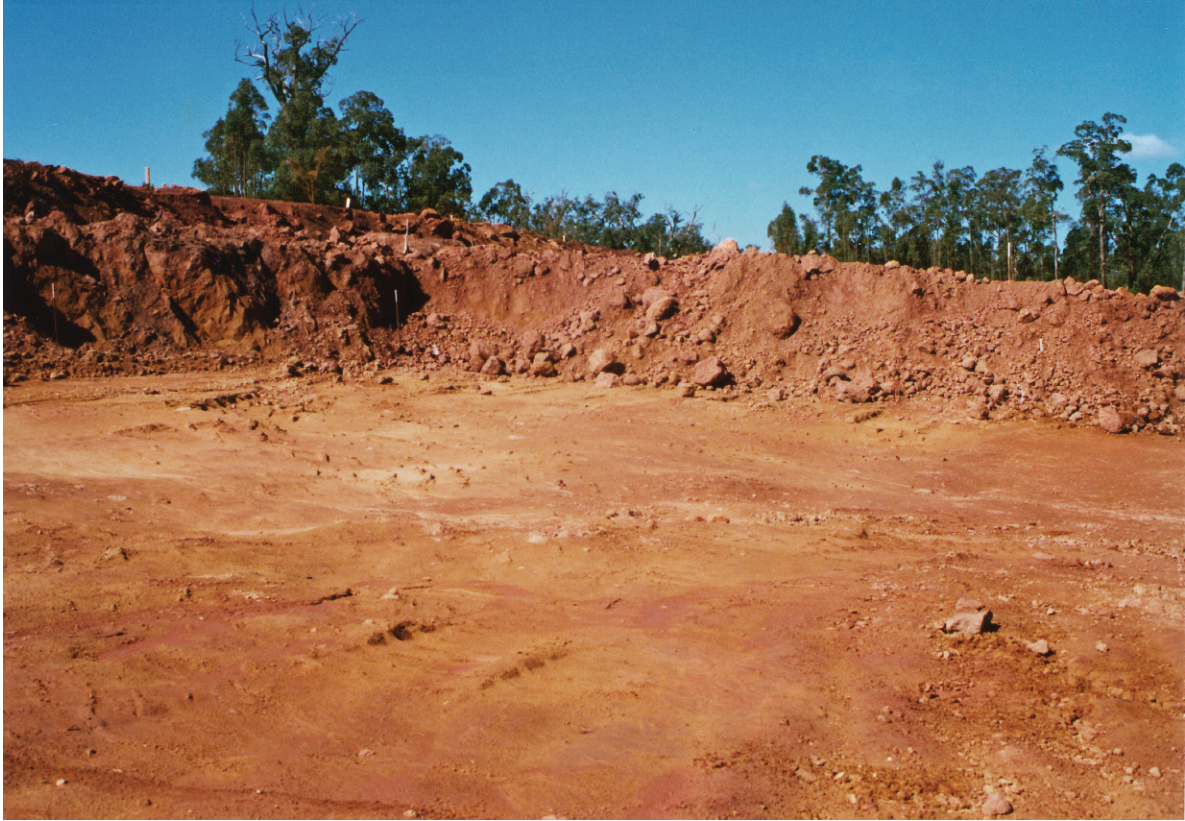
PLATE 4.3. After mining bauxite (background) an ironstone surface remains (foreground).

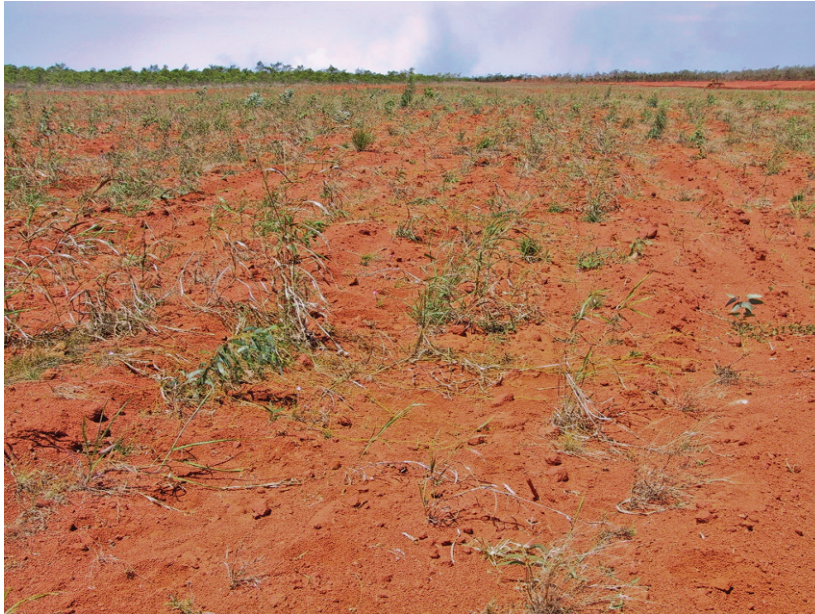
PLATE 4.4. One-year-old revegetated site at Gove.

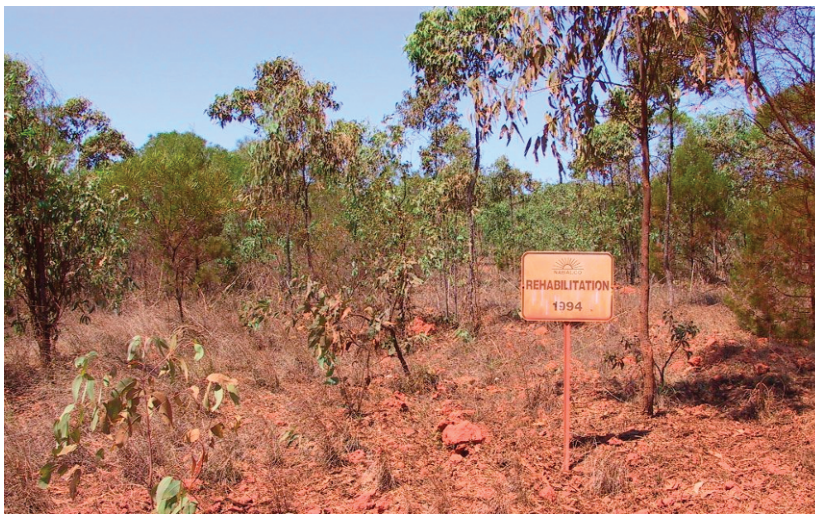
PLATE 4.5. Seven-year-old revegetated site at Gove.

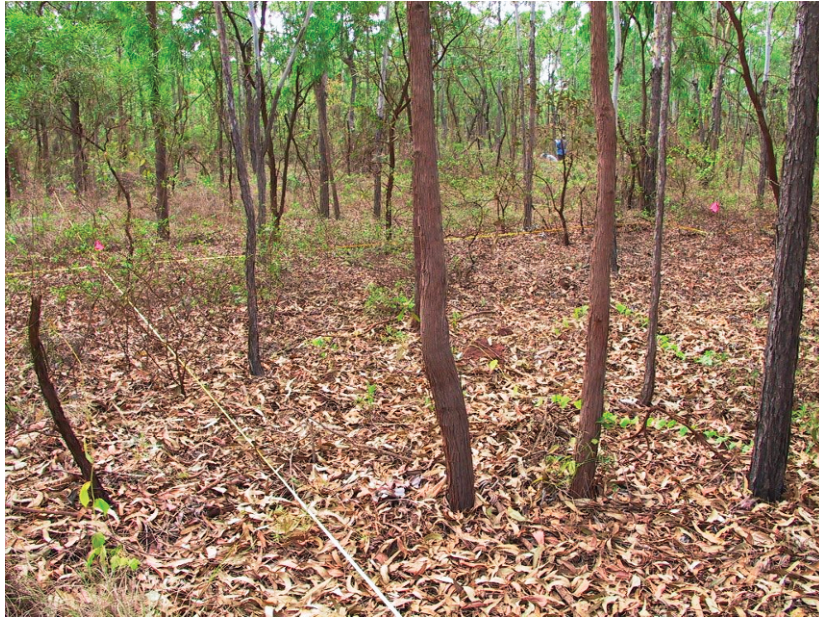
PLATE 4.6. Twenty-year-old revegetated site at Gove.

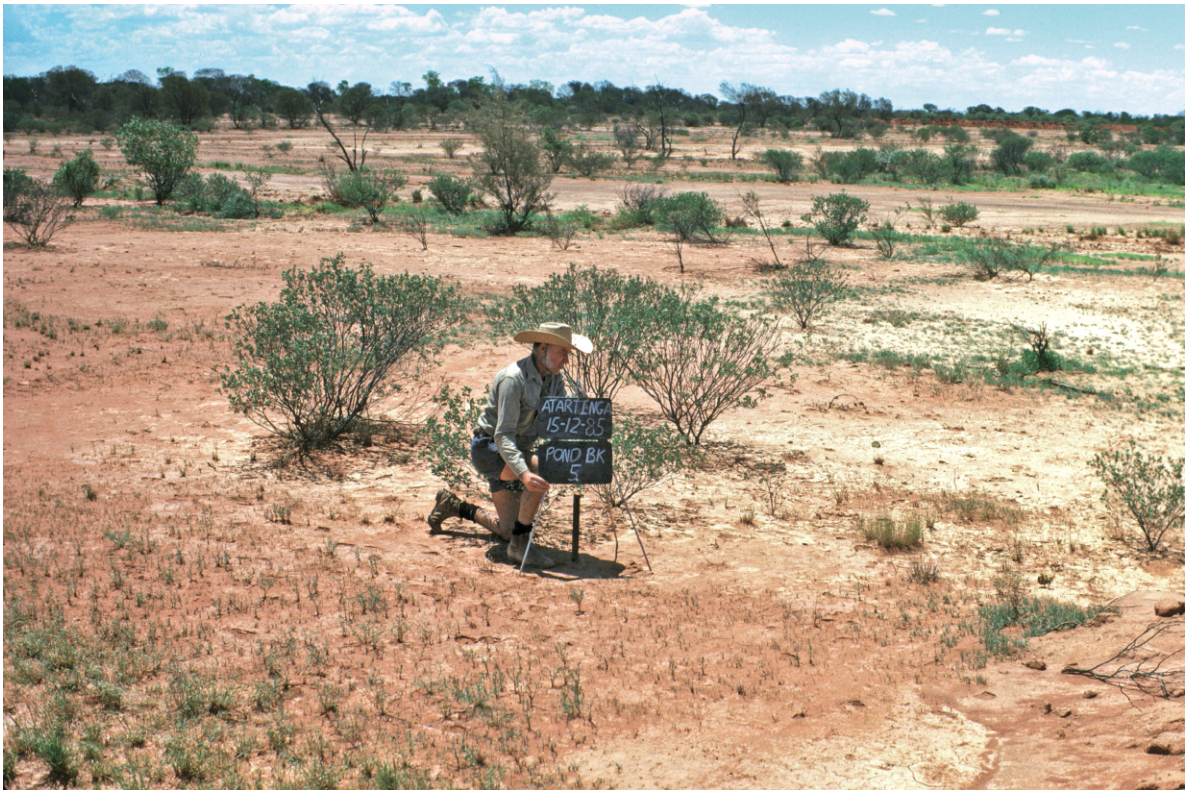
PLATE 5.1. Woodgreen ponding bank 5: photo point in 1985. Photograph courtesy of Gary Bastin.

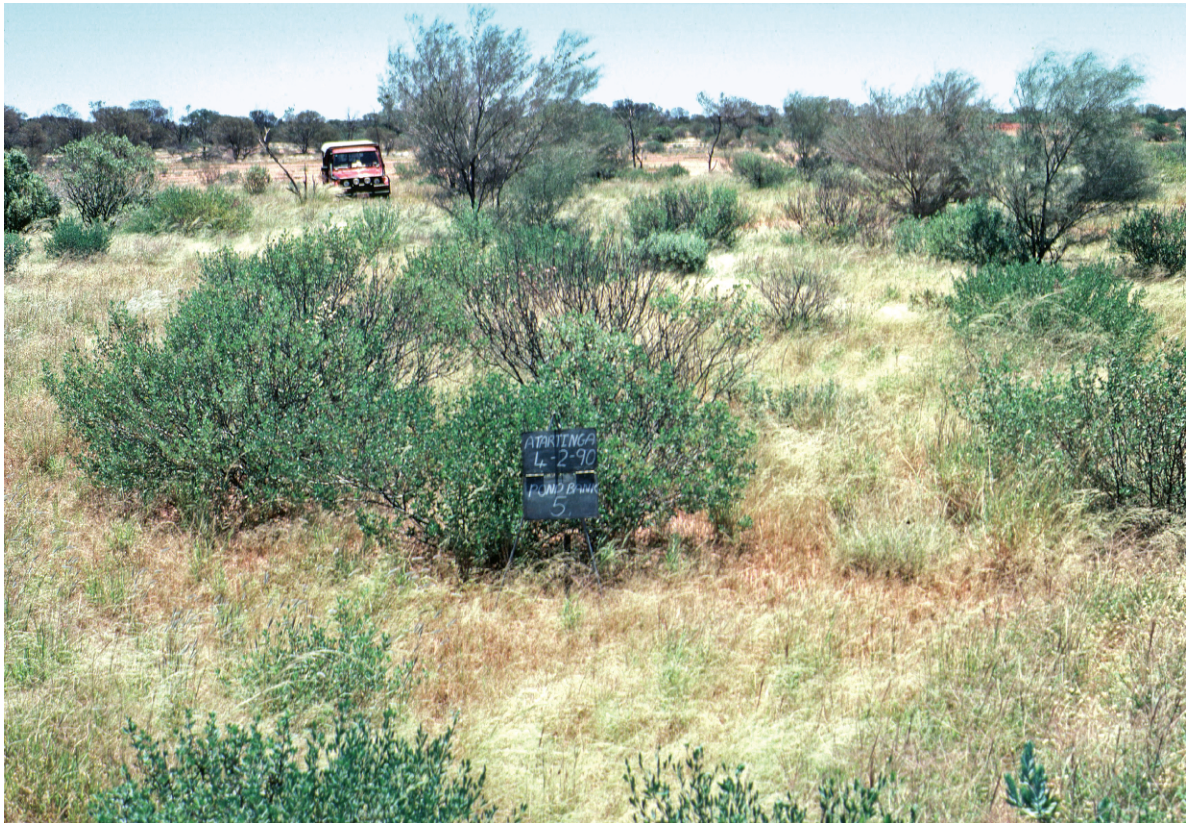
PLATE 5.2. Woodgreen photo point (seen in plate 5.1) in 1990. Photograph courtesy of Gary Bastin.

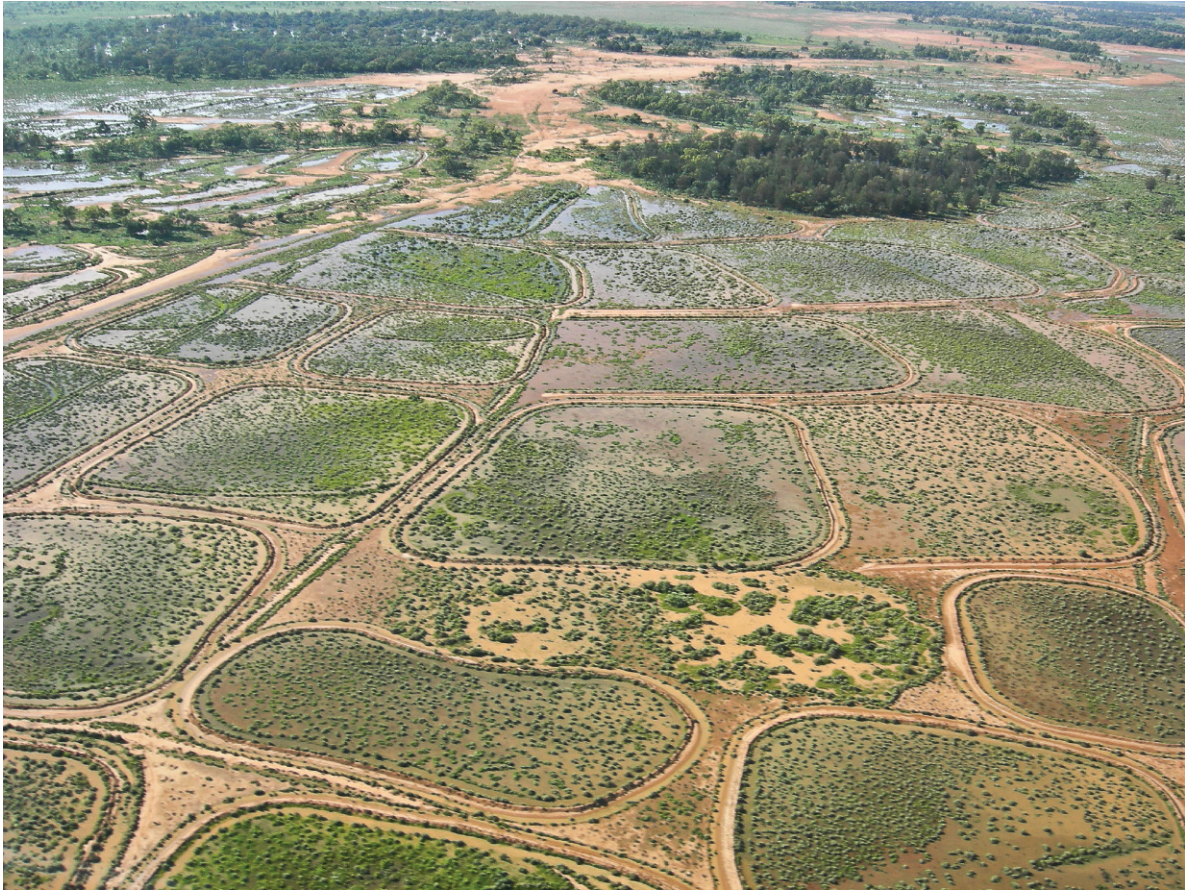
PLATE 5.3. Water ponding on an extensively scalded area. Photograph courtesy of Ray Thompson.

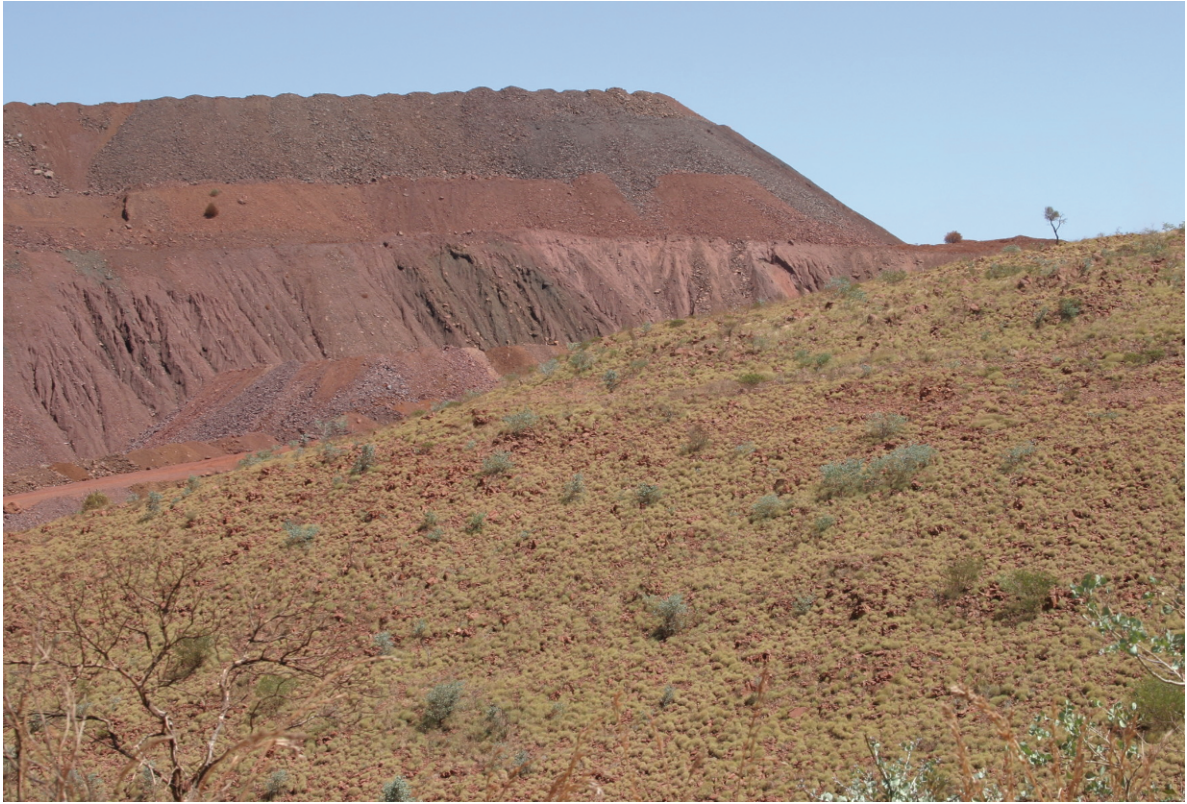
PLATE 6.1. An angle of repose waste-rock dump with active erosion compared to the natural landscape (foreground) where soil erosion can scarcely be detected.

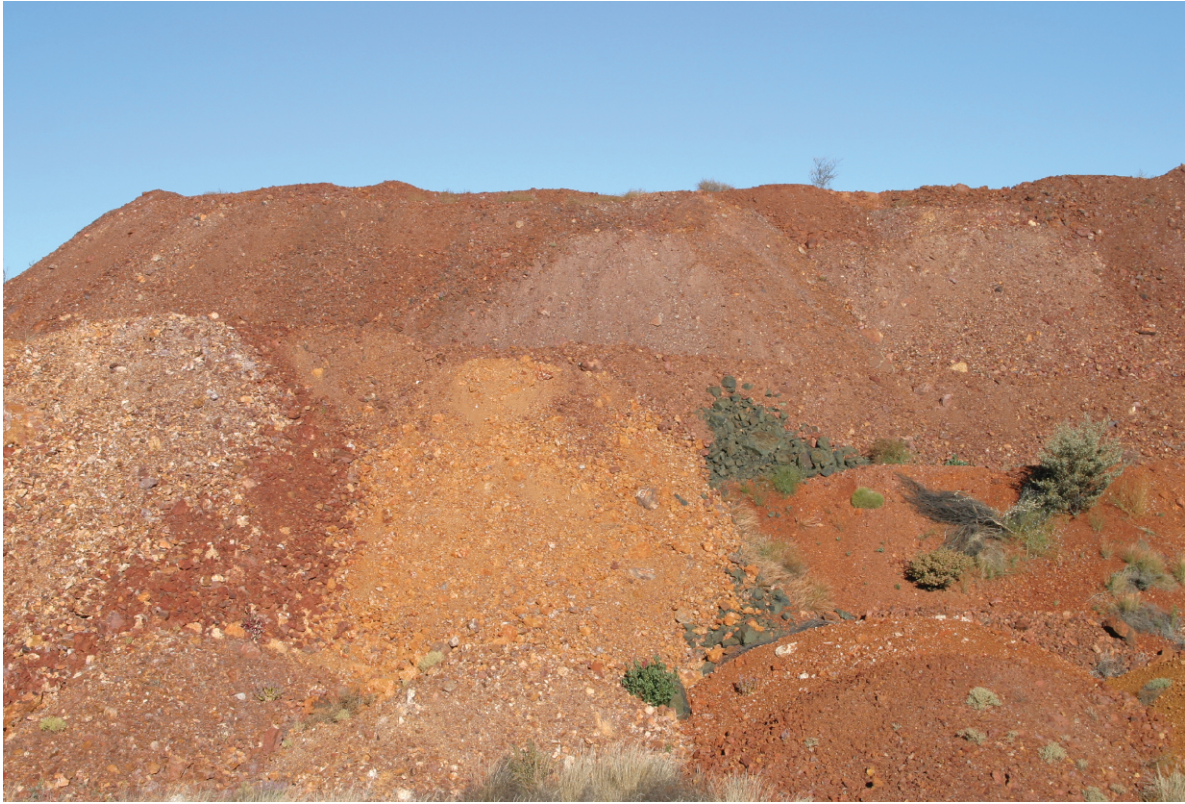
PLATE 6.2. Dump of mixed regolith materials produced by open-cut mining.

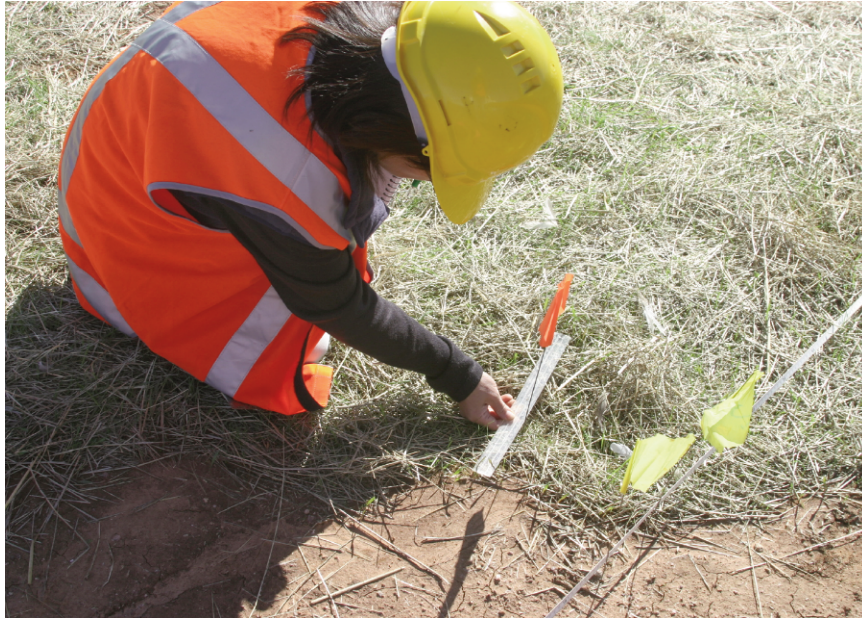
PLATE 6.3. Restoration practitioner making additional measurements that will be used to determine the effectiveness of strips of mulch in trapping sediments eroding from upslope.

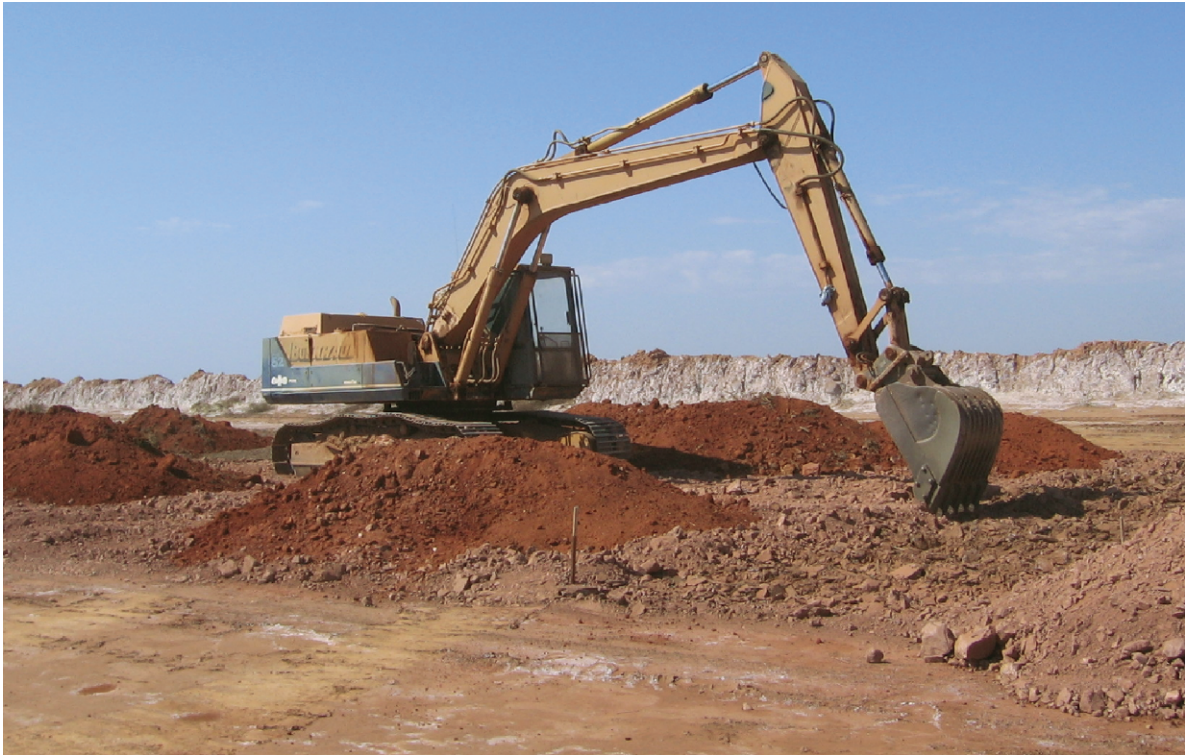
PLATE 7.1. The top of a tailings storage facility being covered with topsoil after capping with coarser materials. Photograph courtesy of Harley Lacy.

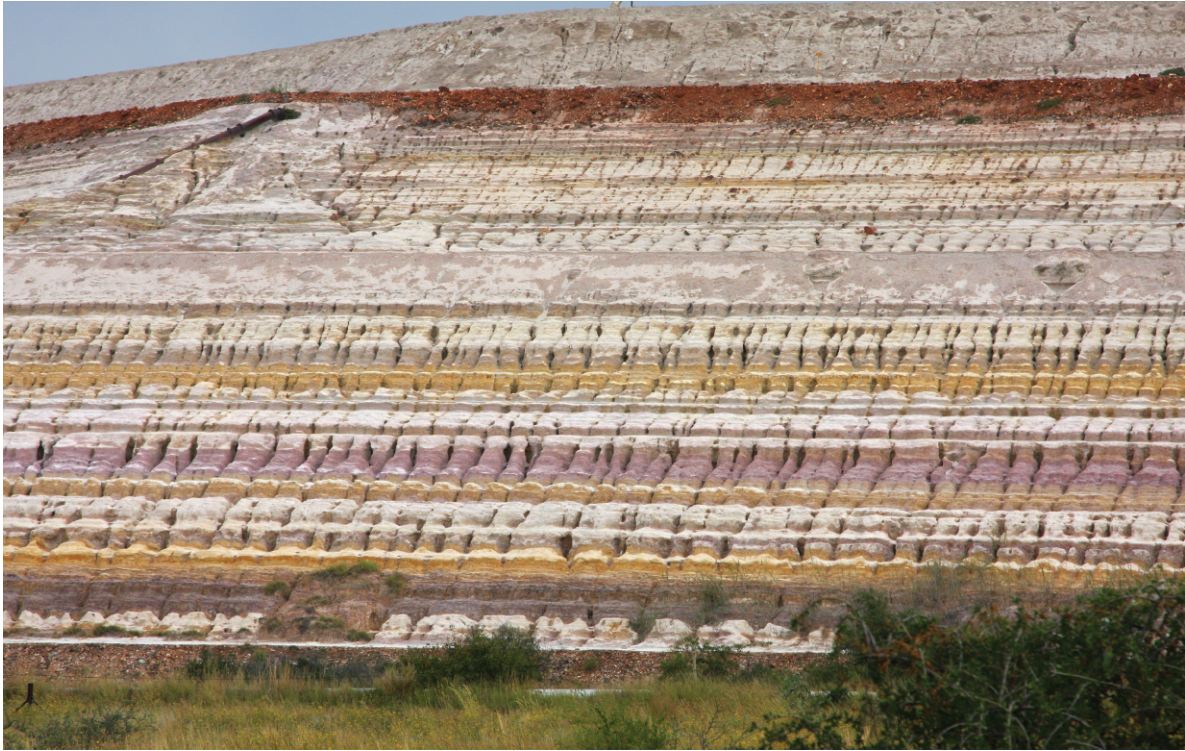
PLATE 7.2. Wall of a tailings storage facility with distinctive bands of different tailing materials.

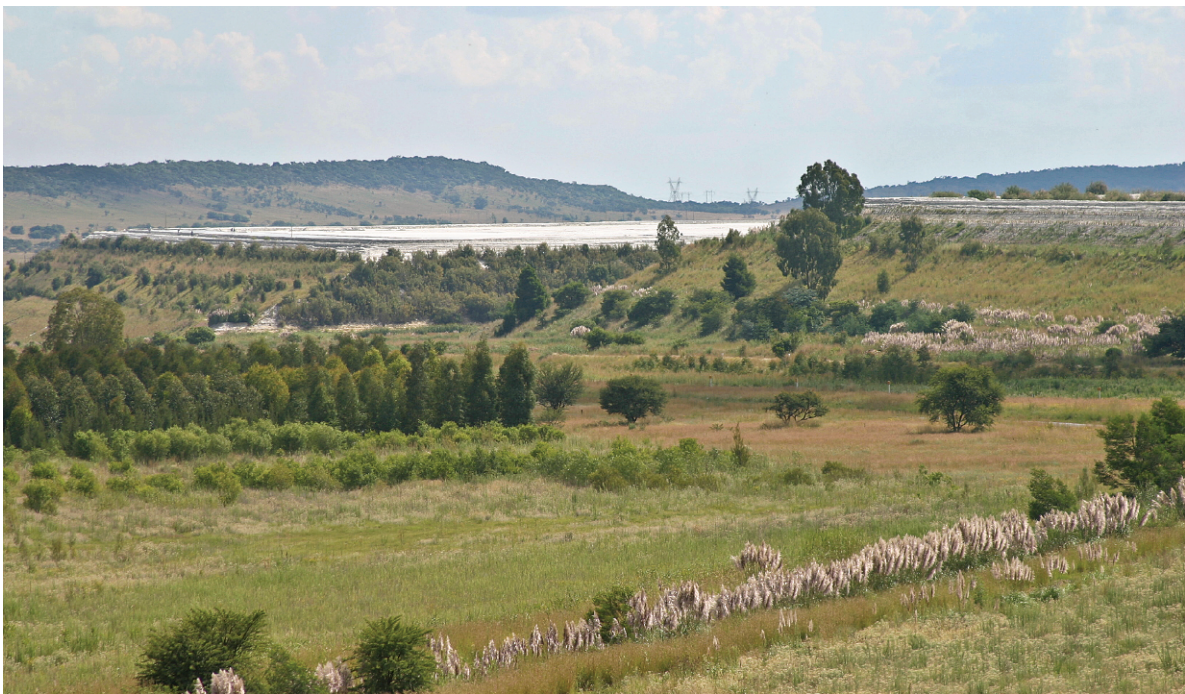
PLATE 7.3. Plantations located at the base of tailings storage facilities.

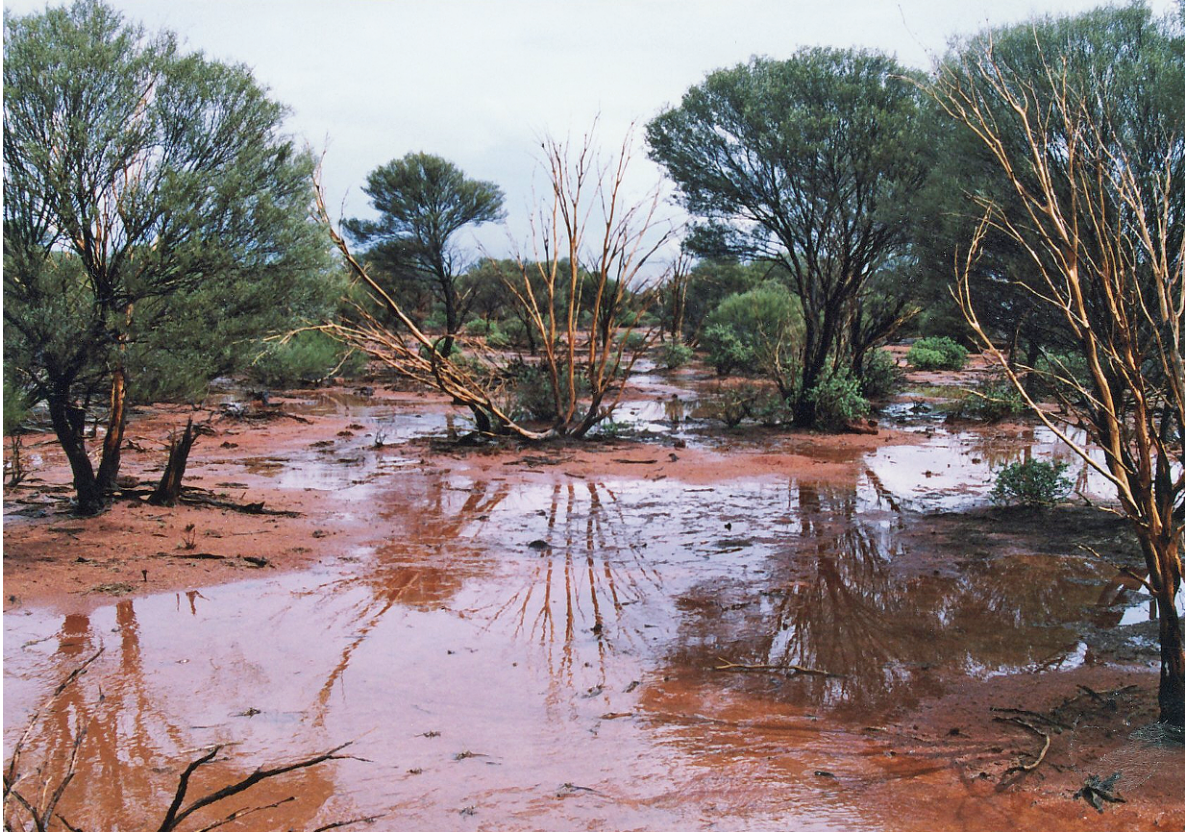
PLATE 9.1. Sheet erosion in action. A broad shallow body of water is removing thin layers of soil in a rangeland.

Grassy rangelands that have become shrubby typically have signs of excessive soil erosion such as surface sheeting and rilling. *Sheet erosion* is the progressive removal of very thin layers of surface soil by water flowing broadly across extensive areas. (See plate 9.1.) There are few, if any, sharp discontinuities to demarcate these eroded areas. Sheet erosion typically occurs on gentle slopes (less than 2 percent) where soil surfaces are exposed. *Rill erosion* is the cutting of minor channels (less than 0.3 meters deep) by flowing water running down the steeper parts of a hillslope. (See plate 2.1.) The channels typically occur on slopes greater than 2 percent and are a sign that water is flowing rapidly and carrying materials such as soil particles, litter, and seeds with it. Gul-

Stakeholders and RPs also analyzed long-term rainfall records and found that rains were highly unreliable in terms of amounts and seasonality. Droughts of three to five years' duration were common. During major rainfall events they observed that rangelands with high grass cover retained (captured) overland flows of water at a fine scale of about 20 to 30 cm. (See figure 9.1, and also figure 2.1 in chapter 2.) Also, in rangelands with dense shrubs, patterns of runoff indicated that losses of water from the landscape were high because of very little obstruction by ground layer vegetation. (See plate 9.1.) Any water retained in the landscape primarily benefitted shrubs.

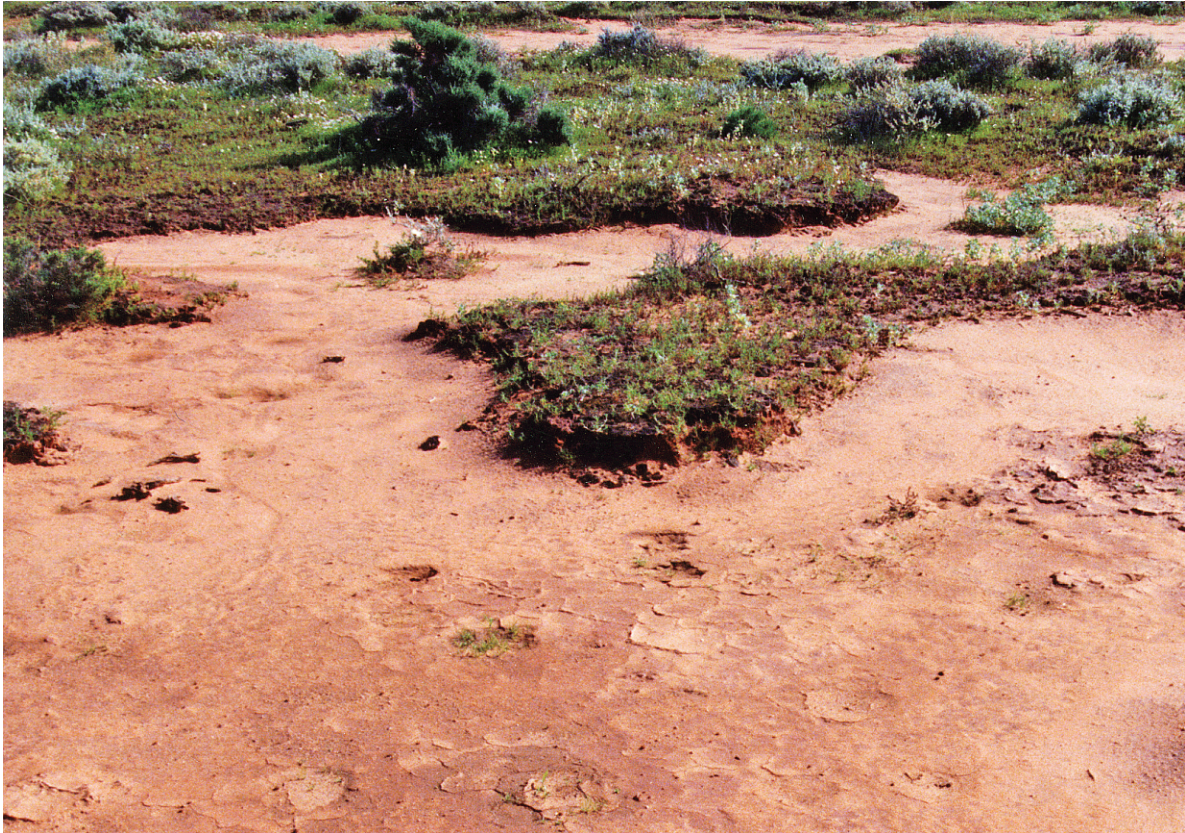
PLATE 9.2. Scald erosion in a rangeland. Over 100 mm of soil has been lost by wind and water action, exposing a dispersive clay subsoil.

In extreme cases of sheet erosion, the flows of water and wind can cause wholesale loss of soil A horizons and expose areas of hard-setting B horizons between remnant patches of vegetation (plate 9.2). These bare areas of soil are referred to as scalds or hardpans, which can be very extensive. We addressed the restoration of scalds in chapter 5.
