Claudio Margottini *Editor*

After the Destruction of Giant Buddha Statues in Bamiyan (Afghanistan) in 2001

A UNESCO's Emergency Activity
for the Recovering and Rehabilitation
of Cliff and Niches

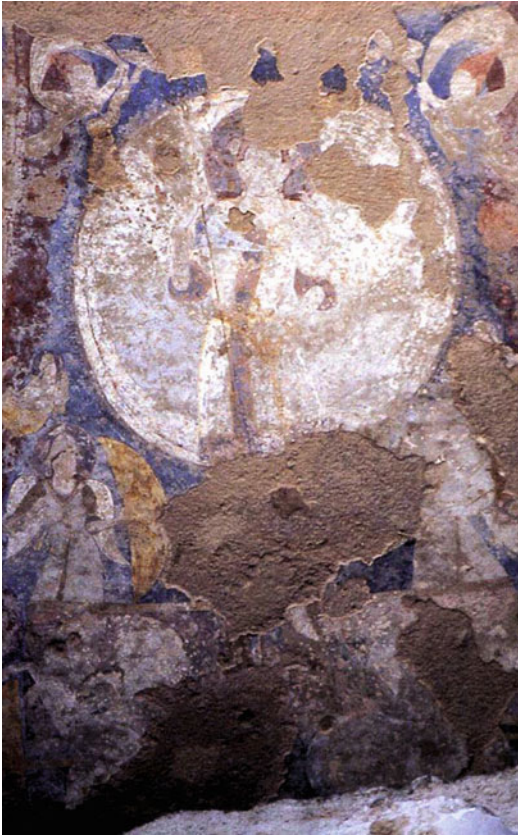
Fig. 2.2 The sun god

divinity (Fig. 2.2). The traditional sun worship of the nomads and also Buddhist symbolism, which metaphorically compared the transcendence of Sakya to the sun, could both be represented here by the sun as the epiphany of supreme divinity. At the same time the artisans would be required to paint the image of the sun god doubled with the conception of the world that the royalty in this province required.

The sun god was painted with the figure who soars in heaven riding on the two-wheeled golden chariot pulled by four winged white horses. The sun god displays a nimbus and ribbons flying up from the both shoulders symmetrically, and wears a mantle, the skirt of which is waving in the wind, on a round-neck tunic, holding straight a rather slender spear in the right hand and also grasping the hilt of a sword hung from the waist belt in left hand. Two legs putting on boots would be painted beneath the solar disk, but the legs cannot be seen

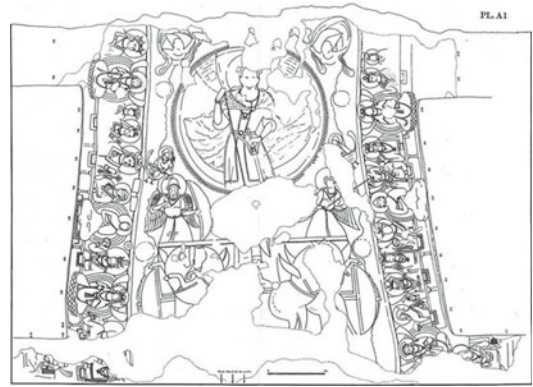
Fig. 2.3 Sketch of ceiling

anymore, because that part of the painting came off. The hair is long enough to reach the shoulders and a round headdress can be seen, but the top part of it cannot be seen (Fig. 2.3).

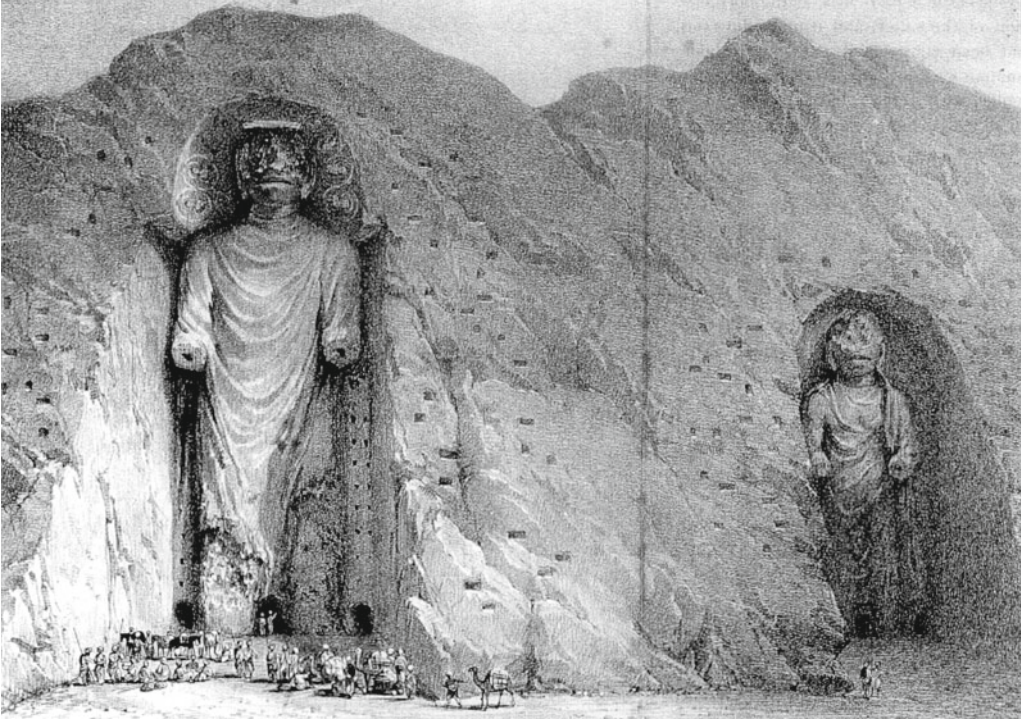
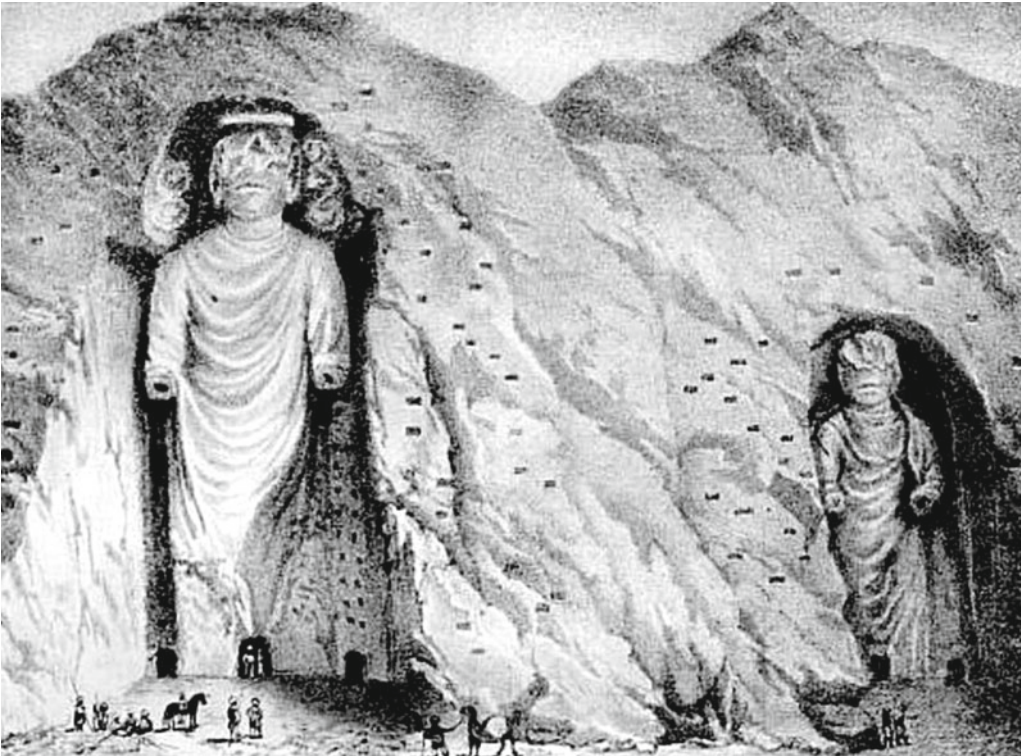
statue. In the sketch executed by Burnes and published in *On the Colossal Idols of Bamian* (Fig. 3.5), he reproduced the Buddha with a face, whereas in reality it had been erased, as correctly shown in the print executed by Haghe Louis and published in *Travels into Bokhara* (Figs. 3.6 and 3.7).¹⁴

In his drawings, Burnes reported technical data such as the dimensions of the two colossi, and chose a lateral point of view to show the digging of the cliff and the rest of the frescoes. It appears to have been a good choice, as in the print by Haghe the arch that surpasses the head of the larger statue appears flattened to stress the presence of frescoes. Nonetheless, both prints are pleasant and well realized. An interesting aspect of Haghe's work is the presence of camels and personages in traditional dresses. These details give a natural Oriental aspect to the whole scene.

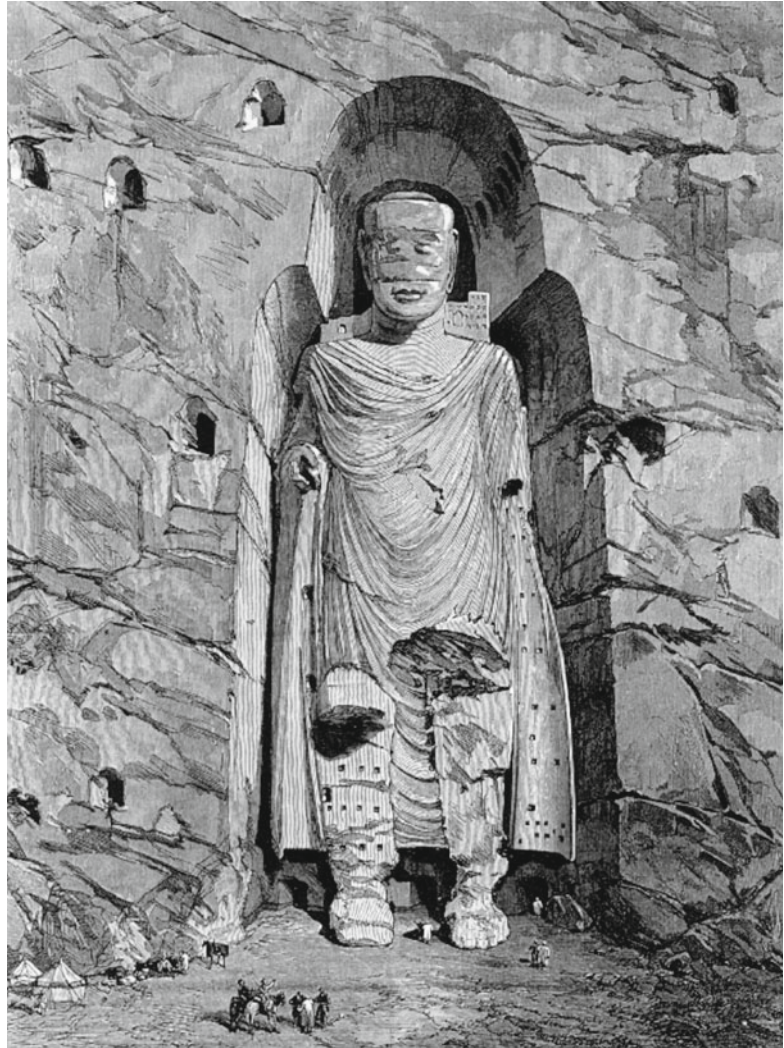
Fig. 3.12 The largest statue.
The Illustrated London News,
 Nov. 6, 1886, pag. 491
 (Courtesy of D. Bukerer)

and Maitland was the author of a series of drawings showing the cliff and statues. These drawings were reproduced by Mr. W. Simpson, who was present during a previous government mission, and published by W. Simpson himself in 1886 (Figs. 3.12 and 3.13) (The Illustrated London News 1886).

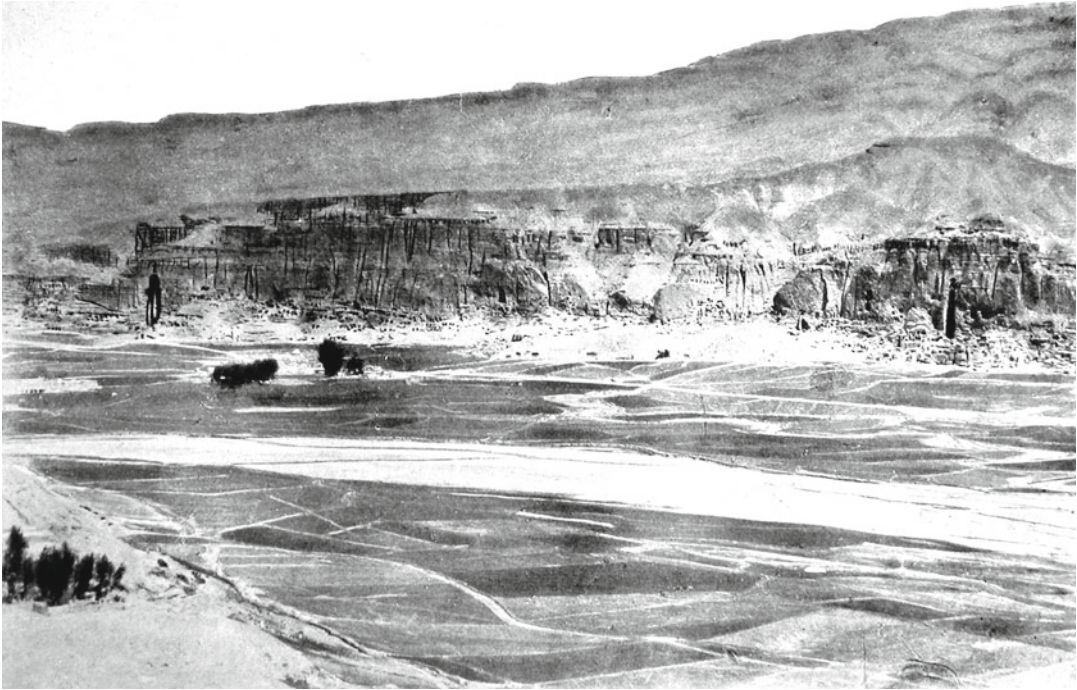
Fig. 3.19 Hayden H.H., *Notes on Some Monuments in Afghanistan*, in *Memoirs of the Asiatic Society of Bengal*, II, 1910

In his article, Hayden published a series of photos of the Bamiyan Valley and its colossi for the first time (Figs. 3.18 and 3.19).

There are at present altogether five statues in Bamián three of which to are in the main valley at Taibut. Plate XII gives general view of the cliff of Tertiary conglomerated on the left side of the valley and shows the two chief niches, one at either end, and two smaller niches between them. Only one of the latter contains to statues and that has suffered, like the two principal figures, from systematic mutilations as well as from the effects of Cannon-ball fired at it by Mahomedan invaders (Hayden 1910).

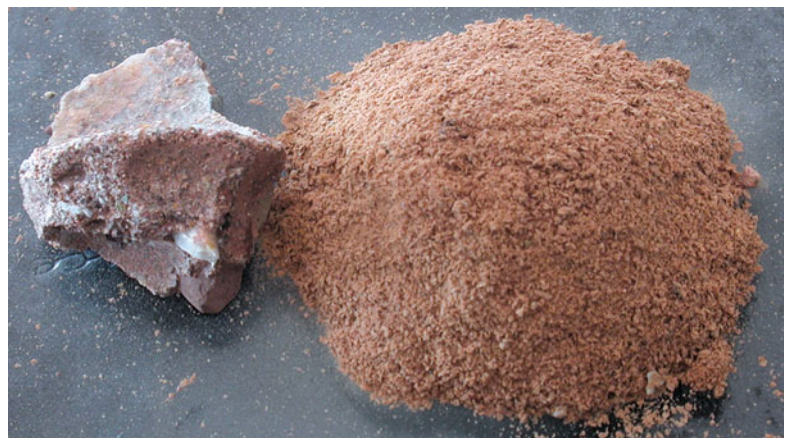
Fig. 5.10 Stability of conglomerate (*left*) and degradation of the siltstone (*right*) when weathered

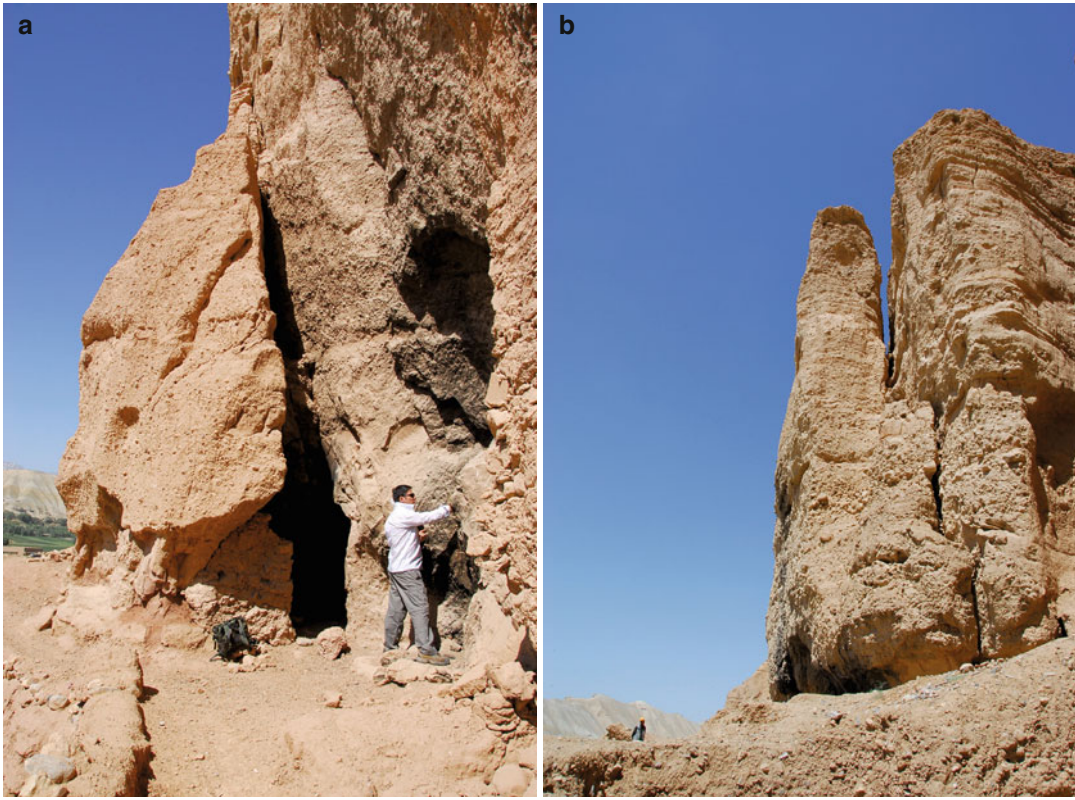
Fig. 5.15 Example of joints parallel to the cliff main orientation

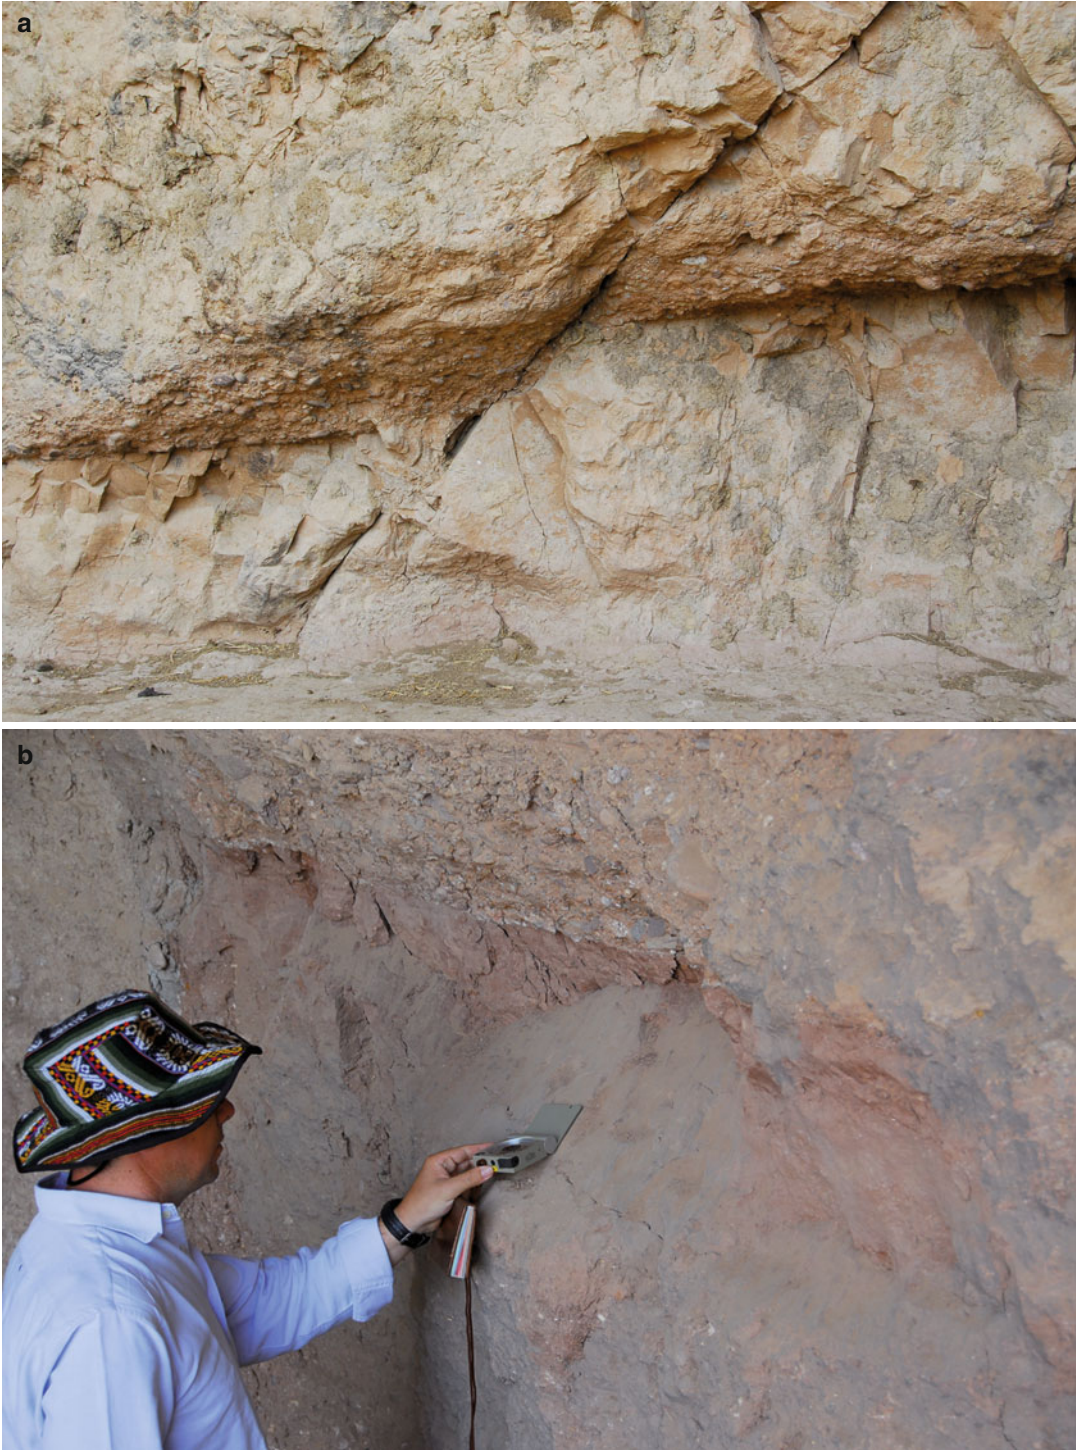
Fig. 5.16 View of medium-low angle faults affecting the outcropping base rocks in the eastern side of the cliff

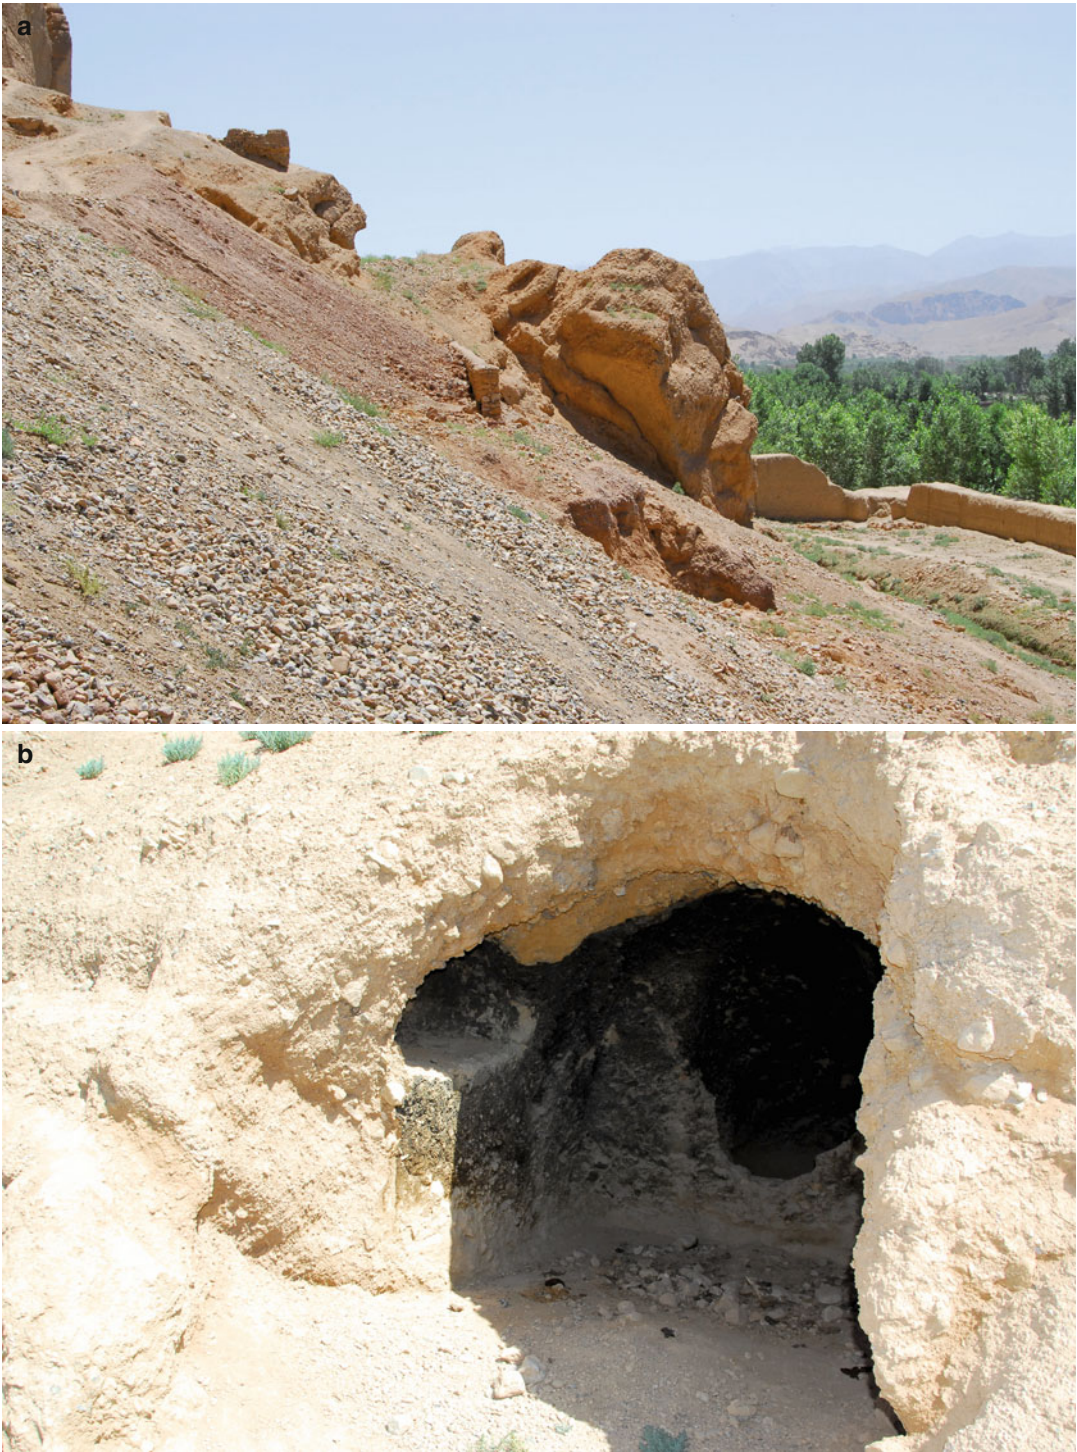
Fig. 5.17 Remains of a block involved by sliding (*top*) and a cave built inside a slid block (*bottom*)

This situation has caused, especially in the past, rock sliding phenomena at the base of the cliff, still clearly visible along all the border of the slope, mostly in an inactive or quiescent state of activity (Fig. 5.17). The presence of quite stable caves with horizontal floor surface (Fig. 5.17, top) in the majority of accumulation material, demonstrates that this type of mass movement is ancient and occurred, mainly, prior to the anthropisation of the cliff. Nevertheless there are some caves, 2 of 13, located in the two most evident rock slides west of the Eastern Giant Buddha and east of the Western Giant one (see geomorphological map of Fig. 5.23), which clearly exhibit cave floors tilted or displaced by the cliff instability (Fig. 5.18). They demonstrate that some rock slides occurred also after the fifth to sixth century A.D., when the anthropisation of the valley begun.

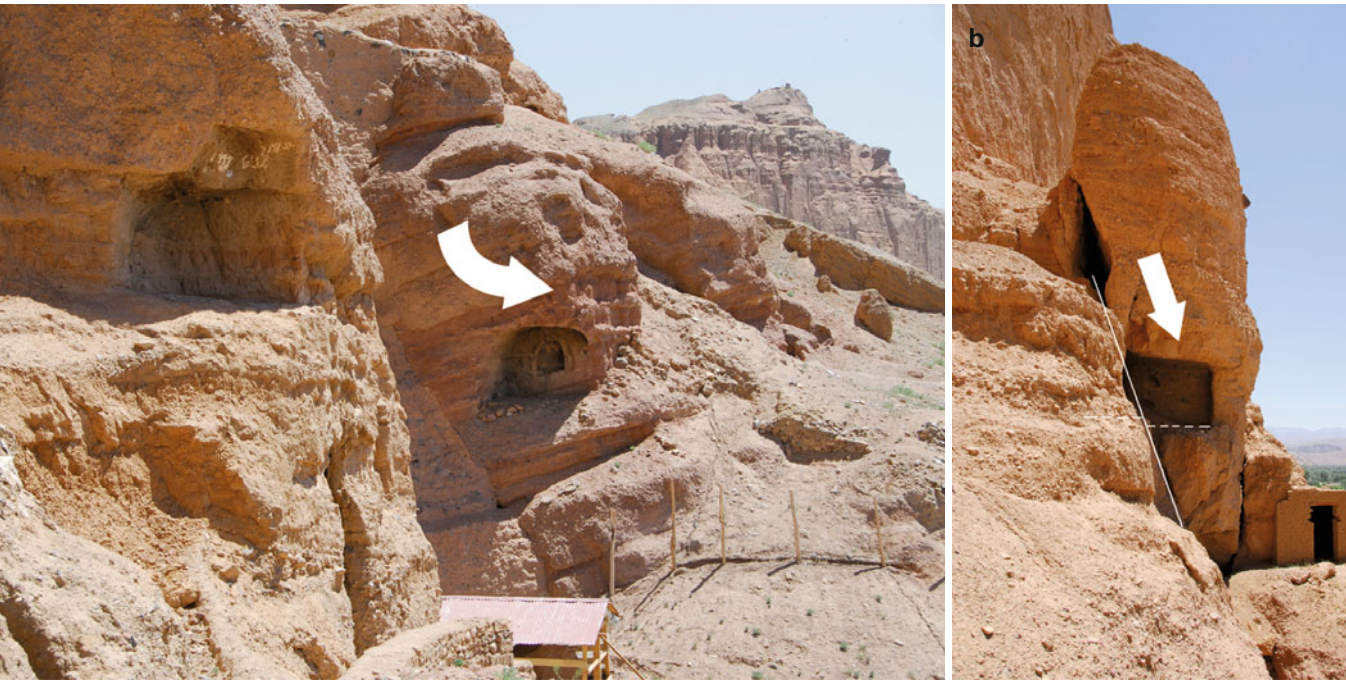
Fig. 5.18 Cave's ground floor tilted after a rock slide east of Western Giant Buddha (*left*) and a cave displaced by a rock slide's plane west of Eastern Giant Buddha (*right*)

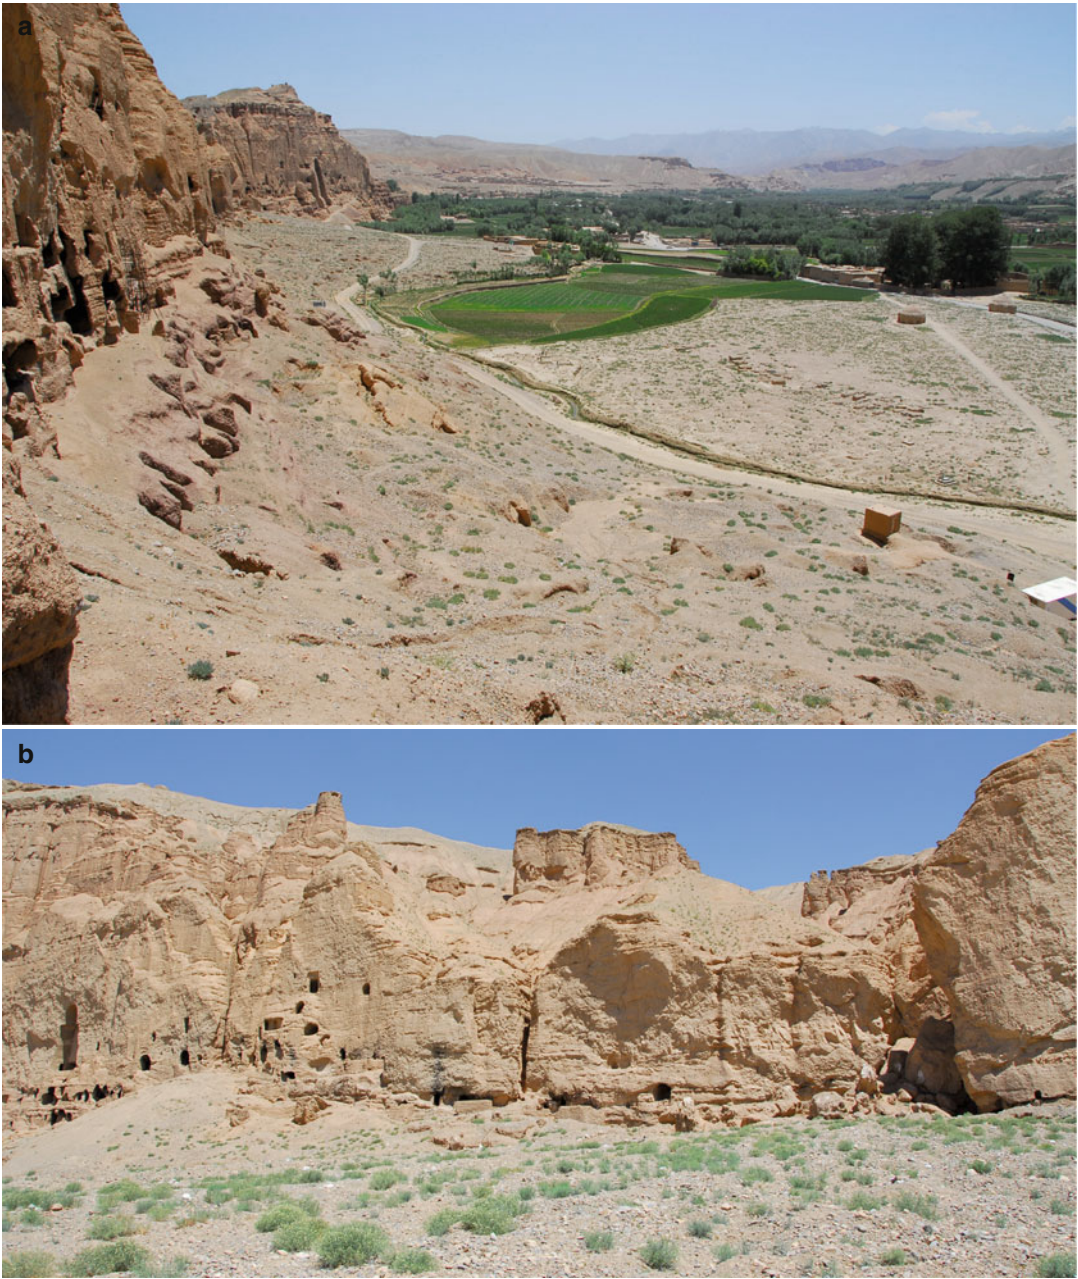
Fig. 5.21 Debris outcropping along the slope toe (*top*) and view of coalescent debris cones located in the middle of the cliff (*bottom*)

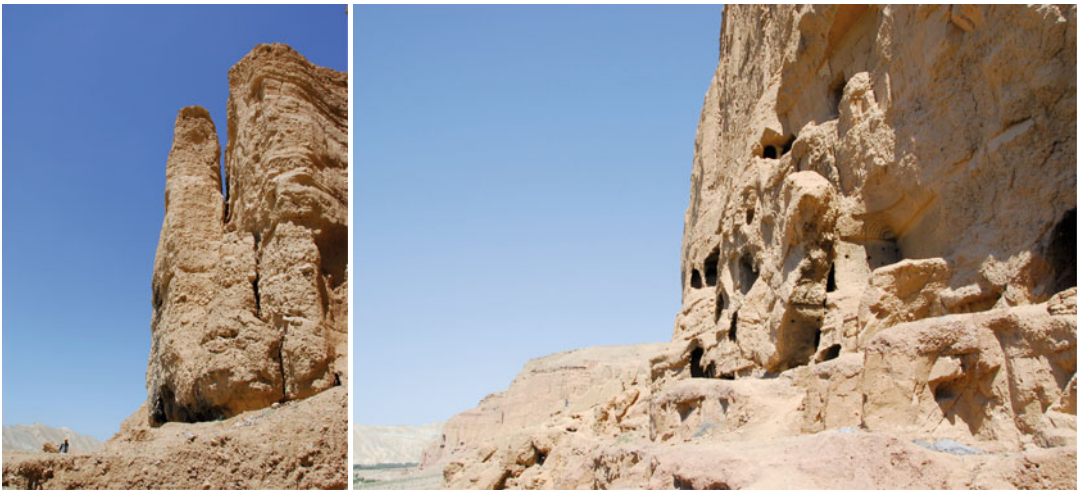
Fig. 5.29 Potential rock toppling in the western side (*left*) and fallen block caused by toppling in the eastern side (*right*)

Figure 5.29 shows some example of toppling failure mode surveyed in the cliff of Bamiyan. The photo on the left represent a potential block sliding detected in the western side of the cliff, developed along a deep discontinuity parallel to the slope, previously affected by gully erosion

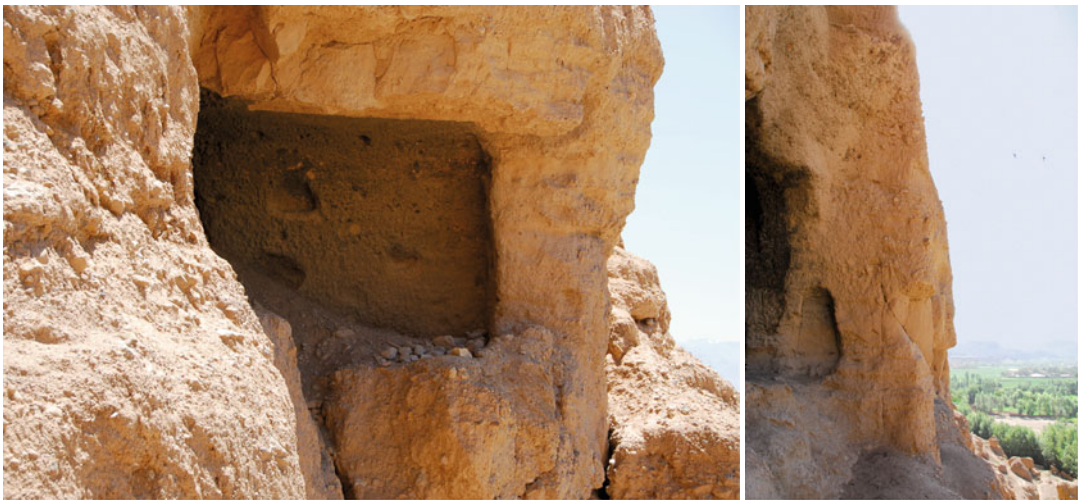
Fig. 5.31 Old rock-block slide reactivated (*left*) and potential rock sliding

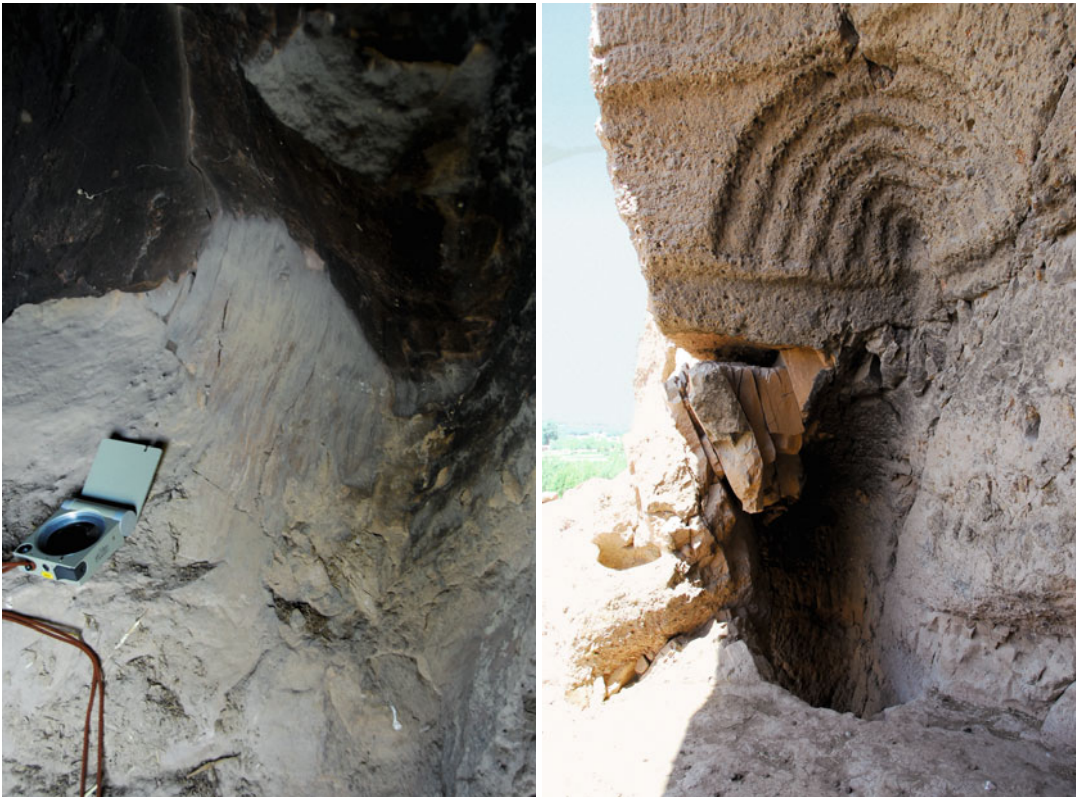
Fig. 5.32 Fault surface with evidence of stress (*left*) and persistent discontinuity where potential planar sliding can develop (*right*)

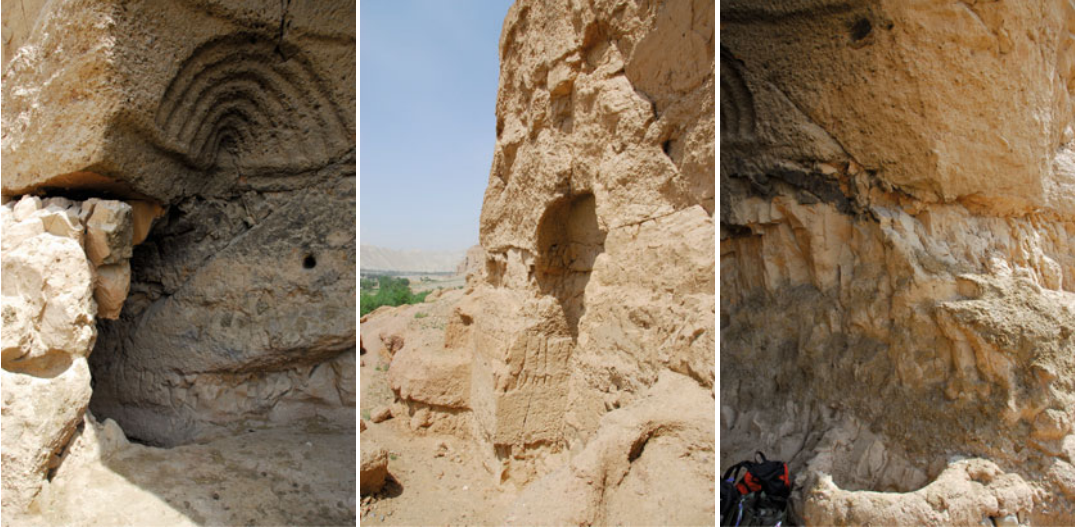
Fig. 5.34 Example of wedge failure potential area in the east side of the cliff

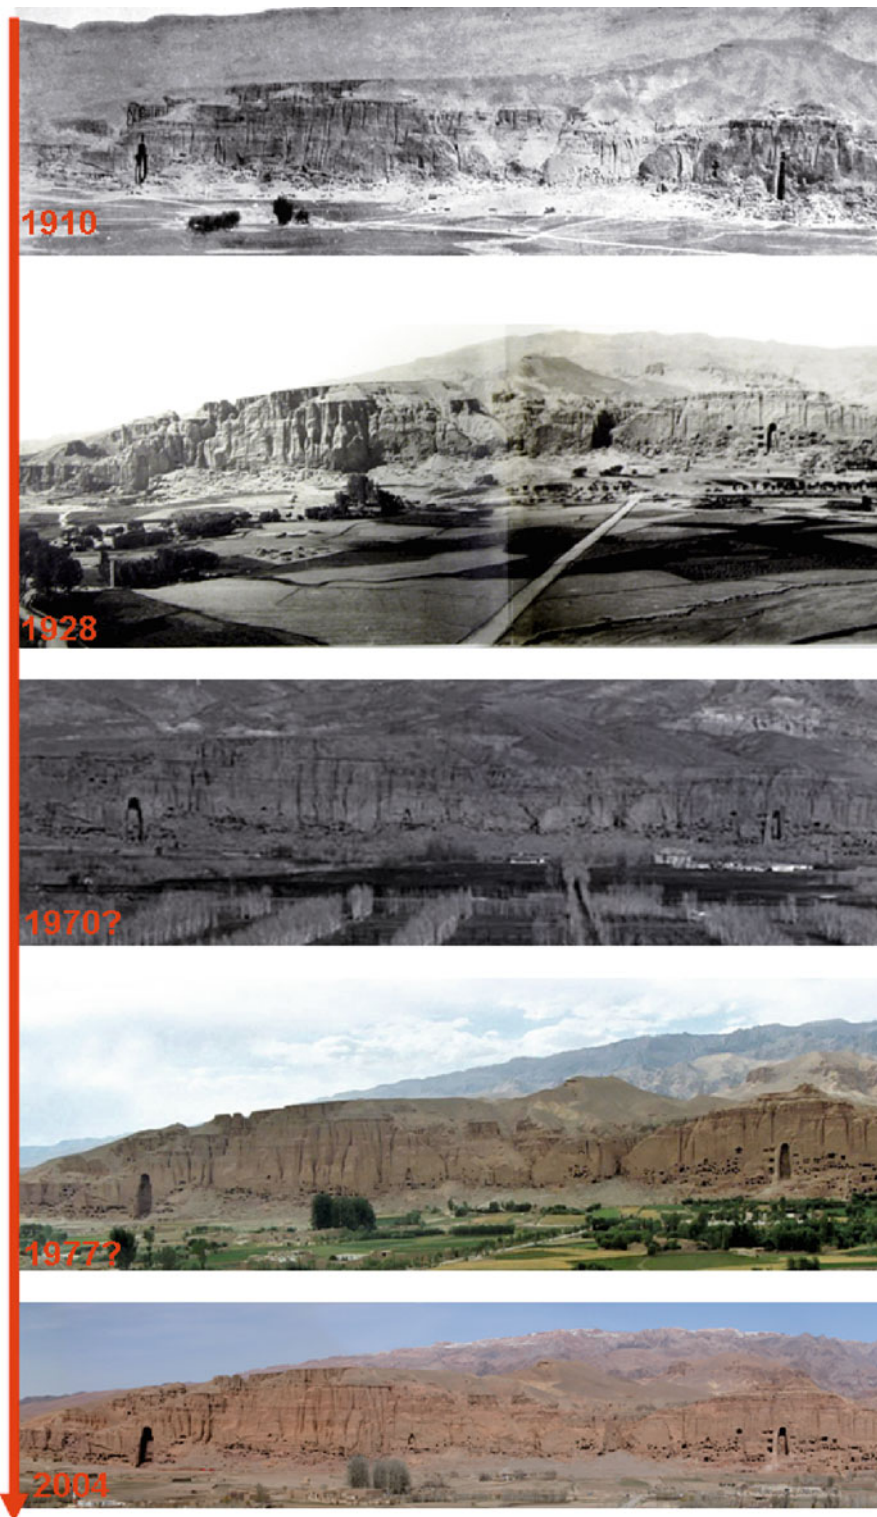
Fig. 5.35 Multitemporal view of the Bamiyan cliff, from 1910 until today

The collected photos were mainly used to evaluate the potential evolution of debris accumulation in time and, secondarily, to identify potential large mass movement(s) occurring in the last century. The obtained information is not very accurate and only a rough estimation is possible. This is because of camera resolution and different positions.

As a major conclusion it can be mentioned that the investigation did not revealing major changes of morphology. The main feature of the cliff remained almost unaltered in time, with the only exception being the area below the Eastern Giant Buddha. In this site, the large construction work performed by the French archaeological mission in about 1968–1972 by the Indian Archaeological Survey, produced a large amount of debris, clearly visible when comparing the image of 1910 with 2004 (Fig. 5.36).

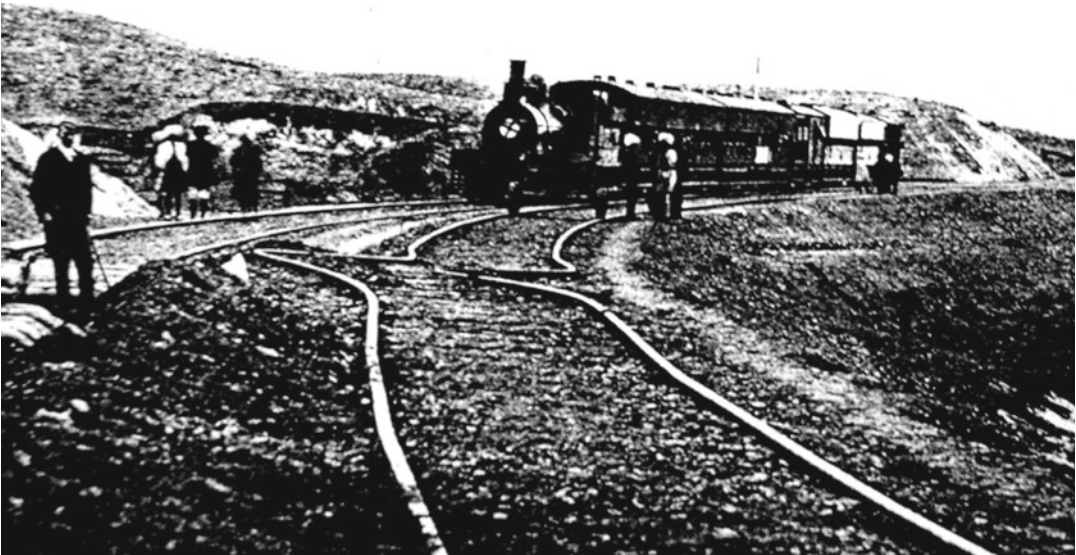
Plate 6.6 Contraction of the railway line where it crossed the 1892 Chaman fault (From Griesbach 1893). The sinistral fault slip is estimated here to have exceeded 70 cm

Although not confirmed by contemporary corroborating evidence, the following estimates of rupture parameters are available: Montessus De Ballore (1906) $L=20$ km $H=80$ cm,

$V=20\text{--}30$ cm; Montessus de Ballore (1924) $L=24$ km $H=60\text{--}75$ cm; Quittmeyer and Jacob (1979) $L>30$ km $H=75$ cm; Lawrence et al. (1992) and Yates et al. (1997) $L=60$ km $H=60\text{--}75$ cm, $V=20\text{--}30$ cm. As a check on the instrumental estimate of magnitude we calculated M_s using the empirical formula of Ambraseys and Jackson (1998), using the maximum length (60 km) and slip (75 cm) inferred for this event. The derived value of M_s 6.8 is the close to the instrumental value. This magnitude is smaller than earlier estimates by previous investigators but is consistent with relatively small area from which the shock was reportedly felt (Ambraseys and Bilham 2003b).

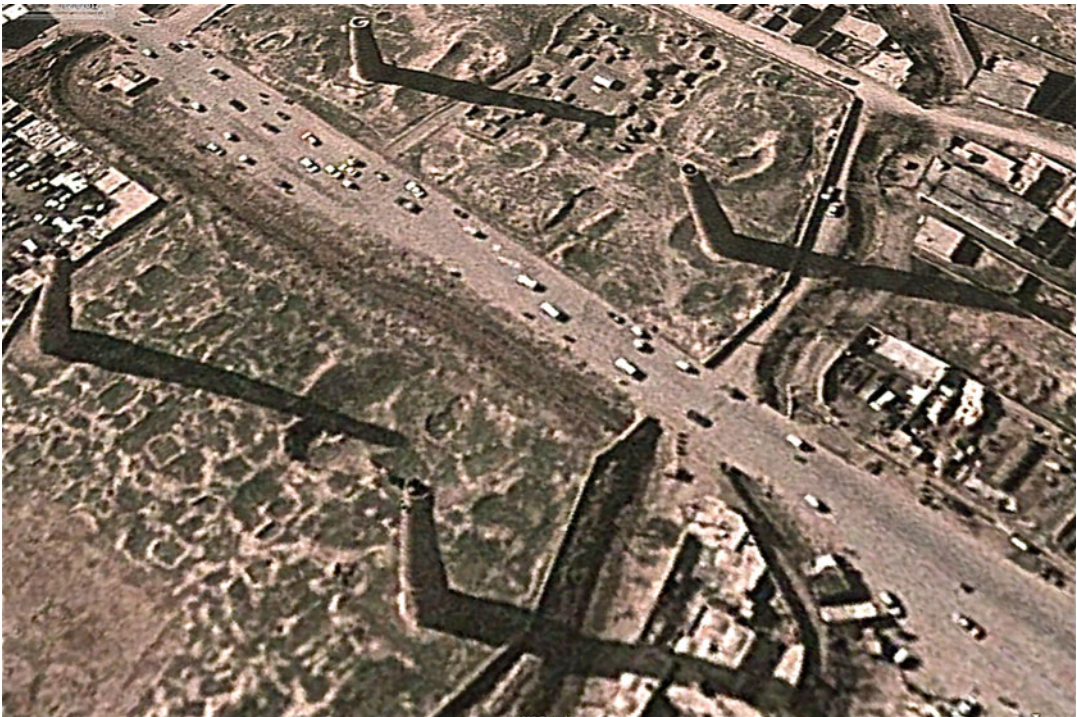
View from space of four of the five remaining minarets in Herat in 2012 (© GoogleEarth). The minarets (~ 55 m high) lean perilously far from the vertical and are the subject of UNESCO restoration

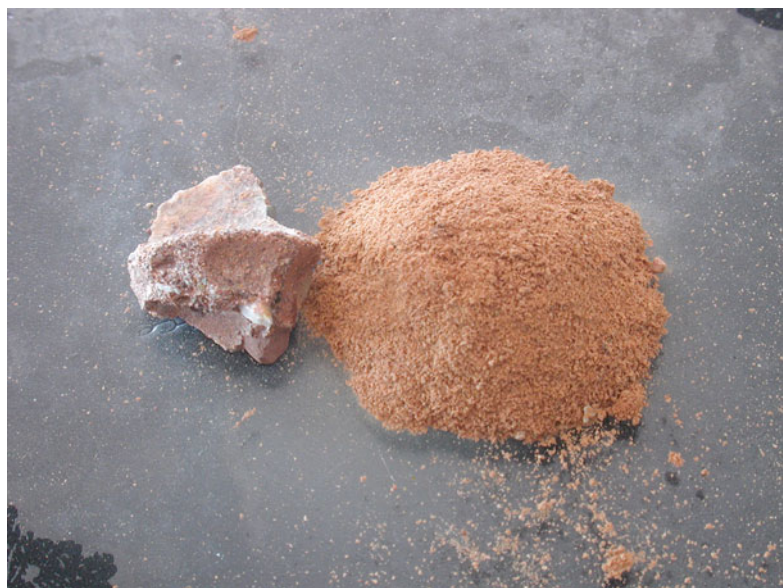
Fig. 7.9 Stability of conglomerate (*left*) and degradation of siltstone (*right*) after only a few minutes of immersion in water

The siltstone samples collected in Bamiyan exhibited very severe slaking (Fig. 7.9), completely disaggregating the material when submerged in water, after just a few minutes (3–10 min, according to different samples).

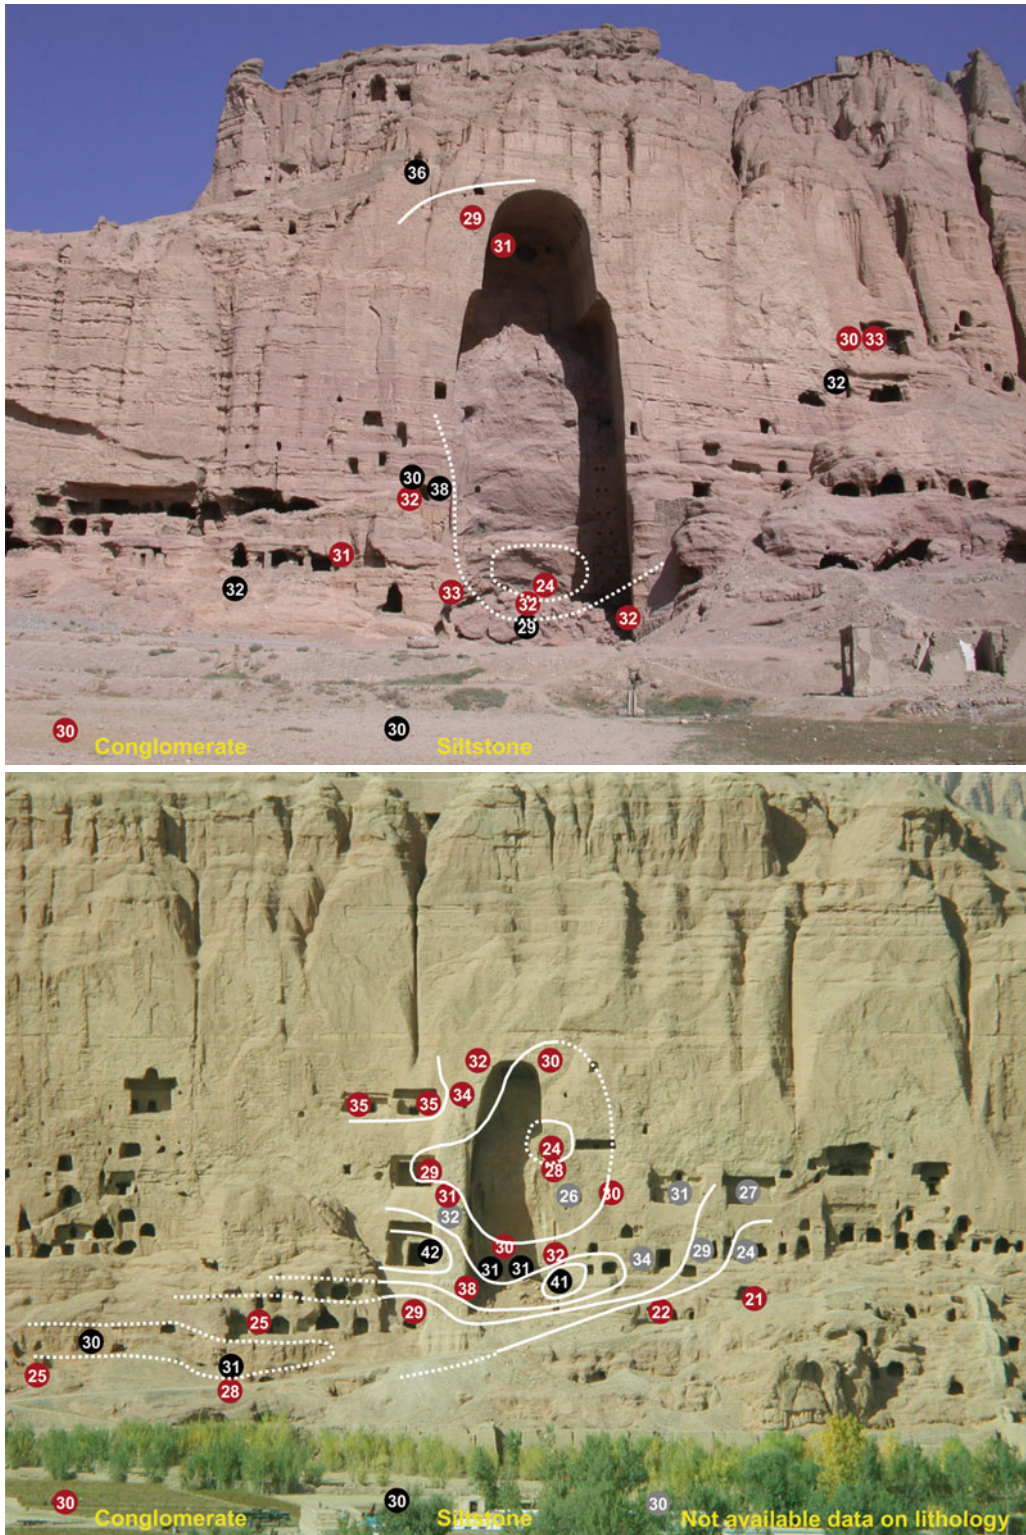
Fig. 7.15 Uniaxial compressive strength (MPa) from Schmidt hammer field survey, in the surrounding of both niches (*top* the Western giant Buddha niche and *bottom* the Eastern Buddha)

The uniaxial compressive strength, evaluated by a field Schmidt hammer, highlights the general satisfactory condition of the materials, at least in the dry season. Lateral variability can be also numerically evaluated by standard deviation, which assumes a consistency of approximately 13 % from the mean for both the conglomerate and siltstone. These numbers and the data reported in Fig. 7.15 do not suggest important variations in the pattern of mechanical properties.

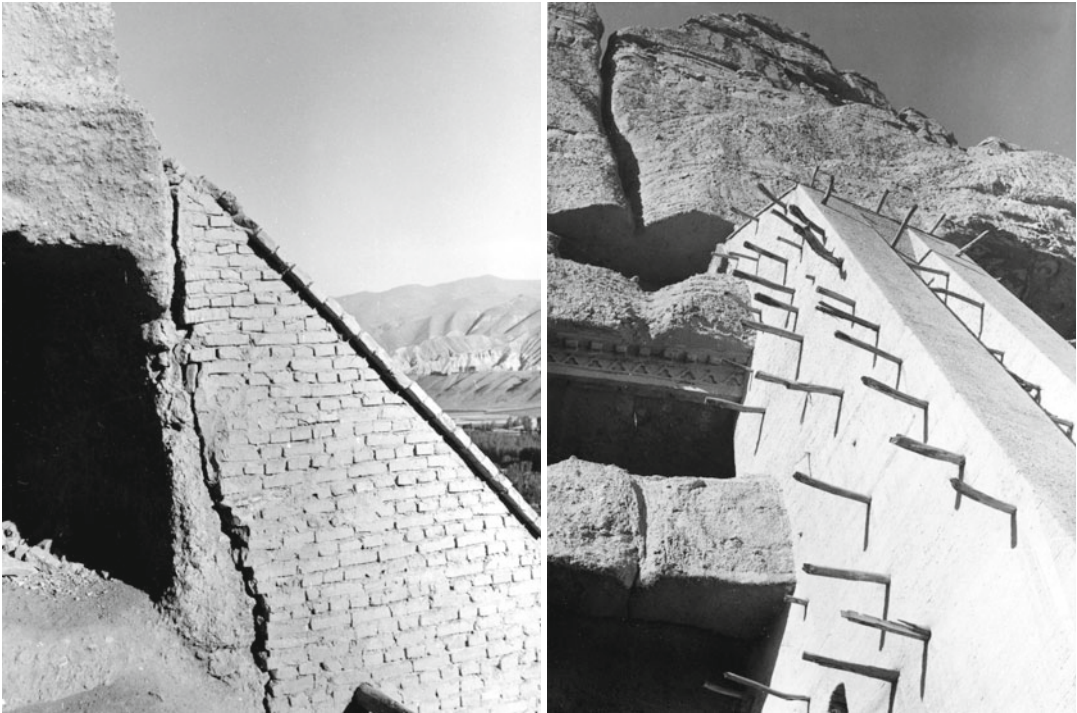
Fig. 9.1 The top of the buttress constructed by the French Archaeological mission (Photos A. Bruno, Sept. 1960)

The construction was performed in brick, and the result, shown in Fig. 9.1, demonstrates the typical intervention of that period: to solve the problem with limited attention paid to the environmental and aesthetic impact of construction. On the other hand, this side of the niche did not suffer too much as a consequence of the explosion of March 2001, confirming the efficacy of this intervention.

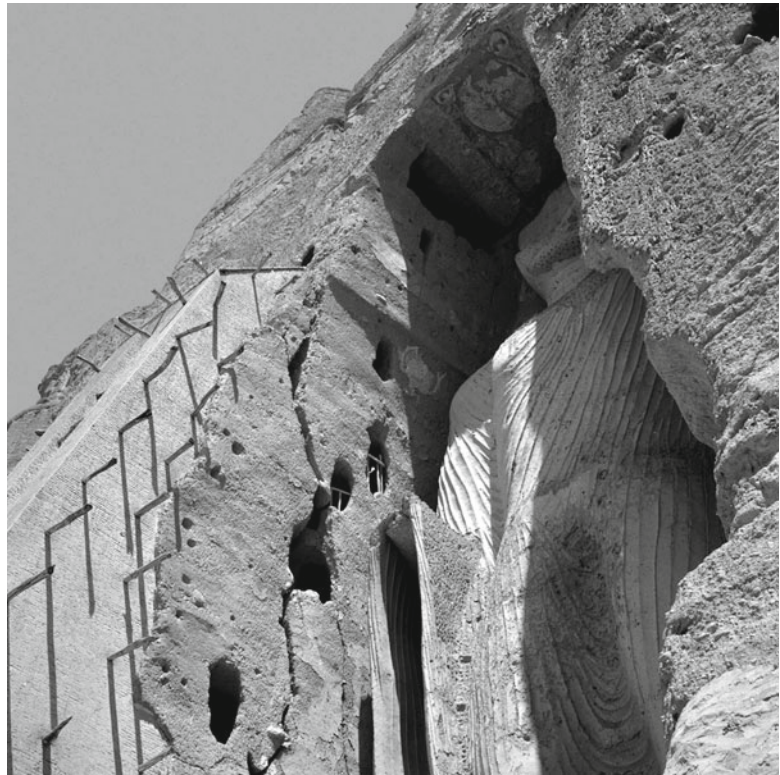
Fig. 9.2 The buttress and the most external part of the cliff showing the large crack and the detached block, which needs support. It is not clear whether the crack was moving at the time of the picture or not. Nevertheless, the crack was detected as slightly open in the 2002 survey by the authors (Photo A. Bruno, Sept. 1960)

Finally, to overcome at least the heavy impact of the buttress, the Indian Archaeological Survey reshaped the structure and covered it with cement and natural earth, producing a camouflage not easy to recognize at first sight (Figs. 9.2 and 9.3).

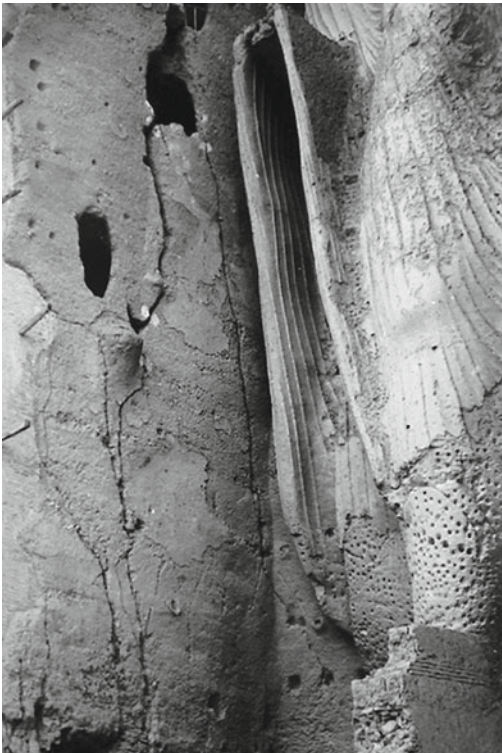
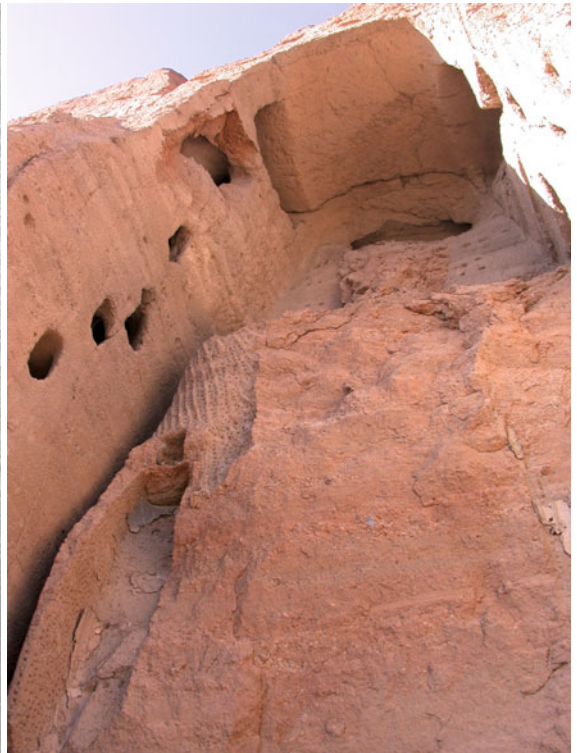
Fig. 9.5 Pattern of discontinuities in the Eastern Giant Buddha niche both before intervention of the Indian Archaeological Survey and currently (Courtesy Michel Jansen)

nities, poses some questions about the possible negative impact of the explosion (Fig. 9.5).
