Claudio Margottini *Editor*

After the Destruction of Giant Buddha Statues in Bamiyan (Afghanistan) in 2001

A UNESCO's Emergency Activity
for the Recovering and Rehabilitation
of Cliff and Niches

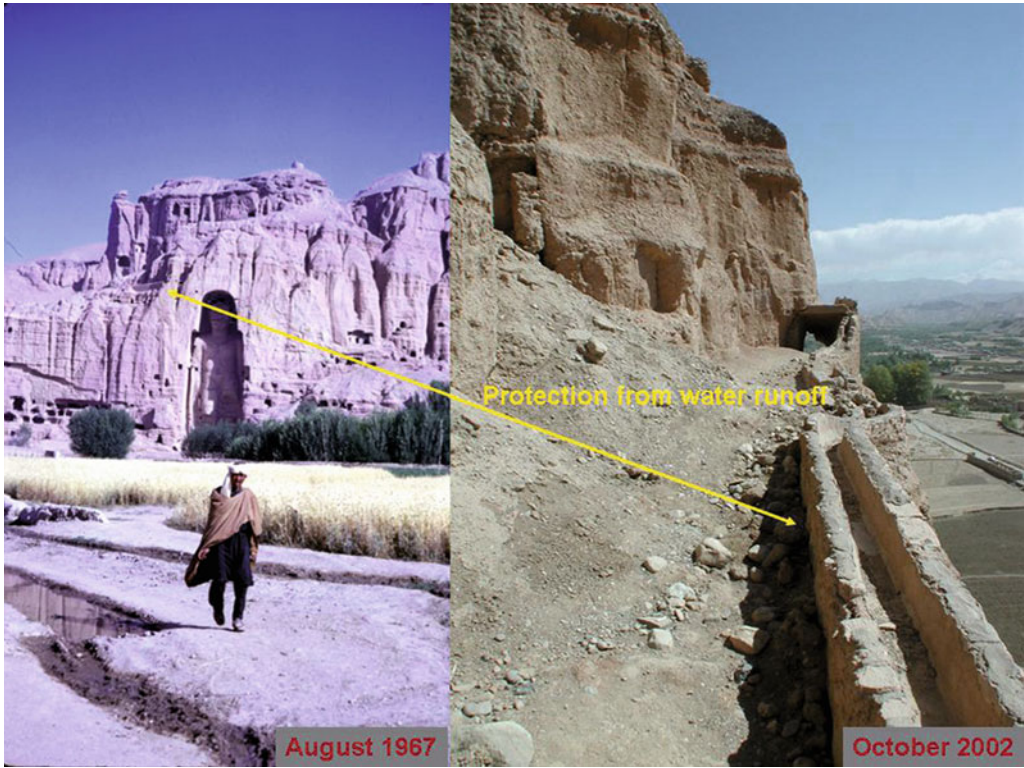
Fig. 9.7 Protection from water runoff and infiltration

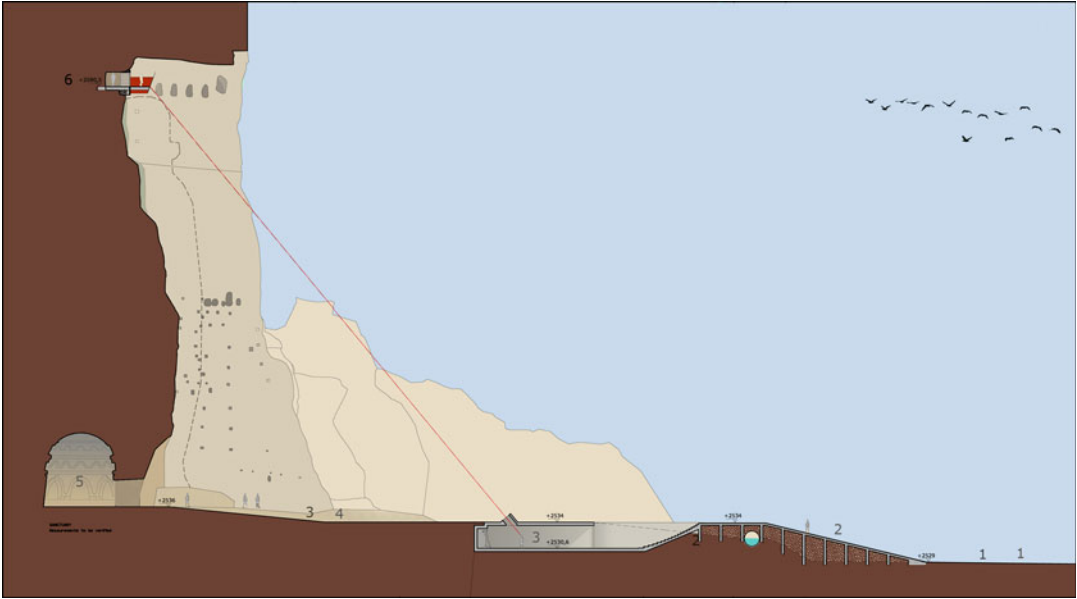
Fig. 9.14 General section of the project of valorisation of the niche in the Western Giant Buddha and requalification of the surrounding area, 2010. Project by Andrea Bruno: Legend for plans and sections: (1) “Great

esplanade” - area in front of the niche. (2) Ramp. (3) Entrance to the new sanctuary. (4) Access to the tunnels. (5) Sanctuaries carved into the rock. (6) Observatory

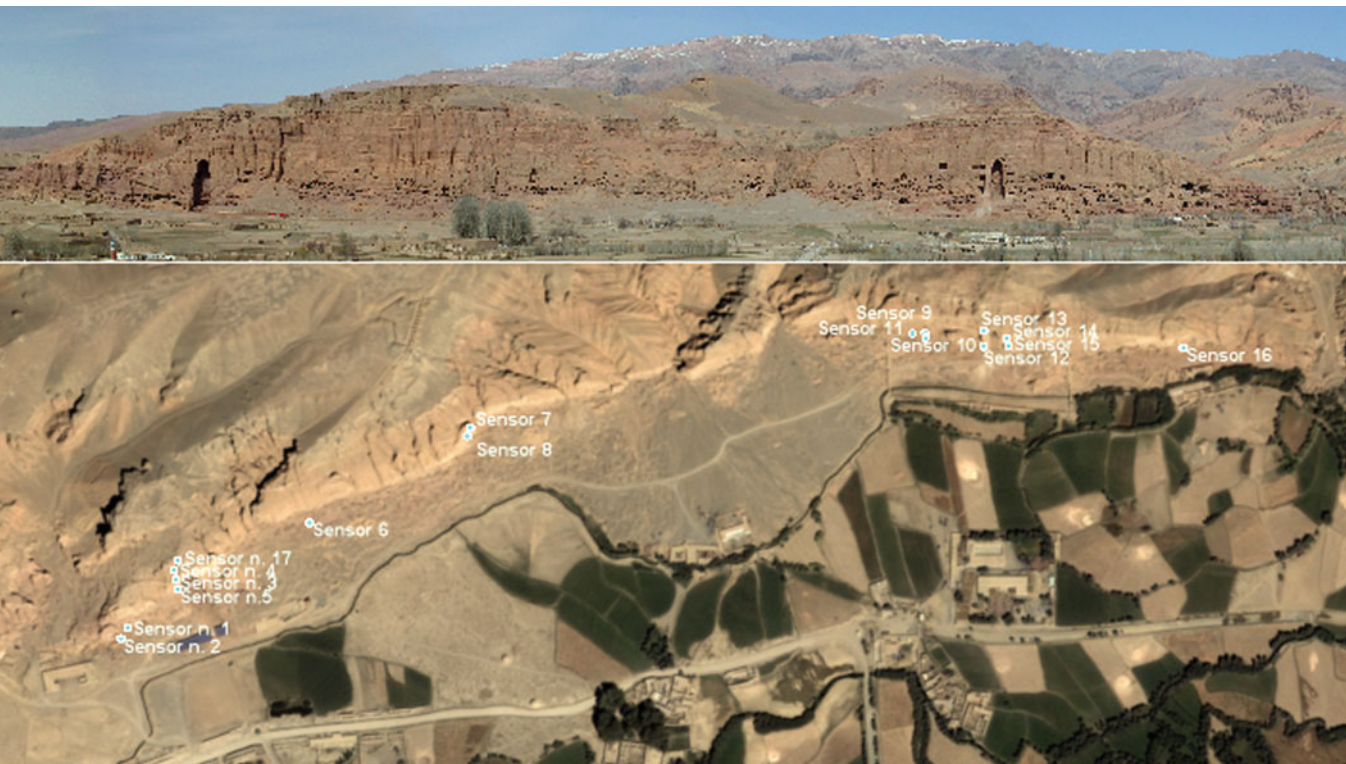
Fig. 10.5 The manual monitoring network for crack gauge measurement

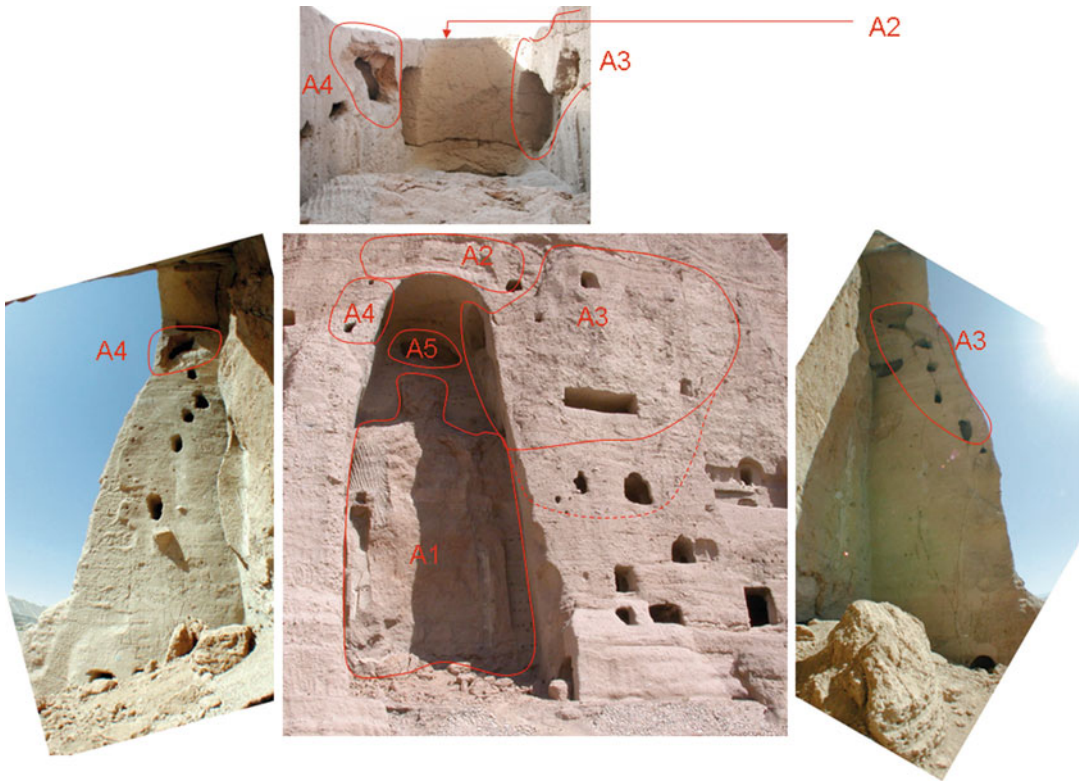
Fig. 11.1 Identification of the most critical instability areas in the Eastern Giant Buddha niche. The A3 block in the Eastern Giant Buddha niche exhibits the most acute instability

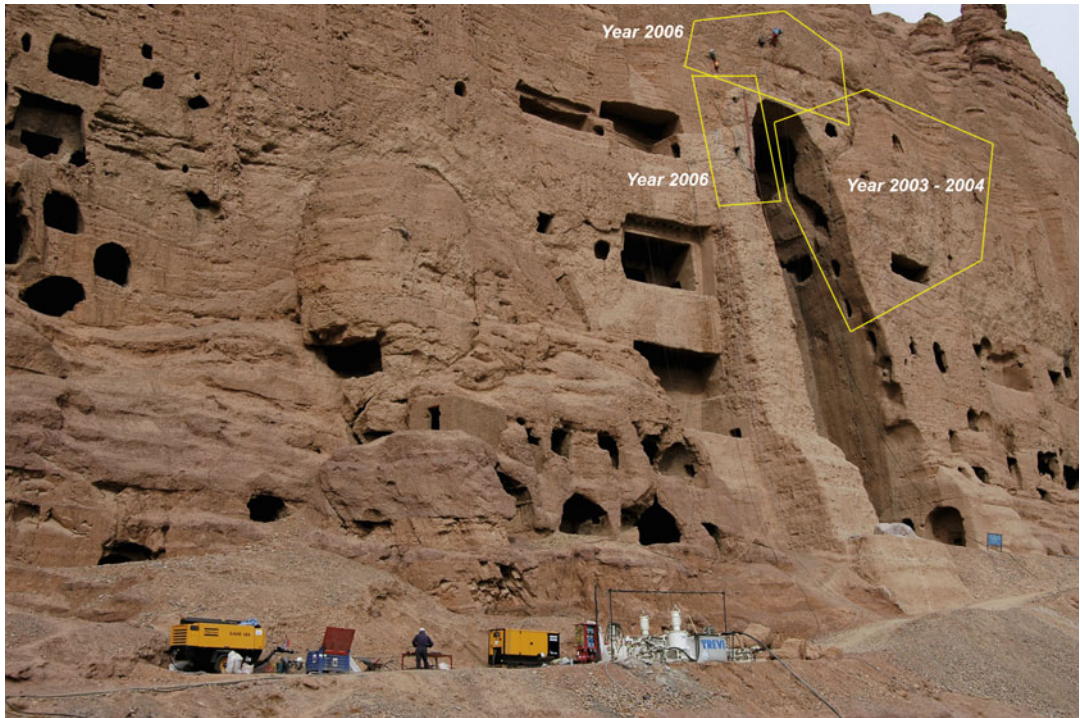
Fig. 11.4 Localization of the three areas of intervention in the Eastern Giant Buddha niche

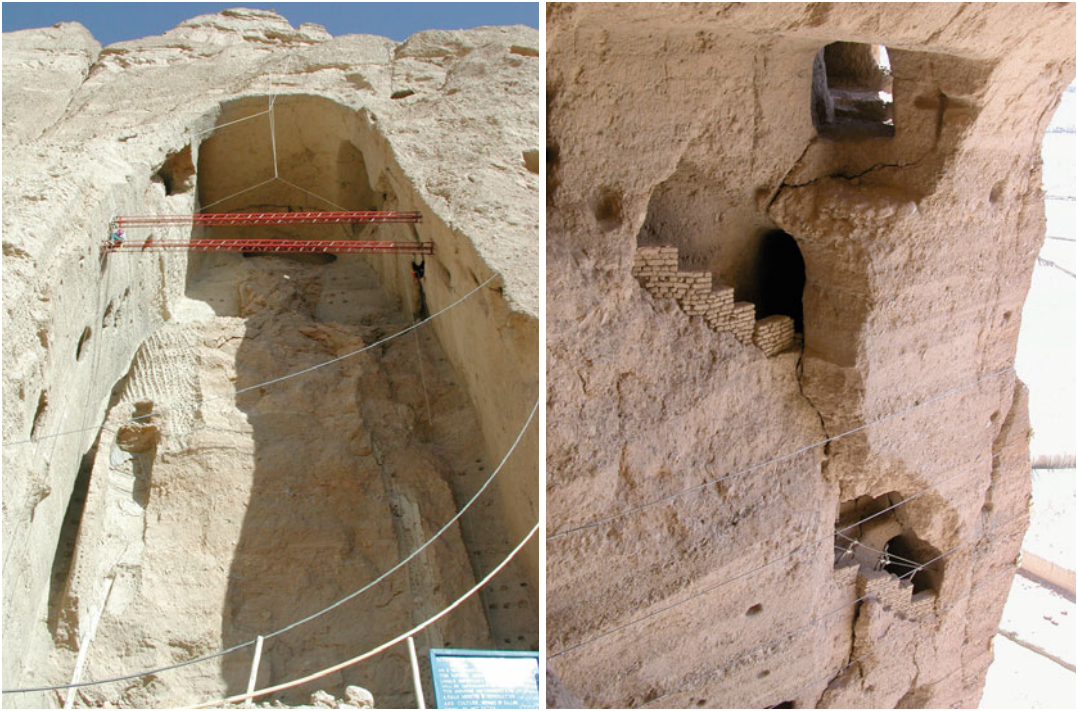
Fig. 11.6 The temporary beams (*left*) and steel cables (*right*) for the temporary support of upper eastern part of Eastern Giant Buddha niche

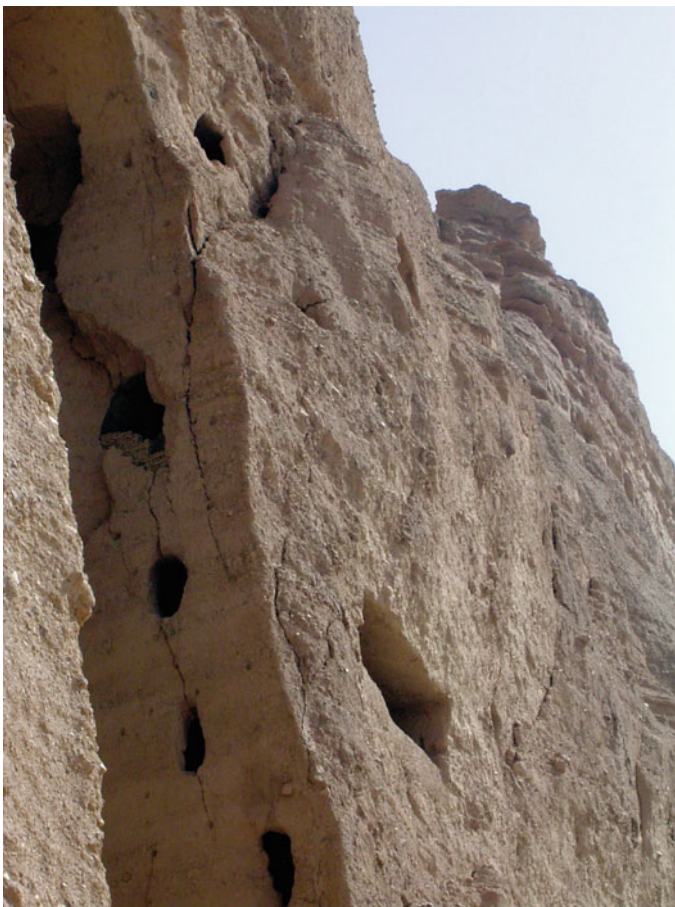
Fig. 11.7 The external block prone to collapse, (left) the geometrical distribution of load and the assumption for calculation (right), moment calculation of anchors and the related factor of safety (next page left) and an evaluation

test about the possibility to generate toppling according to the static loads and the uniaxial compressive strength of material (next page right)

The consolidation was designed by means of passive anchors and nails, correctly grouted. Long anchors are spaced about 4 m apart because they exhibit, in this configuration, a safety factor equal to two, without considering the contribution of nails. Nails will not follow a precise configuration because they have to be designed on site to strengthen the shallower part of the block. Even anchors may have some nonhomogeneous distribution, a function of internal cavities. Details on calculation are reported in Fig. 11.7. In these we have:

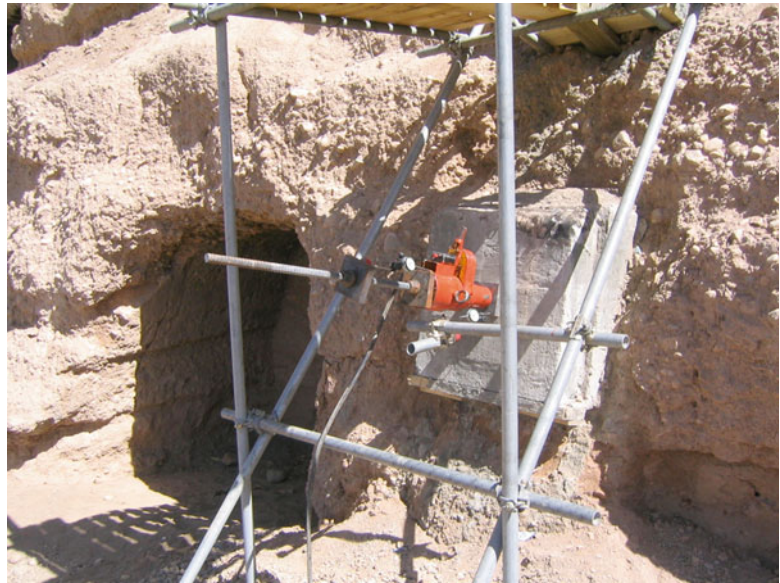
Fig. 11.8 The anchor suitability test site

The correctness of the adopted solution and also of the bounding capacity of grouting mortar is given from the anchor suitability tests (Fig. 11.8), performed in 2004 to understand the

bonding capacity of anchors in both siltstone and conglomerate. The design strength of passive anchors was assumed as 20 t, for a bounded length after the major discontinuity at least of 5 m (about 4 t per linear meter). The anchor suitability test was performed for 1 m length to 40 t, close to the yield capacity of steel. Up to this value no remarkable permanent elongation was detected, to demonstrate the correct bounding effect between siltstone and conglomerate and the anchors (Fig. 11.9). These data confirm, once more, the appropriate choice of superplasticizer as an additive suitable to avoid any slaking phenomena in the siltstone.

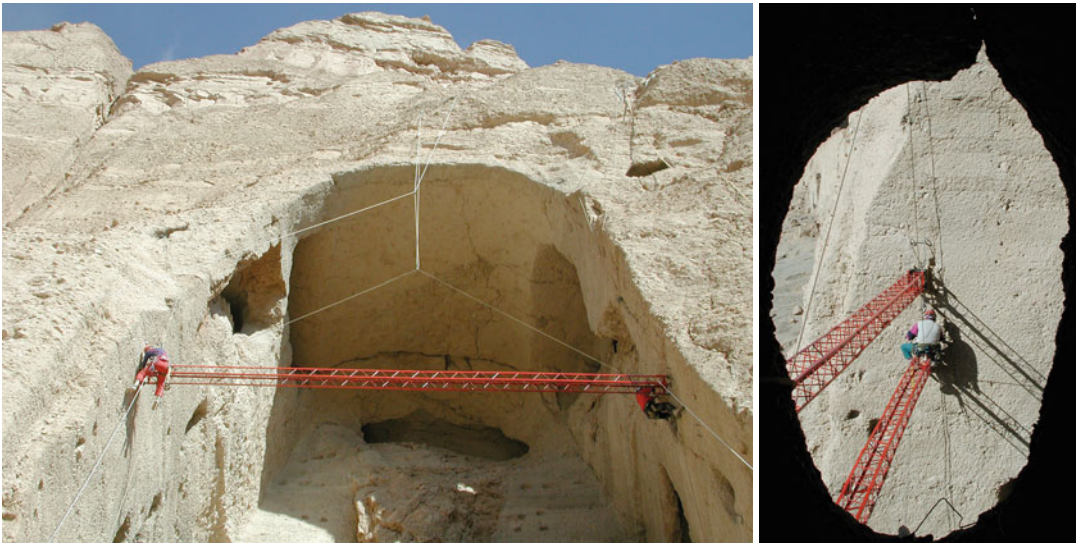
Fig. 11.10 Installation of temporary struts. Note that during the installation, the strut is fixed on top of the cliff in the safe zone

Climbers, also supported by ground staff, operated directly on the surface, hanging from the top of the cliff, in a safe area, moving from top down and then in safe conditions with respect to any potential rock fall (Fig. 11.10). Also a major difficulty was the calibration of drillings with respect to the existing cavities. In fact, a large number of caves (around 800) and tunnels are located on the cliff, constituting a unique example of rupestrian settlement. The selection of drilling then required a detailed investigation into their orientation and inclination to avoid drilling and grouting into the archaeological caves. As mentioned previously, great attention was paid to the methodology for consolidation. Short- (16 mm) and medium- (20 mm) length passive anchors (stainless steel) have been used, with rotary drilling machines with diamond heads to avoid any possible vibration. Use of cooling fluid faced the occurrence of slaking-prone siltstone in the presence of water: because of this, the usage of water was limited when drilling the conglomerate and a mix of compressed air and water was adopted when discontinuities were detected and when a possible level of siltstone was encountered. Pregouted long passive anchors, used only in

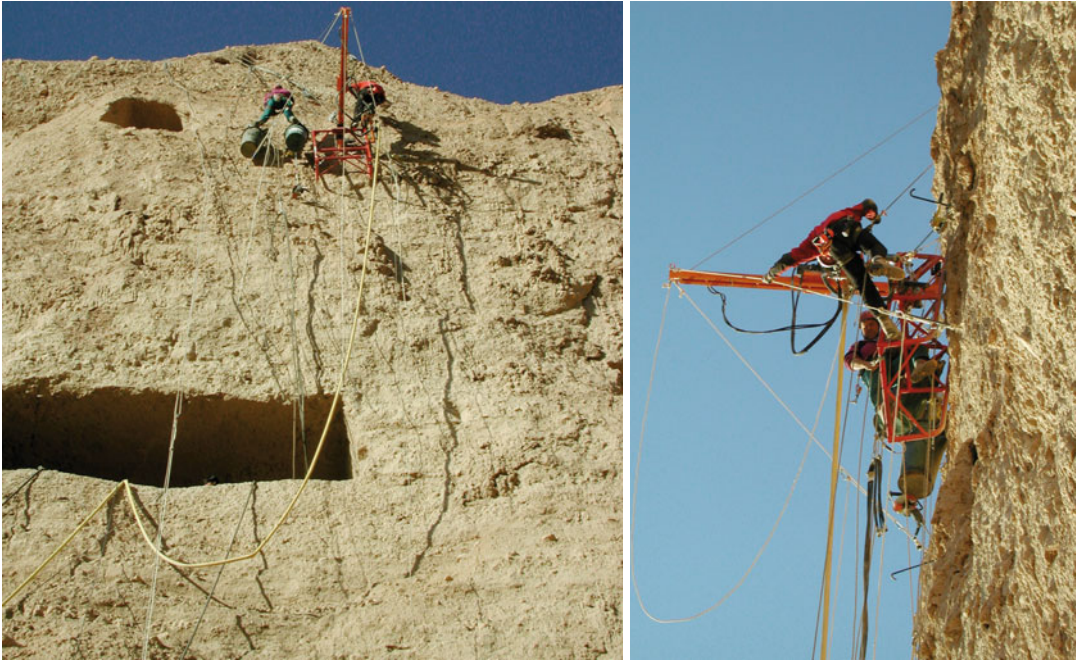
Fig. 11.11 Final consolidation with the use of professional climbers and large rotary machine

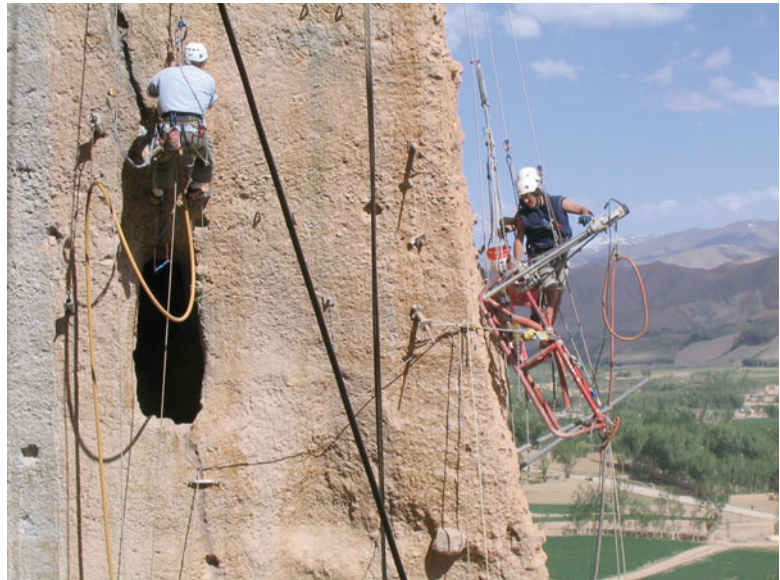
Fig. 11.13 Execution of nails on the roof of the niche

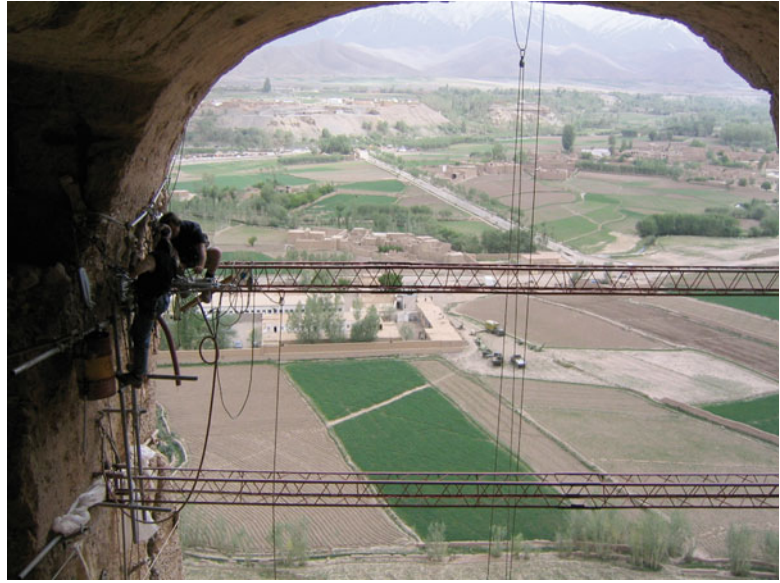
Fig. 11.14 Drilling for nails at the corner of niche

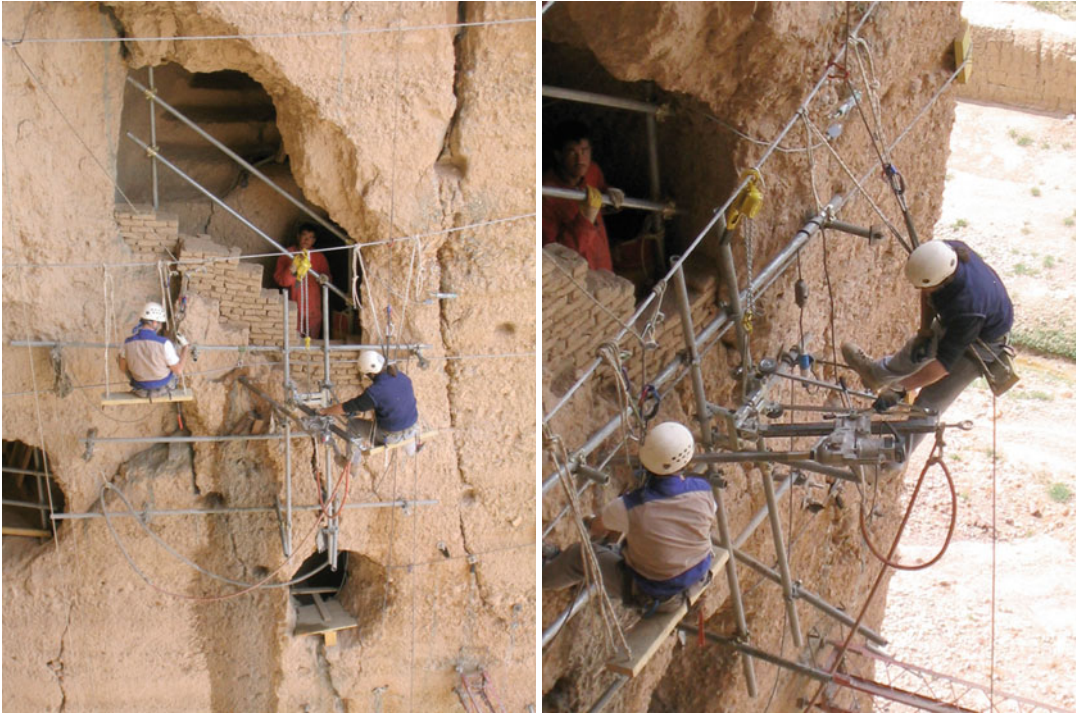
Fig. 11.15 Execution of nails with rotary machine and diamond head, at the inner side of the niche

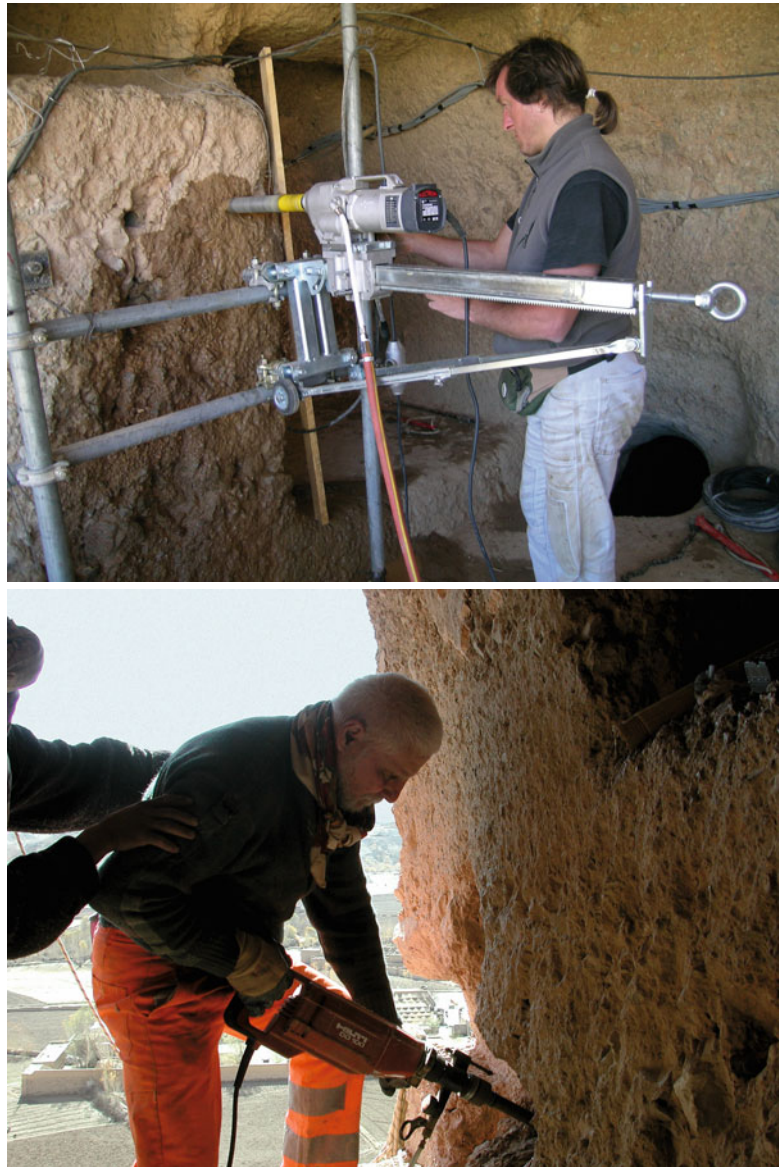
Fig. 11.16 Detail of execution of nails from inside the caves by means of small and very small rotary machines and diamond heads

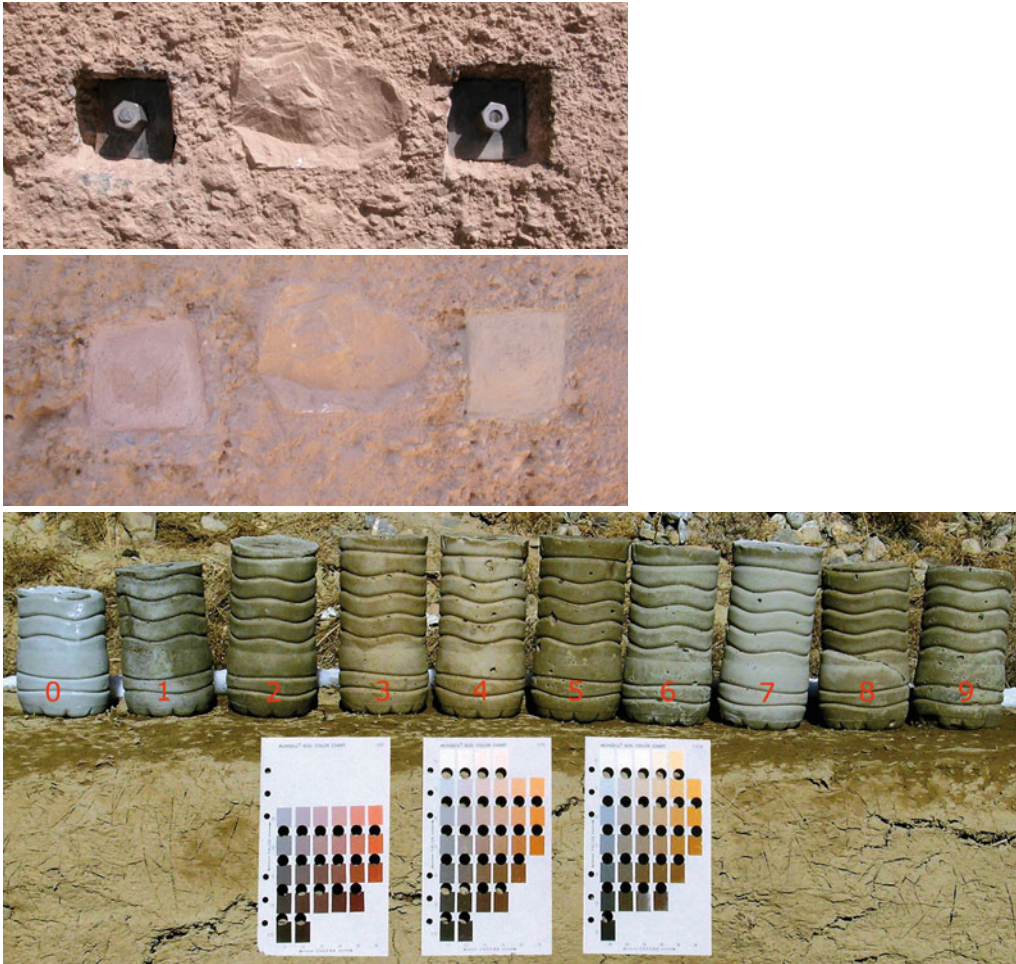
Fig. 11.17 Covering of anchor heads with proper mortar (test site)

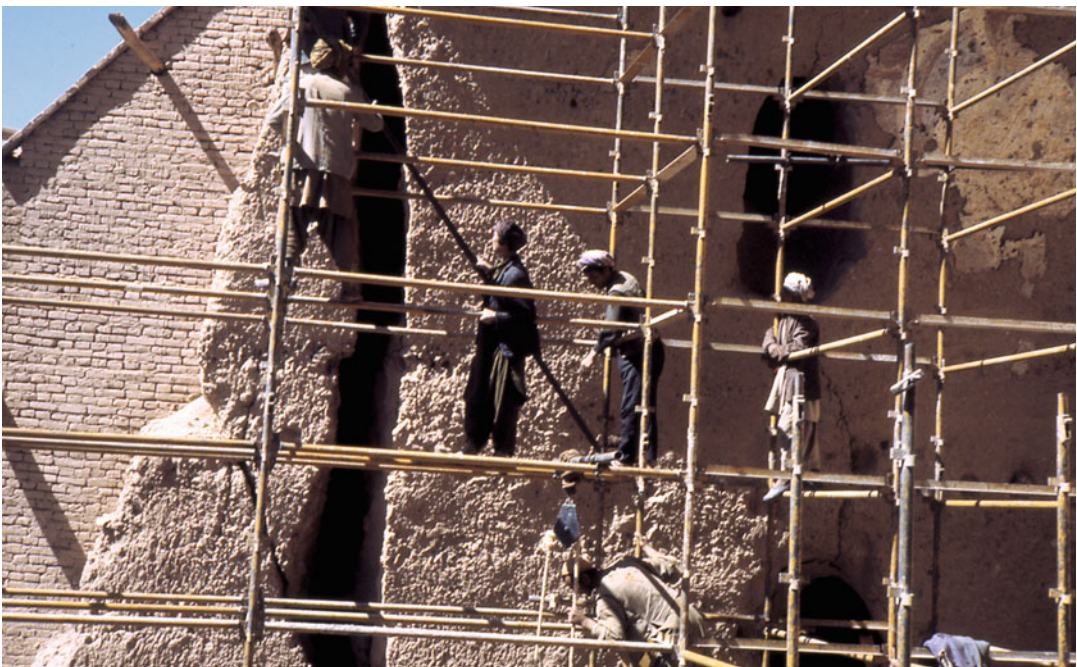
Fig. 11.19 Consolidation work from the Archaeological Survey of India in 1969 (Courtesy of Prof. Maeda)

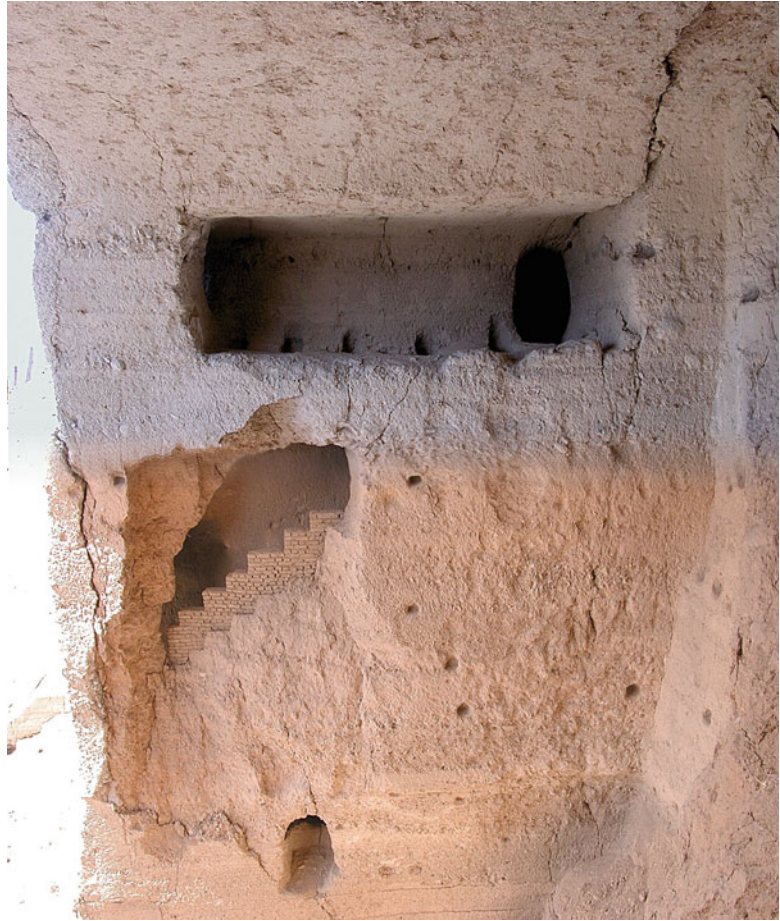
Fig. 11.20 The most unstable element (pillar) in the western side of Eastern Giant Buddha niche

caulking, the main fissures were filled in using 0.96 m³ of low water-release cement grout, with some 1,200 kg of cement. Grout composition utilized was, as usual, $C:W=0.5$ with superplasticizer.

- (b) For the drilling operations, a diamond rotary system, 50 mm dia., has been adopted with the aim of limiting as much as possible interferences, produced by vibratory effects, to the limited stability of the structure in this area. A total of 12 stainless steel passive anchors, dia 20.0 mm, have been installed, with a total drilled length for these 12 anchors of 52.4 m. In detail, nine of these nails connect the pillar internally, in both directions parallel to the face and perpendicular to it

- to create a robust net; two short passive nails (located at below and above the critical pillar, with a depth less than the back side plane where a large crack has been detected after the removal of fragments in the lower caves behind the feet of the statue. One passive anchor parallel to the surface aimed at stabilizing the upper gallery where a large fissure is present;
- (c) Low water-release grouting in the boreholes, maintaining the composition of water and cement successfully adopted in the eastern side, which includes: $W/C=1/2.0$ + superplasticizer. Approx. 2.0 m³ were grouted for the nails installation with 2,400 kg of cement.
4. Minimization of impact follows the same criteria established for the eastern side.

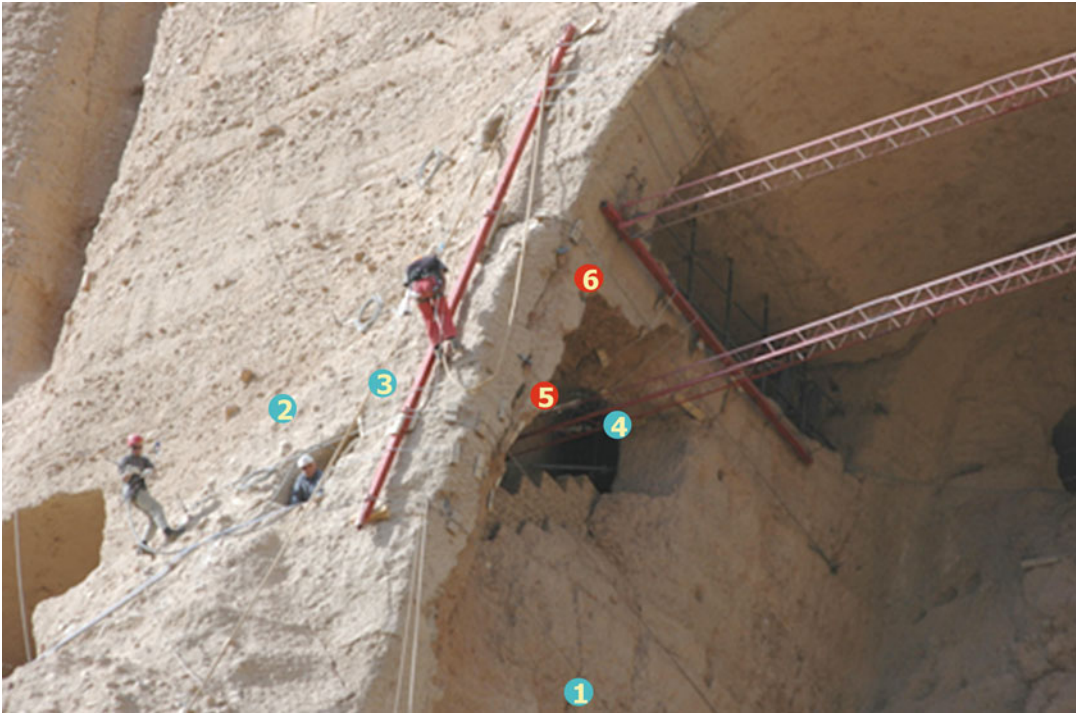
Fig. 11.21 The location of potentiometric crack gauges for discontinuity monitoring and alarm; external sensors are in green and red are internal to the cave

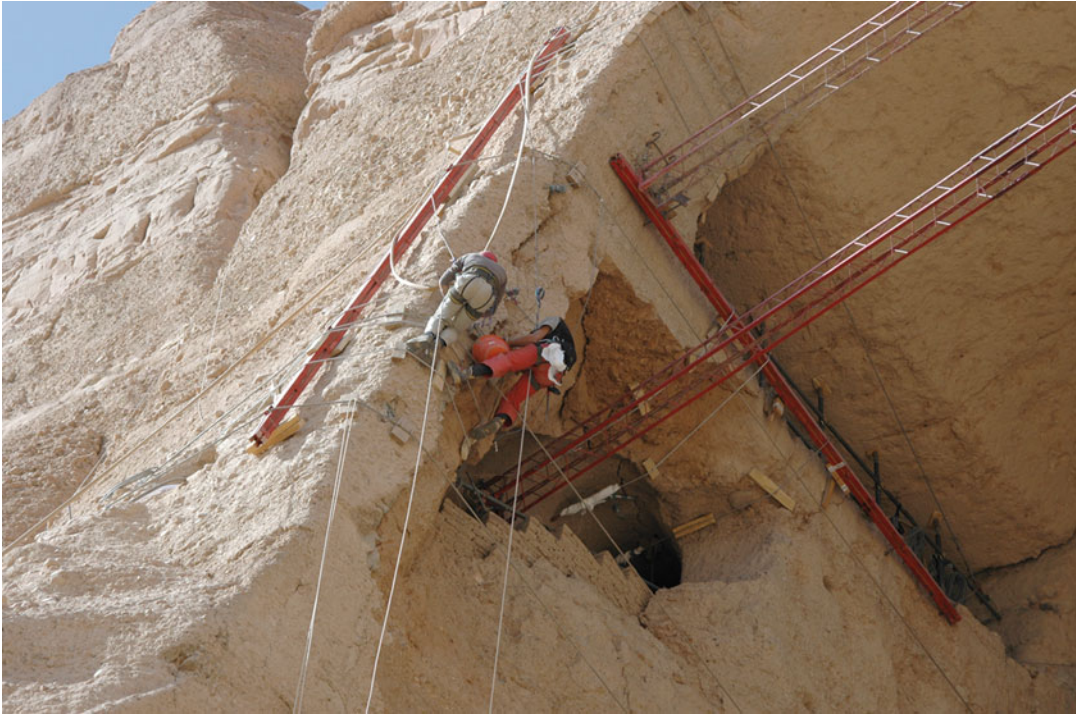
Fig. 11.22 The temporary support necessary for secure execution of the work in the western wall: two long iron beams replaced in the upper part of the niche, the short iron/wood struts for local support and the steel cables

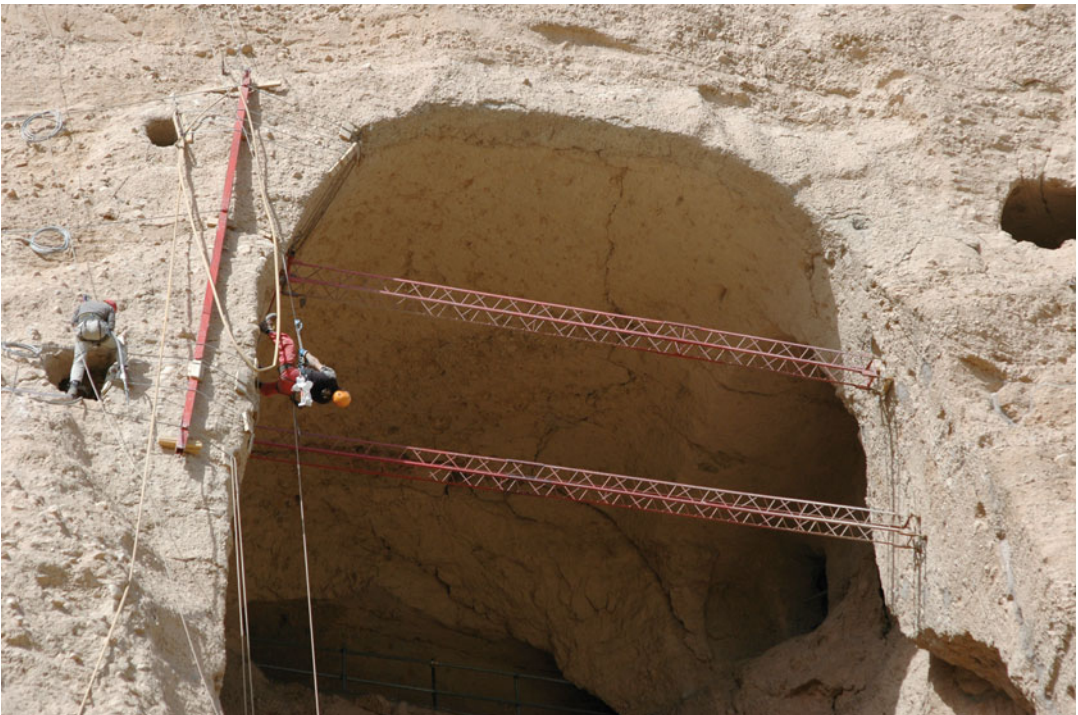
Fig. 11.24 Temporary protection on the west side of the niche

generating additional pore pressure. Execution of the work is indicated in Figs. 11.24, 11.25, 11.26, 11.27, and 11.28.

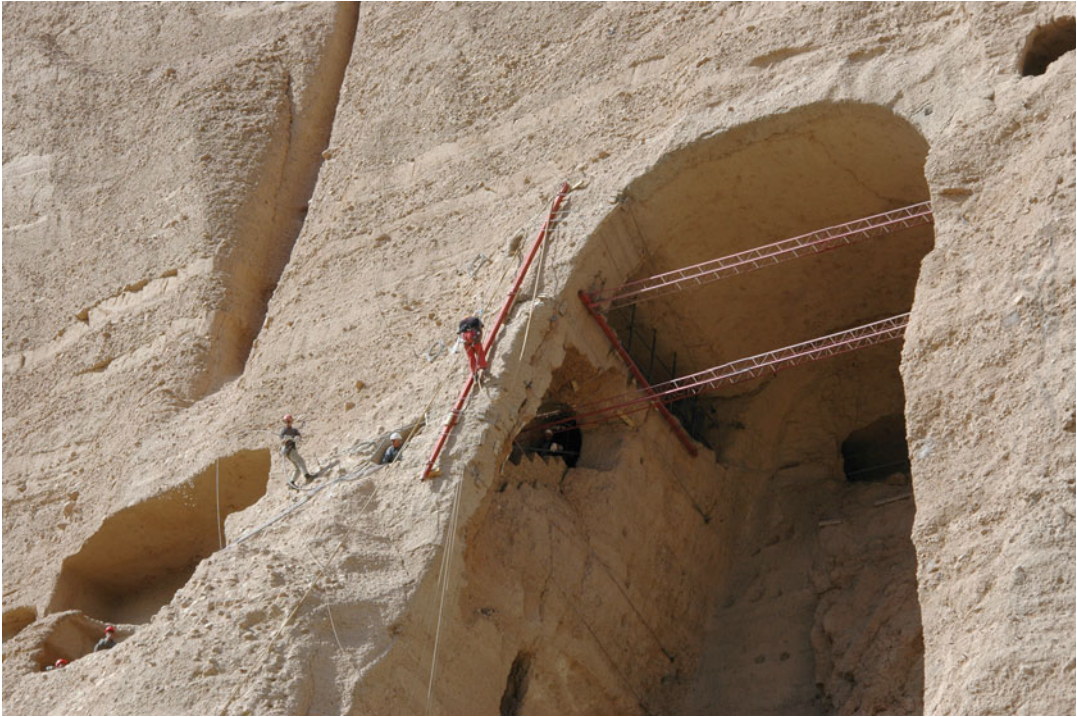
Fig. 11.25 Climbers at work

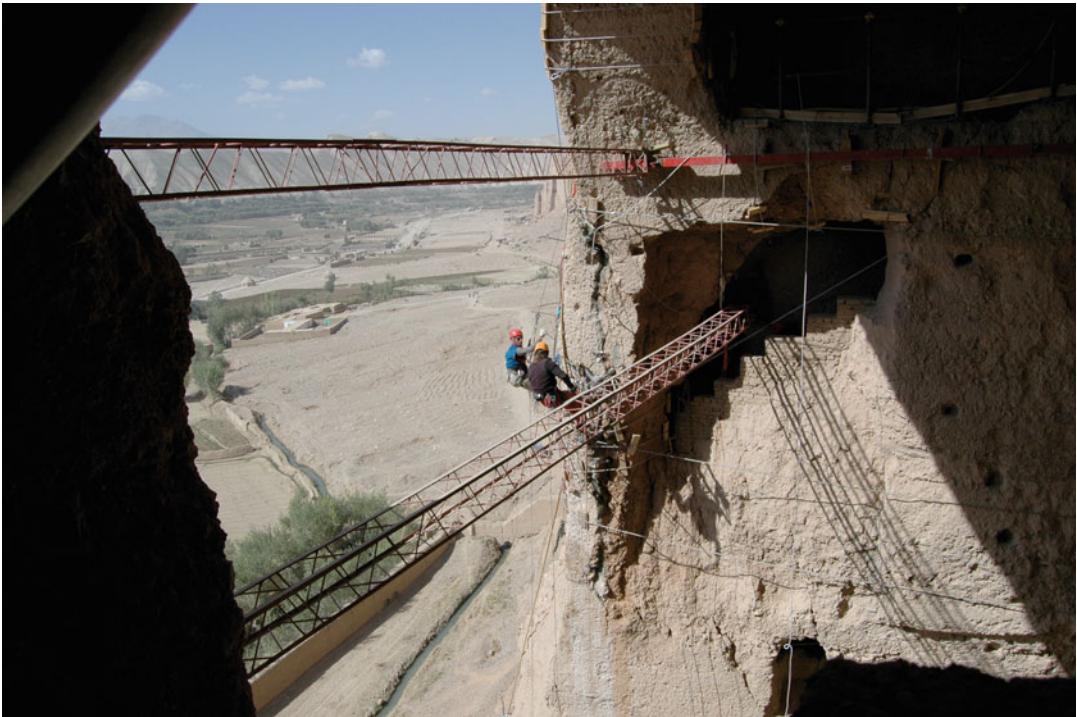
Fig. 11.26 Installation of steel cables as temporary protection

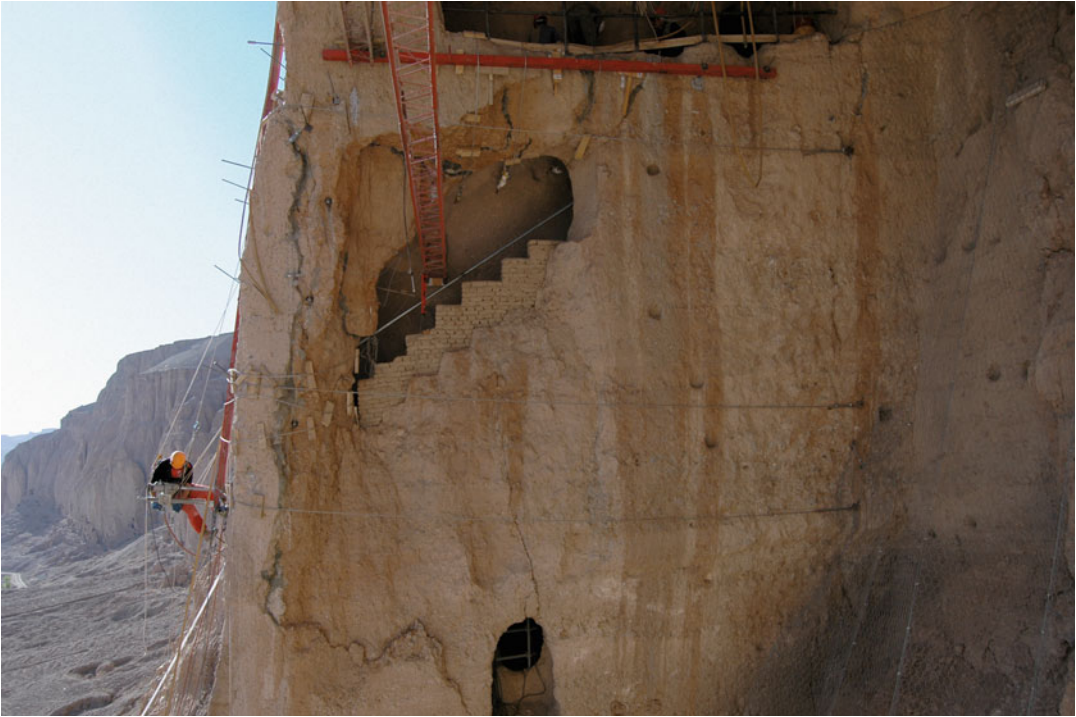
Fig. 11.27 Drilling for nails on the west side, with intermediate power machine and diamond head

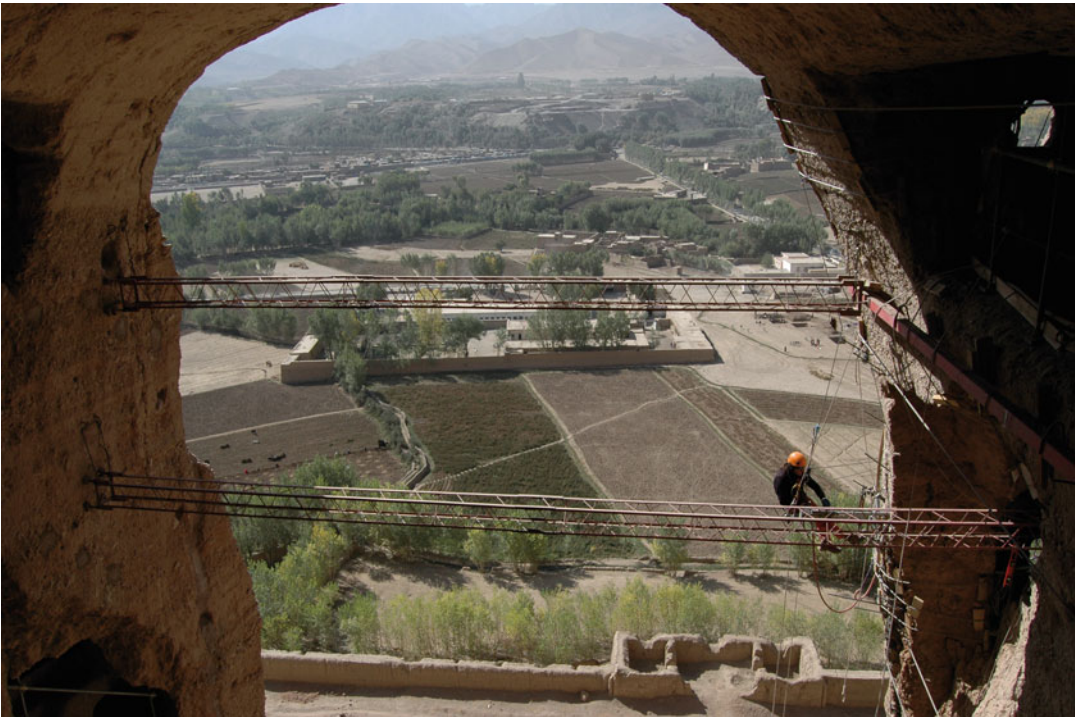
Fig. 11.28 Drilling for nails

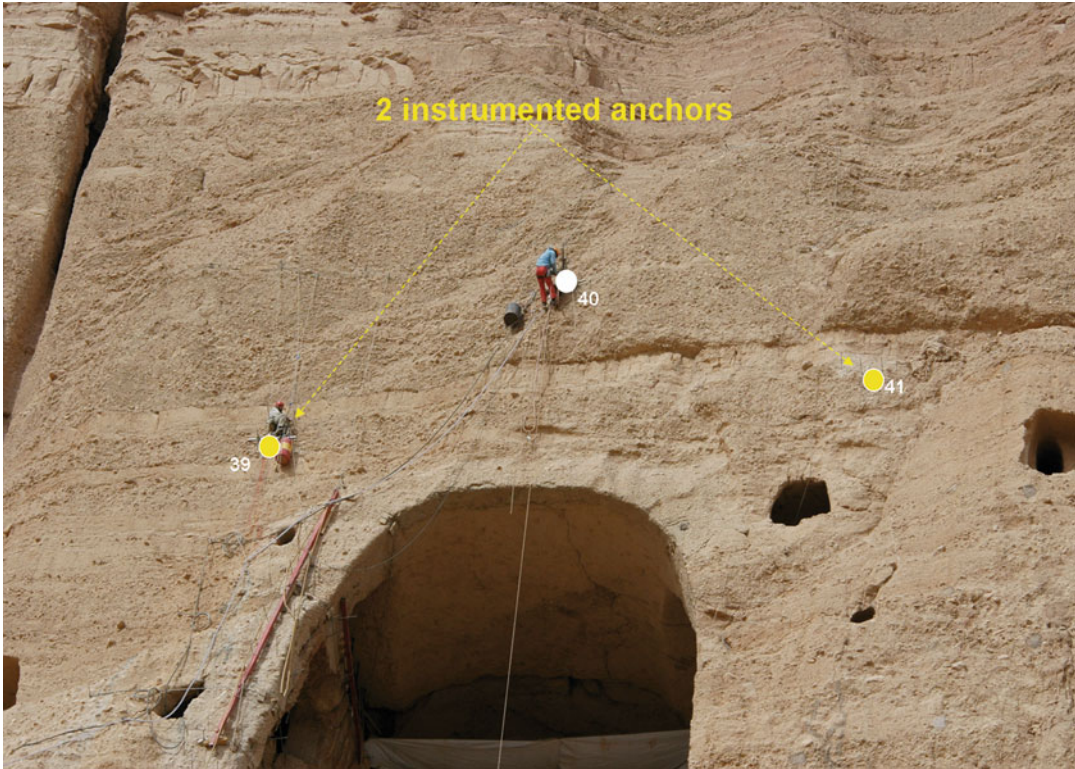
Fig. 11.29 Position of anchors on the top of niche. The *yellow* ones are monitored with 10 strain gauges

The position of these long anchors is reported in Fig. 11.29.

Five hundred and forty liters of cement mix were utilized for the grouting of the anchors (600 kg of cement). Open vertical fissures, reaching downward in the niche, were intercepted in the three boreholes at depths up to approximately 8 m (anchor no 39) and 9 m (anchor 41).

Anchors no. 39 and 41 were instrumented with the installation of a series of five spot-weldable strain gauges (Fig. 11.30) in each anchor. The characteristics of these instruments are described below. The cables connecting the sensors have been conveyed into small grooves to suitable steel boxes located in the niche, where readings can be taken utilizing the portable data logger with LCD display (Table 11.2; Figs. 11.31 and 11.32).

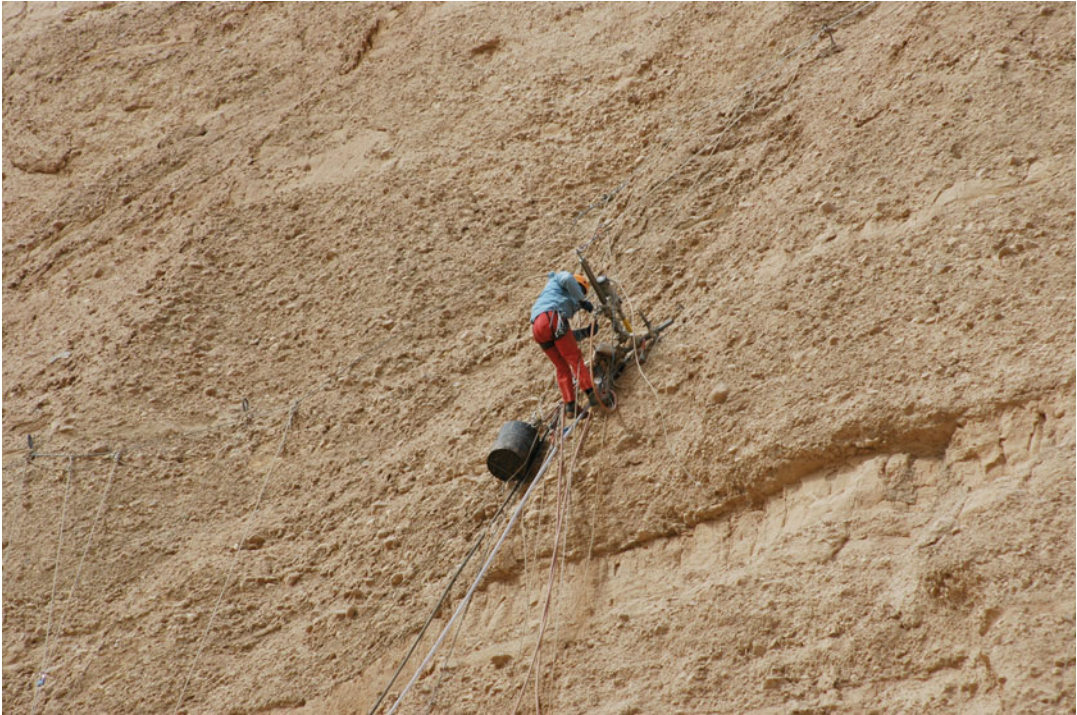
Fig. 11.31 Drilling for the installation of long anchors on top of niche

In the upper part of the niche it was decided to install three permanent stainless steel passive anchors, 12.0 m long, subhorizontally, with the following purposes:

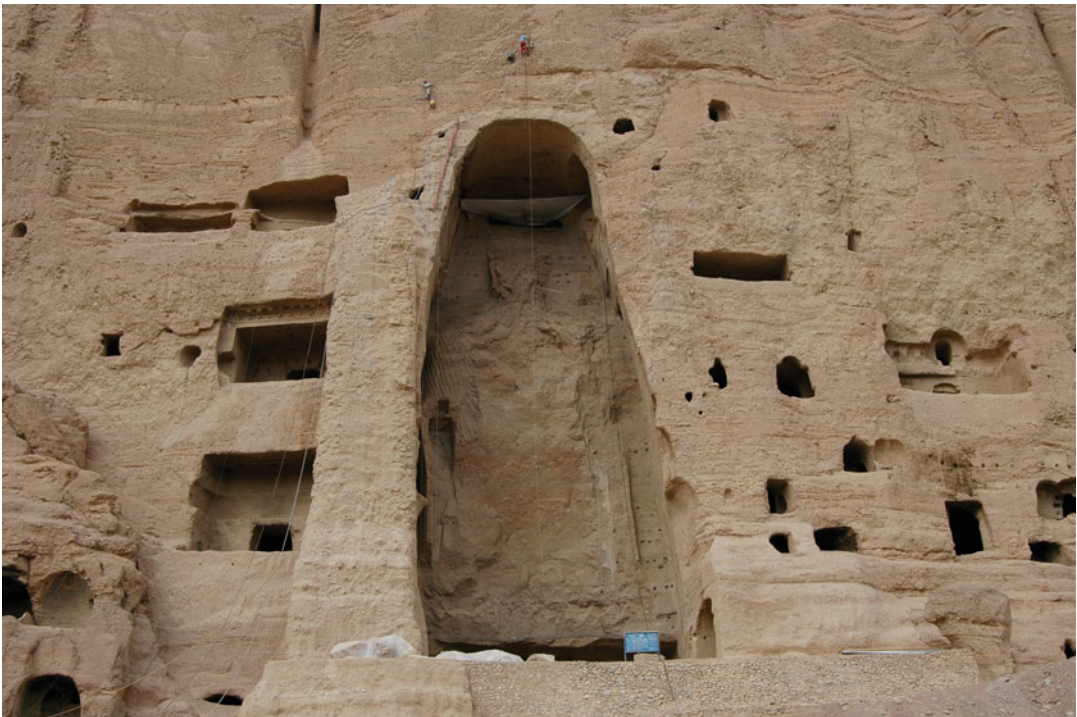
Fig. 11.32 View during execution of the work
