Claudio Margottini *Editor*

After the Destruction of Giant Buddha Statues in Bamiyan (Afghanistan) in 2001

A UNESCO's Emergency Activity
for the Recovering and Rehabilitation
of Cliff and Niches

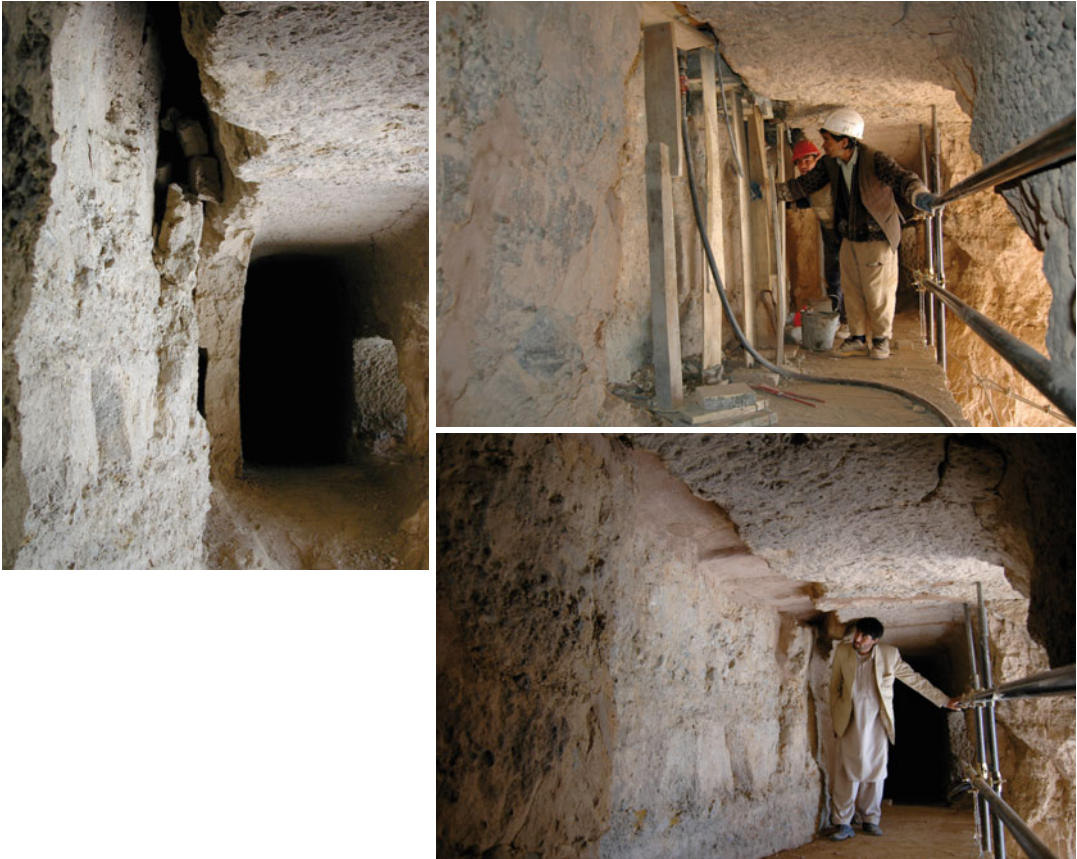
Fig. 11.39 (*The three figures*) The large crack in the corridor on the back side of the niche before, during, and after the grouting

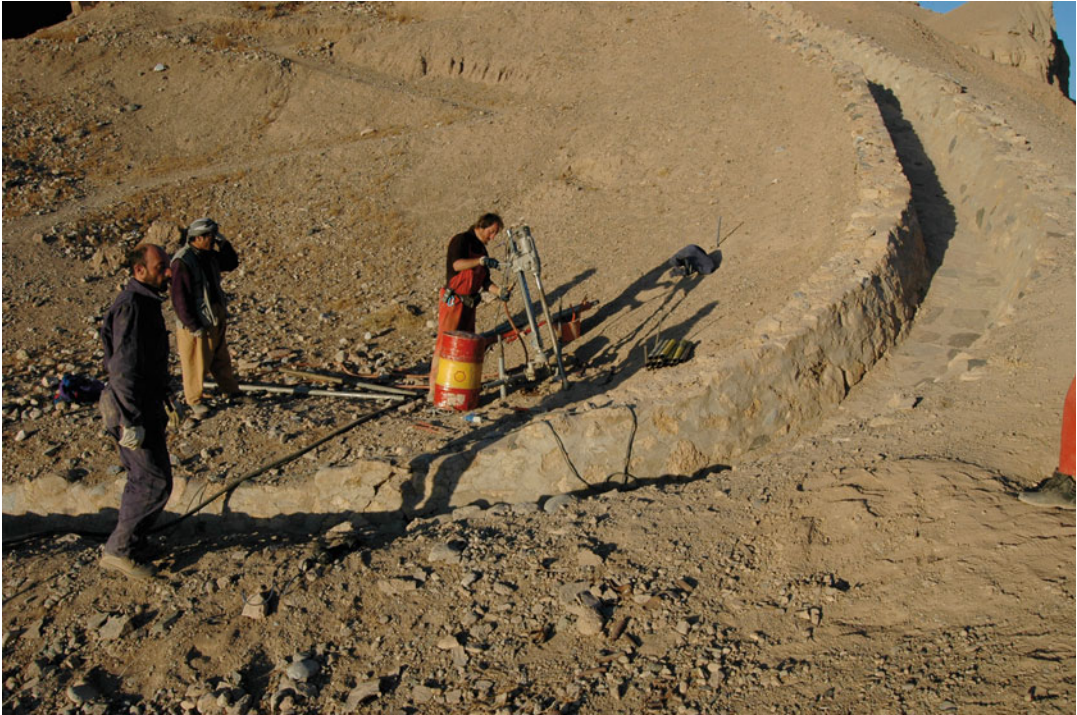
Fig. 11.40 Detail of the grouting from the top of cliff

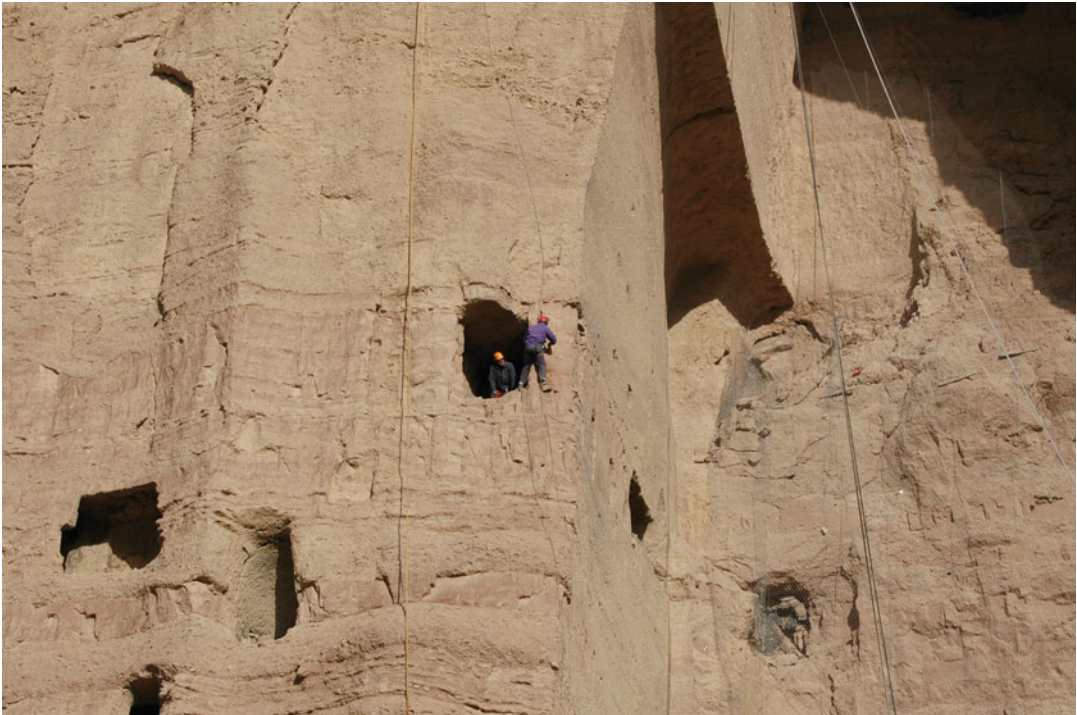
Fig. 11.41 Preparation for consolidating the potential small rock fall at middle level of the niche

Other minor interventions were required in two small sites, as reported in Figs. 11.41, 11.42, 11.43, and 11.44. The possible risk of collapse, even for small pieces of rock, was completely avoided.

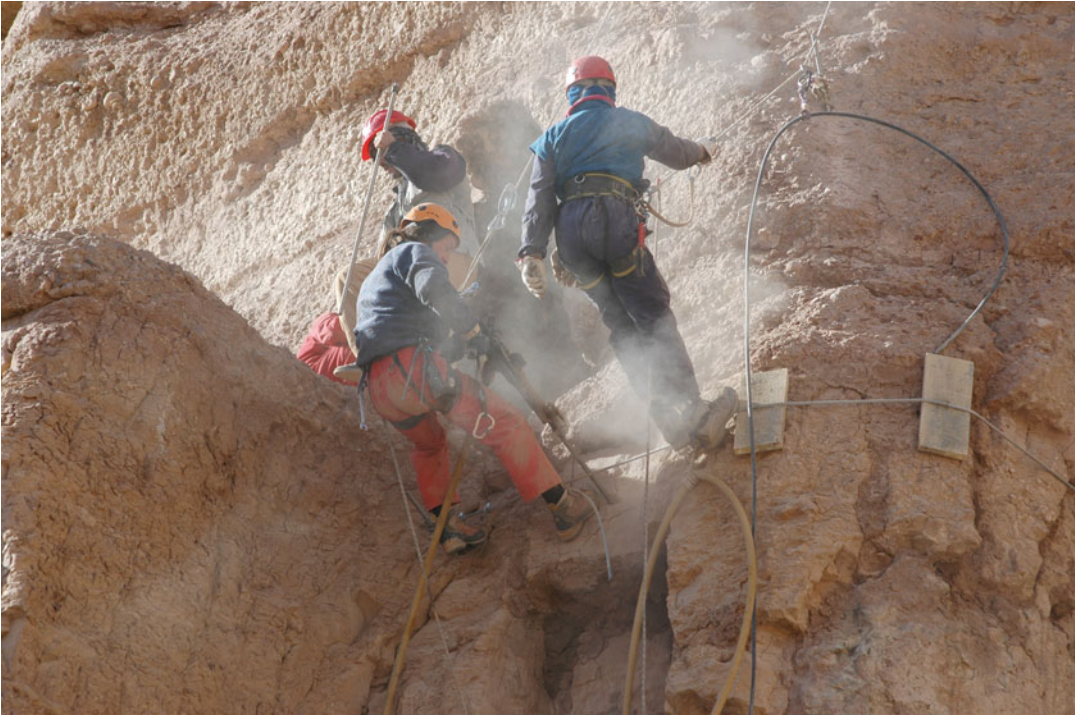
Fig. 11.42 Drilling in the lower part of the niche

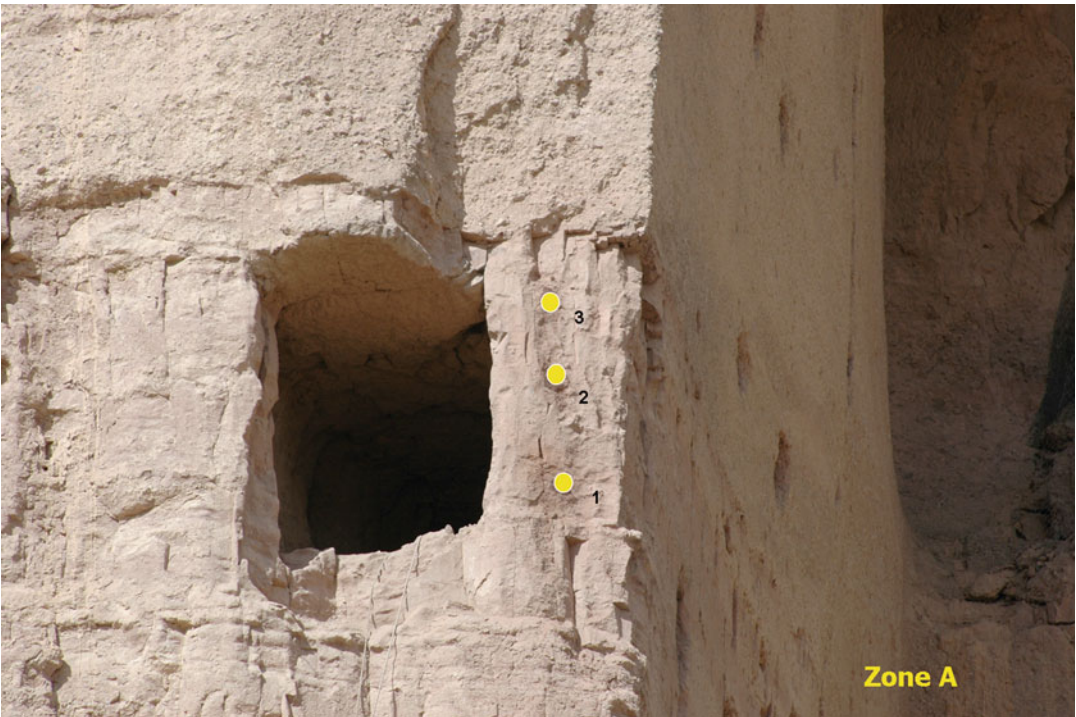
Fig. 11.43 Position of nails in the unstable small rock masses at middle level of the niche

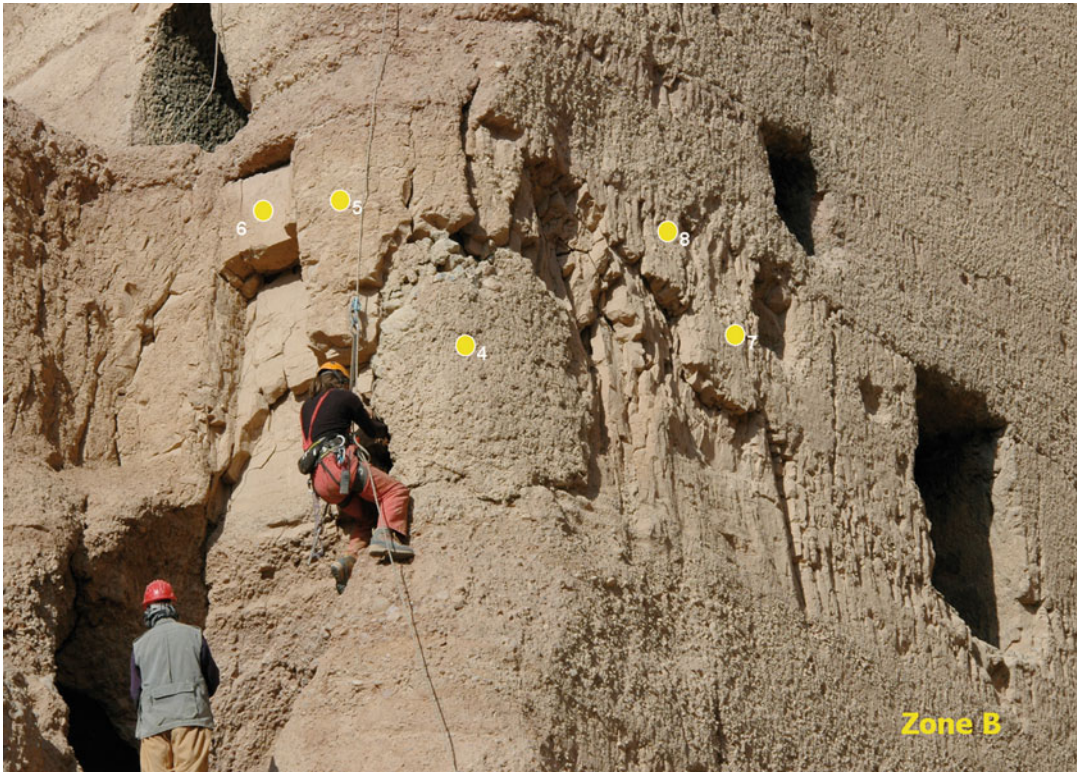
Fig. 11.44 Position of nails in the lower part of the niche

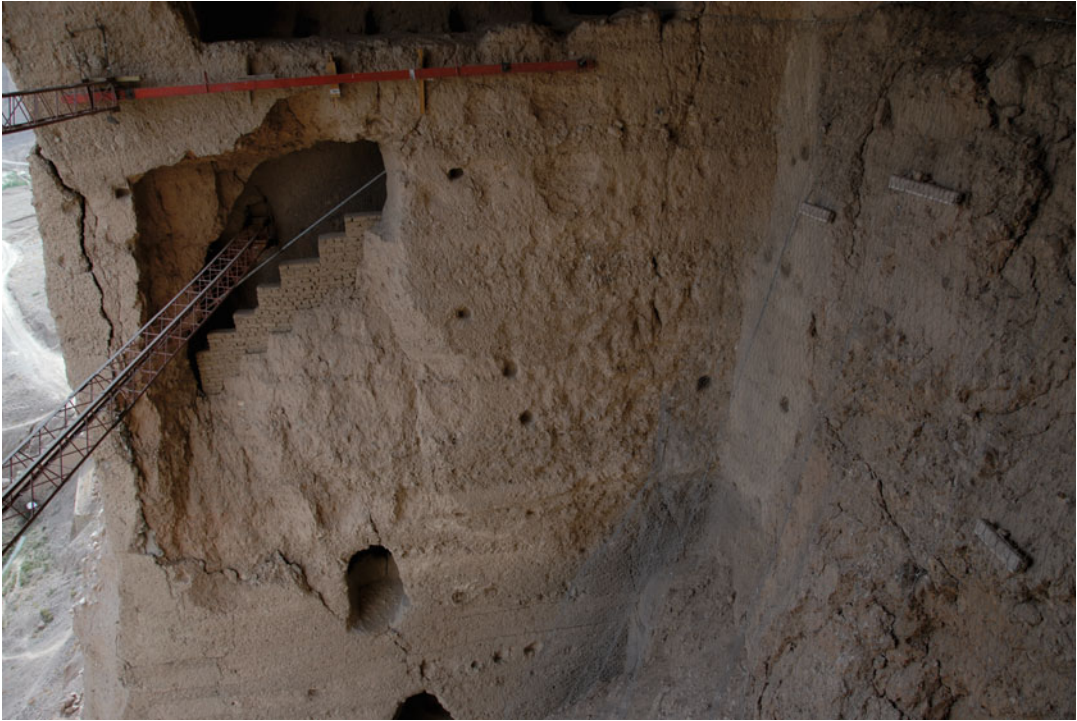
Fig. 12.3 The metallic net protecting from the detachment of small rocks from the shear band of destroyed statue. The photo also shows the wooden spacers, covered

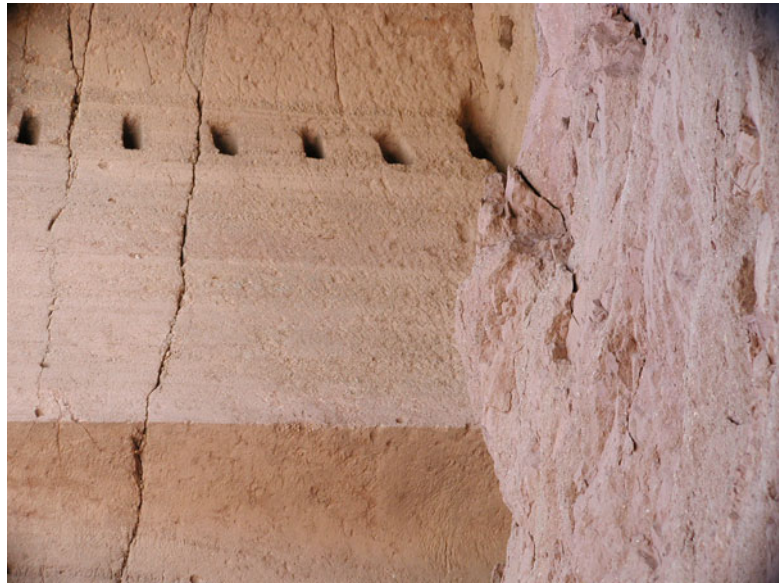
Fig. 12.7 (*Center on the
left*) Detail of detachment in
the Western Giant Buddha

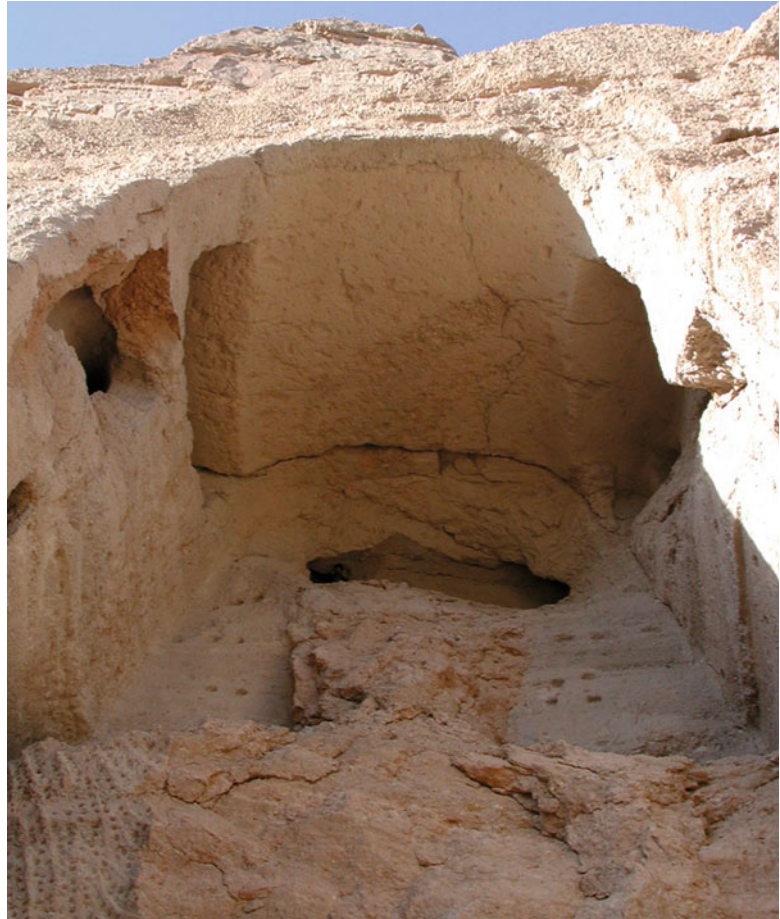
Fig. 12.8 (Center on the right) The shoulders of the Eastern Giant Buddha

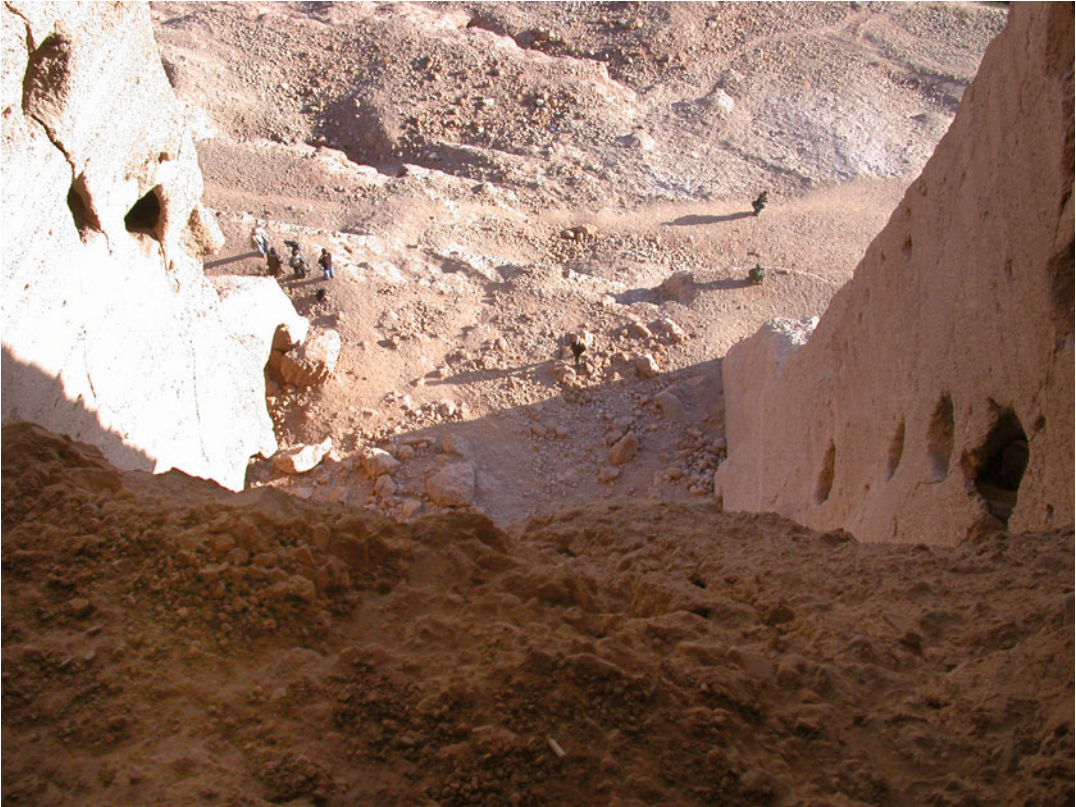
Fig. 12.9 (Low on the left) The shoulders of Eastern Giant Buddha from the top

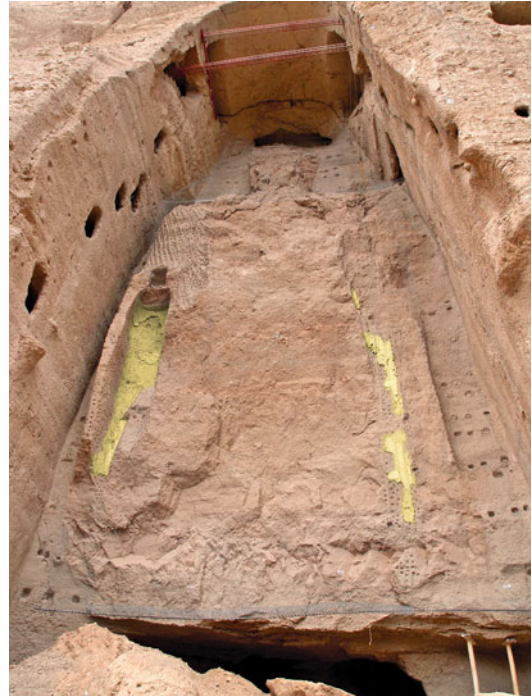
Fig. 13.1 Eastern Buddha, preserved original clay plaster layers (marked in yellow), in total about 21 m², preserved in 2008 by gluing and needling

been put up. In 2008, it was possible to fix these original clay plaster surfaces. For this purpose the scaffold was extended with bracket-shaped cantilevers to get close enough to the clay plaster fragments. These two fragment areas can be found on the left side under the former arm of the Buddha, at a height of 9.6 m and measuring 15 m², and on the right side along a fold of the gown, slightly inside the other arm, at a height of 9.0 m and measuring 6 m² (Fig. 13.1).

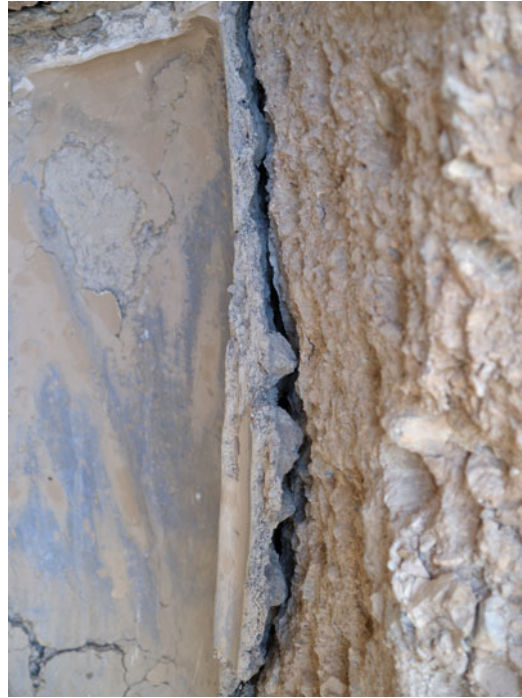
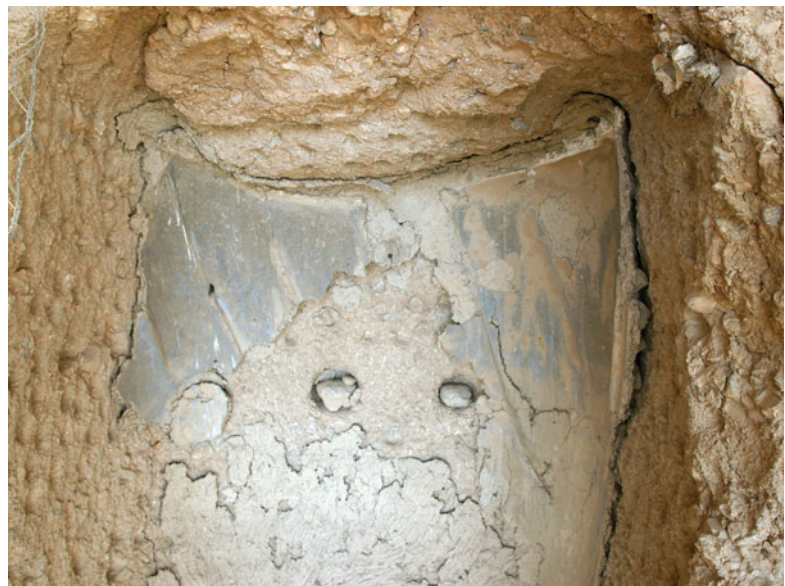
Onto this second layer a fine layer of 2–3 cm was applied, which served as support for the color coat. In several areas only the undercoating remains (Figs. 13.2 and 13.3).

Figs. 13.2 and 13.3 Eastern Buddha: remains of clay plaster on the left, with lapis lazuli. Photo shows condition before treatment. All fragments are slightly detached from the rock face and are only kept together by being wedged on the left and right with the “clay-stone burling”

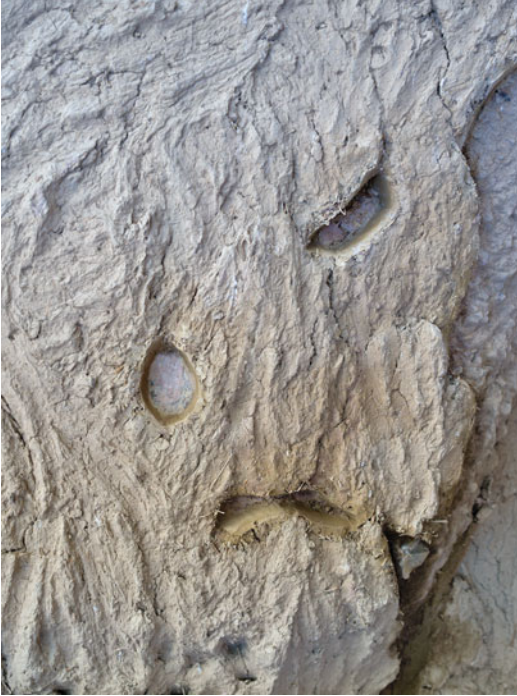
Fig. 13.4 Eastern Buddha, finger traces in the lowest clay plaster layer

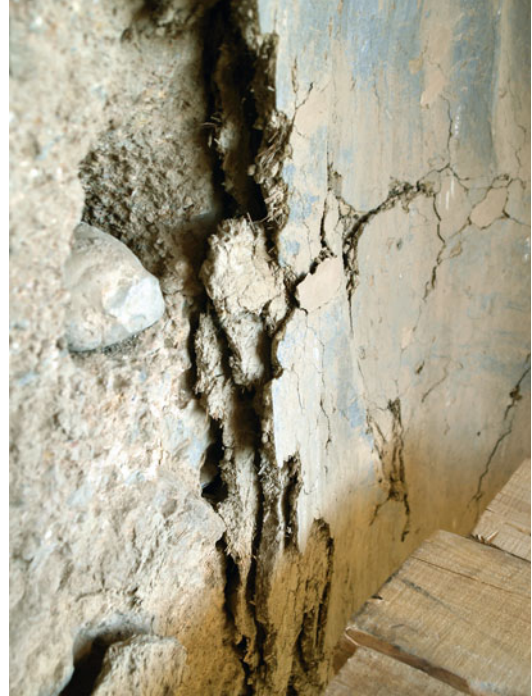
Fig. 13.6 Three layers of clay plaster, partly detached from one another

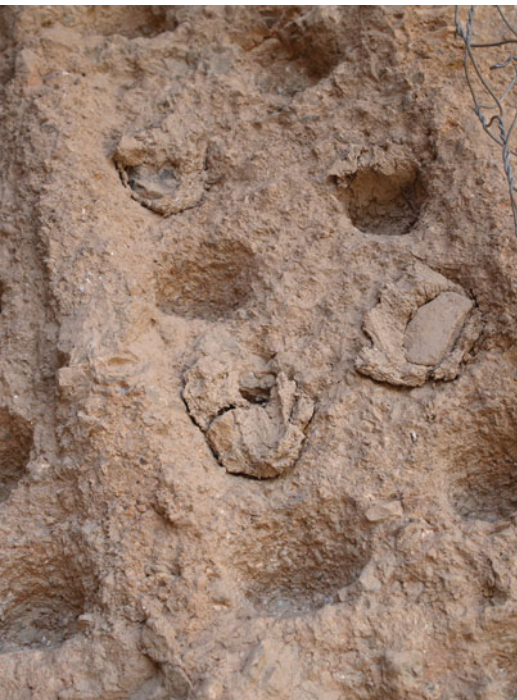
Fig. 13.5 Clay lumps pressed into the holes with stones

mortised holes (diameters of 6–8 cm) with the help of a suitable stone. The actual plaster material was applied onto this layer, a clay mixture containing chaff and animal hair, c. 2–3-cm thick.

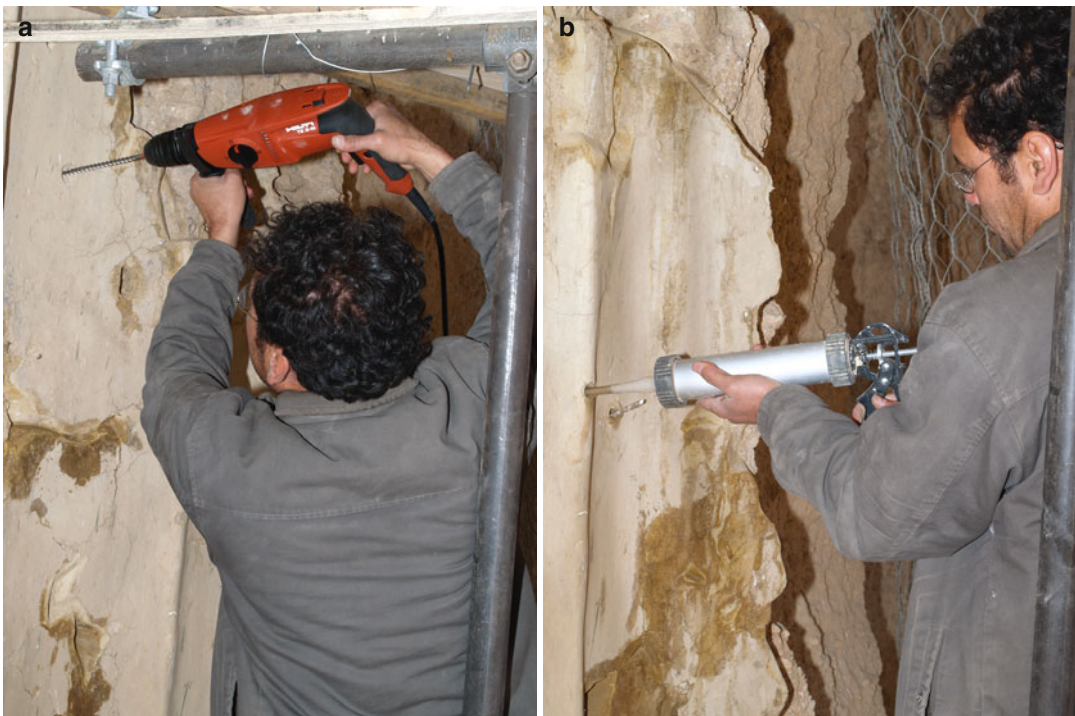
Fig. 13.7 (a, b) Original clay plaster fragments (*right side* of the Eastern Buddha). Preparation for the setting of needles: Mirzai drilling a hole into an existing bullet hole

At first, this work was carried out partly by Bert Praxenthaler and by stone restorer Mujtabah Mirzai, together with up to five Afghan workers. In the course of the work, the reverse-side bonding and the fixing of the edges were mostly executed by the Afghan workers Qurban, Eshaq, Karim, Haidar, and Abdul Ali. However, drilling and needling were only done by Praxenthaler and Mirzai (Fig. 13.7).⁵

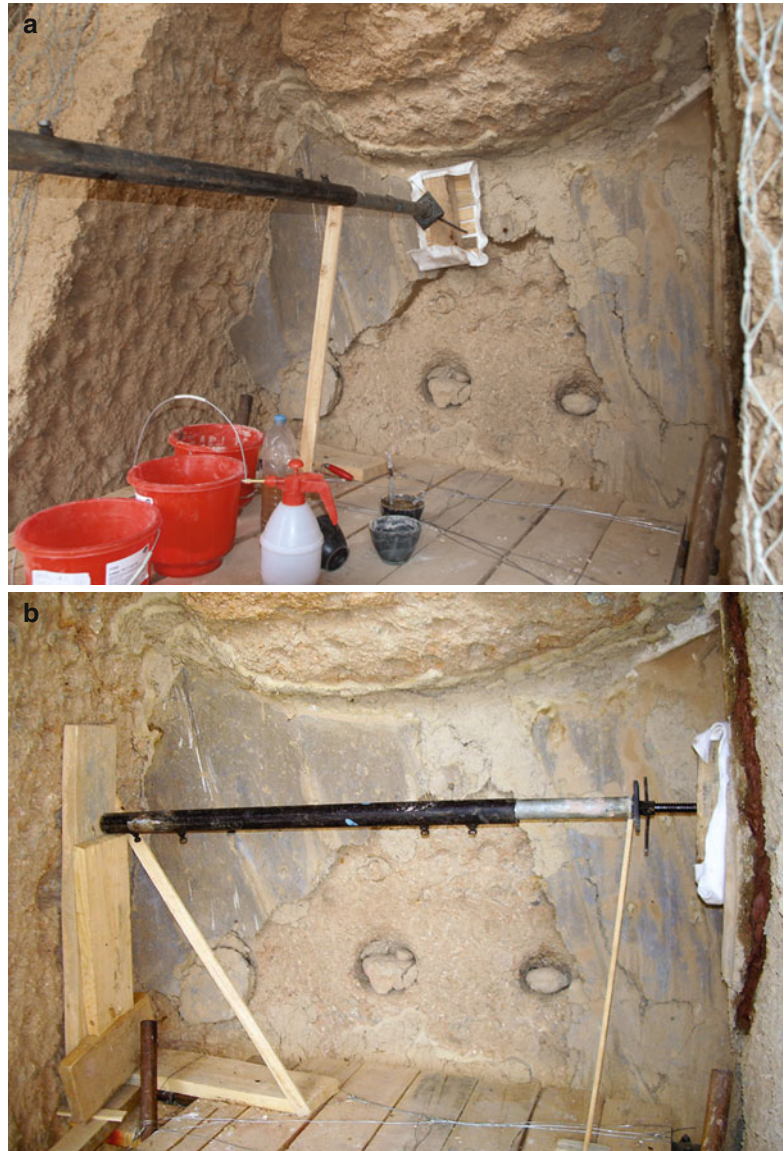
Fig. 13.8 (a–c) Bonding of the clay plaster fragments. By means of a splaying apparatus, pressure is carefully put on the clay plaster fragments. In most cases this apparatus was hinged to the scaffold. The surface of this apparatus was adapted to the texture of the clay plaster and was made of small wooden boards. On the left underneath the arm hole

layers were carefully moistened on their reverse side to make the material a little more malleable. By means of a splaying apparatus, which we had made by metal craftsmen at the Bamiyan bazaar, the clay plaster fragments could be repositioned millimeter by millimeter and were battered afterward.

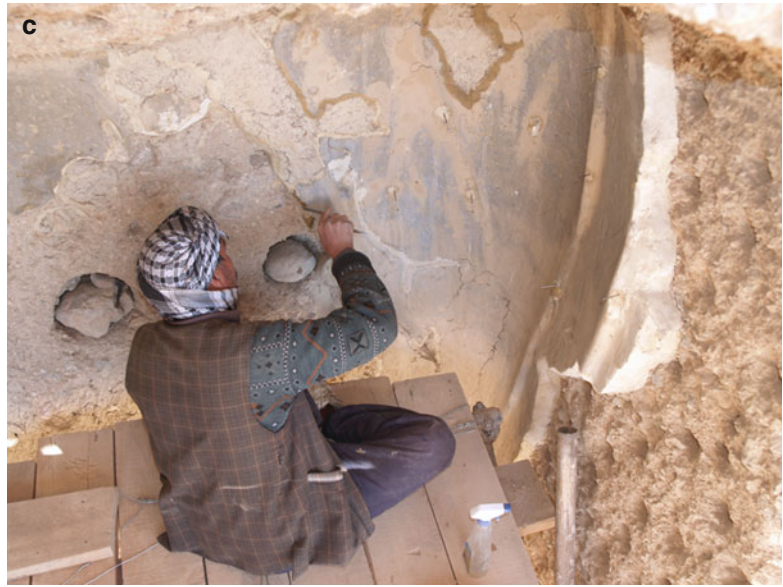
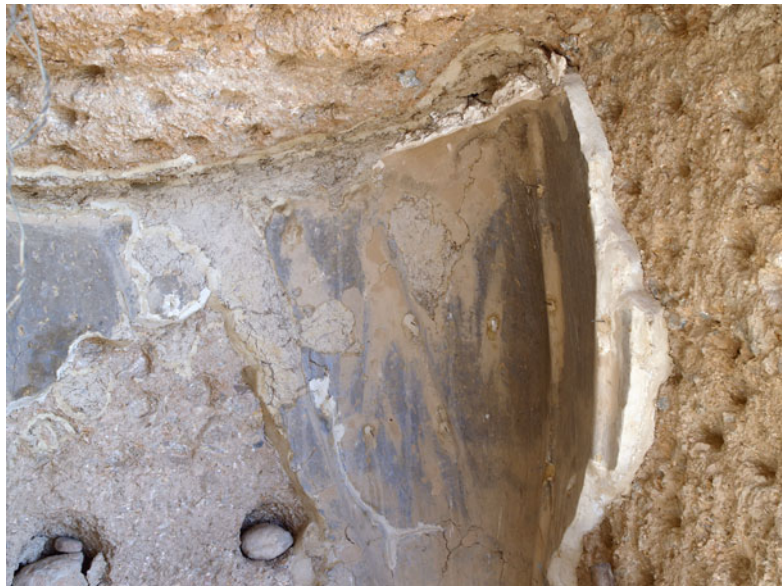
Fig. 13.9 Bonded and secured clay plaster fragment underneath the arm hole

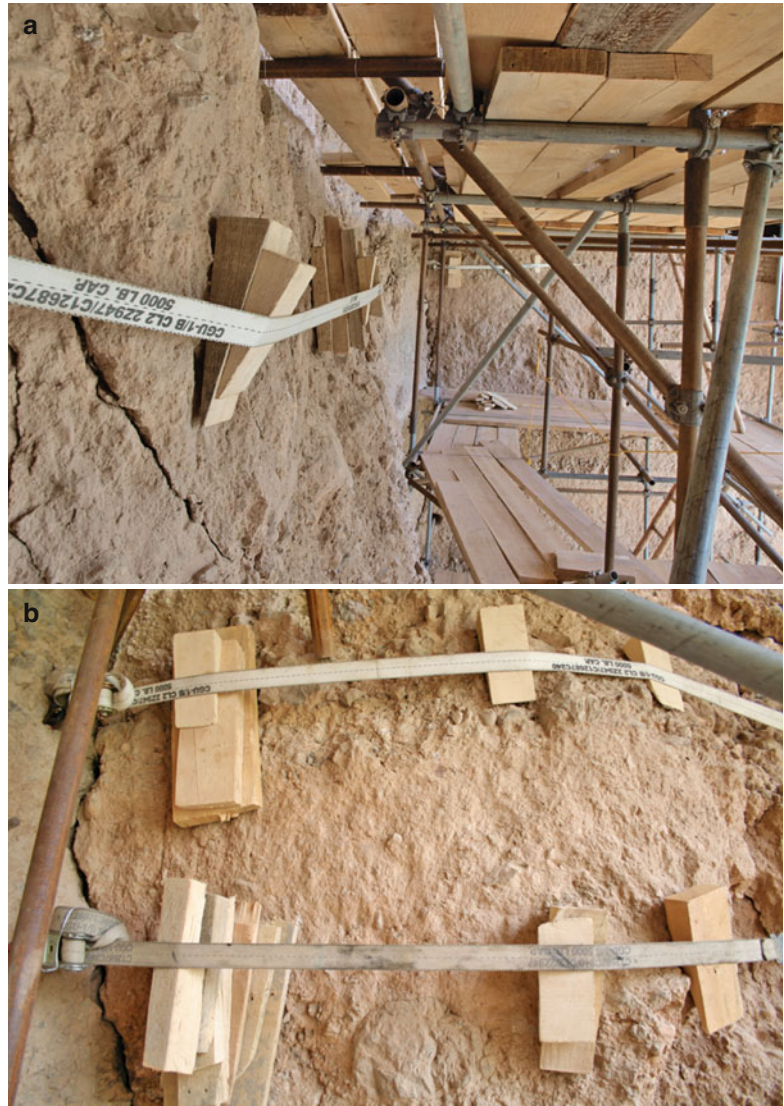
Fig. 13.12 (a–d) Temporary covering of the brittle parts at the Eastern Buddha by means of heavy duty tension belts as a first step of securing the back wall

Bamiyan (see report Margottini 2009), so very exact dosage of treatments could be achieved. Every problem zone of the Buddha got its special application and therapy (Fig. 13.12).

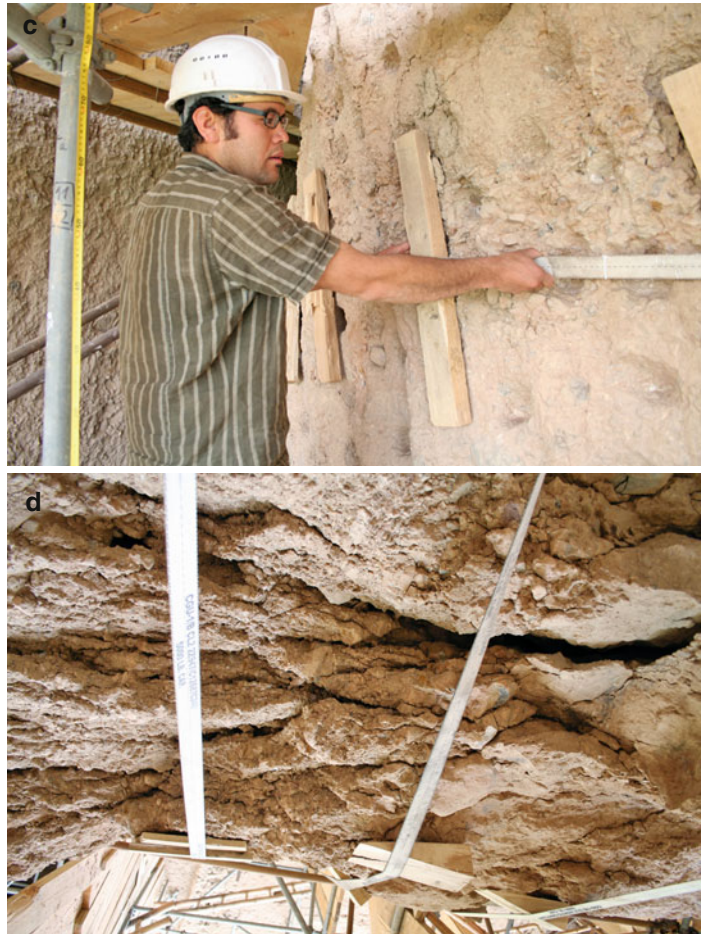
Fig. 13.13 (a, b) Sealing the cracks and backfilling step by step with mortar

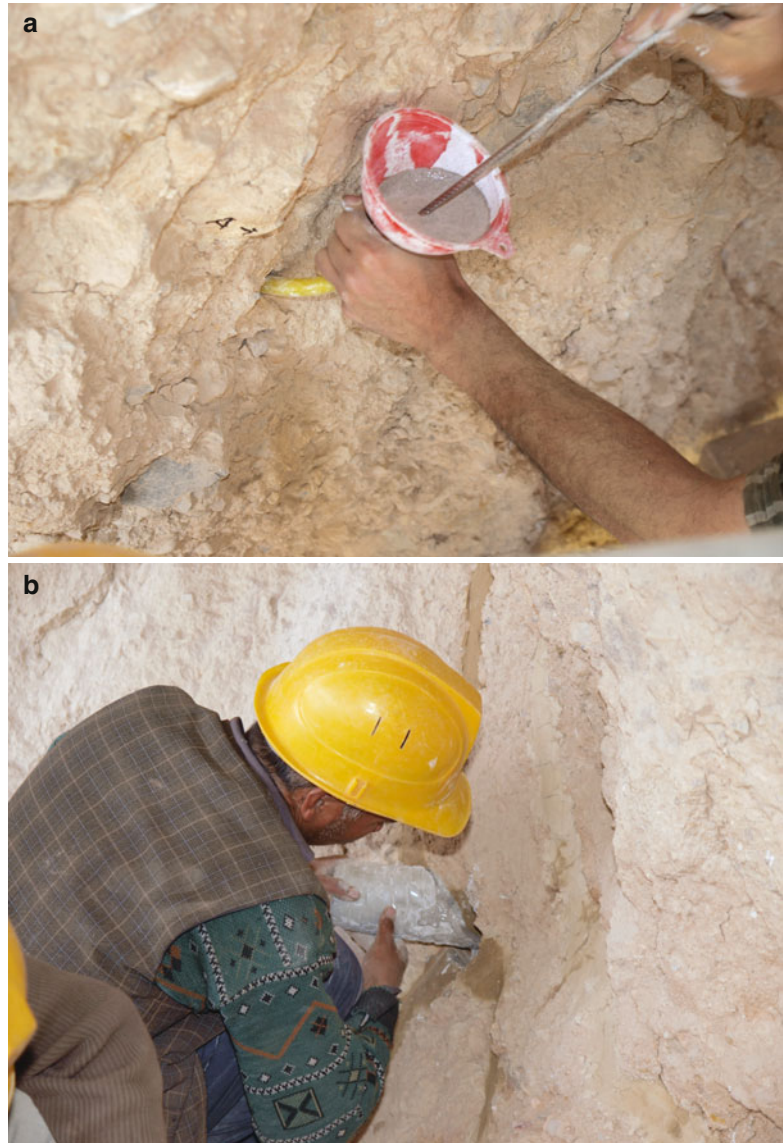
Fig. 13.14 (a, b)
Backfilling the cracks with
mortar

With 10- and 6-mm V2A steel bolts, smaller stable or stabilized portions of rock could be fixed to the rear side. As mortar in those cases mostly Ledan® was the choice, but sometimes cement mortar with super plasticizer (BASF).

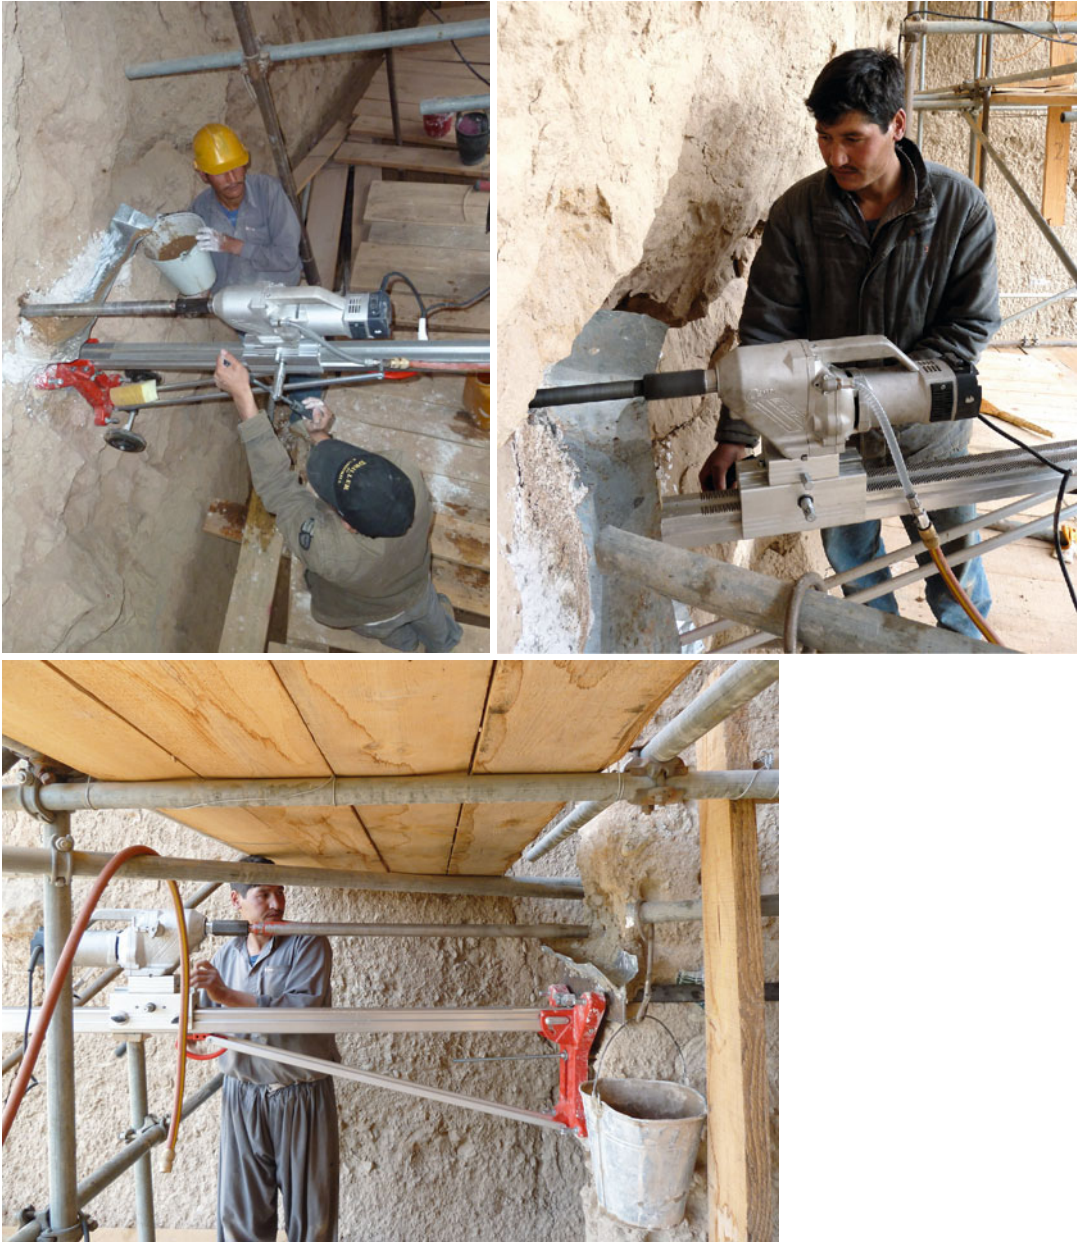
Figs. 13.16, 13.17, and 13.18 Diamond core head drilling in different situations. The water used for cooling is collected by a suitable folded panel in buckets, so the rock surface was protected of water

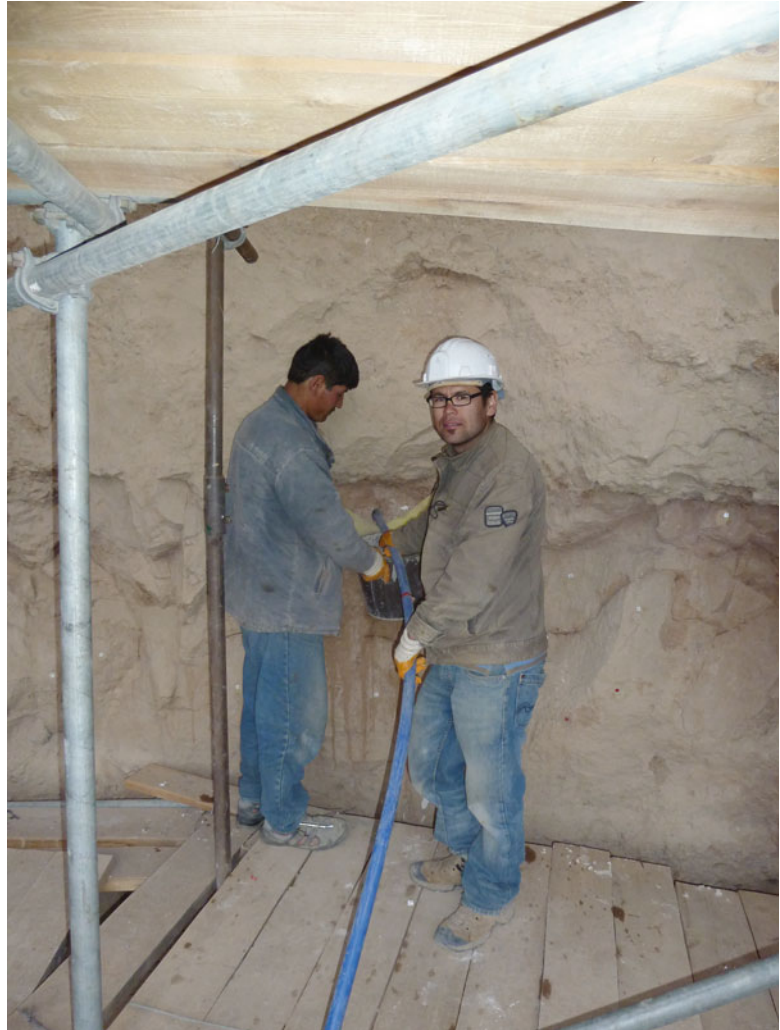
Figs. 13.20 and 13.21 Anchor of stainless steel (V2A) with a thickness of 22 mm
