Protecting Historic Architecture and Museum Collections from Natural Disasters

Edited by
Barclay G. Jones, Ph.D.

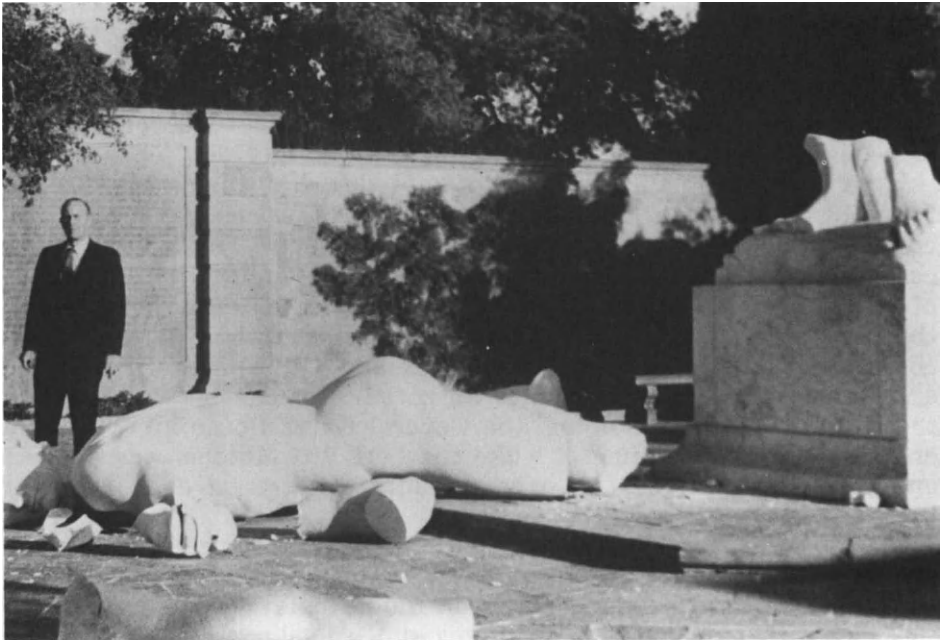
Figure 1.2. Los Angeles, California: Forest Lawn Memorial Park, Marble Copy of David Showing Destruction Caused by Earthquake of February 9, 1971.

We are all quite aware, when we think about it, which apparently is not often enough, that natural disasters have been the cause of destruction that has obliterated much of the most valuable elements from our past. For example, we admire the torso as an art form and associate it with modern sculptors such as Rodin, Mailiol and Brancusi and with Greek and Roman works from antiquity. We seldom consciously acknowledge that the ancient works that provided the inspiration for modern efforts were not designed as torsos but are the major remains of complete figures, the limbs of which were undoubtedly snapped off in earthquakes or were broken when the statues were toppled. (Figures 1.1, 1.2)

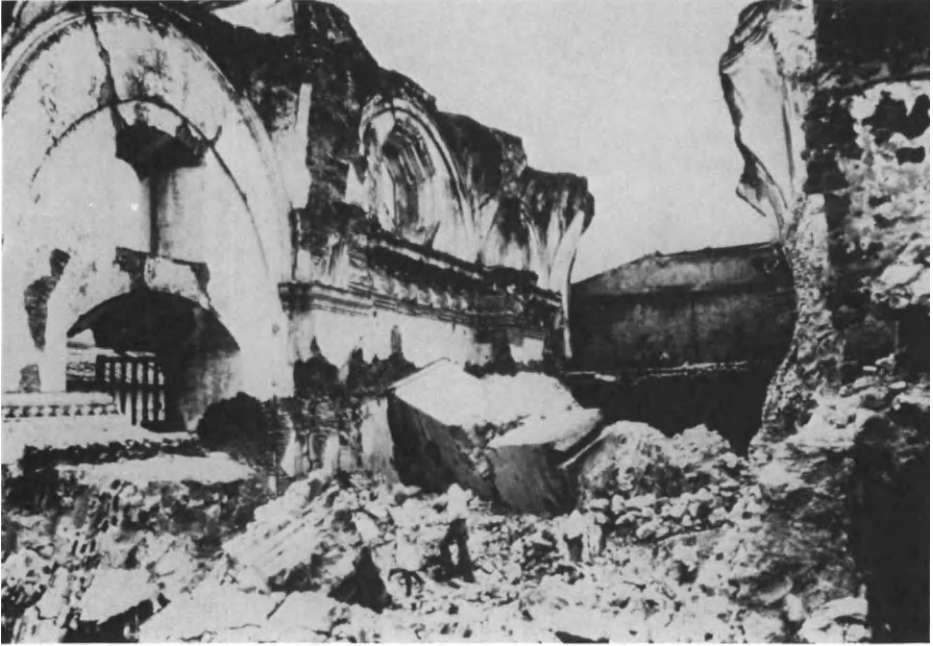
Figure 1.5. Antigua Guatemala, Guatemala: Damage to Ruins of Cathedral of San Augustin by Earthquake of February 4, 1976. USGS.

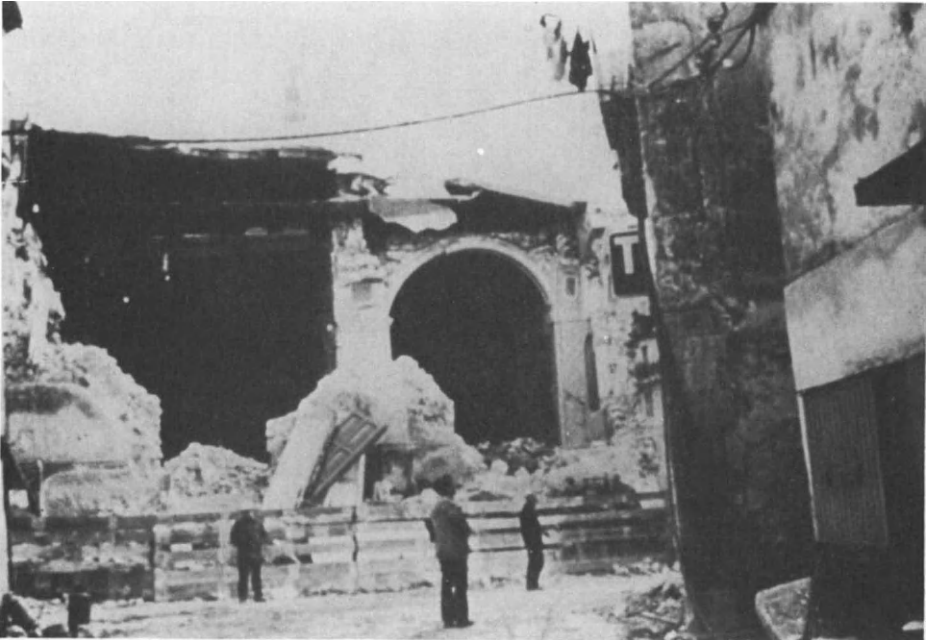
Figure 1.8. Valvano, Italy: Collapse of Church Caused by Earthquake of November 23, 1980. National Academy Press.

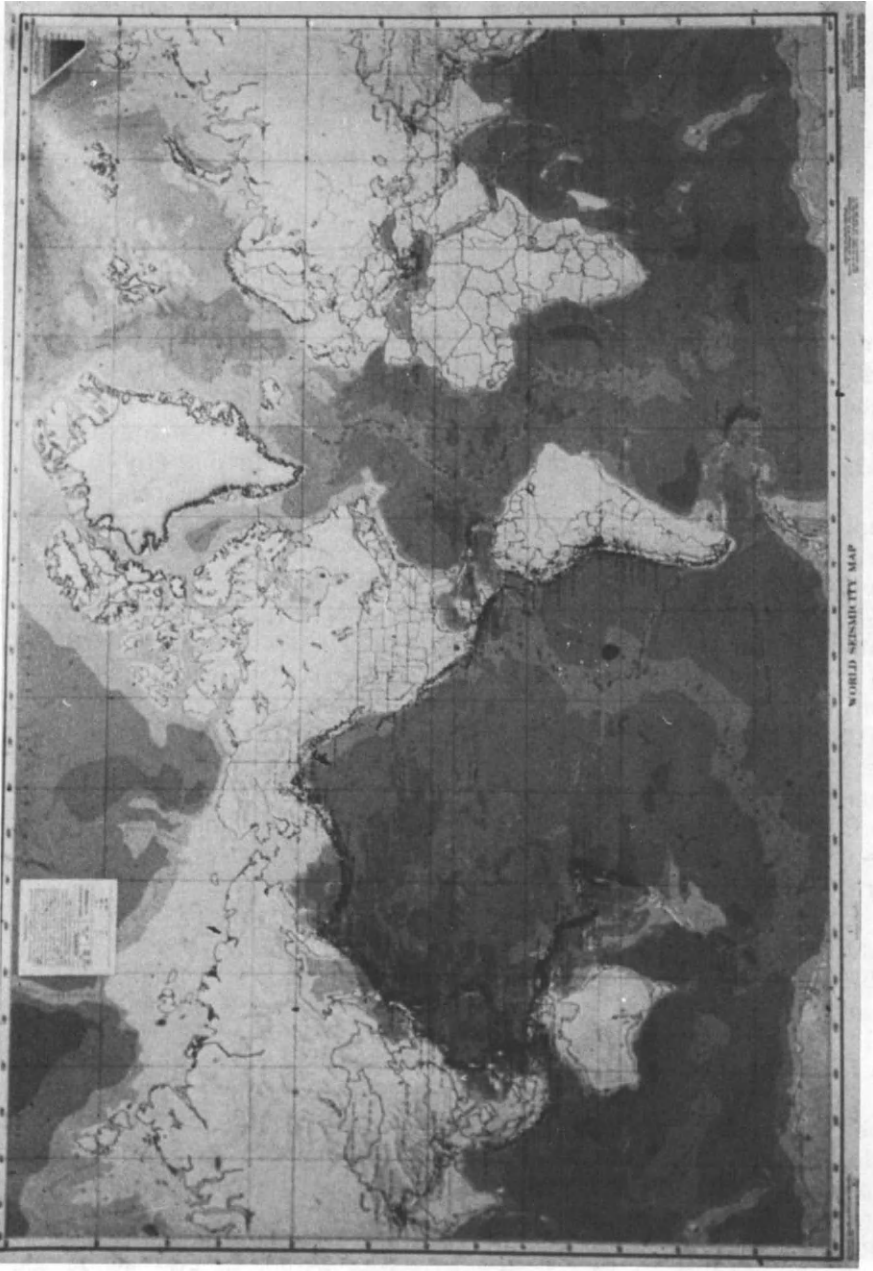
Figure 1.13. World Seismicity Map: July 1963-1972. USGS.

When we look at the World Seismicity Map (Figure 1.13) or study the other data already referred to it is tragically apparent that the areas of the planet earth most affected by destructive earthquakes are also areas exceptionally rich in cultural resources. This unfortunate affinity between areas of intense seismic activity and high concentration of great historic buildings makes a doleful litany: northern China, Italy, Greece, Turkey, Iraq, Iran, the Soviet Union, Afghanistan, Pakistan, Nepal, Burma, Indonesia, China, Japan, The Philippines, and the entire west coast of the United States, Mexico, Central and South America.

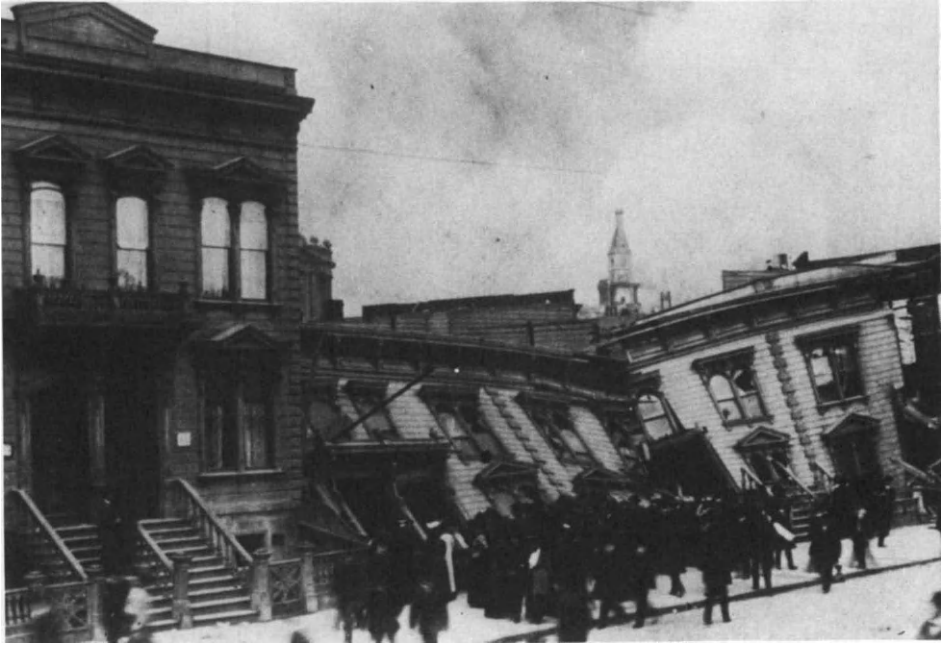
Figure 1.14. San Francisco, California: Buildings Affected by Ground Subsidence in Earthquake of April 18, 1906. NOAA/EDIS.

Less happy is the photograph of a row of two story buildings in San Francisco, California taken during the earthquake of April 18, 1906, showing the buildings collapsed backward away from the street where the ground slumped beneath their foundations. (Figure 1.14) This photograph gives us valuable information about the architecture of early San Francisco, its construction and its failure by earthquake. Later the great San Francisco fire destroyed the entire block.

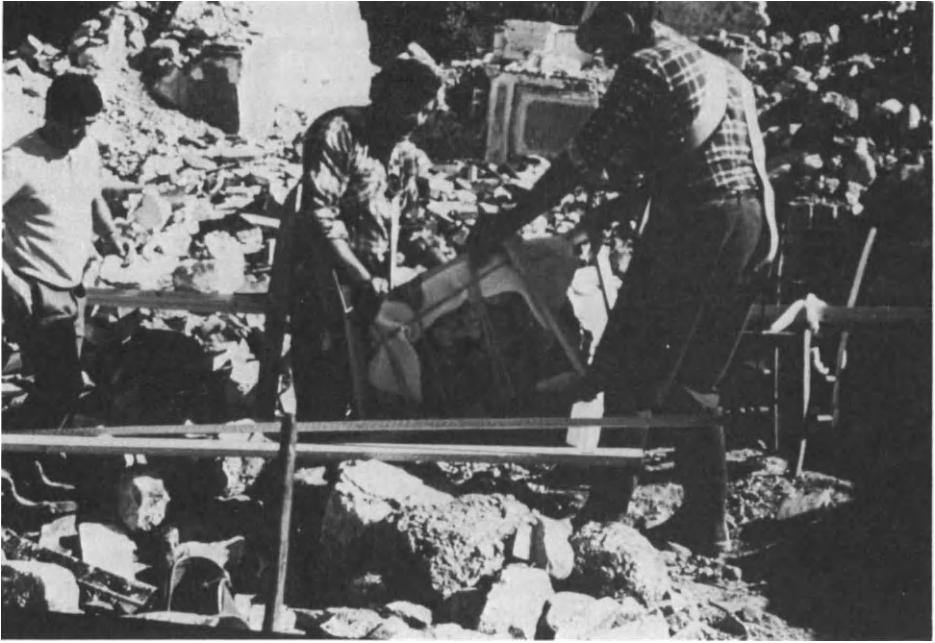
Figure 1.21. Villuzza of Ragogna, Italy: Eleventh Century Fresco Fragments Being Removed with their Supporting Masonry, "Stacco a Massello," Church of San Lorenzo. These Frescoes Came to Light as a Result of Earthquake of May 6, 1976.

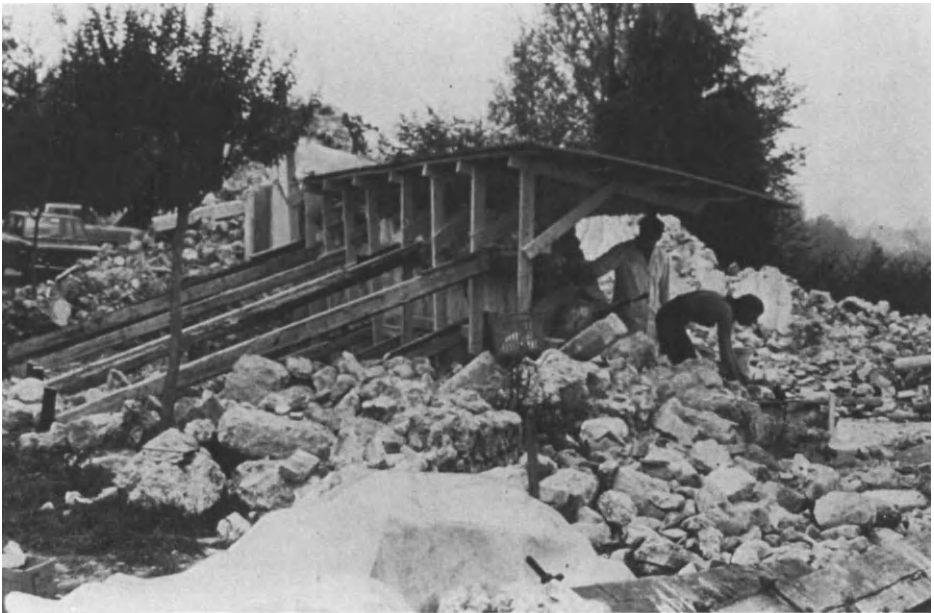
Figure 1.25. Villuzza of Ragogna, Italy: Church of San Lorenzo, Propping and Temporary Roofing Constructed to Protect Frescoes on Walls Which Were to Remain in situ.

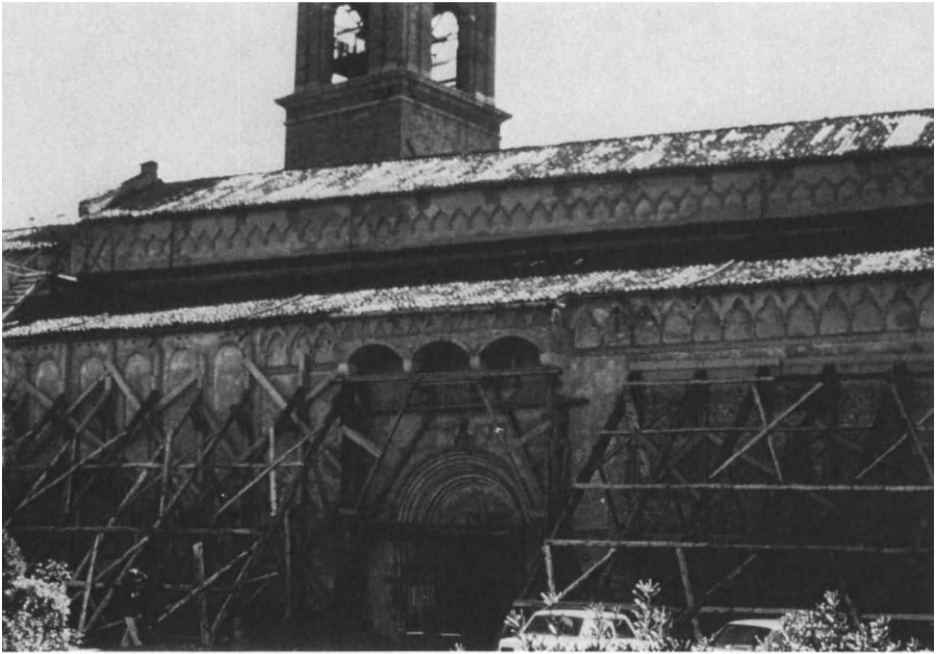
Figure 1.26. Spilimbergo, Italy: Cathedral Damaged in Earthquake of May 6, 1976 Showing Proppings that Helped it Survive Earthquake of September 15, 1976.

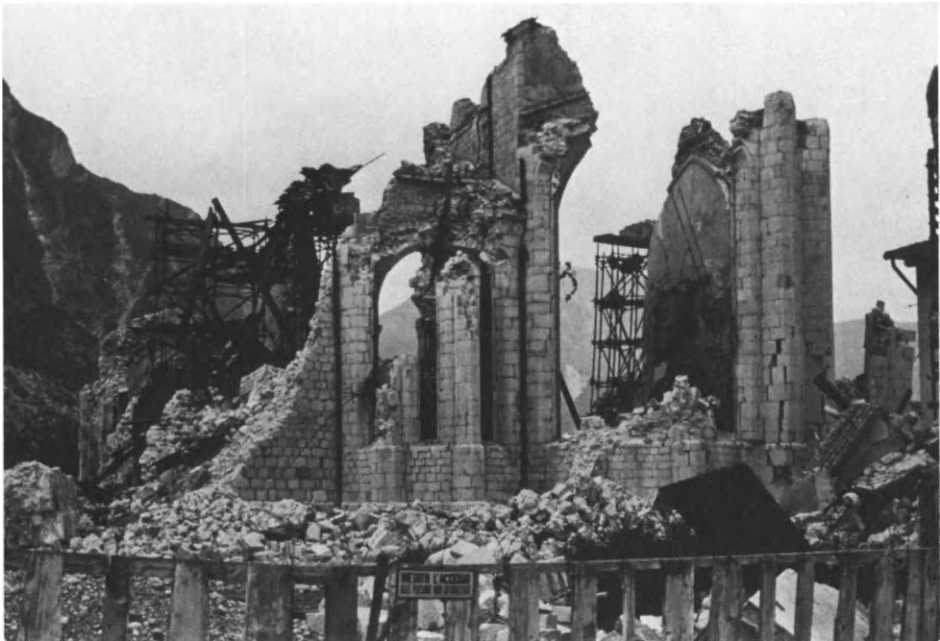
Figure 1.27. Venzone, Italy: Cathedral after its Collapse in Earthquake of September 15, 1976.

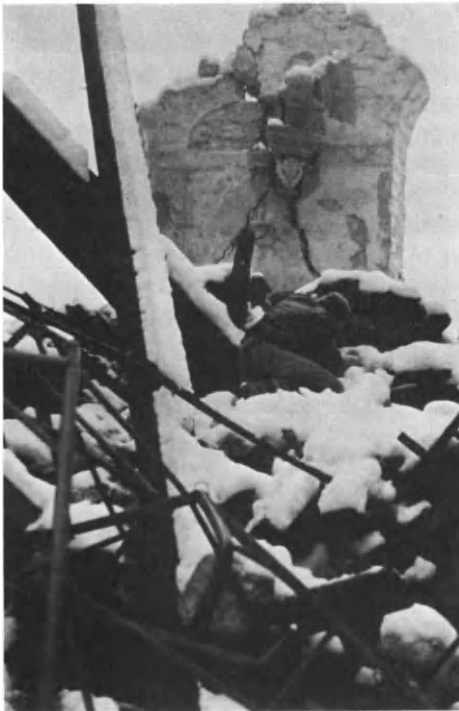
Figure 1.31. Venzone, Italy: Cathedral, the Gonfalone Chapel after its Collapse and the Complete Destruction of the Vault Paintings in the Earthquake of September 15, 1976.

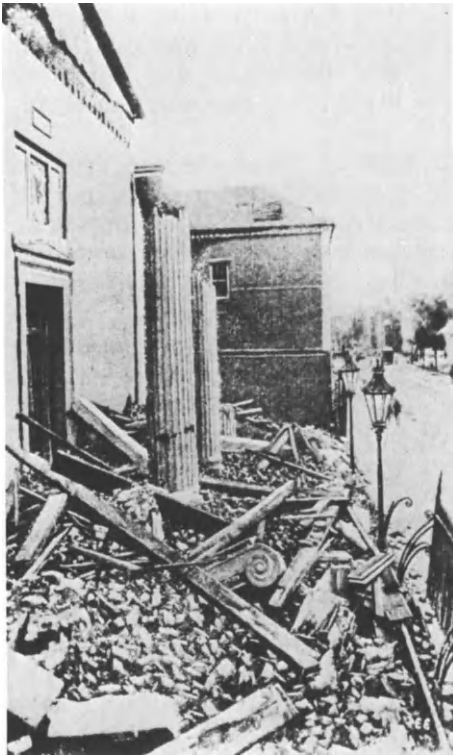
Figure 3.2. Charleston, South Carolina: Damage to Hibernian Hall, 1840, 105 Meeting Street, from Earthquake of August 31, 1886. USGS.

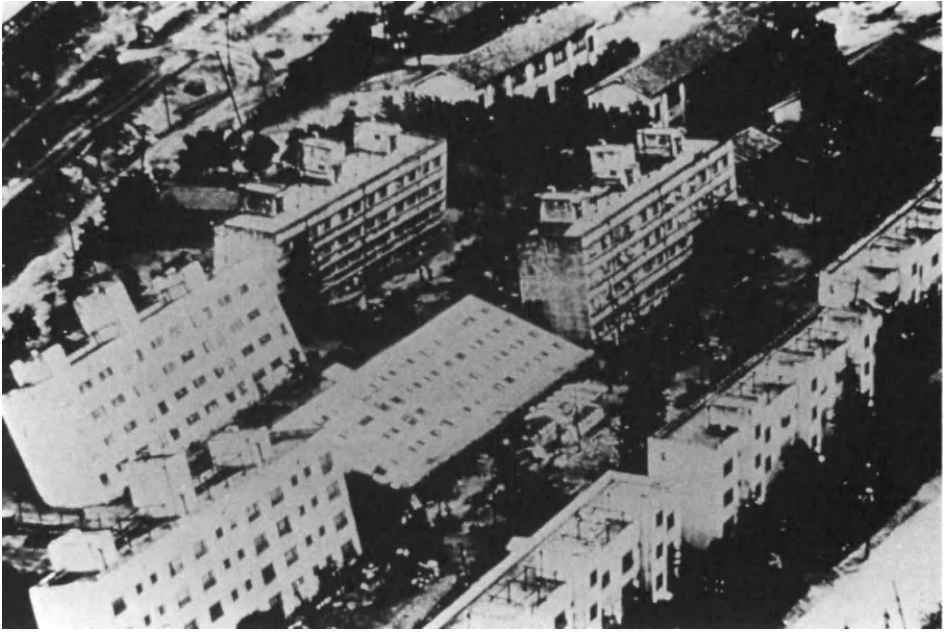
Figure 3.9. Niigata, Japan: Apartment Houses Tilted by Failure of Soil from Liquefaction in Earthquake of June 16, 1964. NOAA/EDIS.

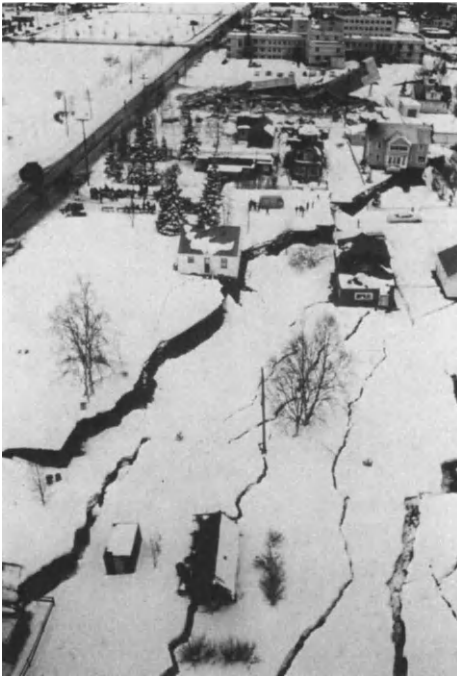
Figure 3.10. Anchorage, Alaska: Aerial View Showing Landslide Area after Earthquake of March 27, 1964. NOAA/EDIS.

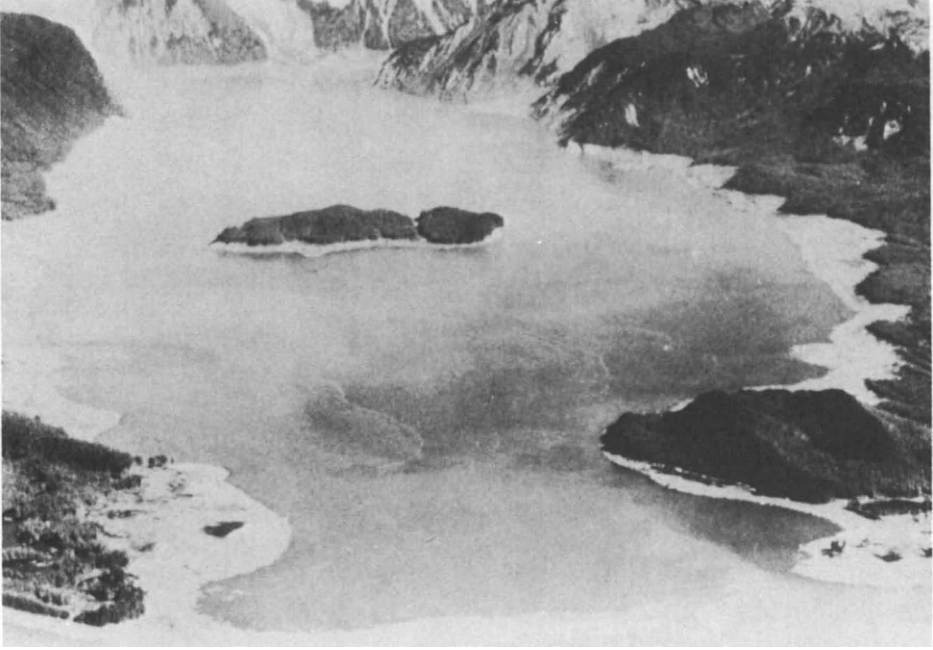
Figure 3.11. Lituya Bay, Alaska: Large Rockslide Induced by Earthquake of July 9, 1958, Plunged into Gilbert Inlet and Generated Wave that Surged 1,720 Feet up Mountainside. NOAA/EDIS.

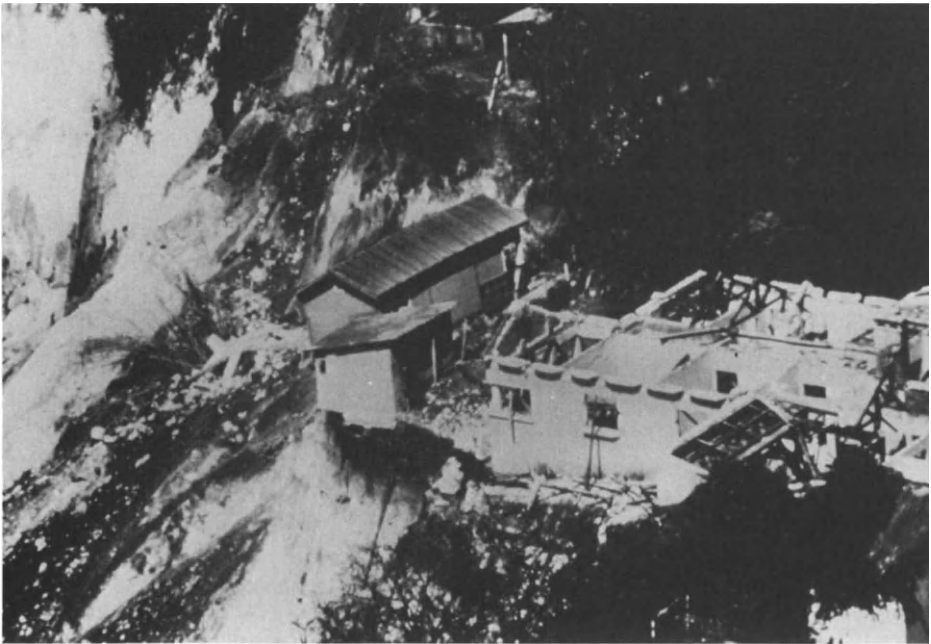
Figure 3.12. Guatemala City, Guatemala: Foundation Failure Due to Landslide Beneath Structures. USGS.

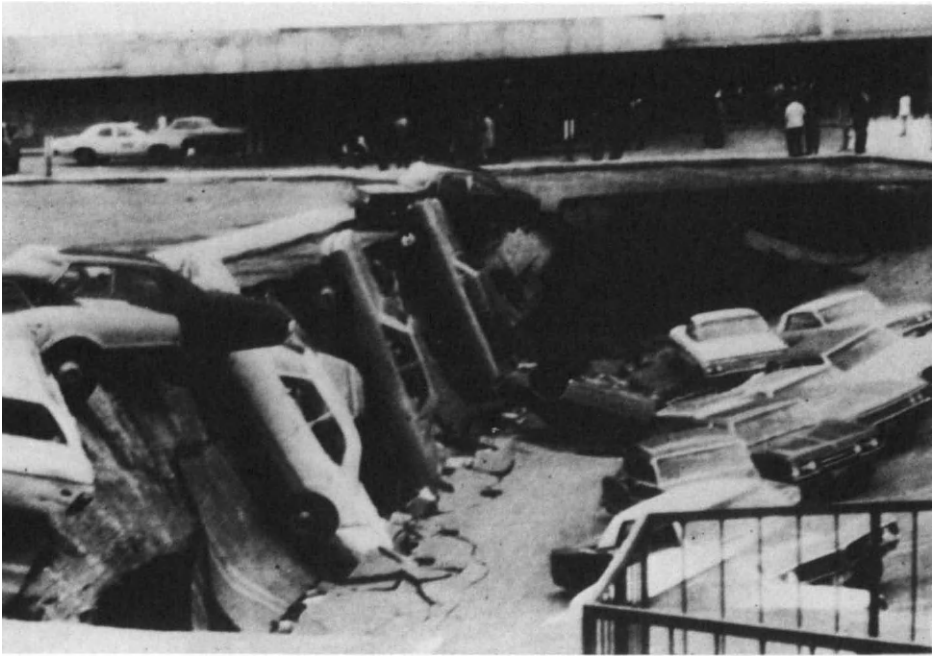
Figure 3.18. Ground Surface Failure from Collapse of Subterranean Chamber.

For convenience, forces acting on a building may be classified as vertical, lateral or dilational. (Figures 3.18, 3.19) The principal vertical forces which act on roof surfaces are snow and rain, when ponded. On floors there are forces caused by functional use of the building, the "live loads". The weight of the structure itself, its cladding, finishings and fixed equipment constitute another set of vertical forces, the "dead load". If the equipment rotates or cyclically translates, it can induce dynamic forces or deleterious vibrations. The effects over long periods of time can be quite severe. Compressors, generators, and ventilating and air conditioning equipment can contribute.

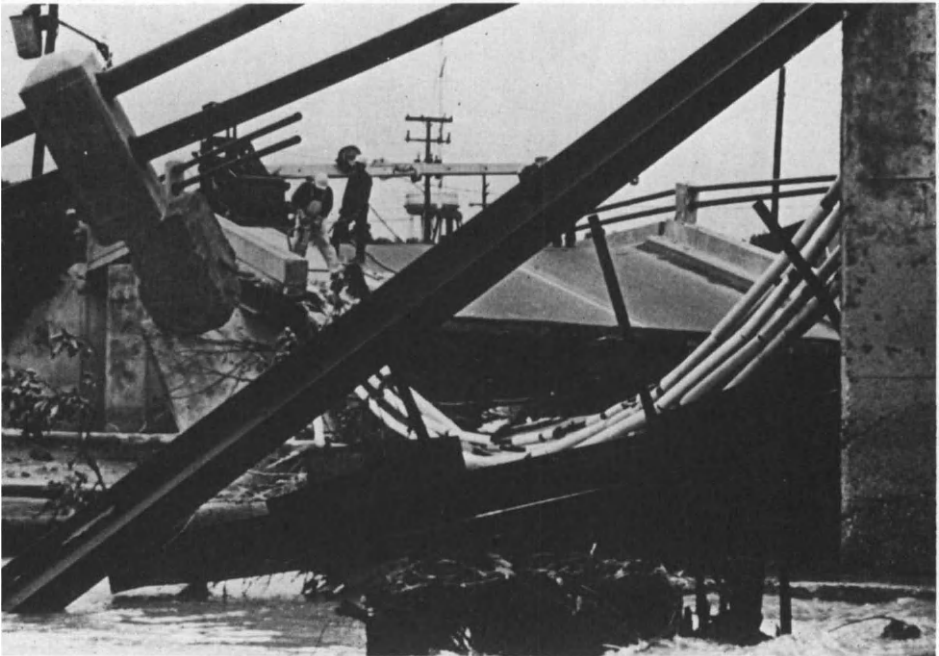
Figure 3.21. Arlington, Virginia: Flood Damage to Bridge Following Hurricane Agnes, June 22, 1972.

Lateral forces, the greatest of which is the wind, principally act on the walls and windows of the building. A special case is wind borne objects which act as missiles. Wind can also act on sloping roof surfaces and on building appurtenances such as marquees, signs, flagstaffs, etc. Lateral forces on the buried portions of basement walls are from adjacent soil and water. Sometimes vehicular traffic near basement walls adds to the lateral earth pressures. In addition, this vehicular traffic can cause deleterious vibrations. Further, freeze/thaw action in the adjacent soil can impose lateral forces. Seismic forces are primarily lateral, and they act through the interfaces of the structure and the surrounding earth. (Figure 3.20) Differential response of different parts of buildings or adjacent structures to seismic forces can lead to battering of one against the other. Buildings in low-lying areas near large streams or other bodies of water may be subject to lateral forces of flood waters, repeated battering by waves, and the pressure and battering of flood borne debris. (Figure 3.21)

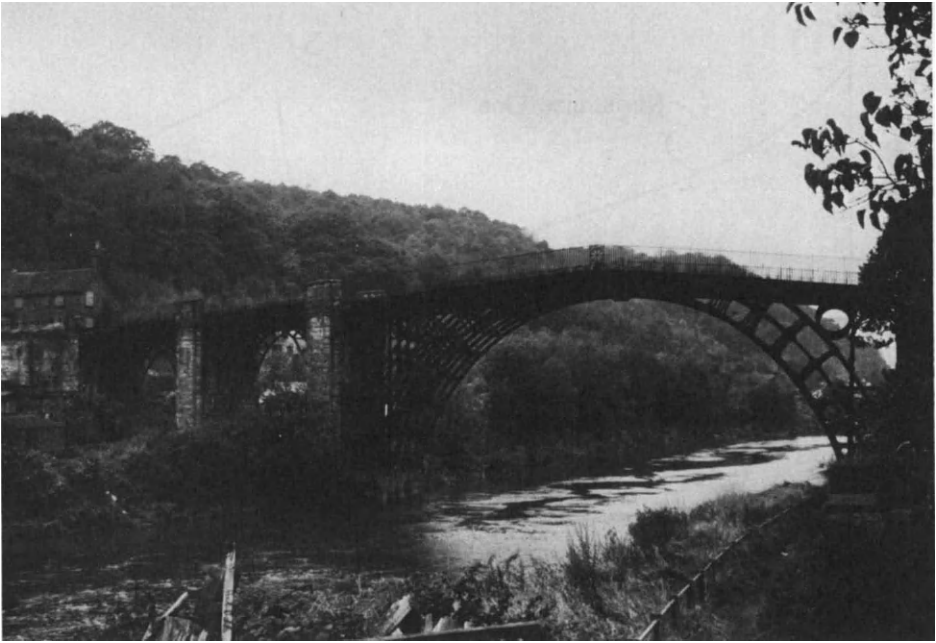
Figure 3.25. Coalbrookdale, England: Iron Bridge Across the Severn River Built in 1779. This First Important Structural Use of Cast Iron was Saved from Effects of Gradual Ground Movement by Inserting a Massive Concrete Bed Underground Between the Stone Piers.

Slow geological movements of the soil up, down and sideways may also be classified as natural disasters although their effects are very slow. The famous Iron Bridge at Coalbrookdale, symbol of the beginning of the Industrial Revolution, was built over the river Severn which follows a geological fault. This fault closed the distance between the two abutments and caused severe distress to the

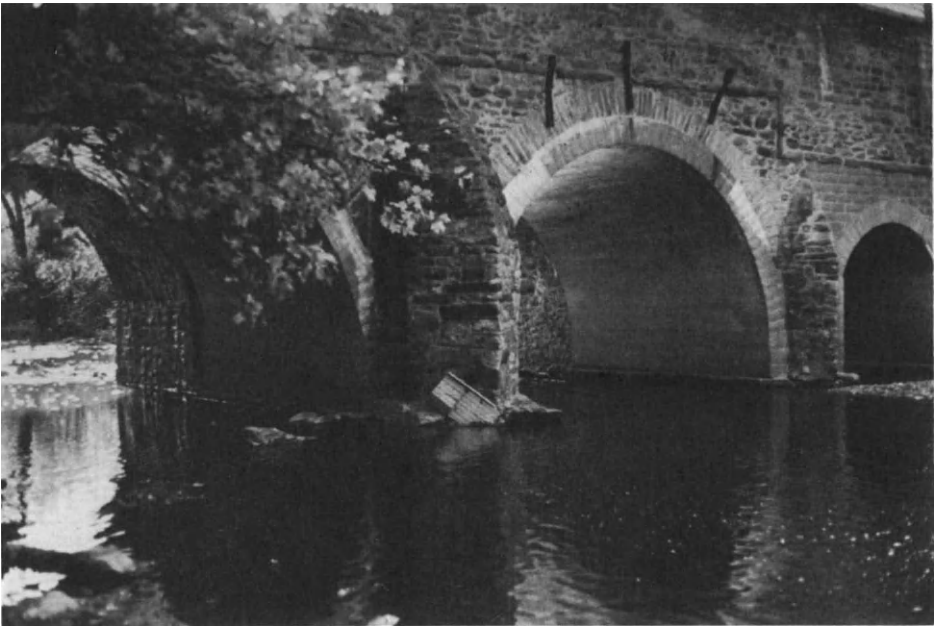
Figure 3.26. Philadelphia, Pennsylvania: Frankford Avenue Bridge over Pennypacker Creek Built in 1694 Showing Metal Straps Reinforcing Center Arch.

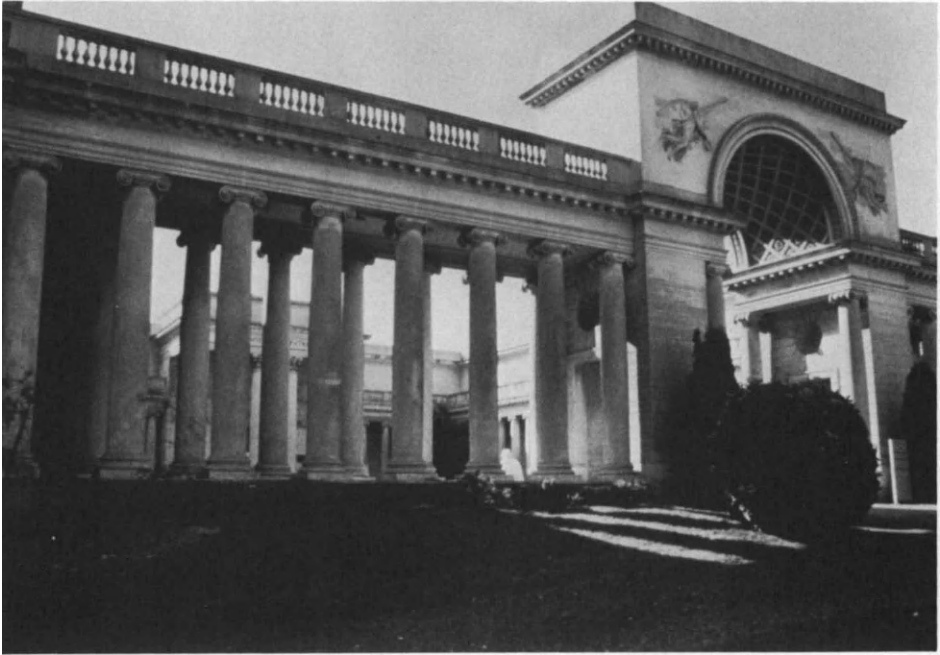
Figure 3.28. San Francisco, California: California Palace of the Legion of Honor, George A. Applegarth, Arch., 1916, Cast-in-Place Concrete Construction.

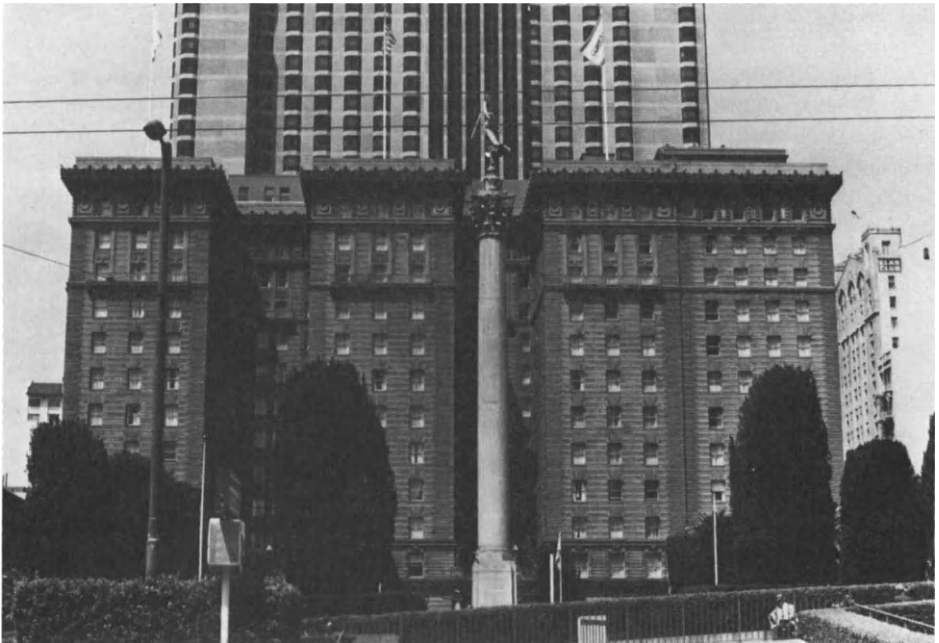
Figure 4.3. San Francisco, California: Dewey Monument, Union Square, a Tall Column and Statue Which Survived Earthquake of April 18, 1906.

be verified. However, objects mounted on bases are themselves usually quite precarious unless well anchored. Where a tall, slender statuary object touches the base at only one or two points (for example, the feet of persons or the shoes of horses), there will be a strong tendency for contact points to be broken in an earthquake. Should the statue fall over, it will no doubt be broken further by impact with the base or the ground. This is really a problem in dynamics and engineering. The use of metal rods—preferably of stainless steel and often of copper—extending from deep in the base well up into the statue's legs or torso is desirable if not essential. (In fact, sculptors would do well to start with a corrosion-resistant interior frame in addition to strong rods extending full height in the figure.) The anchorage rods must also be well bonded to the figure and to the base or else be mechanically connected. Simple dowels set loosely in holes or sockets invite impact, which multiplies the forces.

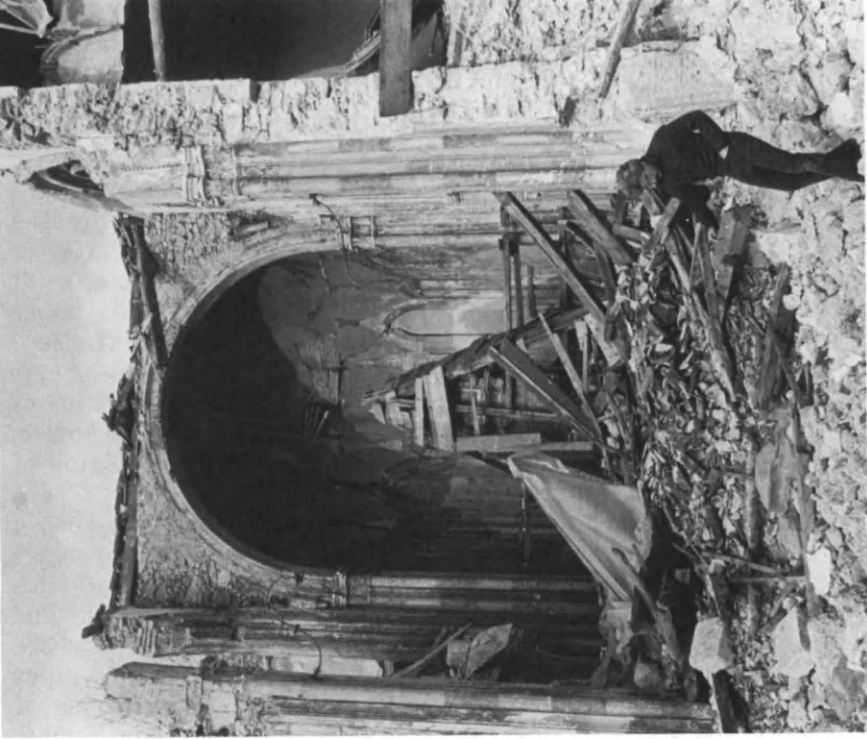
Figure 5.6. Osoppo, Italy: Cathedral, Transept Showing Surviving Altar after Earthquake of September 15, 1976.

After the September 15, 1976, earthquakes, I returned to inspect the damage to the remaining transept. It was satisfying to find that the wood latticed vault had fallen on top of the pyramid built over the altar and that the altar remained intact under it. (Figure 5.6) The same kind of protection saved the fresco situated to one side of the altar on the wall surviving from the first quake. Using salvaged beams and boards and plastic sheets, an inclined structure had been installed over the fresco to protect it from the rain, environmental elements, the transept vault, and the lateral collapse of the wall itself. This protective structure was also demolished by the collapse of the transept vault, but the wall and fresco survived. After the second earthquake, it took a short time to rebuild the same structure over the existing bearing timbers of the pyramid, and install some more plastic sheets. Both the altar piece and the fresco were saved.

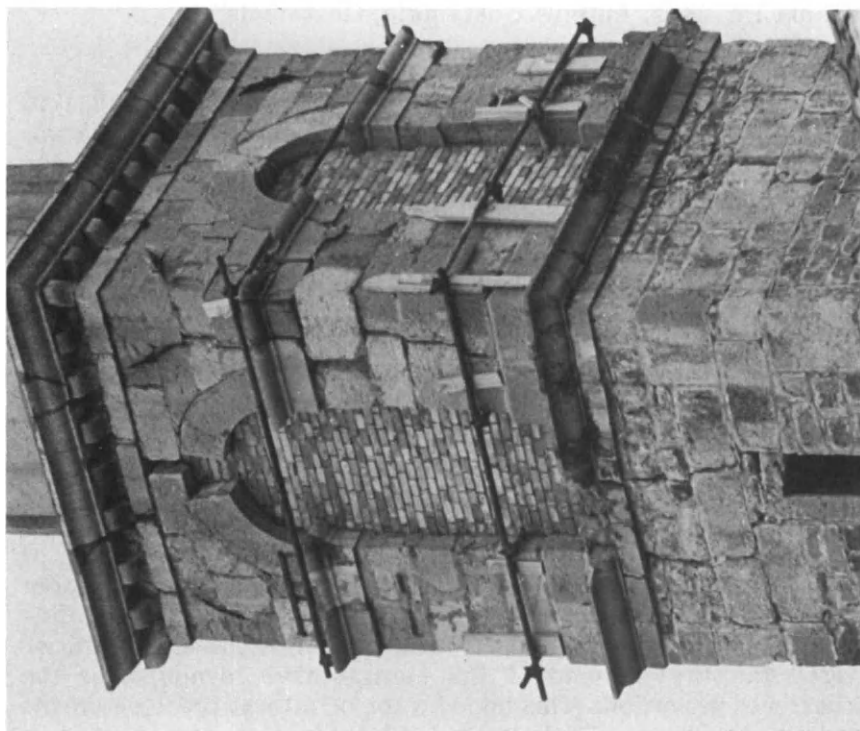
Figure 5.7. Artegua, Italy: Church of San Martino, Tower Showing Reinforcement Erected after Earthquake of May 6, 1976.

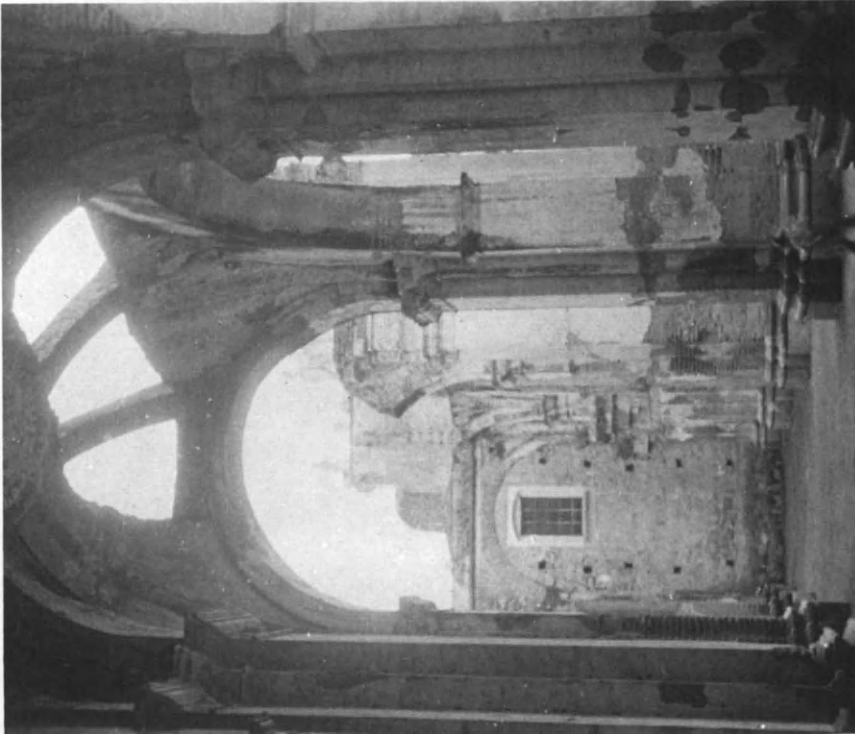
Figure 5.9. Antigua Guatemala, Guatemala: Cathedral, Side Aisle Elliptical Vault Showing Concrete Reinforcing Ribs Installed in 1948.

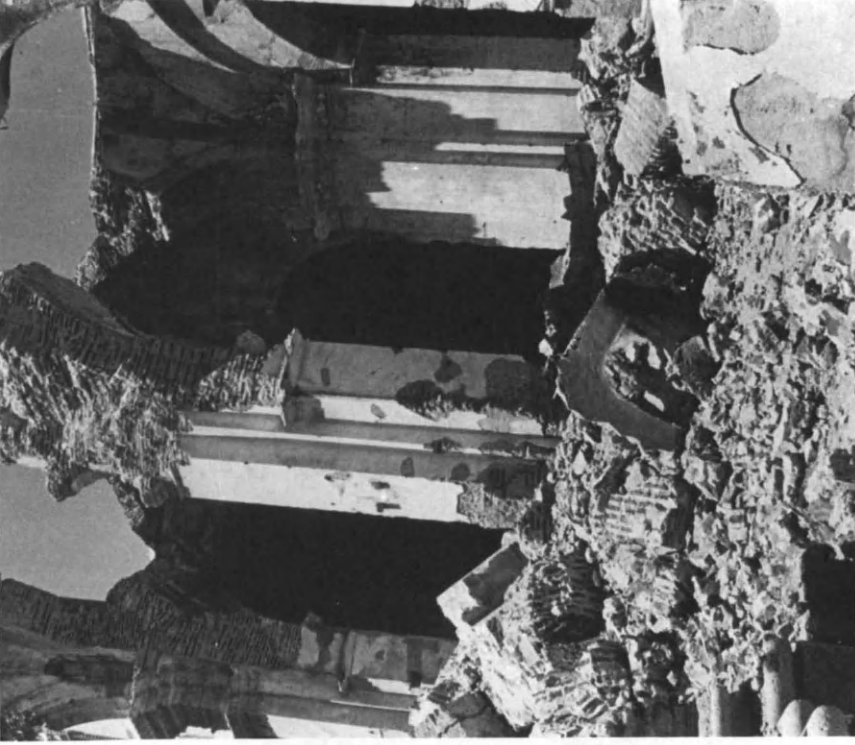
Figure 5.10. Antigua Guatemala, Guatemala: Cathedral, Side Aisle Elliptical Vault Showing Destruction Caused by Battering of Concrete Ribs in Earthquake of February 4, 1976.

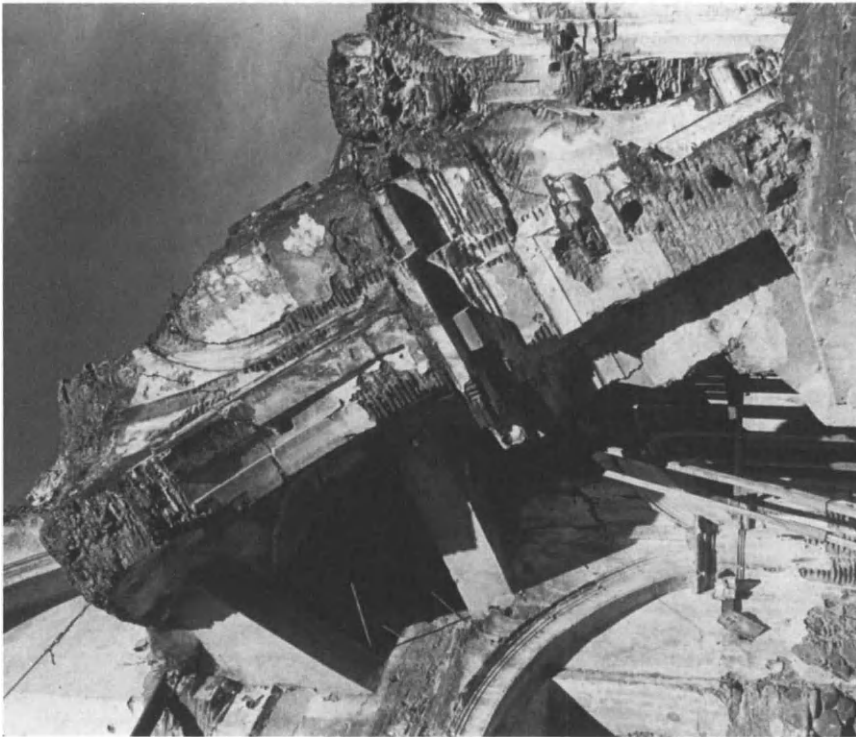
Figure 5.13. Antigua Guatemala, Guatemala: Compañía de Jesús, Main Facade Showing Concrete Connectors Installed in 1948 Between Rear of Facade and Leaning Pillar of Nave.

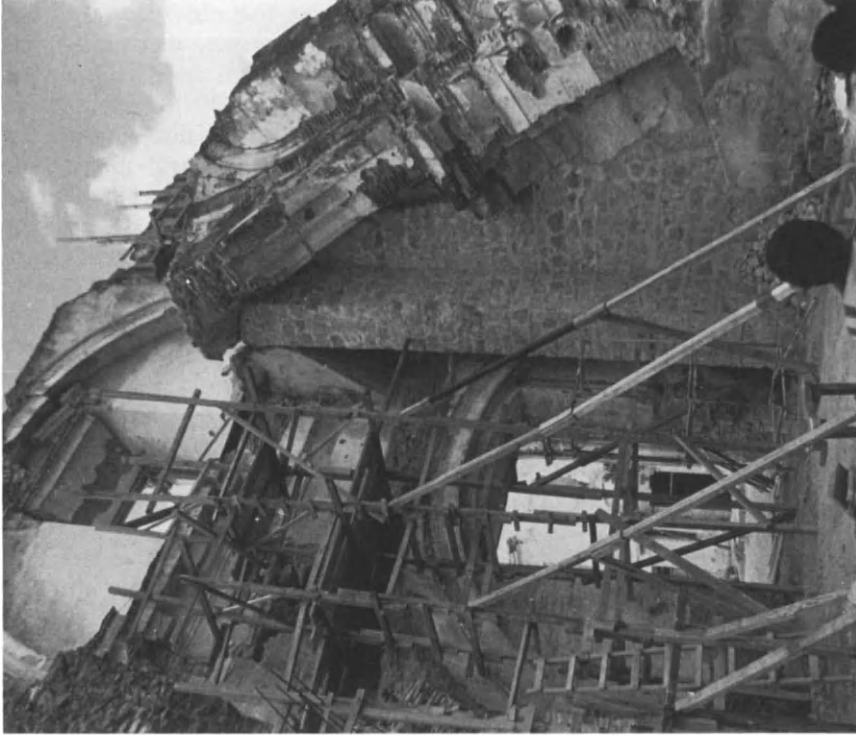
Figure 5.14. Antigua Guatemala, Guatemala: Compañía de Jesús, Main Facade Showing Removal of Concrete Connectors and Separate Buttrressing of Rear of Facade and Leaning Pillar of Nave.

concrete connectors had been installed between the elevation and the leaning column behind it. (Figure 5.13) Having seen the battering that concrete reinforcement had caused in the cathedral in Antigua, the recovery team suggested to use the stone and brick debris as construction material and build a supportive structure underneath the inclined column. This was done two years after the earthquake, and column and main facade were made independent by removing part of the concrete connectors. (Figure 5.14) With the rest of the debris, the end wall of the lateral aisle was rebuilt in order to become a buttress for the rest of the elevation, as well as for the lateral wall which also lost contact with the elevation. By these measures not only was the future of the elevation assured, but the proportions of the complete elevation were restored up to the second level.

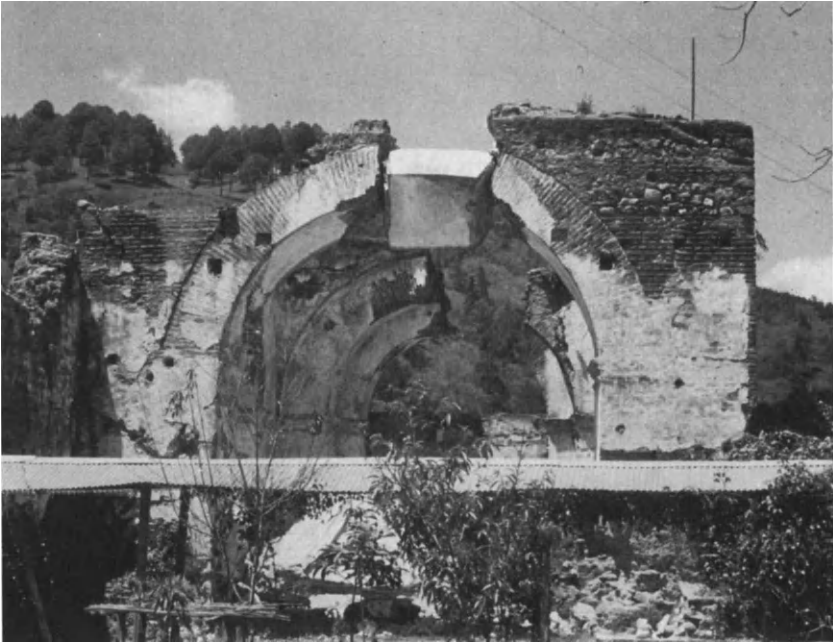
Figure 5.15. Antigua Guatemala, Guatemala: Church of San Francisco, Transept Arch Showing Dislodged Central Portion after Earthquake of February 4, 1976.

The only remaining parts of this XVI Century church were the main facade, which over time had been incorporated into another building, and three of the four arches from the transept. During the February 4, 1976, earthquake, the central portion of one of the surviving arches rotated out of place and wedged itself between the remaining parts of the arch. (Figure 5.15) As soon as possible, a substructure of wood was built underneath a platform designed to support the rotated masonry hanging wedged in the center of the arch. If this key did fall, the entire structural system of the remaining arches and columns would fail because of the interruption of the system's continuity. The reason for building the platform halfway between the dislodged keystone and the ground was so that the workers, in the event of another strong tremor, could jump down to the ground and protect themselves. (Figure 5.16)

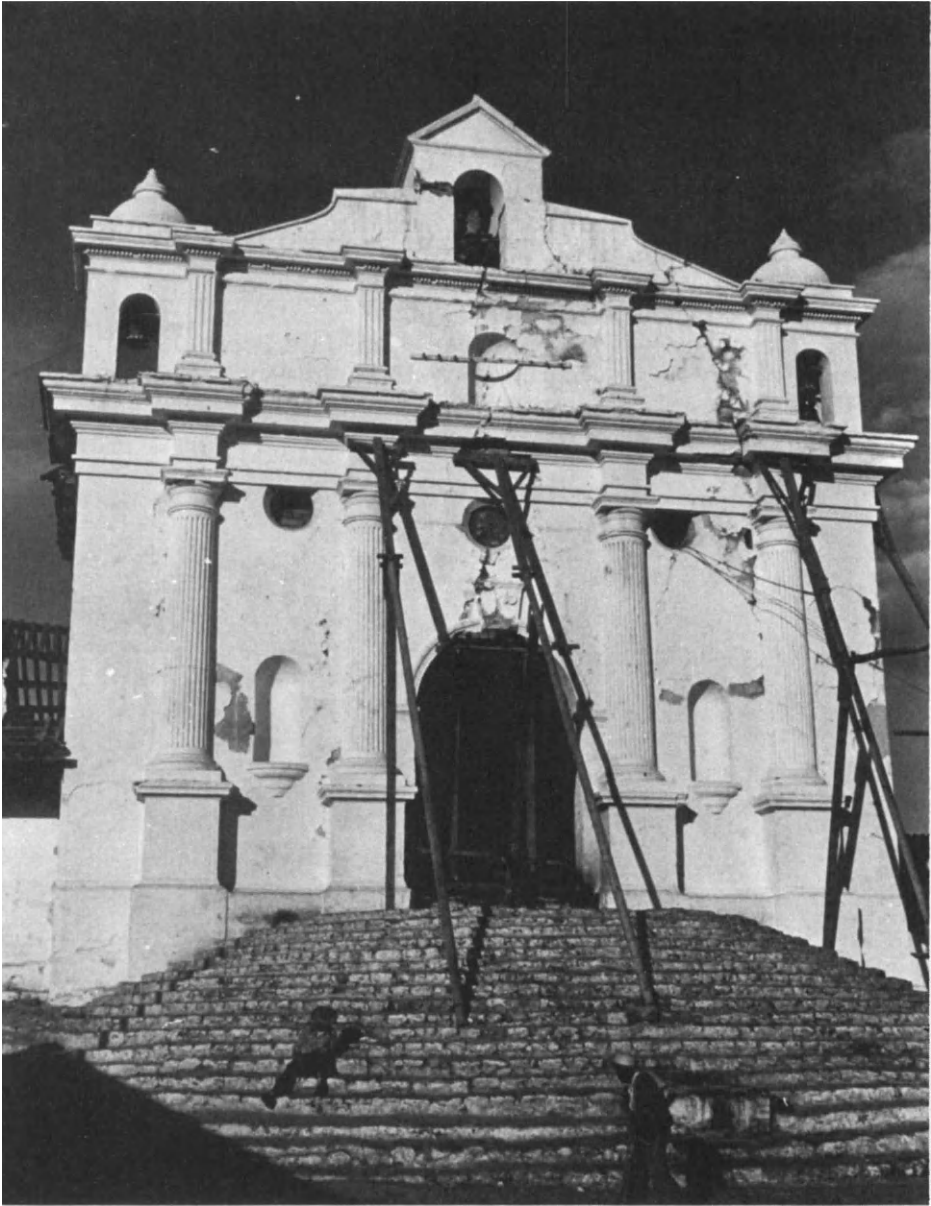
Figure 5.17. Quiche, Guatemala: Church of Santo Thomas Chichicastenango, 17th Century, Facade Showing Bracing Installed After Earthquake of February 4, 1976 to Prevent Unnecessary Destruction.

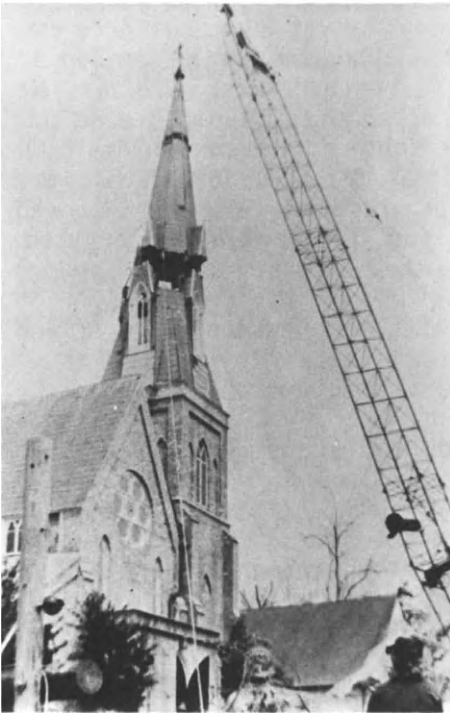
Figure 5.23. Mobile, Alabama: Trinity Episcopal Church, Henry Dudley and Frank Wills, Archts., 1853, Removal by Sections of Steeple Damaged by Hurricane Frederick, September 12, 1979.

After much soul searching, the architects and the Vestry agreed that it would not be wise to rebuild the steeple with wood and slate. The expense of proper maintenance would be prohibitive and the problem of getting good timber today simply cannot be solved. We contracted with a Kentucky firm to build a replica with a frame built of riveted aluminum angles designed to withstand a wind load of 120 miles per hours. The exterior was clad with a combination of anodized aluminum members and shingles made of micro-zinc. As the new steeple was considerably lighter than the old one, a new tie-down system was required so that the weight of much of the masonry tower was used to anchor the steeple. This time the rods had turnbuckles and were tensioned. (Figure 5.24)

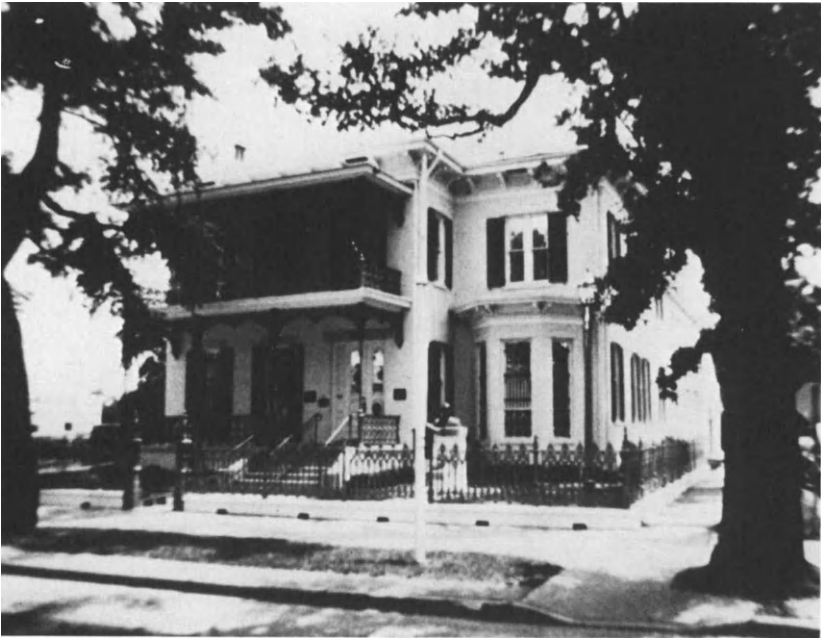
Figure 5.29. Mobile, Alabama: Bernstein House, 1872, Restored With Window Shutters after Hurricane Frederick, September 12, 1979.

We were retained to handle the repairs but work was slow getting under way because Alabama has a law that requires competitive bidding on all public works. This meant documents had to be prepared, advertised, bid, and so forth. But the work was accomplished, and this time the Museum Board found the money to install operable blinds. (Figure 5.29)

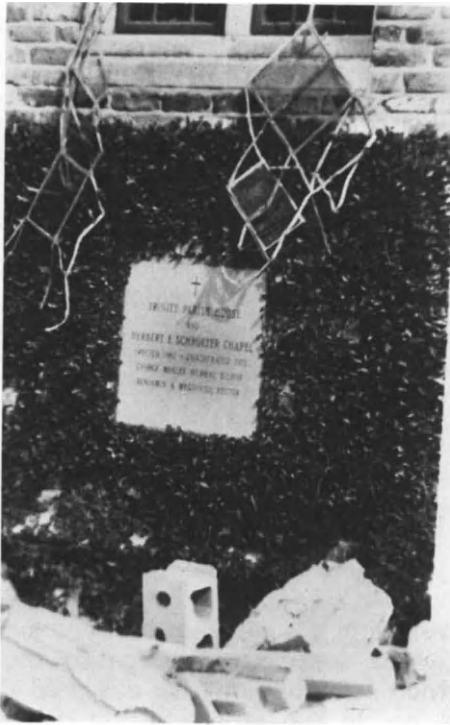
Figure 5.30. Mobile, Alabama: Trinity Episcopal Church, Henry Dudley and Frank Wills, Archs., 1853, Damage to Leaded Glass from Hurricane Frederick, September 12-13, 1979.

The problem of protecting glass is most serious in church buildings. Leaded glass is extremely valuable and lead comes simply do not have the strength to withstand hurricane forces. (Figure 5.30) Exterior coverings of plastic materials such as "Lexan" may offend the eye of the purist, but I know of no window so protected that suffered damage. (Figure 5.31)
