Protecting Historic Architecture and Museum Collections from Natural Disasters

Edited by
Barclay G. Jones, Ph.D.

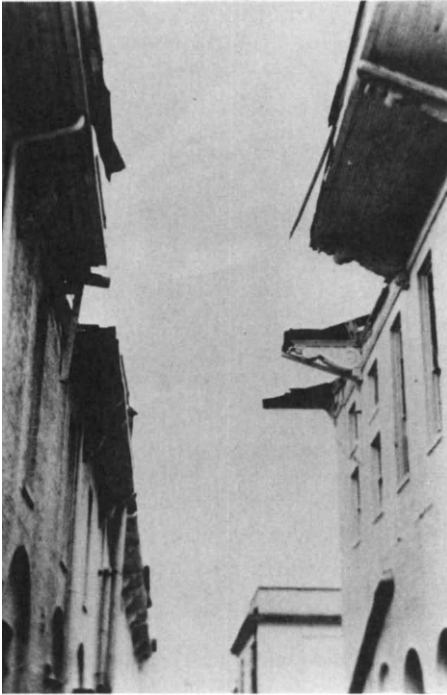
Figure 5.32. Mobile, Alabama: Damage to Eaves of Houses by Hurricane Frederick, September 12, 1979.

Eaves are particularly vulnerable. Some buildings suffered eave damage due to falling trees; others to wind alone. (Figure 5.32) The Gillis House was built in Biloxi in 1839, though it would look more at home in eighteenth century Louisiana. It lost its eaves during "Camille" in 1969. During its rehabilitation, we were particularly concerned with providing additional strength at the corners. Double steel angles were concealed within the corner eave boxings. Steel plates were bolted on the sides of other lookouts—prominent before painting but hardly noticeable after painting. The steel members were rigidly anchored to the main roof framing and these long elegant eaves withstood "Frederic". (Figure 5.33)

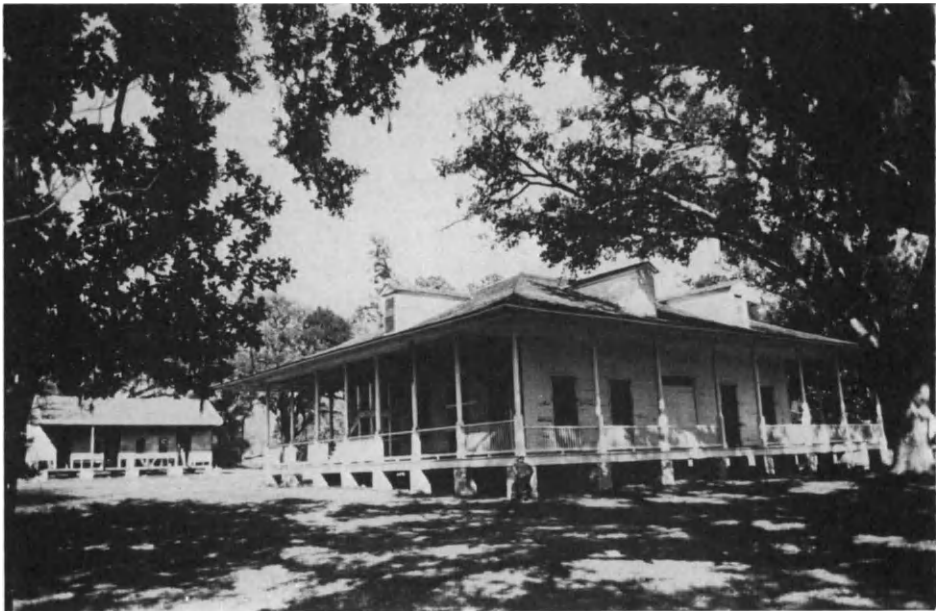
Figure 5.33. Biloxi, Mississippi: Gillis House, 1839, Eaves Lost in Hurricane Camille, August 18, 1969, Restored and Strengthened Which Survived Hurricane Frederick, September 12, 1979.

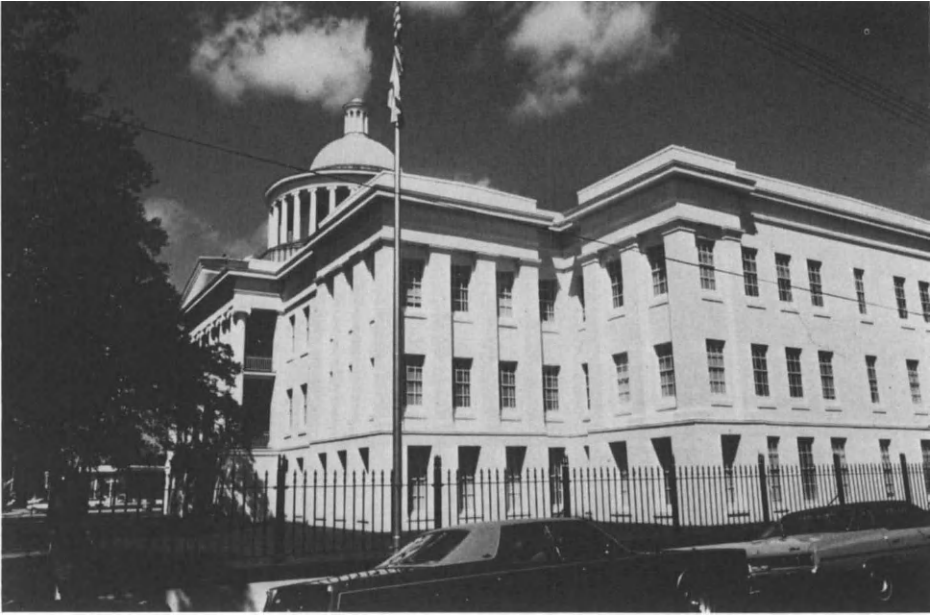
Figure 5.34. Mobile, Alabama: Barton Academy, James Gallier, Sr. and Charles B. Dakin, Archs., 1835.

And what of the masonry walls whose failure caused all the damage? Barton Academy is twenty years older and had no masonry problems. Nor did the Government Street Presbyterian Church, also designed by Gallier and Dakin in 1835. (Figure 5.43) In my opinion, the difference is that City Hall still had its lime stucco, by now weak and friable. The church had its stucco replaced 20 years ago and Barton received new stucco during our work in 1967. In both cases, lime stucco was not reused and there is no apparent ill effects caused by the change.

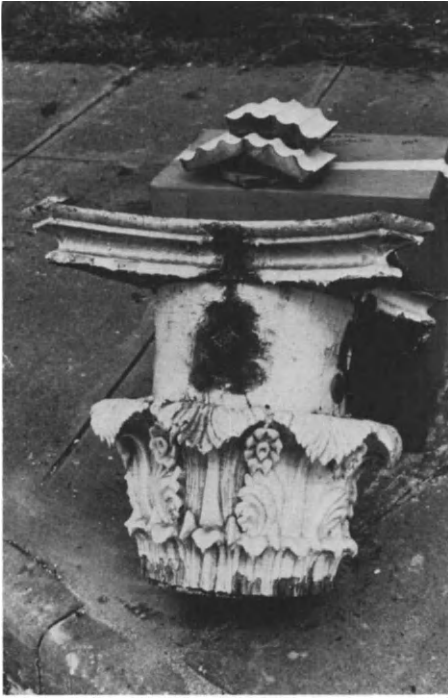
Figure 5.36. Montgomery, Alabama:
Alabama State Capitol, 1850, Deteriorated
Wooden Capital.

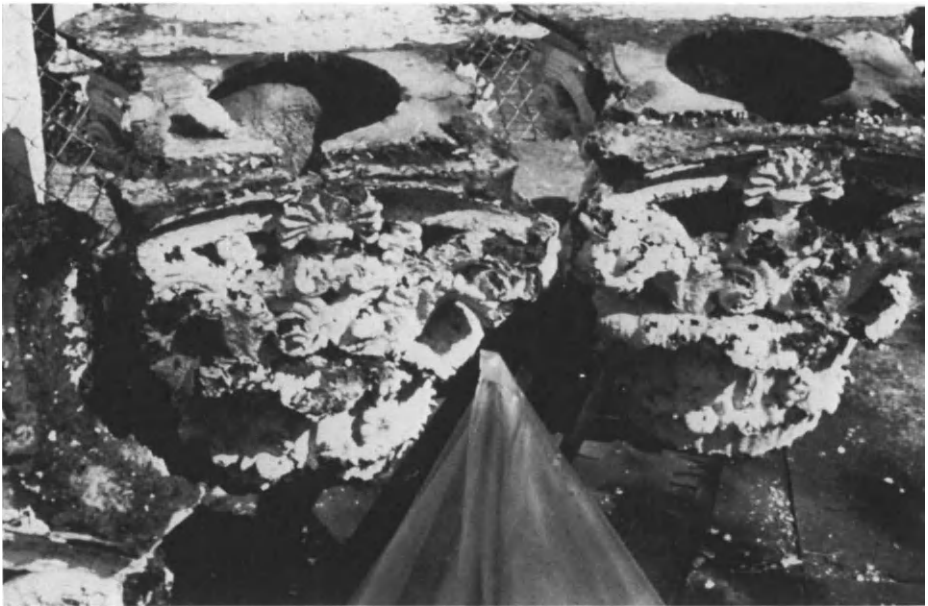
Figure 5.37. Montgomery, Alabama: Alabama State Capitol, 1850, Terra Cotta
Replacement Capitals Made in 1906.

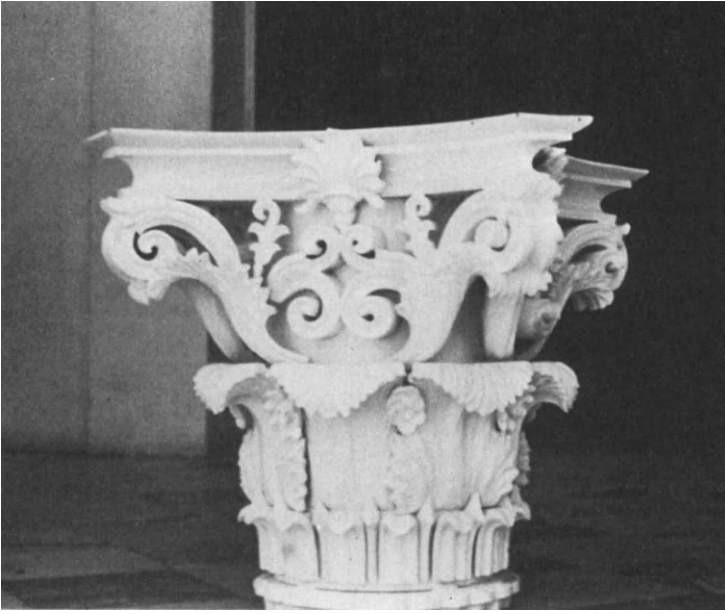
Figure 5.38. Montgomery, Alabama: Alabama State Capitol, 1850, Cast Aluminum Replacement Capitals Made in 1977.

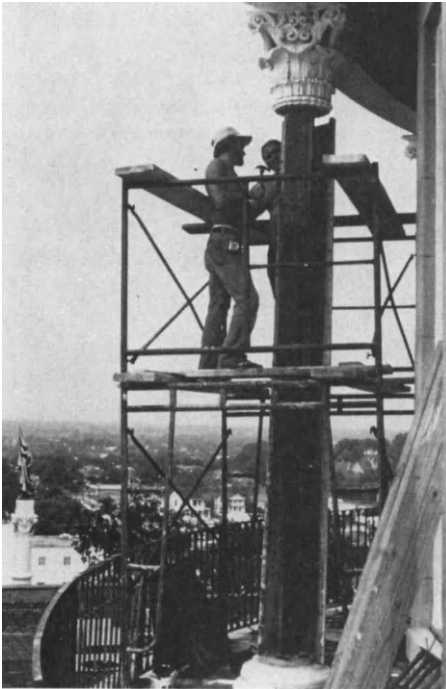
Figure 5.39. Montgomery, Alabama: Alabama State Capitol, 1850, Sectional Steel Columns Threaded Through Base and Capital Being Wrapped by Wood Shafts.

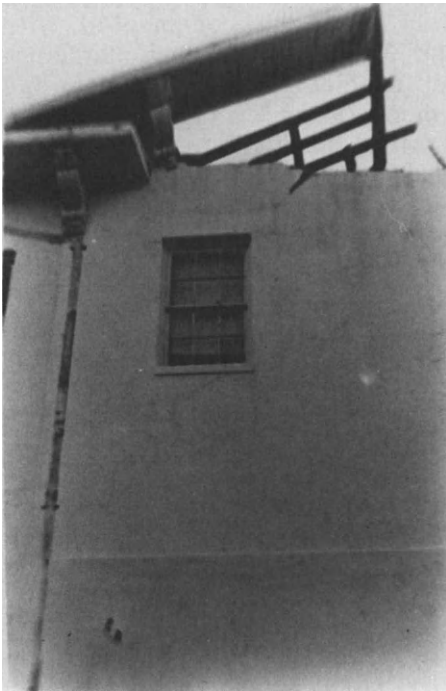
Figure 5.41. Mobile, Alabama: Mobile City Hall, 1854, Gable Wall Blown into Attic by Hurricane Frederick, September 12, 1979.

The masonry failure at City Hall was more spectacular. (Figure 5.40) Our City Hall was built in 1854 with administrative offices on the second floor and the municipal market on the ground level. It is one of the few of its kind left and is now a National Historic Landmark. The walls in the pedimented east facade of the South Annex and the south wing of the main building were both blown into the attic spaces. (Figure 5.41) The wind then blew into the attics and first blew down the ceilings of the second floors. The entire volume of the second floors was then pressurized until huge sections of the the roof literally exploded. Temporary efforts to secure the building failed—the damaged areas were too great. The City rented temporary offices elsewhere, vacated the building and retained us to do not just storm repairs but a much needed total rehabilitation.

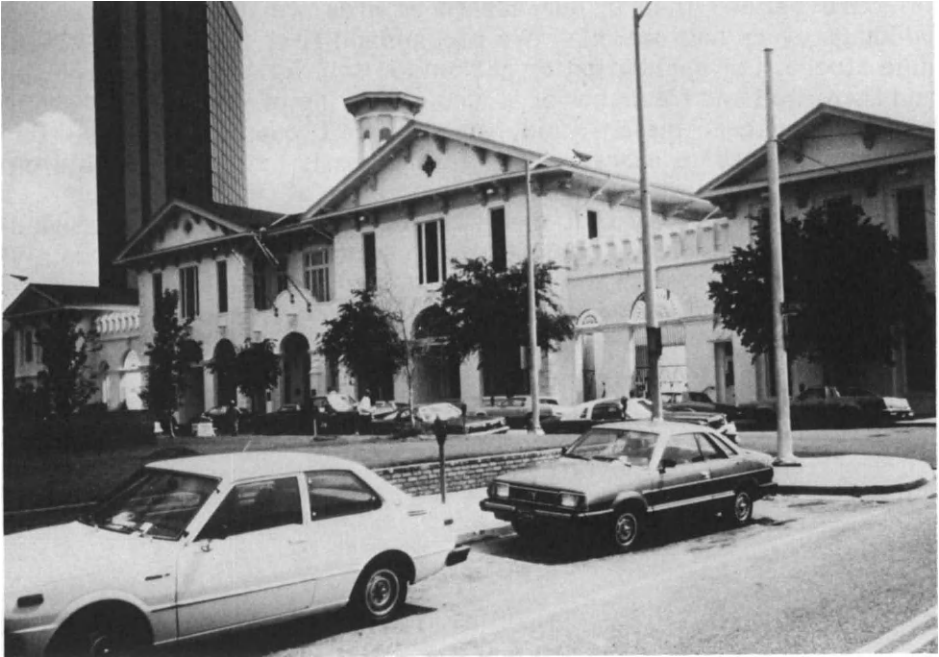
Figure 5.42. Mobile, Alabama: Mobile City Hall, 1854, Restored After Damage by Hurricane Frederick, September 12, 1979.

The rehabilitation is now under way. Among other items of work, all floors will be raised above the high water mark. All king post trusses will receive relieving steel angles and all structural members will be securely anchored. (Figure 5.42)

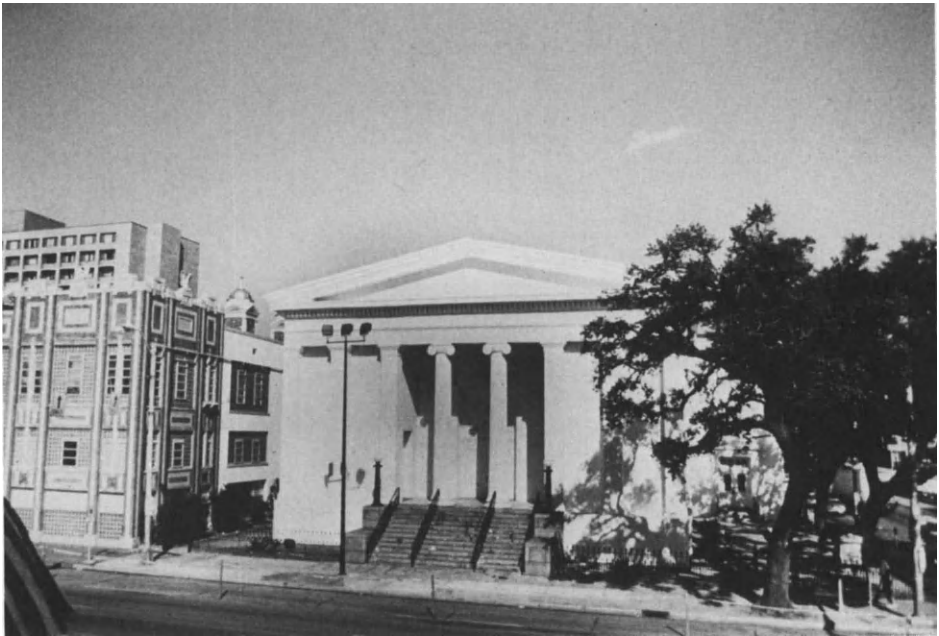
Figure 5.43. Mobile, Alabama: Government Street Presbyterian Church, James Gallier, Sr. and Charles B. Dakin, Archts., 1835, Which Survived Hurricane Frederick, September 12, 1979.

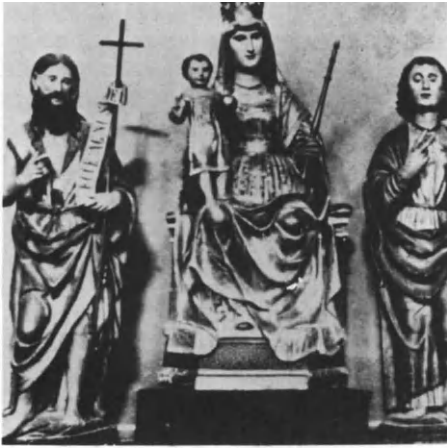
Figure 5.48. Gemona del Friuli, Italy: Chiesa di San Giovanni, 17th Century, Statue of Madonna and Child Before Earthquake of May 6, 1976, Showing Many Coats of Repainting.

Condition Before Treatment. The hardwood support was sponge-like and powdery as a result of damage by wood-boring insects. This weakness apparently exacerbated breakage which occurred during the earthquake. The instability of the sculpture caused by the irregularity of its bottom surface and the statue's top-heaviness led to a fall before we came to the scene. Forty-five fragments were found shortly after the earthquake. The nose, right knee, neck and back of the head were notably missing. (The saint's right hand was lost prior to the disaster according to a pre-earthquake photograph.) Many of the fragments had been abraded, partly because of handling following the earthquake. Checks occurred throughout the sculpture. A second layer of ground had been applied over earlier remaining polychromy. There were scattered areas of poor adhesion between the earlier and later strata.

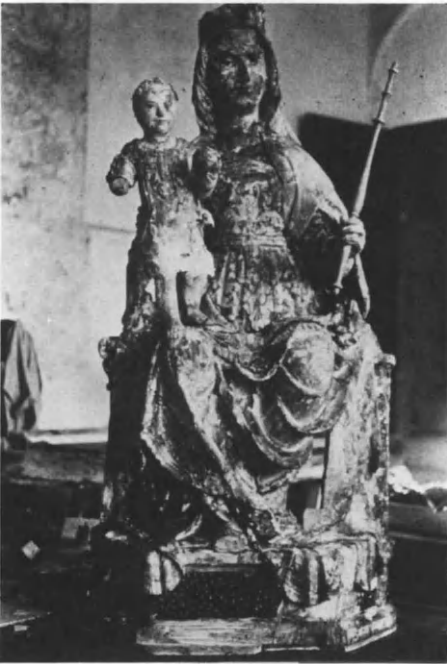
Figure 5.49. Gemona del Friuli, Italy: Chiesa di San Giovanni, 17th Century, Statue of Madonna and Child Reassembled with much Original Color and Gold Leaf Uncovered.

Treatment. All fragments were immersed in a dilute solution of Paraloid B72 in "diluyente nitro" for periods of 48 to 72 hours. Loose paint was reattached with a heated spatula using a dilute solution of Vinavil. Fragments were joined under pressure with Vinavil. Prior to joining, three 6-8 mm dowels were inserted in prepared holes to reinforce the right and left knees and left ankle. A putty composed of Weldwood resin and fine sawdust was used to fill the cavity of the left shin and give leg support lacking in the right knee. A wood-filled putty was applied over the Weldwood putty bringing the lacunae to approximately the level of the original wood surface. Checks were stabilized with Vinavil. Although the neck was missing, it was possible to determine the proper position for reattachment of the head from a pre-earthquake photograph. In order to hold the head with a vertical dowel centered over the body, a balsa wood addition was carved to fit

on the back center of the head. This was adhered under pressure with Vinavil. A 1 cm dowel was then adhered with Vinavil to holes drilled in the balsa wood and the body of the sculpture so that the head was correctly positioned. The area around the base of the dowel was reinforced with a putty of Vinavil, calcium carbonate and coarse sawdust.

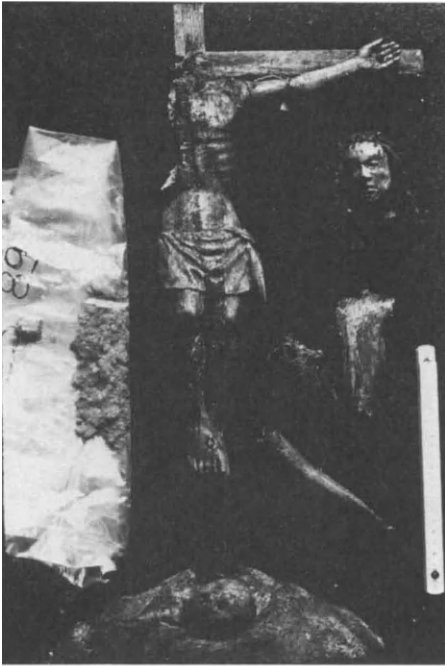
**Figure 5.50. Aprato di Tarcento, Italy:
Chiesa di Madonna Giglio, Crucifixion by
G. A. Agostini, 1604, Damaged Pieces after
Earthquake of May 6, 1976.**

Condition Before Treatment. Wood-boring insects had destroyed the support to such a degree that only the ground and paint held the sculpture together. It was impossible to find a single exposed area of wood from which a small sample could be taken for analysis. There were fresh breaks as a result of the earthquake which separated the figure into eight pieces: torso, two shoulders, head, two arms and two legs; the latter, however, were joined together by a nail which originally fastened them to the cross. (Figure 5.50) The left hand and part of the lower arm were carved from a new piece of wood dowelled to the original upper arm which itself showed an old repair. Parts of all the fingers of the left hand were missing and two fingers of the right hand. The right arm and hand were preserved, but so seriously worm-eaten that a small section joining the arm to the right shoulder was missing. The statue had been repainted and regilded at least once. There appeared to be modern gold on the loin cloth, overlaying a thick layer of light blue paint. Where the original flesh paint had been damaged, as in the large loss of Christ's left cheek, it had been covered by subsequent strata of ground and paint. The original flesh paint was yellowish in color, whereas the top layer was of a rosier tint applied with a coarse bristle brush. Cleavage occurred between the original and subsequent paint layers.

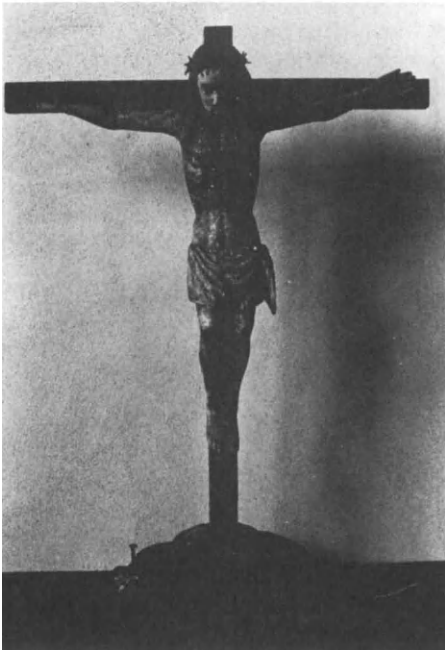
**Figure 5.51. Aprato di Tarcento, Italy:
Chiesa di Madonna Giglio, Crucifixion by
G. A. Agostino, 1604, As Reassembled after
Earthquake of May 6, 1976.**

application until it reached about 20%. Between applications the sections were wrapped in aluminum foil to prevent evaporation and to aid penetration. The torso weighed 950 g before treatment, 1050 g after four days, thus absorbing 100 g of Paraloid B72 solution. Each separate section of the statue was consolidated in this way. Christ's right shoulder weighed 350 g before treatment, 400 g after. Shoulders and head were joined to the torso with Vinavil; elastic bands were used to exert the necessary pressure where clamps were not feasible. The joins were not close because so much of the worm-eaten wood had crumbled away. Arms and legs could not be joined to the torso because of the missing intermediate sections. Also, because the lower vertical member of the cross was missing and there was not time to make a new one, there was nothing to support the feet of Christ. (Figure 5.51)

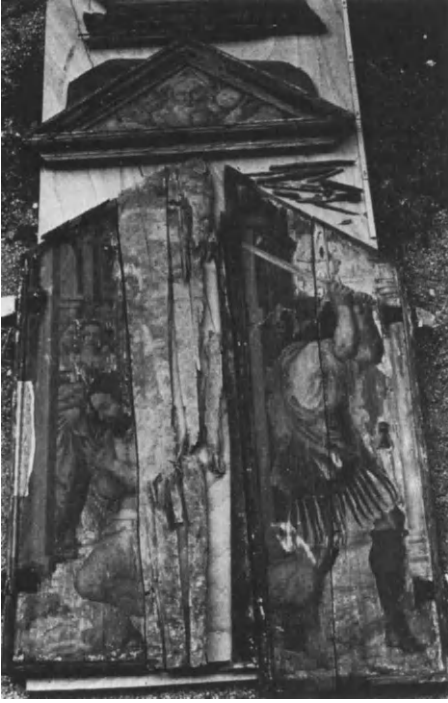
Figure 5.52. Maiano, Italy: Chiesa di San Giovanni Battista, Tabernacle, 17th Century, Broken Pieces after Earthquake of May 6, 1976.

Condition. The tabernacle was in markedly poor and fragmentary condition, covered with a layer of filth and rubble. The support was fractured in numerous places totalling 30 fragments, 13 of which had very little extant design. (Figure 5.52) Each door exhibited a longitudinal split down the entire length which cut the panel in half. The wood was moderately worm-tunnelled but generally was sound and not in need of consolidation. The soft, water-soluble gesso ground was lost or appeared abraded in many areas. Scattered lifting ridges of cleaved gesso were evident, particularly at the bottom of the left door (exterior). In numerous areas the gesso-and-paint film was actively flaking from the support, particularly on the left center of the proper

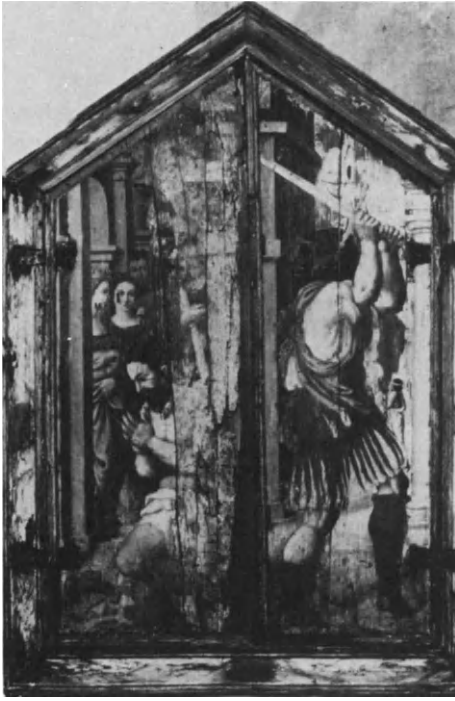
Figure 5.54. Maiano, Italy: Chiesa di San Giovanni Battista, Tabernacle, 17th Century, Rejoined, Closed after Earthquake of May 6, 1976.

The long process of reassembly began by eliminating the distortions in the many fragments. This was accomplished by moistening the individual fragments with hot water and clamping or weighting to coax the distortions back into plane. (Figure 5.53) The pieces were joined by glueing with Vinavil, and dowelling where necessary--5 dowels in the proper left door, 12 in the right. Cavities which were created by insect activity leaving an unsupported design layer were filled with a putty composed of sawdust, calcium carbonate and Vinavil. Three lacunae in the right door, through which daylight was visible, were filled with thin balsa wood inserts, toned to match the surrounding wood, and glued in place with Vinavil. In order further to consolidate the paint and to impregnate the pigments on the fragmentary half of the right door, a dilute solution of Paraloid B72, approximately 5% in "diluyente nitro," was brushed on, thus rendering much of the "lost" design visible. A final coating of 5% Paraloid B72 was then applied. Successive procedural steps were necessary to correct the insecurity of the overall structure. Loose member planks were secured with brass mending straps and screws. These were also used to secure the pediment and its moulding and to mount it in place. The severely corroded iron nails which had held the hinges were removed, the holes left in their place were plugged with dowels, and the doors rehung by fastening the hinges with brass screws. Two horizontal wooden battens were attached to the reverse of the tabernacle with brass screws in elliptical slots to provide security to the framework yet allow slight movement of the wood. Finally, temporary battens were mounted to the reverse to facilitate handling. (Figures 5.54, 5.55)

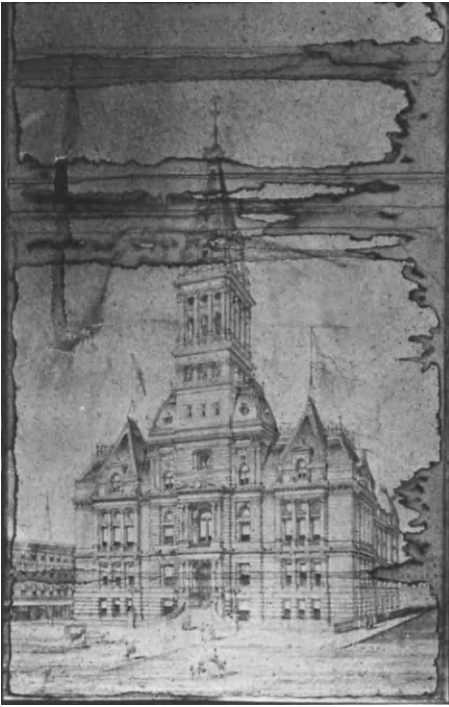
Figure 5.58. Water Stained Drawing.

In the case of a fire, often the most serious damage to the books is caused by the fireman's hose. (Figure 5.58) Materials that are charred but dry are not in any immediate danger and can be dealt with at leisure. A prime example is material partially burned during the great fire at New York State Library in 1911 that NEDCC is now treating, seventy years later. (Figure 5.59)

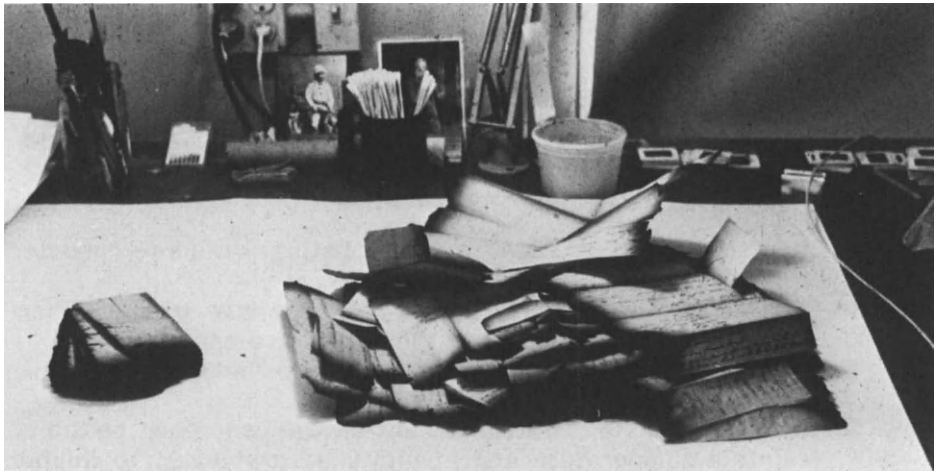
Figure 5.59. Partially Burned Material from New York State Library Fire of 1911
Currently Being Treated by Northeast Document Conservation Center.

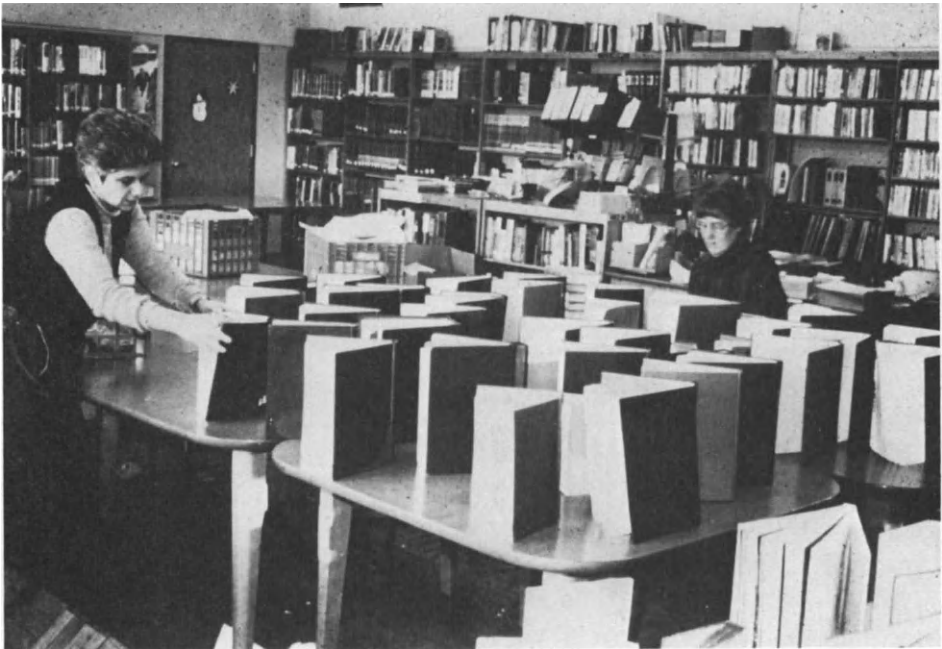
Figure 5.63. Pleasant Valley, New York: Arlington High School Library, Air Drying Books That Had Been Frozen for Stabilization for a Week.

9. Determine which materials can be air dried immediately and which must be frozen. (Figures 5.62 and 5.63)
10. Keep a list of all materials removed from their shelves for air drying or freezing.
11. Separate books from each other with freezer wrap before freezing so that they will not stick together. Pack them in plastic milk crates or in heavy cardboard boxes of about the same size. Wrap wet documents in small packets about the size of a document box. (Figures 5.64 and 5.65)
12. Identify materials wrapped and boxed for freezing on the outside of their packages.
13. Contact insurance company to see if coverage applies.
14. Publicize the disaster in order to mobilize goodwill, services and volunteer help from the community.

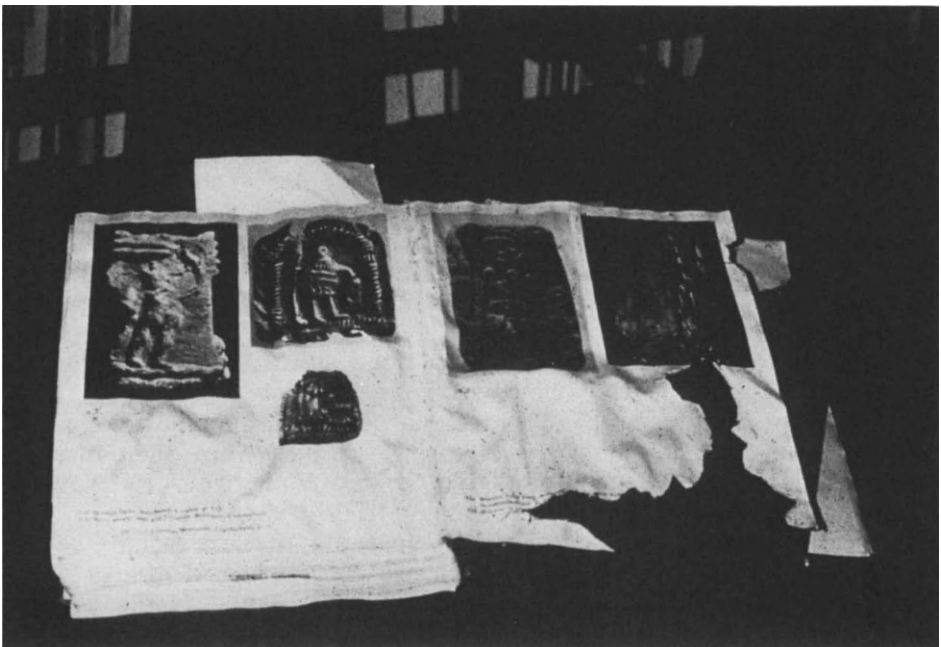
Figure 5.67. Damage to Book Printed on Coated Stock Caused by Fusing of Pages on Drying.

NEDCC's staff of professional book and paper conservators are able to salvage most damaged books and documents, with the exception of books printed on coated stock. (Figure 5.66) Coated pages tend to stick together when wet and can usually be salvaged only by freeze-drying. (Figure 5.67) This requires equipment not available at NEDCC. Salvage of a water-damaged volume might involve simply flattening it, or it might require elaborate restoration, including washing of every page and rebinding of the volume. Restoration is extremely expensive—except for the most valuable books in a collection, it is usually less expensive to replace the book than to restore it.

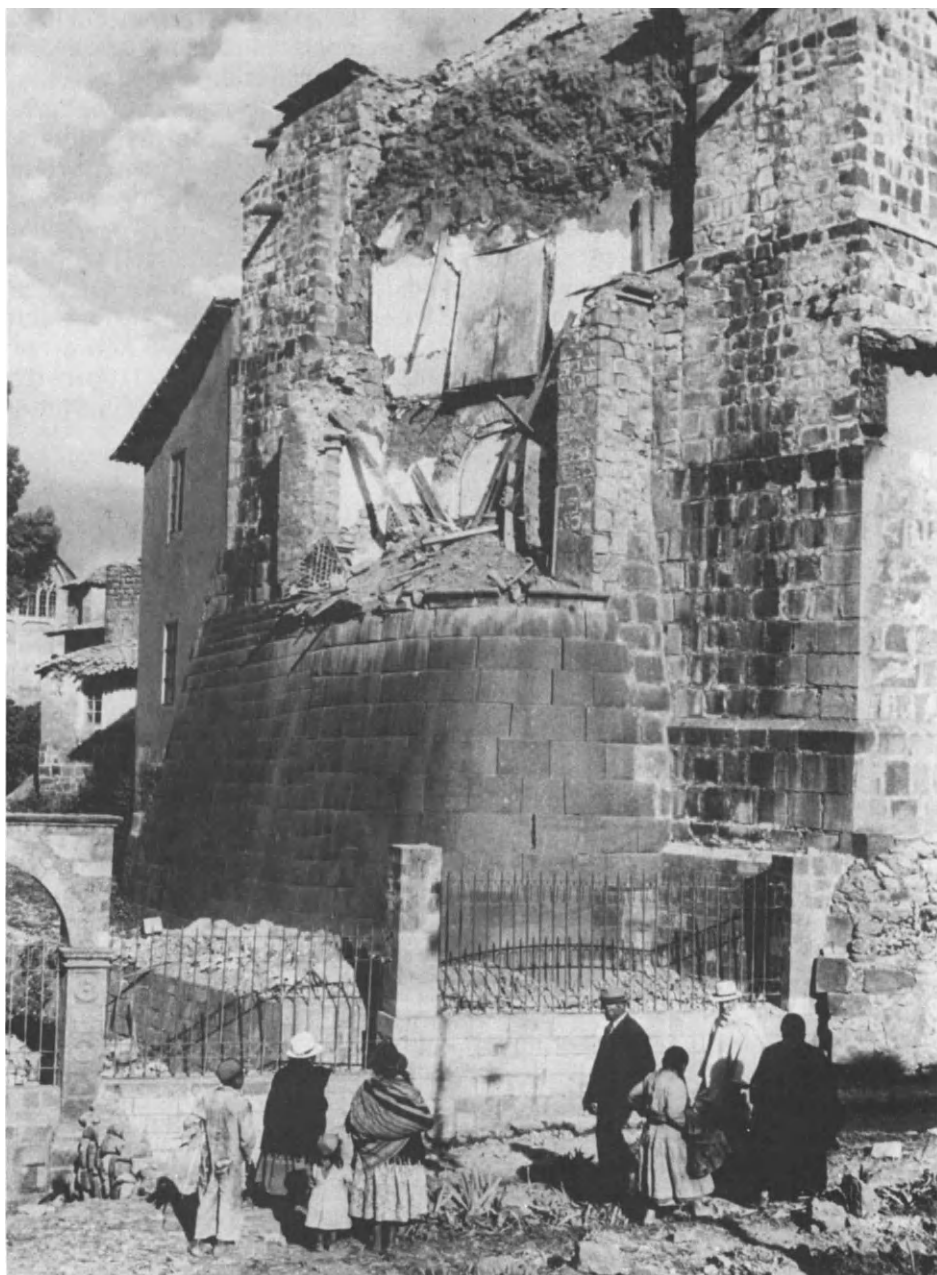
Figure 6.1. Cuzco, Peru: Church after Earthquake of May 21, 1950.

Many of Cuzco's dwellings made of adobe—unbaked clay bricks strengthened with chopped straw and formed in molds—were completely destroyed. This was caused not only by the comparative lack of resistance of the material, but also by poor construction or

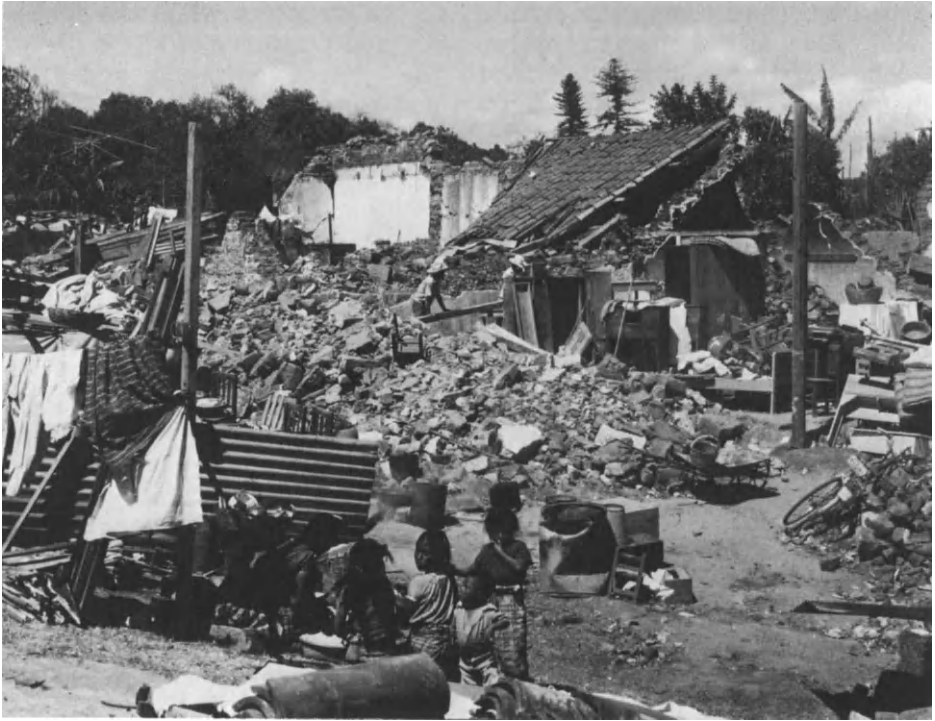
Figure 6.4. Chimaltenango, Guatemala: Destruction of Vernacular Buildings in Earthquake of February 4, 1976.

On February 4, 1976, an earthquake took place in the highlands of Guatemala which measured 7.5 on the Richter scale. It was followed by a number of after shocks resulting in extensive damage to monuments and dwellings. (Figure 6.4) An estimated 23,000 people were killed and 75,000 injured. The scale of the disaster was such that the Government requested UNESCO to launch a campaign to aid it in the preservation of its cultural heritage.

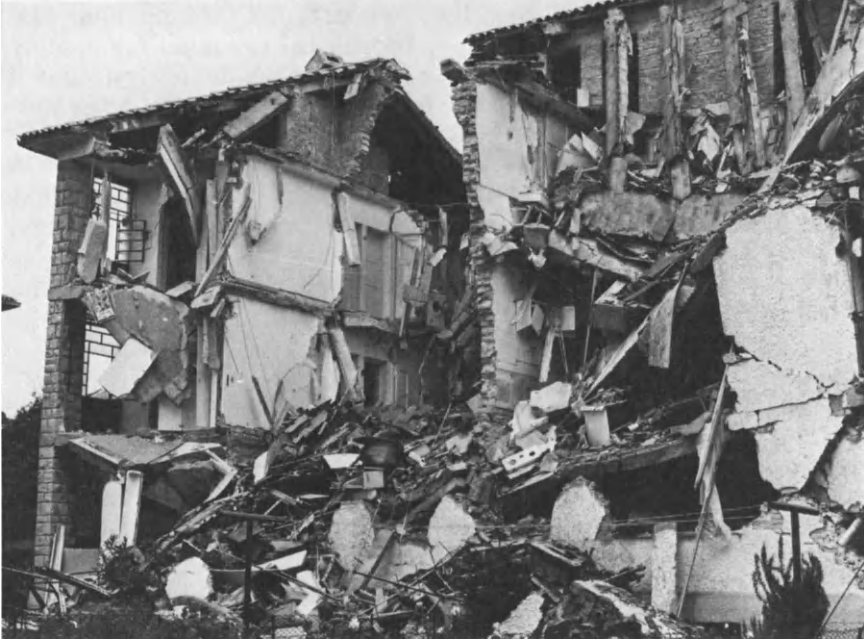
Figure 6.5. Gemona del Friuli, Italy: View of Damaged Buildings after Earthquake of May 6, 1976.

More than three-quarters of the houses in the affected area were old, their walls made up of badly laid rubble masonry, sometimes mixed with bricks and thickly laid clay or lime plaster mortar. Many were two to three stories high with heavy floors and roofs supported by joists of timber which were inserted a few inches into the masonry but which were otherwise unsupported. Some of them had tie rods placed to give greater support to floor beams and such buildings had a better survival rate. Without such reinforcement a slight outward movement of the walls caused the joists to pull free and roofs or floors to collapse. (Figure 6.5 and 6.6) Many of the old houses had been abandoned for several years or had deteriorated badly through lack of maintenance. Such buildings offered little resistance to the earthquakes. Ambraseys added that:

Both old and new houses which had recently been renovated suffered the most. Some of them had a second or third story added, supported partly by old walls and partly by new reinforced concrete columns. Masonry houses had also been tampered with at different times. A common cause of unintentional weakening is the installation of new electricity and water conduits, the relocation of bathrooms and sewer and drainage pipes in old walls. Improper repairs that have weakened the walls and the cumulative effects of such interference with the stability of the structure, have produced buildings each with its own problems; almost none of these damaged are capable of being strengthened economically. [Ambraseys, Pichard and Ziogas, 1976, Part II, p. 10]

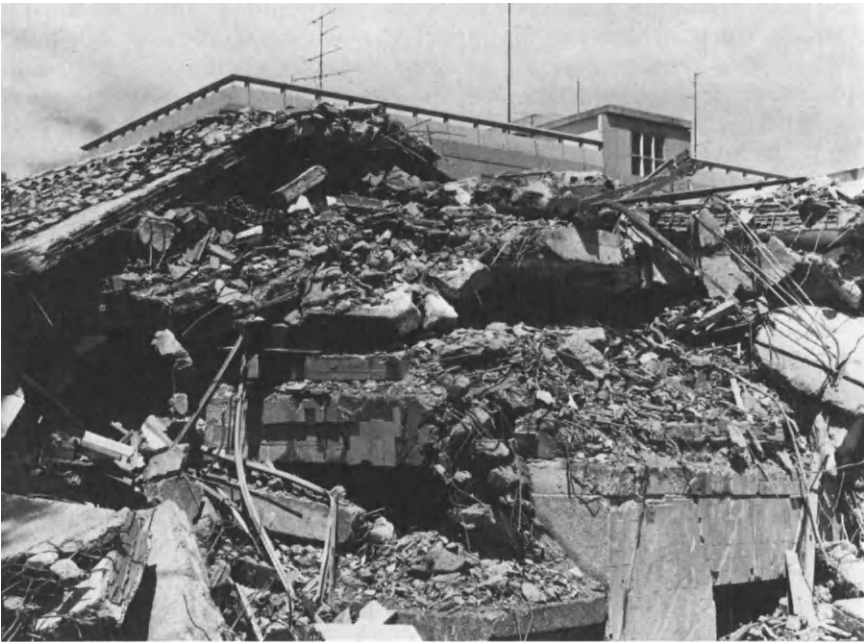
Figure 6.6. Gemona del Friuli, Italy: View of Pancaked Modern Reinforced Concrete Structure after Earthquake of May 6, 1976.

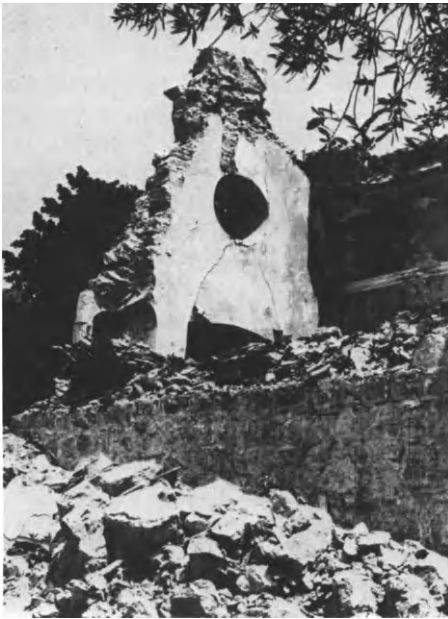
Figure 6.8. Montenegro, Yugoslavia: Church, Showing Destruction Caused by Earthquake of April 15, 1979.

The team found that the most severely affected buildings were old houses—usually built of stone, one to three stories in height—many of which had artistic or historic value. The most important historic complex was the walled town of Opstina Kotor, in which the majority of buildings were weakened or damaged. The second group of importance included the Palace of the Sea Captains in Dobrota and a number of small rural and town churches dating from the 12th to 14th century. Of 454 churches about a fourth (134) were totally destroyed and about the same number (138) heavily damaged. (Figure 6.7 and 6.8)
