Prevention of Premature Staining of New Buildings

Phil Parnham

*Principal Lecturer in Building Surveying, Sheffield Hallam
University, UK*

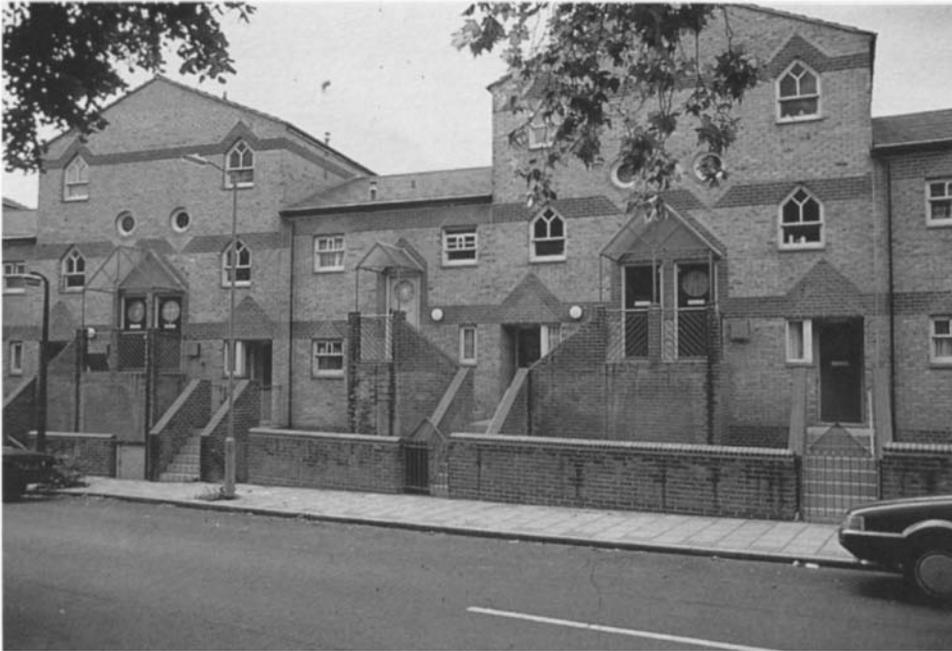
Figure 0.1 Elevation of housing development affected by premature staining.

Despite the pride and excitement surrounding the scheme’s completion, the visual image of the buildings did not stand the test of time. Within a year of completion, ugly algae staining had affected almost every constructional detail on many elevations. The balconies, external staircases, window cills and parapet walls were most badly affected (see [Figure 0.1](#)). The visual effect was so overwhelming that the disfigurement became the most dominant feature of the development to many occupants and observers.

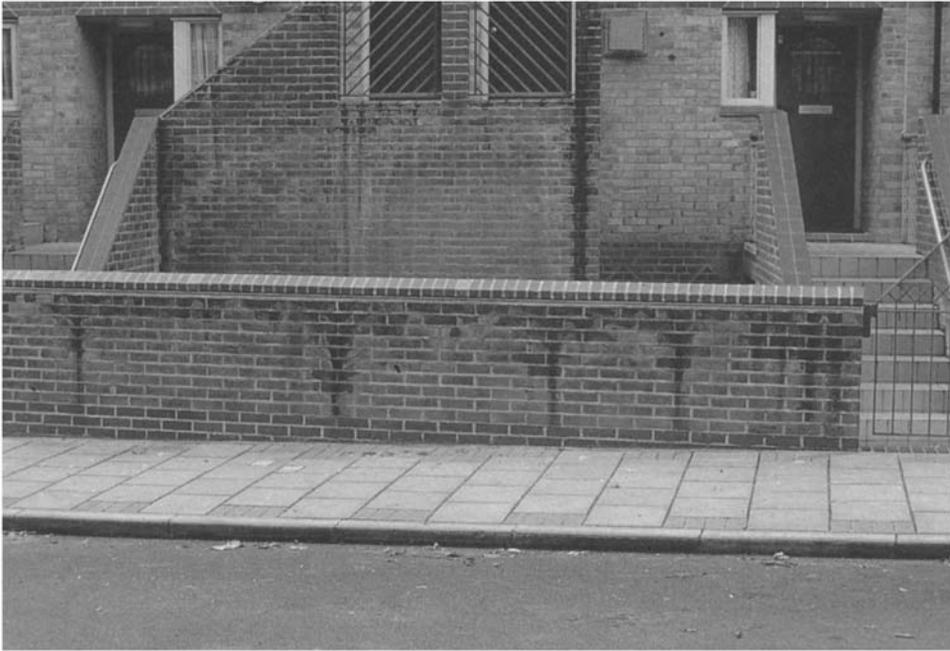
Figure 0.2 The boundary wall was particularly badly affected.

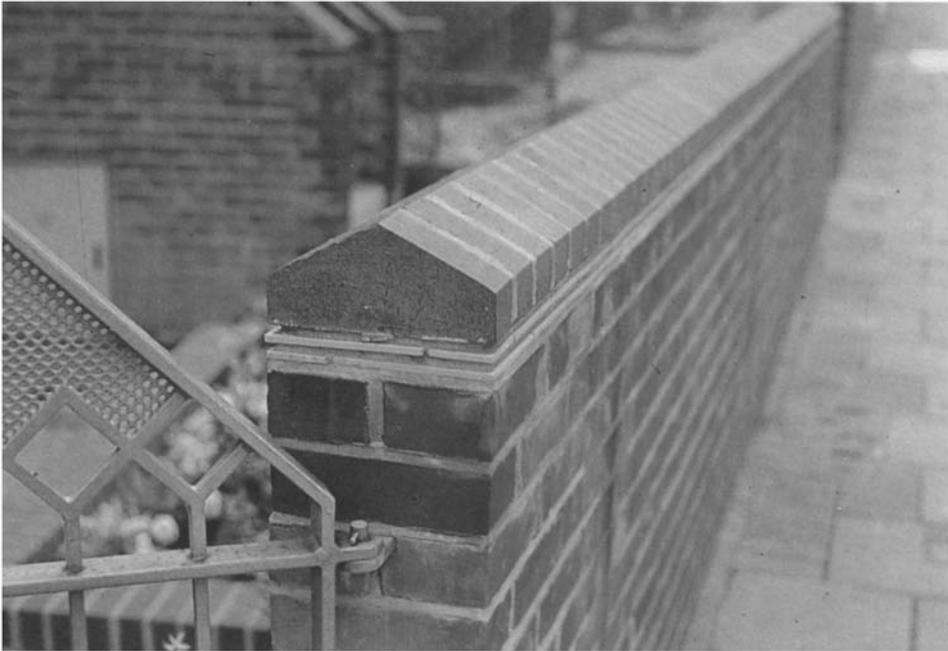
Figure 0.3 Detail of Figure 0.2.

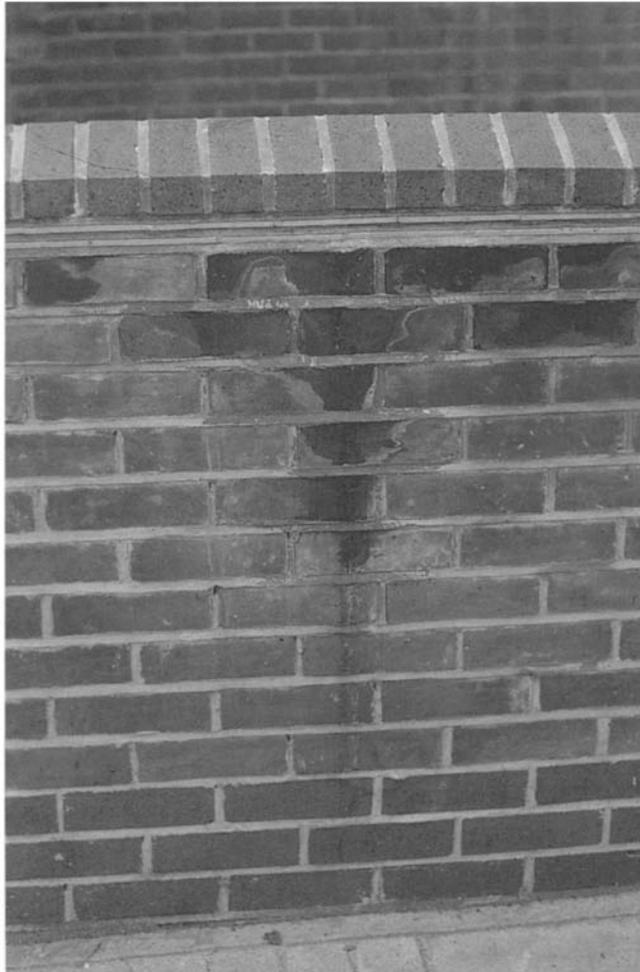
Figure 0.4 Detail of brick coping showing flush tile creasing.

The housing scheme described in the Preface of this book included a tile creasing feature which had been cut back flush to the face of the wall. Although this might have given a reference to a ‘vernacular’ style, it served no useful function (see Figures 0.1 to 0.4). The boundary wall in Figures 4.7 and 4.8 illustrates how a tile creasing below can actually cause staining rather than prevent it.

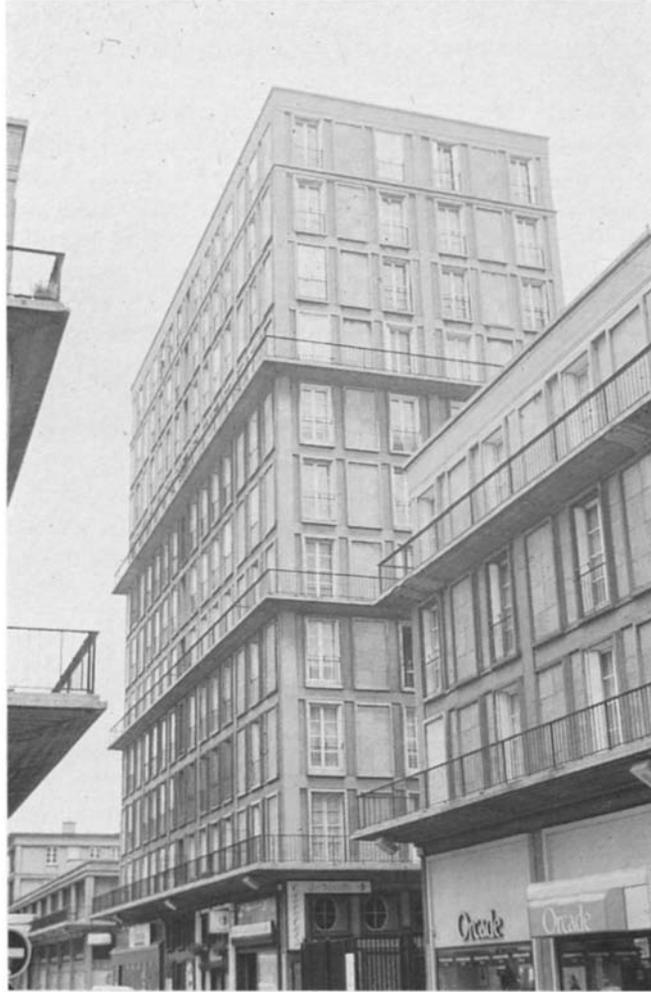
Figures 2.1 and 2.2 Typical examples of Perret's buildings in Le Havre. Note the strong overhanging horizontal/string courses.

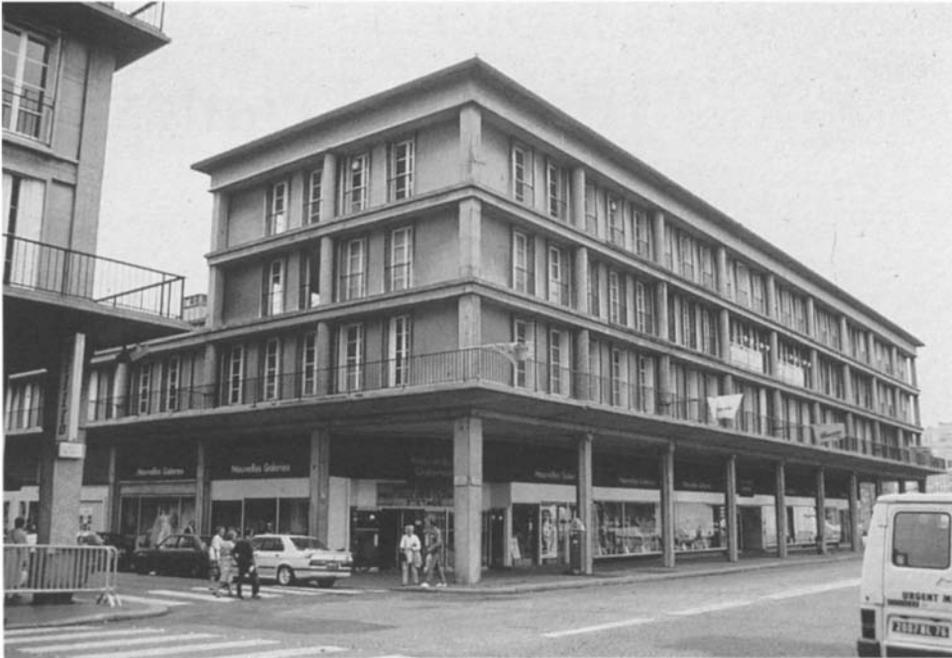
Figure 2.3 Typical ornamental details. This illustration shows details through a column following a classic style. Although heavily ornamented, few of these details would throw flowing water clear of the building.

designer of buildings in the provision of boldly projecting porches, strong roofs of moderate pitch and strong walls...all designed to protect the buildings from the weather' but still recommended details that held true to historical influences rather than their ability to shed water ([Figure 2.3](#)).

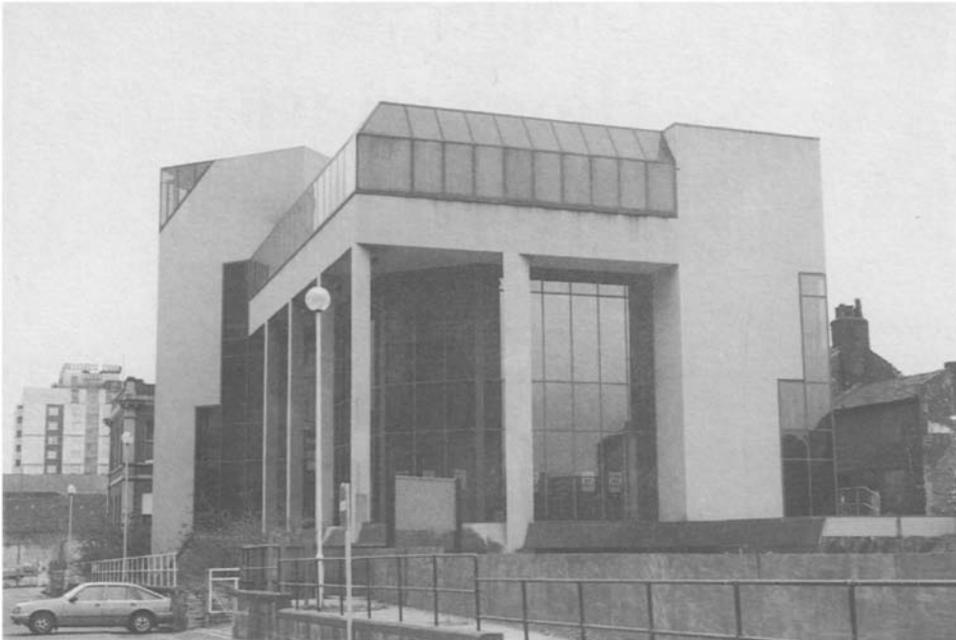
Figure 3.2 General view of a building clad with smooth faced stone panels possibly sandstone.

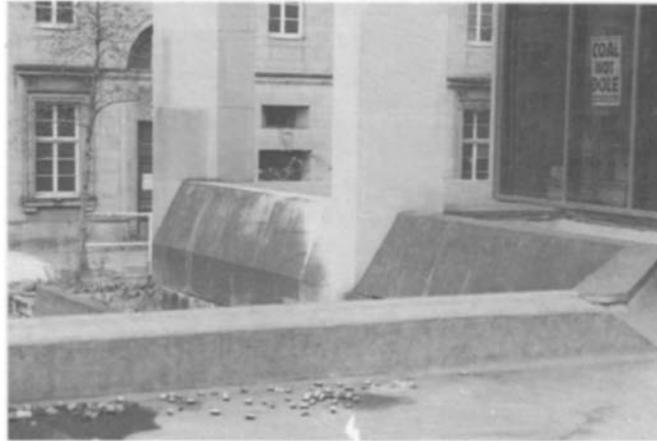
Figure 3.3 Detail showing extensive algae growth to the surface of the cladding around the base of the building. Here water flow from the top of the parapets and hardstanding has been directed over the face of the panels. The elevation faces north.

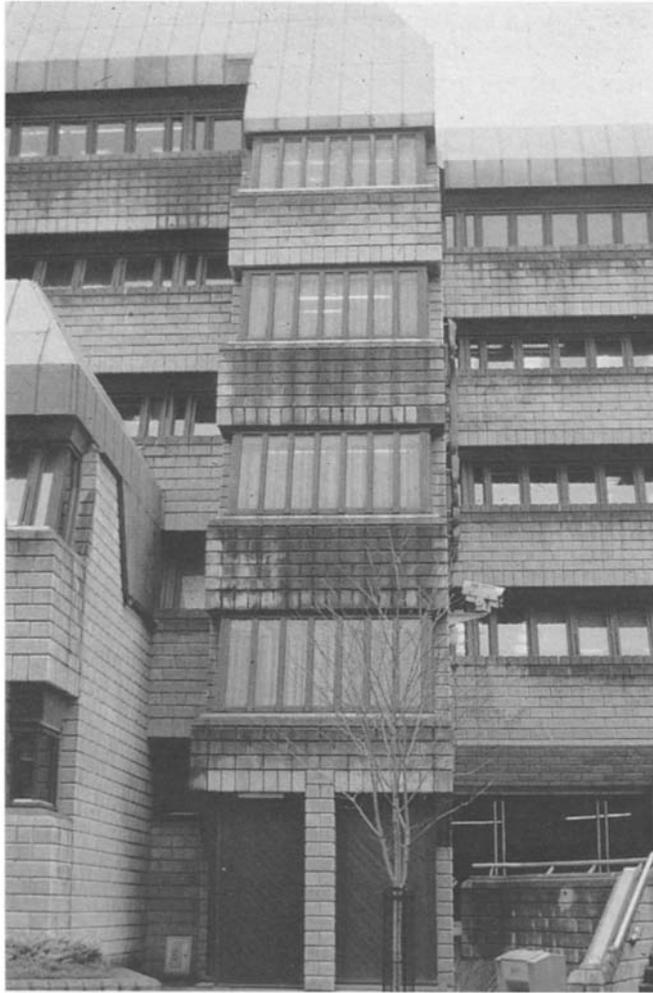
Figure 3.4 Part elevation of a stone-clad building in Glasgow.

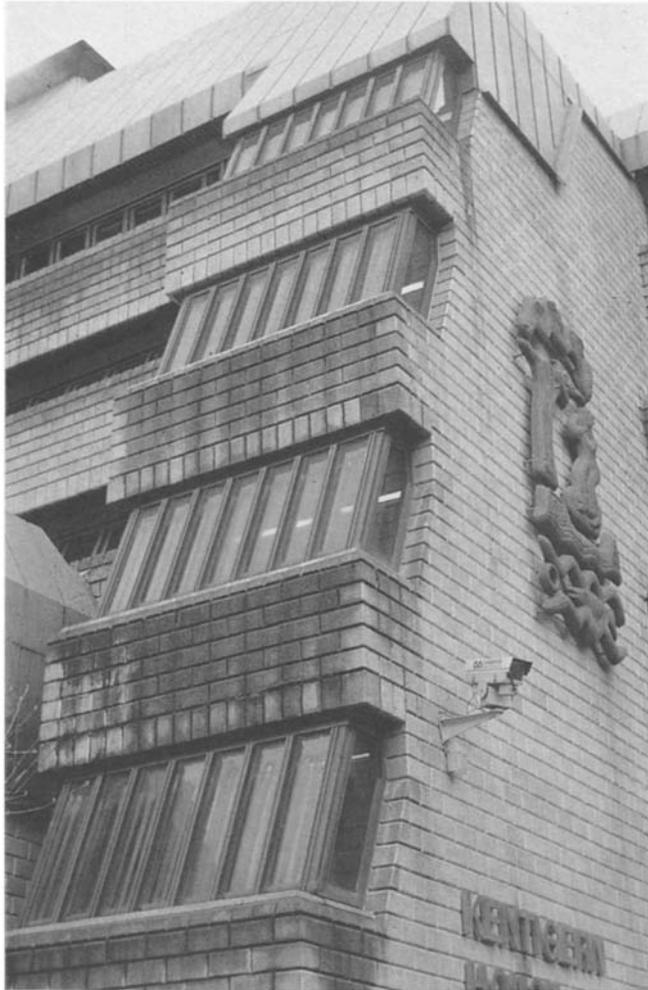
Figure 3.5 Detail of [Figure 3.4](#). Water was allowed to flow off the metal roof and onto each glazed area cumulating as it travelled downwards. There was no gutter or drain to minimize the flow which resulted in extensive algae growth increasing in intensity at lower levels.

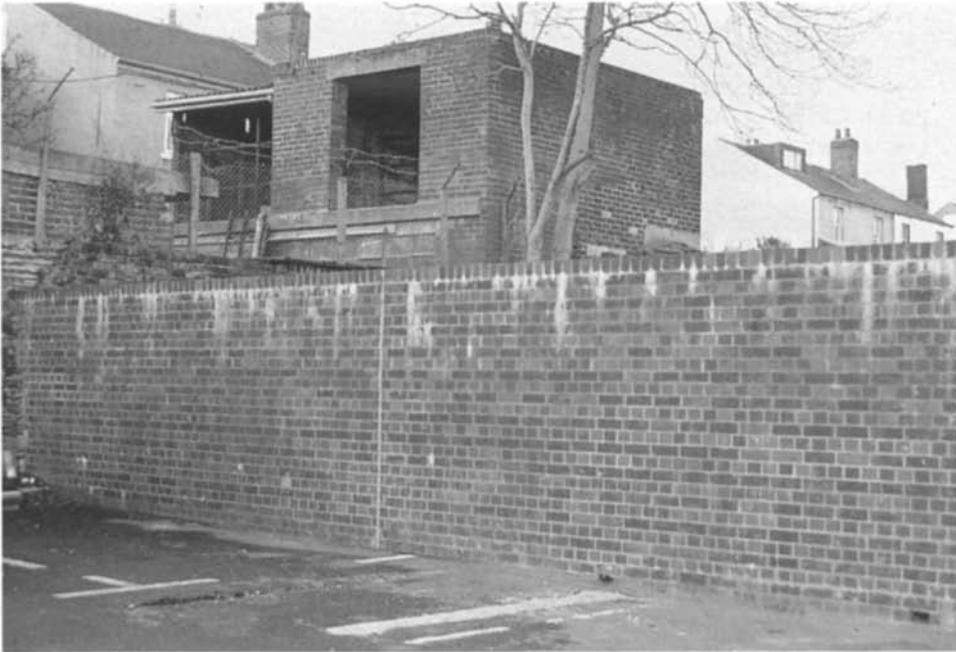
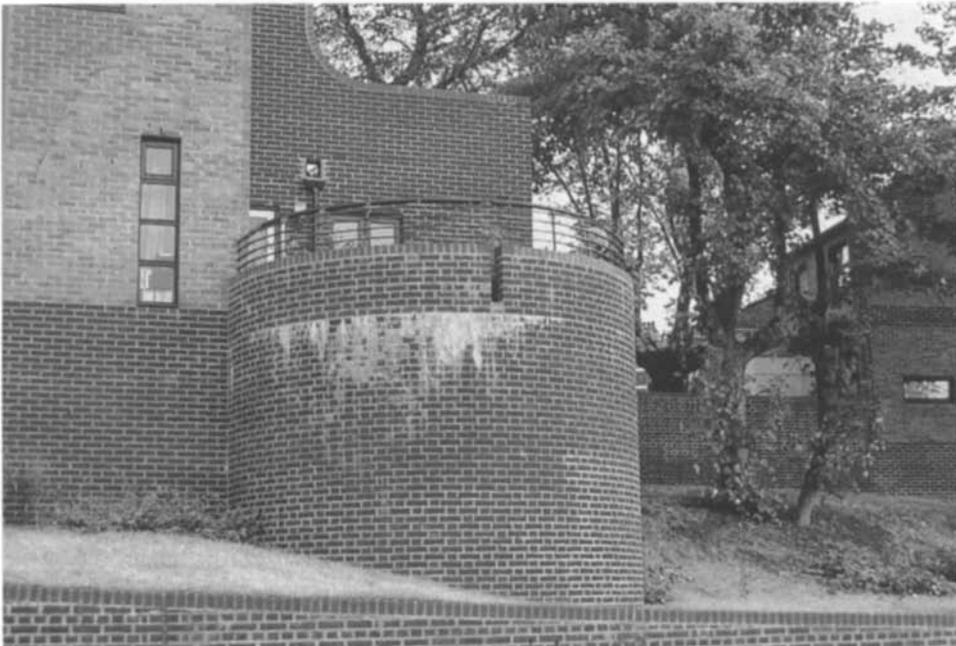
Figure 3.6 Lime staining on (a) brick parapet, and (b) circular wall.

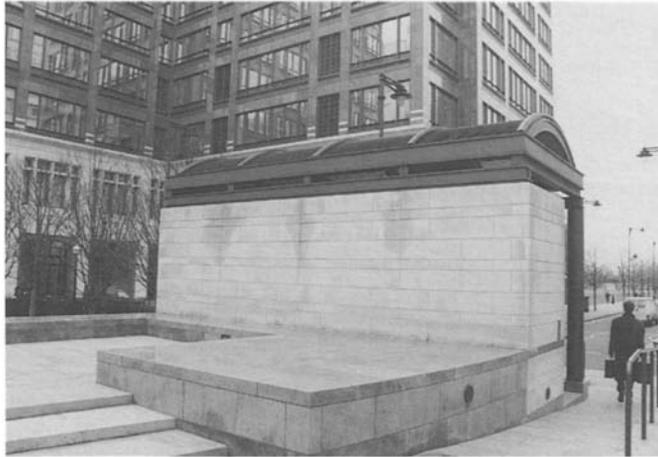
Figure 3.7 Rear elevation of a bus shelter in London that has been faced with smooth stone cladding panels. The roof was metal with a copper component.

For some materials, flowing water can dissolve constituents from it and deposit them on another adjacent material. The most notable examples include water flowing off concrete on to brickwork allowing deposition of white blotches of calcium carbonate and the run-off from copper components producing green staining on other materials. A typical example of this is shown in Figures 3.7 and 3.8.

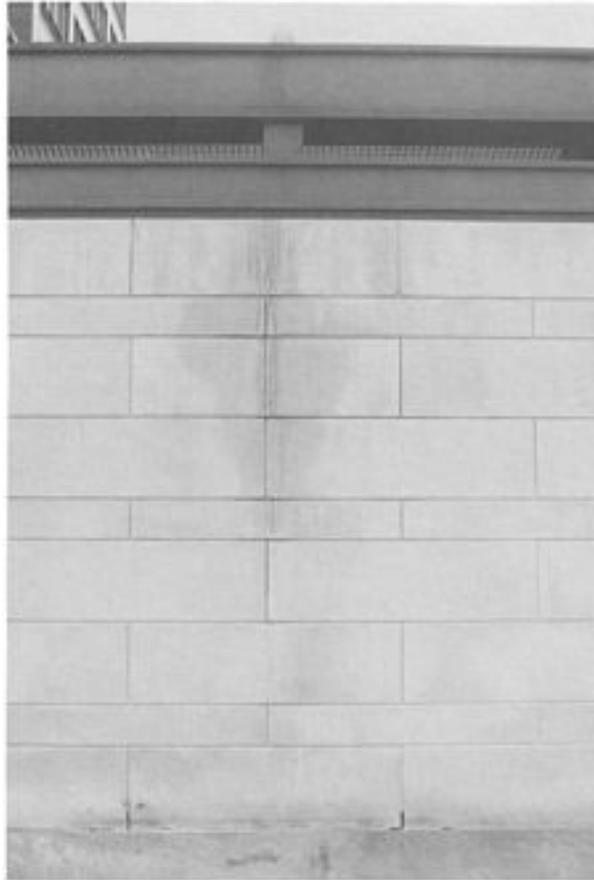
Figure 3.8 Detail of roof/cladding junction. Run-off from the roof components was allowed to flow over the stone depositing green/grey stains on the face.

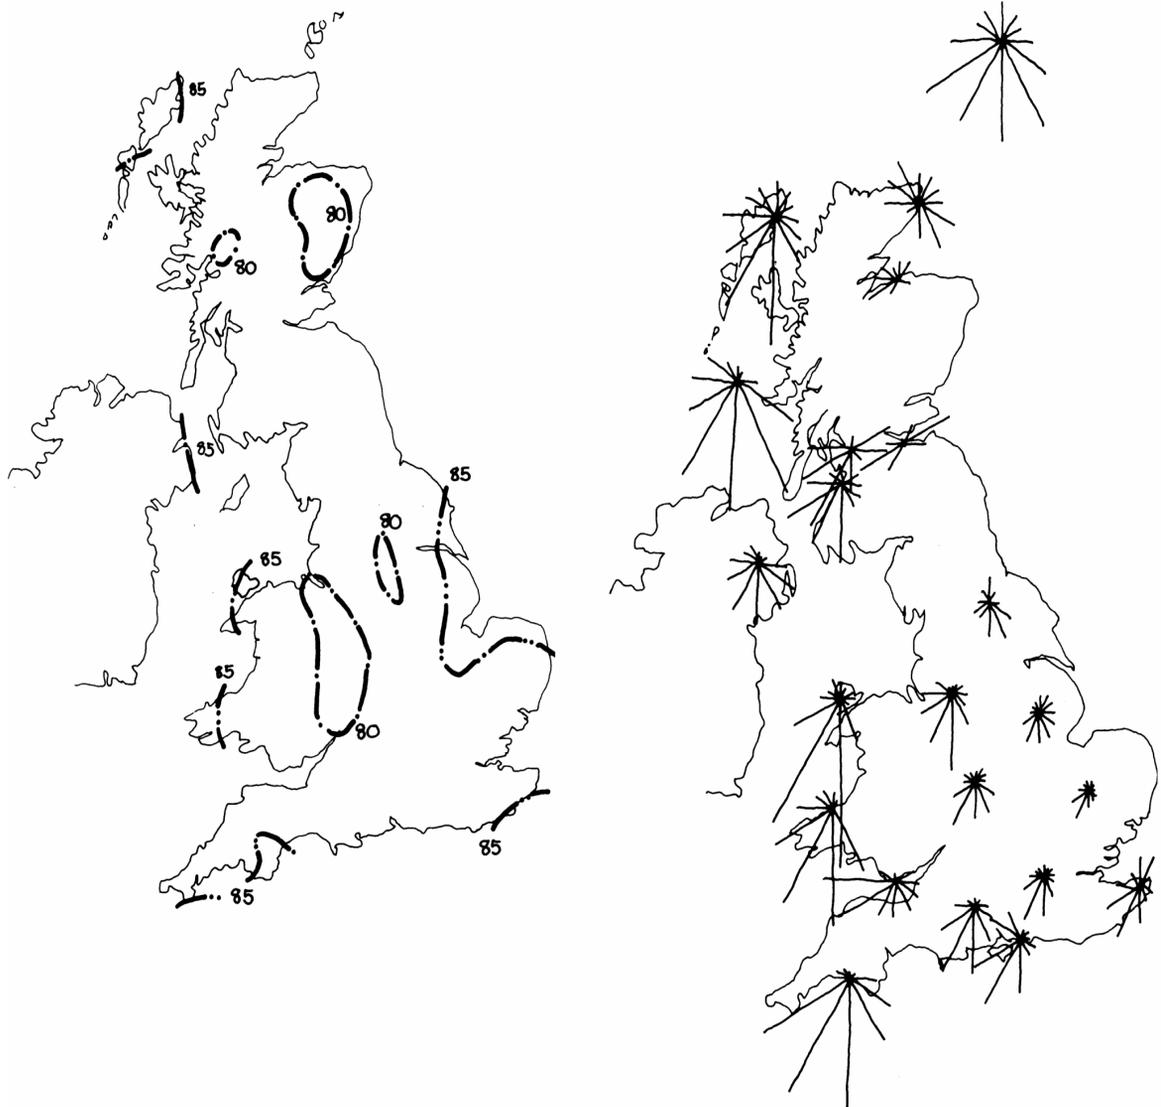
Figure 3.9 (a) Average means of relative humidity in the British Isles during January; (b) map of the UK showing annual mean driving rain roses, 1956–66 (Lacy, 1977).

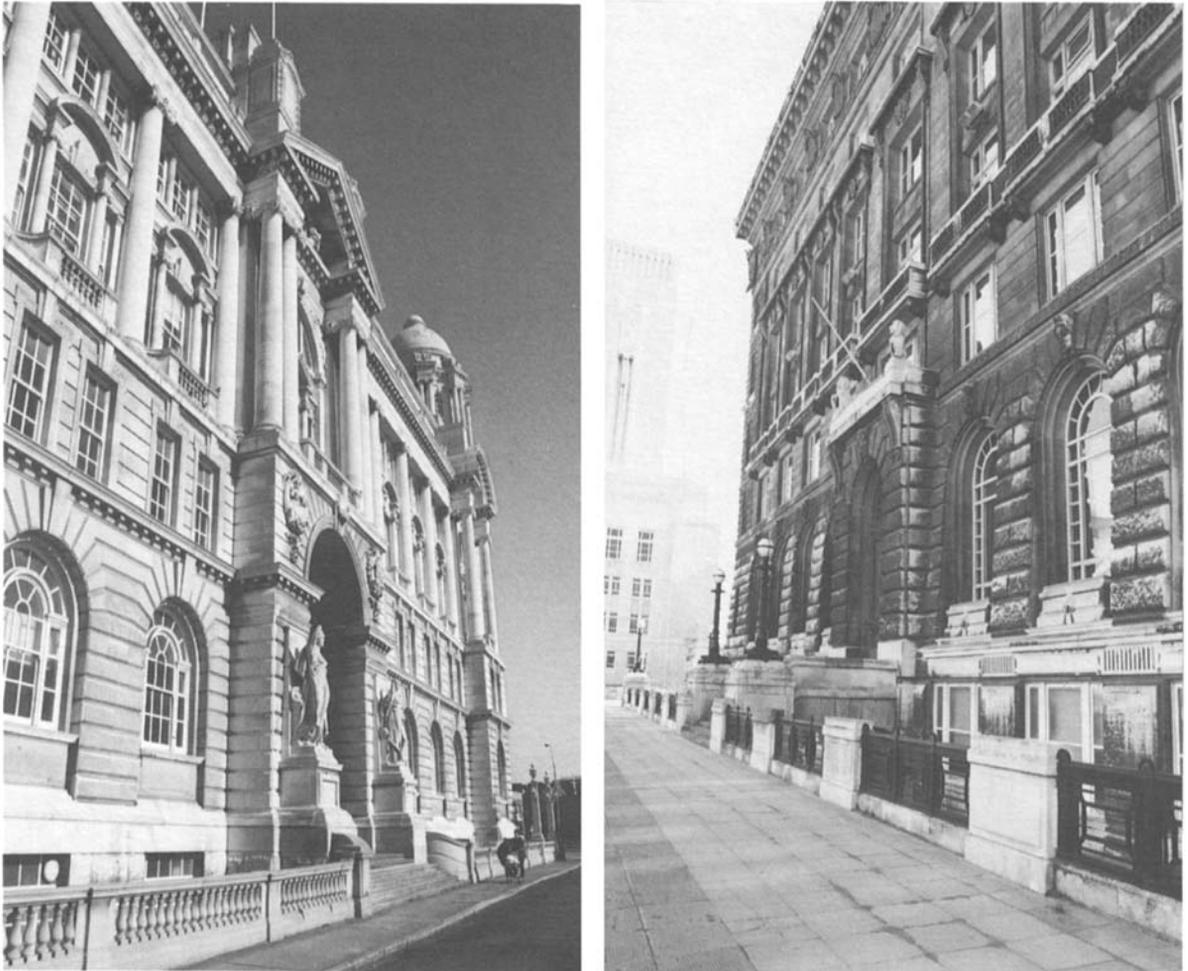
Figure 3.10 Photograph (a) shows an ornate stone façade that faces the Mersey estuary at Liverpool and is almost completely washed clean by the driving rain. In (b), the leeward elevation is heavily stained and is disfigured by differential washing.

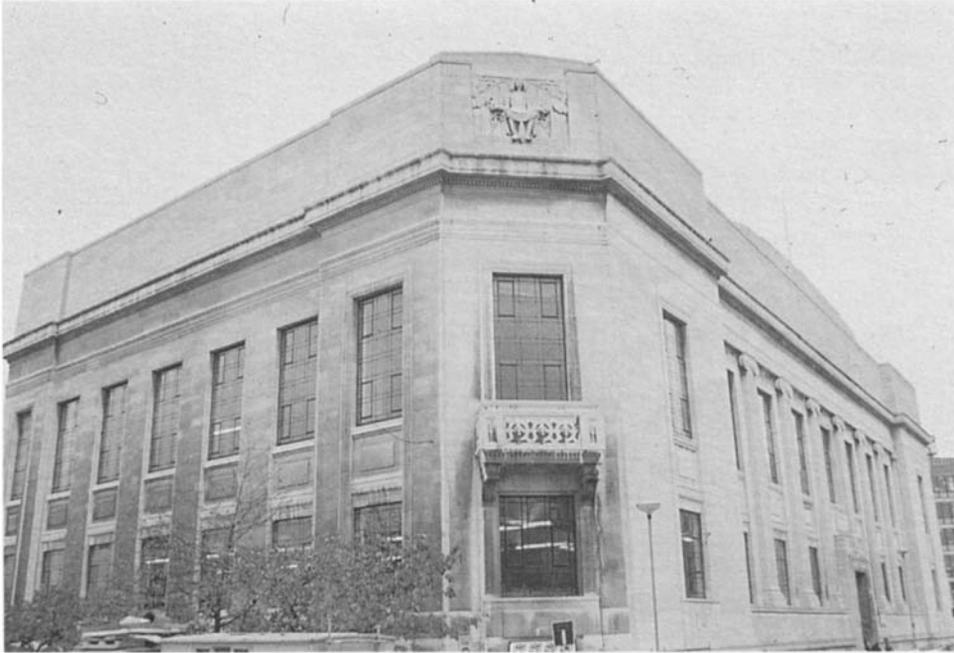
Figure 3.11 The elevation to the right of this public library faces south west while that to the left of the photograph faces north east and is heavily soiled.

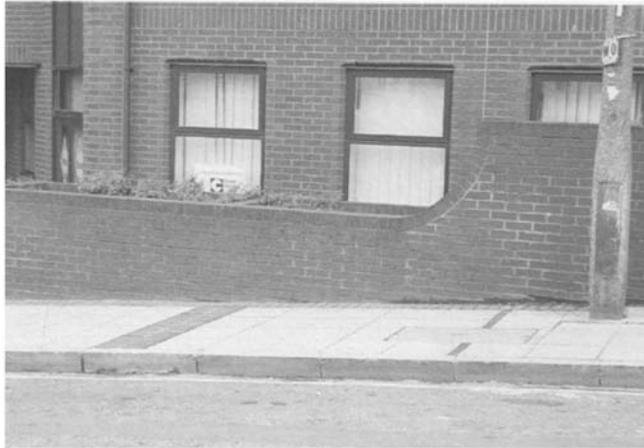
Figure 4.1 General view of brick parapet wall, coping and walling in the same porous brick. This shows algae staining concentrated on the coping but extending down the wall face.

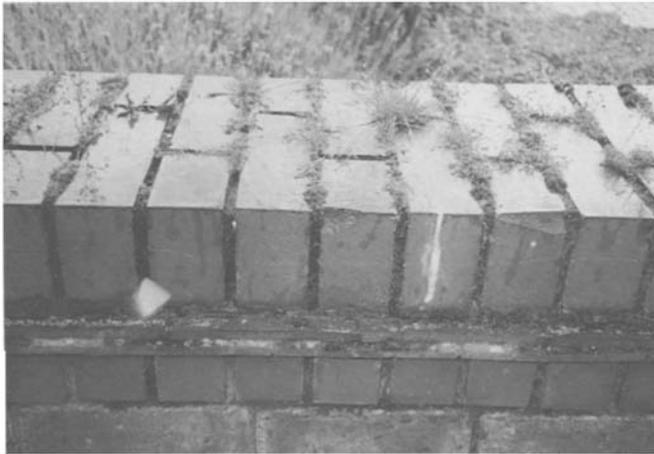
Figure 4.2 Brick coping with relatively impervious bricks and porous mortar. Algae and moss growth is quickly followed by grass and other higher-order plants. Tile creasing is also shown that has been laid flat without weathered mortar pointing allowing moss and lichens to become established.

Where the mortar joints are recessed, moss growth and other higher plant forms are more likely to take hold (Figure 4.2).

- Creasings are often set level, allowing water to flow back into the wall increasing frost and/or sulphate damage.
- The ledge created by the tile creasing is frequently pointed up with a weathered mortar bed. This will retain moisture allowing algae, mosses and lichens to grow (see Figure 4.2).
- Although the creasing does project beyond the face of the wall, without a formal throating on the underside, weather will flow haphazardly with some running back to the face of the wall. This flow is often guided and concentrated by the joints between the tiles.

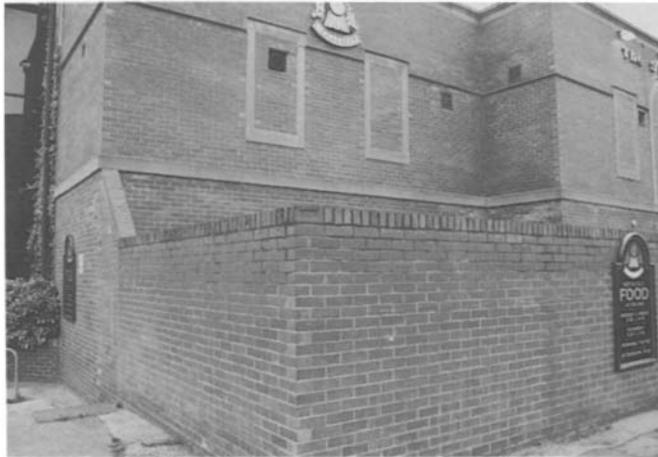
Figure 4.3 General view of a boundary wall where coping and walling are in the same quality non-porous brick.

Copings and walling in same brick (non-porous). In this case, the bricks usually remain relatively clean with the staining concentrating on the mortar joints. How obvious this staining often depends on the colours of both the units and mortar (Figures 4.3 and 4.4).

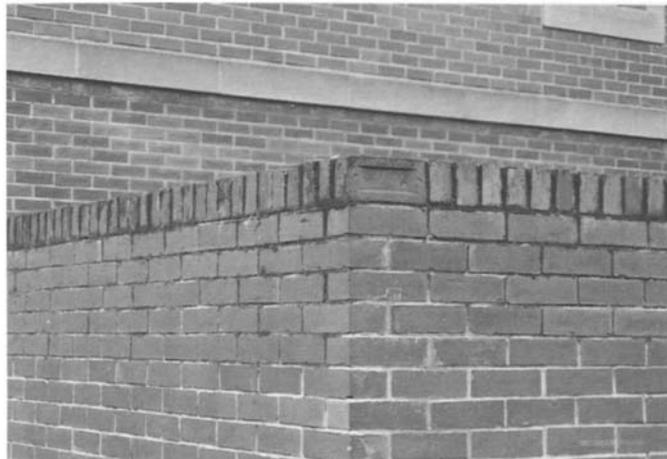
Figure 4.4 Detail of Figure 4.3 showing the concentration of staining to mortar joints through algae and moss growth. Because the mortar is more porous than the bricks, its surface remains damp and provides a good growing medium.

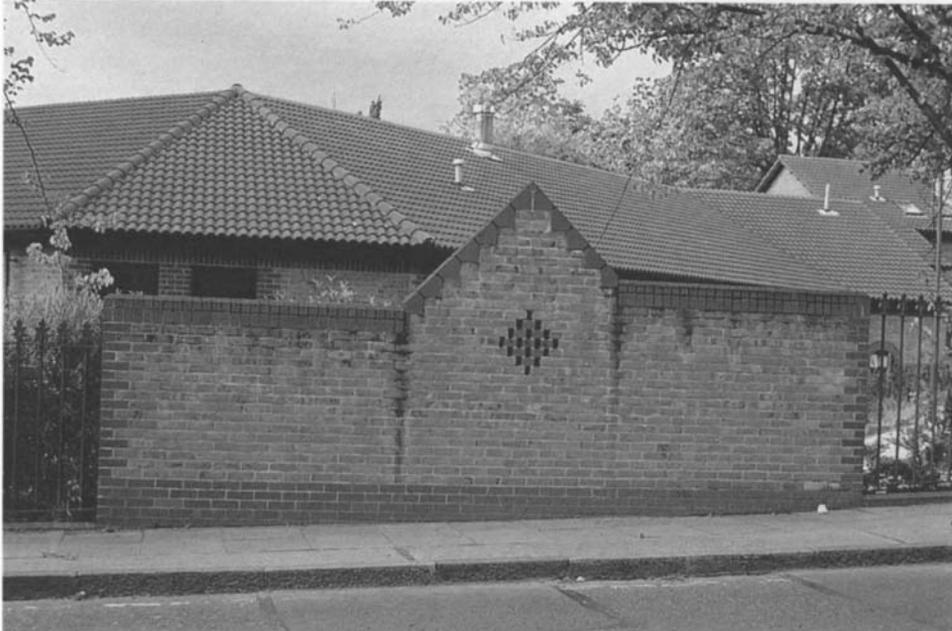
Figure 4.5 A boundary wall where the coping bricks are non-porous and the walling units are porous. The staining is focused on the joints of the coping and the upper courses of the porous walling. Note that the inclined coping has concentrated the run-off to extend the disfigurement beyond 'normal' levels.

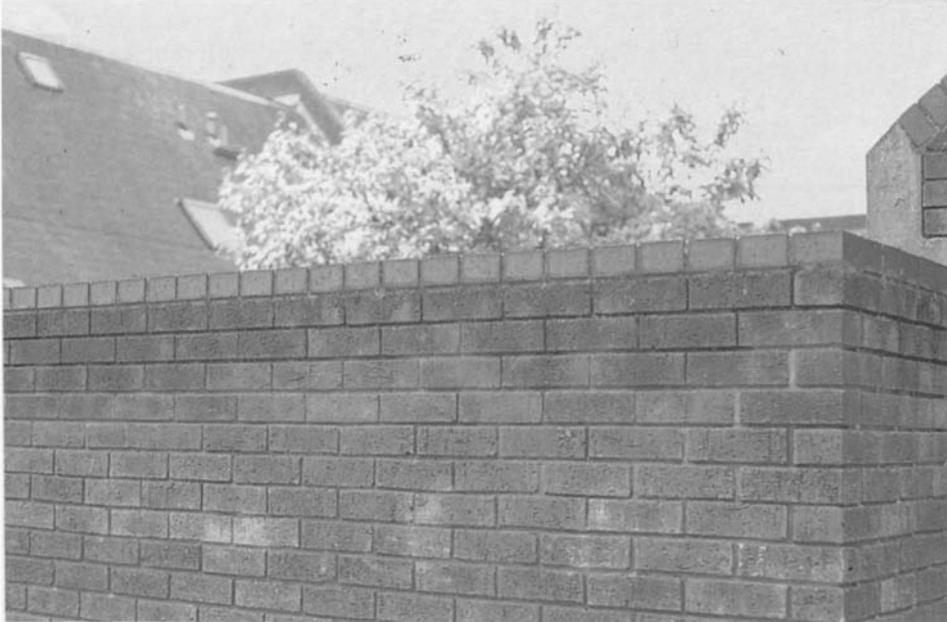
Figure 4.6 Engineering bricks have been used as copings over more porous facings. Staining has occurred at the joints and on the porous brick face. Run-off has been concentrated by the vertical mortar joints of the coping and the corresponding joints of the courses below, causing 'lines' of staining.

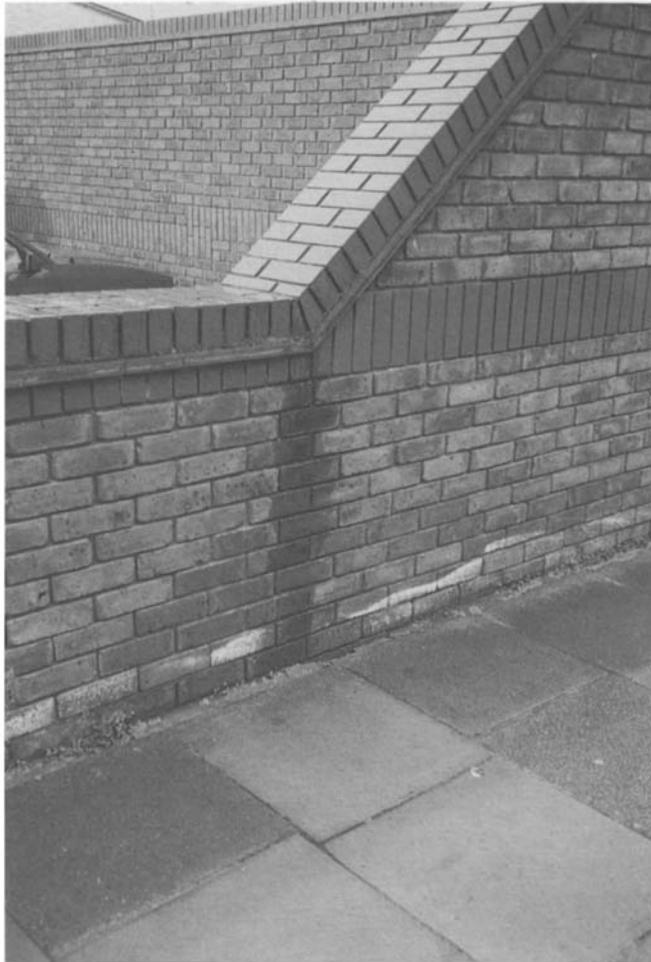
Figure 4.7 The inclined boundary wall with a non-porous coping directs coping run-off directly on to the tile creasing. This flows down the slope and because of the lack of an effective throating beneath the creasing there is a concentrated water flow and consequent staining at the change in direction.

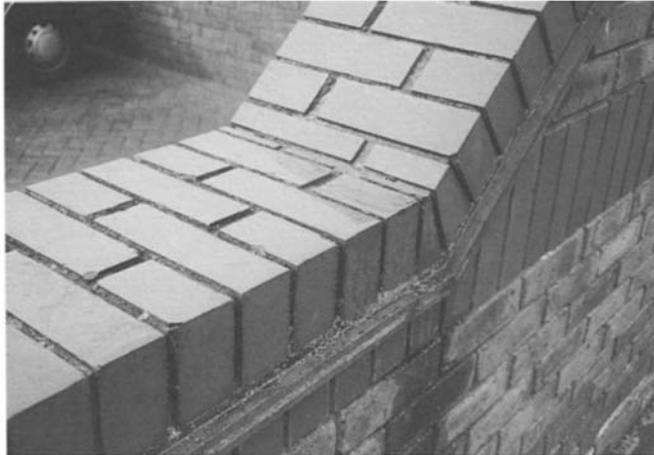
Figure 4.8 Detail of coping illustrated in Figure 4.7.

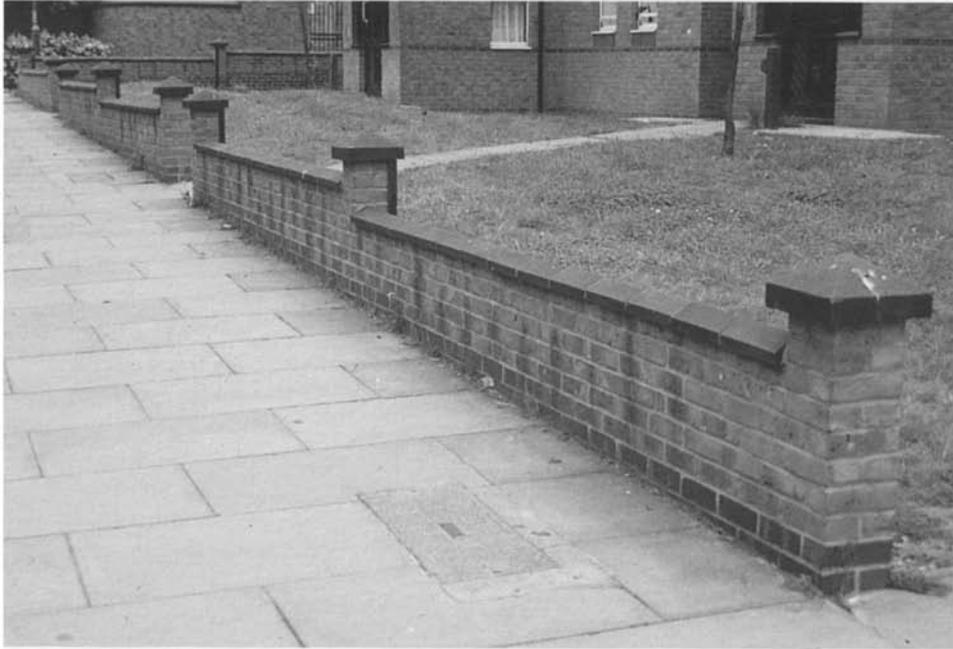
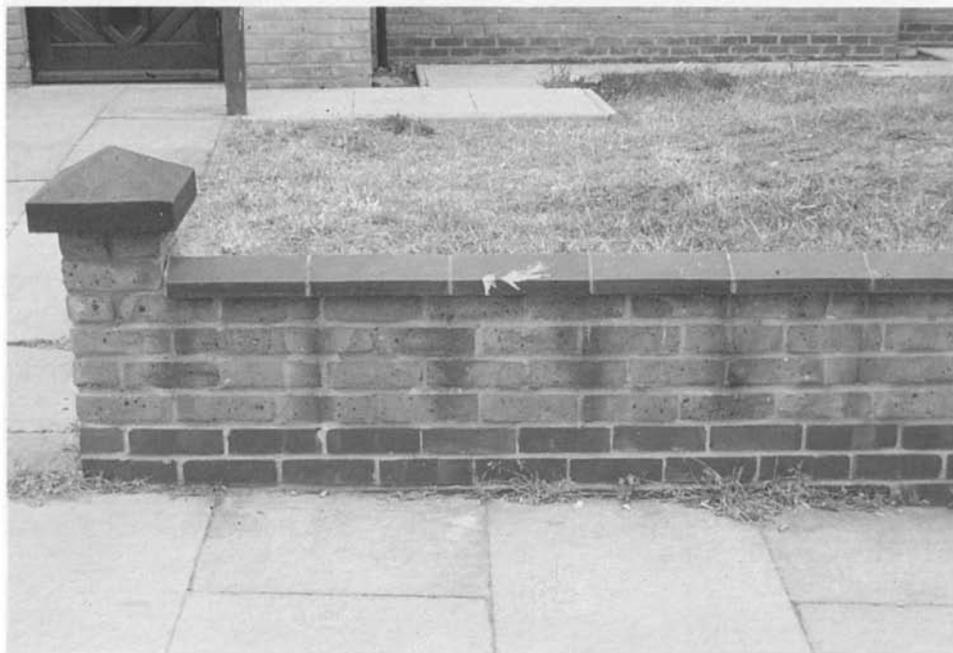
Figures 4.9 and 4.10 These clay coping units have steeply sloping that have throatings cut on the underside. The profile sheds water quickly but concentrates flow at the junctions causing dirt staining, bacteria and algae growth that leave prominent streaks on the wall beneath.

that even coping units manufactured to British Standard guidance do not prevent staining completely. One of the most notable visual effects are areas of concentrated disfigurement at the joints between the coping units themselves. Figures 4.9 and 4.10 show a very common form of staining, at the joints of a clay coping bedded and jointed in mortar.

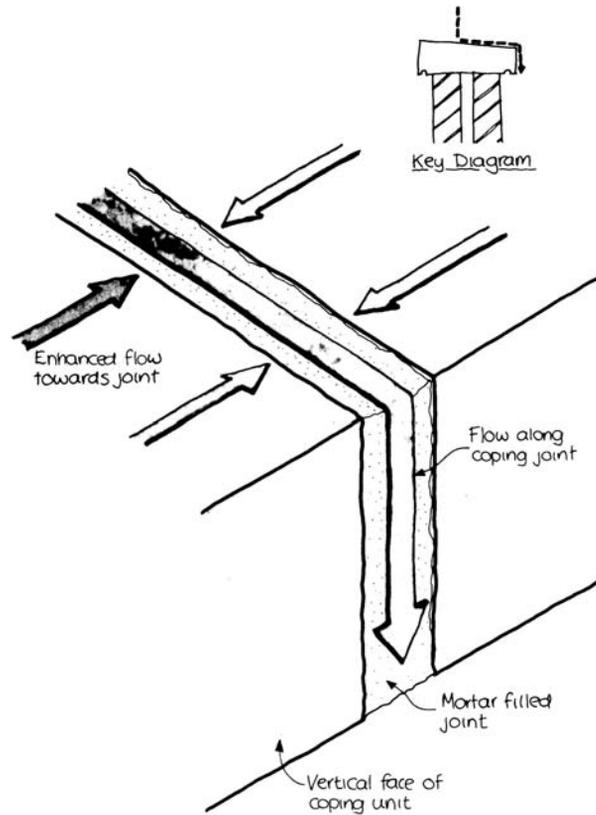
Figure 4.13 Increased water flow along joints between coping units.

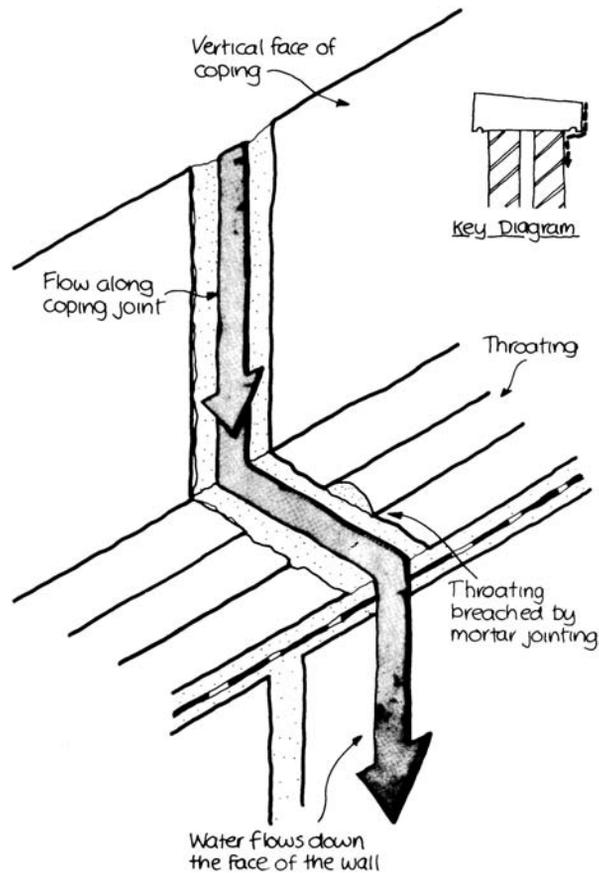
Figure 4.14 Diagrammatic representation of a blocked throating to the underside of a pre-cast coping system.

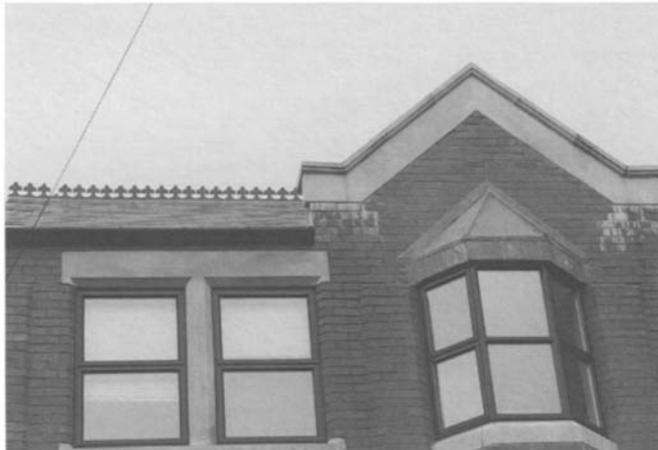
Figure 4.17 Staining caused by inclined copings. This two-year-old feature shows both the disfigurement of lime and premature staining.

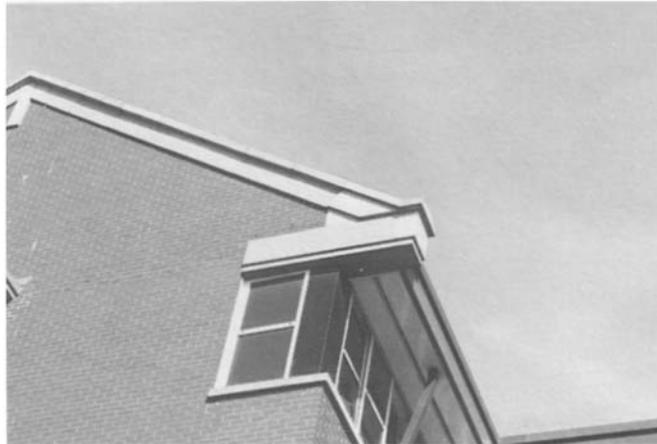
Figure 4.18 The change of coping inclination on this building is bridged by a specially manufactured unit that keeps the throating entire thus avoiding staining.

this change in inclination is formed out of one specially manufactured unit, staining is minimal if present at all. The design of the throating is crucial in this respect (Figure 4.18).

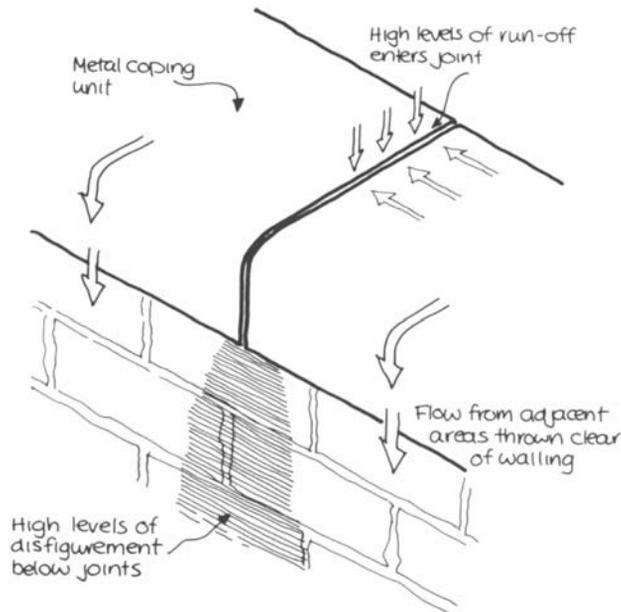
Figure 4.19 Staining at the joints of metal coping units.

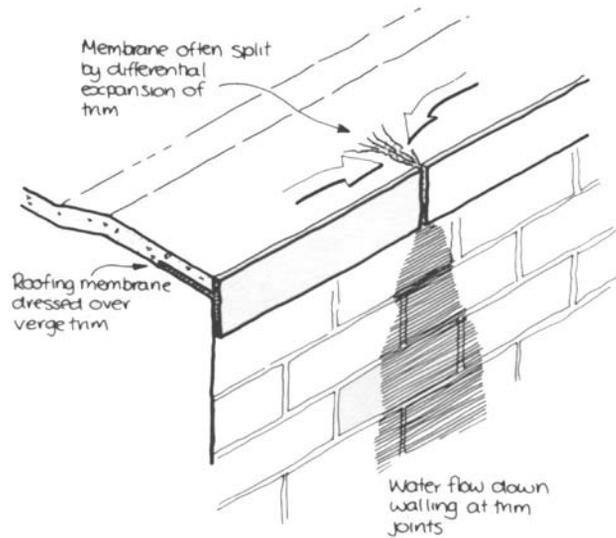
Figure 4.20 Water flow at the junction of verge trims to flat roofs.

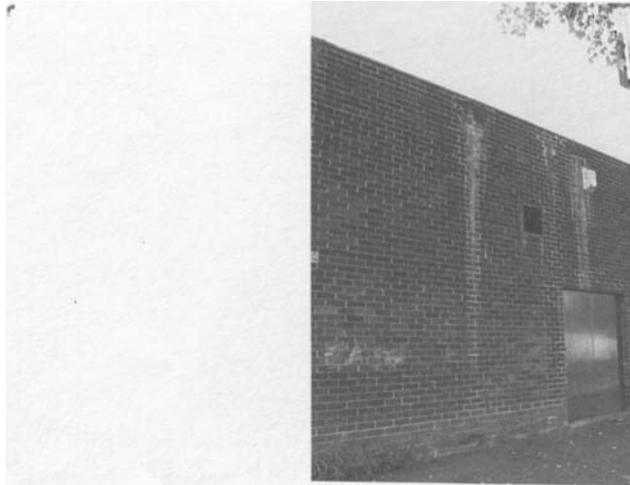
Figure 4.21 Extensive water flow at verge trim joints caused considerable staining before additional drainage was provided to the flat roof of this building.

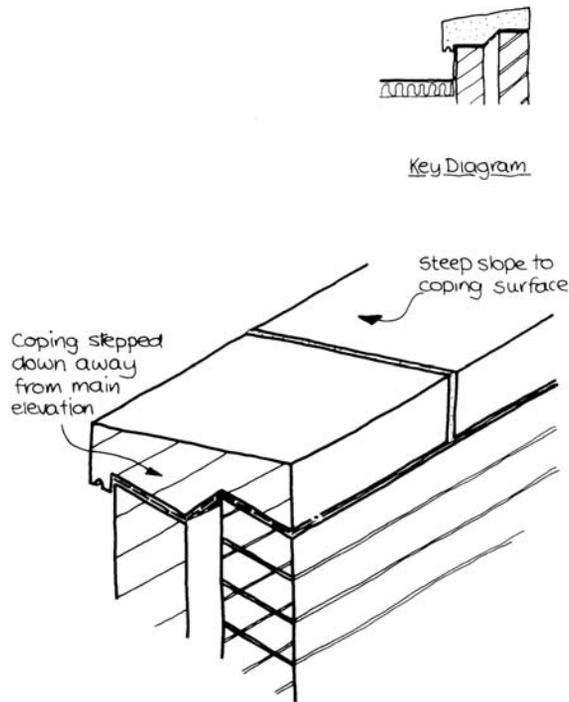
Figure 4.24 Possible design of a stepped steeply sloping coping. surface is insufficient to maintain flow. It is at this point that dirt carried down from higher levels will be deposited. The only way to control this type of staining is to limit the flow. Horizontal string courses bold enough to throw water off the façade are proposed by Verhoff as they can serve several functions:

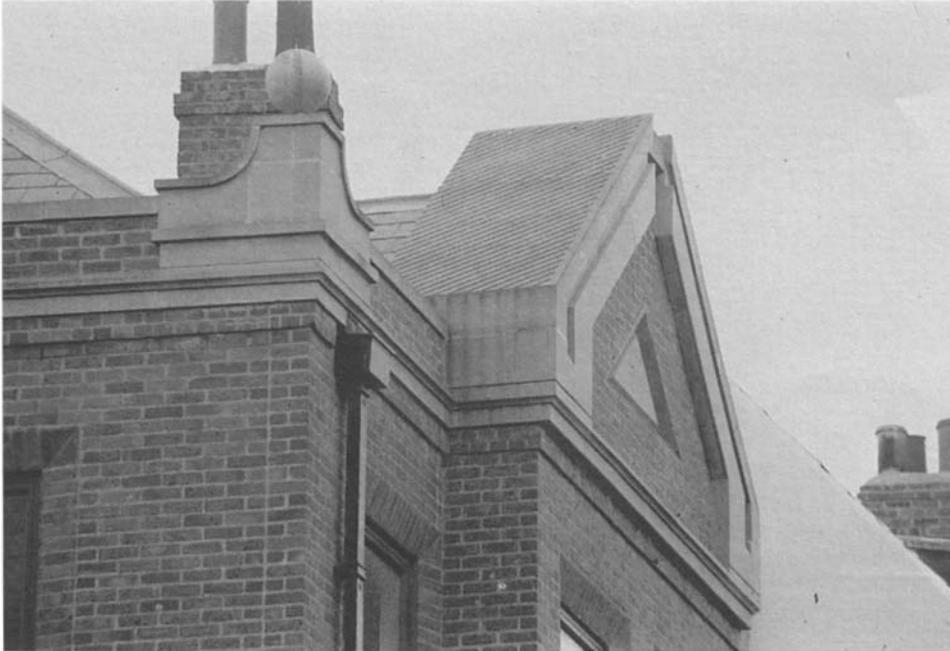
Figure 4.25 This wide inclined stone coping has its top surface fluted which helps to keep water flow down the prominent elevation to a minimum. However the flutes were still allowed to discharge over an observable face causing ugly streaking.

- Provide a steep fall-away from the elevation that is to be the most prominent. This could be achieved through a specially manufactured unit that allows for a step down ([Figure 4.24](#)).
- Ensure that the amount of water settling on the surface of a coping flows away from the prominent elevation by fluting or grooving the surface. This was first observed on a building in York ([Figure 4.25](#)).

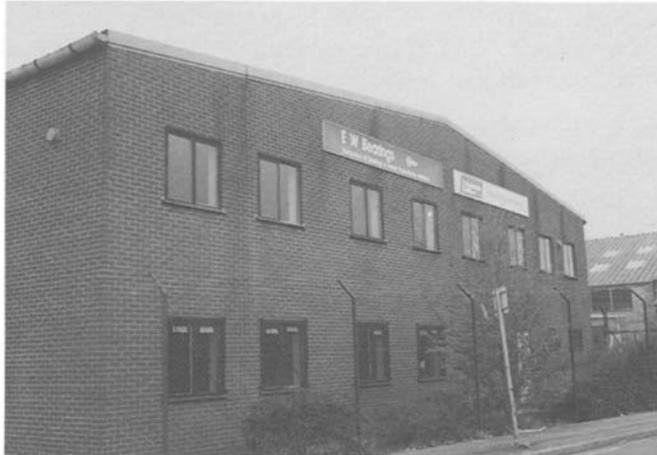
Figure 4.31 Staining at the joints of pre-formed metal verge cladding sections.

The verge detail of many roofs to commercial and industrial buildings is usually protected by pre-formed verge sections that are coordinated in their design with the main profiled metal roof sheeting. They tend to extend across the roof slope by some 100–150 mm and down the wall elevation by a similar amount. This verge component has no drainage function, it merely protects the junction of the roof and wall elements. Because of the width of the horizontal component, a considerable amount of water can flow down the slope. Where the different sections overlap or butt up to each other, capillary action will draw water flow down on to the face of the wall. Figures 4.31 and 4.32 show an example typical of this effect. This form of staining is surprisingly common on many industrial and commercial estates.

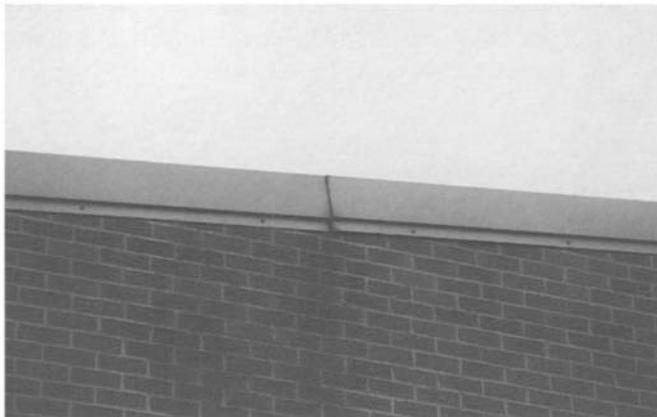
Figure 4.32 Detail of Figure 4.31 showing high levels of water flow at junction of adjacent units.

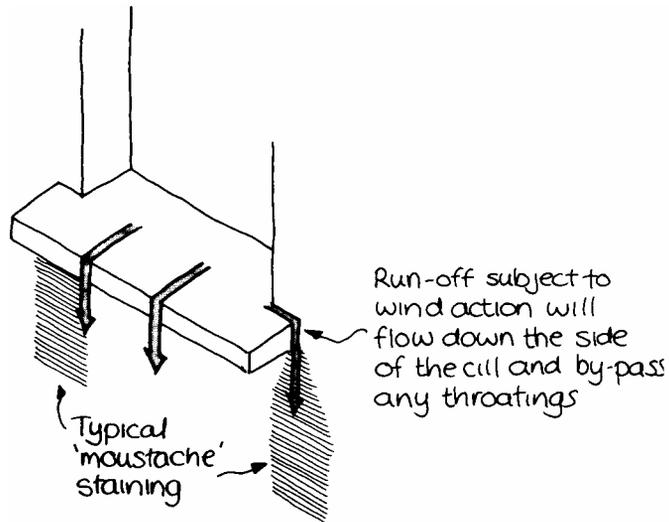
Figure 4.33 Typical 'moustache' staining of a cill without stabling.
