Prevention of Premature Staining of New Buildings

Phil Parnham

*Principal Lecturer in Building Surveying, Sheffield Hallam
University, UK*

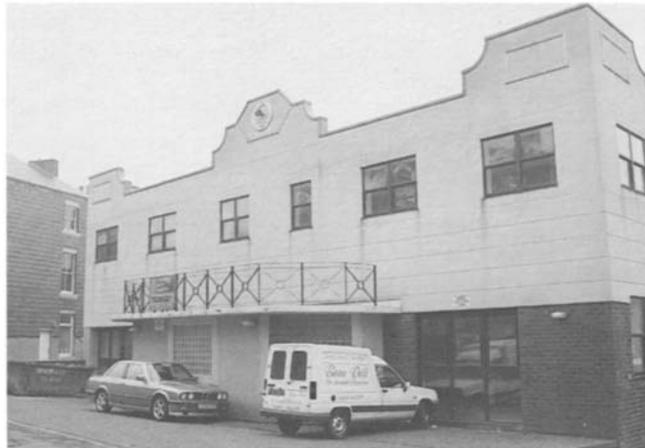
Figure 4.35 Recently refurbished building showing 'moustache' staining.

It has long been recommended practice that cills below windows should be 'stooled', or have their surfaces recessed, leaving upstands at either end to ensure that water does not flow off the edge of the cill during wind gusts, bypass the throating and affect the wall surface (Figures 4.33 and 4.34). Yet many designers still include cills without this feature that will give rise to a 'moustache' at either end of the cill. The building featured in Figures 4.35 and 4.36 shows such a staining pattern. This visual effect is probably

Improvement in the performance of sealants is in the hands of the manufacturers who must ensure that their products are stable and will not allow migration to affect adjacent surfaces. Observations have shown that fully exposed joints, where the sealants and gaskets are open to the elements, appear to be more affected than those that are physically concealed. [Figure 4.44](#) shows sealant staining on the surface of darkly coloured polished stone cladding that would have been more prominent had the cladding been lighter in colour. The moustache staining on the building in [Figures 4.35](#) and [4.36](#) has probably been caused by sealant migration.

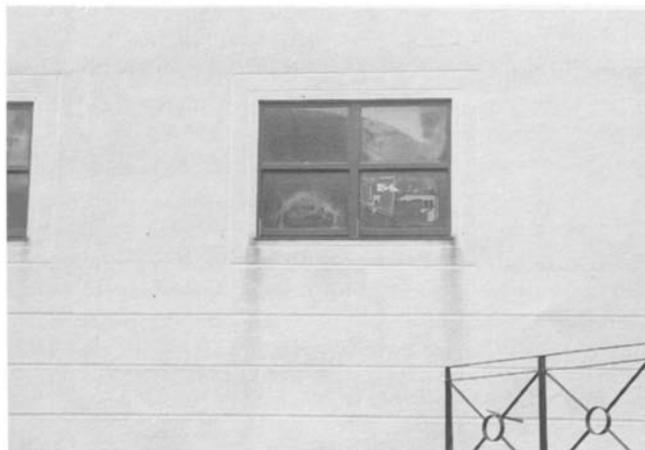
Figure 4.36 Detail of Figure 4.35. This staining has probably been enhanced by the breakdown of the sealant around the frame depositing substances on the walling.

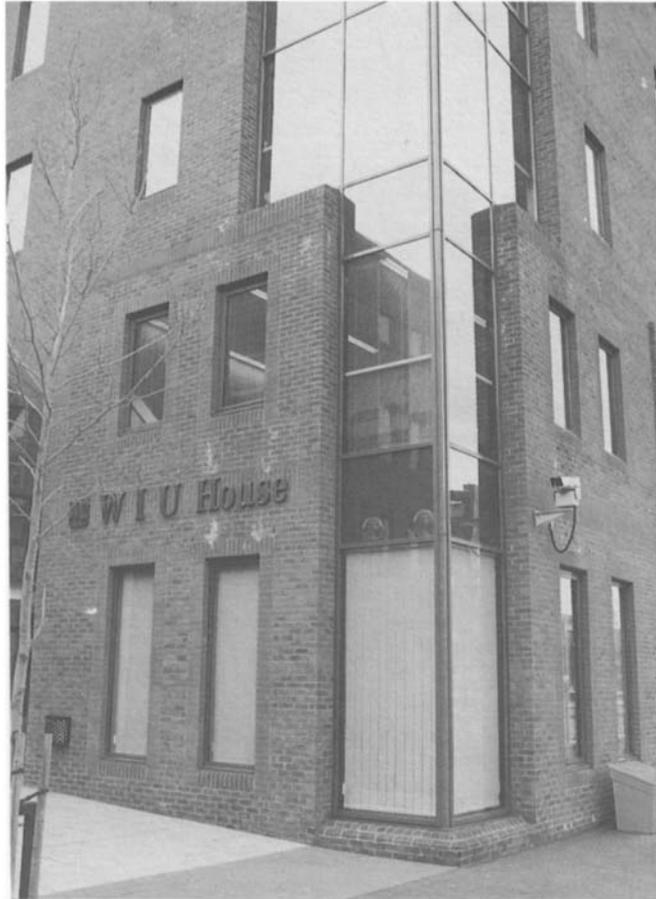
Figure 4.38 Detail of the bottom two storeys showing the lack of any cills at the glass/brick cladding junction.

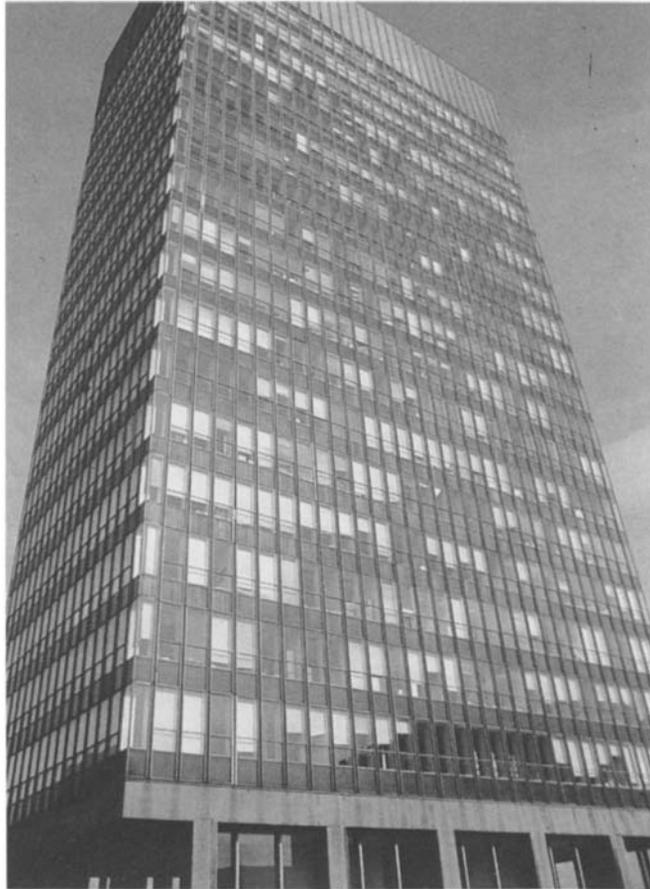
Figure 4.41 General view of multi-storey educational building clad with curtain walling with pronounced mullions.

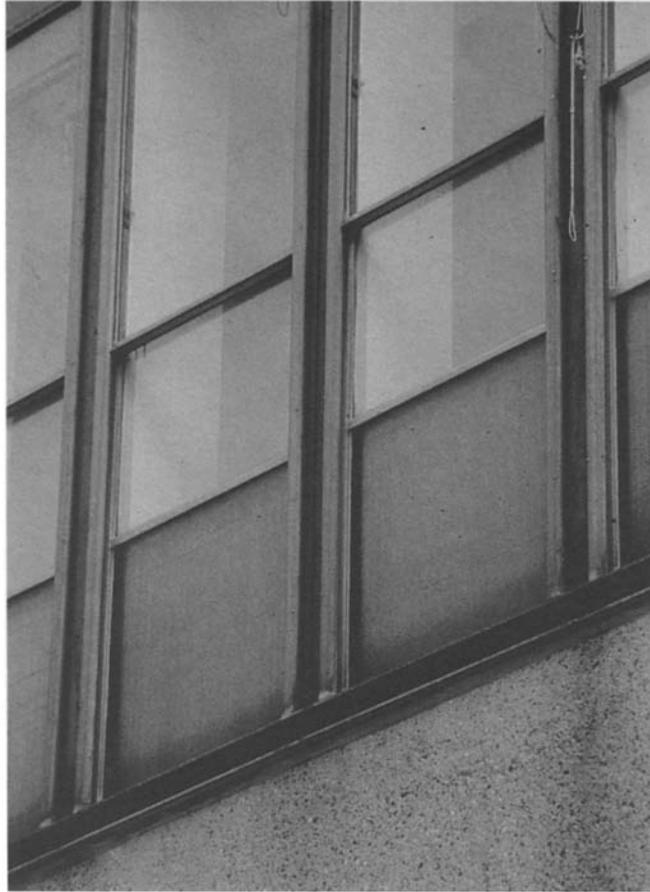
Figure 4.42 Detail at junction of curtain walling and concrete plinth showing concentrated staining at mullion positions.

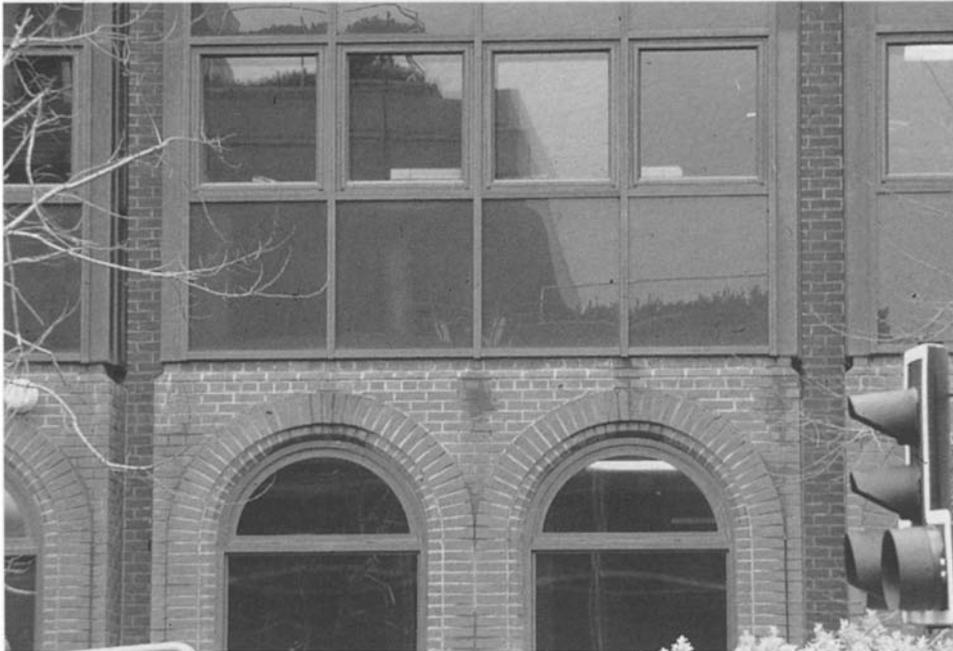
Figure 4.43 Staining at mullion positions where cladding is less pronounced.

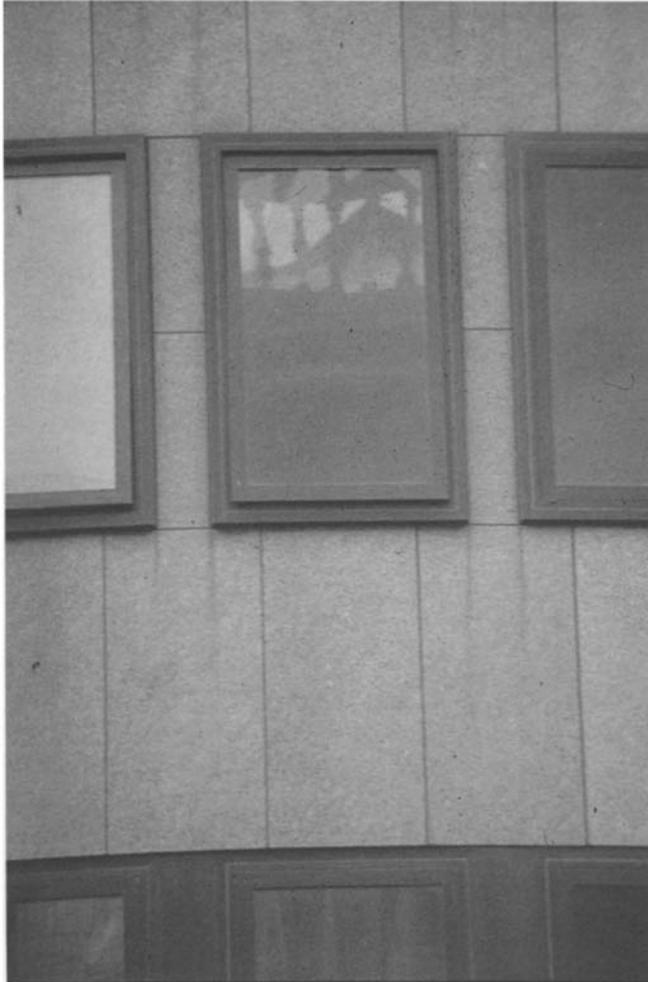
Figure 4.44 Staining caused by sealant or gasket migration.

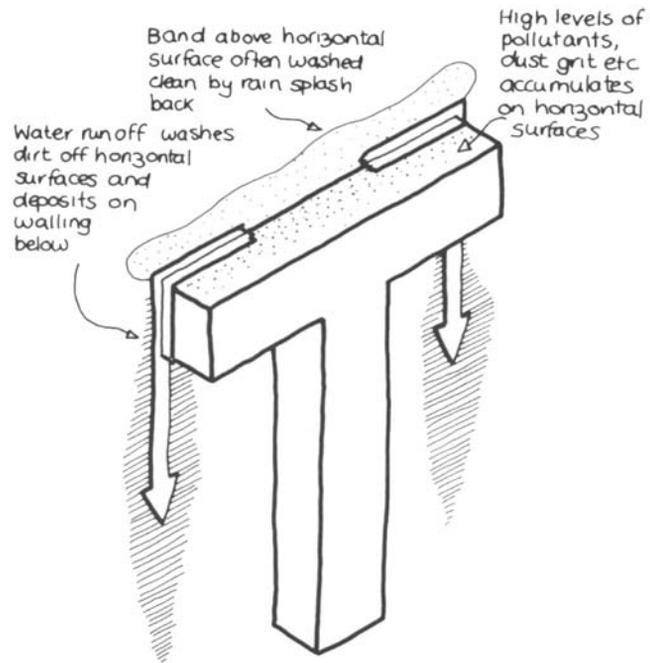
Figure 4.45 Diagram showing the variety of staining and washing effects associated with protruding signs and lettering.

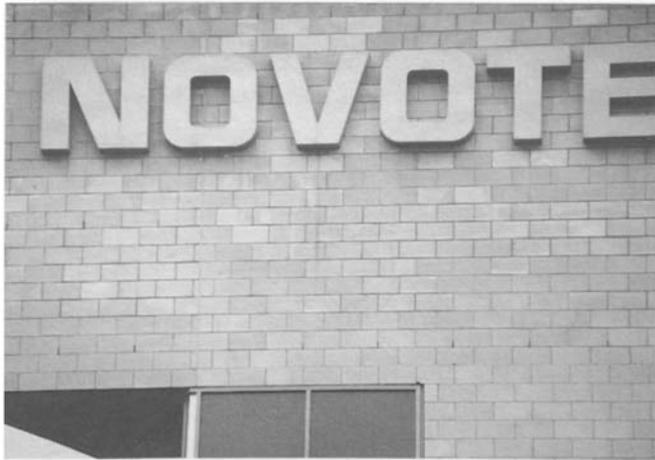
Figure 4.47 Detail of lettering fixed flush to the wall surface. Evidence of early staining especially below the 'V'.

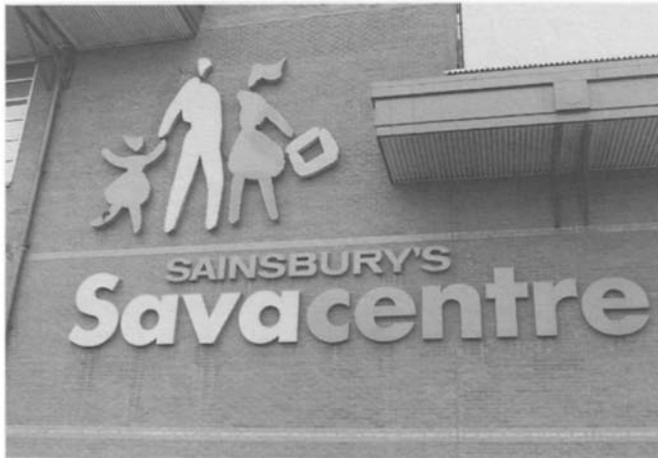
Figure 4.48 Logo and lettering on the elevation of a five-year-old hypermarket.

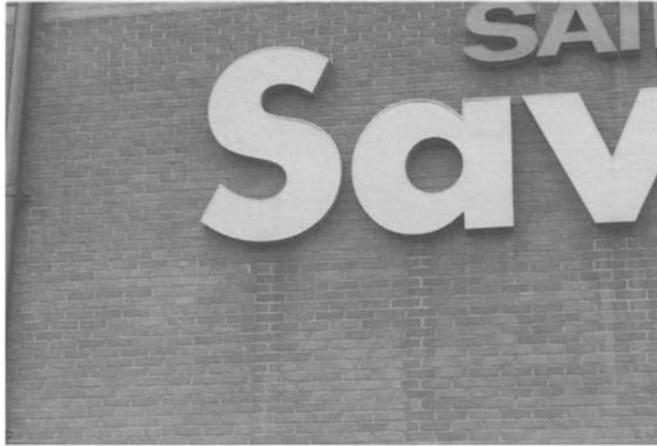
Figure 4.49 Detail of Figure 4.48 showing staining below lettering that is fixed flush to the wall.

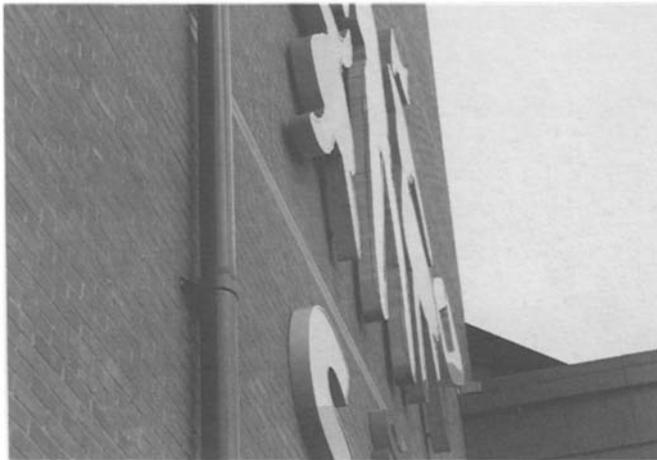
Figure 4.50 Detail of logo showing the different fixing methods used for the logo and lettering. The logo has been fixed approximately 75 mm away from the face of the wall and is yet to be affected by staining. The lettering is fixed flush and already shows signs of disfigurement.

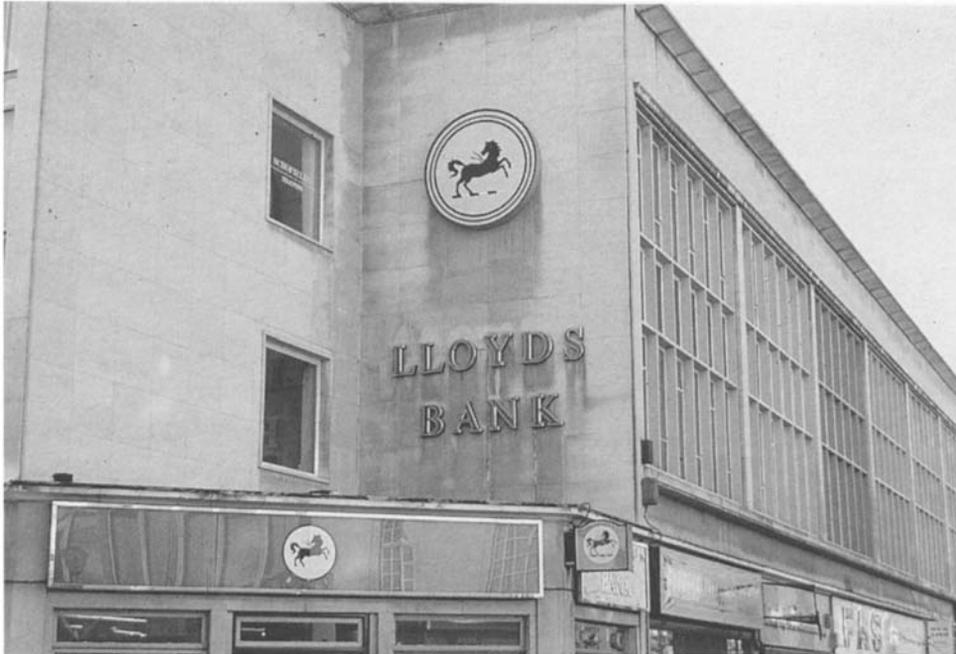
Figure 4.51 Logo and lettering fixed flush to stone cladding causing variable deposition and washing.

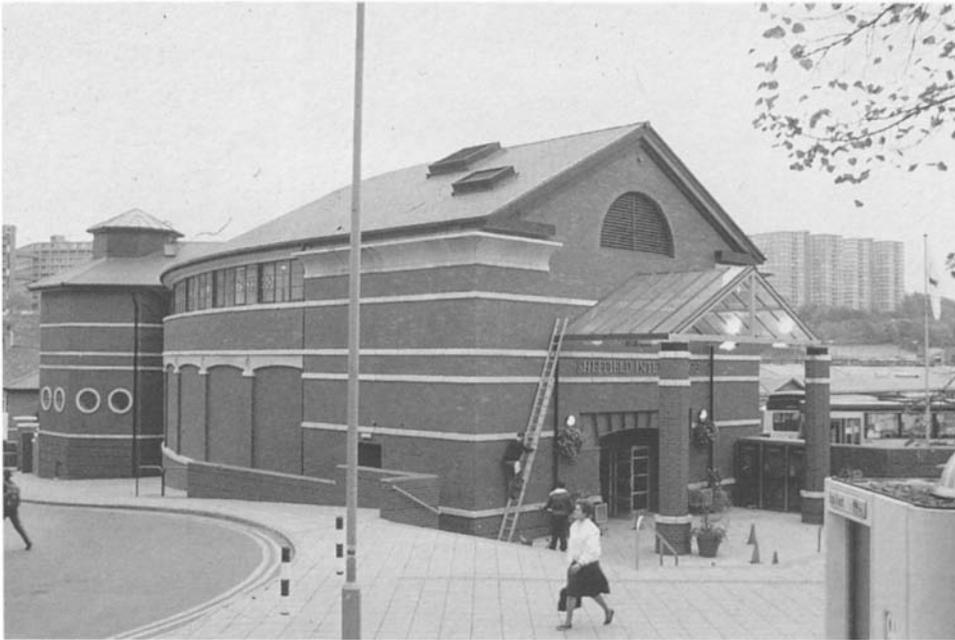
Figure 4.52 General view of building with cornice and string courses.

Despite these positive advantages it is important to ensure that these features are designed correctly; if not they can be the cause of staining problems rather than the solution. The building in [Figures 4.52 to 4.56](#) used light coloured string courses and cornices as central features of the design. Of these, the strongest aesthetic impact is the upper cornice positioned just below the roof eaves ([Figure 4.53](#)) and the design of this creates a number of problems:

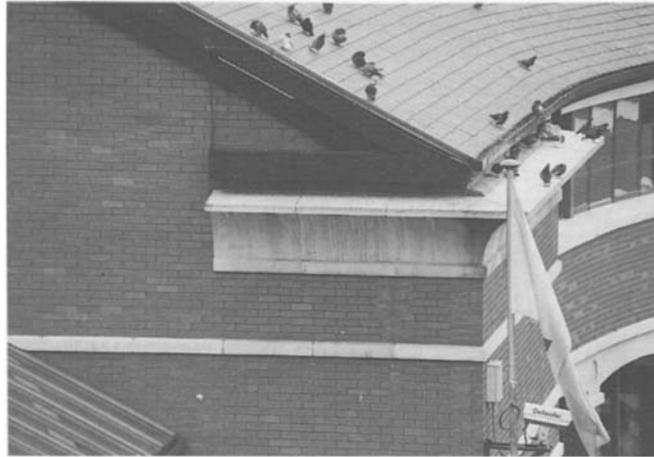
Figure 4.53 Detail of strong visual cornice units. Note that the side facing the camera has been netted to prevent pigeon roosting while the other has not.

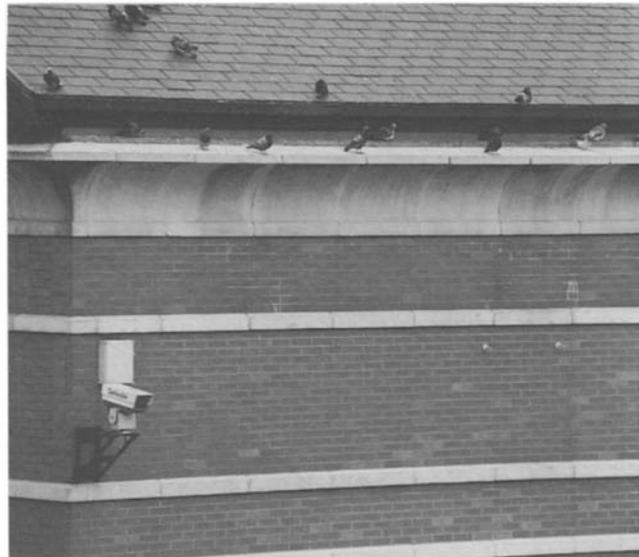
Figure 4.54 General view of the cornice and string courses showing the beginnings of staining concentration following the joints.

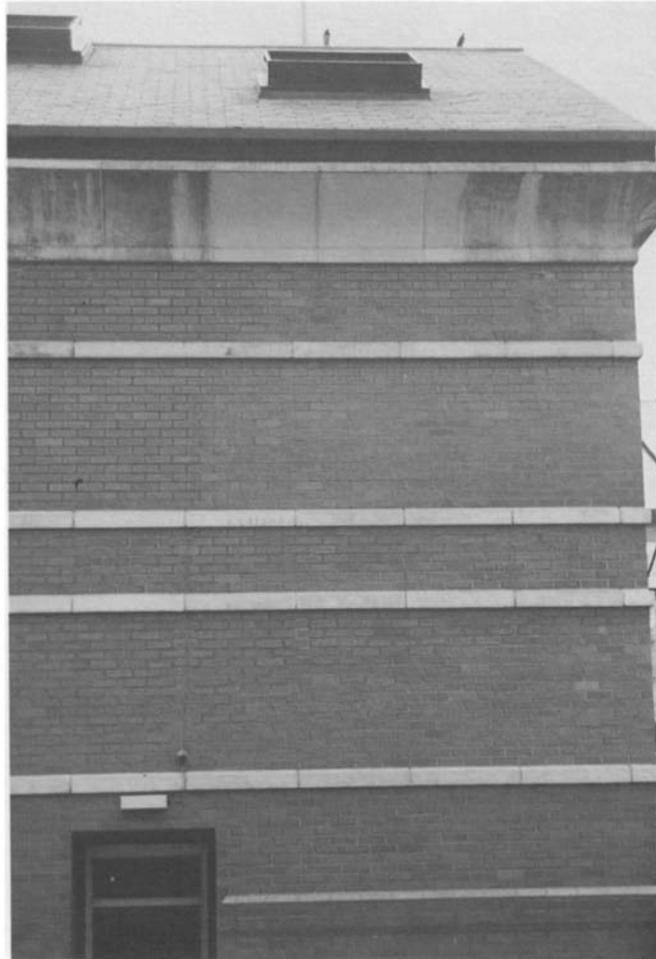
Figure 4.55 General view of the elevation containing two cornice units that have had a throating provided under the leading edge.
waterproofing should match that for any flat roof or usable basement area, with particular care taken to use materials that can withstand an organic environment.

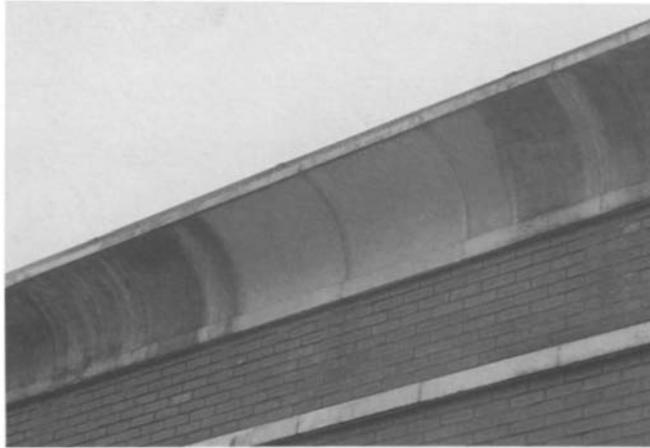
Figure 4.56 Detail of Figure 4.55 showing the clean surface of the two cornice units with throatings compared to those without.

- On one elevation for some unknown reason, two of the cornice units have been provided with throatings under the leading edge (Figures 4.55 and 4.56). The visual effect is dramatic. The two units

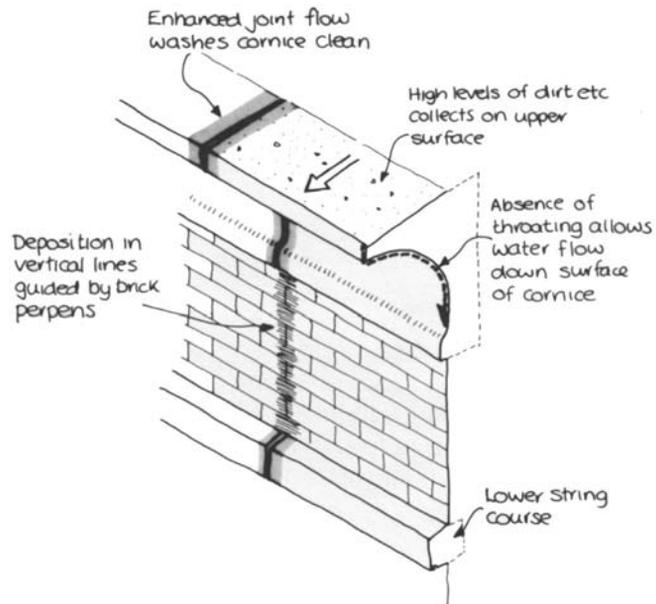
Figure 4.57 Diagrammatic sketch of the staining mechanisms illustrated in Figures 4.52–4.56.

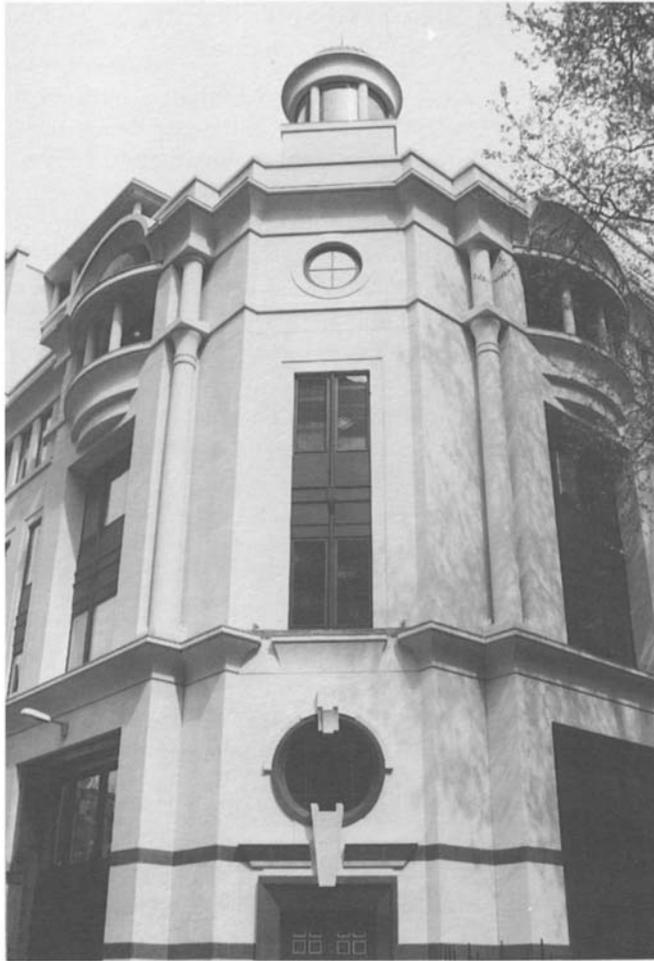
Figure 4.58 Part elevation of a new city centre building with lead-covered string course.

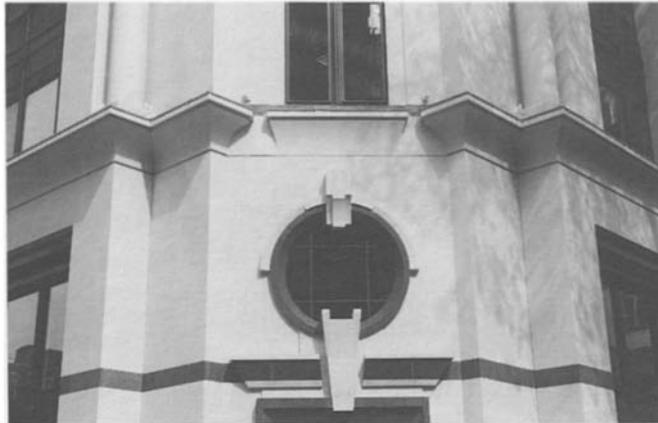
Figure 4.61 Part elevation showing discontinuity of string course above entrance area.

The one feature that lets this elevation down is the way the string course is detailed above the entrance door. By providing a physical gap in the course, water flow from higher levels will extend down and variably stain or wash the walling below the string course. Although this building is very new, streaking has already occurred in this area. Figures 4.61 and 4.62 show this in detail.

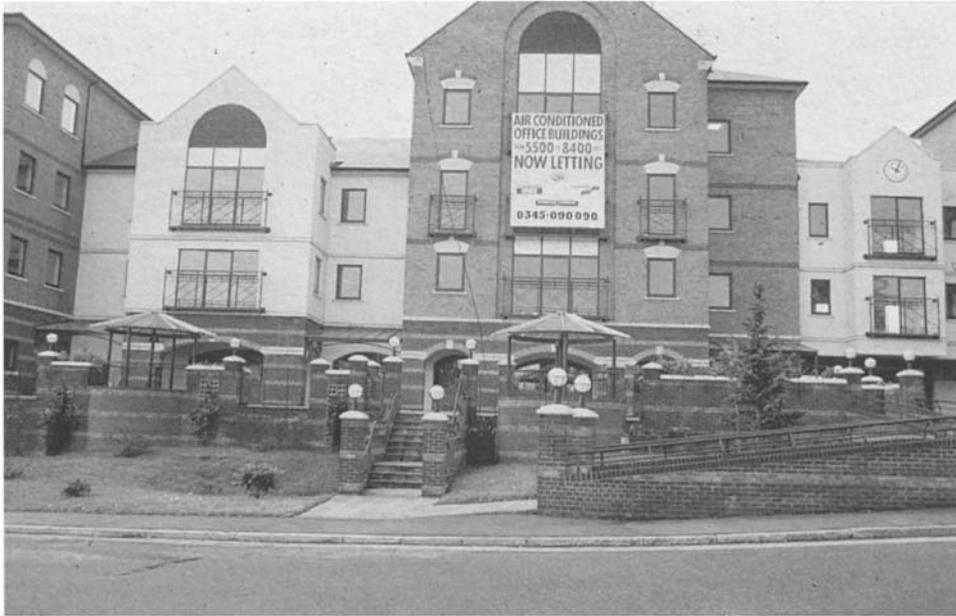
Figure 4.64 Much of the hardstanding is drained by discharging over the face of the retaining walls.

Similar lack of attention to drainage of paved hard-standing areas around entrance areas has also been noted. In some cases water has been directed to flow over the face of prominent elevations to adjacent retaining walls (Figures 4.64, 4.65 and 4.85). A more appropriate approach would be:

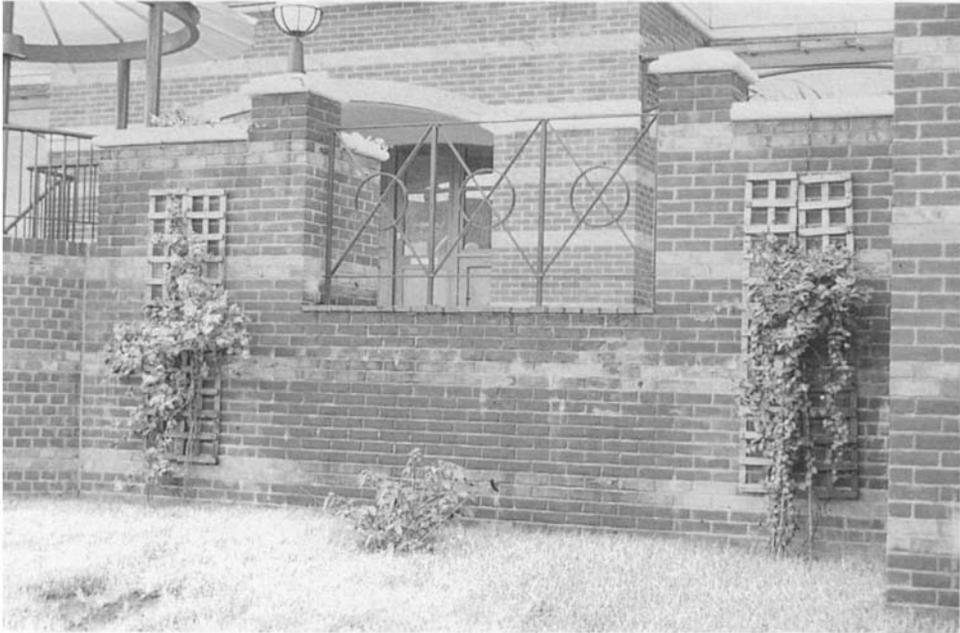
Figure 4.65 Detail of Figure 4.64 showing high levels of disfigurement.

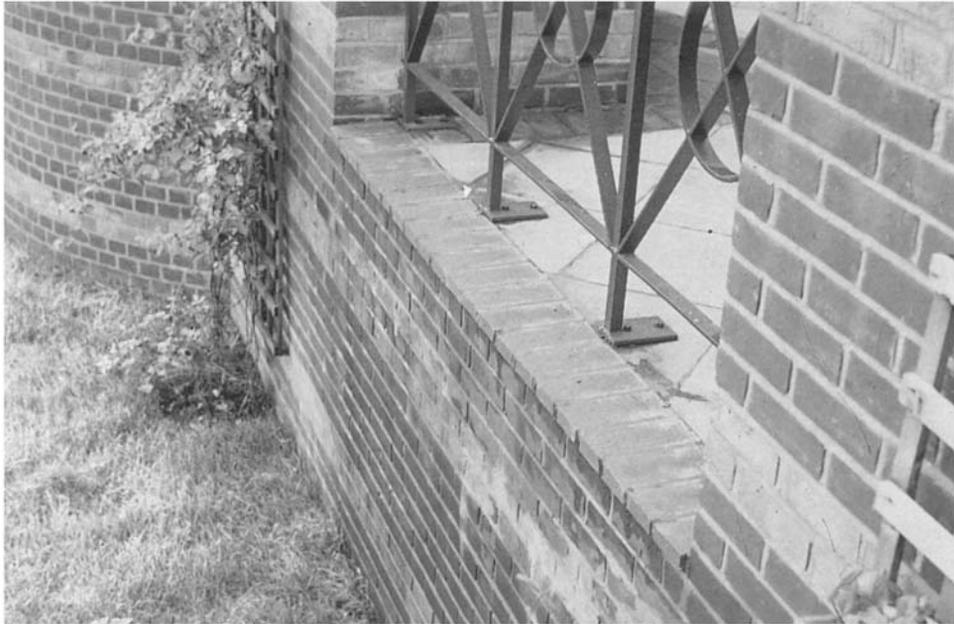
Figure 4.66 Light-coloured coping units have been used around all the brick-built planters.

- All planted areas need to be well drained but unless special care is taken to ensure that the containers are properly waterproofed the visible surfaces of the enclosing structure will be disfigured (Figures 4.66 and 4.70).

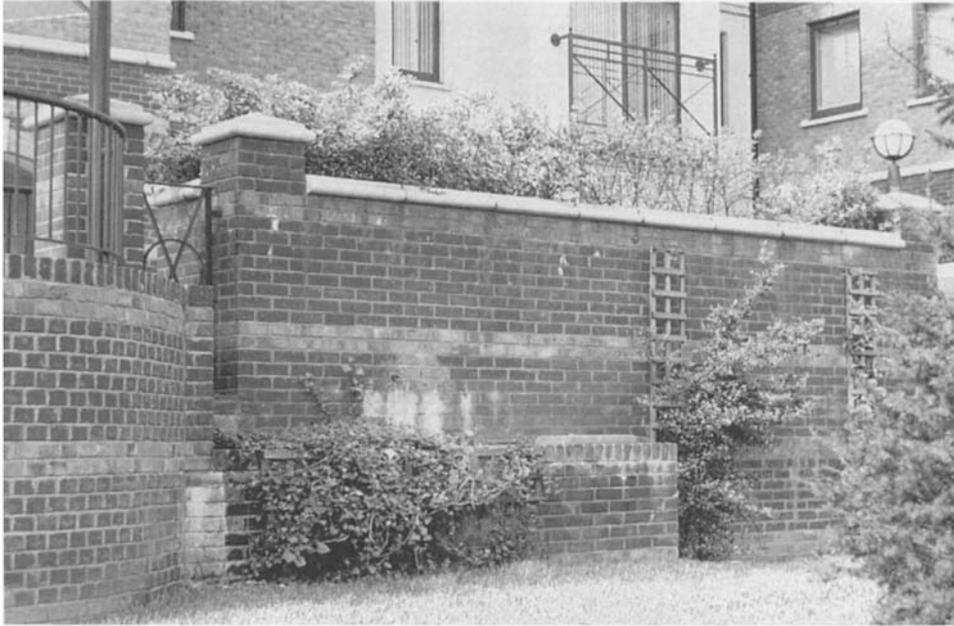
Figure 4.67 The coping units have rounded edges with no throating beneath allowing water to flow down the surface of the walling below.

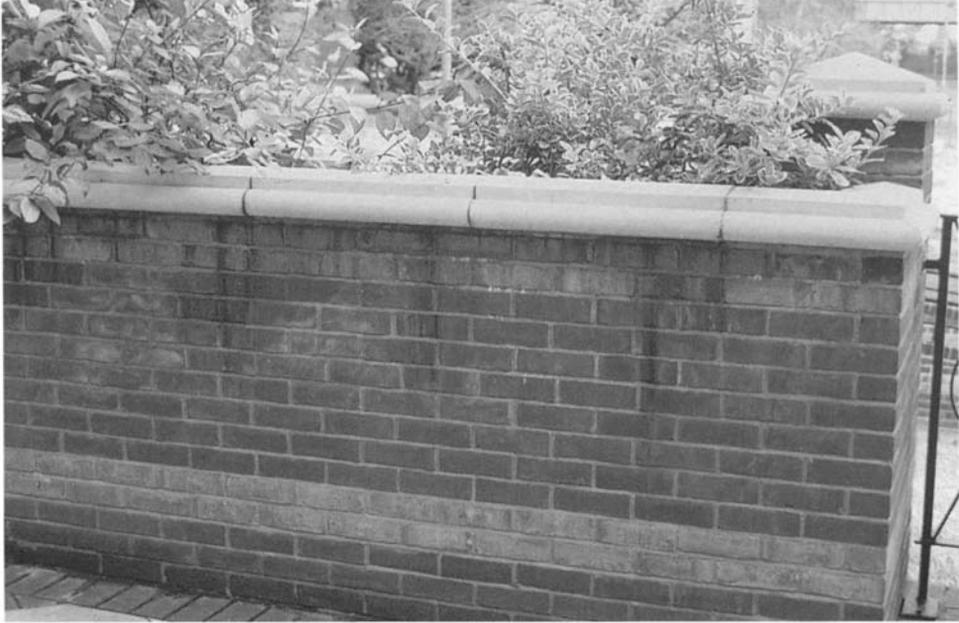
Figure 4.68 Conspicuous joint staining has affected all parapet walls.

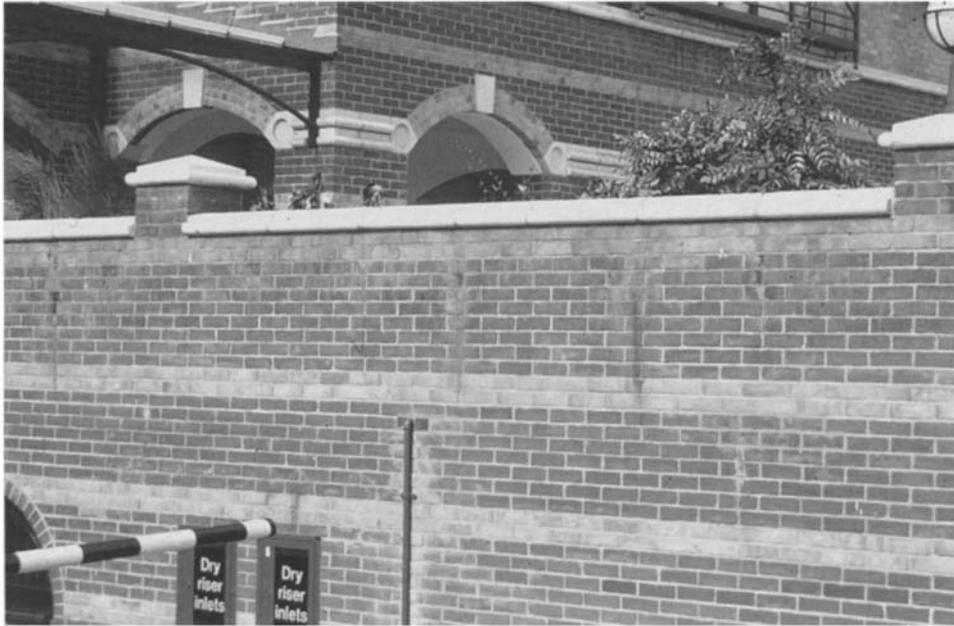
Figure 4.69 In many areas poor damp proofing behind retaining walls has allowed intense lime staining to disfigure the brickwork.

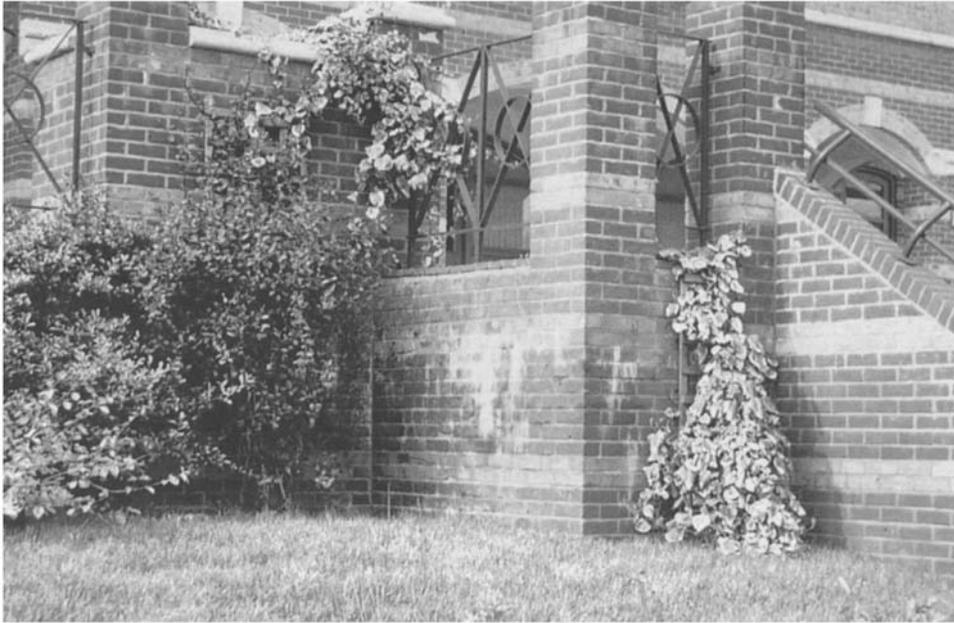
Figure 4.70 An isolated brick plinth has been badly stained by water flow from the hardstanding above and spitter pipes draining the adjacent planters.

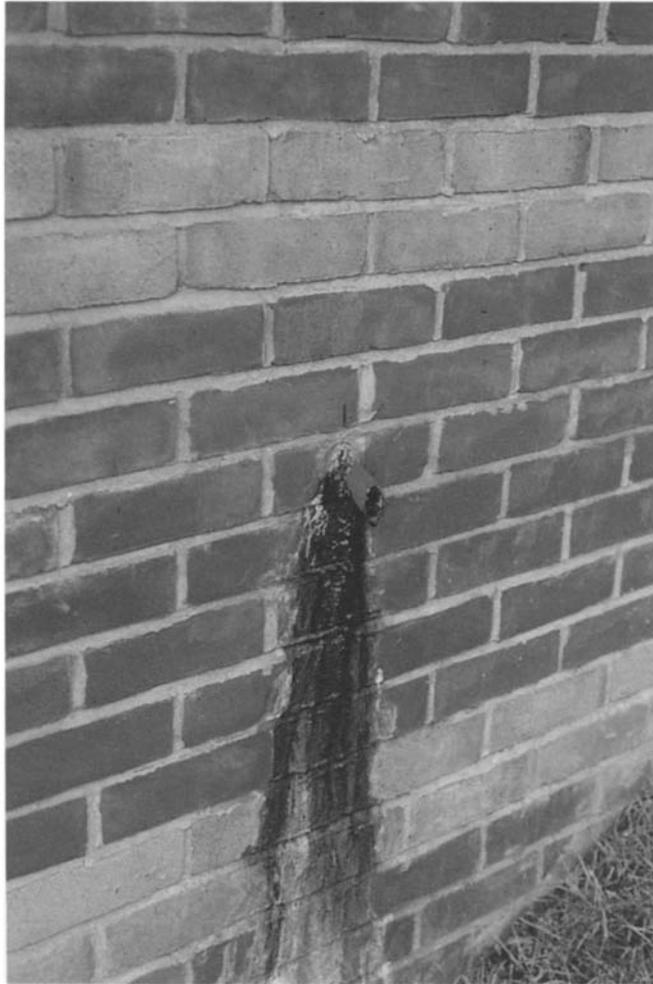
Figure 4.71 The watertightness of virtually all spitter pipes was defective allowing ugly water flow down the face of the brickwork. Here the water is draining around the pipe rather than through it.

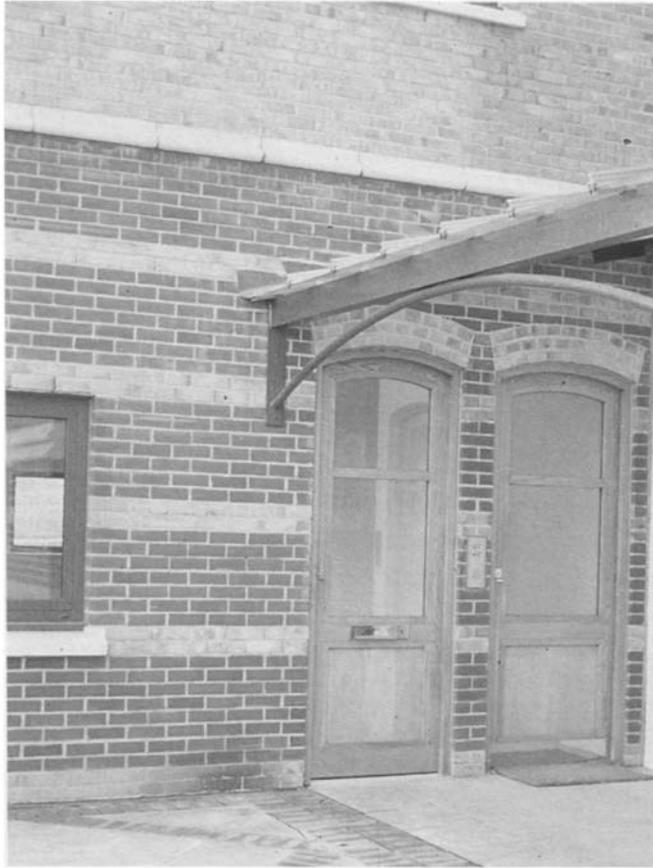
Figure 4.72 The canopies above the main entrances have no guttering which allows rain splashback to stain the walls at low level.

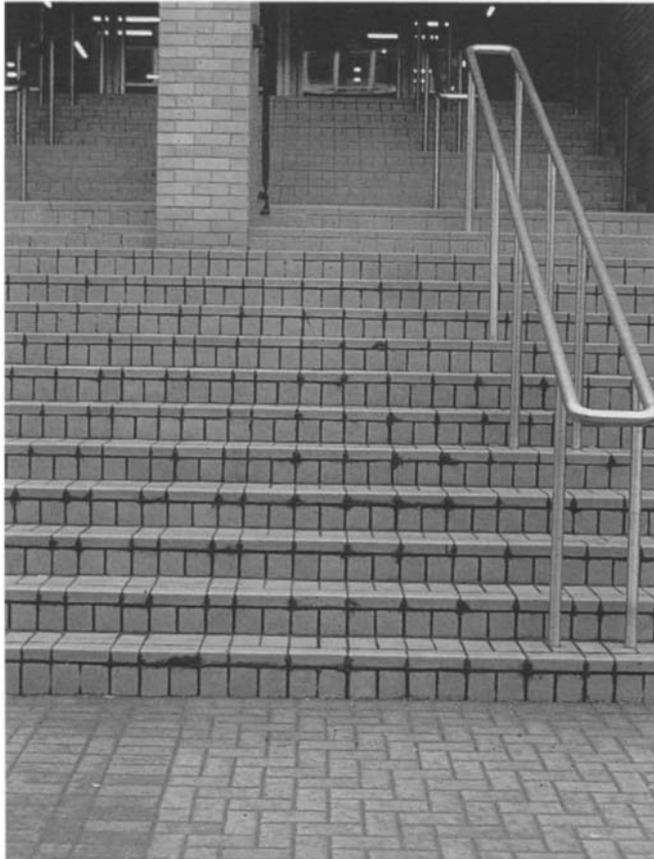
Figure 4.73 External entrance stairs to an arts centre consisting of brick treads and risers.

the risers and the treads. The risers are normally the worst affected, with large amounts of dirt collecting at the joints or masonry perpens (Figures 4.73 to 4.76).

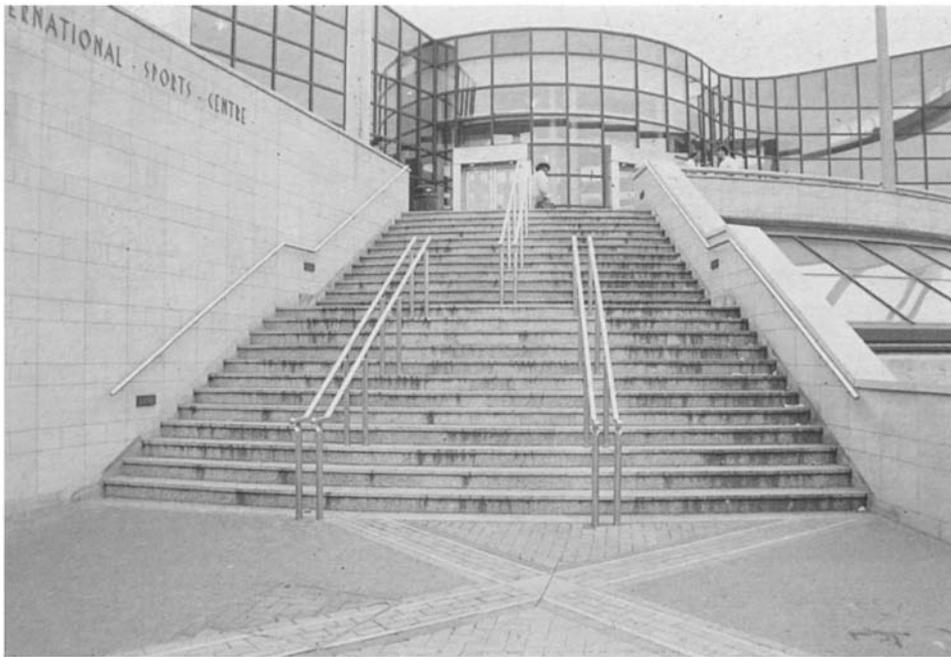
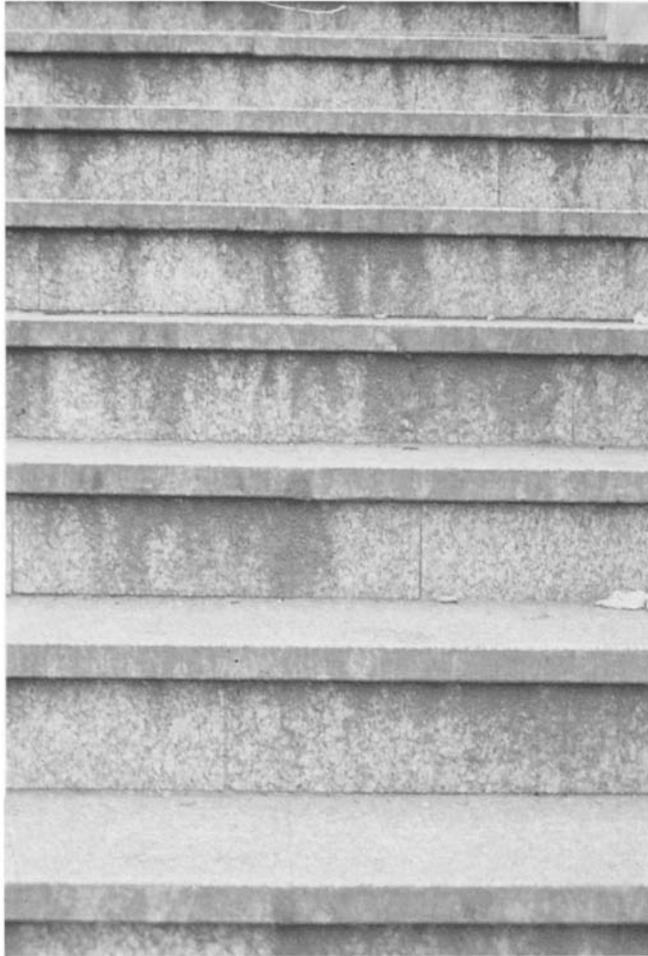
Figure 4.76 Detail of Figure 4.75 showing that despite the overhanging nature of the treads, the risers are still badly soiled.

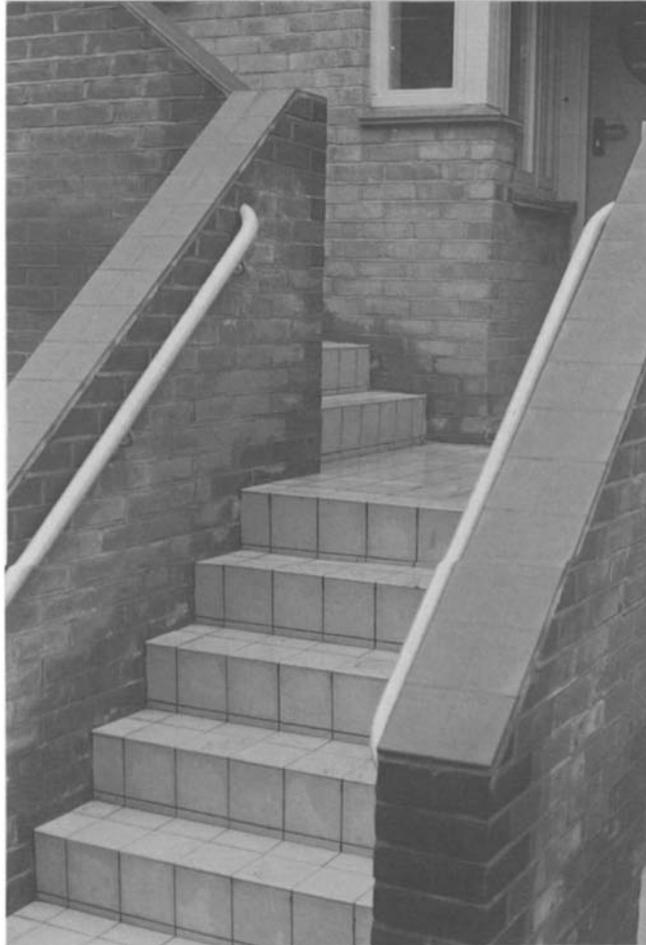
Figure 4.78 Impervious tiled treads and risers will allow considerable splashback to stain adjacent brickwork. The light colour of the tiles will show dirt clearly and the smooth surface makes them very slippery when wet!

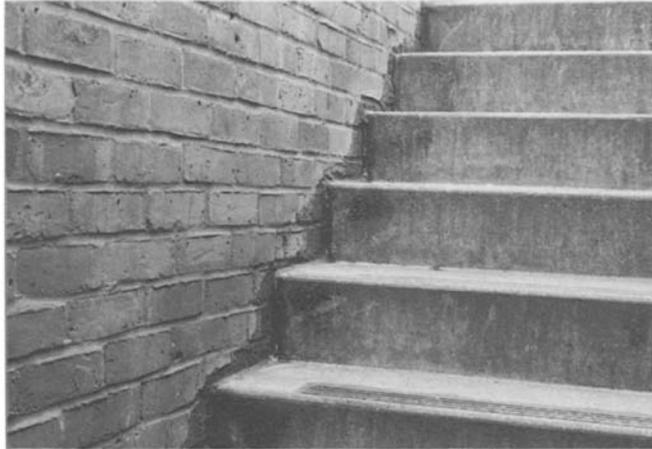
Figure 4.79 Longer exposure to the elements will lead to algae and moss growth at the junction of the steps and brick wall.

The junction of the staircase and side walls can also be badly affected by splashback during rainstorms and will stain the wall as well as promote frost damage. A skirting or upstand of impervious material is essential here (Figures 4.78 and 4.79).

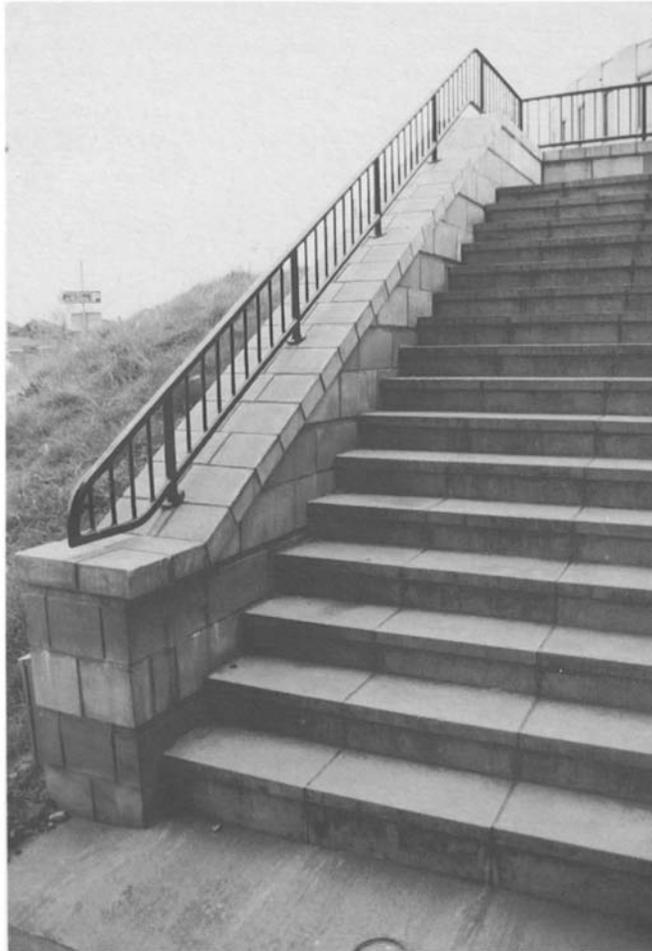
Figure 4.80 Staircase where the handrail and balusters have been fixed through the coping construction. The junctions of the main posts and the copings are very difficult to waterproof, potentially allowing water to stain the walling below.

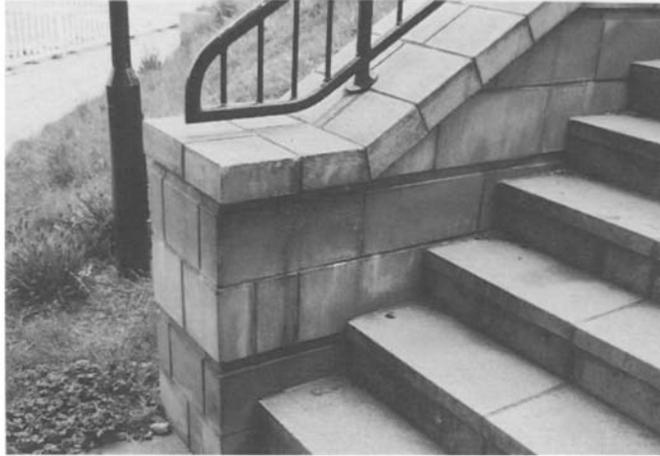
Figure 4.81 The broad flat surface of the parapet wall to this staircase (see Figure 4.80) allows large amounts of water to flow down to the base of the stair and discharge over the walling.

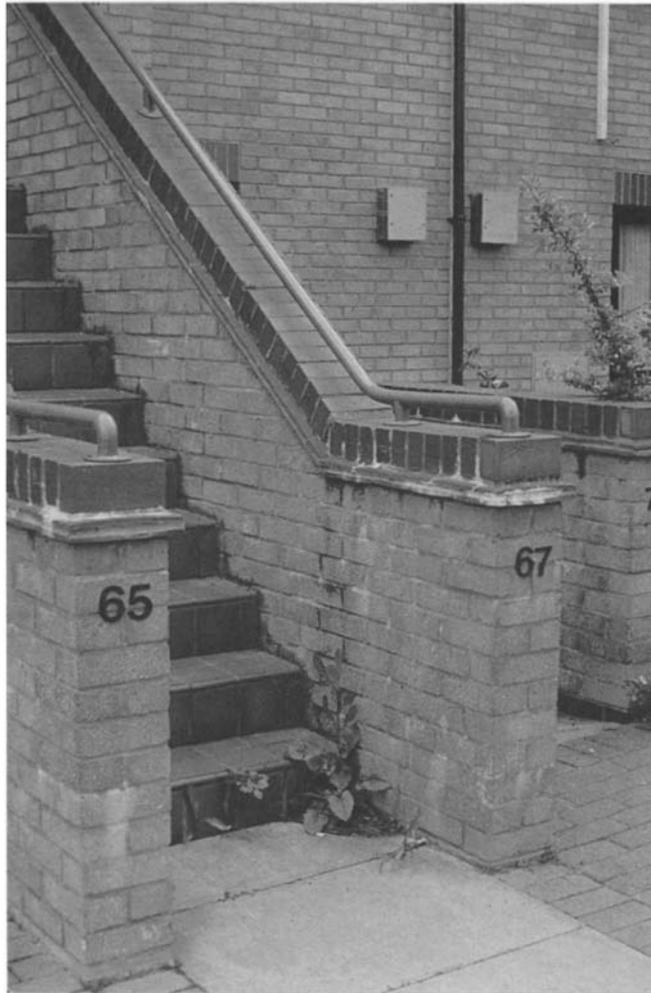
Figure 4.82 Brick on edge coping and tile creasing fails to prevent the increased flow of water at the change in inclination. Lime staining is also evident here.

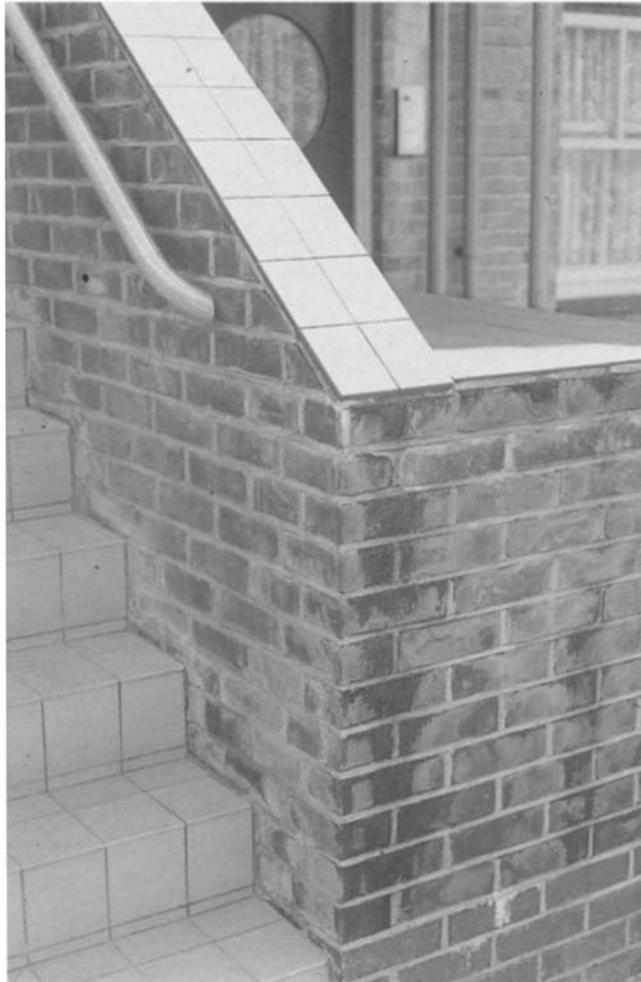
Figure 4.83 The 'clean lines' of this design has resulted in the absence of any form of overhang/throating allowing water flow to affect the face of a brick-built bin store below.

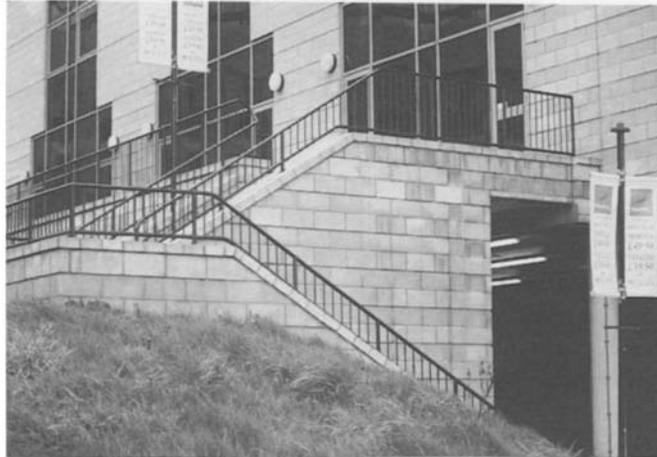
Figure 4.84 The broad flat coping at high level allows water to flow down the face of the prominent elevation disfiguring the reconstituted stone blocks.

- *Change in inclination*—at the base of the staircase the parapet wall will terminate and unless the high levels of water flow down the coping are properly dealt with then the concentrated run-off can cause ugly staining (Figures 4.81 to 4.83). It is important to have well-designed copings that shed as much water as possible with the special attention to the coping unit that spans across the change in the inclination. Thought must be given to which elevation of the staircase is the most prominent, and the coping run-off directed to the other face (Figure 4.84).

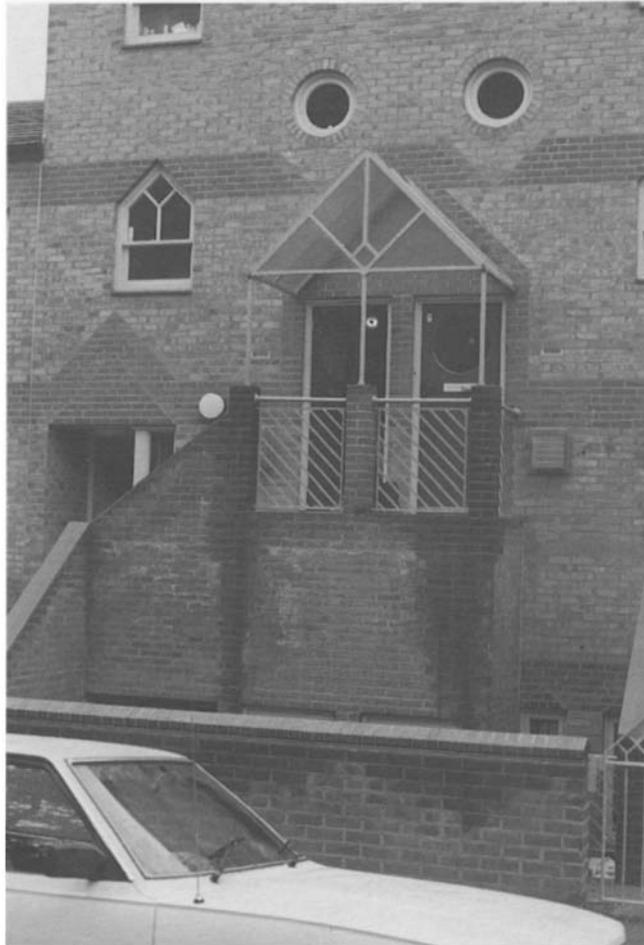
Figure 4.85 This glass-covered canopy has no guttering system and discharges over the flat entrance area below. Because there is no raised upstand on this balcony the water flows over the walling below causing staining.
