Prevention of Premature Staining of New Buildings

Phil Parnham

*Principal Lecturer in Building Surveying, Sheffield Hallam
University, UK*

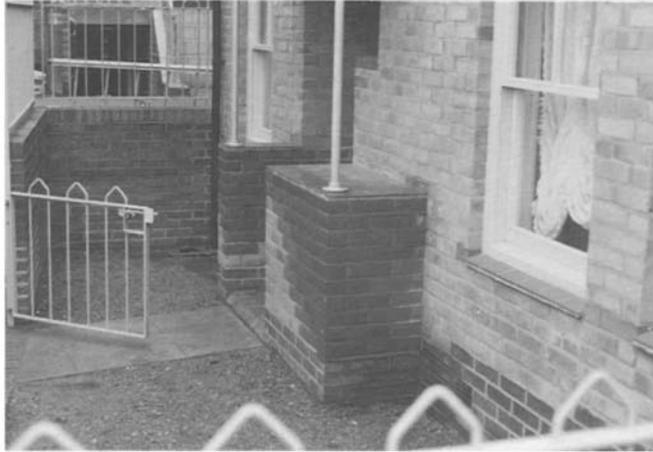
Figure 4.86 Similar effect to Figure 4.85 but on a smaller scale.

Many entrance areas utilize small canopies and roofs either for aesthetic effect or to provide shelter for visitors and users of the building while they gain access to the building. Many appear to be afterthoughts without formal drainage systems, which will inevitably result in the uncontrolled flow of water over adjacent surfaces. The features illustrated in Figures 4.72, 4.85 and 4.86 are clear examples of this practice.

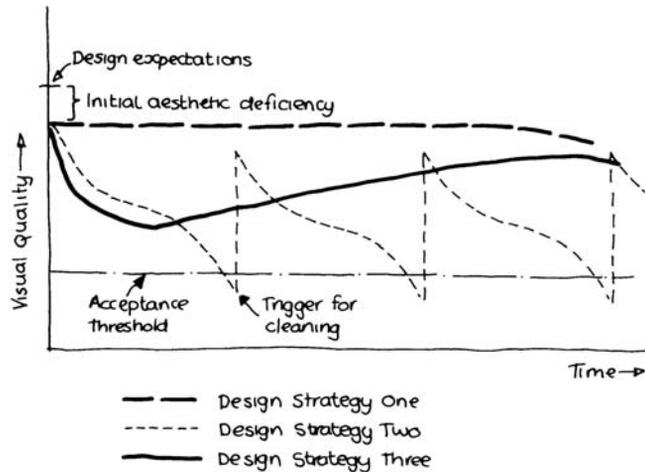
Figure 5.1 Graphical representation of visual quality of a building over time (Verhoff, 1988).

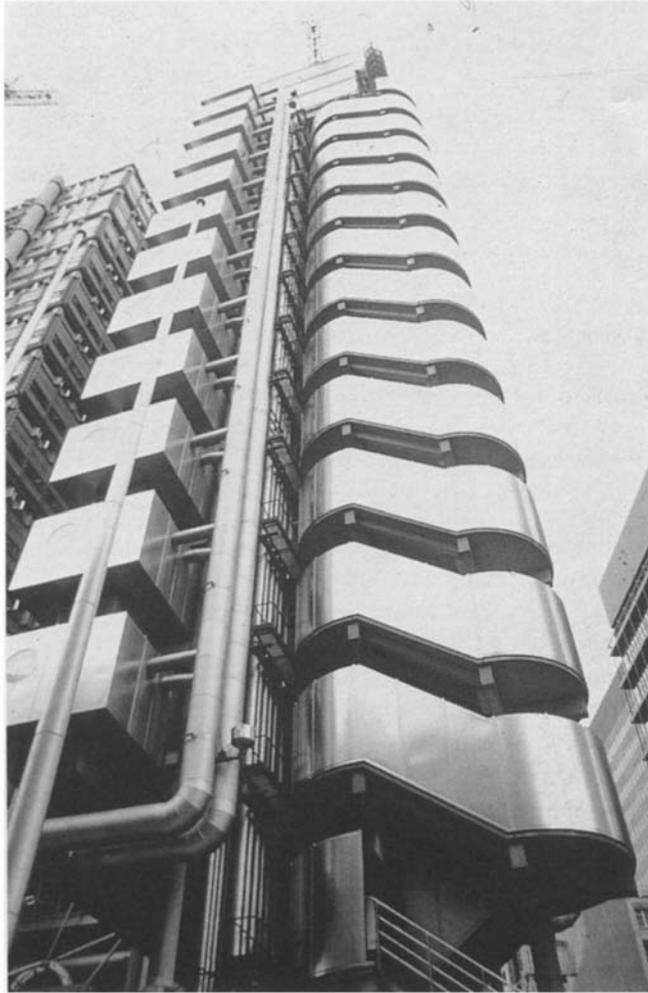
Figure 5.3 Detail of a junction to the exposed concrete frame of the Lloyds building showing uneven washing and staining.

The cost of this approach would be very high and therefore limited to the most prestigious of buildings where the commercial return (or public subsidy) is likely to justify the high initial expense. Examples include the Lloyds building ([Figure 5.2](#)) in the City of London where stainless steel cladding has been used to produce a building in which parts of the elevation weather very well. But this level of performance is not matched by all the components of the building; [Figure 5.3](#) shows typical staining to part of the exposed concrete frame. Verhoff (1988, p. 59) also asked the broader question of whether society wants buildings that stand apart from their environment, never becoming part of the mature and familiar backcloth ‘which has been bequeathed to us by past generations’.

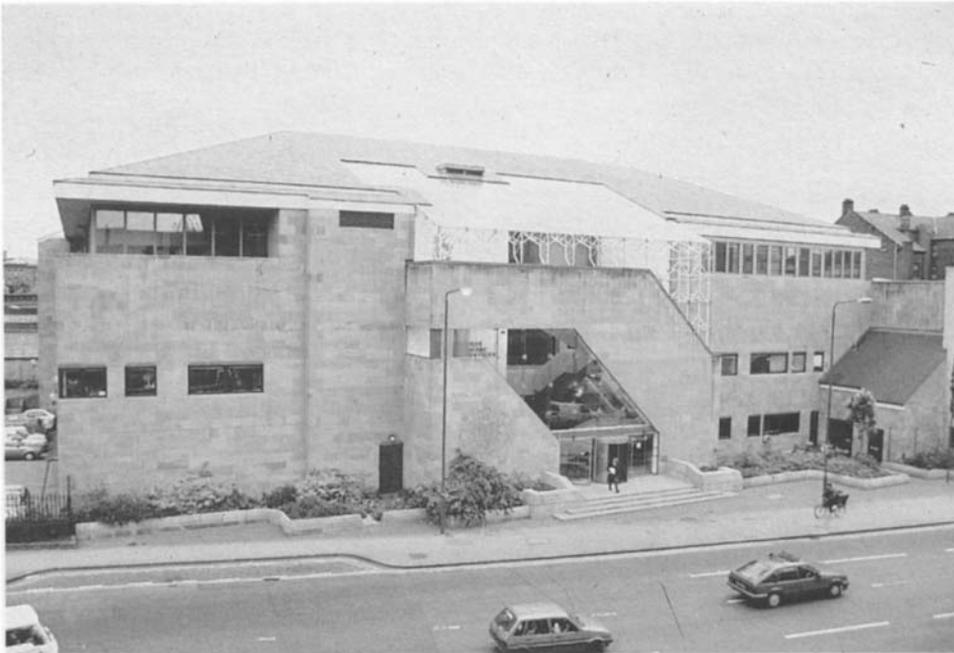
Figure 5.4 General view of stained law court building.

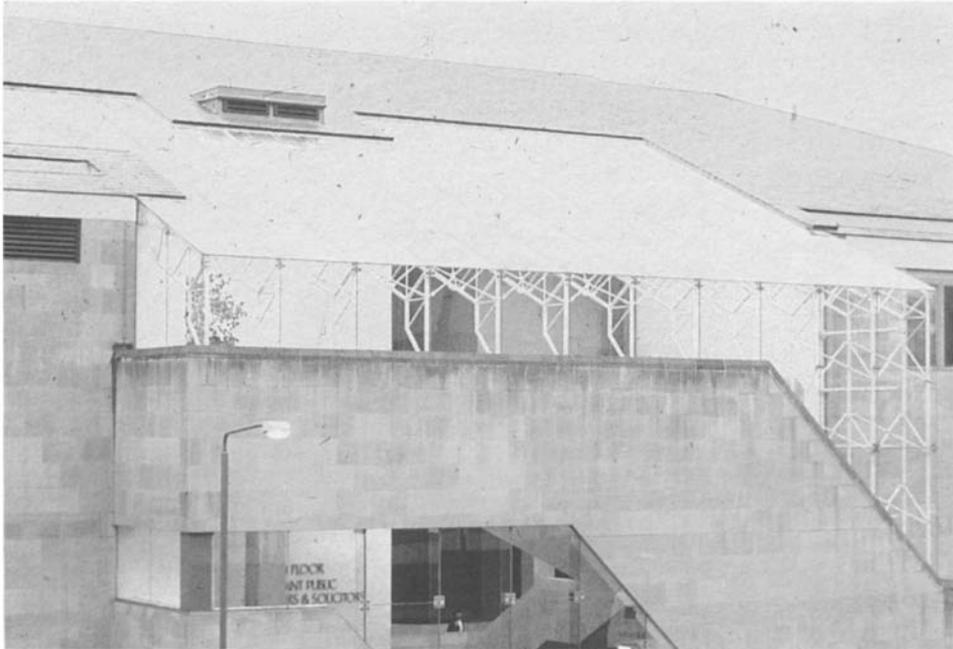
Figure 5.5 The glazed roof and walls to the main entrance and staircase has allowed high levels of water to flow over the stone cladding beneath. The cladding was soon disfigured by algae growths.

Figure 5.9 Same building after cleaning (see Figure 5.5 for comparison) with the former staining patterns clearly visible. It is predicted that algae staining will soon return.

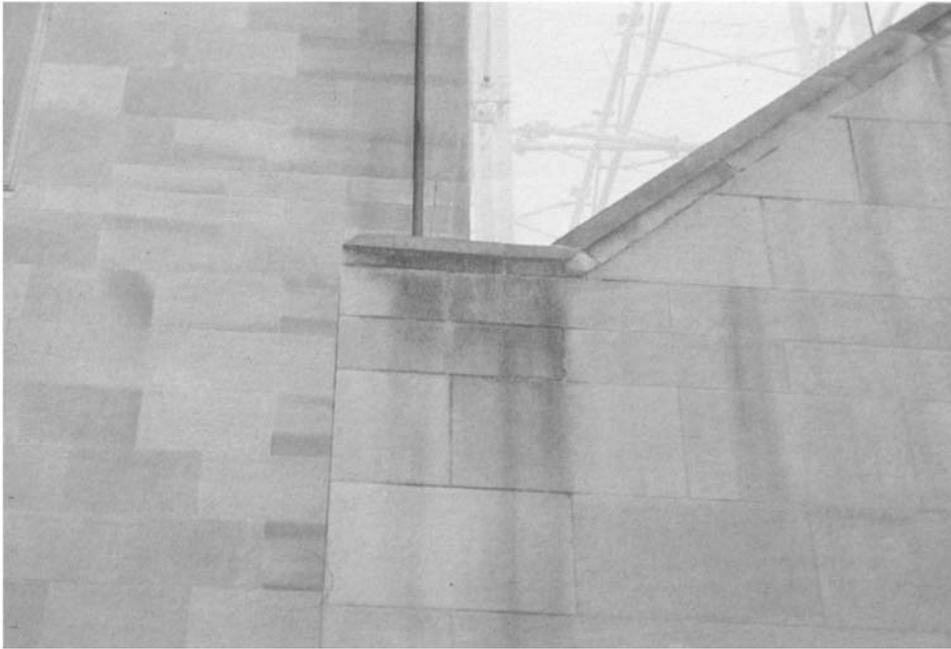
Figure 5.6 The inclined cills beneath the glass cladding concentrated the water flow at the change in inclination.

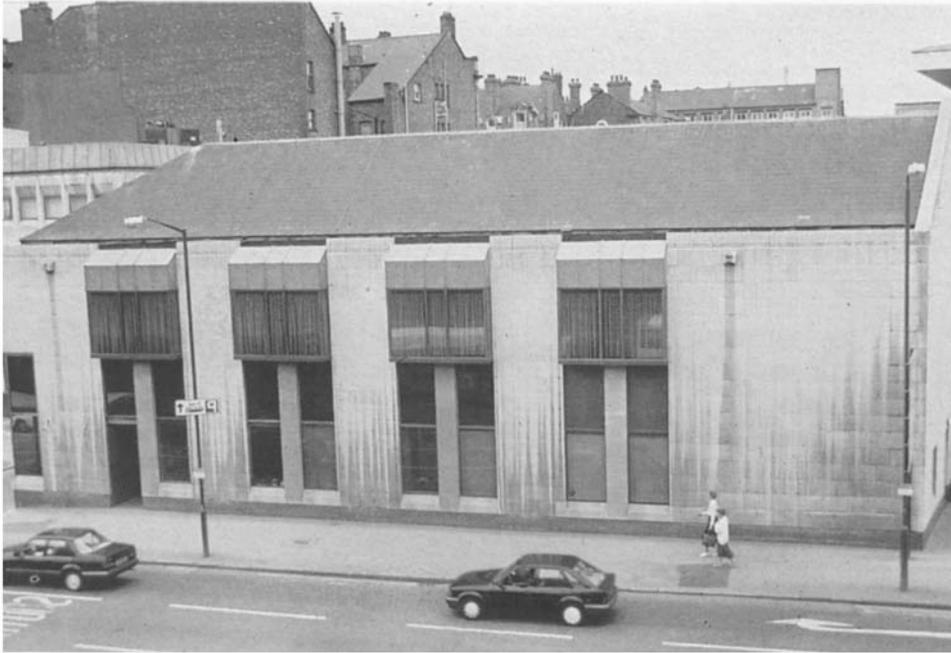
Figure 5.7 An older but associated building with similar stone cladding had already shown signs of uneven washing and deposition.

Figure 5.8 Detail of [Figure 5.7](#) showing the sheltering effects of a protruding detail on the wall surface.

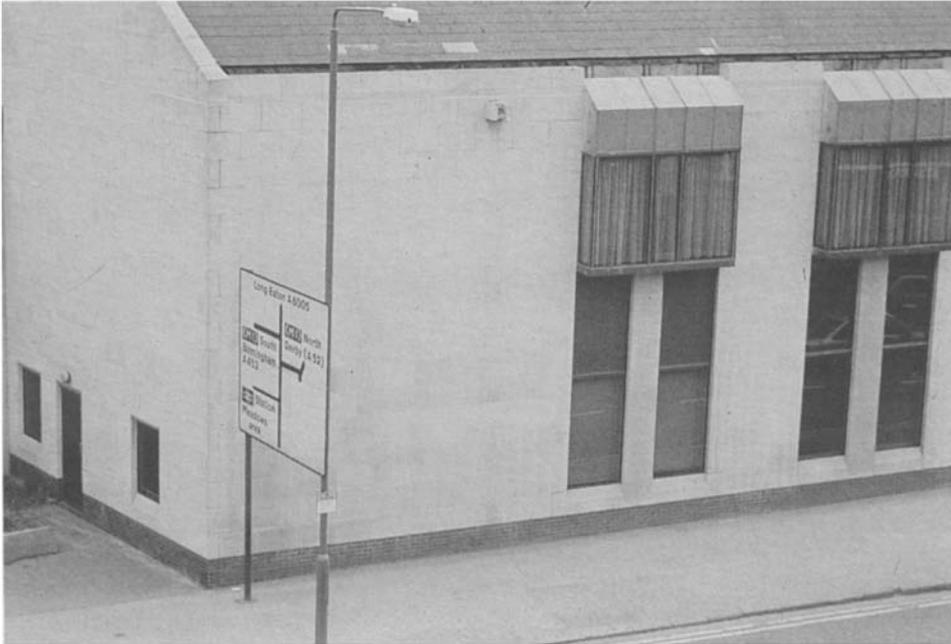
Figure 5.11 Cleaning the older building was slightly more successful but still did not return the façade to its original condition.
