# Environmental Degradation *of* Materials *in* Nuclear Power Systems – Water Reactors

Proceedings of the 18th  
International Conference  
on Environmental  
Degradation of Materials  
in Nuclear Power  
Systems – Water Reactors

Volume 2

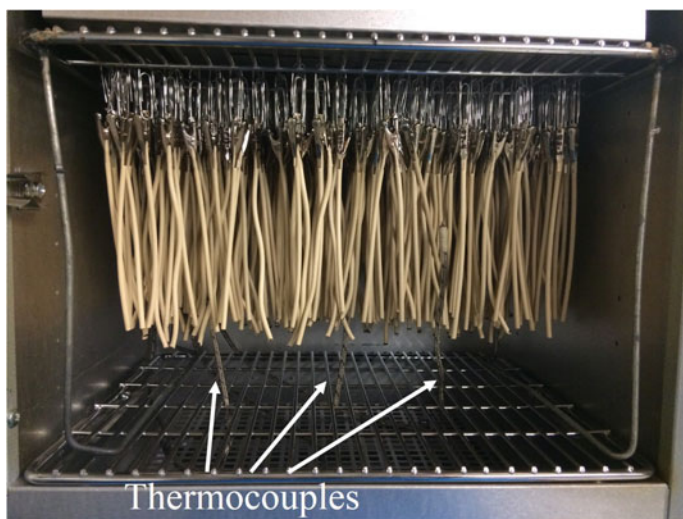
Fig. 3 Photo of oven chamber containing rack of XLPE specimens

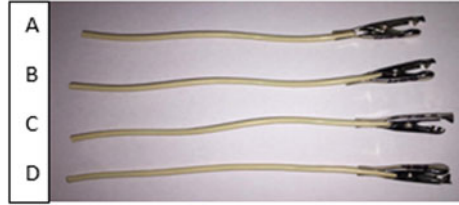
**Fig. 1** Samples thermally aged at 90 °C and radiation aged at dose rate 230 Gy/h for 5 days. Samples labeled A–C are straw samples and sample D (with-conductor, WC) is intact, containing the central conductor

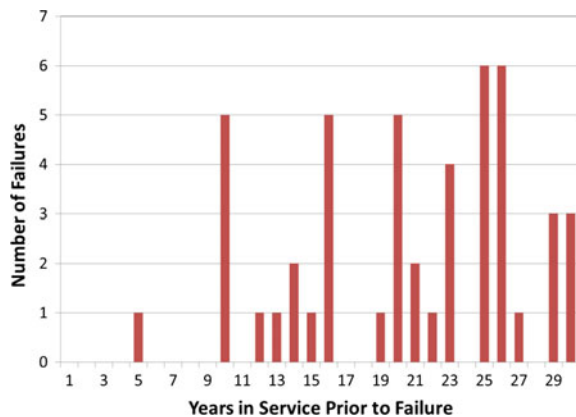
**Fig. 1** Distribution of MV power cable failures with respect to years to failure from NEI survey of existing NPPs [1]

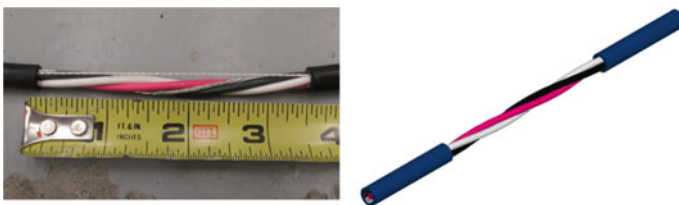
**Fig. 7** (left) Damaged 3.5 in. section at the halfway point of a 100 ft. three-conductor shielded 600 V EPR cable; (right) corresponding ANSYS HFSS finite element model of damaged section

A similar assessment was performed using a 100 ft. section of General Cable FR-EPR/CPE shielded 600 V three-conductor cable [13]. In this case, a 3.5 in. long segment of the cable jacket was removed at the 50 ft. location as shown in Fig. 7.

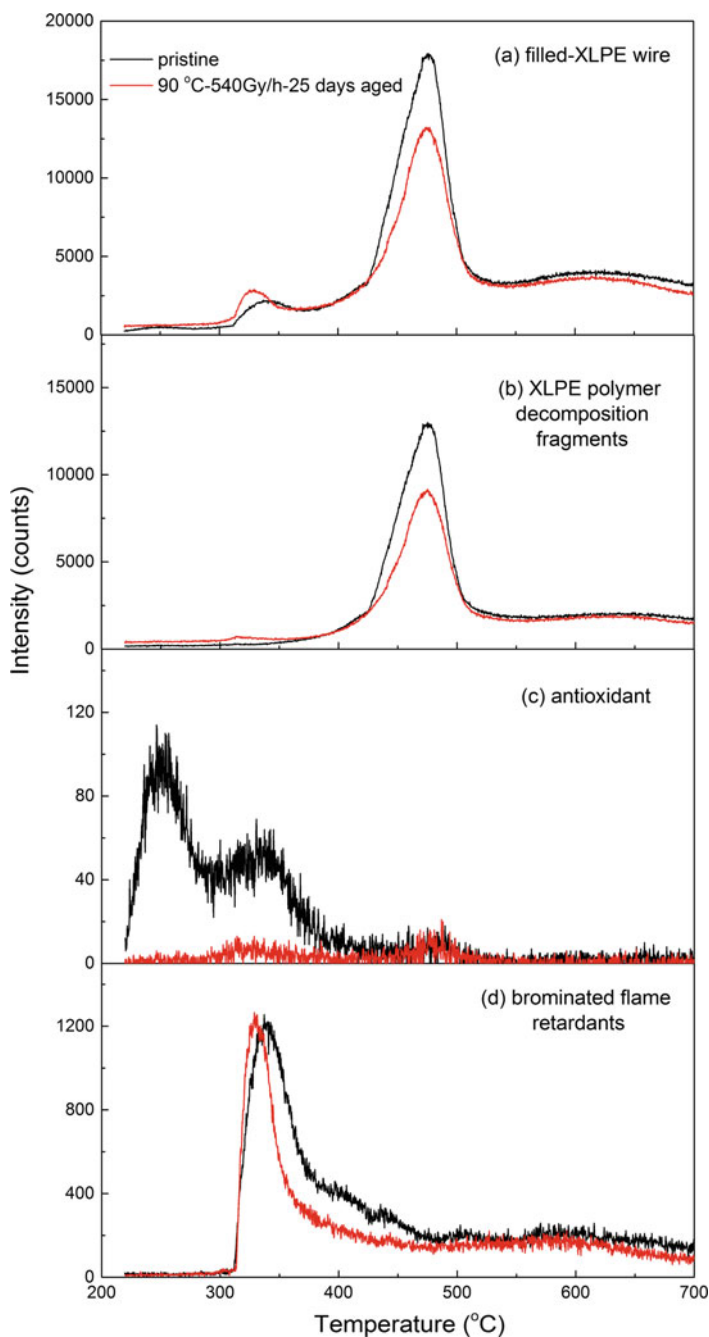
**Fig. 2** EGA data for **a** pristine and aged XLPE wire; **b** the fragments of the decomposition of the XLPE polymer chains; **c** the fragments of the decompositions of the antioxidant; and **d** the fragments of the decomposition of flame retardant decabromodiphenyl ether (DBDE). Note that the antioxidant curve shown in **c** is obtained by summing the mass intensity given by the different fragments of pTMQ; similarly the flame retardant curve shown in **d** is obtained by summing the mass intensity given by DBDE and its fragments

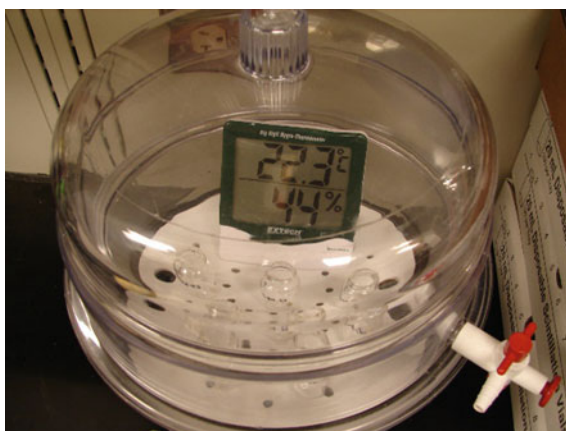
**Fig. 1** Vessel used to pre-condition samples overnight at 44% humidity and room temperature

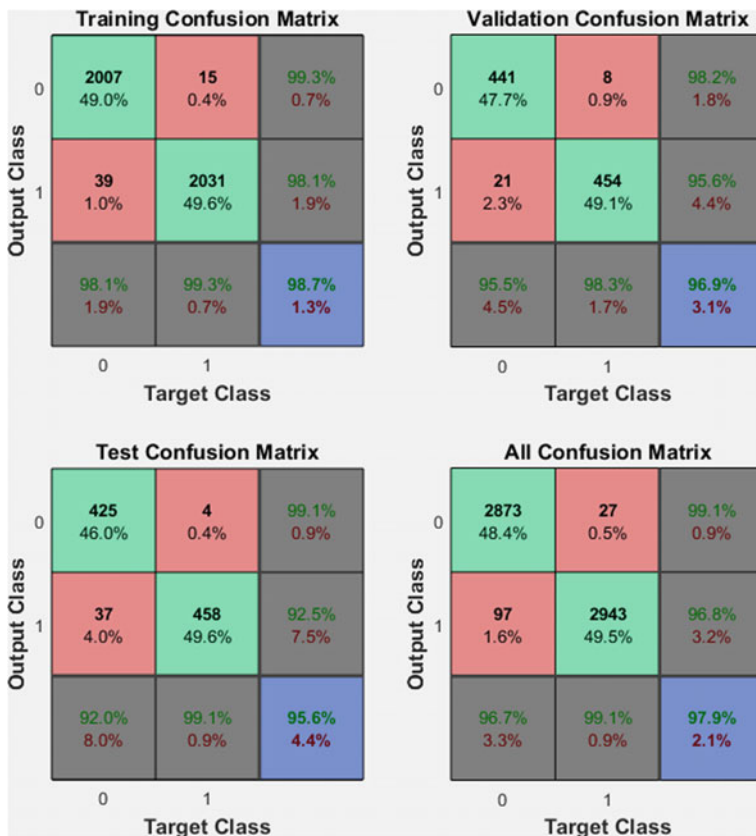
**Fig. 6** Confusion matrices for the data set in four categories: training set, validation set, testing set, and total

It was observed that false positives (i.e., classifying a healthy specimen as damaged) were below half of a percent, while there was an order of magnitude increase in false negatives (i.e., classifying a damaged specimen as healthy). This increase in false negatives may be due to mislabeling of the ground truth data. The significance of the classification could be enhanced by changing the ANN training to a regression problem (i.e., the ANN will return a floating-point value similar to HTI) and consider the damage estimates of neighboring regions as part of the classification of a region of interest. Recall that the ANN considers each transducer pairing time series as a sample. This may be problematic as known classification labeling is at the ultrasound system position level and not at the level of each time series. In other words, every pairing is labeled with the same classification label even though each pairing traces a different path through the sample. It is possible for ASR damage to be present in a scan position but not in the path of a specific transducer pairing. Consequently, the training data sets were regrouped by transducer pair distance.

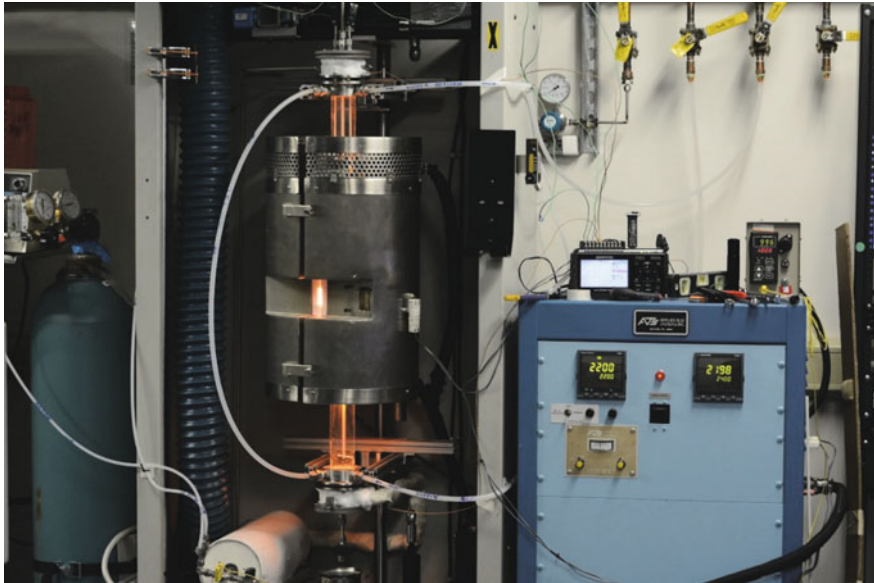
**Fig. 2** High temperature test setup constructed at GE global research

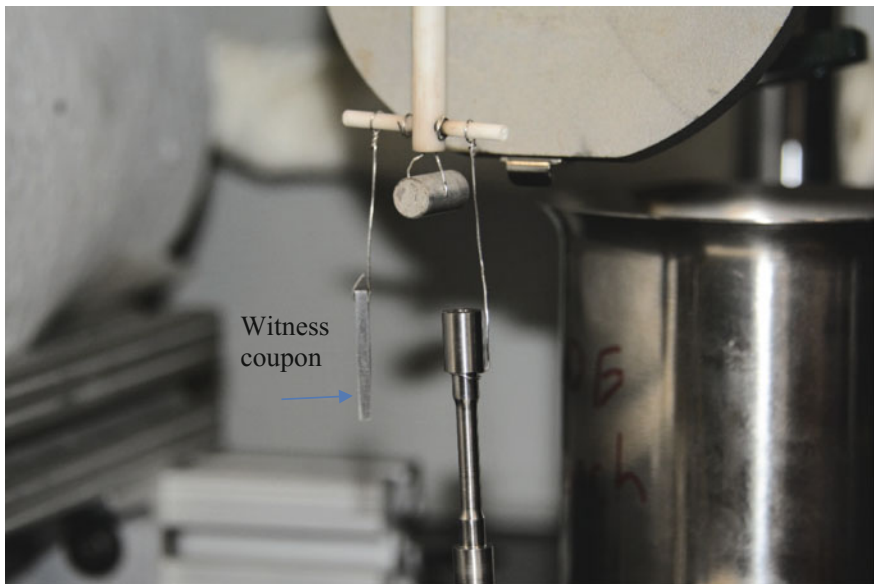
**Fig. 3** Alumina specimen hanger with integrated thermocouple. The tensile specimen is exposed with a witness coupon

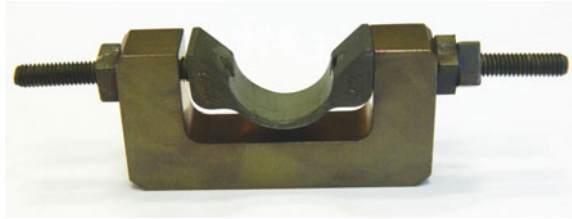
**Fig. 5** Open C-ring loading

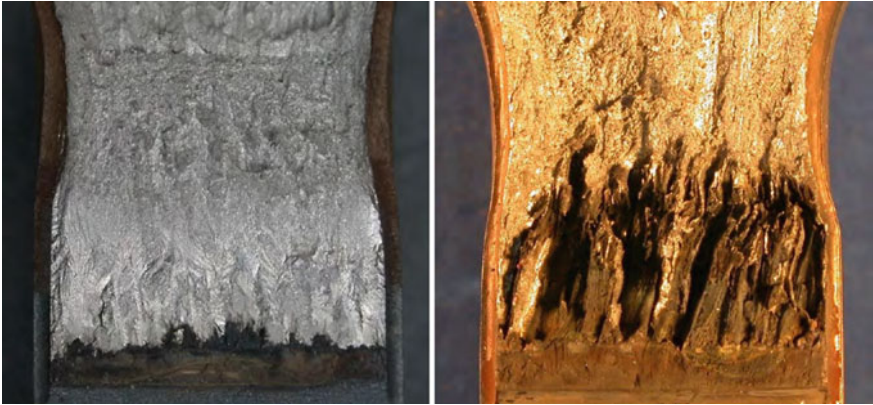
**Fig. 4** Macro photographs of 0.5TCT Alloy 82 SAW specimen c764 (left) and 0.5TCT Alloy 82 MIG specimen c765 (right)

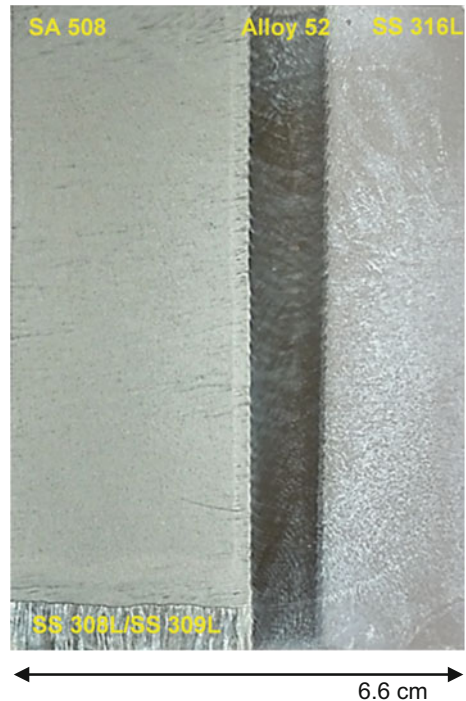
**Fig. 1** A cross-section macrograph of the studied DMW

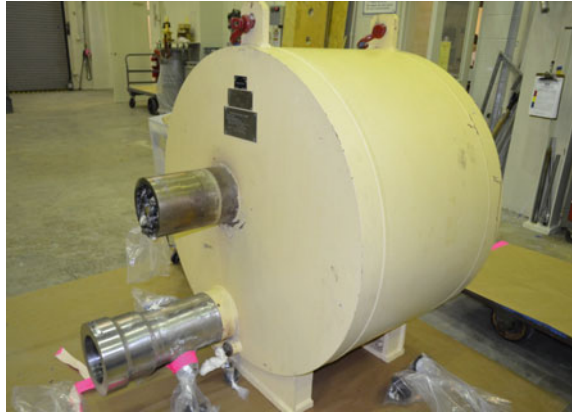
**Fig. 1** Receipt photograph showing the primary flow seal side of the letdown cooler. The primary inlet (near center) and outlet (toward bottom) manifolds are visible

Figure 1 is a receipt photograph taken of the cooler showing the primary side inlet and outlet manifolds. The tubes were dewatered prior to pressure testing, and then each tube was individually pressure tested with 206 kPa (30 psi) helium for

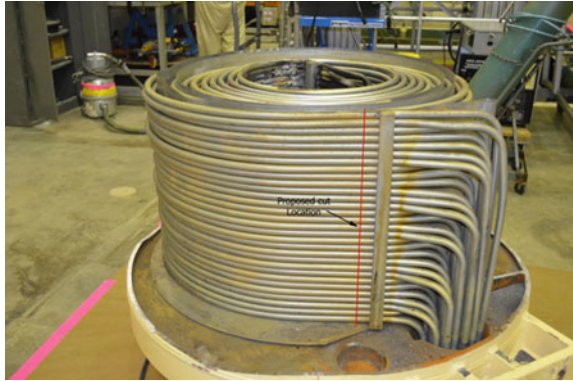
**Fig. 4** The central cavity near the inlet side of the tube bundle. The tube #17 leak location is indicated

The letdown cooler shell was cut just above the primary side end plate and then removed to access the tube bundle. Figures 3, 4 and 5 show the tube bundle and its central cavity. White-to-brown deposits were found on the tubes in the tight radius region on the inlet ends. The deposits were most heavily concentrated on the tube intrados, which corresponds to the underside (i.e., 6:00 position) of the tubes in-service. Few or no deposits were present on the tube extrados. The leak in Tube

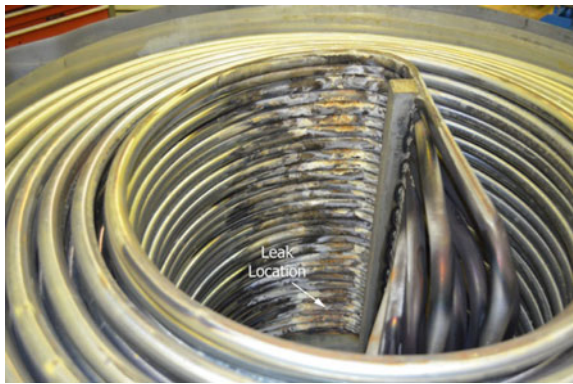
**Fig. 5** Higher magnification view of the tube #17 leak location. Cut locations for the destructive examinations are indicated

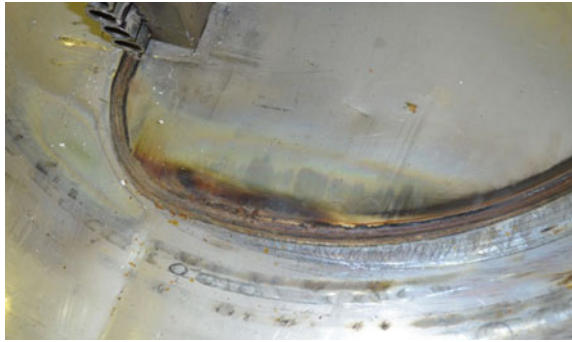
**Fig. 7** Higher magnification view of the tight radius region showing the most pronounced heat tinting

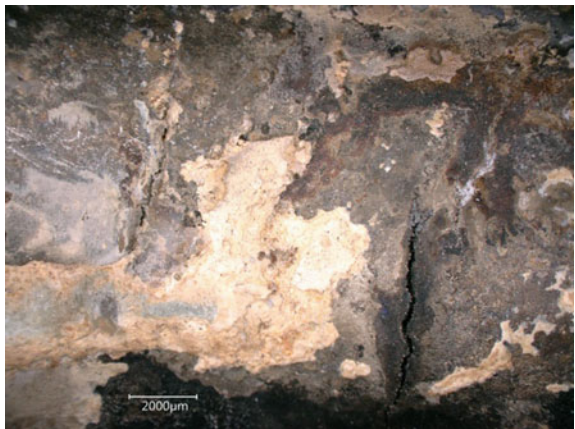
**Fig. 10** Higher magnification view of the tube #17 cracks

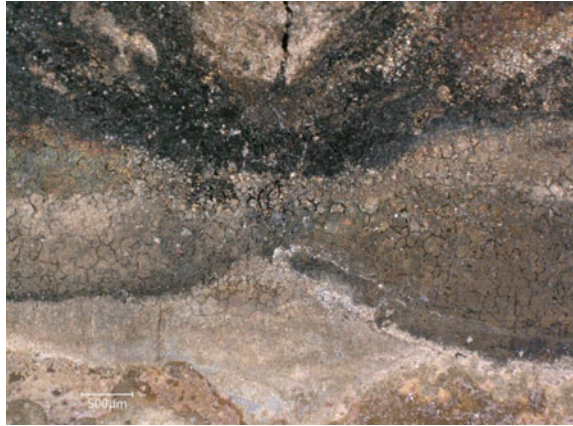
**Fig. 11** IGA-like features were observed at one of the crack tips

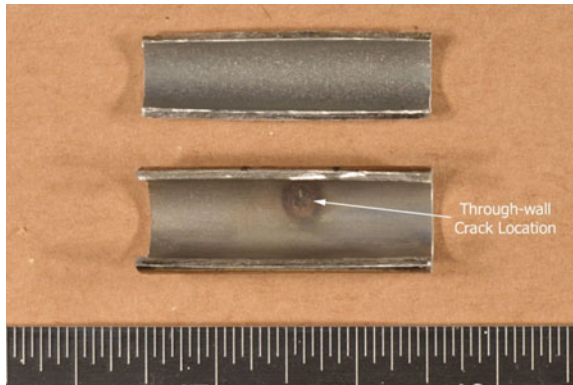
**Fig. 12** Photograph taken after cutting the piece open clamshell-style to reveal the ID surface. The through-wall crack location is indicated

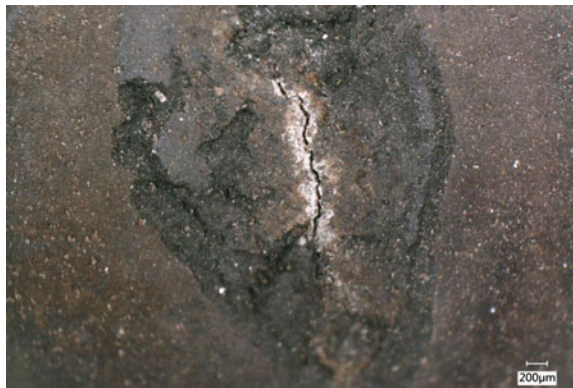
**Fig. 13** Higher magnification view of the through-wall leak location

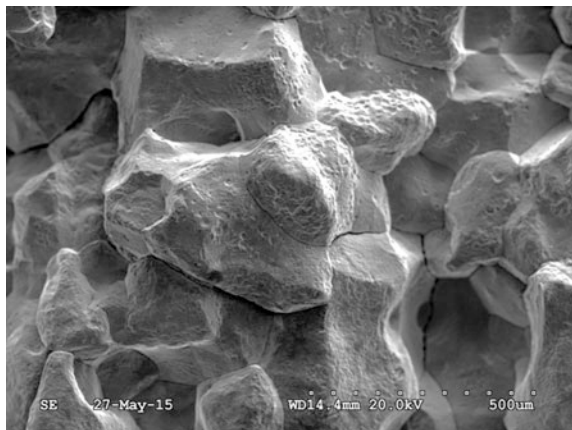
**Fig. 17** SEM image of the opened crack taken in the mid-wall region

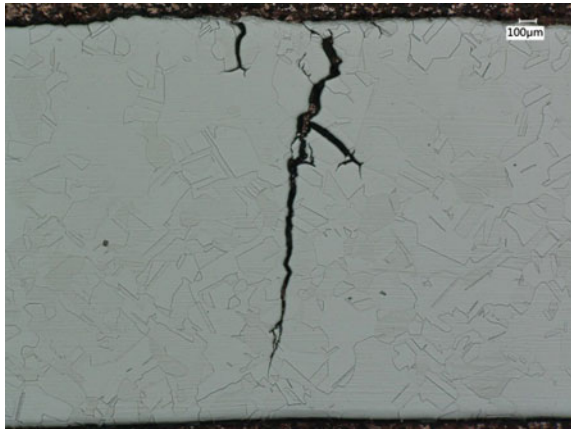
**Fig. 22** Micrograph of the cross section prepared through the tube #17 through-wall crack tip. OD surface is along top edge. Electrolytic 10% oxalic etch

The through-wall crack tip region exhibited a few branches, but was generally straight and unbranched for much of its length (see Figs. 22 and 23). Secondary cracking was noted on the OD surface as well. Intergranular cracking and branching are evident near the OD, but the latter half of the crack was clearly straight and transgranular. There was also evidence of cold work on the OD surface, as evidenced by the presence of disturbed grains in this area.

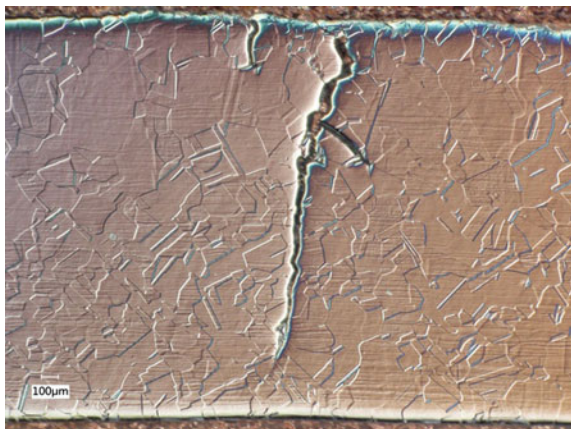
**Fig. 23** Same area as Fig. 24, using Differential Interference Contrast (DIC) illumination

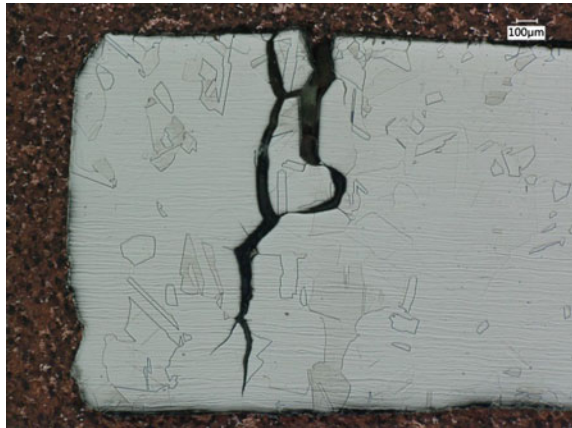
**Fig. 24** Tube #17 secondary crack. Electrolytic 10% oxalic etch

The cross section of a secondary crack in Tube #17 is shown after standard oxalic etching in Fig. 24 and after ASTM A 262 etching in Fig. 25. The cracking extended nearly through-wall in this plane. The grain boundaries exhibited a step structure after the ASTM A 262 etch, indicating that the material microstructure was non-sensitized.

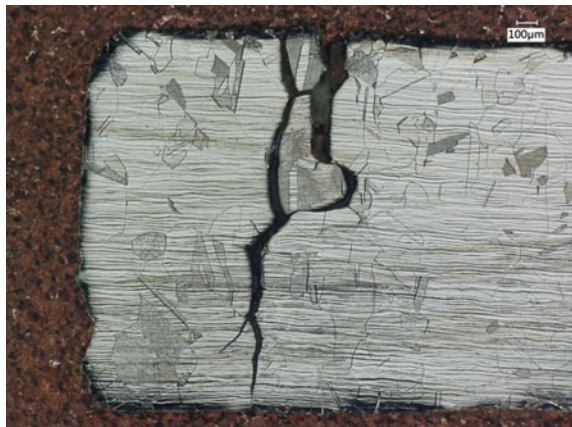
**Fig. 25** Same area as Fig. 24, after etching per ASTM A 262, Practice A. No evidence of ditching was noted at the grain boundaries

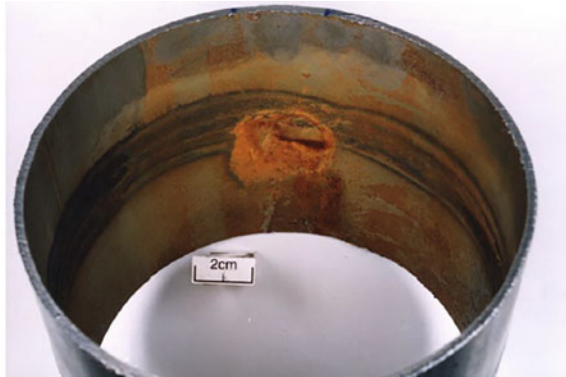
**Fig. 1** Appearance of the inner surface of a leaking FFW pipe made from EN 1.4401 stainless steel. The reddish area is the lower side of the pipe in the piping

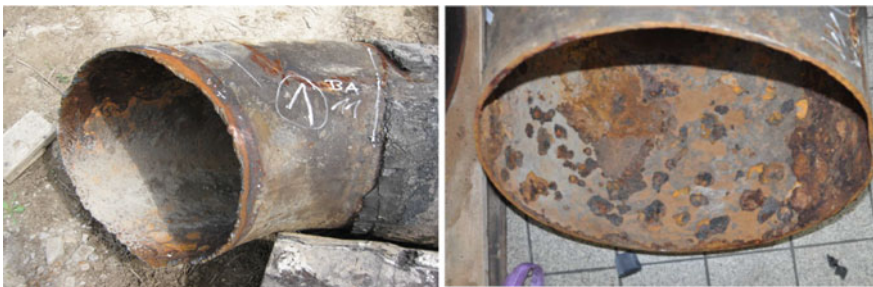
**Fig. 1** Specimen cutting of an  $ND 500 \times 6.3$  mm elbow for post service examination, after excavation and partial dismantling of the outside coating (left), and inner surface after cutting and before sand blasting (right)

Figures 1 to 4 show some typical results of the post service examinations, performed by AREVA Germany.

As Fig. 1 implies, the excavated old pipe was designed without an inner coating. In addition, this old line did not use an active cathodic system for protection of the outer surface, but only an outside coating. In this case, a ND 500 mm elbow with a nominal wall thickness of 6.3 mm was examined.

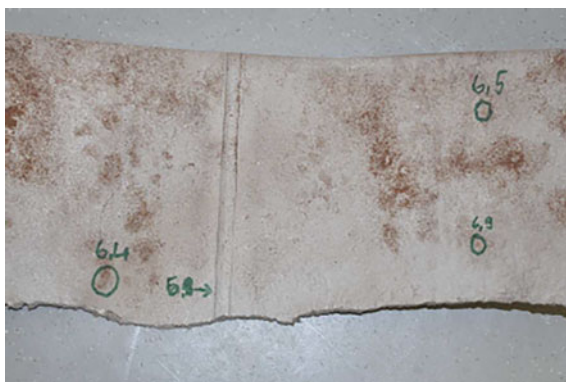
**Fig. 2** Strip from elbow ND 500 × 6.3 mm, inner surface after sand blasting and wall thickness measurement, markings show measured minimum wall thickness values

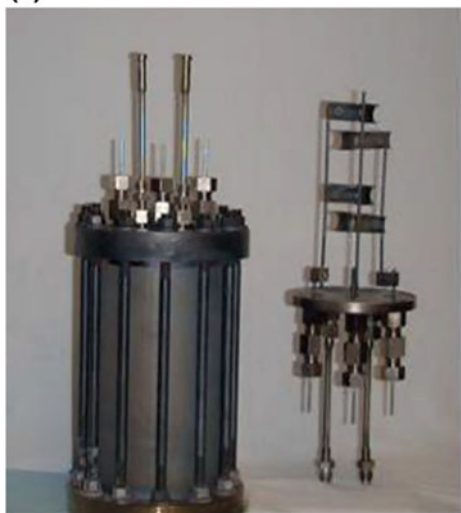
(a)

**Fig. 1** a Autoclave and mount (shown upside down) for RUB specimens for applied ECP tests and b mount for inhibitors testing

A titanium autoclave was used to measure the effect of applied ECP. Up to four specimens were electrically isolated from the autoclave and attached to a potentiostat with a nickel reference electrode as shown in Fig. 1a. The autoclave was sealed and deaerated using a 95% Argon/5% hydrogen cover gas which was pressurized and purged at least three cycles to ensure the solution is deaerated. The cover gas composition corresponds to a starting dissolved hydrogen concentration of 6 ppm. The autoclave was heated up and the samples exposed at 330 °C for periods of time ranging from 432 h to a total of 4296 h. If an autoclave was shutdown, the solution inside was refreshed before the next exposure cycle.
