Structures & construction in historic building conservation

Michael Forsyth

Department of Architecture and Civil Engineering
University of Bath

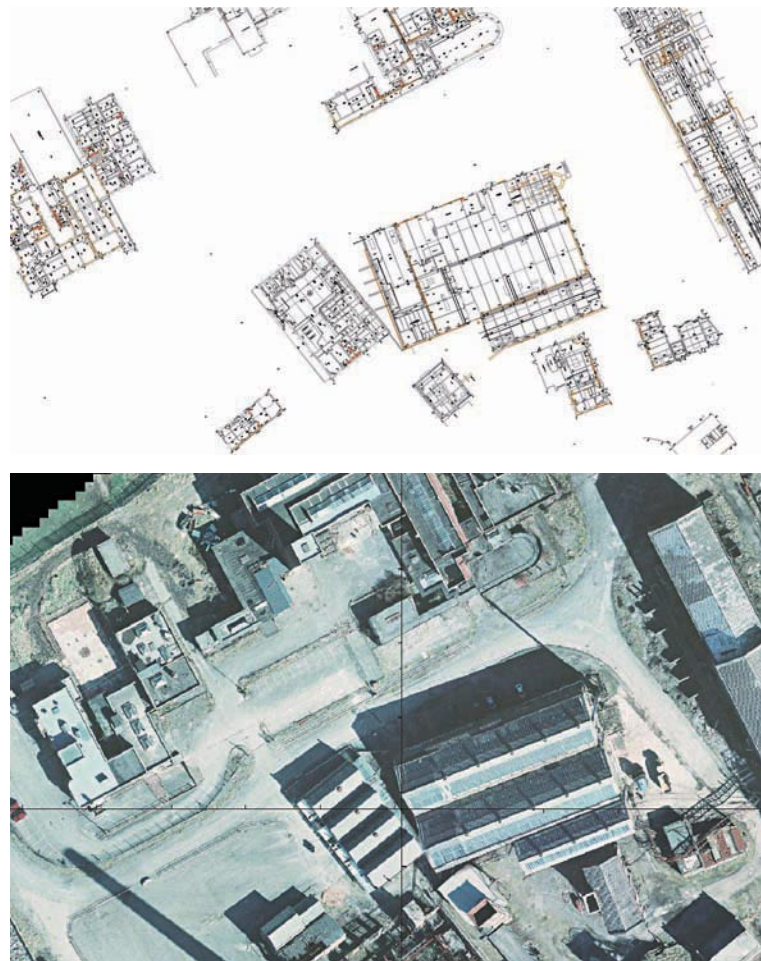
Figure 4.1 Metric survey at Chatterly Whitfield Colliery, Staffordshire: orthophotograph and building plans, originally at 1:200 and 1:50 scale respectively. The survey work was carried out on a common control so composites are possible in CAD without problems of differing scale and orientation.

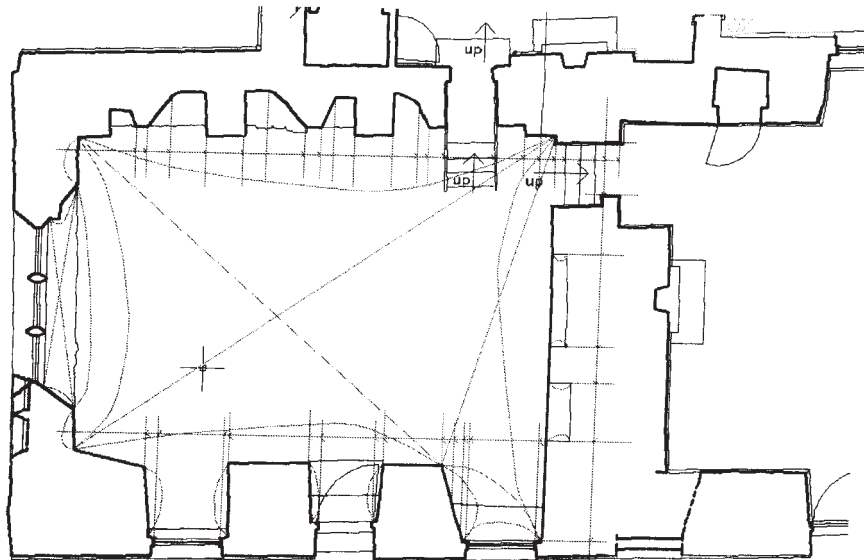
Figure 4.2 Taped triangulation used to control measured drawing. A building floor plan, with baselines, ties for triangulation and chain-lines and 90° offsets, is shown prior to measurement. The principal diagonals and braces are shown as loop lines.

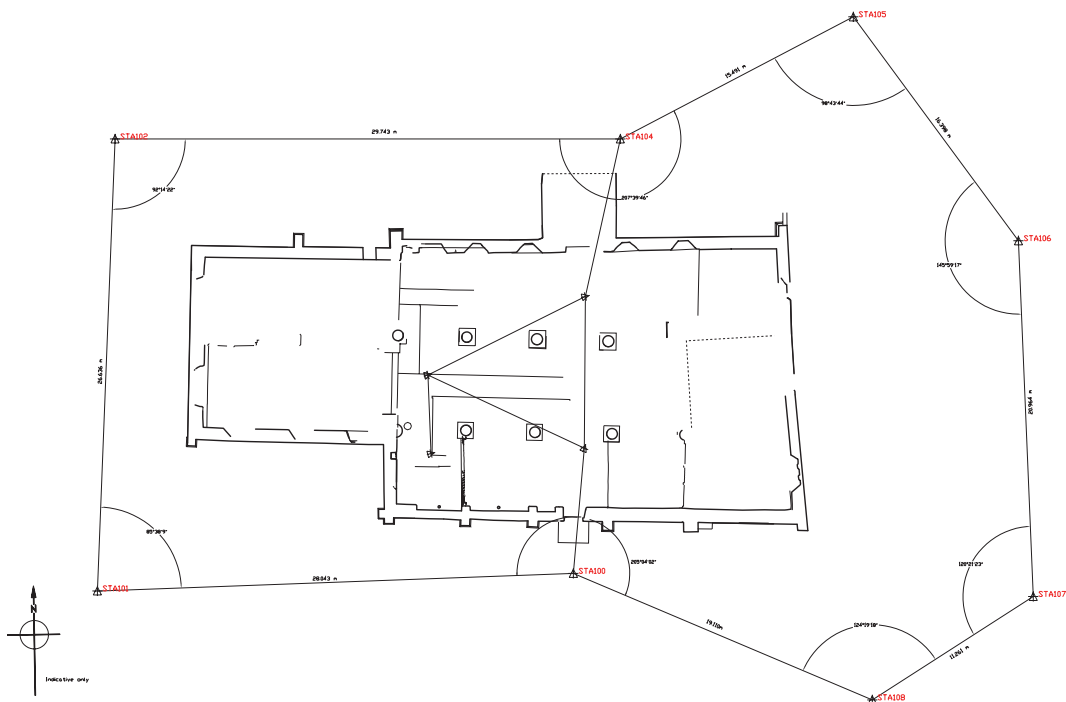
Figure 4.3 Traverse at St Giles' Church, Oxford. The four stations inside the church are tied to the closed loop. The stations on the loop are adjusted and the plan is prepared by polar observation from them. Further interior control is achieved by resection, end over end or spur legs; checks are possible by linking back to the loop. The plan is in progress; wall thickness, window reveals, nave arcade and overhead detail will be recorded from further stations and hand measurement.

A traverse consists of a number of points known as stations linked by lines known as legs (Figure 4.3). To undertake a traverse, at least three

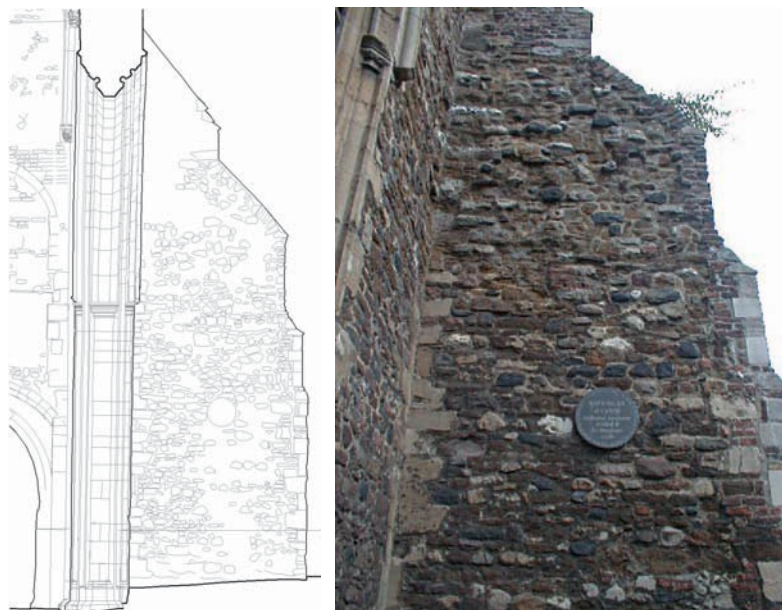
Figure 4.5 Using an REDM CAD trace to control photography of detail. Note the effect of camera tilt in the photograph, corrected on the REDM trace by 3D rotation of the image to fit the wireframe in CAD. The rubble infill was traced off the photograph.

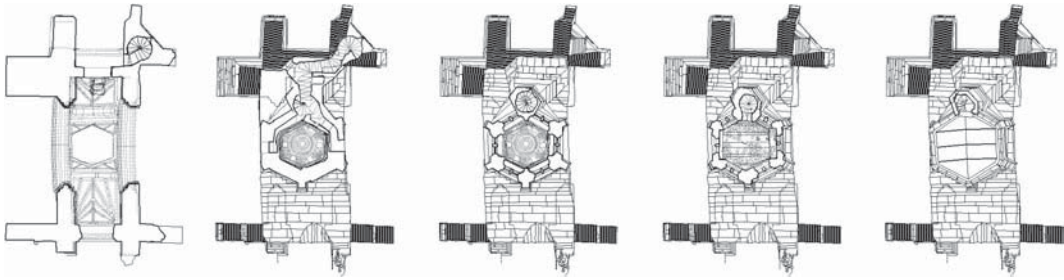
Figure 4.6 Stacked plans to record displacement at Greyfriars Tower, Kings Lynn, Norfolk. The common control used required a traverse to place stations at high level on the floors for consistency of detail position.

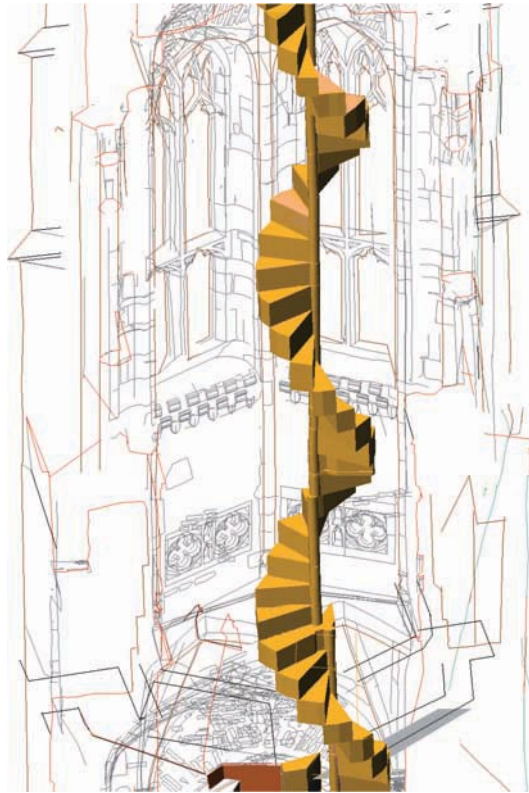
Figure 4.7 3D data collection for 3D model. The spiral stair has been solid modelled; the outline of all other features are in 3D wireframe. Views of the stair on the sectional elevation.

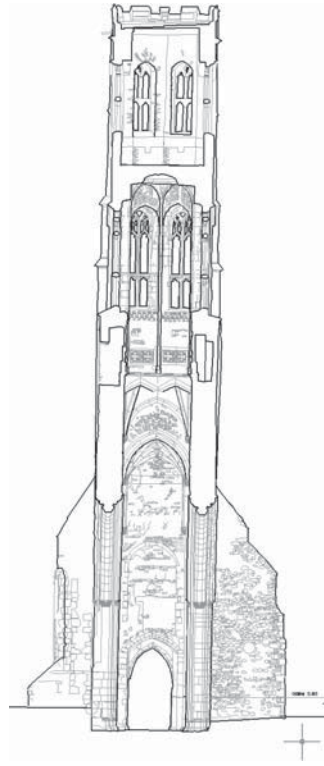
Figure 4.8 Sectional elevation from an REDM survey originally plotted at 1:20 scale. The quatrefoils, tracery and mouldings were drawn up by hand and digitised into position by fitting to the 3D wireframe from TheoLt (see also Figure 4.5).

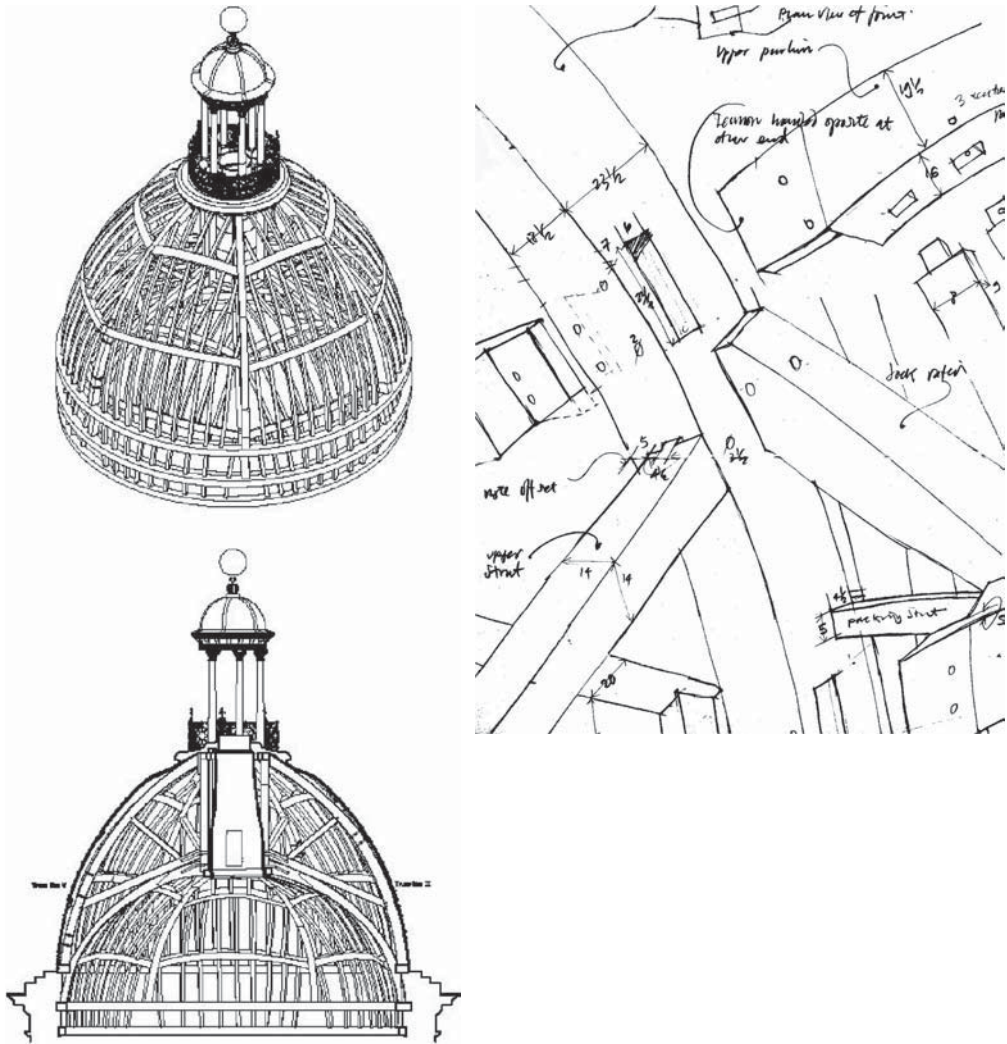
Figure 4.9 The roof space of the Archer Pavilion, Wrest Park, Bedfordshire, recorded by REDM as 3D wireframe. The completion to CAD drawing is impossible without drawing the key details on site, including cross-section measurements of components as they are often absent from wireframes.

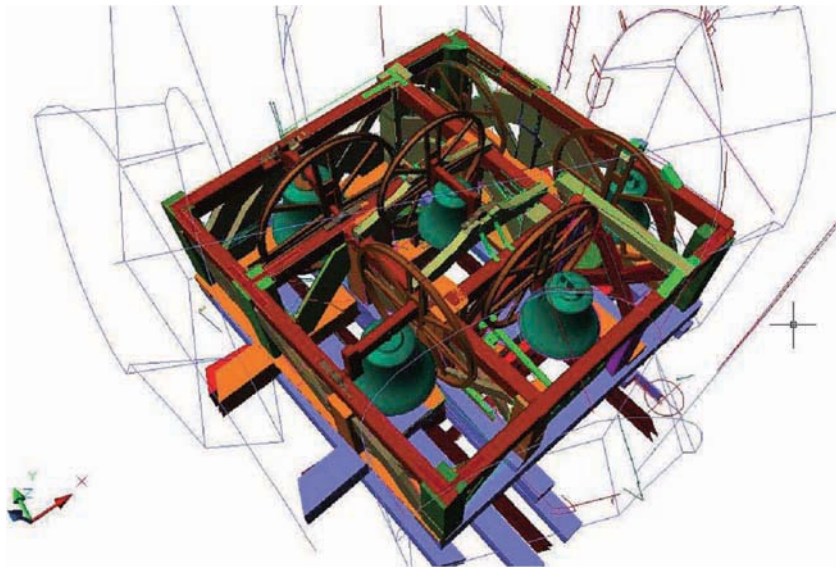
Figure 4.10 A 3D CAD model of the bell frame at St Mary's Church, Attleborough, Norfolk, to help the design of strengthening work and encourage interest in the project, as all the work is hidden from view. The same data was used for traditional plans and sections.

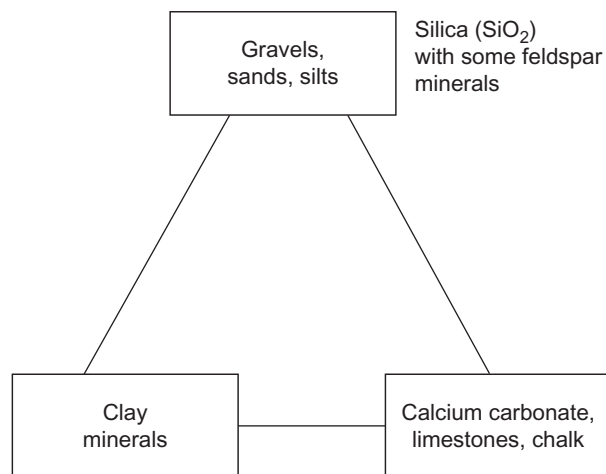
Figure 6.1 Basic constituents of soils and sedimentary rocks. Note also subsidiary deposits of peat and domestic and industrial waste.

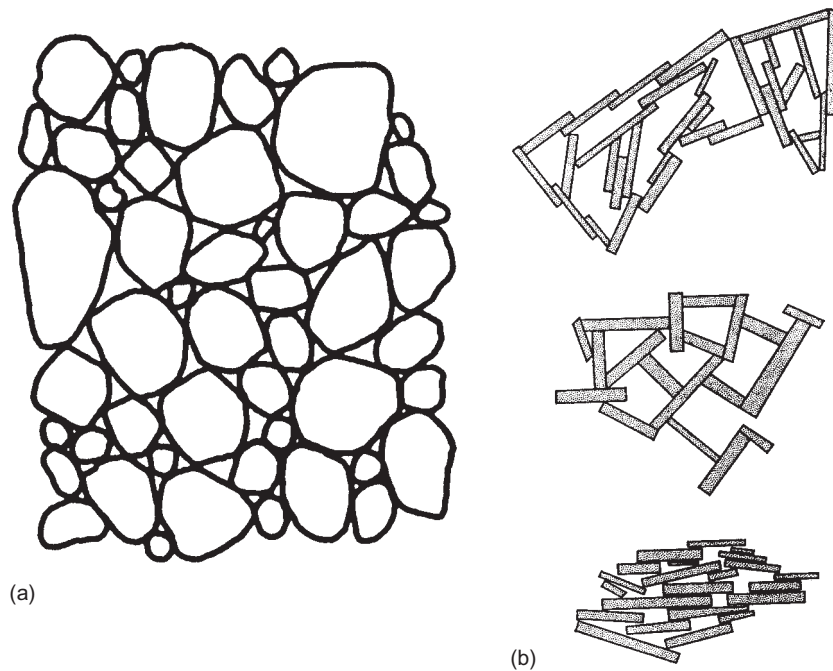
Figure 6.2 (a) Typical cut through a granular soil; (b) 'plate'-shaped assemblies of clay particles.

Soil is thus defined as an assembly of (usually) variably shaped particles in point-to-point contact (Figures 6.2a and 6.2b). Although the plate or flaky shapes of micron-sized clay particle structures differ from those of rounded or angular gravels and sands, the same model is accepted. On the initial basis of a unit volume of solid material, it proportions the voids space (e) as a fraction of the solid volume. For calculation purposes, the diagram in Figure 6.3 is universally accepted. The amount of water occupying the voids

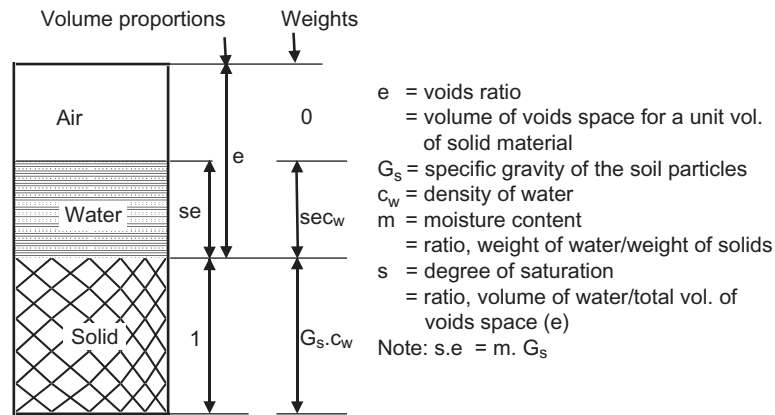
Figure 6.3 Soil model (for calculation).

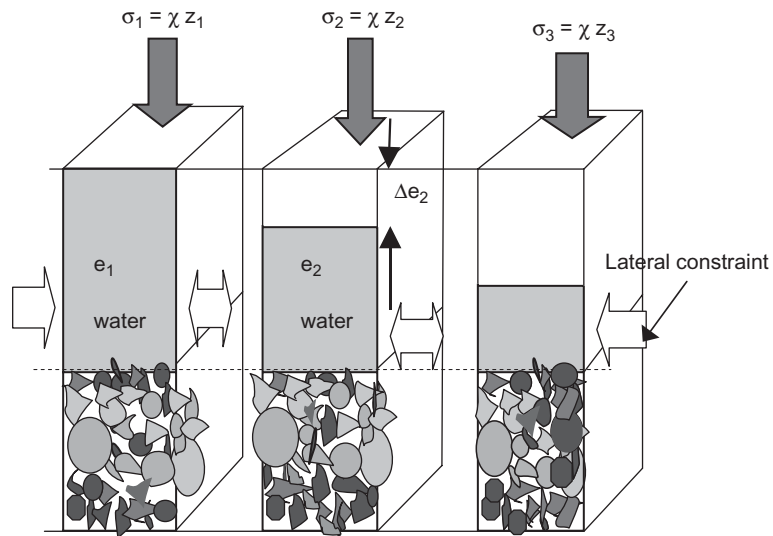
Figure 6.4 One-dimensional sedimentation process. Columns of soil are laterally confined by those adjacent. They can change length or thickness, but not their plan shape.

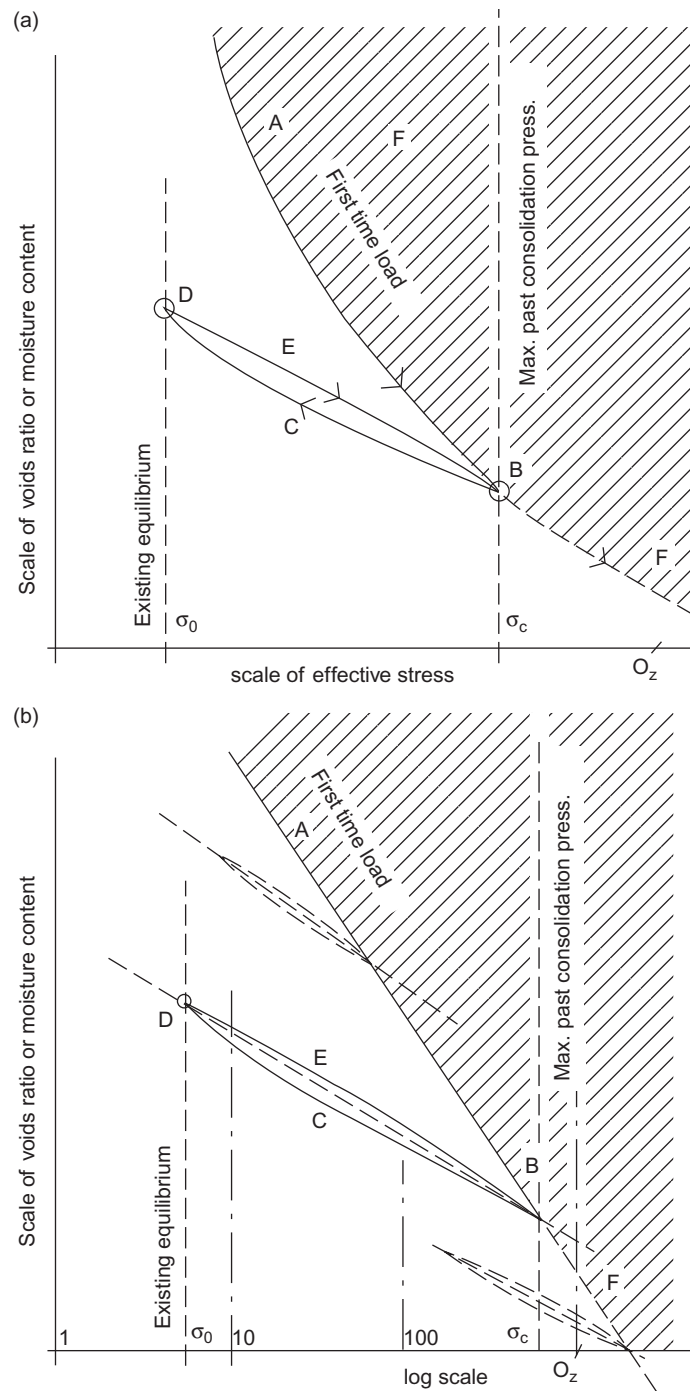
Figure 6.5 (a) and (b) Volume change versus compression during sedimentation. Loading–unloading and re-loading (shown to natural scale and 'log' scale).

- Engineers normally draw the relationship to a logarithmic scale (Figure 6.5b), because the first-time loading and unload/reload curves then follow near straight lines. This is how it would be seen in a test result.
- For a specific material defined by the line A–B–F, no point can exist above and to its right-hand side. However, there are an infinite variety of un-load/re-load possibilities to the left. The pattern is the same for

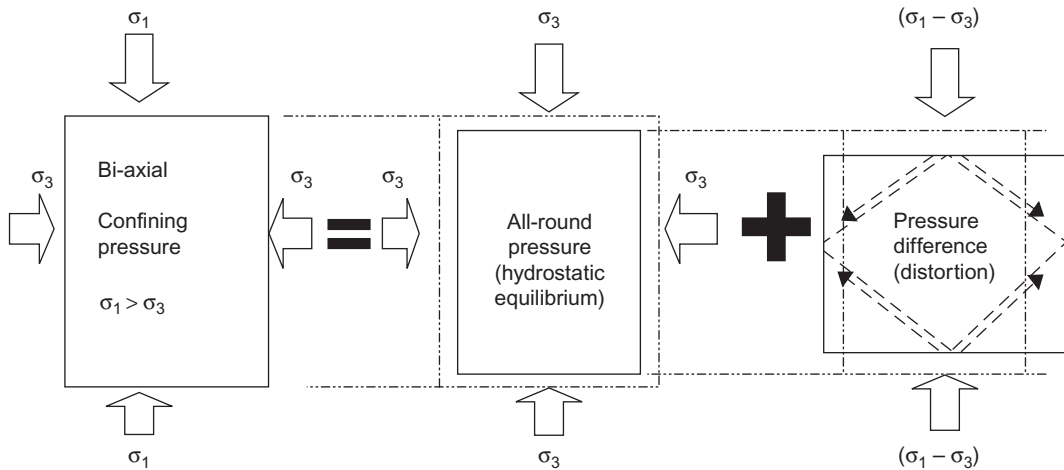
Figure 6.6 Two-dimensional system of pressure subdivision into all-round stress and stress difference.

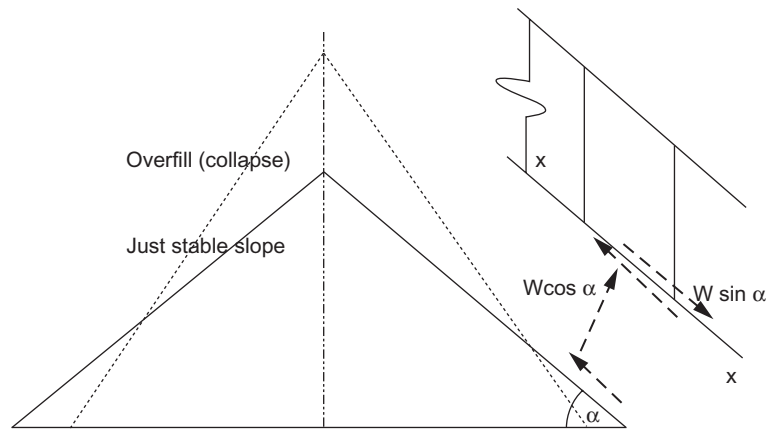
Figure 6.7 Limiting stability of the surface of a sand heap.

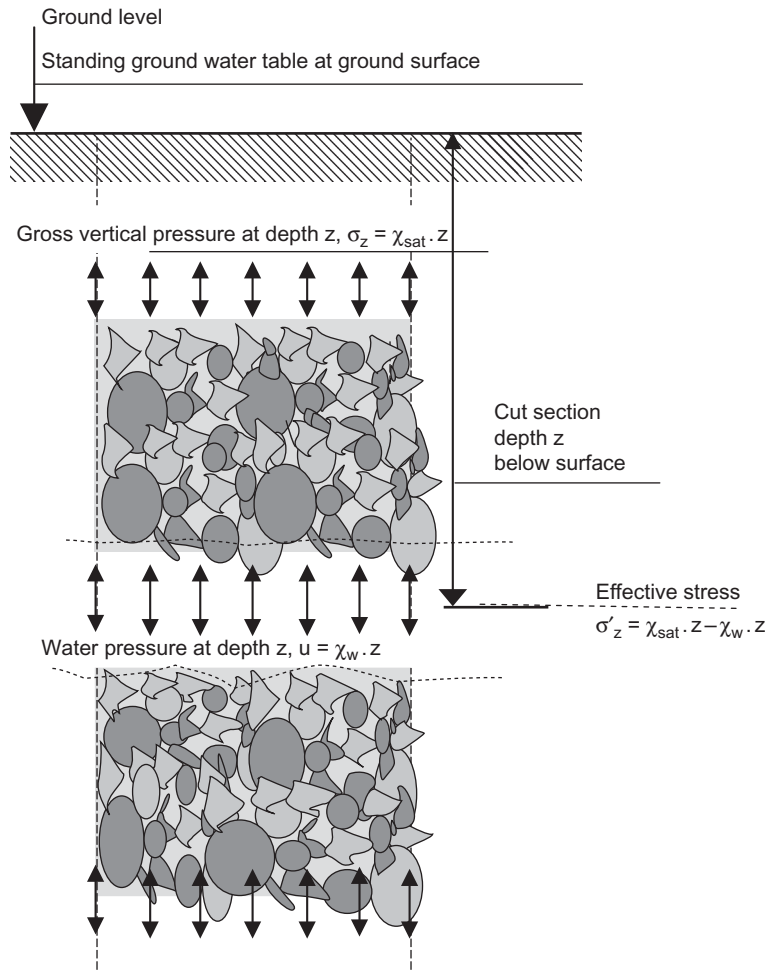
Figure 6.8 Buoyancy. Particle-to-particle effective stress determined by the submerged weight of the soil particles.

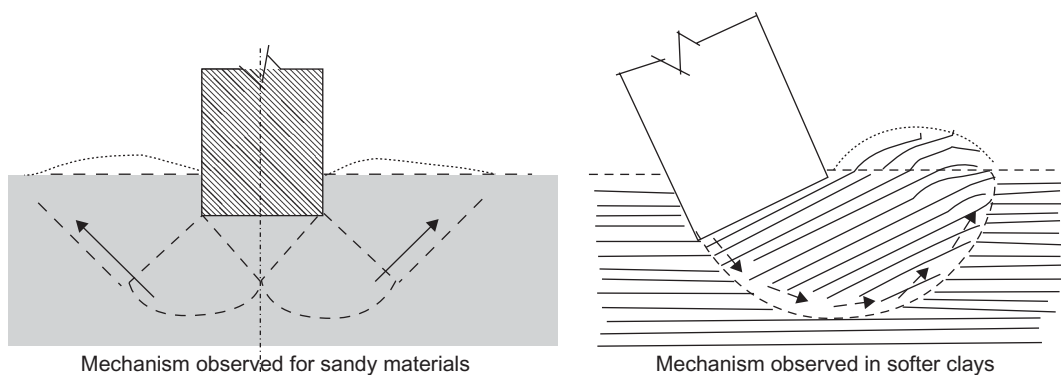
Figure 6.9 Local bearing failure under a strip footing.

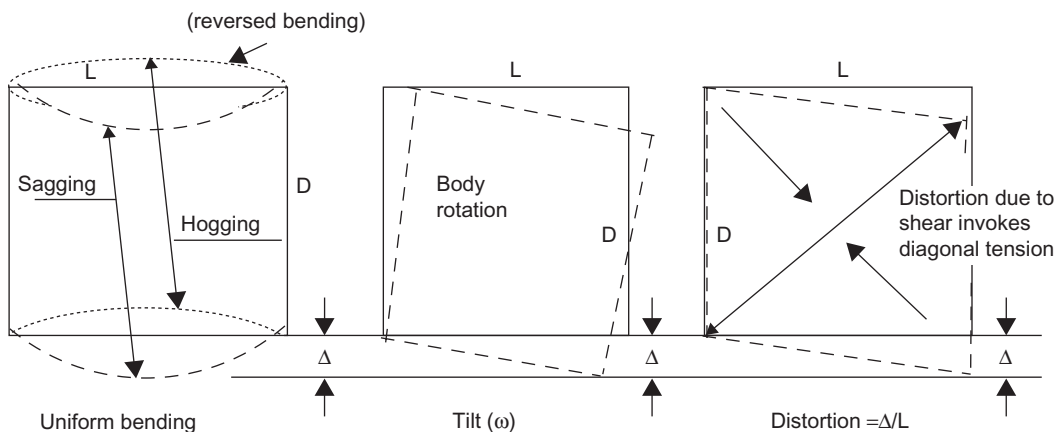
Figure 6.11 Customary definitions of building settlement.

At the risk of stating the obvious, settlement refers to (usually) movement of the finished building structure. Differential settlement is movement that causes the structure to change shape and therefore introduces strains within the fabric. Figure 6.11 reduces the forms of deformation movement

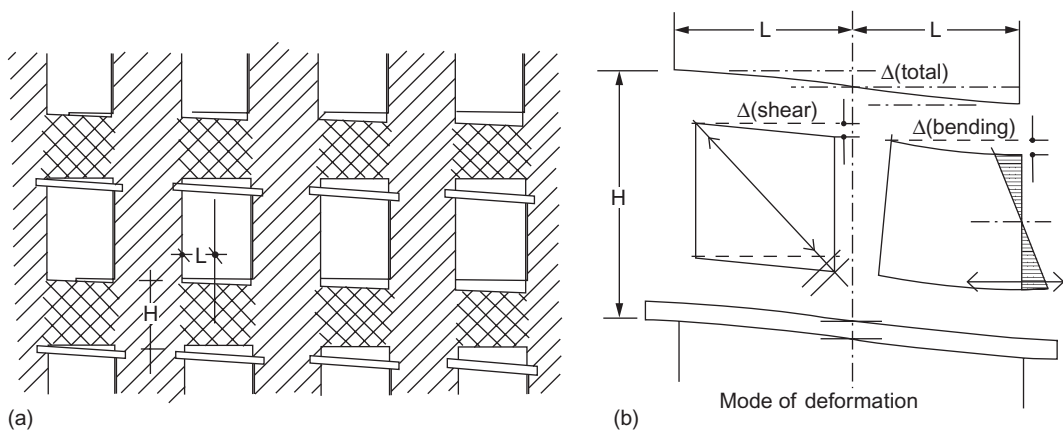
Figure 6.13 (a) Long facade: regular pattern of columns and windows; (b) Spandrel wall acts as a fixed-end beam in shear and bending.

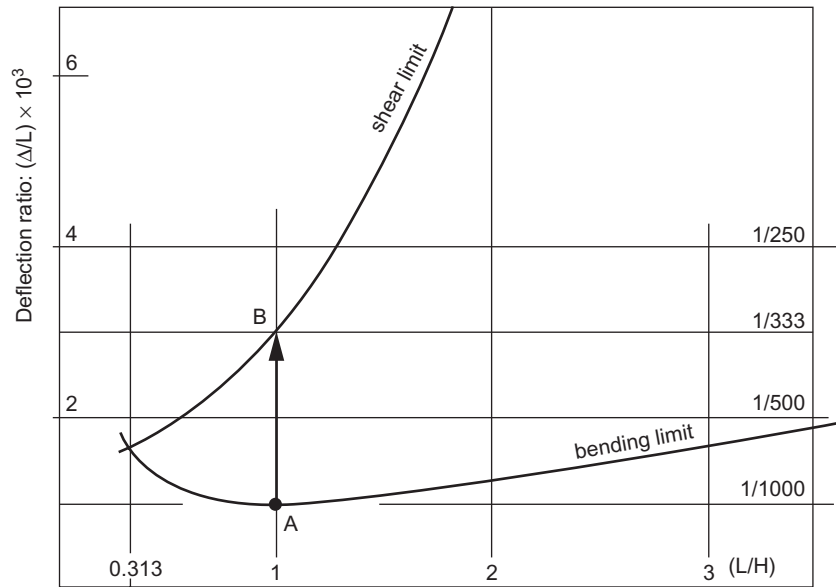
Figure 6.14 Deflection ratio (Δ/L) versus (L/H) , for a limiting tensile strain of 0.075% in shear or bending.

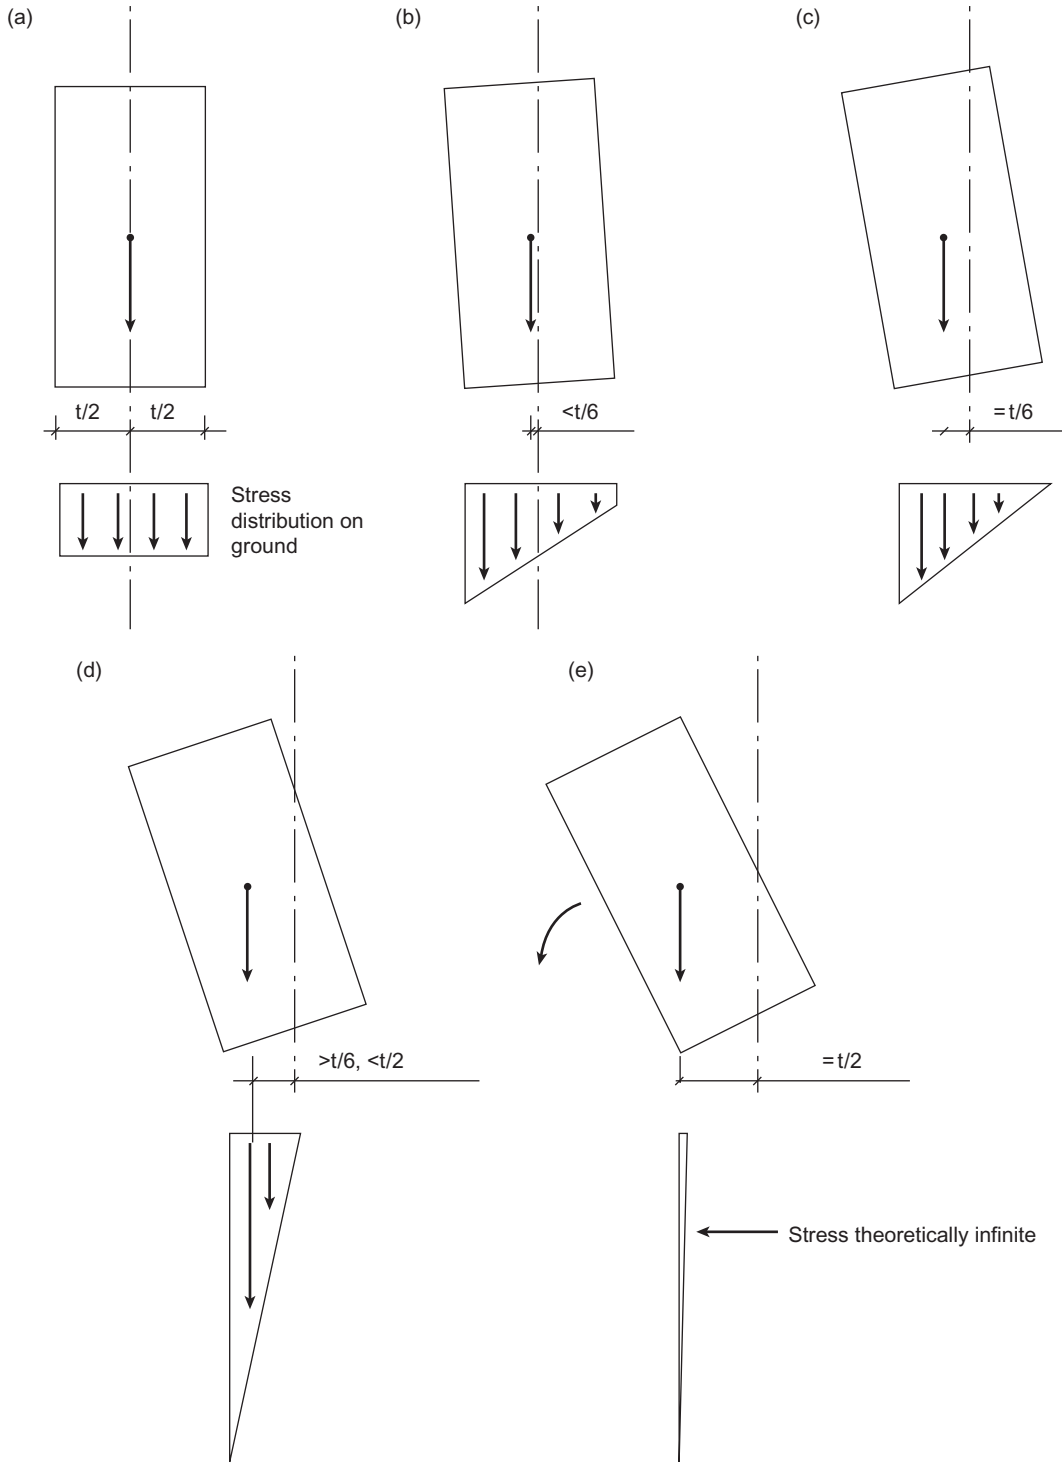
Figure 7.1 Effect of tilt on ground stress distribution and stability.

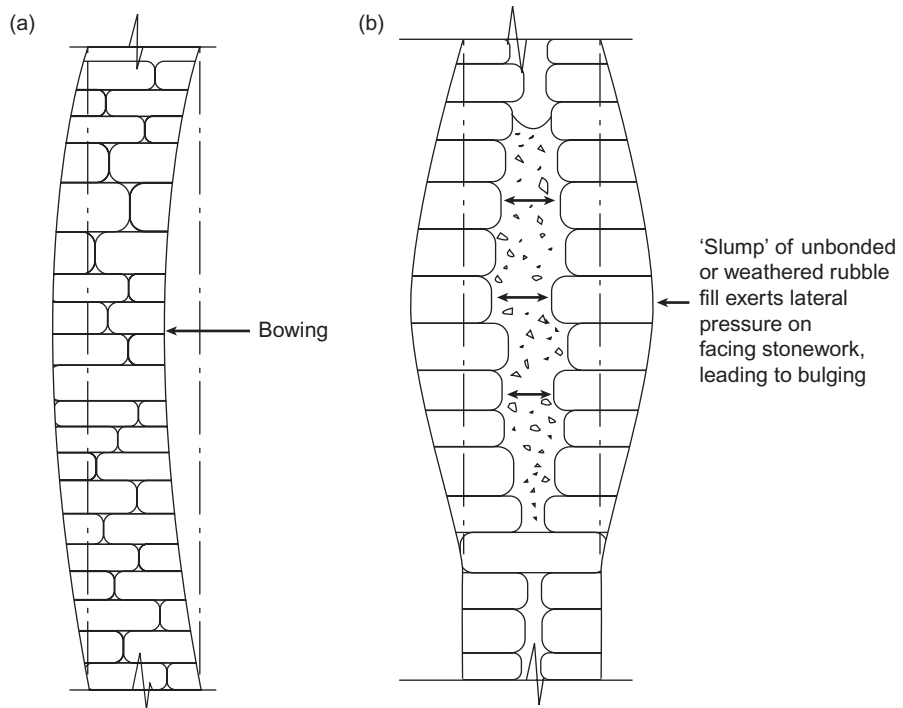
Figure 7.2 Bowing and bulging of a wall: (a) bowing (b) bulging.

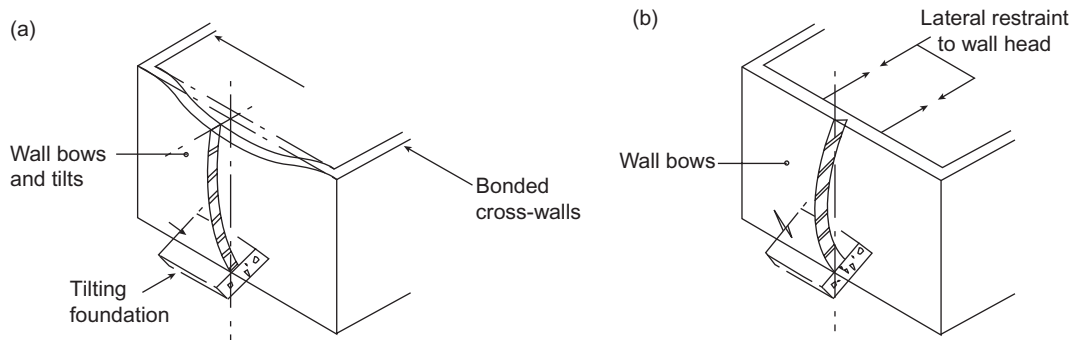
Figure 7.3 (a) Wall both bowing and tilting owing to foundation rotation; (b) tilting of the wall prevented by lateral restraint to head of wall.

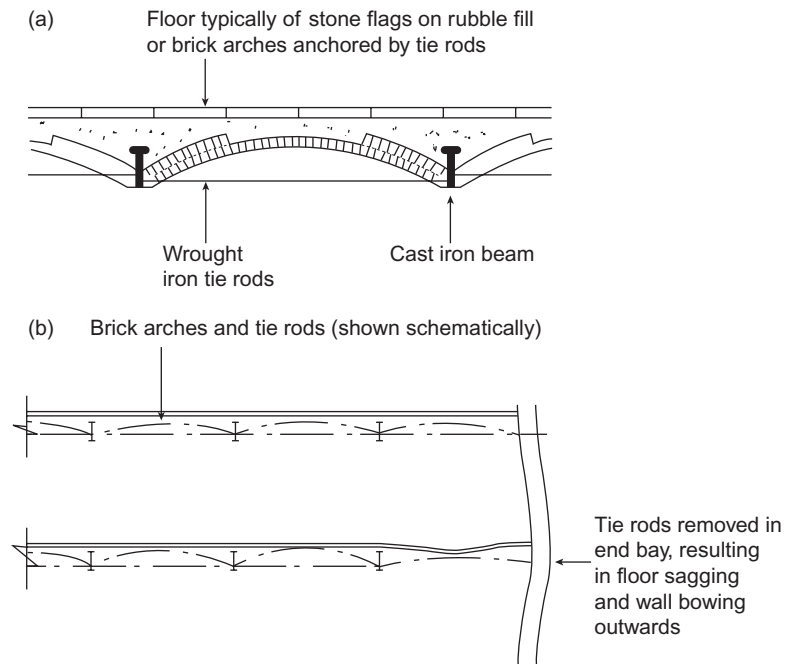
Figure 7.4 (a) Brick 'jack-arches' in floor, restrained from spreading by tie rods; (b) arch spread and distortion of wall arising from omitted or removed tie rods in end bay.

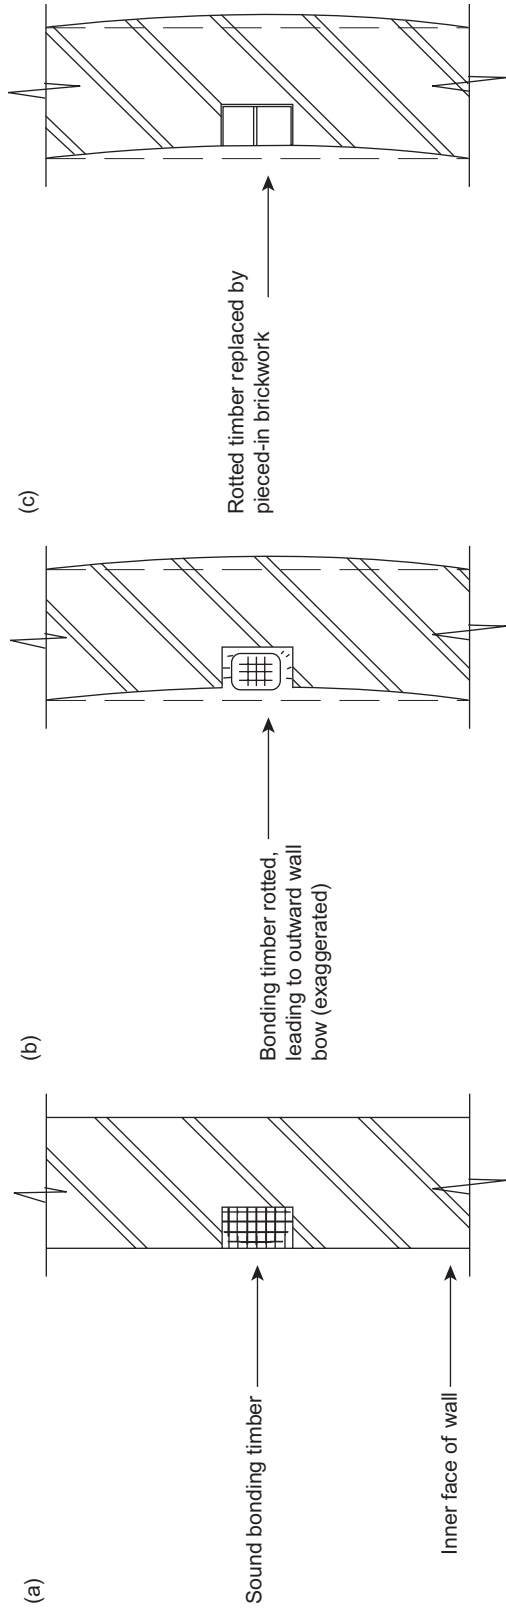
Figure 7.6 (a) Sound bonding timber in external brick wall; (b) timber later rots, leading to bowing of wall; (c) rotted timber replaced by pieced-in bricks.

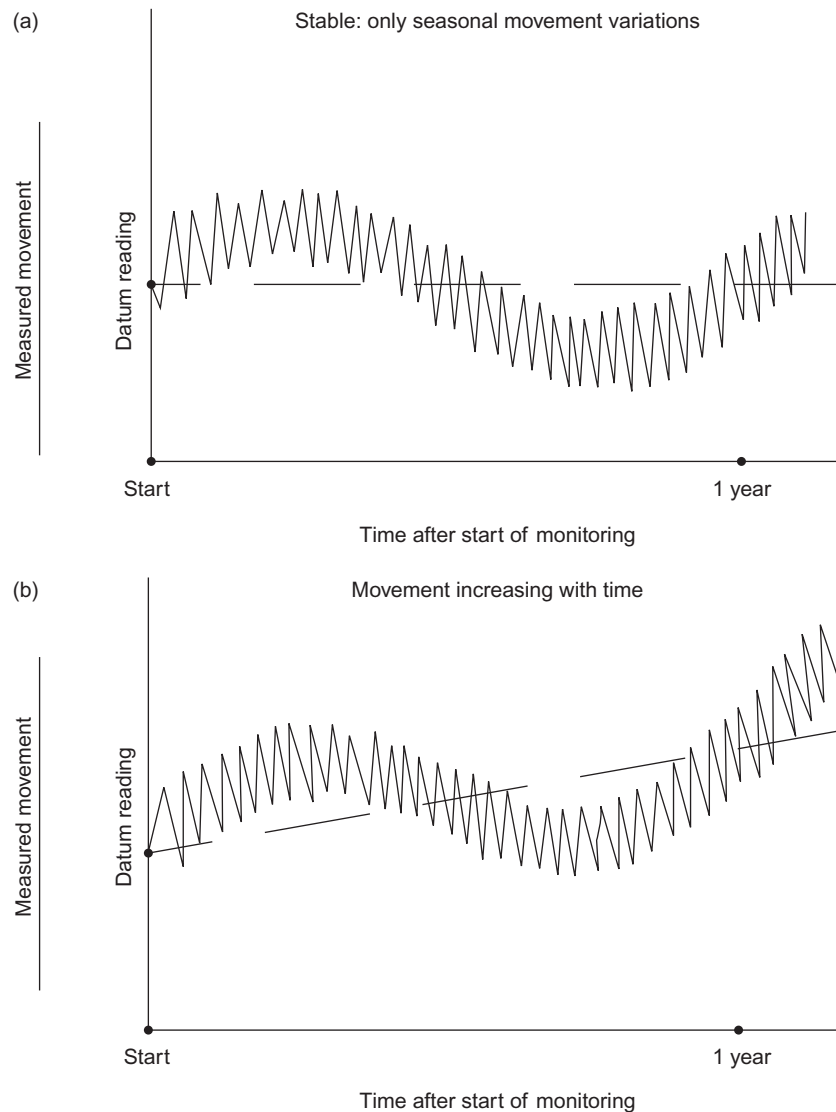
Figure 7.7 Monitoring of movements: (a) recording seasonal variations but no trend of increased movement overall; (b) showing a trend of increasing movement overlaid on seasonal variations.

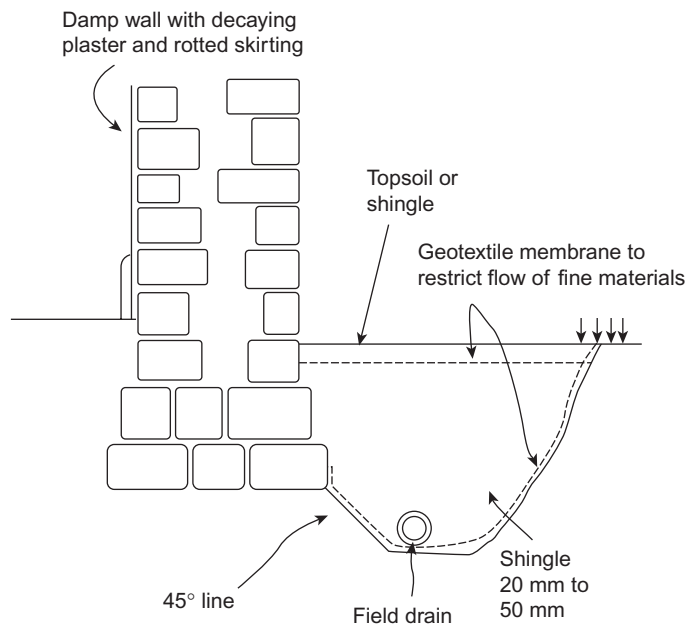
Figure 8.2 French drain. Excavation must not go beneath the wall or encroach within a 45° line from the base of the wall.

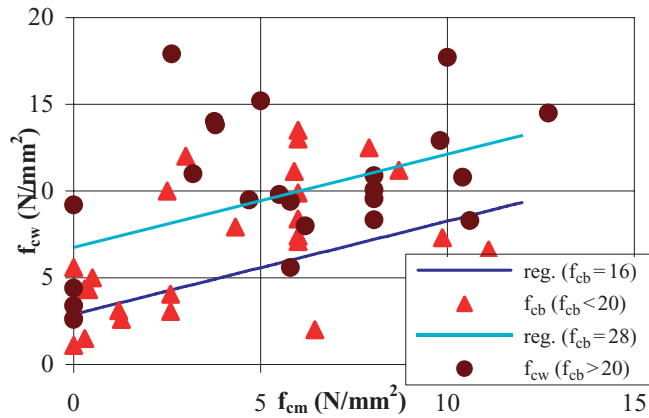
Figure 9.1 Equation (9.1) for discrete values of f_{cb} .

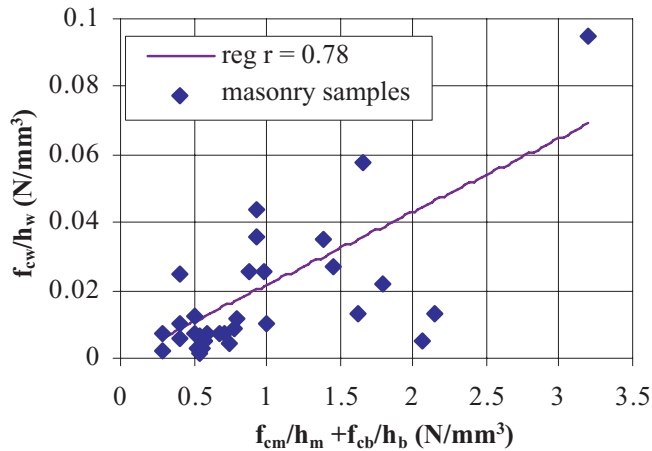
Figure 9.2 Equation (9.2) regression coefficient $r = 0.78$.

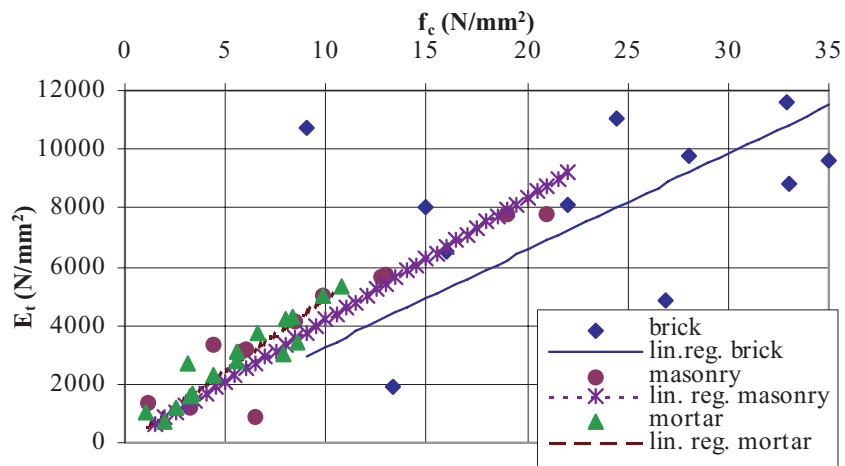
Figure 9.3 Regression of E_t (f_c).

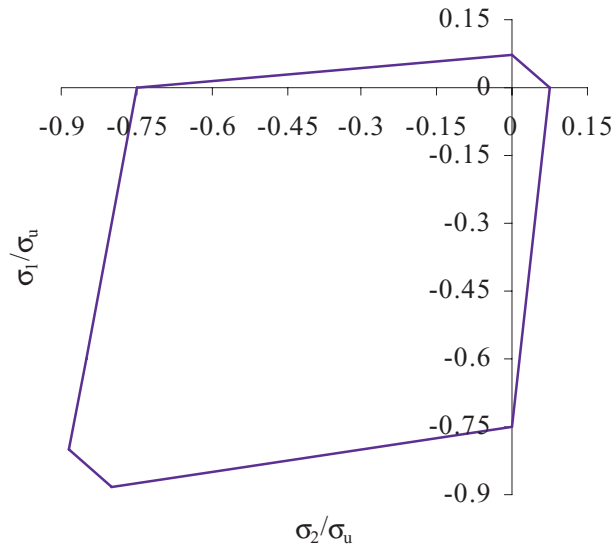
Figure 9.4 Rankine-type failure domain.

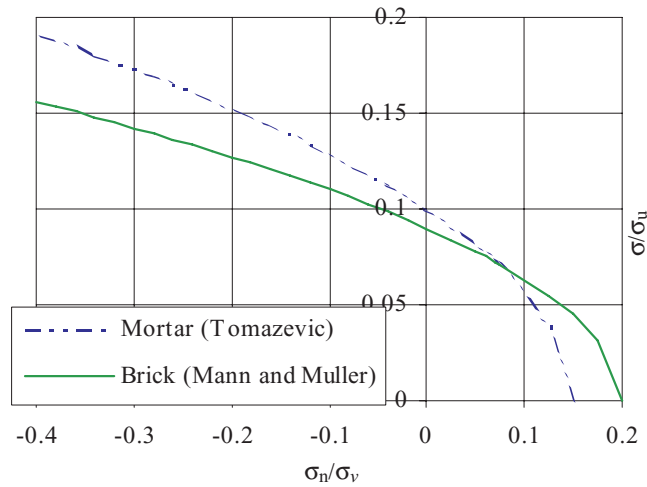
Figure 9.5 Mohr-Coulomb-type failure domain.

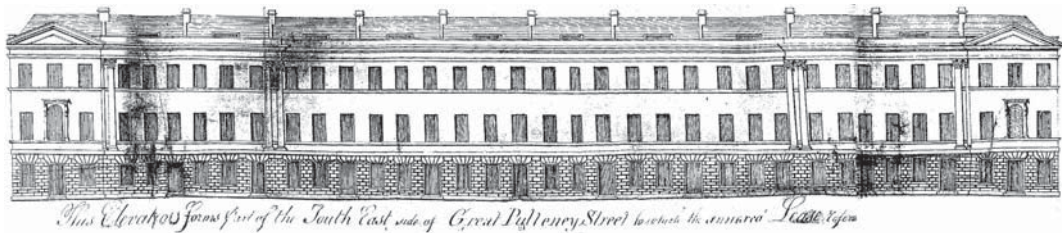
Figure 9.6 Elevation of nos. 42–51 Great Pulteney Street, Bath, by Thomas Baldwin, from a lease of 1791.

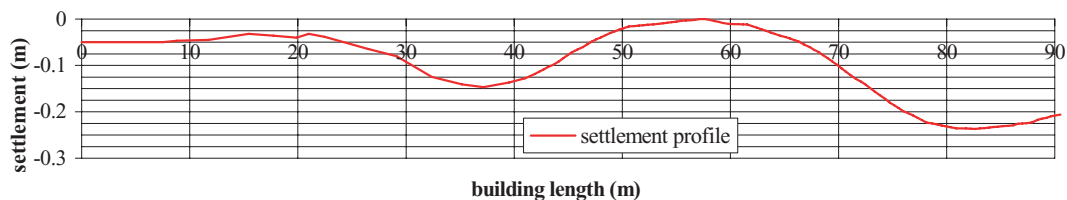
Figure 9.7 Settlement profile as surveyed at cornice level in 1992 by Cook.

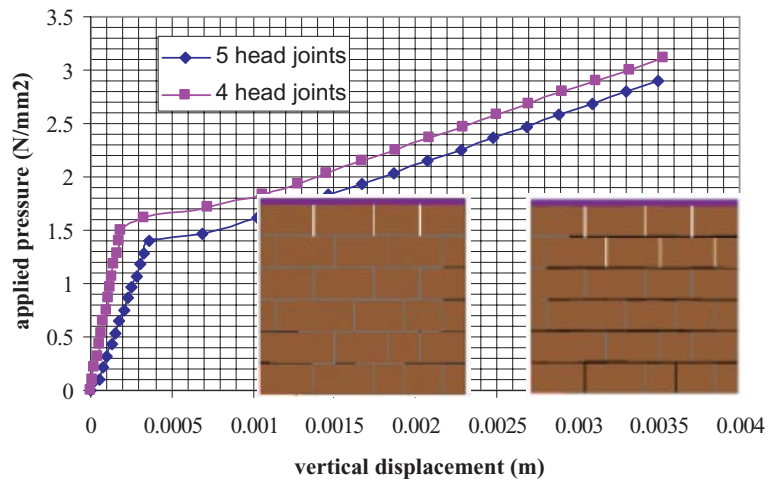
Figure 9.8 p - δ curves for compression test of wallets: white joints indicate tensile failure, black compression.

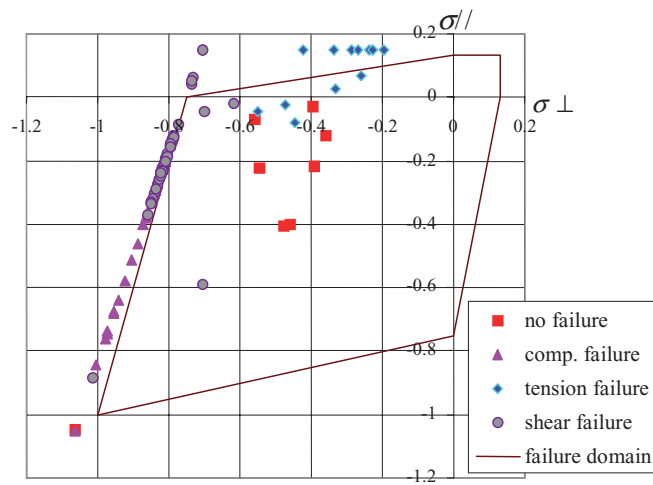
Figure 9.9 Distribution of state of stress for mortar joints.

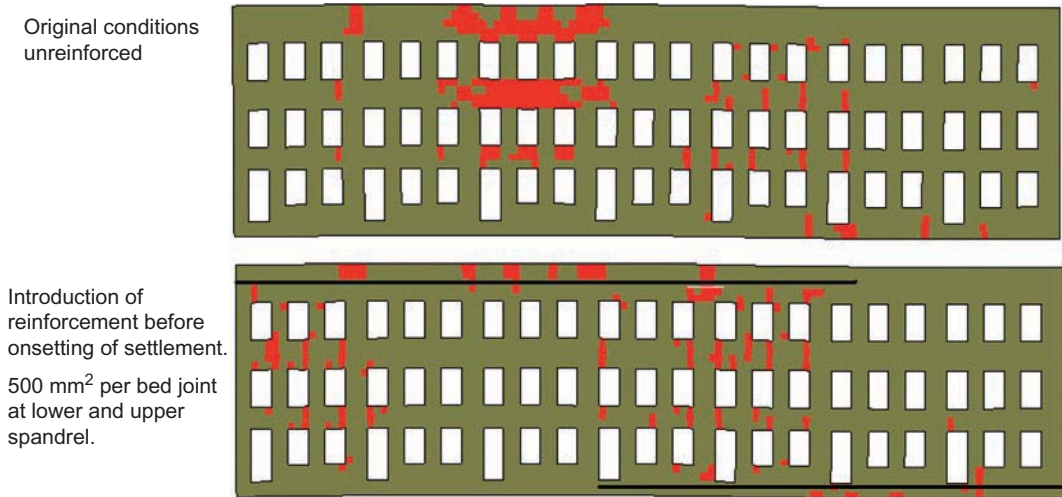
Figure 9.10 Computed crack pattern associated with surveyed settlement.

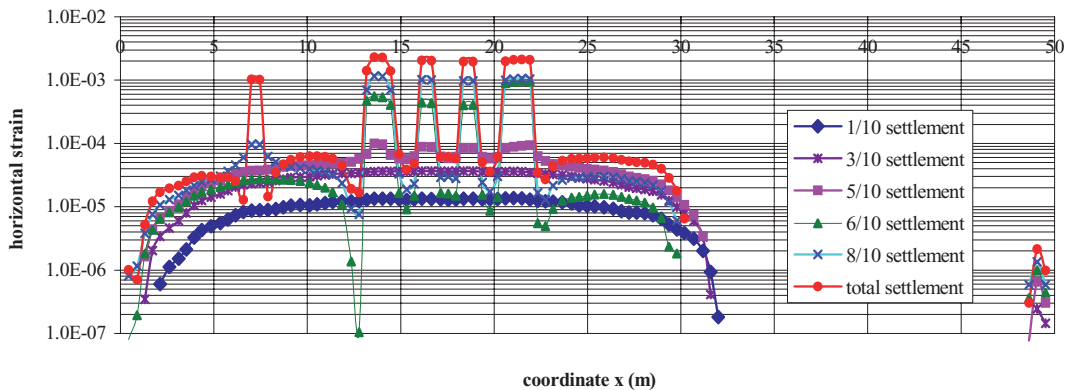
Figure 9.11 Distribution of horizontal strains at top spandrel in original configuration (+ve only).

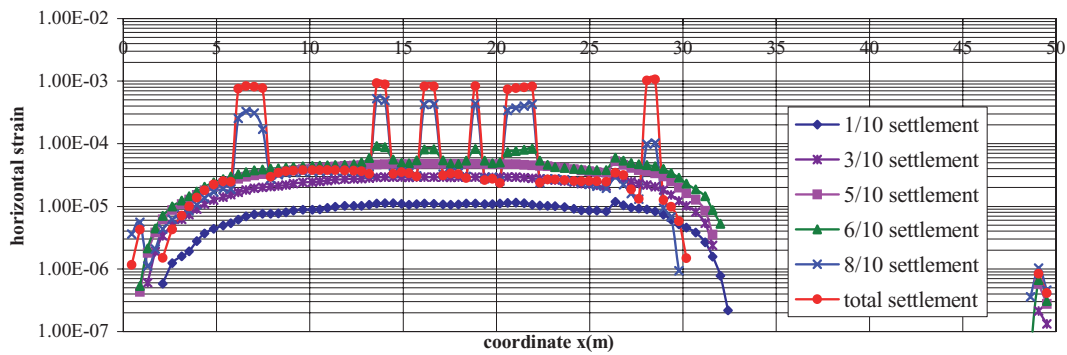
Figure 9.12 Distribution of horizontal strains at top spandrel in reinforced configuration (+ve only).

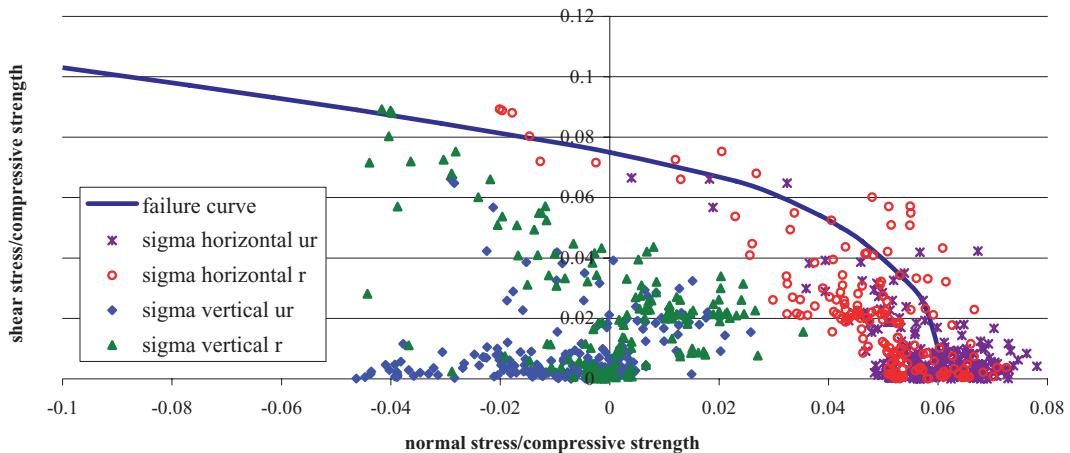
Figure 9.13 Mohr-Coulomb-type failure curve and state of stress of failed element in two perpendicular planes for the unreinforced and reinforced case.
