Structures & construction in historic building conservation

Michael Forsyth

Department of Architecture and Civil Engineering
University of Bath

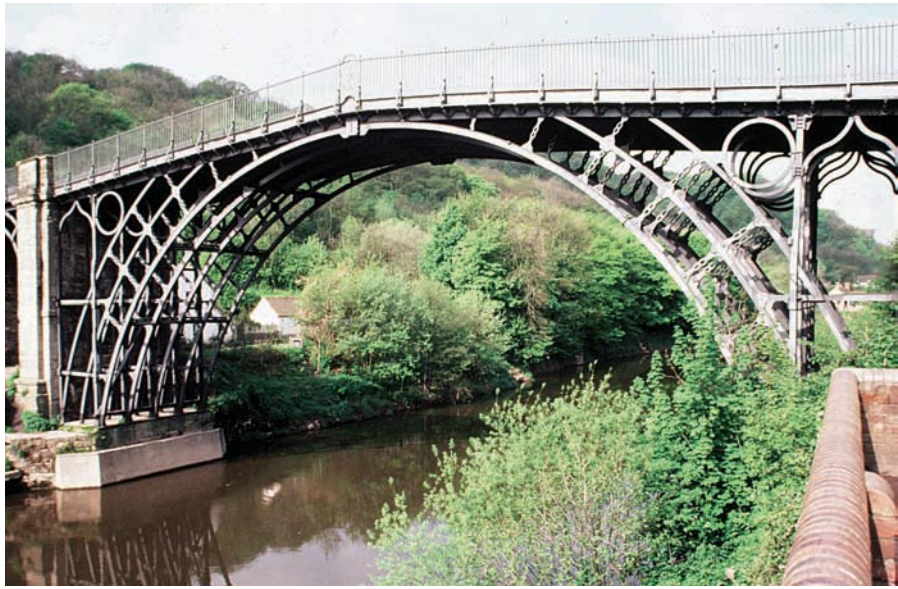
Figure 10.1 Iron Bridge, Shropshire across the River Sever, cast at the nearby Coalbrookdale Works in 1779.

In the 1770s, slender circular cast iron columns were tentatively used in several churches, but the first significant structural use of cast iron in Britain was the 1779 Iron Bridge across the River Severn (Figure 10.1). Indeed, it was the world's first major cast iron arch bridge, with a span of 100 feet (c. 30 metres). Interestingly, joints between members were based on car-

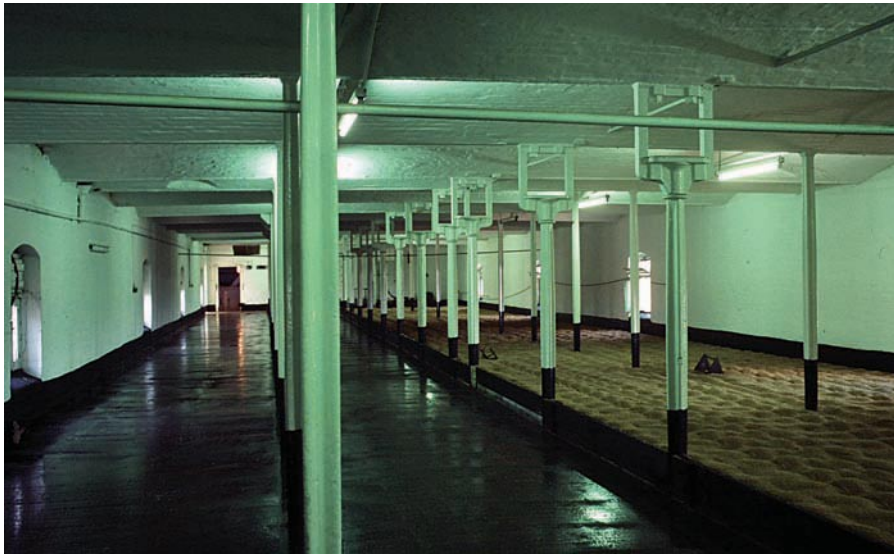
Figure 10.2 Ditherington Mill, Shrewsbury, Shropshire of 1797, the world's first iron-framed multi-storey building, using cast iron for both beams and its cruciform-section columns.

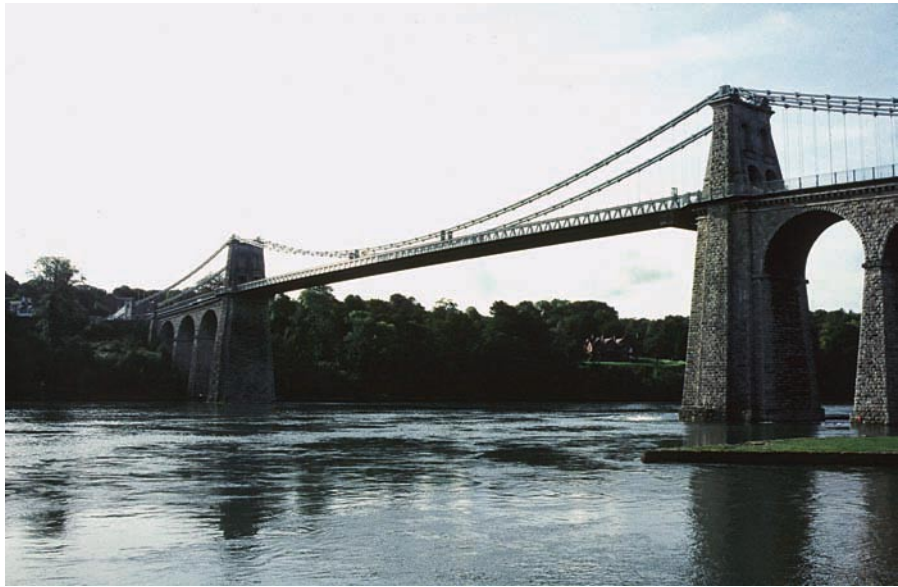
Figure 10.3 Thomas Telford's 1826 Menai Bridge over the fast-flowing strait between Anglesey and the North Wales mainland, a key element in his improvement to the London–Holyhead road (and thence to Ireland).

The need for improved road communications to carry freight (before the coming of the railway) called for longer-span bridges. Thomas Telford, for example, was charged with improving the London–Holyhead road, a key link between Britain and Ireland. Spanning the wide fast-flowing Menai Strait was a challenge, to which Telford responded by designing a suspension bridge (Figure 10.3) – the longest span of this type yet attempted (579 feet/177 metres). Wrought iron was the only material then available that could carry the large tension forces that such a large span induced in the suspension chains. The bridge opened in 1826. Much of the original wrought ironwork has been replaced by steel, but the span still impresses.

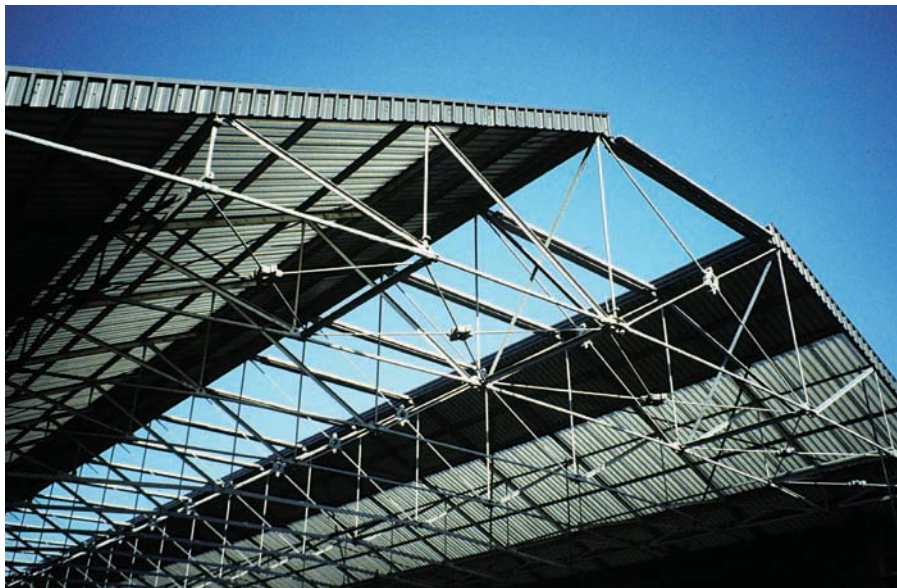
Figure 10.4 Roof over platforms at Huddersfield Station, West Yorkshire, completed in 1850.

Wrought iron came into its own for trusses, beginning as strapping for timber roof trusses and then replacing some or all of the timber elements. From the first all-wrought-iron trusses of 1837 at Euston Station until steel became readily available at the end of the nineteenth century, most roofs of any span beyond the domestic scale were carried on trusses, either entirely of wrought iron or using wrought iron for the tension elements. The wrought iron elements were typically angles and tees for compression members, and flats or rods for carrying tension. Sections of the trusses would be riveted together in the workshop or on site before being lifted into place on temporary falsework, and bolted or site-riveted together. The knowledgeable use of wrought iron by Victorian engineers and iron companies produced roofs of considerable lightness and elegance (Figure 10.4).

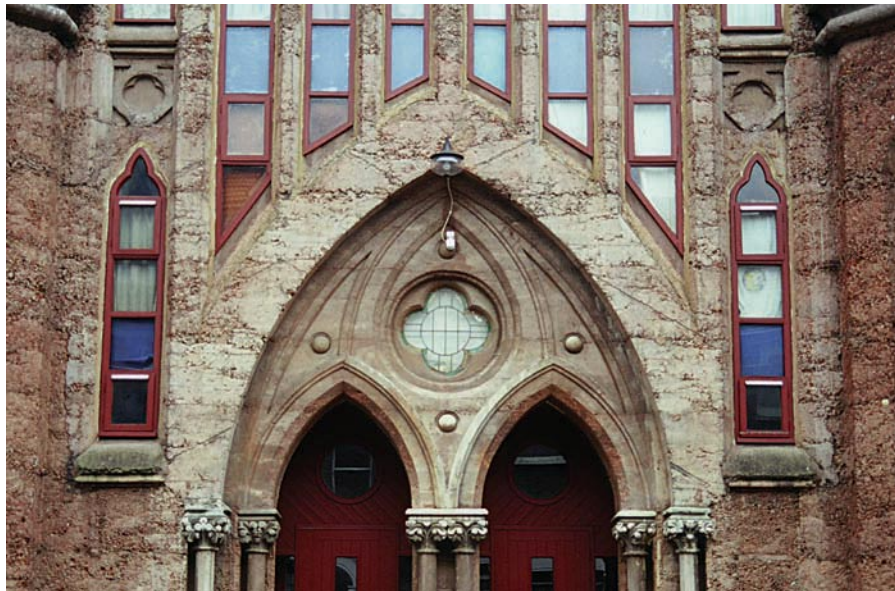
Figure 11.1 The neo-Gothic, unreinforced mass concrete Swedenborg Church, Waldegrave Road, south London, 1883, by W.J.E. Henley.

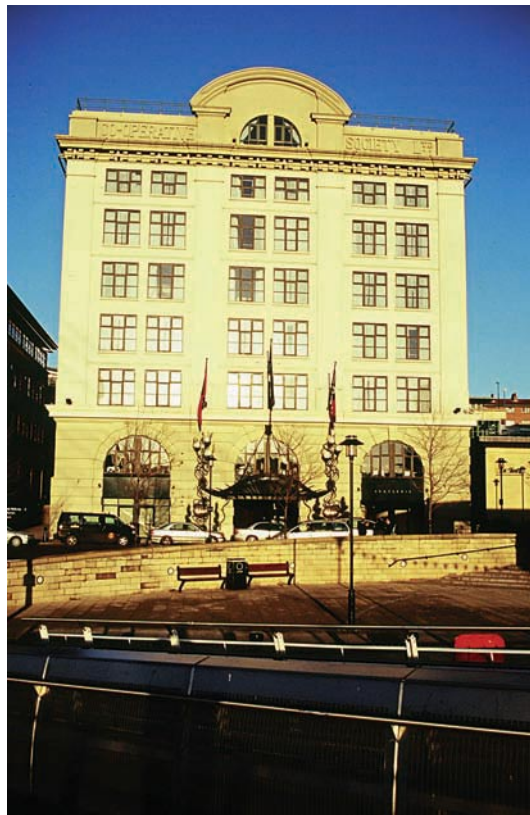
Figure 11.2 The Malmaison Hotel, Newcastle upon Tyne, built in 1901 as a warehouse for the Co-operative Wholesale Society, converted by Terry Farrell & Partners.

What is possibly now the oldest surviving reinforced concrete structure in Britain was built as a Co-operative Wholesale Society warehouse on the Quayside at Newcastle upon Tyne, mostly between 1897 and 1900 (Figure 11.2). This was designed for even higher loadings than Weaver's Mill, in view of the varied nature of goods to be stored in it – 6 cwt/sq. ft (32.3 kN/m²) – and again a load test was successfully carried out. After standing empty for a number of years and escaping the demolition that removed many of its neighbours, the building was transformed into the Malmaison Hotel by Terry Farrell & Partners. A contributory factor to this possibly unlikely reuse is the building's location at the northern end of Wilkinson & Eyre's 'blinking eye' Millennium Footbridge, facing the Baltic Art Centre and Sage Music Centre across the Tyne.

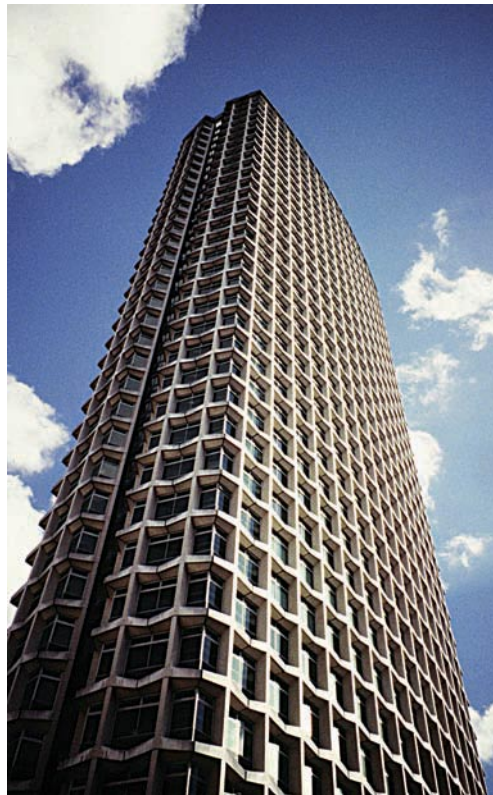
Figure 11.3 One of the more conspicuous additions to the skyline in the twentieth century was Centrepoint, London, 1962–67, by Richard Seifert.

In situ concrete is poured in its final position – typically piles, foundations, floor and roof slabs, walls and frames. There is only the one chance of getting in situ concrete right, unless by demolishing it and rebuilding. **Precasting**, typically in factory conditions, offers better quality control and the opportunity of accepting the precast elements before they are installed. 'Off-the-shelf' standard structural units, such as concrete floor joists and bridge beams, are precast in large quantities. Concrete cladding panels lend themselves well to precasting, with better conditions to achieve consistent quality. Richard Seifert's thirty-six-storey Centrepoint office tower at St Giles Circus, London (1962–67, and listed 1993), is among the most notable buildings to use precast structural cladding – which allowed this tall structure to be erected without scaffolding – here, with a polished finish (Figure 11.3).

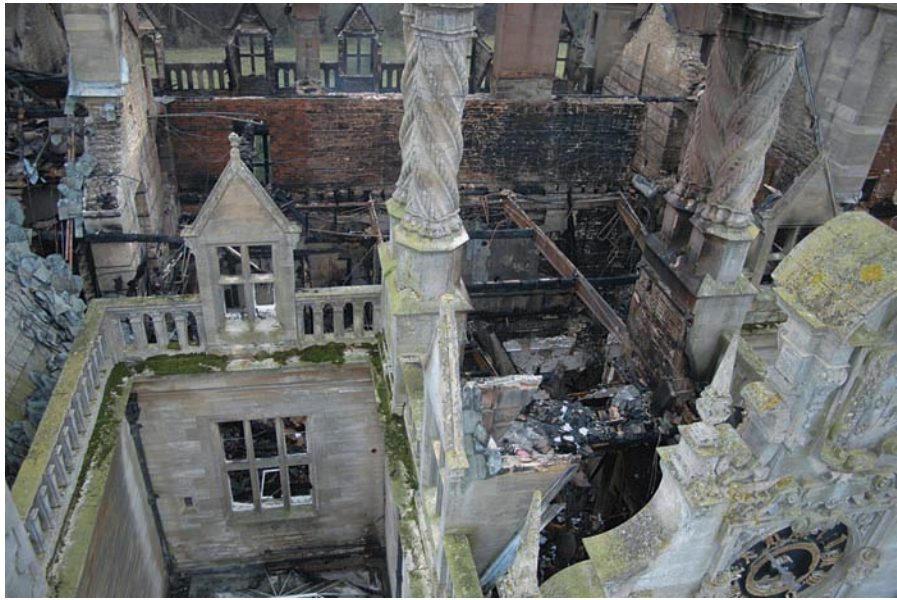
Figure 12.2 Grade I-listed Stoke Rochford Hall, now a residential conference centre, near Grantham, Lincolnshire, was partially destroyed by fire in January 2005. Good access is vital to effective firefighting to limit damage.

Access for firefighting must always be available to all parts of the building and site, and consideration needs to be given to avoiding conflict between security measures and means of escape and the external and internal fire brigade access (Figure 12.2). The optimum degree of access is detailed in Approved Document B5, to allow rapid deployment of fire brigade ladders, hoses and other rescue equipment. However, this is not always possible for some sites – say, town centre sites, islands, walled palaces and castles – and a risk assessment might highlight the need for special compensatory measures, such as provision of
