NONDESTRUCTIVE TESTING METHODS FOR CIVIL INFRASTRUCTURE

A collection of expanded papers on nondestructive testing from
Structures Congress '93

Approved for publication by the Structural Division of the
American Society of Civil Engineering

MODAL ANALYSIS TECHNIQUE FOR BRIDGE DAMAGE DETECTION

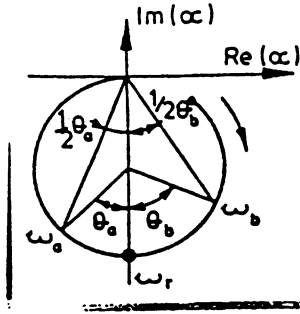
Fig.1 Fitting Circle

Where, ω_b is a frequency below the natural frequency, ω_a is a frequency above the natural frequency, and θ_b and θ_a are related phase angles.

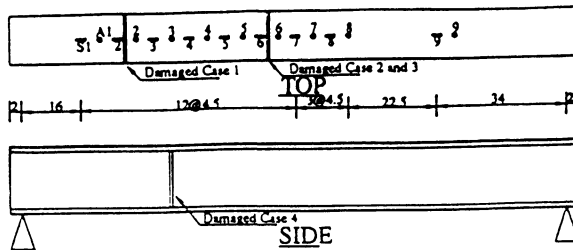
A standard W6X20 steel I-beam with a 12-foot length was used as a model girder bridge in this experimental and analytical study. Fig. 2 is a schematic drawing of the test specimen. The end supports were two hinges connected to the bottom flange of the beam. These supports restrained only the longitudinal and vertical motions. The direction of the introduced vibration was in the plane of the web.

Fig. 2 Layout of Specimen, Cracks and Measuring Stations in Test

Four different damage types were introduced to the beam. Case 1 was a full flange cut located between A1 and A2 at 2.3 inches from A2. Cases 2 and 3 were half deep flange cut and full deep flange cut located between A5 and A6 at 2.3 inches from A6. Case 4 was a vertical cut on the web with a depth of 6 inches (full web height) at A3. The width of the cracks was 1/16 inches introduced by an electric saw in the specimen.

The locations of the accelerometer and strain gage stations are also show. Accelerometers are identified by A1, A2, etc. and strain gages by S1, S2, etc. Since damages were designed to occur between stations A1 to A6, A9 is selected as the reference station for all accelerometer stations and S9 for strain gage stations in the normalization of the mode shapes.

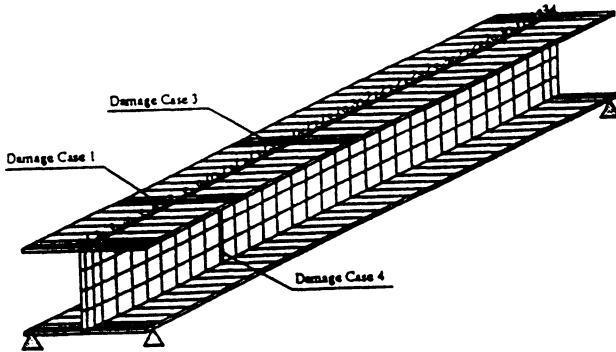
Finite element models using solid elements (Fig. 3) were generated for both the intact and the damaged beams. The undamped natural frequencies, displacement mode shapes and strain mode shapes associated with the first vibration mode in the plane of the web were calculated. In order to compare mode shapes for different damaged cases with the mode shape of the intact beam, a reference station is necessary. Since the damage was designed to occur on the left-hand-side of the beam, station 25 is selected as the reference station for all the cases. Eigen value analyses were performed for the intact and damaged models were performed to obtain the natural frequencies and DMS in the vertical direction. SMS can be analytically predicted by imposing values of DMS on the model through static analysis. The resulting strain values would be the SMS.

The finite element models for the intact structure and the three damaged cases are given in Fig. 3. Stations along the beam from which the data were abstracted are also shown. Damaged Cases 1 and 3 were on the top flange with the cracks located between station 7 and 8 at 2.2 inches from station 7 for Case 1, and between station 15 and 16 at 2.2 inches from station 15 for Case 3. Damaged Case 2 was not simulated by the finite element model. Solid elements

with 1/16 inch width were generated at the damaged locations and the relative elements were removed to simulate the cracks. The nodes located 2 inches away from the ends on the bottom flange were modeled as simply supported to imitate the laboratory model.

Fig. 3 Finite Element Model for The Test Specimen

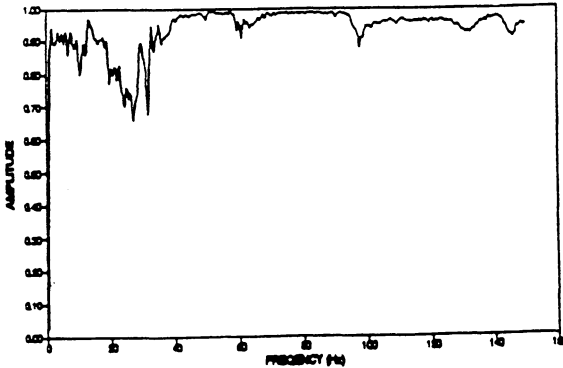
In the experimental study, the coherence of all sampling channels is greater than 0.95 within the interested frequency range of 45 Hz to 52 Hz (Fig. 4), which indicates that the signal noise (S/N) ratio is high enough to achieve good estimates of the response. The mode shapes obtained from test results were consistent within the same test case. The small deviation in measured mode shaped demonstrates the accuracy of the test.

Fig. 4 Typical Coherence Function of Test Response

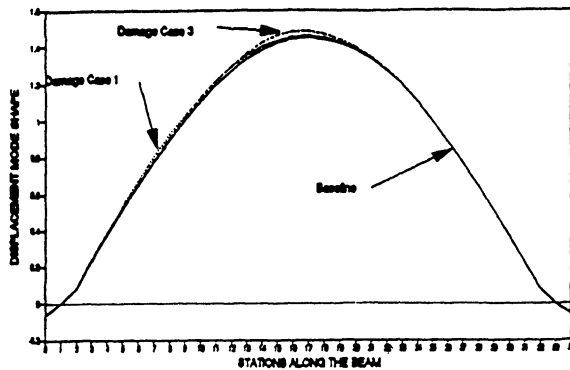
Displacement mode shapes were examined in both the analytical and experimental studies. Fig. 5 shows the analytical displacement mode shapes corresponding to the baseline, Damage Case 1, and Damage Case 3, respectively. Fig. 6(a) and (b) are the experimental displacement mode shape comparisons of

Fig.5 Displacement Mode Shapes in FEM

(1) The largest DMS change occurs near the stations where the damages occur.

(2) In the analytical analysis, a comparison of the changes in Damage Cases 1 and 3, the crack at the location close to center of the beam affects the mode shape associated with the first vibration mode more significantly.

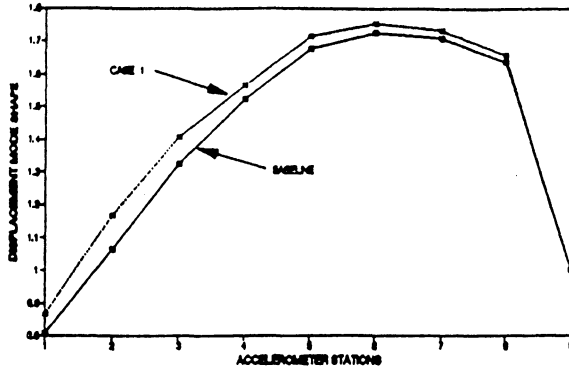
Fig. 6a DMS for Case 1 in Test

Damage Case 1, Damage Case 2, and 3 with the corresponding baseline values. Since the displacement mode shape curve of Damage Case 4 is approximately the same as that of the baseline case in both analyses, it is not shown in these Figures. However, in Damage Cases 1 and 3, an increase in the amplitude of displacement mode shape can be observed within a large range of damage locations. This increase in amplitude indicates that flange cracks lead to detectable global changes of the displacement mode shapes.

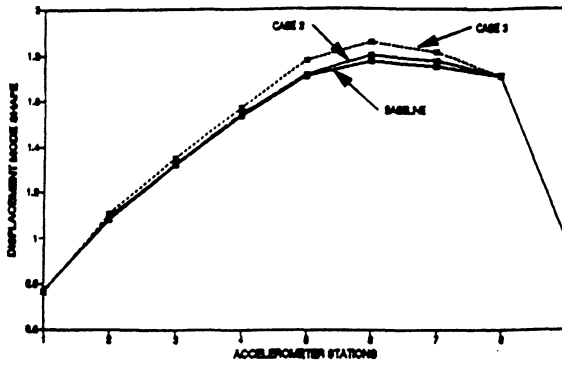
Fig. 6b DMS for Case 2 and 3 in Test

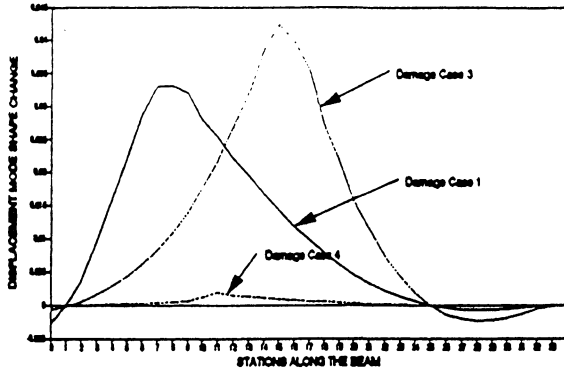
Fig.7 DMS Difference Curves for Cases 1, 3, and 4 in FEM

In order to determine the damage locations from the mode shapes, the differences of the mode shapes for the damage cases with respect to the baseline are shown in Figs. 7 and 8 for the analytical study and experimental study respectively. Because of the slight change observed for Damage Case 4 in the experimental study, this difference curve is not included in Figures 7 and 8.

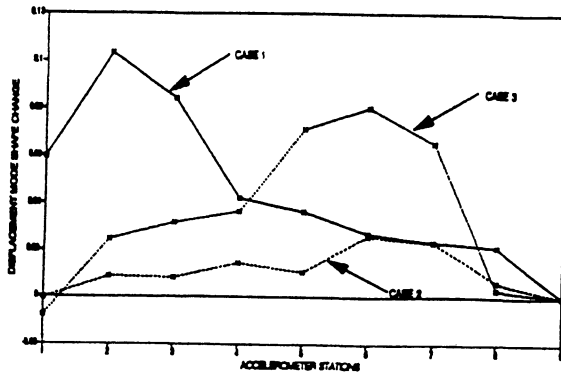
Fig.8 DMS Difference Curves for Cases 1, 2, and 3 in Test

(3) The difference curve for Case 2 also clearly indicates the damage location although the amplitude is relatively small (Fig. 8). compared with the results of modal frequency in which no visible changes can be seen, the DMS is more reliable for the "small" damage. Fig. 7 also shows that the change of mode shape is small for the web-damage case when compared to the flange-damaged cases.

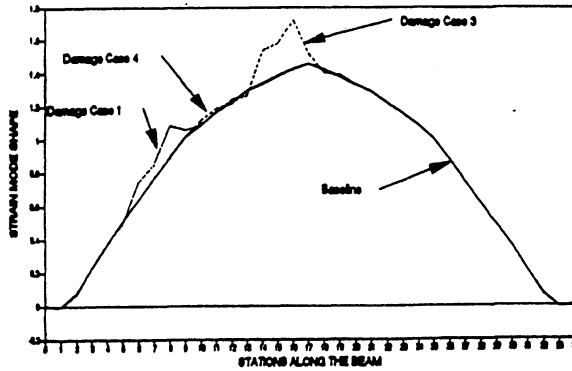
Fig. 9 shows the analytical strain mode shapes of the baseline value, Damage Cases 1, 3, and 4 respectively, while Fig. 10 shows their differences with respect to the baseline obtained in the analytical study.

Fig. 9 Strain Mode Shapes for Case 1, 3, and 4 in FEM

As seen from Figs. 9 through 11, in Damage Cases 1, 2, and 3, increases in the amplitude of SMS is relatively close to the damaged locations. In addition, the SMS shows a much higher sensitivity to the damages as compared with that of DMS because the strain concentration occurs near the cracks. The relatively large localized changes can facilitate the determination of the damage locations. A clear change made by Damage Case 2 is shown at station 6 in the experimental study although there is no significant changes either in frequency or in DMS.

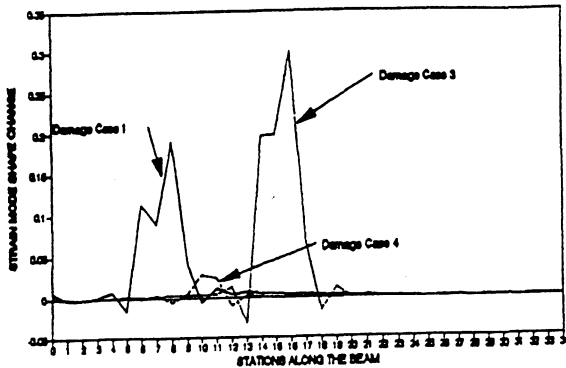
Fig.10 SMS Difference Curves for Case 1, 3, and 4 in FEM

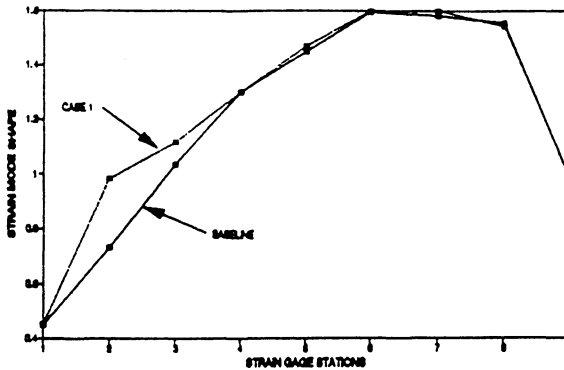
In the experimental study, comparisons of strain mode shapes between the damage cases and the relative baseline for Damage Case 1, 2, and 3 are shown in Figs. 11(a) and (b) respectively. Fig. 12 shows their differences as well. Because Damage Case 4 does not affect the moment capacity of the beam significantly, no changes on strain mode shape are measured. Therefore, Damage Case 4 is not shown.

Fig. 11a Strain Mode Shapes for Case 1 in Test

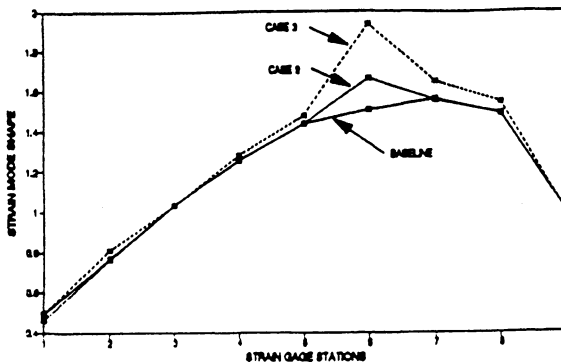
Fig. 11b Strain Mode Shapes for Case 2 and 3 in Test

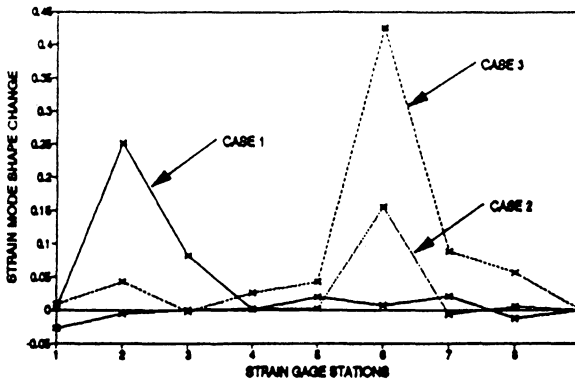
Fig.12 SMS Difference Curves for Case 1, 2, and 3 in Test

From the difference curves, it is also seen that, for the same crack size, the strain mode shape change of Damage Case 3 is more notable than that of Damage Case 1. It is also clearly demonstrated that the significance of strain mode shape change in a given mode is determined by not only the seriousness of the crack but also the position of the crack.

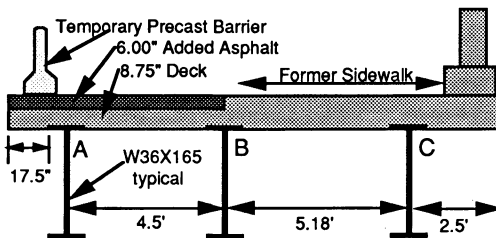
Figure 2. Cross Section of Test Span

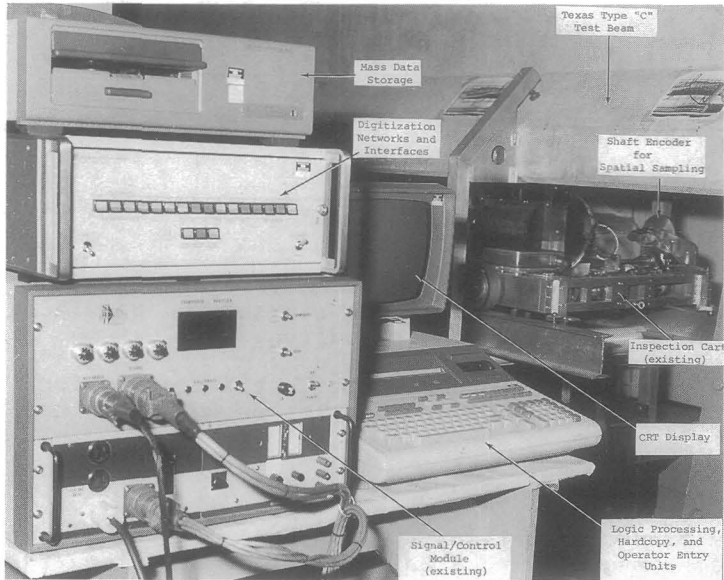
Under a new contract a second generation of the MFD was pursued addressing the needs for improvement that had become obvious in the earlier field trial. [5] A microprocessor was incorporated in the system to digitize the storage of data and enhance the signal analysis as shown in Figure 2.

Figure 2. Photograph of signal processing units with magnetic field disturbance system in the laboratory

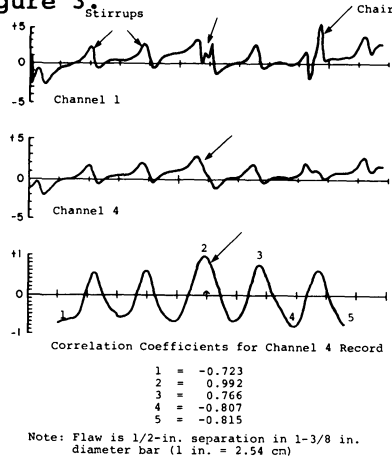
In addition to the subtraction procedure a correlation method of analysis was developed, using the microprocessor to distinguish flaw signals from other signals. Mathematical flaw signal developments (algorithms) were developed and the recorded data plotted as a function of the scan length. This information was presented on a monitor in almost real time and hard copy printout was possible when needed as shown in Figure 3.

Figure 3. Reconstructed display of digitized magnetic signatures before and after enhancement and correlation for flaw in 1 3/8" \emptyset bar.

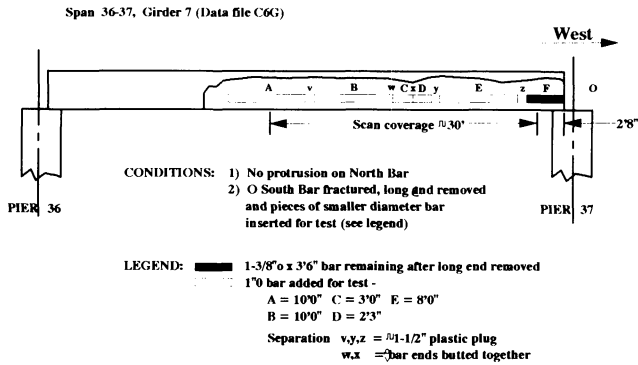
A second field trial was conducted on the same viaduct as in the first field trial and in some cases on identical post-tensioned I beams. In one case a 1 3/8" diameter, 60 foot long, steel rod had fractured and "fired out" of the aluminum duct of the beam. This left an open duct that made it possible for the inspection team to insert, back into the open duct a steel rod with known anomalies of various lengths to simulate breaks and separations at known locations as shown in Figure 4.

Figure 4. Sketch of concrete beam with open duct where a 1-inch diameter steel rod with known separation was inserted and inspected.

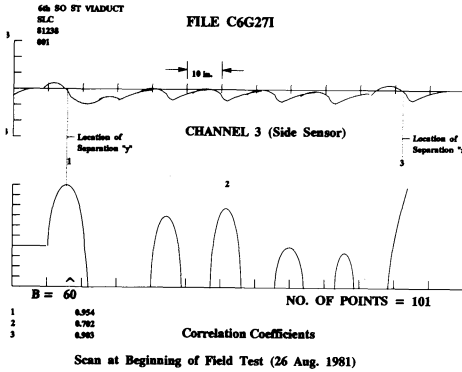
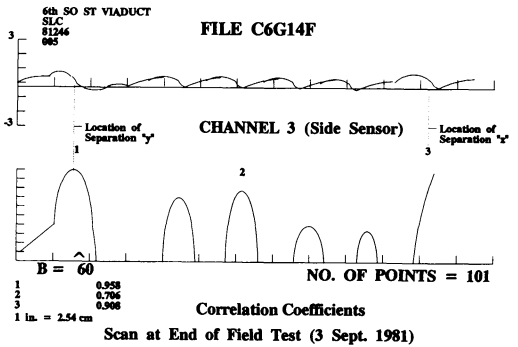
Subsequent scanning of this beam with the MFD showed excellent correlation between known anomalies their size and locations with that of the MFD signal magnitude and location on the recordings as shown in Figures 5 and 6.

Figure 5. Scan at beginning of field test (26 Aug. 1981)

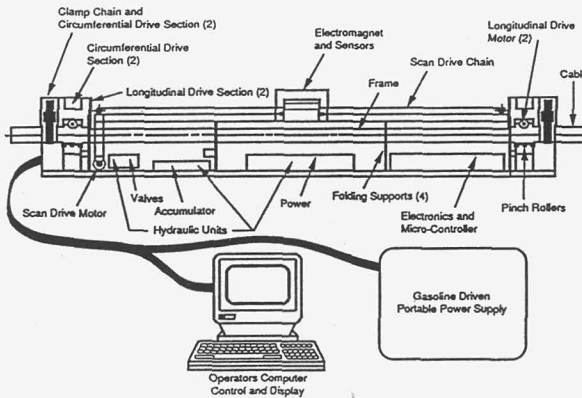
- a magnetic sensor assembly attached to a moving electromagnet
- electrical and hydraulic motors and actuators
- a electronic control and data acquisition system directed by a remotely located host computer, and
- a self-propelled frame housing for the inspection components (see Figure 7).

Figure 7. Block diagram of Magnetic Perturbation System for Cable Inspection

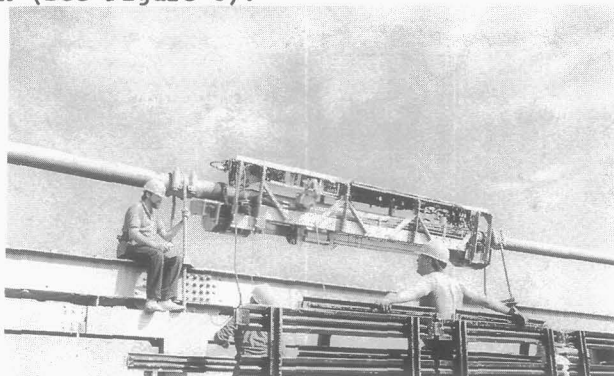
The system is designed to be placed directly upon a bridge cable and is capable of moving itself longitudinally and circumferentially about the cable at approximately 1 inch per second acquiring perturbation data, at precise 0.1 inch intervals. The entire unit weighs approximately 2800 pounds and is 17 feet long. The MPC has been successfully demonstrated (tested) on main cables of five suspension bridges and on two occasions on cable stay specimens that were subject to fatigue and proof loading in the FSEL at the University of Texas at Austin (see Figure 8).

Figure 8. Picture of Magnetic Perturbation for Cable Inspection System on typical suspension cable of bridge

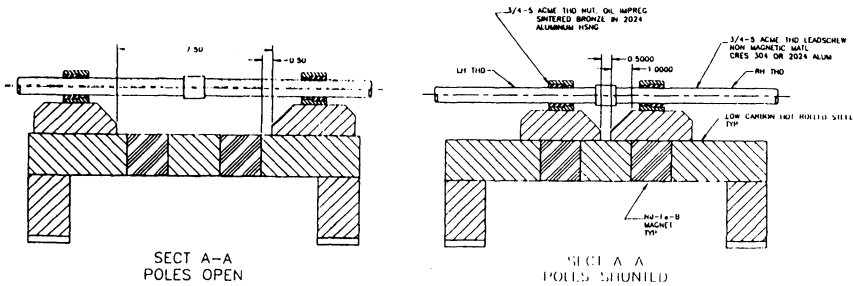
The magnet design is based on a magnetic "core assembly" of two transversely magnetized NbFe B35 magnets, with a low carbon steel space between them and a low carbon steel pole stub extending at each end as shown in Figure 9.

Figure 9. Magnetic and pole pieces in open and shunted positions

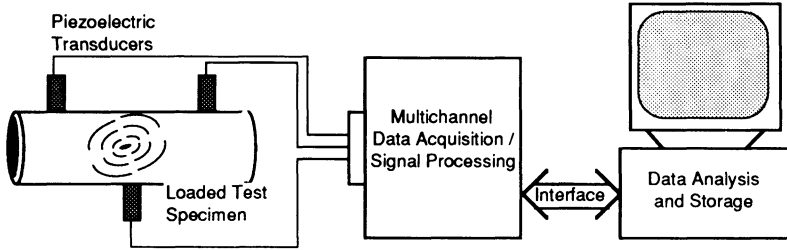
Figure 1. Typical Acoustic Emission Test Setup

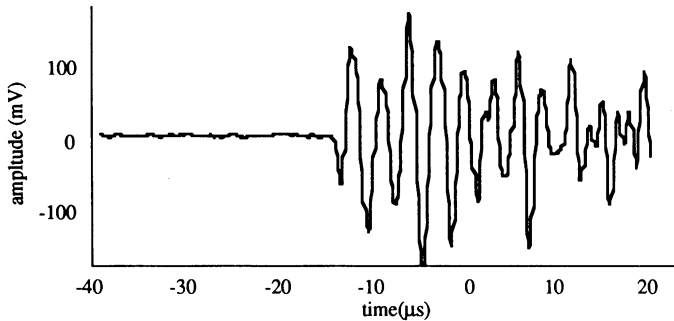
Figure 2. Typical AE Signal

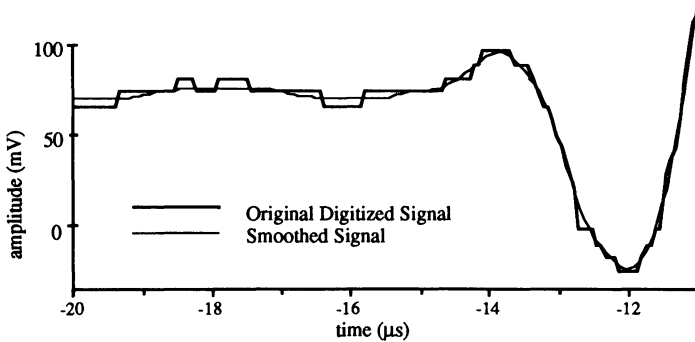
where σ^2 is the sample variance of data points in the vicinity n , and a and b are constants. The constants were determined by setting a maximum T of 16 data points, ($1 \mu\text{s}$), for a variance of zero, and a minimum T of 3 points, ($0.1875 \mu\text{s}$) for a variance of two or greater.

Figure 3. Effect of Adaptive Moving Average Filter

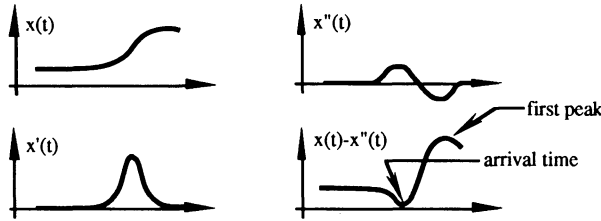
Figure 4. Action of Laplacian Filter

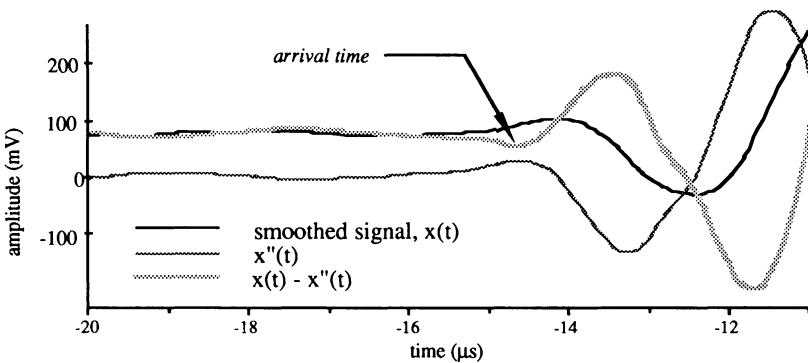
Figure 5. Laplacian Filter and Arrival Time

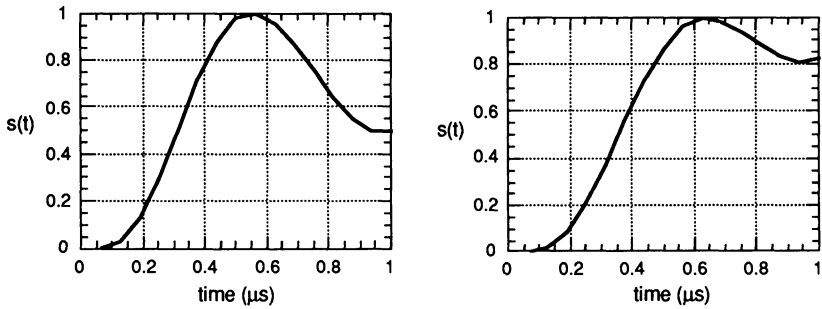
A mortar beam was loaded in three point bending under closed-loop control. The strain (measured by a 4" gage length extensometer) on the tension face of the beam was used as the feedback signal. The dimensions of the beam were 44 x 10 x 10 cm. The span was 40 cm. Eight acoustic emission transducers were mounted on the beam. The AE signals were recorded by a LeCroy modular data acquisition system (LeCroy model TR8837F modular transient recorders housed in a model 8013A CAMAC mainframe). The digitizing rate was 16 MHz at 8 bit resolution. The number of points recorded in each channel was 1024.

Figure 8. Typical recovered source-time functions

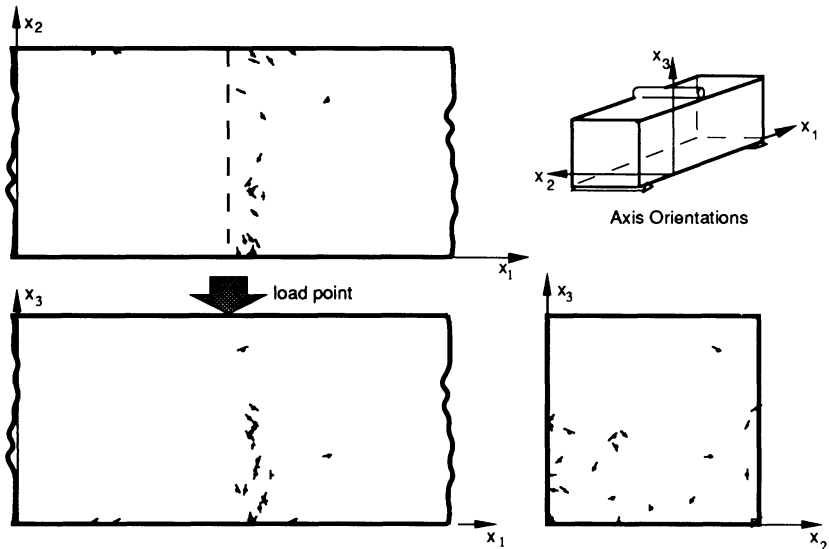
Recovered microcrack orientations are shown in Figure 9. All of the microcracks shown are inclined with at least one of the three specimen axes. Even though the overall fracture of the specimen was mode I (tension), the microcracks were found to be primarily mixed mode and mode II (shear).

Figure 9. Microcrack plane orientations.

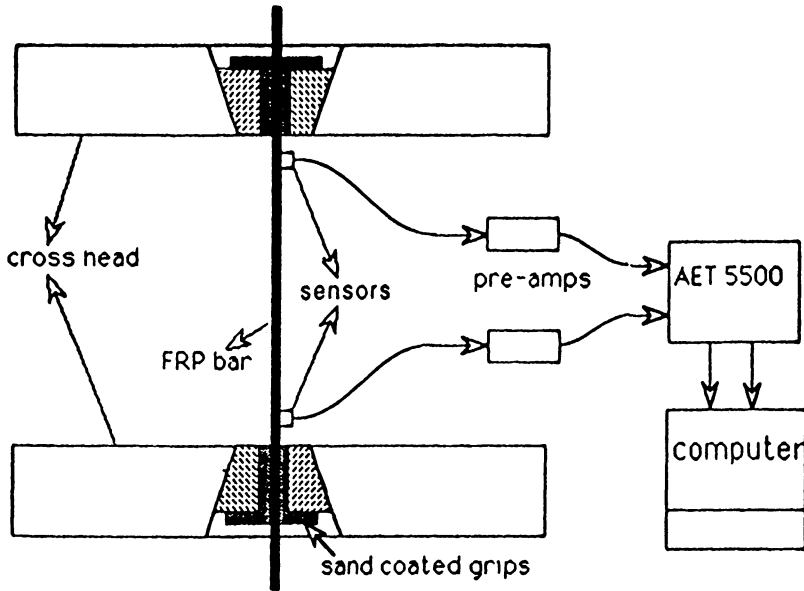
Figure 1 Schematic diagram of the tension test set-up and AE monitoring system

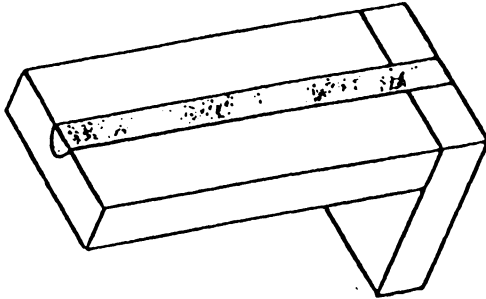
Figure 2 Sand coated grip to hold #2 AFRP bars while testing

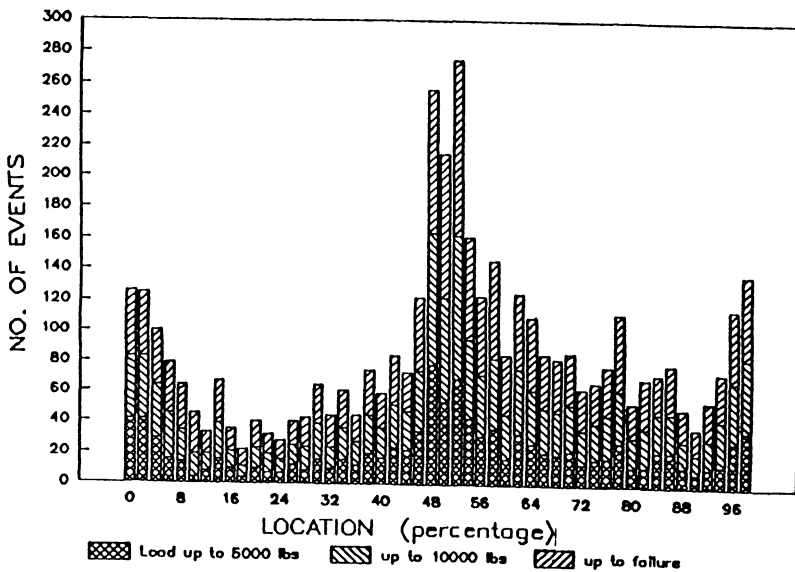
Figure 3 Distribution of AE events versus location for different stress levels

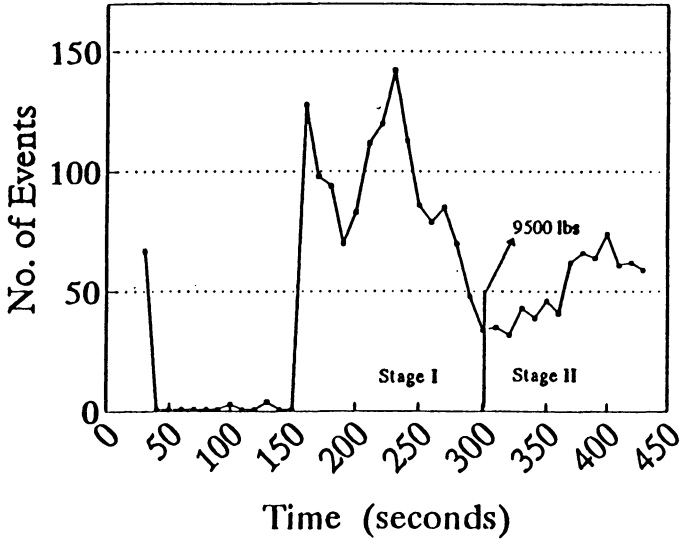
Figure 4 AE events versus time

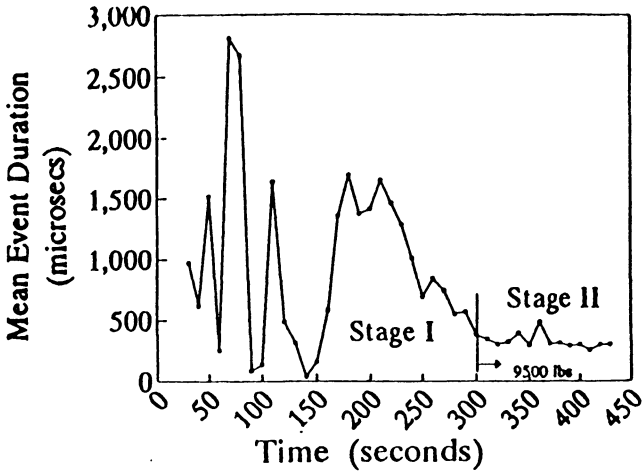
Figure 5 Mean event duration versus time

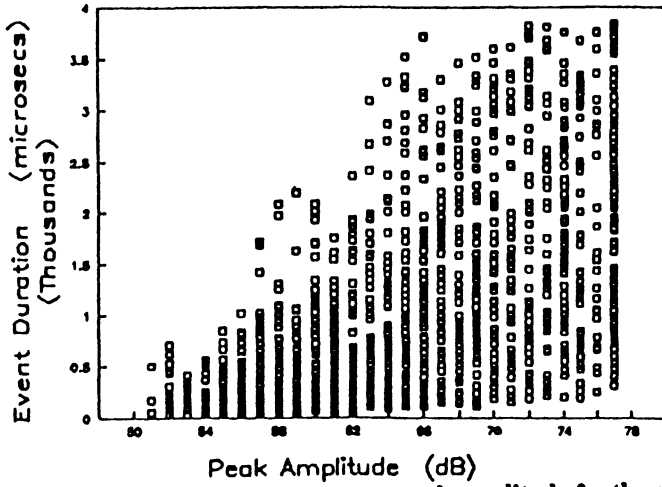
Figure 6(a) Event duration versus peak amplitude for the stage I

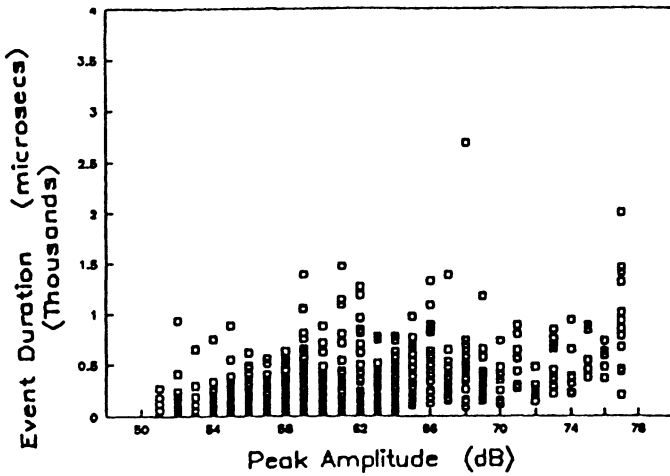
Figure 6(b) Event duration versus peak amplitude for the stage II

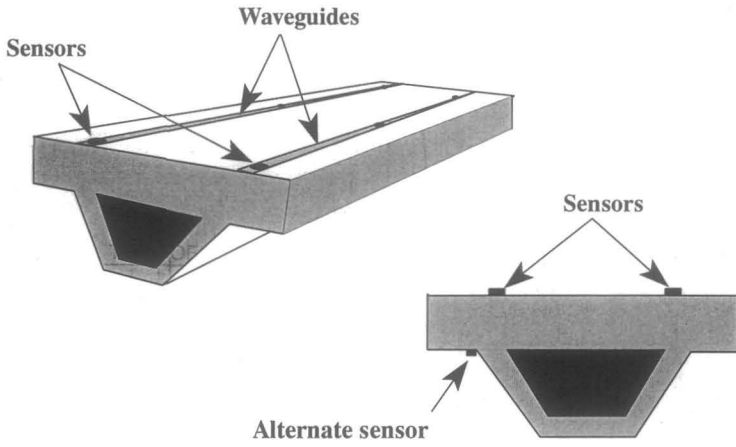
Figure 1. Acoustic Emission Sensor and Waveguide Locations

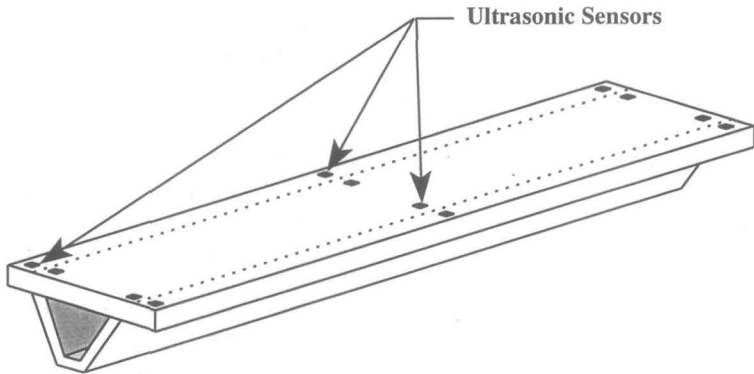
Figure 2. Positioning of Ultrasonic Sensors on Concrete Guideway

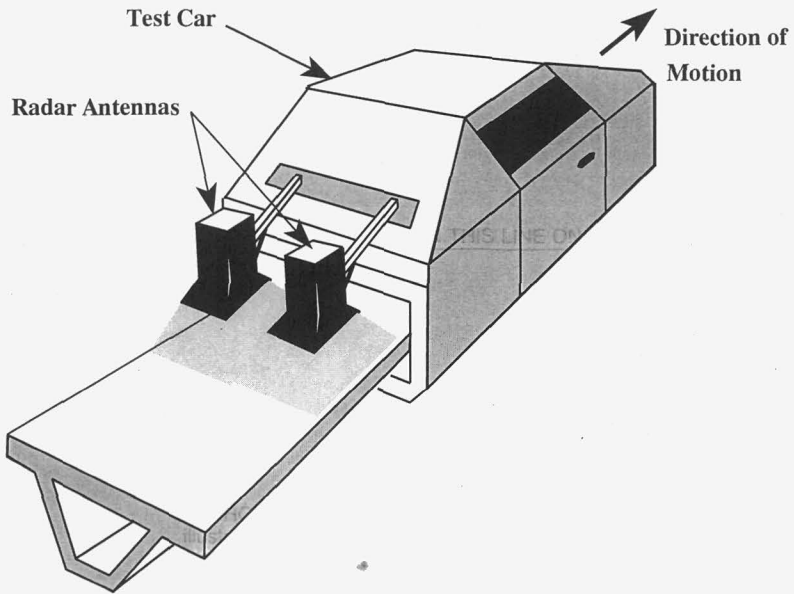
Figure 3. Test Car for Radar Surveying on Guideway

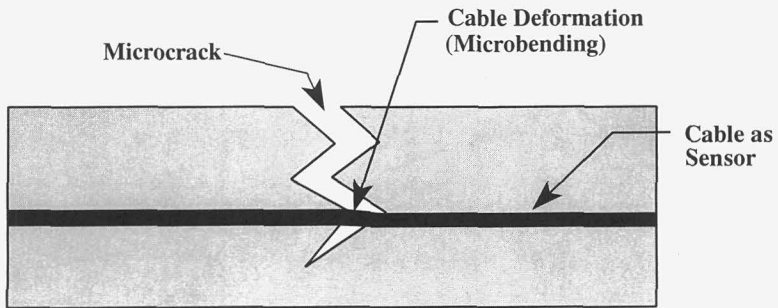
Guideway Section with Magnified Microcrack

Figure 4. Smart Structure Sensor Detecting Microcrack

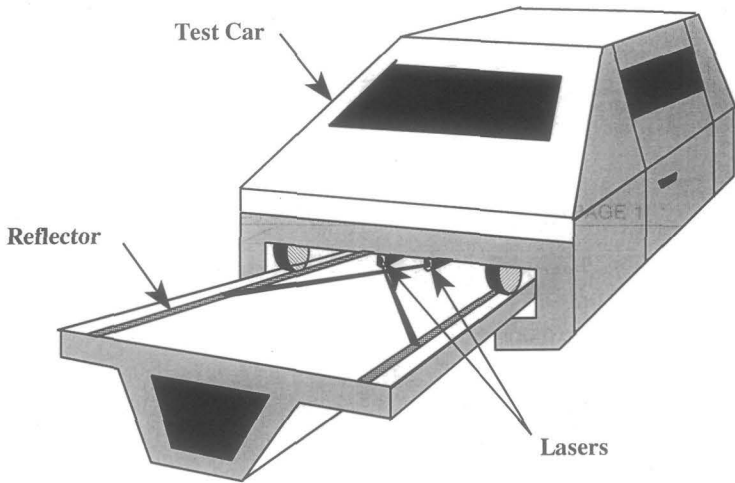
Figure 5. Test Car for Laser Geometric Alignment

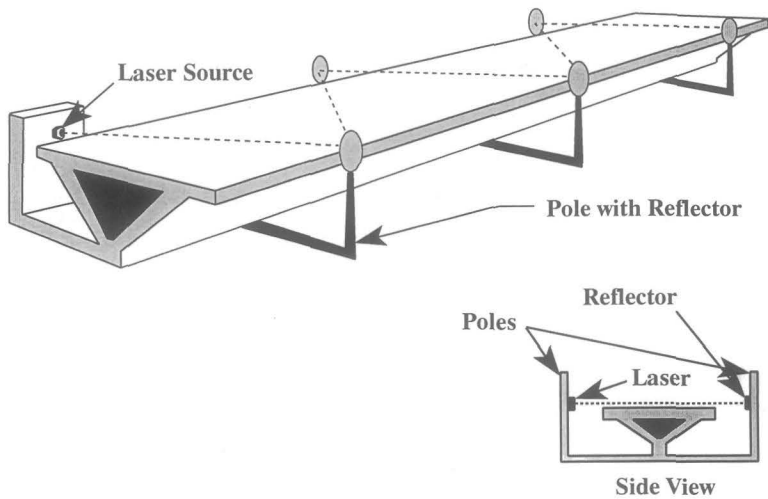
Figure 6. Fixed Laser-Reflector Alignment System
(Also applicable for Debris Detection)

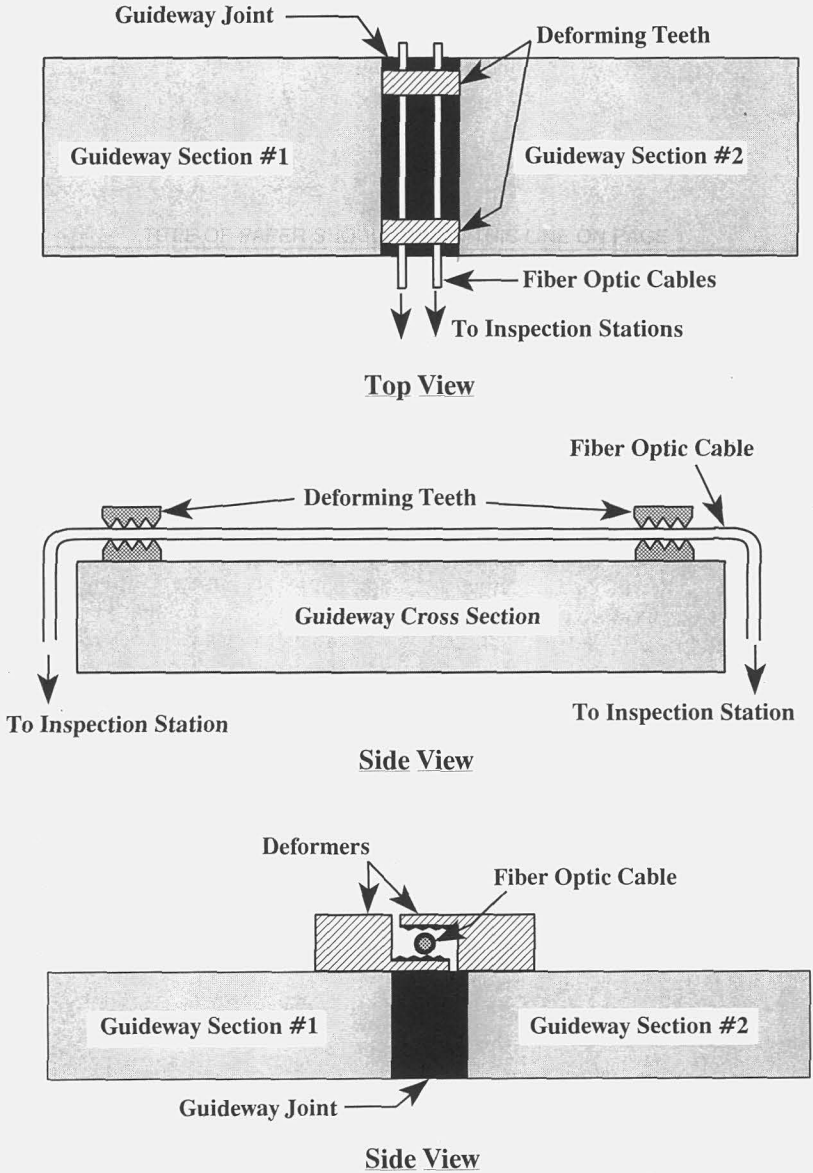
Figure 7. Fiber Optic Guideway Alignment Detector

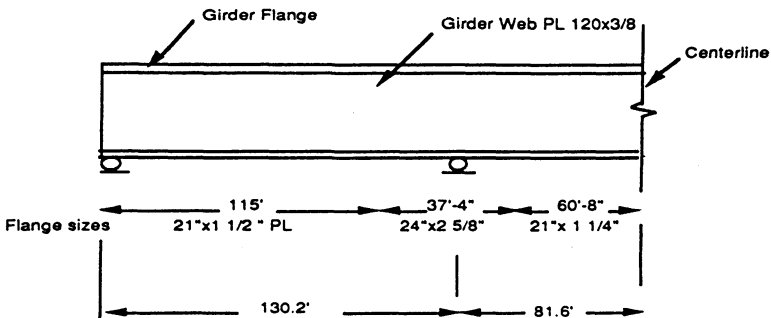
The current structure, built in 1963, is a 1,275 foot long, non-composite bridge consisting of three-span continuous units with spans of 131 feet, 163 feet, and 131 feet each. The structural unit is a two-girder welded with bolted splices design with a floor system (Figures 1, 2, and 3).

Figure 1 Girder Dimensions

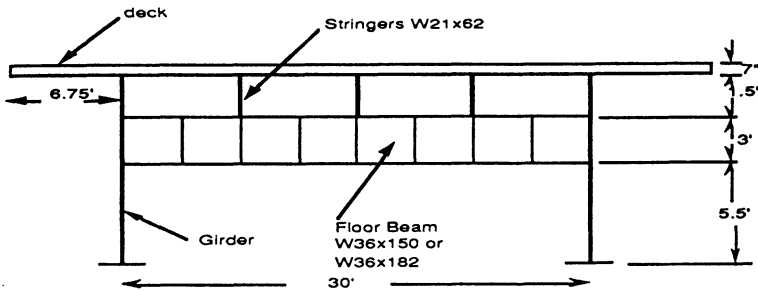
Figure 3 Bridge Cross-Section

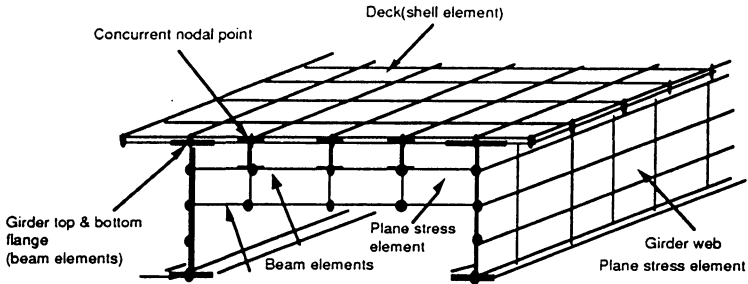
A detailed three dimensional analysis of the bridge was necessary to account for the full interaction of the elements and to model the complex three dimensional behavior of the as-built structure (Fig. 4).

Figure 4 Three Dimensional Model

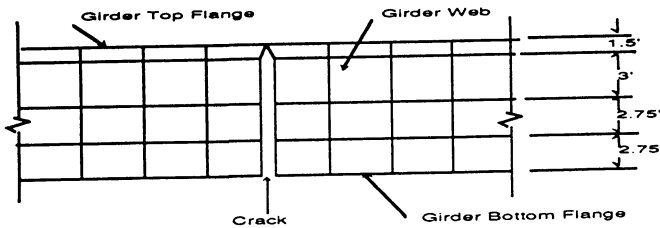
Crack: To model a crack in the girder, coupled nodes were used at all possible crack locations. Except for the fracture location of interest, the other node couples were rigidly linked (Fig. 5).

Figure 5 Modeling of the Crack

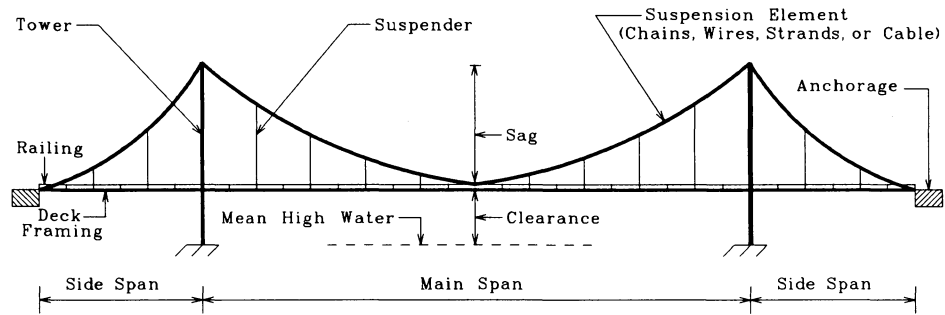
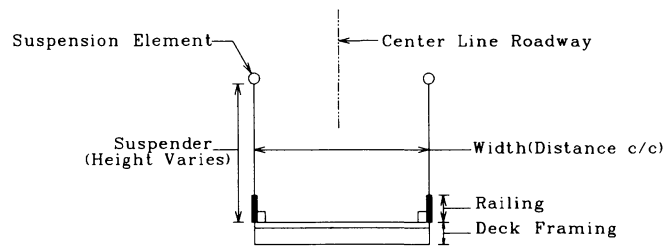
FIG. 1. UNSTIFFENED SUSPENSION BRIDGE

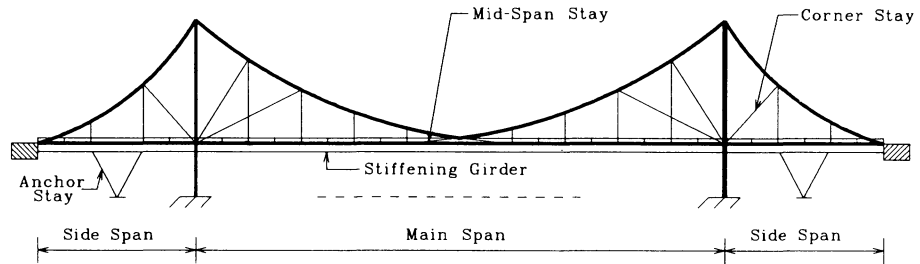
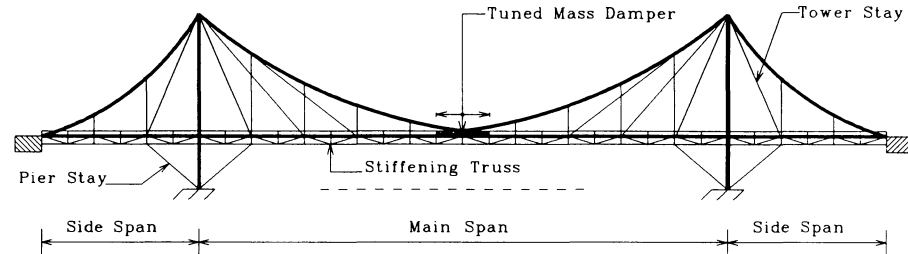
(Showing Stiffening Girder, Anchor Stays, Corner Stays, & Mid-Span Stays)

(For information not shown, see Fig. 1. The elements & devices shown are illustrative and can occur in various combinations)

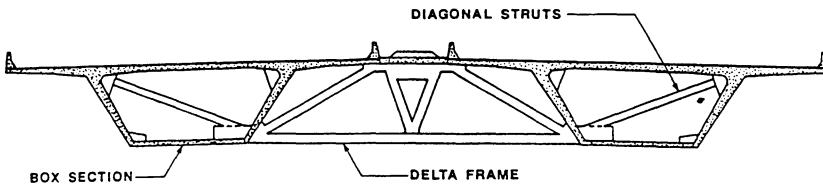
Figure 2. Twin Box Girder Cross-section at Delta Frame

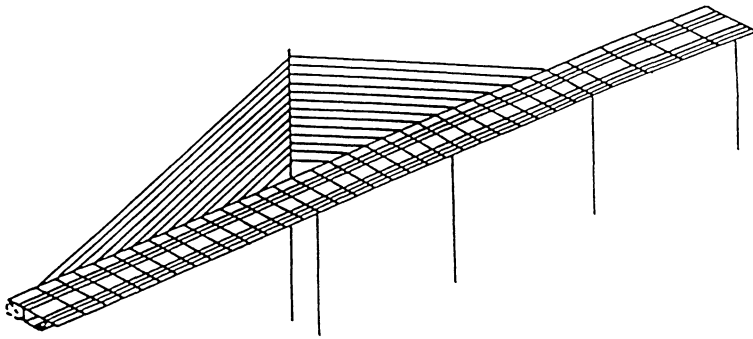
Figure 3. Quarter Bridge Finite Element Model

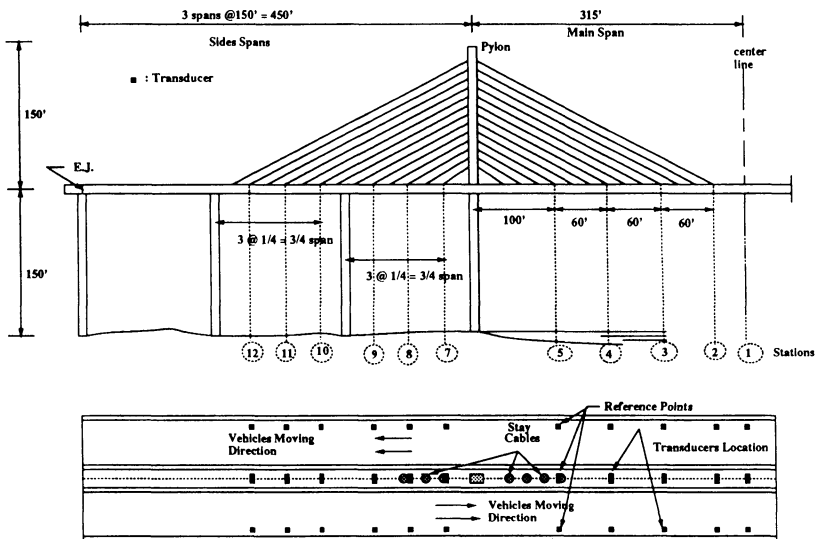
Figure 4. Location of Accelerometers on Completed Bridge

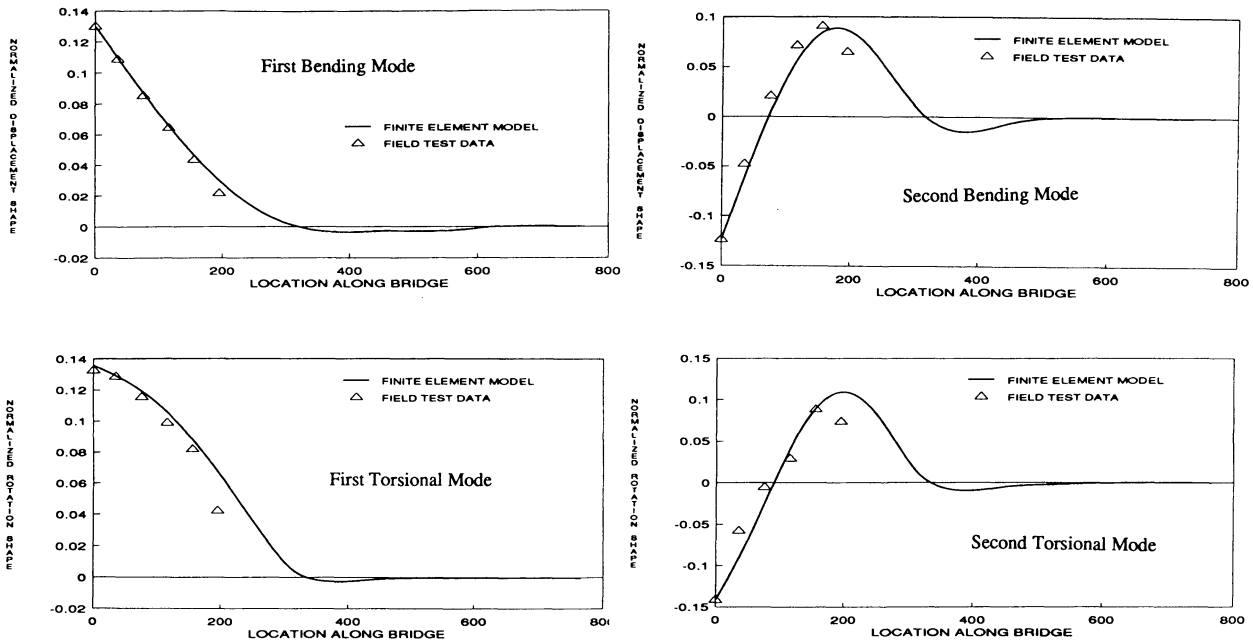
Figure 5. Computed and Measured Mode Shapes - Cantilever Stage

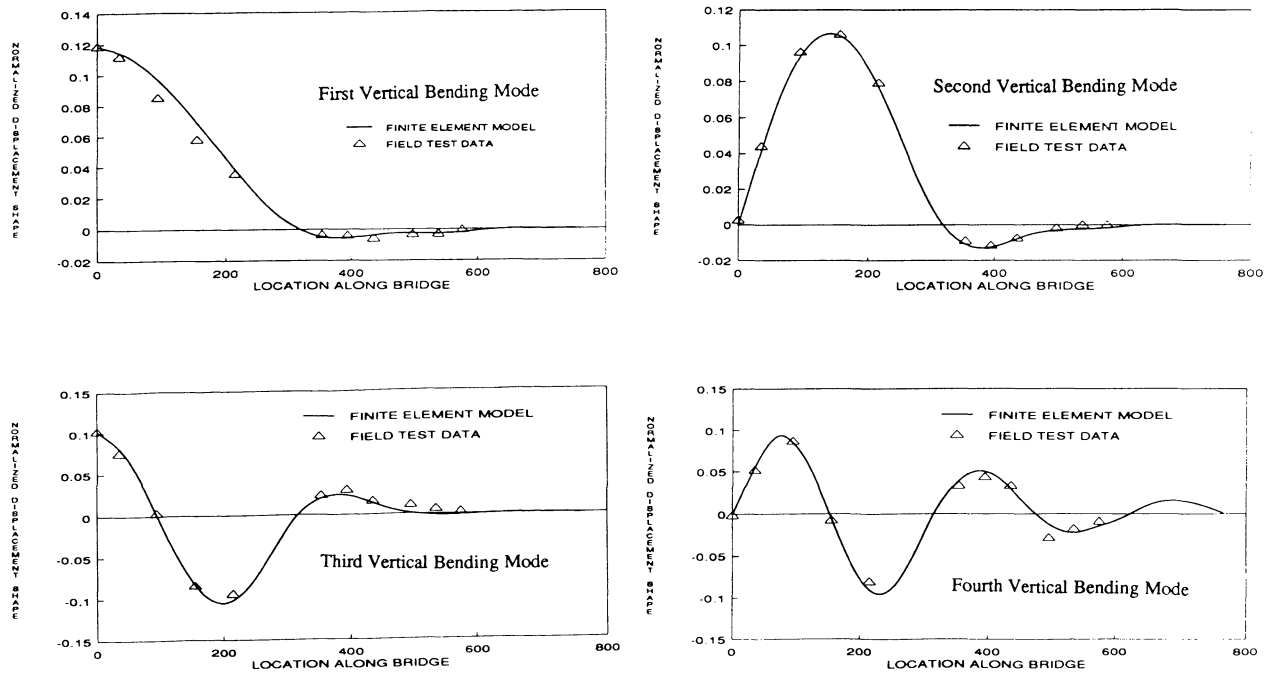
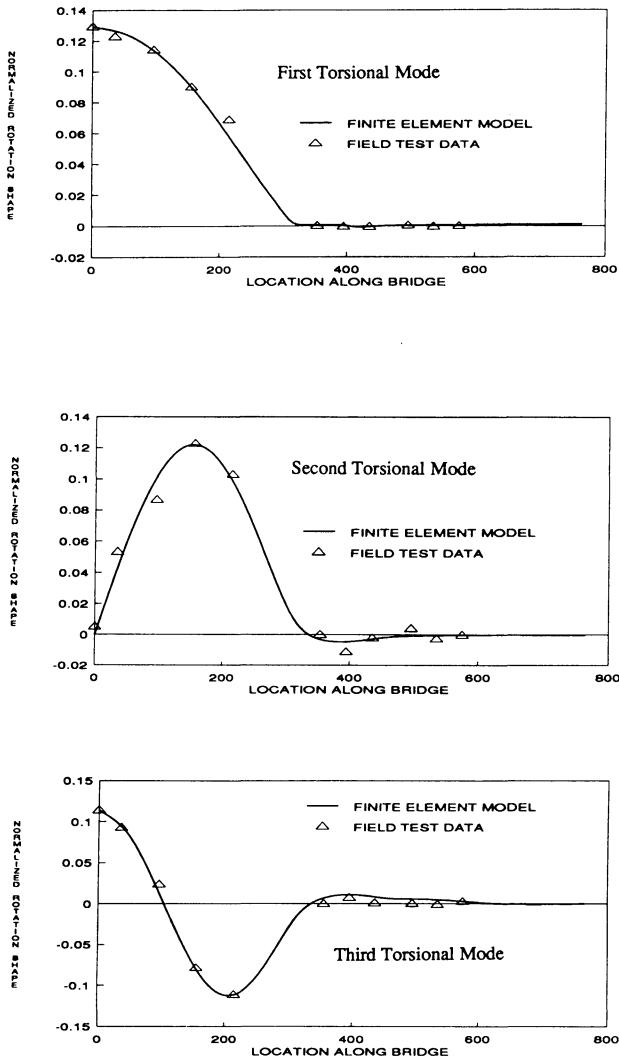
Figure 6. Computed and Measured Mode Shapes - Completed Bridge
