# Sustainable Construction

Building Performance Simulation and  
Asset and Maintenance Management

# Fibre Reinforced Polymers in the Rehabilitation of Damaged Masonry

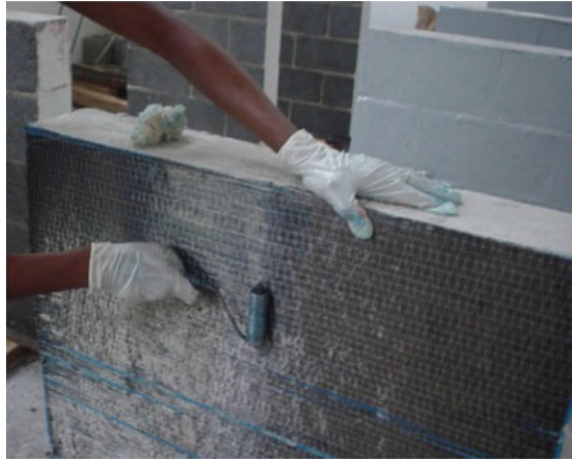
**Fig. 6** Horizontal direction of the fibres in the wallettes.  
 Source Chagas (2005)

The main direction of the fibre was positioned horizontally in the walls, that is, in the direction perpendicular to the axial loading application. This configuration was chosen so that a more effecting enveloping (or confining effect) in the damaged structures could be obtained. The enveloping mentioned above can be understood as the wrapping effect on the wallettes, once the hypothesis is that the thickness of the walls is much smaller than the FRP covered surfaces. The Fig. 6 illustrates this configuration. As a result of such a configuration, an increase in the compressive strength and the shear capacity of the structures was expected.

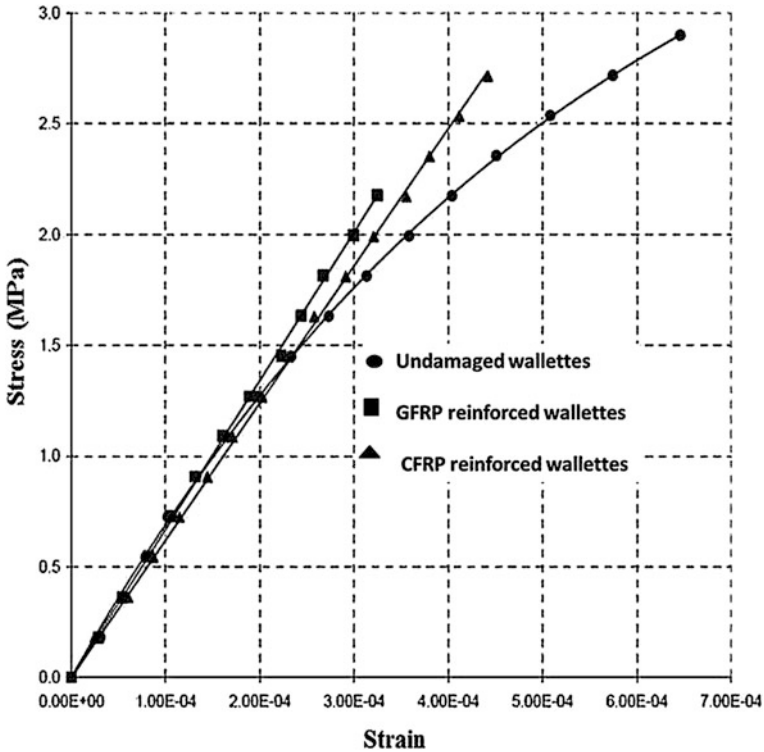
Fig. 7 Mean values for stress–strain curves of the wallettes behaviour before and after the FRP reinforcement

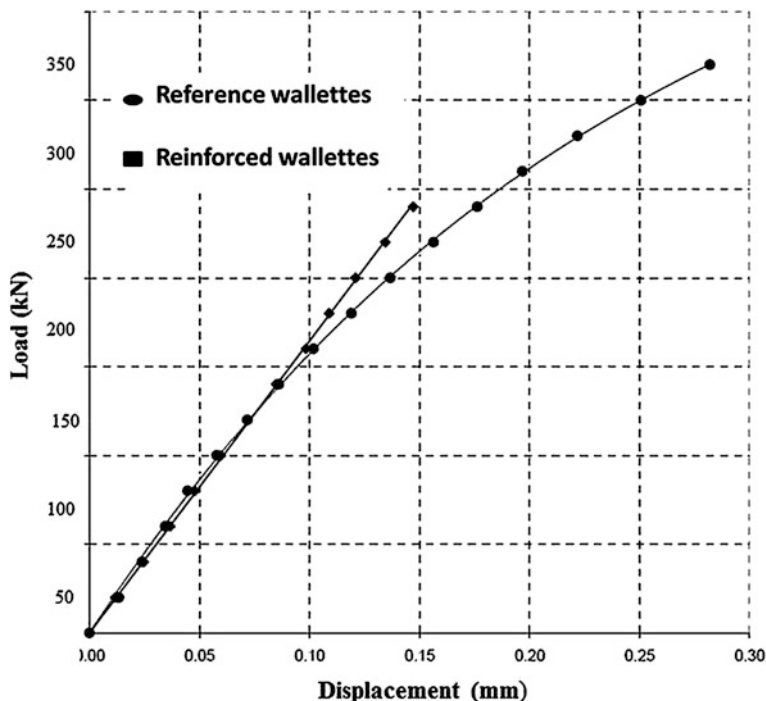
**Fig. 8** Mean values for the load-displacement curves of the wallettes behaviour before and after the FRP reinforcement

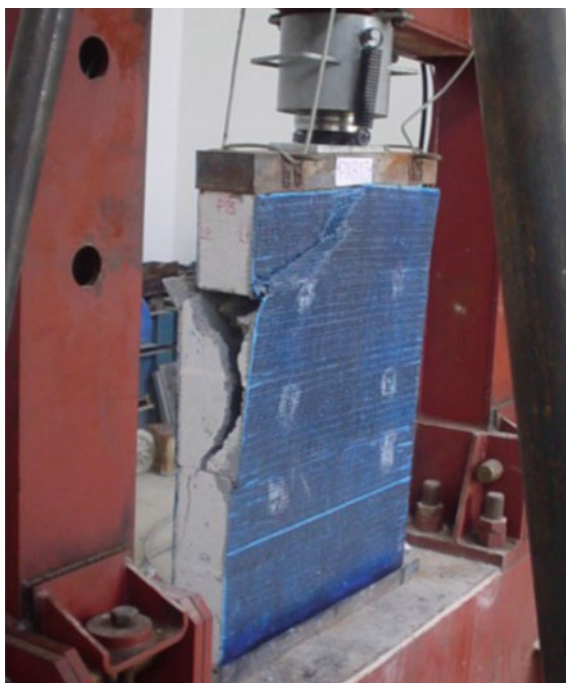
**Fig. 10** Failure of the CW3 wallette reinforced with CFRP (with putty). *Source* Chagas (2005)

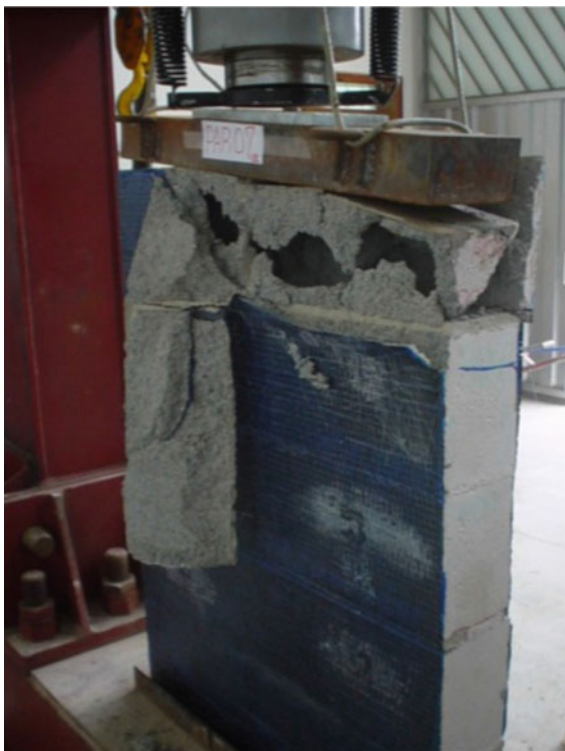
**Fig. 11** Failure of the CW1 wallette reinforced with CFRP (without putty). *Source* Chagas (2005)

However, the specimen that did not receive the putty treatment, CW1 (Fig. 11), offered a premature failure when compared with the specimens CW2 and CW3, as shown in Table 2. From Fig. 11, it is possible to observe the debonding of the reinforcement fibres, when the wallette reached its original failure loading, i.e., the lack of bonding of the FRP limited its performance and it only displayed a small loading capacity improvement.

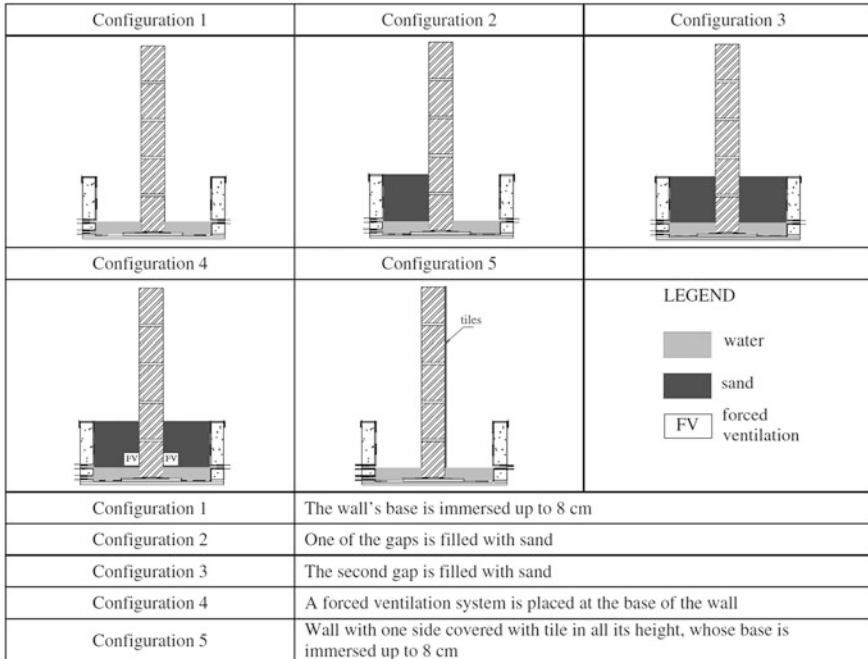
**Fig. 4** Different boundary conditions of reduced models for experimental validation. The selected models consisted of prismatic stone walls built into reservoirs to simulate rising damp with different boundary conditions (Torres 2004; Torres and Freitas 2007)

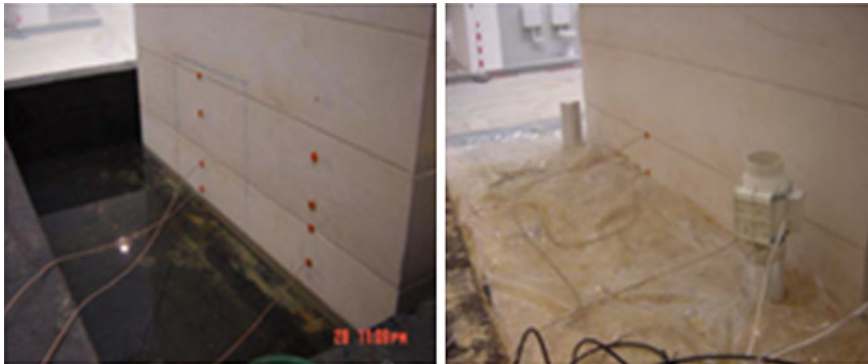
**Fig. 5** Configuration 1 and 4 for experimental validation. In all configurations the wall base was immersed to a height of 8 cm to simulate rising damp. Additionally, the moisture front was monitored by probes at various points in the wall. Configurations without and with a ventilation system are presented (Torres 2004)

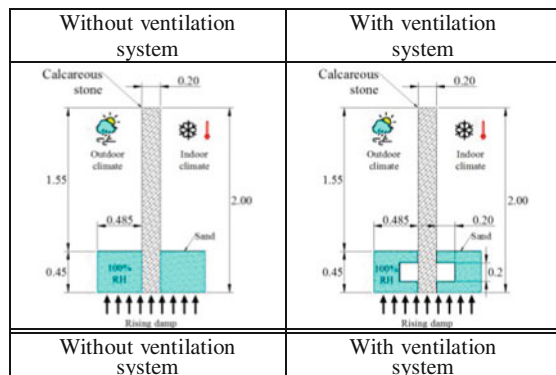
**Fig. 9** Configurations to analyse the influence of the air change rate on the drying process. In this study, we considered a total of seven sub-configurations (one without and six with ventilation systems, with  $ACH$  values of 1, 20, 40, 60, 80 and  $100 \text{ h}^{-1}$ , respectively)

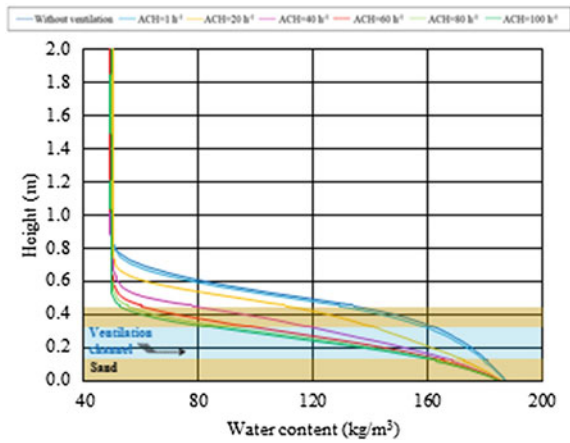
**Fig. 12** Percentage of water content removed from the central section of the wall by the ventilation system after one year of drying out. The ventilation system is able to remove up to 61.0 % of water content for higher values of ACH, but only up to a specific height, in this case approximately 0.8 m

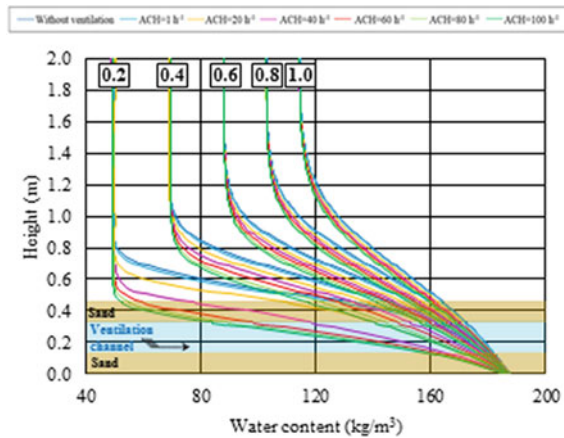
**Fig. 16** Water content of the central section after one year of drying out. [0.2] wall thickness of 0.2 m, [0.4] wall thickness of 0.4 m, [0.6] wall thickness of 0.6 m, [0.8] wall thickness of 0.8 m and [1.0] wall thickness of 1.0 m. The greater the wall thickness, the higher the influence height of the ventilation system due to the lower moisture front of the damp

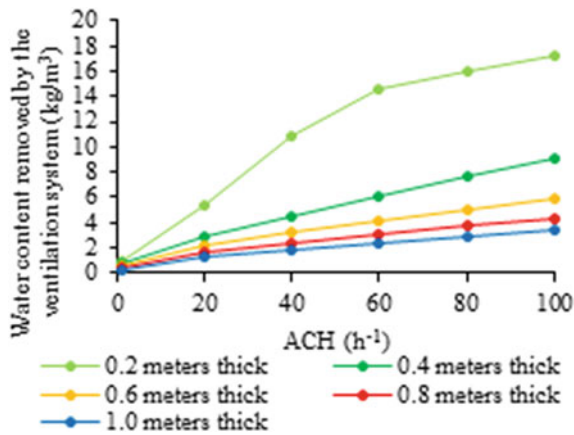
**Fig. 17** Water content removed from the wall by the ventilation system after one year of drying out. When the wall thickness is greater than 0.2 m, an optimum ACH cannot be seen, and the higher the ACH value the greater the moisture content removed from the wall. This is because increased thickness makes the capillarity action of rising damp more important than infiltrations due to a flood in the lower part of the wall, because the moisture front reaches a higher level

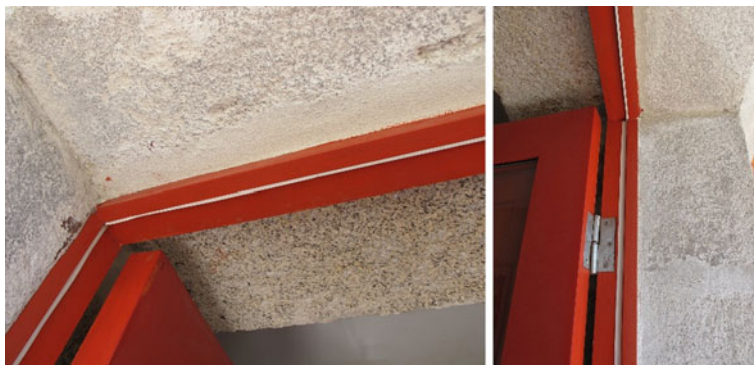
**Fig. 6** Introduction of sealants in the window of the main façade

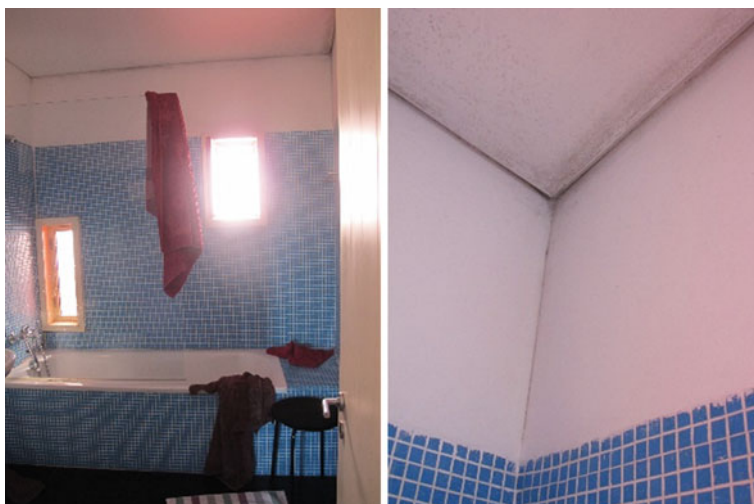
**Fig. 8** Superficial Condensation in the roof of the toilet room on floor 2

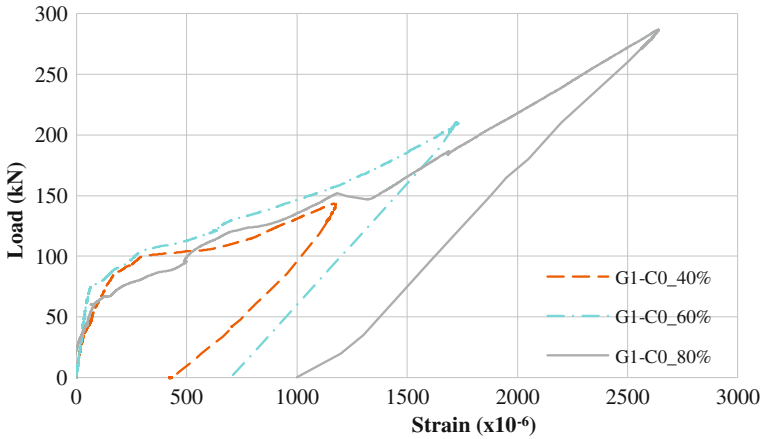
**Fig. 21** Deformations of steel tie in the cross section

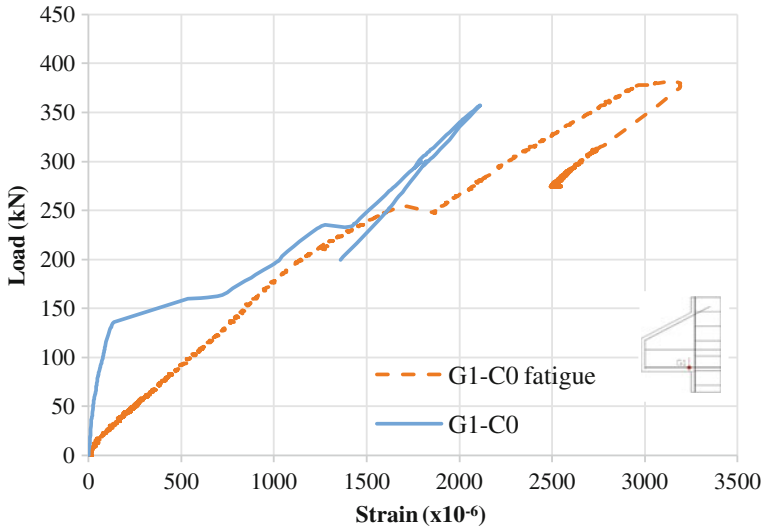
**Fig. 23** Strains of steel for C0 and C0 fatigue corbels

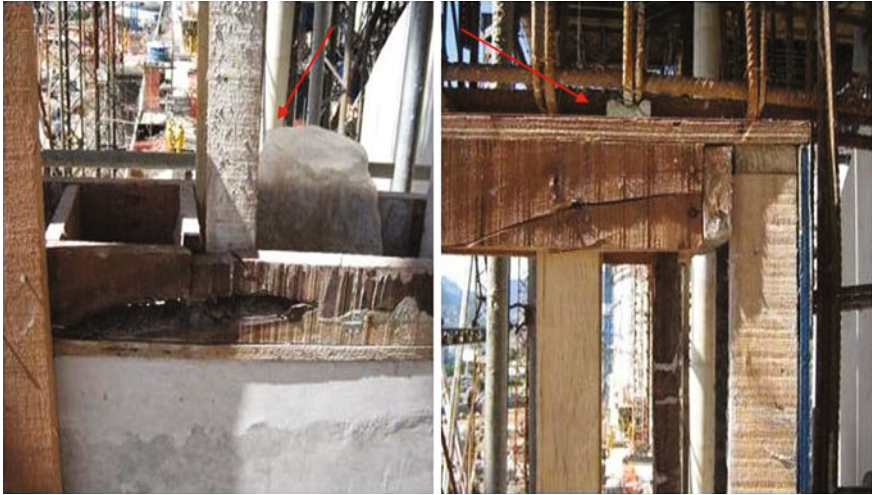
**Fig. 3** Poor quality frames for exposed concrete

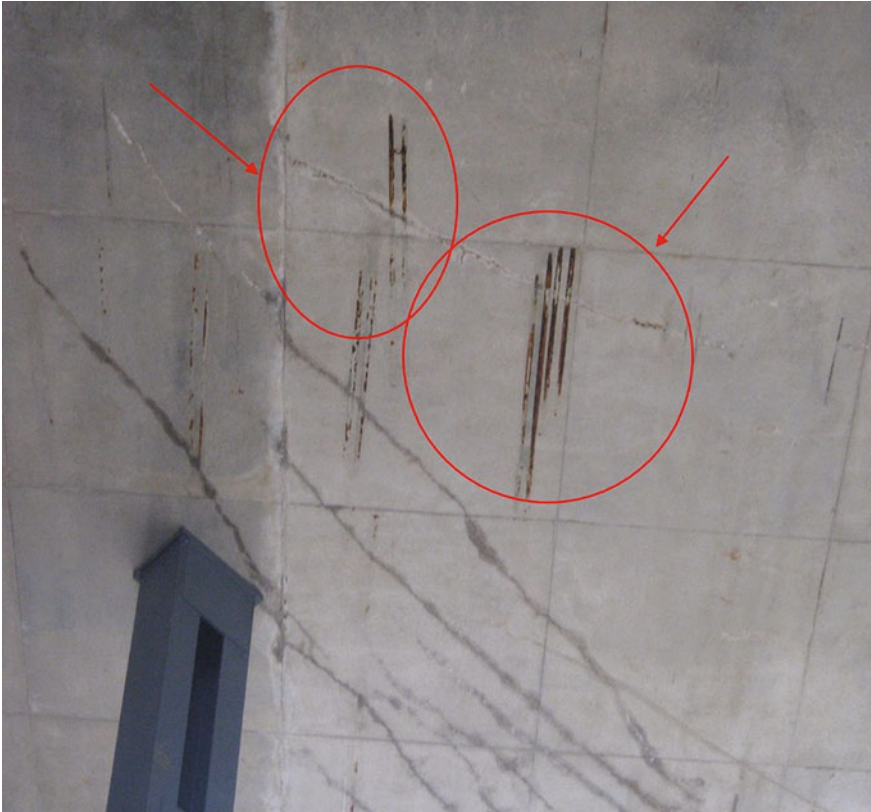
**Fig. 4** Concrete reinforcement exposed
