LANDSLIDES

Risk Analysis
and
Sustainable
Disaster
Management

Proceedings of the First General Assembly of the International Consortium on Landslides

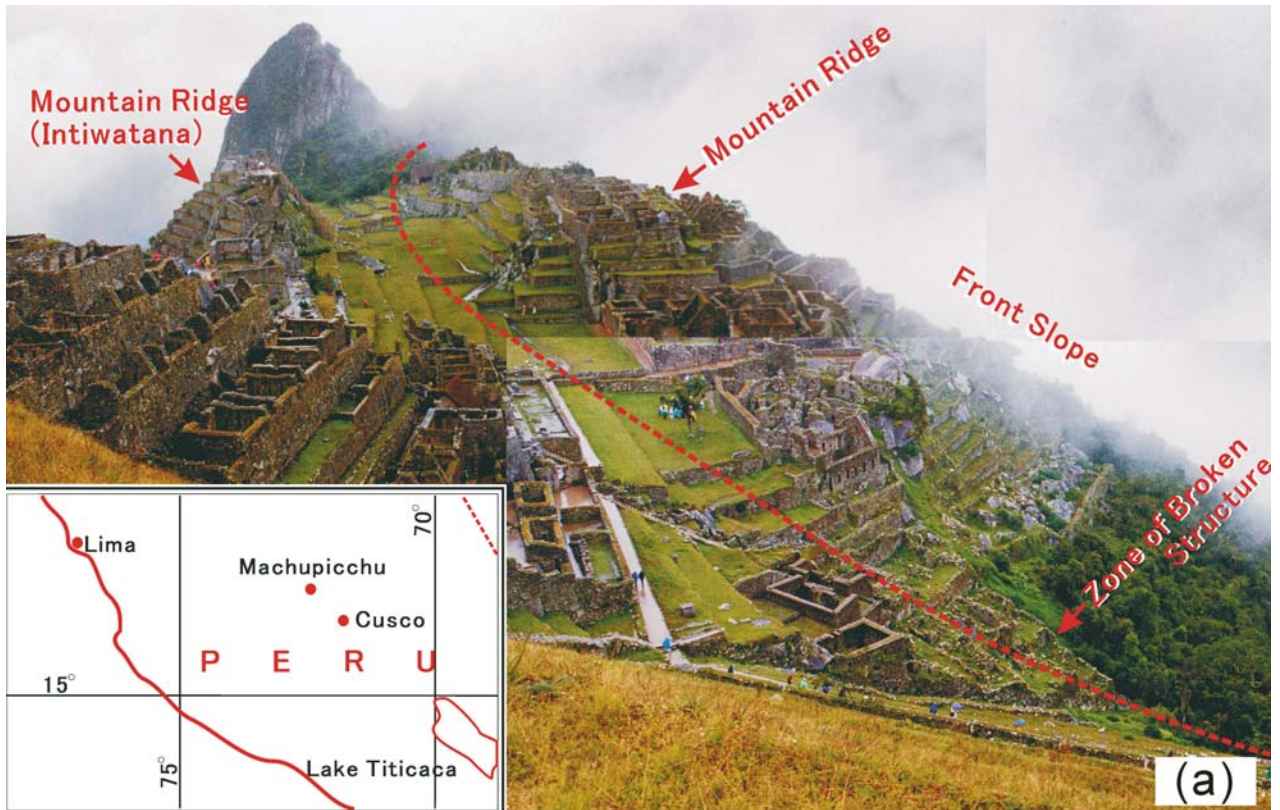
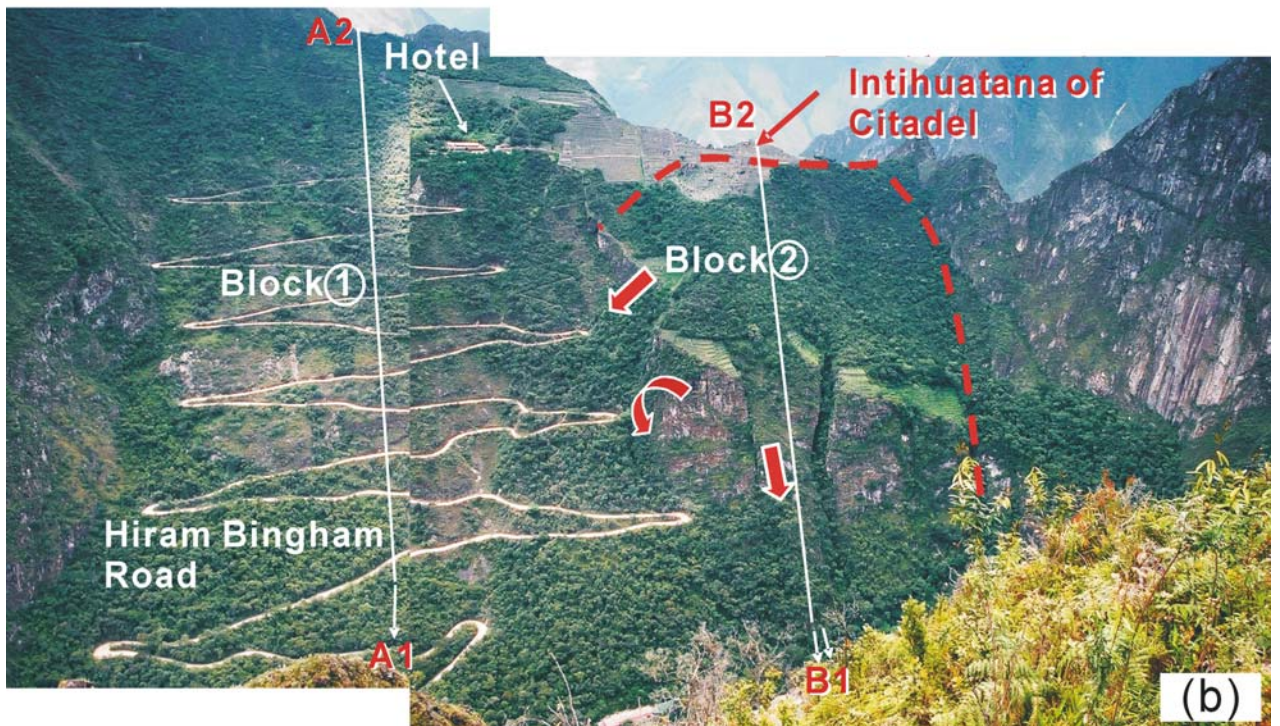
Fig. 1.7. a Machu Picchu Citadel and a line crossing the Plaza as noted taken by Sassa (2000); b Machu Picchu slope with interpretation of block no. 1 (Hiram Bingham area) and block no. 2 (Citadel area) (from Sassa 2005, UNESCO brochure)

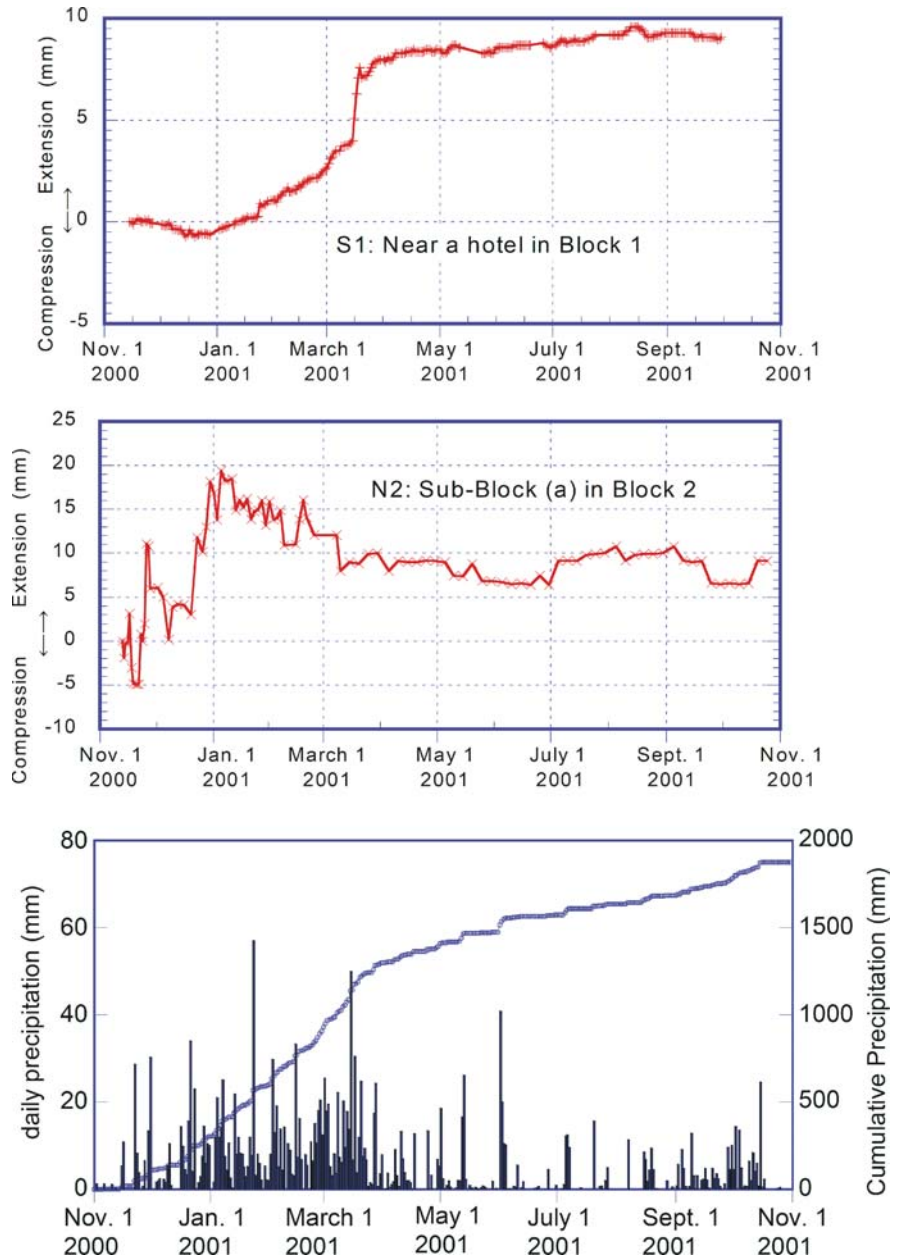
Fig. 2.10. Records of extensometer (S1) in the monitoring site (M1) near Hotel Sanctuary Lodge in block 1 and extensometer (N2) in the monitoring site (M2) in block 2

of relatively large and deep seated landslide. Figure 2.10 (middle) presents the monitoring of the manual reading extensometer N2 installed in site M2 in the border of sub-block (a) of block 2. The movement is rather great in the order of 10 mm. The response on the rainfall event seems to be a bit quicker than that recorded by the extensometer S1. Probably it detected a relatively shallow landslide. Those extensometers were not installed in a series along a line crossing the landslide block as installed in Lishan, China (Sassa et al. 2001b). It is not possible to estimate the landslide size from single extensometer monitoring, however, it is sure that a landslide movement (probably corresponding to large-scale landslides) responding to rain-

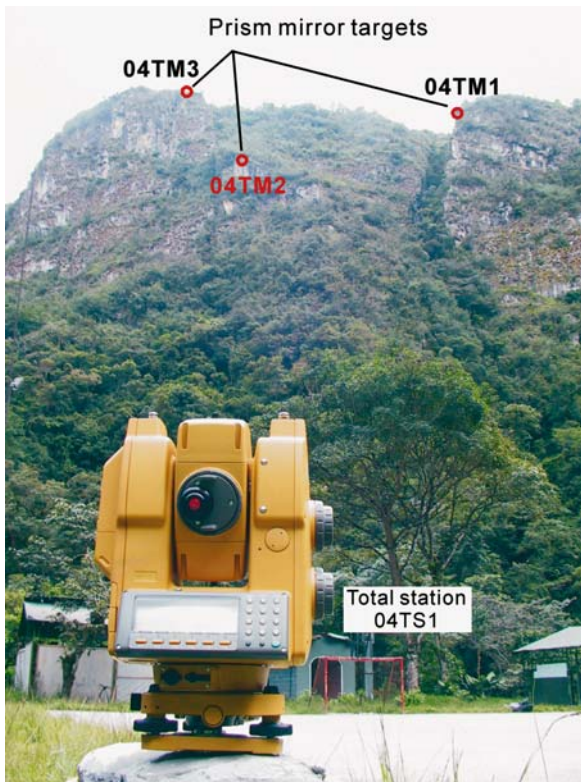
Fig. 2.14. Total station and location of prism mirror targets placed on the head of toe cliff of the block no. 2

Total station is located in the point of 04TS1 in Fig. 2.11 in the garden of the dormitory and the office of the Machu Picchu Sanctuary Lodge Hotel at the Urubamba River side. Figure 2.14 presents the view from the monitoring point to the rock cliff. Three prism mirror targets of 04TM1, 04TM2, and 04TM3 are located on the head of the toe cliff of the block 2. Only the central target 04TM2 showed a small down slope displacement of 1 mm along the line of sight of about 350 m for about 4 months from 27 November 2004 to 23 March 2005. Other two targets showed no displacement more than 1 mm, although this observation period includes a rainy season.

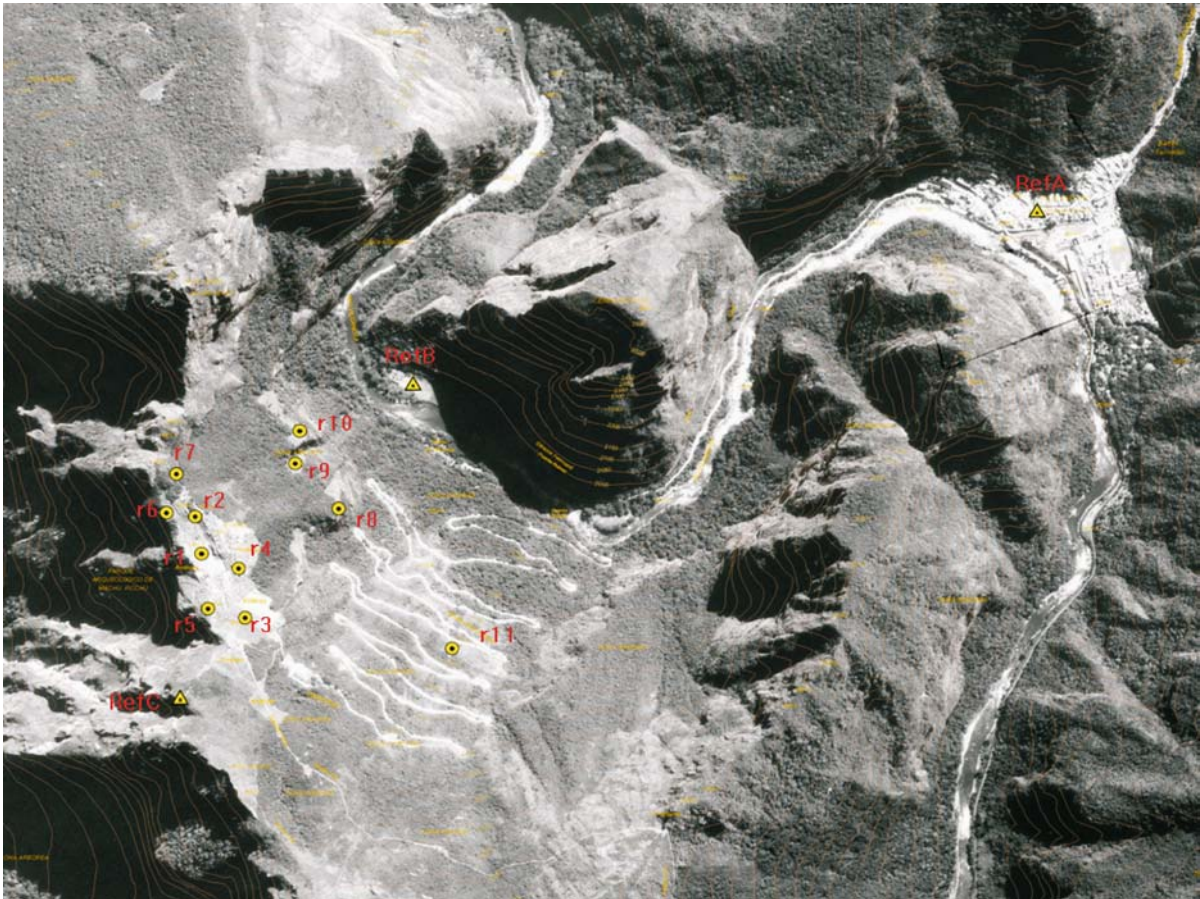
Fig. 3.5. The GPS network of Machu Picchu area

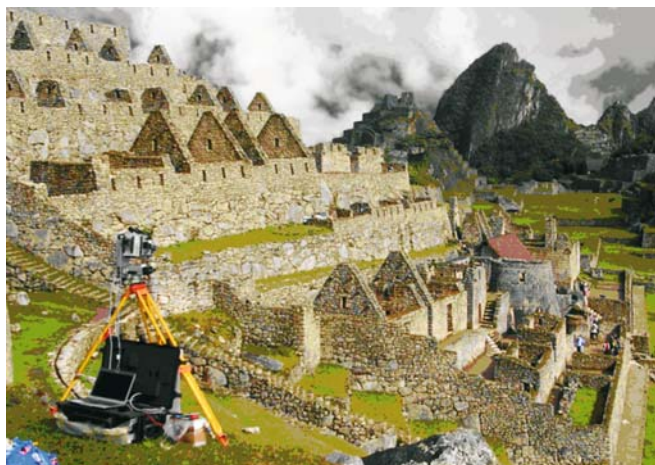
Fig. 3.6. Laser scanner acquisition in the andenes

These dataset constitute a numerical base to generate detailed and dedicated cartography and to realize numerical modeling (Figs. 3.6 and 3.7).

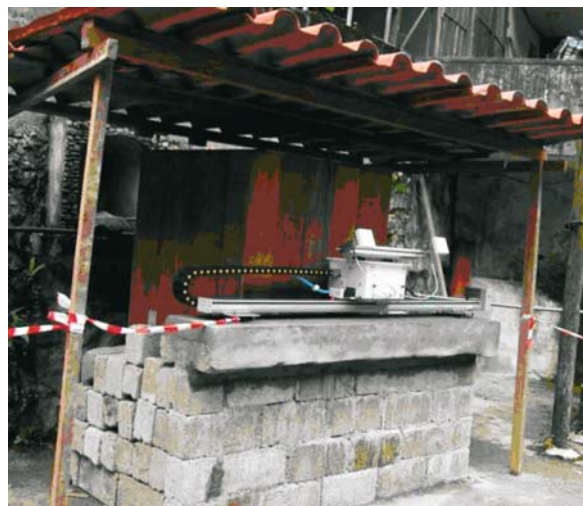
Fig. 3.8. The LISA system

On the 3 October 2004 the LISA Radar system was installed in a small open area which is part of the old train station in Puente Ruinas, at the beginning of the road going up to the archaeological village (Fig. 3.8). From this site (Fig. 3.9) it is possible to see some buildings of the lower part of the “Ciudadela” entrance

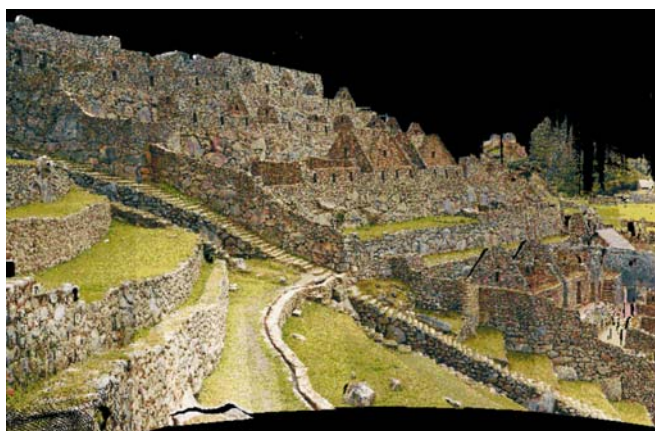
Fig. 3.7. Numerical model corresponding on the acquiring phase of the Fig. 3.6

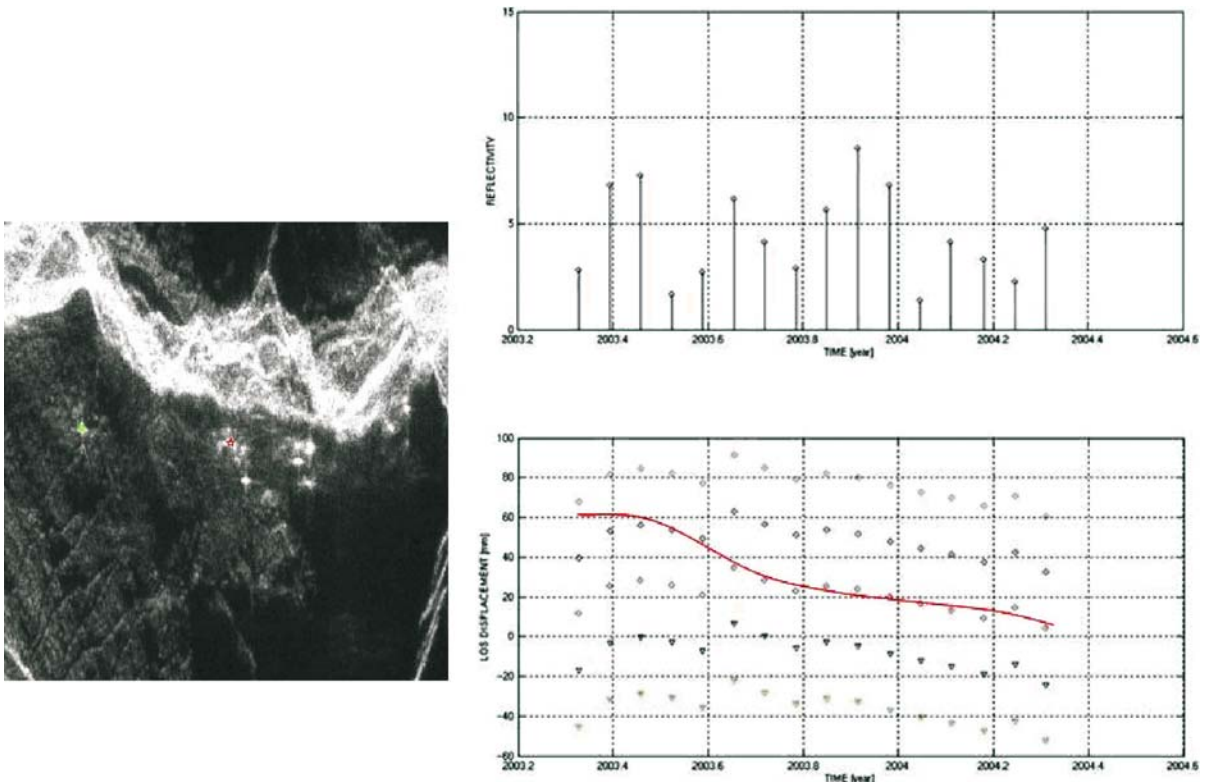
Fig. 3.10. Preliminary results recently obtained by estimating the differential motion between two PS identified in the AOI. Multiple time series show phase ambiguities. Amplitude values of the PS were found to be characterized by high dispersion values

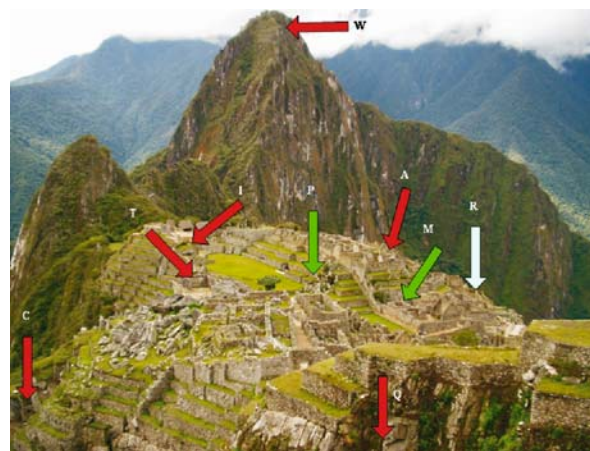
Fig. 4.1. Photo of Machu Picchu archaeological site with localization of dilatometric measurements. C: Cave (measuring site C1); T: Principal Temple (T1, T2, T3); I: Intiwatana (I1, I2, I3); P: Plaza (P1); W: Huayna Picchu (W1, W2, W3); A: Acllawasi (A1); M: Wairana o Mirador (M1, M2, M3, M4); R: Rodadero (R1, R2, R3); Q: Qhata (Q1). Qualitative evaluation of trends of movements. Red color: irreversible movements; green color: without any irreversible movements; light blue: cannot be still interpreted

for measurements by a portable dilatometer was set up on its results. Due to its site-friendly nature, this type of instrumentation was authorized to be introduced under supervision of Peruvian authorities already in 2001 (Fig. 4.1). In 2002, two extensometric profiles have been added to the network. The reason was to test the hypothesis of ongoing large deep-seated slope movements producing mountain ridge spreading, which should take part just across the Main Square site (Fig. 4.2).

Due to the fact that three year time series of measurements will be completed in November 2005, the monitoring results are presented only qualitatively in three categories (sites with non-reversible movements, without any movements, cannot be still interpreted, see Fig. 4.1). Only as a preliminary result, it can be stated that the movements registered on the dilatometric sites have magnitudes up to a millimeter per year. An example of non-

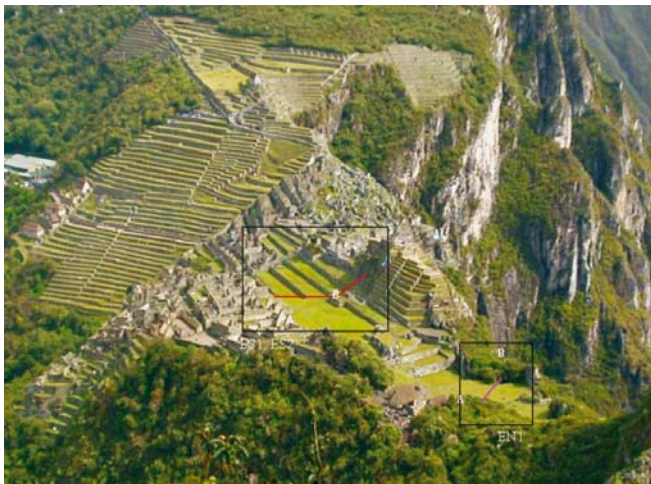
Fig. 4.2. Photo of the archaeological site taken from the top of Mt. Huaynapicchu with localization of two extensometric profiles. Red color: opening; magenta: closing

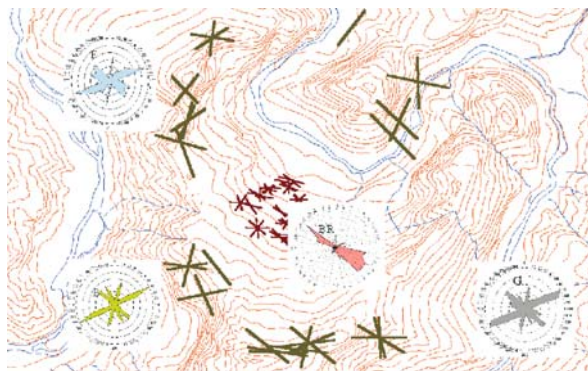
Fig. 4.4. Structural measurements in different areas of Machu Picchu. Ridge: *F*: NE slope outside the Bingham Road (front slope); *BR*: slope of the Bingham Road; *B*: SW slope (back slope); *G*: general summarizing tectonogram

On the east slope of Machu Picchu ridge, these forms seem to be produced by a sequence of several huge slides. Their slide origin is strongly supported by a structural discrepancy between the areas along the Bingham road and side slopes of Machu Picchu and Huayna Picchu Mts. (see Fig. 4.4). On the western slope, they have the form of large rock falls.

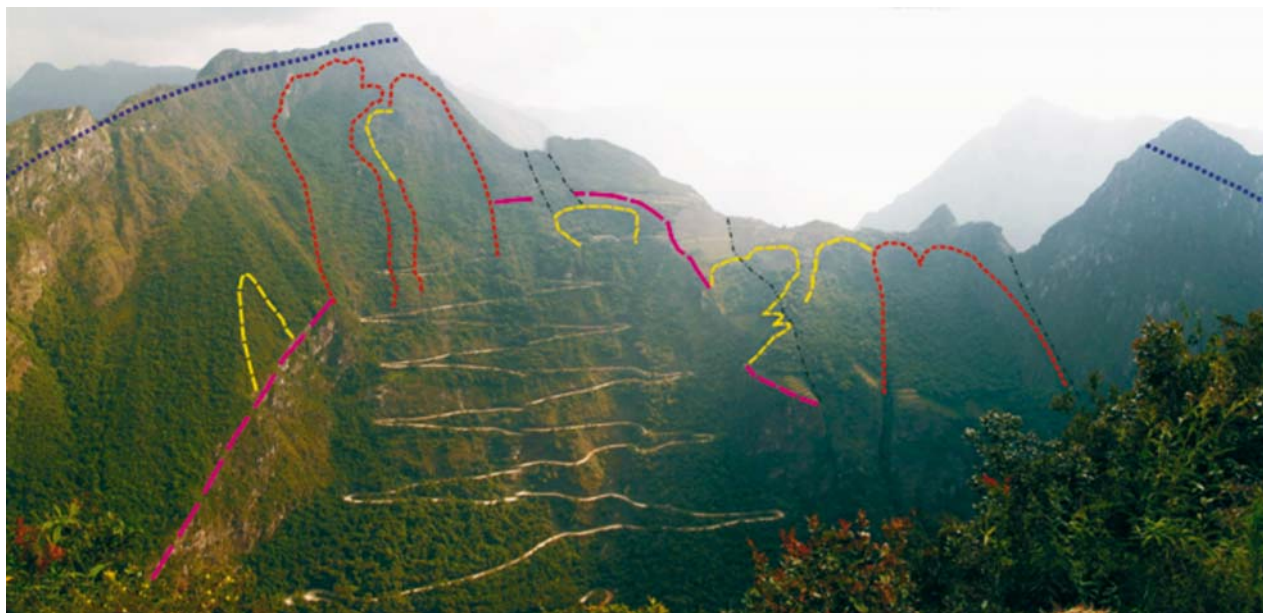
Fig. 4.5. Morphologically apparent boundaries of individual slope deformation bodies depicted in the photo of Machu Picchu archaeological site taken from Mt. Putucusi. *Blue color*: largest deformation of the first hierarchical order (pre-Inca age); *magenta*: large deformation bodies of the second hierarchical order (highly probably of pre-Inca age); *red and yellow*: bodies of the third and fourth hierarchical orders (only according their spatial scales); *black*: morphologically well pronounced structural lines

Lateral slopes in local watersheds are very steep (60–70°) and still in disequilibrium stage which can be documented by various forms of recent slope failures by landsliding (in a very broad sense which includes sliding and flows in soils, various types of rock falls and rock slides). Beside the recent predominantly small-scale landslide forms, also forms reflecting a possible activity of large-scale slope movements have been mapped (Fig. 4.5).

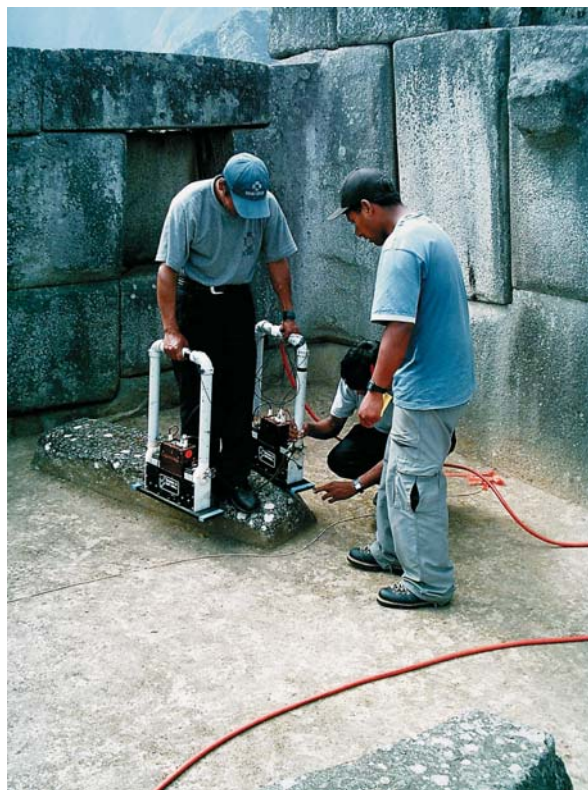
Fig. 5.2. This figure shows the sensors and software 200 MHz transmitter and receiver antenna assemblies. Not shown is the Pulse-EKKO 100 console and the recording laptop computer

A GPR system consists of transmitting and receiving antennas and associated electronics (Fig. 5.2). The trans-

mitting antenna emits a very high frequency (between 25 and 200 MHz for the applications being discussed in this paper) electromagnetic pulse into the ground that propagates as a wave at or near the speed of light. When this emitted wave encounters changes in electrical (dielectric constant) properties of the ground a reflected wave is generated, similar to seismic reflections. The time required for the reflected wave to reach the receiving antenna and the amplitude of this wave is recorded and used to determine the properties of the shallow subsurface.

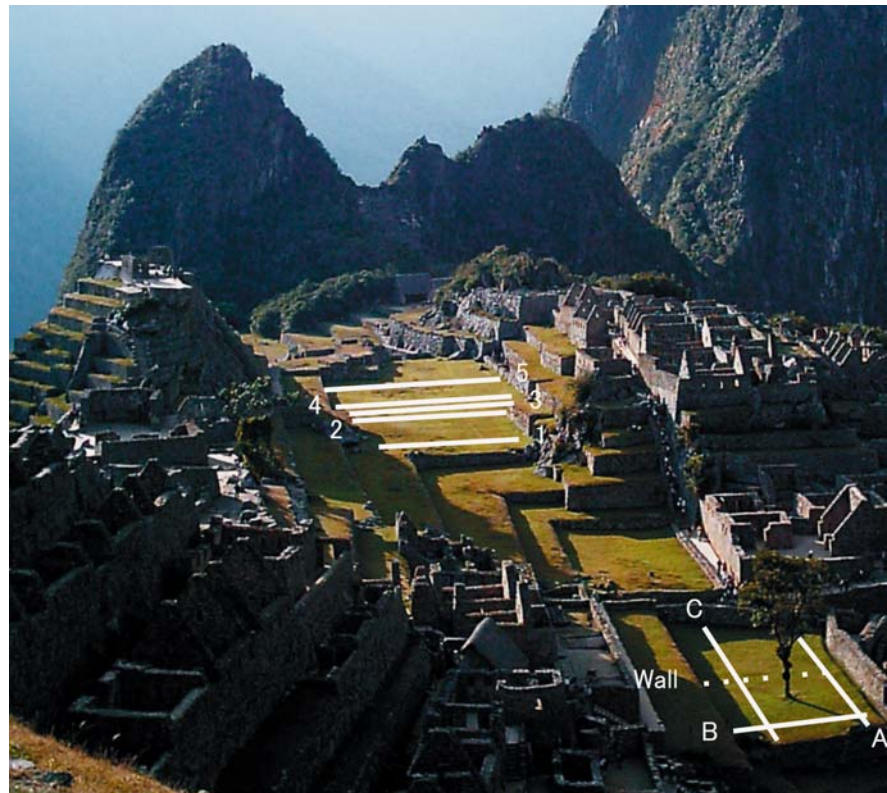
Fig. 5.4.

Location of the radar profiles on the two plazas, viewed from the south. The Intywatana is the hill-top structure on the left (west) side, whereas the Eastern Urban Sector is on the right

One of the first targets of the GPR survey was the Main Plaza area, separating the Intywatana and Western Urban Sector from the Eastern Urban Sector of the citadel (Fig. 5.4). Of primary interest was the subsurface configuration of the bedrock beneath the plaza. Outcrops of granite occur on both east and west sides of the plaza, and it is easy to visualize that the surface of the bedrock could lie at considerable depth, especially given the relief of the adjacent outcrops.

The ground penetrating radar used in the study was a PulseEkko 100, operating at 100 MHz and a pulser voltage of 400 V. Radar velocity was set at 0.1 m ns^{-1} , and the antennae were set 1 m apart, and moved in 25 cm steps. Figure 5.4 shows the location of the Principal Plaza in the background, and the orientation of the survey lines across the plaza. Survey lines were not evenly spaced, but selected, as the data were collected, to make the best use of the time available and generate sufficient coverage to visualize the subsurface configuration of the plaza.

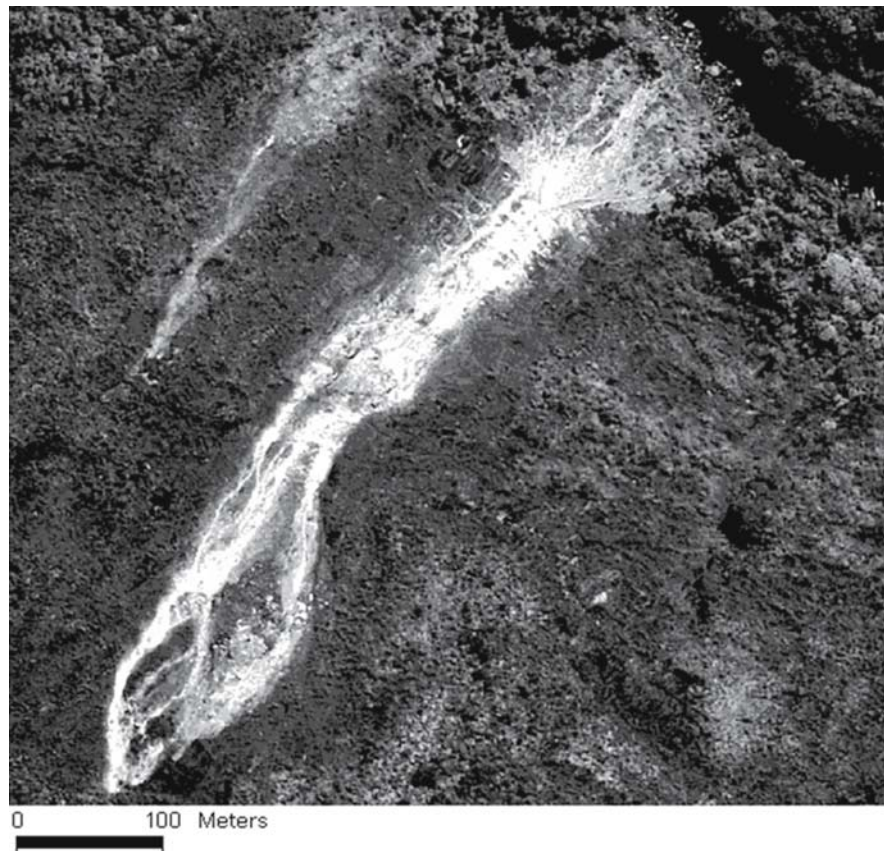
Fig. 6.8. Northern slope of Huayna Picchu: details of the debris flows on the Quickbird satellite image dated 18 May 2004, panchromatic band

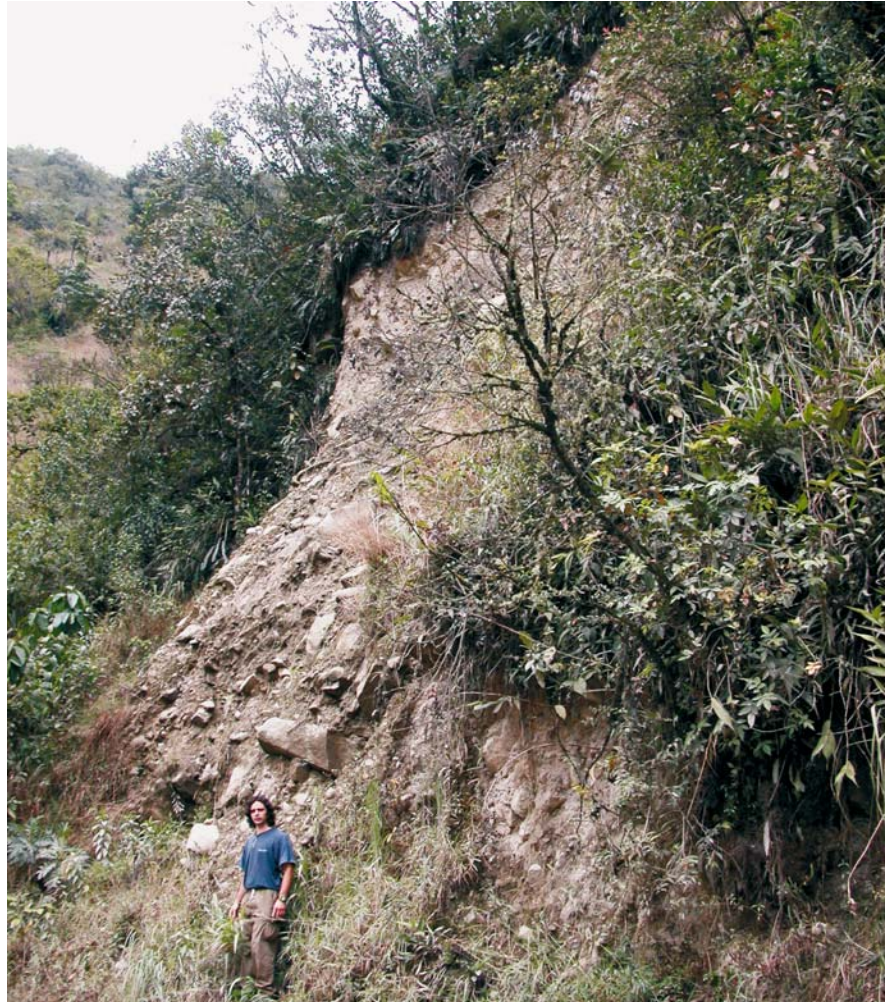
**Fig. 6.10.**

Field survey of debris along the Carretera Hiram Bingham

The main sources of debris flow hazard correspond to the sectors of the slope covered with thick debris deposits. For this reason, during the field survey in September 2004, the debris sheets were characterized with over 80 measurements (Fig. 6.10), aimed at assessing debris thickness, grain size and permeability.

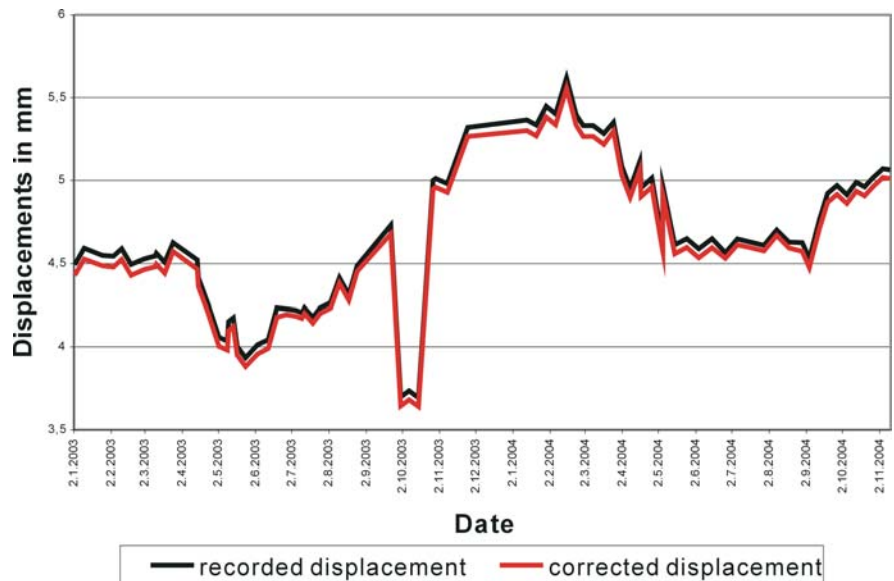
Fig. 7.6.

Typical plot of displacement records at Spiš-Castle from the crack gauge TM-71-1

According the procedure mentioned above the final plot portraying rate of displacements at TM-71-1 (Fig. 7.6) shows the constant trend of slope movement. As far as the monitoring records concerns the correction has no essential effect on the rate of displacement, particularly when long-term monitoring records exist, this only gives the user objective information about monitored phenomenon.

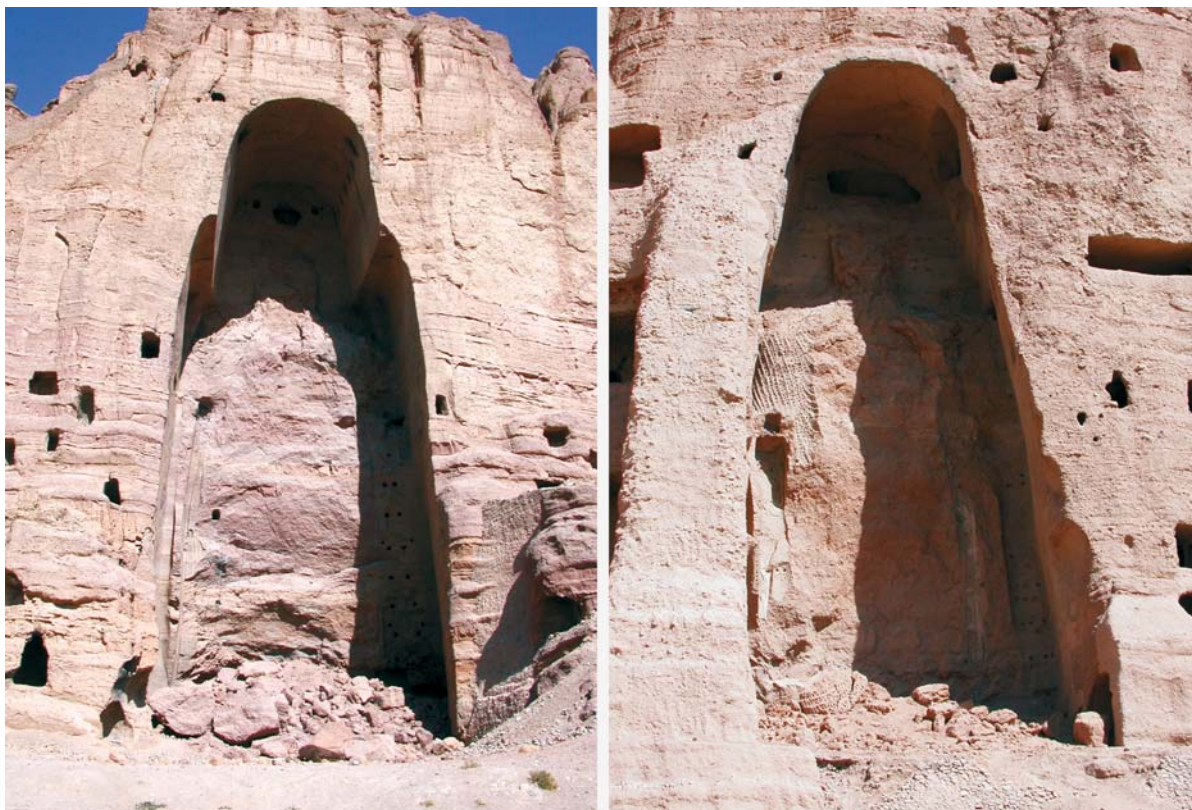
Fig. 8.1. The effect of destruction in the large (left) and small (right) Buddha niches

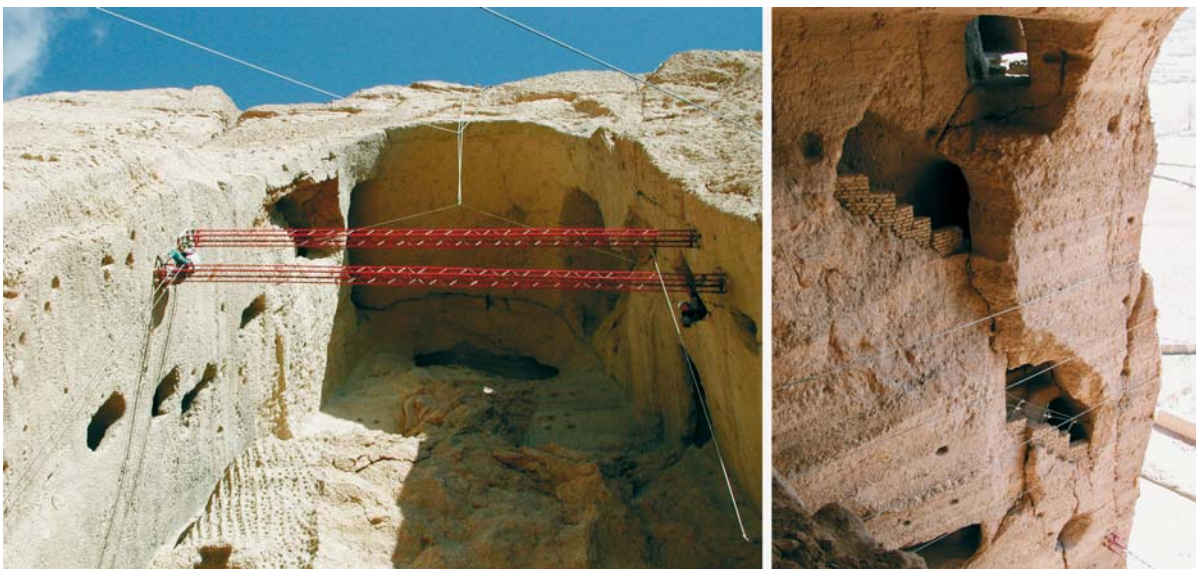
Fig. 8.4. The beam (left) and steel rope (right) for the temporary support of upper Eastern part of small Buddha

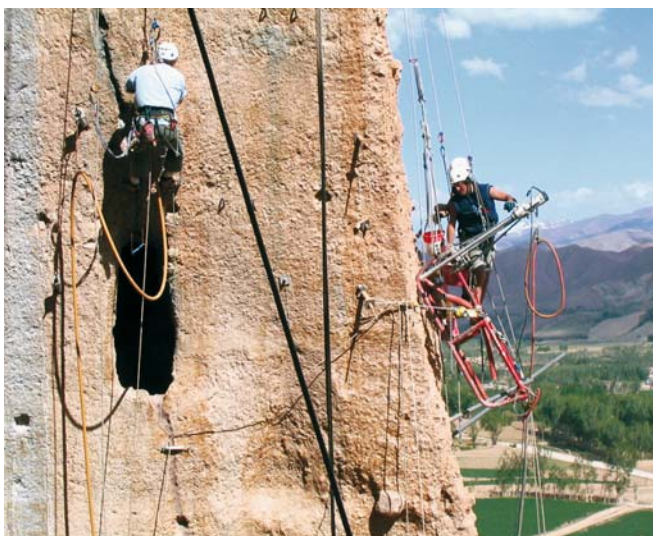
Fig. 8.5. Final consolidation with the use of professional climbers

Since the winter season was approaching soon, speediness was to be given priority and climbers had to be sent to directly operate on the cliff. They were also supported by ground staff when working at consolidating the cavities from the inside to the outside (Fig. 8.5).

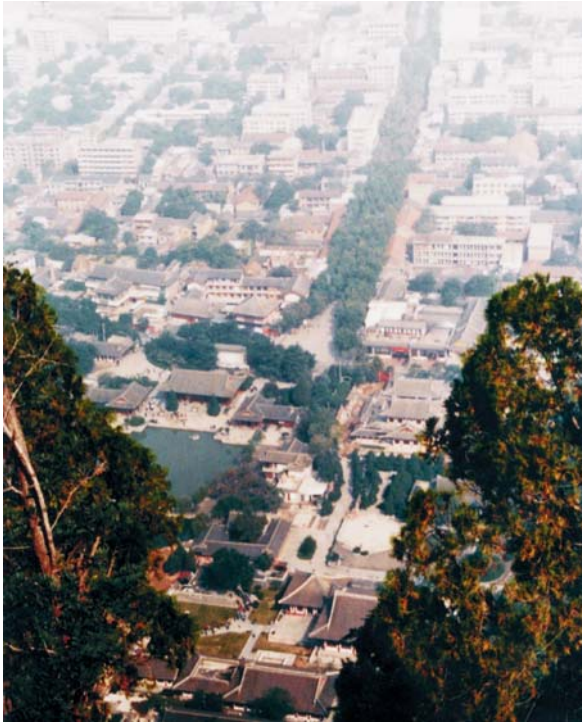
Fig. 9.2. View of Huaqing Palace and the center of Lintong Town from the Lishan slope

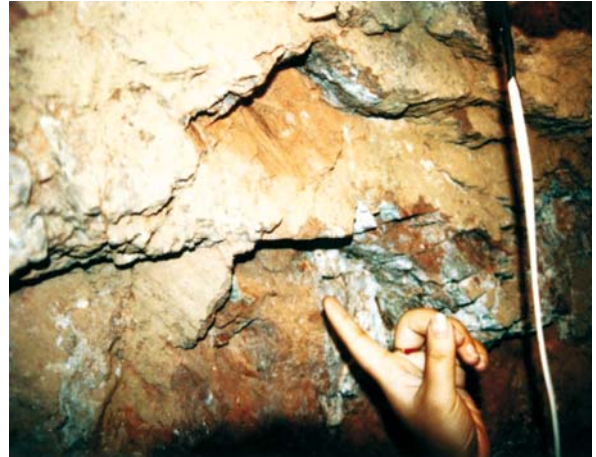
Fig. 9.6. Close-up view of the slickenside within the gently dipping fault (potential sliding surface) found in the lower tunnel

Figure 9.4 shows the central section C-C' of Fig. 9.3. It was estimated from the outcrop of gneiss rock mass, geological borings and two horizontal investigation tunnels. Figure 9.5 shows the geological section of the lower tunnel. In this tunnel, a gently dipping fault was found. At the end of the tunnel, a very hard intact gneiss rock was exposed and then excavation was stopped. The location of lower tunnel is projected to Fig. 9.4, which is situated around the toe of potential sliding surface. Hence, it is referred that the present creeping landslide may use the gently dipping fault as a part of its sliding surface. Figure 9.6 presents a close-up view of the slickenside within the gently dipping fault. Some rounded gravels are found in this shear zone, suggesting that the experienced shear displacement was not very short.

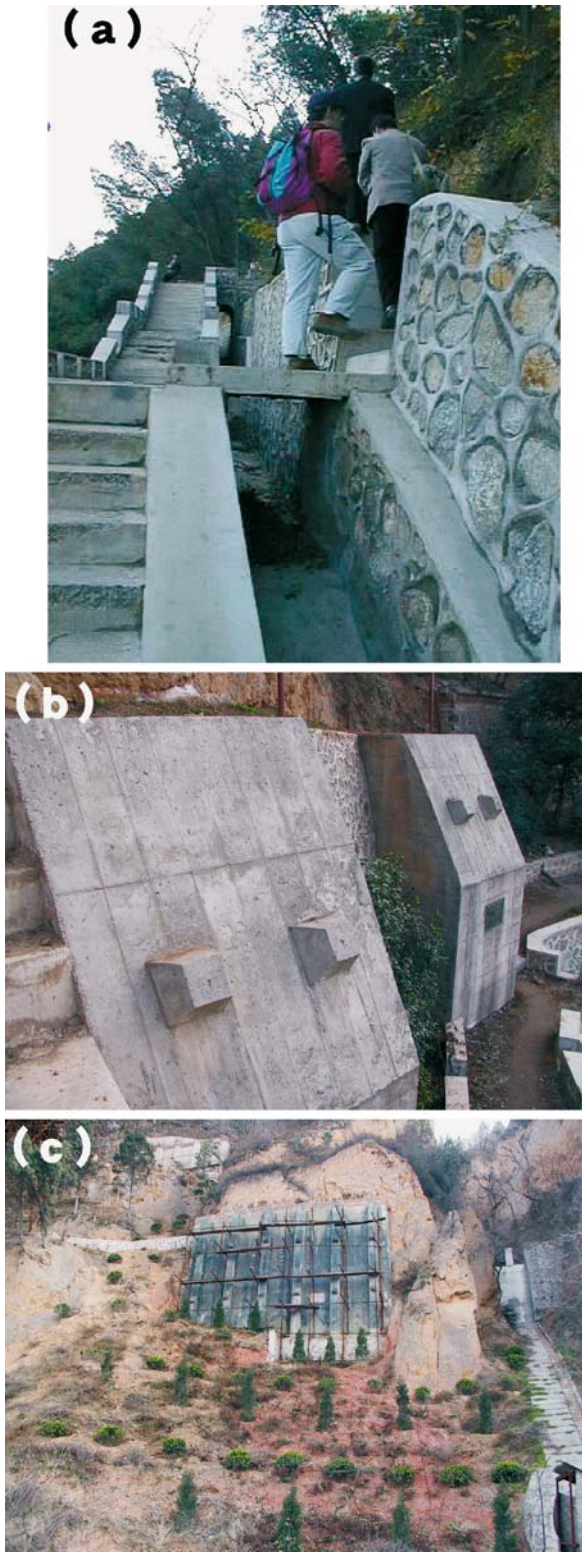
Fig. 9.11. Countermeasures constructed in block 1 of Lishan slope. **a** Surface drainage system installed on the Lishan slope to prevent rain water infiltration into the ground; **b, c** ground anchors on the lower part of the slope

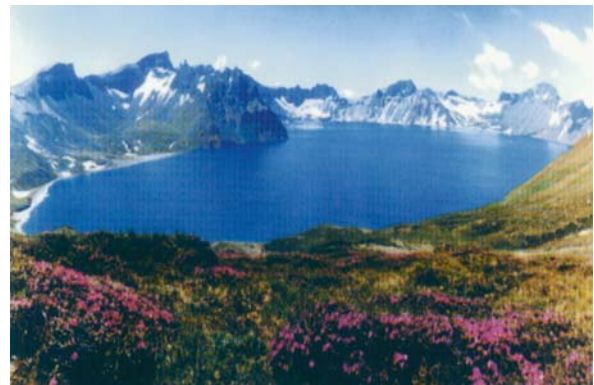
Fig. 10.1. Tianchi Lake of Changbai Mountains

ral landscape (Figs. 10.1 and 10.2). The area of Tianchi Lake is about 20 km² as the highest and the biggest lake of volcanic vent in China.

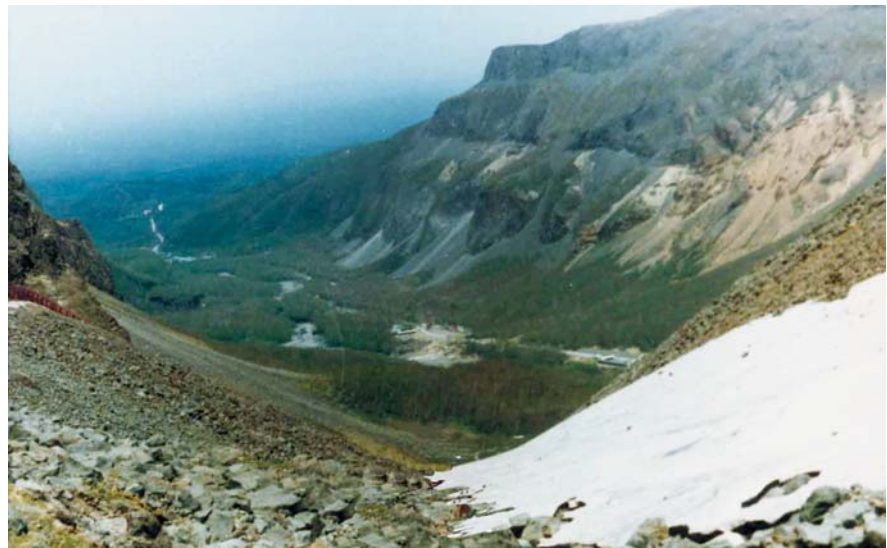
Fig. 10.3.
Distribution of debris flow
in Tianchi Lake Area, China
(modified from Cao et al. 1999)

mulation (Fig. 10.3). Among these gullies the Heifengkou gully and Tianshang Hot Spring gully of debris flow are worthy to study deeply because of their taking place both frequently and intensity.

This kind of debris flow distributes near the south of the Tianshang Hot Spring, the west bank of valley, as well as in the south of Heifengkou, the east bank of valley (Figs. 10.3, 10.7, and 10.8). In the two places the mount were constituted of alternant weak layer and hard layer so it is easy to produce avalanche and landslide and accumulation such as

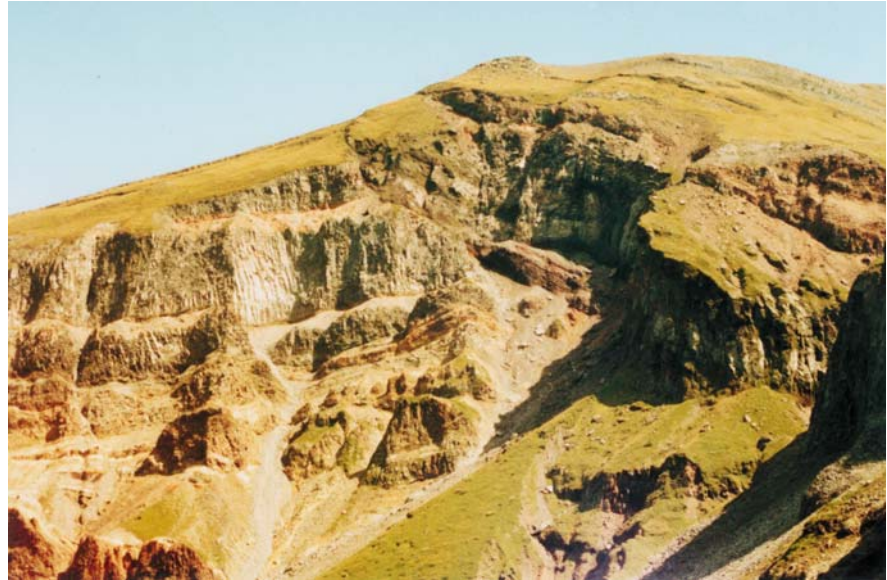
Fig. 10.4.
Alternate layer of weak and hard
rock and formation area of de-
bris flow

volcanoclastic rock as well as the weathering mantle of volcanic ash (Bureau of Geological and Mineral Resources of Jilin Province 1988). The stratum assembly of alternate weak and hard layers offers the condition to the destruction of rock body (Fig. 10.4). The weathering mantle of ash formed in the intermission of volcano has loose texture, which becomes the origin material of accumulation of falling directly, and in another way fail to support upper hard rock and driving it in the state of easy sliding. The developed original prismatic joints in the hard trachyte cut the rock body into broken dollops (rock-fall) (Fig. 10.5). Meanwhile the nearly horizontal weak plane and the gently declining joint are easy to produce landslide. The above provided a rich solid material sources for the debris flow (Cao et al. 1999, 2001).

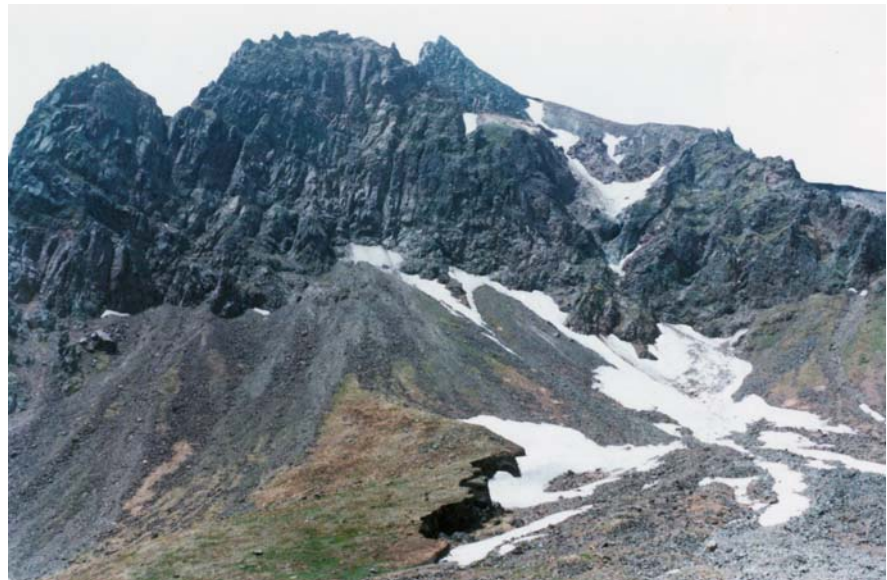
Fig. 10.5.
Rock-fall of hard rock with joints
and formation area of debris flow

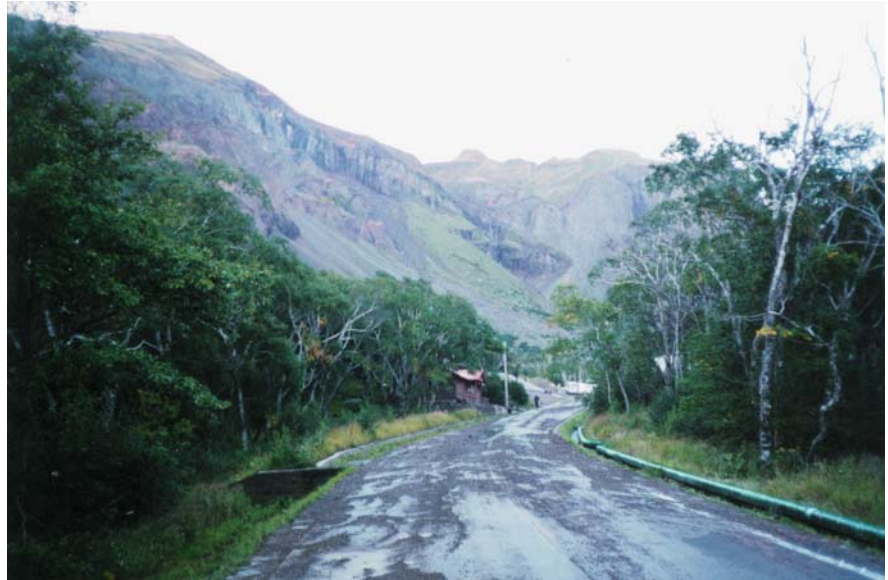
Fig. 10.6.
Heifengkou debris flow induced
by rainstorm

The special meteorological condition in the area represents as a long winter and with abundant precipitation, snow season reaches 7 months and in summer the snow melts into water. The concentration of rain occurs in July and August and achieves certain limit value rapidly to induce the debris flow. According to the survey the daily precipitation amounted to 50–80 mm. Figure 10.7 shows the situation of Heifengkou debris flow taking place in 23 August 2003, which induce a threat to the traffic and even the environment of traveling in the area (Fig. 10.6).

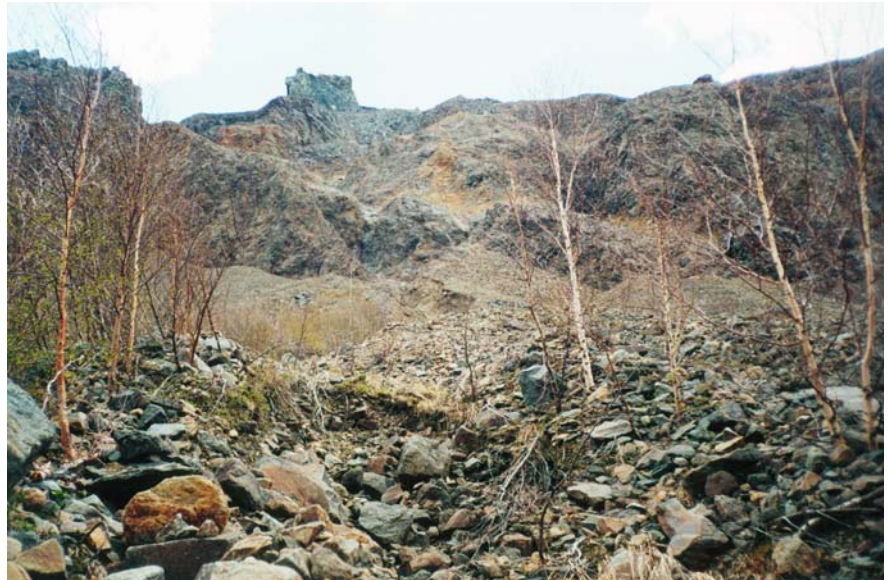
Fig. 10.7.
Accumulation of frequently ac-
tive debris flow at Heifengkou

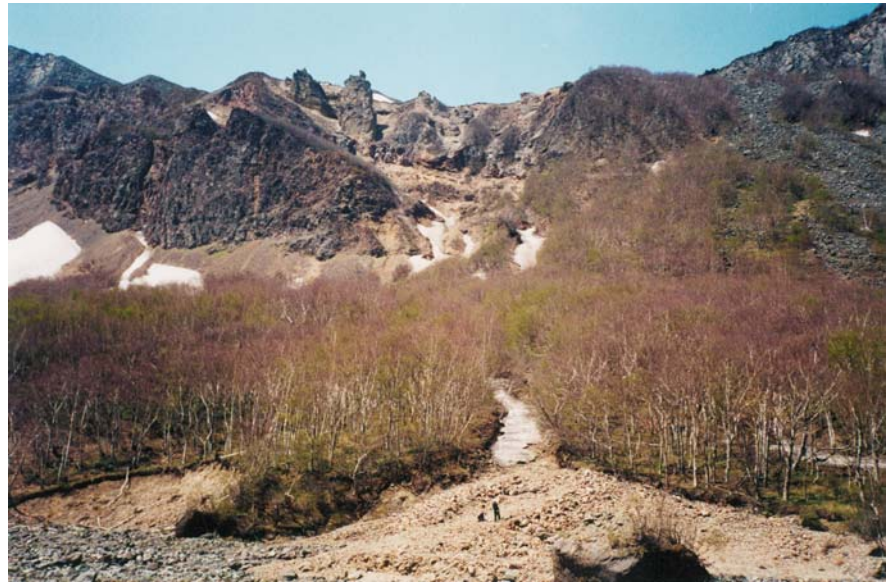
Fig. 10.8.

Full appearance of frequently active debris flow at Tianshang Hot Spring

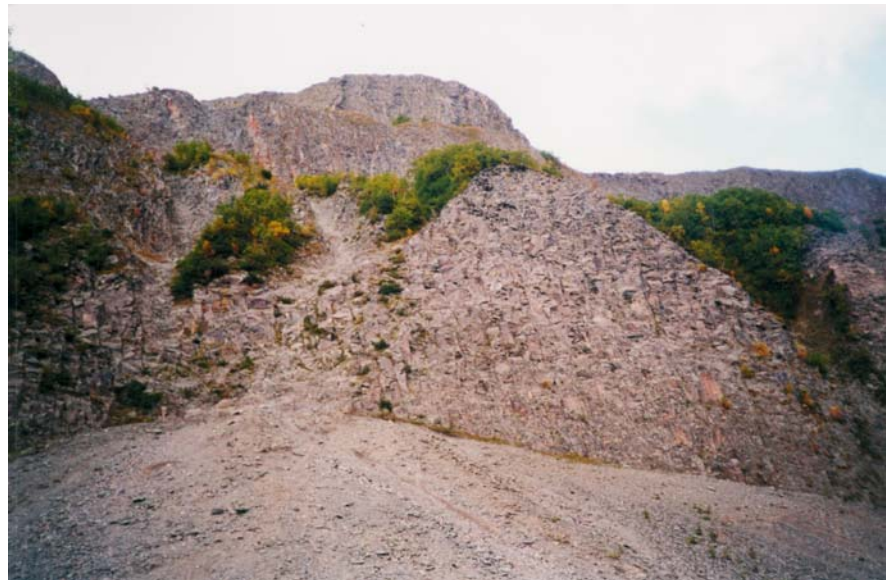
**Fig. 10.9.**

Relatively stable debris flow in high and steep slopes at Changbai Village

This kind of debris flow occurred in the north side to Tianshang Hot Spring at west bank of Erdaobai River as well as north side to Hefengkou at the east bank of Edaobai River (Fig. 10.9). The debris flows pass through the district of the steep slope with multi-steps and constituting of hard rock with joints. At the higher part of slope accumulation of falling becomes the main source of solid material. This kind of debris flow has a small area of movement. Once the fragmental material is rushed out the debris flow will end.
