LANDSLIDES

Risk Analysis
and
Sustainable
Disaster
Management

Proceedings of the First General Assembly of the International Consortium on Landslides

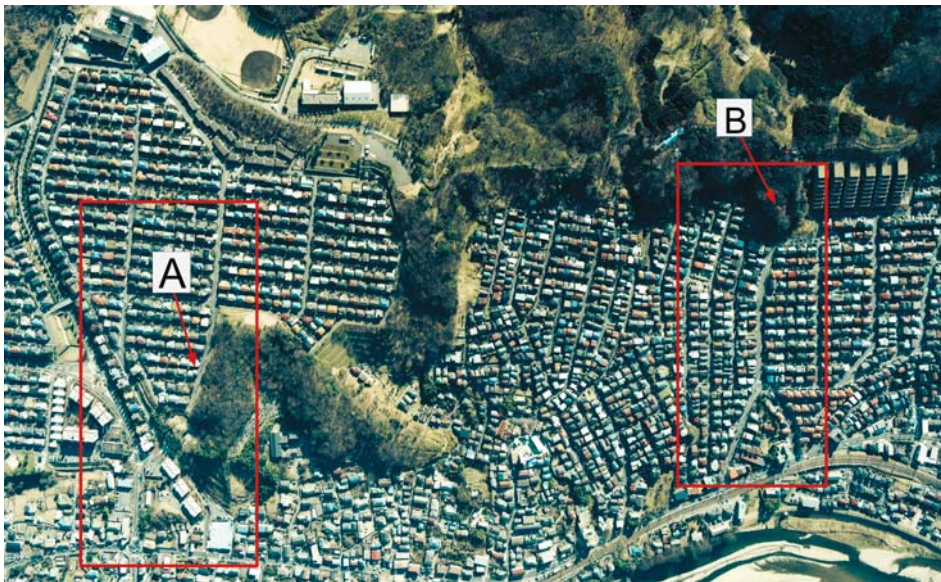
Fig. 11.10.
Air photo of the densely populated developed area near Tokyo (A: Hino site; B: Hachioji site)

Figure 11.10 shows a study area in the hilly Tama area near Tokyo. It is located at the border of Hino and Hachioji Cities. The area is covered by an almost flat sedimentary sandy layer (Kazusa Group soil), which was formed during the Pliocene and Pleistocene. Two sites, A and B, were selected in this area. Site A is a large infilled valley within the residential area. Site B is a projecting ridge toward the residential area. Those areas are shown in the rectangular boxes in Fig. 11.10.

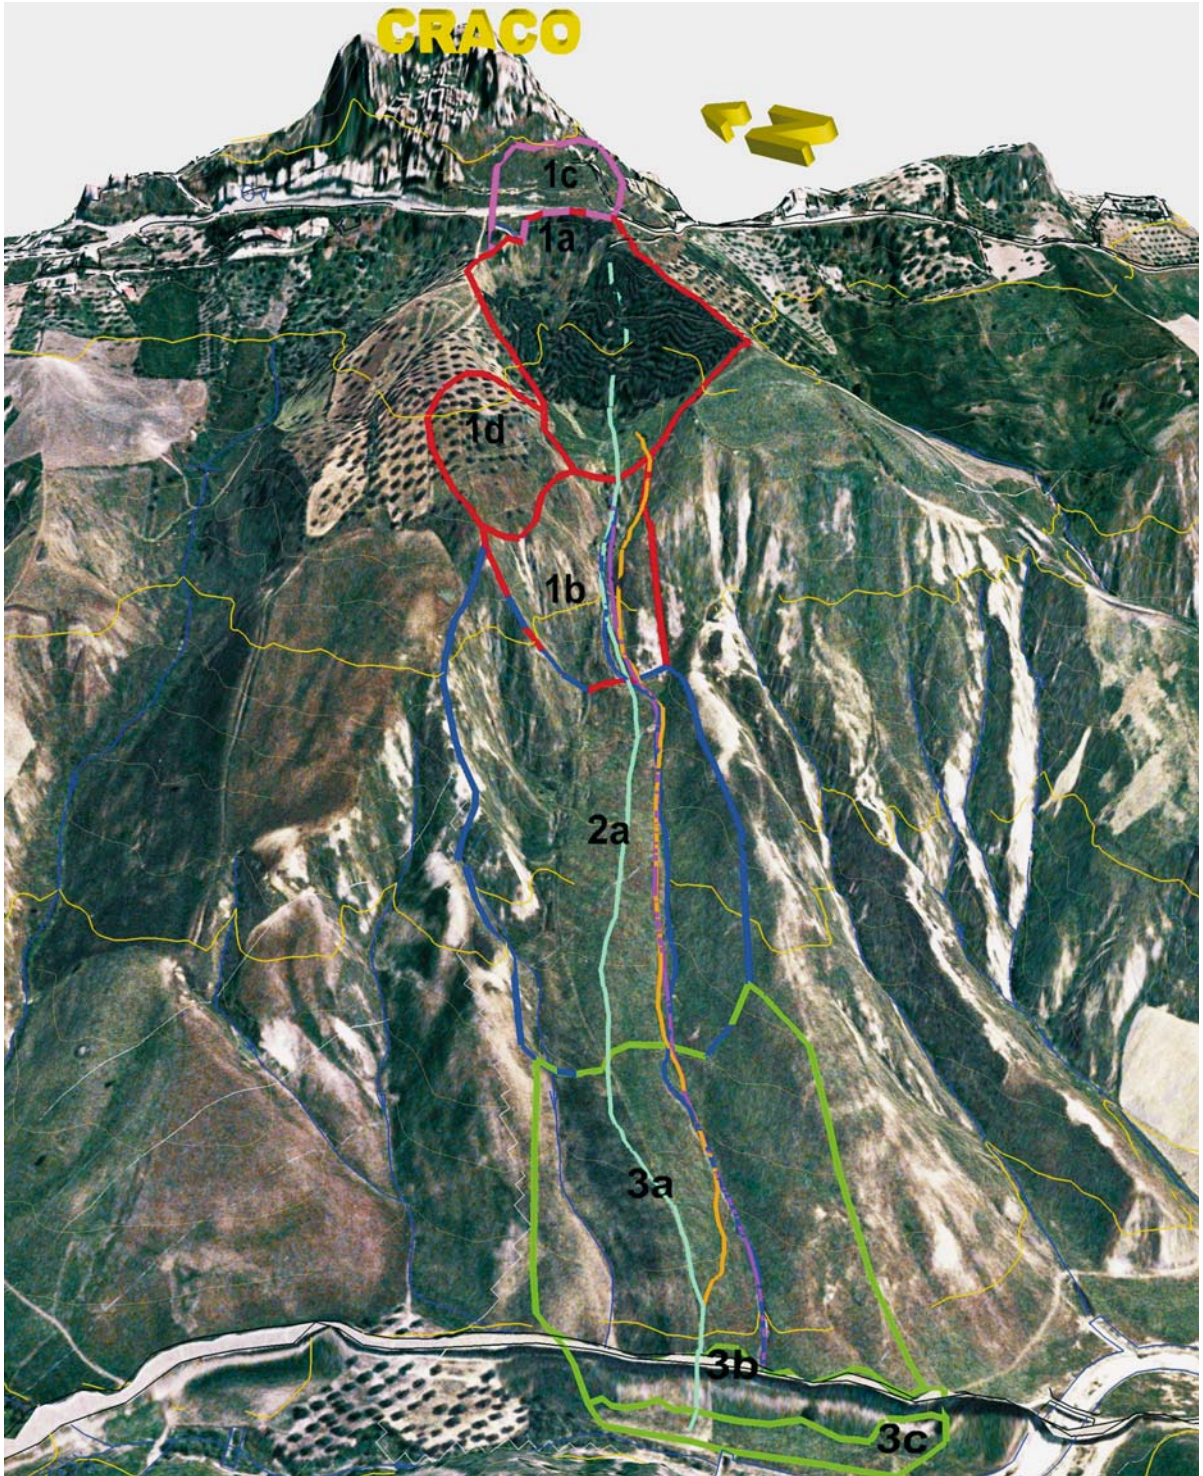
Fig. 13.1. 3D model with landslide sectors interpretation

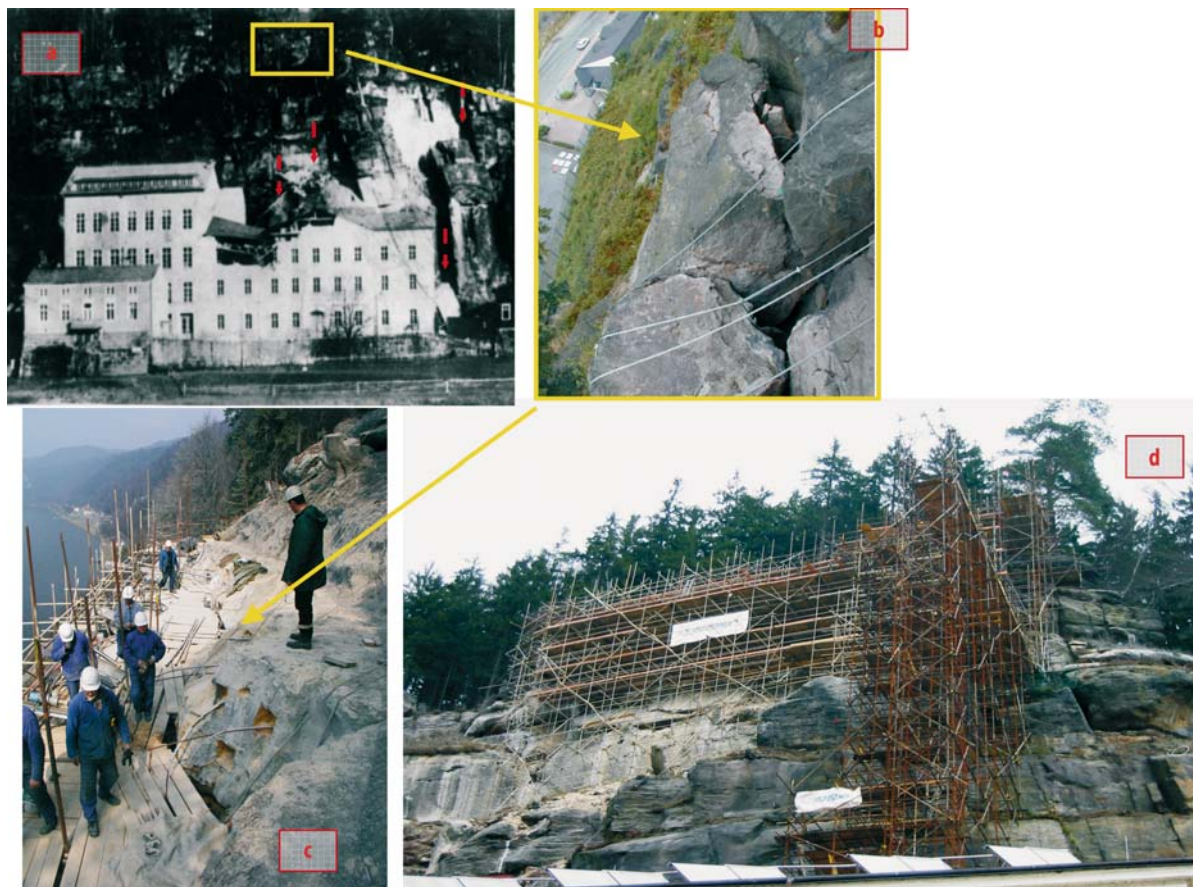
Fig. 14.4. Site of repeated rock fall danger which required technically demanding remedial measures by anchoring in Hřensko Village. **a** Damaged roof and house walls by a 400 m³ rock fall in 1936. *Yellow box* marks the site of new, detailed photo **b**. **b** Fresh opening of joints by restored preparation activity, of another rock fall in late fall 2002. **c** The same site as on photo **b** under progress of remedial measures. **d** Heavy scaffolding was needed to realize anchoring works during winter 2002/2003

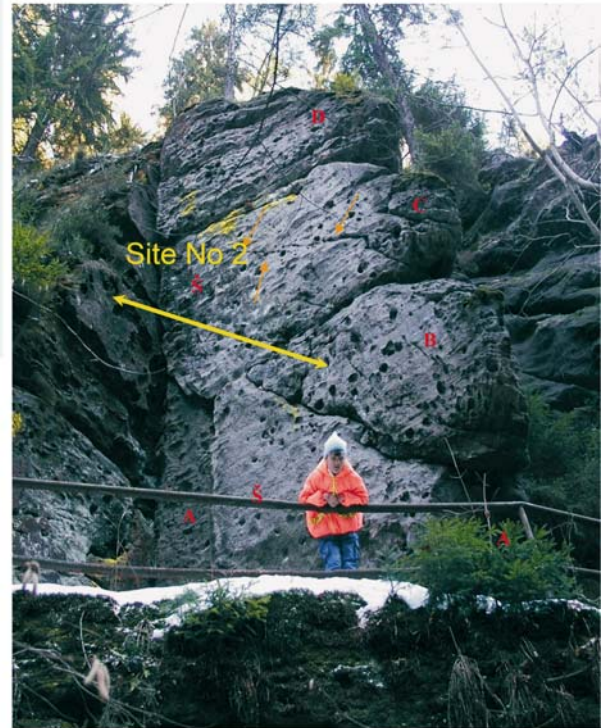
Fig. 14.5. New method of correlograms was used to decipher short, only 4.5 months lasting time series and to launch a rock fall early warning for a rock pillar just above a tourist trail at the bottom of the Wild Gorge of Kamenice River. **a** Current time/displacement plot from the monitoring key site (for its position see photo) is showing only one irreversible jump shortly after the beginning of measurement. **b** Temperature/displacement correlogram: ordered patterns of diagonal, from left to right elongated dot clouds represent well correlated responses of rocks to temperature changes. In contrary to the current plot, many temperature independent micro slip events are clearly visible as dot groups violating the left-right diagonal patterns. The high density area of the slip events is marked by a red curve

tivity of irreversible deformations shown (Fig. 14.5). Conclusion driven from the latter about the high instability of that pillar was then supplemented by a time forecast of rock fall occurrence, which had been given in December 2004, 3 months before the expected collapse event (Zvelebil 2004). The pillar collapsed on 12 March – just in the predicted, to March 2005 restricted time window, providing an evidence for correctness of our interpretations. Falling rocks hit badly the tourist path below, but that path had been closed – in accordance with this stability evaluation, since January (Vařilová and Zvelebil 2005b).

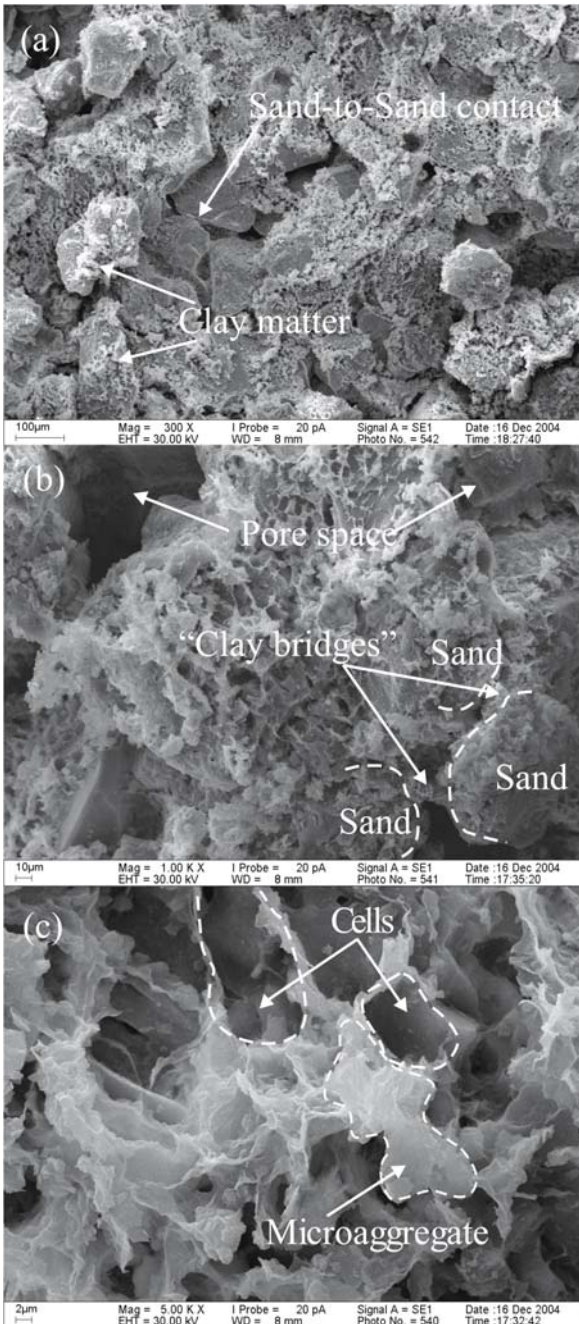
Fig. 15.2. Microstructure of the mixture of sand with 7% bentonite: **a** magnification $\times 300$; **b** magnification $\times 1000$; and **c** magnification $\times 5000$

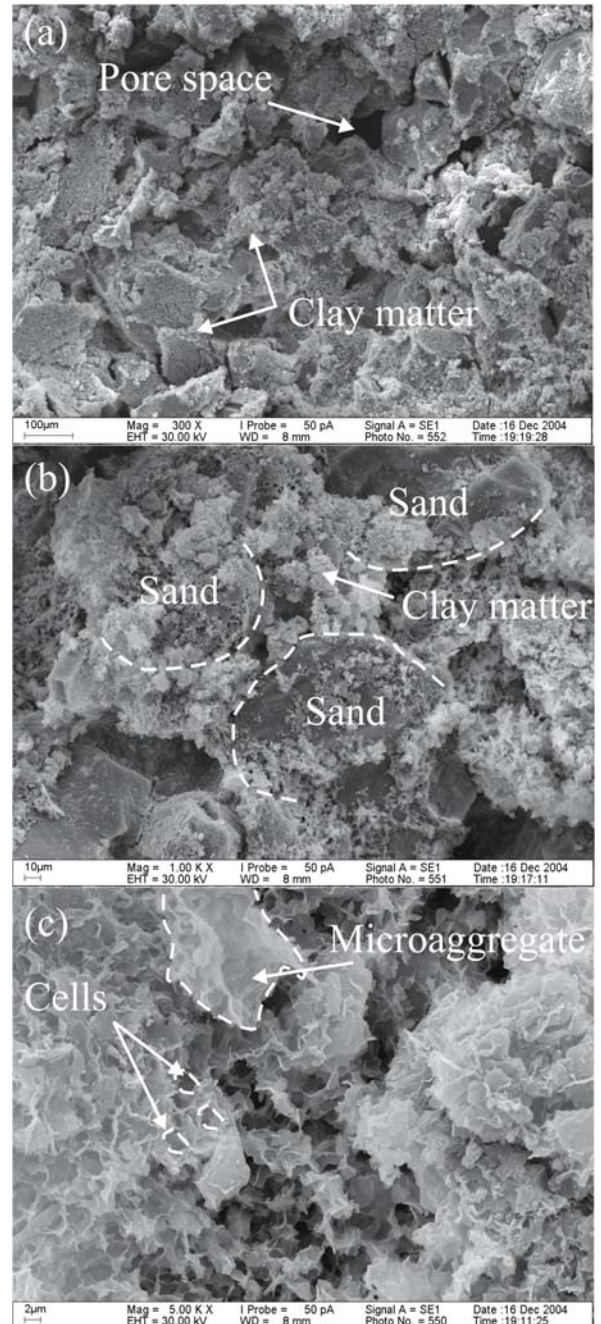
Fig. 15.3. Microstructure of the mixture of sand with 15% bentonite: **a** magnification $\times 300$; **b** magnification $\times 1000$; and **c** magnification $\times 5000$

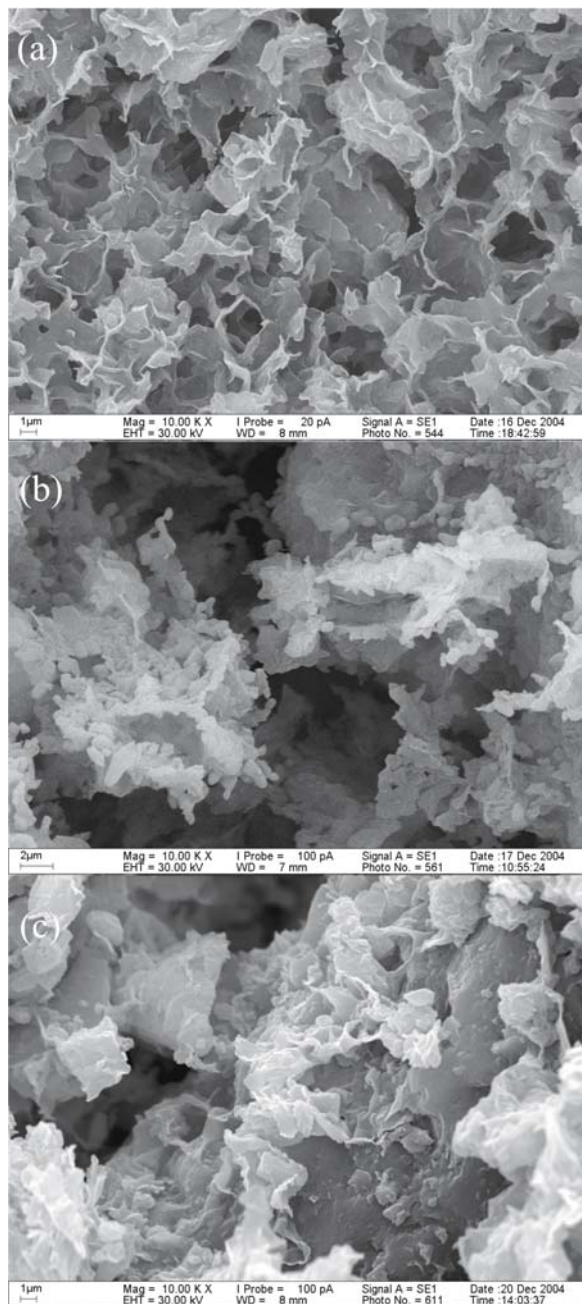
Fig. 15.5. Microstructure of the mixture of sand with 11% bentonite saturated with water (a), and treated with solutions of NaCl (b), and CaCO₃ (c) (magnification $\times 10\,000$)

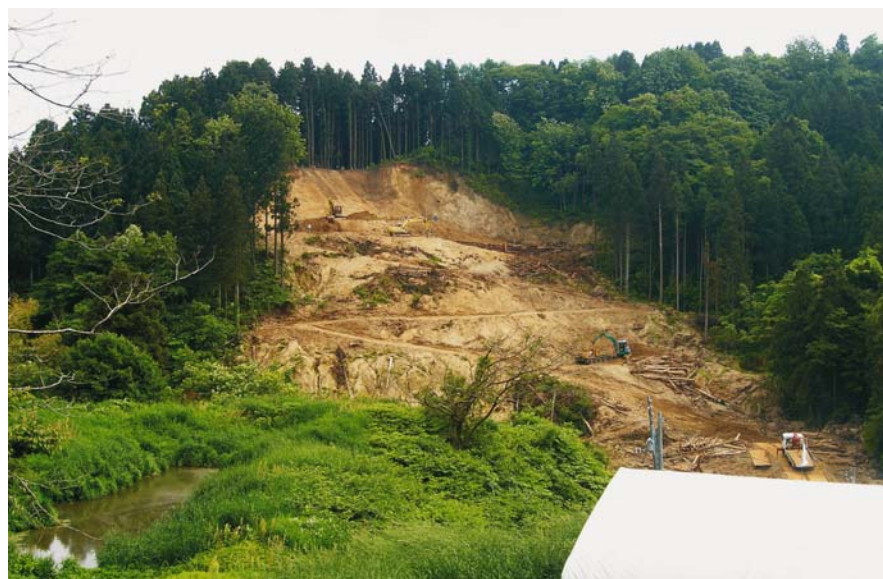
Fig. 16.1. Site of rainfall-induced landslide at Sakashi-dani in Niigata, Japan, in 2004

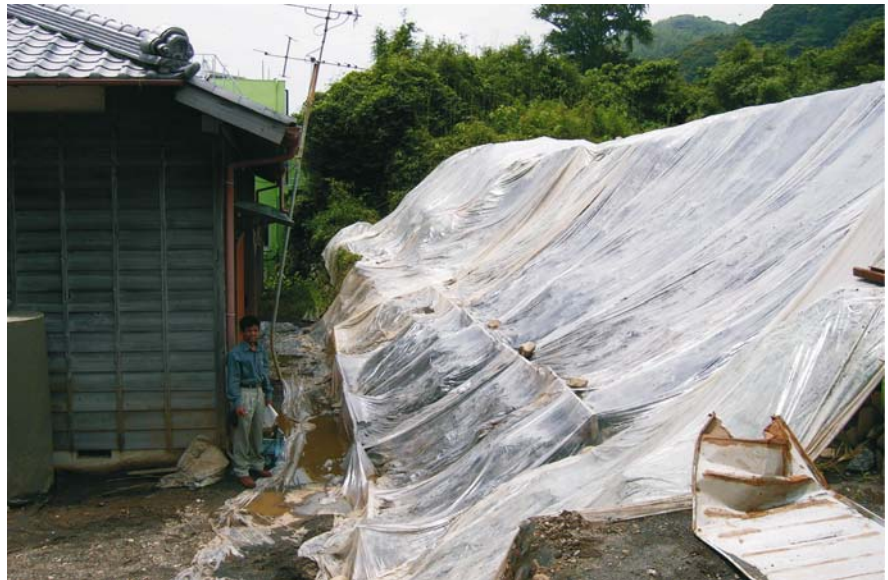
Fig. 16.2.
Small slope instability in
Shizuoka, Japan, in 2004

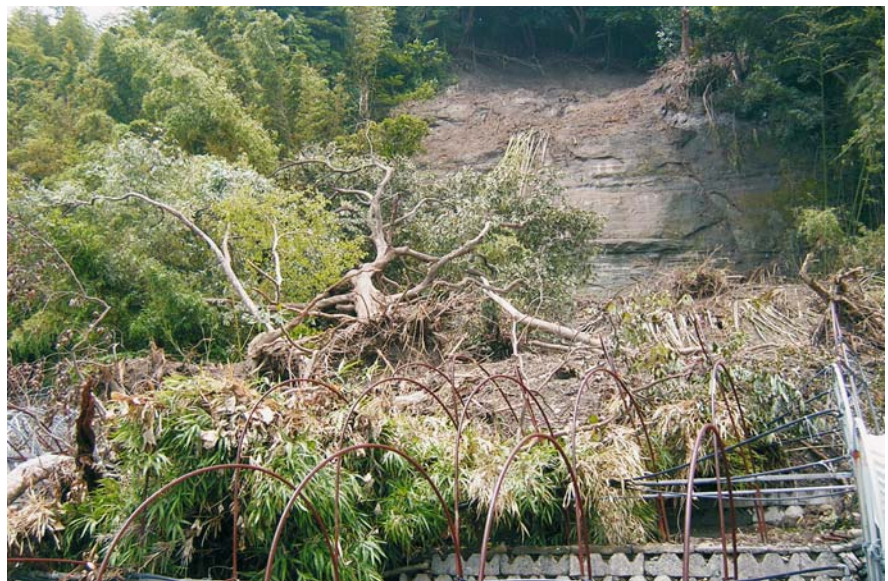
Fig. 16.3.
Small slope failure in Shizuoka,
Japan, in 2004

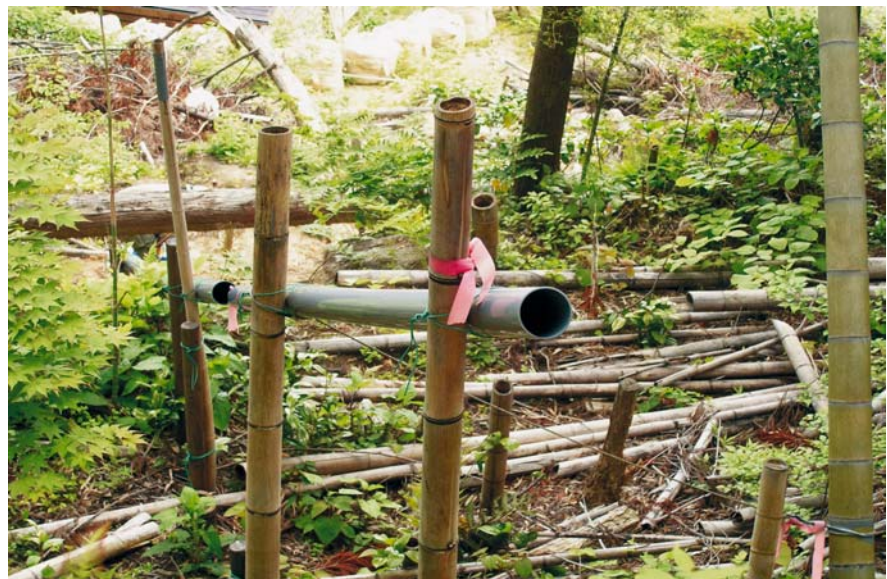
Fig. 16.4. Monitoring of slope displacement in unstable slope by extensometer (Niigata, Japan)

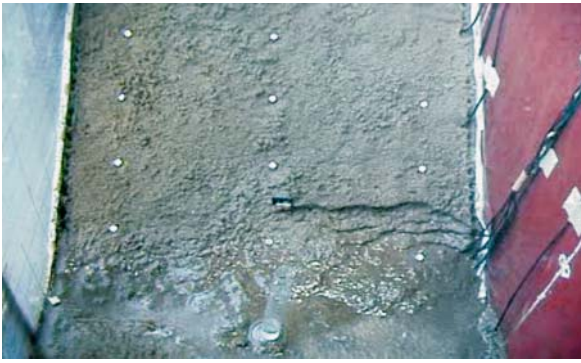
Fig. 16.6. Initiation of rainfall-induced instability from bottom of slope during model tests (case 9 by Shimoma et al. 2004)

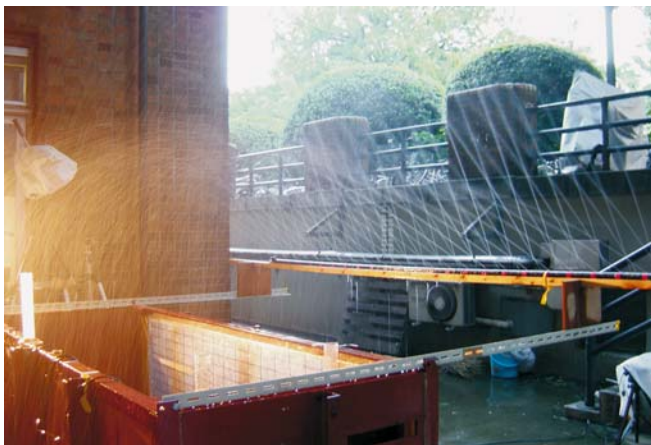
Fig. 16.8. Model test on slope failure with artificial rainfall

It was further attempted by the present authors to investigate the relationship between rainfall-induced displacement and the factor of safety (FOS) against slope failure. Figure 16.8 shows the model container with rainfall, while Fig. 16.9 shows the configuration of the model and the location of transducers.

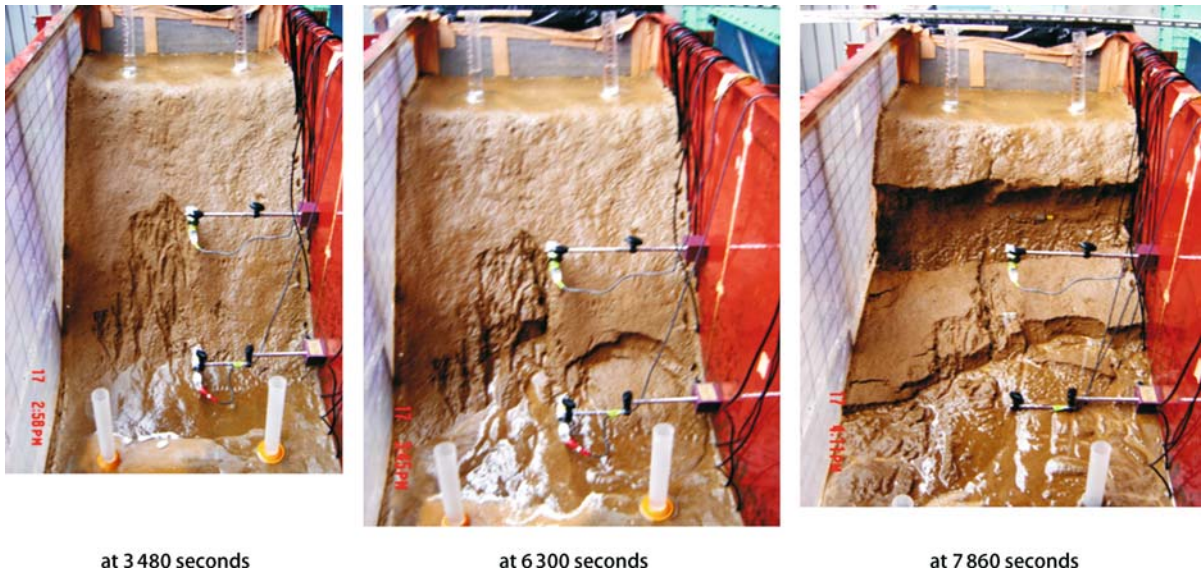
Fig. 16.11. Appearance of model slope during rainfall test

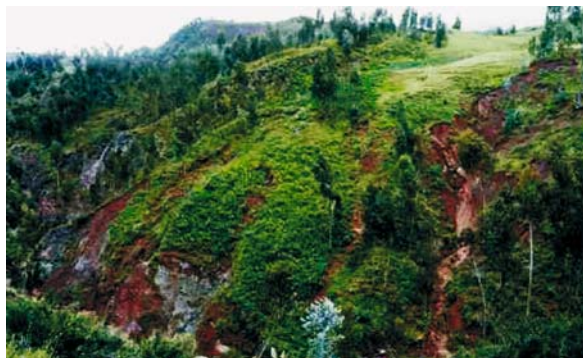
Fig. 17.1. Partial view of a typical landslide developed on Cretaceous formations under lithological influence (Saphy, NW of Cusco)

lent slide episodes. The fluvial erosion evacuates the disintegrated materials pushed easily toward the riverbeds; that is due to the nature and fragile constitution of these marine redbeds (Fig. 17.1).

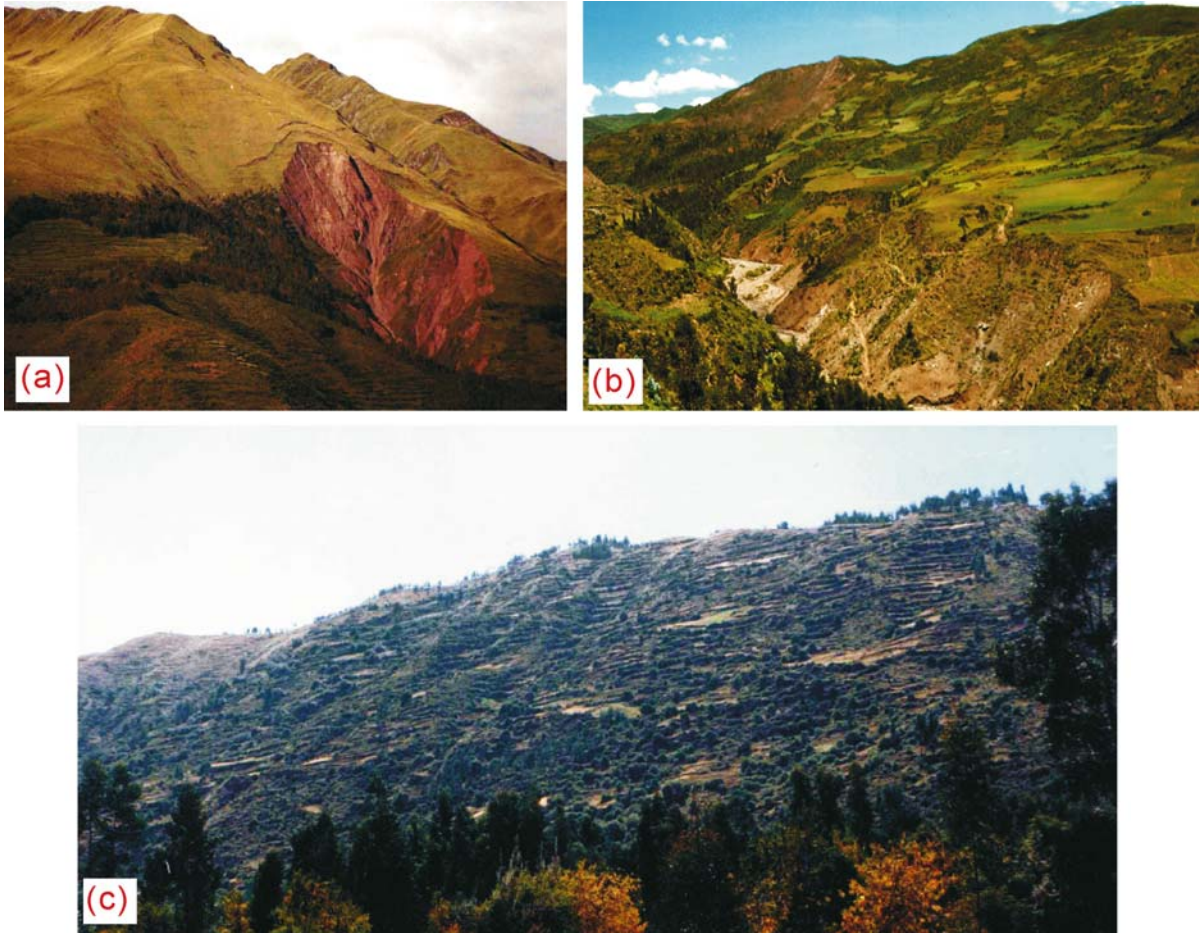
Fig. 17.2. The three types of landslides developed under influence of the structural feature (San Jerónimo Group): **a** Huaynapicol (deep Toppling); **b** Huamancharpa (dip slope); **c** Pumamarca (tabular body defined by parallel faults mirrors)

In conclusion, the genetic factor in the landslide developed in this geological unit is almost exclusively structural (Fig. 17.2): the slide planes have been developed along the hinges of complex Toppling (Huaynapicol and Ch'akiqocha), on the soft levels of lutites which strike is parallel to the slope (Huamancharpa) or in tabular masses defined by parallel faults (Pumamarca).

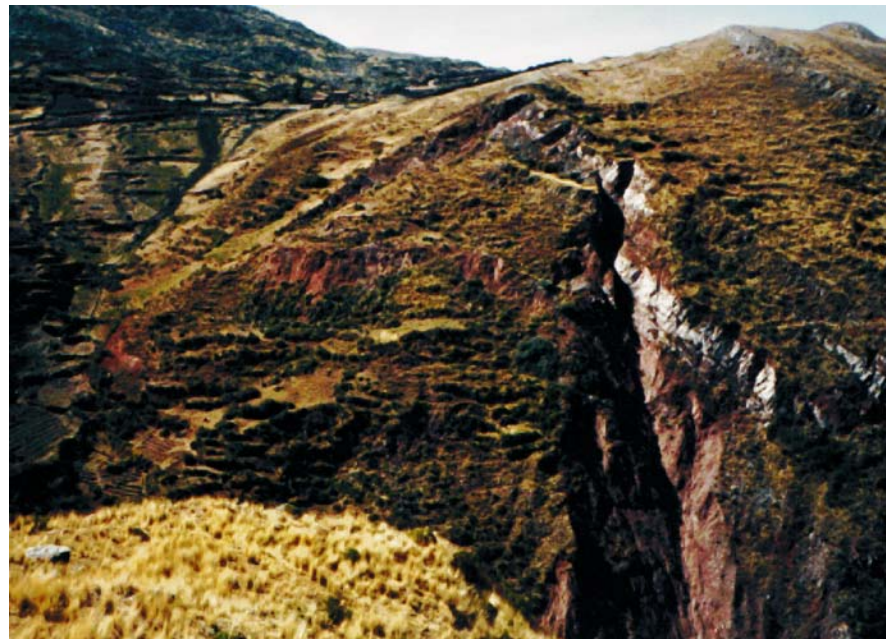
Fig. 17.3. Huacoto landslide (Pachatusan Formation)

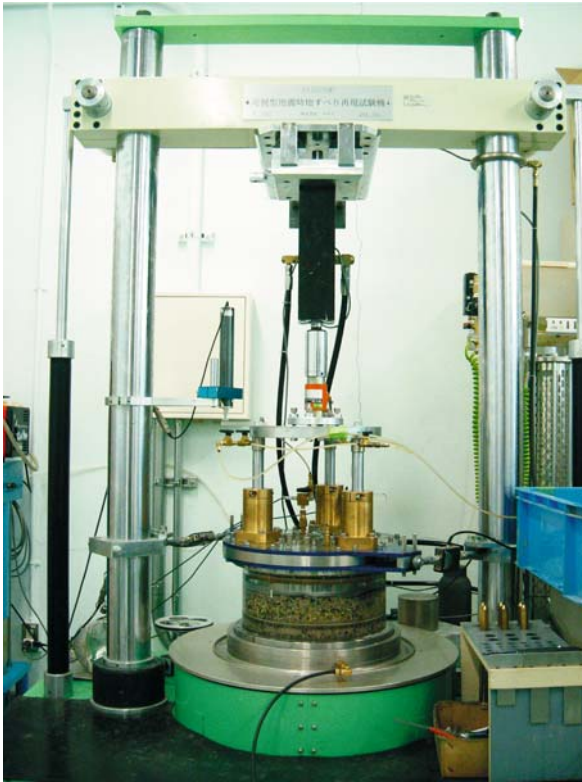
Fig. 18.2. Overview of the ring shear apparatus with a transparent shear box (DPRI Ver. 7)

Fig. 18.3. Schematic diagram of shear box of DPRI Ver. 7

The overview of the ring shear apparatus DPRI Ver. 7 is shown in Fig. 18.2. The basic structure of this apparatus is the same as DPRI-5 and DPRI-6 which are introduced by Sassa et al. (2003, 2004). The size and the capacity of the DPRI Ver. 7 apparatus are shown in Table 18.1. Both of the outer-upper-shear-box and the outer-lower-shear-box are made of transparent acrylic resin and stainless steel. Detailed section of the shear boxes is shown in Fig. 18.3. Rubber edges are fixed on the top surfaces of the lower shear boxes. Constant contact force is applied to the rubber edge and its contact pressure is always kept automatically in a value greater than expected pore pressure to prevent the leakage of water and sample. A thin stainless steel plate of 2.0 mm thickness, is attached to

the bottom of the upper half of the outer shear box contacting to the rubber edge. This plate is necessary to protect the acrylic shear box from damage due to heating during high speed shearing. This system could not observe the exact shear plane and its vicinity because the

shear zone is shaded by invisible contacting parts consisting of the rubber edges and the metal plate as shown in Fig. 18.3. Teflon and grease is coated on the rubber edge to reduce friction during shearing. In addition, the laboratory temperature of a laboratory is kept almost constant by air-conditioner because acrylic is highly inflatable against room temperature rise.

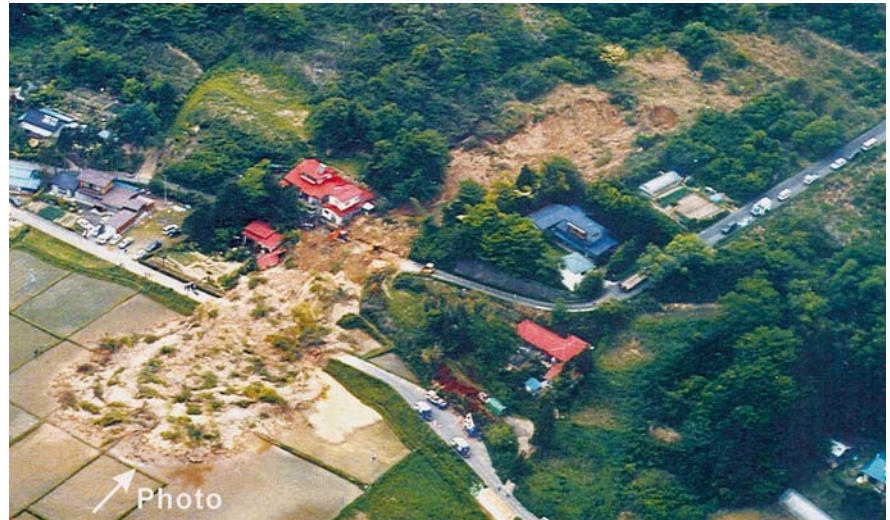
Fig. 19.3.
View from the toe of the Tsukidate landslide

Figure 19.2 presents aerial view of the Tsukidate landslide (taken by Kokusai Kogyo Co., Ltd.). It is seen from this photo that the road on the right side is almost parallel to the landslide, indicating the nature of gentle slope. Figure 19.3 is the view from the toe of the landslide, which was taken four days after the event (at our survey time).

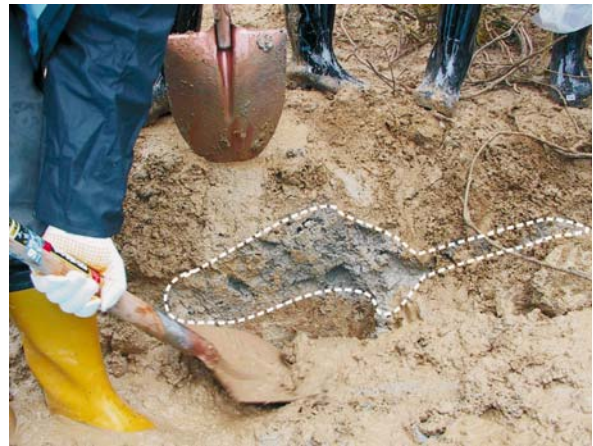
Fig. 19.6. Sampling on the source area

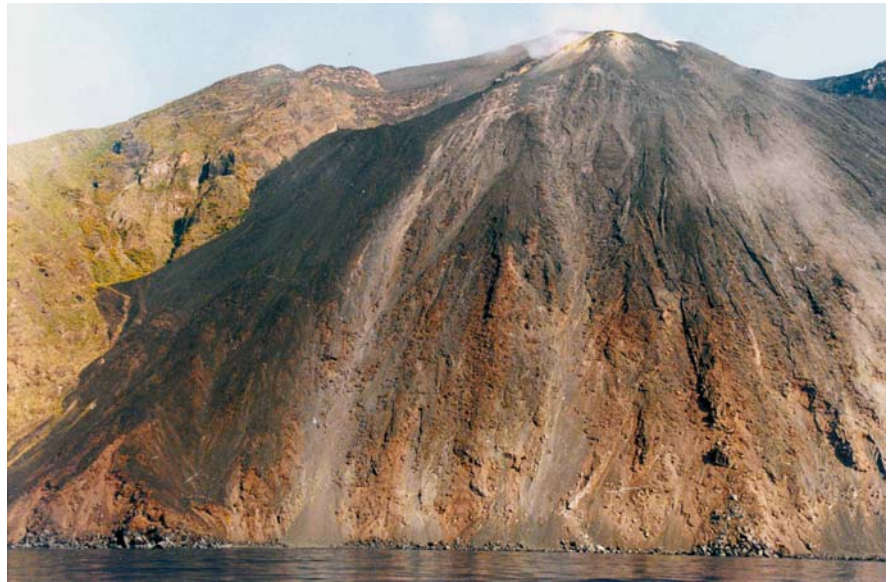
Fig. 21.2.
View of the Sciara foot after the
2002 landslides and detail of the
volcanoclastic deposit (in the
foreground the front of a major
lava flow of the 1985 eruption)

tion over the slope by sheet slides and subsequent grain flows so as to produce a series of irregular, mostly reverse-graded grain-supported layer (Fig. 21.2).

The volcanoclastic material is mainly composed by gravely and sandy layers (Fig. 21.2) that, in the sampling area, have angular to subangular clasts with high surface roughness and low sphericity. Rounding, smoothness and sphericity progressively increase proceeding downslope, due to grain sliding and rolling (Kokelaar and Romagnoli 1995).

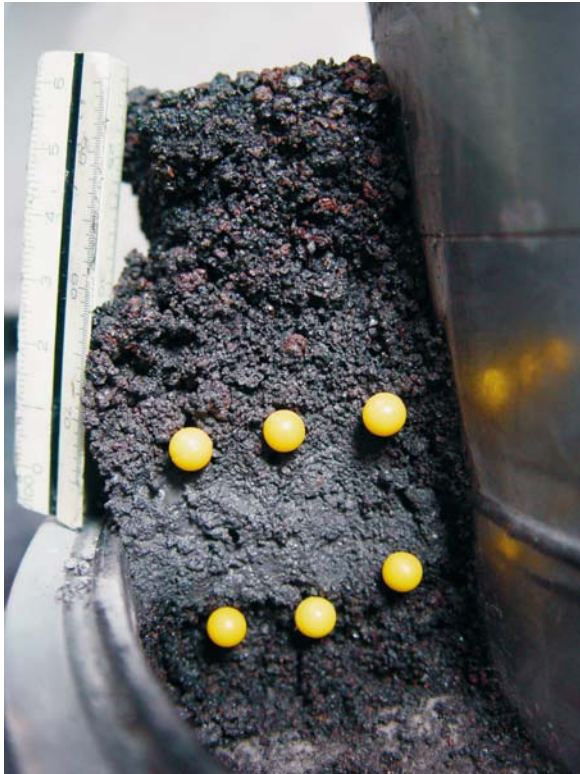
Fig. 21.8. View of the shear zone after the test

Stromboli grains demonstrated to be highly crushable under the applied testing conditions. Particle size distribution of the material taken from the shear zone after the shearing test is also shown in Fig. 21.5. A view of the shear zone after the test is given in Fig. 21.8, where grain crushing due to the shearing process is apparent.

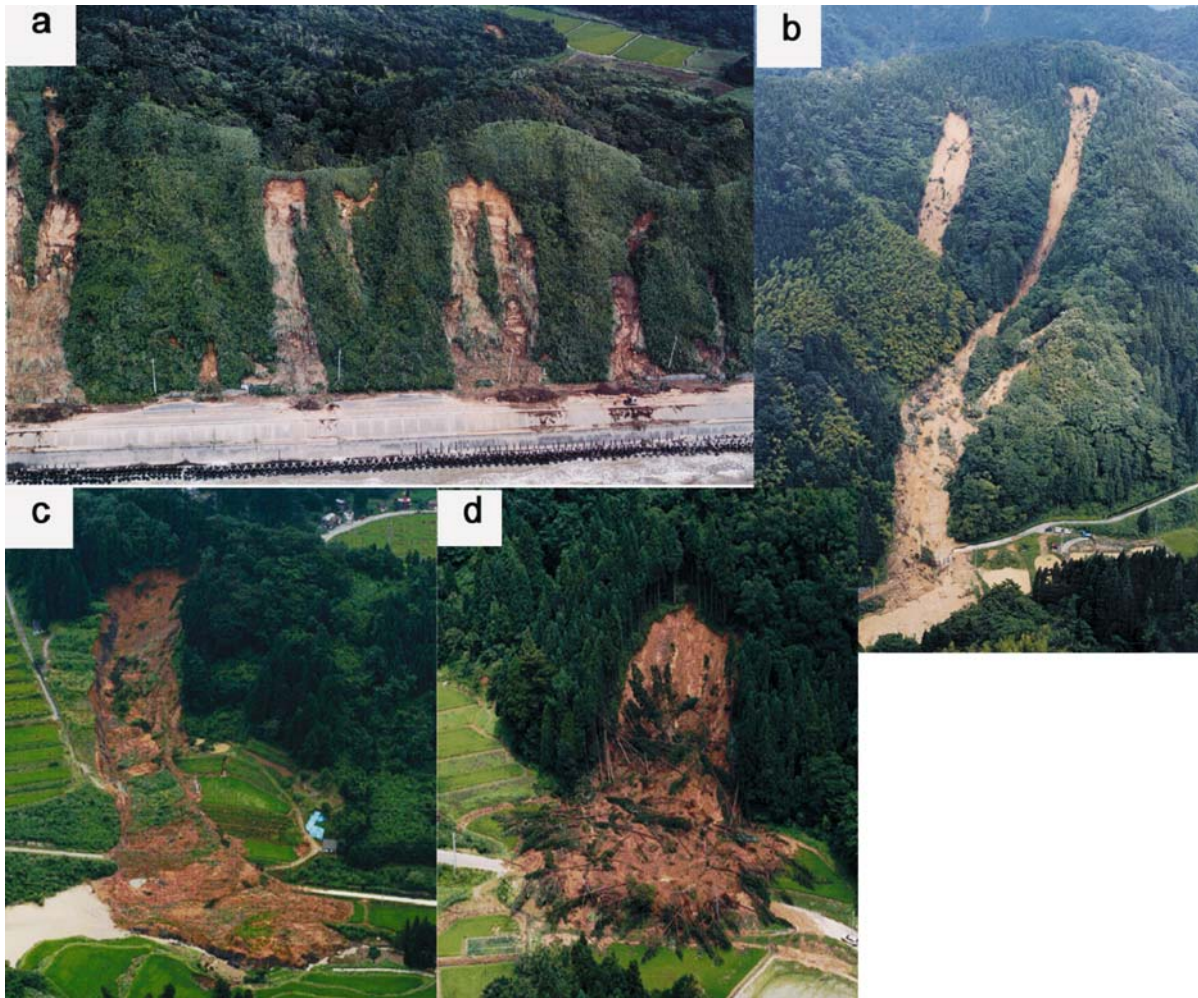
Fig. 22.3. Typical landslide types on 13 July 1994. **a** Planar type surface failure in Washima Beach. **b** Spoon-type failure in Aida, Izumozaki. **c** Deep slide with long-run flow at Tanokuchi, Tochio, **d** the simiar type at Ichinokura, Tochio. Courtesy of Nakanihon Air Service Co. Ltd.)

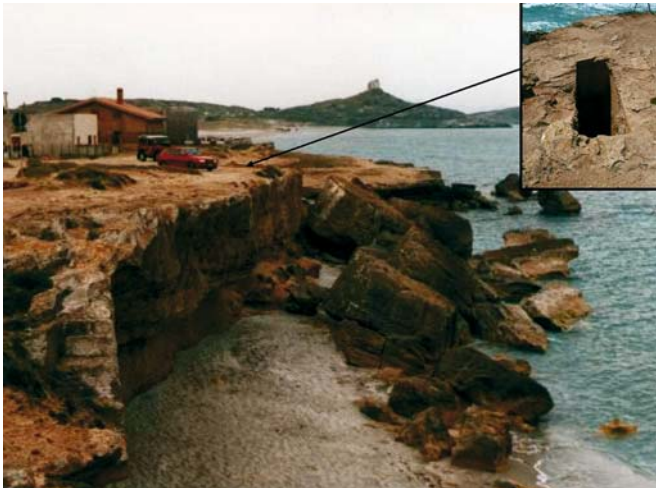
Fig. 23.8.
Rock falls in the San Giovanni necropolis

The necropolis extends along the margin of the cliff in front of San Giovanni di Sinis and contains several rectangular trench-type tombs excavated in the aeolic sandstone of the San Giuseppe Formation. Several tombs near the vertical cliff wall are evidently exposed to the detachment and fall of various sized (from submetric to decametric) blocks so that the tomb chambers are visible in both the bedrock and in the blocks that have fallen on the narrow beach (Fig. 23.8).

The tombs are excavated in the upper massive portion of the aeolic sandstone over the layered basal level; these sandstones closeout a complex stratigraphic sequence, observable from its bottom member to the top along the San Giovanni beach. Below the sandstone, breccias are alternated with cemented conglomerates of medium strength; the sequence is then closed by a calcarenitic layer. The result is a “sandwich” structure in which a level of lower resistance (breccias and conglomerates) is enclosed between two resistant lithotypes (Fig. 23.9). In these conditions the wave action causes differential erosion with the formation of overhanging blocks: this is readily observable in the section of coast where the largest blocks have accumulated (Fig. 23.8).

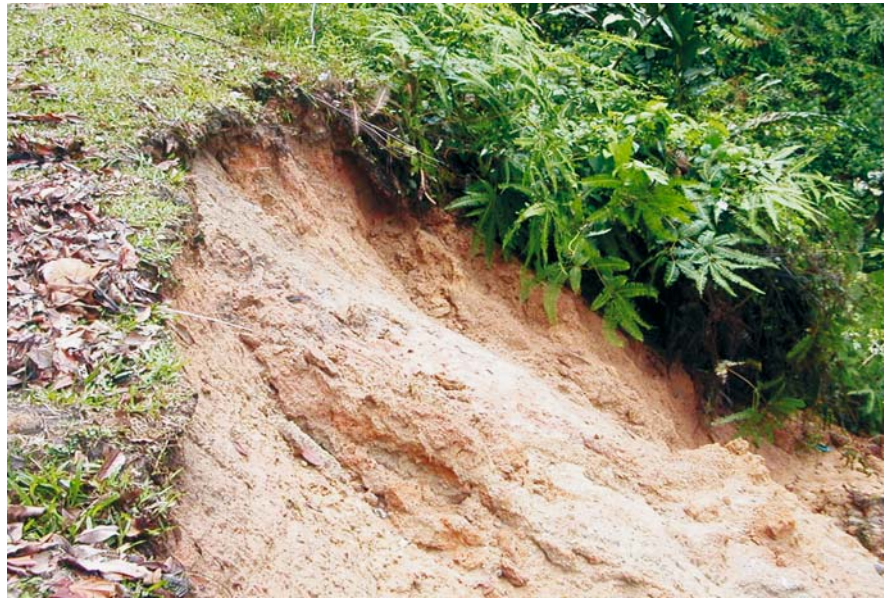
Fig. 24.5.
Soil erosion feature at Genting
Highlands

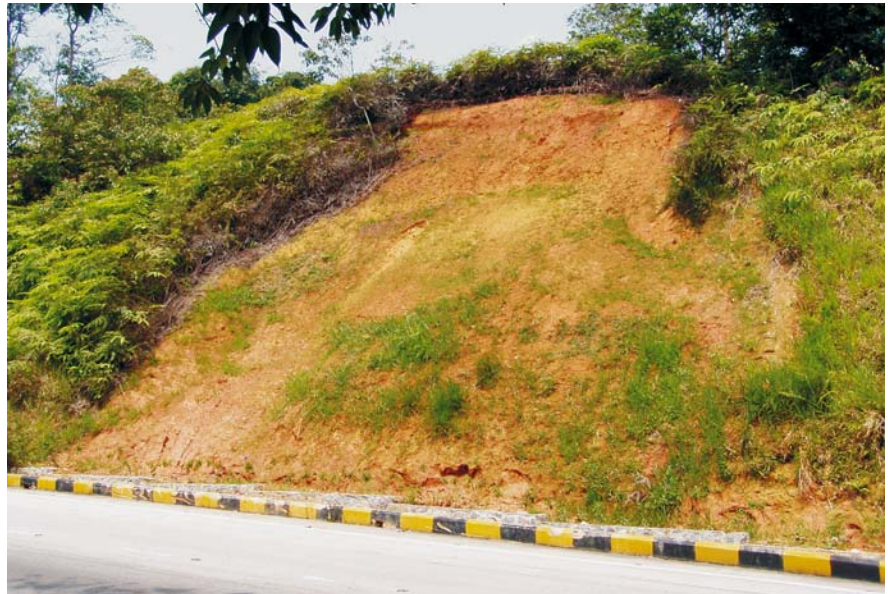
Fig. 24.6.
Soil erosion feature at Fraser Hill

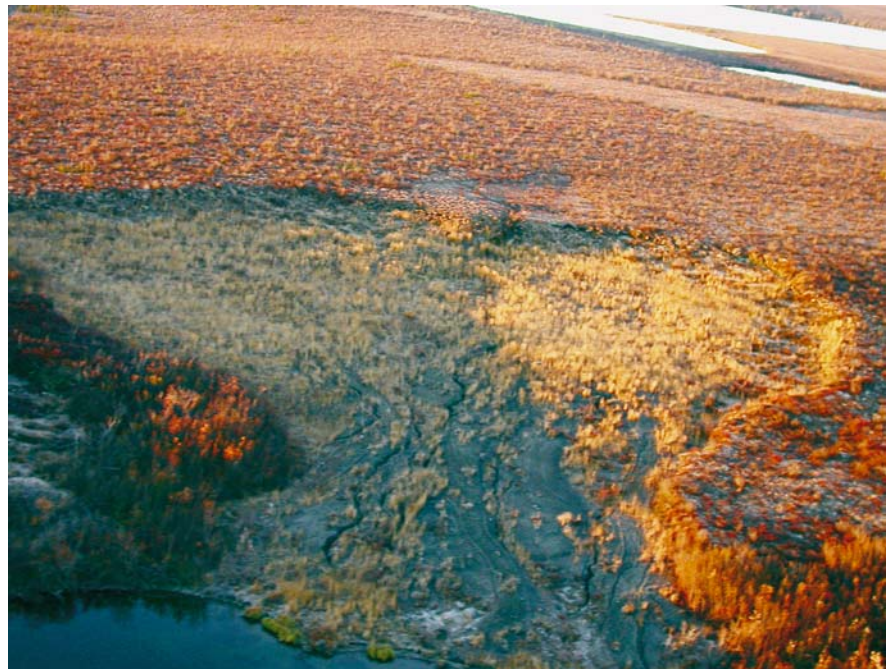
Fig. 25.3.
A typical shallow flow

The apparent shallow slides are often outlined by depressions of ground surface and distinct vegetation within the landslide zone (Fig. 25.3). Deep retrogressive failures often appear to be circular in shape as shown in Fig. 25.4. This type of landslide is sometimes called bi-modal flow (McRoberts and Morgenstern 1974a). It consists of a steep headscarp outlining the extent of ongoing failure and a tongue of flowing materials ablated from the headscarp. The headscarp is often nearly vertical. The height of the headscarps observed ranges from a few meters to over 20 m. The slope of the tongue is often very gentle and can be as

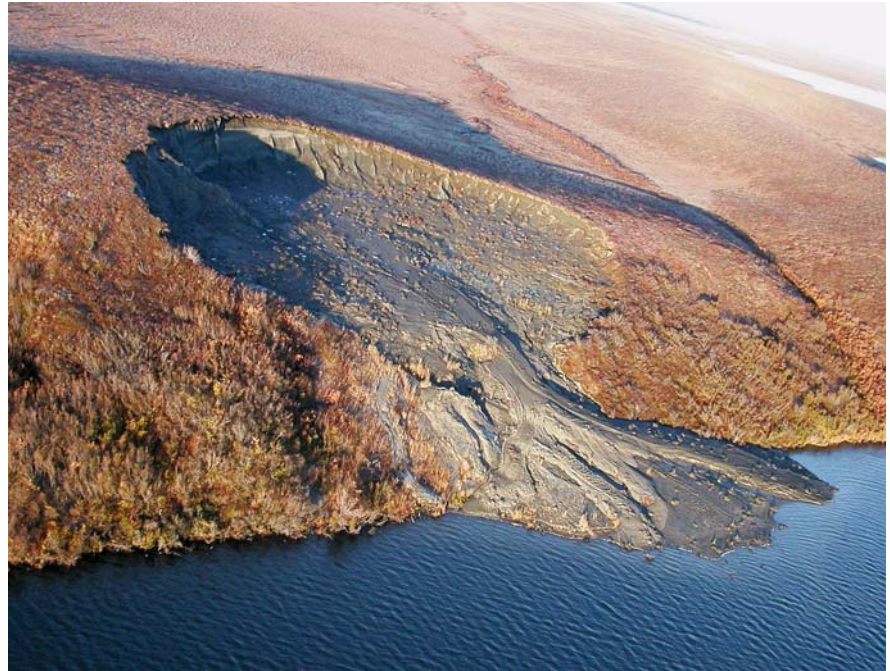
Fig. 25.4.
A typical deep retrogressive failure

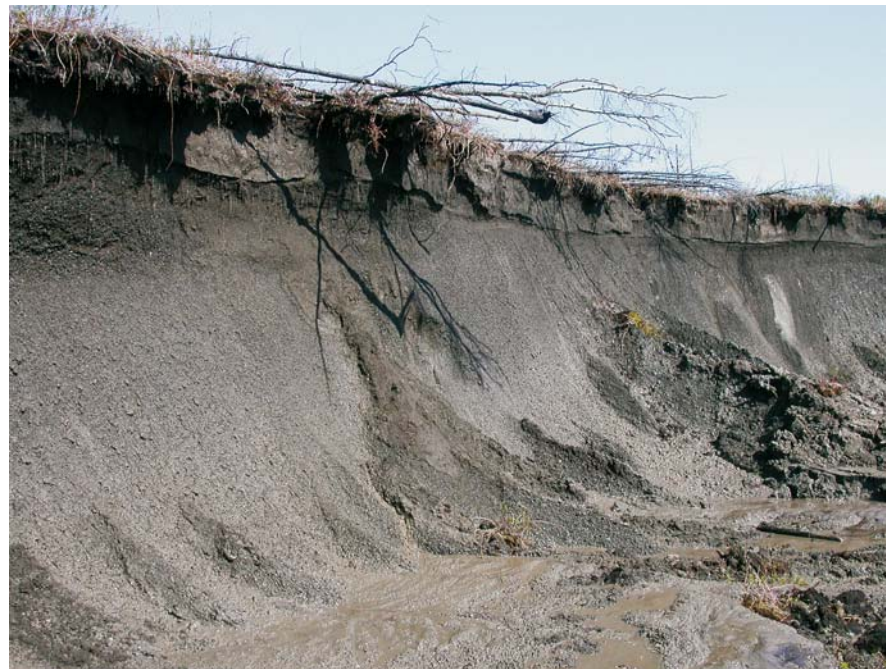
Fig. 25.5.
Head scarp of a retrogressive landslide

The headscarps of the deep retrogressive landslides are generally steep walls of exposed permafrost soils (Fig. 25.5). Continuous ablation of permafrost materials in summer makes it easy to observe the freshly exposed subsurface soils over the headscarp height, which can be as high as 15 m to 20 m.

The most commonly observed soils in regions 1 and 2 discussed earlier are as follows (Figs. 25.5 and 25.6):

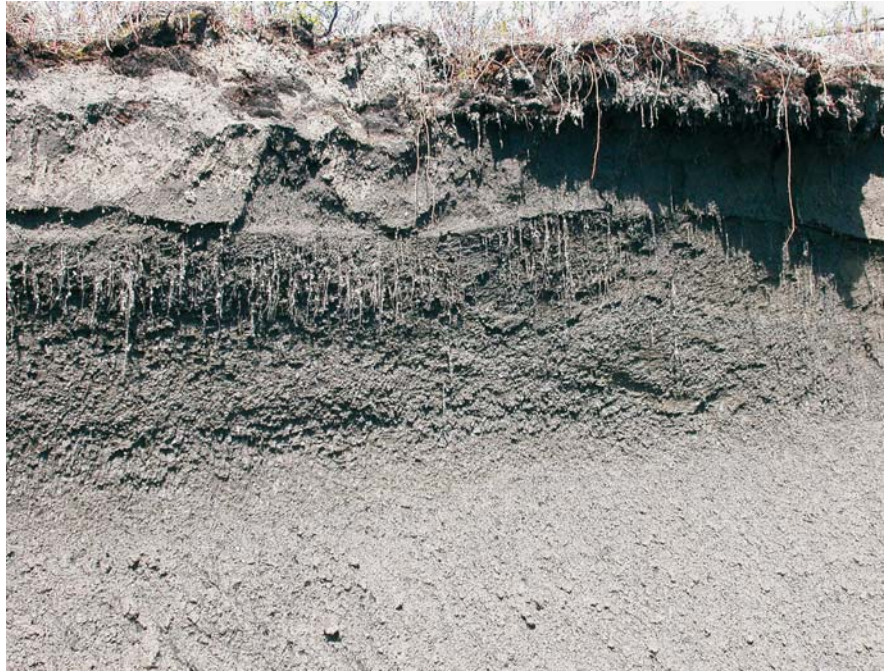
Fig. 25.6.

Typical soil stratigraphy from a headscarp (note active layer marked by depth of roots exposed)

- surface 5 cm to 30 cm (locally thicker): organic mat consisting of roots or moss.
- under organic mat to about 100 cm to 150 cm depth: silty clay or clayey silt, with roots extending to the base of this layer, moist to wet with occasional ice wedges; and
- below 100 cm to 150 cm depth: silty clay or clayey silt with pervasive ice lenses throughout the exposed scarps.

Roots are exposed and hang on the scarp faces when the hosting soil is thawed and slowly ablated (Fig. 25.6). This feature was observed consistently at all landslide sites visited.

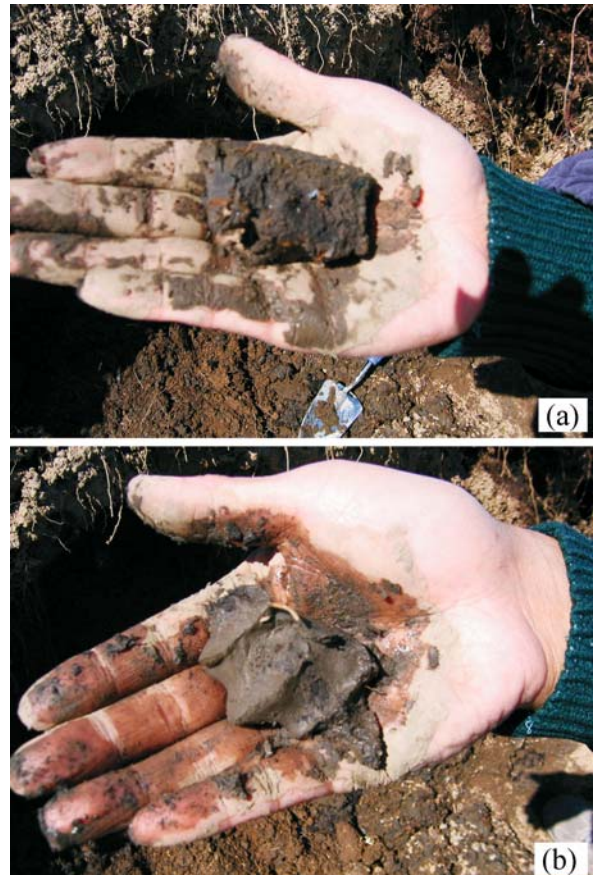
Fig. 25.7. Soil sample taken from lower part of active layer. **a** Frozen state immediately after sample was taken from scarp. **b** Soil sample after being melted by hand

Water content in the upper clay/silt layer appeared to be low compared to the lower clay/silt layer. Few or no ice lenses were visible in this upper layer except for the occasional concentrated ones discussed above. Photos of a soil sample taken from this layer are shown in Figs. 25.7a and b indicating frozen and thawed conditions of the sample. There is a clear contrast to that from the ice-rich layer below (discussed later).

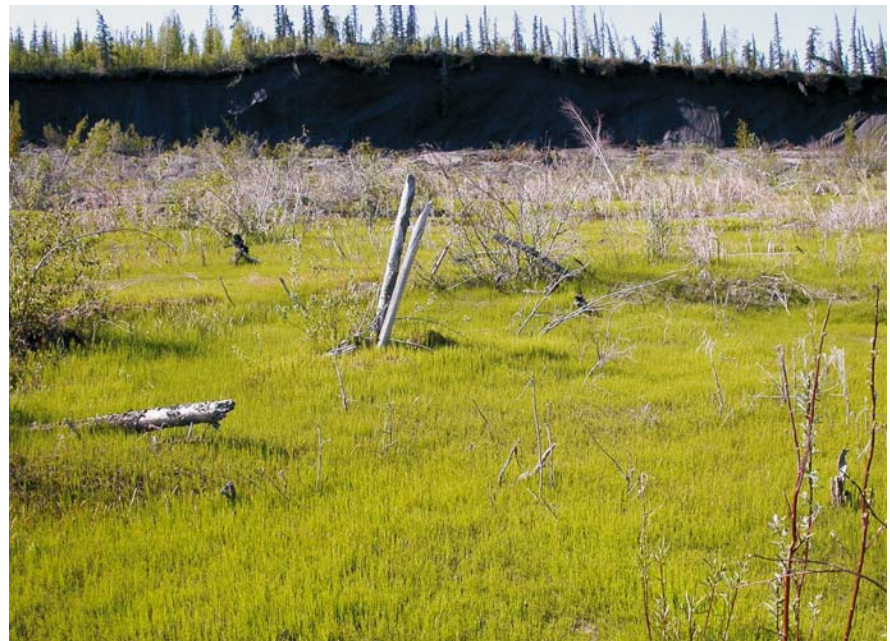
Fig. 25.9. Landslide with active scarp (background) and tongue with vegetation established (foreground)
