LANDSLIDES

Risk Analysis
and
Sustainable
Disaster
Management

Proceedings of the First General Assembly of the International Consortium on Landslides

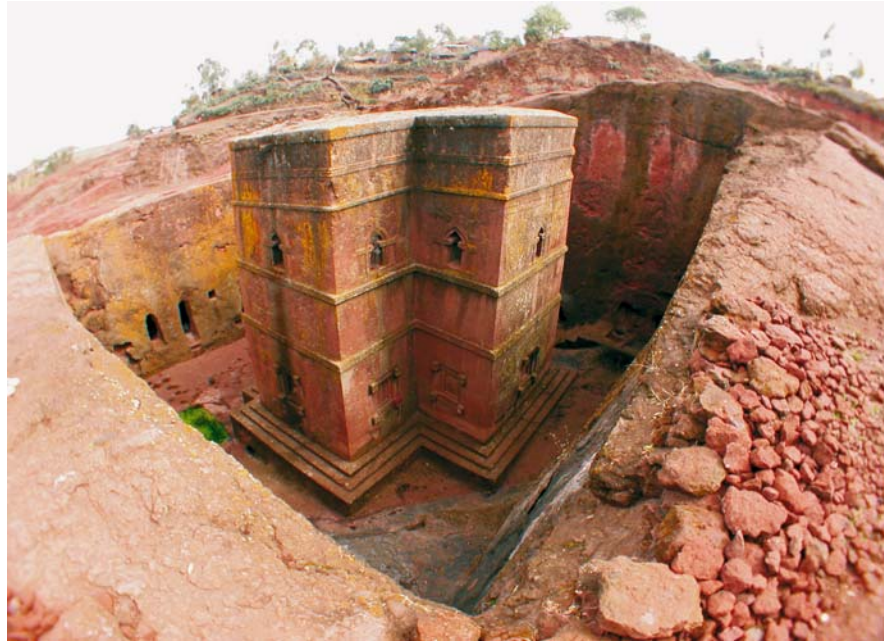
Fig. 26.2.
The church of Bet Gyorgis in
Lalibela (Ethiopia)

Some of the churches are sculpted out of solid volcanic tuff (Fig. 26.2). Some are quarried enlargements of caves. They are almost all connected by long underground tun-

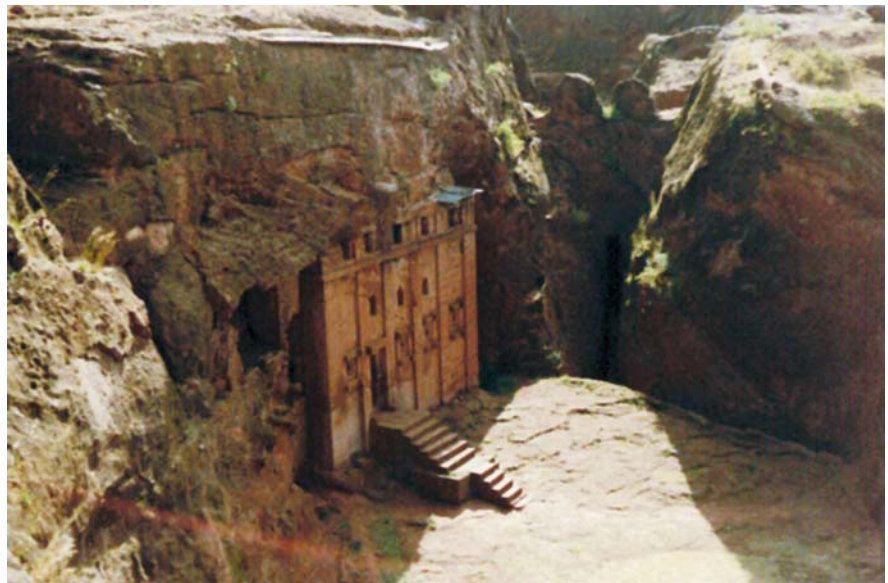
Fig. 26.3.
The church of Bet Aba Libanos
in Lalibela (Ethiopia)

Bet Aba Libanos is a monolithic church anchored to the rock out of which it was carved. By its excavation within the rock face (height of the circular tunnel: 7 m) and by its small dimension, it imitates a cave church (Bianchi Barriviera 1963) (Fig. 26.3).

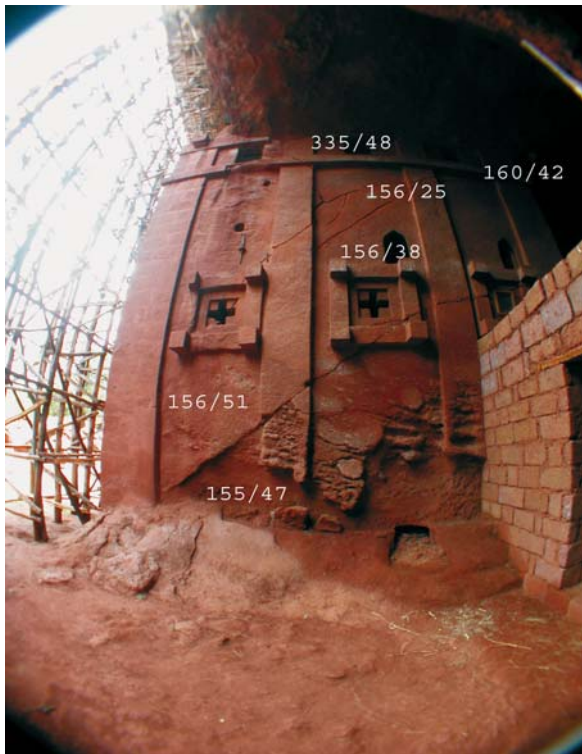
Fig. 26.7. Kinematic analysis of the church of Bet Aba Libanos

nity based on tilt test, the kinematical analysis clearly shows that all the conditions leading to a new possible planar slide are satisfied (Fig. 26.7). In particular, the surface failure is kinematically viable if:

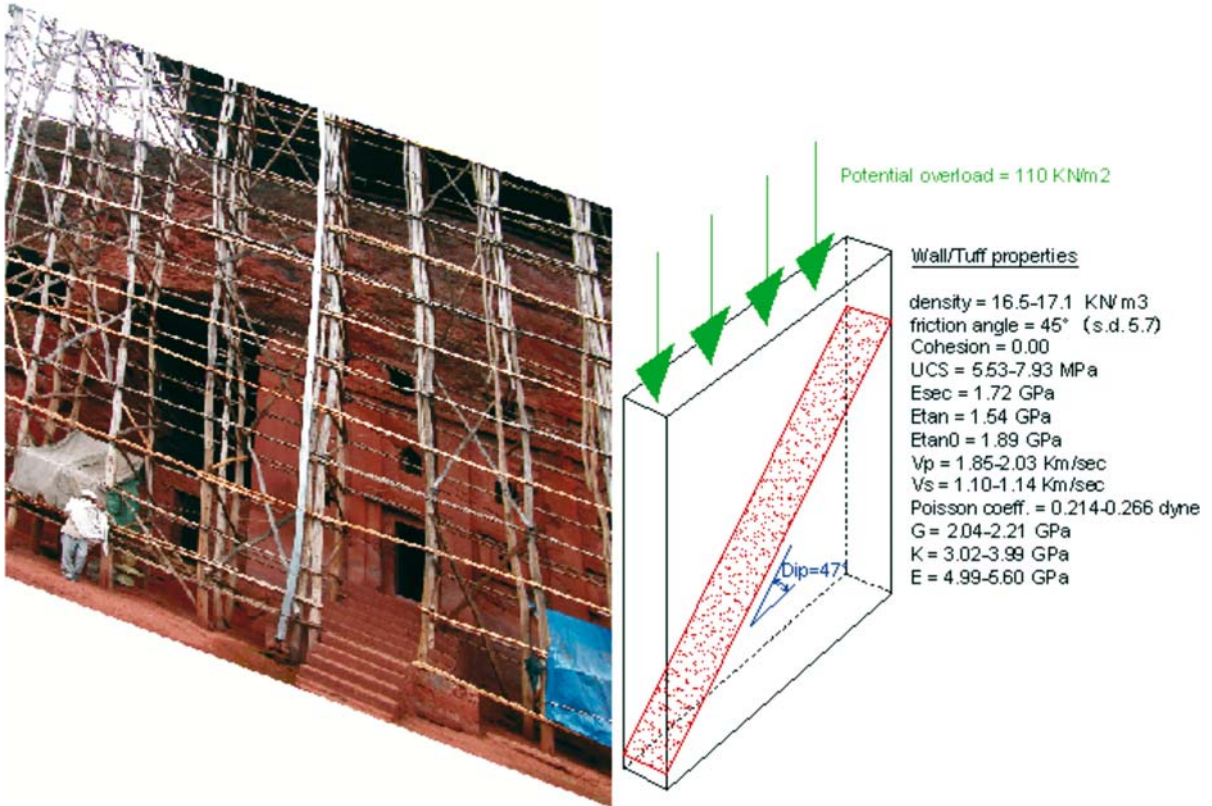
Fig. 26.9. The conceptual model used in the analytical calculation of stability

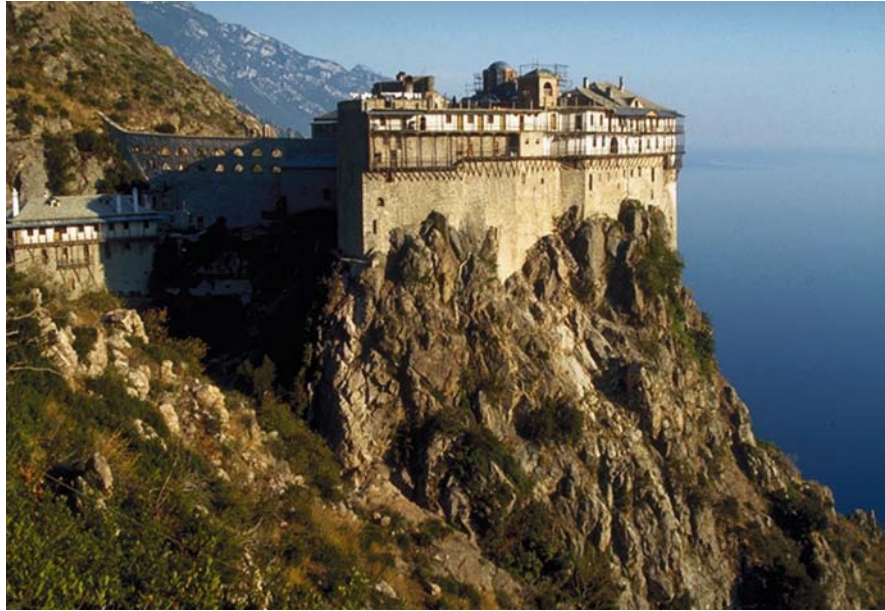
Fig. 30.2.
The Simonos Petra Monastery.
Important faults of E-W direction
are occurred

The area is very fractured and traversed by joints of various directions. Many important faults cut the studied area in E-W and N-S general directions. These discontinuities can cause unstable geotechnical conditions, especially at the slopes of the construction area. These instability phenomena are related to the neotectonic conditions of the broader area. The presence of an important neotectonic fault or large scale joint of SW dip direction ($216^\circ/80^\circ$) distinguishes two sections in the rock mass at the western side of the Monastery, decreasing the stability of the Monastery (Fig. 30.2).

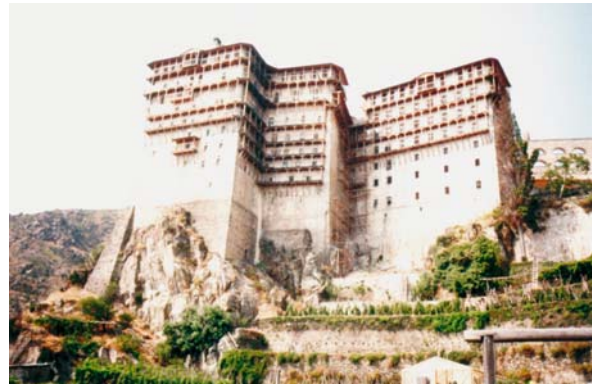
Fig. 30.3. Details from the southern slope

the data elaboration, the rock mass quality in the southern (Fig. 30.3) and western slopes of the foundation area is very low and of limited stability, causing damage to the monument (Christaras et al. 1995).

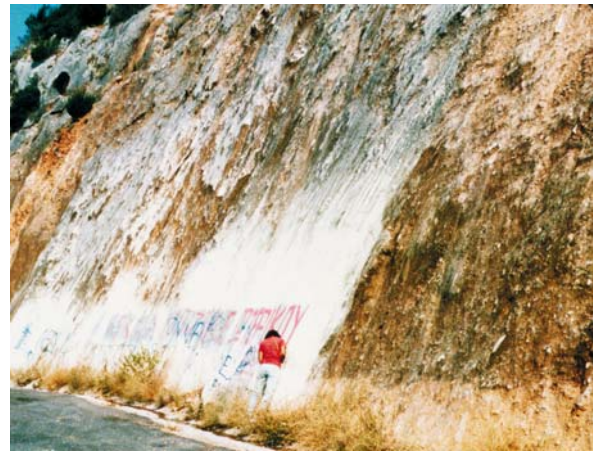
Fig. 31.10. The striated surface (mirror) of Delphi-Arachova active normal fault. Brownish breccia is located to the right of the photo

and surface weathering (Fig. 31.9). On both sides of the Delphi archaeological site, the big fresh fault surface (mirror) with subvertical slickensides is observed. Along this fault the direction varies from 65–100° and the dip is 60–70° (Fig. 31.10).

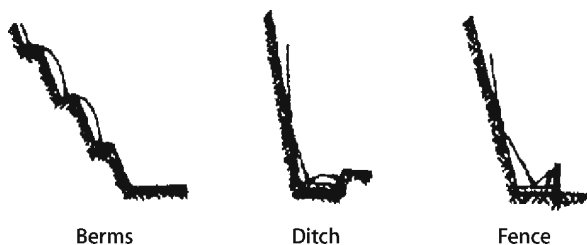
Fig. 31.16. Possible measures to reduce the damage due to rockfalls. Selected after Spang and Rautenstrauch (1988)

If it is accepted that it is not possible to prevent all rockfalls, then methods for restraining those rockfalls, which do occur, must be considered. Some of these methods are illustrated in Fig. 31.16. Berms are a very effective means of catching rockfalls and are frequently used on permanent slopes. The effectiveness of these berms can be checked by means of a rockfall analysis in which the trajectories of falling rocks are simulated mathematically. In the case of Delphi this cannot be accepted, as construction of berms will detract from the appearance of the imposing cliffs at the site.

One of the most effective permanent rockfall protective systems is the construction of a catch ditch at the toe of the slope. The base of this ditch should be covered by a layer of gravel to absorb the energy of falling rocks and a sturdy barrier fence should be placed between the ditch and the site for protection.

The location of the barrier fence can be estimated by means of a rockfall analysis. The criterion for the minimum distance between the toe of the slope and the rock fence is that no rocks can be allowed to strike the fence before their kinetic energy has been diminished by the first impact on the gravel layer in the rock trap.

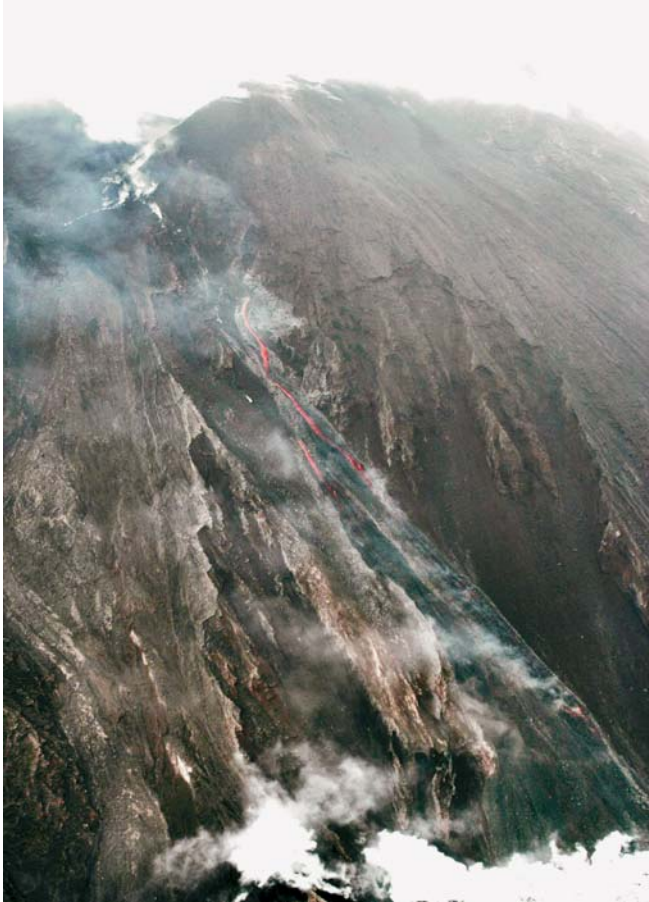
Fig. 32.7. View of the slope taken after the 30 December. The scars of the β (right) and γ (left) slides are apparent (photo by M. Coltelli, INGV)

The largest subaerial scar observed after the tsunami (Fig. 32.7) results from the coalescence of the β slide with retrogressive slumps (Figs. 32.4 and 32.5). The failure involved a volume of $5 \times 10^6 \text{ m}^3$ and exposed impressive sub-vertical lateral scarps up to 40 m high (Figs. 32.5 and 32.7).

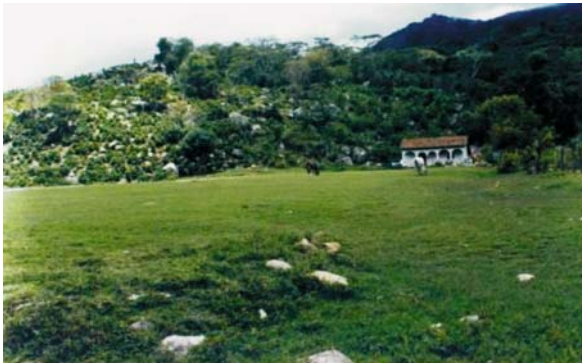
Fig. 34.2. A view of Ajuterique-Playón landslide that involving rocks of Yojoa Group. In second plan, the mass mobilized by one of the last acceleration episodes

The more important lithostratigraphic unit (from the geodynamic perspective) corresponds to the Cretaceous Yojoa Group, divided in four formations: Cantarranas (Neocomian-Lower Albian), Atima (Aptian-Albian), Ilima and Guare (both of the upper Cretaceous) (Fig. 34.2). It's composed by marine sedimentary rocks basically, where the limestones and dolomites prevail, intercalated with levels of sandstones, siltstones and lutites. The landslides have been developed mostly in the limestones and sedimentary rocks of Atima and Ilima Formations.

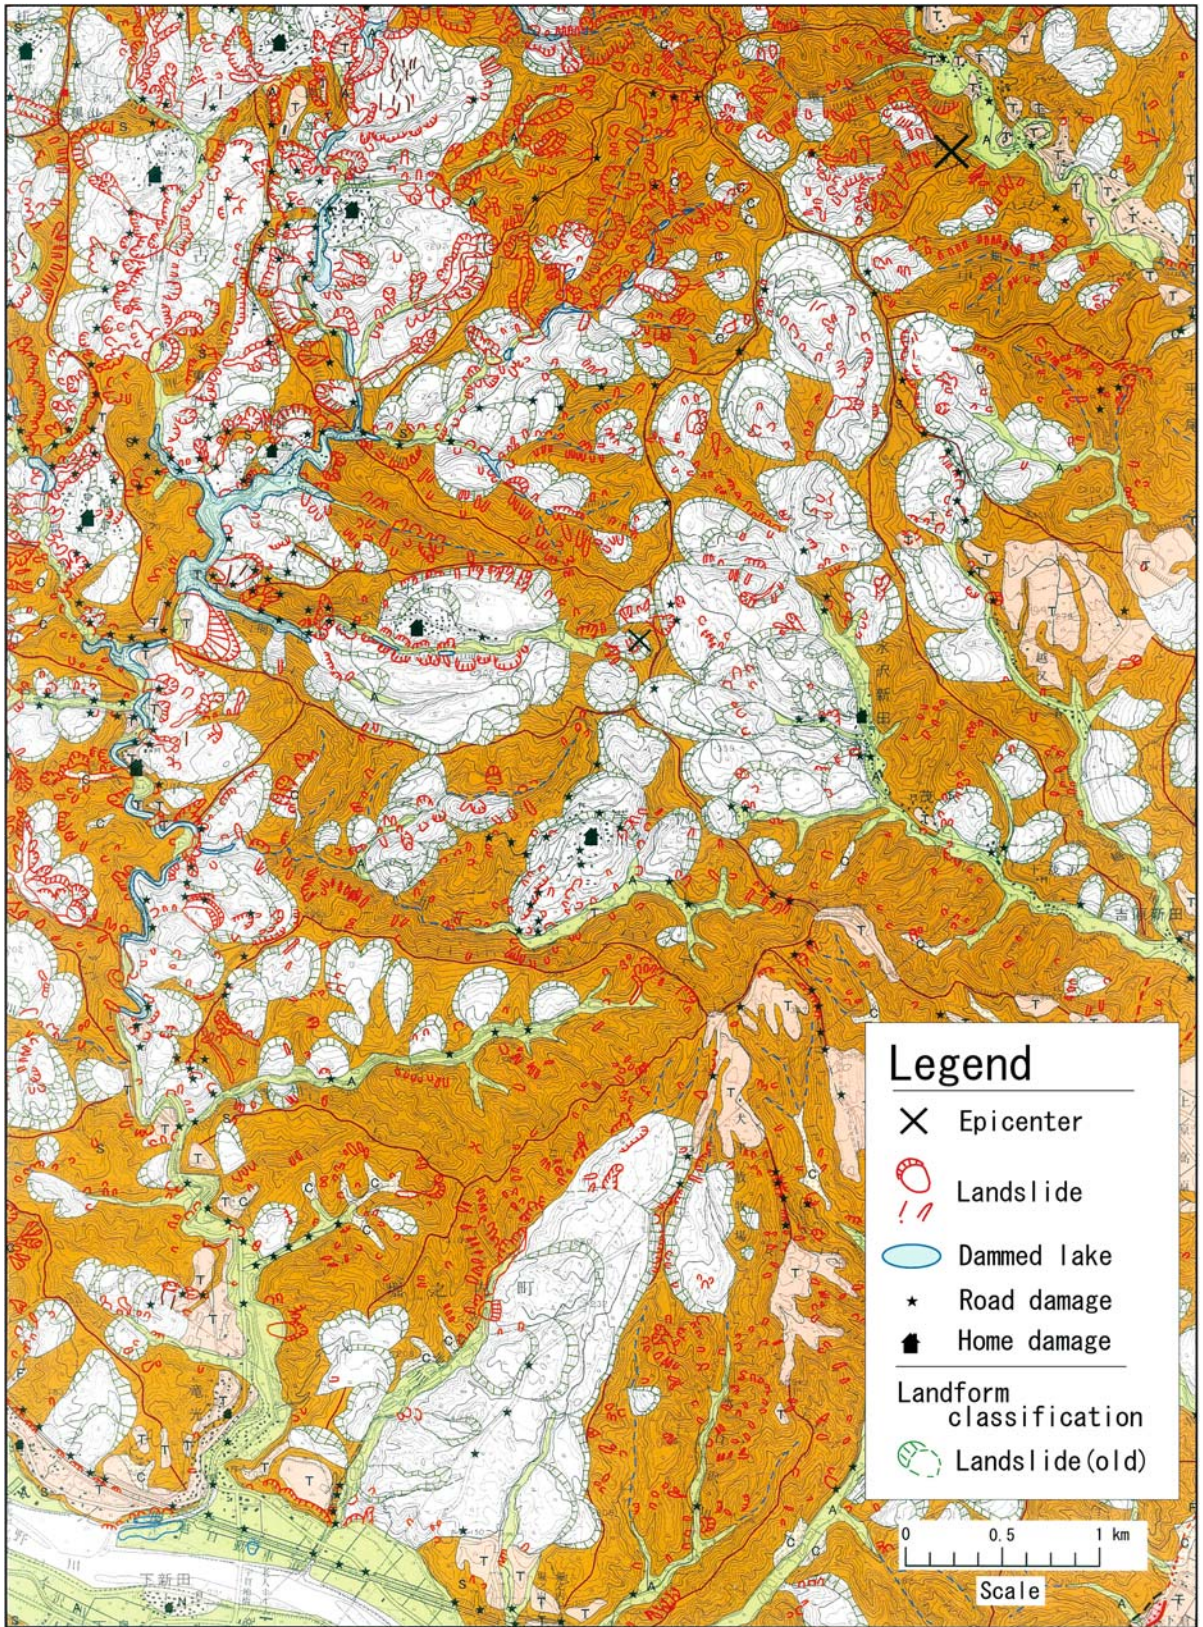
Fig. 35.7. Map A: a damage map (detailed version)

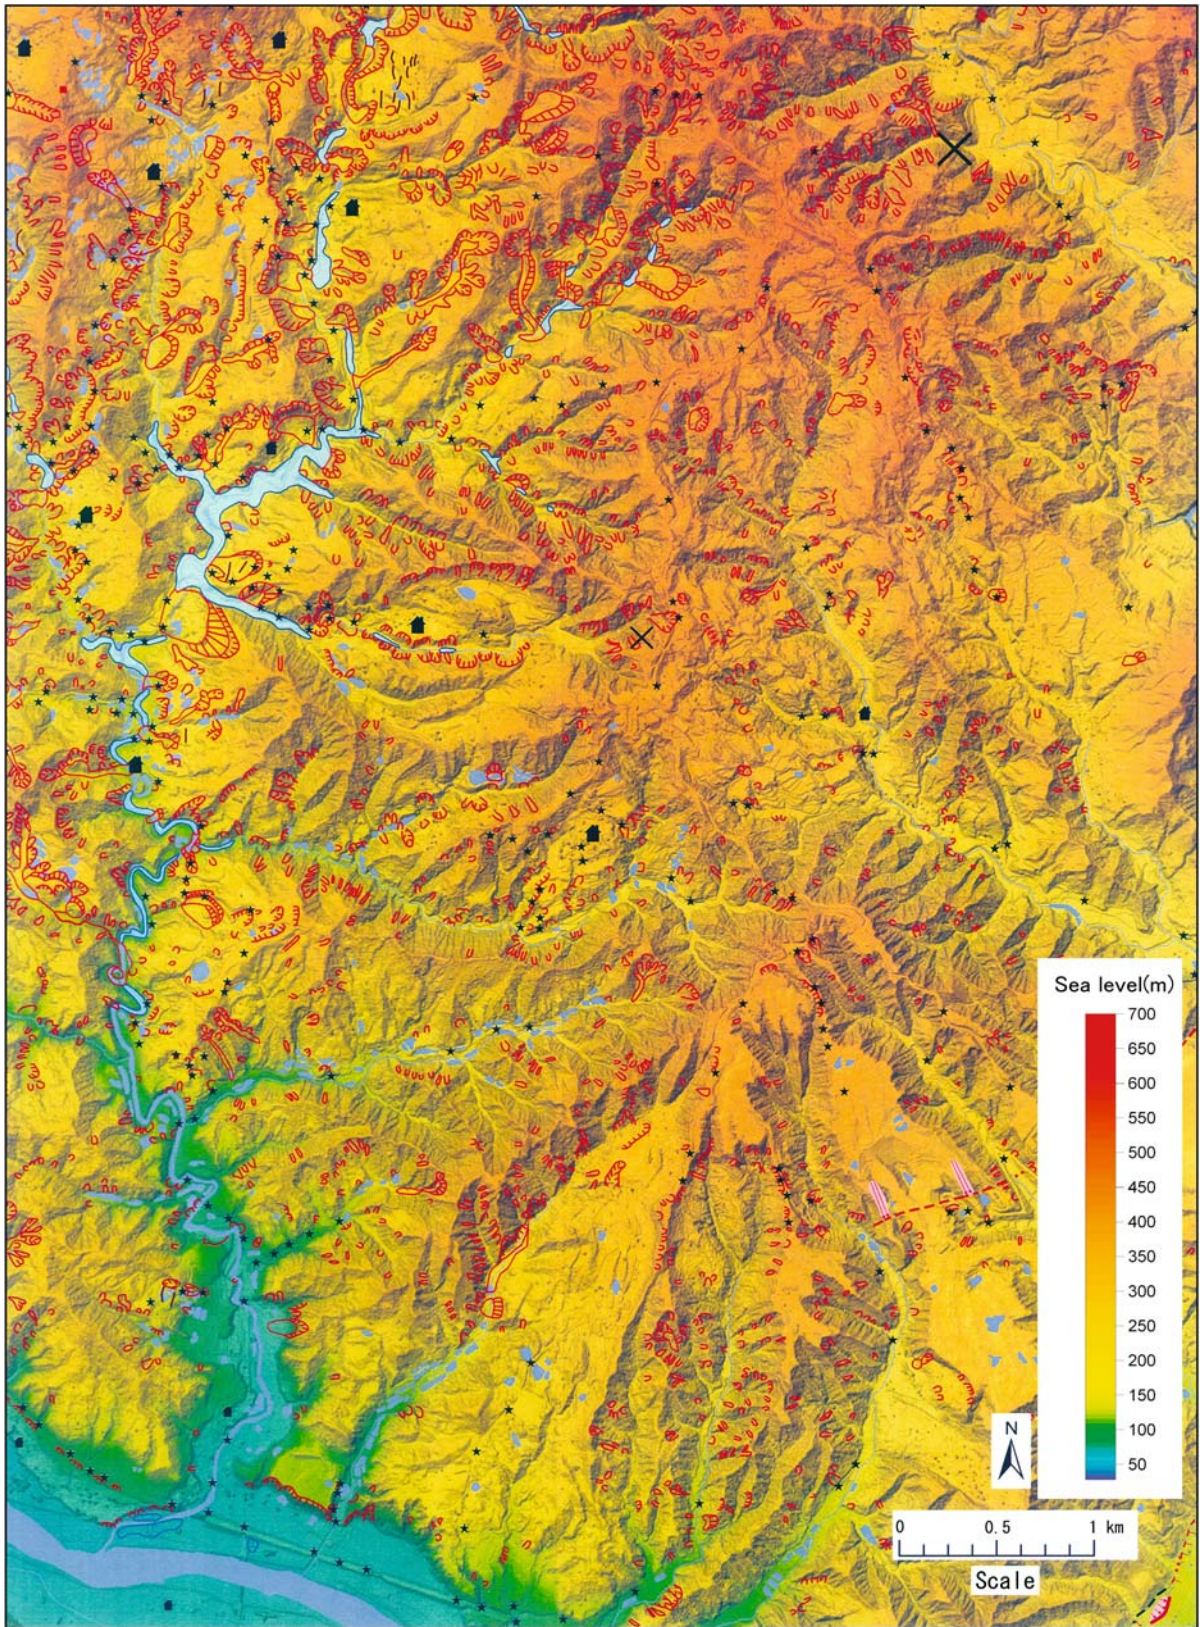
Fig. 35.8. Map B: a damage map (color-shaded version based on laser scanning)

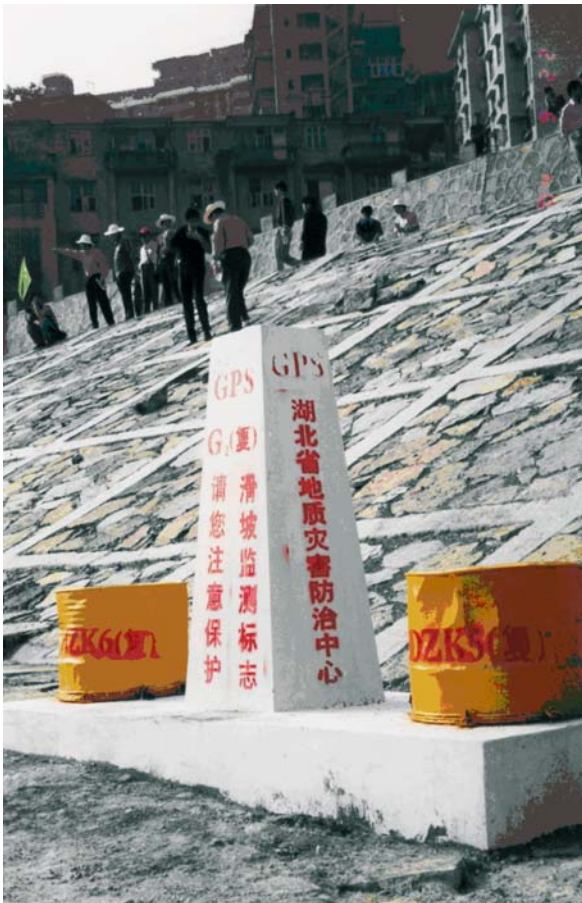
Fig. 36.9. GPS monitoring for the landslide control engineering in Three Gorges Reservoir area of China

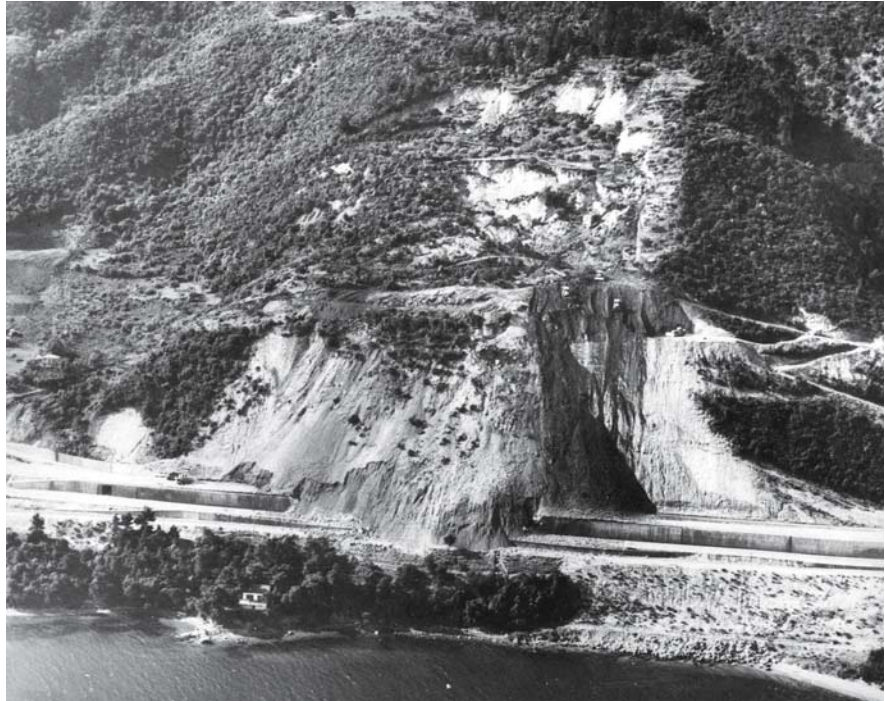
Fig. 37.3.

Landslide of Panagopoula instability zone in western Greece (April 1971). The landslide took place on the lightly sheared transition zone to flysch. The national road of Athens to Patras failed into a zone of about 500 m

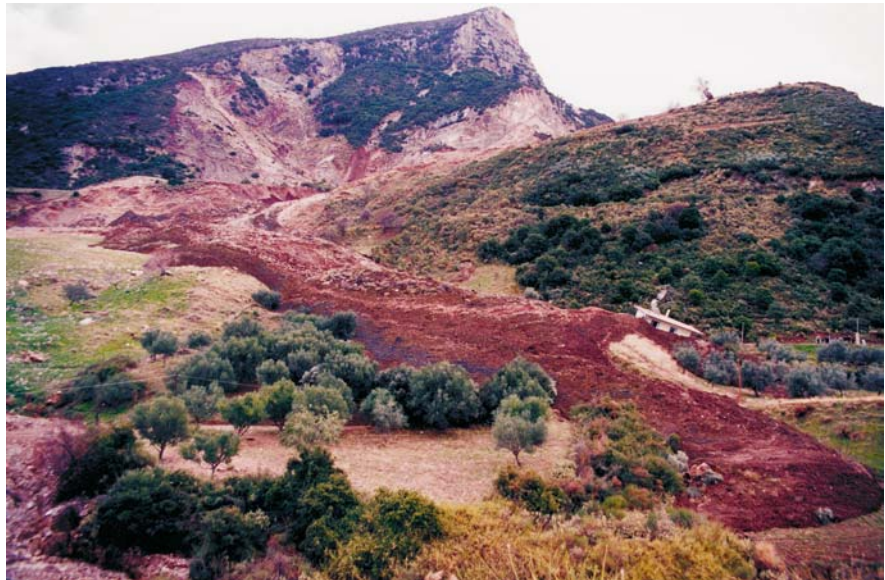
**Fig. 37.4.**

Composite landslide of Karya Village instability zone, western Greece. The landslide took place on the weathered and fractured flysch formations covered by thick limestone debris

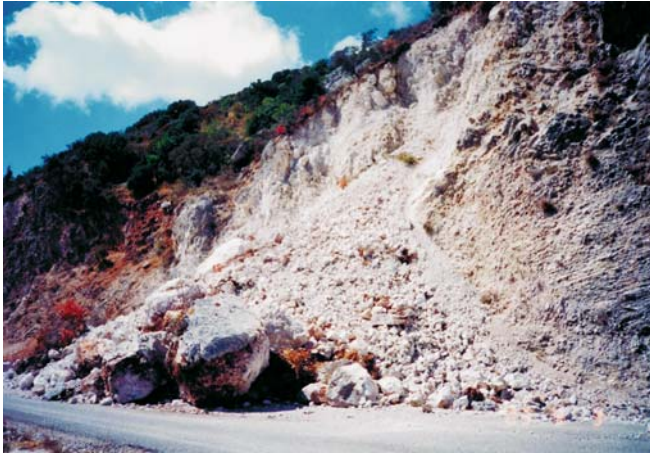
Fig. 37.5. Rock falls occurring in the highly fractured (mylonitized) and weathered zone of limestones, triggered by strong earthquake, in Lefkada Island (August 2003)

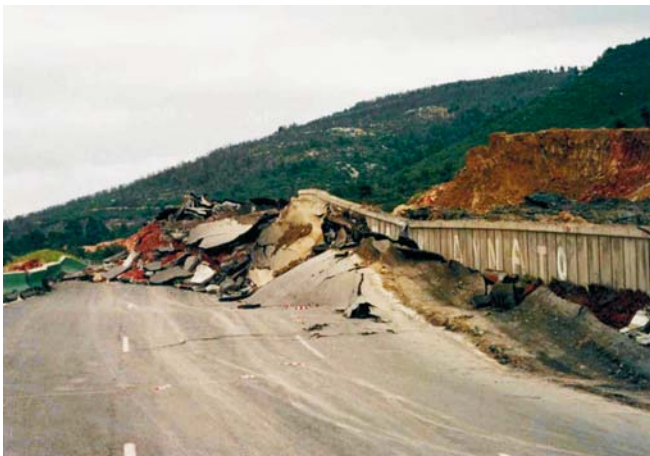
Fig. 37.6. Malakasa landslide, February 1995. Damages on the new highway from Athens to Thessaloniki. The landslide manifested in the tectonized and weathered zone of schists covered by debris

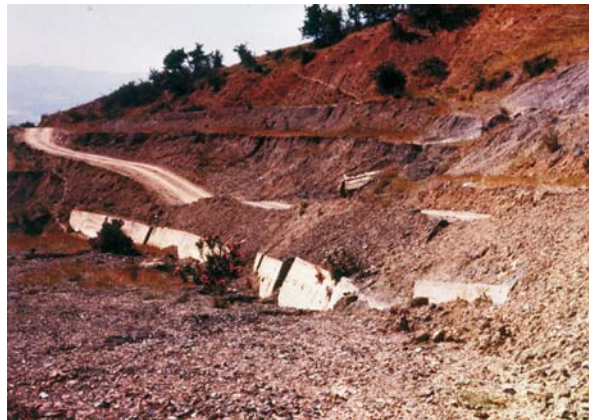
Fig. 37.7. Translational slide along the contact of sandstone and argillaceous phases of flysch

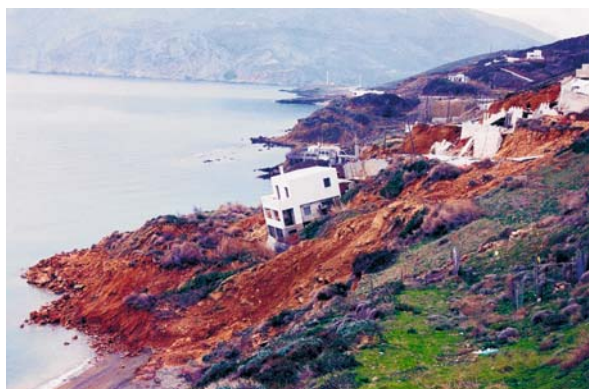
Fig. 37.8. Rotational slide in the fine neo-gene sediments in Skiros Island, triggered by heavy rainfalls

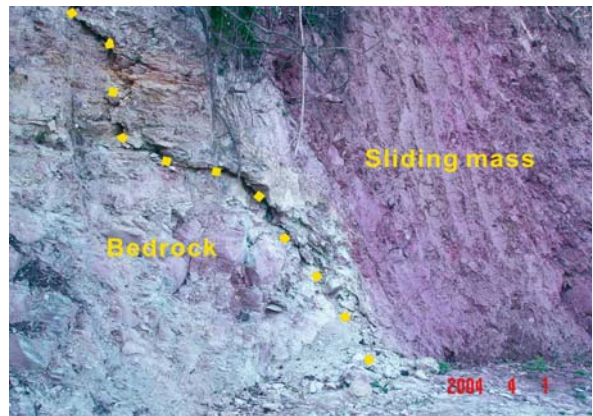
Fig. 40.4. Crack at the right boundary of block 1 outcropped at a roadside

Figure 40.4 shows a crack at the right boundary of block 1 outcropped at a local road. The right-hand side is the sliding mass consisting of red muddy debris of old landslide, and the left-hand side is bed-rock of sandy mudstone, muddy siltstone of Badong Formation of Triassic period (T3b).

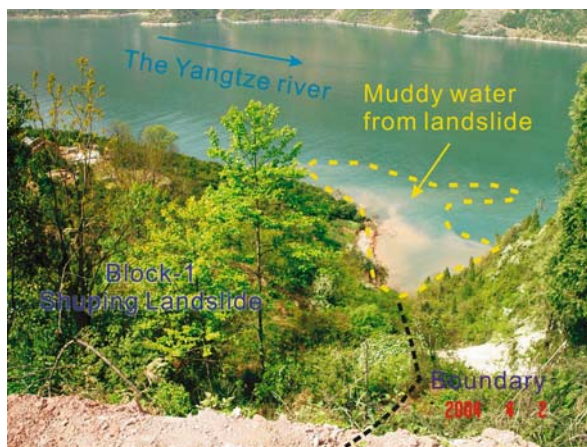
Fig. 40.5. Muddy water seeped out of the toe part of the Shuping landslide

Figure 40.5 shows muddy water coming from block 1. It appears at the river even at continual sunny days showing no relationship with surface water erosion, but the underground water erosion from the inner part of the landslide.

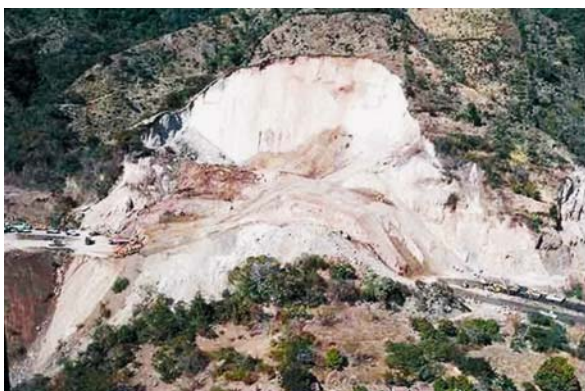
Fig. 41.3. The Pan America Highway in El Salvador was badly damaged by a landslide during the January 2001 earthquake

Typical economic consequences of landslides in the region are damaged houses, blocked roads (Fig. 41.3) and loss of valuable agricultural land. During the El Salvador earthquake in 2001, it is reported that 20% of the country’s coffee plants were damaged (World Bank 2001).

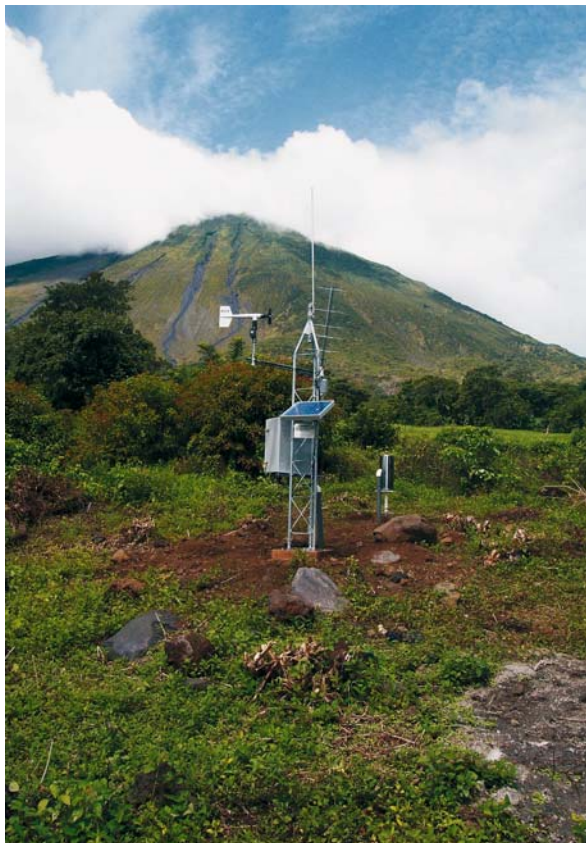
Fig. 41.7. Meteorological station installed in the Concepcion Volcano in Nicaragua, forming a part of a pilot landslide early warning system

The project also included a pilot project of a landslide early warning system. Automatic meteorological stations were installed on slopes of 4 different volcanoes, with satellite transmission of data to the INETER office in Managua, Fig. 41.7. In May 2002 the Concepcion Volcano slope experienced a severe rainfall situation that triggered a major lahar. As can be seen from the plot on Fig. 41.8, this event fitted fairly well with the estimated threshold values for warning that were initially set when the system was installed.

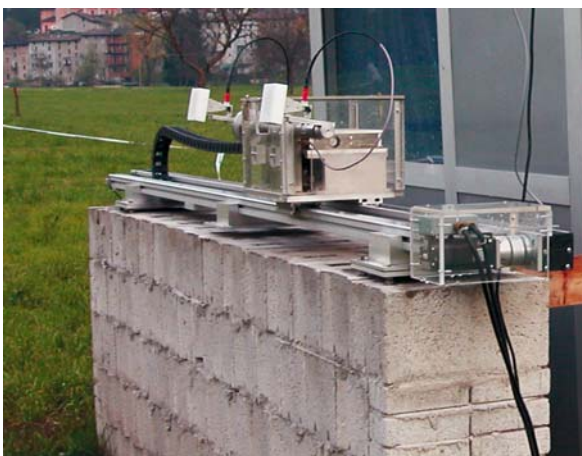
Fig. 43.3. Picture of the LiSA system installed in front of the Cortenova rock slide. The radar rail was placed on a concrete wall specifically built for the monitoring

Synthetic Aperture Radar (SAR) images were acquired by a ground-based system, belonging to the LISA interferometer series designed by the Joint Research Centre of the European Commission (Rudolf et al. 1999) (Fig. 43.3). The system consists of a continuous-wave step-frequency (CW-SF) radar working in the Ku frequency band. A set of antennas is displaced along a 3 m long rail at steps of 6.5 mm, synthesizing a linear aperture. At each position, the radar collects the backscatter return, at 1601 discrete frequencies ranging from 16.70 to 16.76 GHz. The synthesis of the image is achieved by coherently summing

signal contributions relative to different antenna positions and different microwave frequencies. The frequency and radar displacement steps have to be fine enough in order to avoid ambiguities, respectively in range and cross-range. The LiSA system, installed at an average distance of 600 m from the target area and pointed up towards the unstable slope, collected data over the Cortenova landslide since 14 December 2002 up to May 2003. The spatial resolution of the resulting SAR images was of about 3×3 m. The time needed for the acquisition of a single SAR image under the described operational parameters was about 20 minutes. Standard telephone lines were used to transfer these data to JRC's venue, in order to be processed in near-real time. This allowed for the production of a sequence of displacement maps useful to follow the temporal evolution of the landslide movements.

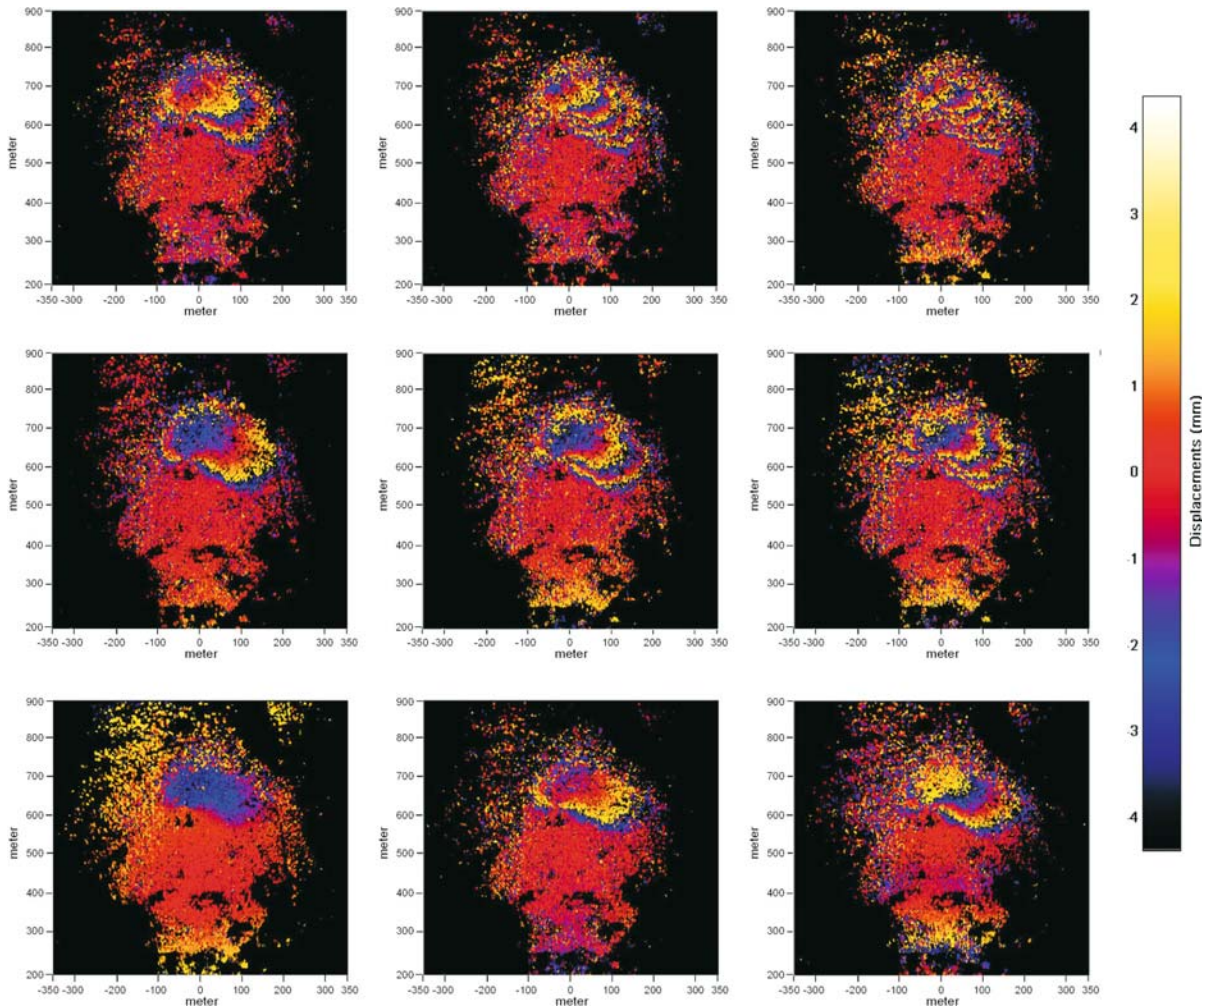
Fig. 43.4. Sequence of interferograms. From the top to the bottom maps refer to deformations occurred in the months of January, February and March 2003. For each month, the three displacement maps (from the left to the right) have been produced by cross-correlating a reference SAR image with three SAR images acquired after 1, 2, and 3 days, respectively

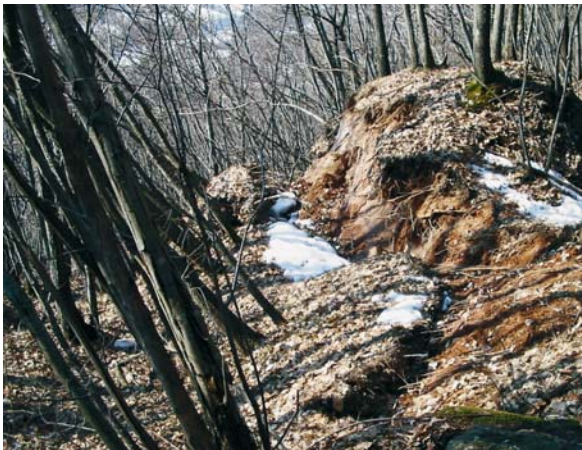
Fig. 43.6. Picture of a trench located in the upper part of the slope, on the slide right hand

Model of the slope. Field surveys, carried out after the removal of the electrical cables, revealed the presence of trenches and tilted trees in the upper part of the slope, suggesting an involvement of this area related to a retrogressive evolution of the movement, as confirmed by the radar data (Fig. 43.6).

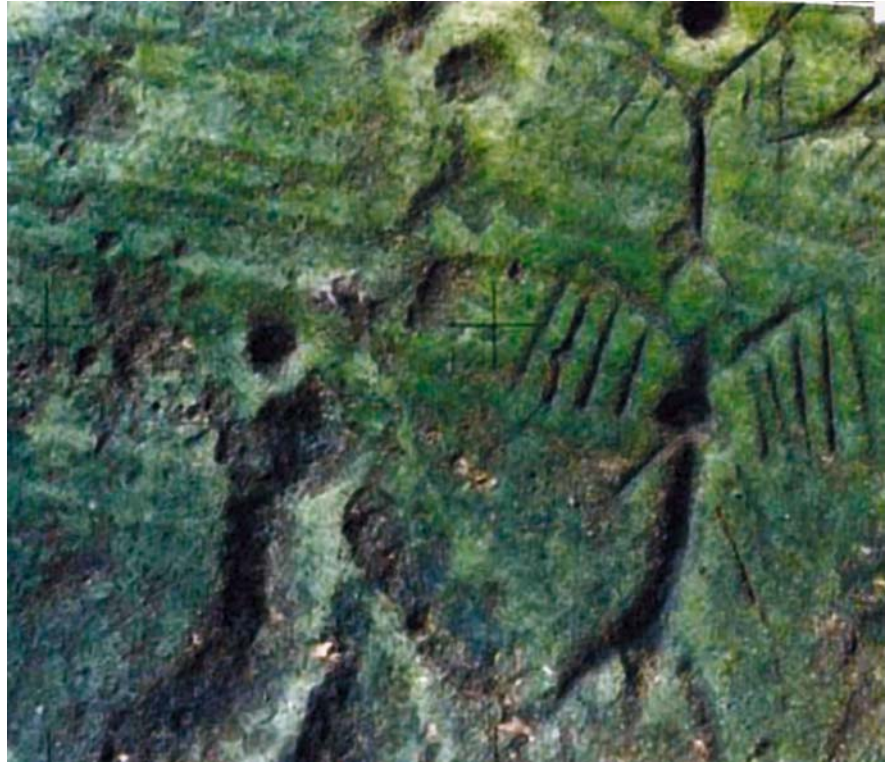
Fig. 44.4. Photo showing the cracks

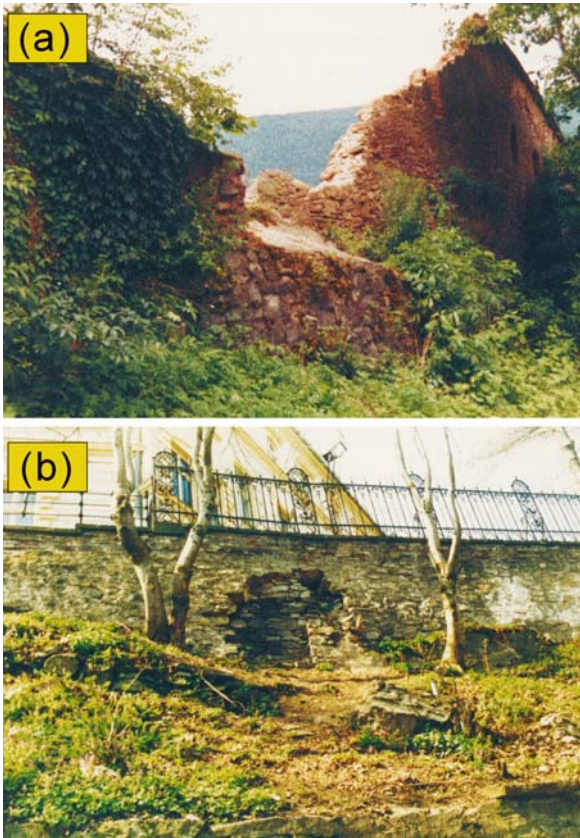
The landslide from the western part of the hill (drilling F3) destroyed a part of the medieval fortified wall in the zone of the cemetery and of the Butchers' Tower (Fig. 45.3). Because of local ground movements and earth pressure, the retaining wall of the Leather Dresser Tower is affected (Fig. 45.4) and the Tinsmiths' Tower is fissured.

This zone suffered in the last years developing processes of degradation like outside sloping of the wall with 0.3–0.7 m and breaking down of the wall on a length of about 20 m (Fig. 45.3a).

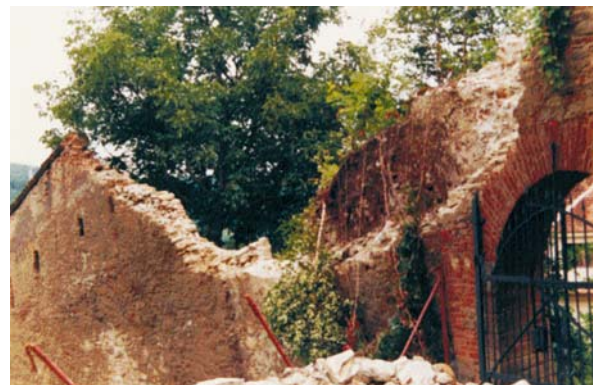
**Fig. 45.5.** The damage produced by a landslide on the citadel wall

The phenomenon of progressive sloping and rotation of the wall is considered an effect of the earth pressure,

amplified by the steep slope of the hill and the accumulation of the underground infiltration water.

Dynamic penetration tests (6 profiles) and exploration ditches (2 manual excavations) inside the precincts have been carried out to evaluate the nature and the properties of the foundation ground and the depth and type of the wall foundation. The damage produced by a landslide on the citadel wall (Fig. 45.5) and some of the penetration profiles obtained in the landslide area are shown (Fig. 45.6). A resulting characteristic geotechnical profile provided by the penetration tests shows at the surface 2–3 m of loose sands and soft silty-clays, then compact sands alternating with consistent clays to the depth of 8–9 m. A lens of plastic clay develops at 3–4 m depth.

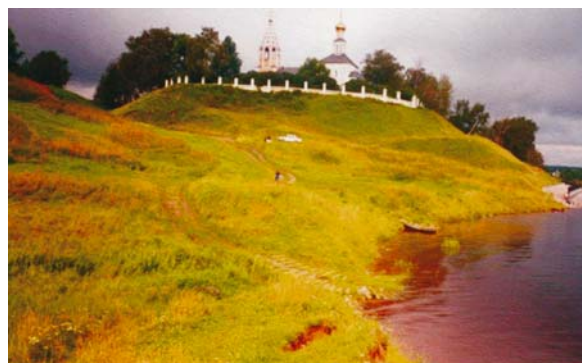
Fig. 46.5. The Blessed Virgin Church (fifteenth century, the village of Gorodnya) located on the remnant of a high slope affected by landslide process

In the village of Gorodnya, a large retrogressive landslide was observed near the fifteenth century Blessed Virgin Church. The total volume of the landslide was estimated to be about 2.5 million m³, and the distance between the landslide crown and its tip to be as long as 350 m, as schematically shown in Fig. 46.4. The retrogressive landslide occurred in the moraine deposits, likely due to river erosion. Two rotational landslide bodies from 50 to 70 m wide, as well as several minor landslides between and above the main displaced blocks were clearly observed. The sliding surface was assumed to be located below the river water line. Groundwater discharge was detected on the surface in different places. The landslide appeared to be active because of a few fresh cracks observed in the landslide crown, potentially affecting the stability of the Blessed Virgin Church, which is erected on the high slope remnant near the Volga River (Fig. 46.5). Although it is protected by the retaining wall and embankment and separated from the native slope by the deep (8 m) man-made ditch, some deformations of the church walls were observed.

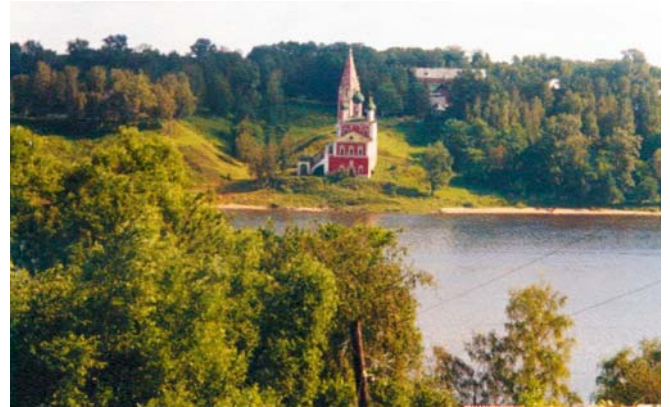
Fig. 46.7. The church of Kazanskoy God Mother (the town of Tutaev) located on the landslide bank of the Volga River

The church of Kazanskoy God Mother is situated on the opposite bank of the Volga River, on one of the landslide steps near the river water line. The church was tilted and turned towards the river (Fig. 46.7).

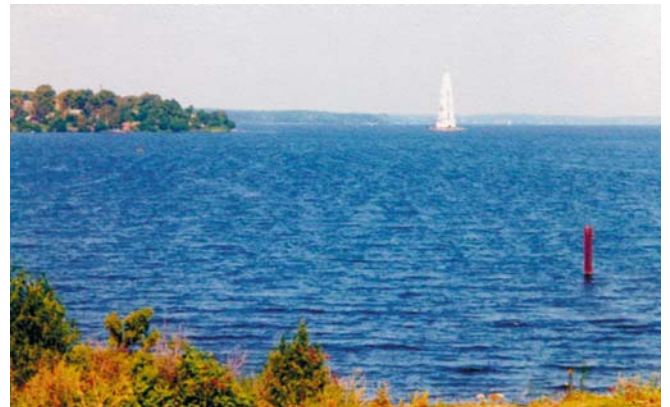
Fig. 46.8. The monastery bell tower surrounded by water in the center of the town of Kalyazin (the Uglich water reservoir)

The creation of a series of water reservoirs (Ivankovskoe, Uglich and Rybinskoe) has set off a number of geological processes in the area. A vast area with settlements and the architectural monuments was flooded by water from the reservoirs provoking a negative change in the environment. One particularly striking example of the dramatic changes that occurred is the monastery bell tower surrounded by water in the center of the town of Kalyazin (Fig. 46.8). The construction of the largest Rybinskoe Reservoir (Fig. 46.1) has caused a number of geological processes such as erosion, abrasion, and landslides. The maximum stretch of the water area of this reservoir is equal to 130 and 57 km from the NW to SE and from SW to NE, respectively; and more than half of it consists of shallow water up to 3–6 m in depth. In the village of Volkovo on left bank of the Rybinskoe water reservoir (Fig. 46.1), strong waves with the height of up to 2 m has been continuously destroying the shores. Figure 46.9 shows the result of only two summer storms, when the coast was reported to retreat by 8–10 m.

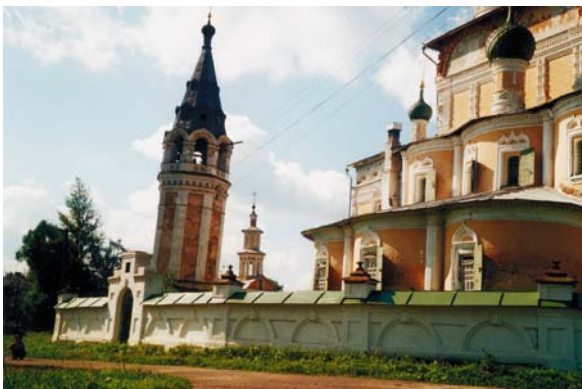
Fig. 46.6. The Resurrection Cathedral (seventeenth century, the town of Tutaev). Wall deformation and tilting of the bell tower

In the town of Tutaev, which is located on both banks of the Volga River approximately 40 km downstream of Rybinsk (Fig. 46.1), several landslides threatening the stability of two churches were observed. The Resurrection Orthodox Cathedral (seventeenth century), which is regarded as a masterpiece of the Yaroslavl architectural school, suffered significant deformation of one of the Cathedral's walls, and tilting of the bell tower (Fig. 46.6).

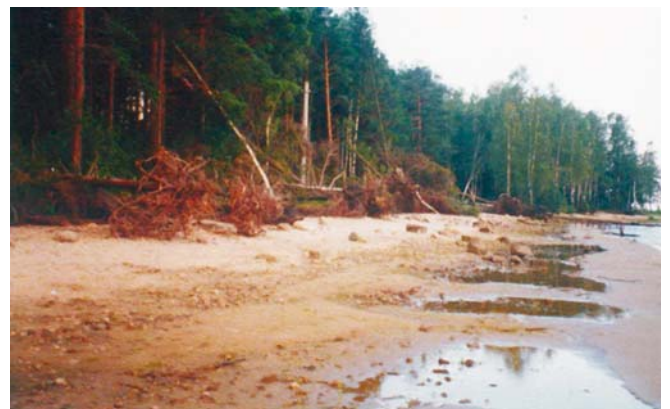
Fig. 46.9. The eastern bank of the Rybinskoe water reservoir (the village of Volkovo). The coastal destruction caused by storms
