V. Santiago-Fandiño
H. Tanaka
M. Spiske *Editors*

Tsunamis and Earthquakes in Coastal Environments

Significance and Restoration

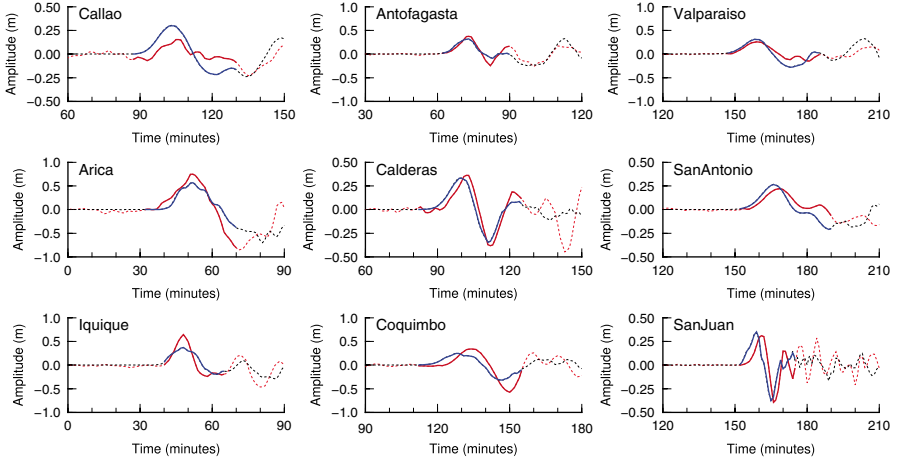
Fig. 1.3 Comparison of the recorded (*red*) and synthetic (*blue*) tsunami waveforms computed from the estimated slip distribution. The time intervals shown in solid lines were used for the inversion; *dashed lines* are shown only for comparison but those were not use in the source model estimation

The comparison of the recorded (red curves) and synthetic (blue curves) tsunami waveforms computed from the estimated slip distribution is shown in Fig. 1.3. In general, the synthetic waveforms agree with the observed data at stations located far from the source. Conversely, there is a 15 cm difference on the estimated maximum amplitude at Callao station. Although the maximum amplitude of Callao, Arica, and Iquique stations is not well reproduced, the phases are well estimated. The inversion results are shown in Table 1.1 and Fig. 1.4a. The total seismic moment was calculated from the slip distribution as 4.07×10^{21} Nm (M_w 8.3) using 4.0×10^{10} N/m² as average rigidity value in an elastic medium. The inversion result indicates that the maximum slip corresponds to the deepest subfaults (No. 9–10), near Camana beach. The land-level changes calculated from the slip distribution suggest a coastal subsidence of approximately 1.07 m near Camana beach (Fig. 1.4b) while GPS measurements estimated 0.84 cm of land subsidence at Camana (Ocola 2008).

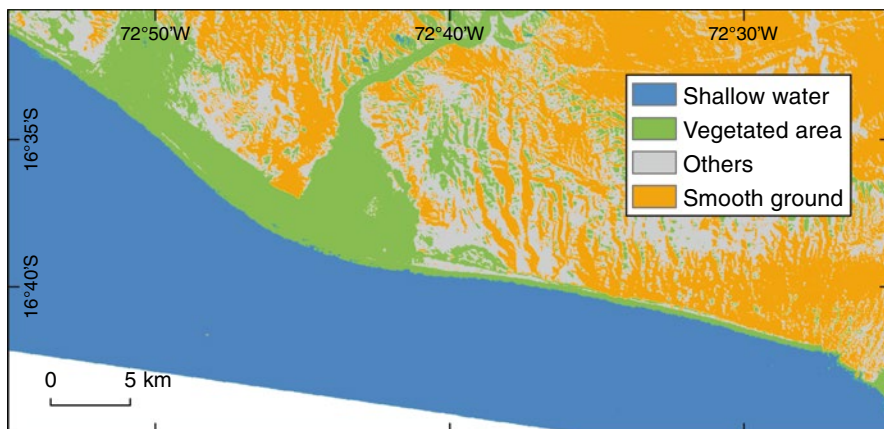
Fig. 1.6 Spatial distribution of roughness coefficient, according to the land-use condition, inferred from the unsupervised classification of pre-tsunami satellite imagery (Landsat-5 TM)

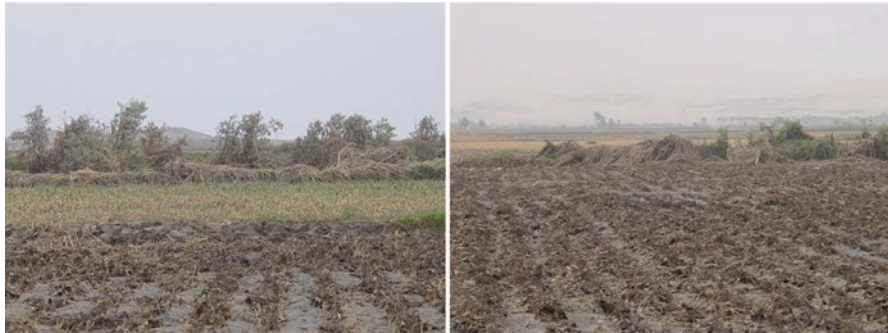
Fig. 1.10 Damage to crops near Playa Pucchun. Similar condition to farmlands along the Camana coast was reported by field survey reports. Salinization and damage to irrigation made difficult to restore vegetation in this areas

Figure 1.9 shows the multi-temporal comparison of the Landsat-5 TM imagery. The extension of the calculate inundation area is shown by the black line. The presence of healthy or unhealthy vegetation can be detected by applying the NDVI index to the temporal satellite images of the areas affected by the tsunami in Camana, as shown in Fig. 1.9. In addition, from optical satellite imagery it is possible to follow the changes on coastline shape and morphology of the area. In the case of Camana coast, from the image taken 1 year after the disaster, approximately 80.1 % of healthy vegetation area had been reduced, while between the two pre-disaster images (1999–2001) the difference in vegetation area in the same season is 2.2 %. Such high reduction of vegetation even 1 year after the disaster can be explained not only by the damage occurred to agricultural areas in June 2001, but also due to the sand deposition by tsunami as reported by Jaffe et al. (2003) which ruined crops with salinization of soil (Olcese 2004), as shown in Fig. 1.10.

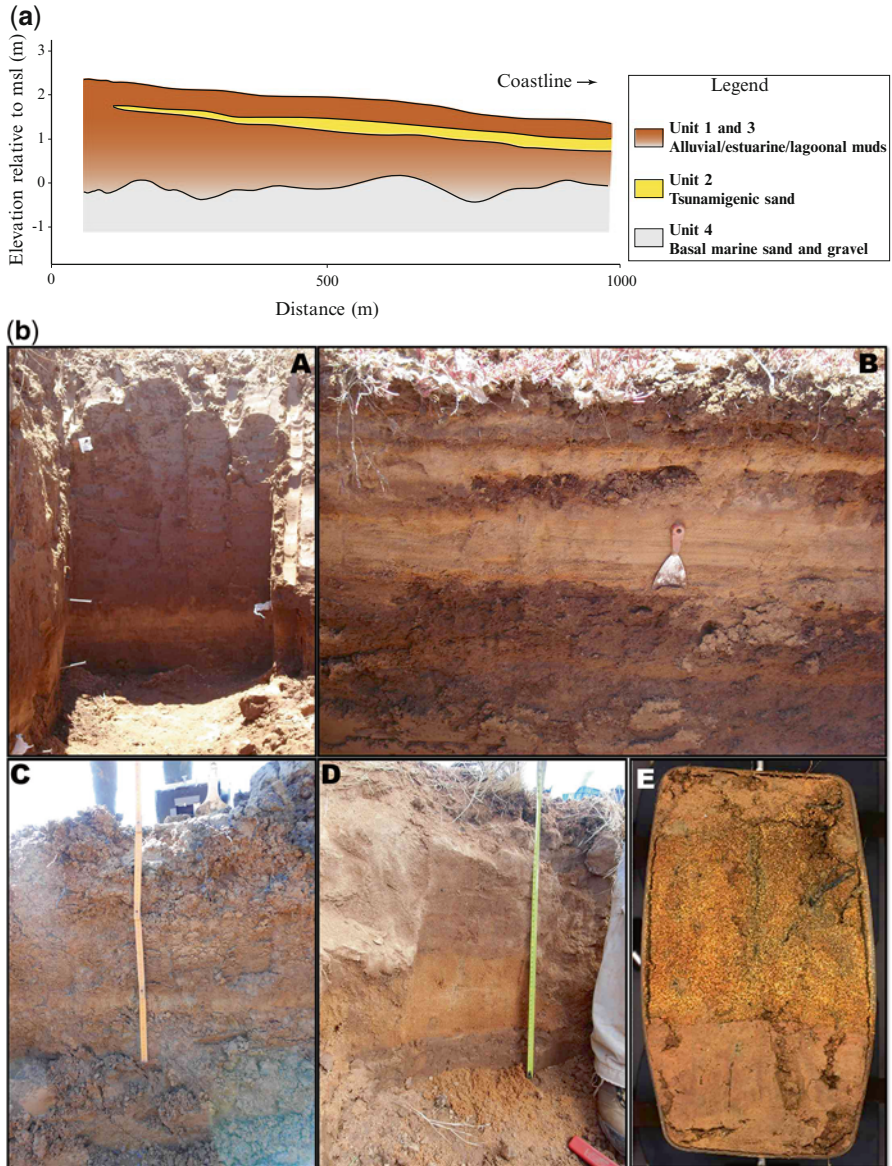
Fig. 2.4 (a) Schematic cross-shore profile showing major stratigraphic units characterizing the Late Holocene infill of the studied lowlands. (b) Sedimentological evidences of the AD1755 in lowlands of the Algarve. *A* Boca do Rio. *B* Martinhal. *C* Alcantarilha. *D* Salgados. *E* box core from Salgados. The vertical scale is app. 1 m for A, 0.30 m for E and app. 0.5 m for all the other images. Please note the contrasting texture of the sandy deposits and the low-energy framing (muddy) sediments. Please also note, that only in Martinhal the top of the sequence presents more than one sandy layer (for details please see discussion below)

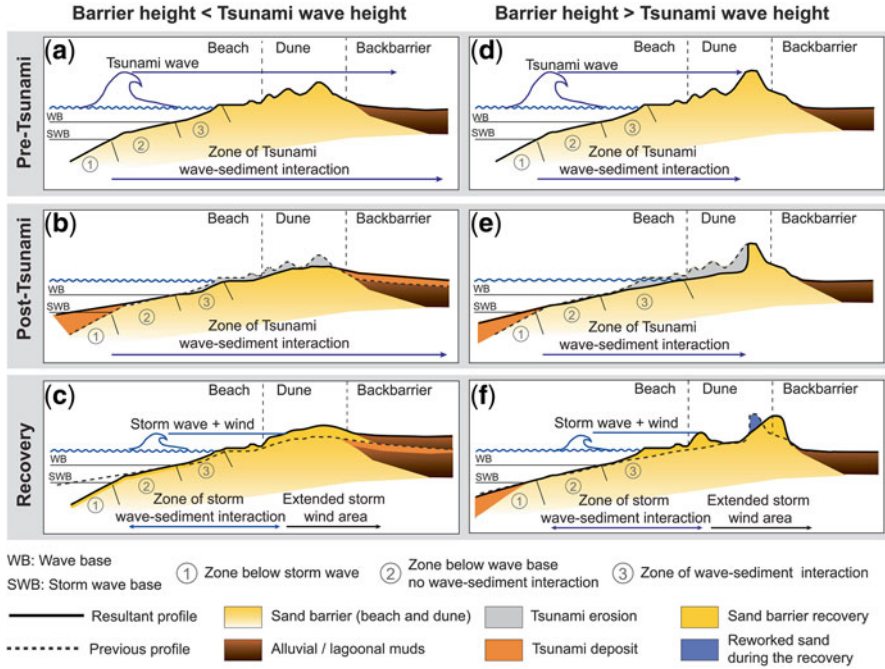
Fig. 2.5 Conceptual model of sand barrier recovery after a tsunami event assuming moderate sediment availability. Two possible scenarios during a tsunami event are considered: barrier height lower (a) and higher (d) than the tsunami wave height. The resultant profile after a tsunami event for each possible scenario is presented in (b) and (e). The recovery after a short geologic time is illustrated in (c) and (f)

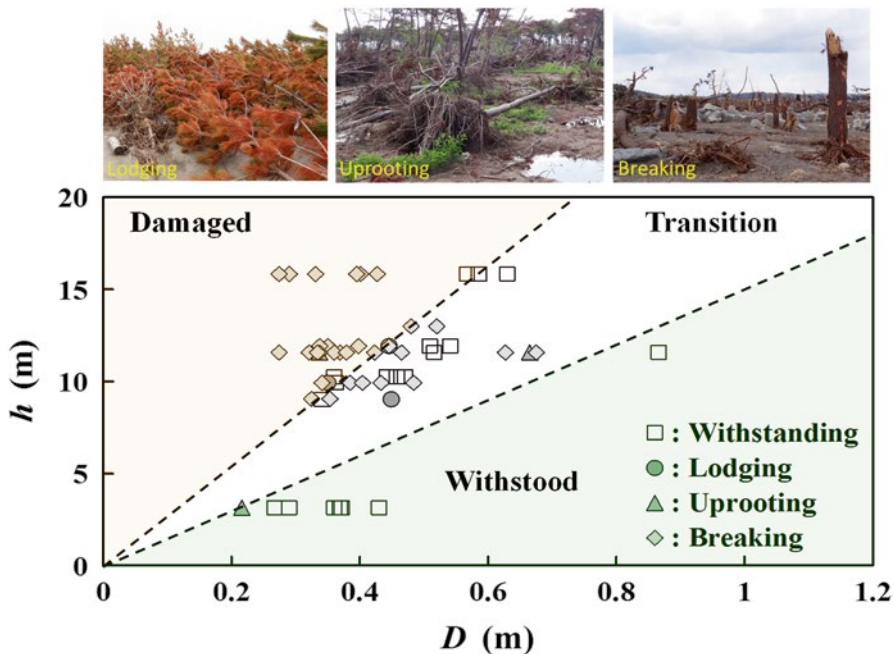
Fig. 3.3 Relationship between the trunk diameter D , inundation depth h and damage type of coastal black pine tree in the 2011 Tohoku tsunami (Matsutomi et al. 2012)

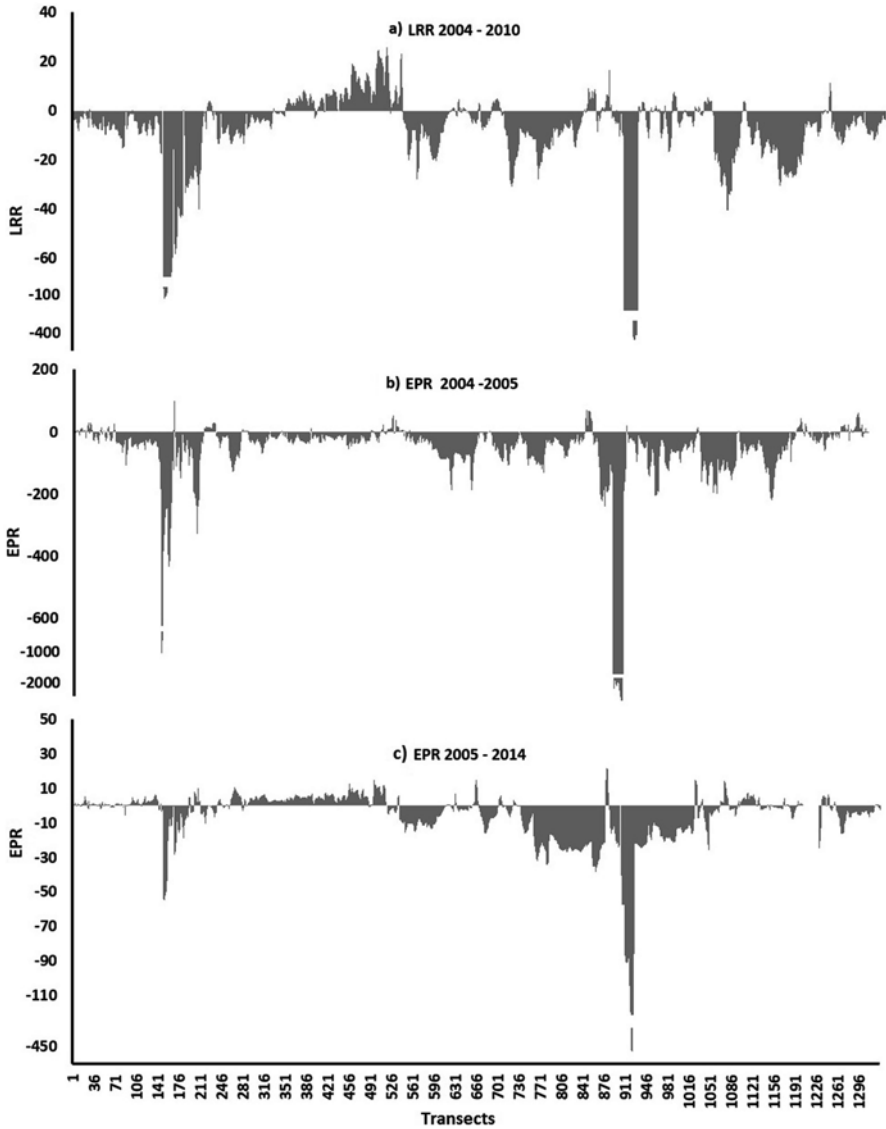
Fig. 5.6 (a), (b) and (c). Shore line rate change estimated for 1328 transects for Katchal Island. (a) Linear regression rate (LRR) for 2004–2010, (b) end point rate (EPR) between 2004 and 2005 and (c) EPR between 2005 and 2014

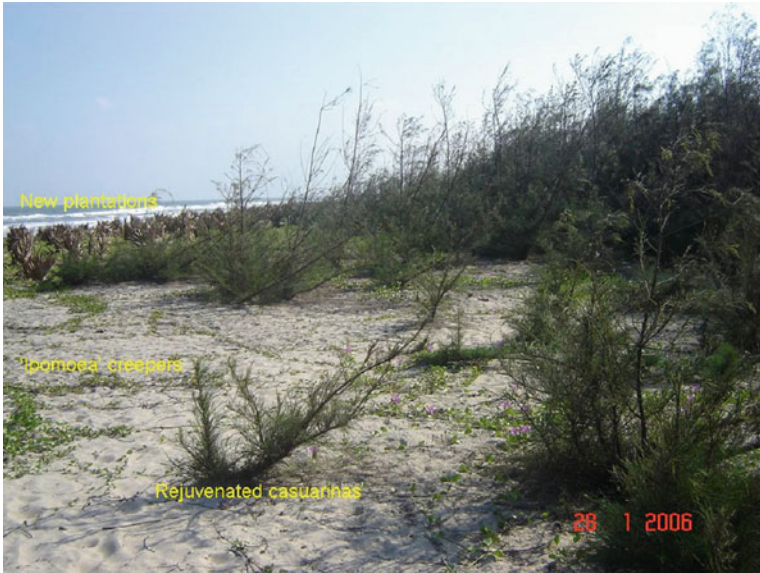
Fig. 7.4 Beach region at Nanjalampettai showing a prominent sand dune with dense vegetation. The village behind this dune was not damaged by tsunami

The coast at Nanjalampettai (Fig. 7.4) is characterized by prominent sand dunes more than 5 m high and very steep seaward gradients as seen in the beach profile. Luxuriant casuarina forests interspersed with dense coconut groves characterize coastal vegetation along this region. As determined by our surveys, the wave up-rush was as high as 3.7 m. It is evident that the wave stopped at the dune, the dune crest being higher. Casuarina plantations that mark this area further aided a complete attenuation of the wave onslaught. The dense vegetation provided the requisite obstruction to the tsunami flow thereby dissipating its energy and stopping the tsunami flow further inland.

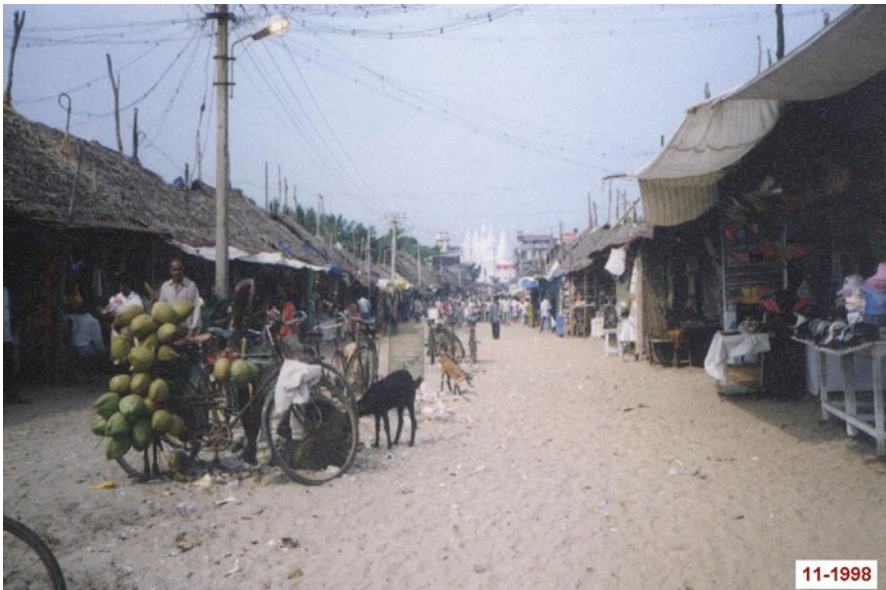
Fig. 7.5 Photo of a flat beach at Velangani that is continuously overused (Note that the huts and temporary huts have existed at this pilgrimage site for a long time (since 1998 at least), as seen in the accompanying photograph. These structures were wiped off in totality. Loss of life was very high)

Before the tsunami, the entire coastal strip, right up to the beach, was occupied by dense make-shift structures occupied by a large fishing community (Fig. 7.5). This strip was probably a dune field, but no evidence is found at present. Coastal geomorphology was obliterated, as sand dunes were flattened in favour of houses. Here, the wave run-up of 3.9 m bypassed the flat beach thus razing whatever came its way. As they lacked natural protection, all the structures were smashed.

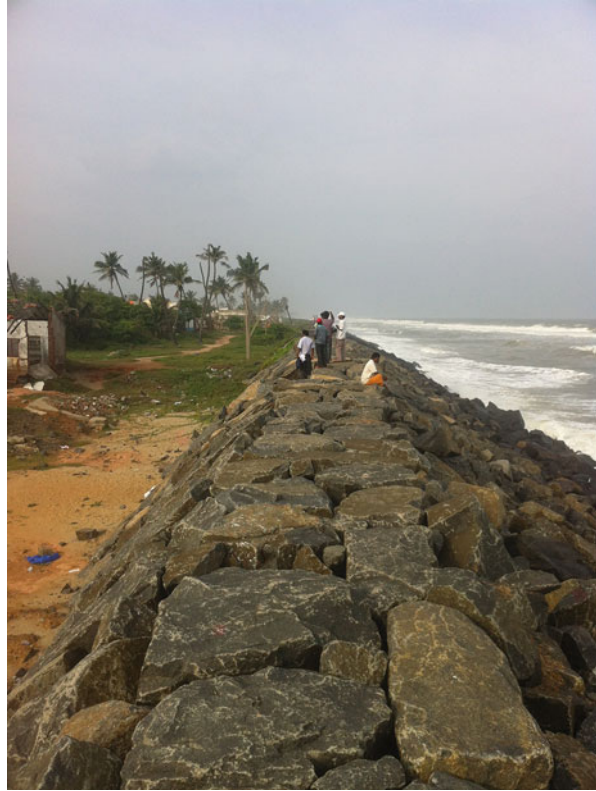
Fig. 7.6 Beach profiles at Thevanampattinam, one of the sites where post tsunami measurements were carried out. The arrow indicates the location of shore protection structure placed on the beach. The site can no longer be used for beach profile studies (Profiles source: Jaya Kumar et al. 2008)

Fig. 7.7 Photo of the beach at Thevanampattinam (December 2013) is now occupied by a rubble mound sea wall. The approximate location of the sea wall is marked on the profile (Note that no beach is visible along the sea wall even at low tide)

Despite scientific research that is available, and without giving a thought to the consequences of erosion control measures, the coastal authorities went about building sea walls as a tsunami protection option. Massive rubble mound shore parallel structures now occupy long stretches of Tamil Nadu coast. By placing the rubble mound shore parallel seawall for coastal protection, the coastal erosion problem is given a boost instead of alleviating it. Hard protection measures have been shown to increase erosion along the coast causing problems on the down drift side of the sediment transport region. Hard protection measures in the inter-tidal region have been shown to increase erosion along the coast causing problems on the down drift side of the sediment transport region (e.g. Pilkey and Wright 1988; Krauss and McDougal 1996). The effect of seawalls on the beaches is not immediately felt in this region, as it is seen that the effects of seawalls on the coast is a long term feature. Figure 7.5 shows the positioning of a 2.5 m high rubble mound sea wall at Thevanampattinam. As a consequence, coast seems to have lost its sand as no beach is visible even at low tide as can be confirmed from the accompanying photograph (Figs. 7.6 and 7.7).

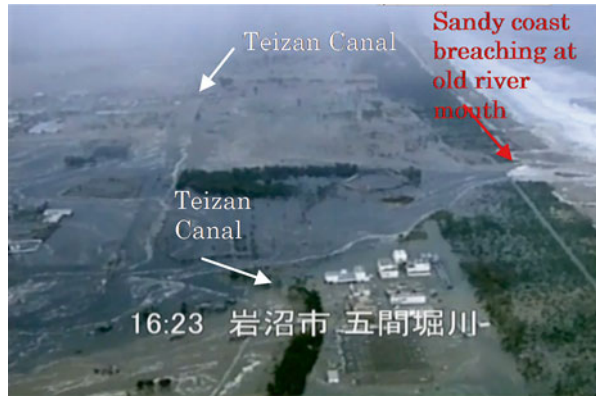
Fig. 9.3 Breaching at Arahama

The study area focusing on Arahama and Akaiko coastlines is shown in Fig. 9.1. Both locations were greatly affected by the 2011 tsunami although most of their shorelines remained relatively unharmed even though breaching occurred in some places. Figure 9.2 shows a video snapshot, captured from a helicopter during the tsunami at Akaiko where it becomes clear that a very strong return flow occurred through the canal also causing breaching on the sandy coastline. Satellite images, captured immediately after the tsunami shows the local breaching due to the tsunami at Arahama and Akaiko (Figs. 9.3 and 9.4 respectively). It is estimated that the breaching width at Arahama was approximately 50 m while the one at Akaiko 130 m approximately.

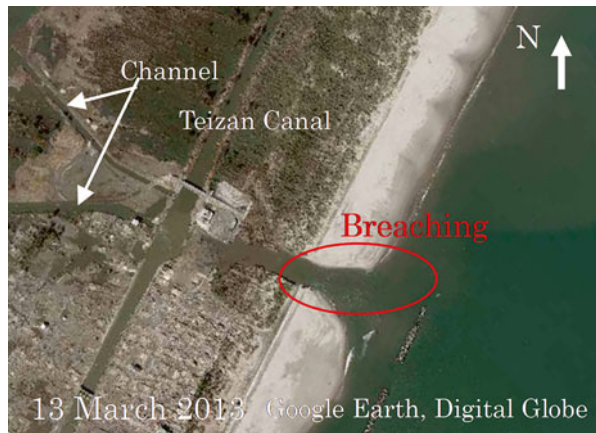
Fig. 9.4 Breaching at Akaiko

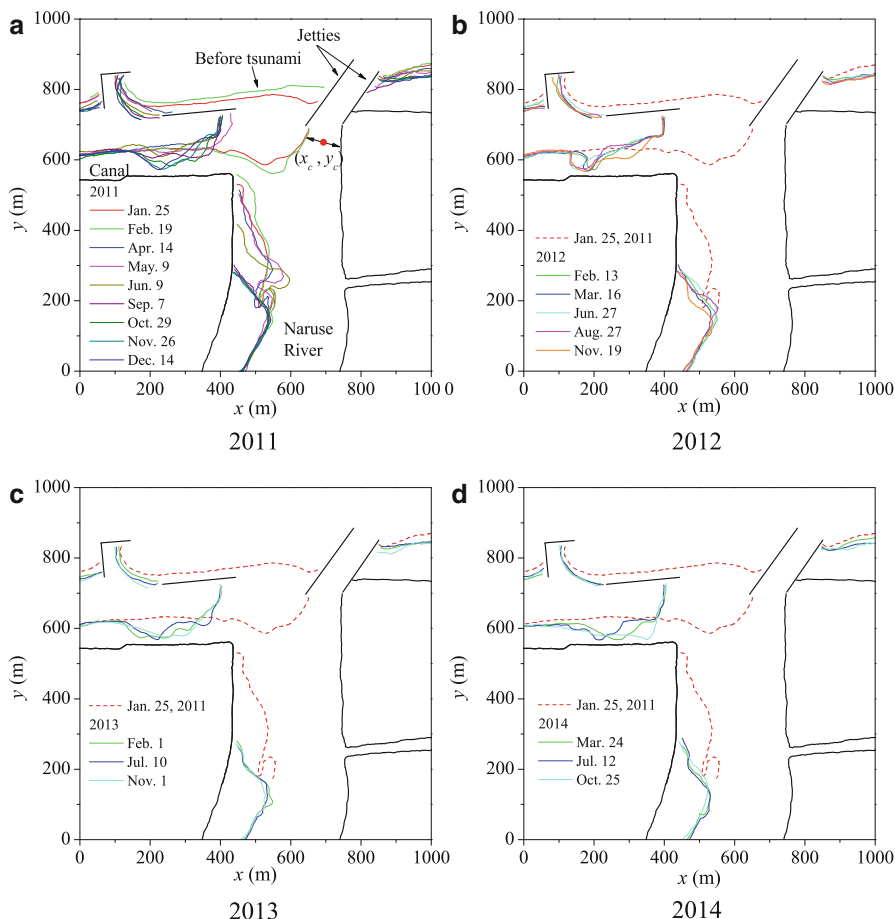
Fig. 10.5 Naruse River mouth changes from 2011 to 2014 by analyzing aerial photographs

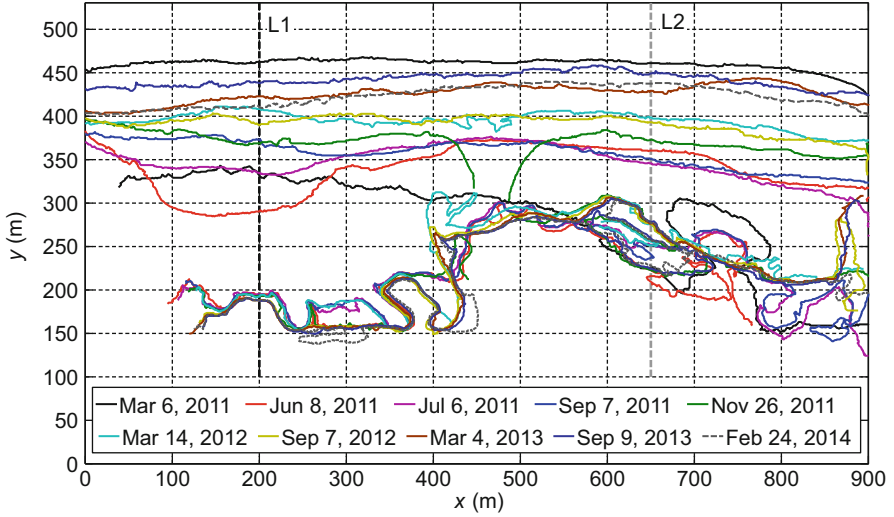
Fig. 11.3 Changes of shoreline and waterline positions at Gamo Lagoon (Origin of coordinates in this figure is represented in Fig. 11.2a)

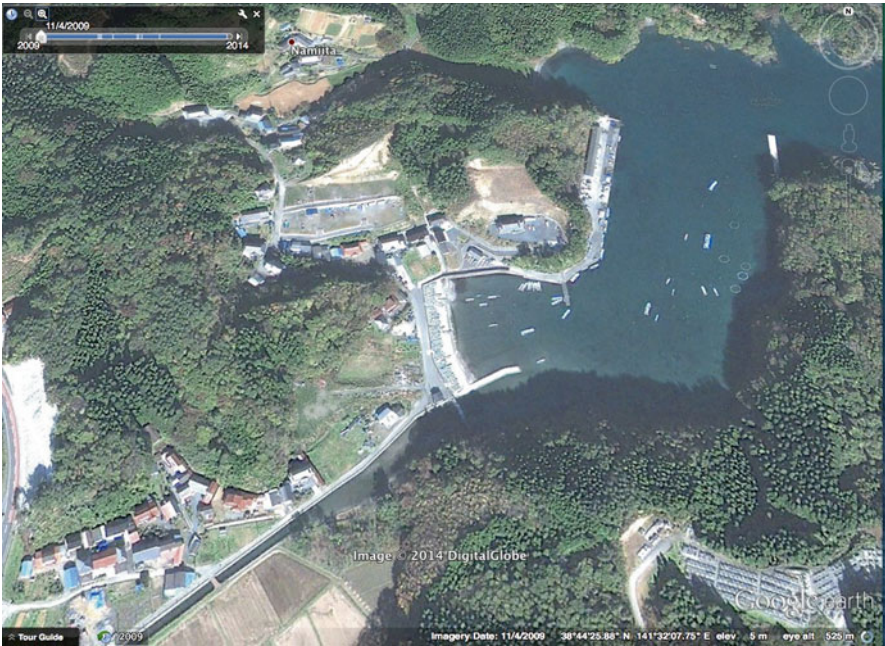
Fig. 12.3 Minatogawa Bay and Port as seen in 2009. The largely modified river and estuary, rice fields and forested hills can be easily identified. Source: Google Map

For many years as result of the implementation of a use and protection rivers policy (Godou 2010), the river and estuary have gone through urbanization, land reclamation, embankment construction, revetment installations and canalization (Fig. 12.3) all impinging on natural sedimentation and land-water interactions, including nutrient exchange and natural purification in the ecotone and riparian environments. Clilverd (2015) has shown that embankments and river canalization produce extensive ecological degradation in rivers throughout the world.

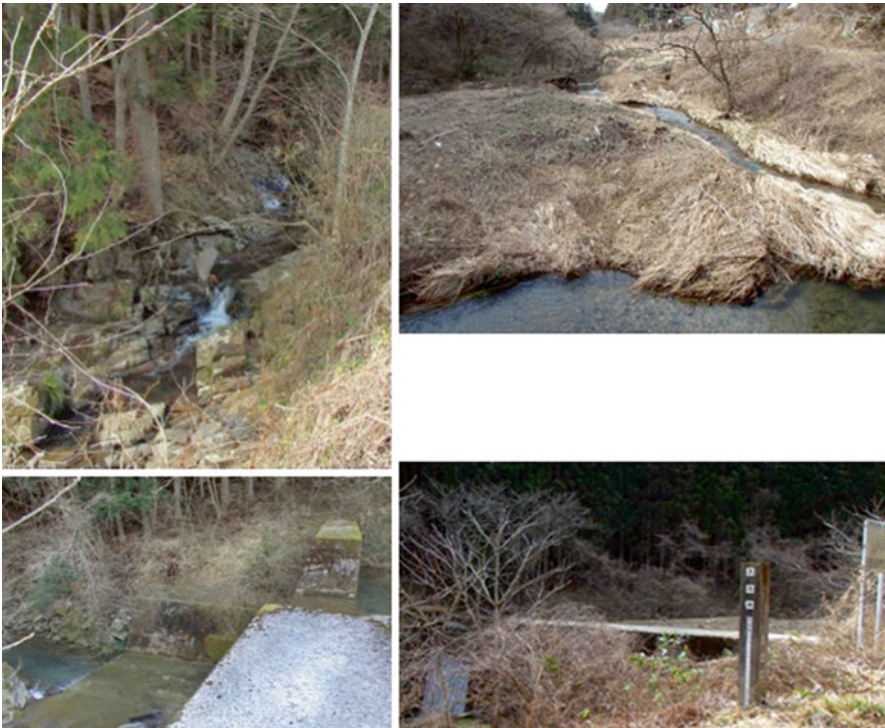
Fig. 12.4 Early Minatogawa River uppershed sediment control dam

A small dam to control sediment and energy flow in Minato River was built 52 m above sea level and 1.8 km from its source in the Nana-une Mountains. This structure also serves as the divide between the upper and lower watersheds (Figs. 12.4 and 12.6).

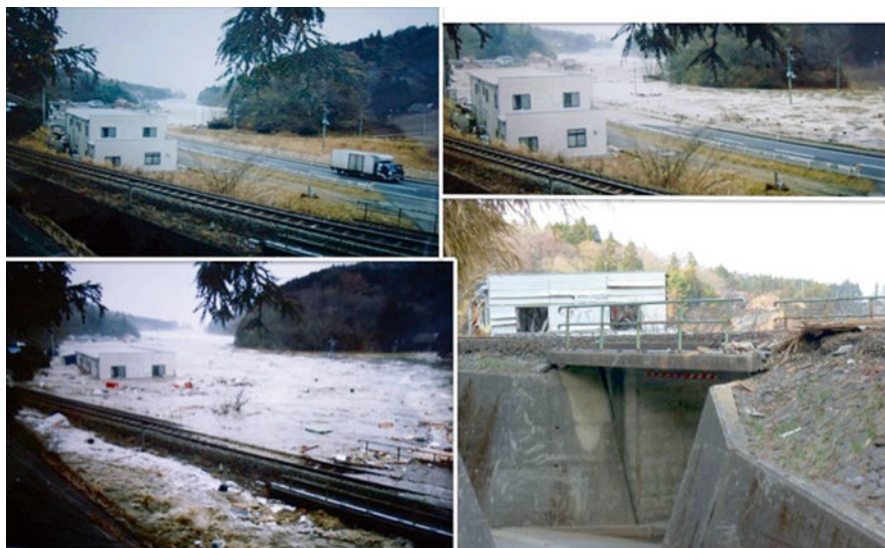
Fig. 12.5 First tsunami wave flowing through the Minatogawa River reaching Route 45 (photos provided by a local citizen), and the 3 m fully submerged underpass

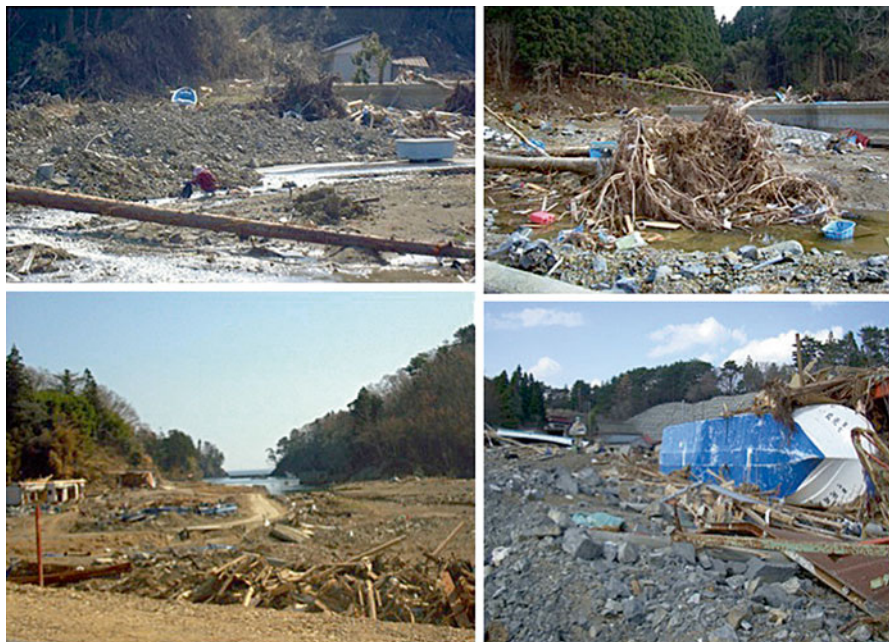
Fig. 12.8 Minatogawa River degradation along the lowershed and estuary a month after the tsunami stroke

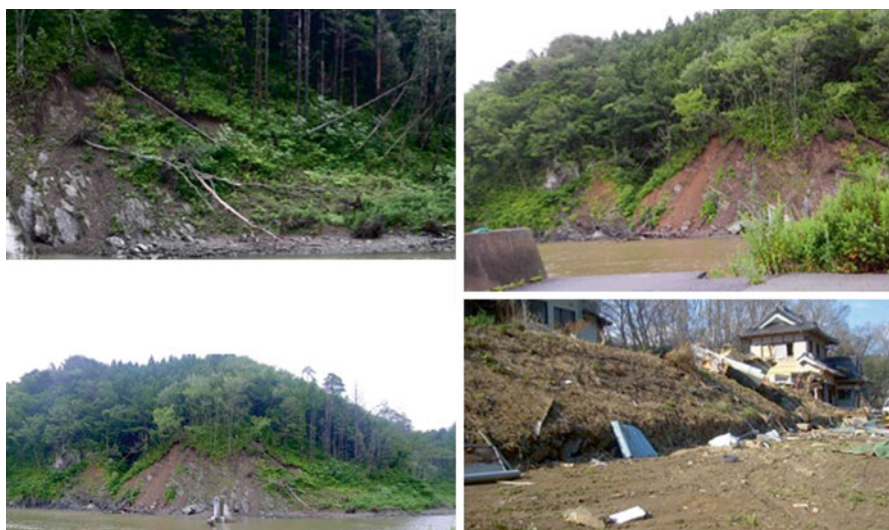
Fig. 12.9 Landslides and ground sinking along the Minatogawa River lowershed

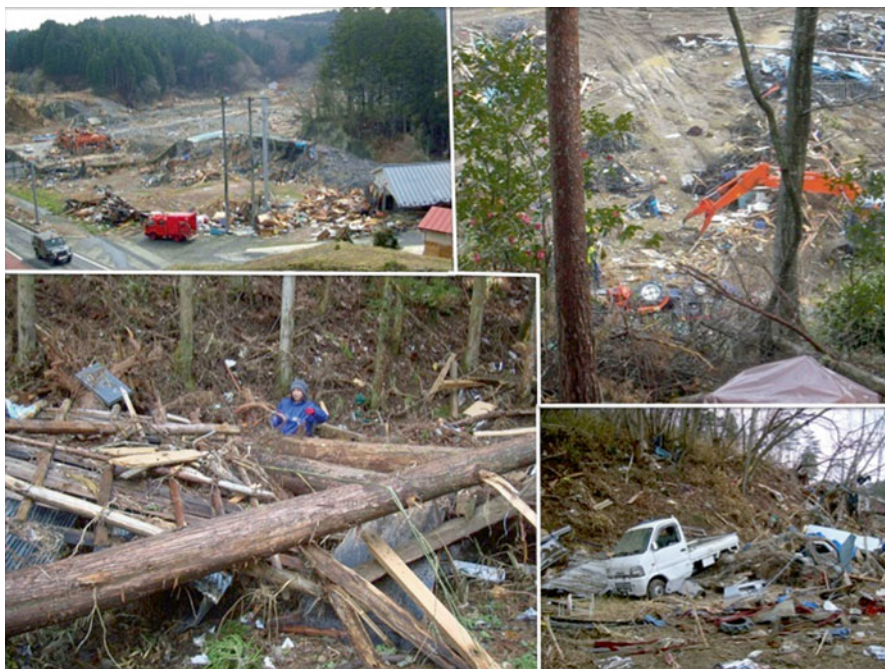
Fig. 12.14 Early debris cleanup works along the Minatogawa River and effluents

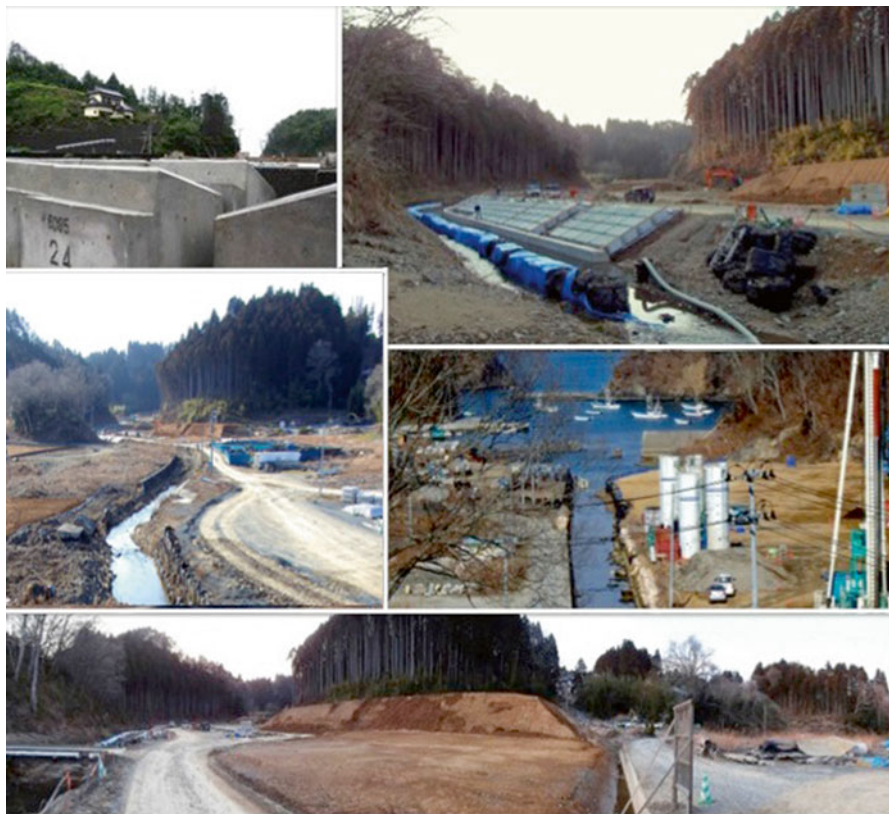
Fig. 12.16 Levee construction as of March 2015. Wide roads, concrete slabs, construction and drilling equipment as well as soil mounds are common sightings along the Minatogawa River shores

Levee construction started in late 2014 (Fig. 12.16) and expected to be finished by the end of 2015 or early 2016. The structure incorporates two embankments and

two sluice gates to control the water flow. One embankment will be 930 m long with a smaller one of only 660 m.

Both embankments will have a height of 9.80 m for the first 412 m from the river mouth and be reduced to 5.6 m thereafter to the end. The width of both structures will vary between 15 and 55 m (MPG 2014). Moreover, to facilitate the river's discharge its course will be straightened in some sections by the levee's design.

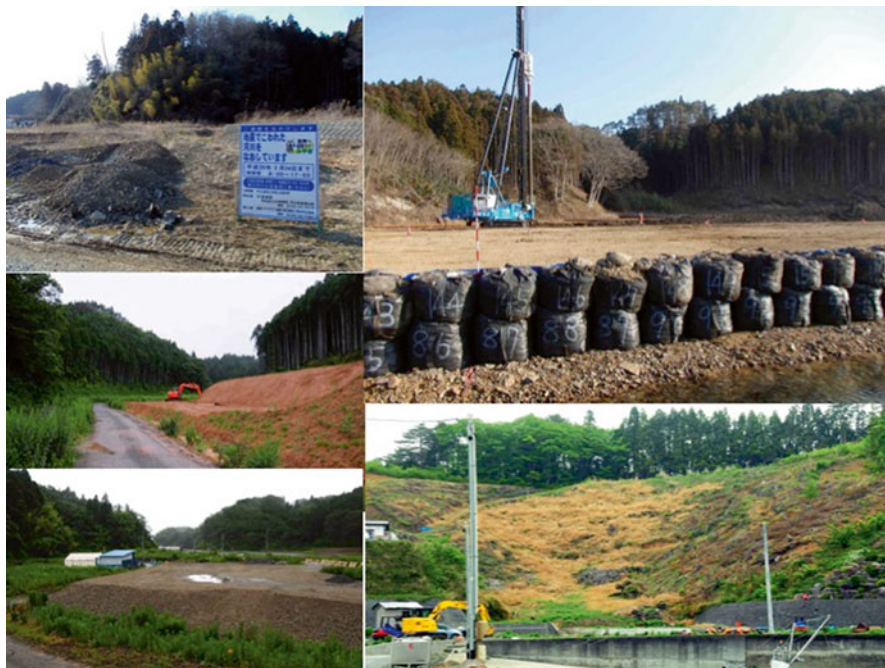
Fig. 12.17 Environmental degradation along the river caused by levee construction and housing relocation including soil compacting, forest clearance and shores alteration

2015. Likewise, reallocation work to build new housing in the nearby hills, forest clearance and the construction of a few local new roads is taking place (Fig. 12.17).
