CONCRETE SOLUTIONS

Concrete Solutions

The Concrete Solutions series of International Conferences on Concrete Repair began in 2003 with a conference held in St. Malo, France in association with INSA Rennes. Subsequent conferences have seen us partnering with the University of Padua in 2009 and with TU Dresden in 2011. This conference is being held for the first time in the UK, in association with Queen's University Belfast and brings together delegates from 36 countries to discuss the latest advances and technologies in concrete repair.

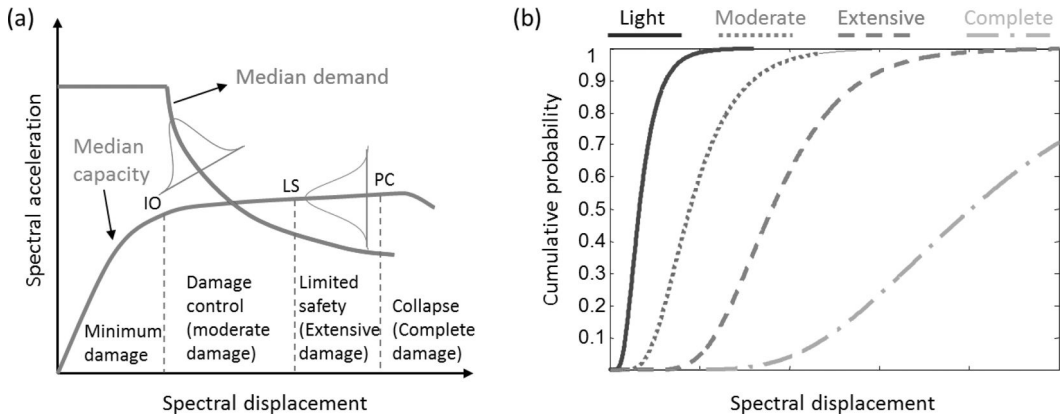
Figure 13. Uncertainties in the demand and capacity spectra (a) and sample fragility curves for different damage states.

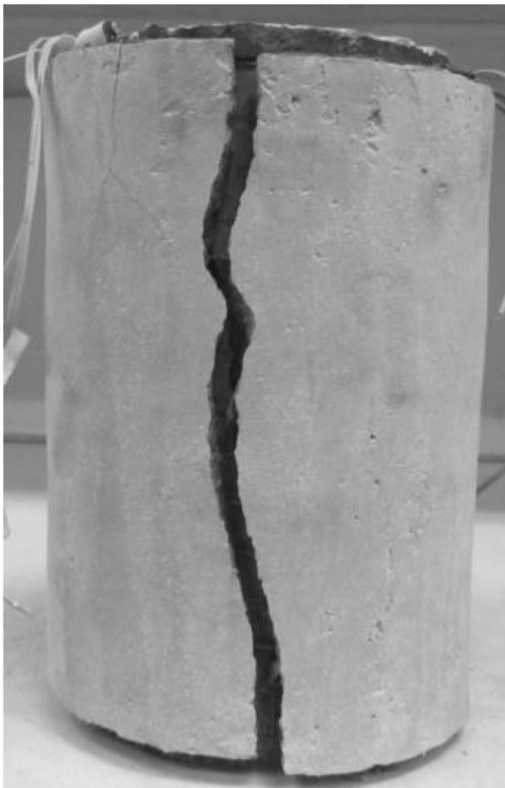
Figure 7. Typical failure mode of jacketed specimen.
