Durability Design of Concrete Structures in Severe Environments

Second Edition

Odd E. Gjrv

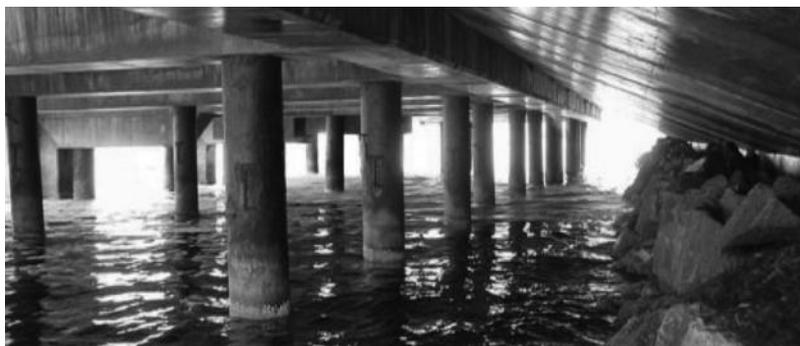
Figure 1.2 Open concrete structures are still the most common type of harbor structures built along the Norwegian coastline.

Gundersen came back to Norway and became the director of the new contracting company AS Høyér-Ellefsen, his newly patented method for underwater placement of concrete became the basis for the construction of a new generation of piers and harbor structures all along the rocky shore of the Norwegian coastline (Gjørsv, 1968, 1970). These structures typically consist of an open reinforced concrete deck on top of slender, reinforced concrete pillars cast under water. Although the underwater cast concrete pillars were gradually replaced by driven steel tubes filled with concrete, this open type of concrete structure is still the most common type of harbor structure being constructed along the Norwegian coastline (Figure 1.2).

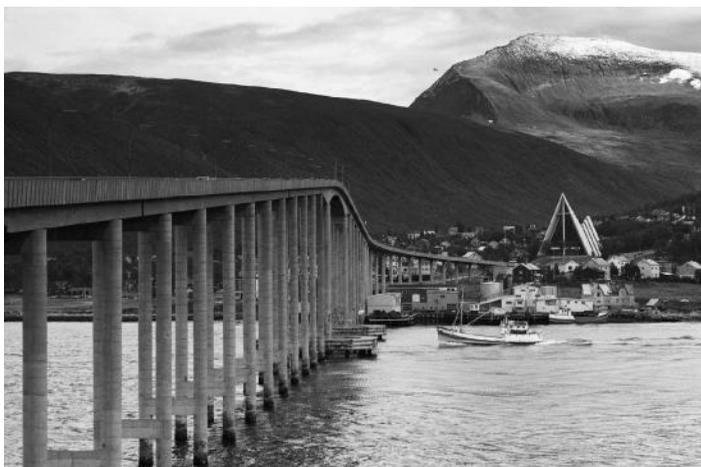
Figure 1.4 The Tromsø Bridge (1960) is a cantilever bridge with a total length of 1016 m. (Courtesy of Johan Brun.)

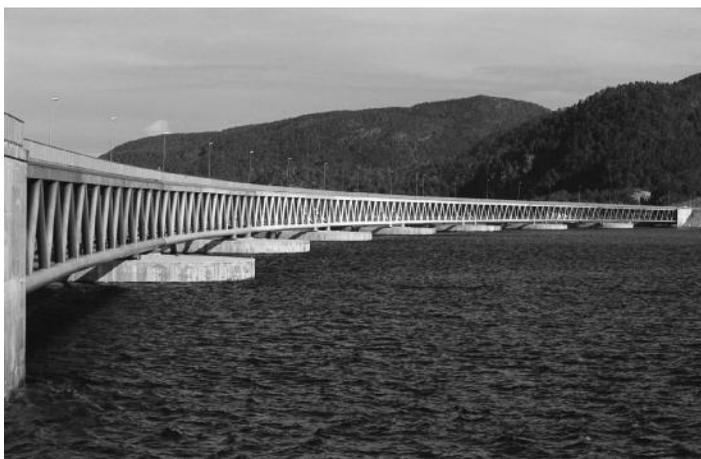
Figure 1.5 The Bergsøysund Bridge (1992) is a floating bridge with a total length of 914 m. (Courtesy of Johan Brun.)

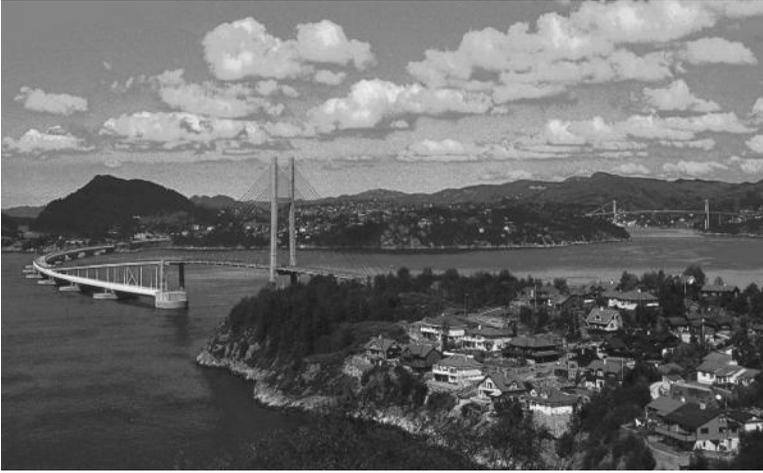
Figure 1.6 The Nordhordlands Bridge (1994) is a combined floating and cable-stayed bridge with a total length of 1610 m. (Courtesy of Johan Brun.)

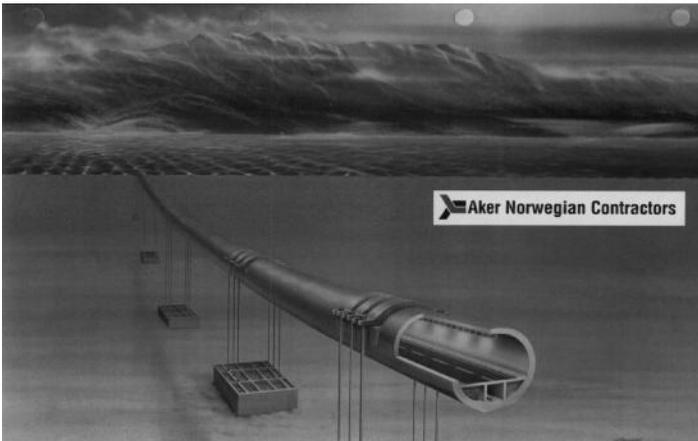
Figure 1.7 One of several designs studied for possible strait crossings by use of submerged tunnels. (Courtesy of the Norwegian Public Roads Administration.)

Due to its very long and broken coastline with many fjords and numerous inhabited islands, Norway has a long tradition on the use of concrete as a construction material in marine environments (Figure 1.3). For many years, this primarily included concrete harbor structures. Gradually, however, concrete also played an increasing role as a construction material for other applications, such as strait crossings (Klinge, 1986; Krokeborg, 1990, 1994, 2001). In addition to conventional bridges (Figure 1.4), new concepts for strait crossings such as floating bridges (Figure 1.5 and 1.6) emerged (Meaas et al., 1994; Hasselø, 2001). Even submerged concrete tunnels have been the subject for detailed studies and planning; one of several types of design is shown in Figure 1.7 (Remseth, 1997; Remseth et al., 1999).

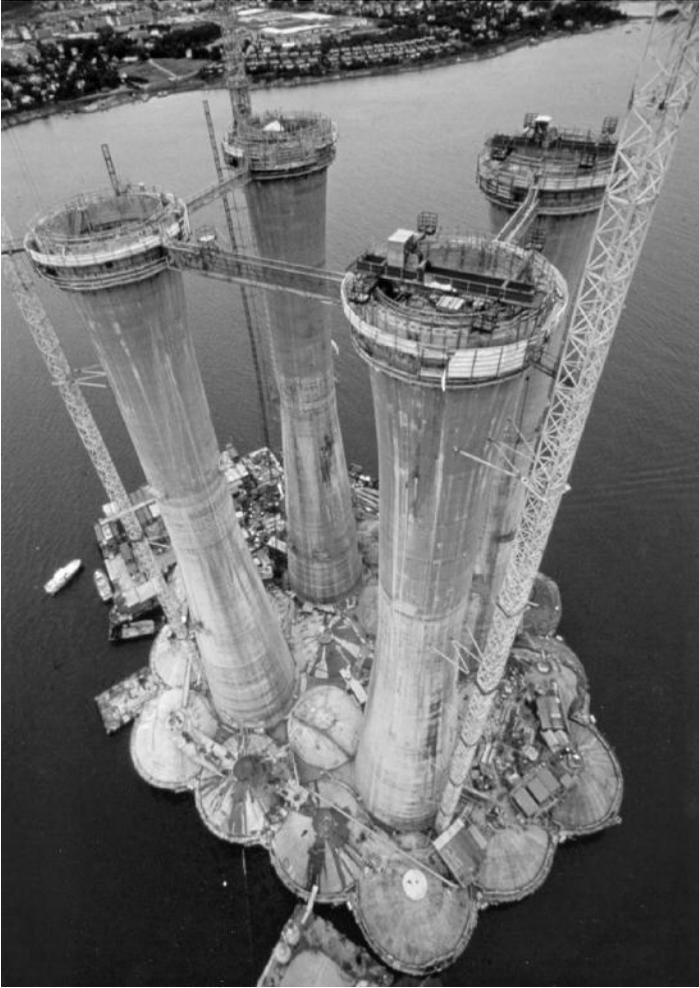
Figure 1.9 The Gullfaks C Platform (1989) during construction in Stavanger. (Courtesy of Norwegian Contractors.)

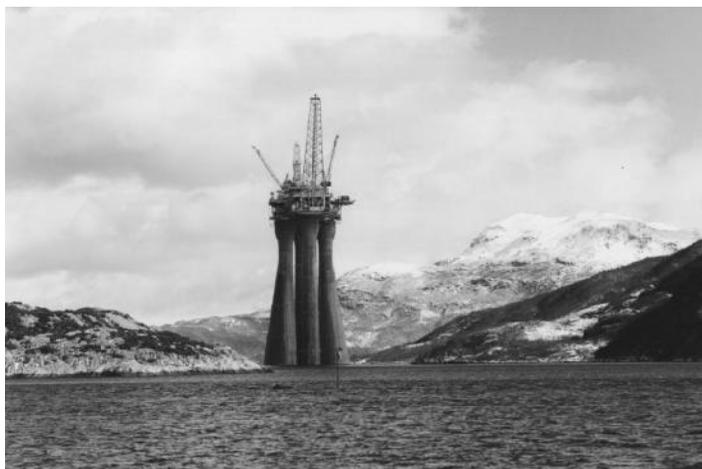
Figure 1.12 After production in one of the deep Norwegian fjords, the Troll A Platform was ready for towing out to the North Sea in 1995. (Courtesy of Jan Moksnes.)

which is taller than the Empire State Building in New York; the artistic view in Figure 1.11 demonstrates the size of the structure. After production in one of the deep Norwegian fjords (Figure 1.12), the Troll A Platform, containing 245,000 m³ of high-strength concrete, 100,000 t of reinforcing steel, and 11,000 t of prestressing steel, was moved out to its final offshore destination, and this operation was the biggest movement of a man-made structure ever made (Figure 1.13). In 1995, the Heidrun Platform was also installed in deep water at a depth of 350 m, but this structure was a tension leg floating platform consisting of lightweight concrete with a design strength of 65 MPa. For the design, detailing, and construction of all these offshore concrete structures, high safety, durability, and serviceability were the subjects of greatest attention and importance.

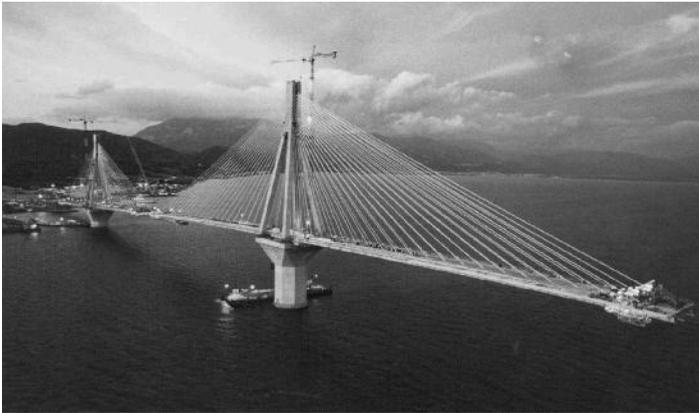
Figure 1.14 The Rion–Antirion Bridge (2001), for which a concrete with an extremely high resistance against chloride ingress was applied. (Courtesy of Gefyra S.A.)

has taken place. As a result, new concrete structures with improved and more controlled durability and service life can now be produced. Thus, for the most exposed parts of the Rion–Antirion Bridge, which was constructed in the southern part of Greece in 2001 (Figure 1.14), concrete with an extremely high resistance to chloride ingress was applied, giving a very high safety against steel corrosion. This type of concrete, which was based on a blast furnace slag cement with a high slag content, showed a 28-day chloride diffusivity of $0.8\text{--}1.2 \times 10^{-12} \text{ m}^2/\text{s}$ according to the rapid chloride migration (RCM) method (NORDTEST, 1999), with achieved values for

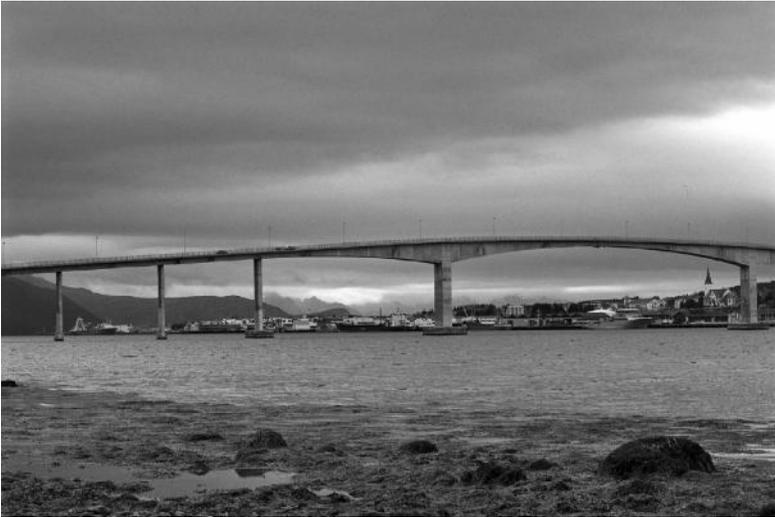
Figure 2.1 The Sortland Bridge (1975) is a 948 m long cantilever bridge in the northern part of Norway. (Courtesy of Johan Brun.)

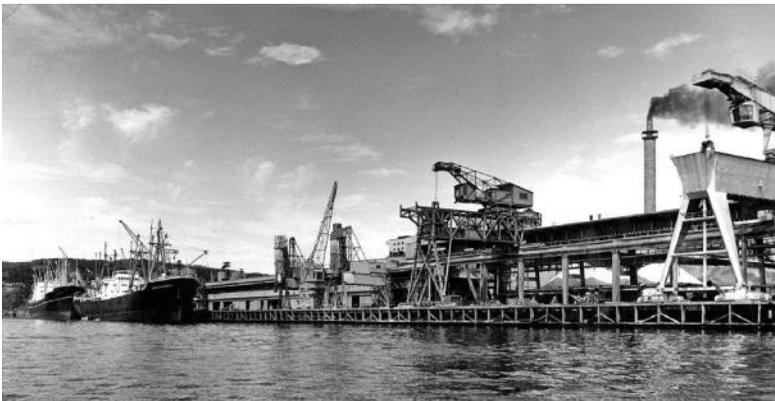
Figure 2.3 A typical industrial concrete harbor structure. (From Gjørnv, O. E., *Durability of Reinforced Concrete Wharves in Norwegian Harbours*, Ingeniørforlaget AS, Oslo, Norway, 1968.)

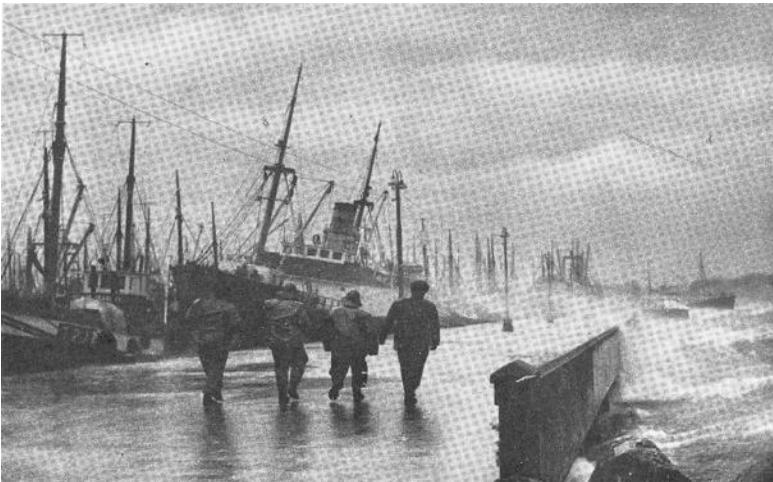
Figure 2.5 Concrete harbor structures along the Norwegian coastline are exposed to the most severe marine environment. (Courtesy of B. SkarbØvik.)

The overall condition of all the concrete harbor structures investigated was quite good. Even after service periods of up to 50–60 years, the structures still showed a high ability to withstand the combined effects of the most severe marine exposure (Figure 2.5) and heavy structural loads. Thus, one of the industrial harbor structures investigated was observed with storage of raw aluminum bars evenly distributed all over the deck, as shown in

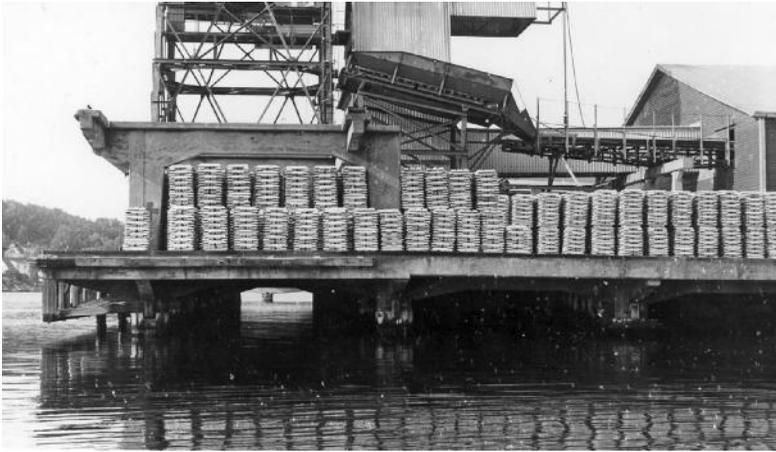
Figure 2.6 A 50-year-old industrial harbor structure (1913) with storage of raw aluminum bars representing an evenly distributed deck load of approximately six times that of the original design load. (From Gjørsv, O. E., *Durability of Reinforced Concrete Wharves in Norwegian Harbours*, Ingeniørforlaget AS, Oslo, Norway, 1968.)

Figure 2.6; this particular deck load was approximately six times that of the original design load. Apart from severe corrosion in all the deck beams, no special sign of any overloading was observed on this 50-year-old concrete harbor structure.

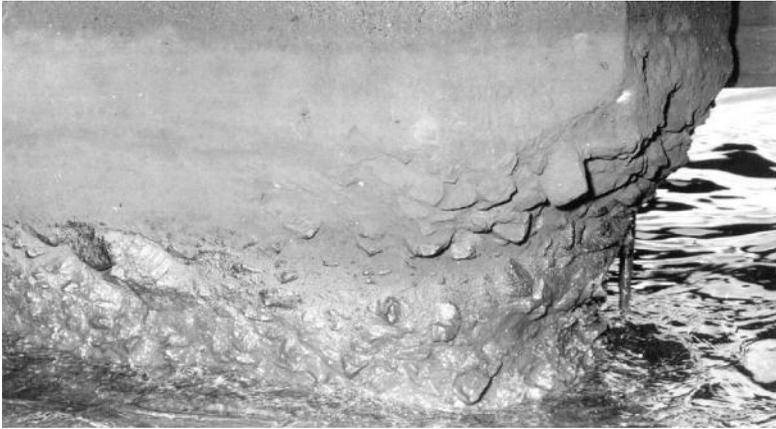
Figure 2.7 Deterioration in the tidal zone mostly due to freezing and thawing. (From Gjrrv, O. E., *Durability of Reinforced Concrete Wharves in Norwegian Harbours*, Ingenirforlaget AS, Oslo, Norway, 1968.)

observed. Within the tidal zone of the structures, only 35- to 40-year-old structures exhibited some concrete pillars with cross-sectional reductions of more than 20%, mostly due to freezing and thawing (Figure 2.7). Above water, only 35- to 40-year-old structures had deck beams severely weakened due to steel corrosion, while on the whole, both the deck slabs and the rear walls behaved much better.

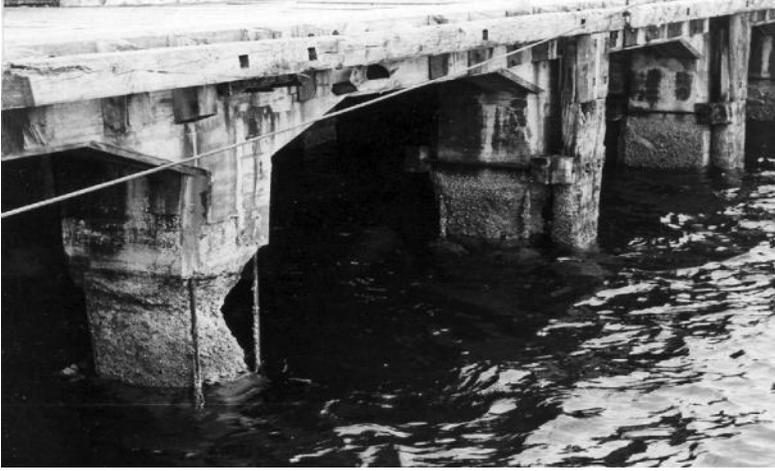
Figure 2.9 Uneven deterioration in the tidal zone due to high scatter and variability of achieved concrete quality from one pillar to another. (From Gjørnv, O. E., *Durability of Reinforced Concrete Wharves in Norwegian Harbours*, Ingeniørforlaget AS, Oslo, Norway, 1968.)

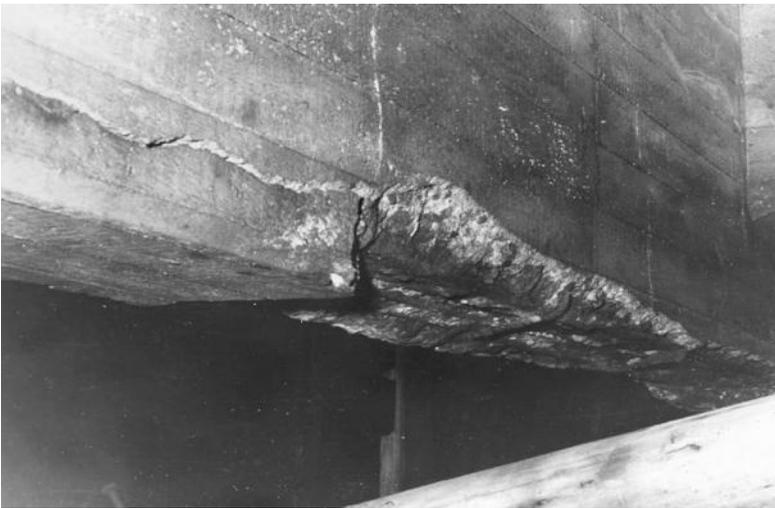
Figure 2.10 The lower parts of the deck beams were typically more vulnerable to steel corrosion than the deck slabs in between. (From Gjørnv, O. E., *Durability of Reinforced Concrete Wharves in Norwegian Harbours*, Ingeniørforlaget AS, Oslo, Norway, 1968.)

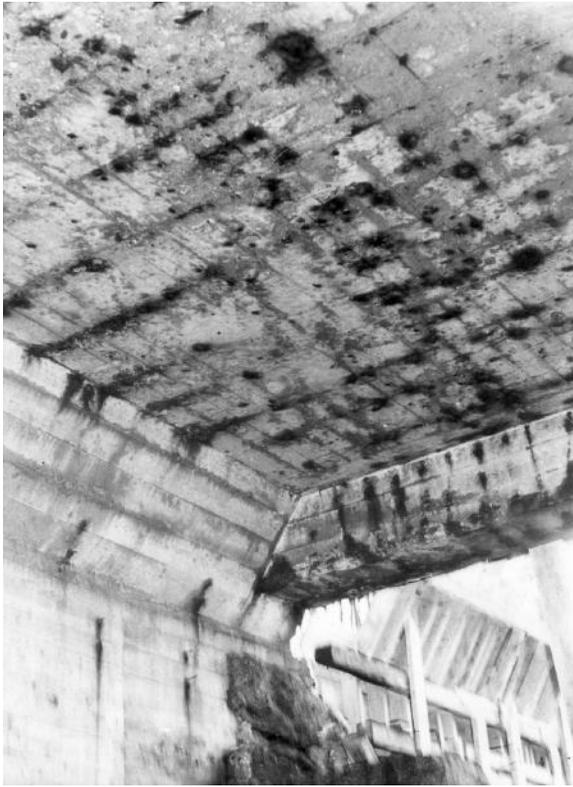
Figure 2.11 The rear parts of the concrete deck adjacent to the seawall were typically more vulnerable to steel corrosion than the rest of the deck. (From Gjørsv, O. E., *Durability of Reinforced Concrete Wharves in Norwegian Harbours*, Ingeniørforlaget AS, Oslo, Norway, 1968.)

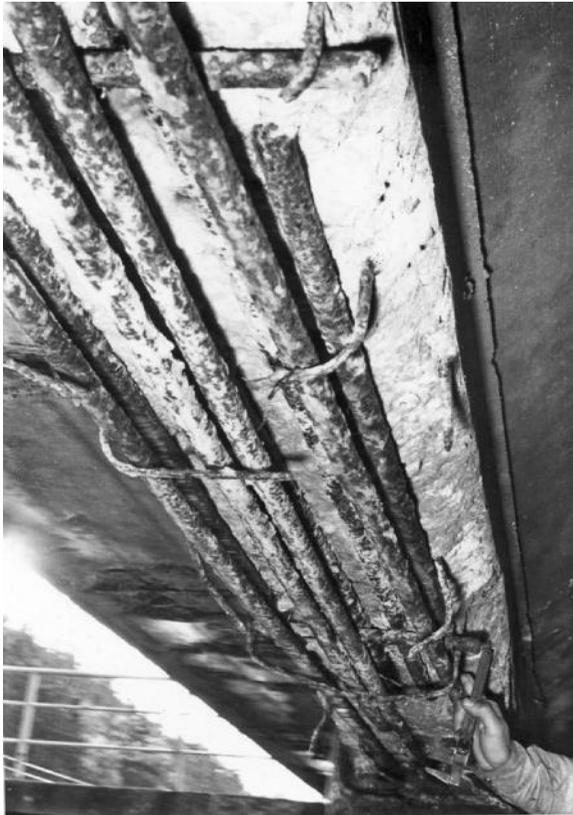
Figure 2.12 When the concrete cover in the lower parts of the deck beams had cracked or spalled off at a very early stage, the steel bars were more uniformly corroded, while the vertical beam stirrups typically showed a more severe pitting and were often rusted through. (From Gjørnv, O. E., *Durability of Reinforced Concrete Wharves in Norwegian Harbours*, Ingeniørforlaget AS, Oslo, Norway, 1968.)

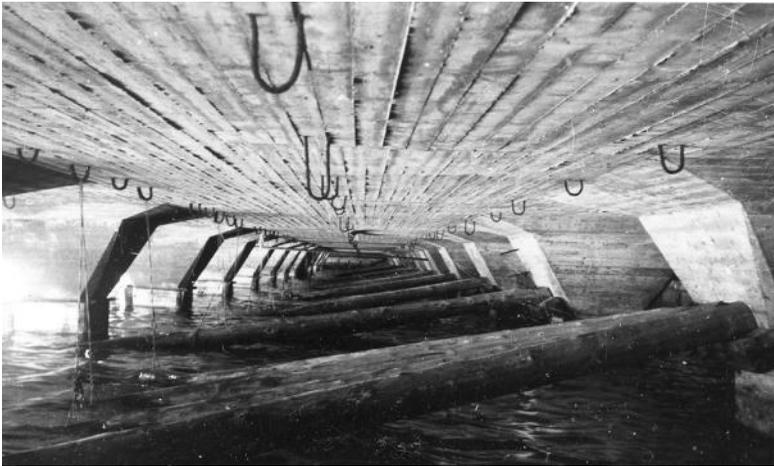
Figure 2.13 Harbor structures with a concrete deck of the flat type typically showed a much better performance than structures with a beam and slab type of deck. (From Gjørsv, O. E., *Durability of Reinforced Concrete Wharves in Norwegian Harbours*, Ingeniørforlaget AS, Oslo, Norway, 1968.)

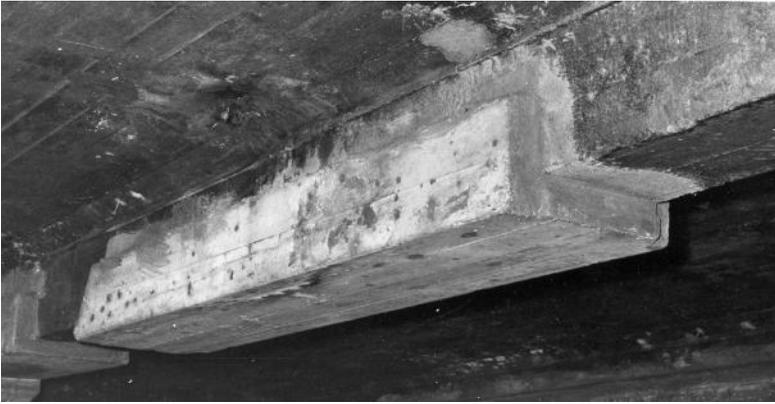
Figure 2.14 Typical patch repair of a corroded deck beam. (From Gjrv, O. E., *Durability of Reinforced Concrete Wharves in Norwegian Harbours*, Ingenirforlaget AS, Oslo, Norway, 1968.)

The extensive repairs carried out due to steel corrosion in the deck beams also typically showed a very short service life, mostly less than 10 years. Typically, the corroded steel in the locally spalled areas had first been cleaned and then locally patched with new concrete, as shown in Figure 2.14. Also, what was not known in these early days was that such local patch repairs would always set up local changes in the electrolytic conditions, and thus local differences in the electrochemical potentials along the embedded steel. As a result, accelerated corrosion adjacent to the local patched areas would develop, the result of which is typically demonstrated in Figure 2.15. This detrimental effect of patch repairs was first observed and systematically

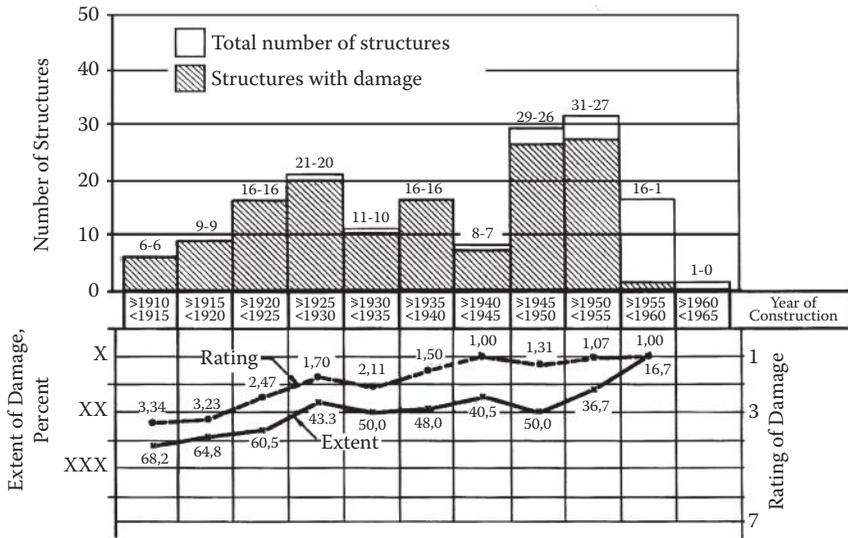
Figure 2.16 Trends for development of deterioration due to steel corrosion in deck beams. (From Gjrv, O. E., *Durability of Reinforced Concrete Wharves in Norwegian Harbours*, Ingenirforlaget AS, Oslo, Norway, 1968.)

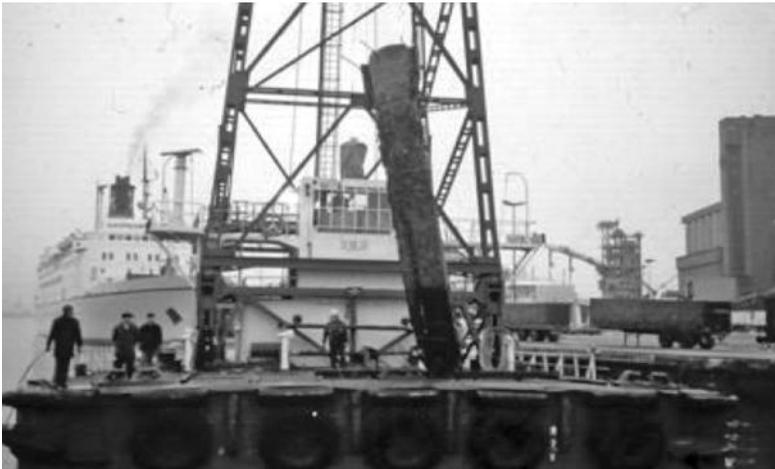
Figure 2.18 Four of the tremie-cast concrete pillars from the concrete jetty in Oslo Harbor (1922) were pulled up on shore for a very detailed condition assessment of the embedded steel.

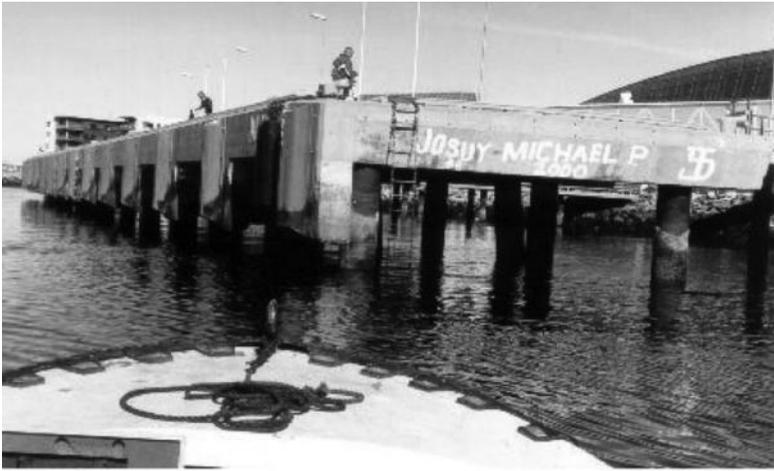
Figure 2.20 The cruise terminal Turistskipskaia (1993) in Trondheim Harbor with steel corrosion in most of the deck beams after eight years of service. (From Gjørsv, O. E., *Durability and Service Life of Concrete Structures*, in *Proceedings, The First FIB Congress*, 8, 6, Japan Prestressed Concrete Engineering Association, Tokyo, Japan, 2002, pp. 1–16.)

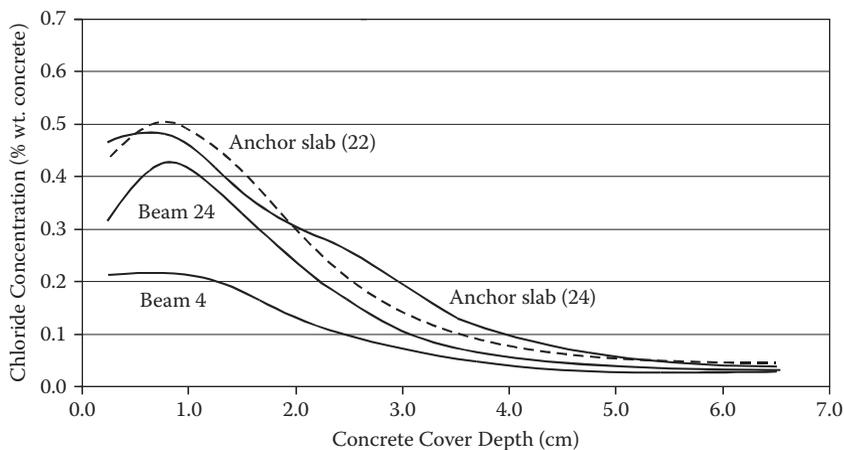
Figure 2.22 Chloride ingress after eight years of exposure in the industrial harbor structure Modulkaia (1995) at Tjeldbergodden. (From Ferreira, M. et al., *Concrete Structures at Tjeldbergodden*, Project Report BML 200303, Department of Structural Engineering, Norwegian University of Science and Technology—NTNU, Trondheim, Norway, 2003.)

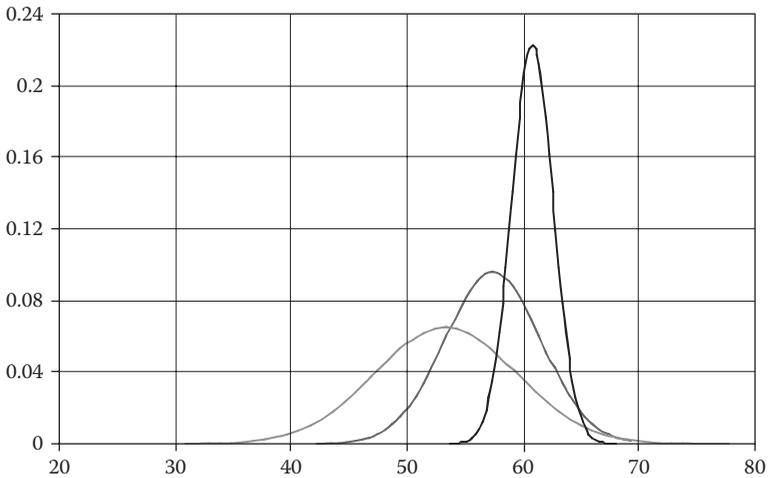
Figure 2.23 Typical variations of concrete cover (mm) in three deck beams from the two industrial harbor structures at Tjeldbergodden. (From Ferreira, M., Probability Based Durability Design of Concrete Structures in Marine Environment, Doctoral Dissertation, Department of Civil Engineering, University of Minho, Guimarães, Portugal, 2004.)

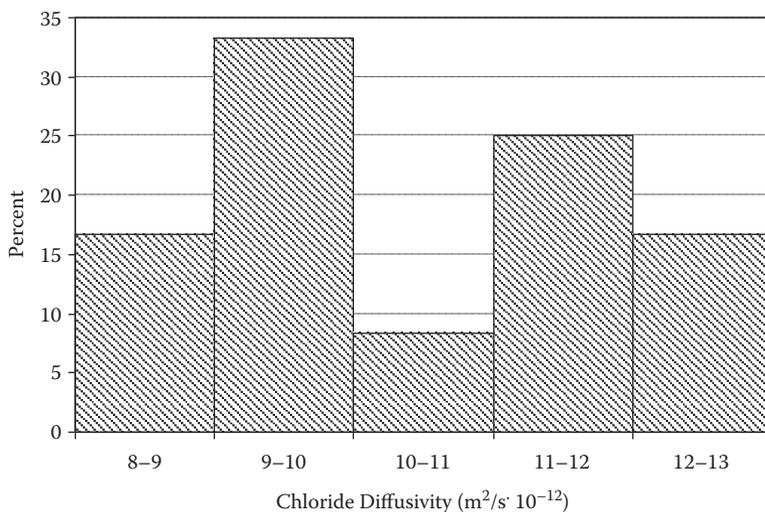
Figure 2.24 Achieved chloride diffusivity in the concrete deck of an industrial concrete harbor structure at Ulsteinvik (2001). (From Guofei, L. et al., *Field Tests with Surface Hydrophobation—Ulsteinvik*, Project Report BML 200503, Department of Structural Engineering, Norwegian University of Science and Technology—NTNU, Trondheim, Norway, 2005.)

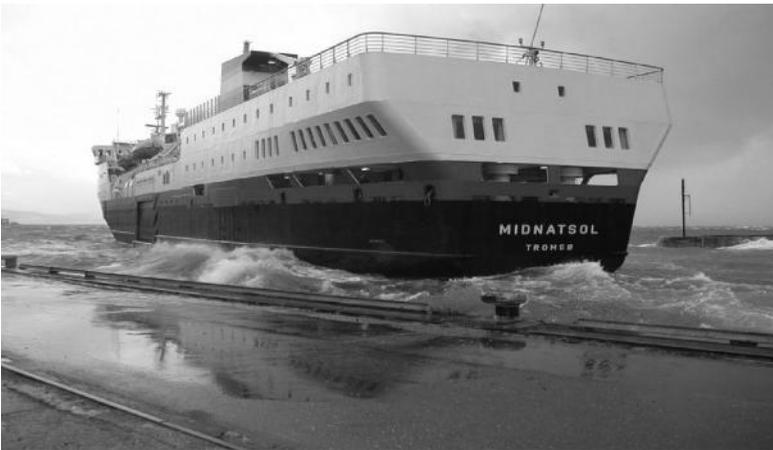
Figure 2.26 Occasionally, concrete harbor structures may be completely submerged in very high tides during stormy periods. (Courtesy of Trondheim Harbor KS.)

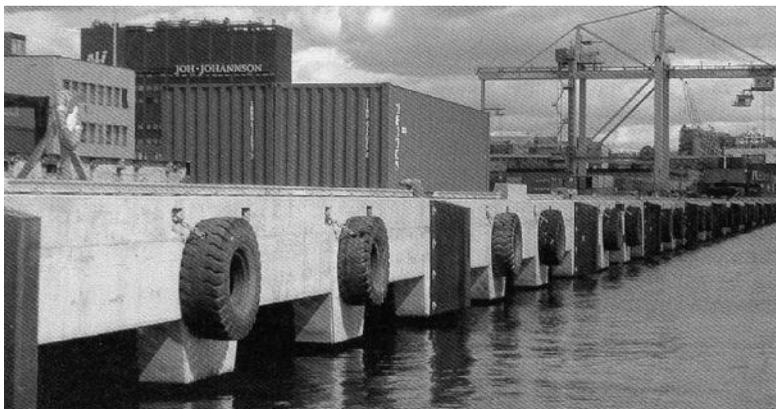
Figure 2.27 During concrete construction of the container terminal Nye Filipstadkaia (2002) in Oslo Harbor, a deep chloride ingress in several of the freshly cast deck beams took place due to heavy wind and high tides. (Courtesy of Oslo Harbor KF.)

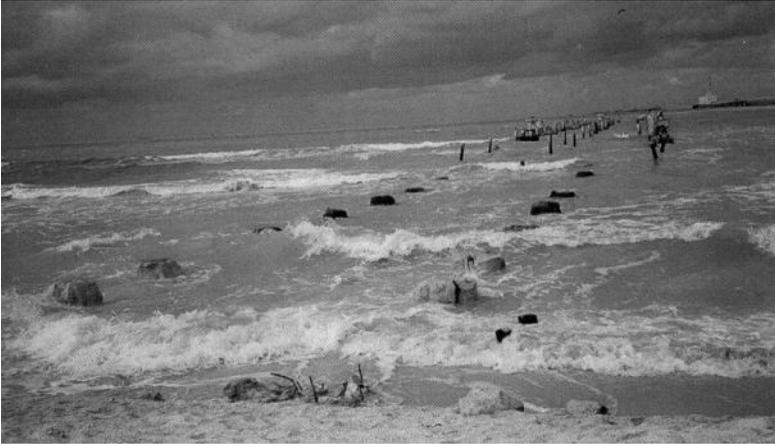
Figure 2.29 Remaining parts of a concrete pier built with black steel reinforcement on the Yucatán Coast in Mexico in the 1960s. (Courtesy of Rambøll Consulting Engineers.)

Thus, in the Persian Gulf countries, quite extreme durability problems are experienced (Matta, 1993; Alae, 2000). Similar problems have been reported from a number of other countries with hot climates. This is clearly demonstrated in the Progreso Port on the Yucatán Coast in Mexico, as shown in Figures 2.29–2.32. Due to very shallow waters, two long concrete piers were constructed in order to provide proper harbor facilities, one of which was constructed with traditional reinforcement in the 1960s. Of this

pier, only small parts of the structure still remained in 1998, while the neighboring pier, which was constructed during 1937–1941 with stainless steel reinforcement, was still in very good condition when it was investigated in 1998 (Knudsen and Skovsgaard, 1999). None of the concrete qualities in these two piers was very good. After a service period of approximately

60 years, however, detailed field investigations of the old pier showed that the $\text{Ø}30$ mm stainless steel (AISI 304) was still in very good condition in spite of high chloride contents adjacent to the steel, typically varying from 0.6 to 0.7% by weight of concrete at depths of 80–100 mm below the concrete surface (Rambøll, 1999).

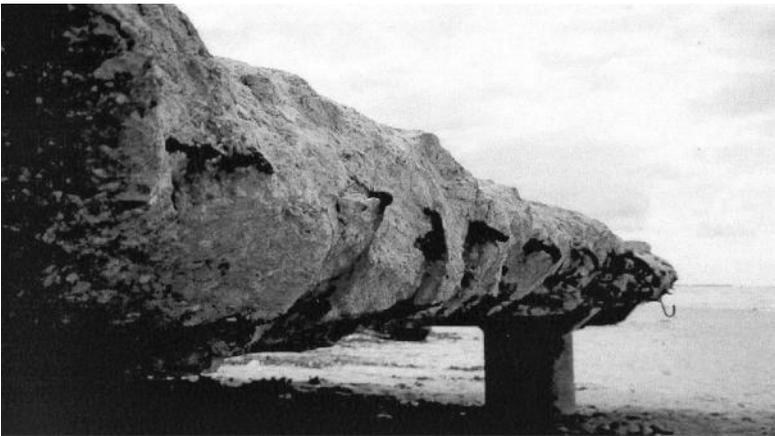
Figure 2.30 Remaining part of the deck from the concrete pier built on the Yucatán Coast in the 1960s. (Courtesy of Rambøll Consulting Engineers.)

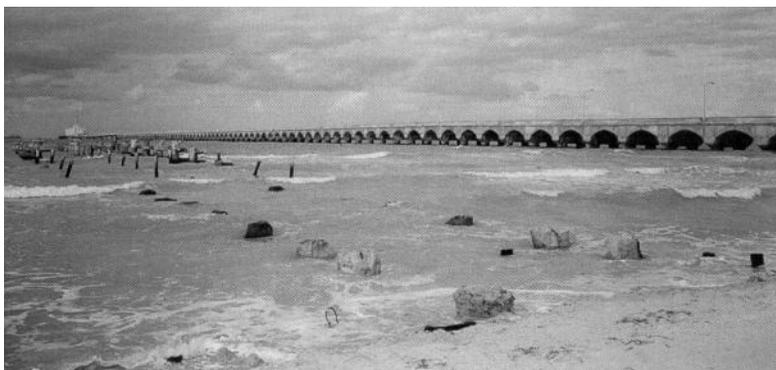
Figure 2.31 Different durability and long-term performance of the two concrete piers on the Yucatán Coast built with black steel in the 1960s (front) and with stainless steel reinforcement during 1937–1941, respectively. (Courtesy of Rambøll Consulting Engineers.)

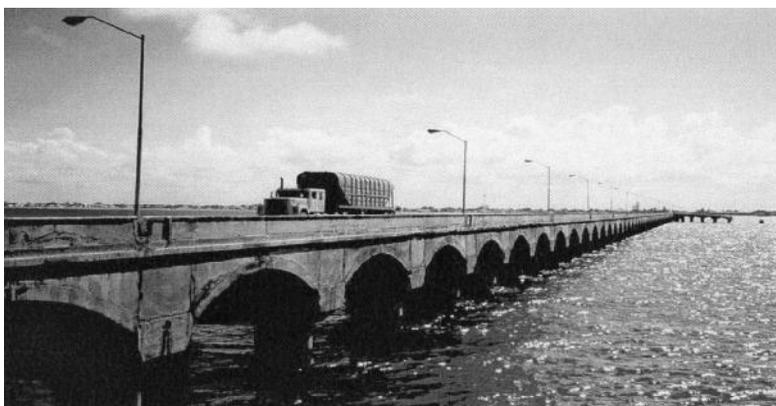
Figure 2.32 Progreso Pier on the Yucatán Coast built with stainless steel reinforcement during 1937–1941. (Courtesy of Rambøll Consulting Engineers.)

traffic by a variety of different types of ships (Figure 2.34). As a basis for the design of the old pier in the late 1930s, it was of vital importance for the owner to keep the pier in safe operation with as little future interruption as possible. Therefore, the owner was willing to pay the additional costs for having the structure built with stainless steel reinforcement. Hence, this project clearly demonstrates how the additional costs of stainless steel later on proved to be an extremely good investment for the owner of the structure (Progreso Port Authorities, 2008).

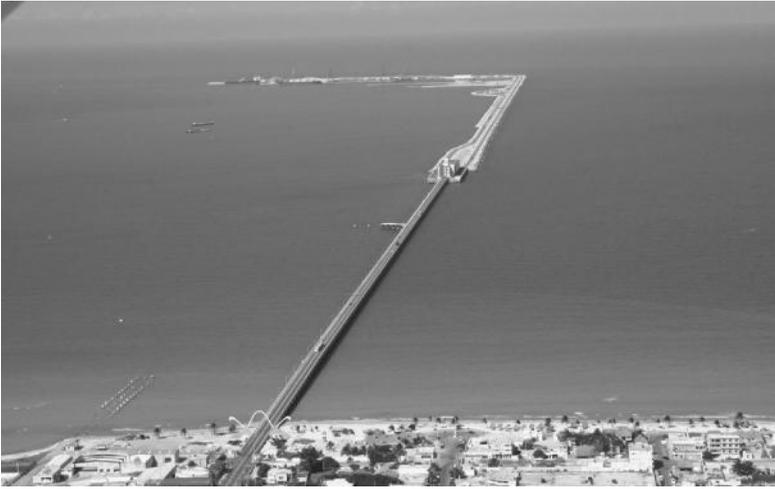
Figure 2.33 Overview of the Progreso Pier with stainless steel reinforcement still in good condition after about 70 years of operation. (Courtesy of Progreso Port Authorities.)

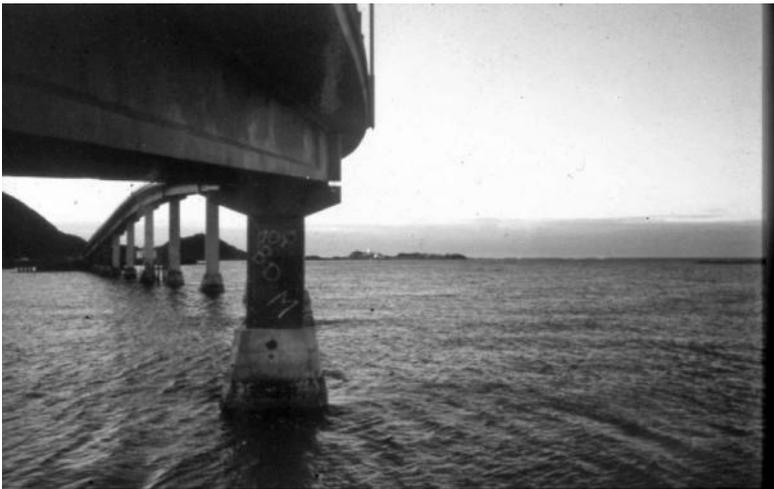
Figure 2.35 Ullasundet Bridge (1970) was demolished after 25 years of service due to heavy corrosion of embedded steel. (Courtesy of Jørn A. Hasselø.)

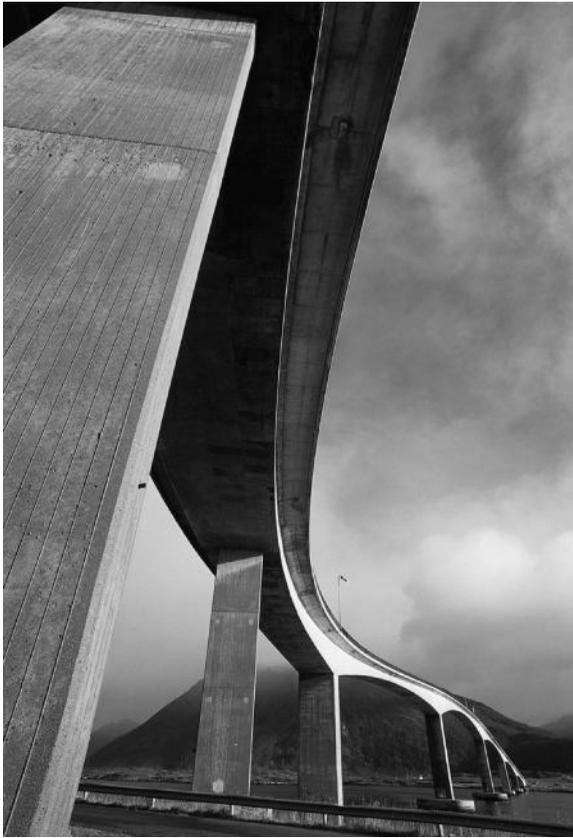
Figure 2.36 Gimsøystraumen Bridge (1981) is a cantilever bridge, which is a very common type of bridge along the Norwegian coastline. (Courtesy of Johan Brun.)

About 10 years later, Gimsøystraumen Bridge (1981) was constructed in the northern part of Norway (Figure 2.36); this is a cantilever bridge that is a more common type of bridge along the Norwegian coastline. However, this bridge also got a deep ingress of chlorides and extensive corrosion after a relatively short period of time. During the repairs of this bridge after 12 years of service, the Norwegian Public Roads Administration selected it as a basis for an extensive research program in order to investigate the effect of various types of patching materials (Blankvoll, 1997).

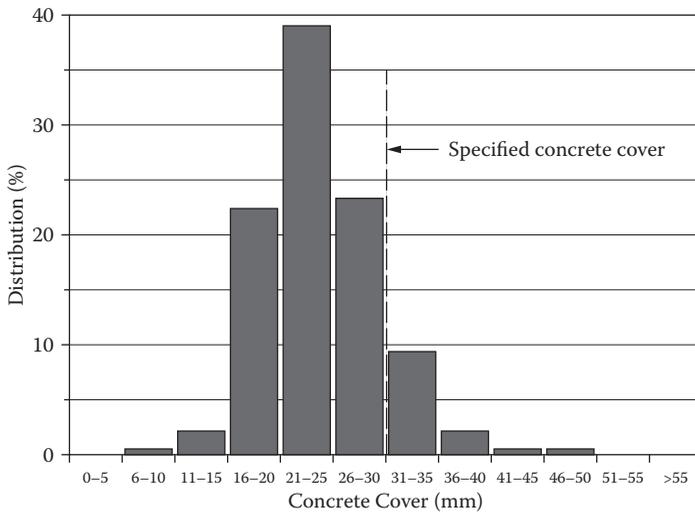
Figure 2.40 Gimsøystraumen Bridge (1981) with observed variation of achieved concrete cover. (From Kompen, R., *What Can Be Done to Improve the Quality of New Concrete Structures? in Proceedings, Second International Conference on Concrete Under Severe Conditions—Environment and Loading*, 3, ed. O. E. Gjorv et al., E & FN Spon, London, England, 1998, pp. 1519–1528.)

Figure 6.1 Variation in achieved concrete cover (mm) in the Gimsøystraumen Bridge (N) previously shown in Figure 2.40 compared to that of a Japanese bridge (J) and more than 100 concrete structures in the Gulf region (GR). (From Kompfen, R., *What Can Be Done to Improve the Quality of New Concrete Structures?* in *Proceedings, Second International Conference on Concrete under Severe Conditions—Environment and Loading*, vol. 3, ed. O. E. GjØrv et al., E & FN Spon, London, England, 1998, pp. 1519–1528.)

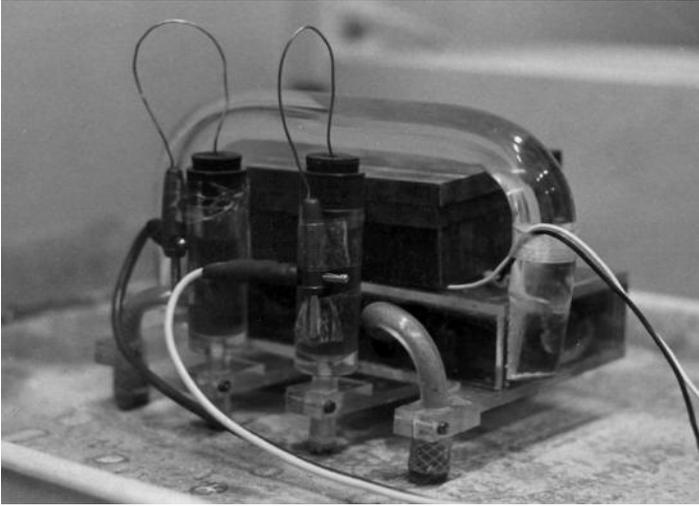
Figure 2.41 The homemade four-electrode device (Wenner) designed by Richard Stratfull in the early 1950s for electrical resistivity measurements along the concrete surface of the San Mateo–Hayward Bridge (1929). (Courtesy of Richard Stratfull, 1970.)

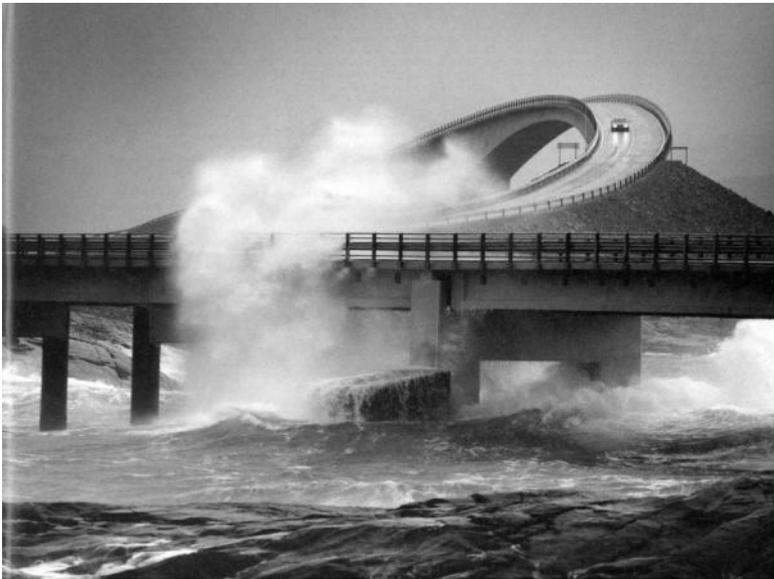
Figure 2.42 During stormy winter periods, Storseisund Bridge (1988) is heavily exposed to splashing of seawater. (Courtesy of Rolf Jarle Ødegaard.)

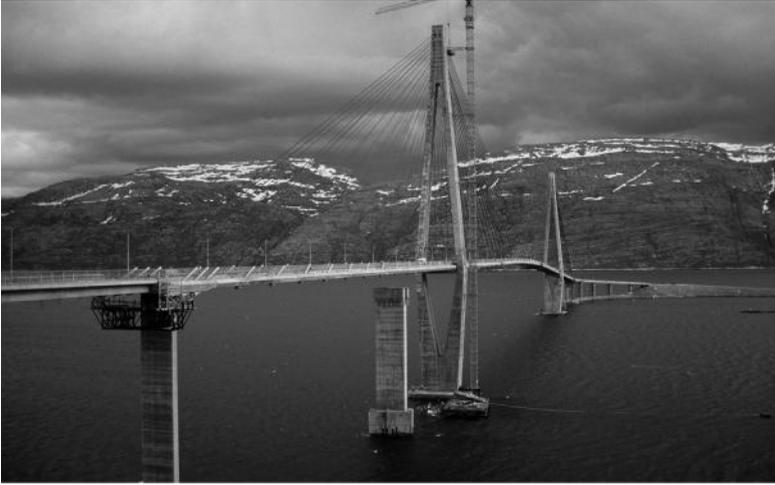
Figure 2.45 The Helgelands Bridge (1991) is a 1065 m long cable-stayed bridge with the largest span of 425 m. (Courtesy of Hallgeir Skog)

In 1991, the 1065 m long cable-stayed Helgelands Bridge (Figure 2.45) was built further north along the Norwegian coastline. During the construction of this bridge, however, the bridge was heavily exposed to severe weather conditions with splashing of seawater already during concrete construction, before the concrete had gained sufficient maturity and density (Figure 2.46a and b). As a result, a deep chloride ingress was already observed shortly after concrete construction (Figure 2.47).

For the Helgelands Bridge, a 45 MPa type of concrete had been applied with an observed in situ strength after two years of 57 MPa; the concrete was produced with 415 kg/m³ cement (CEM I) in combination with 21 kg/m³ silica fume (5%), giving a water/binder ratio of 0.35.

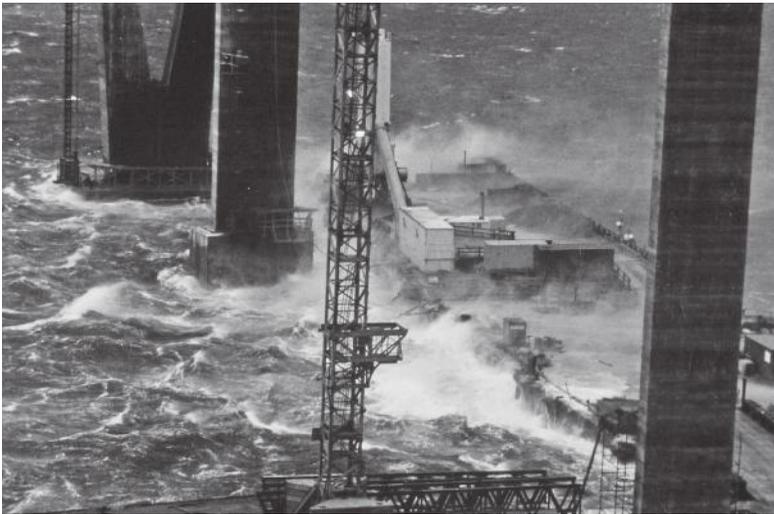
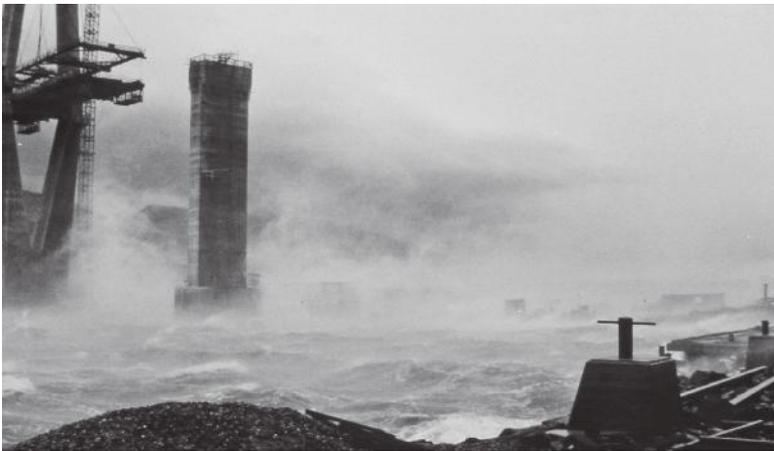
Figure 2.46 During concrete construction, parts of the Helgelands Bridge (1991) were heavily exposed to severe weather conditions with splashing of seawater. (Courtesy of Hallgeir Skog.)

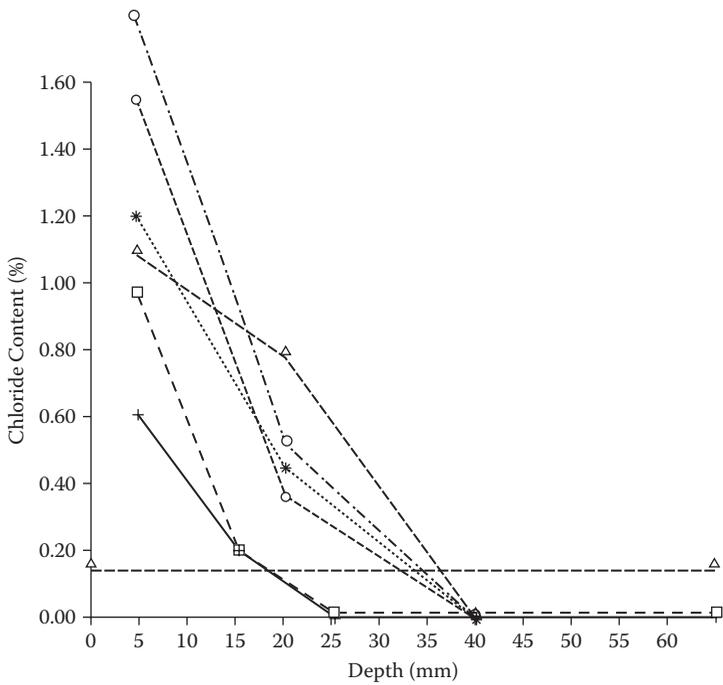
Figure 2.47 The Helgelands Bridge (1991) with observed chloride ingress shortly after concrete construction. (From NPRA, *The Helgelands Bridge—Chloride Penetration*, Internal Report, Norwegian Public Road Administration—NPR A, Oslo, Norway, 1993 [in Norwegian].)

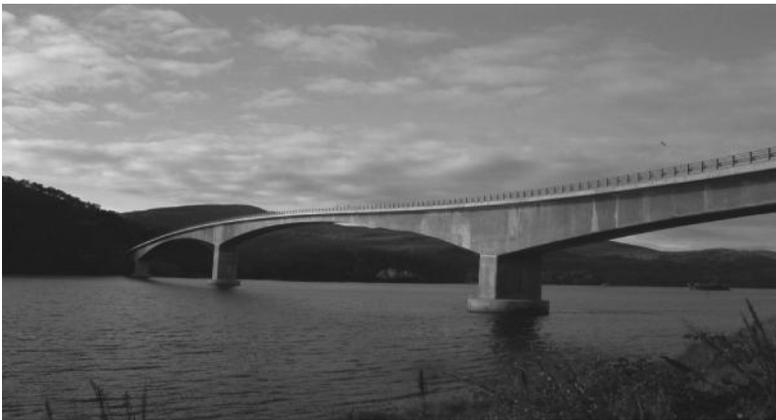
Figure 2.48 The Aursundet Bridge (1995) is a cantilever bridge with a total length of 486 m.

When Aursundet Bridge (1995) was built on the west coast of Norway during 1993–1995 (Figure 2.48), the Norwegian Public Roads Administration selected this bridge as a case study for trying out a new durability design. Thus, on an experimental basis, both a distinctly higher silica fume content in the concrete and a distinctly increased concrete cover in the splash zone were specified. As a result, a concrete based on 400 kg/m³ of cement (CEM I) with 50 kg/m³ of silica fume (12.5%) giving a water/binder ratio of 0.40 was applied. This concrete, which showed a 28-day compressive strength of 55 MPa, was combined with a minimum concrete cover in the splash zone of 80 mm.

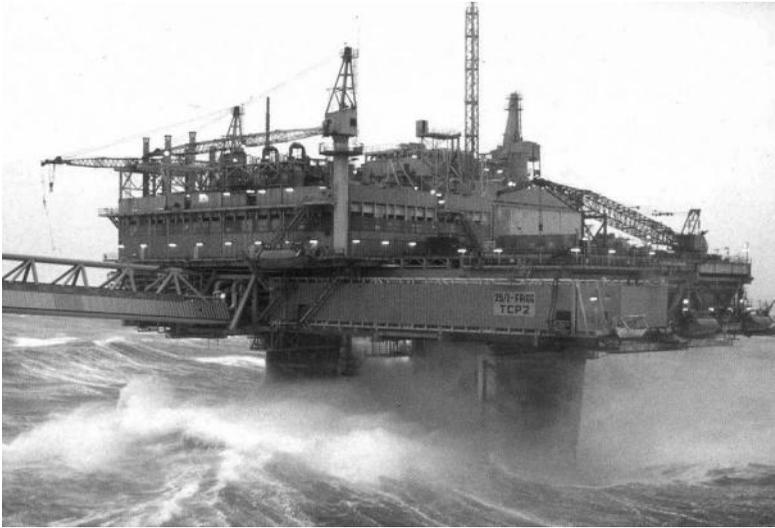
Figure 2.50 The Frigg TCP 2 Platform (1977) in stormy weather.

Since the early 1970s, altogether 34 major concrete structures for the oil and gas explorations in the North Sea have been installed. In spite of the very harsh and hostile marine environment (Figures 2.50 and 2.51), the overall durability and performance of these concrete structures have shown to be very good (Fjeld and Røland, 1982; Hølaas, 1992; Gjørsv, 1994; FIP, 1996; Moksnes and Sandvik, 1996; Helland et al., 2010).

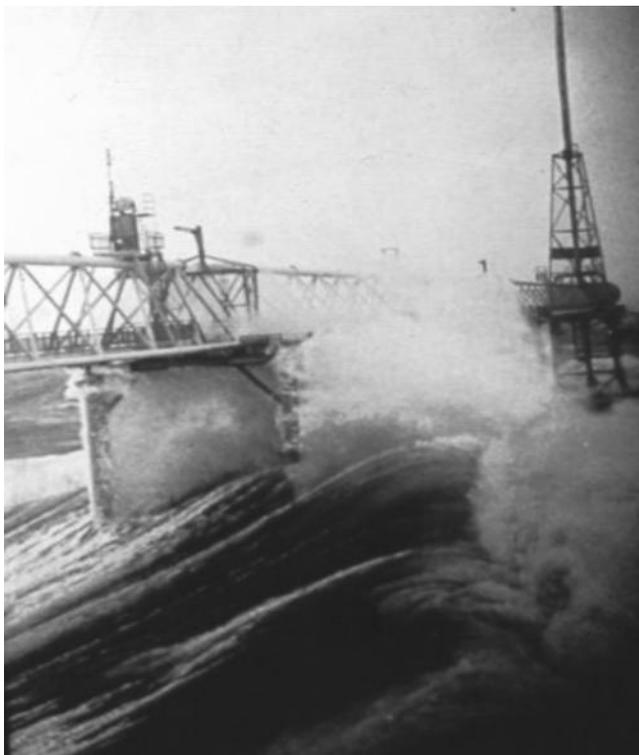
Figure 2.51 All the concrete platforms in the North Sea are exposed to heavy wave loading and splashing of seawater.

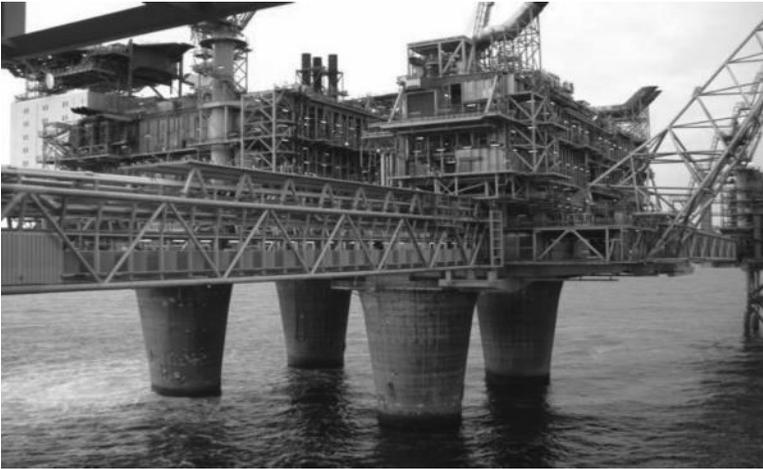
Figure 2.52 The Oseberg A Platform (1988). (Courtesy of Trond Østmoen.)

In spite of the overall good durability and performance, however, a certain amount of very costly repairs due to corrosion of embedded steel has been carried out. Thus, after 13 years of service, extensive repairs based on cathodic protection of the Oseberg A Platform (1988) were carried out (Figures 2.52 and 2.53). For this particular structure, the achieved concrete cover was distinctly less than that specified in the upper parts of the shafts (Østmoen, 1998). A nominal concrete cover of 75 mm had been specified, but the achieved concrete cover was highly variable and partly very low. For the upper parts of the shafts, a 60 MPa type of concrete with a water/cement ratio of 0.37 (CEM I) had been applied.
