Durability Design of Concrete Structures in Severe Environments

Second Edition

Odd E. Gjrv

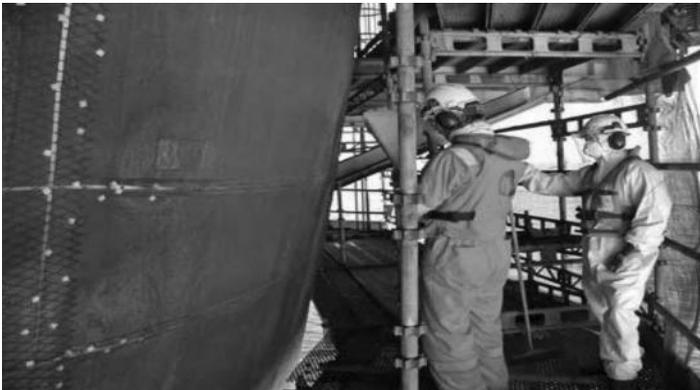
Figure 2.53 After 13 years of service, extensive and very costly repairs based on cathodic protection of the Oseberg A Platform (1988) were carried out. (Courtesy of Trond Østmoen.)

In spite of the overall good durability and performance, however, a certain amount of very costly repairs due to corrosion of embedded steel has been carried out. Thus, after 13 years of service, extensive repairs based on cathodic protection of the Oseberg A Platform (1988) were carried out (Figures 2.52 and 2.53). For this particular structure, the achieved concrete cover was distinctly less than that specified in the upper parts of the shafts (Østmoen, 1998). A nominal concrete cover of 75 mm had been specified, but the achieved concrete cover was highly variable and partly very low. For the upper parts of the shafts, a 60 MPa type of concrete with a water/cement ratio of 0.37 (CEM I) had been applied.

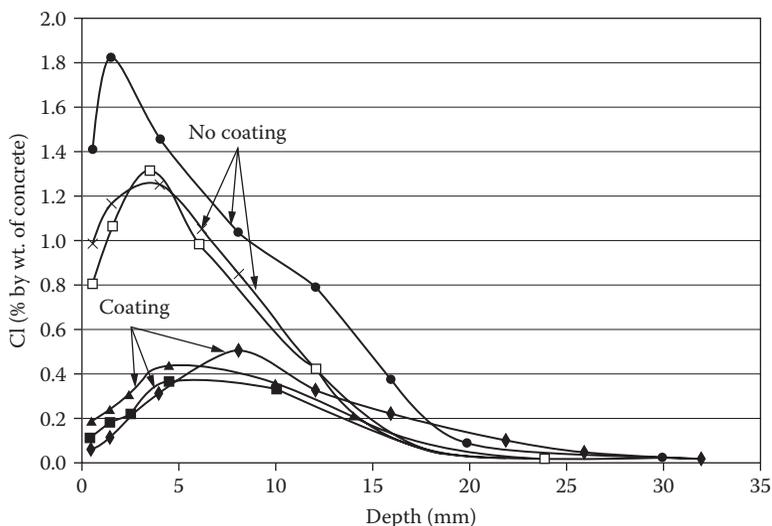
Figure 2.54 Chloride ingress in the Heidrun Platform (1995) after two years of exposure. (From Gjrv, O. E., *Durability and Service Life of Concrete Structures*, in *Proceedings, The First FIB Congress*, 8, 6, Japan Prestressed Concrete Engineering Association, Tokyo, Japan, 2002, pp. 1–16.)

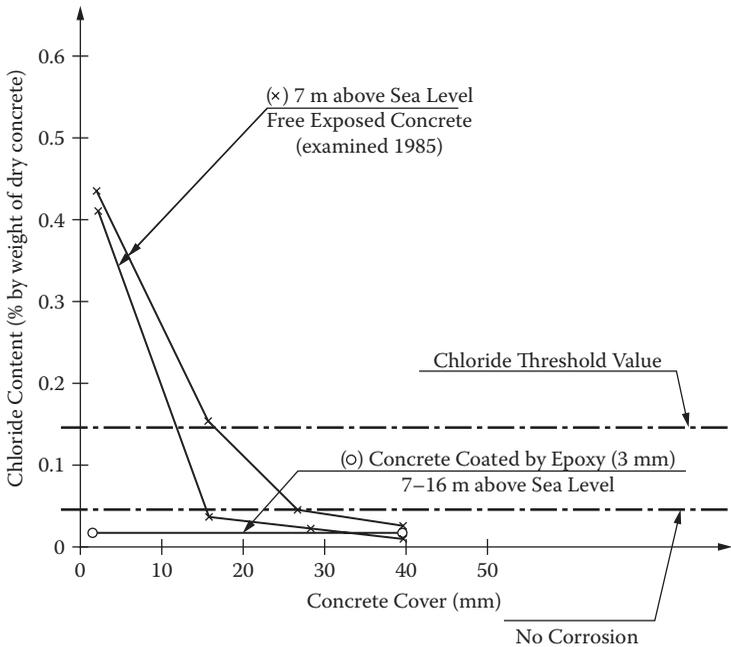
Figure 2.55 Chloride ingress in the Statfjord A Platform (1977) after eight years of exposure. (From Sandvik, M., and Wick, S. O., Chloride Penetration into Concrete Platforms in the North Sea, in *Proceedings, Workshop on Chloride Penetration into Concrete Structures*, ed. L.-O. Nilsson, Division of Building Materials, Chalmers University of Technology, Gothenburg, Sweden, 1993.)

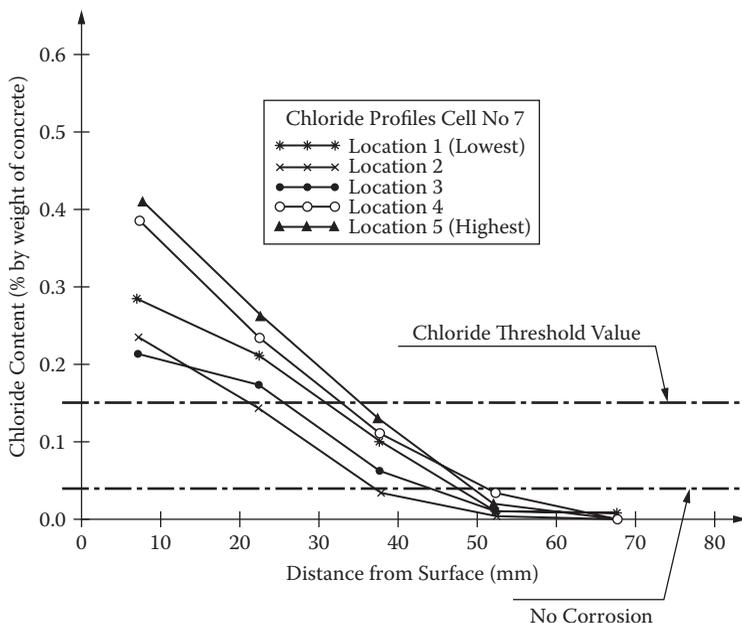
Figure 2.56 Chloride ingress in the Ekofisk Tank (1973) after 17 years of exposure. (From Sandvik, M. et al., *Chloride Permeability of High-Strength Concrete Platforms in the North Sea*, ACI SP-145, ed. V. M. Malhotra, ACI, Detroit, Michigan, 1994, pp. 121–130.)

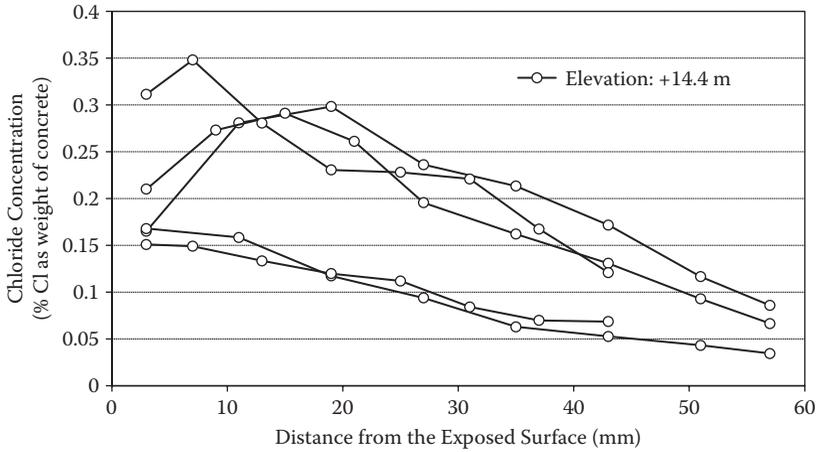
Figure 2.57 The Brent B Platform (1975) with observed chloride ingress at elevation + 14.4 m above water after 20 years of exposure. (From Sengul, Ö., and Gjørv, O. E., Chloride Penetration into a 20 Year Old North Sea Concrete Platform, in *Proceedings, Fifth International Conference on Concrete under Severe Conditions—Environment and Loading*, ed. F. Toutlemonde et al., vol. 1, Laboratoire Central des Ponts et Chaussées, Paris, France, 2007, pp. 107–116.)

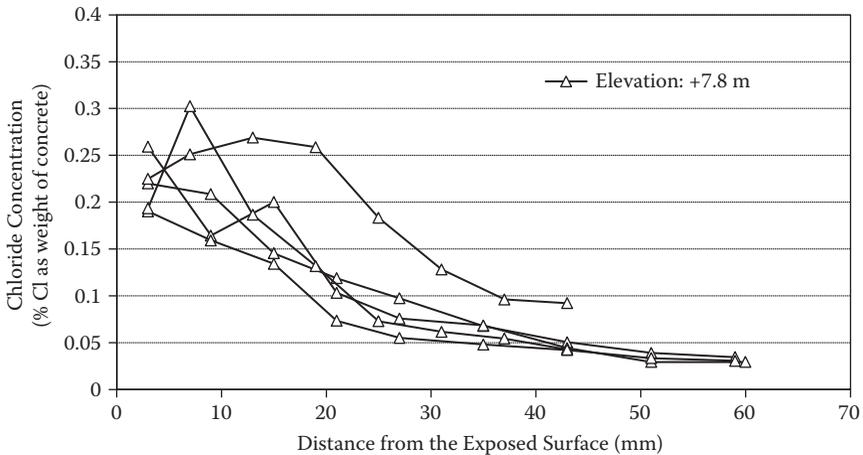
Figure 2.58 The Brent B Platform (1975) with observed chloride ingress at elevation + 7.8 m above water after 20 years of exposure. (From Sengul, Ö., and Gjørv, O. E., Chloride Penetration into a 20 Year Old North Sea Concrete Platform, in *Proceedings, Fifth International Conference on Concrete under Severe Conditions—Environment and Loading*, ed. F. Toutlemonde et al., vol. 1, Laboratoire Central des Ponts et Chaussées, Paris, France, 2007, pp. 107–116.)

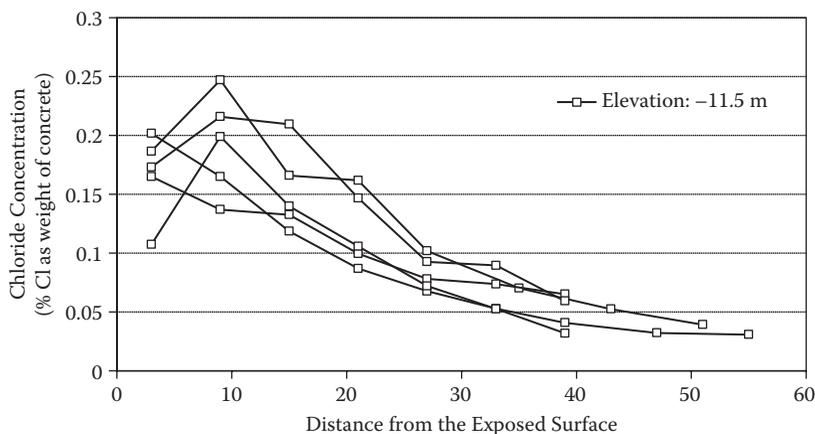
Figure 2.59 The Brent B Platform (1975) with observed chloride ingress at elevation -11.5 m below water after 20 years of exposure. (From Sengul, Ö., and Gjorv, O. E., Chloride Penetration into a 20 Year Old North Sea Concrete Platform, in *Proceedings, Fifth International Conference on Concrete under Severe Conditions—Environment and Loading*, ed. F. Toutlemonde et al., vol. I, Laboratoire Central des Ponts et Chaussées, Paris, France, 2007, pp. 107–116.)

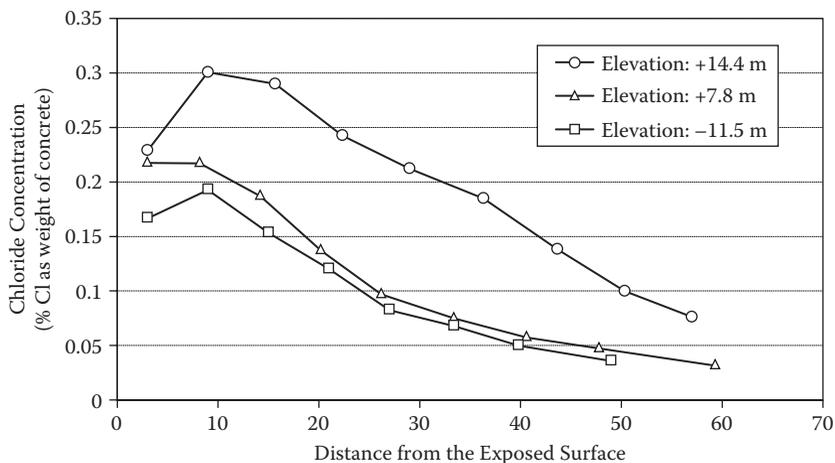
Figure 2.60 The Brent B Platform (1975) with observed chloride ingress after 20 years of exposure. (From Sengul, Ö., and Gjorv, O. E., Chloride Penetration into a 20 Year Old North Sea Concrete Platform, in *Proceedings, Fifth International Conference on Concrete under Severe Conditions—Environment and Loading*, ed. F. Toutlemonde et al., vol. I, Laboratoire Central des Ponts et Chaussées, Paris, France, 2007, pp. 107–116.)

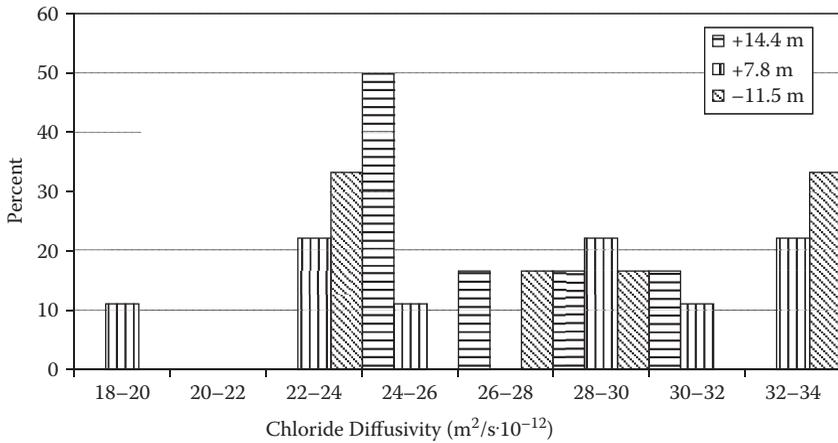
Figure 2.61 Observed chloride diffusivity in the utility shaft of the Brent B Platform (1975). (From Årskog, V., and GjØrv, O. E., Unpublished results, Department of Structural Engineering, Norwegian University of Science and Technology—NTNU, Trondheim, Norway, 2008.)

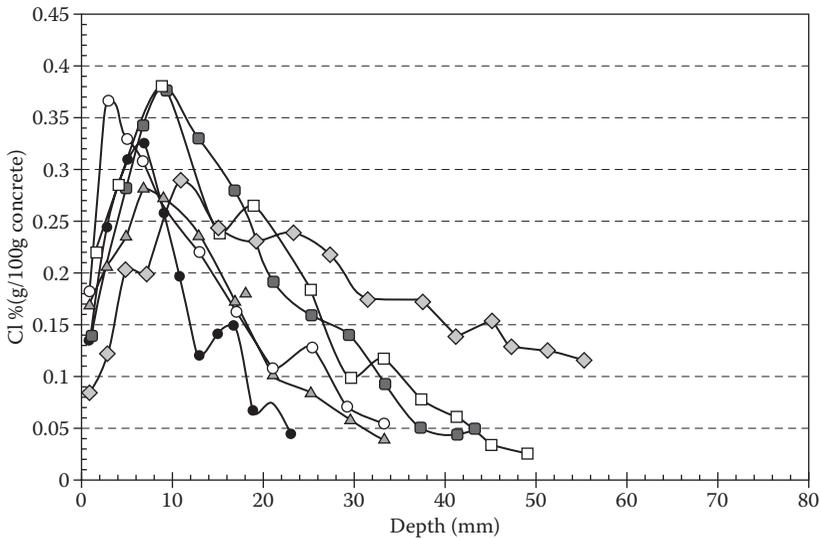
Figure 2.62 The Brent C Platform (1978) with observed chloride ingress below water after 17 years of exposure. (From GjØrv, O. E., Durability and Service Life of Concrete Structures, in *Proceedings, The First FIB Congress*, 8, 6, Japan Prestressed Concrete Engineering Association, Tokyo, Japan, 2002, pp. 1–16.)

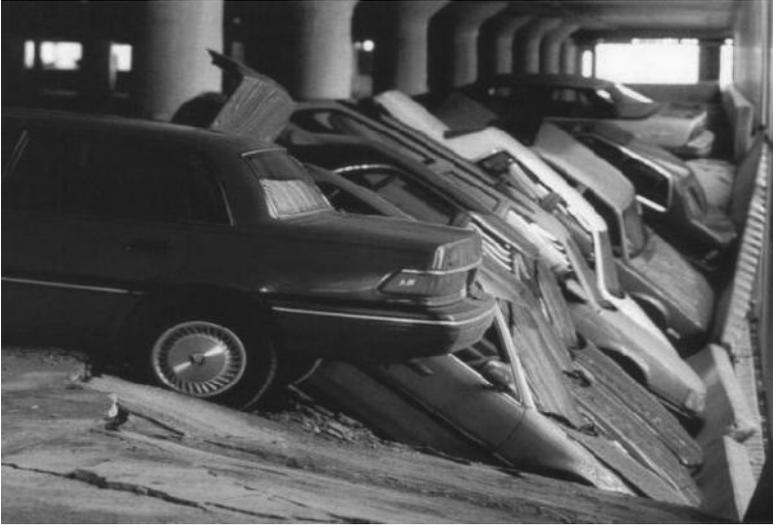
Figure 2.63 The consequences of rebar corrosion in parking garages exposed to de-icing salt contamination have occasionally been quite severe. (From Simon, P., Improved Current Distribution due to a Unique Anode Mesh Placement in a Steel Reinforced Concrete Parking Garage Slab CP System, in *NACE Corrosion 2004*, Paper 04345, 2004.)

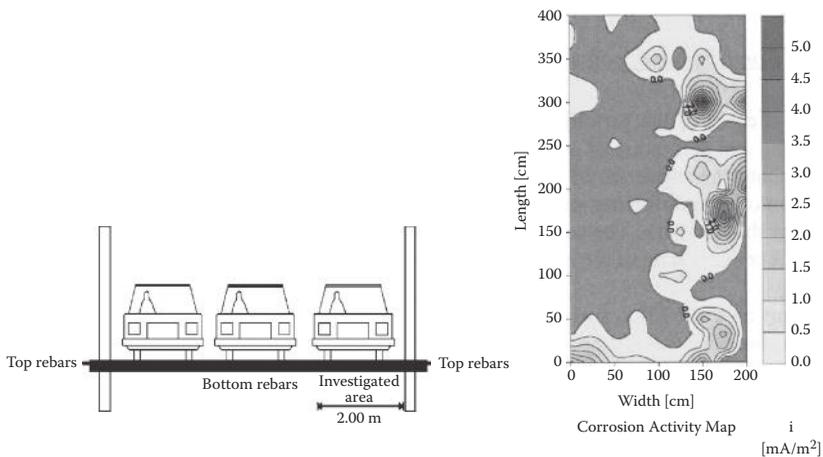
Figure 2.64 Typical pattern of corrosion activities in the parking bays of a parking garage contaminated with de-icing salt. (From Pruckner, F., Diagnosis and Protection of Corroding Steel in Concrete, PhD Thesis 2002:140, Department of Structural Engineering, Norwegian University of Science and Technology—NTNU, Trondheim, Norway, 2002.)

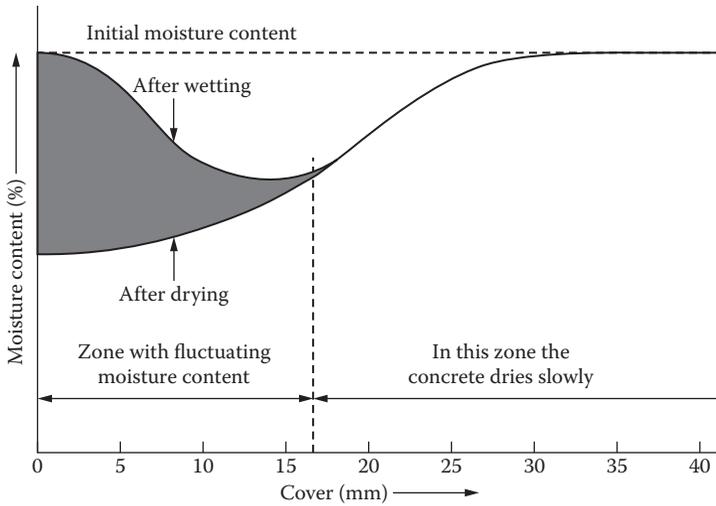
Figure 3.1 Outer layer of the concrete with changing moisture content under splash water conditions along the North Sea coast according to Bakker (1992). (From Bijen, J., *Blast Furnace Slag for Durable Marine Structures*, VNC/BetonPrisma, Hertogenbosch, Netherlands, 1998.)

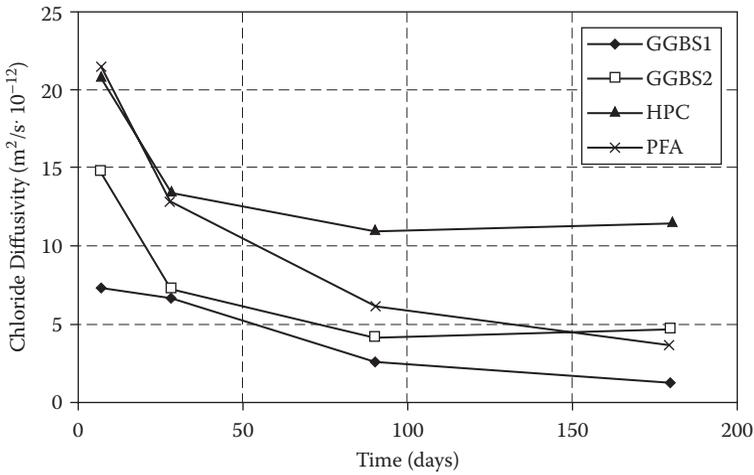
Figure 3.3 Effect of cement type on the resistance of concrete to chloride ingress at a water/binder ratio of 0.45. (From Årskog, V. et al., Effect of Cement Type on the Resistance of Concrete against Chloride Penetration, in *Proceedings, Fifth International Conference on Concrete under Severe Conditions—Environment and Loading*, vol. 1, ed. F. Toutlemonde et al., Laboratoire Central des Ponts et Chaussées, Paris, France, 2007, pp. 367–374.)

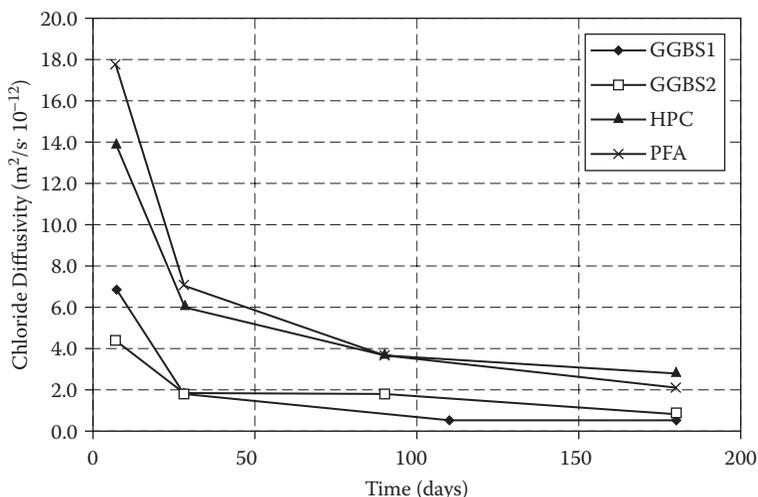
Figure 3.4 Effect of cement type on the resistance of concrete to chloride ingress at a water/binder ratio of 0.38. (From Årskog, V. et al., *Effect of Cement Type on the Resistance of Concrete against Chloride Penetration*, in *Proceedings, Fifth International Conference on Concrete under Severe Conditions—Environment and Loading*, vol. 1, ed. F. Toutlemonde et al., Laboratoire Central des Ponts et Chaussées, Paris, France, 2007, pp. 367–374.)

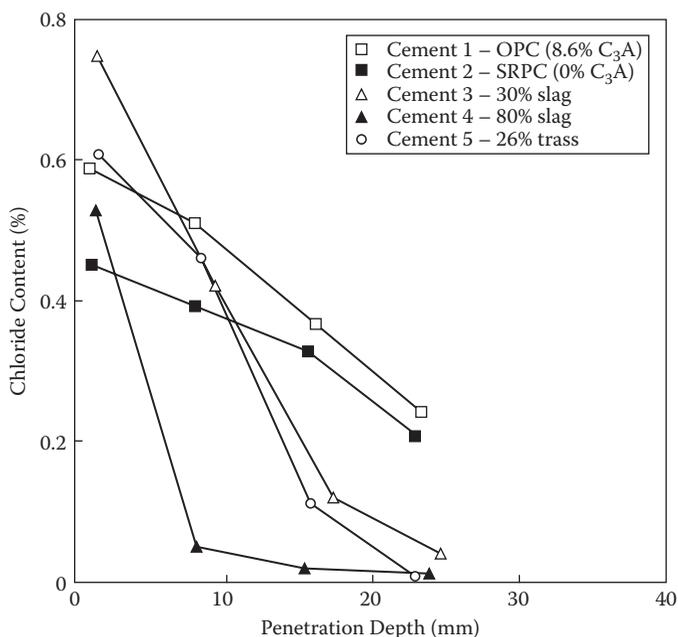
Figure 3.9 Effect of cement type on chloride ingress (by weight of cement) into concrete exposed to fresh circulating seawater. (From Gjørnv, O. E., and Vennesland, Ø., *Cement and Concrete Research*, 9, 229–238, 1979.)

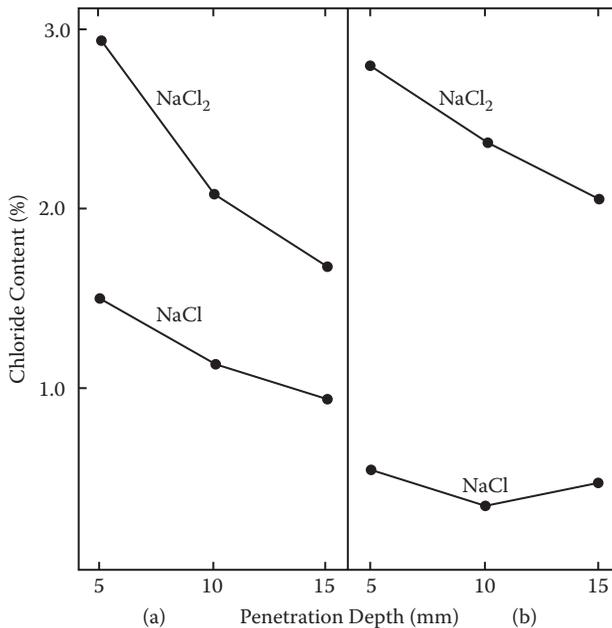
Figure 3.11 Chloride ingress (by weight of cement) into cement paste from two different types of salt solution of the same chloride concentration: (a) after 2 days of hydration and (b) after 40 days of hydration before exposure. (From Trættestad, A., *The Mechanism of Chloride Penetration into Concrete*, SINTEF Report STF65 A77070, Trondheim, Norway [in Norwegian], 1977; GjØrv, O. E., and Vennesland, Ø., Evaluation and Control of Steel Corrosion in Offshore Concrete Structures, in *Proceedings, the Katharine and Bryant Mather International Conference*, vol. 2, ed. J. Scanlon, ACI SP-1, 1987, pp. 1575–1602.)

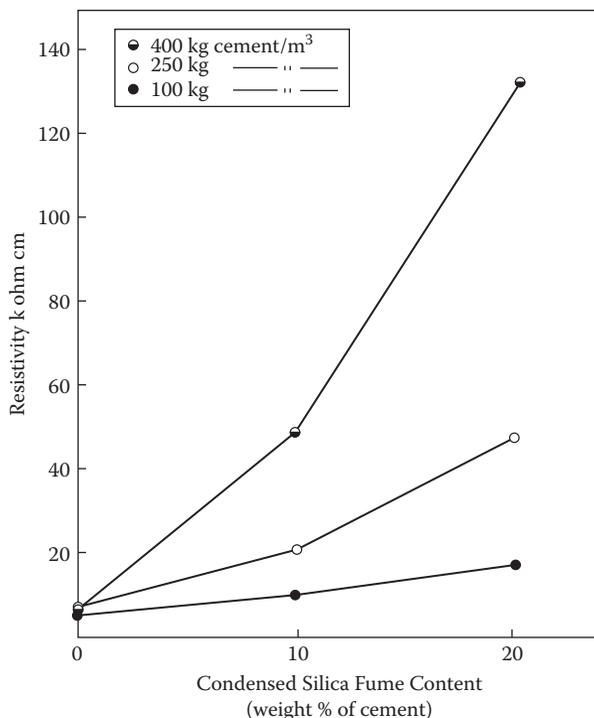
Figure 3.18 Effect of increased additions of silica fume on the electrical resistivity of concrete. (From Vennesland, Ø., and Gjorv, O. E., *Silica Concrete—Protection against Corrosion of Embedded Steel*, in *Proceedings, CANMET/ACI International Conference on Fly Ash, Silica Fume, and Natural Pozzolans in Concrete*, vol. II, ACI SP-79, ed. V. M. Malhotra, 1983, pp. 719–729.)

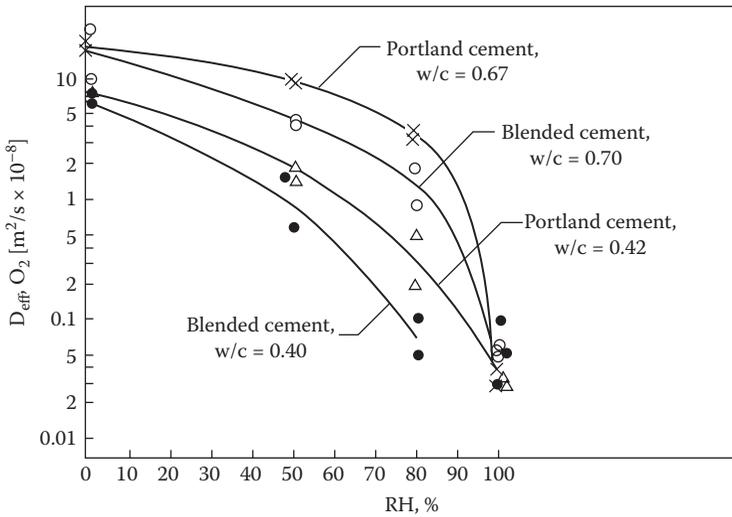
Figure 3.19 Effect of water saturation on the rate of oxygen diffusion. (From Tuutti, K., *Corrosion of Steel in Concrete*, Report 4-82, Cement and Concrete Research Institute, Stockholm, Sweden, 1982.)

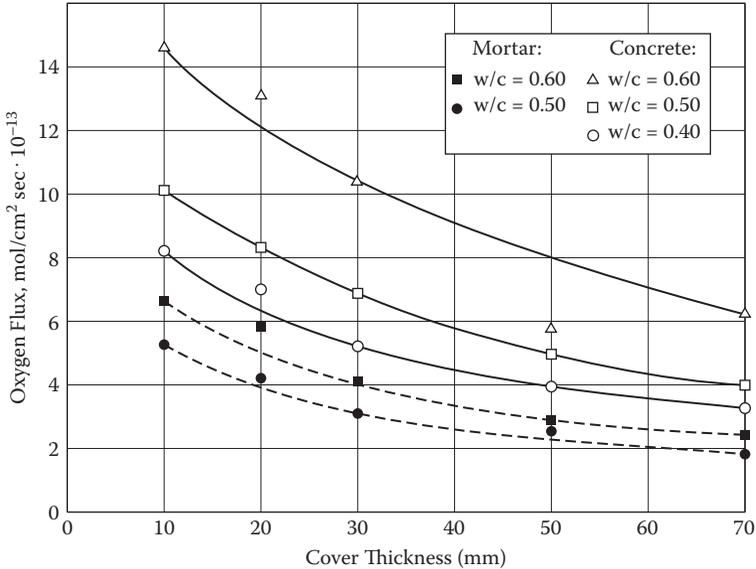
Figure 3.20 Effect of concrete cover on the rate of oxygen diffusion through concrete submerged in water. (From GjØrv, O. E. et al., *Materials Performance*, 25(12), 39–44, 1986.)

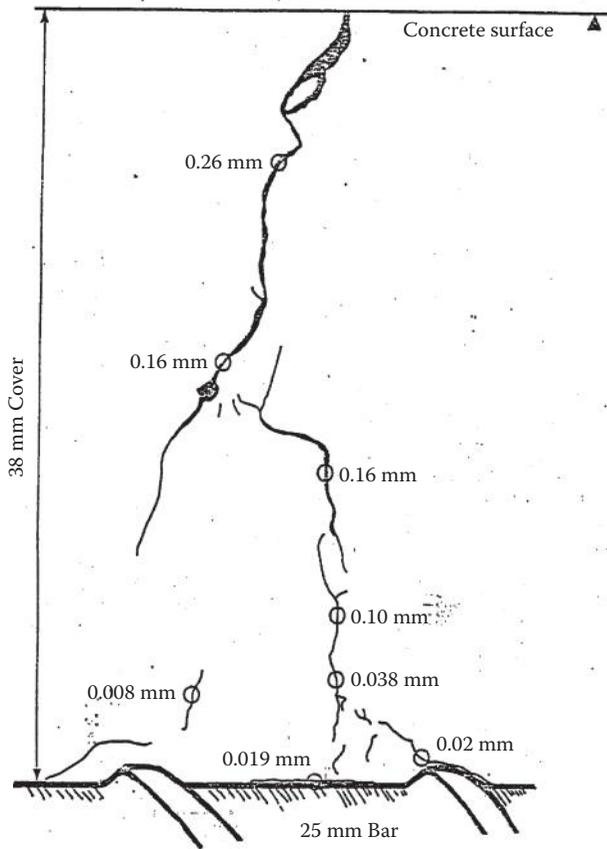
Figure 3.21 The geometry of cracks may be very complex. (From Beeby, A. W., *Cracking and Corrosion*, Report 2/11, UK Research Program on Concrete in the Oceans, 1977.)

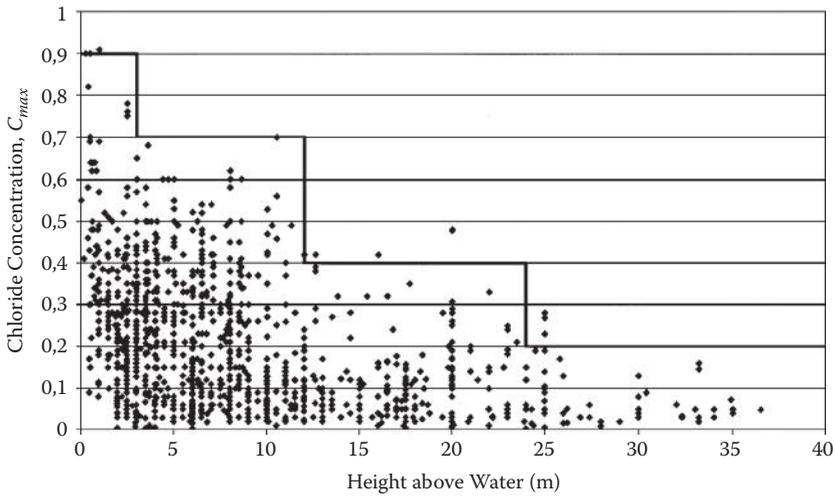
Figure 4.5 Observed maximum surface chloride concentrations by weight of concrete (C_{max}) on Norwegian concrete coastal bridges. (From Fluge, F., Marine Chlorides—A Probabilistic Approach to Derive Provisions for EN 206-1, in *Proceedings, Third Workshop on Service Life Design of Concrete Structures—From Theory to Standardisation*, DuraNet, Tromsø, Norway, 2001, pp. 47–68.)

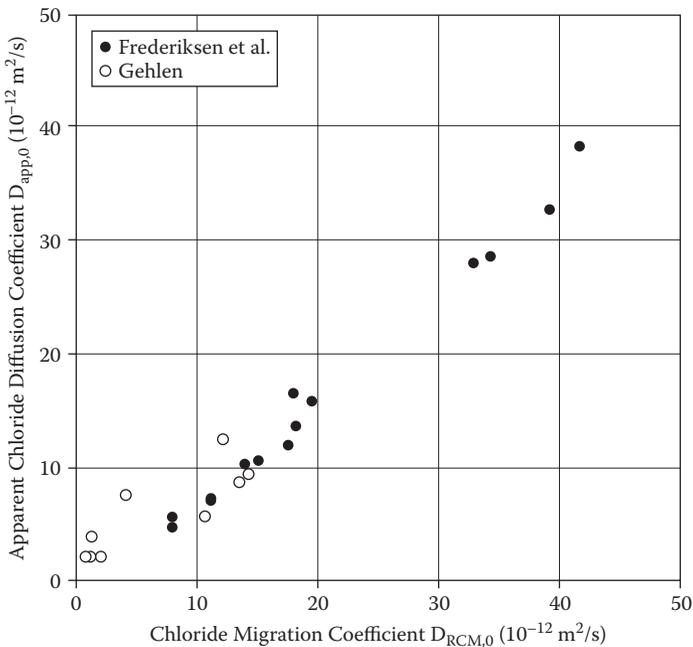
Figure 4.7 Correlation of the effective diffusion coefficients obtained by immersion tests and the RCM method according to Gehlen (2000) and Fredriksen et al. (1996). (From Schiessl, P., and Lay, S., Influence of Concrete Composition, in *Corrosion in Reinforced Concrete Structures*, ed. H. Böhni, Woodhead Publishing, Cambridge, England, 2005, pp. 91–134.)

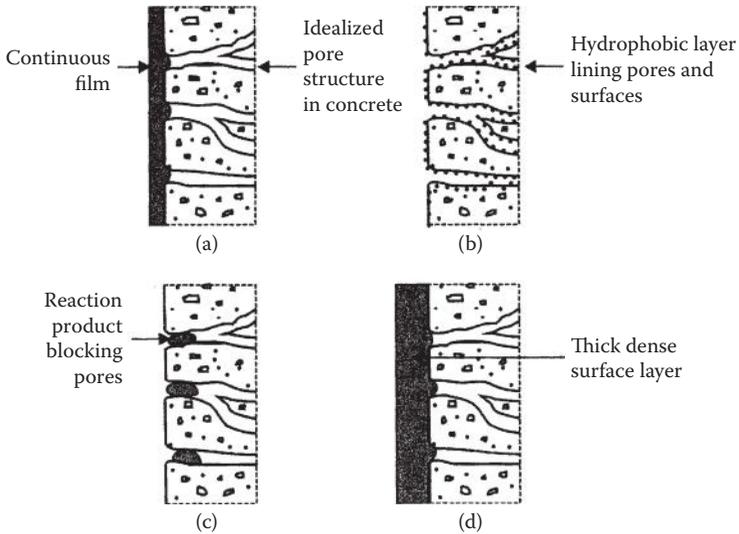
Figure 5.1 Schematic representation of different types of concrete surface protection: (a) organic coating, (b) pore-lining treatments, (c) pore-blocking treatments, and (d) thick cementitious coating, shotcrete, or rendering. (From Bijen, J. M., *Heron*, 34(2), 2–82, 1989.)

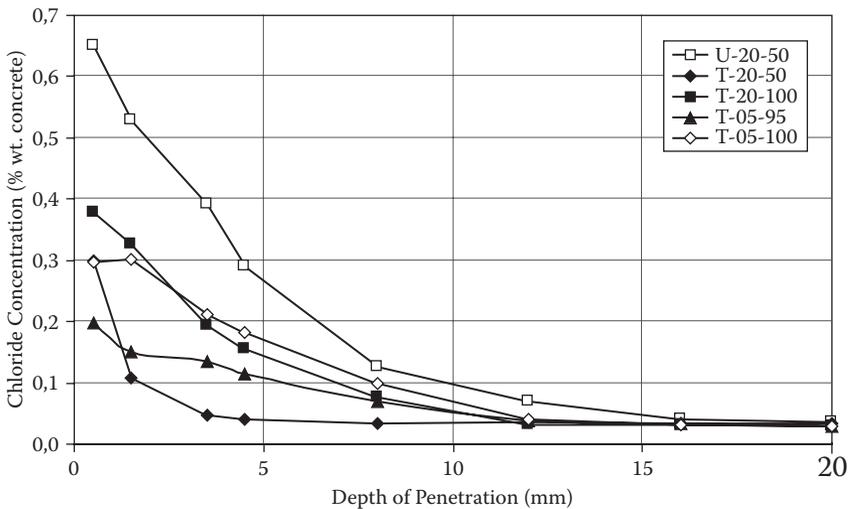
Figure 5.2 Protective effect of a surface hydrophobation against early-age chloride exposure. (From Liu, G. et al., Effect of Surface Hydrophobation for Protection of Early Age Concrete against Chloride Penetration, in *Proceedings, Fourth International Conference on Water Repellent Treatment of Building Materials*, ed. J. Silfwerbrand, Aedificatio Publishers, Freiburg, Germany, 2005, pp. 93–104.)

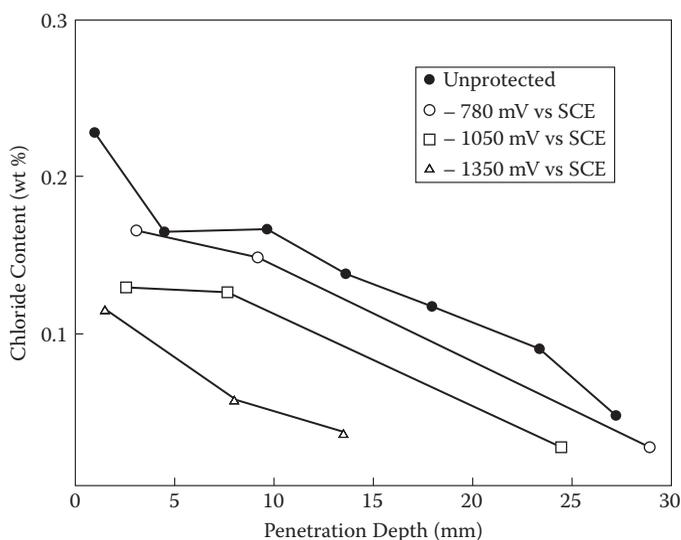
Figure 5.4 Effect of protection potential on rate of chloride diffusion through submerged concrete. (From Gjørsv, O. E., and Vennesland, Ø., Evaluation and Control of Steel Corrosion in Offshore Concrete Structures, in *Proceedings, The Katharine and Bryant Mather International Conference*, vol. 2, ed. J. Scanlon, ACI SP-1, 1987, pp. 1575–1602.)

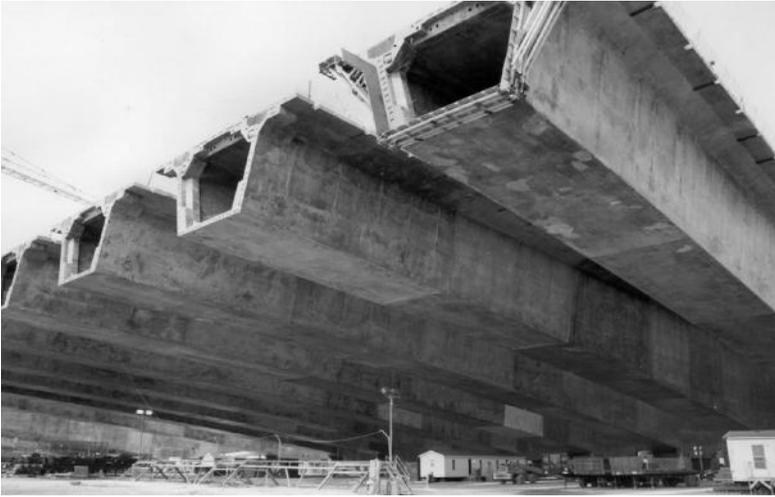
Figure 5.6 Precast cantilever girders for the Northumberland Strait Bridge.

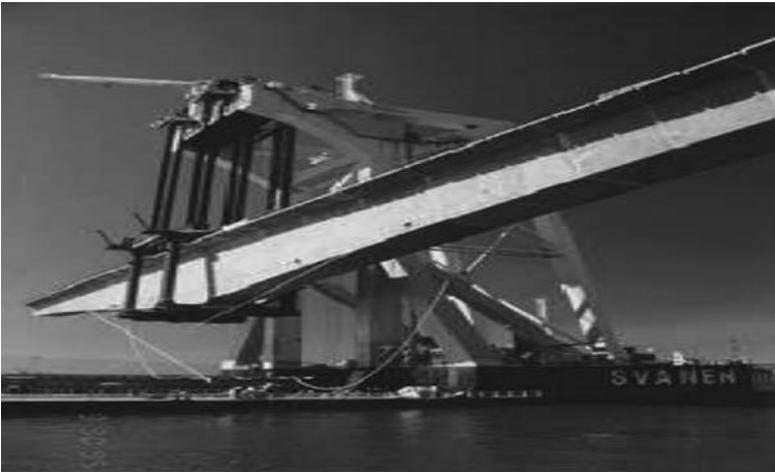
Figure 5.7 Precast cantilever girder for the Northumberland Strait Bridge.

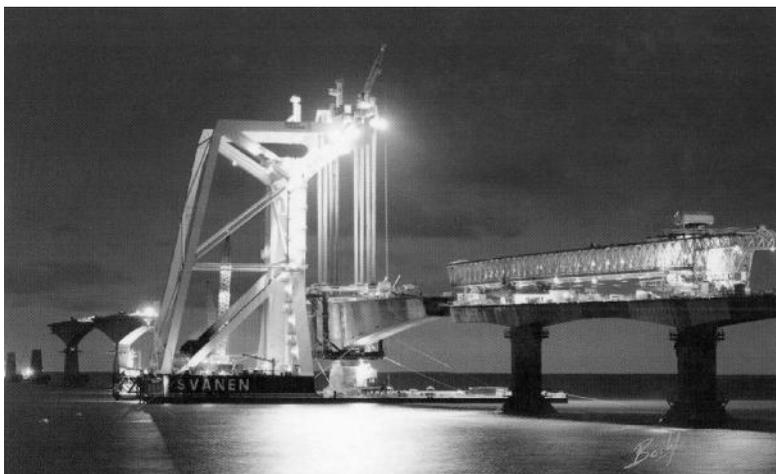
Figure 5.8 Installation of cantilever girders for the Northumberland Strait Bridge. (From Malhotra, V. M., *Proceedings, Third International Conference on Performance on Concrete in Marine Environment*, ACI SP-163, 1996.)

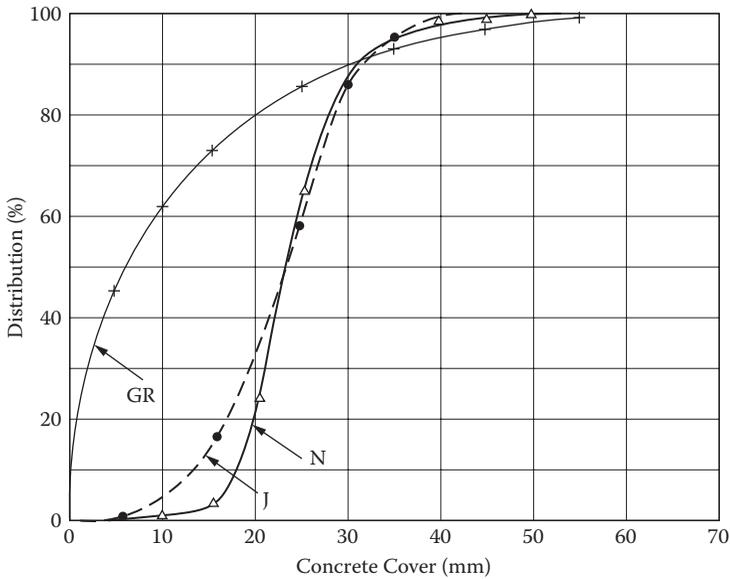
Figure 6.1 Variation in achieved concrete cover (mm) in the Gimsøystraumen Bridge (N) previously shown in Figure 2.40 compared to that of a Japanese bridge (J) and more than 100 concrete structures in the Gulf region (GR). (From Kompfen, R., *What Can Be Done to Improve the Quality of New Concrete Structures?* in *Proceedings, Second International Conference on Concrete under Severe Conditions—Environment and Loading*, vol. 3, ed. O. E. GjØrv et al., E & FN Spon, London, England, 1998, pp. 1519–1528.)

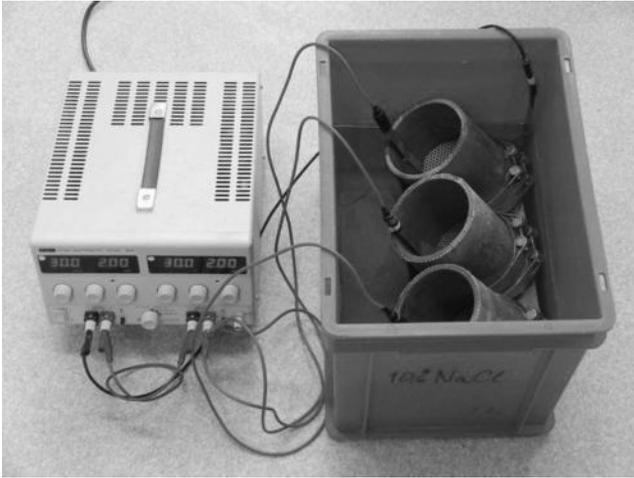
Figure 6.4 Concrete specimens under testing with the RCM method. (From NORDTEST, *NT Build 492 Concrete, Mortar, and Cement Based Repair Materials: Chloride Migration Coefficient from Non-Steady State Migration Experiments*, NORDTEST, Espoo, Finland, 1999; Tang, *The RCM Test (NT Build 492) for Evaluating the Resistance of Concrete to Chloride Ingress*, Tang's CI Tech, Gothenburg, Sweden, 2008, tang.luping@bredband.net.)

Immediately before testing, the test specimens are preconditioned according to a standardized water saturation procedure. Then, the specimens are mounted into rubber sleeves and placed in a container with a 10% NaCl solution, as shown in Figure 6.3, while the inside of the sleeves are filled with a 0.3 N NaOH solution. A set of concrete specimens under testing with the RCM method is shown in Figure 6.4.

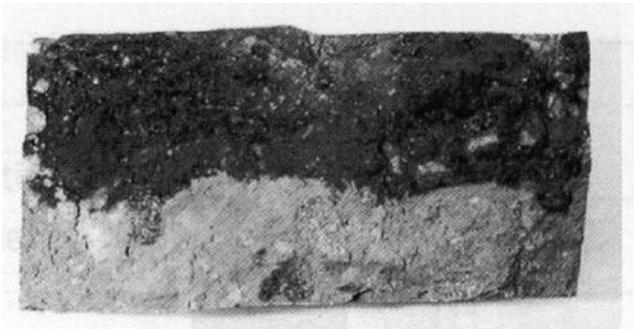
Figure 6.5 Observed depth of chloride penetration on the split concrete surface after spraying of the fresh surface with a standard AgNO_3 solution.

use of a colorimetric technique (Figure 6.5). Based on the observed depth of chloride ingress and the applied testing conditions, the chloride diffusivity is calculated according to an established procedure. As a result, the chloride diffusivity (D) of the concrete is obtained as an average value and standard deviation from the testing of three test specimens. Depending on the

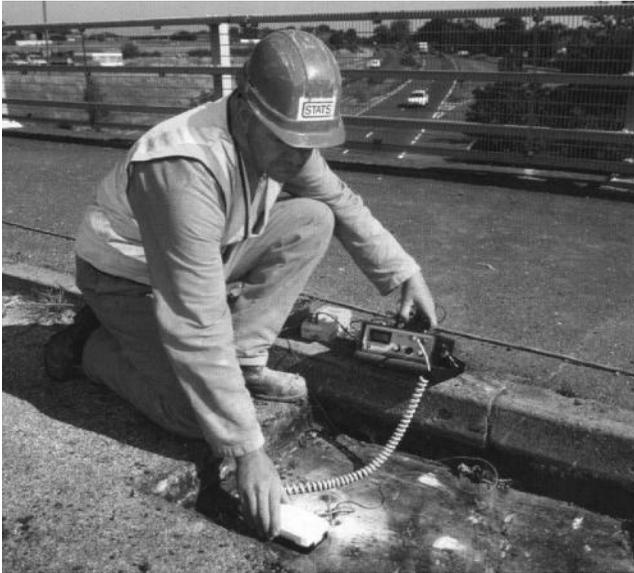
Figure 6.11 Control of achieved concrete cover based on the pulse induction technique. (From Germann, *In-Situ Test Systems for Durability, Inspection, and Repair of Reinforced Concrete Structures*, Germann Instruments A/S, Copenhagen, Denmark, 2008, <http://www.germann.org/>.)

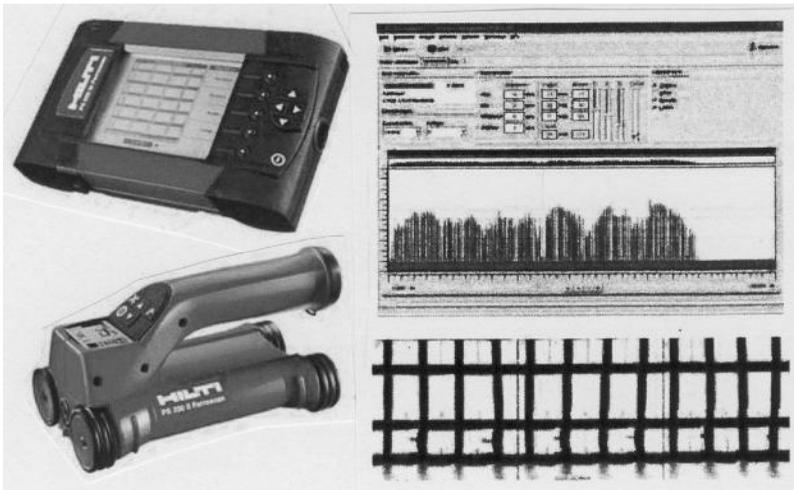
Figure 6.12 Control of achieved concrete cover based on scanning systems. (From Grantham, M., *The Use of NDT Methods in the Evaluation of Structures*, in *Proceedings, Second International Symposium on Service Life Design for Infrastructure*, vol. 2, RILEM, Bagnex, France, 2010, pp. 1003–1012.)

For concrete structures in severe environments, the specified concrete cover is normally very thick, and the reinforcement is often highly congested, making it difficult to measure the cover thickness accurately based on conventional cover meters. The use of stainless steel reinforcement may further complicate such measurements, although cover meters based on pulse induction can then be used (Figure 6.11). Also, more sophisticated scanning systems for control of achieved concrete cover exist (Figure 6.12). With

such equipment available, there should be little excuse for allowing low cover in new concrete structures, yet this seems to continue to be a problem on many construction sites.

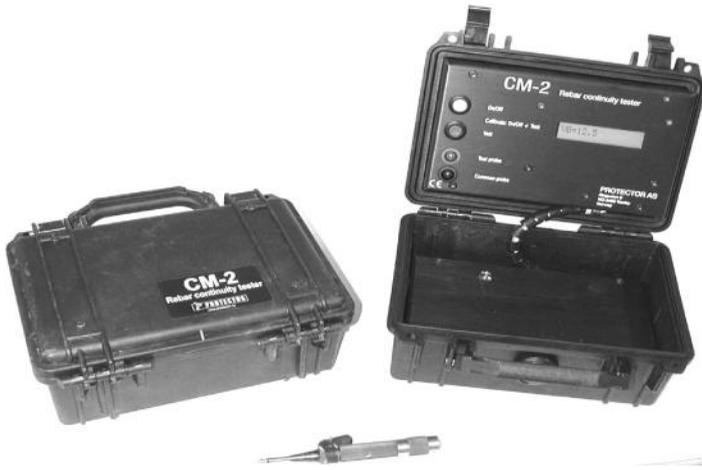
Figure 6.13 Equipment for control of electrical continuity within the reinforcement system. (From Protector, CM2 Rebar Continuity Tester, Protector AS, Oslo, Norway, 2008, [http:// www.protector.no/](http://www.protector.no/))

In principle, the electrical continuity is controlled by measurements of the ohmic resistance between various parts of the reinforcement system, and between any two points in the system, the resistance shall not exceed 1 ohm. In order to avoid the uncertainty of measurements when a traditional multimeter is applied, the measurements should preferably be carried out by use of a relatively high current (1 A) between the various parts of the reinforcement system. Commercial equipment for such measurements is available, where both the ohmic resistance and the rest voltage between the measuring parts 0.1 second after interruption of the current are observed (Figure 6.13).

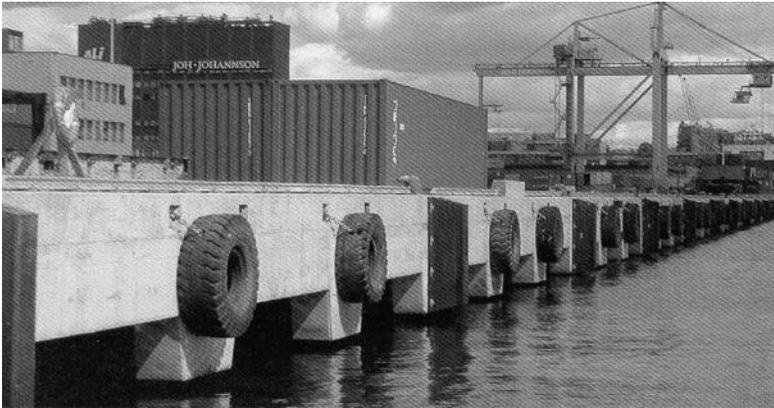
Figure 9.1 Container Terminal I (2002) in Oslo Harbor consists of an open concrete deck on top of driven steel tubes filled with concrete.

This concrete harbor structure consists of an open beam and slab type of deck on top of driven steel tubes filled with concrete (Figure 9.1). The structure, which has a waterfront of 144 m, was constructed in two steps and completed in 2002. At that time, the above procedures for durability design were not available. The specifications for a 100-year service life were therefore based on the then-current Norwegian Concrete Codes with some additional requirements:

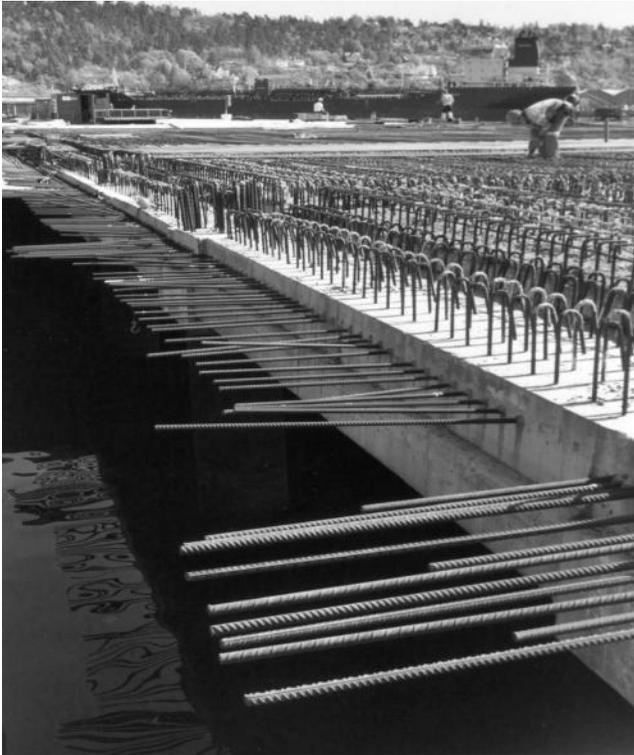
Figure 9.5 Protruding bars in the construction joints of the concrete deck.

Throughout concrete construction, a number of control measurements of achieved concrete cover were also carried out. Due to the very thick concrete cover and very congested reinforcement (Figures 9.5 and 9.6), it was not easy to obtain reliable measurements based on a conventional cover meter. Therefore, all control measurements were based on manually observed concrete covers on protruding bars in the construction joints during concrete construction. Based on altogether 68 individual measurements, an average concrete cover of 99 mm with a standard deviation of 11 mm was obtained.

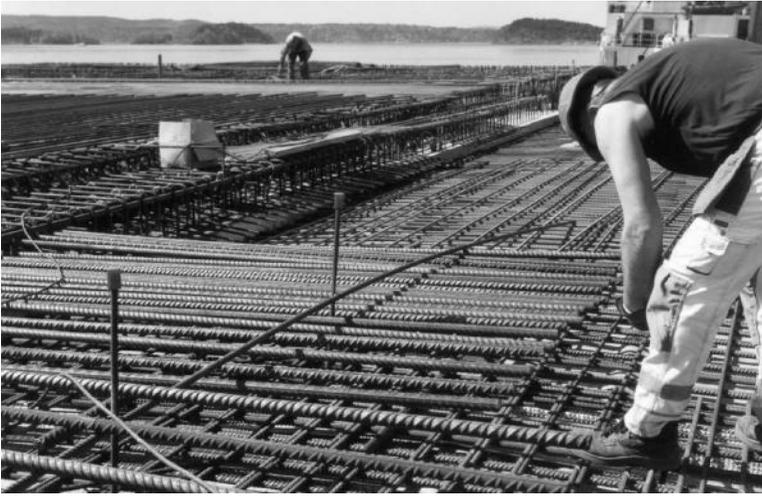
Figure 9.6 The concrete deck had very congested reinforcement.

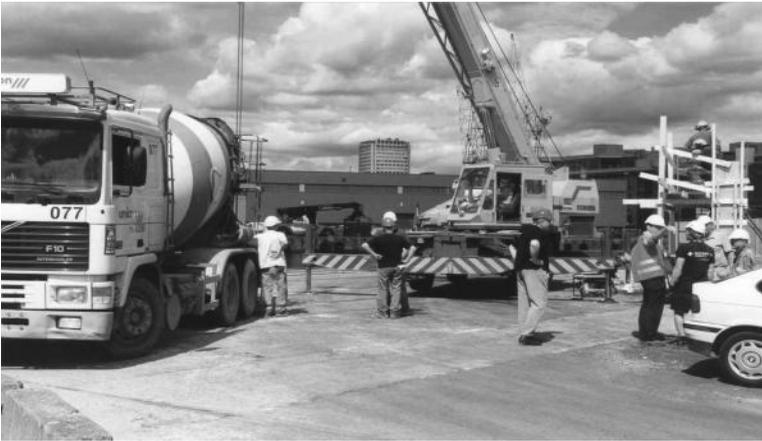
Figure 9.12 Production of a wall type of dummy element on the construction site.

number of concrete cores removed from the given structures during concrete construction. In addition, a number of cores from corresponding dummy elements separately produced on the construction site were also tested. For each concrete structure, one or more dummy elements were produced, and these were either a slab or a wall type of element, or both (Figures 9.12 and 9.13). A typical development of chloride diffusivity on the construction site and in the laboratory for up to one year is shown in Figure 9.14.

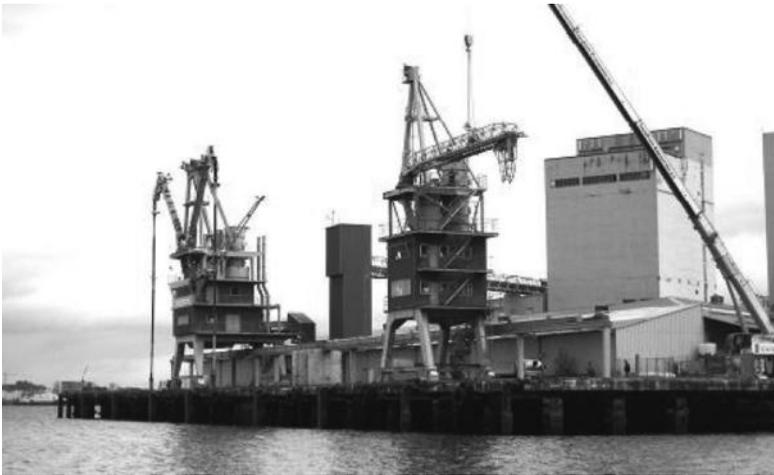
Figure 10.1 A heavily corroding concrete harbor structure from 1964 in Trondheim. (Courtesy of Trondheim Harbor KS.)

In order to demonstrate how an assessment of life cycle costs may provide a further basis for decision making of various technical solutions for improved durability, a heavily corroding concrete structure in Trondheim Harbor was selected for a case study. The structure, which was constructed in 1964, was a traditional concrete harbor structure with an open concrete deck of 132×17 m on top of slender underwater-cast concrete pillars. The concrete deck has 3 longitudinal main girders and 18 transversal secondary beams with two-way slabs in between. The main girders and the secondary beams have dimensions of 90×120 cm and 70×70 cm, respectively, while the top slab is 25 cm thick, including a 6 cm top layer. The mechanical loads on the deck consist mainly of two heavy loading cranes with capacities of 60 and 100 tons, respectively, moving on top of the three longitudinal main girders (Figure 10.1).

After a service period of about 38 years (2002), the general condition of the structure was very poor due to heavy corrosion of the embedded steel. A structural assessment confirmed that the load-bearing capacity of the main girders would only be acceptable for continued operation of the heavy

loading cranes for a very short period of time. The observed rate of corrosion in the girders was so high that an immediate repair was considered very urgent. The concrete pillars were in fairly good condition, but the deck slabs had already reached such a high degree of deterioration that all other traffic on the concrete deck had been prohibited for some time. Of the various technical solutions for repair considered, one option would simply be to construct a new concrete deck on top of the old deck, only using the old deck as a formwork. However, since both the heavy crane facilities and the harbor structure as a whole would not be needed for a continued operation of more than a very limited period of time, the construction of a new concrete deck would represent a too expensive solution. Therefore, a specially designed cathodic protection system was applied in order to reduce the rate of corrosion in the three main girders as much as possible, and thus extend the service life of the structure for a limited period of time (Vælitalo et al., 2004).
