Practical Plant Failure Analysis

**A Guide to Understanding
Machinery Deterioration and
Improving Equipment Reliability**

Neville W. Sachs, P.E.

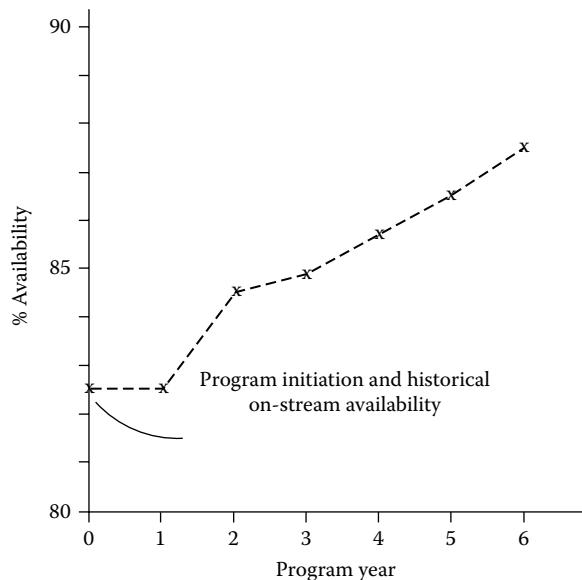
FIGURE 1.2 Equipment availability vs. program year for an effective reliability program.

The plant where I learned about *The Reliability Approach*TM was over 90 years old with a mature process that had not been changed for years. The annual sales volume of the plant was about half a billion dollars, and it had historically lost around 17% of the production capacity to downtime. During the first six years of this reliability program, despite minimal expenditure on capital equipment and a reduction in both the maintenance staffing and the maintenance budget, we were able to increase effective production time by about 1% per year, and the actual output increased by more than that. (The net benefit was about a 1/3rd reduction in downtime for a process that hadn't materially changed in 40 years.) The following graph shows the actual results from the program (Figure 1.2).

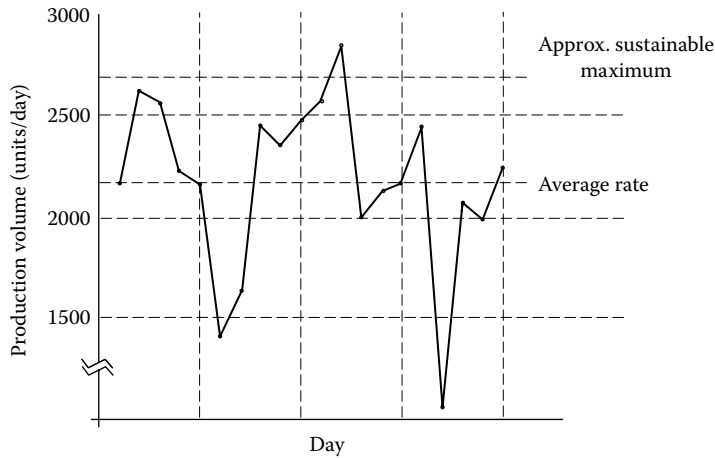
FIGURE 1.3 A plant's production history.

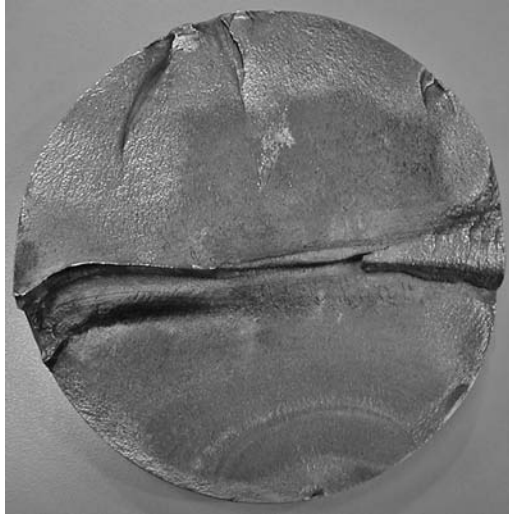
PHOTO 2.1 Fatigue failure of an agitator shaft.

Looking at the failure face and its surroundings will tell almost everything about the physical causes of the failure, i.e., where it started, the magnitude and direction of the forces involved, how long it took to propagate across the piece, and whether there were any material weaknesses that contributed significantly to it. Sometimes it is more difficult than others to see the clues, and sometimes it is difficult to understand all of them, but they are there. Inspection of the failed agitator shaft shown in Photo 2.1 indicates that it was a fatigue failure, was caused by two-way plane bending, had stress concentrations, and was lightly loaded. Further inspection of the shaft exterior surface will present evidence of the faulty maintenance practices that caused the two-way bending.

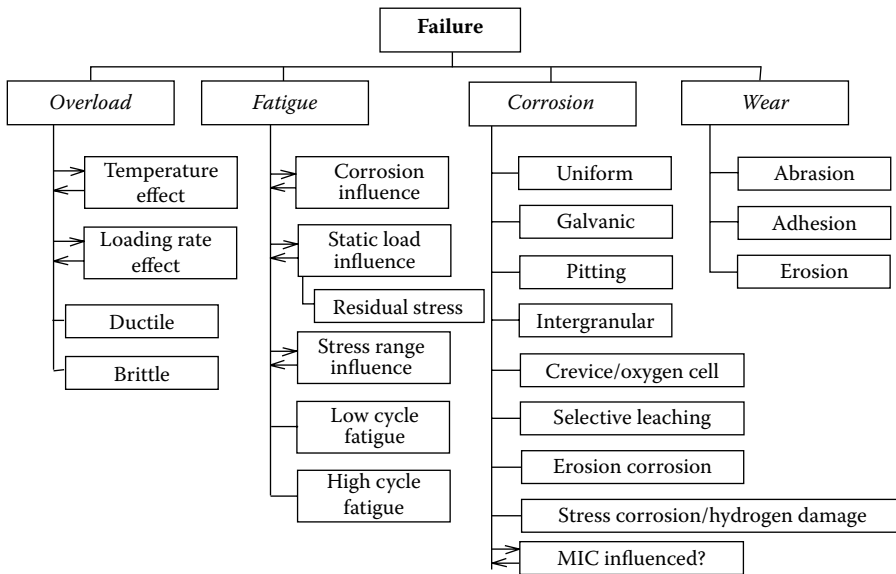
FIGURE 2.4 An expansion of Figure 2.1 showing major failure mechanism contributors.

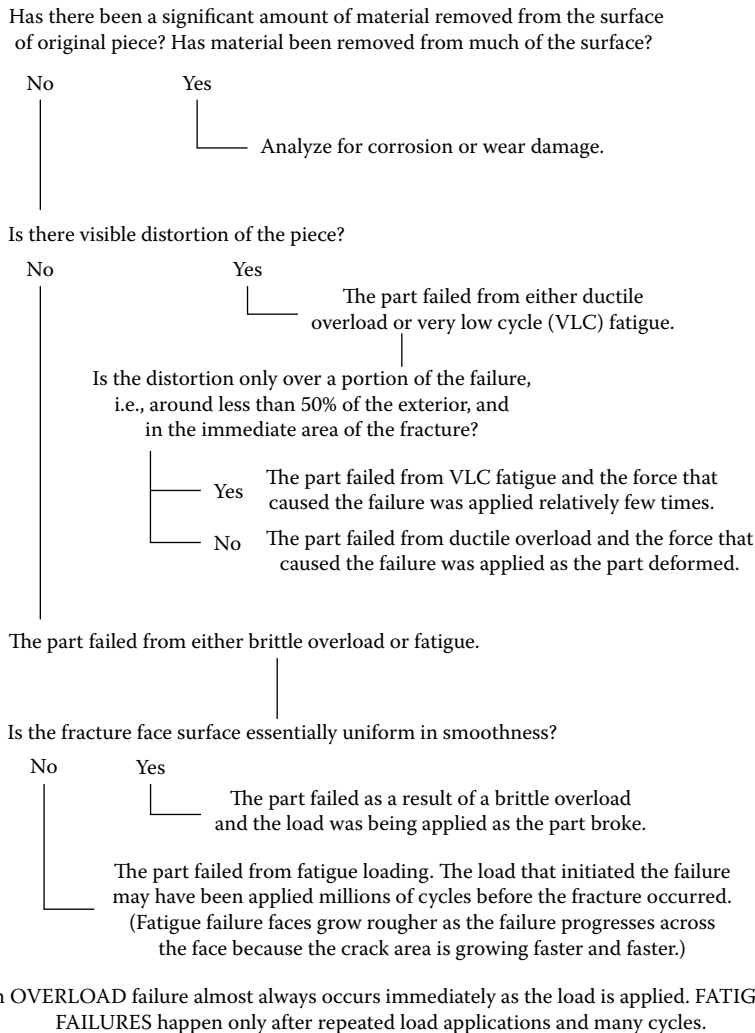
FIGURE 2.5 Determining the basic failure mechanism.

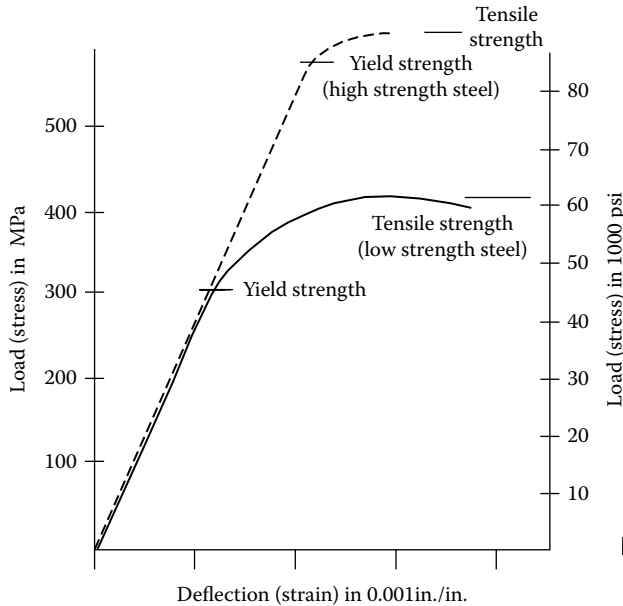
FIGURE 3.4 A basic stress-strain diagram for two different steels.

Figure 3.4 is a stress–strain diagram for two steels. The lower solid line shows mild steel with yield strength of 310 MPa (45,000 psi) and a tensile strength of about 410 MPa (60,000 psi). This means that if the part has a cross-section area of 645 mm² (1 in.²), a load of 309.9 MPa (44,999 lb) can be put on the part before it permanently deforms by 0.2%. If the load on the part is further

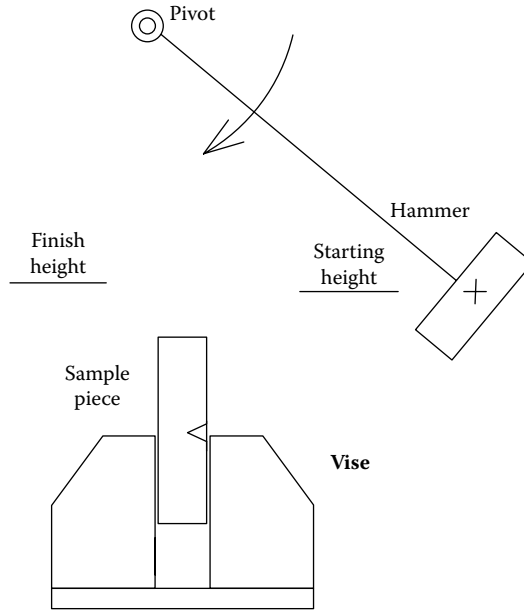
FIGURE 3.6 A Charpy V-notch impact test. (There are similar tests where the piece is not notched.)

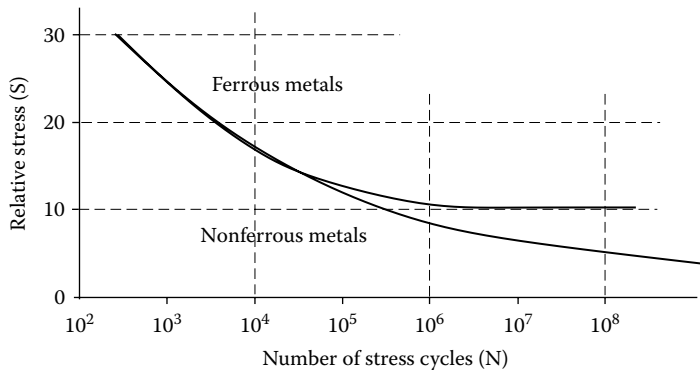
FIGURE 3.8 A typical S–N curve showing how the ferrous and non-ferrous materials react to repeated stress cycles.

The fatigue strength of a metal depends on both how heavily the part is loaded and how many times the load is applied. Figure 3.8 is an SN diagram, where S is the stress and N is the number of load cycles, and it shows how fatigue strength changes with the number of cycles. In the SN

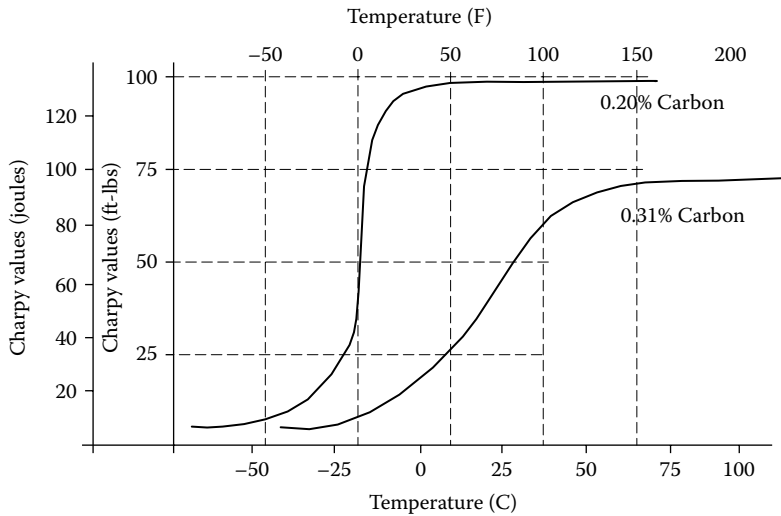
FIGURE 4.2 Comparing the impact strength of two low-carbon steels.

On the ski lift, the impact loads occurred as the chairs swung and hit the support for the wire rope wheel at the top of the ski hill. At the operating temperatures, the specified weaker material would require between 100 and 115 J (75 and 85 ft.-lb) of energy, whereas the stronger AISI 1030 chairs would fail at about one tenth of that value.

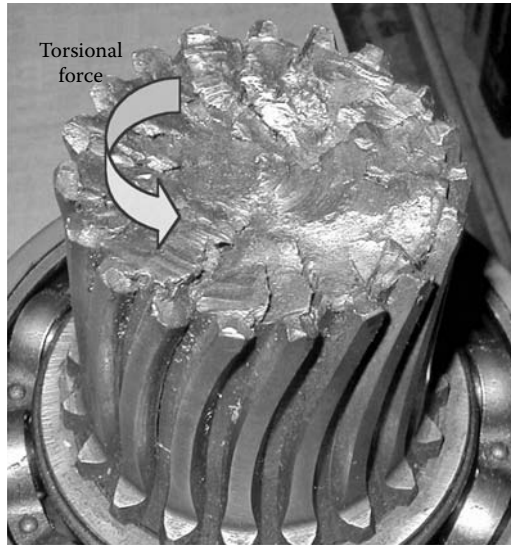
PHOTO 4.3 The input spline of a small reducer. This shaft failed as a result of another failure that jammed the reducer.

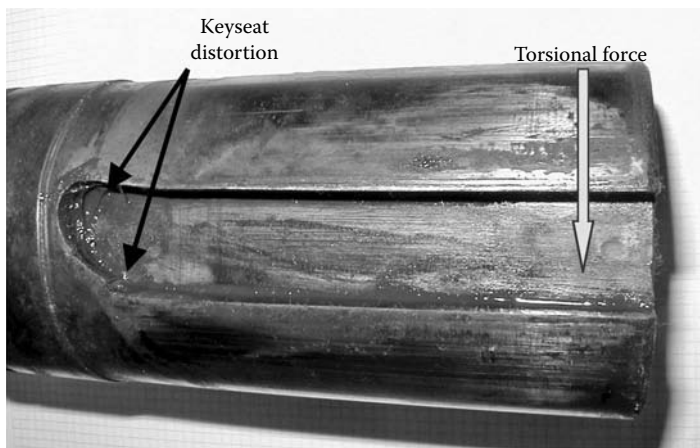
PHOTO 4.4 The keyway deformation is proof that the shaft has been overloaded.

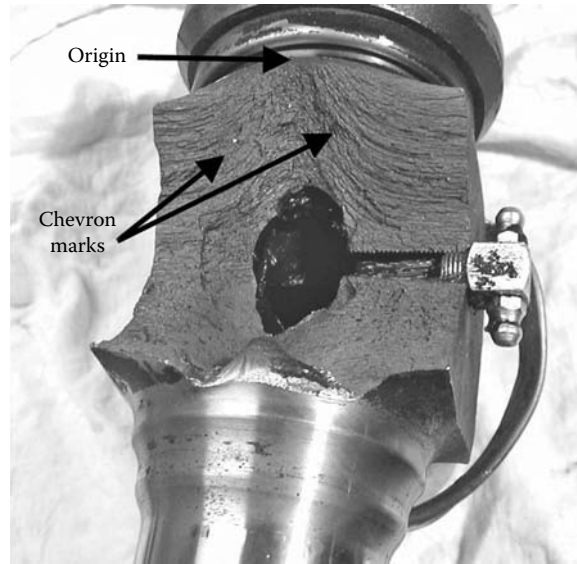
PHOTO 4.10 A universal joint with the Chevron marks clearly pointing at the origin of this brittle fracture.

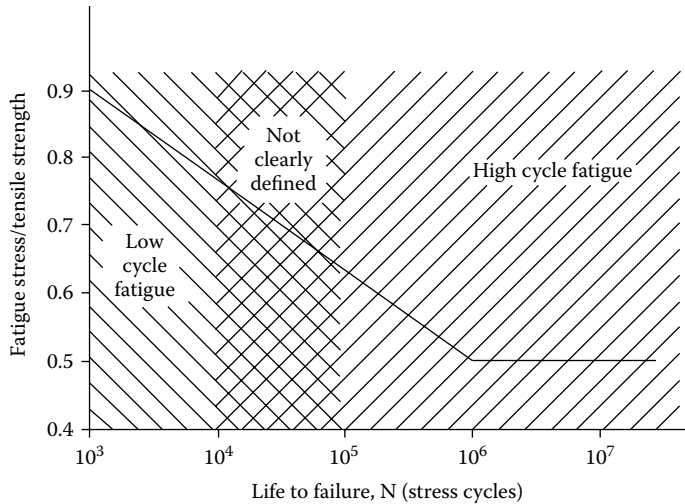
FIGURE 5.1 An S/N chart showing the ranges for low and high cycle fatigue failures. (VLCF would be off the left side of the chart.)

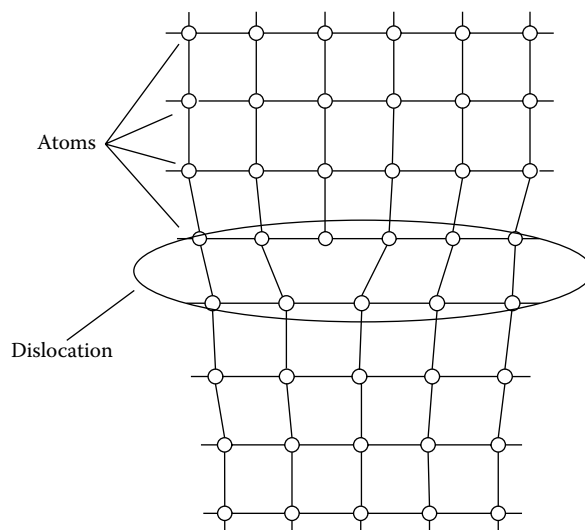
FIGURE 5.3 The cross section of a metal crystal showing a dislocation in the structure.

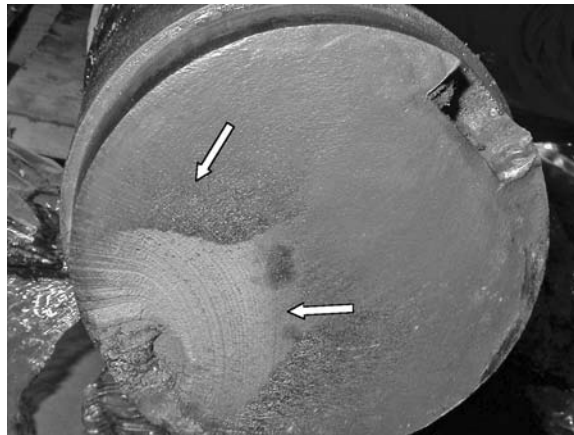
PHOTO 5.1 This fatigue failure started at the keyway. The fracture face is relatively smooth up until the ends of the two arrows. From there to the final fracture progression marks are readily visible.

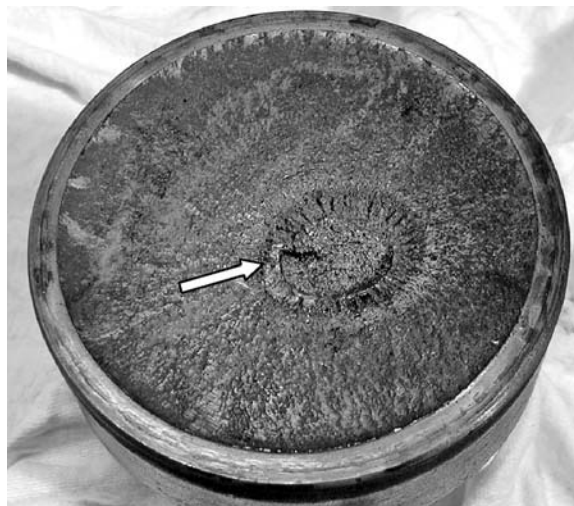
PHOTO 5.7 A rotating bending failure with multiple origins around the perimeter. The small IZ indicates the shaft was lightly loaded at the time of final failure.

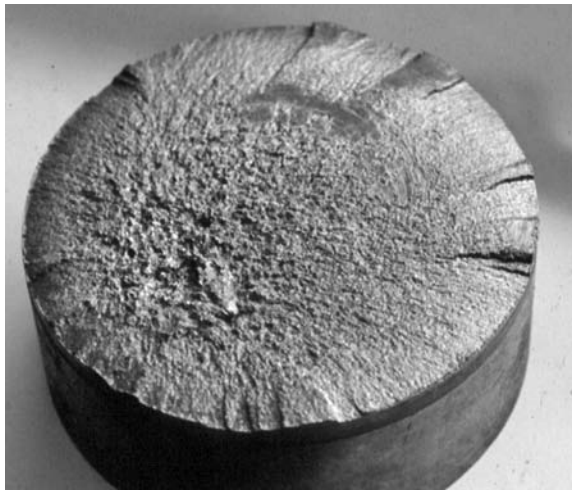
PHOTO 5.9 This one lasted only 12 hours.

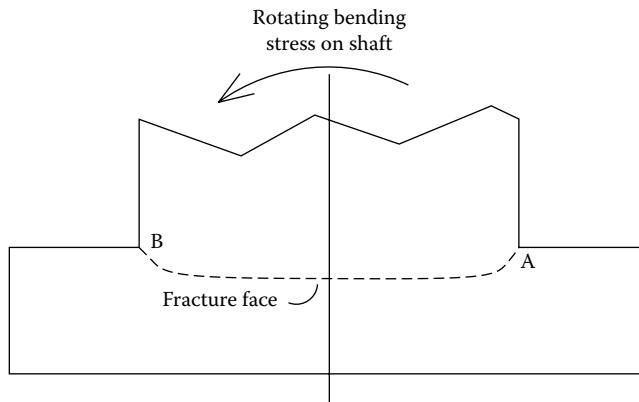
FIGURE 5.10 The contour of the fracture is always perpendicular to the plane of maximum stress. This fracture face profile suggests a very high stress concentration.

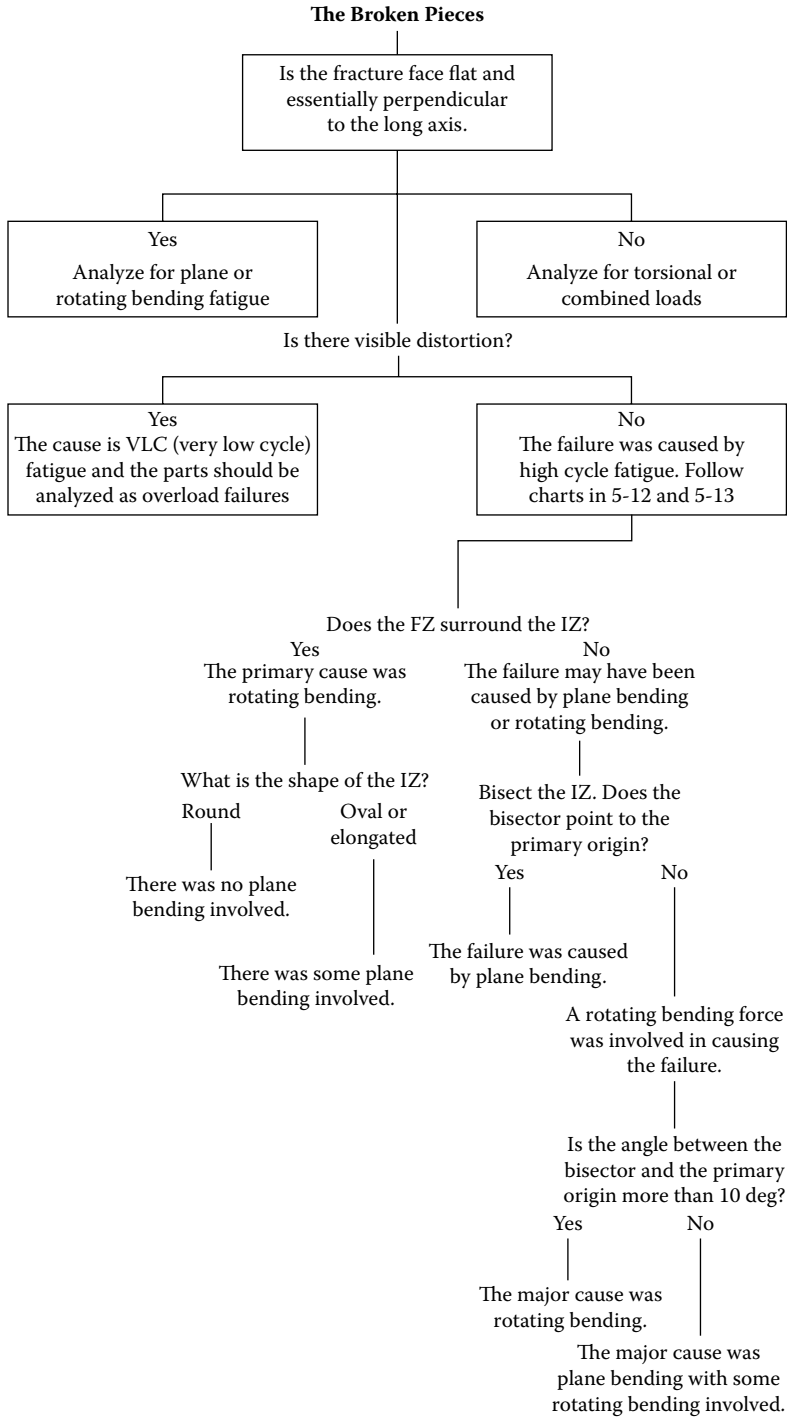
FIGURE 5.11 The first steps in a fatigue failure analyses.

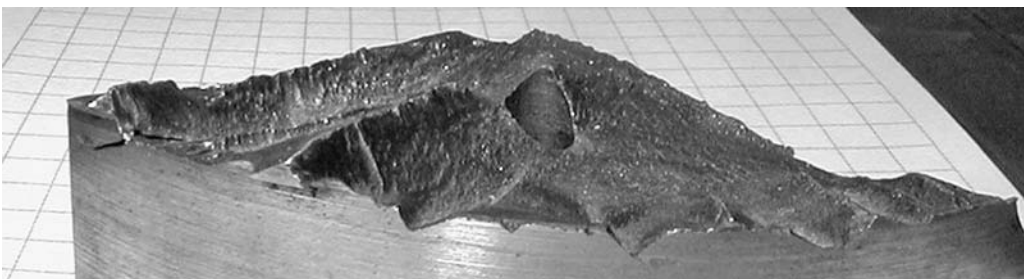
PHOTO 6.3 This section of a failure shows many ratchet marks with angled sides indicating multiple torsional fatigue crack origins.

- a. If there is pure torsion, the cracks will grow toward the center, and the angle will be similar to that seen in Photo 6.2, or even steeper.
- b. If there are other contributory forces, the sides of the ratchet marks will be diagonals, as shown in Photo 6.3, and the fracture face will be close to flat.

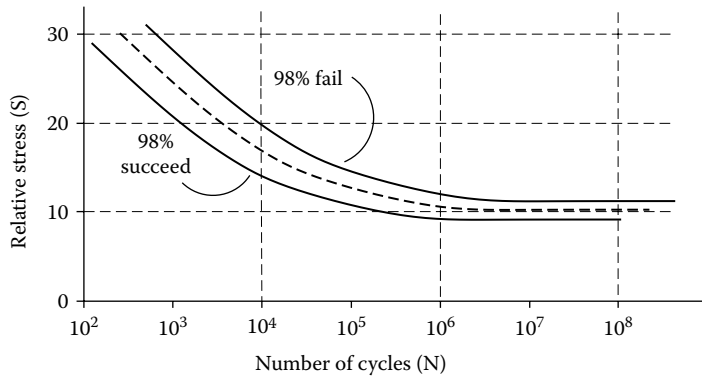
FIGURE 6.2 Confidence bands showing that the actual fatigue strength of a piece may vary by an order of magnitude.

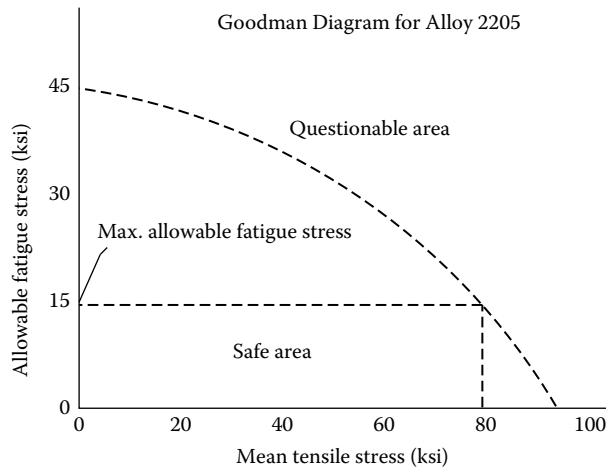
FIGURE 6.4 A Goodman diagram such as this allows us to calculate the combined effects of steady state and fatigue stresses.

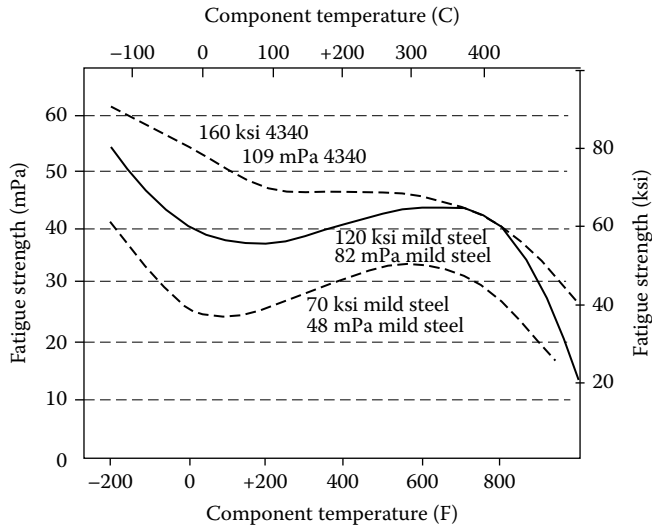
FIGURE 6.5 Fatigue strength vs. temperature for three steel alloys.

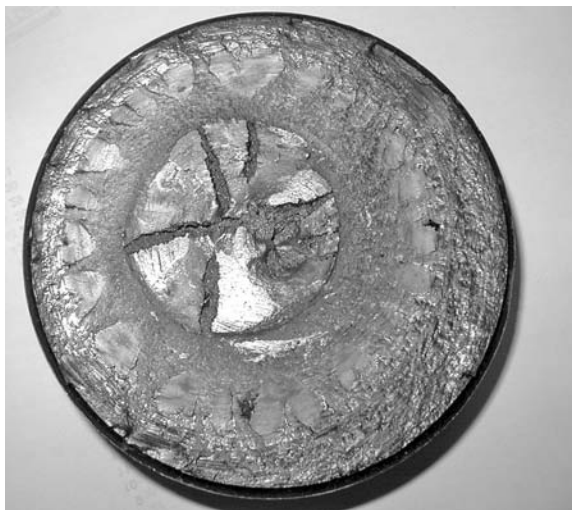
PHOTO 6.12 The very low cycle torsional fatigue failure of a large machine shaft.

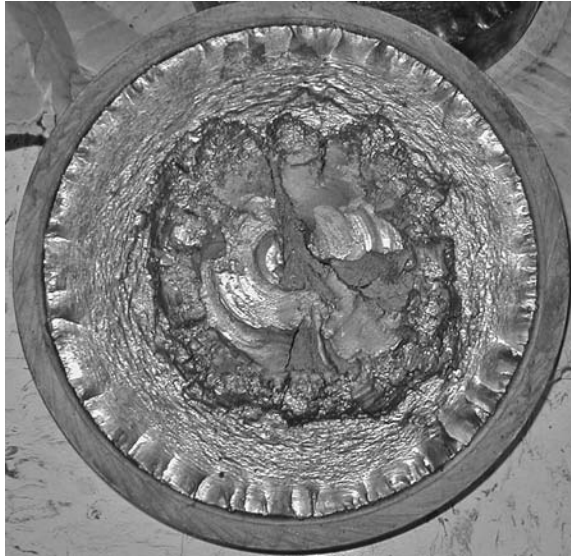
PHOTO 6.13 This low cycle torsional fatigue failure saw more stress cycles than the previous shaft.

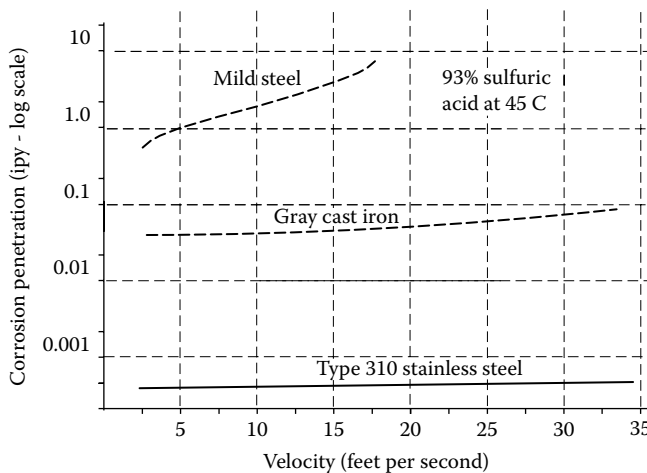
FIGURE 7.7 Corrosion rates vs. solution velocity for three materials with differing corrosion mechanisms.

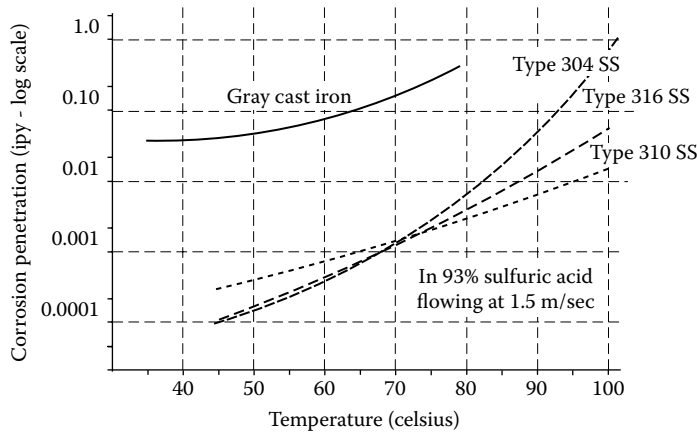
FIGURE 7.9 Corrosion rates vs. temperature for two of the materials shown in Figure 7.7.

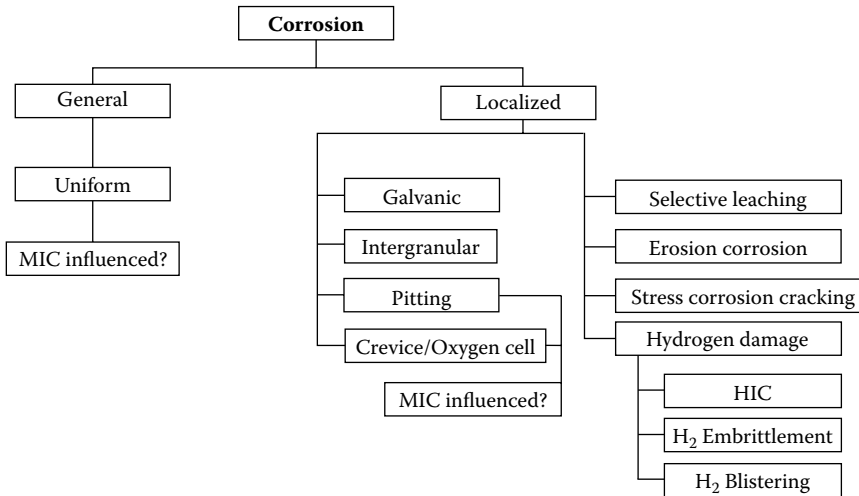
FIGURE 7.10 A breakdown of the major corrosion categories.

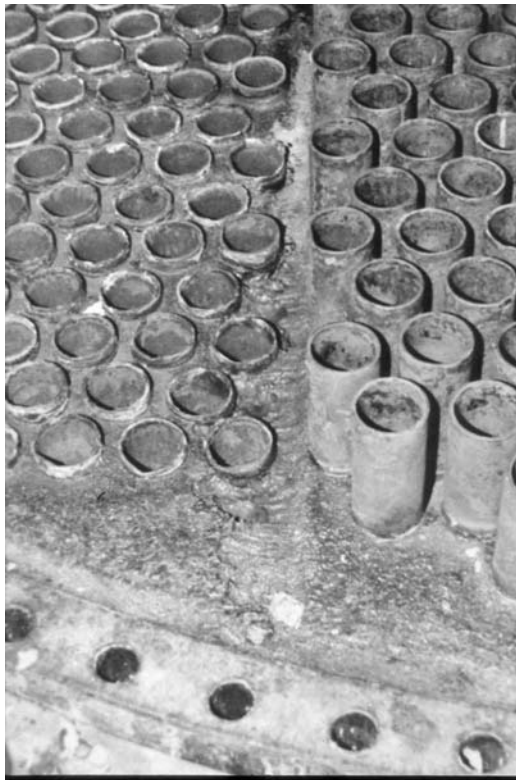
PHOTO 7.3 The increased velocity under the baffle plate on this heat exchanger caused increased corrosion rates.

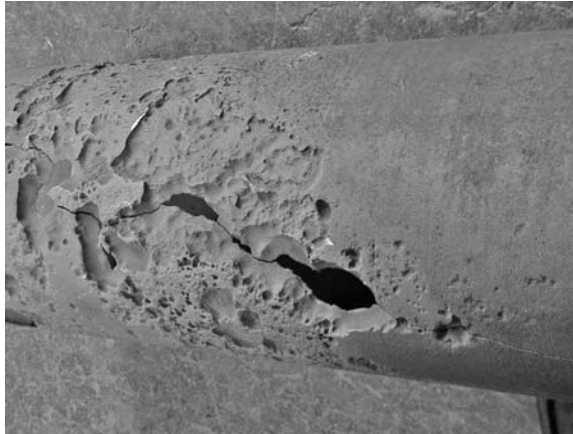
PHOTO 7.8 Selective leaching of a buried pipe.

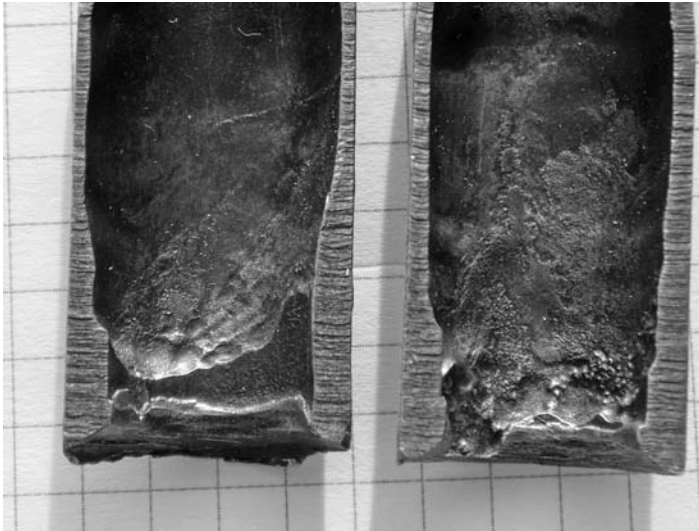
PHOTO 7.10 Erosion corrosion of two heat exchanger tubes.

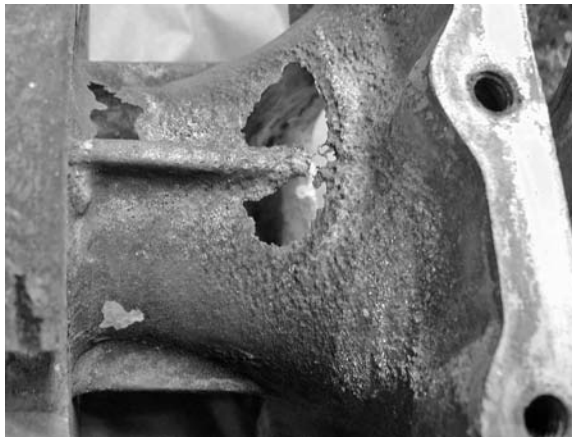
PHOTO 7.17 The heavily pitted surface caused by elevated temperatures.

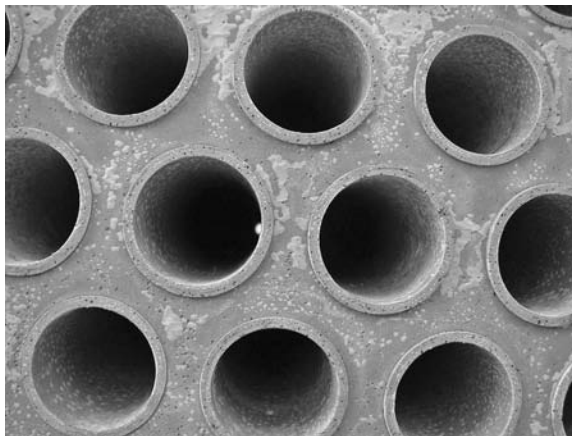
PHOTO 7.18 The pitted surface of a heat exchanger. In this case the pitting was caused by increased solution concentration.

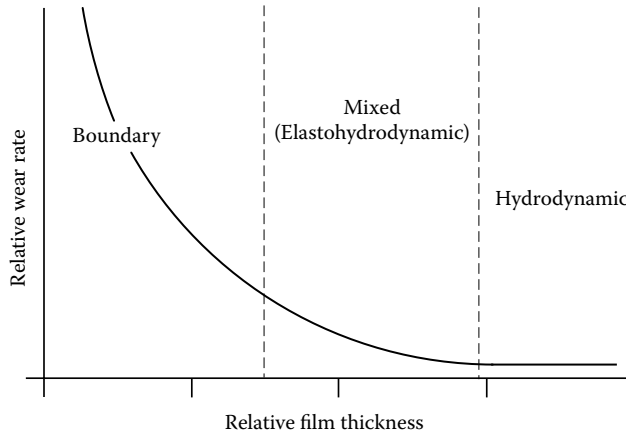
FIGURE 8.1 The three basic lubrication regimes with greatly decreasing wear rates as the film thickness increases.

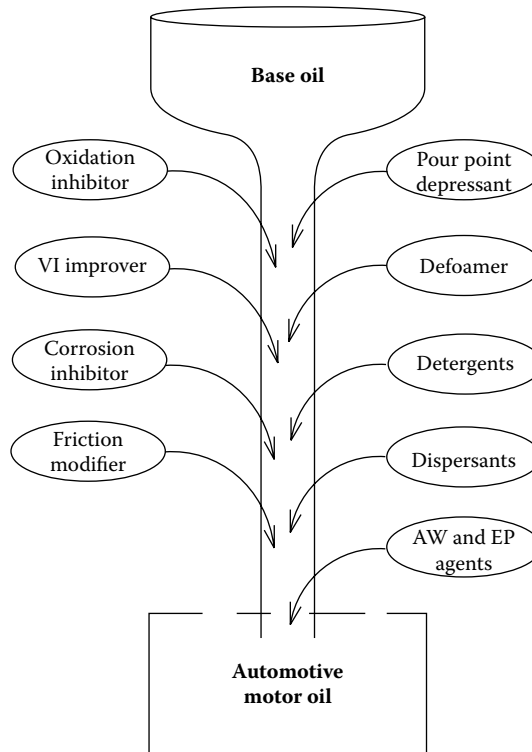
FIGURE 8.9 Making an automotive engine oil.

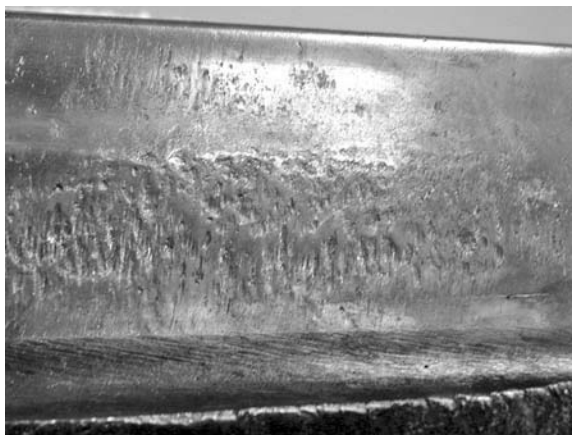
PHOTO 8.1 Adhesive wear of a through-hardened gear tooth.

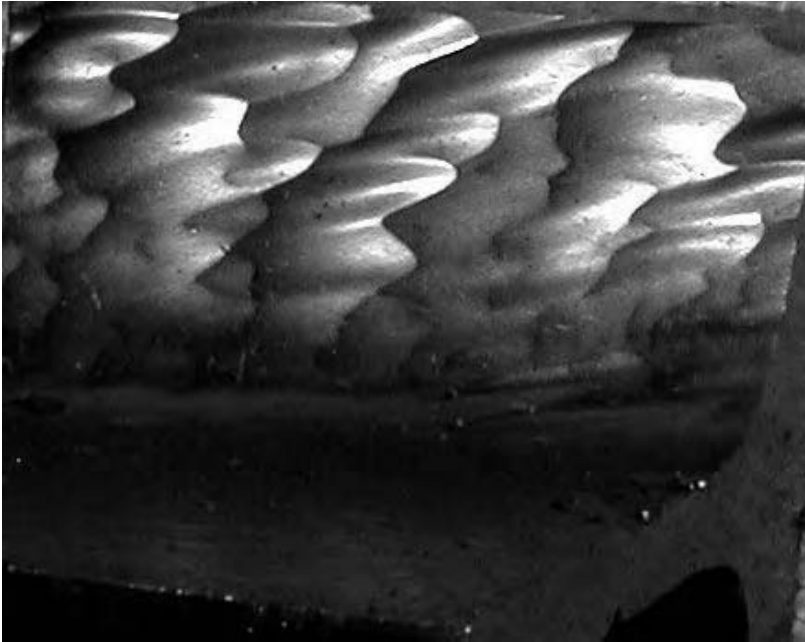
PHOTO 8.6 Pump impeller damaged by solid particles in a liquid flowstream.

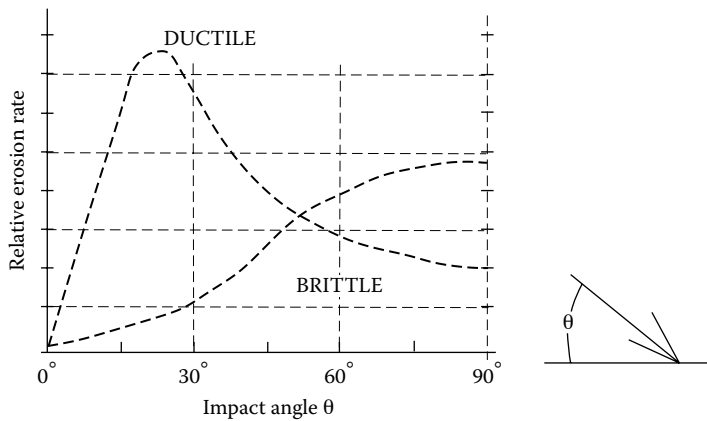
FIGURE 8.17 Relative erosion rate vs. impact angle (from numerous sources based on the work by J.G.A. Bitter).

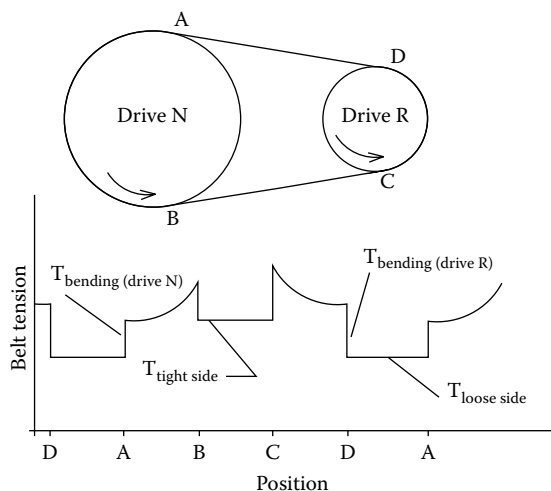
FIGURE 9.4 This figure shows the stress cycles the tension numbers go through during a revolution.

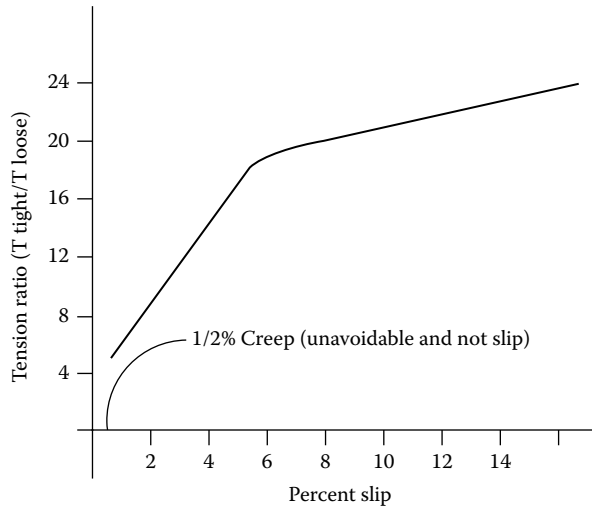
FIGURE 9.5 Tension ratios vs. % slip for a V-belt drive.

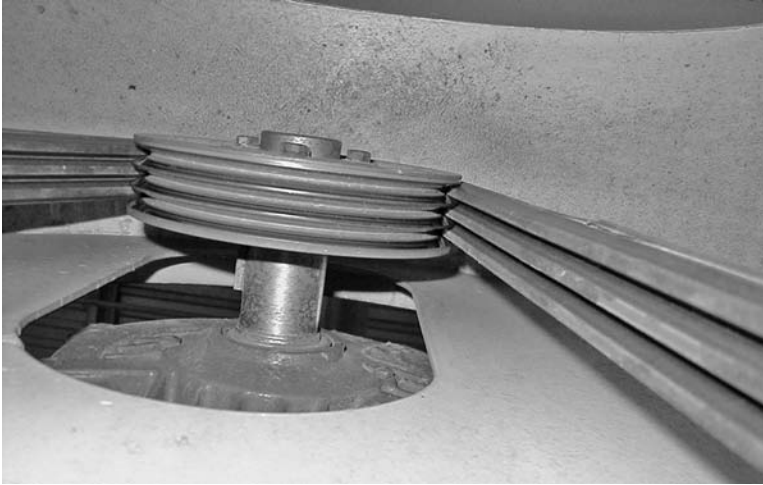
PHOTO 9.3 The cover separation on the right side of the sheave is obvious. This is the result of improper installation procedures.

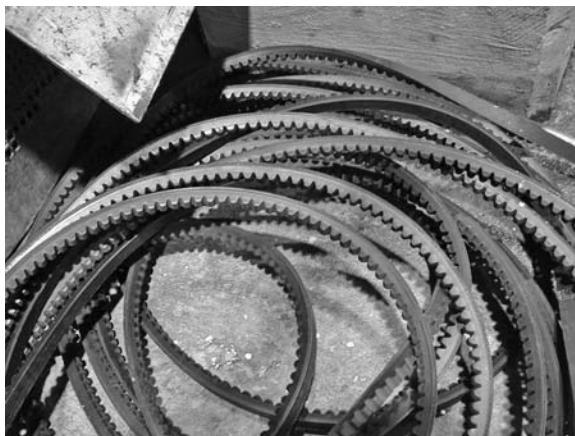
PHOTO 9.5 This is a pile of belts that has just been removed from a large fan. The elastomer on the sheave contact surfaces is shiny and polished, proof that the belts have been slipping.

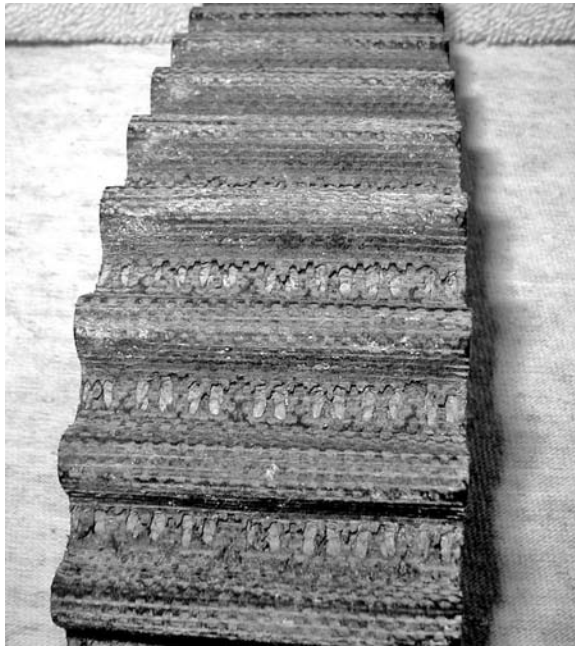
PHOTO 9.7 The worn teeth on this synchronous belt are coming off, proof that the belt has reached the end of its design life. The evenness of the fractures shows that the alignment was excellent.

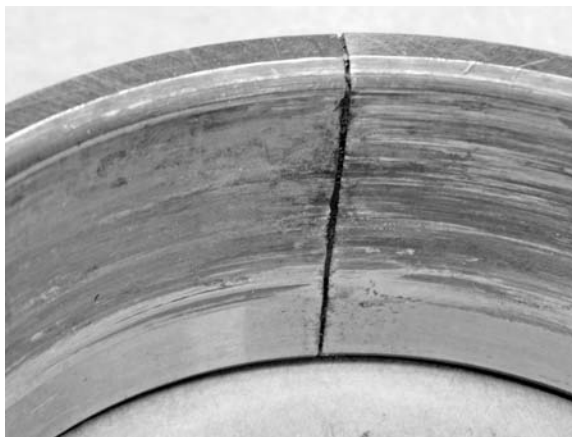
PHOTO 10.2 This shows the shaft fit from a through-hardened bearing. The crack extends to the rolling surface and a catastrophic failure is not far away.

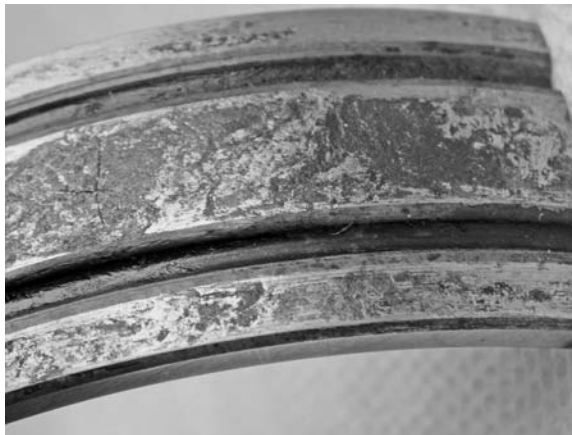
PHOTO 10.14 A heavily fretted surface with a visible crack.

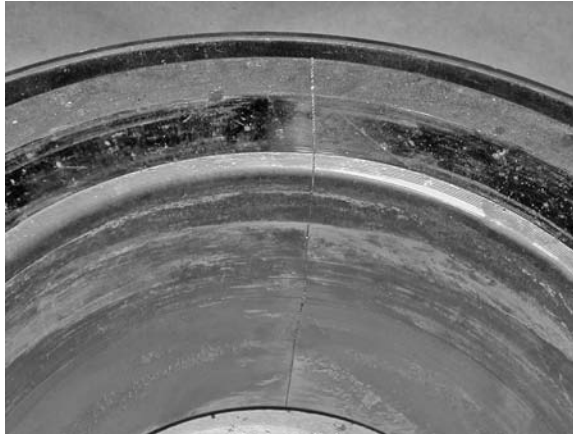
PHOTO 10.15 The cracked inner ring of a through-hardened bearing.

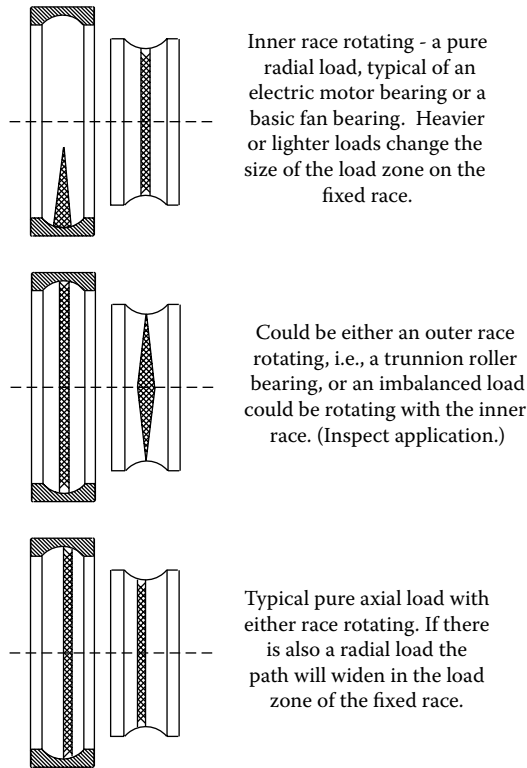
FIGURE 10.6 Typical normal load zones in a ball bearing.

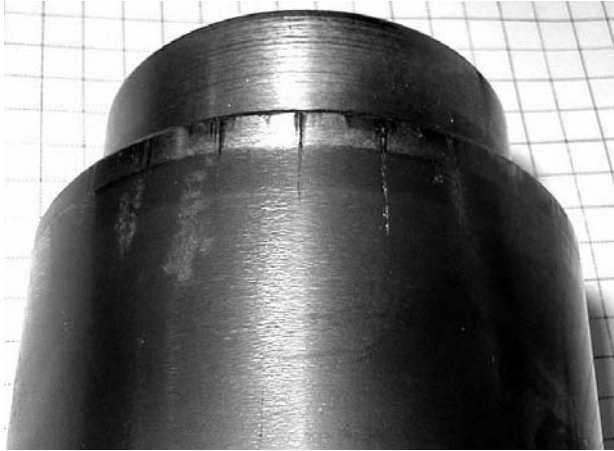
PHOTO 10.26 A forklift truck spindle that has been brinelled by careless assembly procedures.

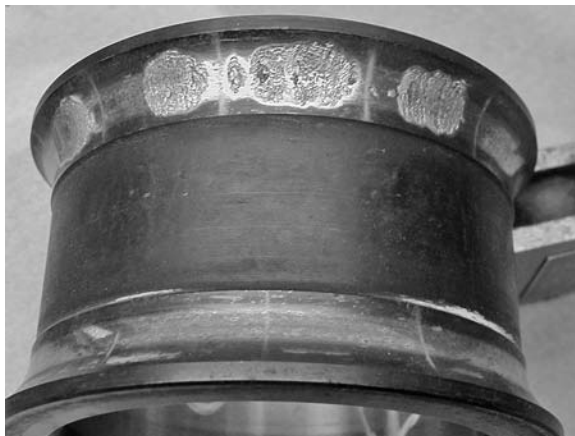
PHOTO 10.32 This ball path shows a combinatin of problems, probably brinelling combined with an inadequate lubricant.

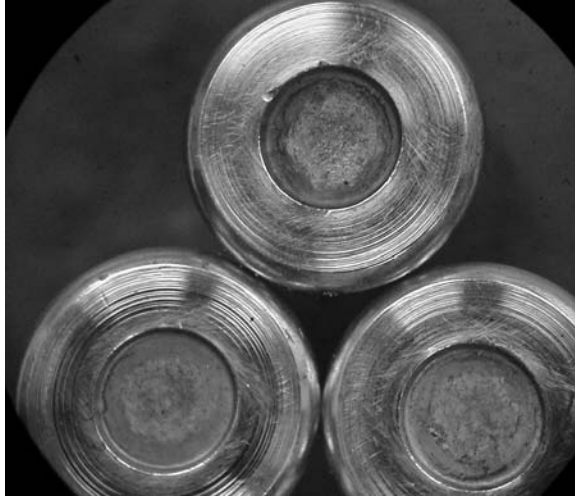
PHOTO 10.42 The grooves and rings on these rollers show the thrust load has overcome the lubricant film.

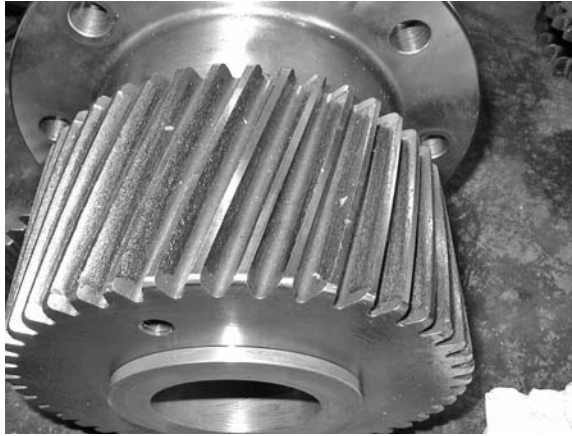
PHOTO 11.4 The gear drives in only one direction. The wear on the “back” or inactive side of the teeth shows the peak drive load is more than twice the average load.

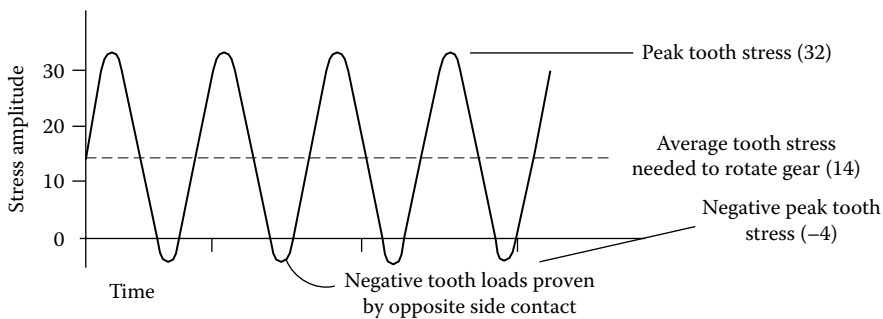
FIGURE 11.6 In a drive with torsional vibration the stresses are more than double the design loads.

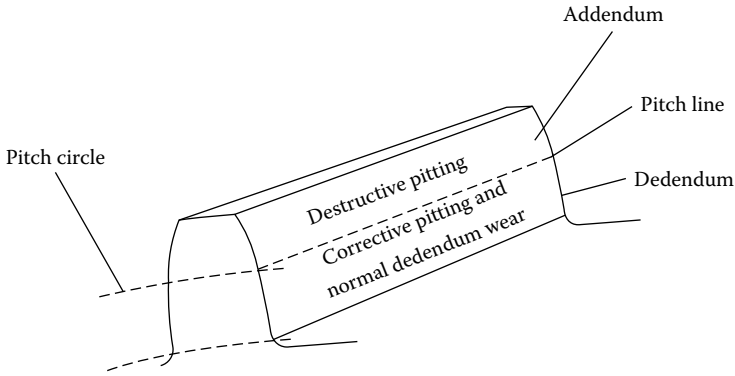
FIGURE 11.9 Common pitting locations on a through-hardened gear.

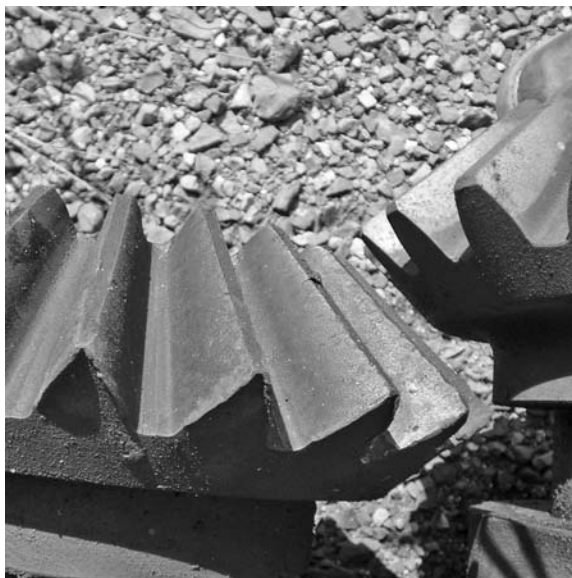
PHOTO 11.11 A through-hardened steel mill gear with heavily worn teeth that show rolling damage.

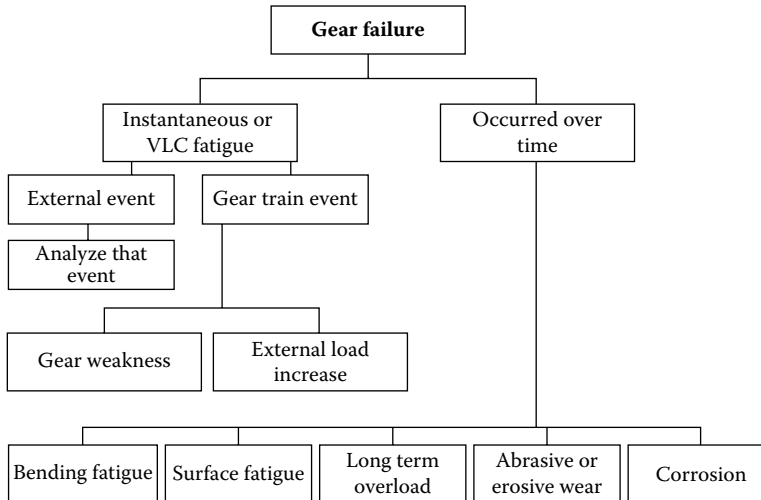
FIGURE 11.12 A basic gear failure analysis tree.

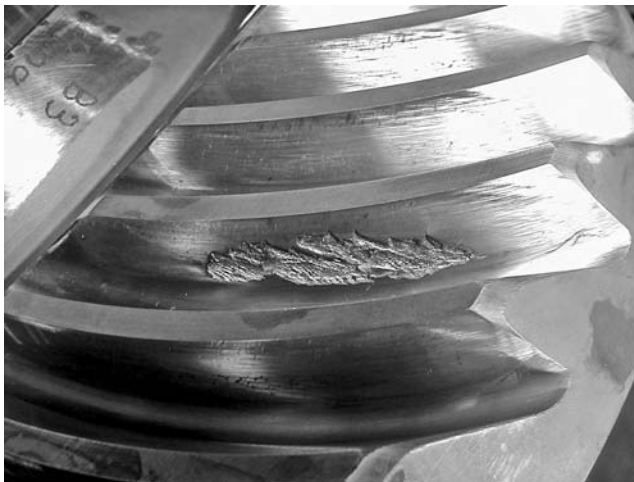
PHOTO 11.18 Spalling of an intermediate spiral bevel pinion — the result of a manufacturing problem.

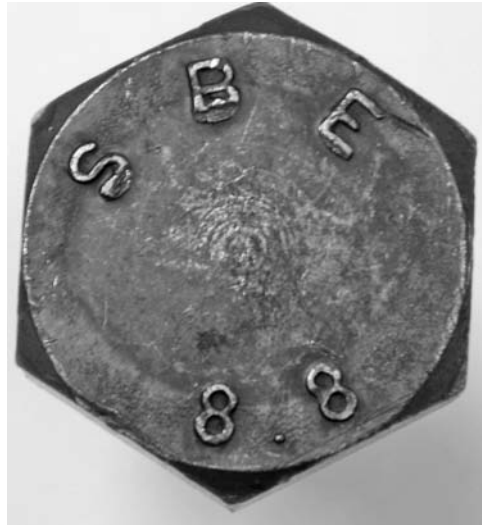
PHOTO 12.1 A general purpose metric fastener can be identified by the number (8.8) showing the strength level.

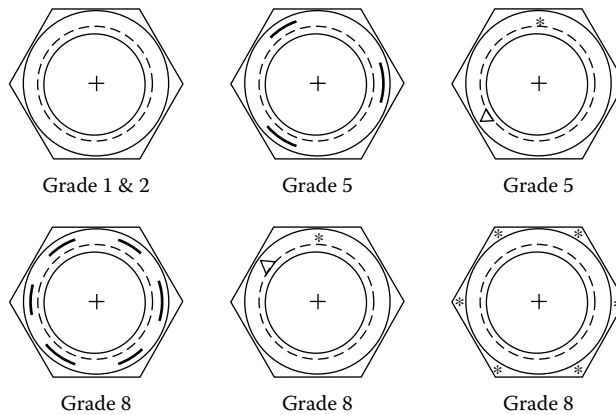
FIGURE 12.6 Identification of some US thread steel nuts.

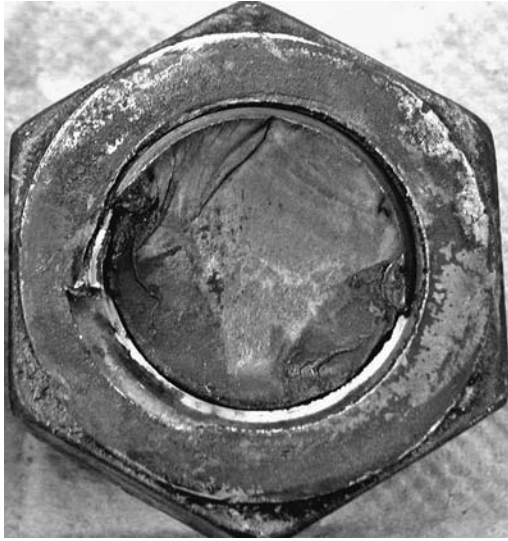
PHOTO 12.4 The face of the nut shows uneven contact and wear at both the 10:30 and 2 o'clock positions.

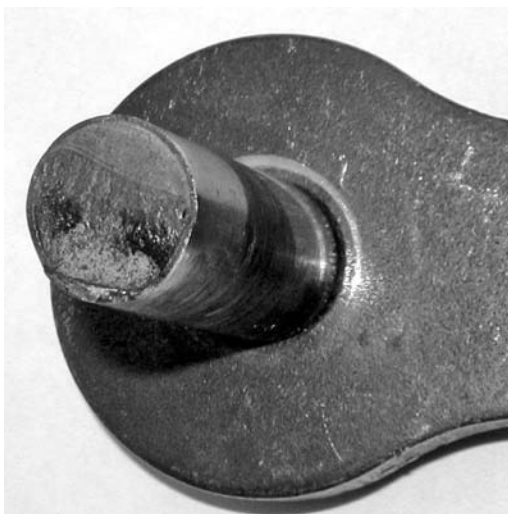
PHOTO 13.2 The fatigue fracture of a case-hardened pin.

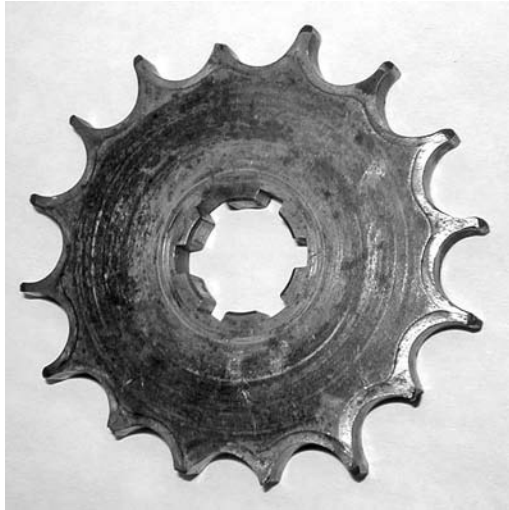
PHOTO 13.3 A born worn unhardened sprocket.
