Atlas of Perioperative 3D Transesophageal Echocardiography

Cases and Videos

Wei-Hsian Yin
Ming-Chon Hsiung

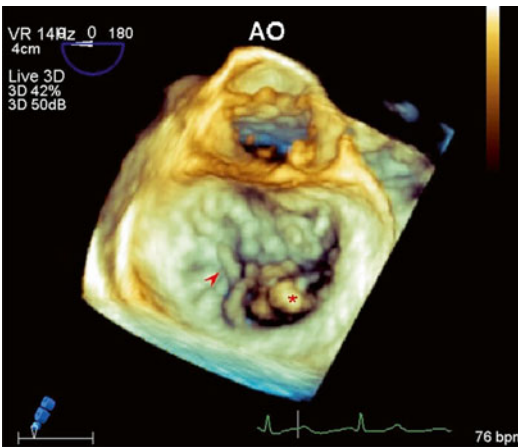
Fig. 1.3 3D TEE image, en face view, showed prolapse of P2 scallop (*) and chordae rupture (arrow)

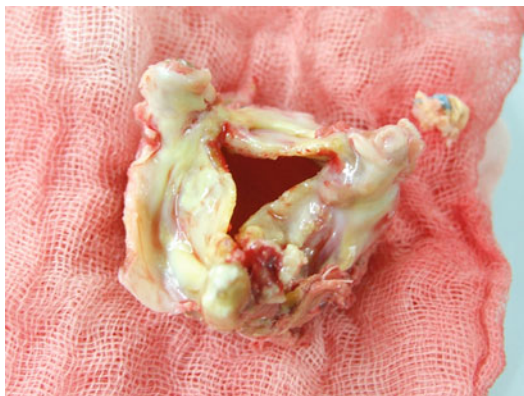
Fig. 3.15 3D TEE color Doppler, status post redo TV replacement (TVR), showed normal tricuspid prosthesis function without stenosis

The prosthetic valve is difficult to image due to shadowing by the valvular graft sometimes, where the Doppler can deal with the situation.

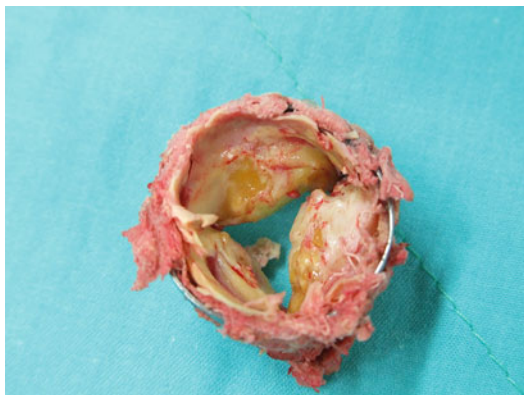
Figs. 3.16 and 3.17 Gross specimen of the calcified and stenotic tricuspid prosthesis

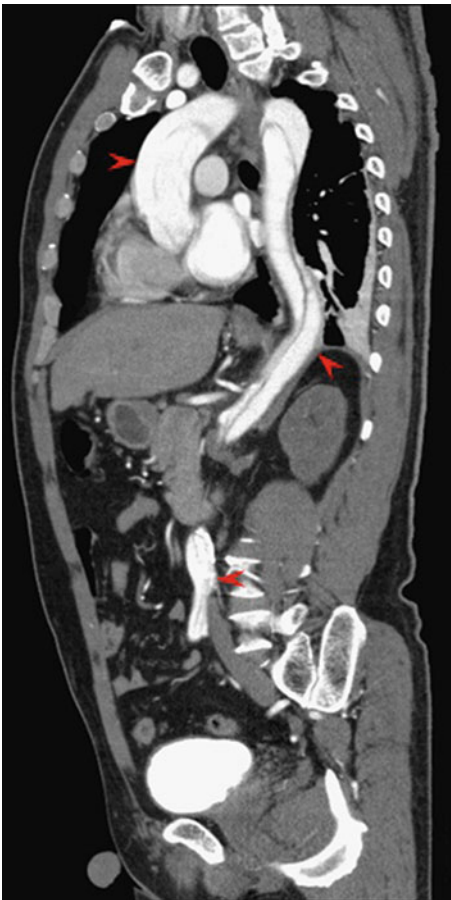
Figs. 5.18 and 5.19 Contrast-enhanced CT images showed type A aortic dissection from ascending aorta down to all the way extending (*arrows*)

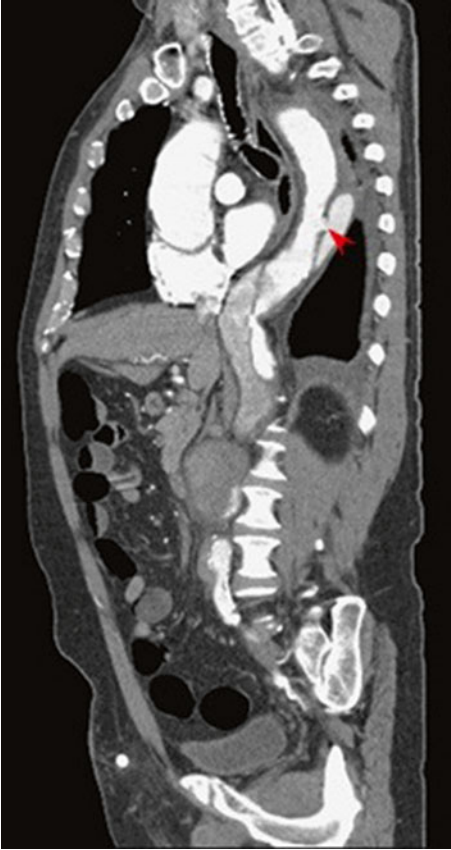
Fig. 5.53 Preoperative contrast-enhanced CT image showed type B aortic dissection from proximal portion of the descending aorta to lower abdominal aorta and intimal flap tear at descending aorta (*arrow*)

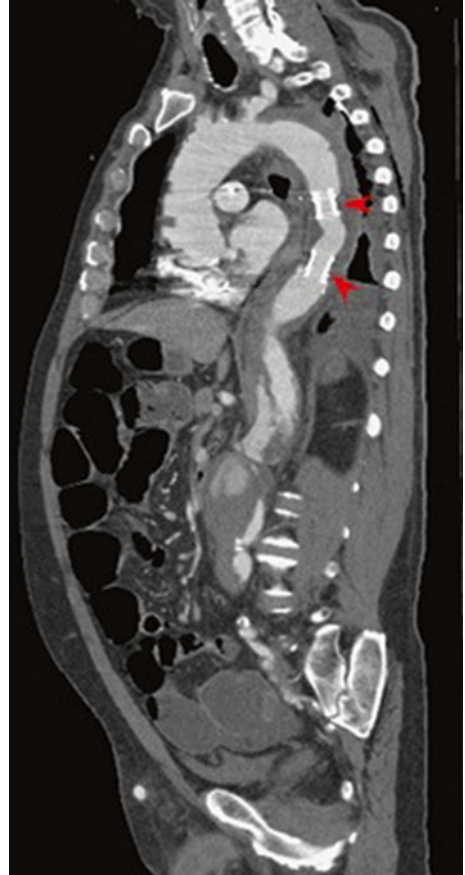
Fig. 5.54 Contrast-enhanced CT image, status post aortic reconstruction, showed artificial grafts (*arrows*) in descending aorta

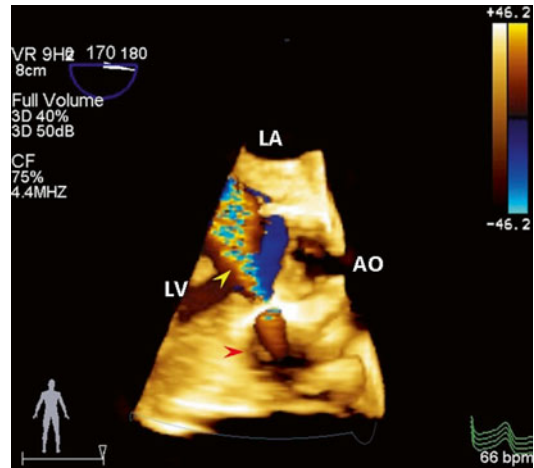
Fig. 5.58 3D TEE color Doppler, long-axis view, showed dehiscence of the AV replacement. An echolucent space (red arrow) was seen posterior to the prosthetic aortic annulus with continuous flow (yellow arrow) from aorta to LV

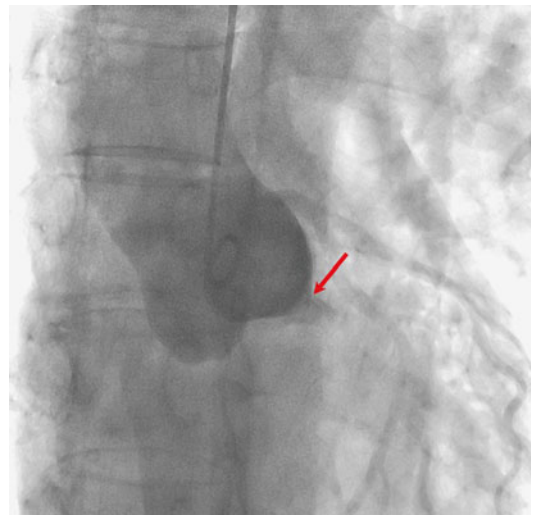
Fig. 5.81 Fluoroscopy showed ruptured sinus Valsalva aneurysm with an insignificant shunt (arrow)

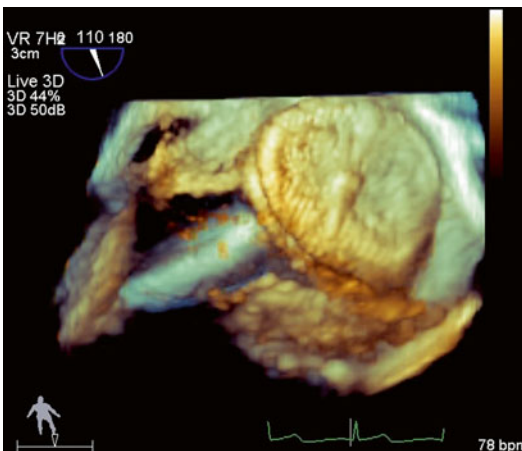
Fig. 7.8 3D TEE, view from LA perspective, status post occluder implantation, showed the occluder was successfully deployed

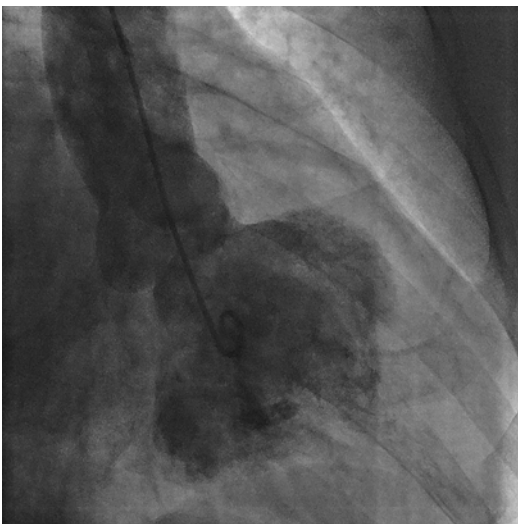
Fig. 8.8 Fluoroscopy showed a spade-like LV demonstrating apical hypertrophic cardiomyopathy

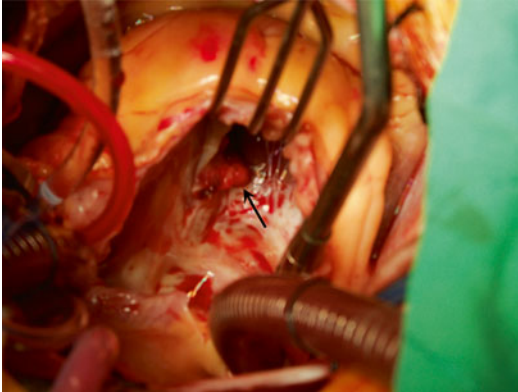
Fig. 9.58 Picture during operation, showed the septal tricuspid vegetation (*arrow*)

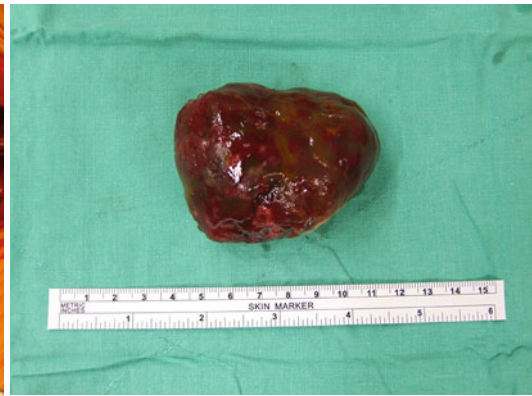
Figs. 10.34 and 10.35 Picture during operation (*left*) and gross specimen (*right*) showed the RV myxoma measuring 6 cm×5 cm×4 cm in fresh state
