# Specialty Construction Techniques for Dam and Levee Remediation

Edited by Donald A. Bruce

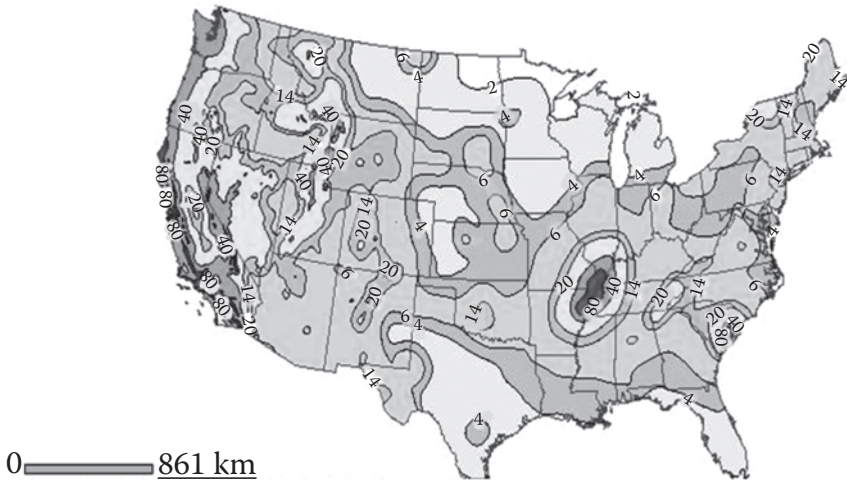
Figure 1.5 Peak horizontal acceleration with 2 percent probability of exceedance in 50 years. Note: The contour values represent peak ground accelerations in percent g. (From U.S. Geological Survey, *National Seismic Hazard Maps of Conterminous U.S.*, <http://earthquake.usgs.gov/hazards/apps/>, 2008.)

Figure 1.5 is the U.S. earthquake hazard map for 2 percent probability of ground motion exceedance in fifty years, that is, a 2,500-year return period. A slightly different appreciation is given in Figure 1.6, although the overall message is the same: areas of extreme seismicity exist in the Mississippi/Tennessee river area (focused on the New Madrid fault system) and, of course, along the West Coast and in the eastern Rockies. The high frequency of damaging earthquakes in New England surprises many, although one must also take into consideration the larger and more intense human habitation of that area and so the high sensitivity and precision of the historical database.

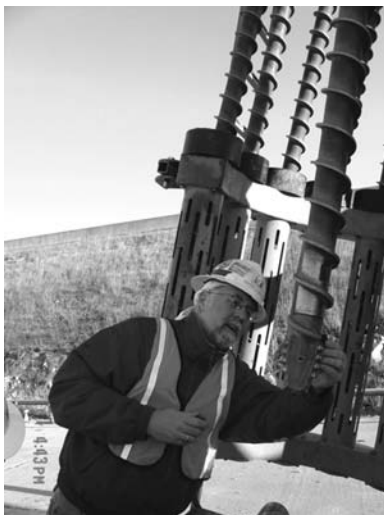
*Photo 2.1* Inner auger used to clean out drilled casing. (Courtesy of Advanced Construction Techniques, Ltd.)

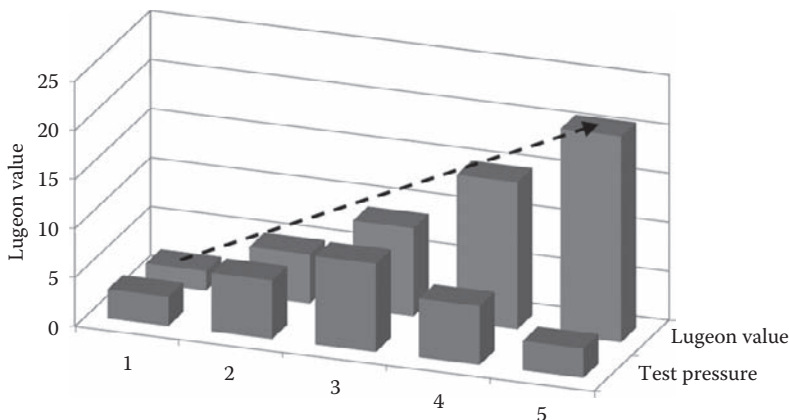
Figure 2.5 Erosion trend signature—increasing Lugeon value during stepped pressure test. (Courtesy of Gannett Fleming, Inc.)

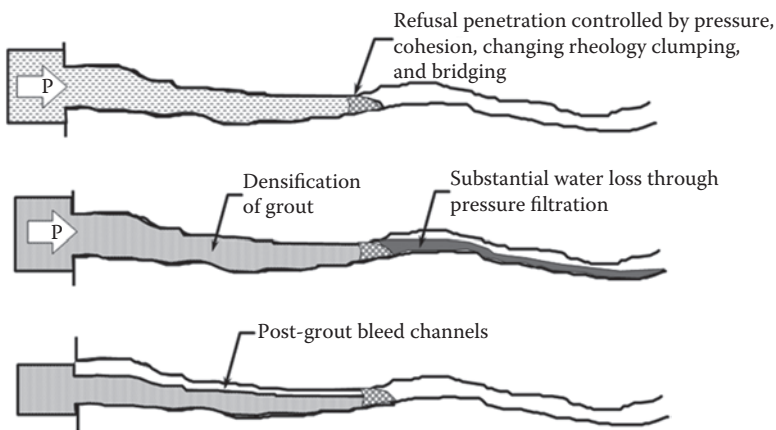
Figure 2.7 Performance of neat cement grouts during and after injection. (Courtesy of Gannett Fleming, Inc.)

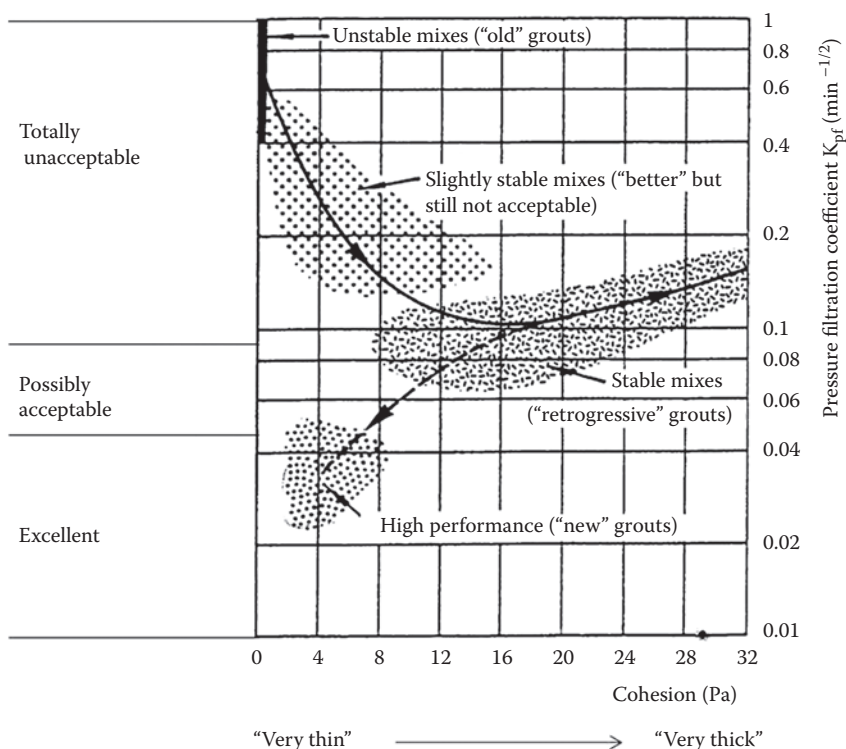
Figure 2.8 Historical path of development from unstable mixes to contemporary balanced multicomponent mixes. (Modified after De Paoli, B., B. Bosco, R. Granata, and D. A. Bruce., *Grouting, Soil Improvement and Geosynthetics*, Proceeding of the ASCE Conference, 1992. With permission.)

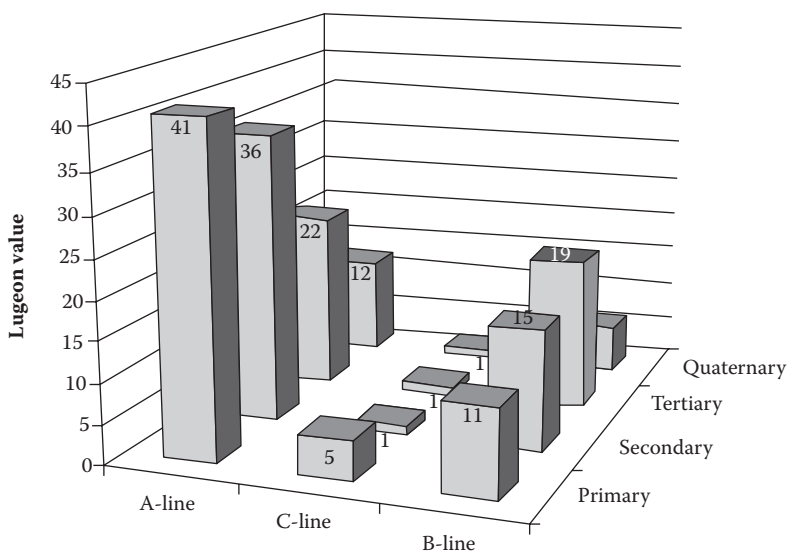
Figure 2.12 Patoka Lake Dam water test results by grout line and hole series. (Courtesy of Gannett Fleming, Inc.)

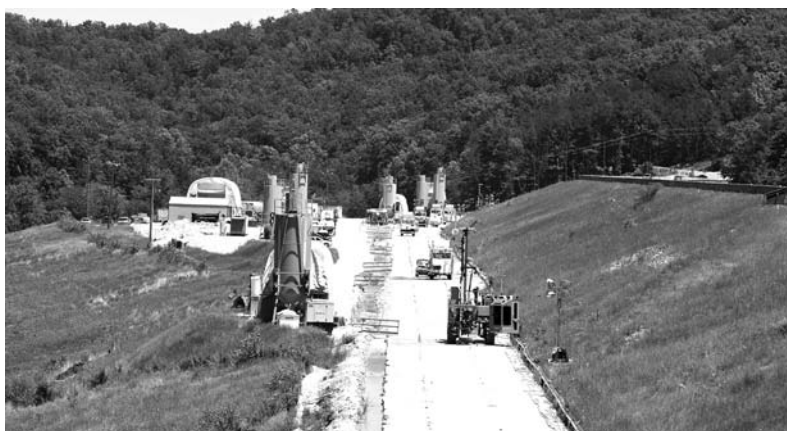
Photo 2.5 Drilling and grouting operations at Clearwater Dam. (Courtesy of Advanced Construction Techniques, Ltd.)

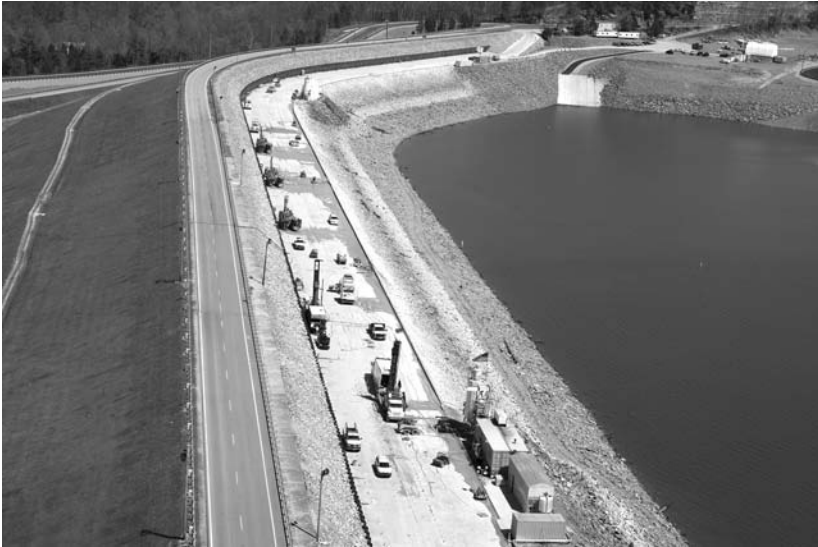
*Photo 2.6* Wolf Creek Dam, Kentucky, embankment foundation grouting project. (Courtesy of Advanced Construction Techniques, Ltd.)

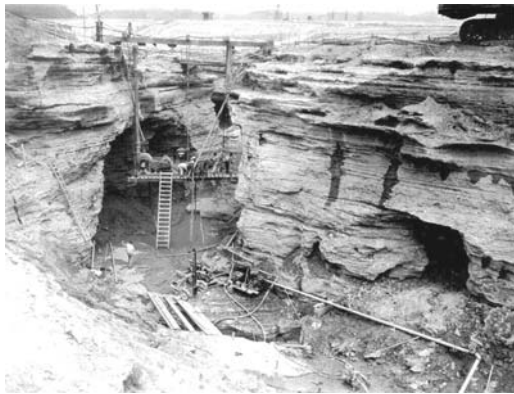
*Photo 2.7* Photo of the system of caves uncovered during excavation of the dam foundation, Wolf Creek Dam, Kentucky. (Courtesy of U.S. Army Corps of Engineers.)

during the original excavation of the embankment core trench (Photo 2.7) (Kellberg and Simmons 1977). The system lies below the transition of the concrete gravity structure and the earth embankment section and is the location of where the majority of the seepage issues have occurred. The system of caves and solution features is the result of karstic limestone of the Liepers and Catheys formations, both of Ordovician age. Several attempts have been made to mitigate the seepage occurring at the dam, including

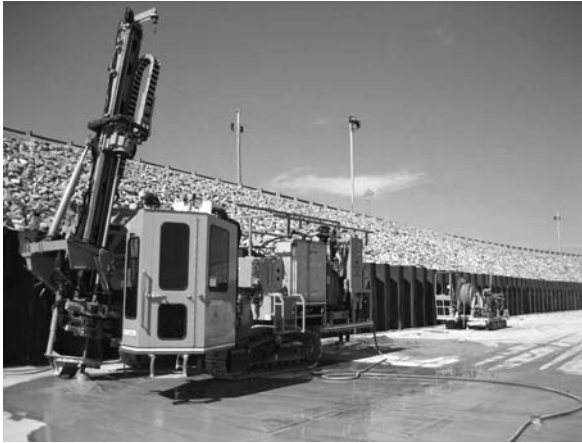
*Photo 2.8* Drilling with down-the-hole rotary percussion water hammer, Wolf Creek Dam, Kentucky. (Courtesy of Advanced Construction Techniques, Ltd.)

grouting operations for the two-line curtain were conducted from a work platform constructed along the upstream slope of the earth embankment at EL 748 feet (Photos 2.8 and 2.9). A total of 1,317 holes were drilled on the upstream and downstream grout lines. A total of 192,644 L.F. of overburden drilling, 238,625 L.F. of rock drilling, 818,317 gallons of injected grout, and 5,623 hours of grouting were completed in a twenty-month schedule of operations including twenty-four-hour drilling and grouting. This contract was performed from January of 2007 to August of 2008.

State-of-art-drilling equipment included DTH rotary percussion hammers with water flush. The drilling equipment allowed for the grout holes to be drilled to the depth and angle required quickly, accurately, and within

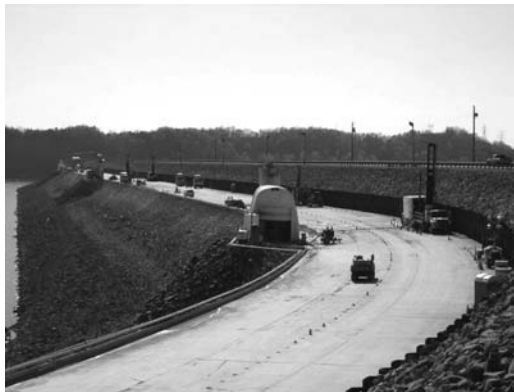
*Photo 2.9* Multiple drilling and grouting operations at Wolf Creek Dam, Kentucky. (Courtesy of Advanced Construction Techniques, Ltd.)

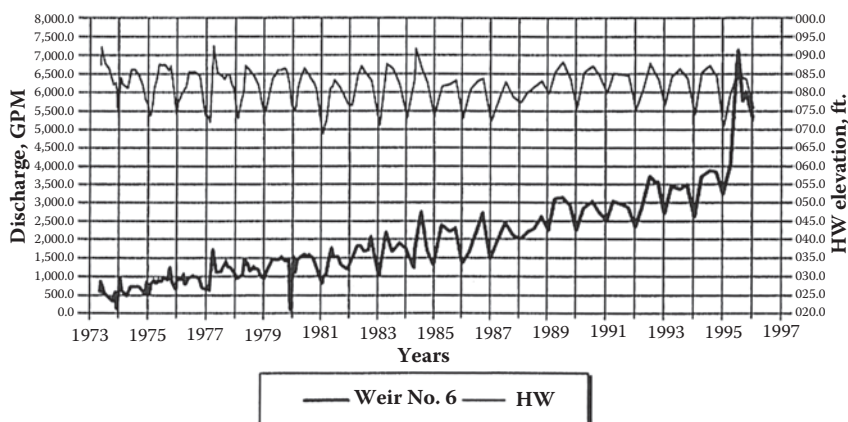
Figure 2.14 Right rim discharge at Leak 6 through 1995, Tims Ford Dam, Tennessee. (From Hamby, J. A., and D. A. Bruce, "Monitoring and Remediation of Reservoir Rim Leakage at TVA's Tims Ford Dam." U.S. Commission on Large Dams (USCOLD) 20th Annual Meeting, 2000. With permission.)

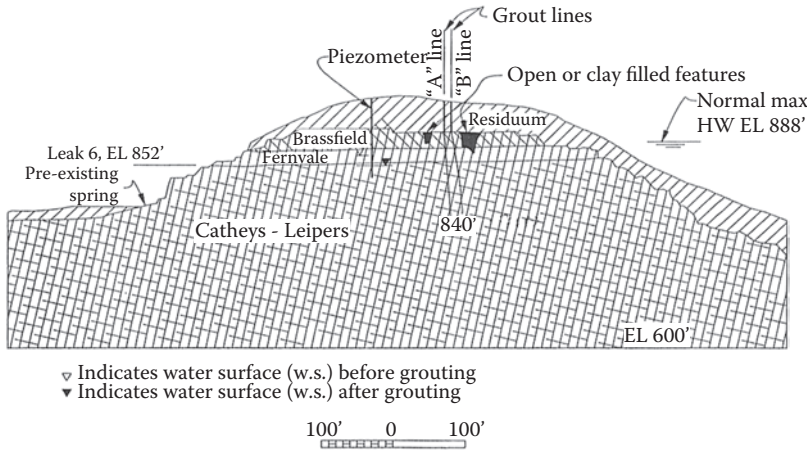
Figure 2.15 Section A-A of right rim at Leak Area 6. (From Hamby, J. A., and D. A. Bruce, "Monitoring and Remediation of Reservoir Rim Leakage at TVA's Tims Ford Dam." U.S. Commission on Large Dams (USCOLD) 20th Annual Meeting, 2000. With permission.)

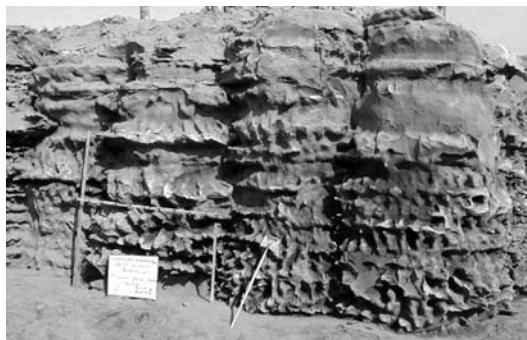
*Photo 2.10* Exposed test columns, Sacramento, California. (Pacchiosi Promotional Information, [www.pacchiosi.com](http://www.pacchiosi.com))

65,000 square feet of wall. Columns were vertical except for some inclined columns and panels under the Union Pacific Railroad line. Photos 2.10 and 2.11 show exposed test columns and panels, respectively.

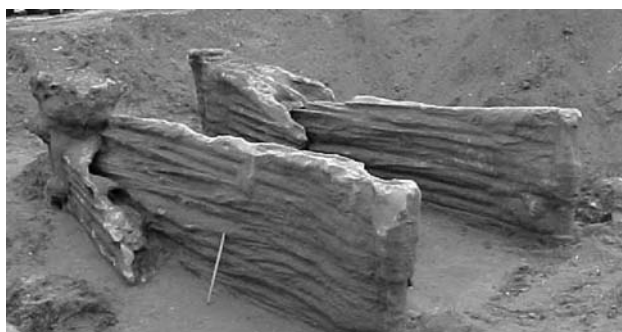
*Photo 2.11* Exposed test panels, Sacramento, California. (Pacchiosi Promotional Information, [www.pacchiosi.com](http://www.pacchiosi.com))

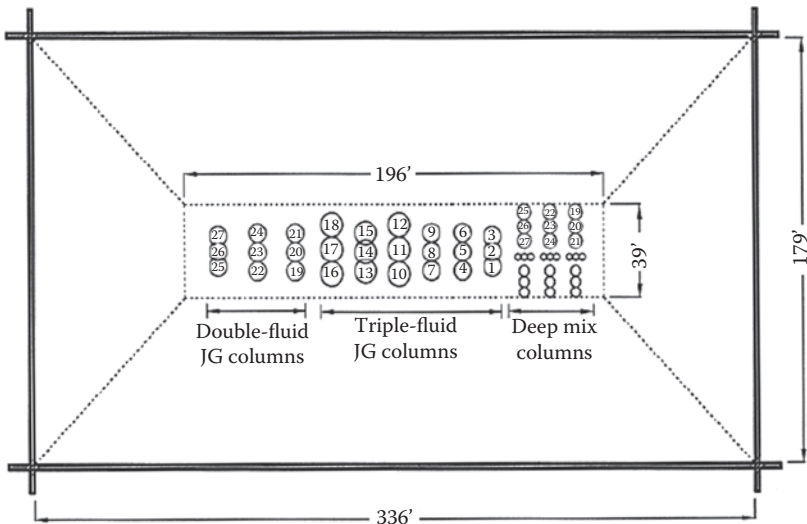
Figure 2.19 Test area layout, Tuttle Creek Dam, Kansas. (From Mauro, M., and F. Santillan, “Large Scale Jet Grouting and Deep Mixing Test Program at Tuttle Creek Dam.” *Proceedings of the 33rd Annual and 11th International Conference on Deep Foundations*, 2008. With permission.)

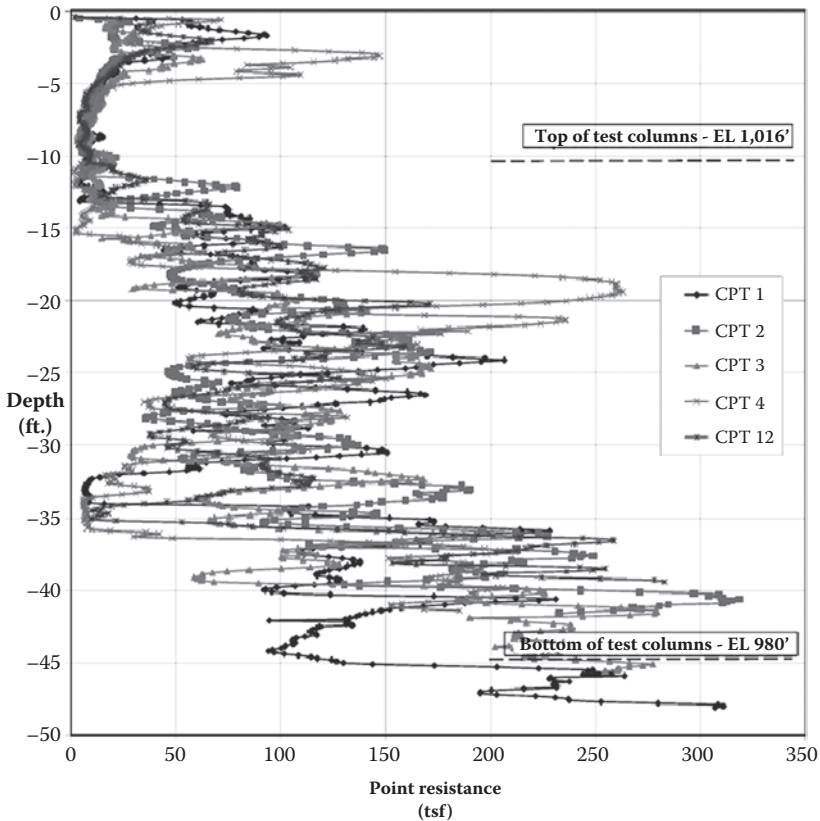
Figure 2.21 CPT point resistance at the test area, Tuttle Creek Dam, Kansas. (From Mauro, M., and F. Santillan, “Large Scale Jet Grouting and Deep Mixing Test Program at Tuttle Creek Dam.” *Proceedings of the 33rd Annual and 11th International Conference on Deep Foundations*, 2008. With permission.)

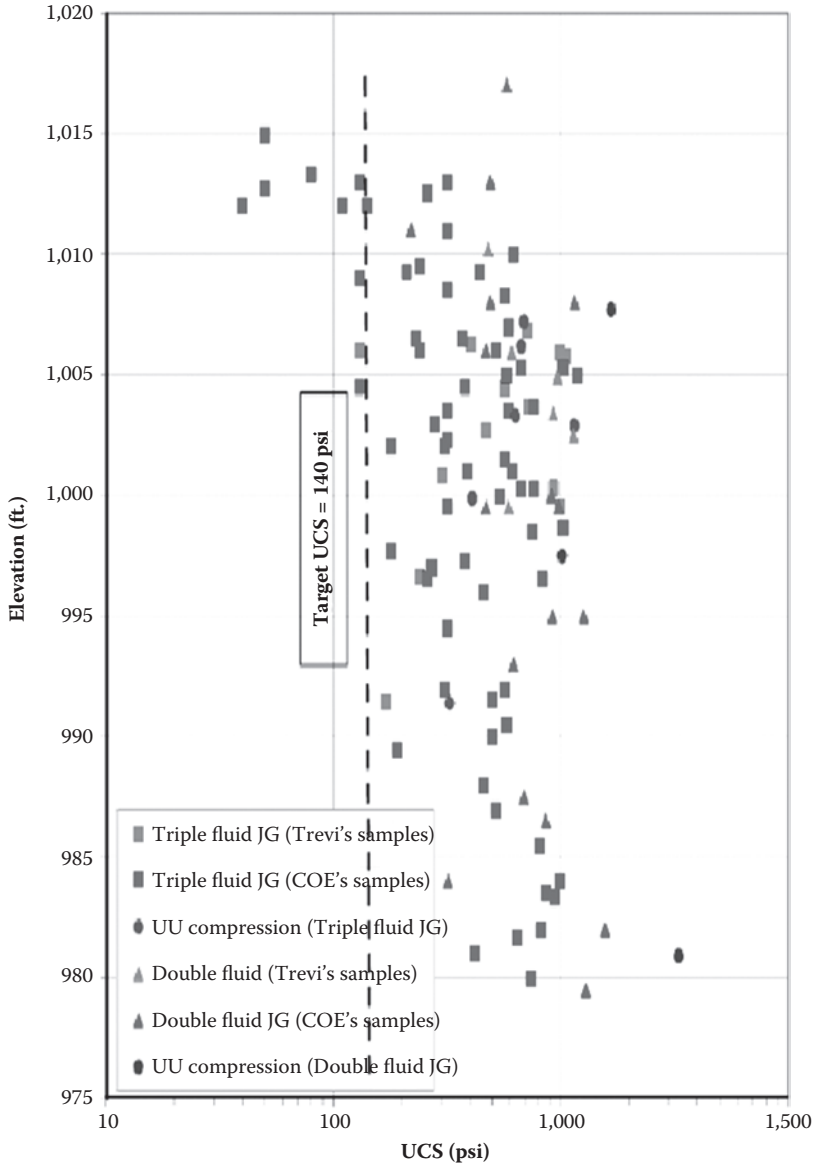
Figure 2.22 UCS and UU test results on the jet grout core samples, Tuttle Creek Dam, Kansas. (From Mauro, M., and F. Santillan, "Large Scale Jet Grouting and Deep Mixing Test Program at Tuttle Creek Dam." *Proceedings of the 33rd Annual and 11th International Conference on Deep Foundations*, 2008. With permission.)

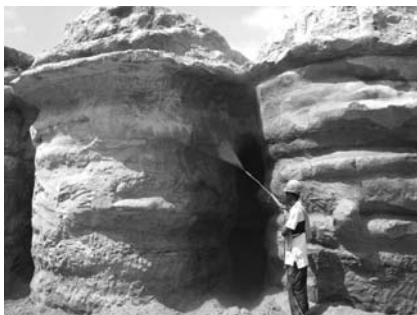
*Photo 2.13* Exposed triple-fluid columns, Tuttle Creek Dam, Kansas. (From Mauro, M., and F. Santillan, “Large Scale Jet Grouting and Deep Mixing Test Program at Tuttle Creek Dam.” *Proceedings of the 33rd Annual and 11th International Conference on Deep Foundations*, 2008. With permission.)

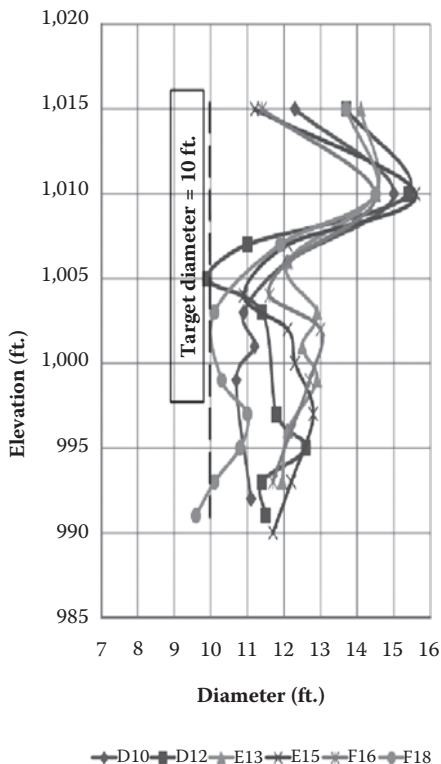
Figure 2.24 Diameter of the triple-fluid columns with  $E_s = 230\text{--}300$  MJ/m, Tuttle Creek Dam, Kansas. (From Mauro, M., and F. Santillan, “Large Scale Jet Grouting and Deep Mixing Test Program at Tuttle Creek Dam.” *Proceedings of the 33rd Annual and 11th International Conference on Deep Foundations*, 2008. With permission.)

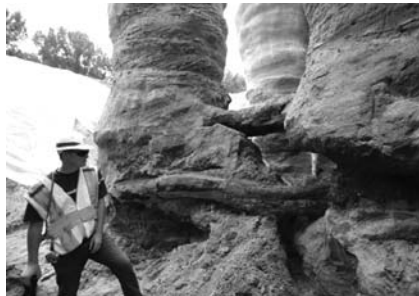
Photo 2.15 Effect of an obstruction in a double-fluid jet grout column, Tuttle Creek Dam, Kansas. (From Mauro, M., and F. Santillan, “Large Scale Jet Grouting and Deep Mixing Test Program at Tuttle Creek Dam.” *Proceedings of the 33rd Annual and 11th International Conference on Deep Foundations*, 2008. With permission.)

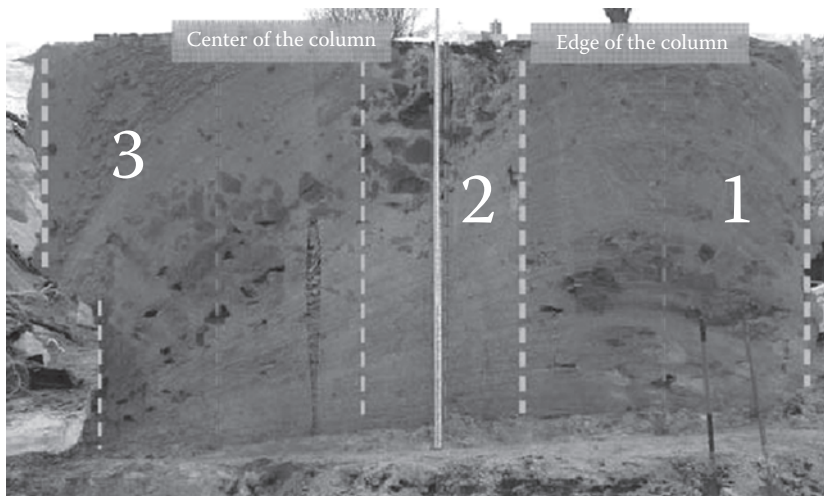
*Photo 2.16* Saw-cut of three triple-fluid jet grout columns, Tuttle Creek Dam, Kansas. (From Mauro, M., and F. Santillan, “Large Scale Jet Grouting and Deep Mixing Test Program at Tuttle Creek Dam.” *Proceedings of the 33rd Annual and 11th International Conference on Deep Foundations*, 2008. With permission.)

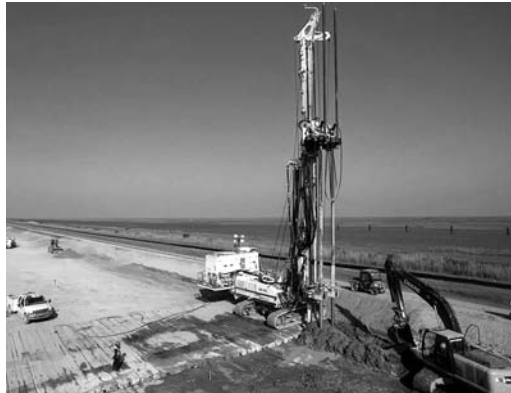
*Photo 3.1* Twin Axis DMM machine (WJE system) installing soilcrete panels on a levee in New Orleans, Louisiana. (Courtesy of TREVIICOS Corp.)

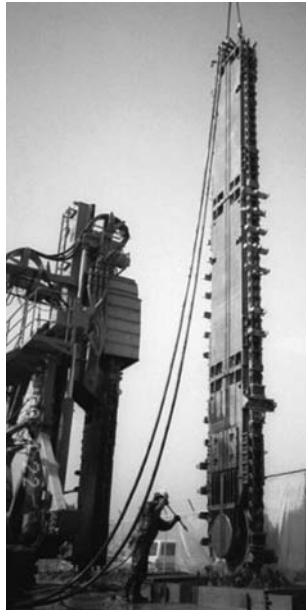
*Photo 3.2* TRD “cutting post,” showing the cutting chain to the right, and the carrier machine to the left. (TRD promotional information.)

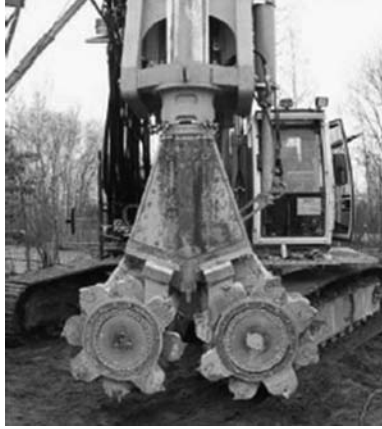
Photo 3.3 The CSM cutter head suspended from a Kelly bar. (Courtesy of Bauer Maschinen.)

In contrast, the CSM (cutter soil mix) method, developed during a German-French cooperation, and the Italian method, CT Jet, use hydro-mill (i.e., cutter) technology previously developed for conventional diaphragm walls (Chapter 4, this volume) to create vertical soilcrete panels, rectangular in plan (Photo 3.3). As is described in Section 3.4, CSM has

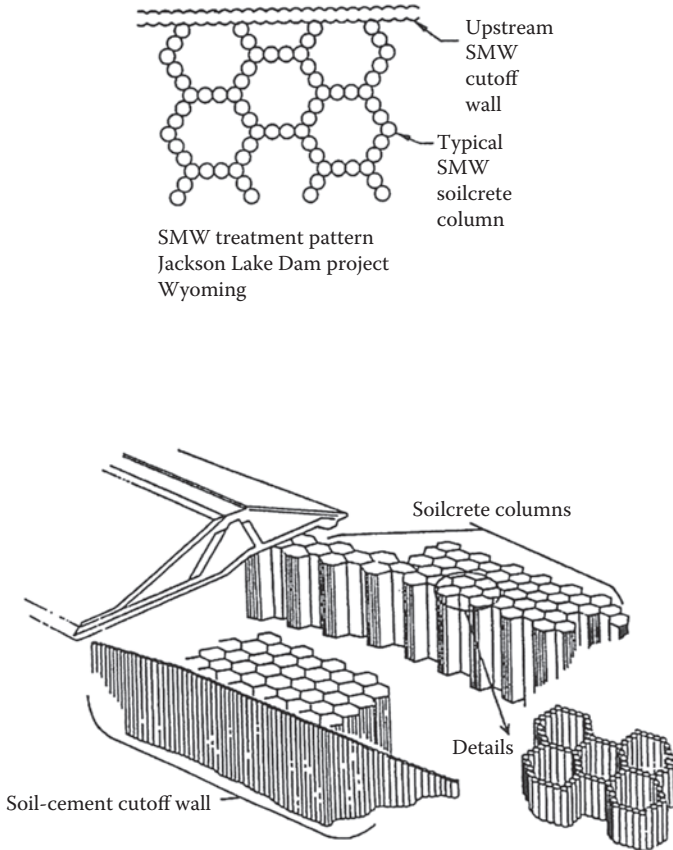
Figure 3.2 DMM used for liquefaction control and seepage cutoff, Jackson Lake Dam, Wyoming. (From Ryan, C. R., and B. H. Jasperse, *Proceedings of the ASCE 1989 Foundation Engineering Congress, Foundation Engineering: Current Principles and Practices, Vols. 1 and 2*, Evanston, IL, 1989. With permission.)

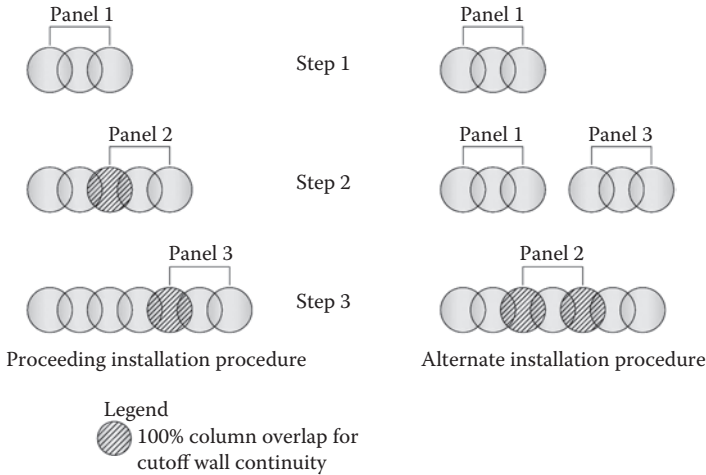
Figure 3.4 Construction of DMM cutoff walls for seepage control.

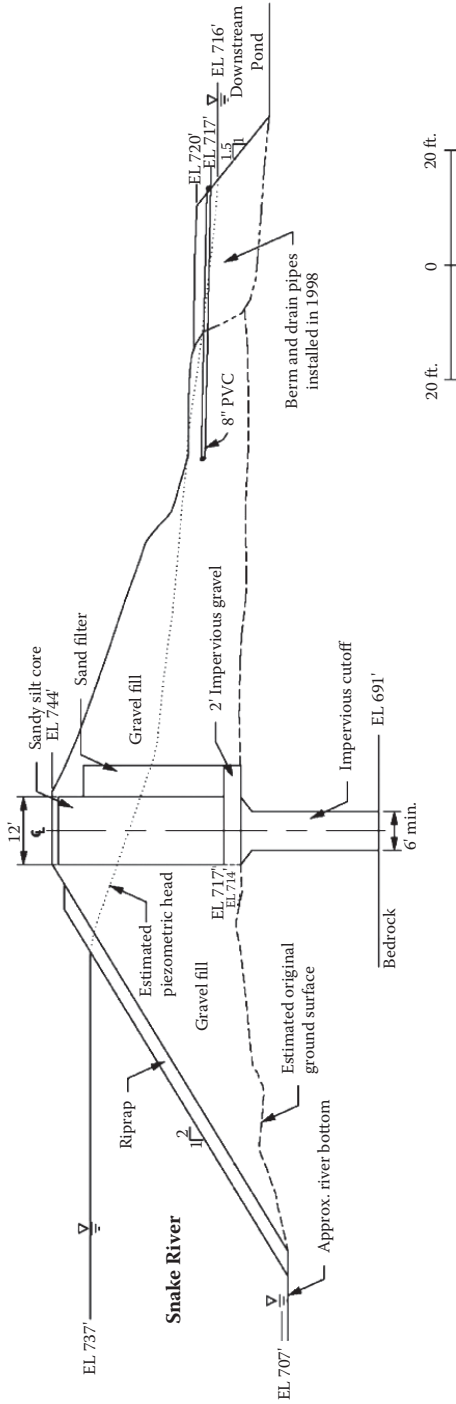
Figure 3.5 Cross section in seepage area, West Lewiston Levee, Idaho. (After Gibbons, Y. R., and G. J. Buechel, "Lewiston Levees DSM Wall Construction," 18th Annual Conference of the Association of State Dam Safety Officials, www.damsafety.org, Snowbird, Utah, 2001; Courtesy of Association of State Dam Safety Officials.)

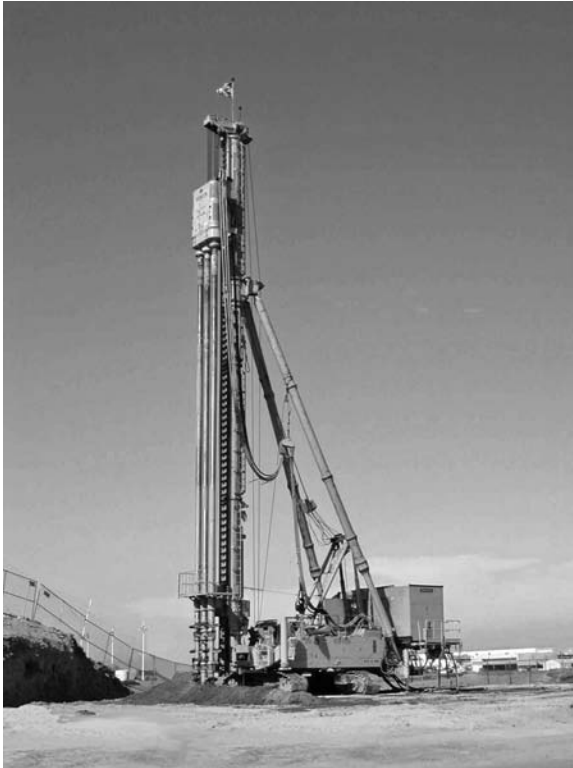
*Photo 3.4* DMM triple axis rig (WRE). (Courtesy of Raito, Inc.)

The DMM rig employed by specialty subcontractor Raito, Inc., consisted of a crawler base machine, a lead to support and guide an electric top drive motor, and triple-shaft mixing tools as shown in Photo 3.4. The

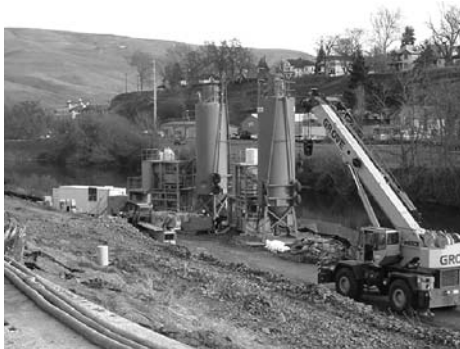
*Photo 3.5* Batch plant on the seepage berm at the landside toe of Lewiston Levee, Idaho. (After Gibbons, Y. R., and G. J. Buechel, "Lewiston Levees DSM Wall Construction," 18th Annual Conference of the Association of State Dam Safety Officials, [www.damsafety.org](http://www.damsafety.org), Snowbird, Utah, 2001; Courtesy of Association of State Dam Safety Officials.)

The batch plant consisted of two fifty-ton-capacity cement silos and two slurry mixing systems. Water, cement, and bentonite were measured with automatic batch scales to accurately determine mix proportions. Due to limited space on top of the levee, the batch plant shown in Photo 3.5 was located on the seepage berm at the landside toe of the levee about midway along the 500-foot alignment.

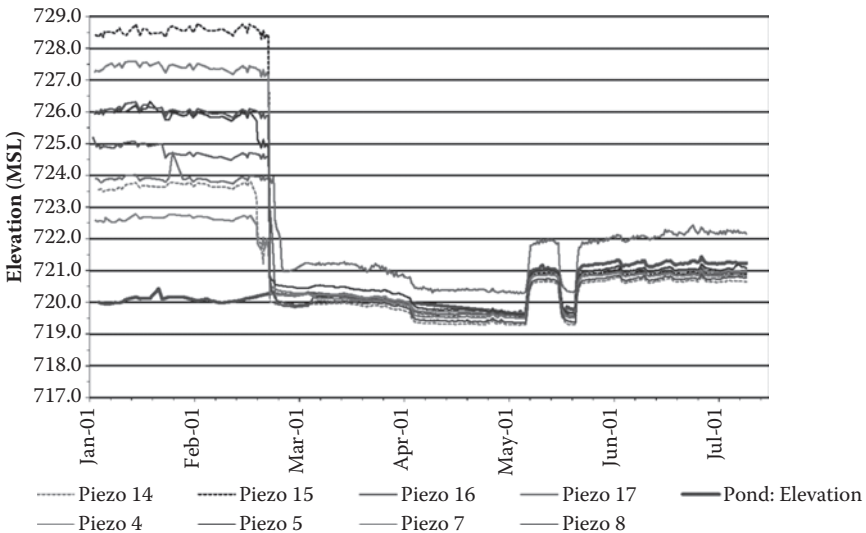
Figure 3.7 Piezometric levels during cutoff wall construction, Lewiston Levee, Idaho. (After Gibbons, Y. R., and G. J. Buechel, "Lewiston Levees DSM Wall Construction," 18th Annual Conference of the Association of State Dam Safety Officials, [www.damsafety.org](http://www.damsafety.org), Snowbird, Utah, 2001; Courtesy of Association of State Dam Safety Officials.)

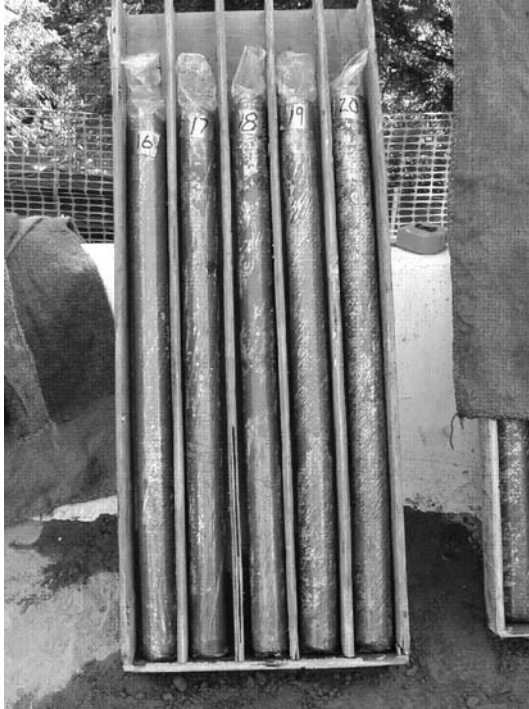
*Photo 3.6 Core samples from Sacramento Levee, California. (After Yang, D. S., 5th International Conference on Landslides, Slope Stability & the Safety of Infrastructures, CI-Premier, Kuala Lumpur, Malaysia, 2008.)*

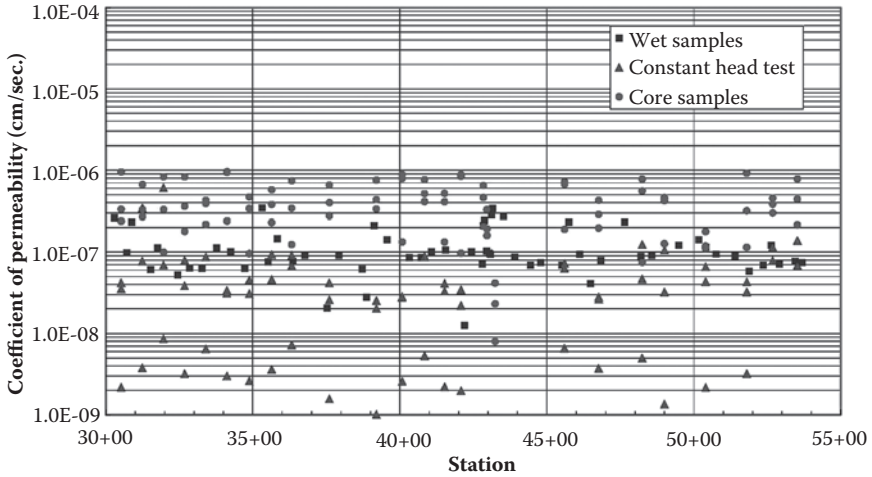
Figure 3.8 Permeability testing results from Sacramento Levee, California. (After Yang, D. S., *5th International Conference on Landslides, Slope Stability & the Safety of Infrastructures*, CI-Premier, Kuala Lumpur, Malaysia, 2008.)

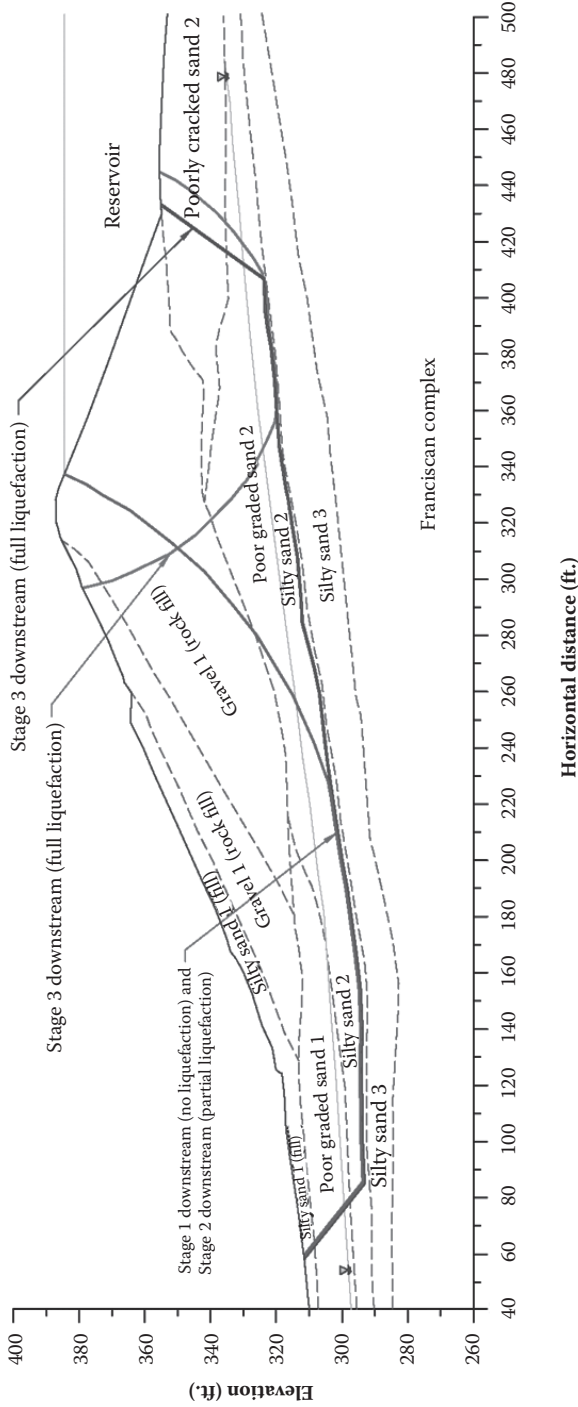
Figure 3.12 Embankment cross section and critical slide surfaces, Sunset Dam, California. (After Barron, R. F., C. Kramer, W. A. Herlache, J. Wright, H. Fung, and C. Liu, *Proceedings of Dam Safety 2006*, [www.damsafety.org](http://www.damsafety.org), 2006; Olivia Chen Consultants Report, *Geotechnical Investigation Embankment Stability Evaluation*, Sunset Reservoir North Basin San Francisco Public Utilities Commission, 2004; Courtesy of Association of State Dam Safety Officials.)

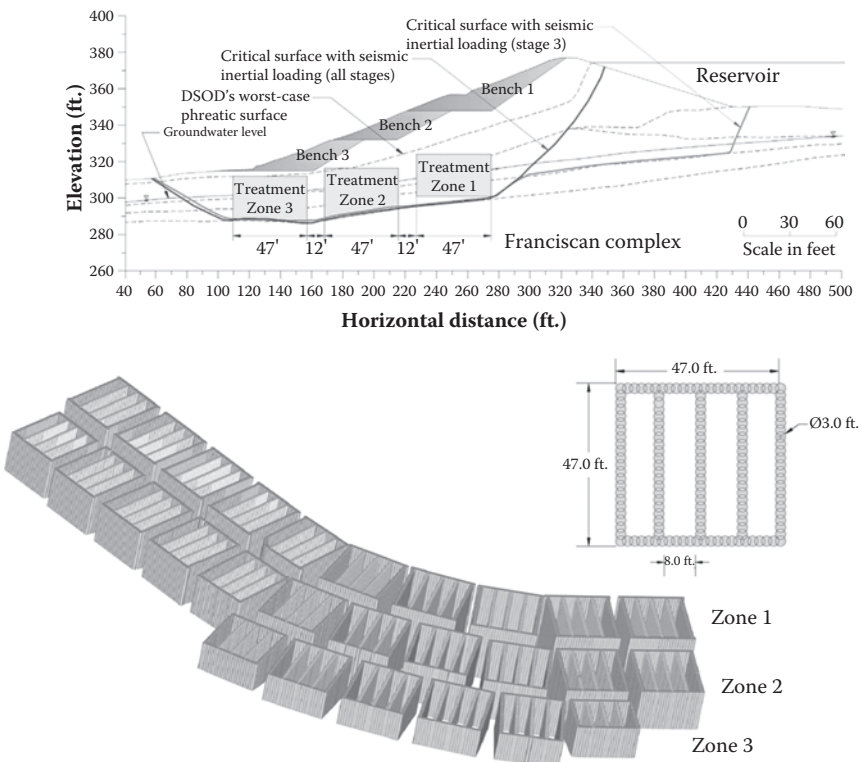
Figure 3.13 DMM treatment plan for Sunset Dam, California. (After Barron, R. F., C. Kramer, W. A. Herlache., J. Wright, H. Fung, and C. Liu, *Proceedings of Dam Safety 2006*, www.damsafety.org, 2006; Olivia Chen Consultants Report, *Geotechnical Investigation Embankment Stability Evaluation*, Sunset Reservoir North Basin San Francisco Public Utilities Commission, 2004; Courtesy of Association of State Dam Safety Officials.)

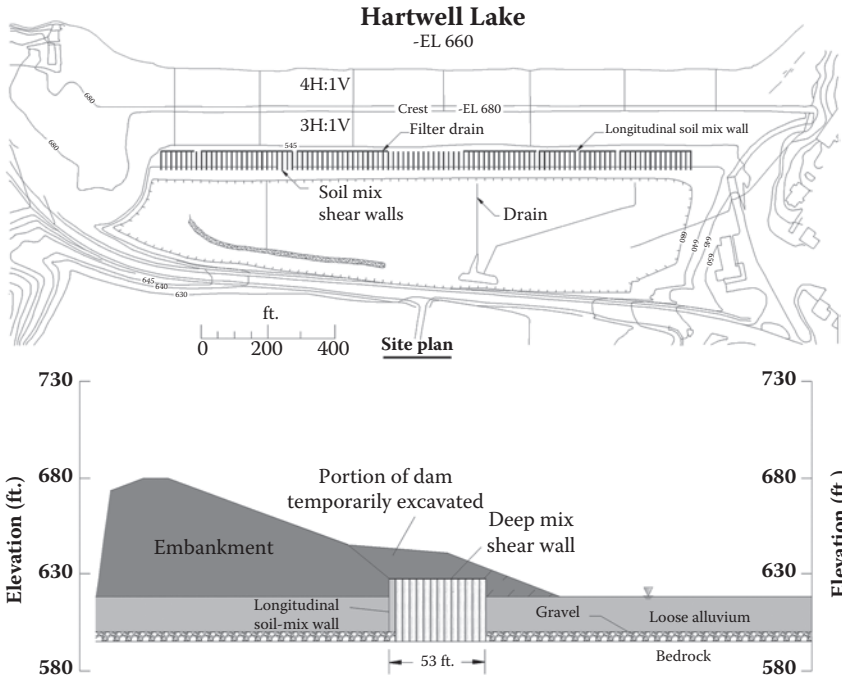
Figure 3.14 Plan and section of DMM layout at Clemson Dam, South Carolina. (After Wooten, R. L., and B. Foreman, *Proceedings of the 25th Annual United States Society on Dams Conference, 2005*; Courtesy of USSD.)

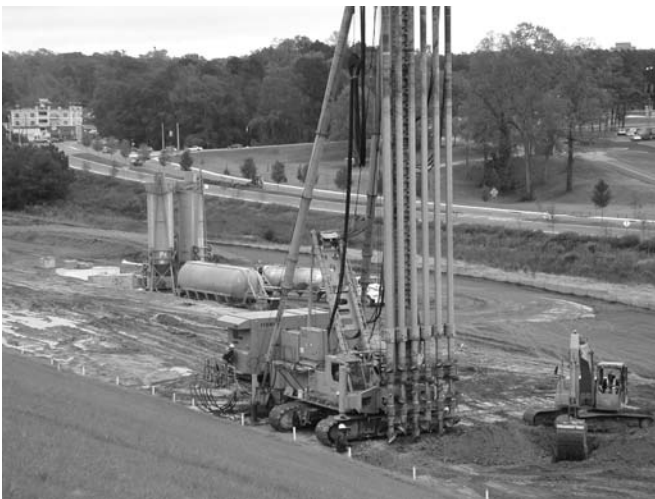
Photo 3.7 Six-axis DMM Rig at Clemson Dam, South Carolina. (Courtesy of Ratio, Inc.)

A portion of the downstream berm was excavated temporarily to create a level work platform for DMM construction. A six-axis DMM rig was used to install the overlapping DMM elements forming the shear walls. Photo 3.7 shows the DMM rig installing a 50-foot-long transverse shear wall. The soil-cement wall had an average width of 2.76 feet. To maintain the wall

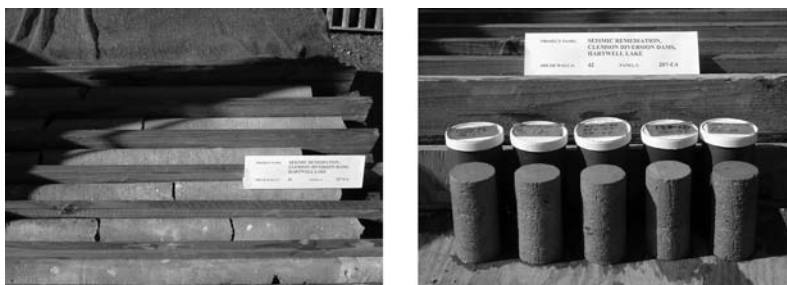
Photo 3.8 Core samples and test specimens from Clemson Dam, South Carolina.

For quality assurance, the specifications required strength testing on specimens cast using wet-grab bulk sampling. The core sampling was considered to be slower and more expensive and would be used only in cases where wet-grab sample strengths fell below criteria. However, the contractor tried numerous methods to obtain the wet-grab samples with no success since the soil-slurry mixture was very viscous due to the need to use a mix design with low water:cement ratio in order to achieve the relatively high target strength. As an alternative, full-depth continuous cores were retrieved from the shear walls at about 28-day curing age for quality-control strength testing. The cores are more representative of the wall material than the wet-grab samples and have continuity throughout the entire depth of the wall to allow the selection of test specimens at various depths. USACE selected six specimens from each core for 28-day strength testing and agreed on a frequency of one core per day, or about one core for two shear walls, based on the consistently high strengths of the samples. Representative core samples and test specimens are shown in Photo 3.8. USACE accepted all DMM shear walls installed in the Lower Dam based

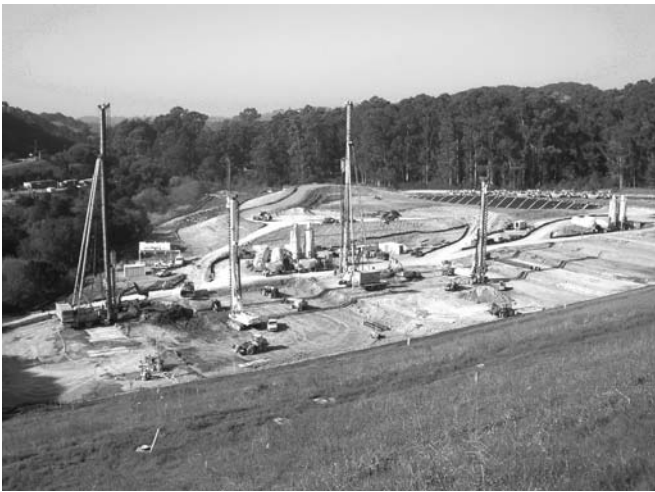
Photo 3.9 Predrilling and DMM treatment at San Pablo Dam, California. (Courtesy of Yujin Nishimura, Raito, Inc.)

The two main challenges of the DMM work at San Pablo site were toeing the DMM shear wall into bedrock and maintaining the continuity of the deep DMM shear wall. The bedrock varied significantly in depth and strength across the site. The bedrock material within the three-foot key-in depth generally consisted of slightly weathered to severely weathered, very soft to moderately hard siltstone. Based on the results of the 2007 test section, it was concluded that the DMM equipment could not penetrate three feet into the weathered rock as required by the specifications. Therefore during full production in 2009, a single-shaft machine was used to predrill three feet into the weathered rock to allow the triple-shaft DMM mixing tool to reach the key-in depth in bedrock. The predrilling and DMM installation operation are shown in Photo 3.9. The DMM can serve its design function as a shear wall only if it is continuous; if the DMM elements were not aligned, the overall lateral stiffness of the treated zone would be reduced. Verticality of DMM elements can only be maintained to 1:100 (horizontal to vertical). Therefore wall continuity for the deep shear walls needed could not be assured if the neighboring elements were partially overlapped by only one foot. A full column overlapping between neighboring DMM elements was therefore specified to ensure the shear wall continuity for transferring lateral forces. The shear wall construction sequence using predrilling, full column overlapping, and alternate installation procedure (primary and secondary procedure) is the same as the sequence used for the installation of the DMM cutoff wall at Lake Cushman Dam, Washington (Figure 3.11b).

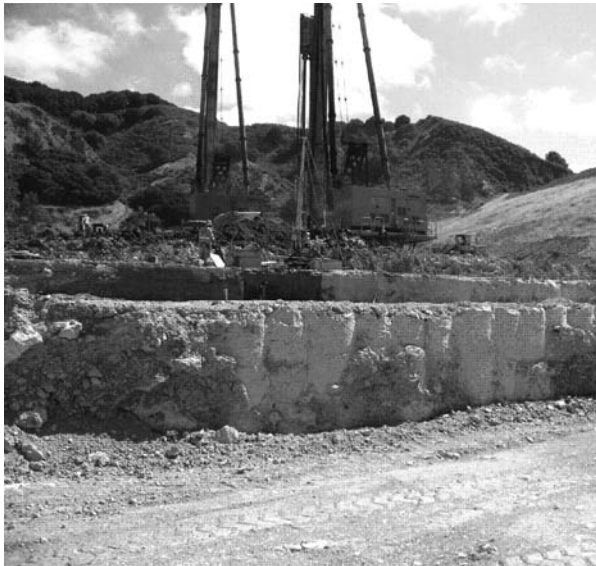
Photo 3.10 Exposed soil-cement shear wall at San Pablo Dam, California.

For verification of deep mixing work, both wet-grab samples and continuous core samples were retrieved. The wet-grab samples were taken at the same core locations selected by the engineer. Both molded wet-grab samples and core samples were used for establishing the strength gain of the soil-cement with curing time. The final acceptance of the deep mixing work was based on the uniformity and unconfined compressive strength test results from the core samples. The requirements were as follows: (1) average 28-day unconfined compressive strength tests of seven core samples from each full-depth core should exceed 655 psi and the minimum strength should exceed 327 psi; (2) average core recovery should be greater than 90 percent for every full-depth core and minimum core recovery should be greater than 85 percent for every four-foot core run; and (3) total unmixed soil should be less than 15 percent of every four-foot core run and every occurrence should be less than six inches. The average strength of 655 psi was selected based on the data obtained from the preproduction test section. The preproduction test section, consisting of three 50-foot-long shear walls at three locations of the site, was performed to verify that the equipment, installation procedure, and mix design would produce DMM shear walls meeting the design intent. DMM construction was started in December 2008 and completed in September 2009. A total of 137,300 cubic yards of shear walls with depth varying from 20 to 120 feet were installed. A section of an exposed DMM shear wall is shown in Photo 3.10.

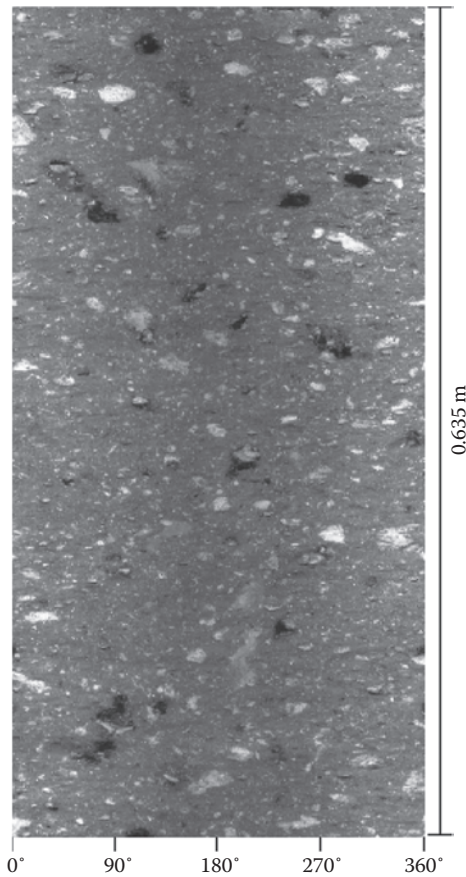
Photo 3.11 Borehole camera photo of *in-situ* cured material created by TRD method, Herbert Hoover Dike, Florida.

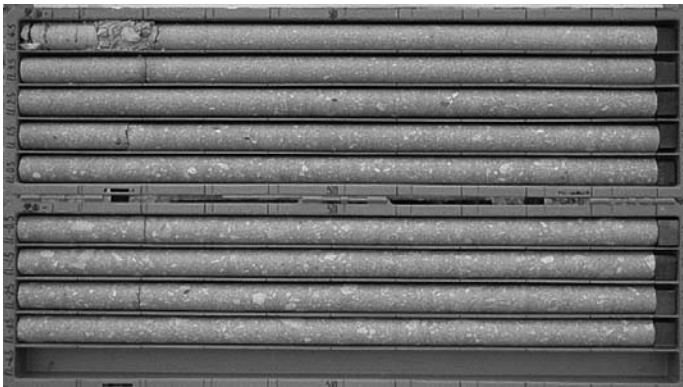
Photo 3.12 TRD core sample from Okinawa, Japan. (Courtesy of Tenox Corporation, Japan.)

Photo 3.12 and Figure 3.29 show a cored sample, and the tested permeability and strength data, respectively. Excellent vertical homogeneity and mixing quality were obtained.

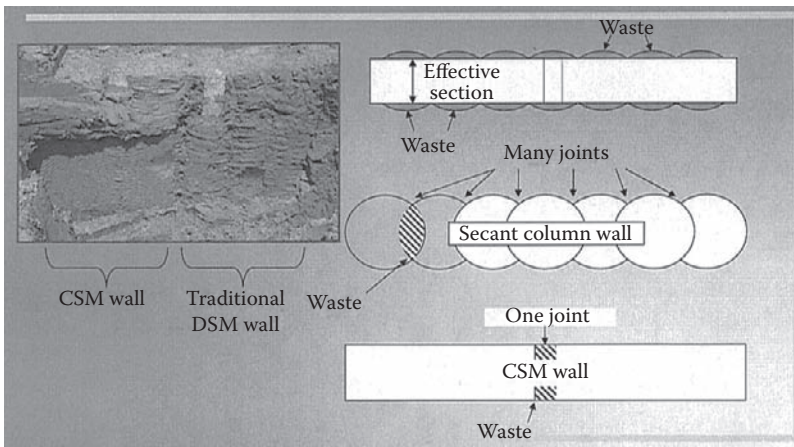
Figure 3.33 Comparison between CSM and conventional DSM products. (Bauer promotional information.)

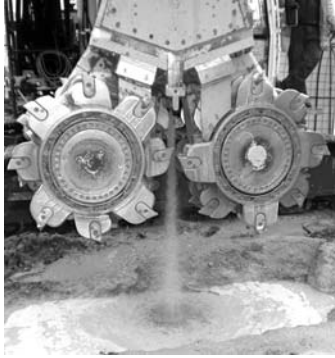
Photo 3.14 Slurry injected between the cutting and mixing wheels of the CSM head.

1. Conventional excavation of a guide trench which is also used for slurry retention and handling.
2. Fluidization of the soil mass during penetration to the target depth. During cutting the natural soil is mixed with cementitious slurry which is induced through a nozzle located between the cutting and mixing wheels (Photo 3.14). Depending on the prevailing conditions, bentonite or cement slurry is used for the mixing and fluidization process during penetration. The rate of slurry usage is determined by the rate of cutter penetration.
3. During withdrawal, the balance of the volume of cement slurry required for producing the final wall product is added.

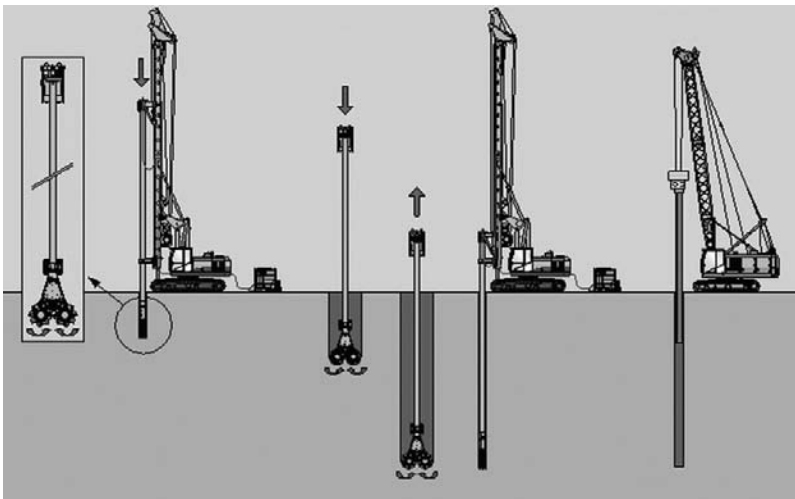
Figure 3.34 CSM working sequence for the single-panel process. (Bauer promotional information.)

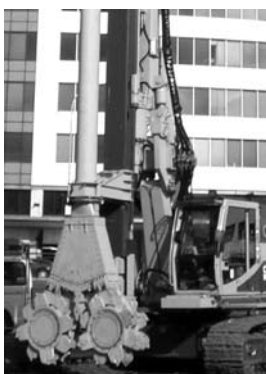
Photo 3.15 Kelly (round) guided CSM unit for depths up to 65 feet.

The CSM head is either mounted on a guided Kelly bar or on a rope-suspended cutter frame equipped with special steering devices (Photos 3.15 and 3.16). The standard setup is the “Kelly-guided” setup, capable of reaching depths up to 140 feet. “Rope-suspended” systems are particularly suited

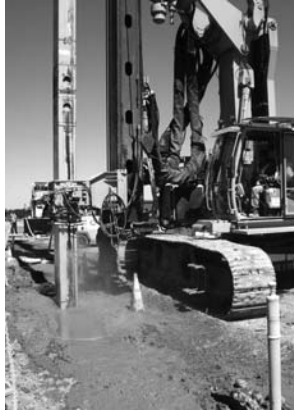
*Photo 3.16* Kelly (square) guided CSM unit for depths up to 140 feet.

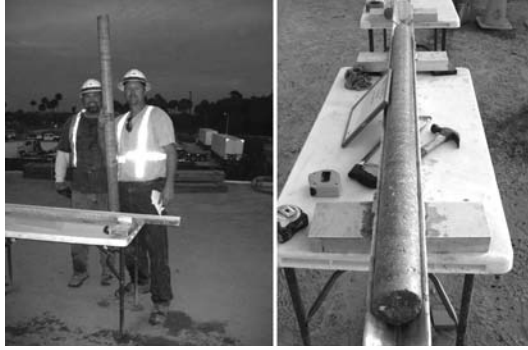
*Photo 3.18* Core recovery and samples obtained during CSM demonstration section coring, Herbert Hoover Dike, Florida.

Considering the potential for a negative impact on wall homogeneity and strength, the contractor elected to remove substantial peat layers and replace them with controlled quality granular backfill prior to mixing with the CSM. The cores taken from these horizons, and at all the other elevations in different lithologies, proved to have exceptional quality, homogeneity, and uniformity (Photo 3.18).

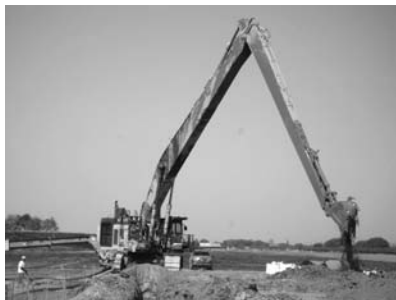
Photo 4.1 Long-reach backhoe, Marysville, California.

In general, slurry wall trenches are excavated using a hydraulic track excavator fitted with specialized “long-reach” or “long-front” equipment (Photo 4.1). The long fronts are custom built for slurry wall trenching and

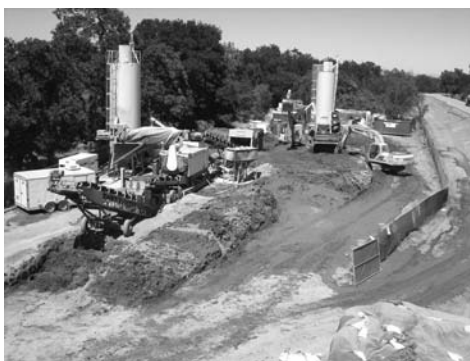
*Photo 4.2* Pugmill mixing plant, Mayhew Levee, Sacramento, California.
