# Specialty Construction Techniques for Dam and Levee Remediation

Edited by Donald A. Bruce

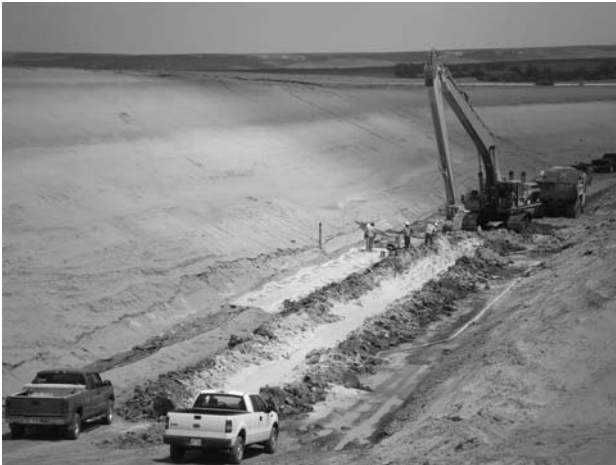
Photo 4.3 Excavation for CB cutoff, Horsethief Dam, Kansas.

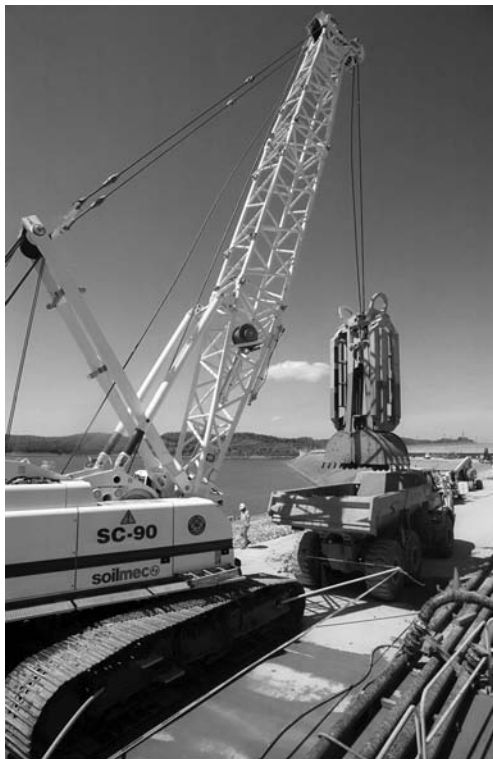
Photo 4.4 Cable-suspended and activated clamshell. (Courtesy of TREVIICOS Corp.)

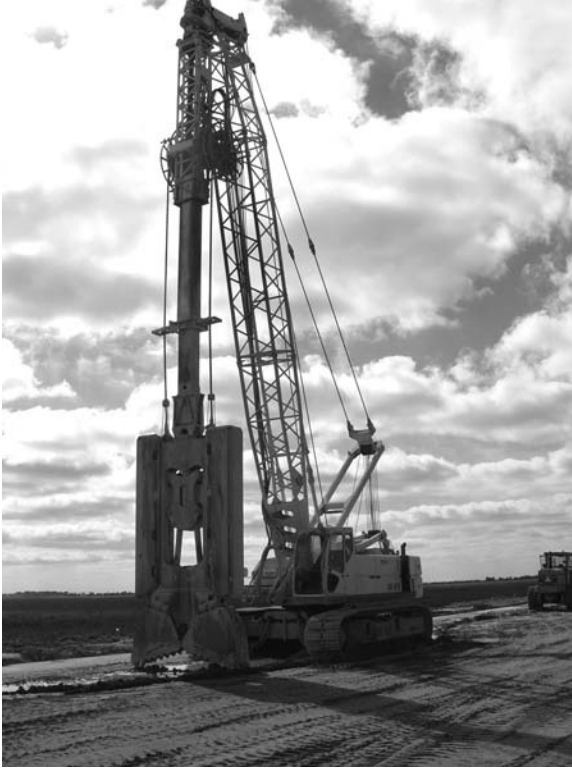
*Photo 4.5* Semi Kelly-mounted, hydraulically activated clamshell. (Courtesy of TREVIICOS Corp.)

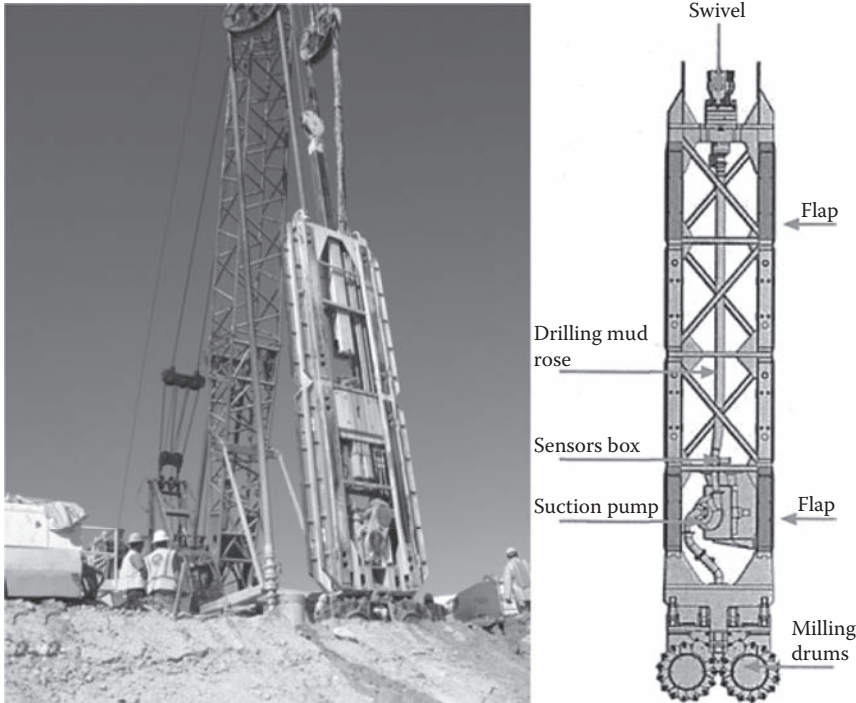
Figure 4.4 Hydromill being extracted from trench, at Herbert Hoover Dike, Florida. (Courtesy of TREVILCOS South.)

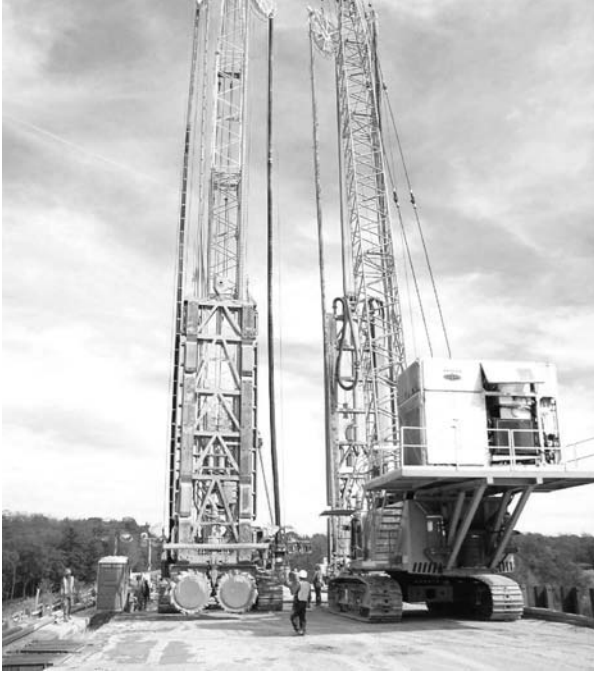
*Photo 4.6* Hydromill being moved along the work platform at Mississinewa Dam, Indiana. (Courtesy of Bencor-Petrifond JV and USACE.)

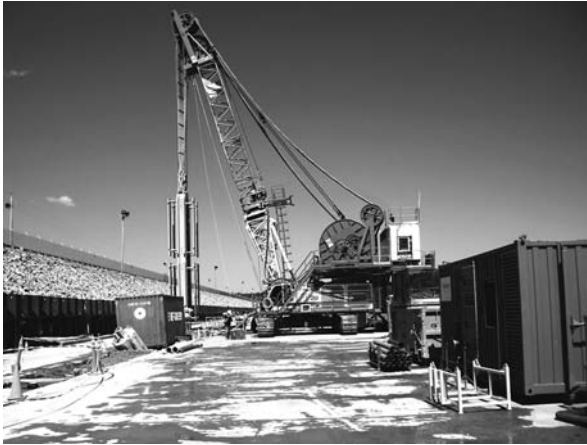
*Photo 4.7* Hydromill operation at Wolf Creek Dam, Kentucky. (Courtesy of TREVIICOS Soletanche JV USACE.)

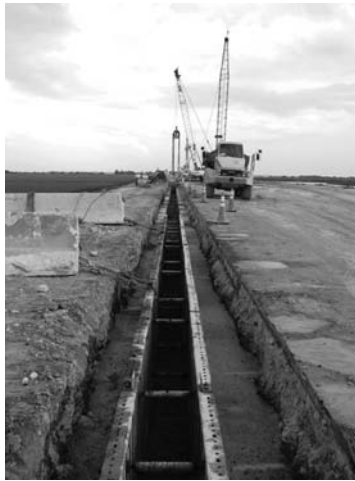
*Photo 4.8* Guide wall installed prior to excavating a remedial cutoff wall. (Courtesy of Bencor.)

The plan location of panel or secant walls is most simply and effectively controlled by the use of guide walls (Photo 4.8). These are reinforced concrete structures, firmly and very accurately prepositioned in the working platform, so that the *starting* position of the cutoff is verified. The traditional “land surveyor” techniques of former years have been complemented in more recent years with the use of GPS techniques of astonishing

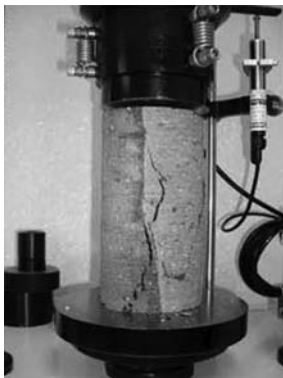
Photo 4.9 Compression test on a cored inter-element sample that shows different colors of self-hardening slurry. (Courtesy of TREVICOS Corp.)

In general, walls with an unconfined compressive strength of about 100 psi or more can be cored, provided the appropriate coring equipment and methods are used: there is no question that the coring of these walls is a specialized form of drilling, and one wherein penetration rate must be sacrificed for good recovery and verticality. Special attention must also be paid to the selection of the drill flush characteristics and parameters. Otherwise there is the potential for core recovery to be poor, and/or for borehole walls to be cracked. Special standards of care must be imposed during the selection of an acceptably qualified driller. Cores can be taken of the interior of the element itself (i.e., vertical), of inter-element joints (i.e., vertical, but difficult due to hole deviation tendencies), or both (i.e., by holes inclined across joints, in the longitudinal plane of the wall). Interpretation of the core samples is facilitated when the concrete used in the primary and secondary panels has been colored with distinctive dyes. Whereas it is not atypical to find minor smearing of joints in Category 1 walls formed with high-strength concrete, it is equally common to find excellent contact in “softer” walls, for example, the self-hardening slurry wall joint shown in Photo 4.9, or in plastic concrete walls. Concerns over the quality of extracted cores can be resolved by conducting optical or televiewer surveys of these holes, which permit the actual *in-situ* conditions to be clearly exposed. Permeability tests (falling head or constant low head or rising head) can be a run on such joints

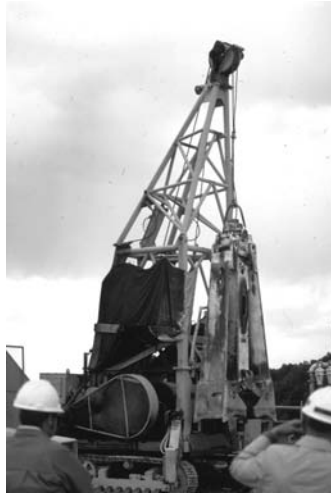
Photo 4.10 Cable-suspended grab in operation off a specially developed tracked rig, Wolf Creek Dam, 1975–79. (Courtesy of Arturo Ressi.)

After a 24-hour wait for the grout to strengthen, the ballast was lifted out of the permanent casing and a tremie pipe inserted. Concrete (3,000 psi) was tremied into the permanent casing. Once two permanent casings (primary elements) were completed, the embankment and overburden between them was excavated under a thin bentonite slurry by a “Wolf Creek” rig and chisel bucket (Photo 4.10). The chisel bucket was a specially designed

clamshell that had a small set of jaws and biconcave chisels that rode the outsides of the two permanent casings. Once excavation reached top of the rock, a star chisel broke out the rock remaining between the two permanent casings. After the cuttings were removed by alternate use of a special clamshell and bailer, the entire excavation for the secondary element was filled with 3,000 psi concrete using the tremie method.

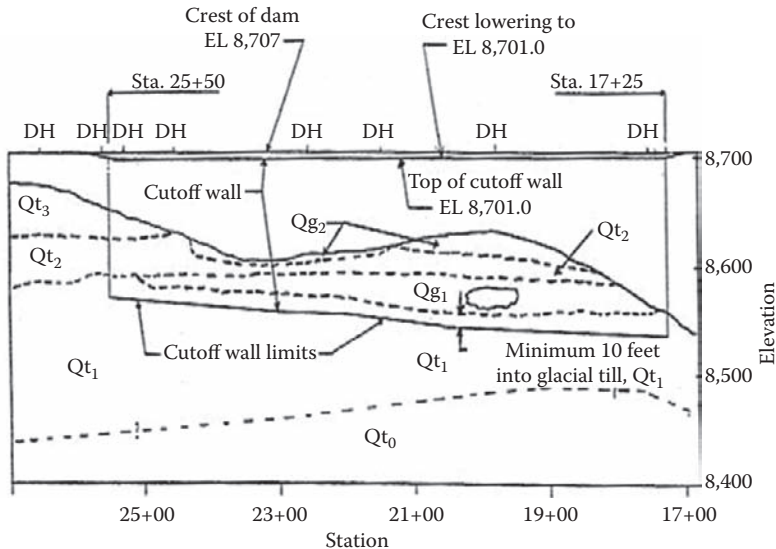
Figure 4.11 Geologic profile of left abutment, Meeks Cabin Dam, Wyoming. (From Gagliardi, J., and R. Routh, "Geotechnical Modifications at Meeks Cabin Dam," *ASCE Specialty Conference on Geotechnical Practice in Dam Rehabilitation*, North Carolina State University, Raleigh, NC, 1993. With permission.)

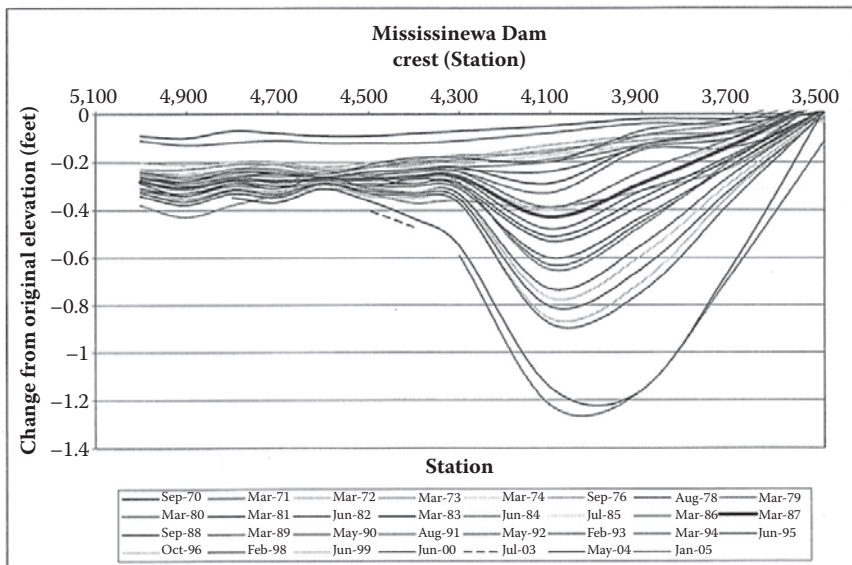
Figure 4.12 Change in vertical crest movement, 1970–2005, Mississinewa Dam, Tennessee. (From Henn, K., and B. E. Brosi, “Mississinewa Dam—Settlement Investigation and Remediation,” *Association of State Dam Safety Officials 22nd Annual Conference*, Orlando, FL, 2005. With permission.)

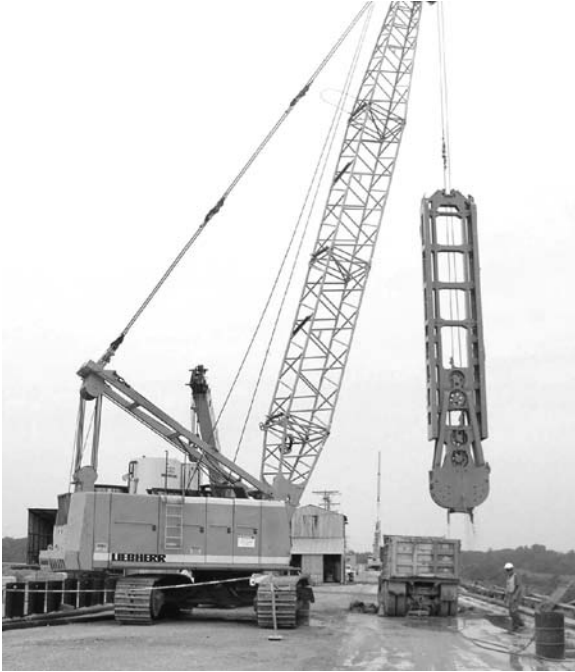
Photo 4.11 Heavy-duty cable-suspended and operated clamshell, Mississinewa Dam, Indiana. (Courtesy of Bencor-Petrifond JV and USACE.)

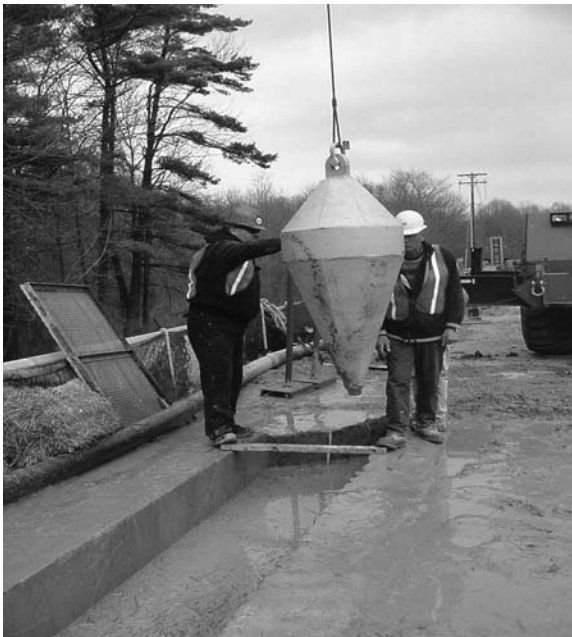
Photo 4.12 Traditional plumb-bob method as used in concert with modern methods to check panel deviation. (Courtesy of Bencor-Petrifond JV and USACE.)

1. An inclinometer and gyroscope were installed in the hydromill frame to provide a real-time evaluation of verticality and torsion.
2. A Kodon ultrasonic monitor was used at the open-panel end points and panel midpoints to measure panel verticality and shape.
3. A 500-pound plumb-bob almost the same diameter as the panel width (Photo 4.12) was suspended from a crane to measure transverse deviations every 5 feet along each panel.

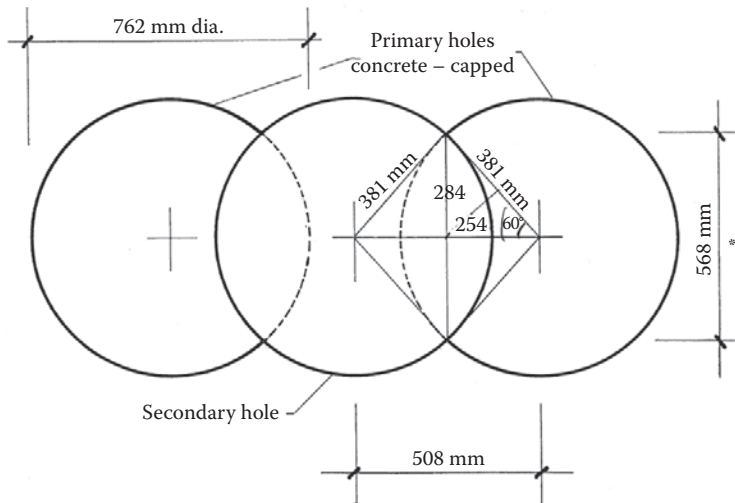
Figure 4.13 Spacing and diameter of secant piles, Khao Laem Dam, Thailand. (From Rodio, Khao Laem Multipurpose Project—C3—Concrete Diaphragm Wall—Construction Method Analysis, Internal Report, 1980. With permission.)

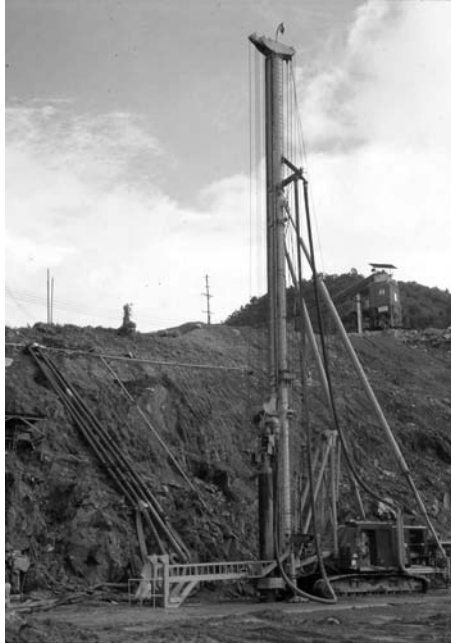
*Photo 4.14* The secant pile rig showing the rod-loading system, Khao Laem Dam, Thailand. (From Rodio, Khao Laem Multipurpose Project—C3—Concrete Diaphragm Wall—Construction Method Analysis, Internal Report, 1980. With permission.)

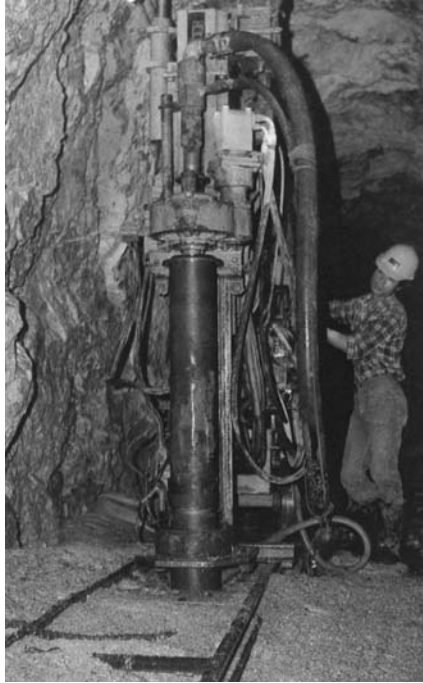
*Photo 4.15* Drilling with 300-mm DTH hammer in the galleries, Khao Laem Dam, Thailand. (From Rodio, Khao Laem Multipurpose Project—C3—Concrete Diaphragm Wall—Construction Method Analysis, Internal Report, 1980. With permission.)

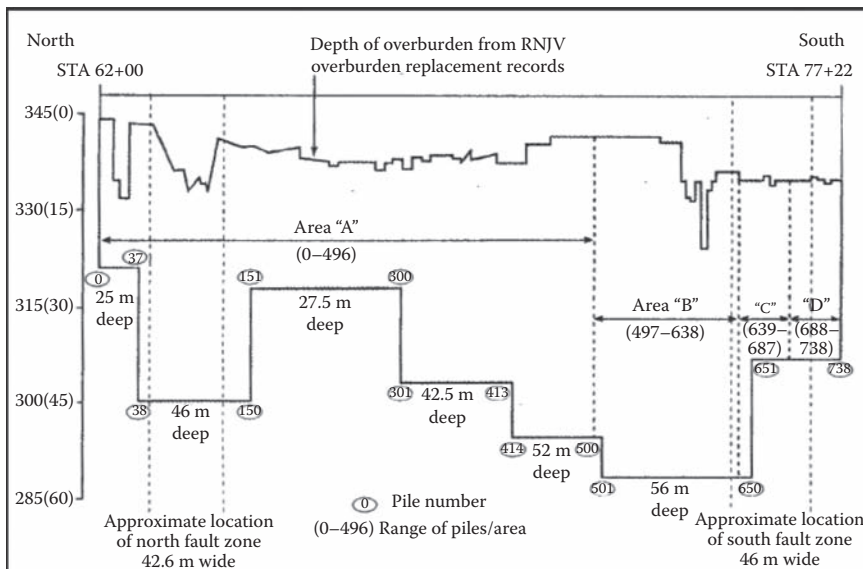
Figure 4.15 Elevation of the cutoff wall showing main construction areas, Beaver Dam, Arkansas. (From Bruce, D. A., and S. Stefani, “Rehabilitation of Beaver Dam: A Major Seepage Cutoff Wall,” *Ground Engineering*, 29, 5, 1996. With permission.)

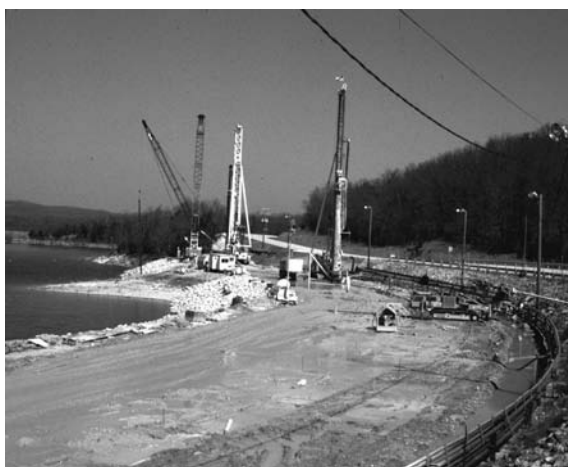
Photo 4.16 Secant pile operations at Beaver Dam, Arkansas. (Courtesy of Rodio-Nicholson JV.)

Two rigs (Photo 4.16) employed 32-inch-diameter drill rods in 30-foot lengths. While most of the drilling was conducted with a conventional DTH, successful experiments were made with a Fisher-Soppe “cluster” DTH comprising five 8-inch hammers on a 24-inch diameter casing. Drill penetration rates for primary holes ranged from 8 to 21 feet per hour (average 14.5), and from 13.5 to 23 feet per hour (average 18) in secondaries. These rates varied considerably between areas and between rigs.

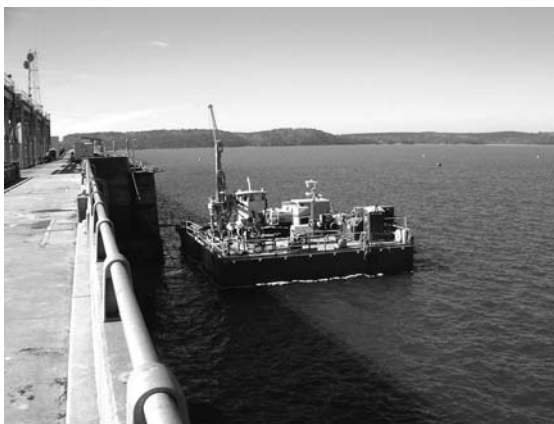
Photo 4.18 The exploratory and grouting campaign being conducted from a barge, W. F. George Dam, Alabama. (M. Siepi, personal communication, 2011.)

Before cutoff wall construction began, an exploration and grouting campaign was completed along the entire centerline of the wall (Photo 4.18), in order to fill any large cavities or solution channels that may have had a negative impact on the installation of the cutoff wall, and to minimize the fluid losses. Although the grout takes on the 100 holes drilled from a barge were generally modest, totaling 350 cubic meters (Figure 4.17), the grouting program increased the level of confidence in, and knowledge of, the rock in which the cutoff had to be installed.

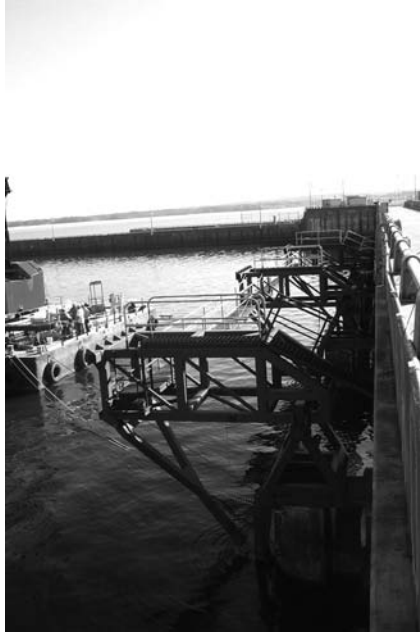
*Photo 4.19* Template supports out from the buttresses of the dam, W. F. George Dam, Alabama. (M. Siepi, personal communication, 2011.)

The secant piles were to be installed in the main portion of the wall in the classic primary/secondary sequence. Once the working apron was in place, the contractor installed a system of modular mobile templates secured to the concrete dam to place and drive the temporary casings into the apron with the necessary accuracy. These templates were positioned so that the cross frames cantilevered out far enough to avoid the toe of the dam (Photo 4.19 and Figure 4.18). Modification and customization of the main support had to be completed on site, to follow the profile of the dam, and to avoid the obstructions found on the anticipated alignment. This leveraged the flexibility of the secant pile method, which naturally allows virtually any alignment to be followed. Fixed positions were provided on the frames at the same spacing as the piles, acting as guides to install the 35-m-long temporary casings. Each casing, fitted with a positioning sleeve, was then positioned using a survey instrument on each axis to assure plumb installation, and then driven into the apron using a vibratory hammer, or an impact hammer.

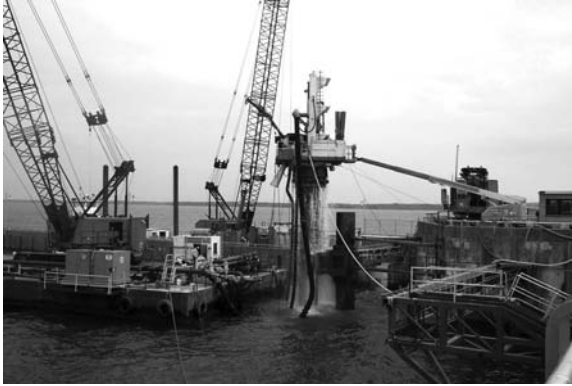
Photo 4.20 Top pile rig excavating with reverse-circulation method, W. F. George Dam, Alabama. (M. Siepi, personal communication, 2011.)

The main equipment for the excavation of the piles was two Wirth reverse-circulation drill rigs, assisted by two cranes mounted on large barges (Photo 4.20). The piles were drilled to a final depth of about 70 m from top of casing, using water from the lake as the drilling fluid.

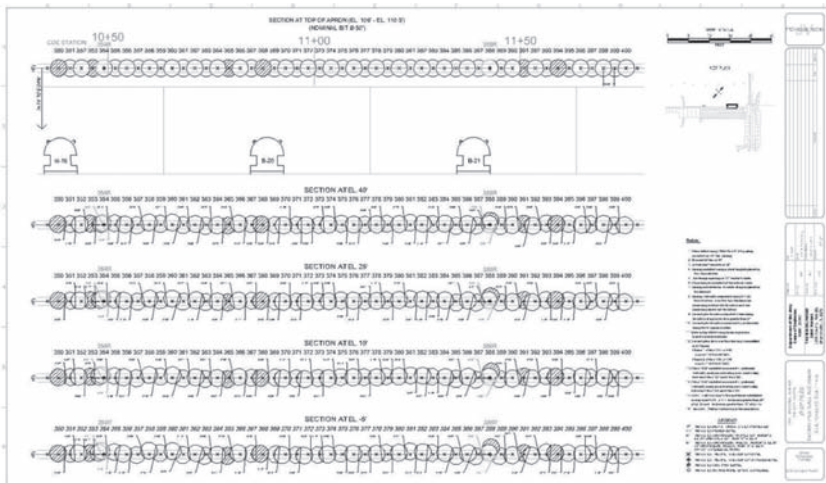
Figure 4.19 As-built drawing of the secant pile cutoff wall at different elevations, W. F. George Dam, Alabama. (Ressi di Cervia, A., "Construction of the Deep Cutoff at the Walter F. George Dam," *United States Society on Dams, 25th Annual Conference*, Salt Lake City, UT, 2005. With permission.)

Upon completion of drilling, the pile was surveyed for verticality by using a biaxial inclinometer. The results of these measurements were plotted to assure that the requirement of the specifications were met, and the positive cutoff assured. Figure 4.19 shows an example of the as-built conditions of a section, where the position of each pile is shown, successively, at top of apron, at EL 40 feet, 25 feet, 10 feet, and -5 feet (final elevation).

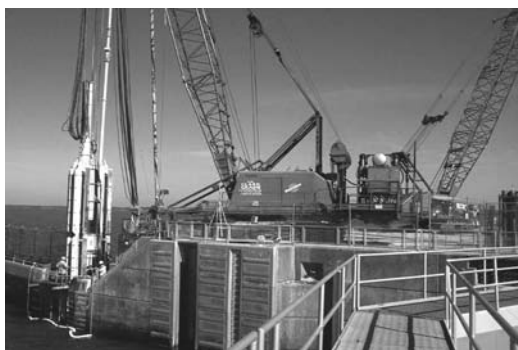
Photo 4.21 Hydromill cutting the lock walls standing on the concrete dam, W. F. George Dam, Alabama. (M. Siepi, personal communication, 2011.)

walls on the east and west embankments. The two walls of the navigation lock needed to be perforated in order for the secant pile cutoff to be continuous. A hydromill was used to cut a slot 1.8 m thick in the two concrete lock walls (33.5 m deep and up to 26.8 m thick at their base), and a submerged retaining wall (Figure 4.20). Several alternatives were studied for cutting of the lock walls but all utilized divers extensively: by utilizing the hydromill, divers were not required. The crane carrying the hydromill was mounted on the concrete

platform (Photo 4.21) or on a barge. In the west area, an underwater retaining wall had to be penetrated before installation of the cutoff wall and soil improvement by jet grouting was necessary at the back of the wall (Figure 4.21) since the mass excavation needed in this area would have created a risk of collapse.

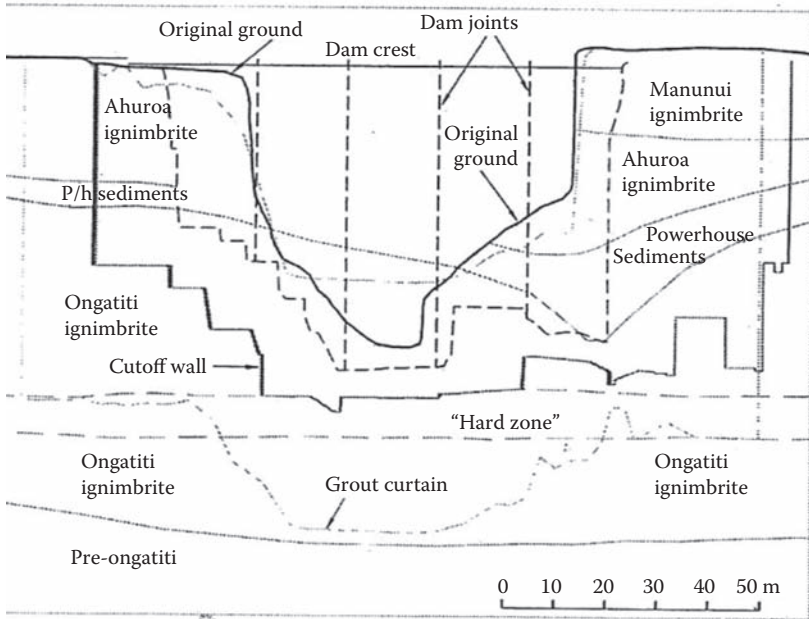
Figure 4.22 Elevation of Arapuni Dam, New Zealand, looking downstream. (Amos, P. D., D.A.Bruce, M.Lucchi, N.Watkins, and N.Wharmby, "Design and Construction of Deep Secant Pile Seepage Cutoff Walls Under the Arapuni Dam in New Zealand," USSD 2008 Conference, Portland, OR, 2008. With permission.)

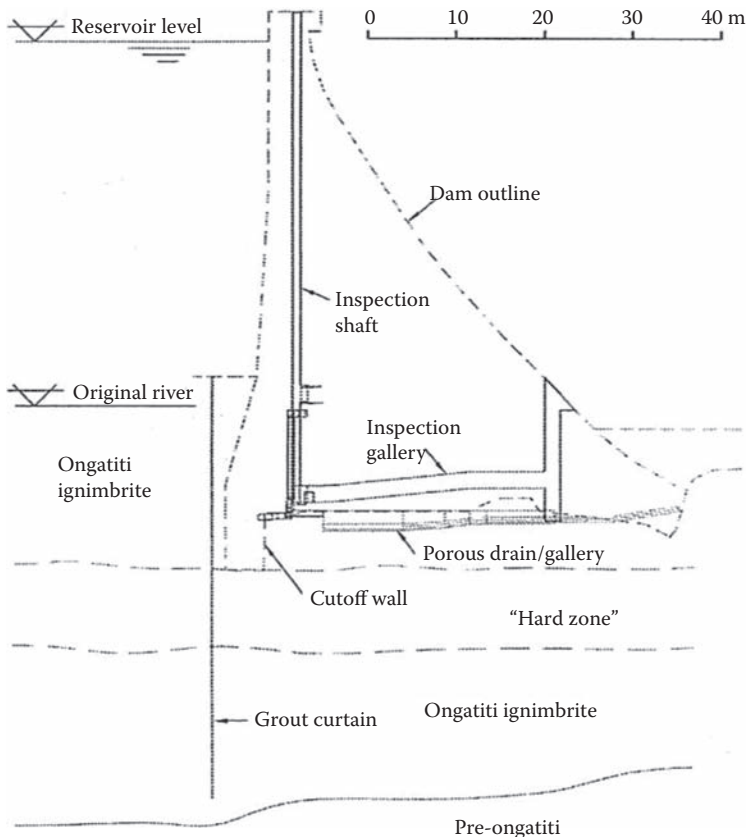
Figure 4.23 Cross-section of Arapuni Dam, New Zealand, looking west. Note the spatial separation of the grout curtain from the dam. (From Amos, P. D., D. A. Bruce, M. Lucchi, N. Watkins, and N. Wharmby, "Design and Construction of Deep Secant Pile Seepage Cutoff Walls Under the Arapuni Dam in New Zealand," *USSD 2008 Conference*, Portland, OR, 2008. With permission.)

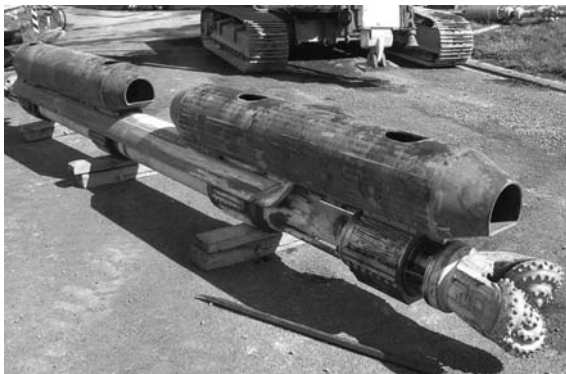
Photo 4.23 The guide connected to the drill-string, Arapuni Dam, New Zealand. (M. Siepi, personal communication, 2011.)

Drilling rates were lower than anticipated, especially in the concrete of the dam (UCS in the range 40–45 MPa), most probably because of the aggregate, a greywacke quarried locally and ranging in size from 10 to 100 mm. The guide frequently jammed in the hole, causing high friction

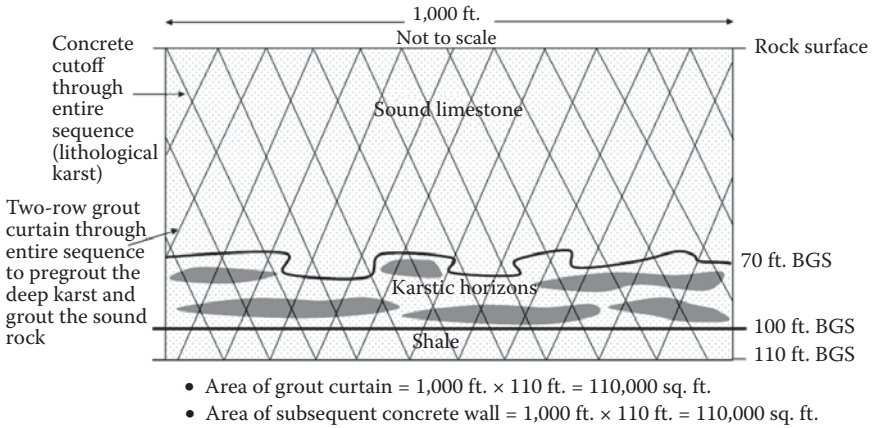
Figure 5.2 Heavily karstified horizons are found at depth during predrilling and grouting. Therefore the concrete cutoff is required for the full extent. The grouting has pretreated the karstic horizons to permit safe concrete cutoff construction.

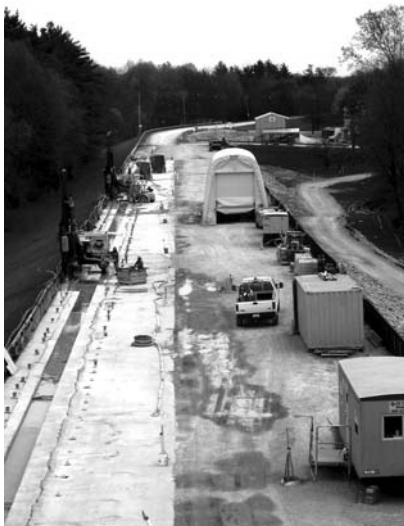
*Photo 5.1* View of the remediation works at Mississinewa Dam, Indiana. (Courtesy of ACT, Gannett Fleming, and the USACE.)

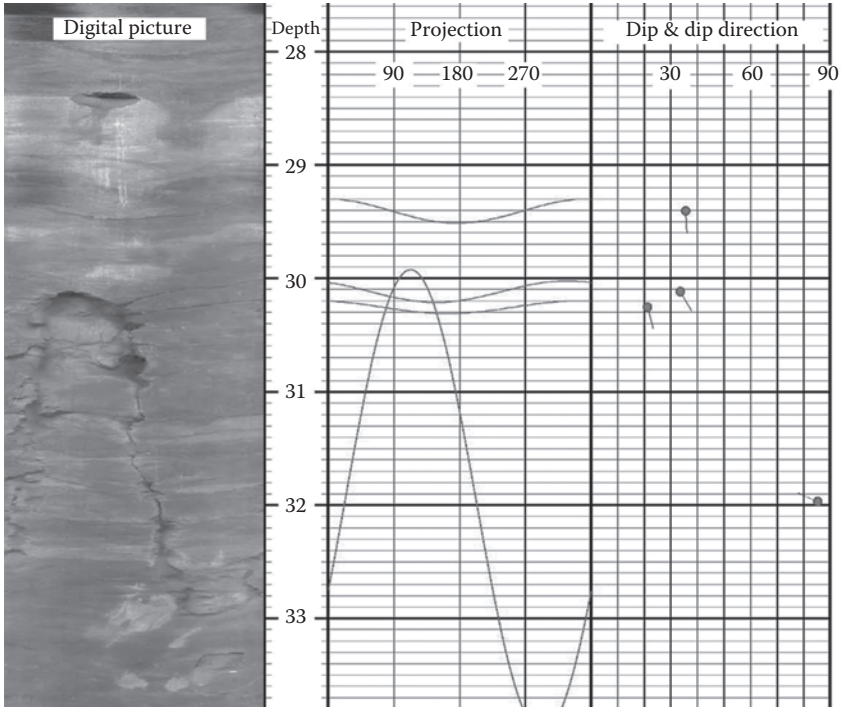
Figure 5.4 Section of optical televiewer log showing mapped fracture. Depth in feet. (Charlton, J. E., C. H. Ginther, and D. A. Bruce, "Comprehensive Foundation Rehabilitation at Bear Creek Dam," *Environmental and Engineering Geoscience*, 16, 3, 2010.)

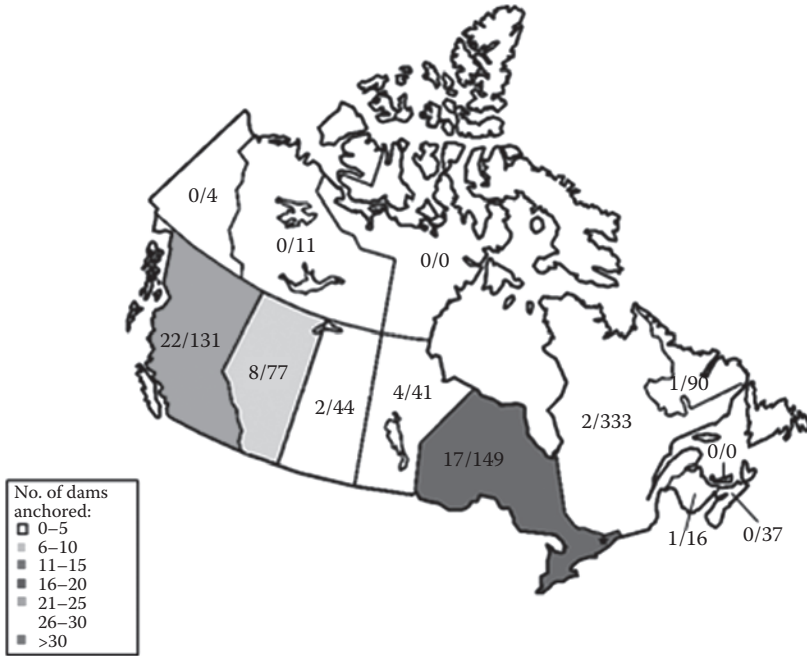
Figure 6.4 Numbers of dams anchored/number of large dams per Canadian province. (From Bruce, D. A., “Dam Remediation by Anchors and Cut-Offs: A Summary of Two National Research Programs,” Ohio River Valley Soils Seminar, ORVSS XXXVIII, Louisville, KY, 2007. With permission.)

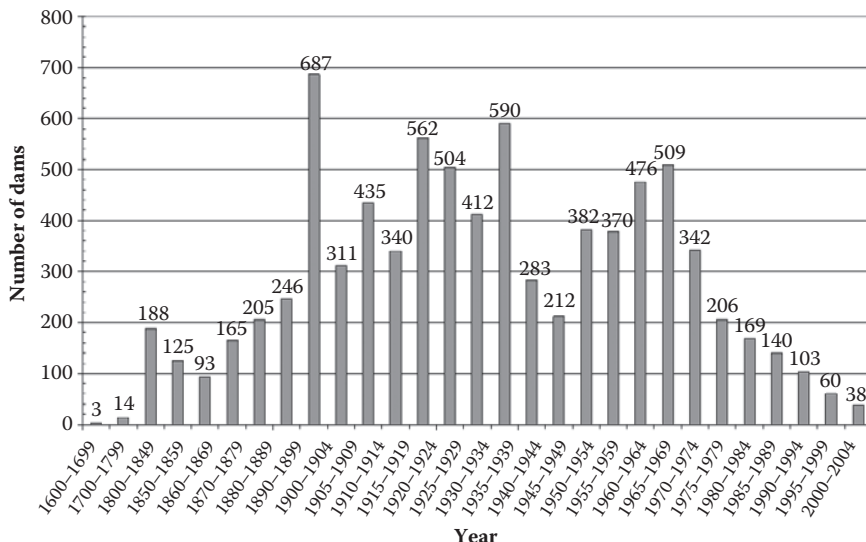
Figure 6.5 Histogram of U.S. dam construction by dam (1600–2004) for dams listed as concrete, gravity, buttress, arch, multiple arch, masonry, or dams listed as having a controlled spillway. Note the National Inventory of Dams lists 79,777 dams in total. This excludes approximately 9,500 dams with unreported/invalid data. The total number of dams shown in the histogram above is 8,178. (From Bruce, D. A., and J. Wolfhope, “Rock Anchors for North American Dams: The National Research Program Bibliography and Database,” Paper presented at Institution of Civil Engineers, Ground Anchorages and Anchored Structures in Service, London, England, 2007. With permission.)

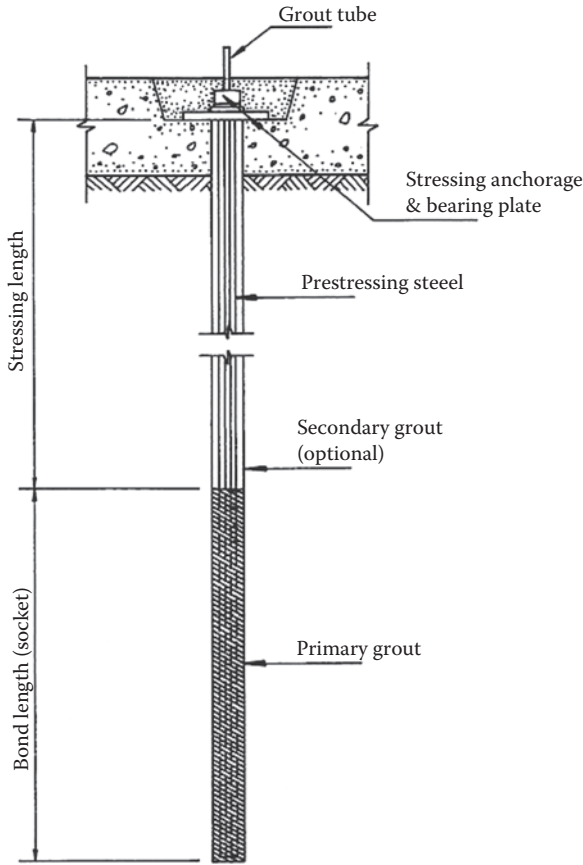
Figure 6.6 Rock anchor components. Note the lack of protection to the steel tendon other than cement grout. (From Prestressed Concrete Institute (PCI), *Tentative Recommendations for Prestressed Rock and Soil Anchors*. Phoenix, Arizona, 1974. With permission.)

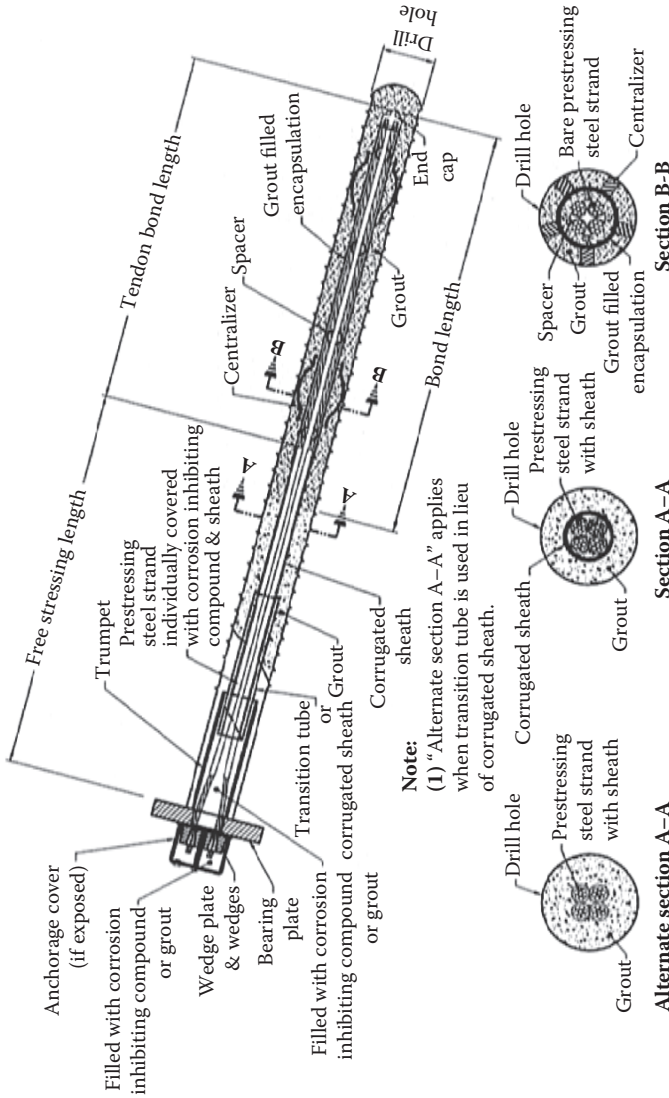
Figure 6.7 Class I Protection—Encapsulated Strand Anchor. (From Post-Tensioning Institute (PTI), *Recommendations for Prestressed Rock and Soil Anchors*, 4th ed., Phoenix, Arizona, 2004. With permission.)

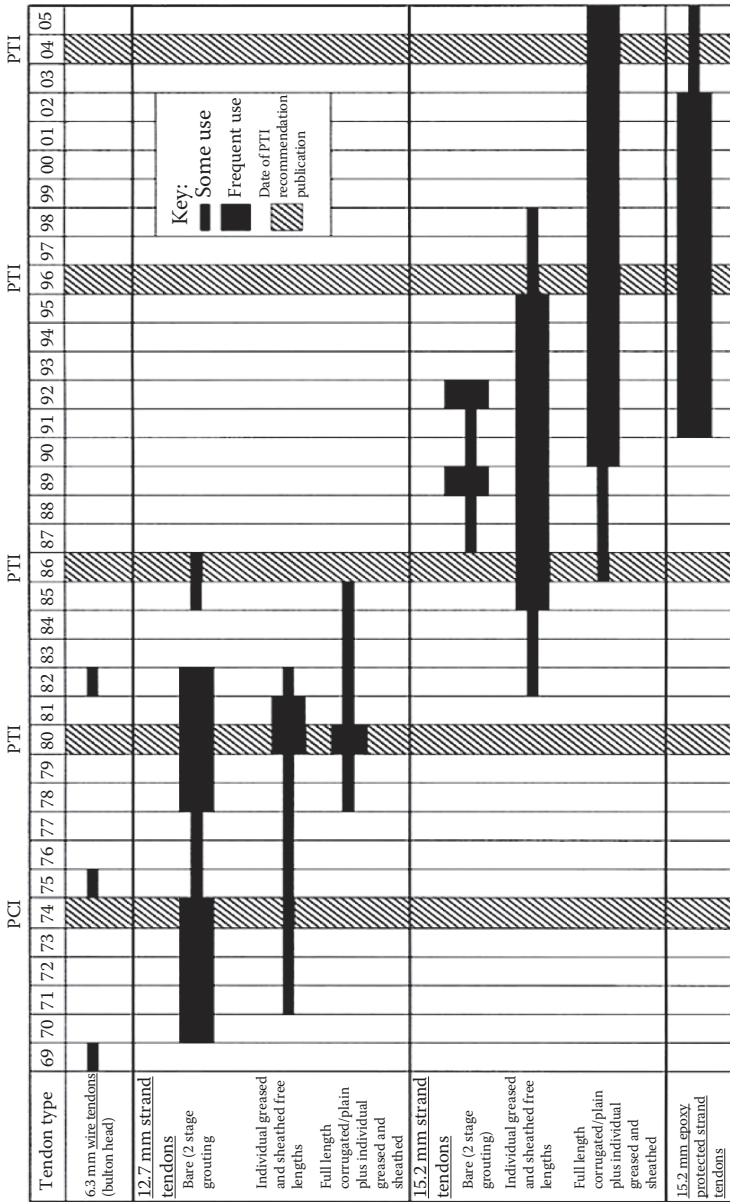
Figure 6.8 Illustrating how the types of corrosion protection evolved. (From Bruce, D. A., and J. Wolfhope, "Rock Anchors for North American Dams: The National Research Program Bibliography and Database," Paper presented at Institution of Civil Engineers, Ground Anchorages and Anchored Structures in Service, London, England, 2007. With permission.)

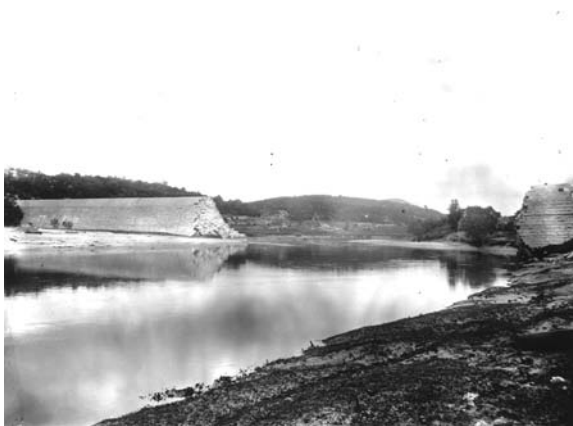
*Photo 6.1* The 1900 failure of Tom Miller Dam, Texas. (Courtesy of Lower Colorado River Authority archives.)

impounds Lake Austin, the last in a series of reservoirs referred to as the “Highland Lakes” of central Texas. The dam was originally constructed from 1890 to 1893 as an uncontrolled overflow gravity spillway. The original dam was a cyclopean structure built using a core of mortared irregular limestone rocks faced with granite masonry. The dam failed catastrophically in 1900 when a 500-foot-long section of the spillway slid downstream, as shown in Photo 6.1.

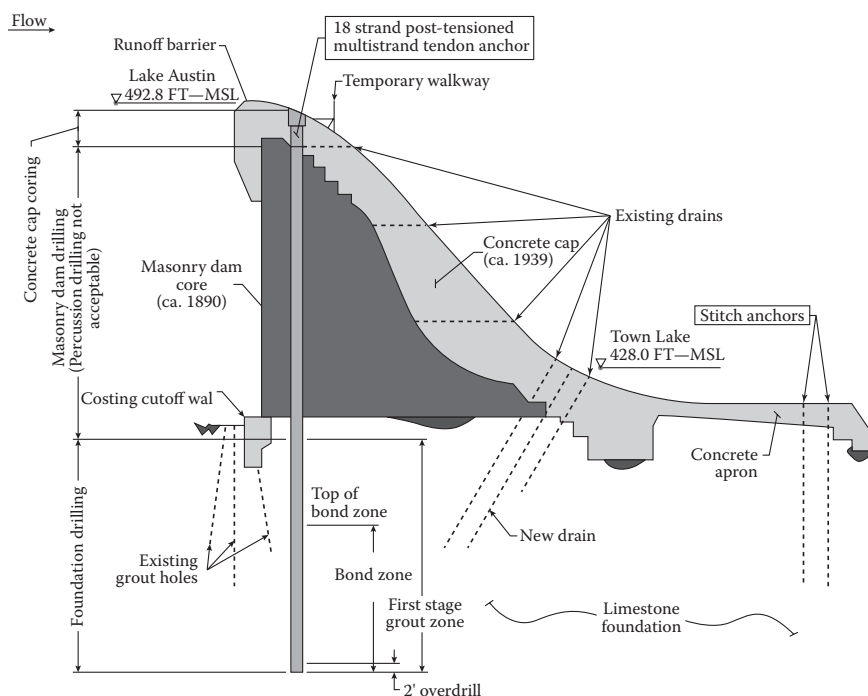
Figure 6.9 Schematic cross-section of the overflow section, Tom Miller Dam, Texas. (From Bruce, D. A., J. J. Jensen, and J. S. Wolfhope, "High Capacity Rock Anchors for Dams: Some Fundamental Observations on the Analysis of Stressing Data." Paper presented at USSD 2005 Conference, Salt Lake City, UT, June 6–10, 2005. With permission.)

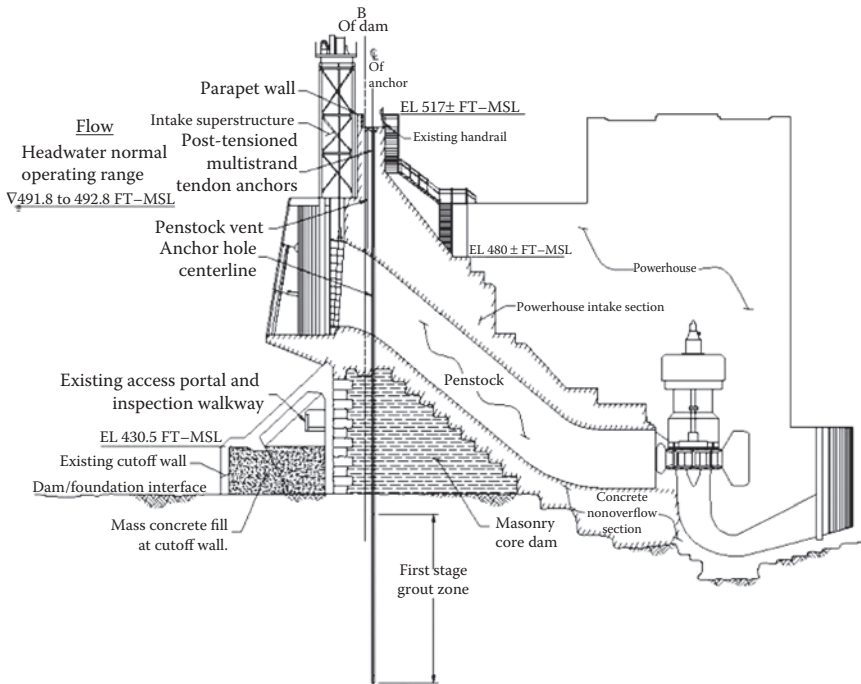
Figure 6.10 Location of the anchors in the Powerhouse intake structure, Tom Miller Dam, Texas. (From Bruce, D. A., J. J. Jensen, and J. S. Wolfhope, "High Capacity Rock Anchors for Dams: Some Fundamental Observations on the Analysis of Stressing Data." Paper presented at USSD 2005 Conference, Salt Lake City, UT, June 6–10, 2005. With permission.)

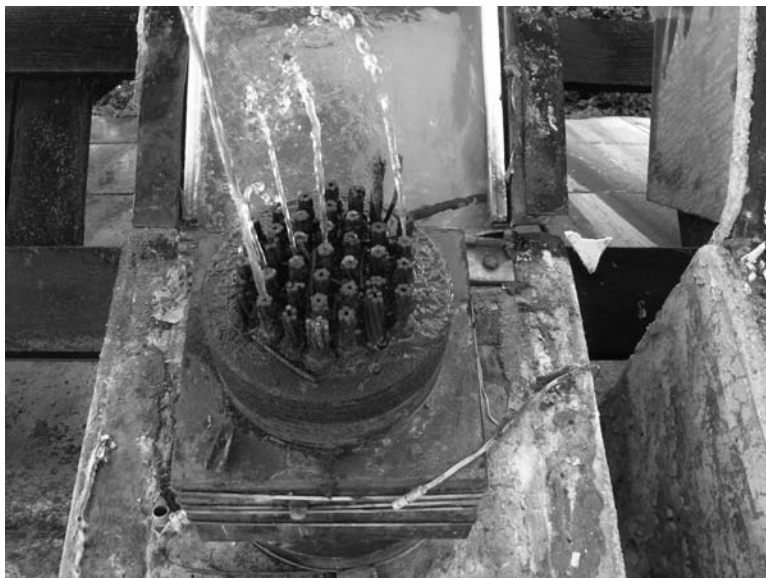
*Photo 6.4* Typical corroded anchor head in 2008 at John Day Dam, Washington. (Note water spraying out of strands.) (From Heslin, G., D. A. Bruce, G. S. Littlejohn, and T. Westover, "Performance of Aging Post-Tensioned Rock Anchors in Dams," ASDSO Northeast Regional Conference, State College, PA, 2009. With permission.)

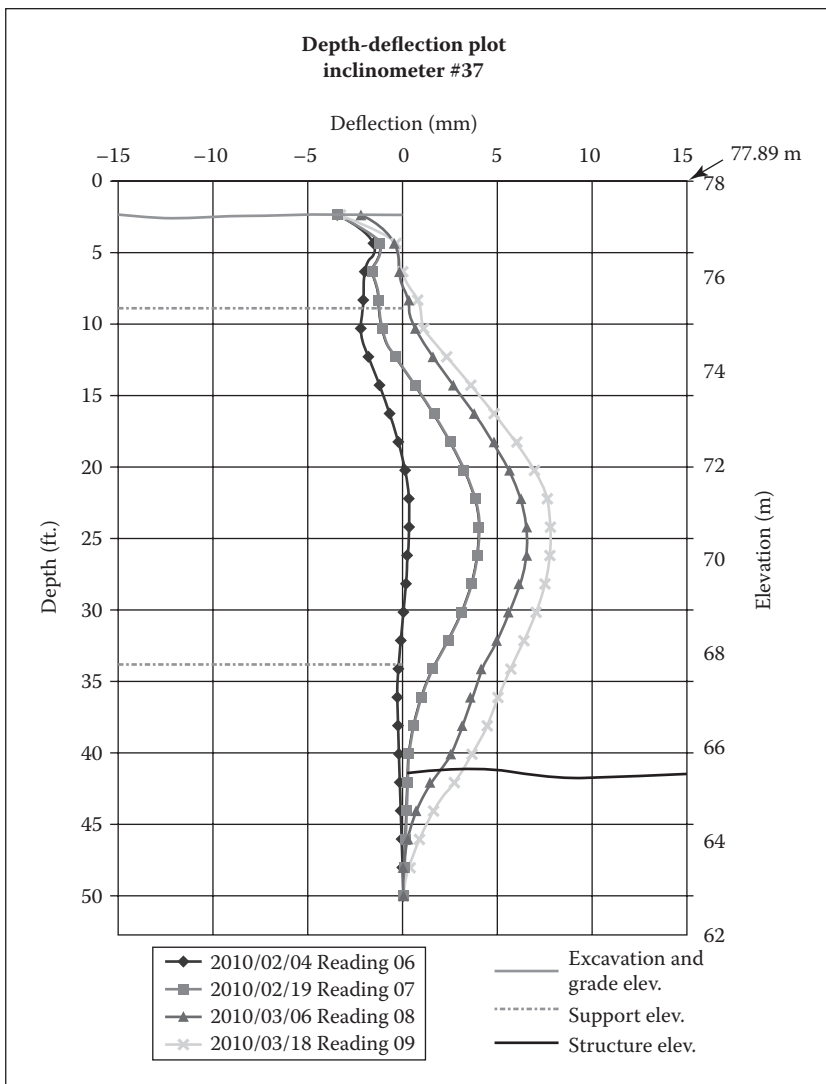
Figure 7.6 Inclinometer depth-deflection profile.

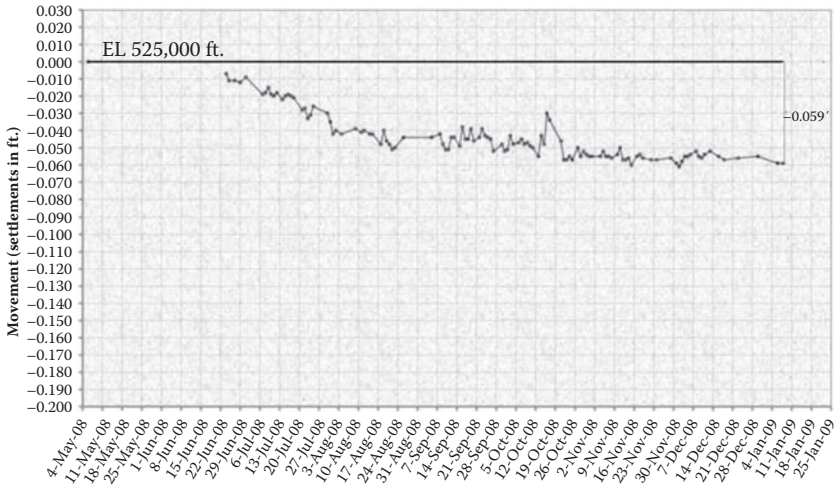
Figure 7.9 Time-history plot of movement monitoring data.
