SINKHOLES and SUBSIDENCE

**Karst and Cavernous Rocks in
Engineering and Construction**

**Tony Waltham, Fred Bell
and Martin Culshaw**

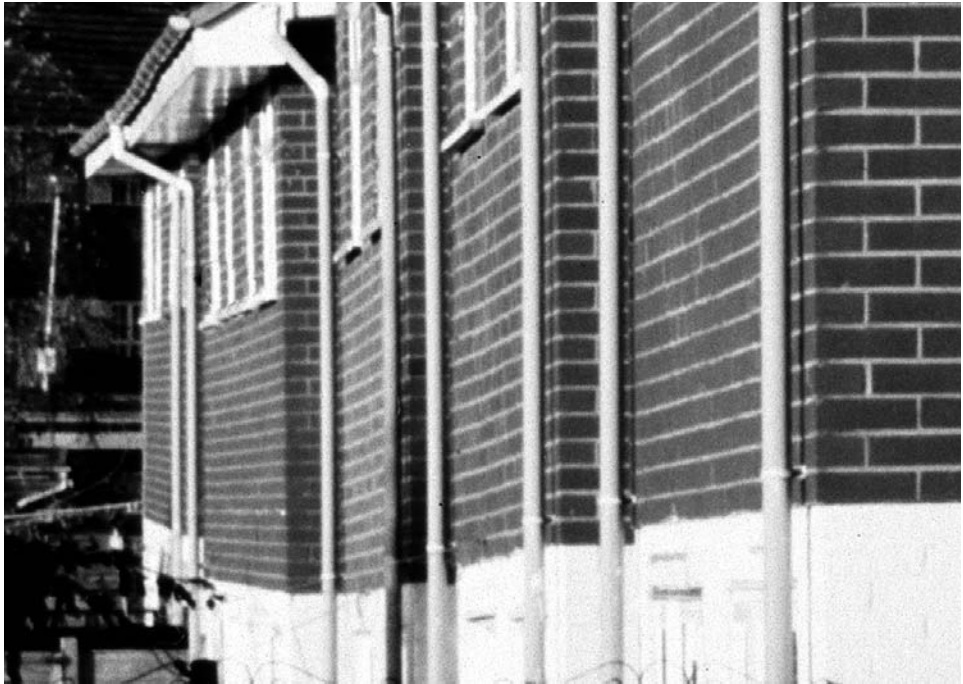
Figure 2.8. Houses in Sandbach subsided and tilted due to dissolution and removal of salt from the rockhead zone beneath 20 m of drift cover, in the Cheshire Plain, U.K.
TW.

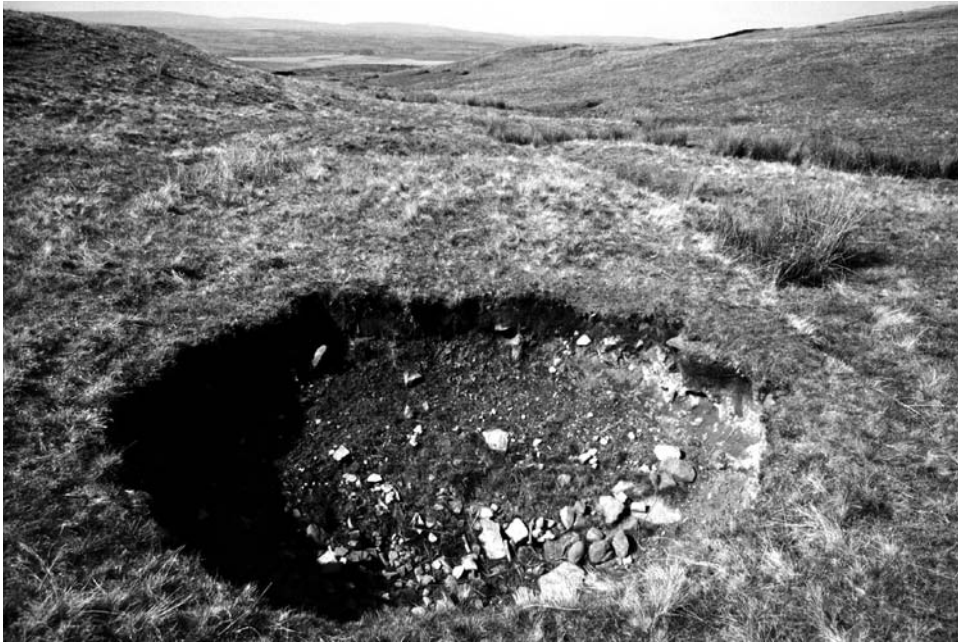
Figure 4.1. A typical small, fresh subsidence sinkhole formed in till overlying cavernous limestone in the Yorkshire Dales, U.K.; the new sinkhole is only about 3 m wide and 1 m deep, and it does not expose the limestone as rockhead is at a depth of about 3 m. TW.

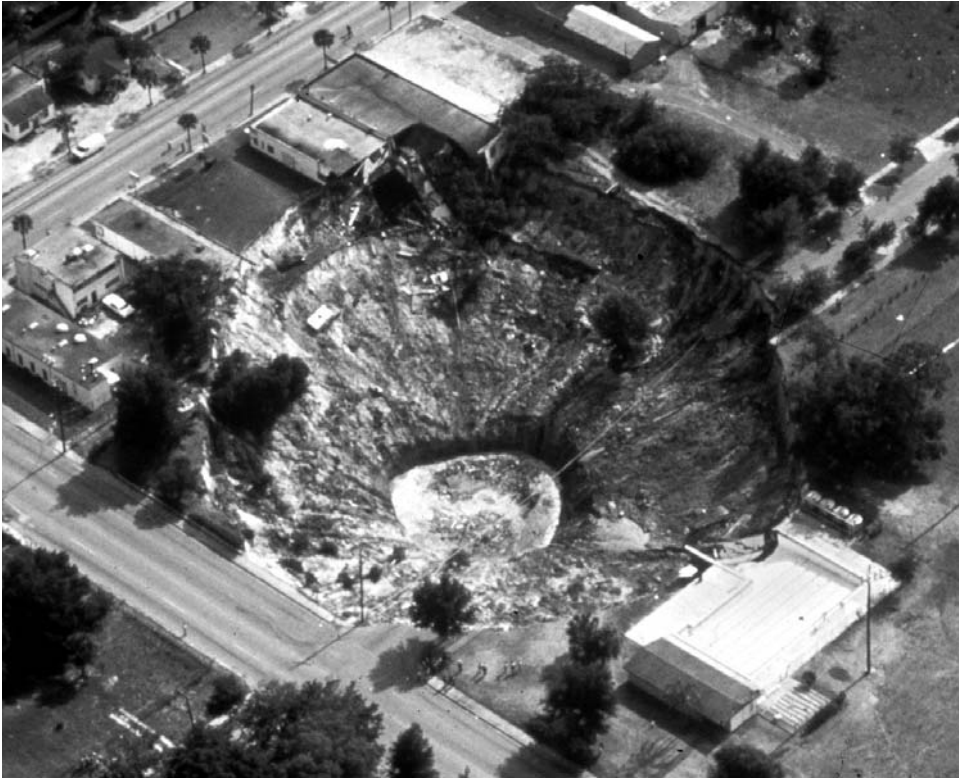
Figure 4.2. The large subsidence sinkhole in Winter Park, Florida, just after its initial dropout in May 1981; water is ponded within the steep-sided throat down through the clay soils, while the upper slopes were at the time still actively slumping back to form the wide bowl in the sand cover.

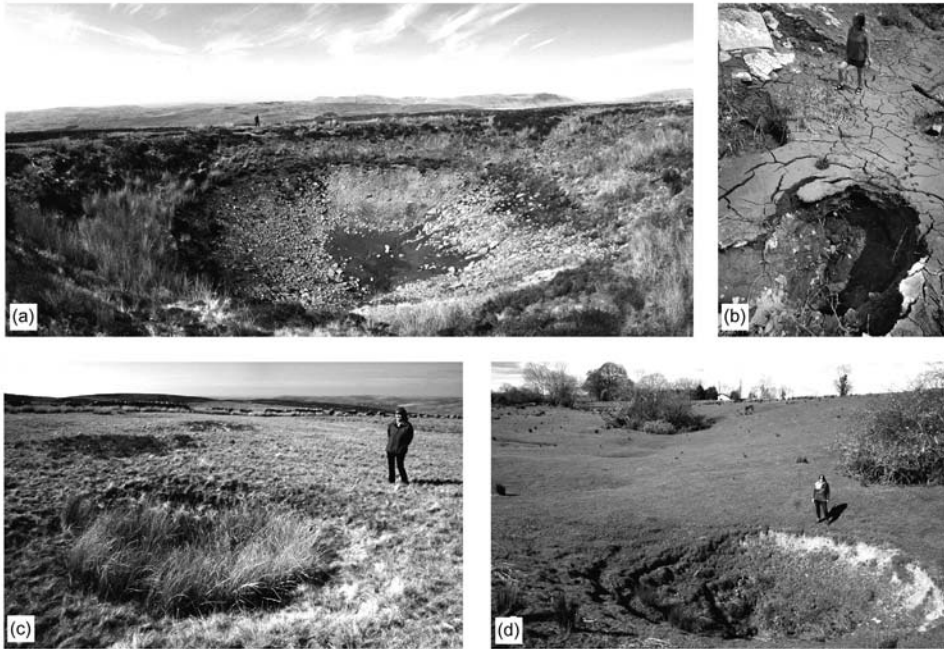
Figure 4.3. Variations in morphology of subsidence sinkholes; (a) – a large and old sinkhole in till, that holds a lake in wet weather but drains out in dry conditions, in the Yorkshire Dales karst, U.K.; (b) – a small new sinkhole in clays that floor a valley in Pennsylvania that loses all its water underground; (c) – an old, degraded sinkhole with its fissure drain sealed by inwashed clay so that it has reed grass growing in a small pond, in the Yorkshire Dales, U.K.; (d) – a newly reactivated sinkhole with fresh scars in its soil slopes, on the limestone of County Cavan, Eire.

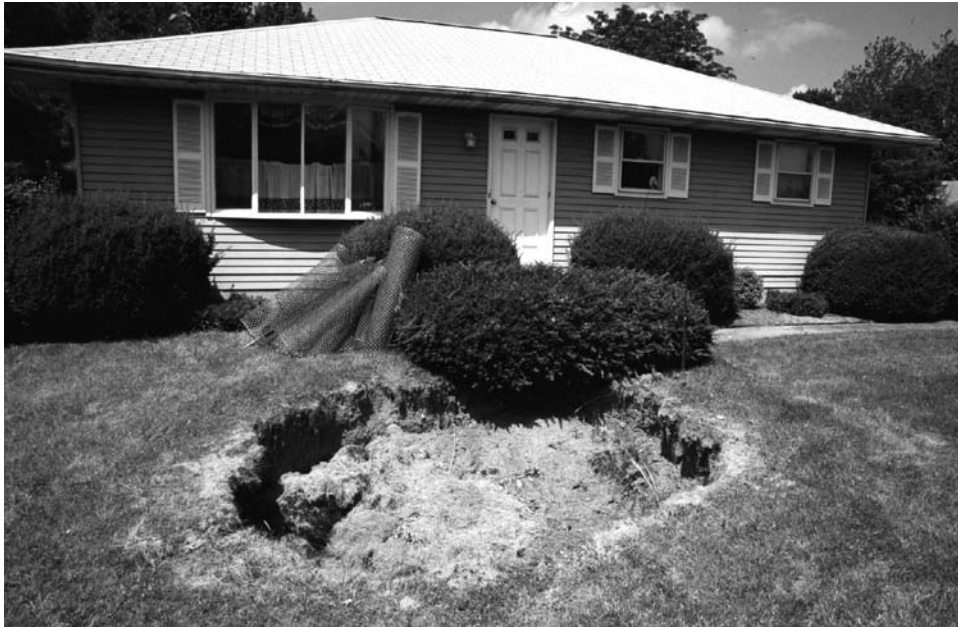
Figure 4.8. A dropout sinkhole in the front lawn of a house in Pennsylvania; the hole was originally 5 m deep but was filled with soil to prevent the sides flaring out, and the soil fill had compacted and settled by 0.7 m by the time this photo was taken.
TW.

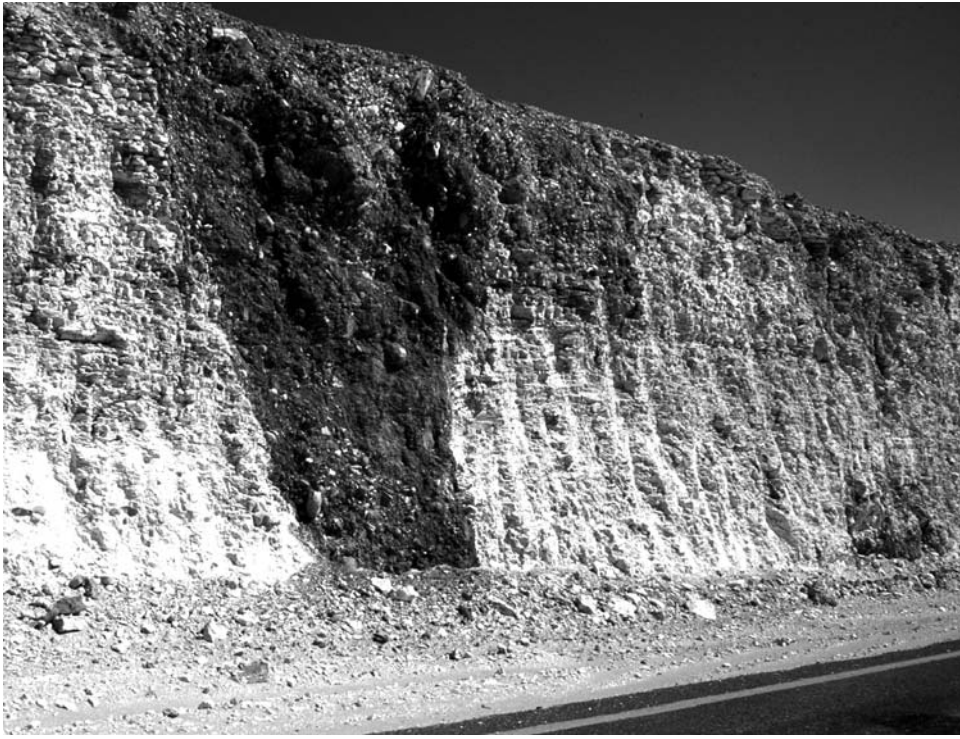
Figure 5.8. An ancient buried sinkhole bisected by a road cutting in the limestone of Egypt's Kharga Plateau; much of the cohesive fill remains in place in the modern dry environment. TW.

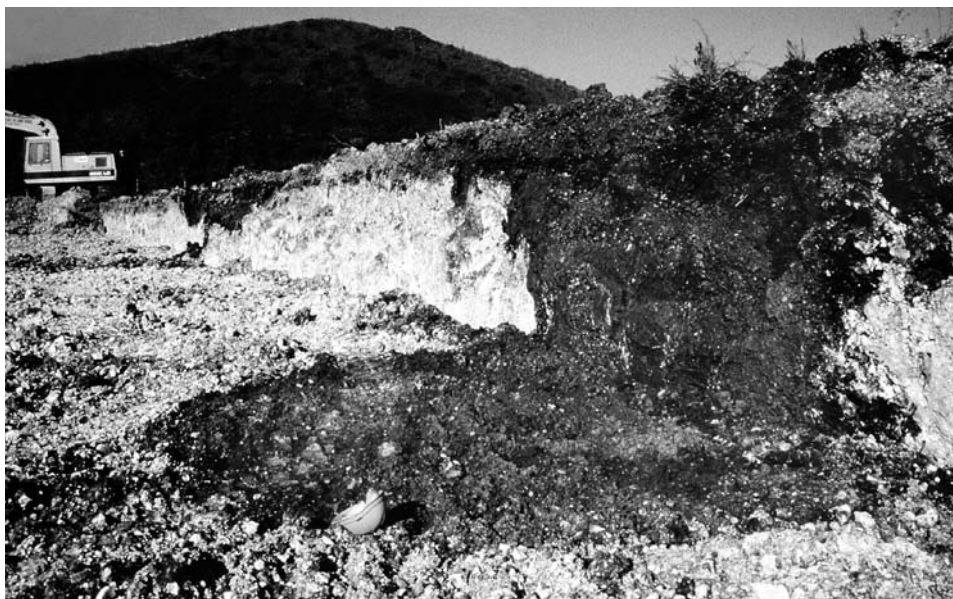
Figure 5.13. A single clay-filled pipe in chalk, exposed in both plan and profile on a building site in southern England.

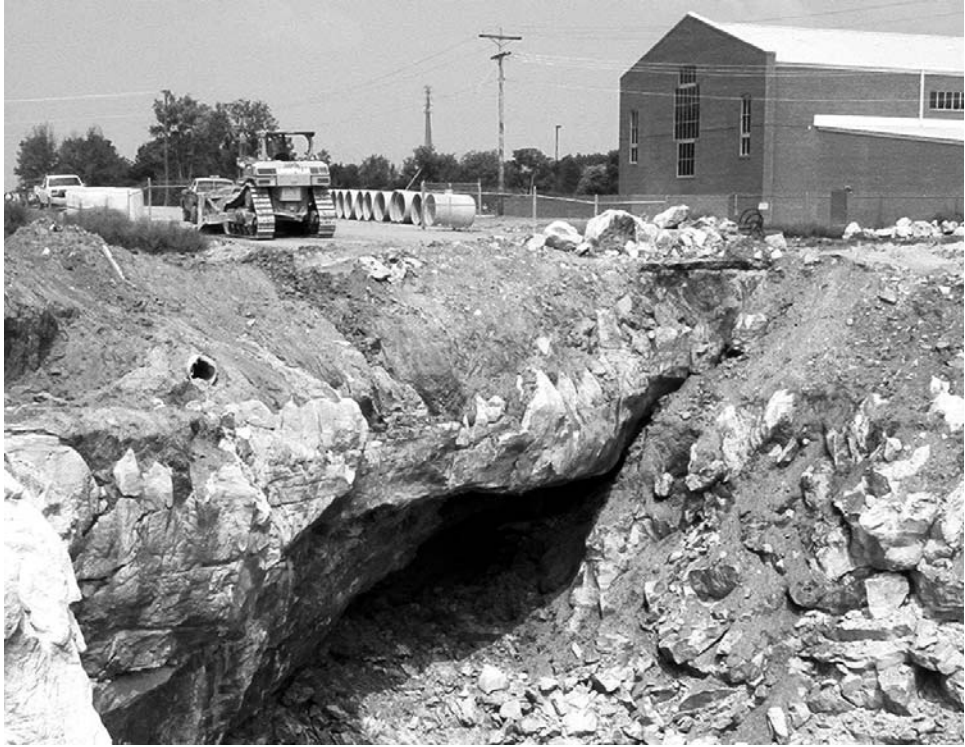
Figure 7.1. Fractured rock around the margin of the new collapse sinkhole that destroyed Dishman Lane in Bowling Green, Kentucky, in 2002.

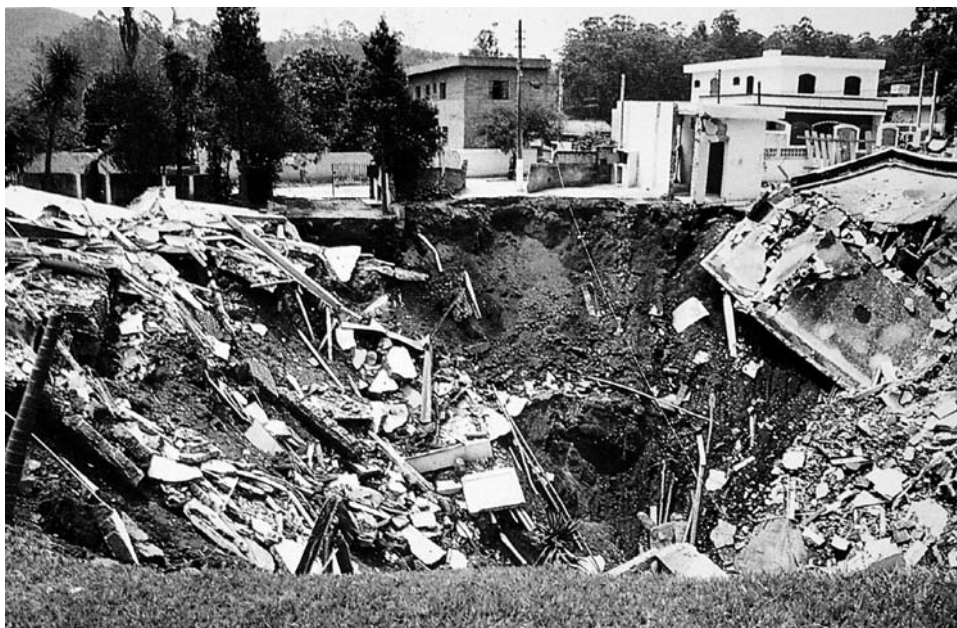
Figure 8.7. Collapse of a house in Cajamar, Brazil, in 1986 over a sinkhole induced in a thick soil cover by excessive groundwater abstraction at a nearby industrial site.

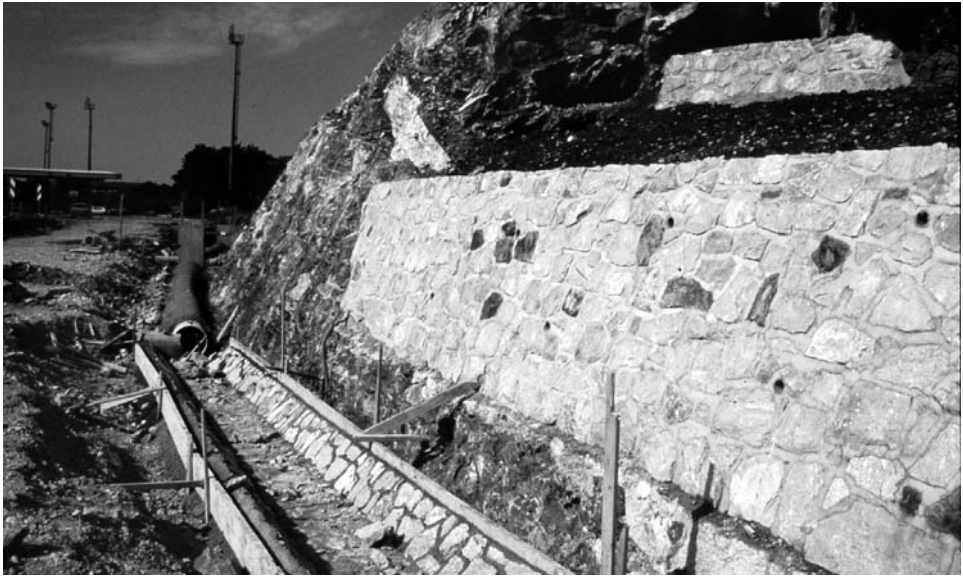
Figure 13.3.5. Construction of an impermeable roadbed through a cutting where a breached cave has been walled off, along a motorway to Italy.

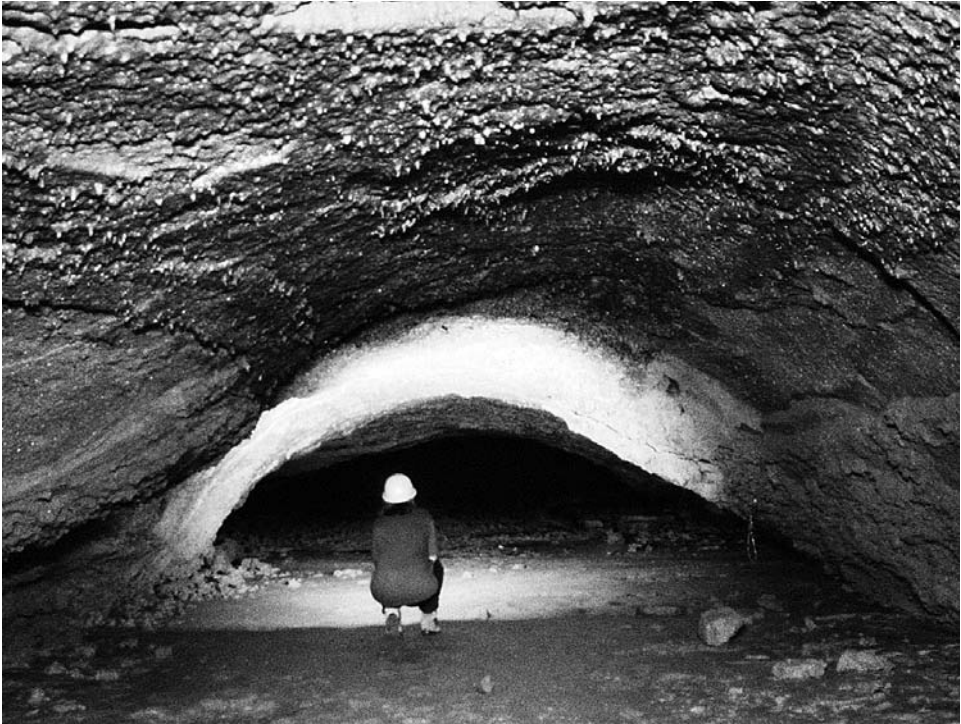
Figure 13.4.4. The stable arch roof in sound basalt where the Sung Gul lava tube lies directly beneath the main road.
TW.
