Airfield Safety and Capacity Improvements

Case Studies on Successful Projects

AIRFIELD SAFETY AND CAPACITY IMPROVEMENTS

CASE STUDIES ON SUCCESSFUL PROJECTS

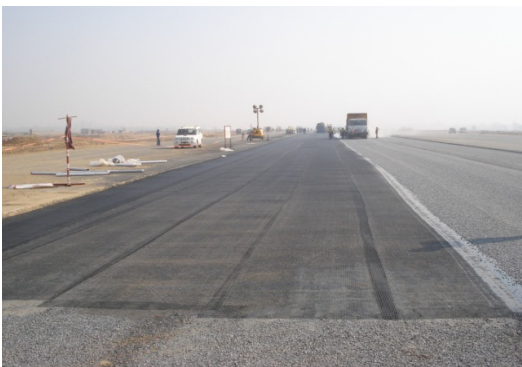
Figure 1-8. Imported glass grid
Source: Delhi International Airport Limited (DIAL); reproduced with permission

Five cement spreaders and four soil stabilizers/ recyclers imported from Germany were mobilized to construct the cement stabilization work. For the subgrade and base layers, eight 18 tonne vibratory soil compactors were used. Six, 27-tonne, 8-wheeled pneumatic tire rollers and more than 20 8-tonne, tandem vibratory rollers with maximum working weight of 10.4 tonnes were used primarily for asphalt works. Three specially designed tractors were used for placing glass grids on the asphalt layer. A custom made aggregate spreader was used for uniform and speedy distribution of aggregates over the glass grids and PMB. A power sweeper was used for cleaning the paved surface and a truck mounted sprayer with temperature control, heating arrangements and pressure control was used to uniformly distribute polymer modified bitumen over the glass grid layer (Figure 1-8) prior to spreading of aggregates.

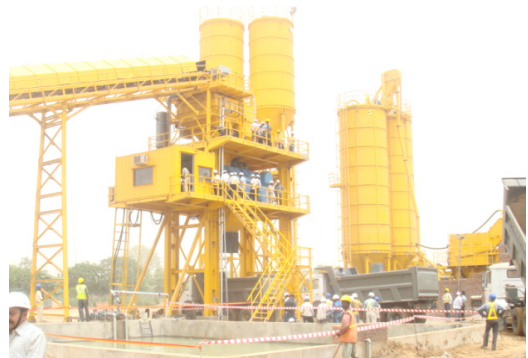
Figure 1-9. Batching plant
Source: Delhi International Airport Limited (DIAL); reproduced with permission

Ten sensor operated pavers were imported from Germany for use in paving operations. Two batching plants of capacity 240 cubic meters/hr each were installed to produce PQC and CTB respectively. Three more batching plants (Figure 1-9) of capacity 110 cubic meters, 20 cubic meters and 30 cubic meters were erected to produce concrete for drainage works and the boundary wall.

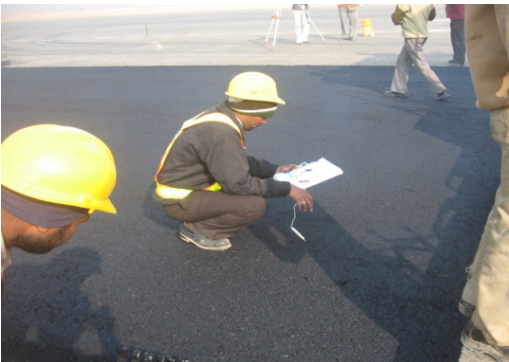
Figure 1-10. Temperature check
Source: Delhi International Airport Limited (DIAL); reproduced with permission

Multilevel quality control and quality assurance checks were performed under a Quality Management System to ensure the required product was delivered. Temperature checks (Figure 1-10) were conducted and density meters were used as an initial compaction check (Figure 1-11) during the placement of the asphalt layer.

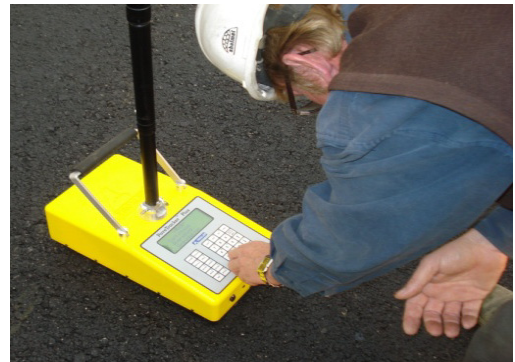
Figure 1-11. Density meter check
Source: Delhi International Airport Limited (DIAL); reproduced with permission

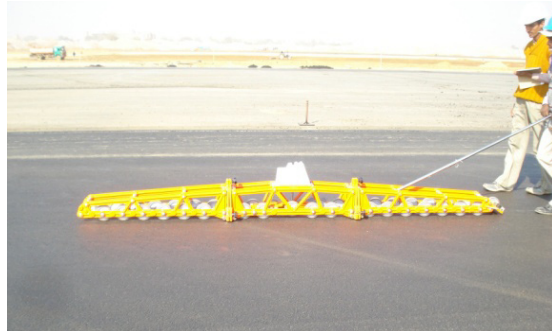
Figure 1-12. Rolling straight edge check

As the work was completed in stages, the rolling straight edge check (Figure 1-12) was conducted to check surface irregularity and confirm surface smoothness.

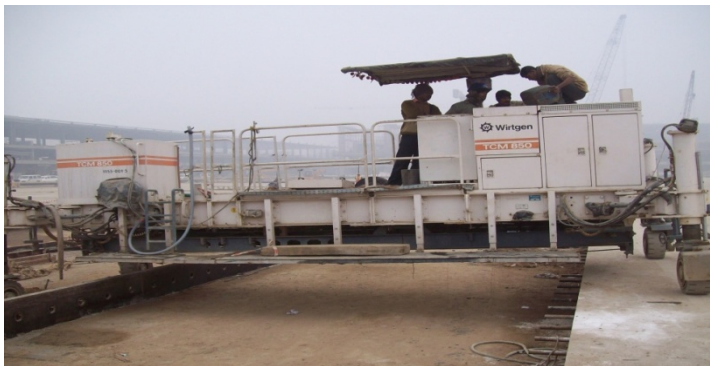
Figure 1-13. Wirtgen slip form paver

Three Slip Form concrete pavers (two of these were of Wirtgen make shown in Figure 1-13) were used to meet the project production requirements. These were used in tandem at different locations on phase 1A airside works.

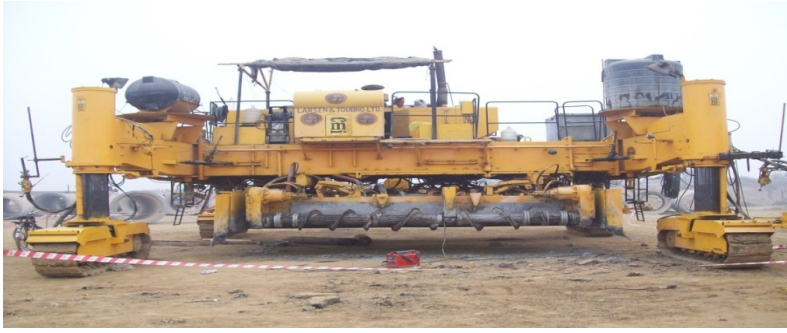
Figure 1-14. Paver for PQC

The third paver (Figure 1-14), which was a bigger arrangement, was preferred for long runs of PQC. More than 1000 running meters of steel formwork was fabricated to support the placement of PQC.

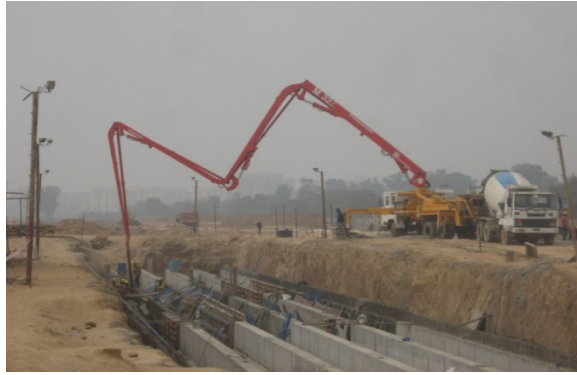
Figure 1-15. Boom placer

Five boom placers/pump trucks (Figure 1-15) with capacity of 105 cubic meters/hr were mobilized to facilitate pouring of concrete. Their use was shared with PTB and Pier works but at least one was in constant use for airside drainage works.

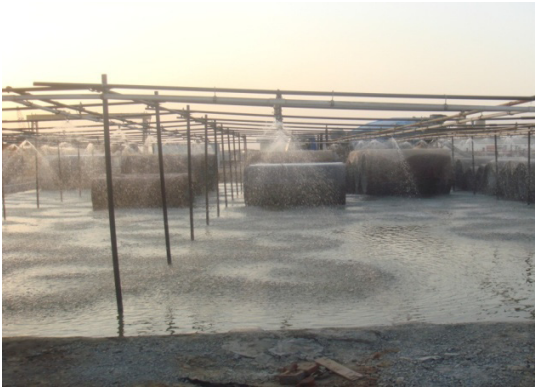
Figure 1-16. Curing of pipes by sprinklers

A concrete pipe manufacturing unit was established on site as the market supply was not sufficient to meet the project demand rate. A vertical casting unit with major parts imported from USA, was erected and its peak production rate was 40 pipes per day. Two horizontal casting units were also erected and their peak production rates reached 15 pipes per day. Curing of these pipes was done using sprinklers (Figure 1-16) and water tanks.

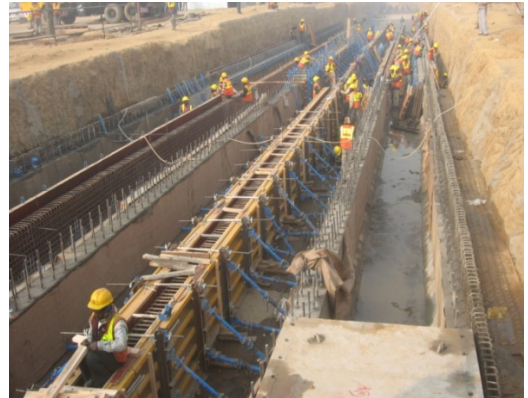
Figure 1-17. Box culvert construction

More than 1080 meters of 2 cell, 3 cell and 5 cell box culverts were constructed. The top covers of box culverts (Figure 1-17) were pre cast to expedite the work.

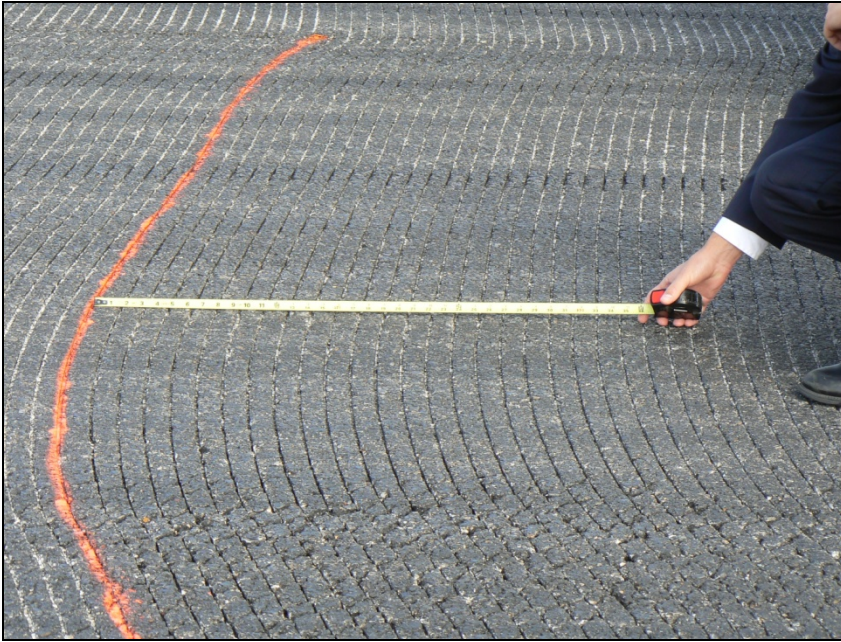
Figure 3-2. Shoving of Wearing Course on Runway 9-27

cause of the evident distress (Figure 3-2 and 3-3) and provide data to develop a cost-effective, site-specific rehabilitation design.

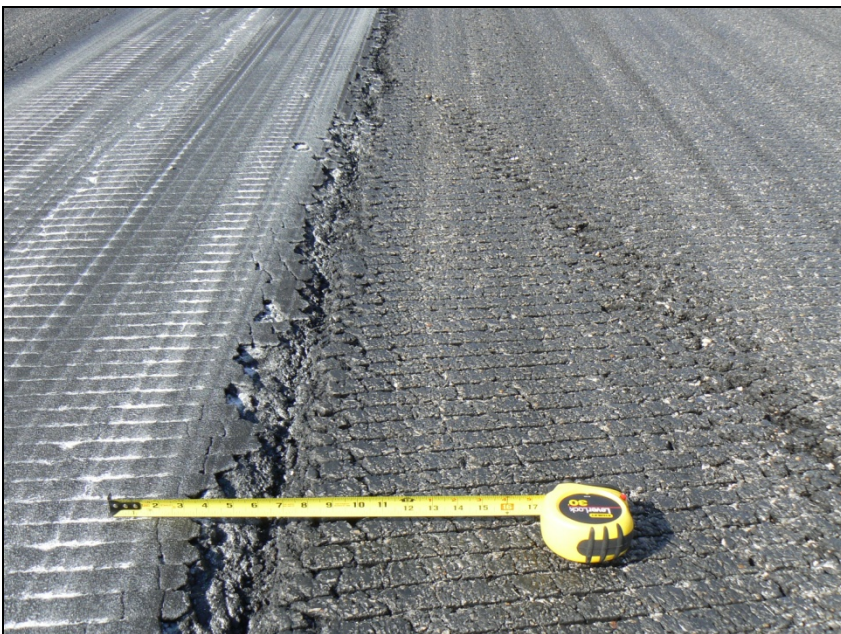
Figure 3-3. Longitudinal Fatigue Cracking of Wearing Course on Runway 9-27

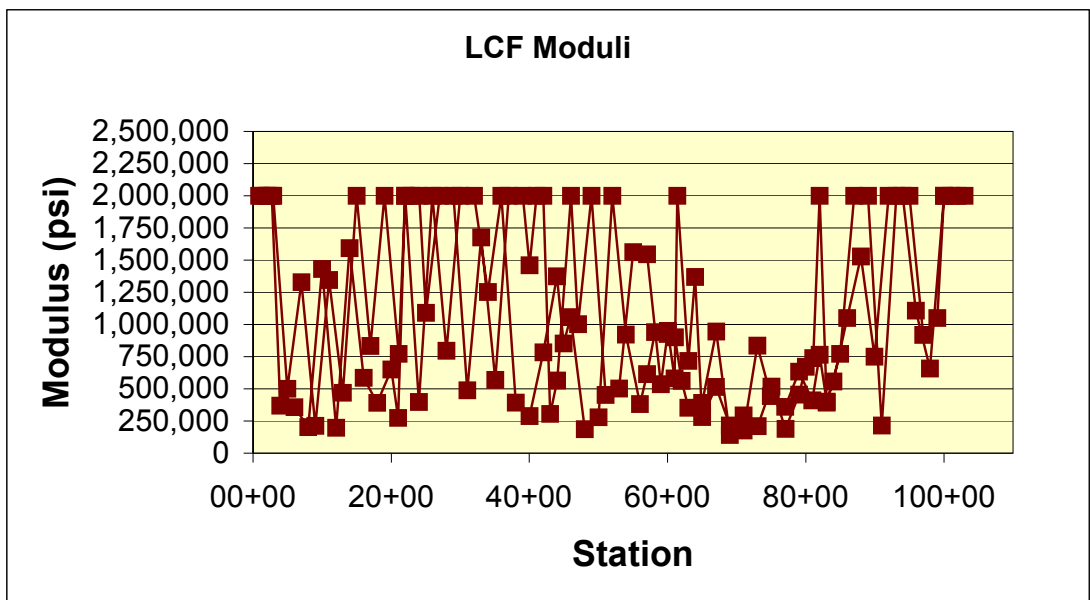
Figure 3-4. Elastic Modulus of Asphaltic Concrete

The deflection data from the heavy weight deflectometer (HWD), along with thicknesses from the geotechnical investigation, were used with the back-calculation software, Deflexus, to determine the modulus of the pavement layers and the subgrade. Figures 3-4 and 3-5 graphically show the back-calculated moduli for the AC and LCF layers. Upper and lower limits were set in Deflexus for the AC, LCF, and subbase layers, which served as maximum and minimum allowable moduli for each layer. The limits are necessary to control the range of the outputs.

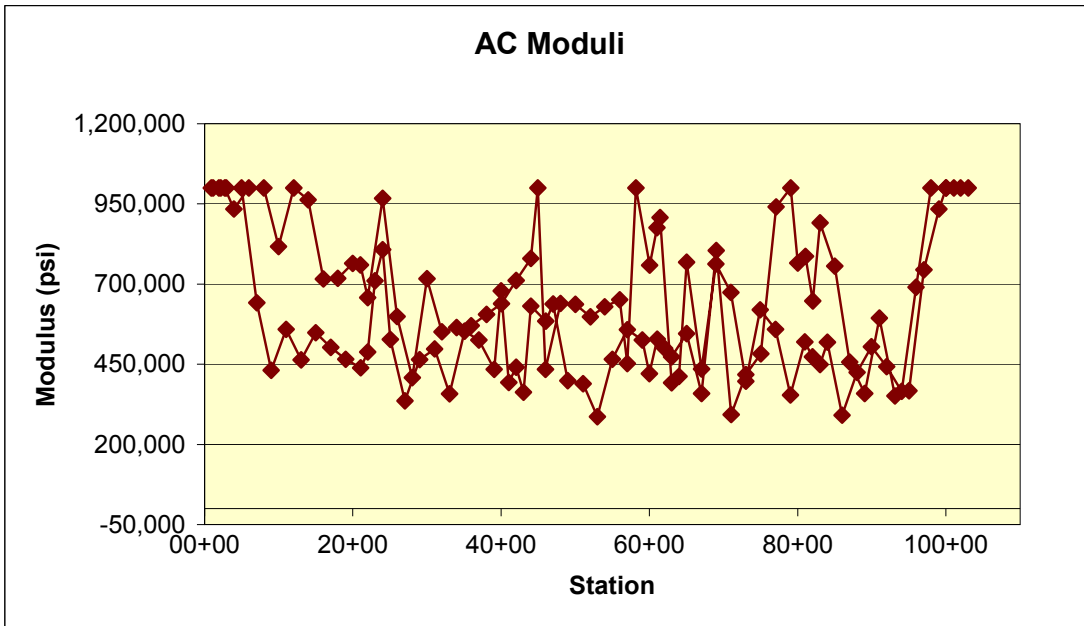
Figure 3-5. LCF for Runway 9/27

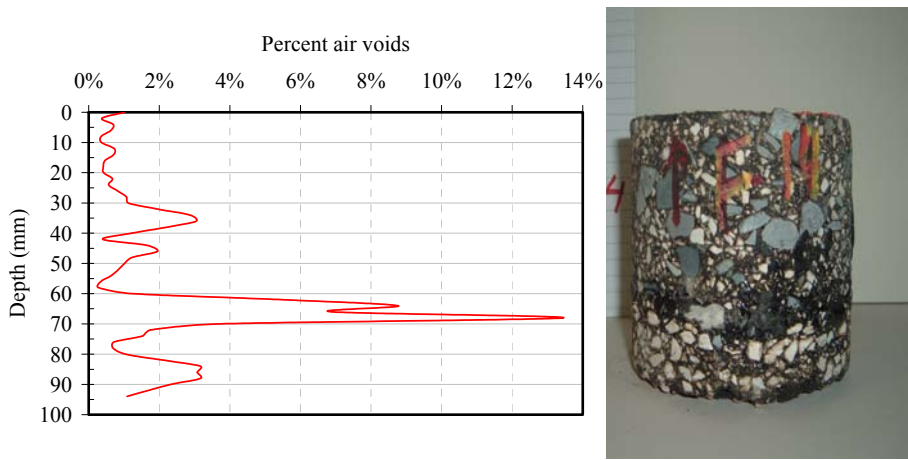
Figure 3-6. Air Void Distribution in Core F14

Results from Core F14, provide an indication of the data developed from this analysis: Core F14 exhibited low air voids except in the location of the SAMI layer (Figure 3-6). The low void content is an indication of mix instability or shoving, which was observed in this location during the site visit. This location has three characteristics that make it different than all other sections. First, the SAMI layer in this core is thicker than in all the other cores. Second, the SAMI layer is at a depth of about three inches from the surface, which is the smallest depth to SAMI among all cores. The third characteristic is that the aggregate source, which is a darker aggregate, appears to be different than the aggregates used in the rest of RW 9-27. Figure 3-7 includes images captured at different depths within the core, and Figure 3-8 shows the three dimensional distribution of air voids in F14. These images show the percent of air voids within the SAMI layer is much higher than in the rest of the core.

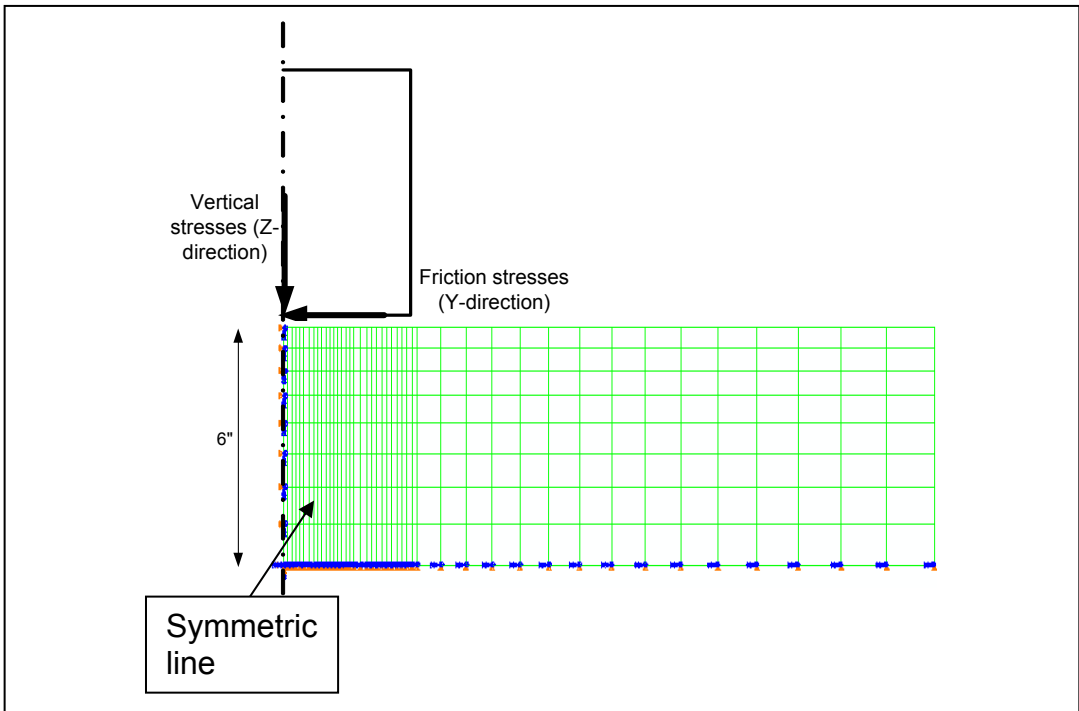
Figure 3-9. Illustration of the Applied Loads in the Finite Element Model

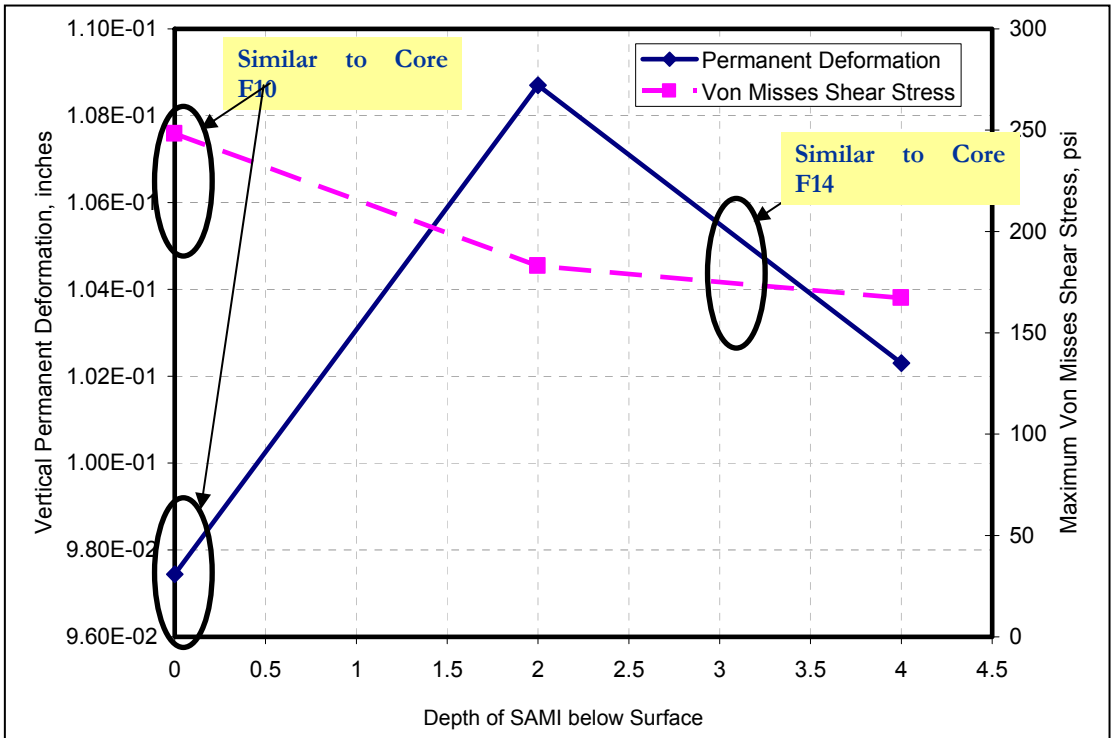
Figure 3-10. Permanent Deformation and Shear Stresses in Asphalt Layer Due to Different SAMI Layer Depth

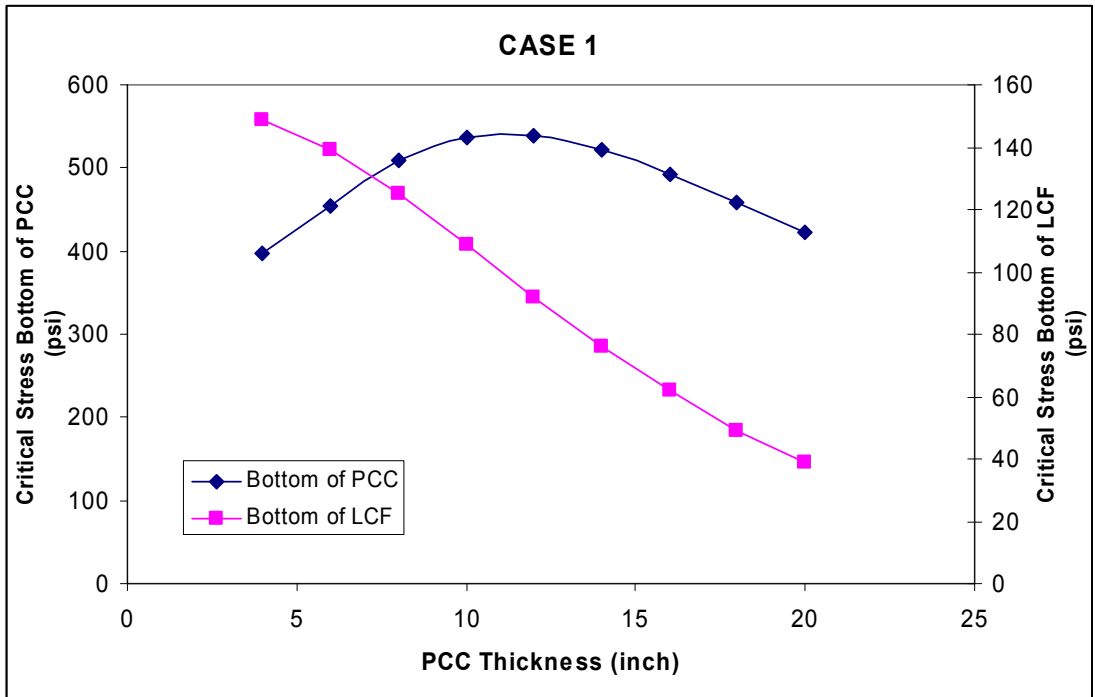
Figure 3-11. Case 1 - HMA as Totski Interface (with Temperature Gradient)

The result of this analysis demonstrates that a PCC thickness between approximately 10 and 15 inches (25.4 to 38 cm) has little impact on critical PCC stresses. However, the thickness of the PCC significantly impacts critical stresses in the LCF, particularly when a Totski interface is not considered (Figure 3-12). Subsequently, the design thickness was developed with two goals in mind: the first to limit the stress in the PCC and the second to minimize the stress in the LCF layer. Based on the results of this analysis detailed in Figures 3-11 and 3-12, it is apparent that the optimum thickness is approximately 14 inches (35.6 cm), which would provide adequate support to protect the PCC as well as the bottom LCF layer. A thickness of 10 inches (25.4 cm) would likely provide the needed support for the PCC layer, but degradation would likely occur in the LCF layer over time.

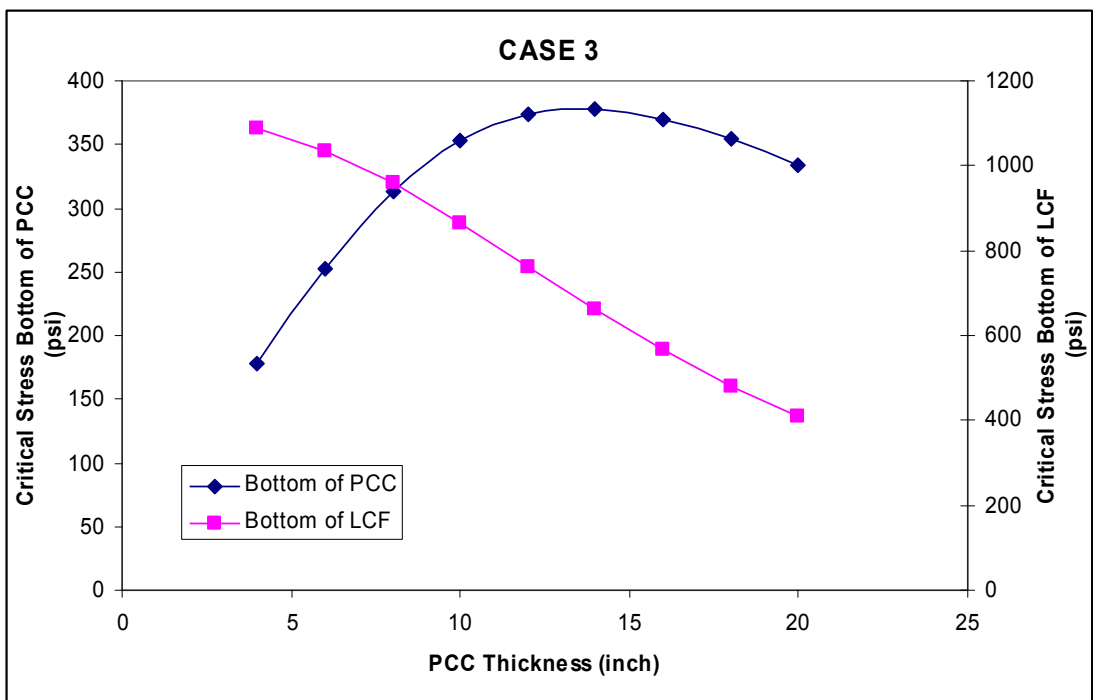
Figure 3-12. Case 3 HMA and LCF as Composite Layer (with no Temperature Gradient)

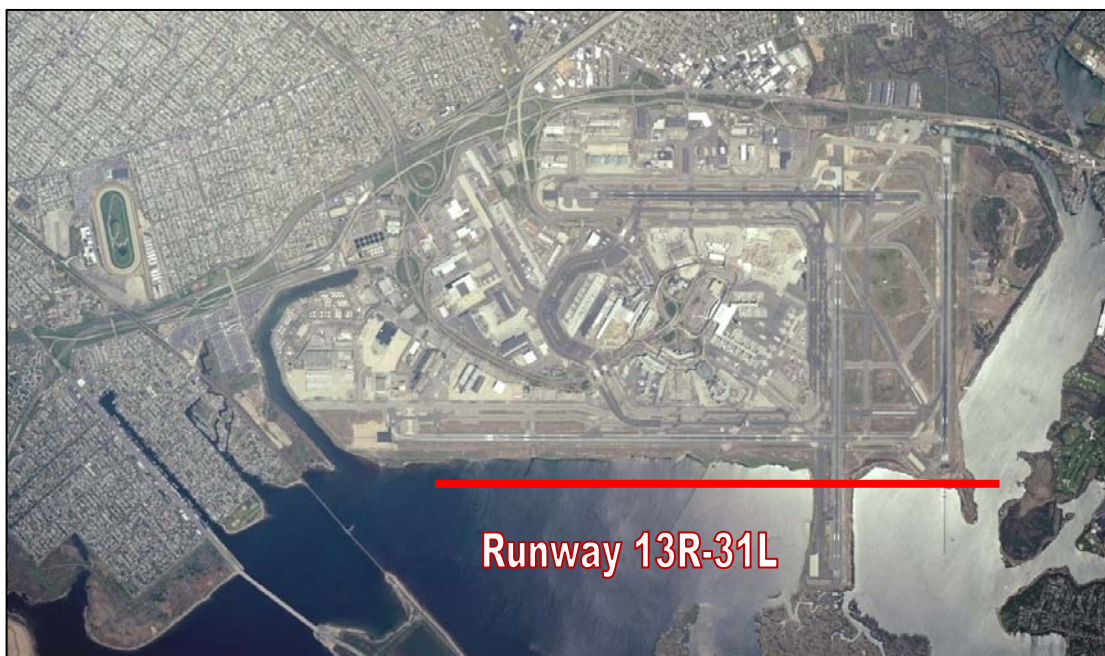
Figure 4-1. Aerial View of JFK Airport with Runway 13R/31L Highlighted

The Runway 13R-31L Reconstruction Project included rebuilding of one of the longest and busiest runways in the United States (US) while minimizing the impact on airfield operations. John F. Kennedy International Airport's (JFK) Runway 13R-31L (see Figure 4-1) is the second longest commercial service runway in the US at 14,572 feet (4,442 meters) and is used by over 120,000 departing aircraft each year.

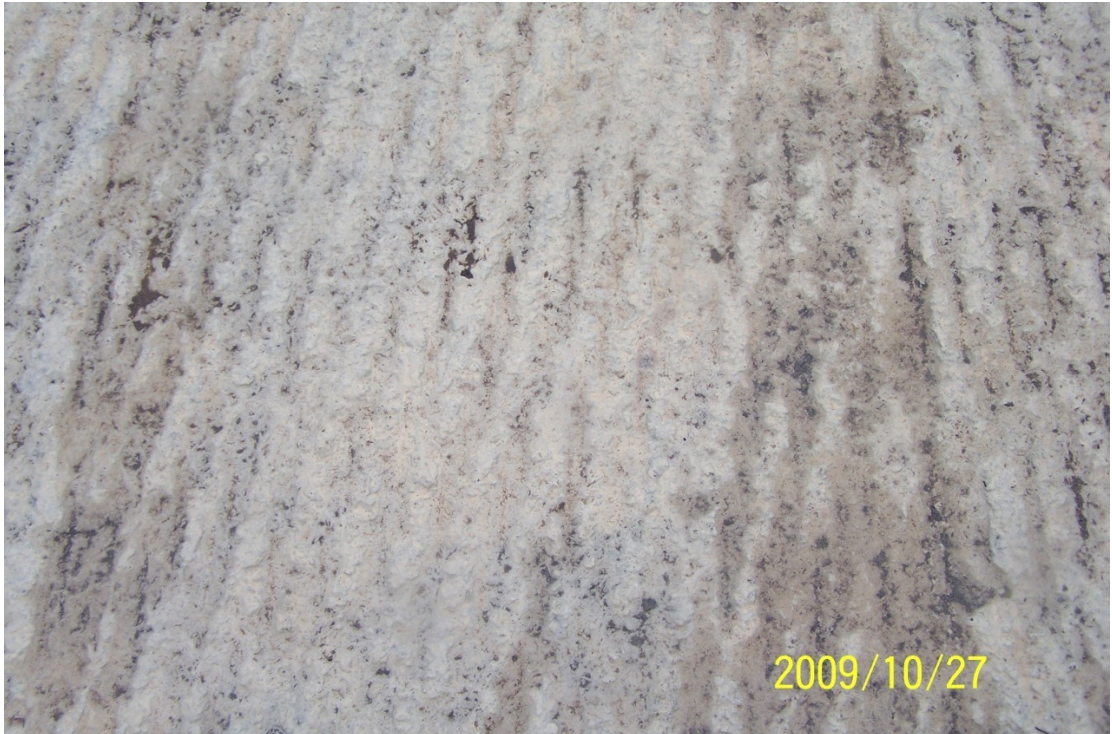
Figure 4-2. Whitewashed Milled Surface

To optimize the surface grades the design called for milling the existing HMA runway surface to 6 inches (15 cm) below existing grade. Since PANYNJ already had good experience placing PCC on asphalt-stabilized base, it was decided that the PCC would be placed directly on the milled surface. The concrete mix requirements limiting drying shrinkage also influenced the decision not to place an asphalt bond breaker on the milled surface. The specifications called for the milled surface to meet a 1/4-inch grade tolerance and a 1/4" (0.6 cm) in 10-foot (3 meter) smoothness tolerance. Whitewashing the milled surface with a liquid membrane-curing compound prior to placing the PCC was specified to eliminate bonding of the PCC pavement to the milled surface and to lower the surface temperature (Figure 4-2)

Whitewash was applied to the milled surface (see Figure 4-2 above) at a rate of one gallon per 200-square feet (3.8 liters per 18.6 square meters) to serve as a bond breaker. Dowels on chairs were installed at the transverse joints. In-pavement lights were installed within cages (Figure 4-3) as recommended by an Innovative Pavement Research Foundation Study.¹

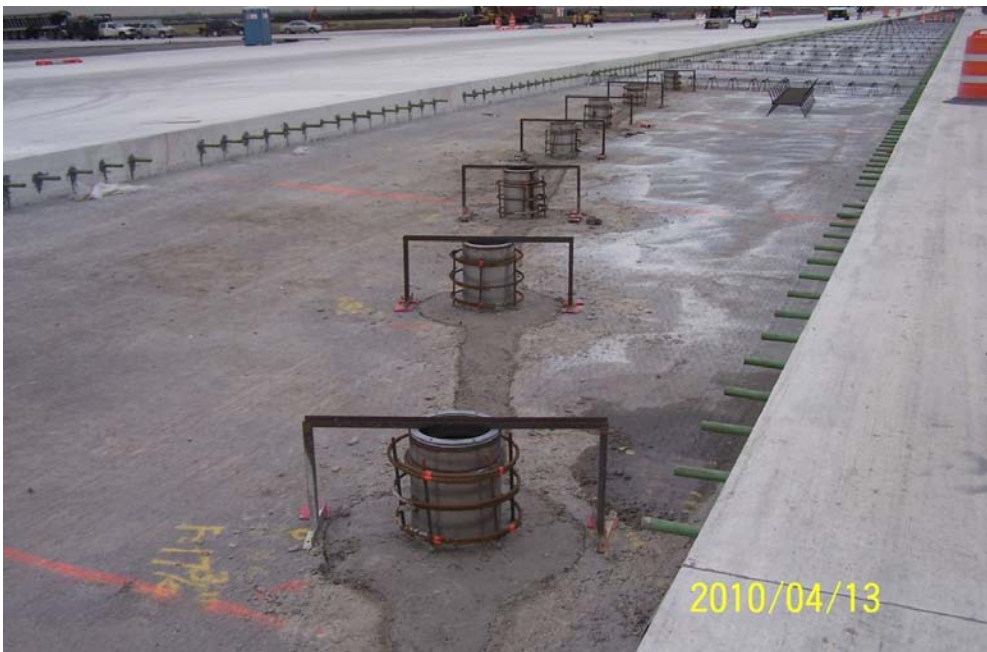
Figure 4-3. Reinforcing Cage around Light Can with Alignment Jig In-place

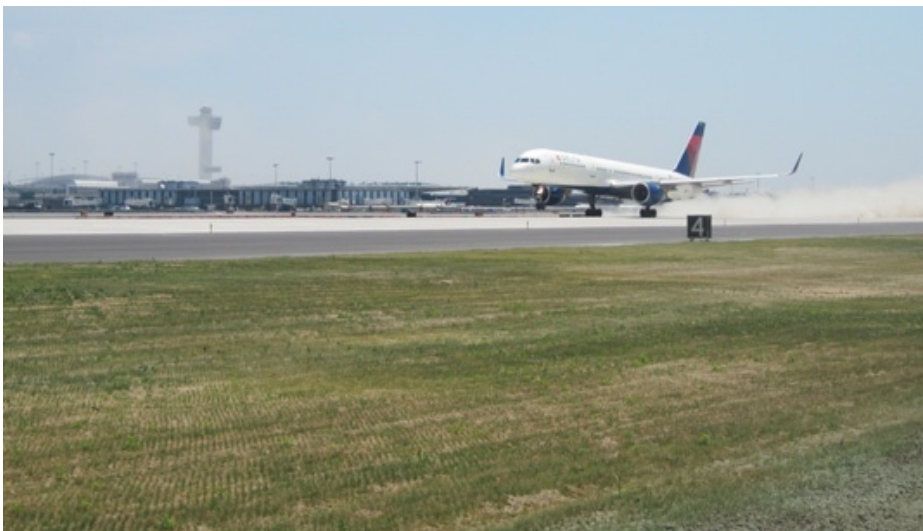
Figure 4-4. Stage I Completed and Runway Reopened

All PCC and HMA acceptance testing was performed by PANYNJ Materials Engineering. The average 28-day flexural strength of the PCC was 1,105 psi (7.6 mPa) with a standard deviation of 92 psi (0.6 mPa). The average permeability was 667 coulombs with a standard deviation of 92. Port Authority surveyors checked final surface grades. Less than 0.4% exceeded the grade tolerance of .04 foot (1.2 cm) prior to grinding. Smoothness acceptance was based on profile measurement using a lightweight profilometer, which was then evaluated using a California Profilograph simulation. The final surface, after limited grinding, had an average profile index of 6.7 inches (17 cm) per mile, using a 0.2-inch (0.5 cm) blanking band. The runway was reopened to air traffic at 11:40 am June 28, 2010, one day ahead of schedule (Figure 4-4) and remained open for the duration of the contract.

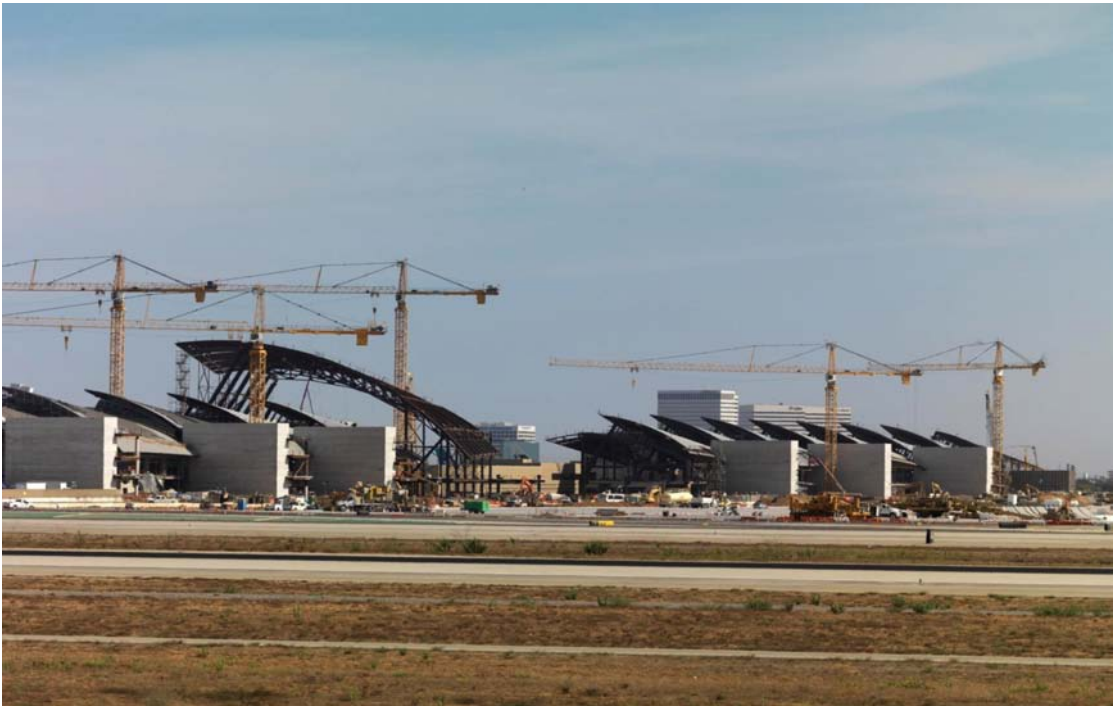
Figure 5-2. Construction of the Tom Bradley International Terminal West

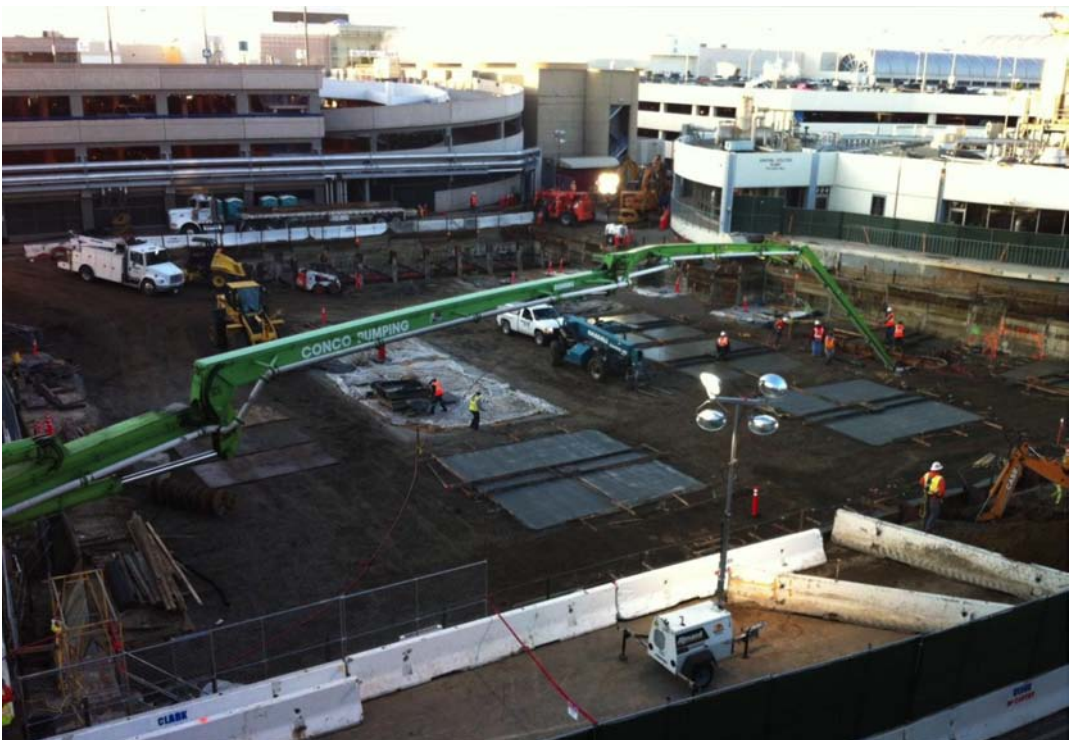
Figure 5-5. Replacement Central Utility Plant Construction

The second major project is a \$438 million effort to replace the 50-year old existing Central Utility Plant (CUP) with a more modern and energy efficient facility (see Figure 5-5 and Figure 5-6). The new facility will provide additional capacity for air conditioning, heating and lighting of the airline terminals and other airport buildings, which will enhance passenger comfort and the reliability of utility service and safety.

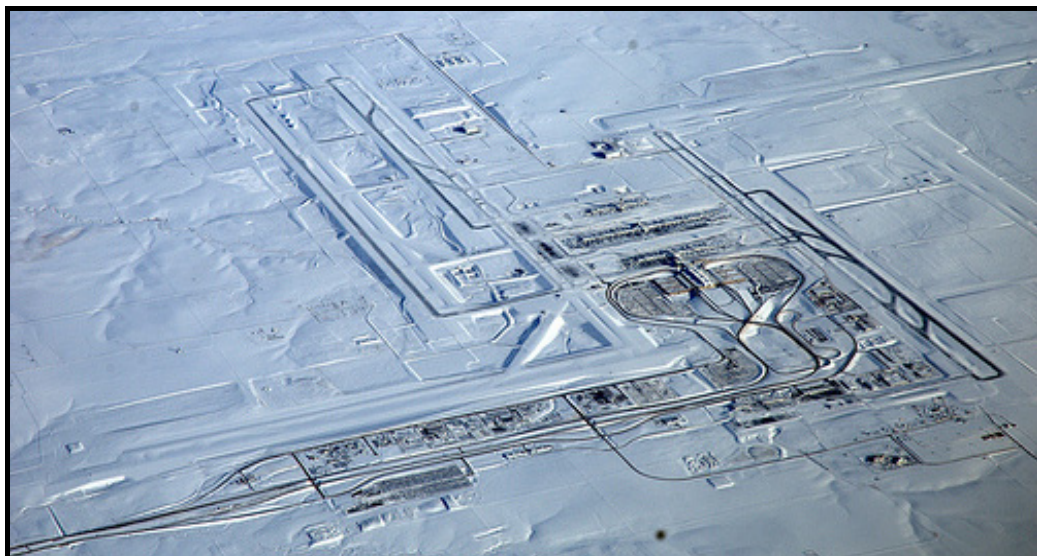
Figure 6-2. Snow Event of 2006: Only Three Runways Open

Airfield construction is planned primarily on safety. In addition to the normal safety considerations of occupational construction safety, the safety of aircraft and passengers are paramount. The real challenge, of course, is balancing all three of these interrelated values during the planning and design phases of each project. At DEN, the Planning and Development Division performs no less than four major airfield projects each construction season; so the balancing act is further complicated by the impacts of adjacent projects. Generally, construction work is performed from April to October due to the debilitating effect of snow events. Snow removal operations at DEN involve the orchestration of over 100 pieces of equipment and the added risk of avoiding ongoing airfield construction is highly undesirable. Figure 6-2 is an aerial view of the DEN airport during the remarkable snow storm of 2006, which serves as stark example of the massive snow removal requirements when such adverse weather strikes at the airport.
