Heritage Masonry

Materials and
Structures

EDITOR:
S. Syngellakis

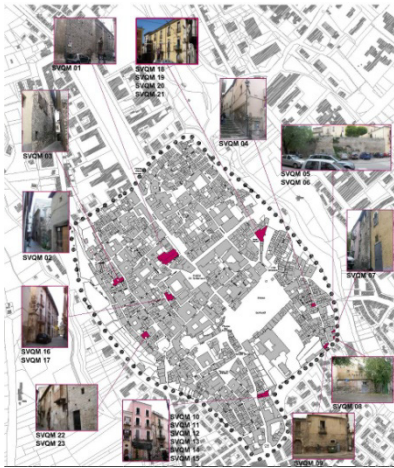
Figure 3: Recognition of building facades without plaster for masonry qualification.

Subsequently, a template aimed at “Masonry quality evaluation” was adopted and applied to selected buildings characterized by facades with no plaster finishes, therefore having their stonework masonry texture available to visual inspection (figs. 3 and 4). The prediction of the seismic vulnerability of stonework masonry, and particularly of the multiple wythe one, can only be performed provided the intrinsic characteristics of the masonry have been accurately detected. The behavior of masonry highly depends on the construction technique and this is evident from the section layout. In fact, the outer face frequently does not reveal how the masonry section is built since apparently similar facing textures (e.g. regular bonding) may correspond to different types of sections, as one or multiple wythes [7]. A systematic study of the mechanical behaviour of stonework masonry begins from an extensive investigation taking into account the different layers constituting the wall and the kind of constraints which may or may not exist between the layers themselves. From the analysis of this information, constitutive laws for modeling the masonry behavior and for designing possible repair interventions (e.g. injection of grout) can be selected. Input data for the structural analysis with numerical methods are the section survey and the type of connection between the layers. These features can also be taken into account when modeling the in-plane or out of plane failure mechanisms.

Significant building complexes were identified (painted red in fig. 3 and blue in fig. 4) and subjected to a systematic investigation which included the following phases: (i) geometrical survey of the building and of its crack pattern, (ii) interpretation of the crack pattern and definition of the damage or collapse mechanisms affecting each building, (iii) detection of the connections between walls and between roofs and vaults to walls, (iv) non destructive evaluation of damage, (v) survey of the masonry texture and of the morphology of the wall sections, (vi) on-site characterisation of the masonry walls through sonic and flat-jack tests, (vii) sampling and laboratory characterisation of mortars, plasters and stones through chemical, physical and mechanical tests.

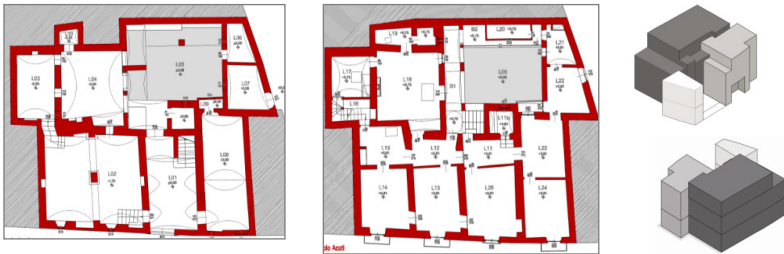
Figure 7: Ground floor of block 69. Figure 8: First floor of block 69. Figure 9: Macro-elements.

Complexes of historical buildings have generally been subjected to the addition of several volumes in different times, and the possible discontinuities between the different volumes could affect the overall seismic behaviour. In fig. 6, block 69 in Acuti street is shown as an example. Its volume was apparently rather simple when looked from the outside, whereas required to be subdivided into three macro-elements once surveyed in more detail (figs. 7–9). For a reliable interpretation of signs of damage, the preliminary in-situ survey, useful to obtain details of the geometry of the structures, identifying irregularities such as vertical deviations and rotations, needed complementary indication coming from the investigation of the historical evolution of the structure in its complexity (fig. 10).

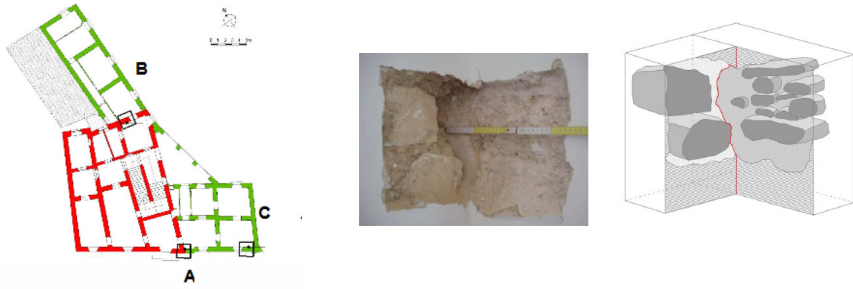
Figure 13: Sardi Palace in Palizze street:
 ■ original parts;
 ■ parts added in 19th century.

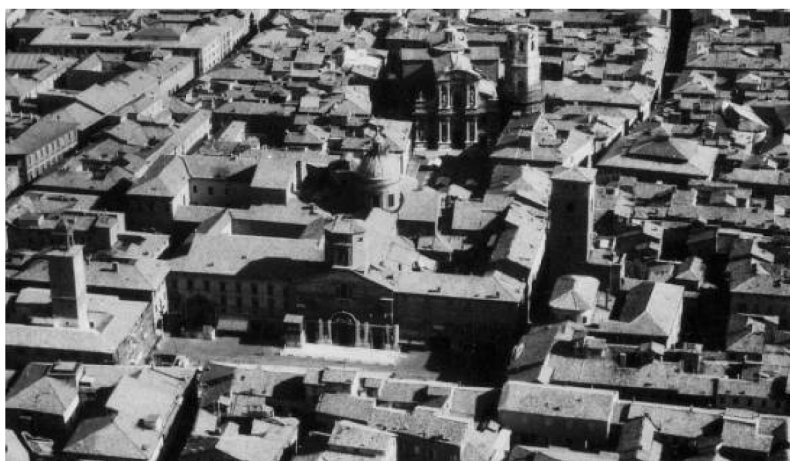
Figure 1: Santa Maria Assunta cathedral in the city centre of Reggio Emilia.

The cathedral presents an original Latin cross plan, with central nave, two aisles and transept. The length of the church is 77.40 m, the width is 33.80 m, the span of nave and aisles is 10.15 m and 6.50 m, respectively. The maximum height of 44.60 m is reached at the top of the dome; the height of the façade dome lantern is 33.80 m and the height of the roof above the central nave corresponds to 22.25 m. The cathedral is mainly composed by clay brickwork masonry. The diverse construction phases brought about the use of different materials, and some structural elements or parts (e.g. Romanesque pillars, lower façade veneers) are made of stone (fig. 1).

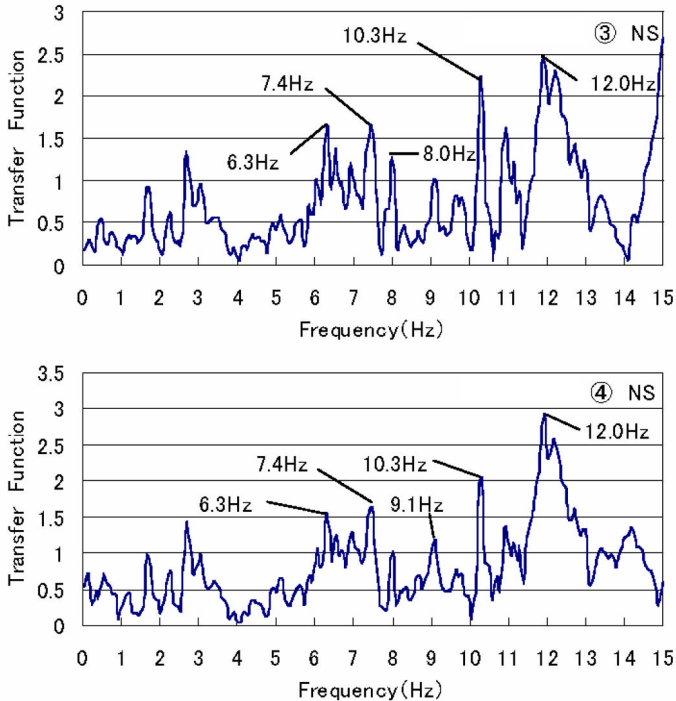
Figure 4: Transfer function results for NS direction.

transfer function at each measured point of the structure was divided by the one at the first floor level, to obtain only the vibration characteristics of the upper structure. According to these transfer function results, multiple peaks can be observed in such a way that it is not possible to obtain only one characteristic frequency. Therefore, the mode of vibration is not a simple horizontal normal mode. Instead, the modes of vibration are complex. These complex modes of vibration can be explained by the concentration of the mass of the structure in the walls instead of in the slab.

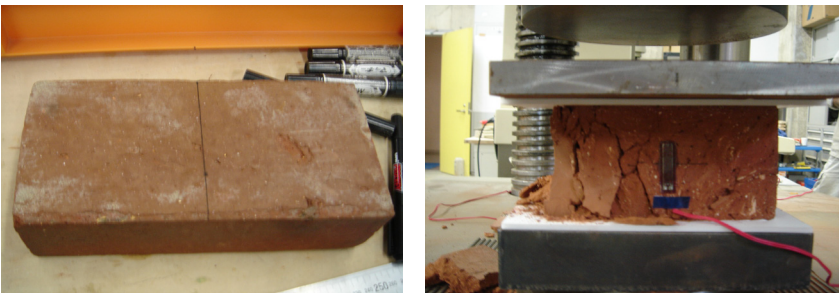
Figure 5: Brick units employed to obtain the physical and mechanical properties.

Brick units selected from those that were stocked near the building were used to determine the physical and mechanical properties of the bricks. From the stock, it was difficult to distinguish between those units used in the old construction and those used for the repair works. Independently of this distinction, units showing good condition were selected for the laboratory tests. These units can be seen in fig. 5.

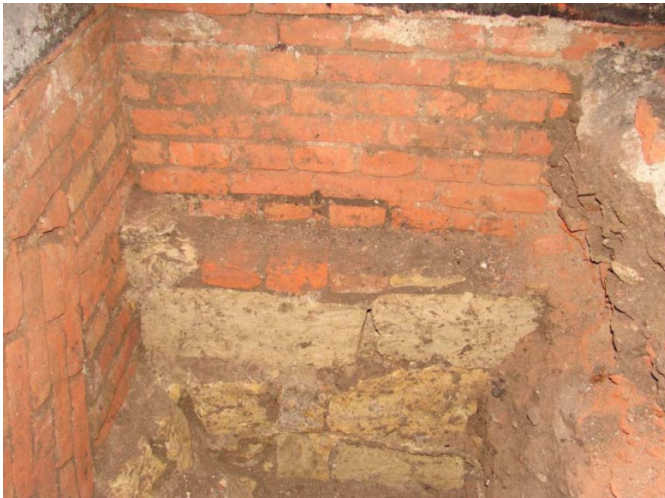
Figure 2: Masonry of a wall and foundations.

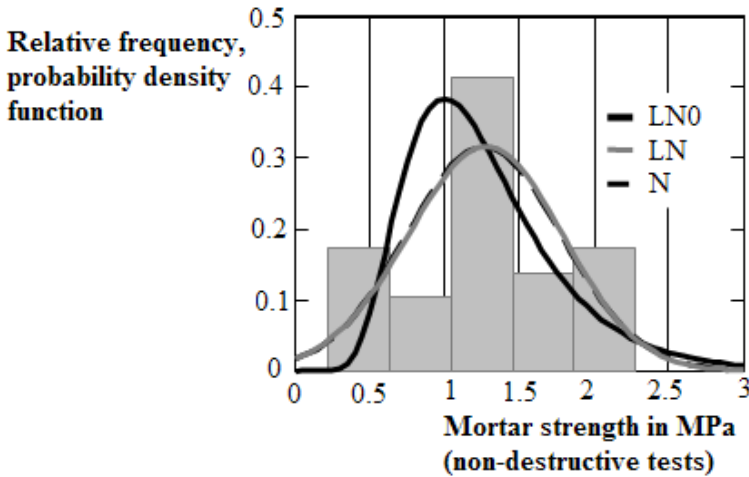
Figure 5: Histogram of the mortar strength obtained by the non-destructive tests and the considered theoretical models.

This method is used in the assessment. The histogram from 29 measurements is indicated in fig. 5. Point estimates of the sample characteristics given in table 1 are estimated using the method of moments. The sample coefficient of variation of mortar strength is considerably greater than that of the strength of masonry units. The sample distribution seems to be nearly symmetric as the skewness is around zero. This indicates that a normal distribution might be a suitable model. However, the normal distribution is not recommended for the description of the variables with the coefficient of variation exceeding, say, 0.20 as negative values can be predicted. Due to the zero skewness, a three-parameter lognormal distribution yields a similar model as the normal distribution. Therefore, the lognormal distribution LN0 is assumed hereafter for the mortar strength estimated by the non-destructive tests. Probability density functions of the theoretical models are shown in fig. 5.

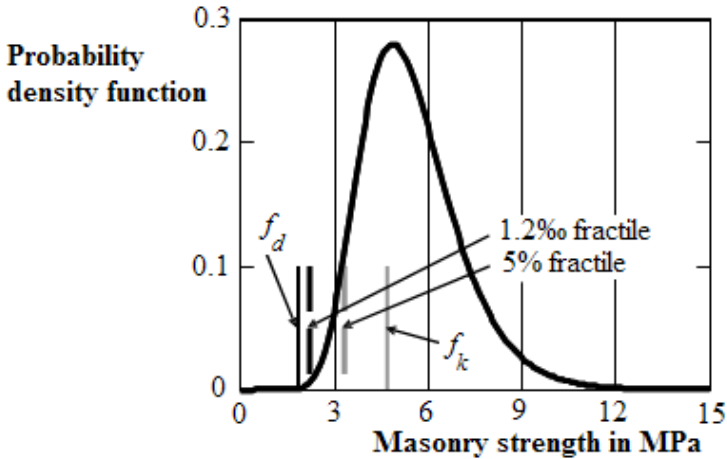
Figure 6: Probability density function of the masonry strength and the characteristic and design values.

The 1.2‰ fractile of the probability distribution is 2.3 MPa. Remarkably, the theoretical design value is by about 20% greater than the design value estimated by eqn (4). It follows that the assumed partial factor 2.5 may be rather conservative since, from the probability distribution, the partial factor 1.4 is estimated.

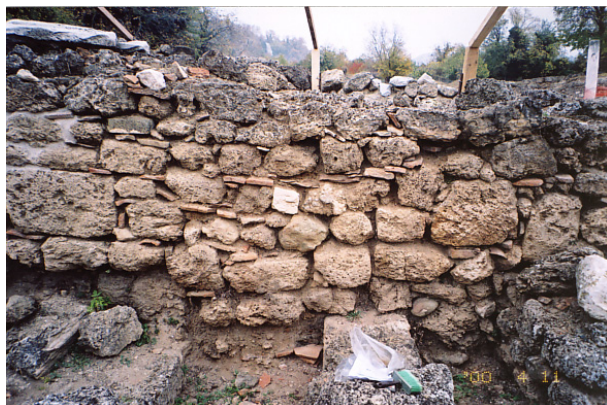
Figure 1: Absence of joints due to mortars' loosening.

- Absence of joints due to mortars' loosening (fig. 1);
- Intense cracking in bricks and stones due to intense temperatures alterations and frost action (fig. 2);
- Biological growth;
- Color alteration of stones due to black crust deposition.

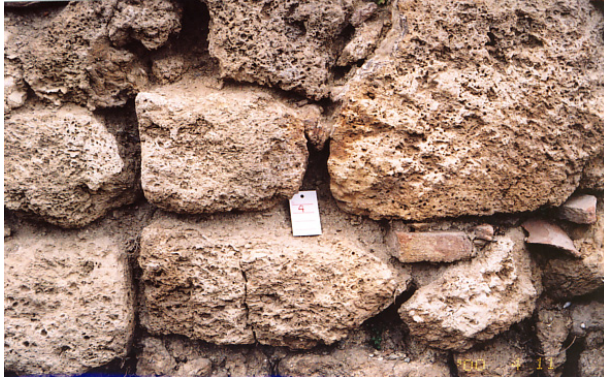
Figure 2: Cracks in stones.

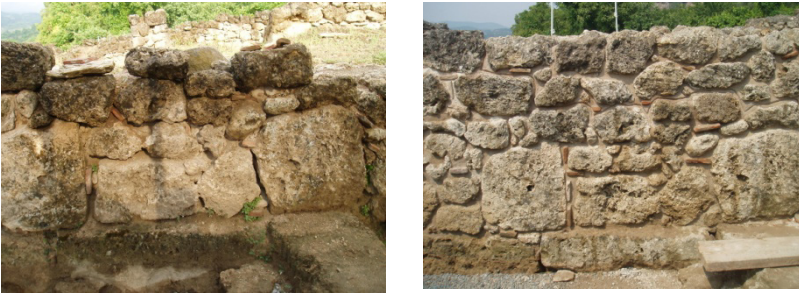
Figure 3: Historic masonry before (left) and after (right) restoration.

For the in situ application, technical guidelines were given concerning the mixture of raw materials, the water demand, as well as the curing conditions of fresh mortars. The restored walls were kept wet for seven days in order to avoid rapid drying which could cause early cracking. The proposed mortars were successfully applied and monitored before and after application (fig. 3).

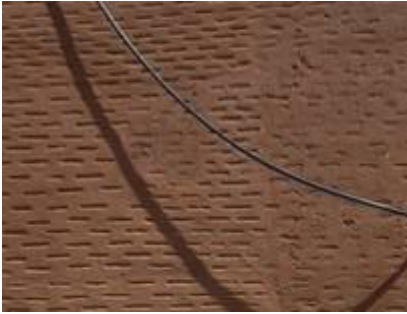
Figure 3: Image of the wall.

The first approaches with the IR thermocamera gave interesting results for the detection of building material discontinuity under the façade coatings. This device was able to capture images of the building walls, producing thermal images showing lintel elements as in figs. 1 and 2, also previous repairs and signs of demolished walls on the existing ones, as in figs. 3 and 4. A previous window that had been walled up was also identified, as in figs. 4–6.

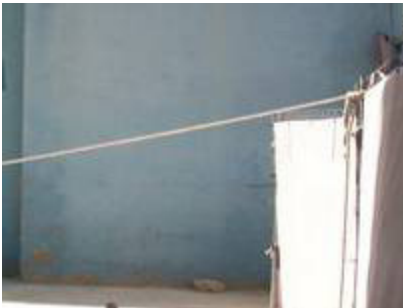
Figure 5: Image of a wall.

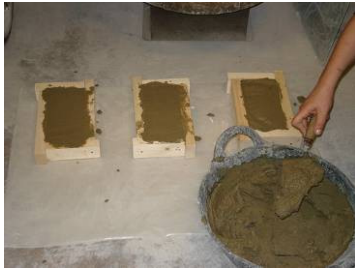
Figure 12: Cement mortar samples.

Samples 1, 4, 7 and 10 were prepared with cement mortar, those numbered 2, 5, 8 and 11 were prepared with lime mortar, and finally, samples 3, 6, 9 and 12 were prepared with gypsum mortar, always varying the thickness: 1, 2 and 3 cm. Samples 10, 11 and 12 did not contain iron plates and have a 3 cm thick coating. IRT images were captured at different times: 15:30, 16:30 and 17:30. The obtained results were very revealing.

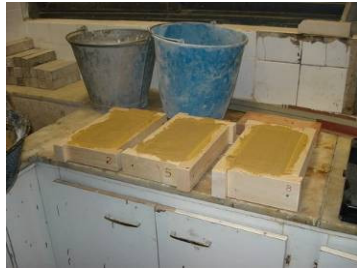
Figure 13: Lime mortar samples.

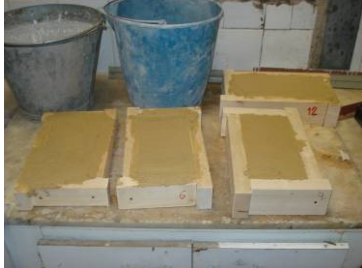
Figure 15: Gypsum mortar samples.

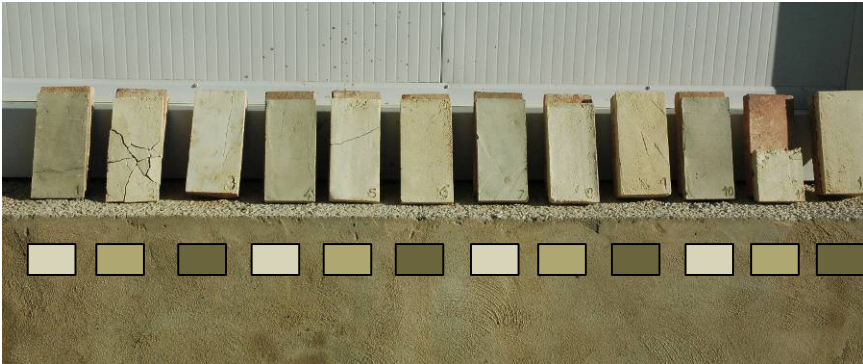
Figure 16: General view of the mortar samples.

The mortars prepared as samples were: cement mortar, 1:3; lime mortar, 1:3; gypsum mortar, 1:2, with increasing thickness as shown in table 1. Iron plates were introduced beneath the mortar coatings in nine of the mortar samples (1 to 9), with the aim of detecting their presence thermographically. The preparation of the samples can be seen in figs. 10–15. The samples exposure to sun radiation is shown in fig. 16 and the corresponding IRT images at 16:30 hours are shown in figs. 17 and 18.

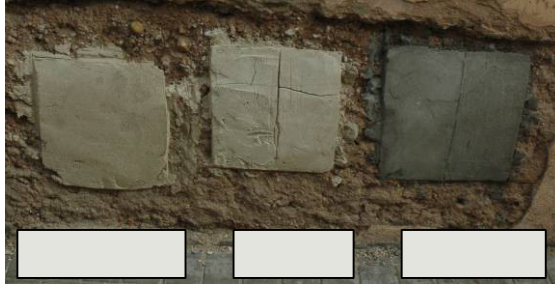
Figure 20: Mortar samples at the south façade.

As the wall coatings had deteriorated, it was possible to prepare “in situ” samples, $30 \times 30 \text{ cm}^2$, 1 cm thick, using the same proportions as of those prepared in the laboratory. A small coin was introduced at the centre of each sample, in order to detect them with the IRT images.

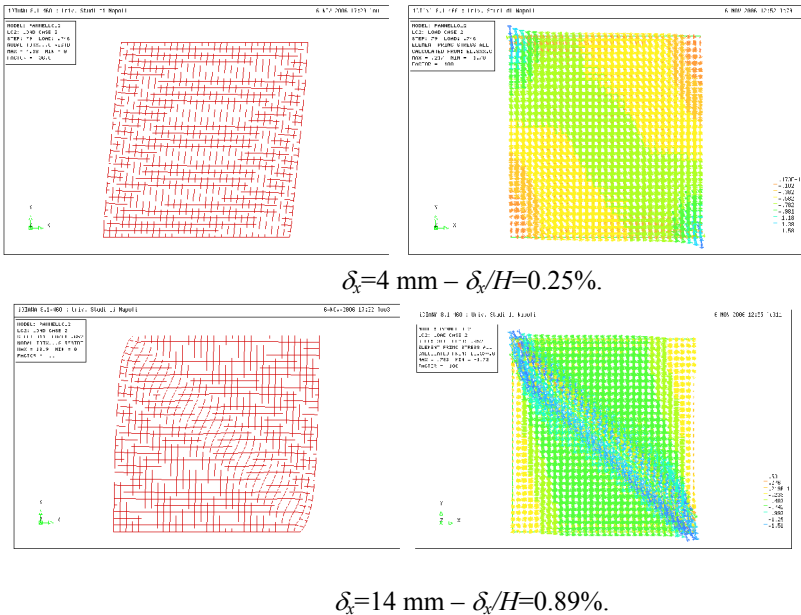
Figure 2: Deformed mesh and principal directions of stresses at different drifts δ_x/H .

An overall good agreement is found even in the post-peak phase. The numerical response of the wall is depicted in fig. 2, in terms of deformed meshes and principal stresses at displacements of 4 and 14 mm, corresponding to 0.25% and 0.89% drift δ_x/H ratios, respectively. During the entire loading process, cracks in the panels developed in a large band that goes through the top-left and the bottom right corner. This again agrees with the general trend of experimental results. It was observed that a large reserve of strength was shown and a concentration of the minimum principal stresses in the shear band, that lead to local crushing of the corners. Therefore, the failure mechanisms observed in the experiments are well captured by the model.

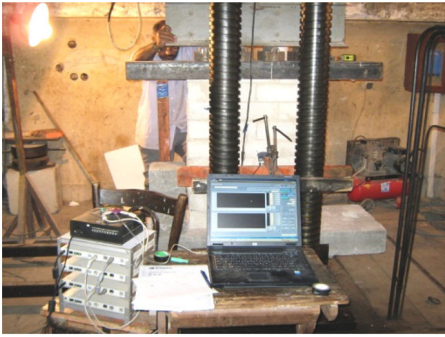
All specimens were built on a reinforced concrete base beam to facilitate movement and placement of the specimens on the test frame after 28 days from construction. To ensure even distribution of compression loads on the top of wall models, a system of steel beams were used to distribute the point load of the actuator evenly on the wall (figs. 2 and 3). The capacity of the test frame is 5000 kN connected to a load cell of the same capacity. The instrumentation attached to the specimens also included LVDT to measure the vertical displacement of the wall; LVDT to measure the out of plane movement of the wall during testing, and strain gauges attached to the face of the stone blocks to measure vertical and horizontal strain (fig. 4). All specimens were loaded by

Figure 2: Experimental set-up.

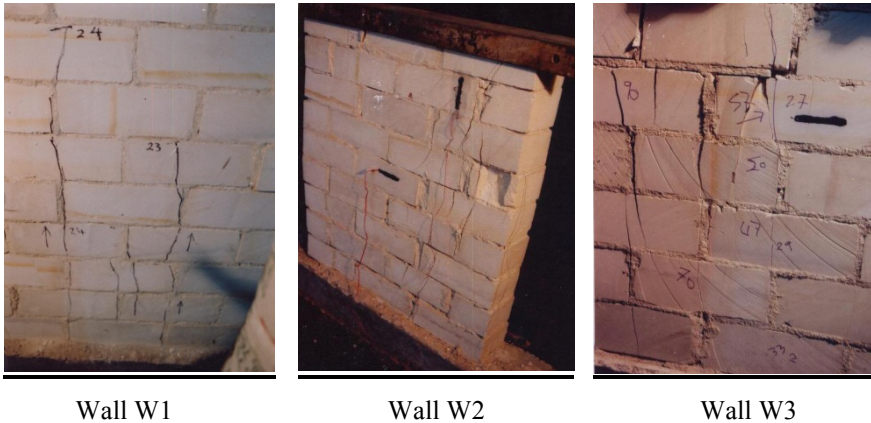
Figure 5: Crack pattern at failure of single leaf wall structure.

The wall specimens were continuously loaded up to failure, and the data was recorded using a data acquisition system connected to a personal computer. In all tested specimens of single leaf wall models W1 to W6, it was observed that the initial cracking started from a stone above the vertical joint and extended up to the top of the wall as shown in fig. 5. The average stress on the wall section was calculated by dividing the applied load by the gross cross sectional area of the wall. Figs. 6–11 show the variation of average stress with the average strain up to failure for single leaf wall models. The values of failure loads and the corresponding stresses for all walls are summarized in table 2.

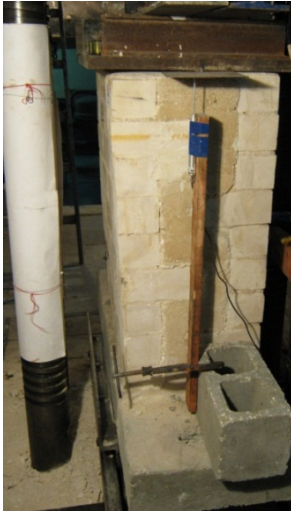
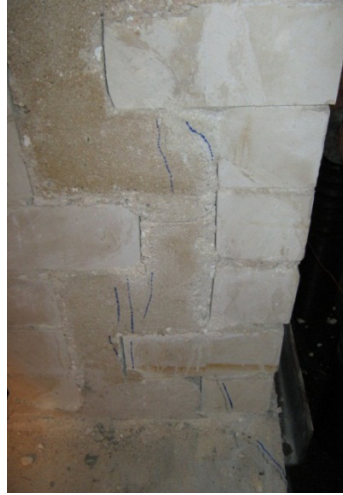
W12 during testing

Crack initiation in W12

Figure 15: Stress-strain relationship of specimen W7 to failure.

Wall W12 is a cavity wall (450 mm thickness) build with lime stone blocks 120 mm thick on the outer faces with 15 mm thick mortar joints. The wall faces are bonded together with 210 mm thick strong mortar with limestone rubble as infill between the wall faces. The specimen was continuously loaded up to failure load at 600 kN. The cracking started from the two side faces of the wall, and propagated upward. The mode of failure was mainly due to separation of the two faces of the cavity wall as shown in fig. 15. Cracks propagated around the

stones instead of through stone blocks due to the weakness of the thick mortar infill compared to the stone blocks.

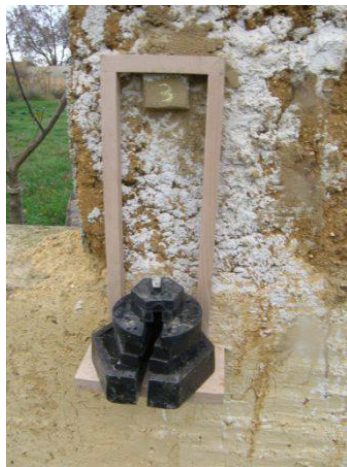
Figure 1: Load device.

also used in the shrinkage test. They were cut in order to get 4 samples of 50 mm × 40 mm and 20 mm thick. Thus, 6 samples were obtained per formulation: 2 “shaped” and 4 “cut”. Samples were loaded up to failure with a load device (fig. 1), by increments of 0.5 kg every 60 s for T17.5, T12, T9 and T6 samples (table 1 and 2) and then, for reasons of precision, loaded by increments of 0.25 kg every 30 s for the other samples.

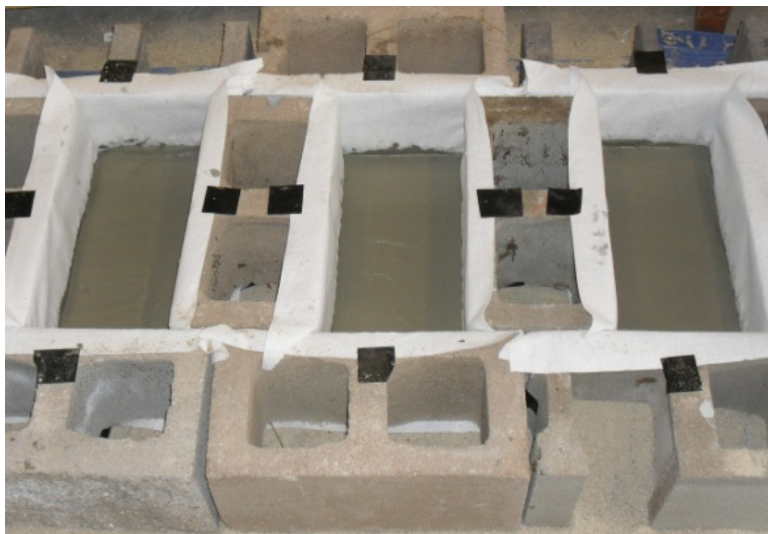
Figure 1: CIF specimens cast for water repellency testing.

Water repellency properties were evaluated using adaptations of National Concrete Masonry Association (NCMA) tests for characteristics of concrete masonry units (CMU) with IWR. Water absorption was measured in accordance with variations of NCMA Methods CMU-WR1, *Standard Test Method for Water Droplet and Water Stream Tests of Concrete Masonry Units* [11] and CMU-WR3, *Standard Test Method for Assessing Water Uptake Potential of Concrete Masonry Units* [12] were used. Since these tests are intended to be performed on portions of CMU face shells, CIF specimens were cast with dimensions similar to a CMU face shell, as seen in fig. 1, for this purpose. Three samples were made using the base mix and three using each IWR mix, and all tests were performed after a minimum cure time of 28 days. In the water droplet test, multiple drops of water were placed on the hardened CIF surface and the ability of the material to resist the absorption of water was evaluated over time based on visual observation. In the water uptake test, the oven-dried specimen is placed in 0.1 inch (3 mm) of water and the water absorption is evaluated by measuring the change in weight of the specimen for the next 24 hours.

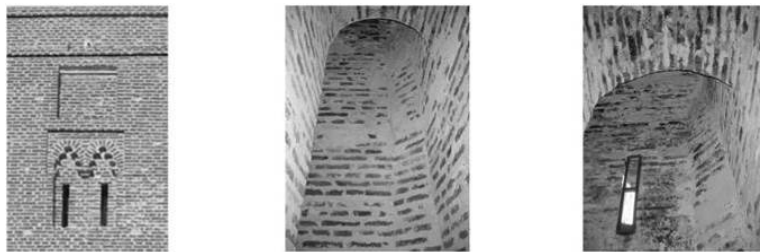
Figure 2: Aspects of the irregular mortar-brick disposition.
